## Therac-25 Accidents: We Keep on Learning From Them

Silvis-Cividjian, Natalia

IEEE Computer  
2024

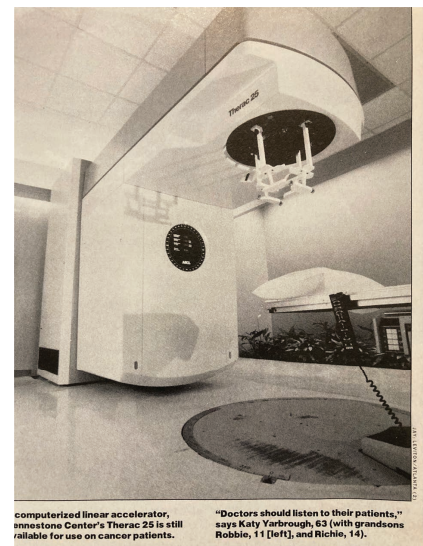
**HAGER:** No. All of these pictures are showing a newer type of linac. The reason you cannot find any visual information about the Therac-25 is because immediately after the accidents, AECL retrieved all of the user manuals related to this particular machine. I only have a newspaper cut from an old *People's Weekly Magazine*<sup>13</sup> showing the real Therac-25 [Figure 3(a)].

**FIGURE 3.** Images from the private collection of Dr. Fritz Hager. (a) A newspaper cut from Plumer<sup>13</sup> showing the "real" Therac-25 (b). The light flash created by the exit electron beam passing through a water phantom simulating a patient during the Malfuction 54 reproduction at ETCC.

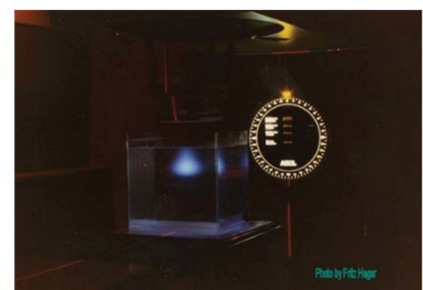
(b)

**PROFESSOR AND STUDENTS:** In [Figure 3(b)], we see another photo from your private collection, showing the flash of light created by the flawed machine that you recorded during the reproduction of the accidents. It gives an idea of the enormous radiation dose that was received by the unfortunate patients. But about this later.
