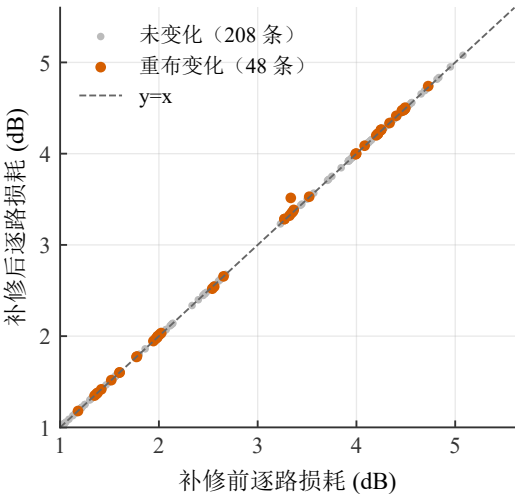
(a) 256 通道 F56 补修前后逐路对照

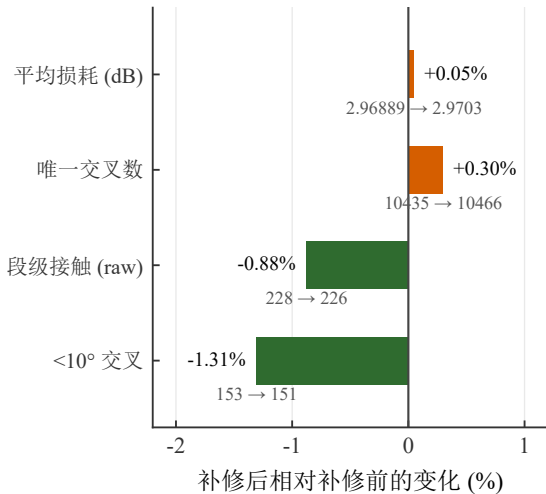
(b) 256 通道 F56 补修前后变化率 (#7/#31 重合 152.007 mm)
