Road Safety Audit Report

Automated Video-Based Road Condition Assessment

Audit Date: 2025-12-11T18:46:53.046626

Final PCI Rating: Satisfactory

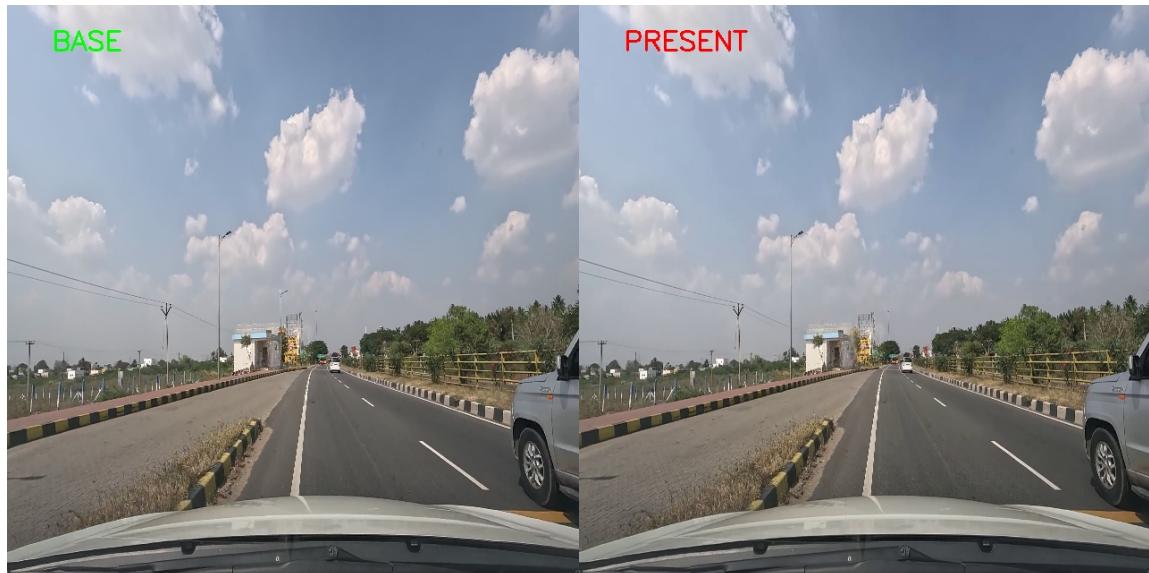
Figure 1: Comparison Frame 00027

Defect: Guardrail / Furniture

- **Roadside Furniture:** Missing or damaged roadside asset(s) (high)

Action: Replace/repair guardrail (W-Beam)

IRC Reference: MORTH Section 800

Materials: W-beam panel, Crash barrier posts

Notes: Ensure embedment depth, spacing and proper torque tightening.

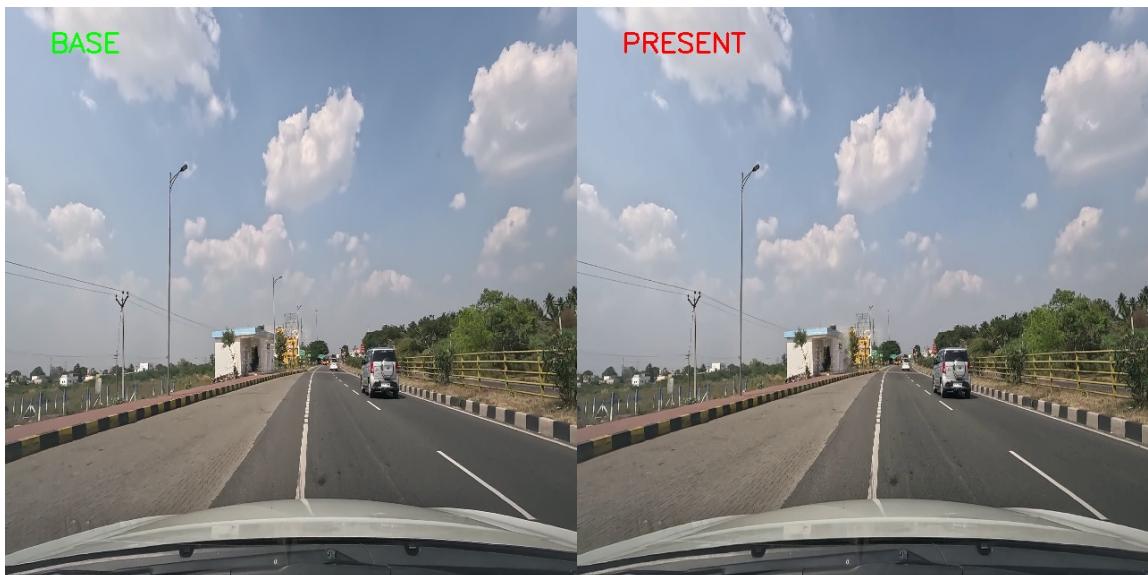
Figure 3: Comparison Frame 00034

Defect: Crack

- **Cracks:** New or widened cracks observed (medium)

Action: Crack sealing

IRC Reference: IRC:82-2015

Materials: Cold-applied crack sealant

Notes: Suitable for hairline cracks (<3 mm). Clean crack before sealing.

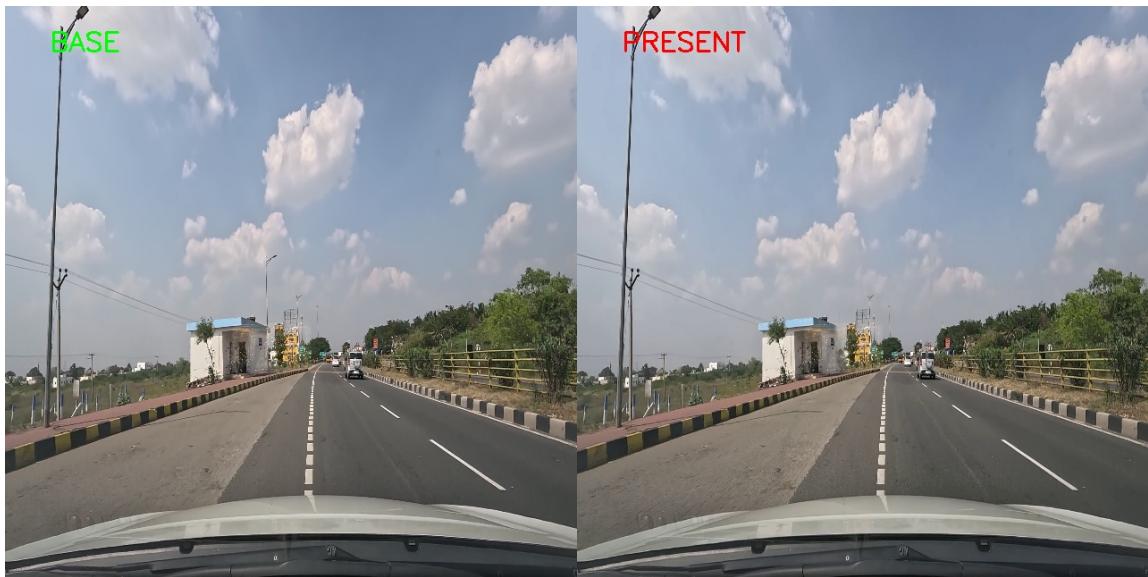
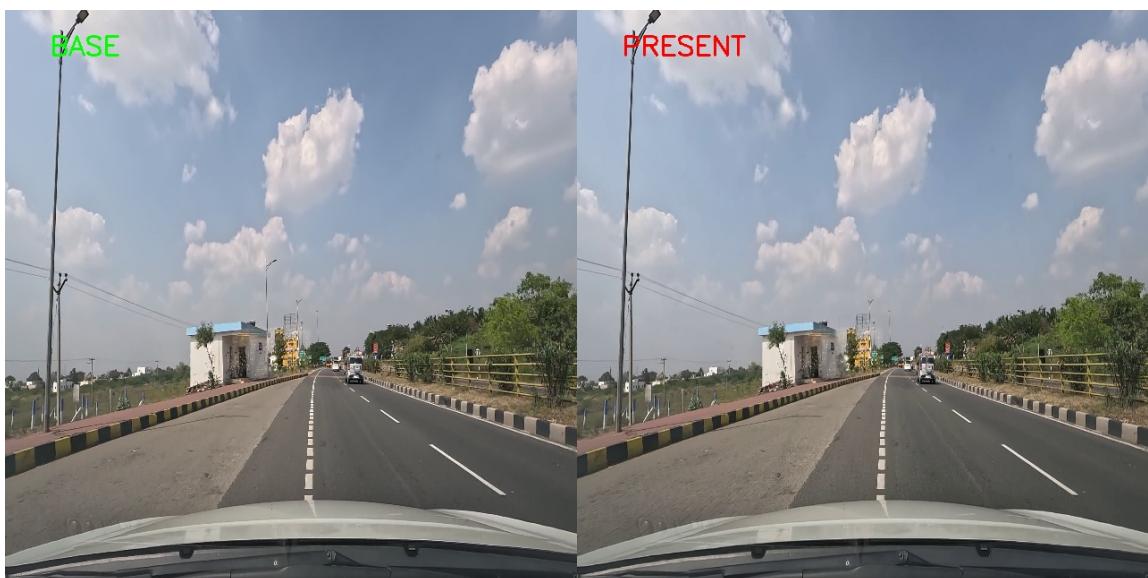
Figure 4: Comparison Frame 00040

Defect: Road Sign

- **Road Signs:** Possible missing or damaged sign(s) (high)

Action: Install/repair damaged or missing sign

IRC Reference: IRC:67-2012

Materials: Retro-reflective signboard, GI Post, M20 concrete

Notes: Follow IRC dimensions, mounting height and lateral clearance.

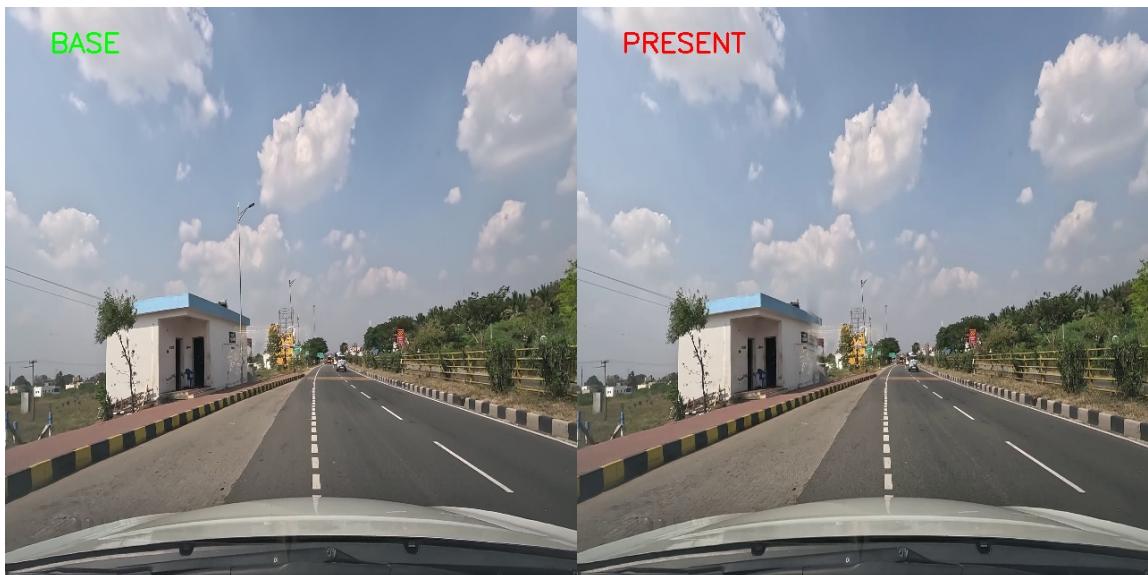
Figure 5: Comparison Frame 00049

Defect: Guardrail / Furniture

- **Roadside Furniture:** Missing or damaged roadside asset(s) (high)

Action: Replace/repair guardrail (W-Beam)

IRC Reference: MORTH Section 800

Materials: W-beam panel, Crash barrier posts

Notes: Ensure embedment depth, spacing and proper torque tightening.

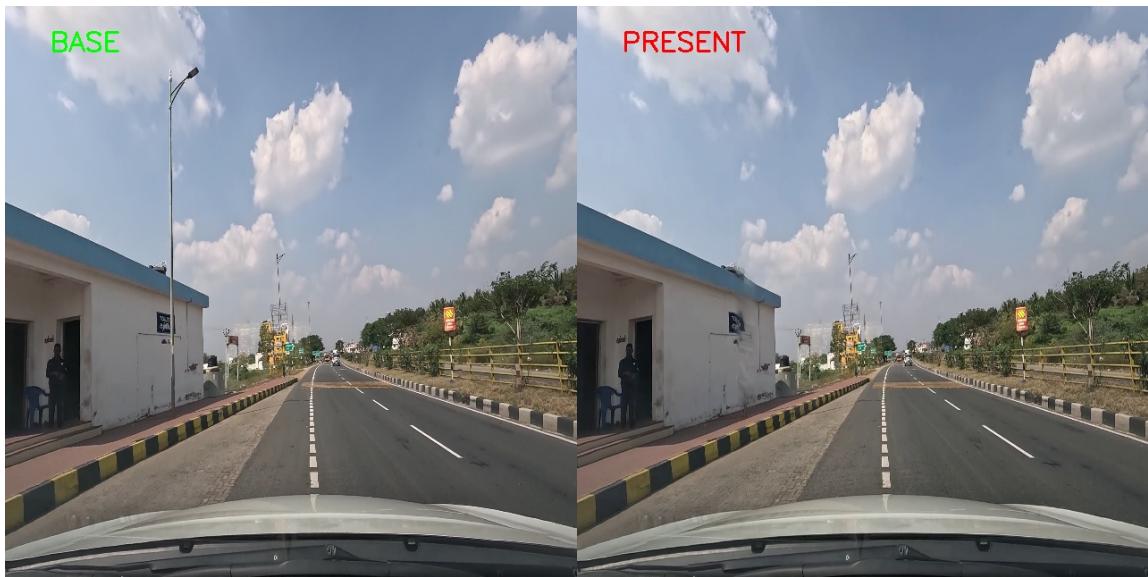
Figure 6: Comparison Frame 00057

Defect: Guardrail / Furniture

- **Roadside Furniture:** Missing or damaged roadside asset(s) (high)

Action: Replace/repair guardrail (W-Beam)

IRC Reference: MORTH Section 800

Materials: W-beam panel, Crash barrier posts

Notes: Ensure embedment depth, spacing and proper torque tightening.

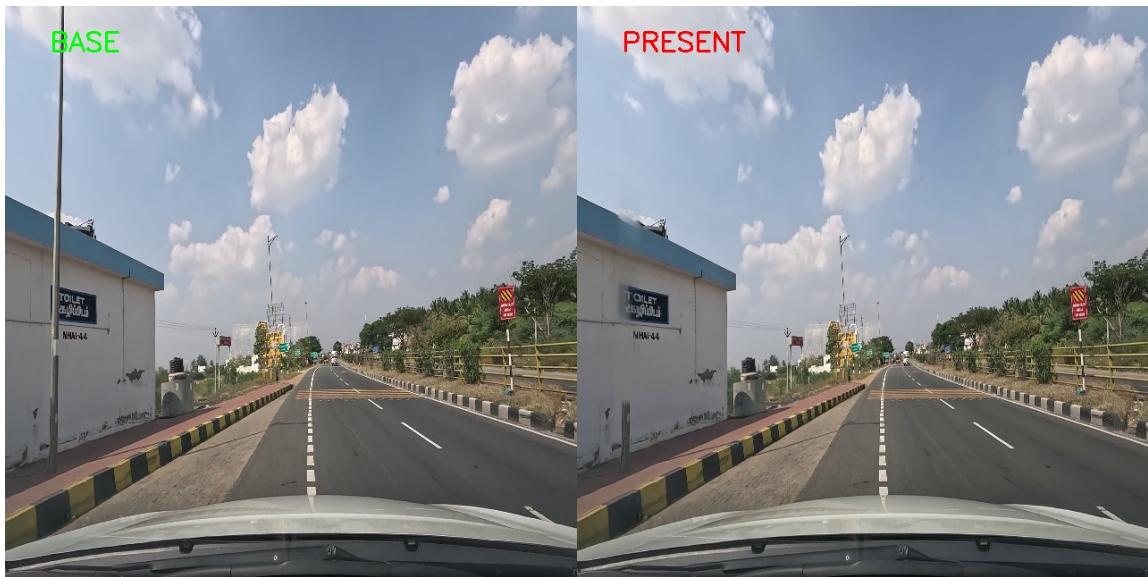
Figure 10: Comparison Frame 00061

Defect: Guardrail / Furniture

- **Roadside Furniture:** Missing or damaged roadside asset(s) (high)

Action: Replace/repair guardrail (W-Beam)

IRC Reference: MORTH Section 800

Materials: W-beam panel, Crash barrier posts

Notes: Ensure embedment depth, spacing and proper torque tightening.

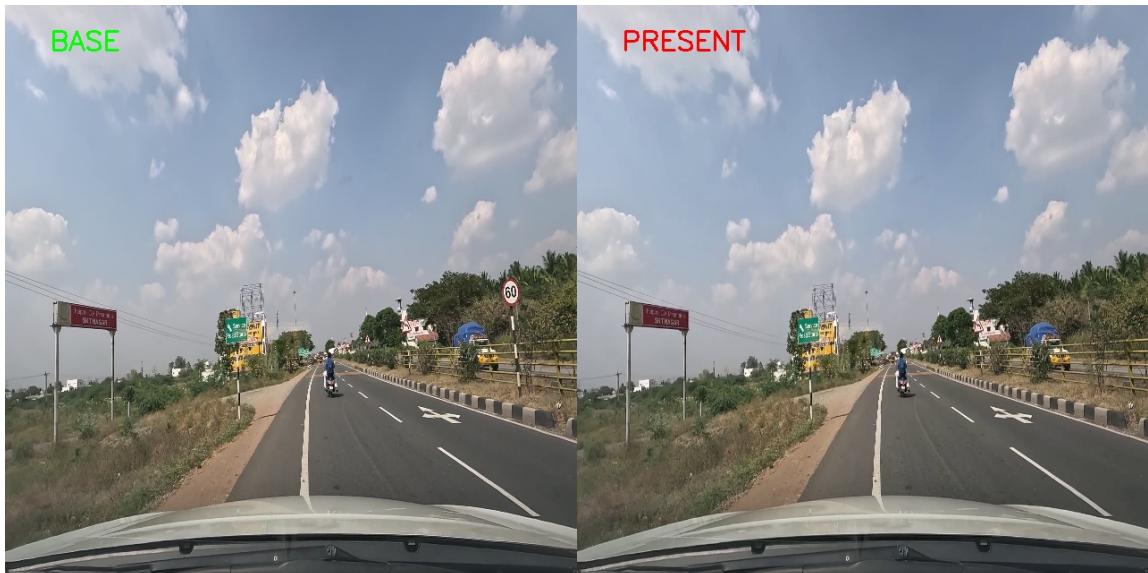
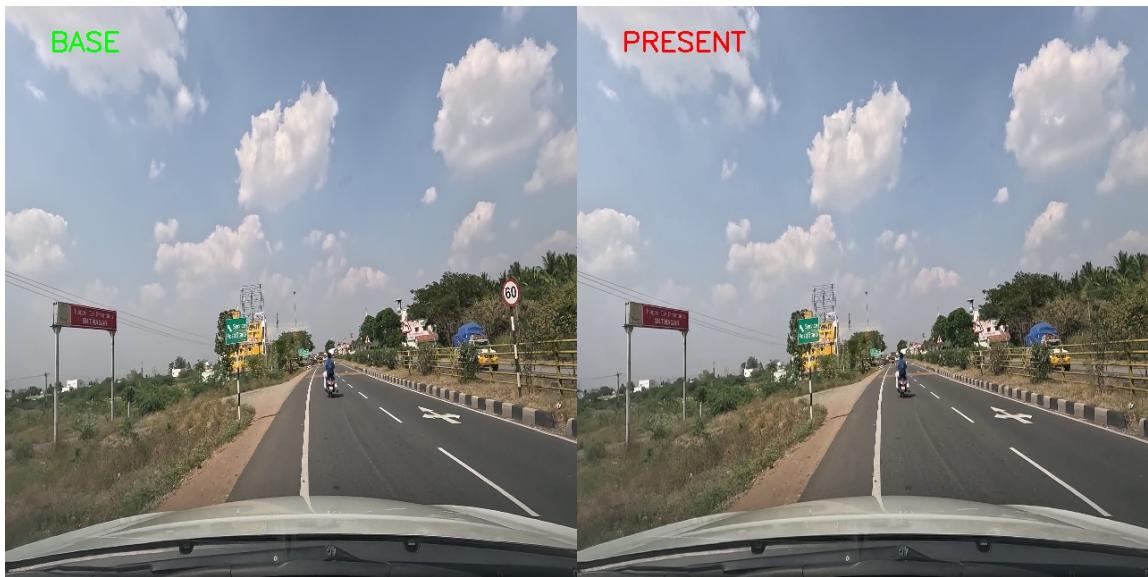
Figure 11: Comparison Frame 00092

Defect: Road Sign

- **Road Signs:** Possible missing or damaged sign(s) (high)

Action: Install/repair damaged or missing sign

IRC Reference: IRC:67-2012

Materials: Retro-reflective signboard, GI Post, M20 concrete

Notes: Follow IRC dimensions, mounting height and lateral clearance.

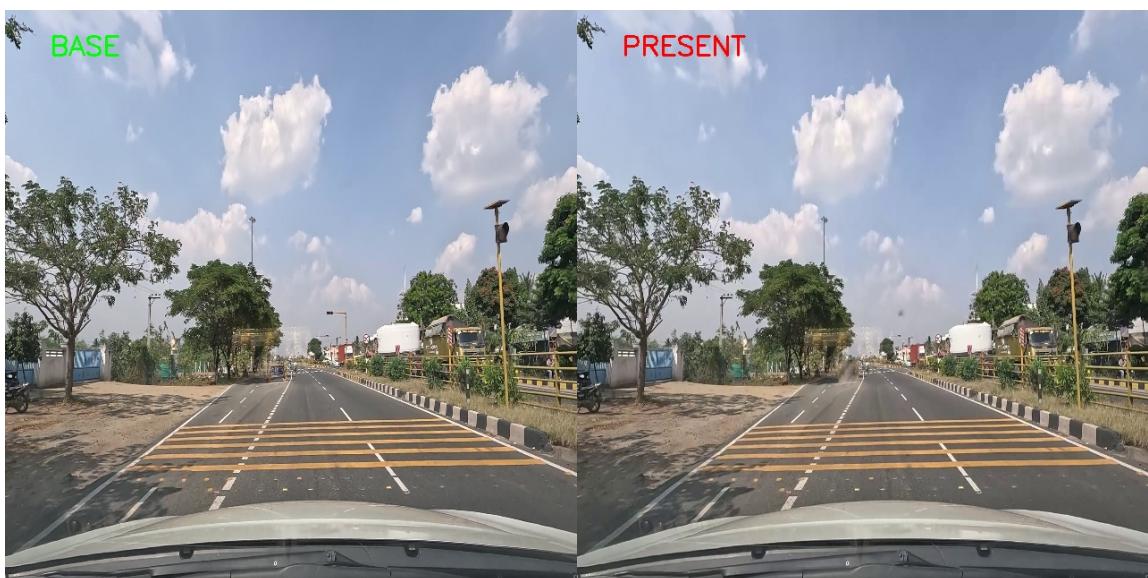
Figure 15: Comparison Frame 00169

Defect: Guardrail / Furniture

- **Roadside Furniture:** Missing or damaged roadside asset(s) (high)

Action: Replace/repair guardrail (W-Beam)

IRC Reference: MORTH Section 800

Materials: W-beam panel, Crash barrier posts

Notes: Ensure embedment depth, spacing and proper torque tightening.

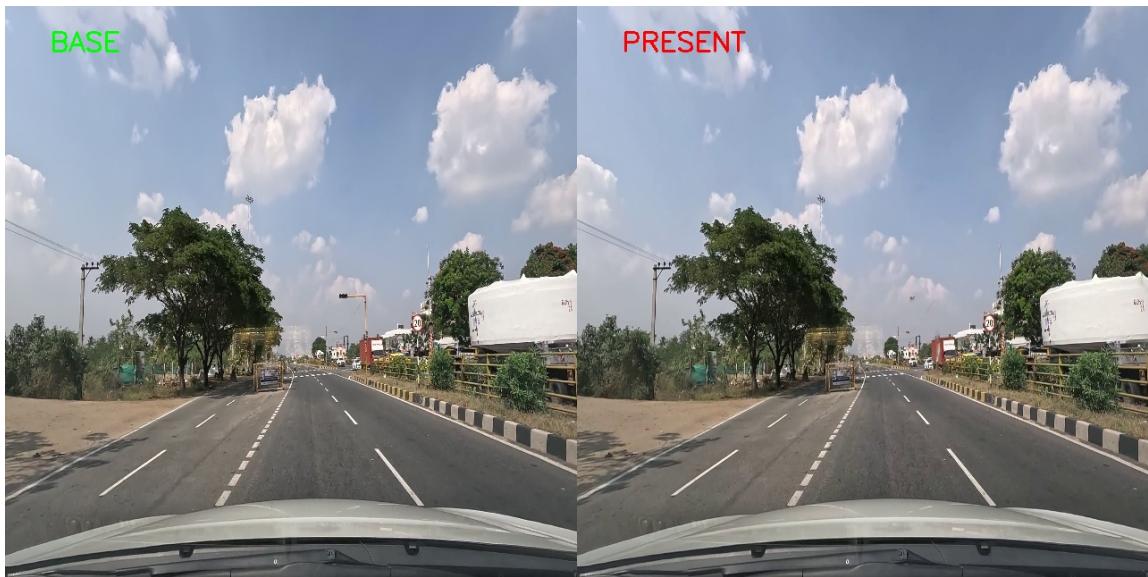
Figure 16: Comparison Frame 00178

Defect: Crack

- **Cracks:** New or widened cracks observed (medium)

Action: Crack sealing

IRC Reference: IRC:82-2015

Materials: Cold-applied crack sealant

Notes: Suitable for hairline cracks (<3 mm). Clean crack before sealing.

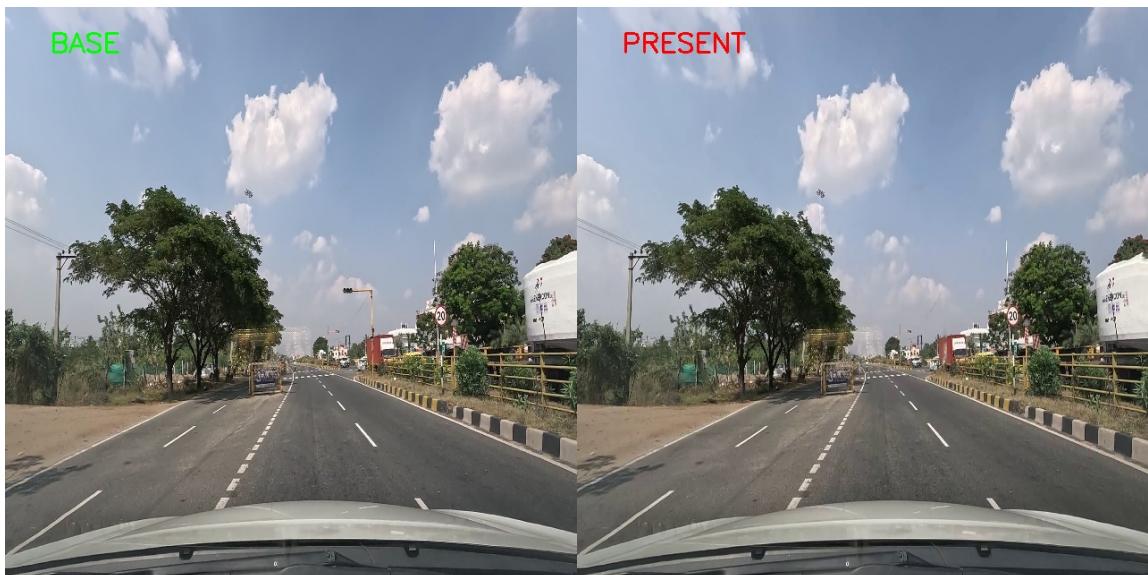
Figure 17: Comparison Frame 00180

Defect: Guardrail / Furniture

- **Roadside Furniture:** Missing or damaged roadside asset(s) (high)

Action: Replace/repair guardrail (W-Beam)

IRC Reference: MORTH Section 800

Materials: W-beam panel, Crash barrier posts

Notes: Ensure embedment depth, spacing and proper torque tightening.

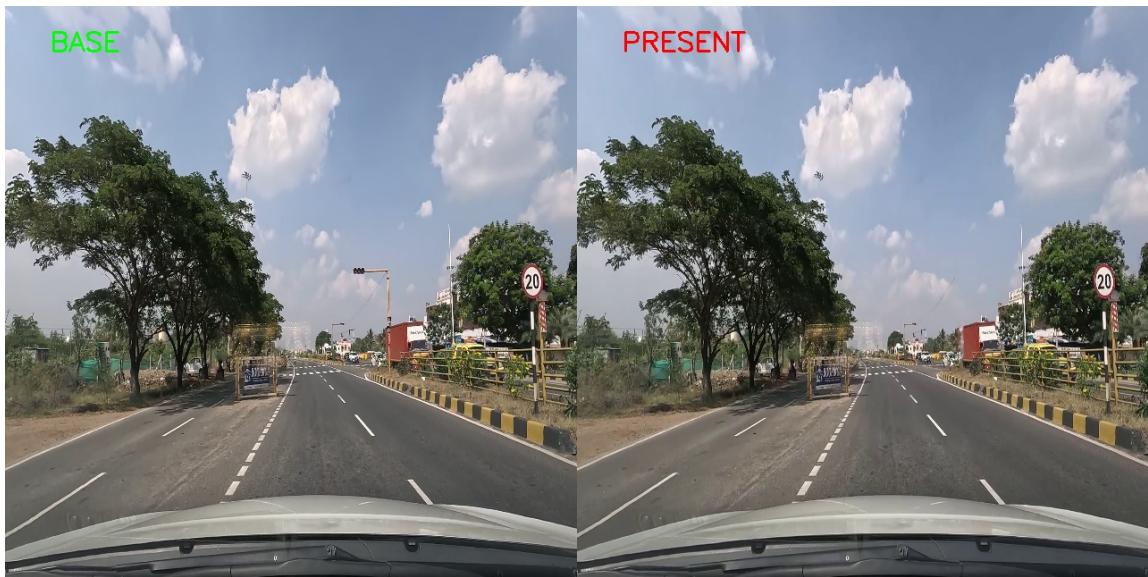
Figure 20: Comparison Frame 00184

Defect: Guardrail / Furniture

- **Roadside Furniture:** Missing or damaged roadside asset(s) (high)

Action: Replace/repair guardrail (W-Beam)

IRC Reference: MORTH Section 800

Materials: W-beam panel, Crash barrier posts

Notes: Ensure embedment depth, spacing and proper torque tightening.

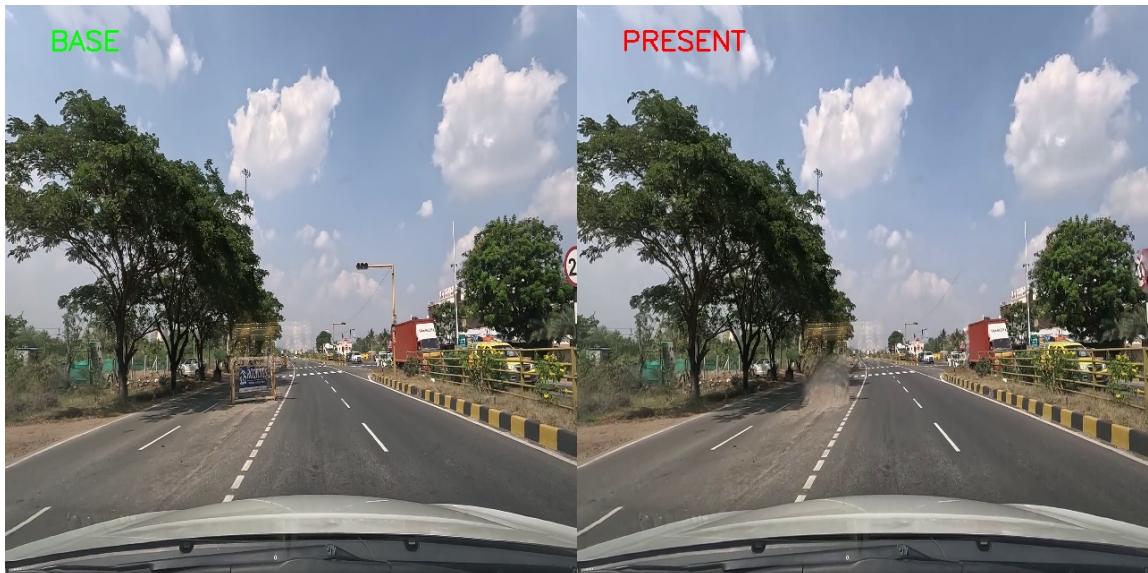
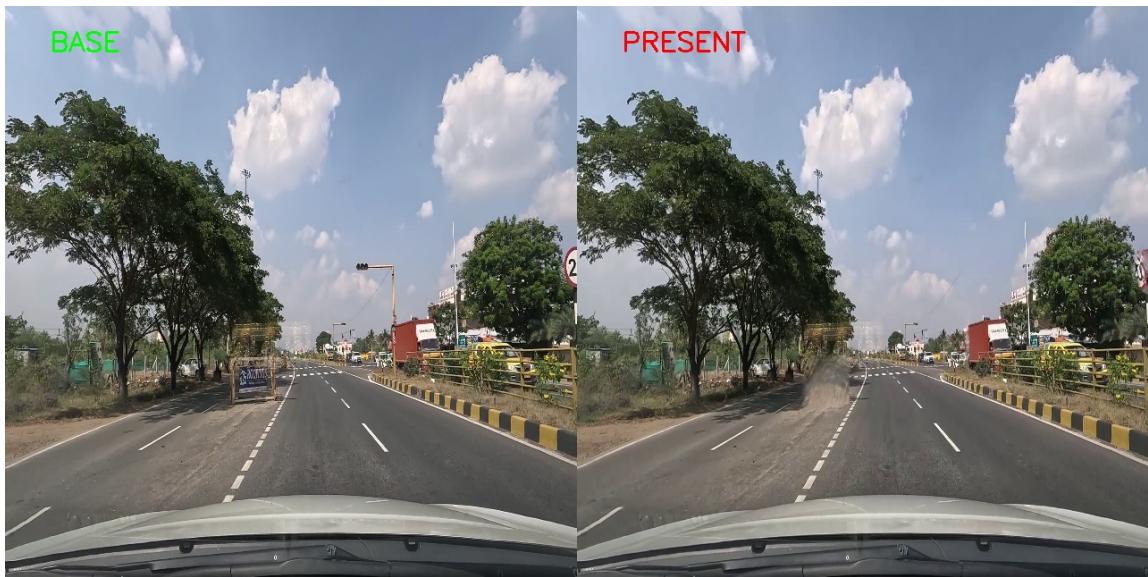
Figure 21: Comparison Frame 00185

Defect: Road Sign

- **Road Signs:** Possible missing or damaged sign(s) (high)

Action: Install/repair damaged or missing sign

IRC Reference: IRC:67-2012

Materials: Retro-reflective signboard, GI Post, M20 concrete

Notes: Follow IRC dimensions, mounting height and lateral clearance.

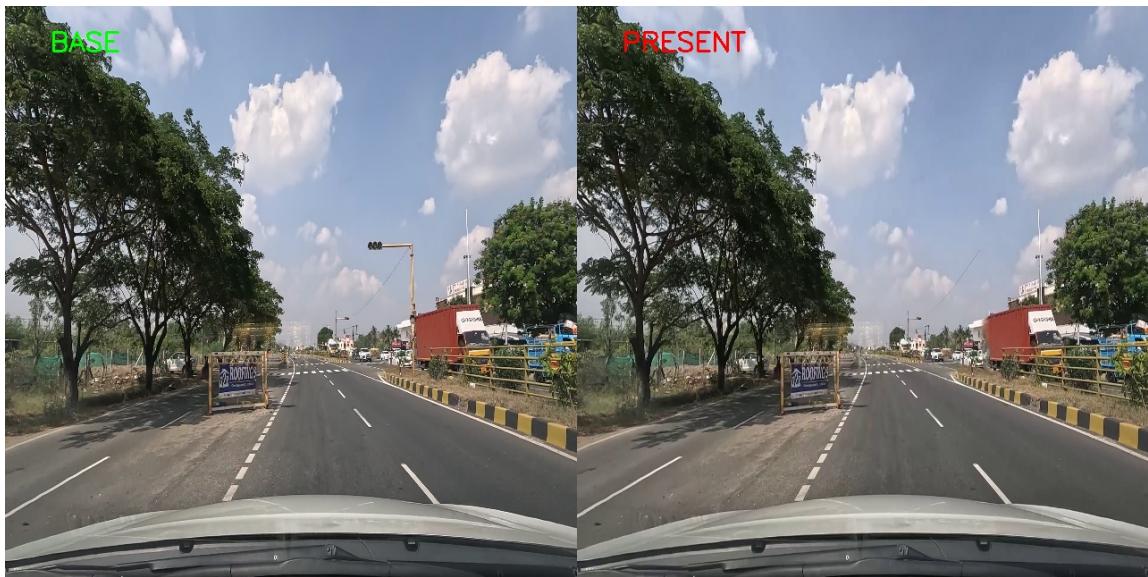
Figure 24: Comparison Frame 00188

Defect: Guardrail / Furniture

- **Roadside Furniture:** Missing or damaged roadside asset(s) (high)

Action: Replace/repair guardrail (W-Beam)

IRC Reference: MORTH Section 800

Materials: W-beam panel, Crash barrier posts

Notes: Ensure embedment depth, spacing and proper torque tightening.

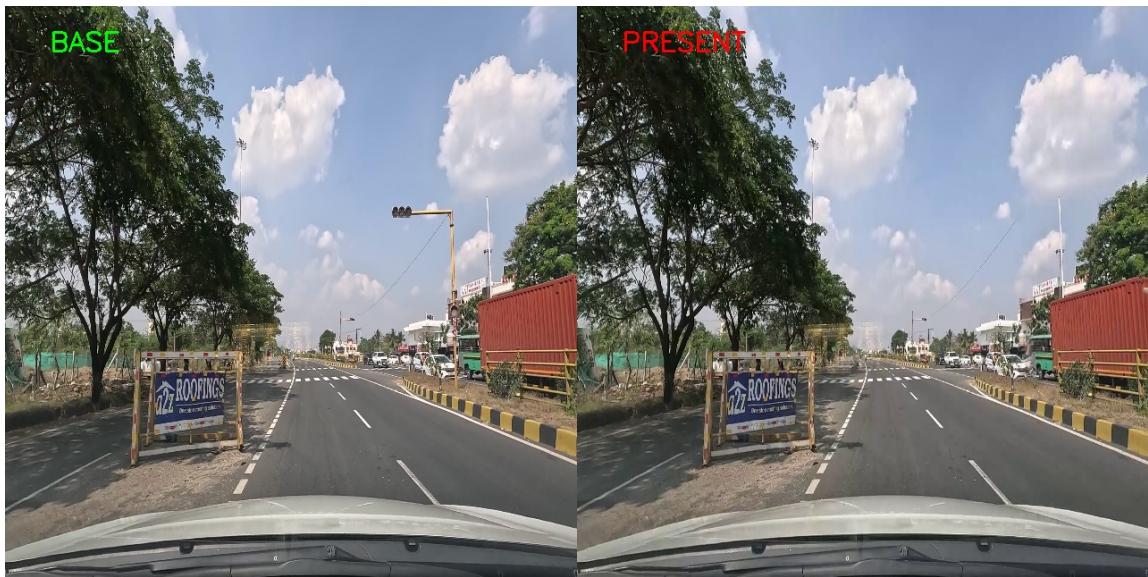
Figure 28: Comparison Frame 00192

Defect: Guardrail / Furniture

- **Roadside Furniture:** Missing or damaged roadside asset(s) (high)

Action: Replace/repair guardrail (W-Beam)

IRC Reference: MORTH Section 800

Materials: W-beam panel, Crash barrier posts

Notes: Ensure embedment depth, spacing and proper torque tightening.

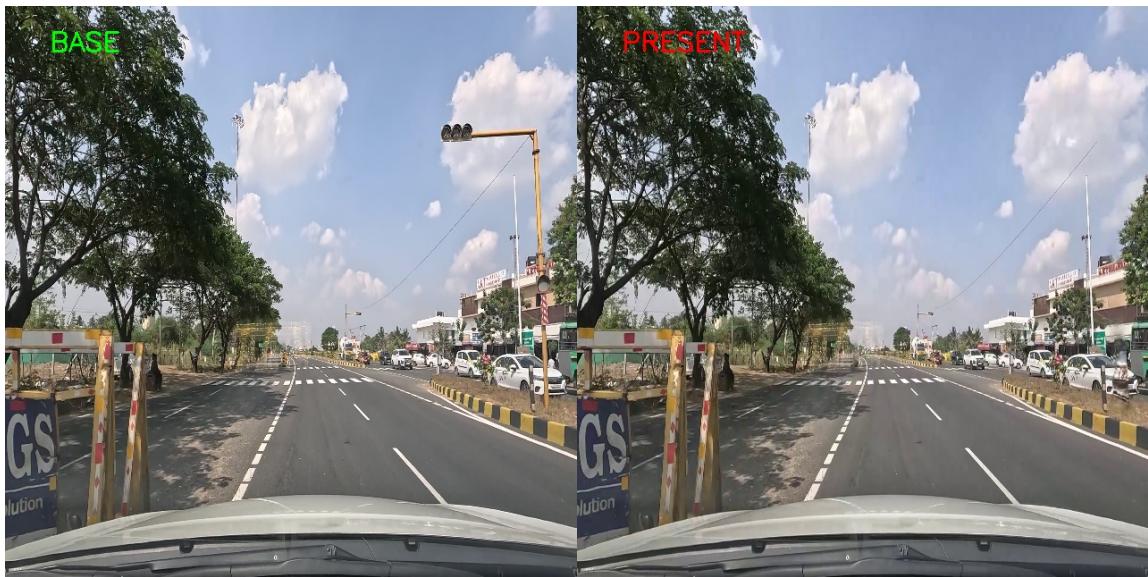
Figure 32: Comparison Frame 00196

Defect: Guardrail / Furniture

- **Roadside Furniture:** Missing or damaged roadside asset(s) (high)

Action: Replace/repair guardrail (W-Beam)

IRC Reference: MORTH Section 800

Materials: W-beam panel, Crash barrier posts

Notes: Ensure embedment depth, spacing and proper torque tightening.

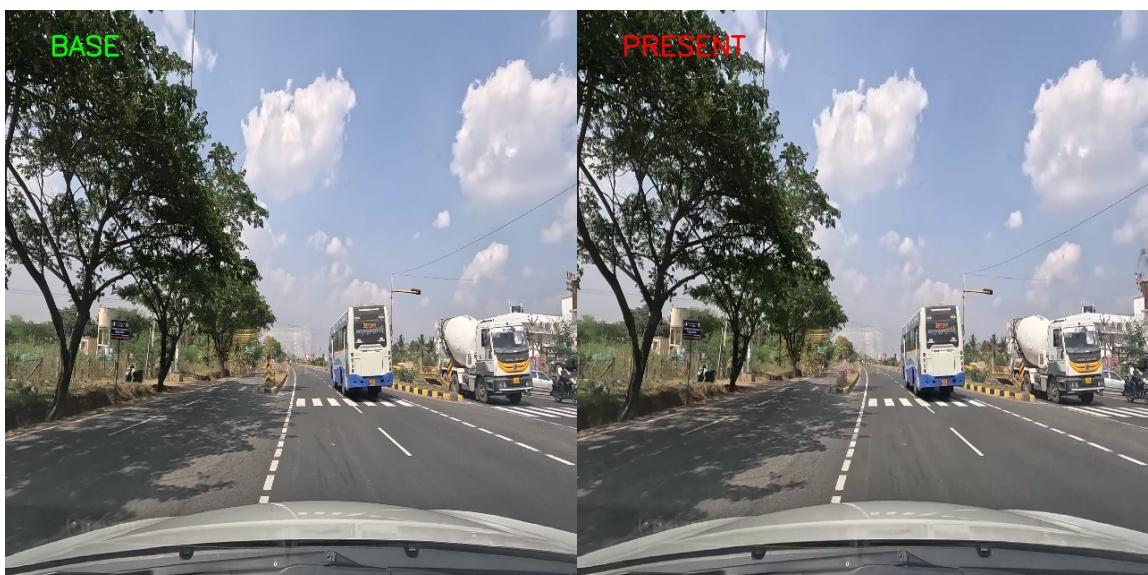
Figure 35: Comparison Frame 00217

Defect: Crack

- **Cracks:** New or widened cracks observed (medium)

Action: Crack filling + slurry seal

IRC Reference: IRC:82 / MORTH 300

Materials: Bituminous filler, Slurry seal

Notes: Fill and overlay with slurry; inspect for progressive fatigue.

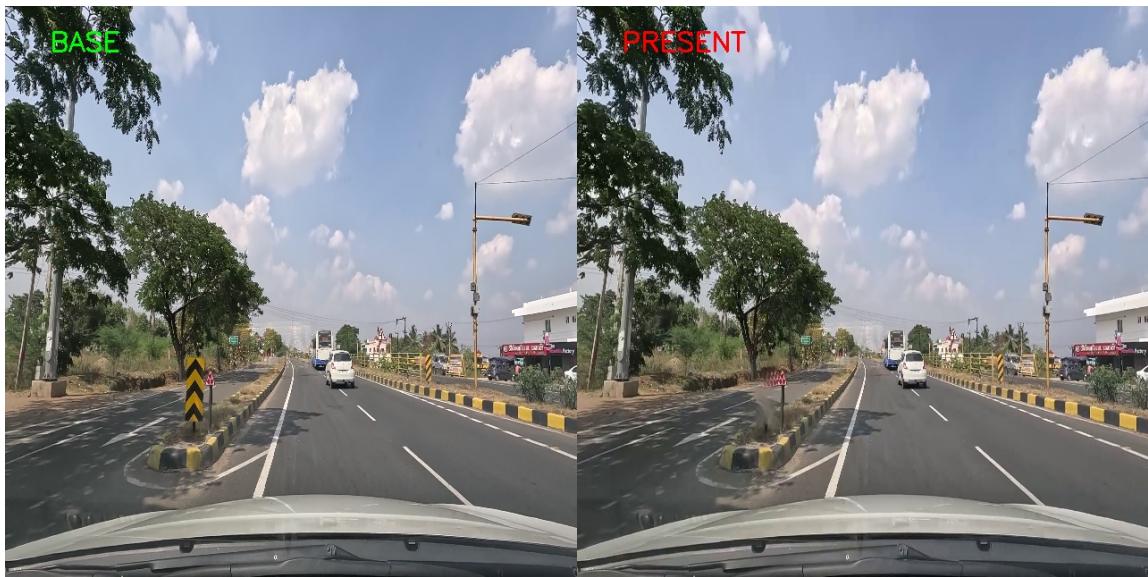
Figure 36: Comparison Frame 00229

Defect: Guardrail / Furniture

- **Roadside Furniture:** Missing or damaged roadside asset(s) (high)

Action: Replace/repair guardrail (W-Beam)

IRC Reference: MORTH Section 800

Materials: W-beam panel, Crash barrier posts

Notes: Ensure embedment depth, spacing and proper torque tightening.

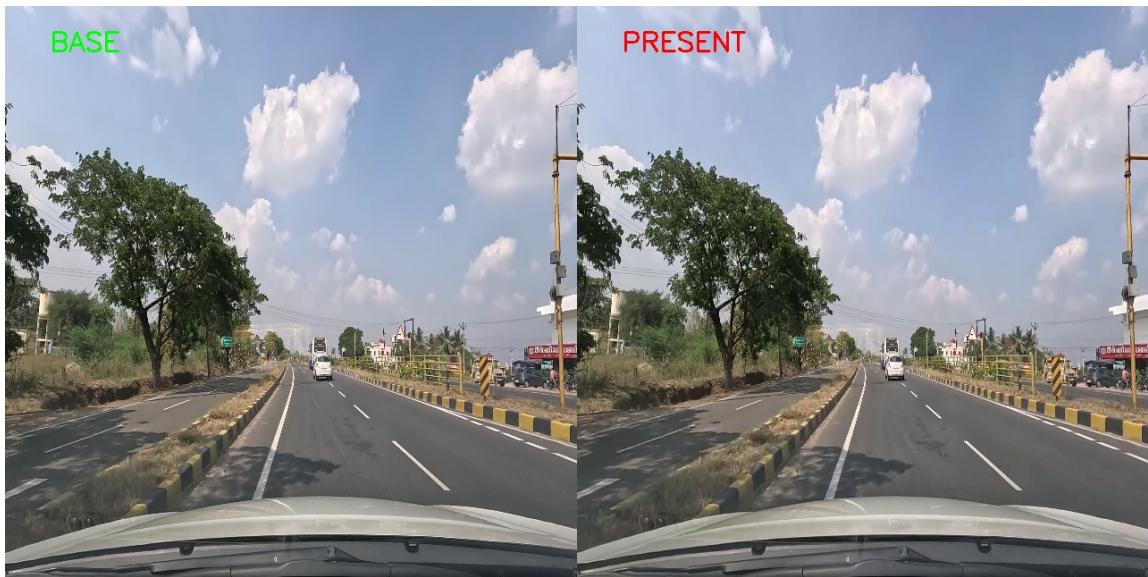
Figure 38: Comparison Frame 00233

Defect: Crack

- **Cracks:** New or widened cracks observed (medium)

Action: Crack sealing

IRC Reference: IRC:82-2015

Materials: Cold-applied crack sealant

Notes: Suitable for hairline cracks (<3 mm). Clean crack before sealing.
