# National Transportation Safety Board

DCA22WA102

## **COCKPIT VOICE AND FLIGHT DATA RECORDER**

Combined Download Report  
July 1, 2022

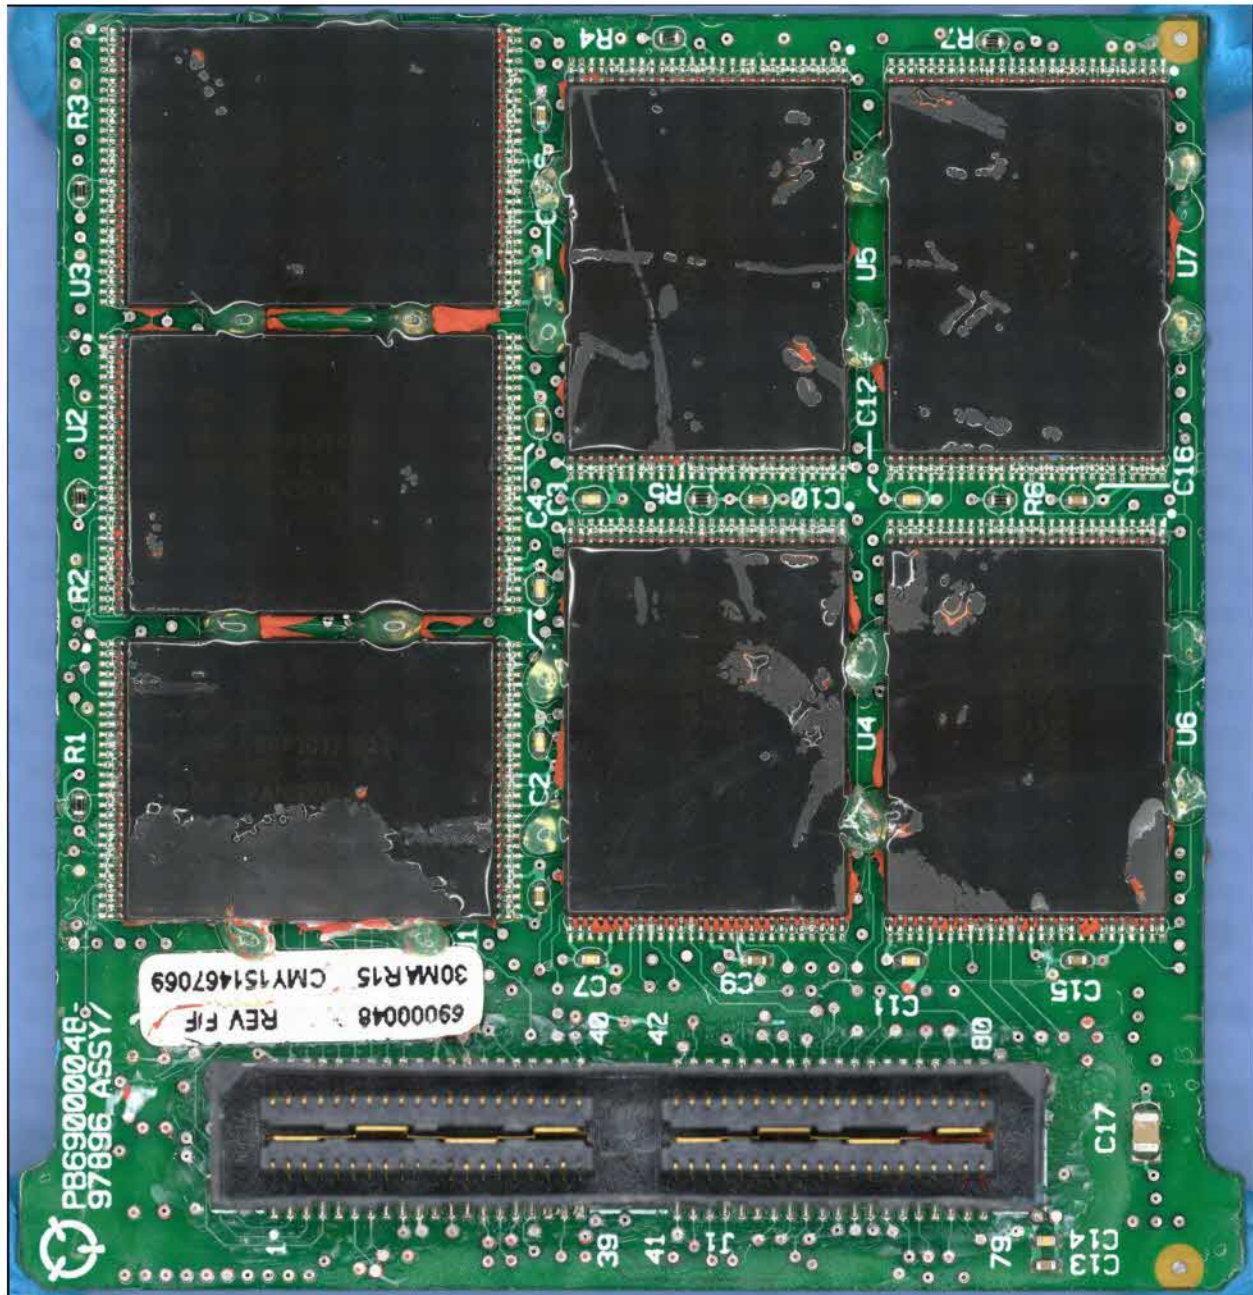
The CVR memory module was presented to the NTSB for microscopic inspection. Figure 1 shows the connector side of the board and Figure 2 shows the opposite side. Both sides have FLASH memory chips containing data. Preliminary findings showed the board to have substantial damage to the connector area of the device. Numerous solder pads attaching the connector to the board and providing the electrical signal path to the data chips were found bent or completely dislodged from the board. (See Attachment 1, CMM Recovery Report, for additional details and specifics of connector damage). The damaged pins corresponded to chip data lines and address lines. This damage would be significant to the download and is consistent with the audio artifacts present in the data. Damage to chip data lines would manifest as quantization error-type digital noise and damage to chip address lines would manifest as stuttering, echoing, and repeating-type noises.

**Figure 1. CVR memory module board, connector side.**

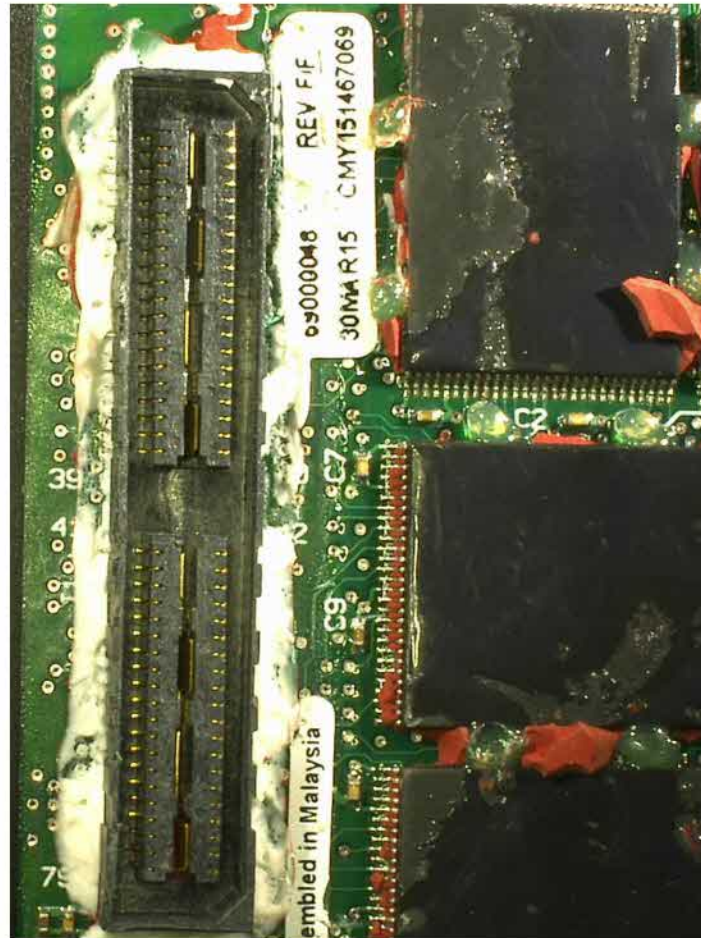
Further inspections also revealed that the plastic portion of the connector itself was deformed subtly out of its normal state. The long edge along the board end was

raised above its normal position, and the pins along that edge were recessed inside the connector housing. In this state it would have been difficult for the male pins on the recovery cable to make a reliable connection with the board. The long edge facing the memory chips was crushed down below its normal position with the pins projecting out notably from the connector housing. It was also found that the ground plane between the two sides of the connector was damaged underneath the connector housing. Several sections of the ground plane were severed or lifted from the board. Figure 3 shows the connector, as received.

**Figure 3. Detail of CVR memory module connector, as received.**

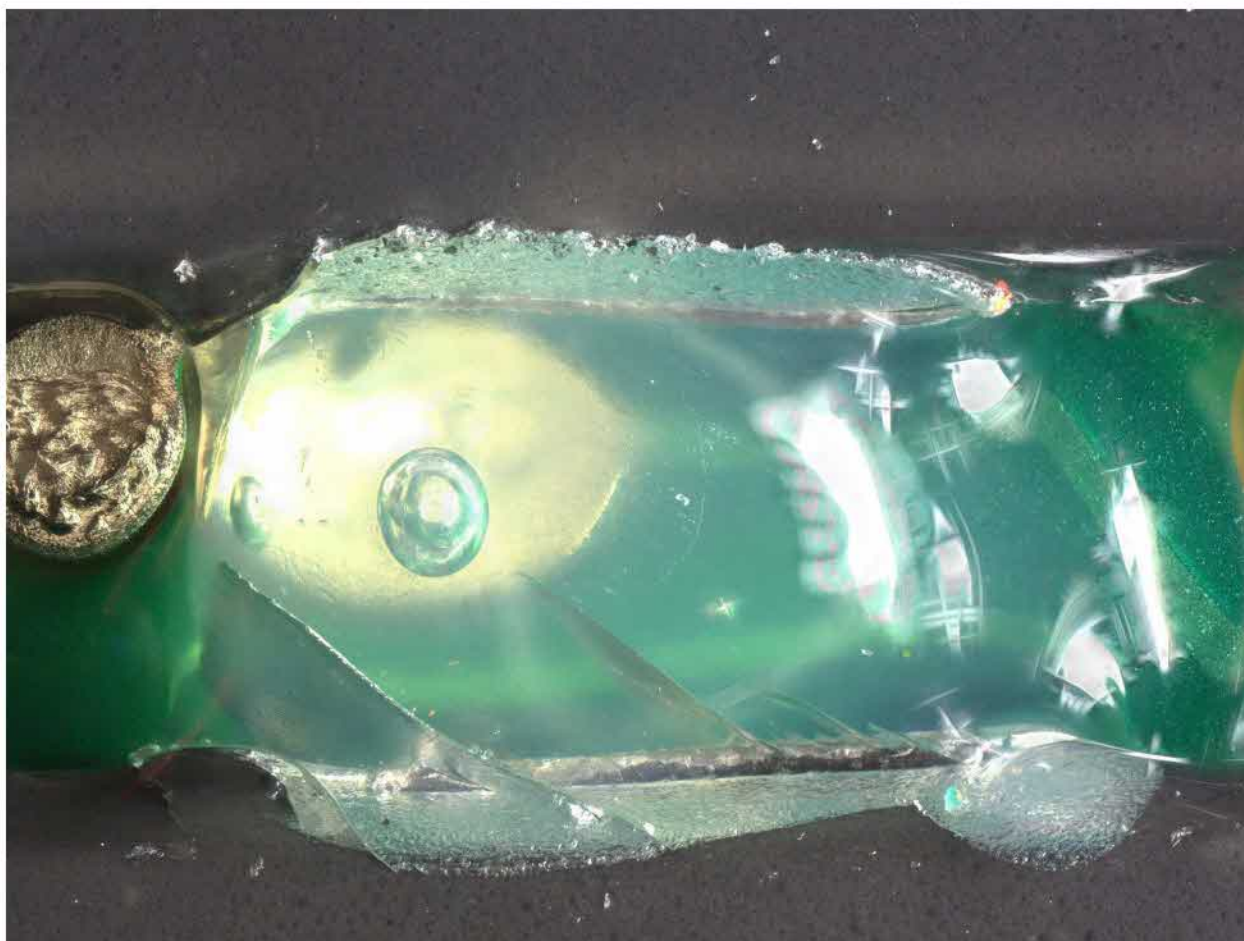
**Figure 9. Example of cracks seen in epoxy bond between chips U1 and U2.**

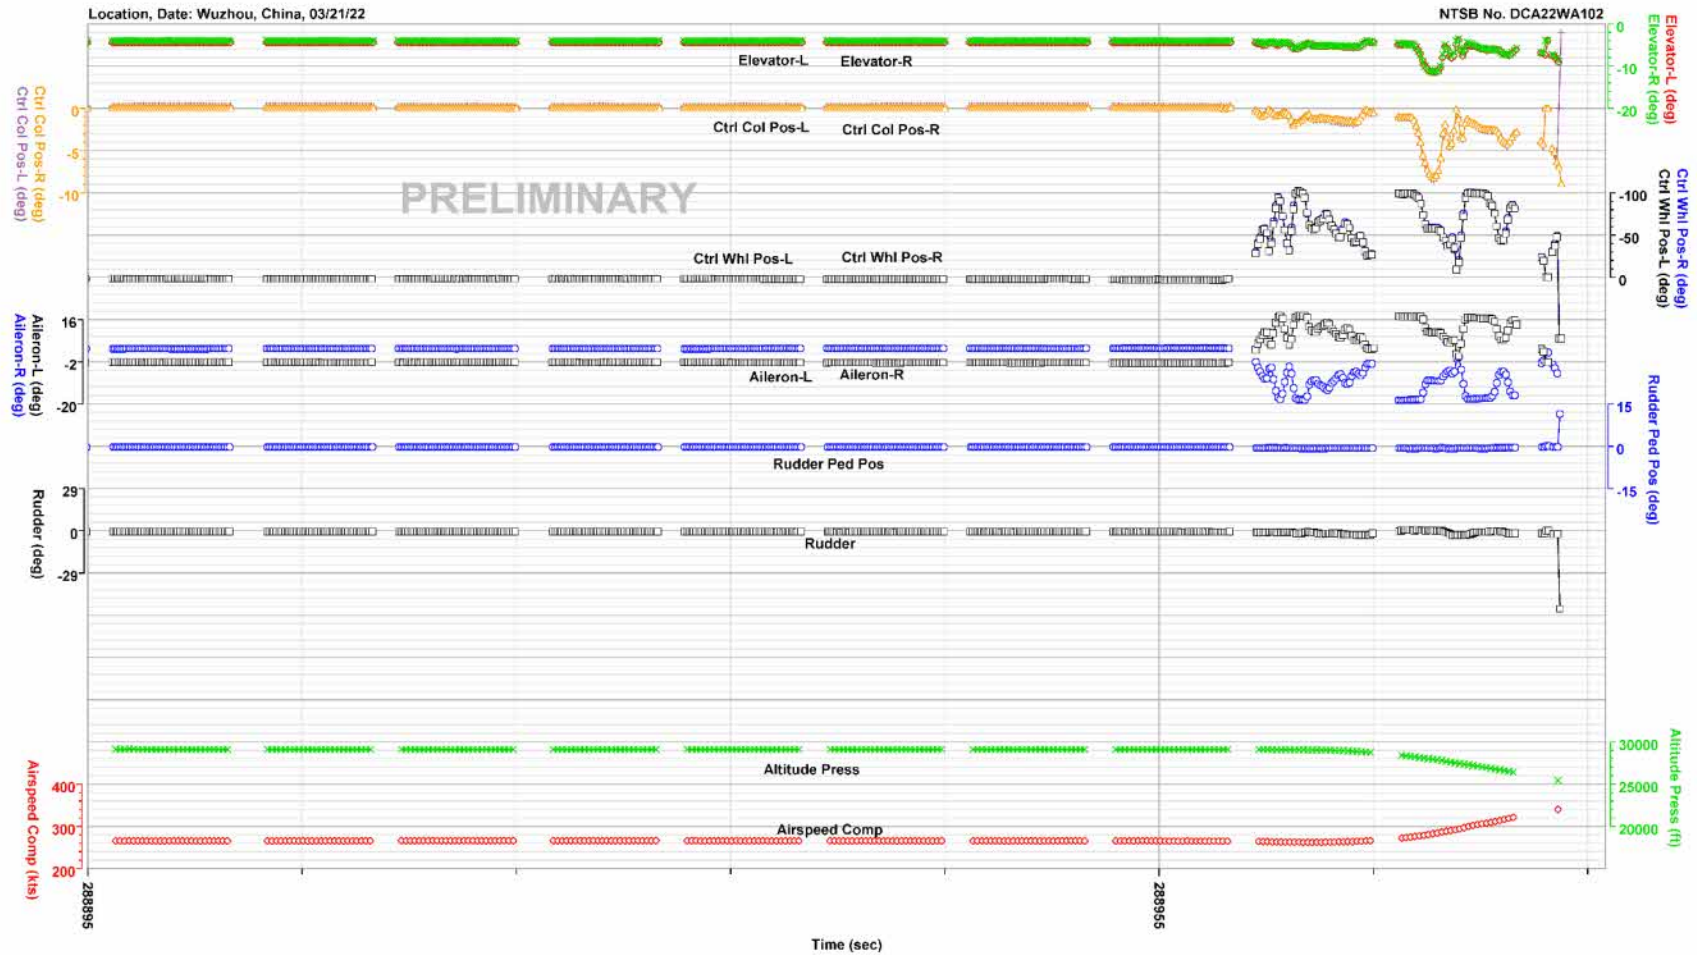
**Figure 12. Flight control and input positions for final 90 seconds of recording.**
