## UNDERCOATING ON OXYGEN SENSORS

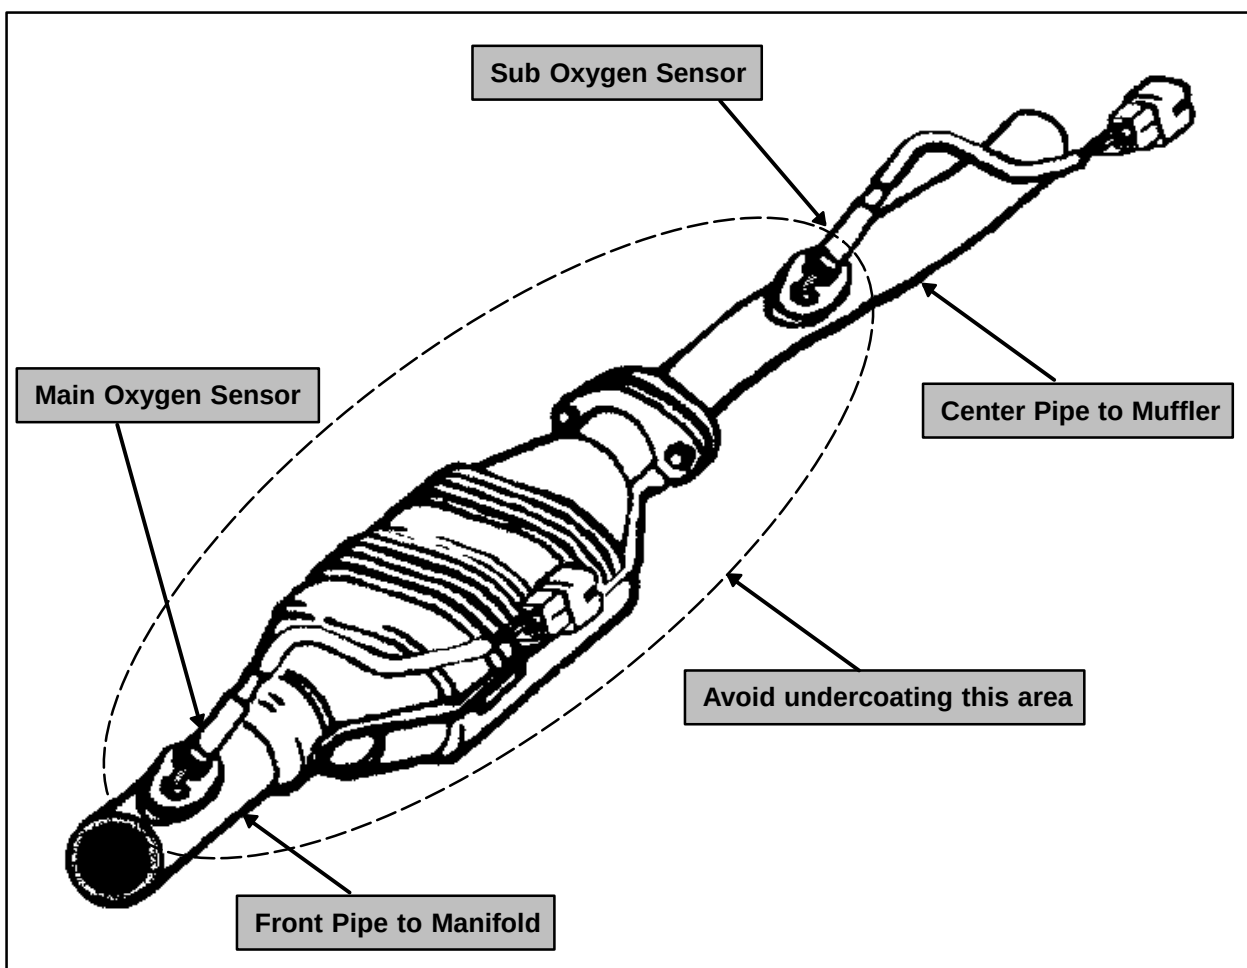
During vehicle processing by Dealers, care must be taken to avoid applying undercoating in the area surrounding the Oxygen Sensors. Application of undercoating on or near the Oxygen Sensors can cause insufficient air to flow around the sensor, and inaccurate information storage by the ECM. If this condition occurs, the Malfunction Indicator Light (MIL) may illuminate.
