## COLLISION REPAIR INFORMATION BULLETIN

| <b>SUBJECT:</b> | <b>REPAIR PROCEDURES FOR RUST-RESISTANT SHEET METAL</b> | | |
| <b>BULLETIN NO.:</b> | <b>TS–TCI–CRIB–2029</b> | <b>DATE ISSUED:</b> | <b>May, 2013</b> |
| <b>MODELS:</b> | <b>All Toyota &amp; Scion Models</b> | <b>SECTION:</b> | <b>Refinish</b> |

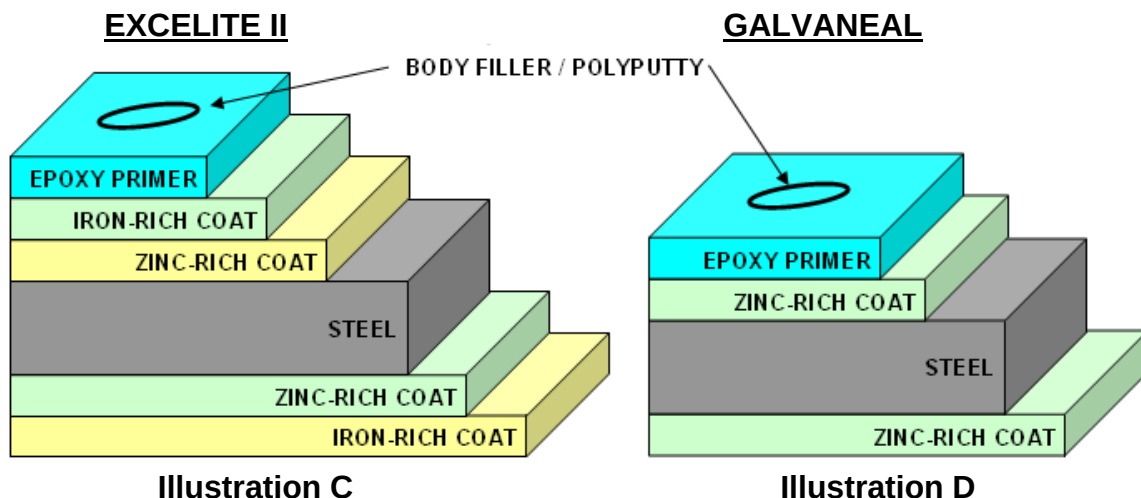
**NOTICE:** Body fillers and two component polyputties applied over bare Excelite II or bare Galvaneal metal substrates will not adhere adequately and may result in blistering or peeling. An epoxy primer must first be applied to the bare metal before the application of body filler. See illustration C. When using a wash primer over Excelite II or Galvaneal, always use an epoxy primer before applying body filler. See Illustration D below.

The following repair procedure is recommended:

- Degrease the panel using wax and grease remover (follow VOC rules for your area).
- Prepare the sheet metal.
- Straighten as necessary.
- Apply epoxy primer or wash primer over the bare metal. Do not apply body filler over bare metal.

- Apply body filler following the manufacturer or supplier instructions or recommendations.
- Sand the body filler using progressively finer grades of sandpaper. Begin with 40 grit open coat dry sandpaper, followed by 100 grit open coat dry sandpaper, then finish with 220 grit open coat dry sandpaper.
