## COLLISION REPAIR INFORMATION BULLETIN

| <b>SUBJECT:</b> | <b>QUARTER PANEL SECTIONING (CUT-P) PROCEDURE</b> | | |
| <b>BULLETIN NO.:</b> | <b>TS-TCI-CRIB-2033</b> | <b>DATE ISSUED:</b> | <b>May, 2013</b> |
| <b>MODELS:</b> | <b>All Toyota &amp; Scion Models</b> | <b>SECTION:</b> | <b>Structural</b> |

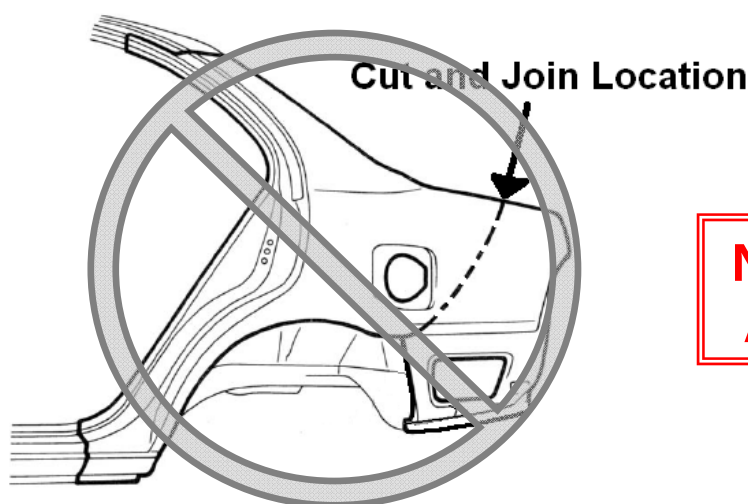
**NO LONGER  
APPROVED**

The Quarter Panel Sectioning (CUT-P) procedure, as illustrated in certain Toyota/Scion Body Collision Damage Repair Manuals, and sometimes referred to as “vertical cut” is no longer an approved repair procedure (when replacing a damaged quarter panel) for any Toyota/Scion vehicle. See illustration below.

This procedure may not satisfy customer expectations in terms of visible repair quality. As a result, Toyota/Scion no longer approves this CUT-P procedure for the following reasons:

- Cut and join locations from inner trunk compartment may be visible
- Body character lines are difficult to weld across and may not produce a quality appearance
- High degree of difficulty to perform an undetectable and quality repair
- Vehicle value may be reduced

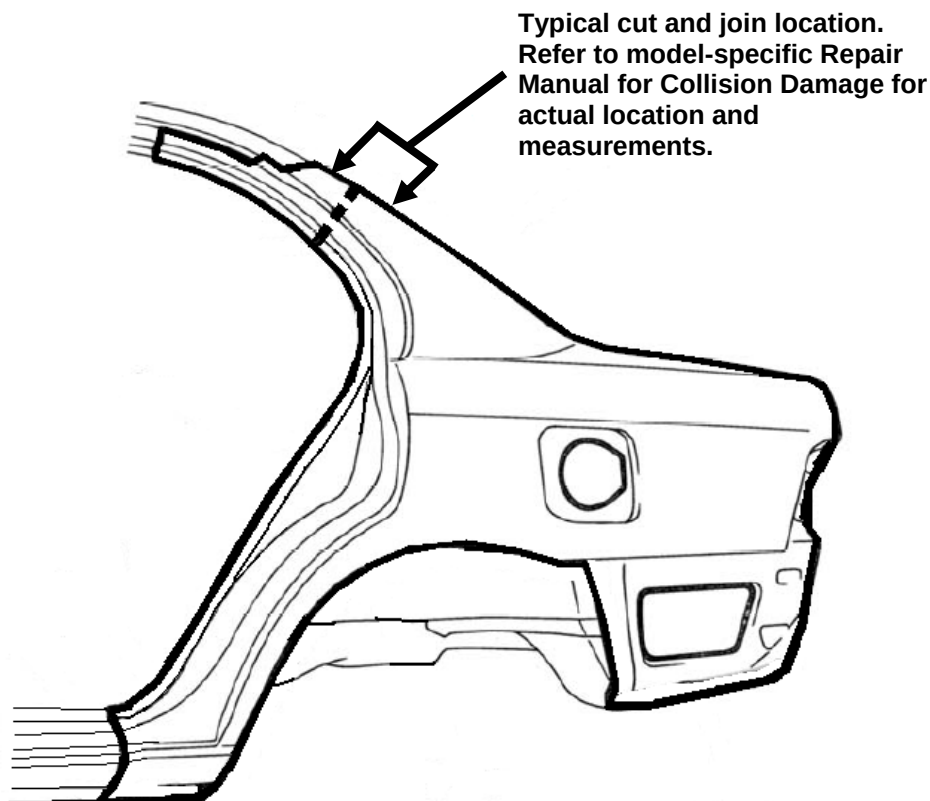
Any revised removal and installation instructions and specifications for Quarter Panel sectioning are set out in the model-specific Repair Manual for Collision Damage (Body Panel Replacement section-Quarter Panel (CUT) Procedure). The diagram below illustrates the recommended cut and join location for most Toyota/Scion models.

Always refer to the Toyota/Scion model-specific repair manual for the actual cut/join location measurements, welding requirements and other important information.
