## COLLISION REPAIR INFORMATION BULLETIN

| <b>SUBJECT:</b> | <b>REFINISH PROCEDURES FOR PANELS WITHOUT BODY LINES</b> | | |
| <b>BULLETIN NO.:</b> | <b>TS-TCI-CRIB-2034</b> | <b>DATE ISSUED:</b> | <b>May, 2013</b> |
| <b>MODELS:</b> | <b>All Toyota &amp; Scion Models</b> | <b>SECTION:</b> | <b>Refinish</b> |

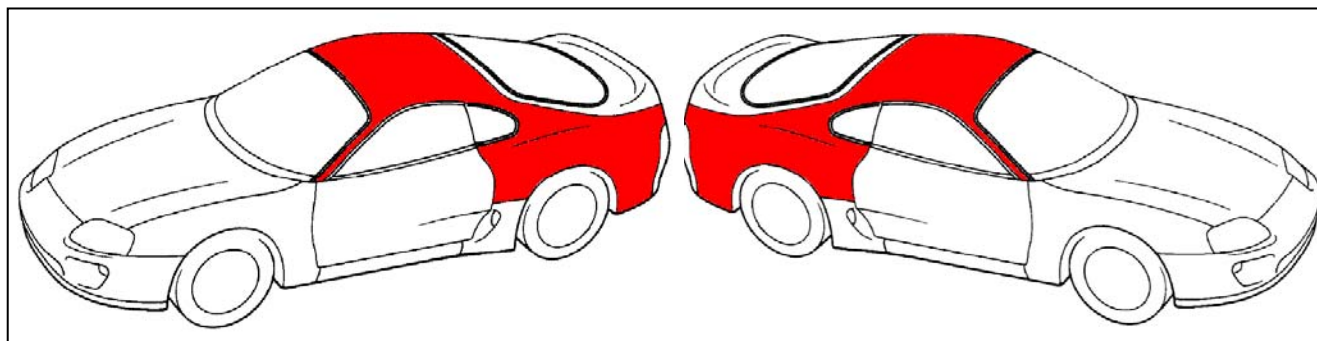
**Illustration A**

As Illustration A below shows, the vehicle has no body lines or drip rails that break up the quarter panel from the roof, the opposing quarter panel and the A-pillar, therefore, applying the last coat of clear coat to the nearest panel edge is necessary to help ensure a professional looking finish. In the illustration shown, when painting the left quarter panel, the final coat must extend into the roof, the left A-pillar, the right quarter panel and the right A-pillar. All trim (i.e.: rubber window mouldings, door handles, trim, etc.) and any headlights/tail lights must be removed to ensure the final coat is under those components to prevent visible paint lines. This will also help ensure that peeling will not occur in or near those locations due to poor adhesion between the original factory and refinish coat. By doing so, the finish will not be affected by ultra-violet sunlight.

The process is virtually the same for refinishing any panel, but to obtain really professional results, the difference is where the application of the last top coat (solid paint or clear coat) ends. Properly spraying the final full coat insures maximum adhesion, ultra-violet sunlight protection and is environmentally safer compared to using over-reduced clear coats. Using over-reduced clear coats during a solvent blend does not provide the same level of high quality repairs for newer models with factory clear coat.

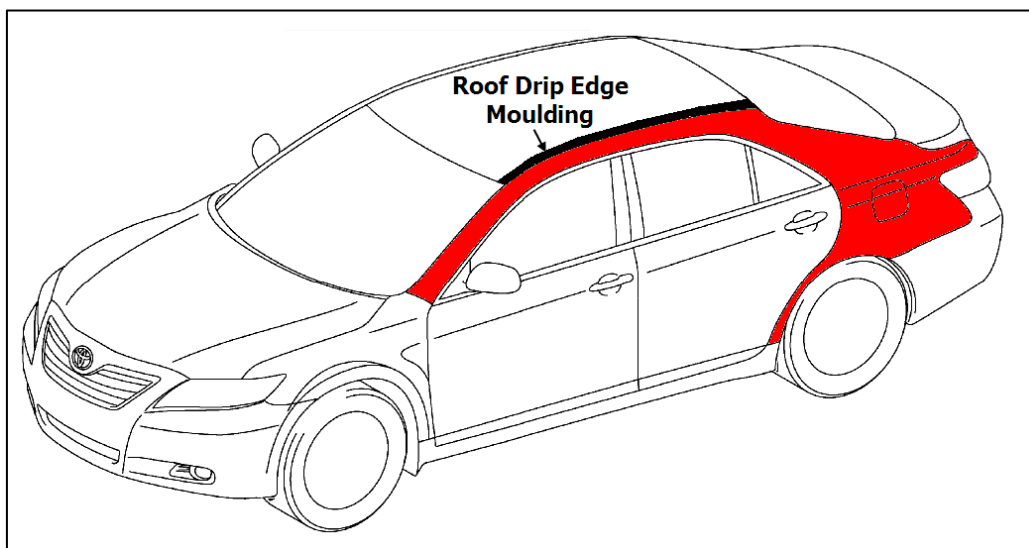
**Illustration B**

Most newer generation vehicles incorporate a drip edge moulding on the roof to break up larger panels like the quarter panel from the roof as shown in Illustration B to the right. This is very helpful when faced with the same situation as above with a quarter panel repair. When a roof drip edge moulding is present, only the quarter panel, the small section of the roof above the doors up to the moulding and the A-pillar on the same side will require refinishing.

If a character or body line does exist however, using a method known as “reverse taping” is recommended. This procedure is well known in the automotive refinishing industry. Reverse taping is performed by taping half of the sticky side of the tape on the part of the car you want to protect, rolling the other half up and back loosely and hold it with a few tabs of tape. This leaves only a soft edge of the sticky side of the tape and if removed while the paint is wet will leave almost no visible paint edge.

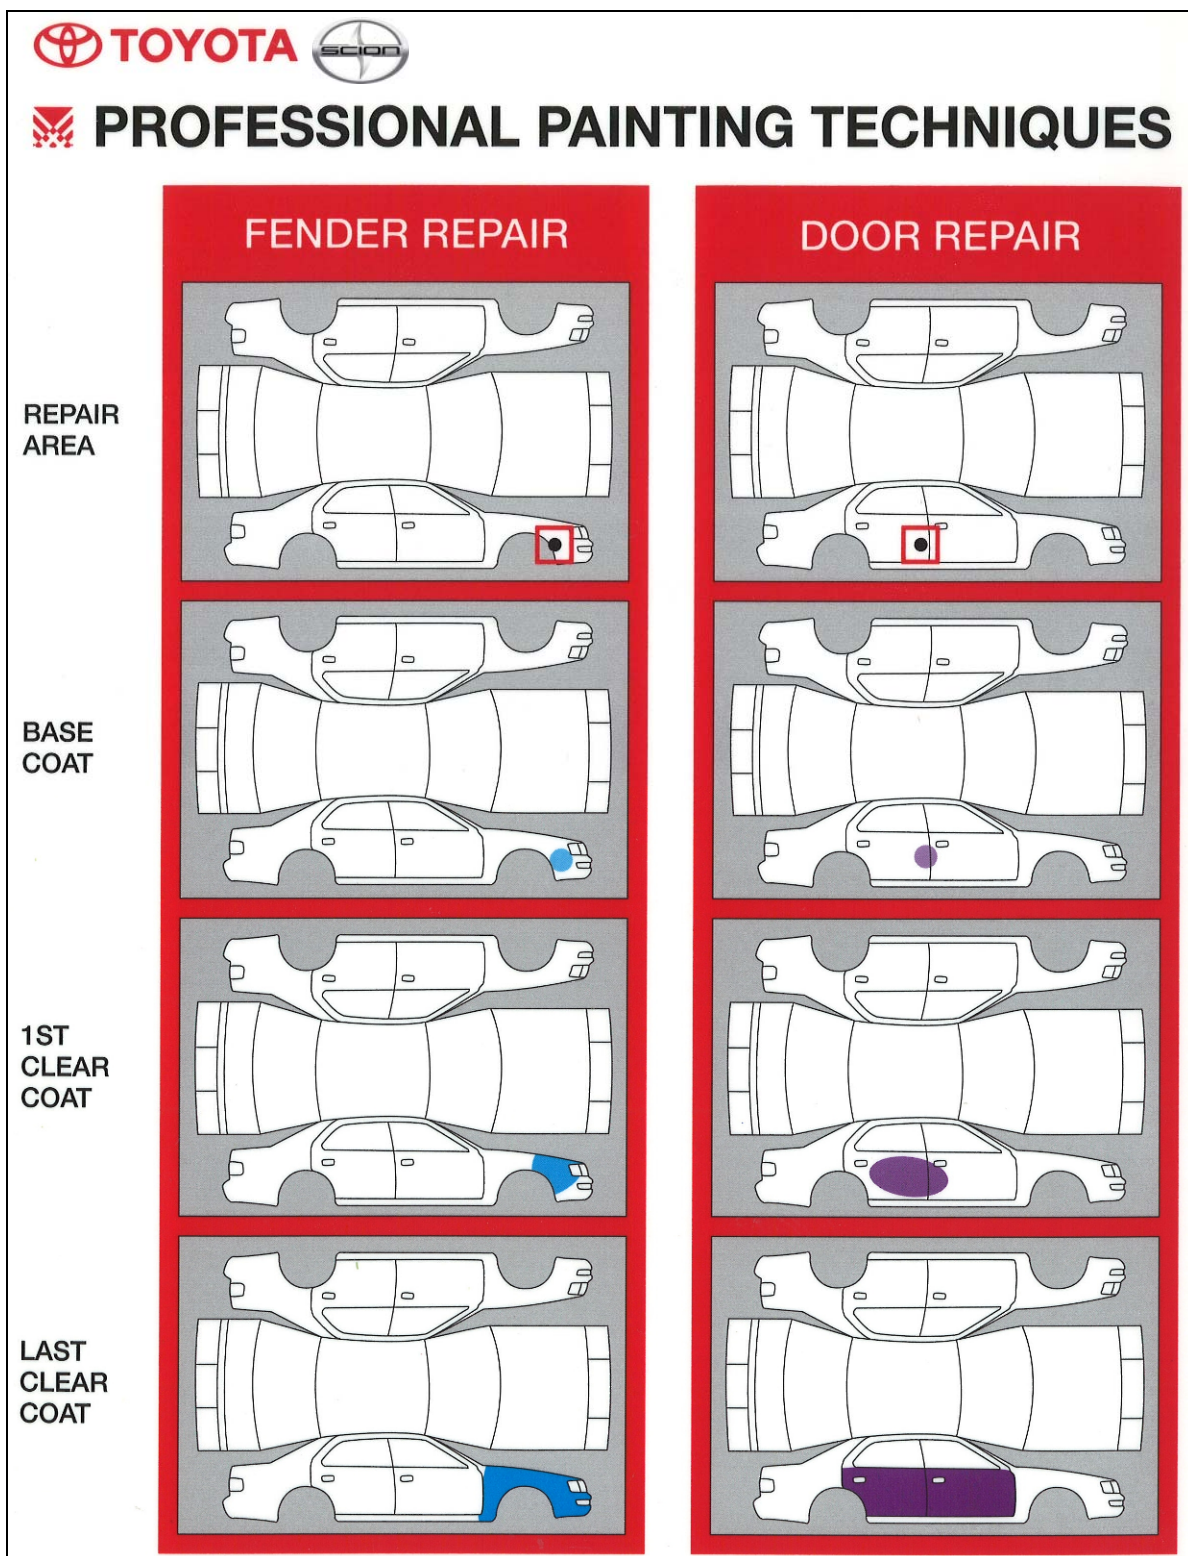
## REFINISH PROCEDURES FOR PANELS WITHOUT BODY LINES

For specific Toyota/Scion guidelines for professional painting techniques, please refer to the next two pages of this bulletin for recommended paint refinishing processes. Always follow the proper safety procedures and use any required protective clothing or equipment when carrying out the operations described in this bulletin.
