# COLLISION REPAIR INFORMATION BULLETIN

| <b>SUBJECT:</b> | <b>STRUCTURAL REPAIR PRECAUTIONS</b> | | |
| <b>BULLETIN NO.:</b> | <b>TS-TCI-CRIB-2036</b> | <b>DATE ISSUED:</b> | <b>August, 2013</b> |
| <b>MODELS:</b> | <b>All Toyota &amp; Scion Models</b> | <b>SECTION:</b> | <b>Structural</b> |

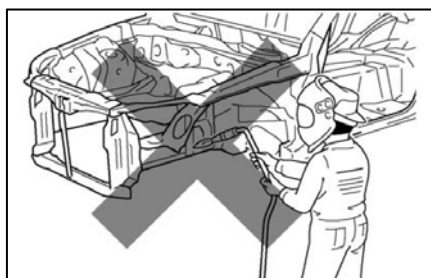
**Toyota/Scion does not approve of the use of open flame heating to stress relieve High Strength Steel (H.S.S.)** because it is extremely difficult to accurately control the temperature at the correct level in actual repair operations, which subsequently deteriorates the quality, durability and strength of the steel.

“Cold Straightening” (stress relieving) is the only repair method use to repair unibody structural members and perimeter frames (excludes all components noted in “Replacement Information”). If the structural member or perimeter frame cannot be satisfactorily restored to original dimensions during this process, it should be replaced.
