TECHNICAL SUPPORT FOR APS RELATED TO MCMICKEN THERMAL
RUNAWAY AND EXPLOSION

McMicken Battery Energy Storage System Event Technical Analysis and Recommendations

Document No.: 10209302-HOU-R-01

Date: July 18, 2020

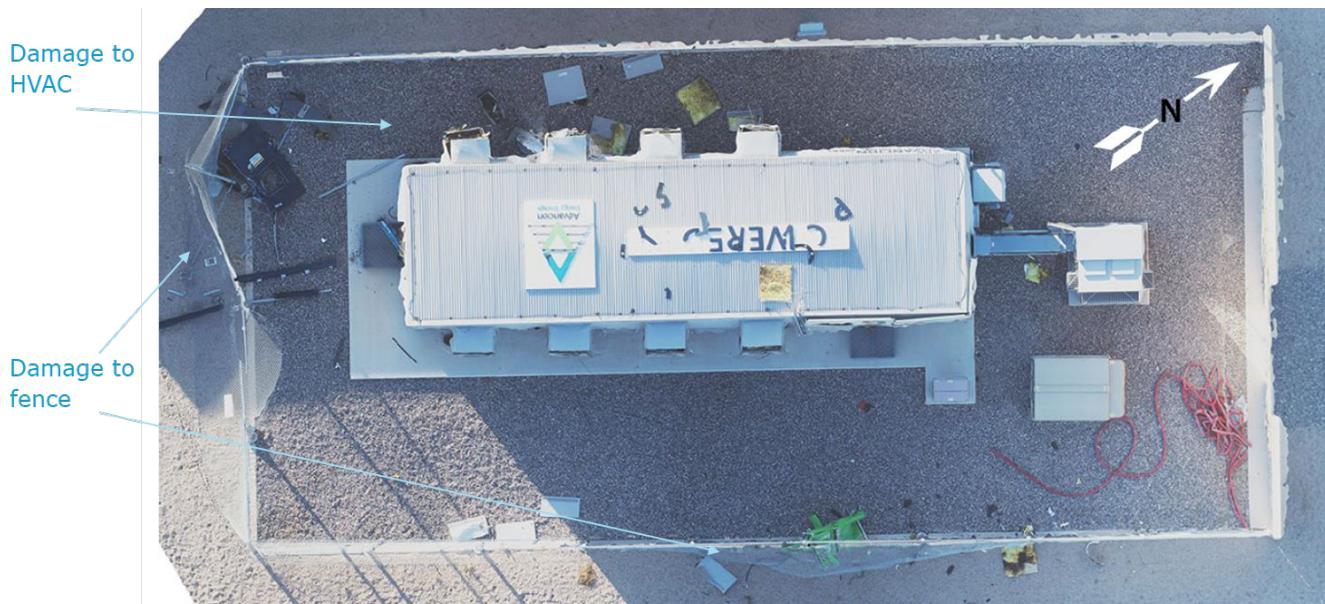
Figure 5 Aerial view of damaged BESS (image credit: Colwell Consulting)

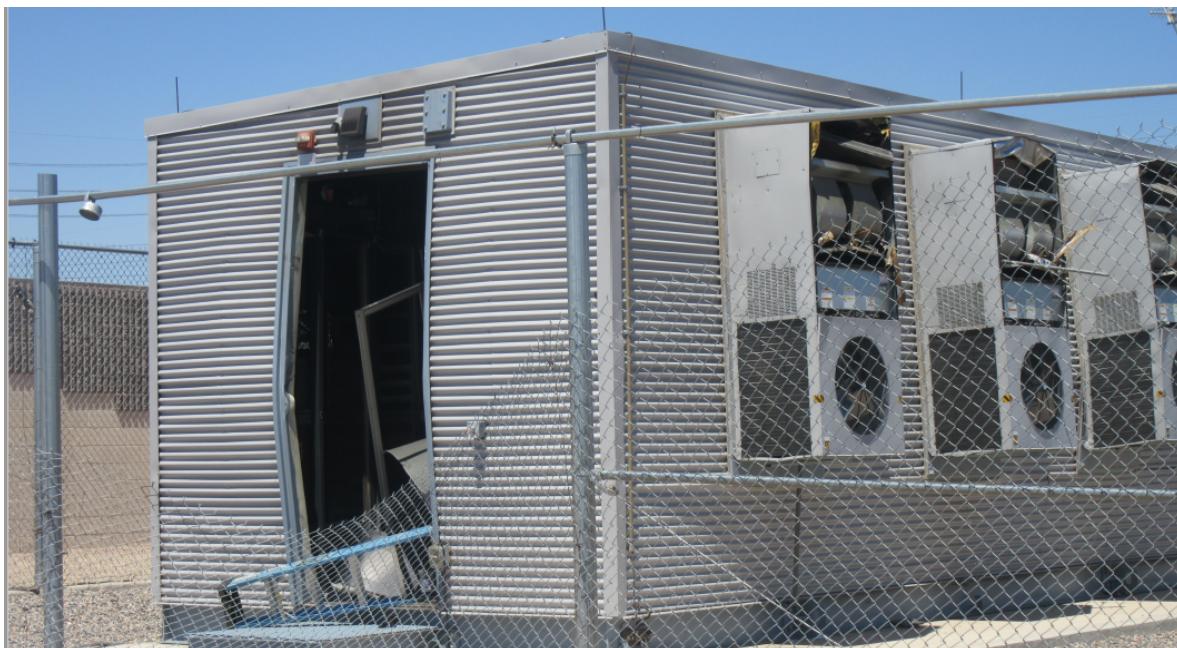
Figure 6 Damage to the rear door and HVAC systems of the McMicken BESS

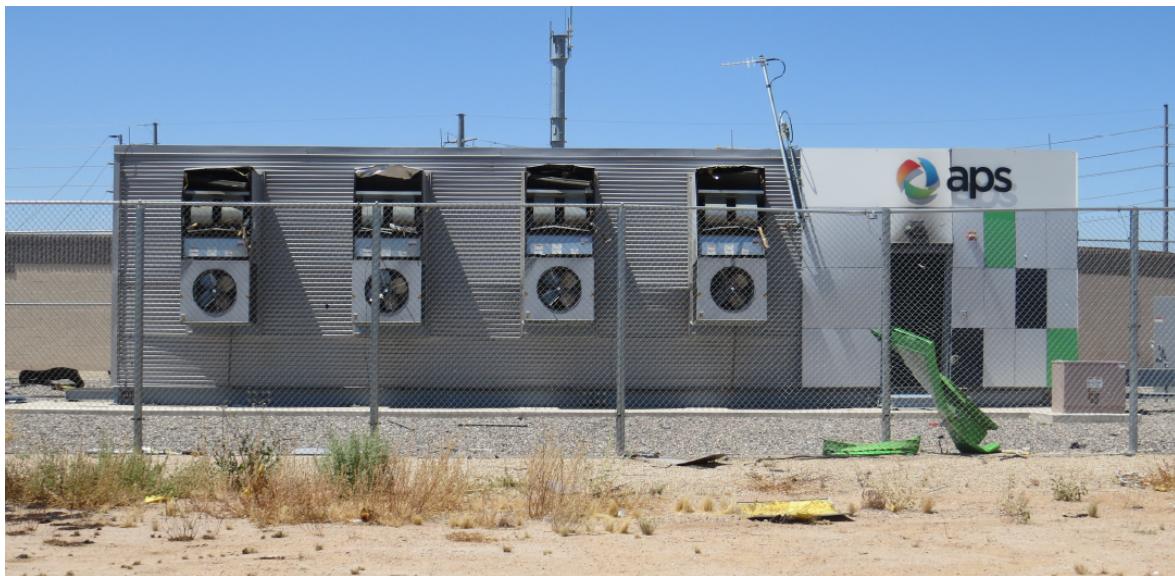
Figure 7 The side door to the McMicken BESS was ejected in the explosion and can be seen laying against the fence in the foreground

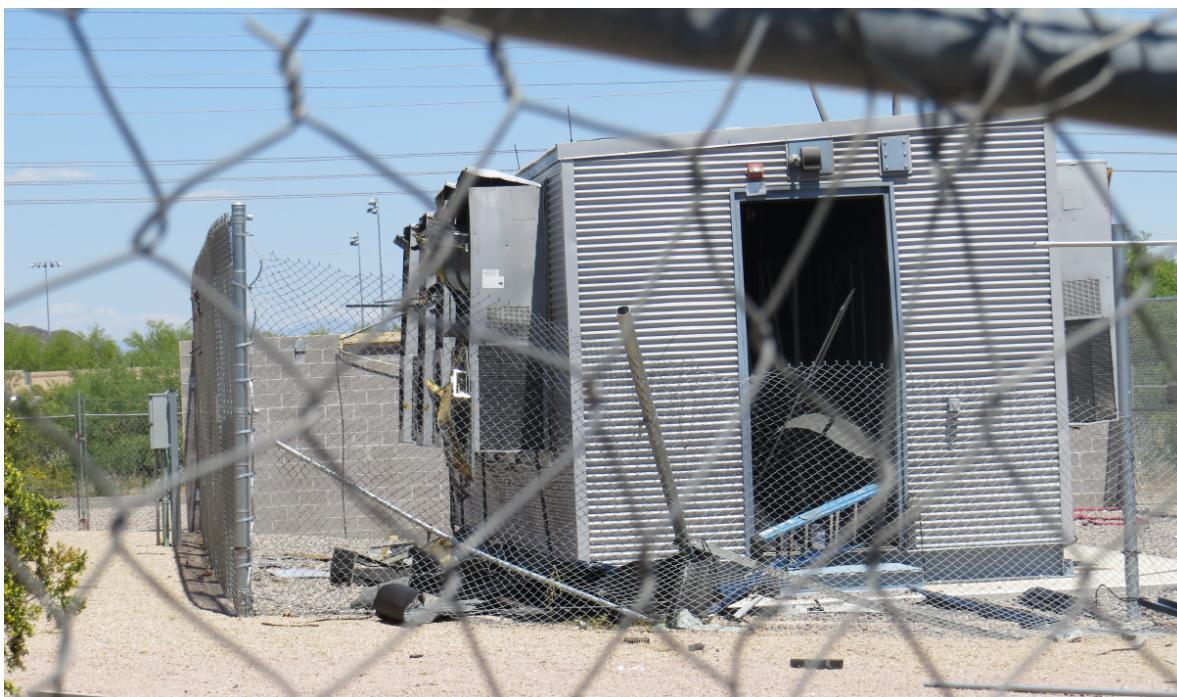
Figure 8 Additional view of debris and damage to the rear door, HVAC systems, and the container

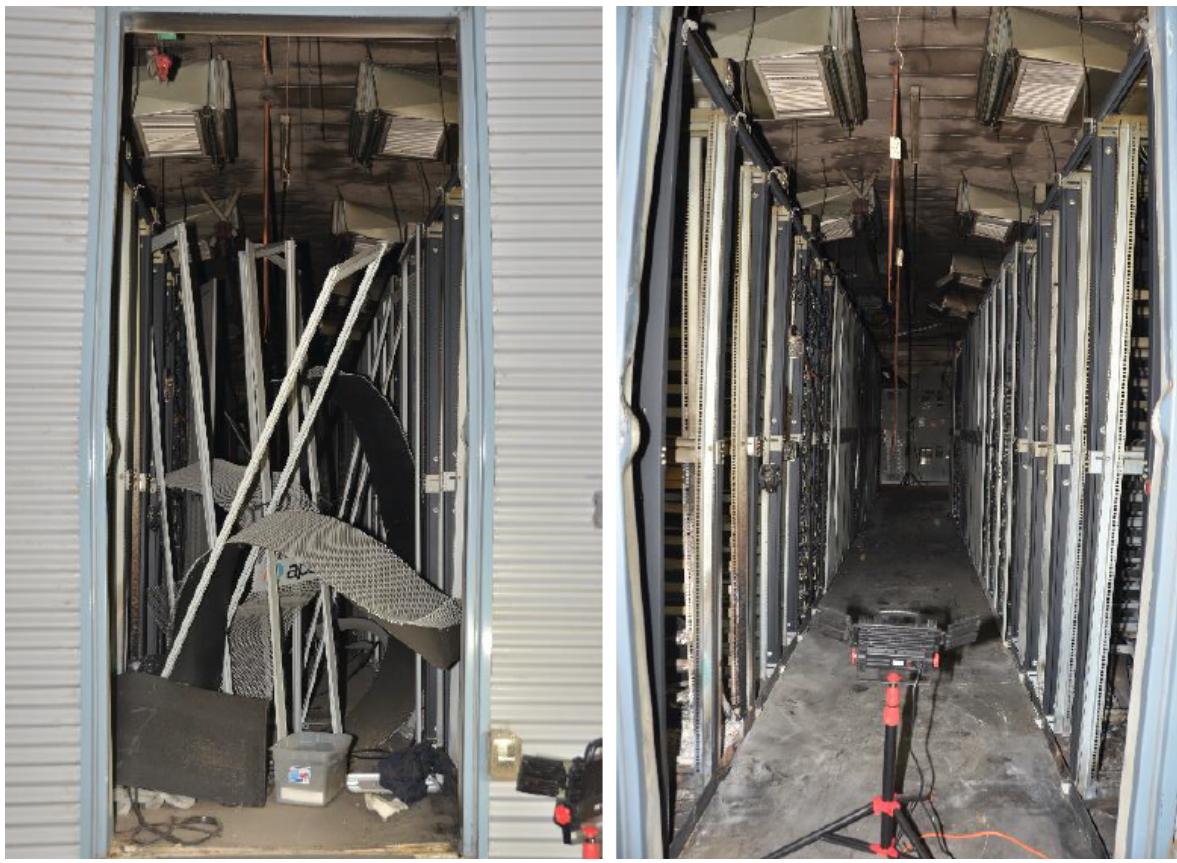
Figure 9 Interior damage to the energy storage system with the condition after the explosion (left), and condition after debris was removed to gain access to the interior and begin the forensics analysis (right)

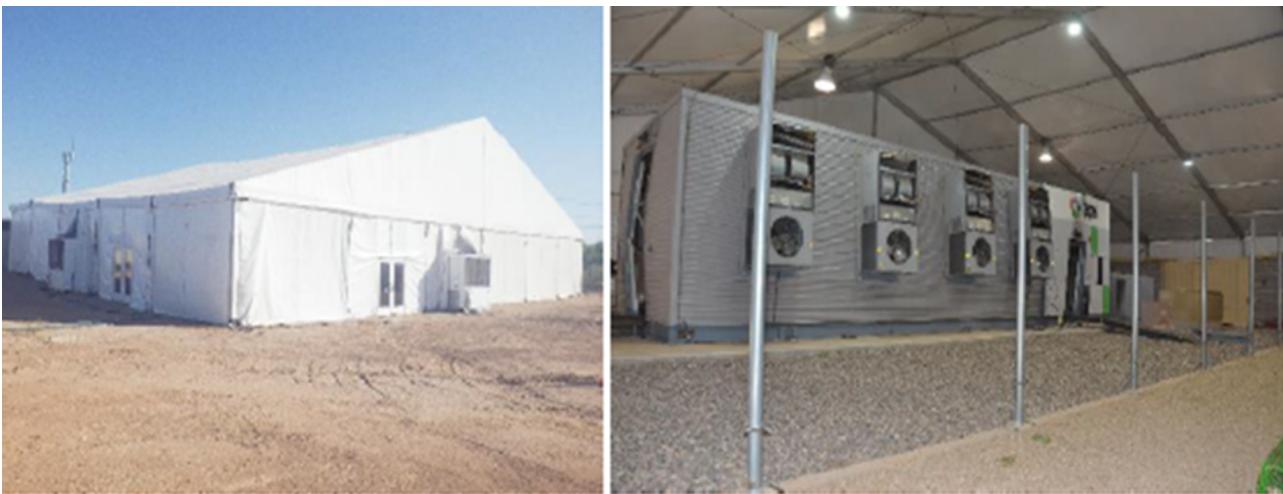
Figure 10 Climate controlled tent structure erected by APS to preserve the BESS site during the investigation (image credit: APS)

APS built a temporary work environment around the BESS, which included power connections, facilities for staff and evidence storage, and a secure, environmentally controlled tent over the entire BESS container (as shown in Figure 10). Prior to the dismantling and discharging of the battery racks and modules, a team had to enter the container and clear access to the critical BESS equipment. This required clearing of debris from the hallway (Figure 9).

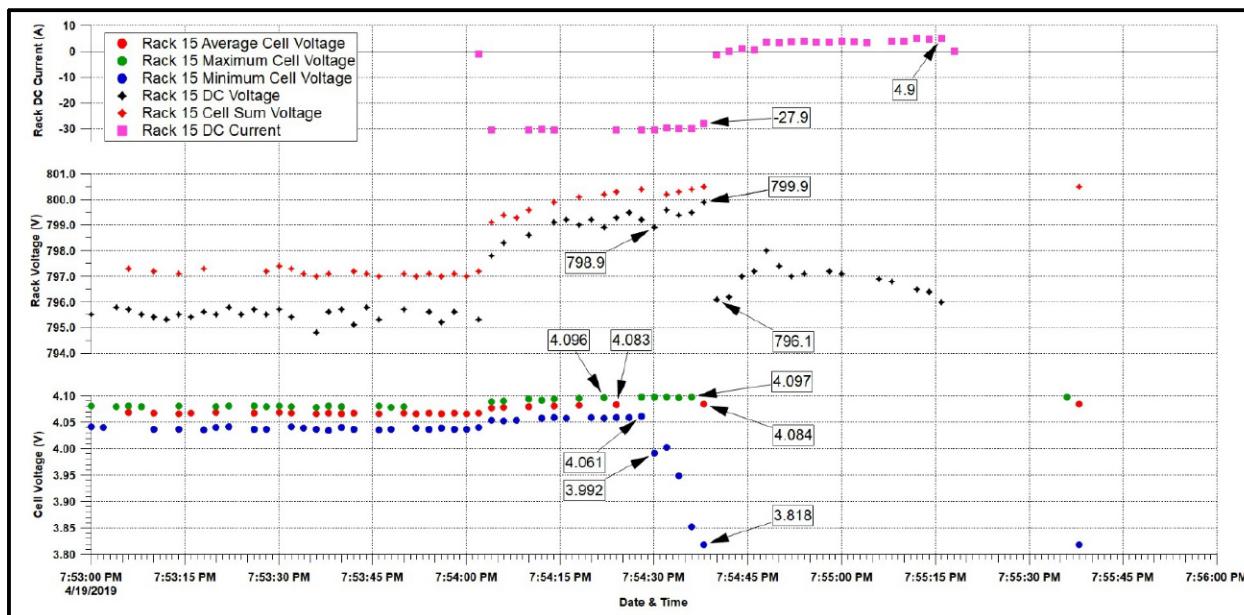
Figure 14 Voltage data for the minimum cell voltage in the rack and total rack voltage showed a drop (image and analysis: SEL)

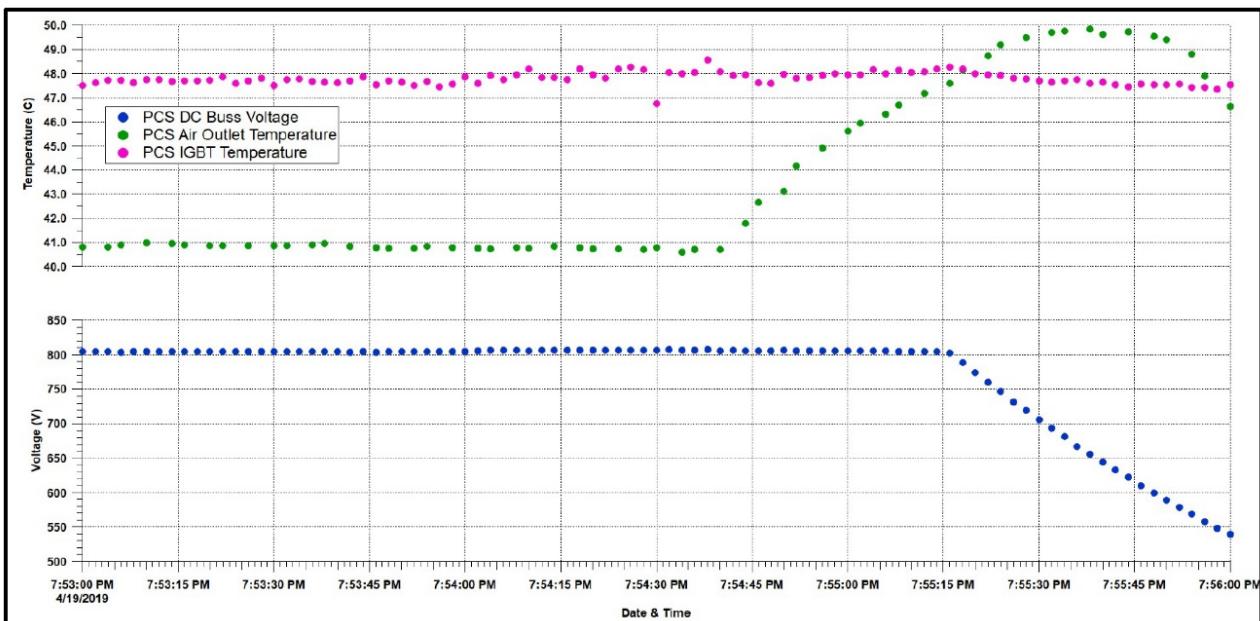
Figure 15 Air temperatures increased as voltage in Rack 15 declined (image and analysis: SEL)

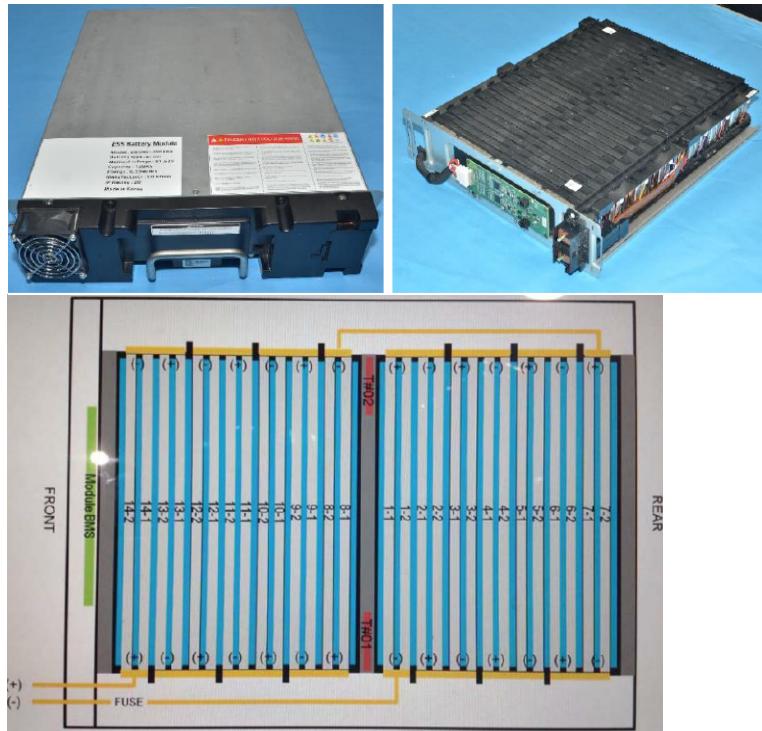
The evidence provided by the APS investigation teams provides strong data supporting that rack 15, module 2, battery cell pair 7 was the origin. Specifically, battery 7-2, located at the very rear of the module suffered an internal failure, which was indicated by the ejection of internal battery cell material and further confirmed by visual observations of the heat damage on neighboring cells and the module exterior. The location of battery 7-2 is shown in Figure 16.

Figure 16 A description of the battery cell numbering in the LG Chem battery modules. Battery 7 is the last two cells (pair); 7-1 is next one inward, 7-2 is rearmost (image credit: APS)

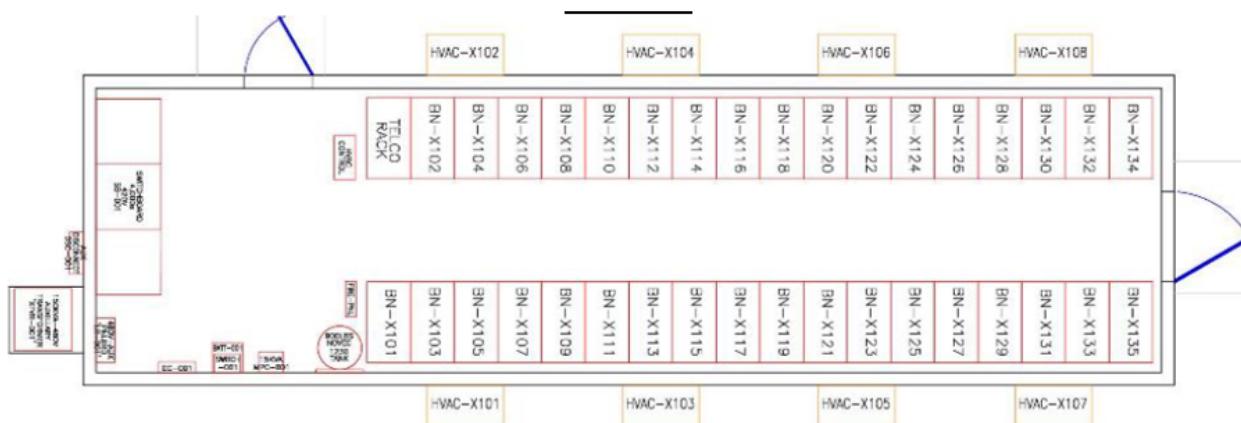
Figure 17 Rack numbering layout inside the energy storage container

With the exception of the telecommunications rack, the official nomenclature of the racks follow a BN-X## format. The rack where the failure occurred was BN-X115. Modules are numbered from the bottom upward. There are 36 rack positions in the system. (BN-X115 position in the BESS is shown in Figure 17.)

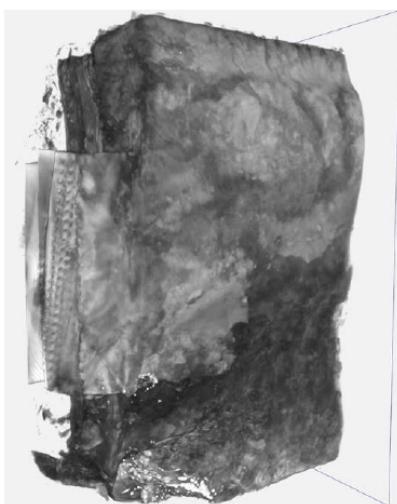
- It is believed to a reasonable degree of scientific certainty that this internal failure was caused by an internal cell defect, specifically abnormal Lithium metal deposition and dendritic growth within the cell.

Figure 18 A 3D reconstructed image of the CT-scanned battery cell 7-2 demonstrates the absence of material in the bottom corner of the battery cell (image credit: SEL)

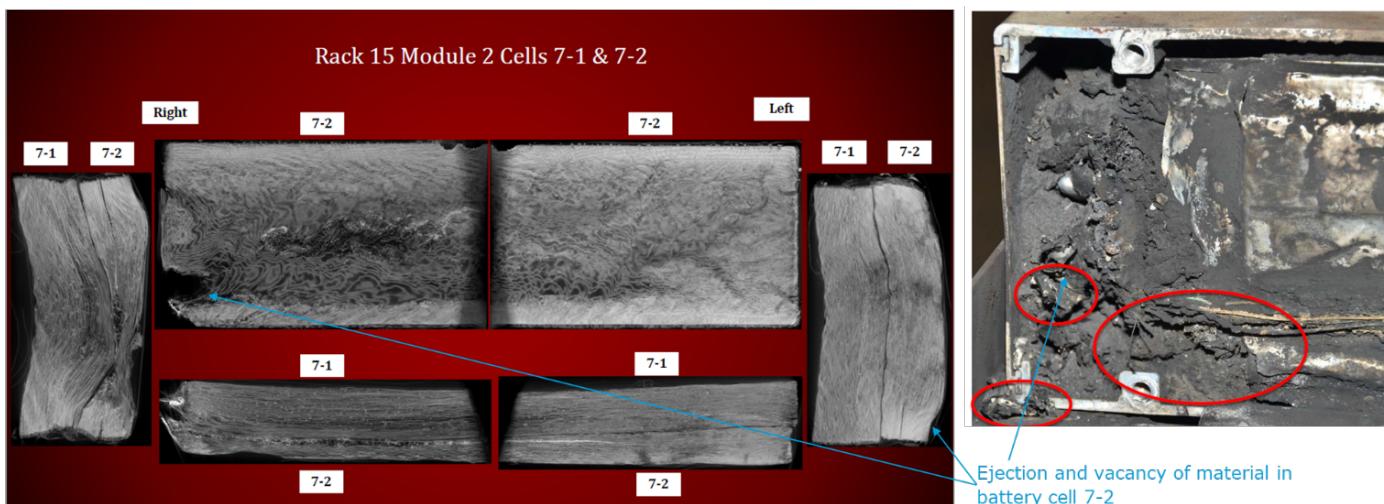
Figure 19 Vacancy of material in battery cell 7-2 during x-ray tomography (left) and evidence of ejected material during the disassembly of Module 2, Rack 15 (right) (images and analysis: SEL)

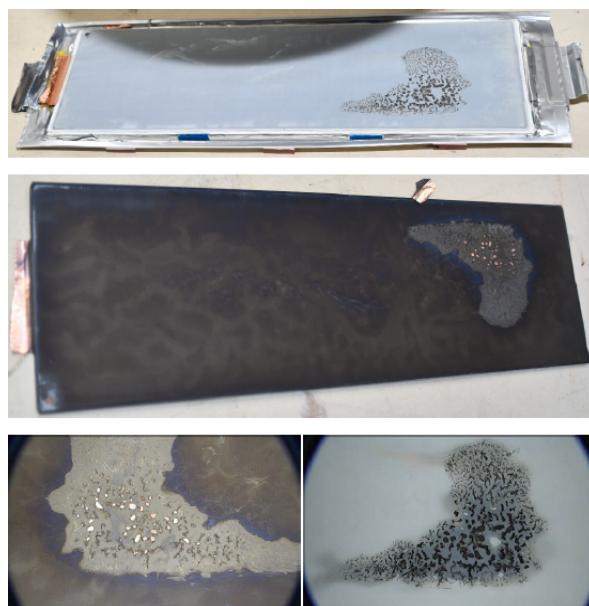
Figure 20 Deposits and dendritic growth observed on other McMicken battery cells during the investigation (image credit: SEL)

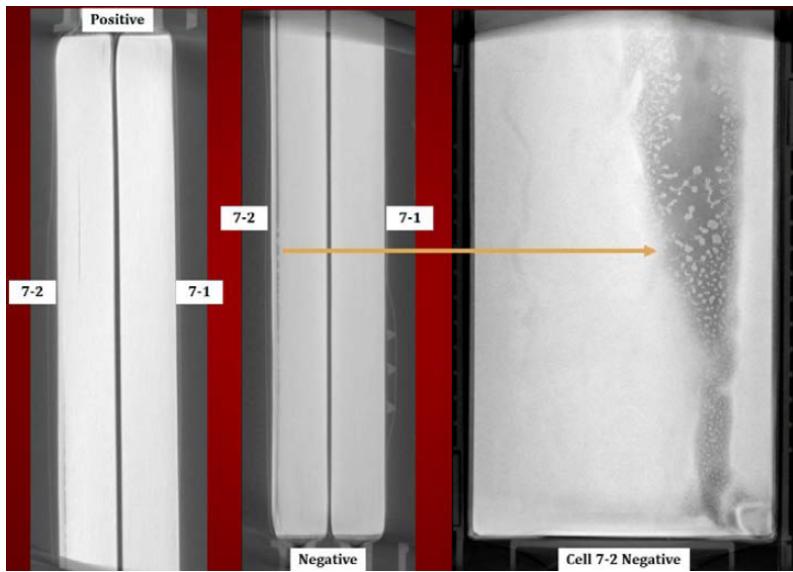
Throughout its investigation and analysis, SEL analyzed and inspected a random subset of non-Rack 15 modules, as well as modules from the Festival Ranch BESS. Analysis of battery cells from non-rack 15 battery modules from the BESS revealed internal Lithium deposits and abnormal dendritic growth populating the electrode layers of a significant number of cells. Their presence on the surface of the anode and their propensity to absorb moisture and react exothermically when exposed to open air makes them consistent with metallic Lithium plating. These deposits were also observed in similar frequency and morphology on many of the Festival Ranch battery cells analyzed. For example, Figure 20 demonstrates the internal Lithium deposits and dendritic growth found in battery cell 7-2 of Module 6 of Rack 24 of the McMicken BESS.

Figure 21 Deposits and dendritic growth observed in other McMicken battery cells outside of Rack 15 (Rack 24, Module 6, Cells 7-1 and 7-2) (image credit: SEL)

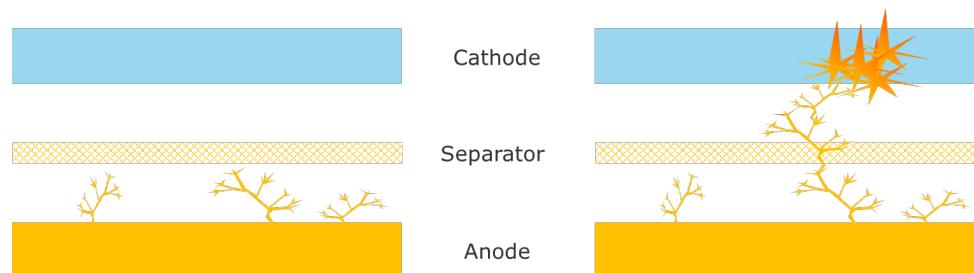
Figure 22 Li dendrites form during cycling (left), but under certain conditions may cyclically grow to penetrate the separator and short the electrodes (right), causing thermal runaway

The verification of Lithium deposits in the battery cells is important because the abnormal accumulation of Lithium deposits and dendritic growths can cause battery swelling, electrolyte degradation, exothermic reactions, separator damage and shorting internal to the cell (as shown in Figure 22). This damage to the cell may in turn cause thermal runaway.

Because module 2, cell 7 was significantly damaged in the thermal runaway event, it was not possible to directly identify evidence of Lithium plating and dendritic growth in that cell. However, based on the significant evidence of Lithium plating and abnormal dendritic growth found in a significant number of randomly selected representative samples from the BESS and Festival Ranch, and the scientific consensus that Lithium plating and abnormal dendritic growth can cause an internal short leading to thermal runaway, SEL and Dr. Hill believe to a reasonable degree of scientific certainty that the observed cell defects (Lithium plating and abnormal dendritic growth) caused the internal cell failure in module 2, cell 7.

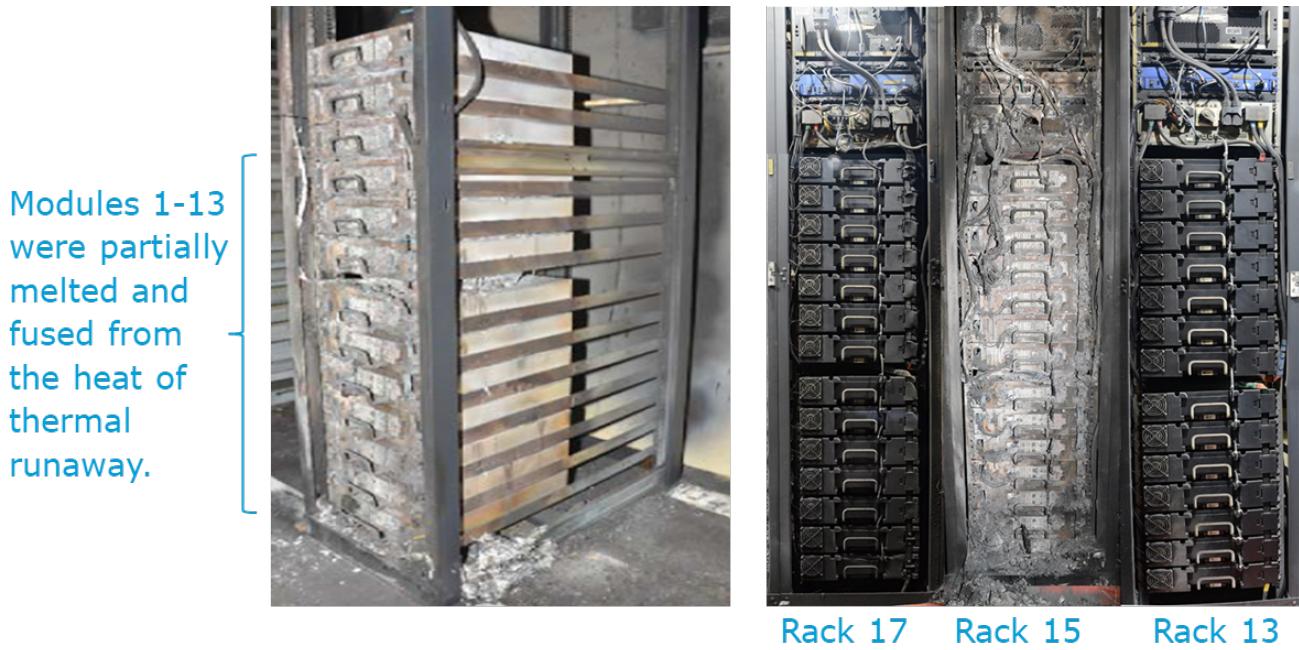
During its investigation of Rack 15, SEL observed significant yielding and/or melting of the aluminum on module frames and compromised structural integrity. In some cases, the modules were melted together. The melting point of aluminum is $\sim 660^{\circ}\text{C}$, and as shown in Figure 12, it would be possible for a single battery cell to exothermically generate temperatures $> 400^{\circ}\text{C}$. Since it was highly likely that more than one cell was undergoing thermal runaway at any given time, it was certainly possible that multiple exothermic reactions during cascading thermal runaway were additive to generate temperatures as high as 660°C . The strength of aluminum (and most common metals) decreases as the temperature increases. This is important because the sagging of the modules may have aided in the cascading from one module to the next throughout Rack 15.

Figure 23 All of the modules in Rack 15 were damaged by thermal runaway while leaving the neighboring racks mostly undamaged (image credit: APS)

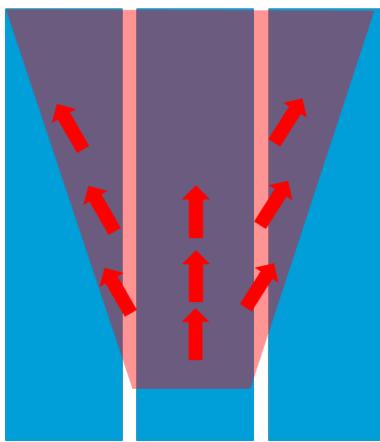
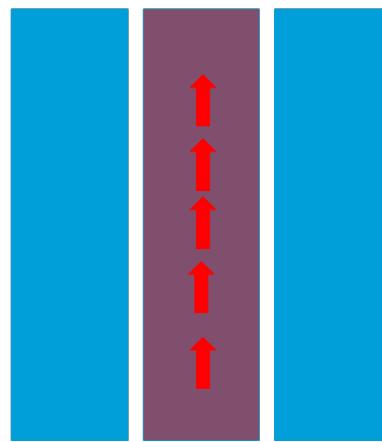
Figure 24 Difference in expected damage pattern between an open fire in the battery rack, and heat transfer vertically through the rack due to thermal runaway

However, as demonstrated by Figure 23, the thermal runaway was isolated to Rack 15. In fact, the modules in the neighboring racks all maintained the voltage in their final charge state at the point of system shutdown. This evidence indicates that thermal runaway in Rack 15 was transferred vertically between all battery modules in Rack 15 via heat transfer rather than by flame. For example, the neighboring racks did not show burn damage that would be expected from a conventional fire. As shown in Figure 24, the isolated, module-to-module damage to Rack 15 is characteristic of cascading thermal runaway between modules via heat transfer, rather than a burning fire with open flame and soot, which would have likely caused a damage pattern similar to a vertical "V" shape. In the BESS, it appears as though the materials and air gaps between racks prevented horizontal heat transfer and initiation of thermal runaway in adjacent racks, resulting in only vertical propagation through rack 15.²⁰

Conventional fire, V-shape direction due to direct flame and heat.

Thermal runaway, primarily heat transfer

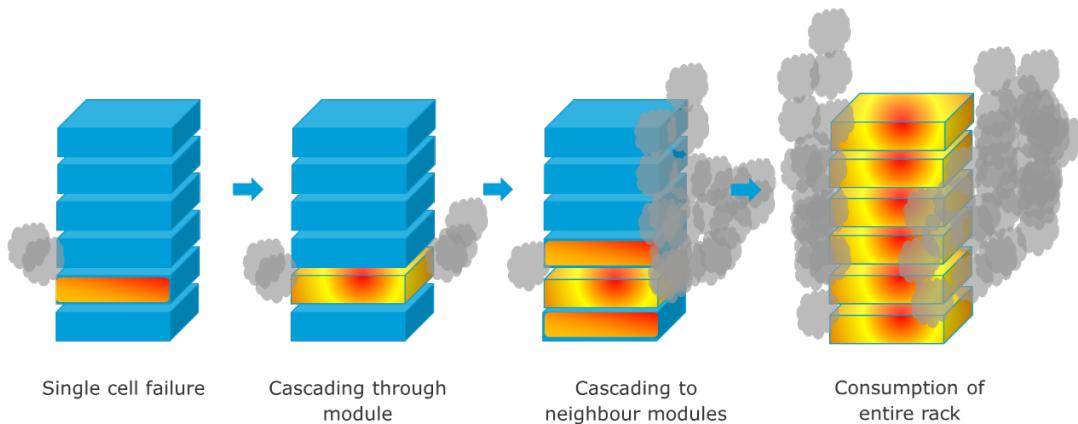
A key factor exacerbating this incident was the absence of any means by which the battery modules could prevent the continued propagation and cascading from a single cell. The Novec 1230 discharged shortly after the first cell failed, yet thermal runaway continued to propagate. (Figure 25) The Novec 1230 system could only discharge once, by design, yet the flammable gases continued to emerge as each new cell cascaded in thermal runaway. The Novec 1230 discharge may have played a role in preventing the ignition of flammable gases when they were released, but Novec 1230 and other clean agents are not intended to stop the progression of a cascading thermal runaway. Consequently, the spread of thermal runaway led to the generation of a large quantity of gases, **which were not burned as they were emitted**. Figure 25 illustrates the chain of events based on the evidence available.

Figure 25 A single cell failure propagated through Module 2, then consumed the whole rack, releasing a large plume of explosive gases. This process could have occurred without visible flame, which would explain why the gases were not burned as they were emitted.

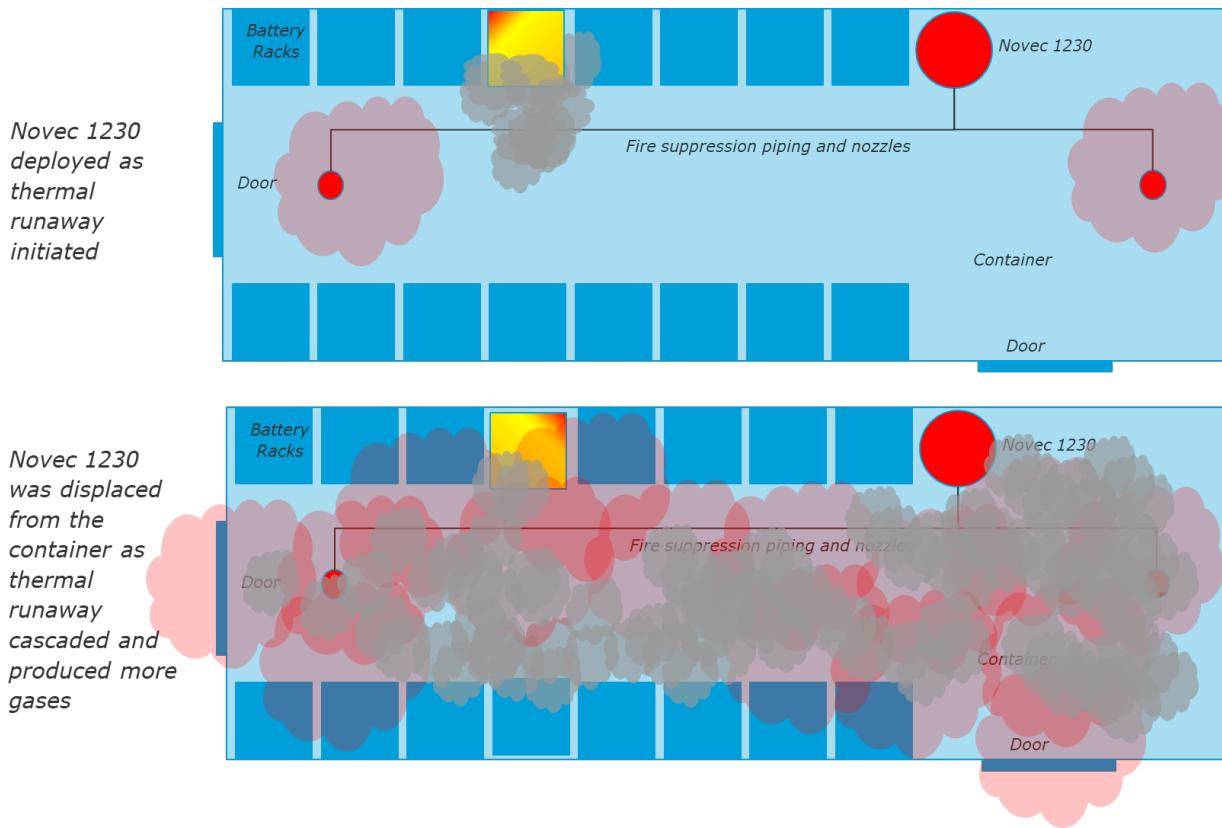
Colwell's analysis of the BESS suggests that the hotter, flammable gases rose to the upper level of the container while the Novec 1230-air mixture would descend due to its higher mixture density and cooler temperature. Over time, the hotter rising flammable gases displaced the Novec 1230-air mixture as it leaked from the doors and other seals in the container. The amount of time from the initial discharge of Novec 1230 to the opening of the door provided ample opportunity for the flammable gases to concentrate, as illustrated in Figure 26. The Novec 1230 is red in the figure, and the flammable gases from thermal runaway are grey.

Figure 26 Flammable gases continued to concentrate as thermal runaway propagated through the rack

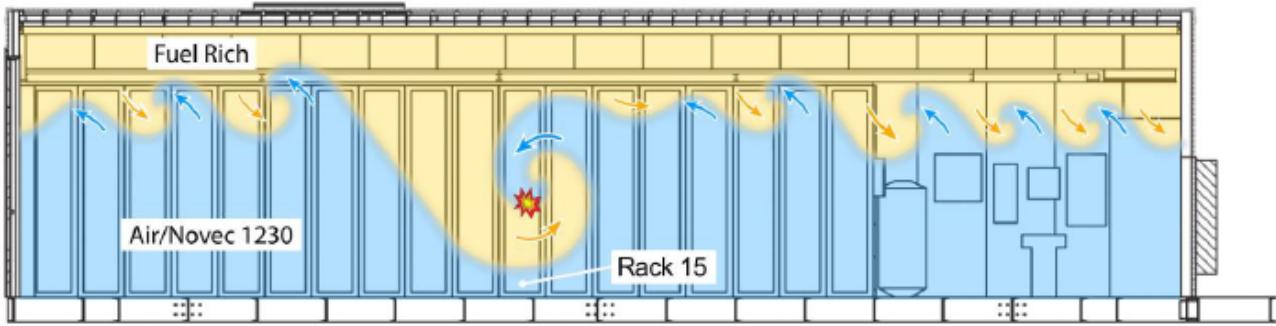
Colwell hypothesized that when the container door was opened, the flammable mixture came into contact with a thermal source, which was likely to be the still hot batteries in Rack 15, as illustrated in Figure 27. It is Dr. Hill's experience that residual heat within a battery module that has experienced thermal runaway damage can remain for minutes and hours after thermal runaway appears to be complete (see Figure 34 in following sections), so this ignition mode is plausible.

Figure 27 Colwell's simplified illustration of flammable gases near the top of the container rolling back as a reaction to the door opening, putting them in contact with residual heat or spark at Rack 15 (image credit: Colwell)

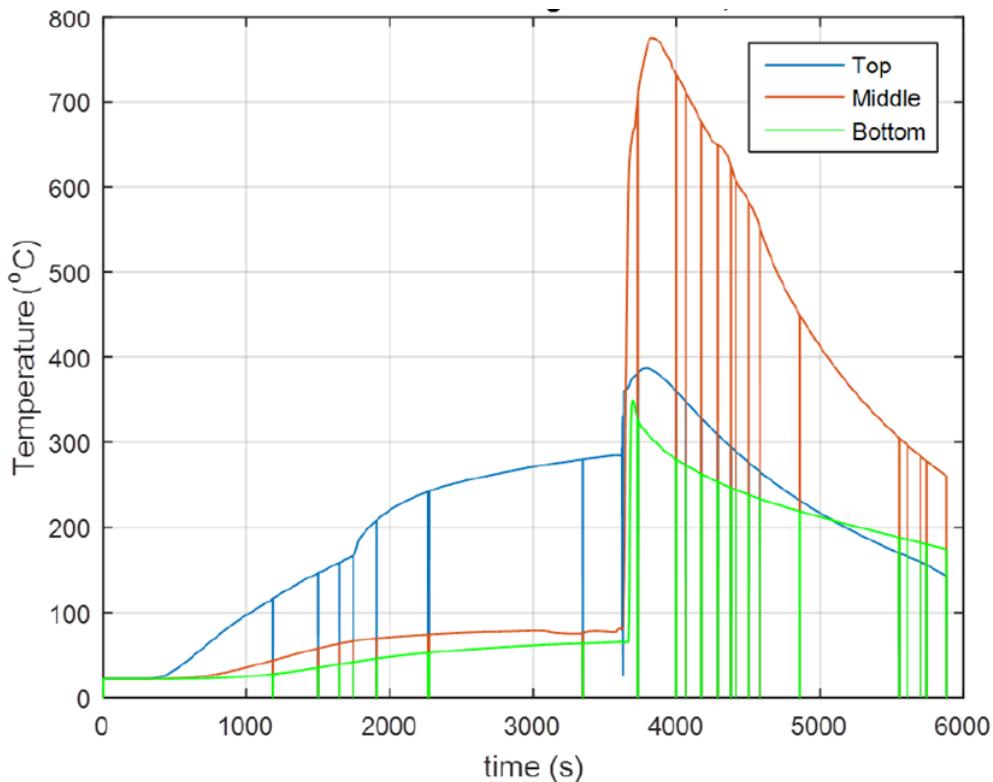
In Figure 33, based on testing conducted in the Con Ed report, [16] it is clearly demonstrated that cells that are permitted to touch - and subsequently go into thermal runaway - trap a significant amount of heat.

During the test it is shown that even after thermal runaway ended and the exterior temperatures are decreasing, the interior temperature (between the cells) remains nearly unmitigated. This residual heat can cause reignition of battery cells after extinguishing has occurred and can become an ignition source if it comes into contact with the flammable gases released during and after the thermal runaway event. In a large group of battery cells, such as the BESS, this residual heat poses a risk to restart propagation of thermal runaway for minutes to hours. Cells that have not yet undergone thermal runaway eventually will unless the batteries are separated or cooled (recall the fire triangle in Figure 11).

Figure 33 Temperatures between cells remained ~300 °C higher than external temperatures during aerosol extinguishing

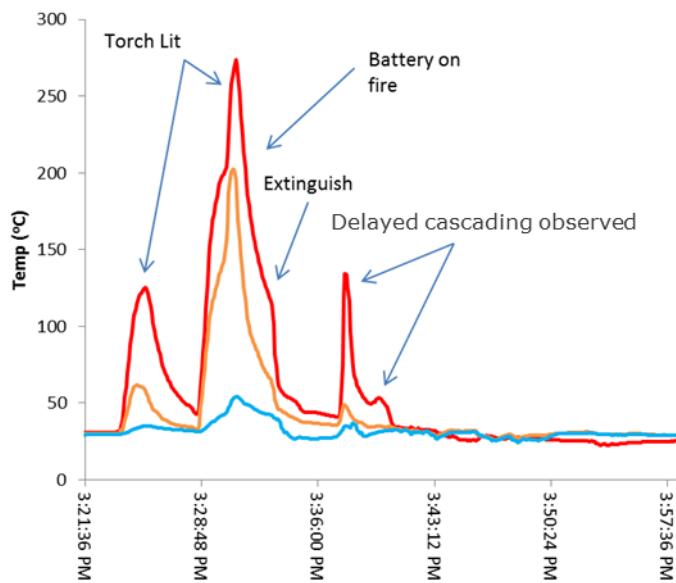
As an example of how “delayed cascading” occurs, consider the following thermal runaway test performed on a battery module with multiple pouch cells stacked together, face to face, without any barrier between them to prevent cascading. The timeline of what occurred is shown in Table 4, and the results are shown in Figure 34.

Time 0:	Torch is lit and test starts.
7 Minutes:	The battery temperatures spike. Thermal runaway has begun, eventually open flames are produced.
13 Minutes:	Fire is extinguished with water. The smoldering battery continues to be observed with a thermal camera.
13-19 Minutes:	The thermal camera measures a gradual temperature rise on the smoldering battery. No external heat is being applied. Test engineers and fire crews watch as the battery continues to self-heat and gradually produce more smoke.
18-19 Minutes:	The module reignites into flame and temperatures spike again. It is allowed to burn for another 3-4 minutes.
23 Minutes:	The fire is extinguished to final test completion.

Figure 34 A thermal runaway test demonstrates a battery that contained residual heat, which restarted the cascading process within 20 minutes after the initial fire was extinguished

This test demonstrates several factors that are relevant to the McMicken incident. Tightly packed batteries trap and hold heat between them, as was shown in Figure 33. If a thermal barrier is absent or ineffective, or if there is no physical separation of the cells to prevent the trapping of heat, or if there is no mechanism to dissipate this heat, it will remain there as a thermal hazard that can reintroduce thermal runaway to any unburned cells and/or potentially ignite any flammable gases that continue to smolder. Cascading will continue in a design that does not prevent battery cells from coming into thermal contact.

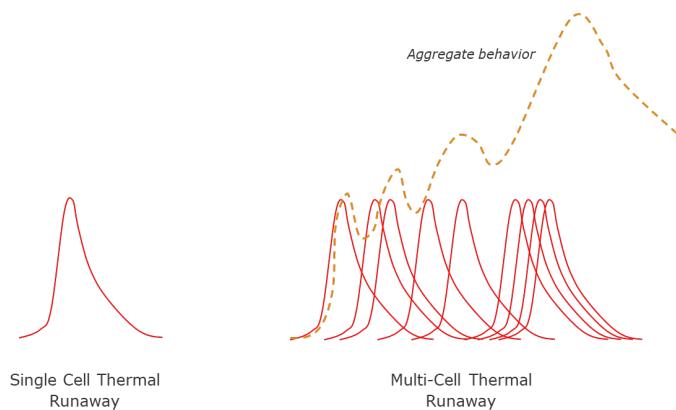
thermal runaway, the associated heat and gas behavior is a building sum of all the smaller events that produced it (recall Figure 31). This is illustrated conceptually in Figure 35. The heat load and gas load follow similar behaviors, looking like bell curves over time.

Figure 35 Single cell thermal runaway produces a single peak, while multi-cell thermal runaway produces a cumulative buildup of heat and gases (illustrative)

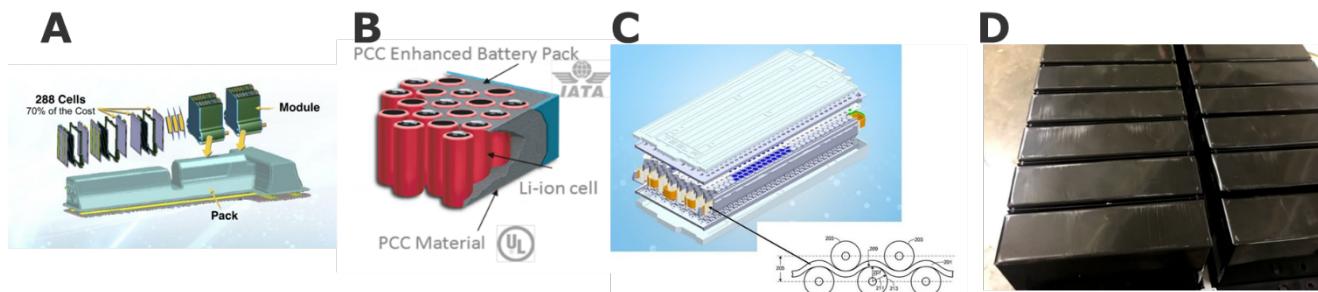
Figure 36 Examples of different approaches to cooling and anti-propagation measures

- A. The Chevrolet Volt battery pack uses aluminum plates sandwiched between LG Chem battery pouch cells to provide superior cooling and substantial protection against cascading.²⁶ The aluminum plates are torqued to a compression specification that keeps the pouch cells compressed. Because the aluminum plates are actively water cooled, they are highly effective at distributing and controlling heat. Also, the plates are thick enough that they can dissipate heat which slows or prevents heat from being concentrated in neighboring cells during thermal runaway. This is a very robust design, and as such, can increase cost or the BOM of the battery pack. The plates themselves provide structural rigidity, which reduces the need for exterior structural enhancements. Similar alternating aluminum plate designs have been adopted by several battery pack integrators in the marine industry because of the high safety and performance benefits.

- C. The Tesla Model S and Model 3 battery module approach begins with smaller cells that contain less energy such that if one were to catastrophically fail, the total heat energy it would release is limited by its small size—i.e., there is less heat concentrated because there is less initiating mass, and because the cells are highly energy dense, the energy density and BOM are also reduced.²⁸ In addition to the small cell size, an aluminum cooling ribbon is woven into the battery pack structure to provide cooling and some structural reinforcement to the already-semi-rigid cylindrical cells. The aluminum ribbon is the main mechanism to cool the cells; however, it is part of a combined mass of materials to reduce the rate of heat transfer, and thus cascading, during a failure. While not as deliberate in its design as the Volt pack, the aluminum in the Tesla pack adds thermal mass to slow cascading. And because the cells themselves are small, a single cell initiation is brief and less intense than it would be if the cells were larger.

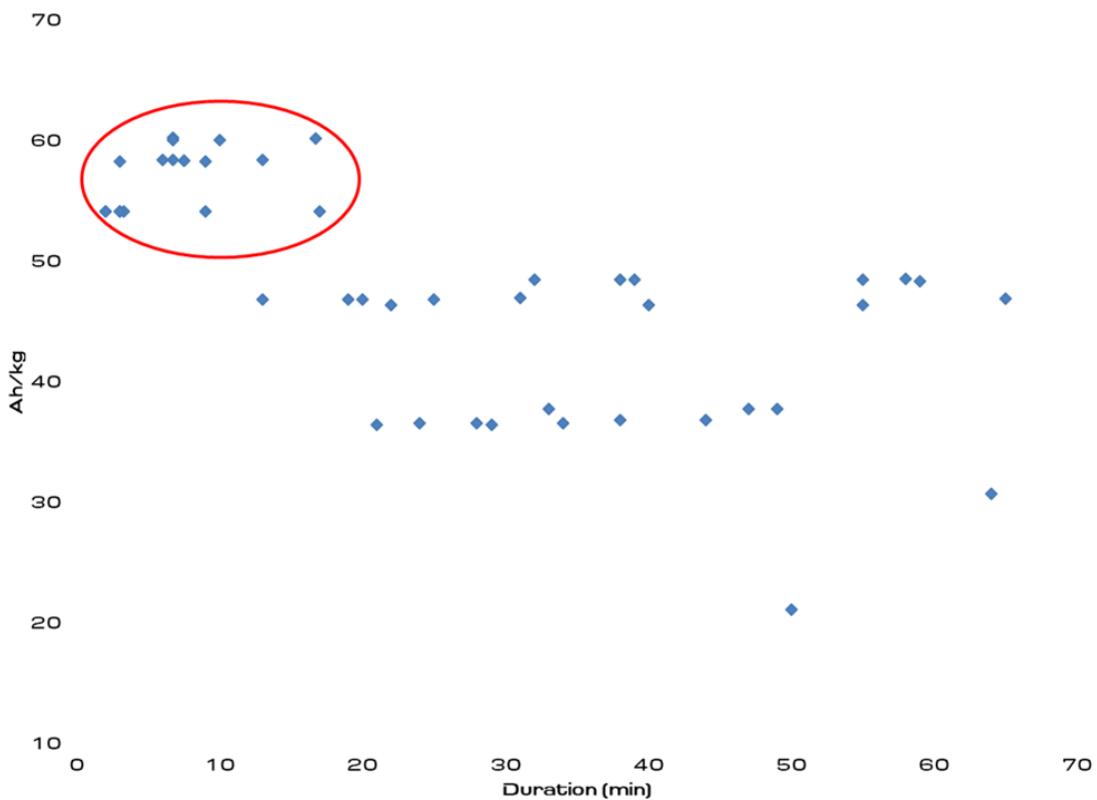
As shown in Figure 37, in the aggregation of dozens of individual thermal runaway tests on battery cells, a plot of duration vs. energy density (Ah/kg) is shown. A cluster of data points in the 2-20-minute timeframe is shown in the upper left within the red circle. These tests were performed on cylindrical 18650 battery cells. The rest of the data points are pouch or prismatic battery cells. The cylindrical cells have somewhat higher energy density, but more notable is that the duration of the burn is much less, perhaps 3x less, than a pouch or prismatic cell. Cylindrical cells are typically 3-5 Ah whereas pouch cells are larger, typically > 30 Ah.

Figure 37 The difference in duration of a cell failure for small cells vs. larger cells

This demonstrates that smaller cells burn for a shorter amount of time and emit less gas overall. Therefore, a design philosophy that can isolate, contain, and independently vent sub-groups of batteries will allow for safer management of battery thermal runaway by reducing the overall quantity of explosive gases. Both smaller cells and smaller sub-groups would achieve the same goal. It should then be no surprise that there is a correlation in Figure 38 between module mass and peak temperatures reached.

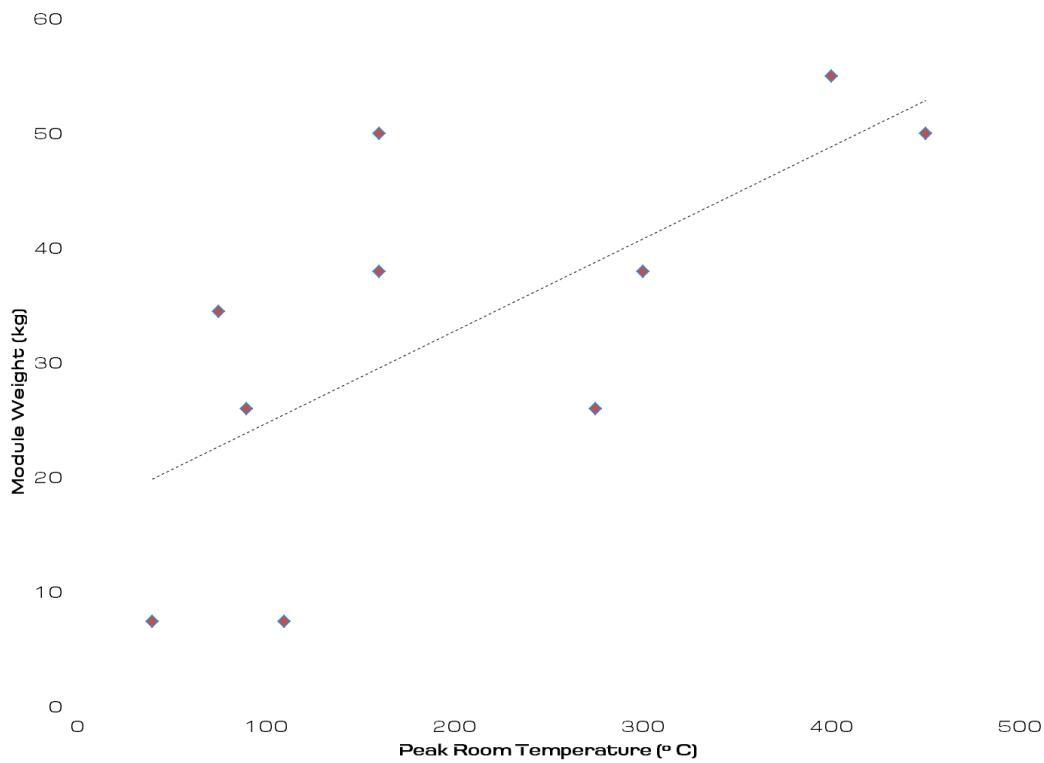
Figure 38 Peak temperatures reached in a thermal runaway testing chamber are directly proportional to the mass of the modules

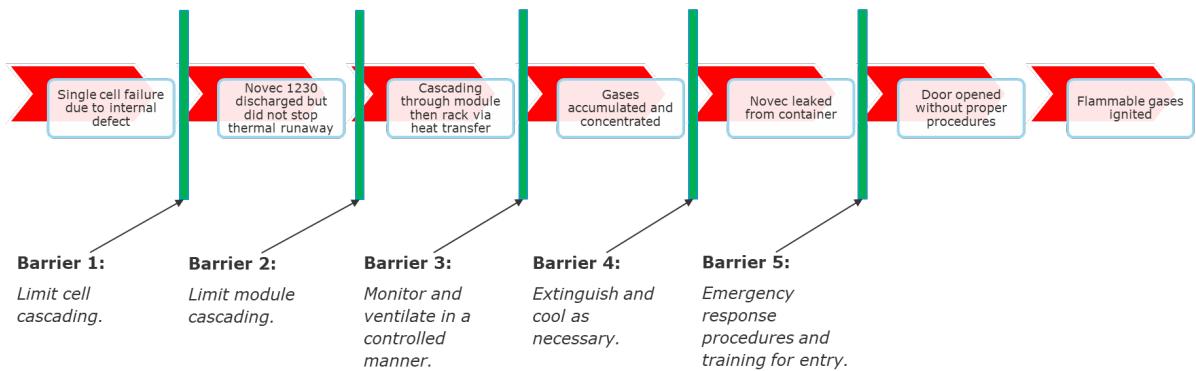
There are best practices available in the industry that have been outlined and documented in this report. As shown in Figure 39, a few barriers, if in place, would have likely prevented this incident. First, cell quality should be a major focus in the industry going forward. In addition, the following factors should be addressed:

Figure 39 Five barriers, if implemented in this scenario, may have ultimately prevented an explosion

At any stage of Figure 39, if the mass available to burn was limited, compartmentalized, and independently vented, the rest of the chain may have been broken. It should be noted that the final barrier is actually system entry, meaning that all the prior measures must be complete and verified before access is granted.

- **Cell-to-cell cascading:** A barrier to limit the rate, or prevent cascading altogether, would have reduced the quantity of gases in the atmosphere of the container such that they would have never met the LFL, regardless of whether the Novec 1230 leaked from the BESS container. See "Preventing cascading" on page 53.

- **Proper extinguishing:** A clean agent or aerosol alone is not enough to prevent cascading thermal runaway or manage the concentration of flammable gases that will follow. A combined strategy of fire suppression followed by ventilation and cooling strategies should be a requirement going forward. See "Ventilation and cooling" on page 51.

- **Response plans and entry:** Response procedures that incorporated system monitoring, the detection of gases, ventilation practices, extinguishing methods, and information to gather before entry, may have prevented first responders from opening the door in unsafe conditions. If such training is conducted early in the project development and commissioning process, it permits the local jurisdiction and their first responder parties to learn about the system and be aware of its hazards. These procedures should be documented, available outside the BESS container or building, and demonstrated through training which should be refreshed and updated periodically.

Present codes and standards are insufficient in addressing cascading thermal runaway and prescribe the extinguishment of thermal runaway through conventional firefighting means. The standards should instead acknowledge that cell-to-cell cascading is the primary risk to address in the scale of the thermal runaway hazard, and there are solutions which prevent or slow cascading thermal runaway. Owners, system integrators, vendors and suppliers, and O&M service providers should also focus on educating stakeholders on the processes shown in Figure 39, and develop and implement training necessary to execute the third, fourth, and fifth barriers.
