# Typhoon-Induced Turbine Failure at Wenchang Wind Power Plant

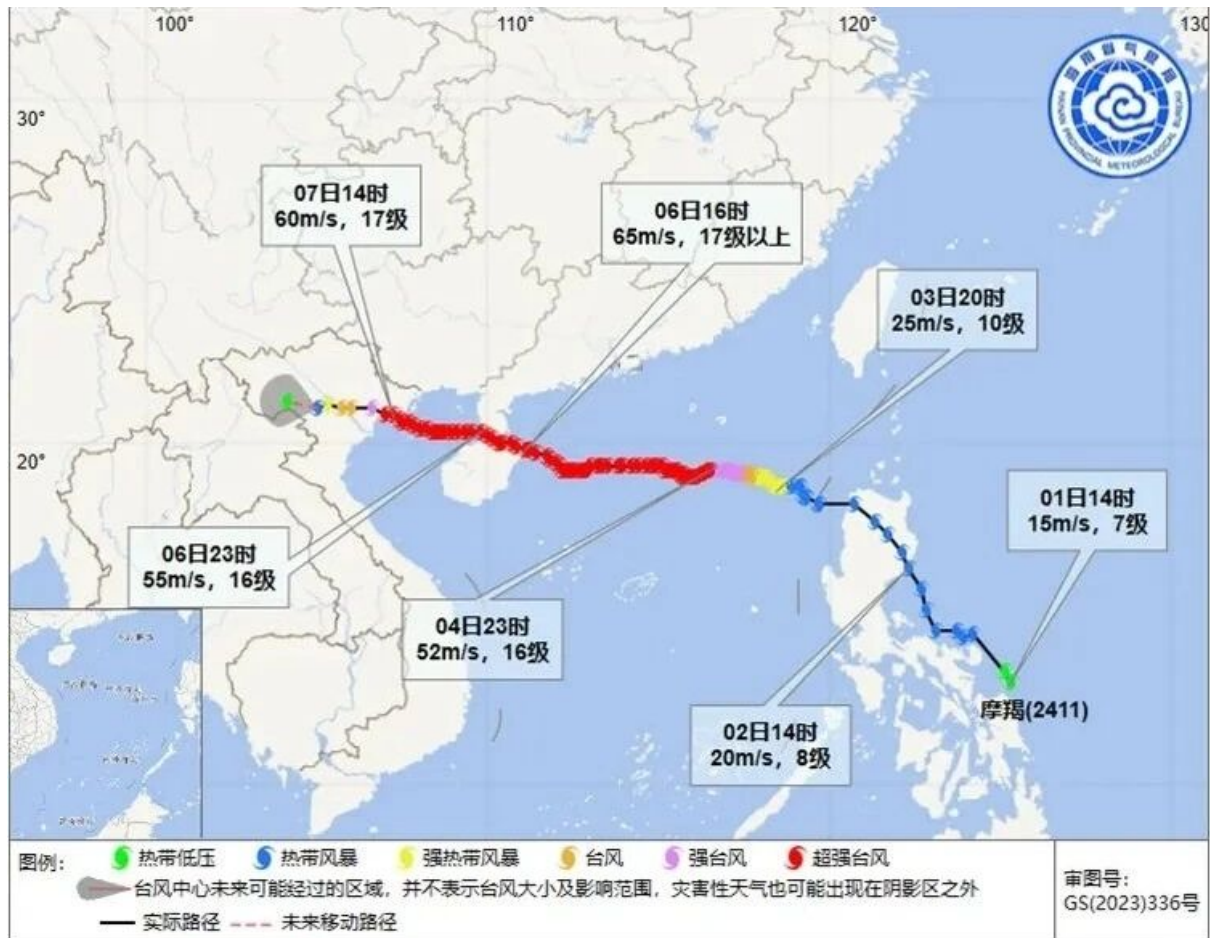
At 16:20 on September 6, 2024, Typhoon Yagi made landfall in Wengtian Town, Wenchang City, passing within approximately 7 km of the project site. As a super typhoon, it recorded a maximum sustained wind speed of 63.9 m/s and a central pressure of 915 hPa (He et al., 2025), exceeding the 60 m/s design limit specified for typhoon-resistant wind turbine systems. Figure 7 illustrates the typhoon track. Yagi was the strongest typhoon to strike China since Rammasun in 2014, affecting over 526,000 people in Hainan Province and causing four fatalities and 95 injuries (Xinhua, 2024).

Figure 7: Track Map of Typhoon Yagi (image from CECS Wind Disaster Mitigation and Wind Energy Utilization, 2024).
