Geotechnical Effects of the 2015 Gorkha, Nepal Earthquake and Aftershocks, as Determined By Field Reconnaissance: A Case Study Review

Abstract- Following the 7.8 Magnitude Earthquake in Gorkha, Nepal, the Geotechnical Extreme Event Reconnaissance (GEER) organization sent two teams to collect data regarding fault ruptures, landslides, soil failures including liquefaction, and structural damage due to geotechnical issues.

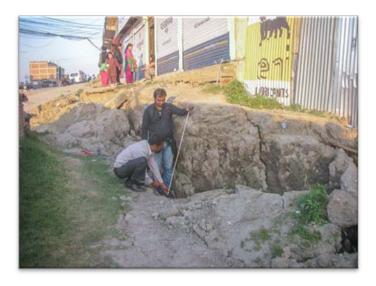
One interesting finding was an observed lateral crack along a highway in Lokanthali, with fissures extended to a depth of 2 m and a nearly 1.5 m vertical offset, on ground sloping toward a channel (Figure 2).

Figure 2. Measurement of a large lateral crack spreading along the highway.

Initially, there was a lack of evidence for liquefaction. However, further trenching uncovered complex failure planes and buried liquefaction escape structures embedded within a thick sand layer. The slip surface from the mainshock seemed to offset this later, suggesting the occurrence of another type of earthquake-induced landslide; lateral spreads. As we discussed in class, lateral spreads generally involved weak soils due to their low residual strengths.
