## CERTIFICATE OF TEST

Report No. : 25-1390-105

Instrument Details : Description : Laminar Air Flow  
Manufacturer : BIOBASE  
Model : BBS-V800  
Serial No. : BBS8V1909291 D  
ID No. : 6530-032-0009-1/63  
Class / Type : Class II / A2  
Location : Special Lab

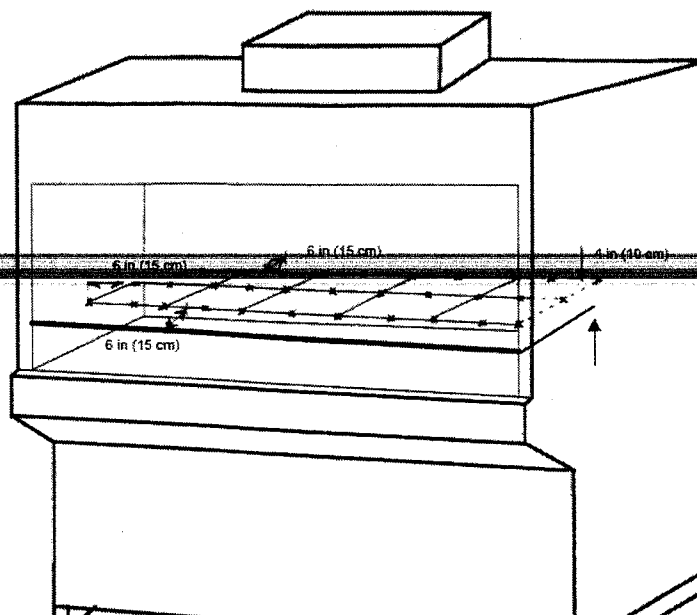
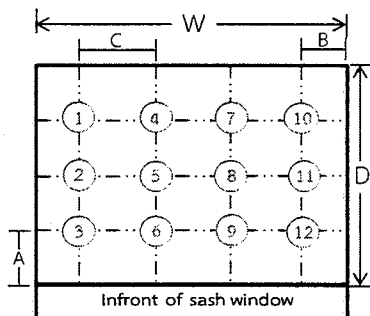
Downflow velocity diagrams of measurement

| Air velocity measurement (m/s) | | | | | |
|---|---|---|---|---|---|
| 0.38 | 0.39 | 0.38 | 0.39 | 0.41 | 0.40 |
| 0.36 | 0.33 | 0.34 | 0.33 | 0.32 | 0.35 |

| Mean<br>Downflow velocity (m/s) | Minimum<br>Downflow velocity (m/s) | Maximum<br>Downflow velocity (m/s) | ± 20% of Mean<br>Downflow velocity (m/s) |
|---|---|---|---|
| 0.37 | 0.32 | 0.41 | 0.30 to 0.44 |

PASS

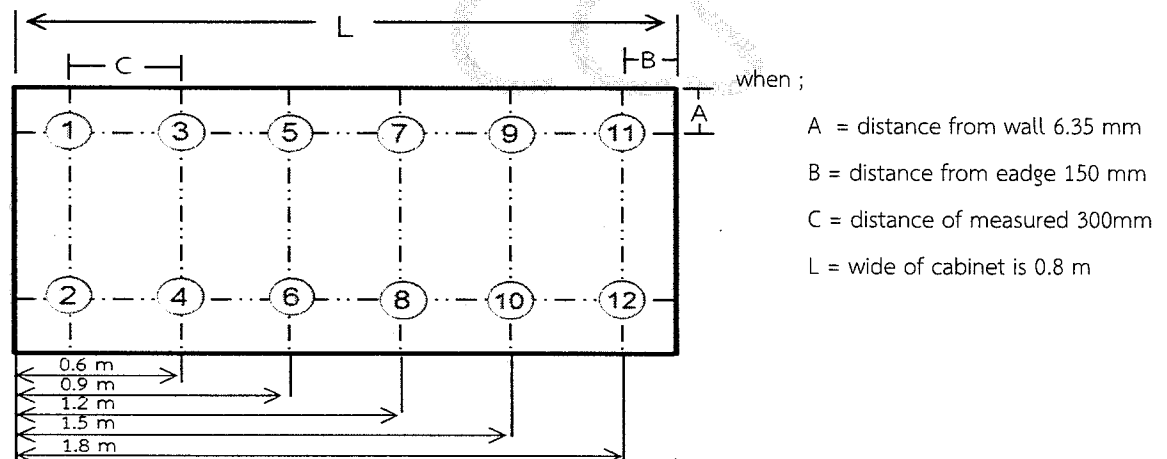
Diangrams of Illumination and UV measured on work surface

| 1 | 2 | 3 | 4 | 5 | 6 | 7 | 8 | 9 | 10 | 11 | 12 |
|---|---|---|---|---|---|---|---|---|---|---|---|
| 761 | 770 | 671 | 822 | 768 | 765 | - | - | - | - | - | - |

| Mean of illumination at<br>work surface (Lux) | Acceptance of illumination<br>(Lux) | Judgment<br>Refer to EN 12469 |
|---|---|---|
| 760 | > 750 | Pass |
