COLORADO DIVISION OF MINERALS AND GEOLOGY  
MINERALS PROGRAM INSPECTION REPORT

MINE NAME: Larimer Quarry OPERATOR: CEMEX, Inc.

MINE ID # OR PROSPECTING ID #: M-1977-341

INSPECTION DATE: 4/20/04

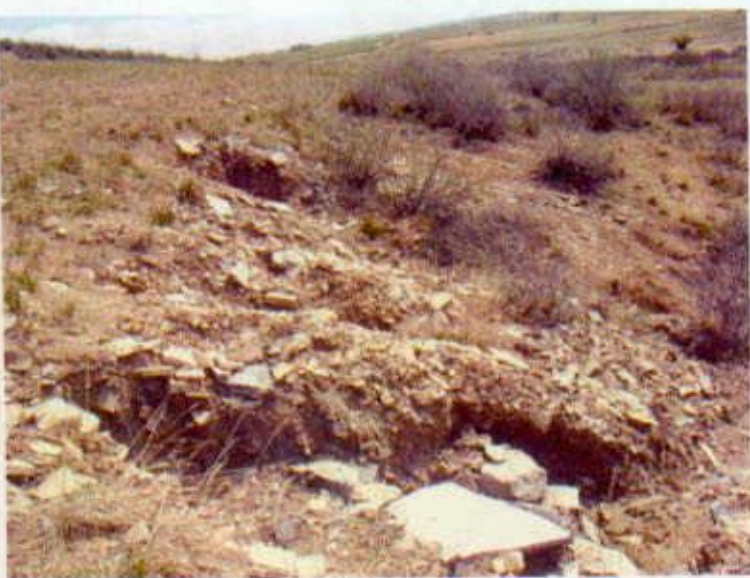
**Topsoil Replacement and Revegetation-** Topsoil has been hauled in and spread over the lower area of the C-Pit. This work was conducted in response to the Division's inspection of December 6, 2002 that identified erosion problems in the area. According to George Martin, approximately 5,000-6,000 tons of topsoil was replaced on 4-acres of disturbed land in the fall of 2003. The area was revegetated in February, 2004 with a dryland seedmixture. Vegetation was starting to emerge in this area, but may take a few years to fully establish. The operator will need to control the presence of noxious weeds in this area if they are present. All parties should be reminded that vegetation must be established before the site can be released in its entirety.

4/20/2004  
Erosion features at base of C-Pit

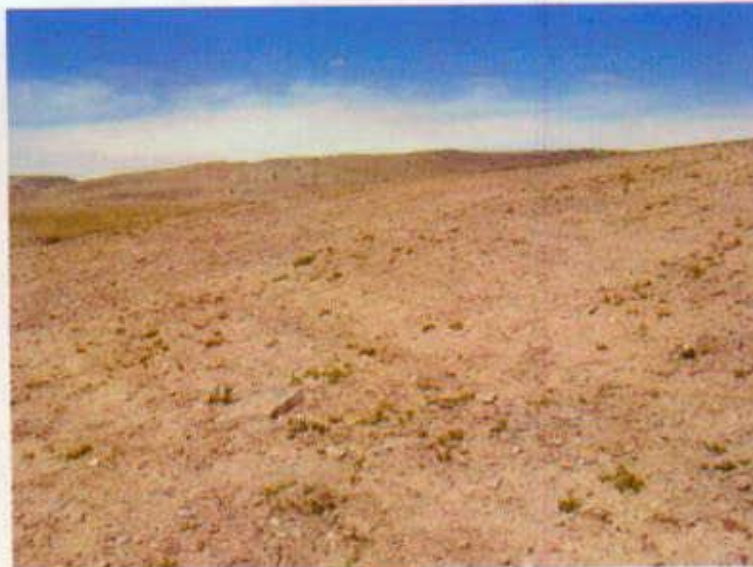
4/20/2004  
C-Pit; topsoiled & seeded in 2003 & 2004

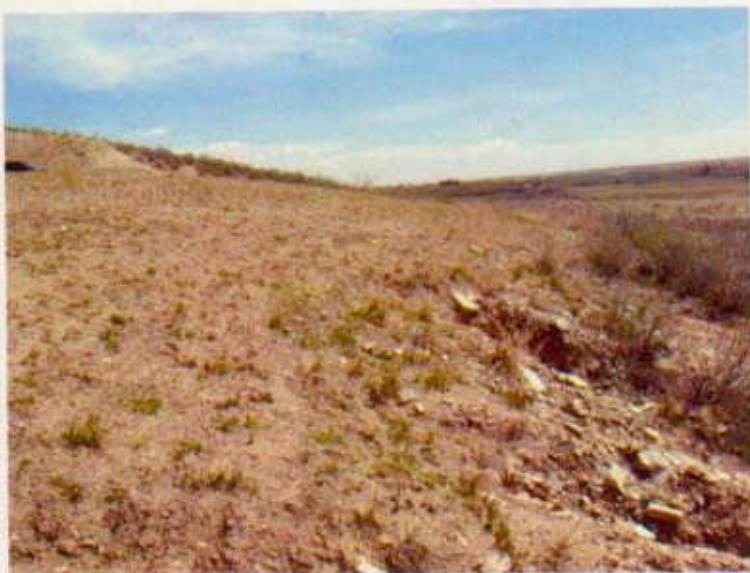
4/20/2004  
Topsoil Replaced & Reseeded at base of C-Pit

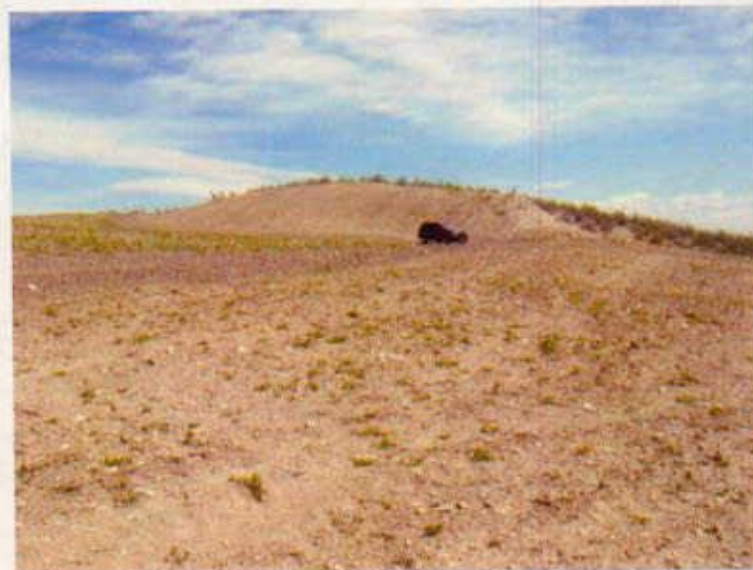
4/20/2004  
Topsoil & Revegetation at base of C-Pit

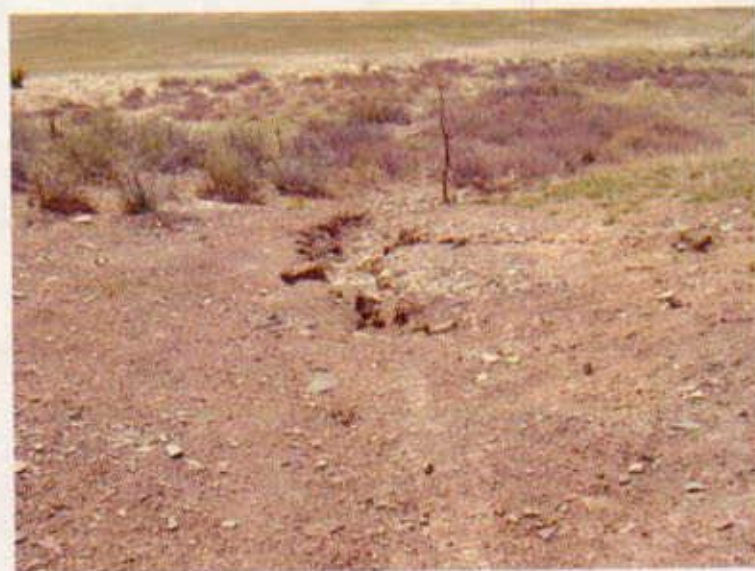
4/20/2004  
Erosion feature at base of C-Pit

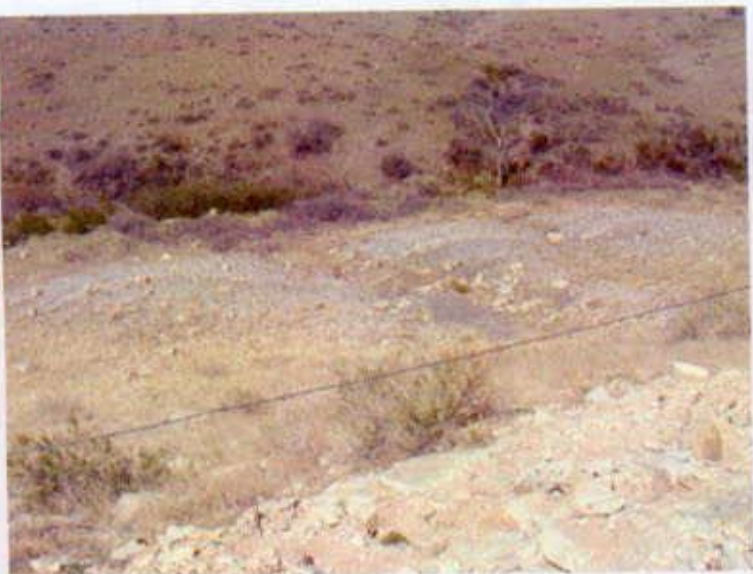
**Rocks-** Large rocks were pushed over the edge of the B-Pit into undisturbed land within the permit boundary. The rocks are located on the west side of the B-pit where mining did not occur. The rocks vary in size from 6" in diameter to over 2 feet in diameter. The rocks appear to be remnants of blasted overburden and limestone mined from the quarry in the 1990's. The natural slope of the undisturbed area is 2h:1v or less. Access to these steep slopes is limited in nature, and the additional rocks should not pose any additional hazard or conflicts to the postmining land use of rangeland. The Division does not believe that these rocks conflict with the postmining land use of rangeland, and do not need to be removed by the operator.

4/20/2004  
B-Pit; rocks on undisturbed area

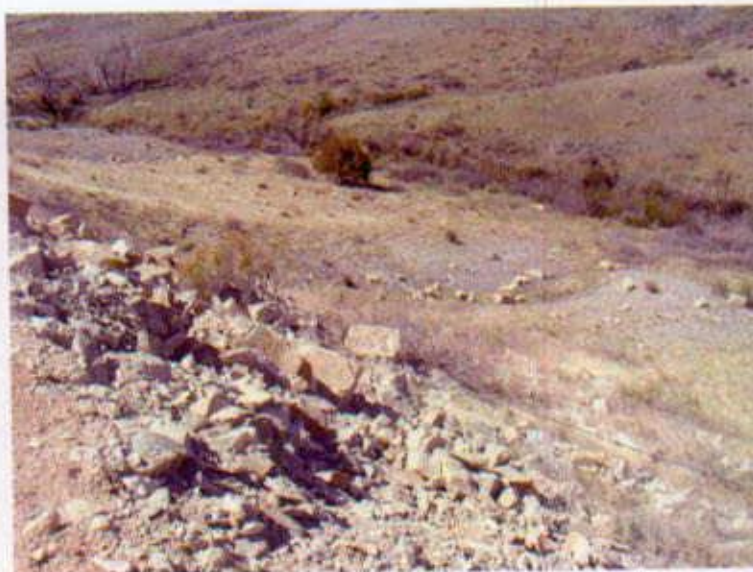
4/20/2004  
B Pit- looking down at rocks

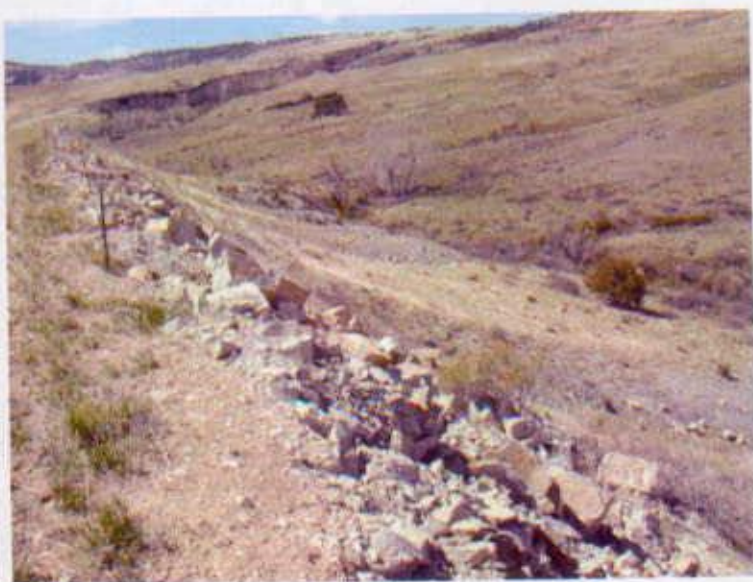
4/20/2004  
B-Pit; rocks in undisturbed area

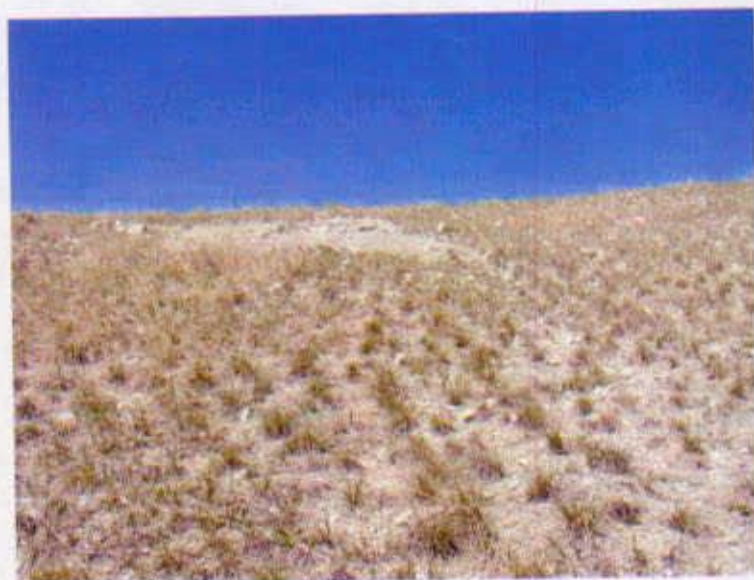
4/20/2004  
B Pit- Area handseeded

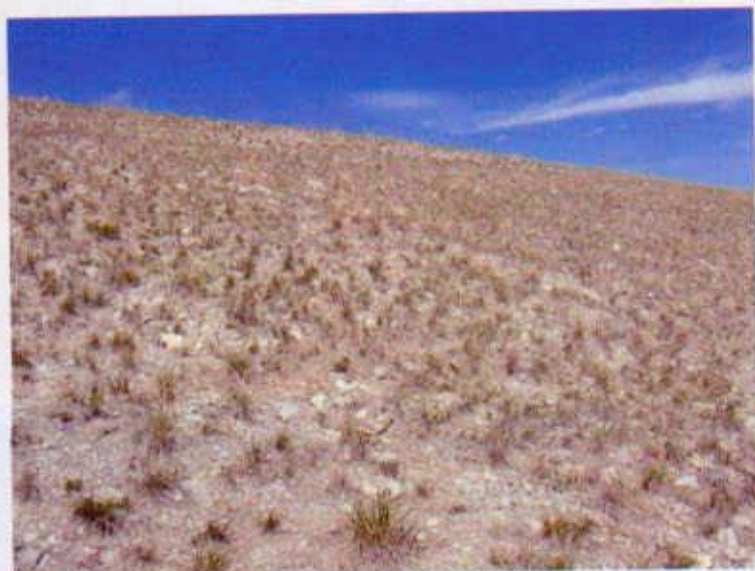
4/20/2004  
B-Pit; Area reseeded

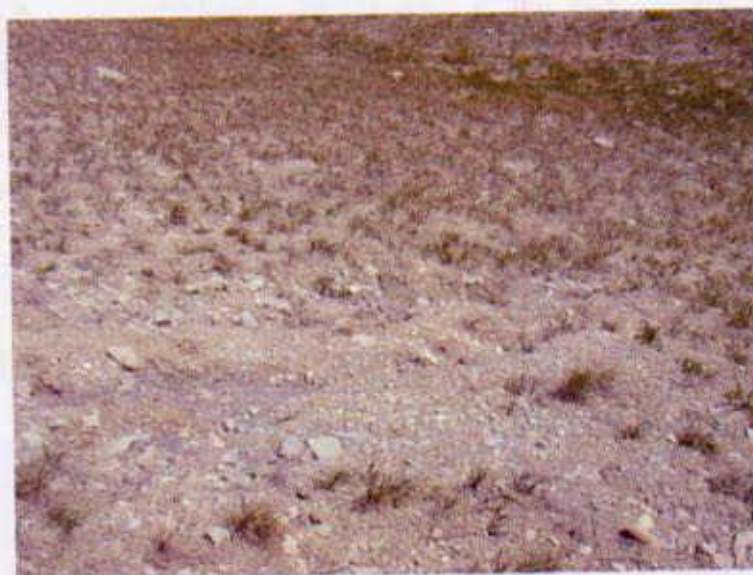
4/20/2004  
B-Pit; Area reseeded by hand

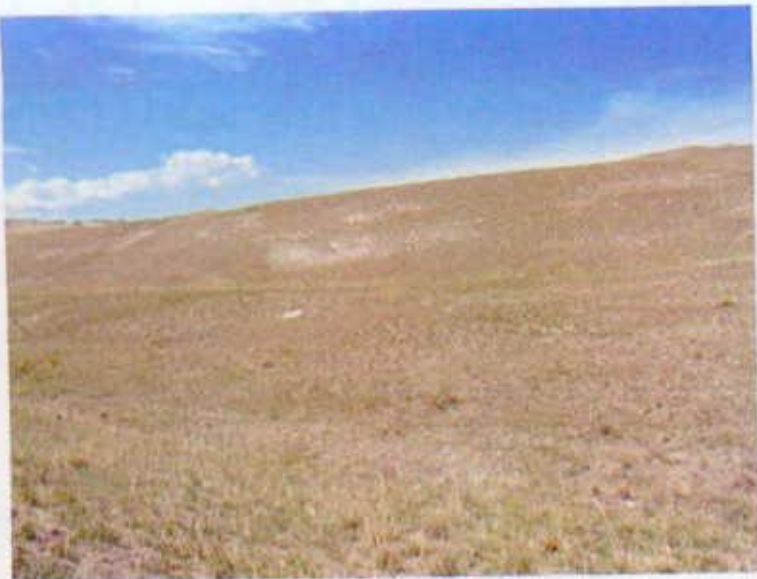
4/20/2004  
View of B-Pit Area reseeded

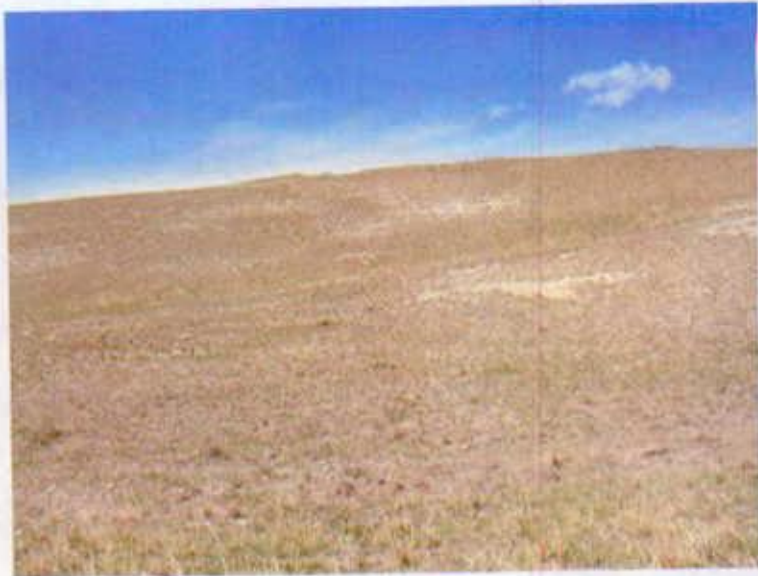
4/20/2004  
B-Pit slope that was hand seeded
