**COLORADO DIVISION OF RECLAMATION, MINING & SAFETY**  
**MINERALS PROGRAM INSPECTION REPORT**  
**PHONE: (303) 866-3567**

MINE NAME: Larimer Quarry OPERATOR: CEMEX, Inc.  
COUNTY: Larimer MINERAL: Limestone TYPE OF OPERATION: 112c  
INSPECTOR(S): Peter Hays *[Signature]* 6/17/08  
MINE ID # OR PROSPECTING ID #: M-1977-341  
INSPECTION DATE: 06/13/08 DATE OF COMPLAINT: NA  
INSPECTOR'S INITIALS: PSH TIME OF DAY (MILITARY): 10:00  
INSPECTION TYPE CODE<sup>(1)</sup>: MI POST INSP. CONTACTS<sup>(2)</sup>: NA  
JOINT INSP. AGENCY CODE<sup>(2)</sup>: NO REASON FOR INSP. CODE<sup>(3)</sup>: IE  
WEATHER CODE<sup>(4)</sup>: CR BOND CALCULATION TYPE<sup>(5)</sup>: NN  
OP. REP. PRESENT: Patrick Fischer with CEMEX, Inc.

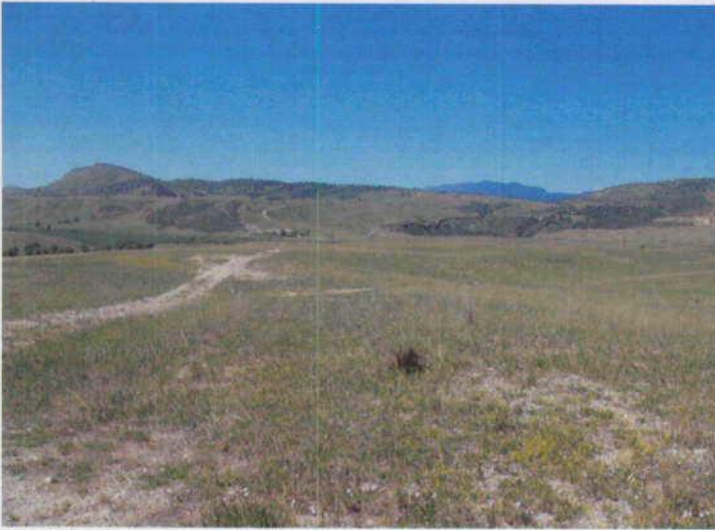
Looking west at the 5-acre area

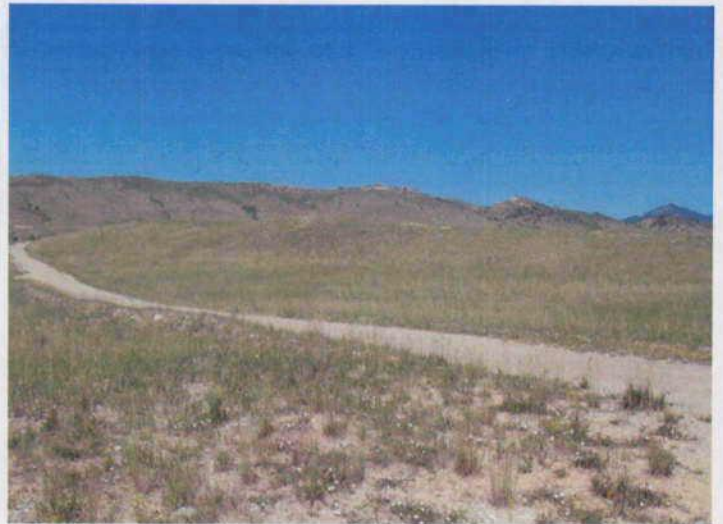
Looking northwest at the 5-acre area

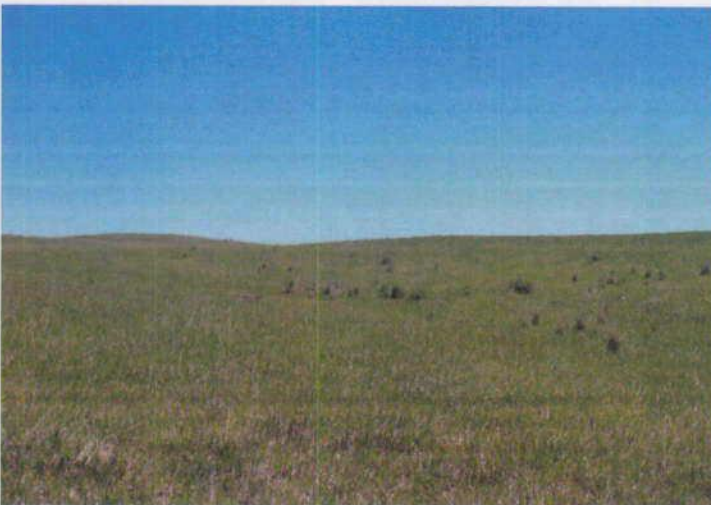
Looking north from bottom of the 5-acre pit

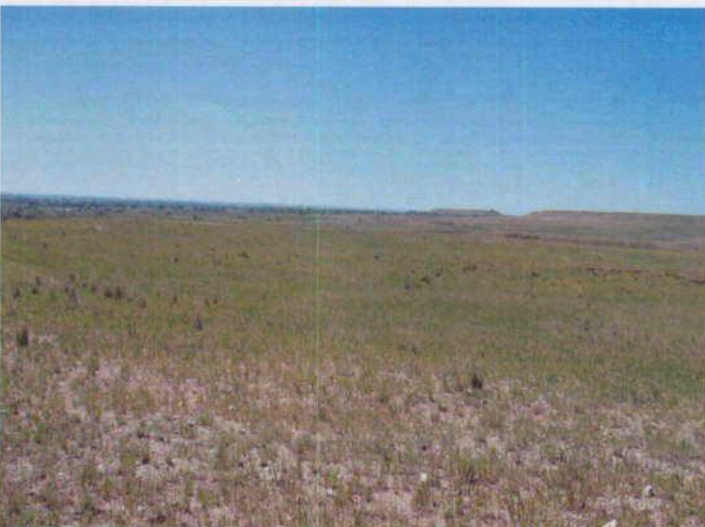
Looking southeast from north side of the 5-acre pit
