CBM - Ultrasonic Leak Detection

Area: Properzi 1 | Plates
Date of Leak Inspection: August 15 2025
Type of Gas: Air - 7 | LPG - 10

Inspected by: Lorenzo Angelo Rabino | 40001240

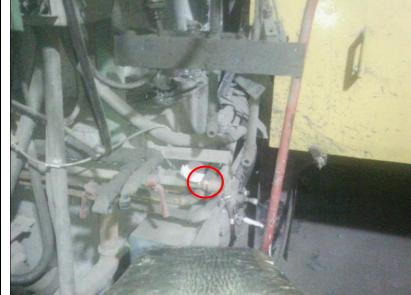
Record Number	1	
Gas Line	LPG	
Location	Properzi 1 21T Melting Pot	
Problem Description	Fabricated Elbow Leak	
dB reading	8	
Size of Leak (CFM)	0.1	
Energy Avoidance(kWH)	N/A	
Cost Avoidance (Php)/ Month	5,187	
Leak Condition (N-New Leak, Previous Rec # - Old Leak)	1	
Leak Category (1,2,3,4)	1,3	
With Isolation Valve	~	
Isolation Affected Area	Properzi 1 21T Melting Pot	
Record Number	2

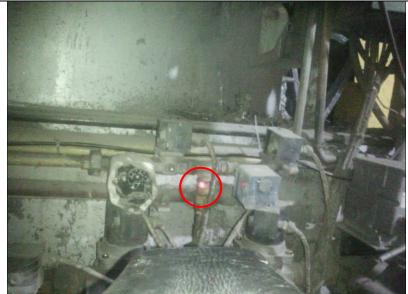
Record Number	2	
Gas Line	LPG	
Location	Properzi 1 21T Melting Pot	
Problem Description	Nipple Pipe Thread Leak	
dB reading	9	
Size of Leak (CFM)	0.1	
Energy Avoidance(kWH)	N/A	
Cost Avoidance (Php)/ Month	6,502	
Leak Condition (N-New Leak, Previous Rec # - Old Leak)	2	
Leak Category (1,2,3,4)	1,3	
With Isolation Valve	✓	
Isolation Affected Area	Properzi 1 21T Melting Pot

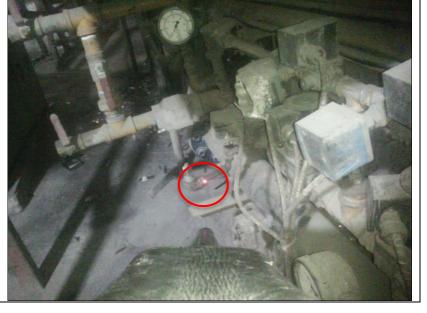
Record Number	3		
Gas Line	LPG		
Location	Properzi 1 21T Melting Pot		
Problem Description	Nipple Pipe Thread Leak		
dB reading	19		
Size of Leak (CFM)	0.3		
Energy Avoidance(kWH)	N/A		
Cost Avoidance (Php)/ Month	27,265		
Leak Condition (N-New Leak, Previous Rec # - Old Leak)	3		
Leak Category (1,2,3,4)	1,3		
With Isolation Valve	✓		
Isolation Affected Area	Properzi 1 21T Melting Pot

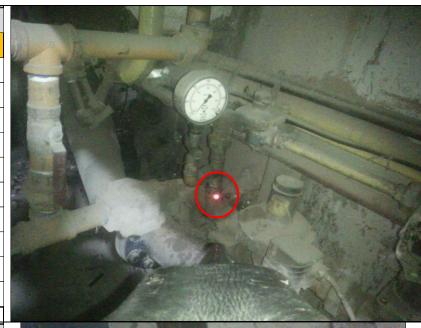
LPG	
Properzi 1 21T Melting Pot	
Union Patente Thread Leak	
8	
0.1	
N/A	
5,187	
4	
1,3	
✓	
Properzi 1 21T Melting Pot

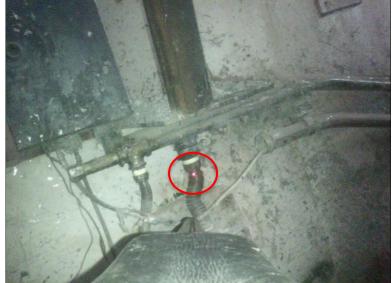
Record Number	5	
Gas Line	LPG	
Location	Properzi 1 8T Melting Pot	
Problem Description	Adapter Thread Leak	
dB reading	21	
Size of Leak (CFM)	0.3	
Energy Avoidance(kWH)	N/A	
Cost Avoidance (Php)/ Month	33,036	
Leak Condition (N-New Leak, Previous Rec # - Old Leak)	5	
Leak Category (1,2,3,4)	1,3	
With Isolation Valve	✓	
Isolation Affected Area	Properzi 1 8T Melting Pot

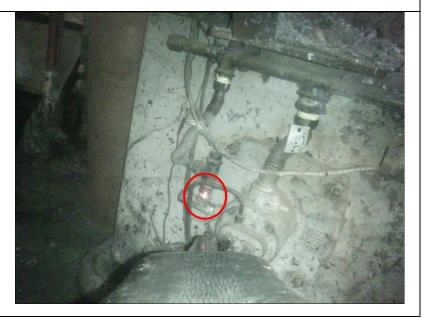
Record Number	6		
Gas Line	LPG		
Location	Properzi 1 8T Melting Pot		
Problem Description	Adapter Thread Leak		
dB reading	7		
Size of Leak (CFM)	0.0		
Energy Avoidance(kWH)	N/A		
Cost Avoidance (Php)/ Month	4,014		
Leak Condition (N-New Leak, Previous Rec # - Old Leak)	6		
Leak Category (1,2,3,4)	1,3		
With Isolation Valve	✓		
Isolation Affected Area	Properzi 1 8T Melting Pot

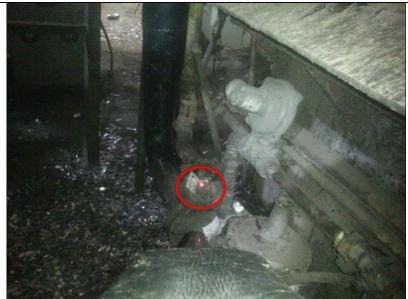
Record Number	7	
Gas Line	LPG	
Location	Properzi 1 8T Melting Pot	
Problem Description	End Plug Thread Leak	
dB reading	9	
Size of Leak (CFM)	0.1	
Energy Avoidance(kWH)	N/A	
Cost Avoidance (Php)/ Month	6,502	
Leak Condition (N-New Leak, Previous Rec # - Old Leak)	7	
Leak Category (1,2,3,4)	1,3	
With Isolation Valve	✓	
Isolation Affected Area	Properzi 1 8T Melting Pot	
Record Number	0

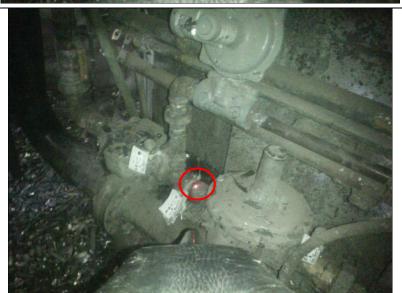
Record Number	8	
Gas Line	LPG	
Location	Properzi 1 8T Melting Pot	
Problem Description	Nipple Pipe Thread Leak	
dB reading	7	
Size of Leak (CFM)	0.0	
Energy Avoidance(kWH)	N/A	
Cost Avoidance (Php)/ Month	4,014	
Leak Condition (N-New Leak, Previous Rec # - Old Leak)	8	
Leak Category (1,2,3,4)	1,3	
With Isolation Valve	✓	
Isolation Affected Area	Properzi 1 8T Melting Pot

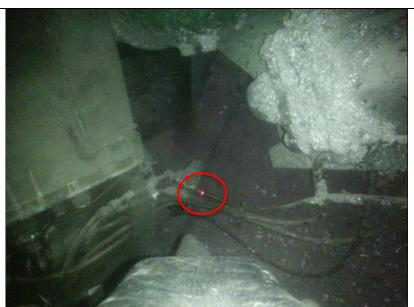
Record Number	13	
Gas Line	Air	
Location	Properzi 1 Casting	
Problem Description	Push-in Male Fittings Leak	
dB reading	76	
Size of Leak (CFM)	5.4	
Energy Avoidance(kWH)	12162	
Cost Avoidance (Php)/ Month	5,169	
Leak Condition (N-New Leak, Previous Rec # - Old Leak)	16	
Leak Category (1,2,3,4)	1,3	
With Isolation Valve	✓	
Isolation Affected Area	Properzi 1 Casting	
Record Number	14	
Gas Line	Air	
Location	Properzi 1 Casting	
Problem Description	Push-in Male Fittings Thread Leak	
dB reading	65	11
Size of Leak (CFM)	4.3	11
Energy Avoidance(kWH)	9623	
Cost Avoidance (Php)/ Month	4,090	
Leak Condition (N-New Leak, Previous Rec # - Old Leak)	17	
Leak Category (1,2,3,4)	1,3	
With Isolation Valve	✓	
Isolation Affected Area	Properzi 1 Casting	
Record Number	15	
Gas Line	Air	
Location	Properzi 1 Casting	MAL
Problem Description	Solenoid Valve Leak	
dB reading	97	
Size of Leak (CFM)	7.8	
Energy Avoidance(kWH)	17528	
Cost Avoidance (Php)/ Month	7,449	Y

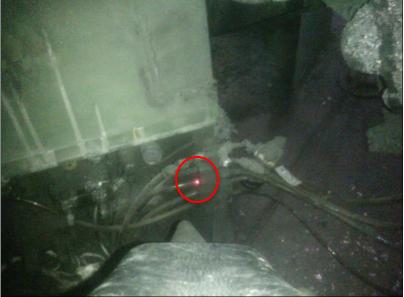
Leak Condition (N-New Leak, Previous Rec # - Old Leak)	18	
Leak Category (1,2,3,4)	1,3	
With Isolation Valve	✓	111

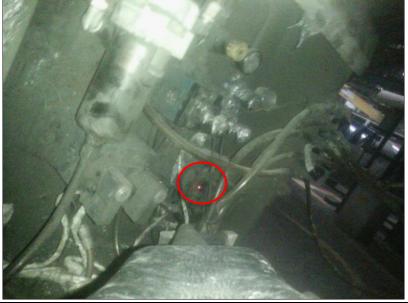
Record Number	16
Gas Line	Air
Location	Properzi 1 Casting
Problem Description	Pneumatic Cylinder Rod Seal Leak
dB reading	61
Size of Leak (CFM)	3.9
Energy Avoidance(kWH)	8750
Cost Avoidance (Php)/ Month	3,719
Leak Condition (N-New Leak, Previous Rec # - Old Leak)	19
Leak Category (1,2,3,4)	1,3
With Isolation Valve	✓
Isolation Affected Area	Properzi 1 Casting
Record Number	
Record Number	17
Gas Line	17
Gas Line	Air
Gas Line Location	Air Properzi 1 Timmer
Gas Line Location Problem Description	Air Properzi 1 Timmer FRL Leak
Gas Line Location Problem Description dB reading	Air Properzi 1 Timmer FRL Leak 69
Gas Line Location Problem Description dB reading Size of Leak (CFM)	Air Properzi 1 Timmer FRL Leak 69 4.7
Gas Line Location Problem Description dB reading Size of Leak (CFM) Energy Avoidance(kWH) Cost Avoidance (Php)/	Air Properzi 1 Timmer FRL Leak 69 4.7
Gas Line Location Problem Description dB reading Size of Leak (CFM) Energy Avoidance(kWH) Cost Avoidance (Php)/ Month Leak Condition (N-New Leak,	Air Properzi 1 Timmer FRL Leak 69 4.7 10524 4,473

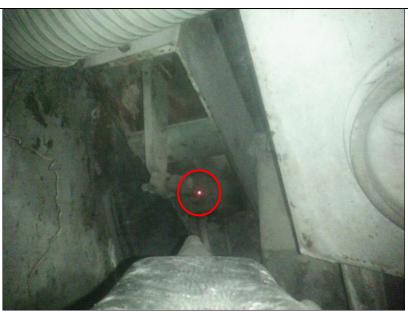
Gas Line Location Problem Description dB reading Size of Leak (CFM) Energy Avoidance(kWH) Cost Avoidance (Php)/ Month Leak Condition (N-New Leak, Previous Rec # - Old Leak)	Air Properzi 1 Timmer FRL Leak 69 4.7 10524 4,473
