## Root cause analysis and Resolution of a brass extrusion mandrel failure

Mandrels made of DIN 1.2367 (AISI H10) hot-work tool steel are critical components in the hot extrusion of seamless C27000/C38500 brass tubes. In this case, after a change in the tooling supplier, mandrel life dropped to ~ 10% of the historical benchmark, with premature brittle fractures occurring during routine production. A comprehensive failure investigation was performed combining chemical composition verification (ASTM E415), tensile testing (ASTM E8), hardness mapping (ASTM E18), surface roughness measurements, Charpy impact testing (ASTM E23), fractographic examination of fracture surfaces, and finite-element simulations of the extrusion stage. The steel chemistry complied with DIN 1.2367; however, the hardness in the upper region exceeded the specified range, consistent with reduced toughness. Fractography showed crack initiation at the inner surface of the cooling channel, where drilling-induced surface damage (e.g., high roughness, burrs, and potential microcracking) served as critical stress concentrators within a region exhibiting hardness gradients. FEM confirmed that this bore is subjected to

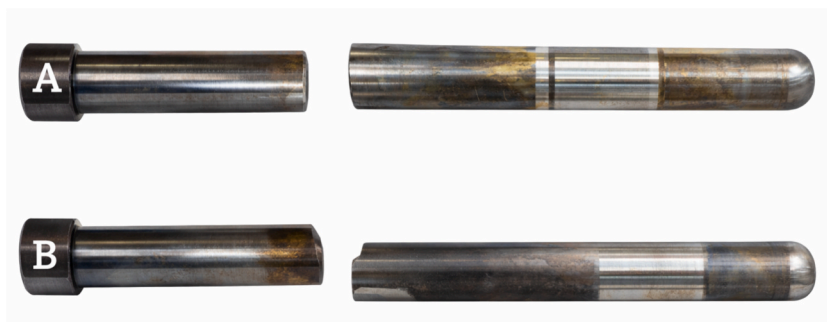
Following a change in the tooling supplier, a significant reduction in the service life of mandrels used for the hot extrusion of seamless tubes was observed. Mandrels from the new batches exhibited brittle fracture during forming, failing to meet the previously established durability criterion (see Fig. 1).

Fig. 1. Examples of brass-tube extrusion mandrels failed by brittle fracture.
