## **Restoring Fish Passage in the Fraser Region - 2023**

**Prepared for  
Ministry of Transportation and Infrastructure**

**Prepared by  
Al Irvine, B.Sc., R.P.Bio. and Lucy Schick, B.Sc.  
New Graph Environment Ltd.**

**Version 0.0.1 2025-03-26**

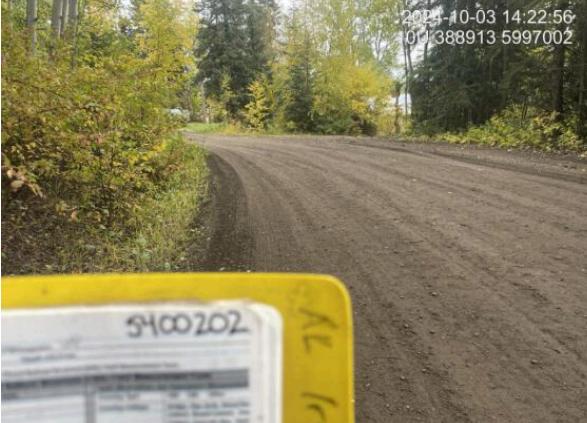
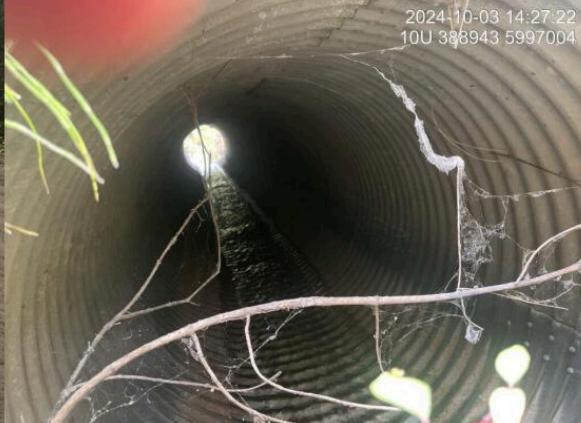
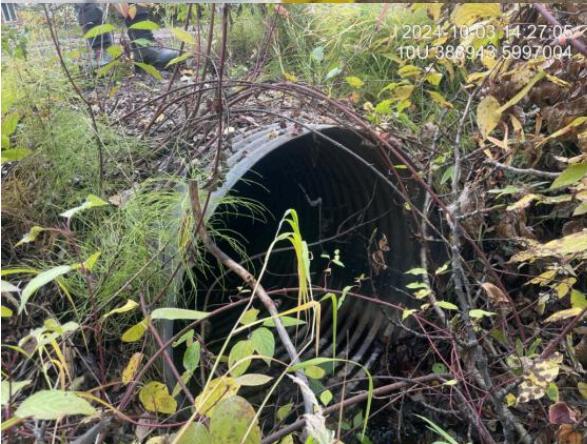
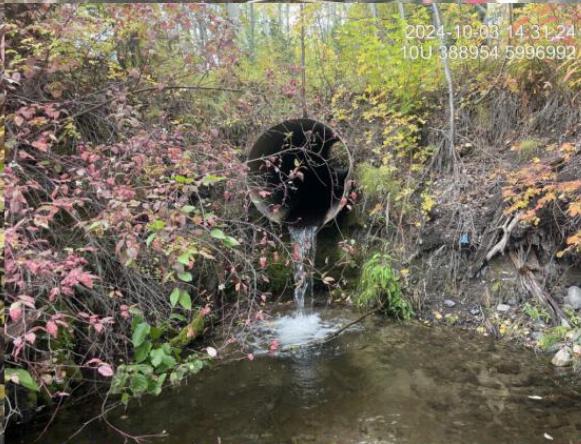
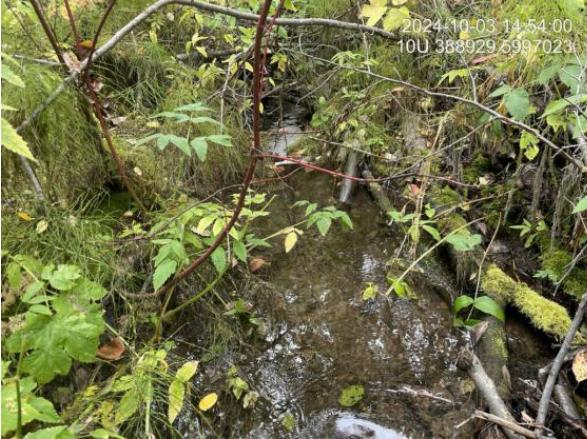
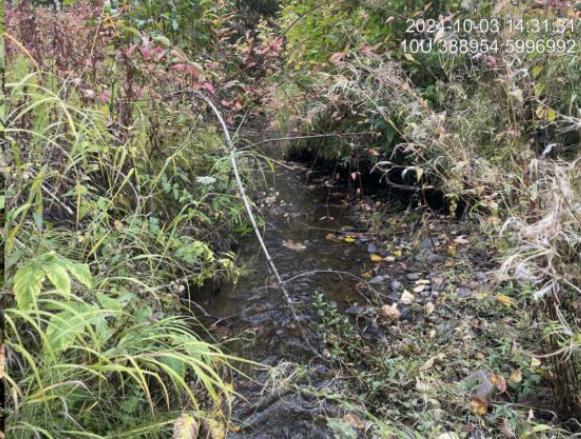
Location and Stream Data	Crossing Characteristics
<p>Comments: The local name of the stream is Burnt Cabin Creek. It had a large outlet drop and a heavily eroded outlet pool, indicating the culvert was undersized. The stream provided complex habitat for fish with abundant cover. The low-traffic dirt road had minimal road fill, making construction relatively straightforward.</p>	
<p>MoTi chris_culvert_id: 1790951</p>	
<p>Photos: From top left clockwise: Road/Site Card, Barrel, Outlet, Downstream, Upstream, Inlet.</p>

Should restoration/maintenance activities proceed, replacement of the Gala Bay Road crossing (199171) with a bridge (15 m span) is recommended. This culvert had a 0.9m outlet drop, likely inhibiting fish passage. At the time of reporting in 2025, the cost of the work is estimated at \$ 1,500,000.

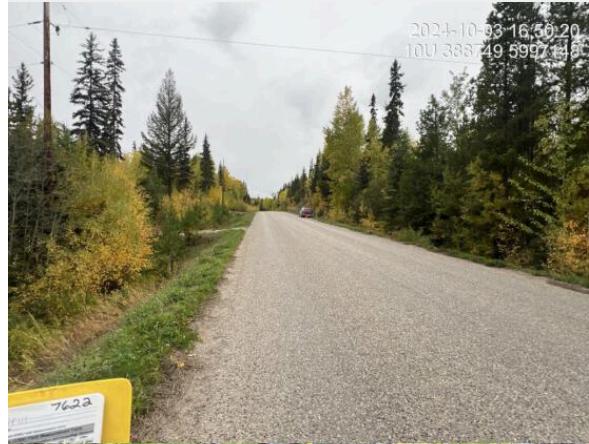
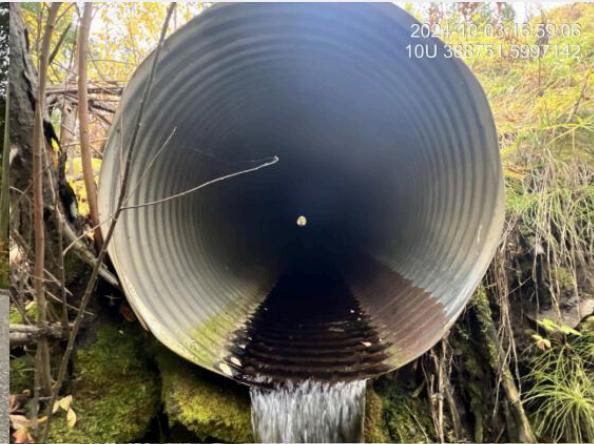
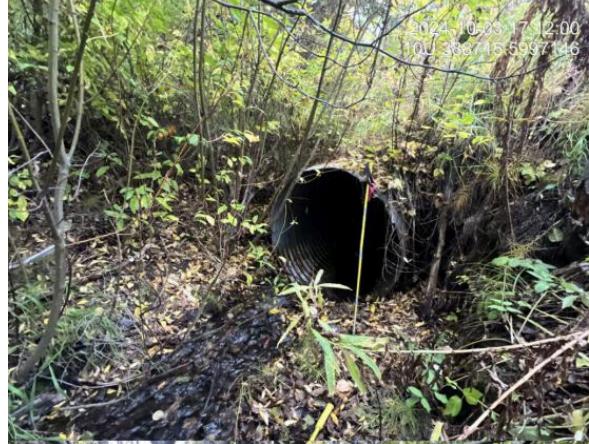
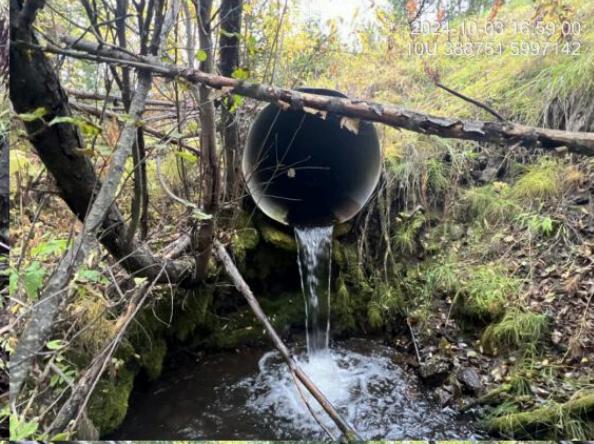
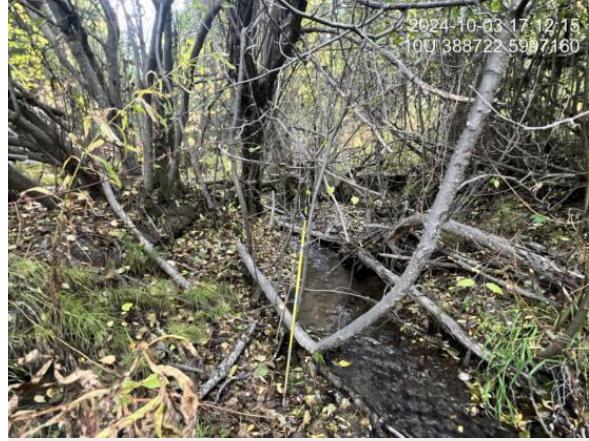
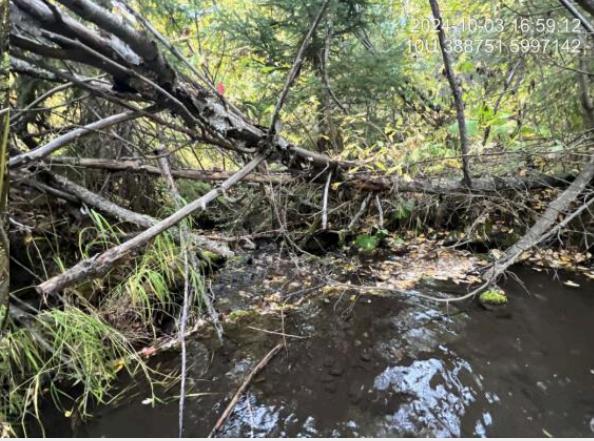
A photograph of a yellow site card with the number "7622" handwritten on it, positioned next to a gravel road in a forested area.

Location and Stream Data	Crossing Characteristics
<p>Comments: The culvert is undersized for current flow volumes, as indicated by a very large 1.15m outlet drop. Habitat confirmation was completed upstream, downstream, and below Gala Bay Road. MoTi chris_culvert_id: 1794196</p>	
<p>Photos: From top left clockwise: Road/Site Card, Barrel, Outlet, Downstream, Upstream, Inlet.</p>

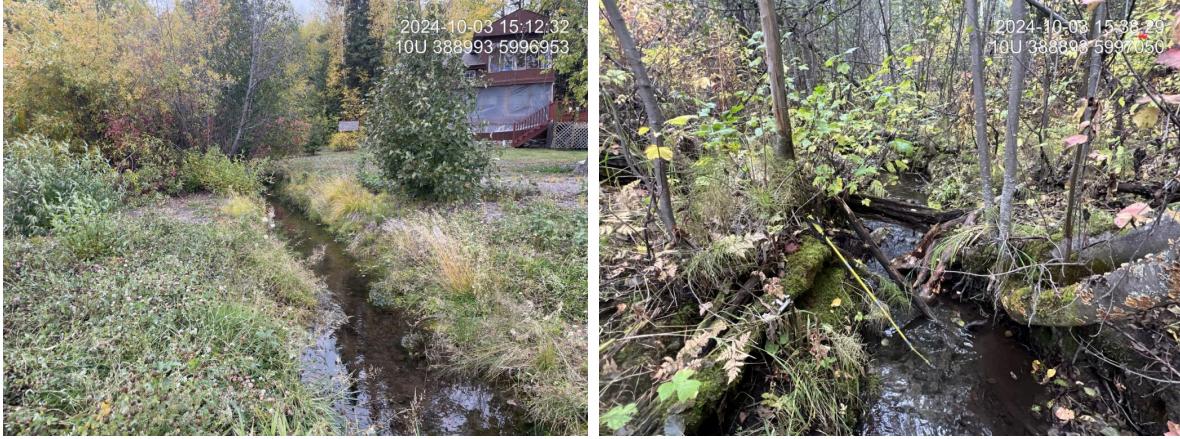
The stream was surveyed downstream from crossing 199171 for 50m (Figure 4.2). The stream was highly channelized due to residential properties on both sides. The habitat was rated as medium with minimal cover and few pools suitable for fish, but gravels were present for spawning. Anecdotal information from a neighboring landowner suggested the stream below Gala Bay Road had been diverted to accommodate a driveway for a recreational property. The average channel width was 2.4m, the average wetted width was 1.4m, and the average gradient was 1.3%. The dominant substrate was gravels with fines sub-dominant. Total cover amount was rated as moderate with overhanging vegetation dominant. Cover was also present as small woody debris and undercut banks.

The stream was surveyed upstream from crossing 199171 for 275m , all the way to crossing 7622 on Stella Road (Figure 4.2) The habitat was rated as medium value, with good flow and abundant gravels, flowing through several private properties with newly established quad and foot traffic trails. Pools were limited and predominantly shallow. Total cover amount was rated as moderate with small woody debris dominant. Cover was also present as large woody debris, undercut banks, and overhanging vegetation. The average channel width was 2.4m, the average wetted width was 1.2m, and the average gradient was 4.5%. The dominant substrate was gravels with cobbles sub-dominant.

Figure 4.2: Left: Typical habitat downstream of PSCIS crossing 199171. Right: Typical habitat upstream of PSCIS crossing 199171 and downstream of PSCIS crossing 7622.

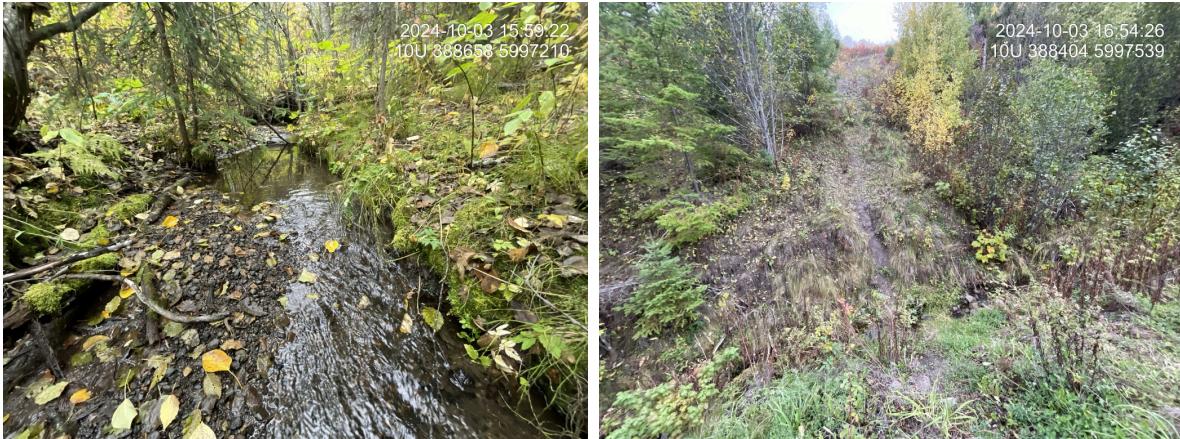
Figure 4.3: Left: Typical habitat upstream of PSCIS crossing 7622. Right: Bank erosion and riparian removal at the pipeline upstream of crossing 7622.

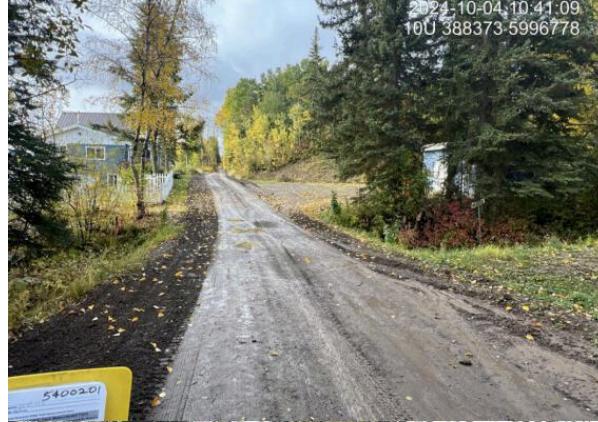
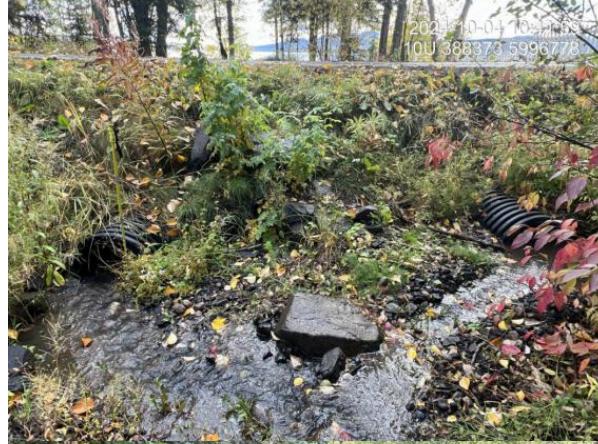
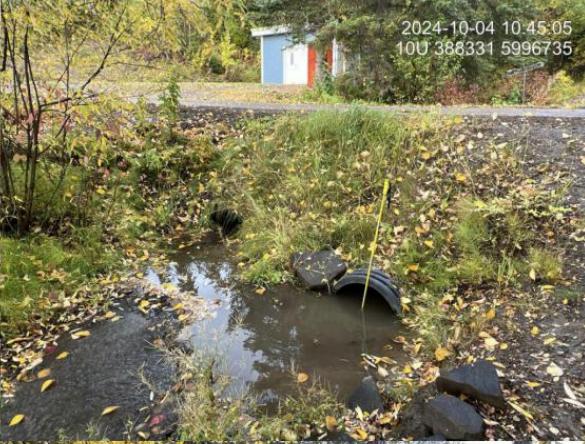
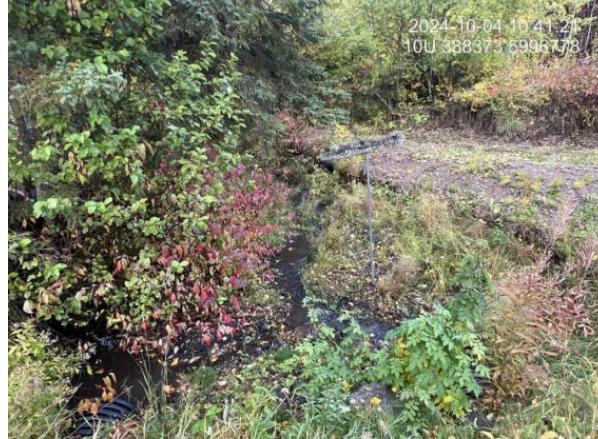
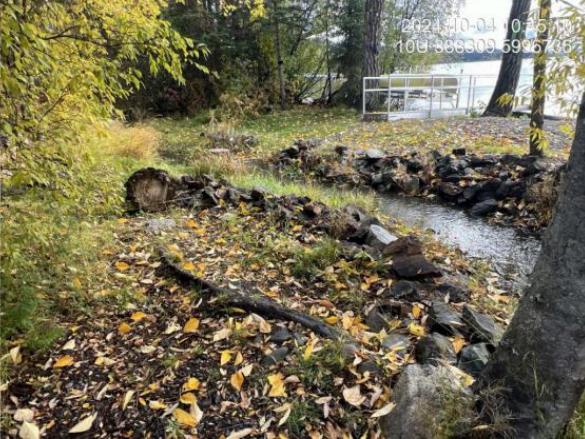
Location and Stream Data	Crossing Characteristics
<p>Comments: Two fully embedded PVC pipes, each 0.7m in diameter. One pipe was completely backwatered. Medium-value habitat was observed, with extensive gravels suitable for spawning upstream and downstream. A historic Chinook spawning point was recorded adjacent to the road. Habitat confirmations were conducted upstream, downstream, and above Stella Road. MoTi chris_culvert_id: 1790947</p>	
Photos: From top left clockwise: Road/Site Card, Barrel, Outlet, Downstream, Upstream, Inlet.

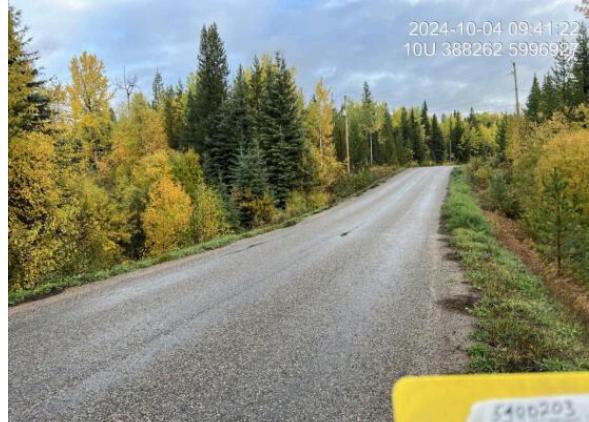
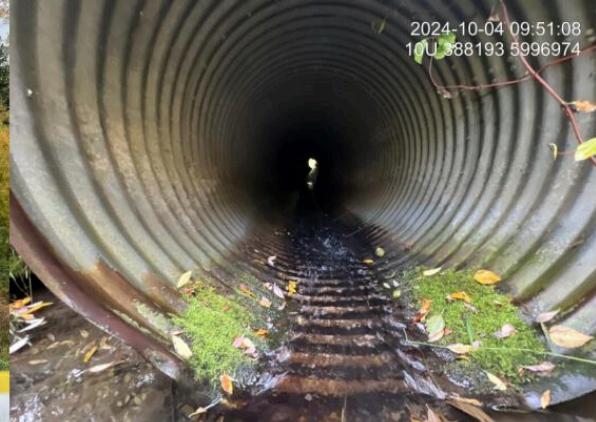
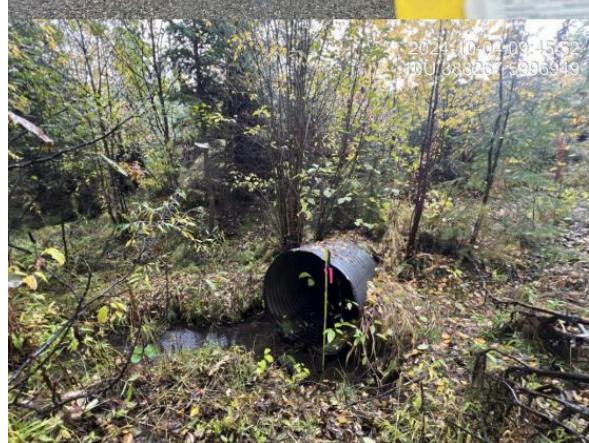
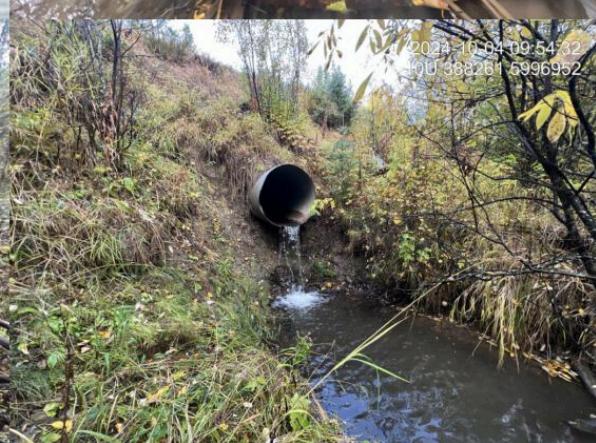
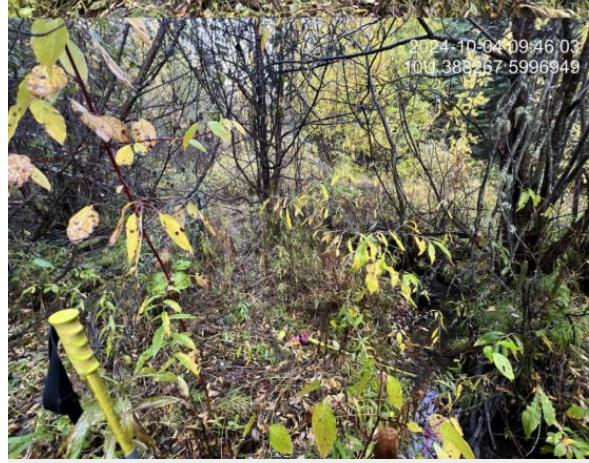
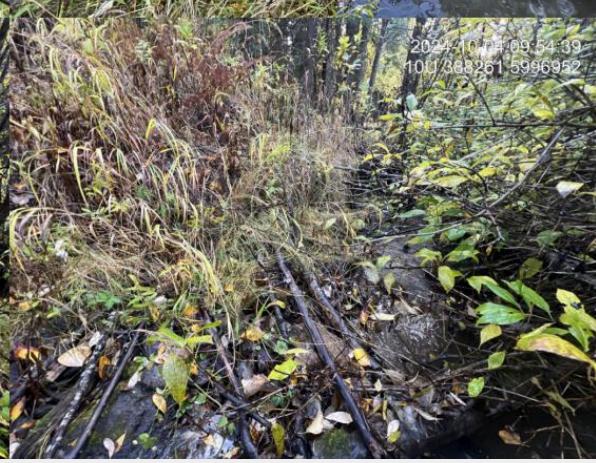
Table 4.16: Summary of fish passage assessment for PSCIS crossing 203297.

Location and Stream Data	Crossing Characteristics
<p>Comments: The culvert was very undersized for the stream, as evidenced by the large outlet drop. The stream had a good amount of flow for the time of year. Habitat was of medium value, with abundant large woody debris creating complex habitat and pools, providing ample cover for fish. Adjacent landowners reported that the stream was previously used as a water source for bottling and distribution across the province. Habitat confirmation was completed upstream and downstream. MoTi chris_culvert_id: 1794199</p> <p>Photos: From top left clockwise: Road/Site Card, Barrel, Outlet, Downstream, Upstream, Inlet.</p>

<b>Location and Stream Data</b>		<b>Crossing Characteristics</b>	
Date	2024-10-04	Crossing Sub Type	Round Culvert
PSCIS ID	203297	Diameter (m)	1.05
External ID	2024100450	Length (m)	8
Crew	LS	Embedded	No
UTM Zone	10	Depth Embedded (m)	—
Easting	388199	Resemble Channel	No
Northing	5997060	Backwatered	No
Stream	Scotch Creek	Percent Backwatered	—
Road	Private Driveway	Fill Depth (m)	2
Road Tenure	Private	Outlet Drop (m)	0.7
Channel Width (m)	2.5	Outlet Pool Depth (m)	0.55
Stream Slope (%)	4	Inlet Drop	No
Beaver Activity	No	Slope (%)	2
Habitat Value	Medium	Valley Fill	Deep Fill
Final score	31	Barrier Result	Barrier
Fix type	Replace with New Open Bottom Structure	Fix Span / Diameter	15
Comments: Two pipes, 0.6m and 0.45m in diameter, were present. There was a 0.7m outlet drop, and only the larger pipe conveyed flow. The inlet side of the road had completely eroded into the stream, obstructing the view of the inlet. No light was visible through the culverts from the outlet side, though water was still flowing. A landowner had placed a barricade across the road, likely to prevent access due to severe erosion of the road. The stream provided high-quality habitat with abundant large woody debris creating pools and gravels suitable for spawning. Just downstream, a functioning water intake shack was located in the middle of the stream, likely supplying the adjacent landowner's property. Plastic pipes extended from the intake shack downstream to the lower Stella Road crossing. The heavily overgrown and collapsing road appeared to be private access and would be a good candidate for removal. Due to inlet erosion, culvert length and slope were estimated as the inlet could not be located.

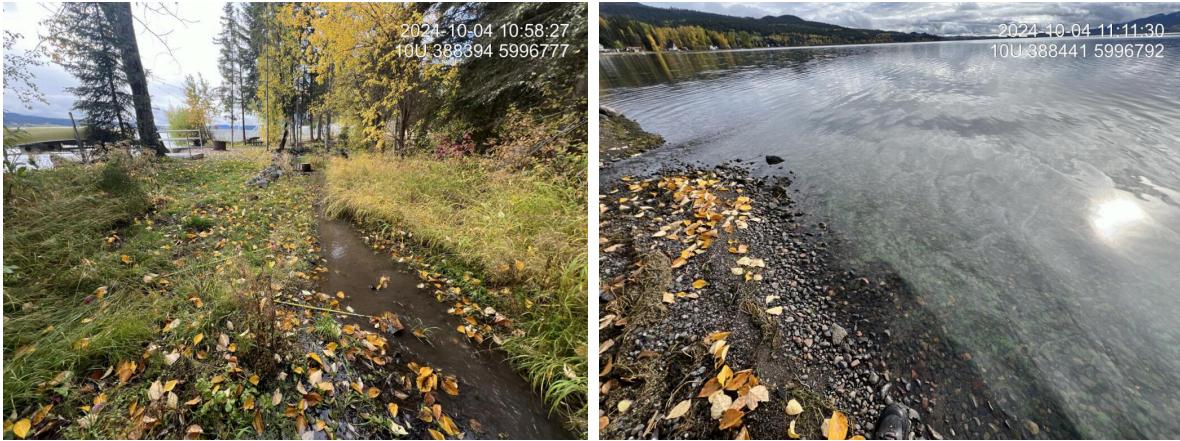
Figure 4.4: Left: Typical habitat downstream of PSCIS crossing 199328. Right: Algal bloom observed downstream of PSCIS crossing 199328 in Fraser Lake.

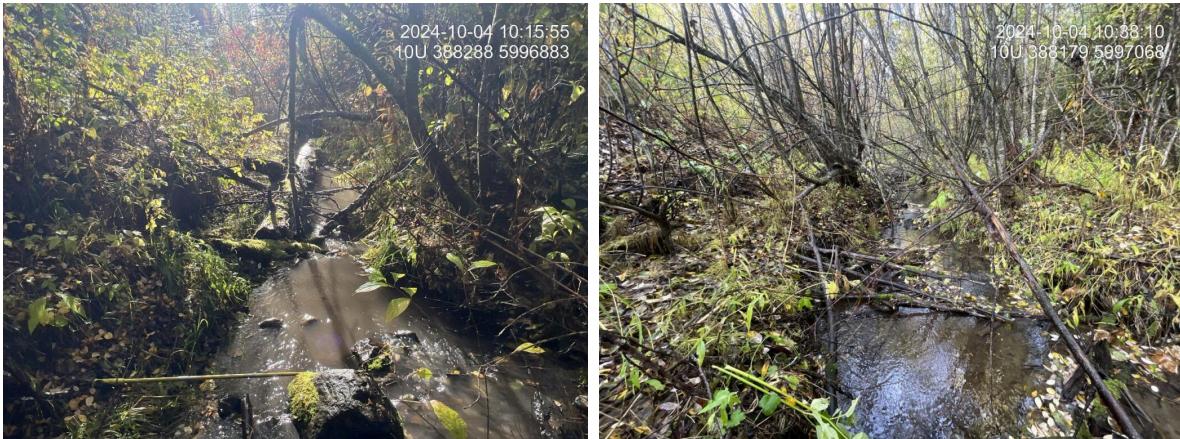
The stream was surveyed from Gala Bay Road upstream to Stella Road, a distance of approximately 270m (Figure 4.5) The habitat was rated as medium value, with limited pools; however, abundant overhanging vegetation and small woody debris provided cover, and gravels suitable for resident salmonid spawning were present. Incision was evident, beginning with a deep cut at the culvert outlet under Stella Road and continuing downstream to Gala Bay Road. The riparian area was generally intact through most of the survey, except for the downstream 75m, where private land development on the north side had resulted in a lawn and riparian vegetation removal up to the channel edge. Total cover amount was rated as moderate with overhanging vegetation dominant. Cover was also present as small woody debris and undercut banks.The dominant substrate was gravels with cobbles sub-dominant.The average channel width was 2.1m, the average wetted width was 1.3m, and the average gradient was 3%.

The stream was surveyed upstream from crossing 199172 for 550m (Figure 4.5). The habitat was rated as medium value, with abundant functional large woody debris creating pools 20–30cm deep, suitable for overwintering juvenile fish. Overhead cover was extensive, and occasional gravels were suitable for spawning. Approximately 400m upstream of Stella Road, the stream transitioned into a beaver-impounded area with four consecutive dams (1–1.5m high) impounding a large volume of water. Flow was maintained over or under the dams and the impounded area extended to the upper end of the surveyed area. A fish (~40mm) was observed after the second dam. The dominant substrate was gravels with fines sub-dominant.The average channel width was 2.6m, the average wetted width was 1.5m, and the average gradient was 4.3%.Total cover amount was rated as abundant with large woody debris dominant. Cover was also present as small woody debris, undercut banks, and overhanging vegetation.

Figure 4.5: Left: Typical habitat upstream of PSCIS crossing 199328 and downstream of PSCIS crossing 199172. Right: Typical habitat upstream of PSCIS crossing 199172.

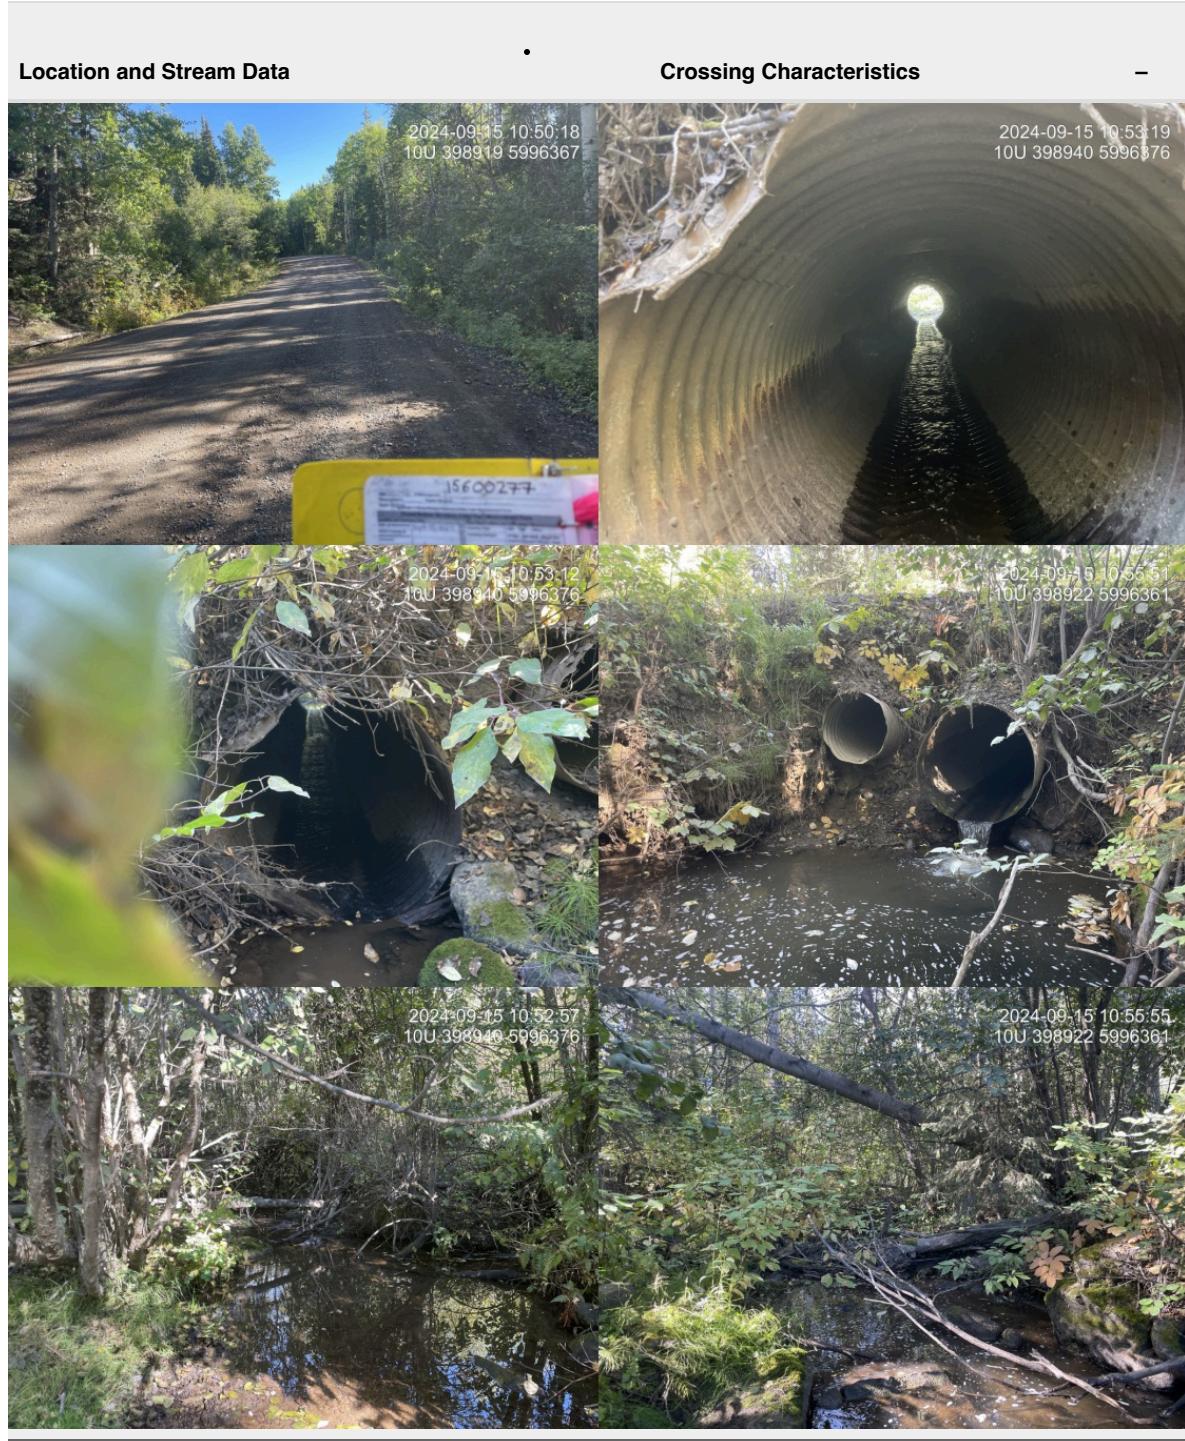
<b>Location and Stream Data</b>		<b>Crossing Characteristics</b>	
Date	2024-09-15	Crossing Sub Type	Round Culvert
PSCIS ID	199173	Diameter (m)	0.9
External ID	–	Length (m)	10
Crew	LS, AI	Embedded	No
UTM Zone	10	Depth Embedded (m)	–
Easting	398923	Resemble Channel	No
Northing	5996362	Backwatered	No
Stream	Tributary To Nechako River	Percent Backwatered	–
Road	Dog Creek Road	Fill Depth (m)	1
Road Tenure	MOTI	Outlet Drop (m)	0.35
Channel Width (m)	3	Outlet Pool Depth (m)	0.7
Stream Slope (%)	4	Inlet Drop	No
Beaver Activity	Yes	Slope (%)	2.5
Habitat Value	Medium	Valley Fill	Deep Fill
Final score	31	Barrier Result	Barrier
Fix type	Replace with New Open Bottom Structure	Fix Span / Diameter	15
Comments: The culvert had a moderate outlet drop with some erosion around the pipe at the outlet. The pipe was in good condition. The stream provided excellent habitat, with several pools and abundant undercut banks. Fish were observed during the assessment (~40-90mm in length). Upstream of the crossing, the stream was channelized with some pockets of gravel suitable for rearing rainbow trout and potentially Chinook. It then transitioned into beaver-impounded wetland areas storing large quantities of water, likely sustaining year-round stream flow at this crossing. Photos: From top left clockwise: Road/Site Card, Barrel, Outlet, Downstream, Upstream, Inlet.

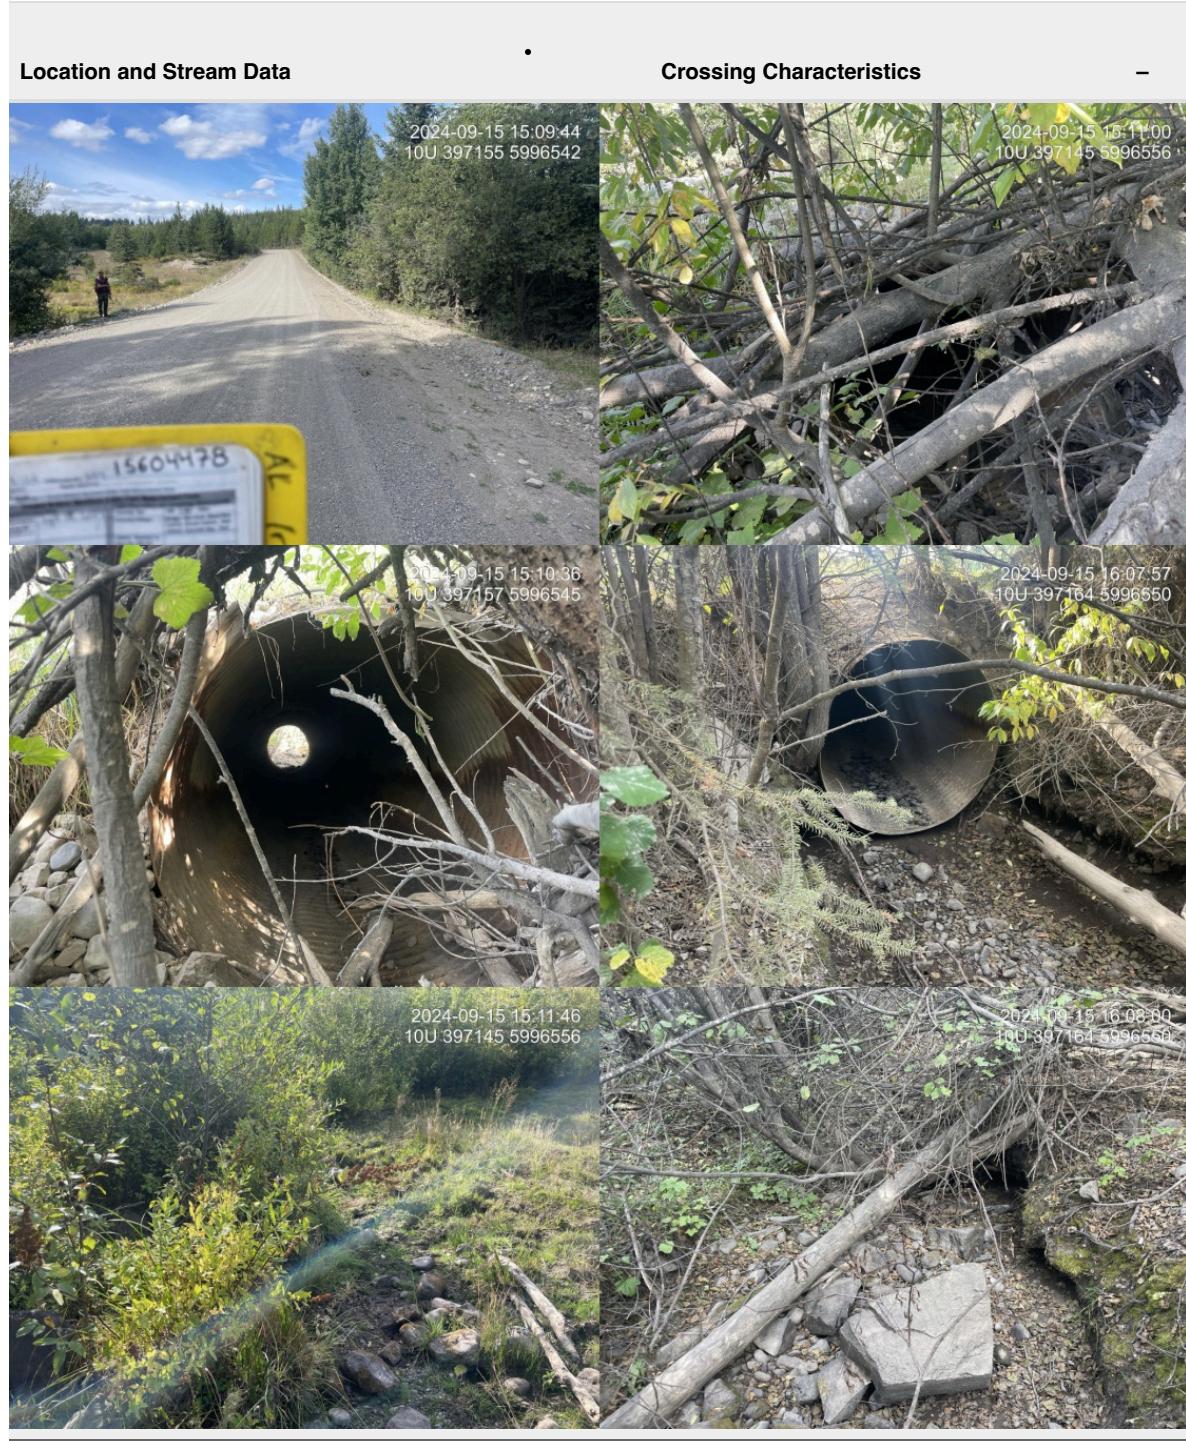
Location and Stream Data		Crossing Characteristics	
Date	2024-09-15	Crossing Sub Type	Round Culvert
PSCIS ID	199174	Diameter (m)	1.5
External ID	–	Length (m)	15
Crew	LS	Embedded	No
UTM Zone	10	Depth Embedded (m)	–
Easting	397160	Resemble Channel	No
Northing	5996574	Backwatered	No
Stream	Tributary To Nechako River	Percent Backwatered	–
Road	Sutherland FSR	Fill Depth (m)	0.4
Road Tenure	MoF	Outlet Drop (m)	0
Channel Width (m)	2.5	Outlet Pool Depth (m)	0
Stream Slope (%)	1.2	Inlet Drop	No
Beaver Activity	No	Slope (%)	1
Habitat Value	–	Valley Fill	Deep Fill
Final score	24	Barrier Result	Barrier
Fix type	Replace with New Open Bottom Structure	Fix Span / Diameter	15
<p>Comments: At the time of assessment, the stream was dry at the crossing; however, it contained medium-value habitat. Upstream of the culvert, the stream was primarily dry for the first 300m, then intermittent pools began to appear, associated with beaver activity. Approximately 450-500m upstream, the stream became nearly fully watered, with pools up to 40cm deep. Downstream of the crossing was dominated by beaver-impounded wetland areas, which were storing large quantities of water, likely sustaining year-round stream flow at the downstream crossing on Dog Creek Road. Further downstream, approximately 300m upstream of the crossing on Dog Creek Road, the stream transitioned to a channelized system with some pockets of gravel suitable for rearing rainbow trout and potentially Chinook. However, heavy cattle impacts were observed at both this crossing and the downstream crossing on Dog Creek Road.</p> <p>Photos: From top left clockwise: Road/Site Card, Barrel, Outlet, Downstream, Upstream, Inlet.</p>

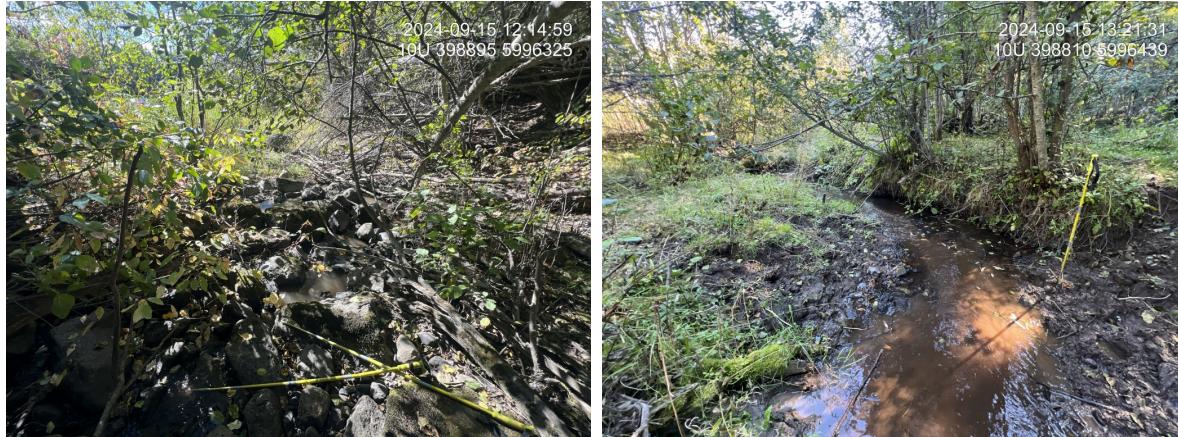
The stream was surveyed downstream from crossing 199173 for 115m (Figure 4.6). The habitat was rated as medium value, with undercut banks suitable for juvenile chinook and rainbow trout rearing. No natural or man-made barriers were present between Dog Creek Road and the Nechako River. Fish (~40–90mm in length) were observed during the assessment. The dominant substrate was cobbles with fines sub-dominant. The average channel width was 3.5m, the average wetted width was 1.3m, and the average gradient was 6%. Total cover amount was rated as moderate with undercut banks dominant. Cover was also present as small woody debris and boulders.

The stream was surveyed upstream from crossing 199173 for 575m (Figure 4.6). The habitat was rated as medium with pockets of gravels suitable for rainbow trout and potentially chinook rearing, and fish were observed throughout the survey area. Heavy cattle impacts were evident, particularly in low-gradient sections with easily accessible banks. Fencing intended to restrict cattle access was present but had been breached. Approximately 300–350m upstream, the stream transitioned from a channelized section to a beaver-impounded wetland, with over three mature dams—some up to 1.5m high—vegetated and well-developed. These dams impounded large volumes of water, likely sustaining year-round stream flow downstream at the Dog Creek Road crossing. Total cover amount was rated as moderate with small woody debris dominant. Cover was also present as large woody debris, deep pools, and overhanging vegetation. The average channel width was 3m, the average wetted width was 1.5m, and the average gradient was 2.4%.

Figure 4.6: Left: Typical habitat downstream of PSCIS crossing 199173. Right: Typical habitat upstream of PSCIS crossing 199173.

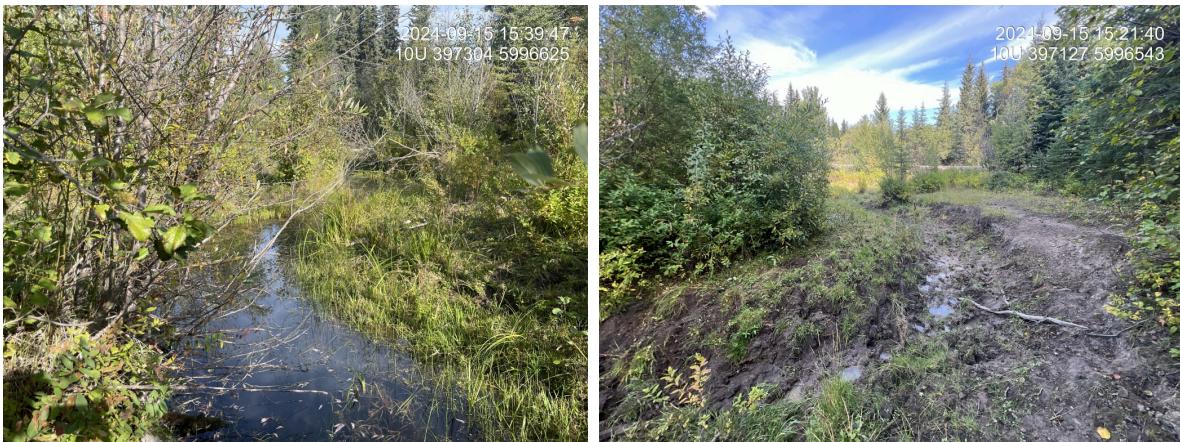
The stream was surveyed downstream from crossing 199174 for 300m (Figure 4.7). The stream was intermittent for the first ~70m before transitioning into a beaver-impacted wetland area. Approximately 250m downstream of Sutherland FSR, several large, mature, consecutive beaver dams were present and appeared to continue as far as the area surveyed. Signs of cattle trampling were observed throughout the stream, and the channel frequently split into several smaller channels. The habitat was rated as medium value, with few gravels for spawning but abundant pools created by beaver dams. The dominant substrate was fines with gravels sub-dominant. The average channel width was 2m, the average wetted width was 1m, and the average gradient was 1.2%. Total cover amount was rated as abundant with small woody debris dominant. Cover was also present as large woody debris, undercut banks, deep pools, and overhanging vegetation.

The stream was surveyed upstream from crossing 199174 for 650m (Figure 4.7). The habitat was rated as medium value and had been heavily impacted by cattle, with evidence of bank trampling and extensive low-gradient muddy sections. Upstream of the culvert, the stream was primarily dry for the first 300m, with young forest and shrubs. At this point, intermittent pools began to appear,

Figure 4.7: Left: Typical habitat downstream of PSCIS crossing 199174. Right: Typical habitat upstream of PSCIS crossing 199173.

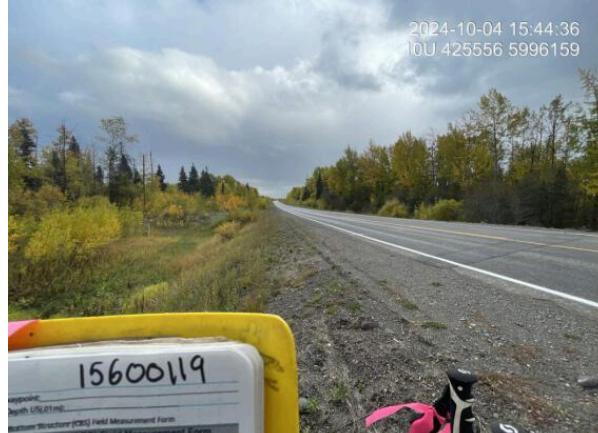
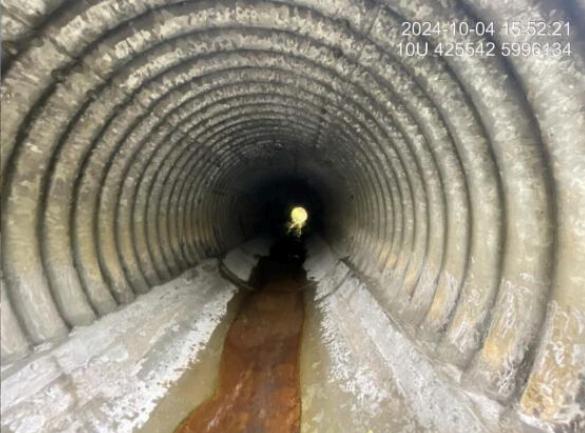
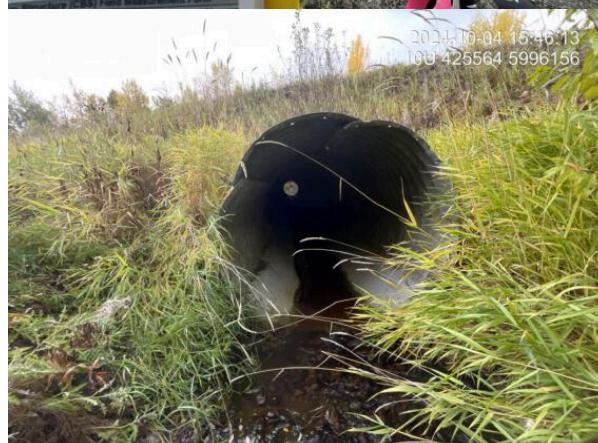
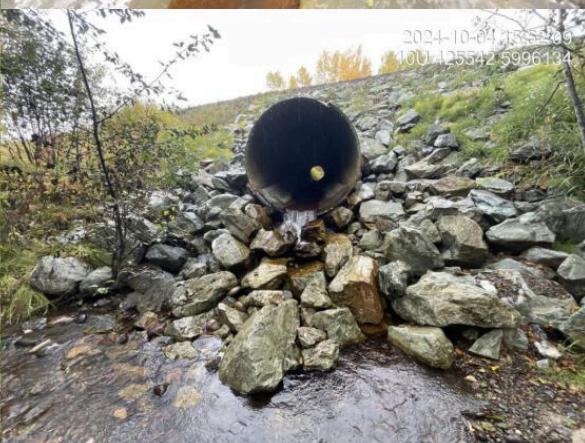
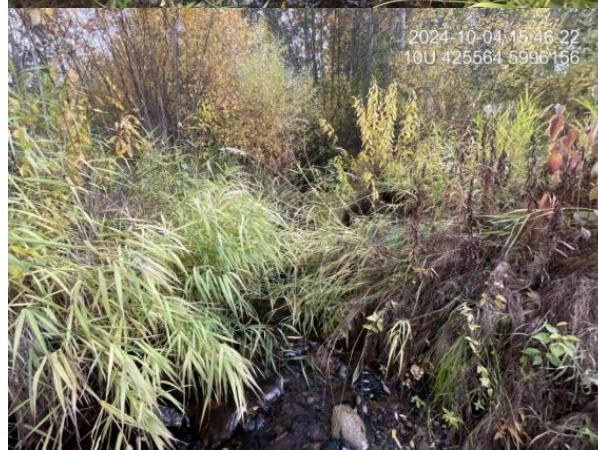
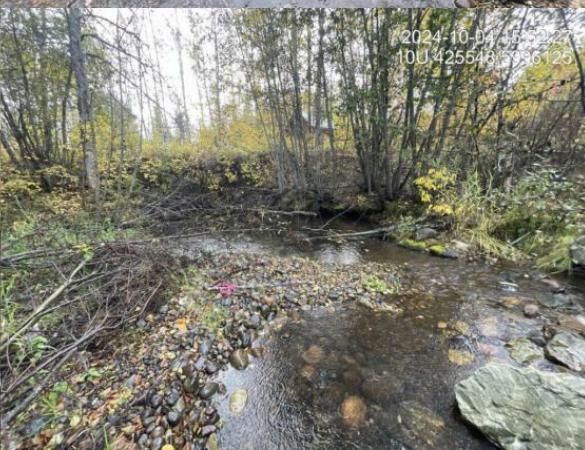
Location and Stream Data		Crossing Characteristics	
Date	2024-10-04	Crossing Sub Type	Round Culvert
PSCIS ID	199190	Diameter (m)	1.85
External ID	–	Length (m)	28
Crew	LS	Embedded	No
UTM Zone	10	Depth Embedded (m)	–
Easting	425557	Resemble Channel	No
Northing	5996165	Backwatered	No
Stream	Clear Creek	Percent Backwatered	–
Road	Highway 27	Fill Depth (m)	3
Road Tenure	MOTI	Outlet Drop (m)	1
Channel Width (m)	5.22	Outlet Pool Depth (m)	0.2
Stream Slope (%)	1.25	Inlet Drop	No
Beaver Activity	No	Slope (%)	3
Habitat Value	Medium	Valley Fill	Deep Fill
Final score	39	Barrier Result	Barrier
Fix type	Replace with New Open Bottom Structure	Fix Span / Diameter	15

Location and Stream Data	Crossing Characteristics
Comments: The bottom of the culvert had been reinforced with concrete, likely to address holes noted in the previous assessment. A large pile of riprap was placed at the outlet, possibly to reduce the outlet drop, though its placement appeared unusual and could inhibit fish passage. The habitat was high quality, with a large pool just downstream of the culvert and abundant gravels suitable for spawning fish. MoTi chris_culvert_id: 1806163	
Photos: From top left clockwise: Road/Site Card, Barrel, Outlet, Downstream, Upstream, Inlet.

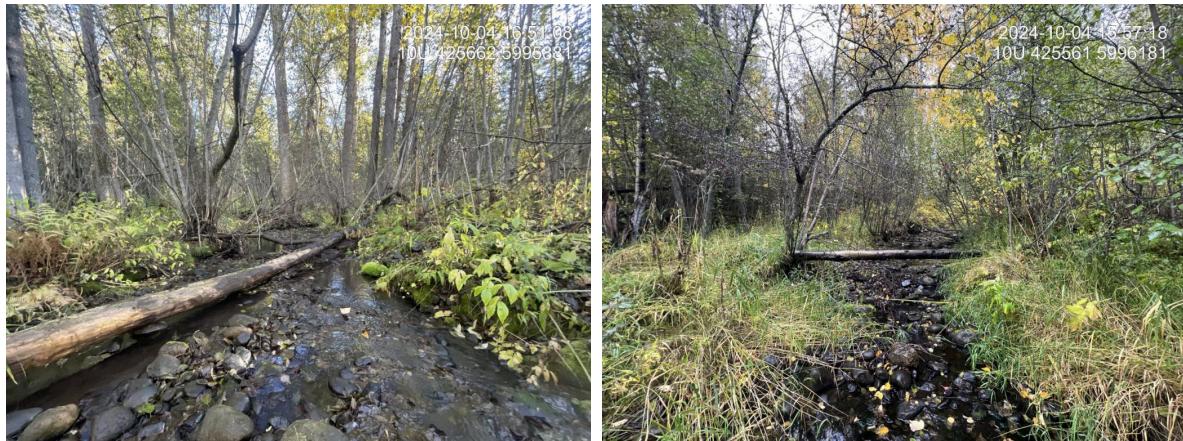
The stream was surveyed downstream from crossing 199190 for 335m (Figure 4.8).. The habitat was rated as high value for salmonid spawning and rearing. The stream contained frequent pools suitable for overwintering fish, with abundant cobbles but limited gravels. Evidence of extreme seasonal flows was observed, including large eroding banks, extensive gravel deposits from channel widening (20–30m), and significant log jams. The average channel width was 5.4m, the average wetted width was 4m, and the average gradient was 1.2%.The dominant substrate was cobbles with fines sub-dominant.Total cover amount was rated as abundant with large woody debris dominant. Cover was also present as small woody debris and undercut banks..

The stream was surveyed upstream from crossing 199190 for 550m (Figure 4.8). The habitat was rated as low value. The stream had good flow and provided high-quality habitat for the first 100m before transitioning to subsurface flow. By approximately 200m upstream of the highway, adjacent to a quarry, the stream was fully dewatered to the top of the surveyed reach. The channel was highly confined, lacked complexity, and consisted primarily of a straight, coarse cobble and boulder substrate. While some small and large woody debris were present, they did not appear to contribute to habitat formation during periods of flow. The average channel width was 5.2m, the average wetted width was 3.1m, and the average gradient was 1.3%.Total cover amount was rated as trace with boulders dominant. Cover was also present as overhanging vegetation.The dominant substrate was cobbles with boulders sub-dominant.

Figure 4.8: Left: Typical habitat downstream of PSCIS crossing 199190. Right: Typical habitat upstream of PSCIS crossing 199190.

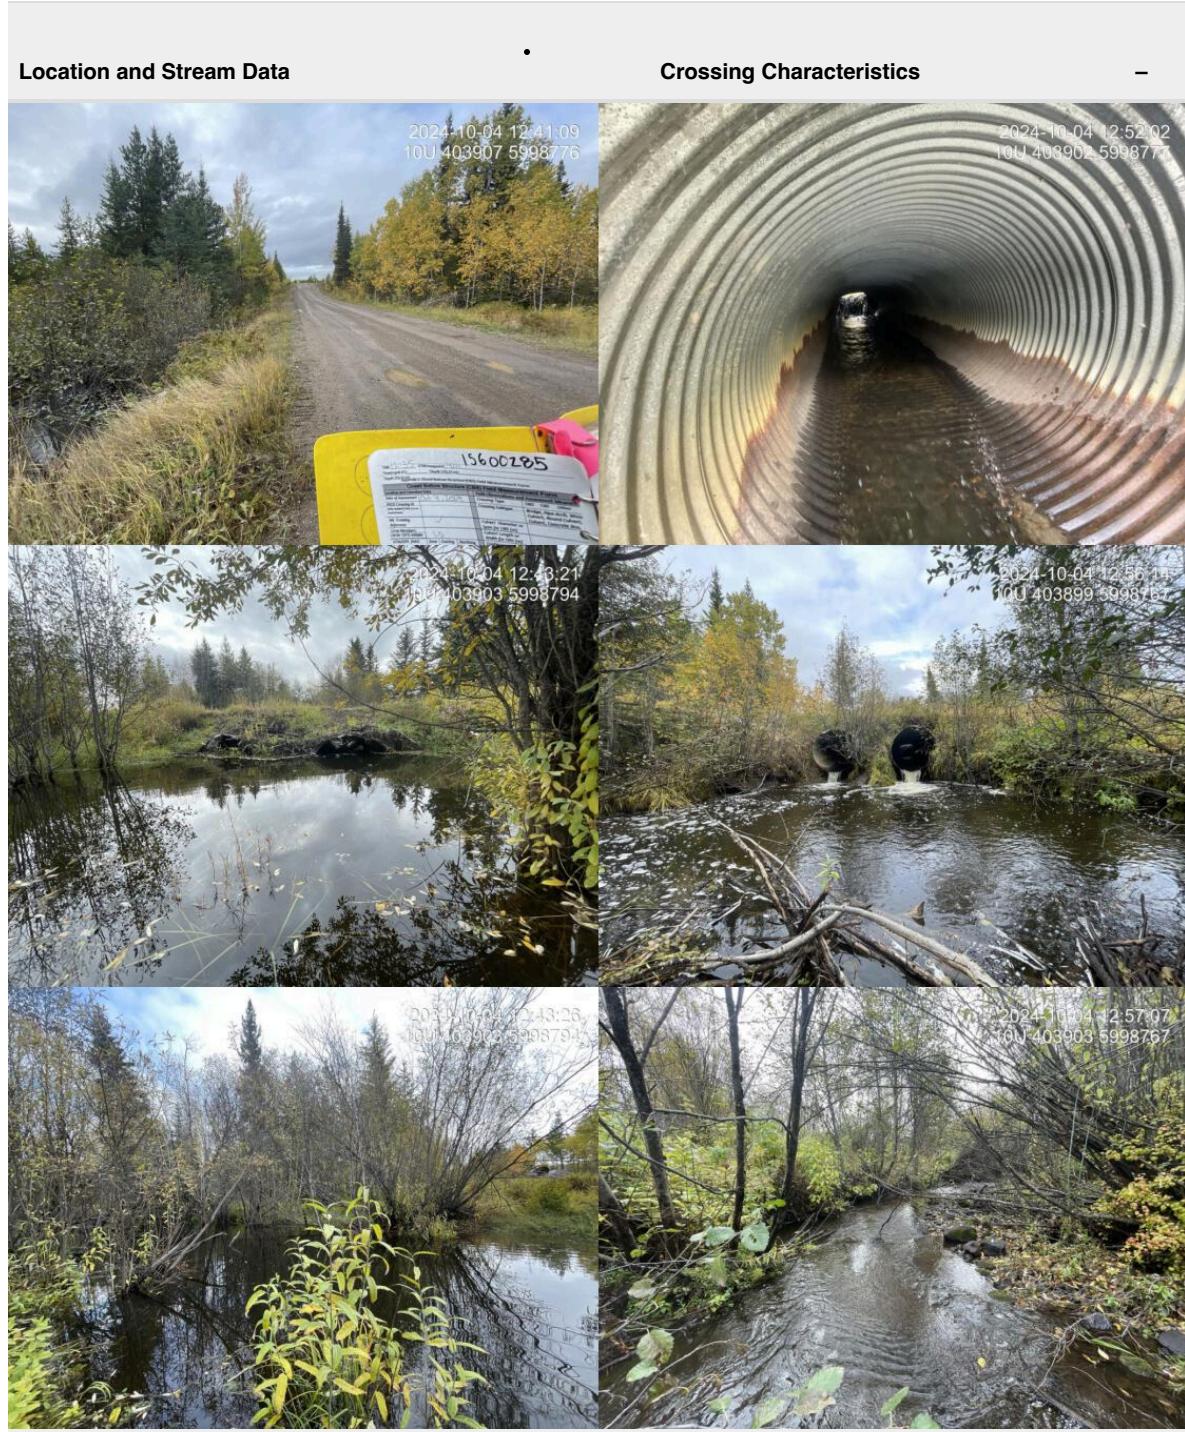
Table 4.29: Summary of fish passage assessment for PSCIS crossing 199204.

Location and Stream Data		Crossing Characteristics	
Date	2024-10-04	Crossing Sub Type	Round Culvert
PSCIS ID	199204	Diameter (m)	3.2
External ID	–	Length (m)	12
Crew	LS	Embedded	No
UTM Zone	10	Depth Embedded (m)	–
Easting	403906	Resemble Channel	No
Northing	5998777	Backwatered	No
Stream	Nine Mile Creek	Percent Backwatered	–
Road	Settlement Road	Fill Depth (m)	0.5
Road Tenure	MOTI	Outlet Drop (m)	0.5
Channel Width (m)	5.5	Outlet Pool Depth (m)	1.4
Stream Slope (%)	0.5	Inlet Drop	No
Beaver Activity	Yes	Slope (%)	2
Habitat Value	Medium	Valley Fill	Deep Fill
Final score	31	Barrier Result	Barrier
Fix type	Replace with New Open Bottom Structure	Fix Span / Diameter	15
<p>Comments: The inlets of both culverts were dammed by a beaver, backing up water to most of the culverts' height. Two pipes, each 1.6m in diameter, were present. A large outlet pool indicated the pipes were likely undersized for the stream. Another beaver dam was being constructed at the outlet of the pool. The dirt road had minimal road fill, making construction relatively straightforward. The road appeared to be used for pipeline access. Outlet pool depth was estimated as it was too deep to wade. Fish approximately 40mm in length were observed downstream during habitat confirmation. MoTi chris_culvert_id: 1793923</p> <p>Photos: From top left clockwise: Road/Site Card, Barrel, Outlet, Downstream, Upstream, Inlet.</p>

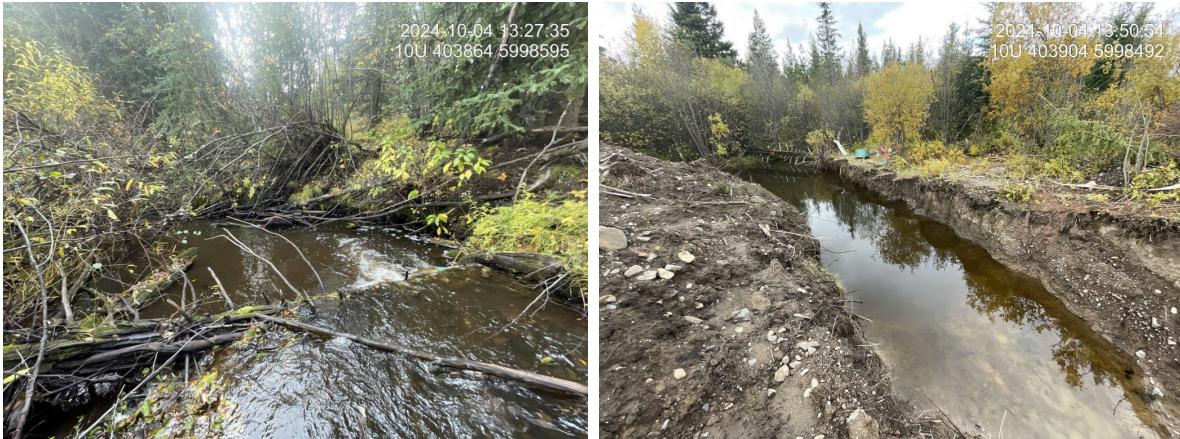
Figure 4.9: Left: Typical habitat downstream of PSCIS crossing 199204. Right: Large, artificially entrenched pool located ~300m downstream of PSCIS crossing 199204.
