## **Restoring Fish Passage in the Fraser Region - 2023**

**Prepared for  
Ministry of Transportation and Infrastructure**

**Prepared by  
Al Irvine, B.Sc., R.P.Bio. and Lucy Schick, B.Sc.  
New Graph Environment Ltd.**

**Version 0.0.1 2025-03-26**

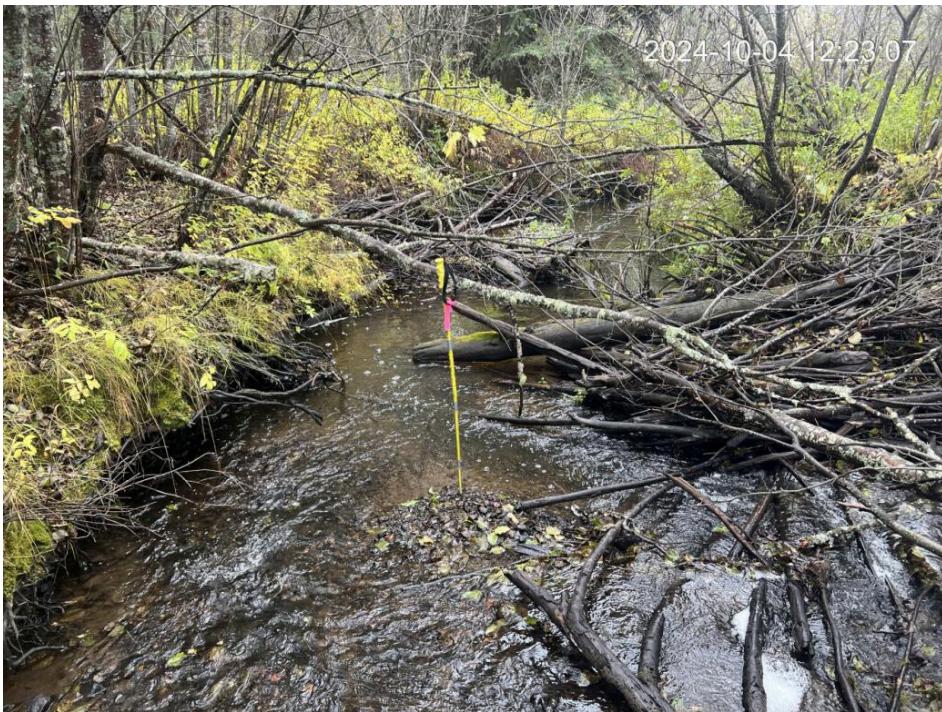
The stream was surveyed upstream from crossing 199204 for 425m (Figure 4.10). The habitat was rated as medium value for spawning and rearing. The stream was a larger system with significant beaver activity, creating impoundments behind dams ranging from 0.3 to 1.5m in height. Heavy cattle use was evident in riparian areas, with trampled banks, extensive browsing of riparian shrubs, and a significant amount of manure within seasonally inundated areas. Nutrient loading to the stream appeared high, with large amounts of algae present on the primarily gravel substrates in sections of the channel linking beaver-impounded areas. Total cover amount was rated as moderate with deep pools dominant. Cover was also present as small woody debris, overhanging vegetation, and instream vegetation. The dominant substrate was fines with gravels sub-dominant. The average channel width was 6.2m, the average wetted width was 4.4m, and the average gradient was 3%.

Figure 4.10: Typical habitat upstream of PSCIS crossing 199204.

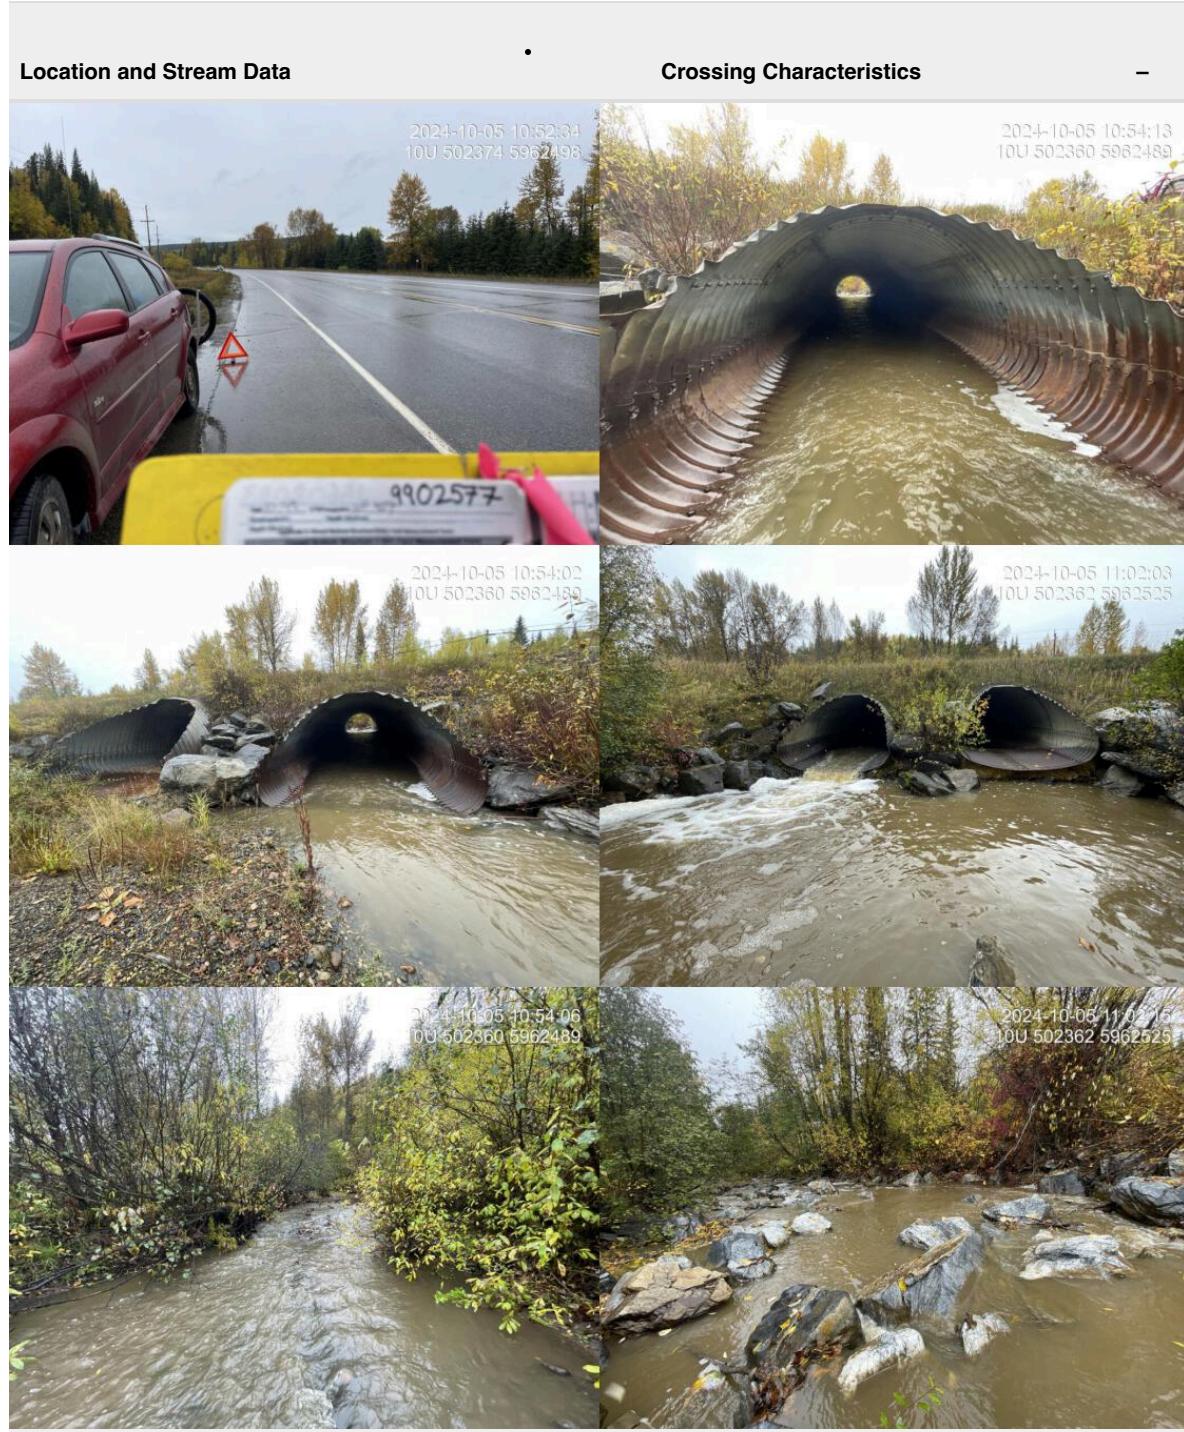
At the time of the 2024 assessment, PSCIS crossing 199232 on Highway 16 was un-embedded, non-backwatered and ranked as barrier to upstream fish passage according to the provincial protocol (MoE 2011) (Table 4.33). Two 2.8m diameter pipes were present, with no flow observed in the more northern pipe. The culverts had a significant 1.05m outlet drop.

Should restoration/maintenance activities proceed, replacement of the Highway 16 crossing (199232) with a bridge (15 m span) is recommended. At the time of reporting in 2025, the cost of the work is estimated at \$ 11,250,000.

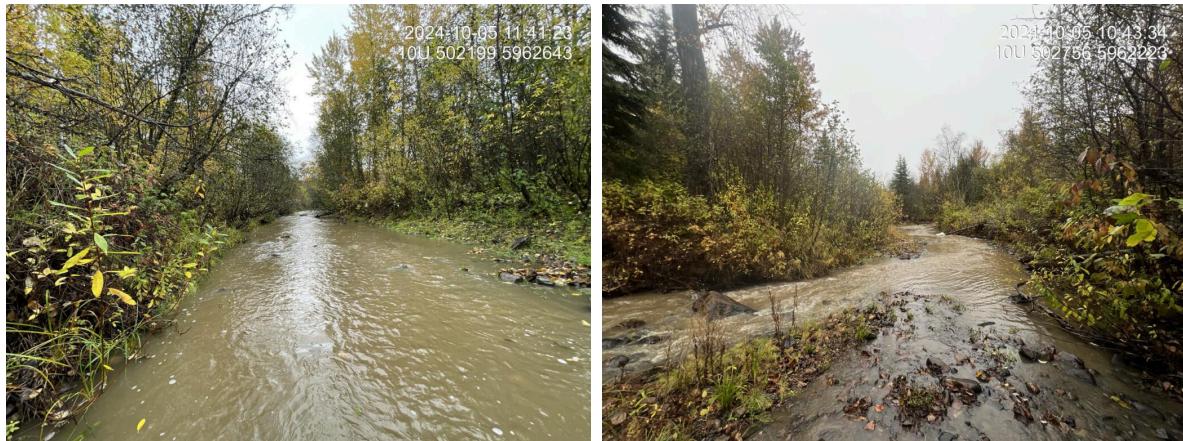
The stream was surveyed downstream from crossing 199232 for 300m (Figure 4.11). The habitat was rated as medium value due to sparse large woody debris, a lack of pools, and high turbidity from recent rainfall likely obscuring gravels. Below the outlet, large boulders were placed in rows to backwater the culvert, which was somewhat effective, though the culvert itself remained unbackwatered. This section had a steeper gradient (3–4%) before transitioning to ~0.5% for the remainder of the area surveyed. The upper section of the stream was somewhat channelized due to residences on both sides, while lower sections showed significant bank erosion. The average channel width was 9.6m, the average wetted width was 6m, and the average gradient was 2%. Total cover amount was rated as moderate with large woody debris dominant. Cover was also present as boulders. The dominant substrate was cobbles with gravels sub-dominant.

The stream was surveyed upstream from crossing 199232 for 725m (Figure 4.11). The habitat was rated as high value, with abundant gravels suitable for chinook spawning. Pools were infrequent, primarily located on outside bends and behind large woody debris. Some evidence of anthropogenic manipulation was observed, including cut cottonwood trees that had fallen into the channel. The riparian zone was in good condition, with mature shrub communities and old-growth cottonwood that should contribute to future habitat complexity. Water levels were elevated to moderate conditions due to heavy rainfall over the previous evening and preceding weeks. The dominant substrate was gravels with cobbles sub-dominant. The average channel width was 11.9m, the average wetted width was 8m, and the average gradient was 0.6%. Total cover amount was rated as moderate with overhanging vegetation dominant. Cover was also present as small woody debris and boulders.

Figure 4.11: Left: Typical habitat downstream of PSCIS crossing 199232. Right: Typical habitat upstream of PSCIS crossing 199232.

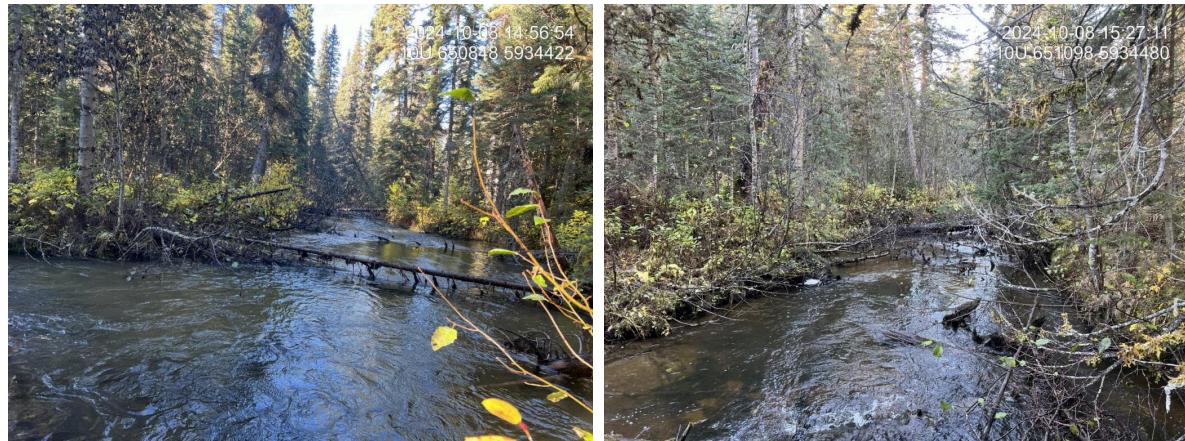
PSCIS crossing 199237 on Highway 16 had a significant 0.65m outlet drop and is a moderate priority for replacement. Downstream of Highway 16, chinook have historically spawned at the confluence of Snowshoe Creek and the Fraser River (Salmon Watersheds Program 2025), indicating this stream has provided valuable spawning habitat. Given that the habitat upstream of Highway 16 was rated as high value for spawning and rearing during the 2024 assessment, fish sampling is recommended to further assess whether the crossing is inhibiting fish passage.

Figure 4.12: Left: Typical habitat upstream of PSCIS crossing 199237 on the west fork on Snowshoe Creek. Right: Typical habitat upstream of PSCIS crossing 199237 on the east fork on Snowshoe Creek.

Should restoration/maintenance activities proceed, replacement of the Highway 16 crossing with a bridge (19 m span) is recommended. At the time of reporting in 2025, the cost of the work is estimated at \$ 14,250,000.

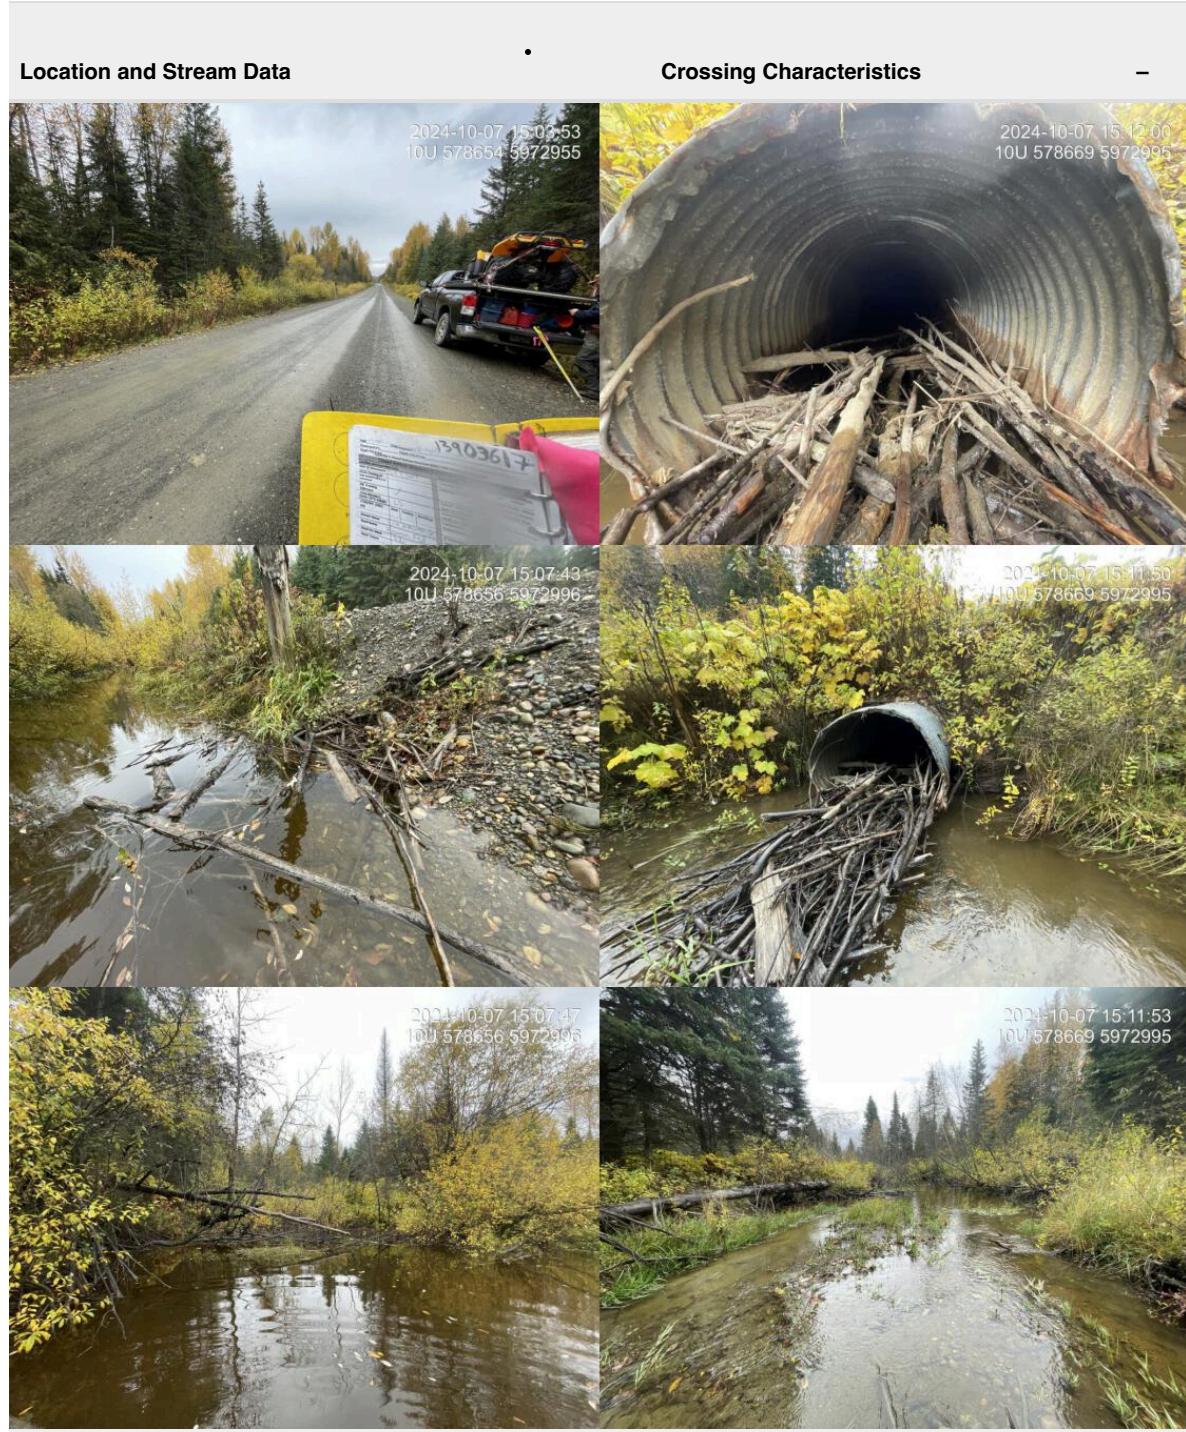
Location and Stream Data		Crossing Characteristics	
Date	2024-10-07	Crossing Sub Type	Round Culvert
PSCIS ID	199255	Diameter (m)	1.1
External ID	–	Length (m)	13
Crew	LS	Embedded	No
UTM Zone	10	Depth Embedded (m)	–
Easting	578664	Resemble Channel	No
Northing	5972996	Backwatered	No
Stream	Tributary To Kenneth Creek	Percent Backwatered	–
Road	Bowron FSR	Fill Depth (m)	1.5
Road Tenure	MoF	Outlet Drop (m)	0
Channel Width (m)	10.5	Outlet Pool Depth (m)	0.25
Stream Slope (%)	0.5	Inlet Drop	No
Beaver Activity	Yes	Slope (%)	1.5
Habitat Value	Medium	Valley Fill	Deep Fill
Final score	21	Barrier Result	Barrier
Fix type	Replace with New Open Bottom Structure	Fix Span / Diameter	15
<p>Comments: The inlet of the culvert was completely submerged, with a large beaver pond area just upstream. The outlet was plugged with beaver sticks, and it appeared the beaver had dammed the culvert entirely, creating a large pool at the inlet. Despite this, the culvert still had flow. A beaver dam approximately 0.7m in height was located about 40m downstream. A new culvert had been installed 60m north on the FSR, with flow from that crossing entering the outlet pool from the north. Downstream of the culvert, the stream flowed through the forest with minimal defined channel. Where a defined channel was present, it ranged from 13m wide, but most of the area consisted of 15-17m of wetted forest with some flow. Culvert slope was estimated due to the submerged inlet. Habitat confirmations were conducted upstream and downstream.</p> <p>Photos: From top left clockwise: Road/Site Card, Barrel, Outlet, Downstream, Upstream, Inlet.</p>

Should restoration/maintenance activities proceed, replacement of the Bowron FSR crossing (199255) with a bridge (15 m span) is recommended. At the time of reporting in 2025, the cost of the work is estimated at \$ 450,000.

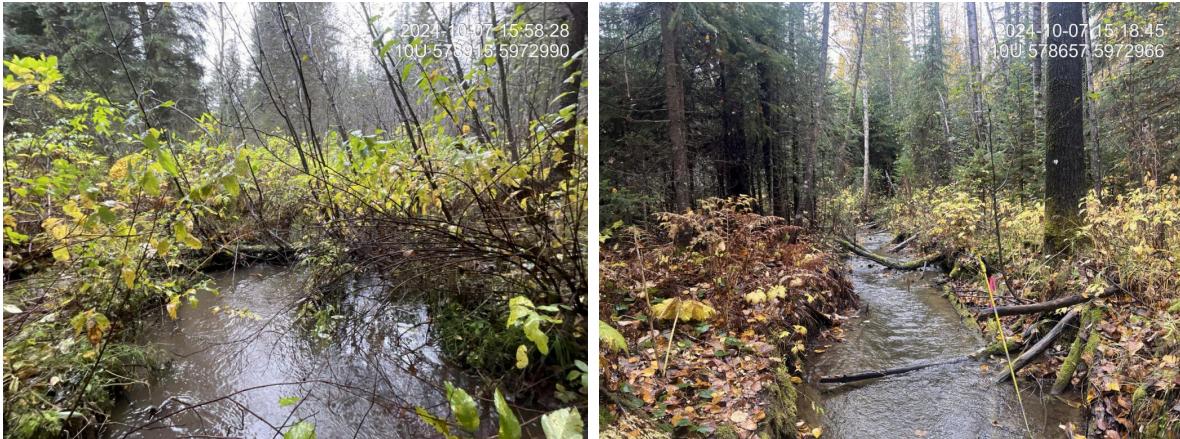
The stream was surveyed downstream from crossing 199255 for 270m (Figure 4.13). The habitat was rated as low value for spawning and rearing with no gravels or cobbles observed and the substrate consisting entirely of fine mud. Fish habitat was limited, with very few pools present. The first 130m of the stream was a beaver-affected area, with a beaver dam approximately 0.7m high located ~40m downstream of the culvert. The dam had flooded the surrounding forest, with no main channel observed. Occasional sections had a somewhat defined channel, but the majority of the surveyed area consisted of water flowing through a wet forest. The dominant substrate was fines with fines sub-dominant. The average channel width was 10.3m, the average wetted width was 7m, and the average gradient was 0.8%. Total cover amount was rated as moderate with overhanging vegetation dominant. Cover was also present as small woody debris, undercut banks, and instream vegetation..

The stream was surveyed upstream from crossing 199255 for 650m (Figure 4.13). The habitat was rated as medium value with good flow and abundant gravels suitable for bull trout and cutthroat trout spawning. Occasional shallow pools provided habitat for juvenile salmonid rearing. Banks were stable, with an intact mixed mature forest. The stream was small and had some short sections with gradients up to 5% but was primarily a low-gradient riffle-gravel system. The dominant substrate was gravels with cobbles sub-dominant. Total cover amount was rated as moderate with undercut banks dominant. Cover was also present as small woody debris, large woody debris, and overhanging vegetation. The average channel width was 3.4m, the average wetted width was 2.8m, and the average gradient was 2.8%.

Figure 4.13: Left: Typical habitat downstream of PSCIS crossing 199255. Right: Typical habitat upstream of PSCIS crossing 199255.

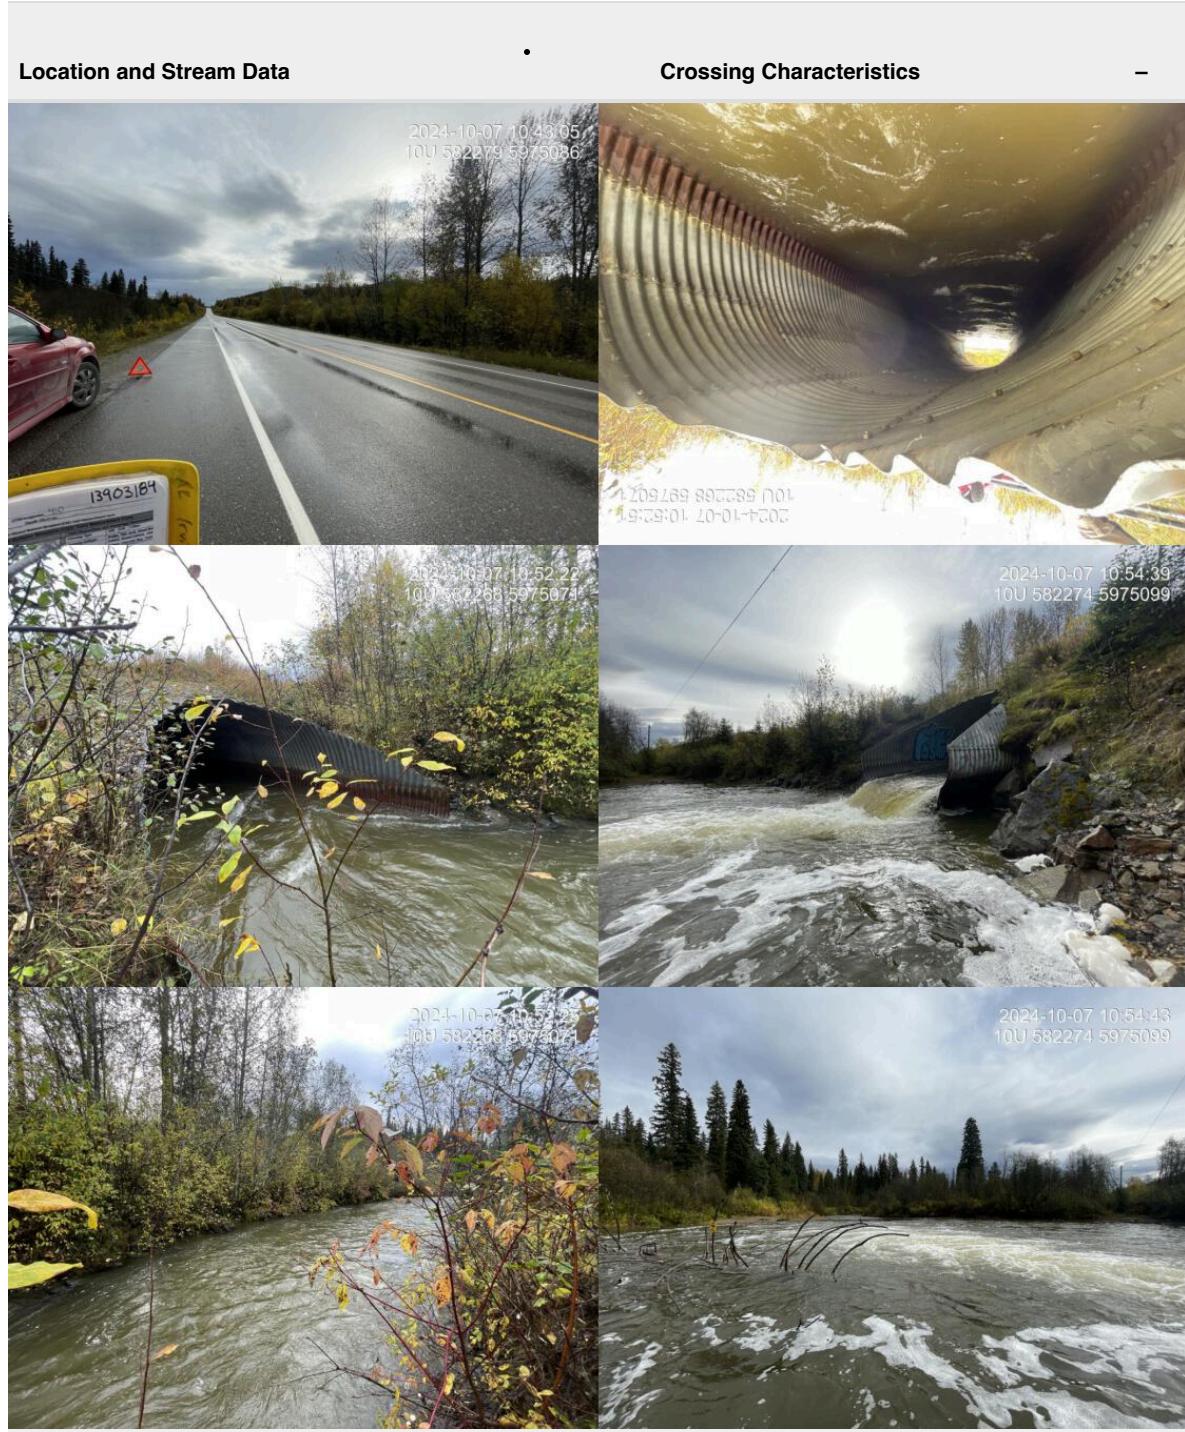
Location and Stream Data		Crossing Characteristics	
Date	2024-10-07	Crossing Sub Type	Oval Culvert
PSCIS ID	199256	Diameter (m)	5.5
External ID	–	Length (m)	30
Crew	LS	Embedded	No
UTM Zone	10	Depth Embedded (m)	–
Easting	582279	Resemble Channel	No
Northing	5975090	Backwatered	No
Stream	Kenneth Creek	Percent Backwatered	–
Road	Highway 16	Fill Depth (m)	1.5
Road Tenure	MOTI	Outlet Drop (m)	0.7
Channel Width (m)	19	Outlet Pool Depth (m)	2
Stream Slope (%)	0.5	Inlet Drop	No
Beaver Activity	No	Slope (%)	1
Habitat Value	High	Valley Fill	Deep Fill
Final score	37	Barrier Result	Barrier
Fix type	Replace with New Open Bottom Structure	Fix Span / Diameter	24
Comments: Large multi-plate oval culvert with a substantial 50m-wide outlet pool. The stream had high flow at the time of assessment. Culvert slope and outlet pool depth were estimated as the pool was too deep to wade. Deep pools over 1m, formed by functional large woody debris, provided good overwintering habitat for fish of all ages. Gravels suitable for spawning were present. Downstream of the culvert, the stream ran parallel to the highway with banks reinforced by riprap and large wood secured with metal wiring to create habitat and reduce flow. MoTi chris_hwy_structure_road_id: 3750

Kenneth Creek is a large, gravel-dominated stream with high-value habitat for salmonid spawning and rearing. Although chinook and bull trout have been documented upstream (Norris [2018] 2024; MoE 2024a), the crossing had a significant 0.7m outlet drop, and fish sampling is recommended to determine if it is currently inhibiting fish passage. Additionally, `bcfishpass` modeling indicates nearly 50km of potential chinook spawning habitat upstream. The crossing is a moderate priority for replacement.

Should restoration/maintenance activities proceed, replacement of the Highway 16 crossing (199256) with a bridge (24 m span) is recommended. At the time of reporting in 2025, the cost of the work is estimated at \$ 18,000,000.

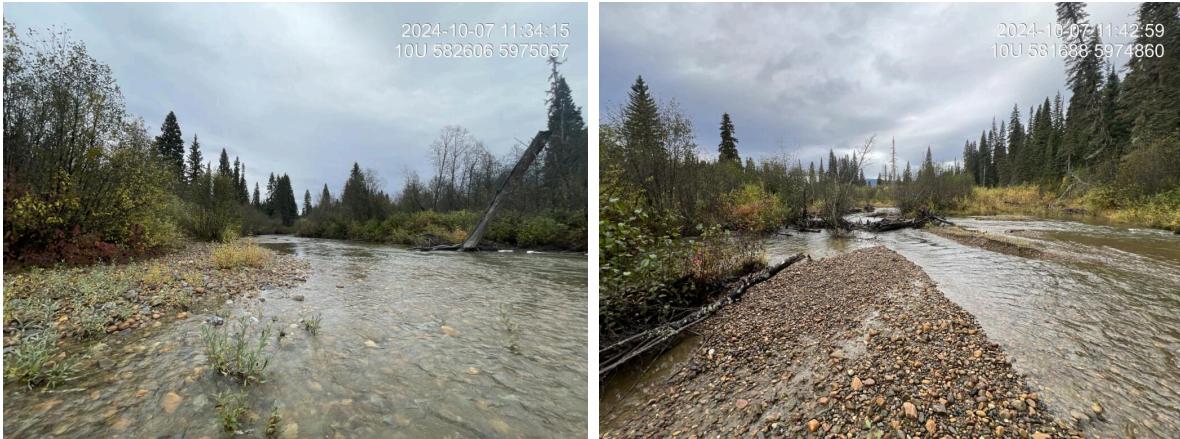
The stream was surveyed downstream from crossing 199256 for 370m (Figure 4.14). The habitat was rated as high value, with abundant spawning gravels and deep pools (>1m) formed by functional large woody debris, providing high-quality overwintering habitat for fish of all ages. The dominant substrate was cobbles with gravels sub-dominant. The average channel width was 19m, the average wetted width was 16.1m, and the average gradient was 0.7%. Total cover amount was rated as abundant with large woody debris dominant. Cover was also present as small woody debris, deep pools, and overhanging vegetation.

Downstream of the culvert, the stream ran parallel to the highway, with banks reinforced by riprap. Large wood, secured with metal wiring, was placed to create habitat and reduce flow, arranged in three sets of two logs spaced approximately 5m apart (Figure 4.15). These structures were likely installed to mitigate habitat loss caused by the riprapped banks.

The stream was surveyed upstream from crossing 199256 for 950m (Figure 4.14). The habitat was rated as high value, with gravels suitable for chinook and resident salmonid spawning. The stream was large and gravel-dominated, with extensive deep runs, deep pools, large woody debris, and multiple channels throughout. The riparian area was intact throughout, consisting of a mix of shrub-dominated wetland areas and mature mixed forest. The dominant substrate was gravels with cobbles sub-dominant. The average channel width was 22.8m, the average wetted width was 16.7m, and the average gradient was 0.8%. Total cover amount was rated as moderate with deep pools dominant. Cover was also present as small woody debris, large woody debris, undercut banks, and overhanging vegetation.

Figure 4.14: Left: Typical habitat downstream of PSCIS crossing 199256. Right: Typical habitat upstream of PSCIS crossing 199256.

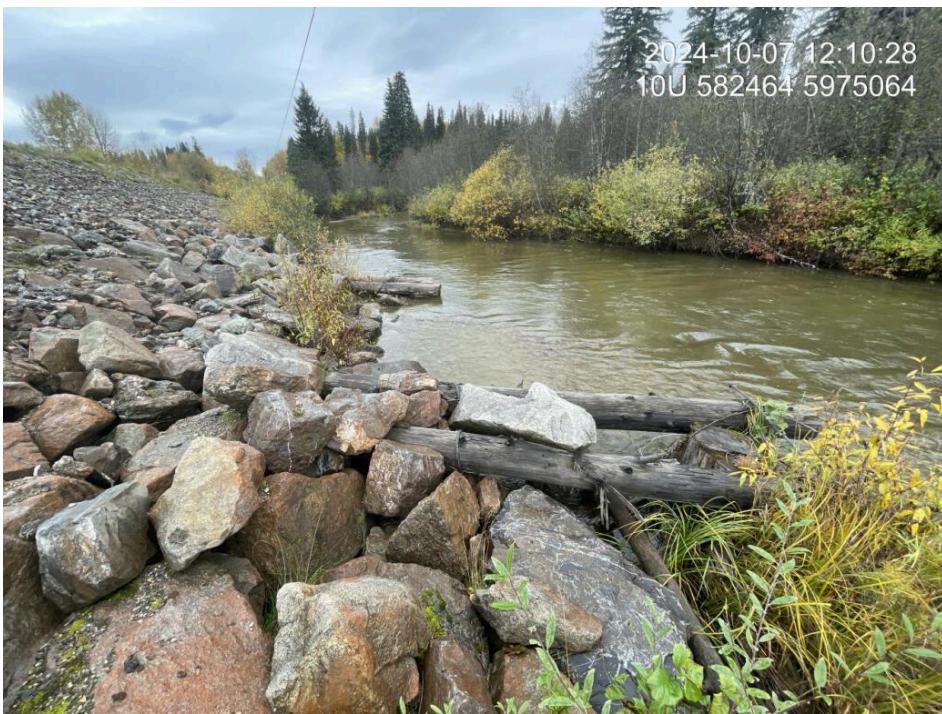
Figure 4.15: Ripwrapped banks and large wood structures secured with metal wiring located downstream of crossing 199256.

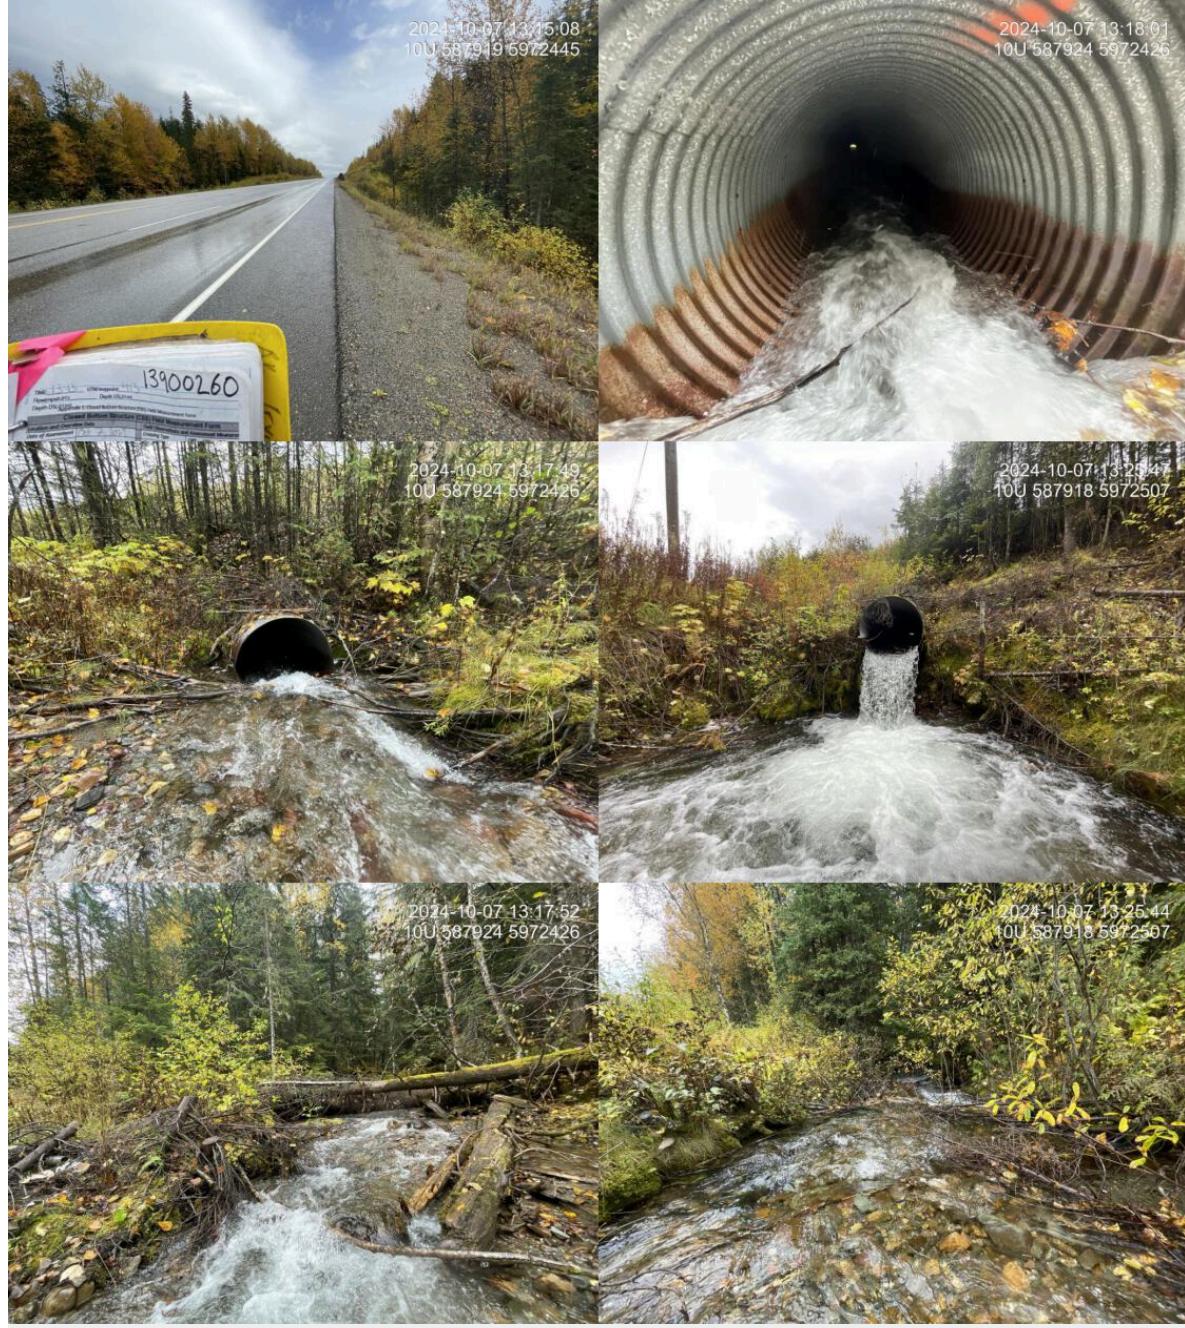
Location and Stream Data	Crossing Characteristics
<p>Comments: The culvert had a significant 1.4m outlet drop, and inlet drop due to a small debris jam. The stream flowed through mature old-growth forest and provided high-quality habitat with steep gradients, step pools, and cascade pools, suggesting the potential presence of bull trout. The highway crossing had a large amount of road fill, making construction difficult and expensive. The site would be a good candidate for replacement if feasible. The riparian area at the outlet had been cleared due to overhead powerlines. MoTi chris_culvert_id: 1992815</p> <p>Photos: From top left clockwise: Road/Site Card, Barrel, Outlet, Downstream, Upstream, Inlet.</p>

PSCIS crossing 199260 had a substantial 1.4m outlet drop and is a high priority for replacement. Average gradients were generally above the maximum thresholds for chinook spawning and rearing (4.5% and 5.5%, respectively), suggesting the stream is unlikely to support chinook but falls within the suitable range for bull trout spawning and rearing (5.5% and 10.5%, respectively). The habitat upstream was rated as medium value for bull trout spawning and rearing, with bcfishpass modeling indicating ~900m of potential bull trout rearing habitat upstream of the crossing. Given the crossings location within Sugarbowl-Grizzly Den Provincial Park and the park's ecological significance, restoration efforts could align with broader conservation initiatives and public engagement, increasing the likelihood of funding and project momentum.

Should restoration/maintenance activities proceed, replacement of the Highway 16 crossing (199260) with a bridge (33 m span) is recommended. At the time of reporting in 2025, the cost of the work is estimated at \$ 24,750,000.

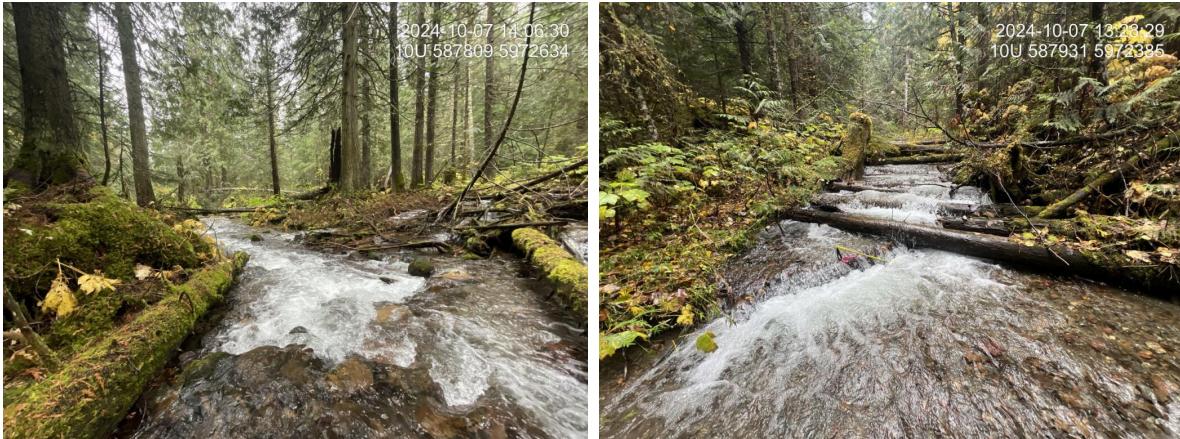
The stream was surveyed downstream from crossing 199260 for 320m (Figure 4.16). The habitat was rated as high value, with gravels suitable for spawning and occasional pools ranging from 0.2–0.4m deep providing overwintering habitat. The stream flowed through a healthy, mature old-growth forest. The average channel width was 7m, the average wetted width was 4.2m, and the average gradient was 5.3%. The dominant substrate was cobbles with boulders sub-dominant. Total cover amount was rated as abundant with large woody debris dominant. Cover was also present as small woody debris and boulders.

The stream was surveyed upstream from crossing 199260 for 650m (Figure 4.16). The habitat was rated as medium value, and appeared suitable for large bull trout spawning and rearing. The stream was a larger, steeper system with intact, mature coniferous cedar-hemlock riparian cover, primarily stable banks, and abundant large woody debris throughout. A step-pool morphology was present, characterized by pools up to 80cm deep and debris jam steps ranging from 30–60cm. The dominant substrate was cobbles with gravels sub-dominant. Total cover amount was rated as moderate with large woody debris dominant. Cover was also present as small woody debris, boulders, undercut banks, deep pools, and overhanging vegetation. The average channel width was 6.1m, the average wetted width was 5.1m, and the average gradient was 7.1%.

Figure 4.16: Left: Typical habitat downstream of PSCIS crossing 199260. Right: Typical habitat upstream of PSCIS crossing 199260.

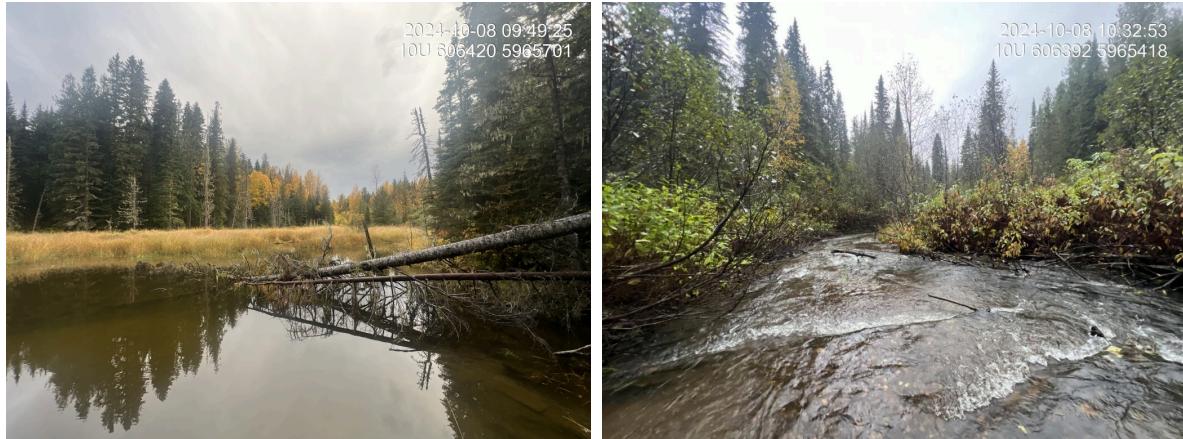
The stream was surveyed upstream from crossing 199267 for 600m (Figure 4.17). The habitat was rated as high value for spawning and rearing. The stream was a low-gradient, gravel-dominated system with an extensive shrub-sedge wetland area and beaver activity in the lower 200m. Deep pools up to 1m were present throughout, influenced by abundant large woody debris contributed from the adjacent mature, primarily coniferous forest. The average channel width was 8.9m, the average wetted width was 8.7m, and the average gradient was 0.5%.Total cover amount was rated as moderate with large woody debris dominant. Cover was also present as small woody debris, undercut banks, deep pools, and overhanging vegetation.The dominant substrate was gravels with cobbles sub-dominant.

PSCIS crossing 199267 on Highway 16 had a significant 0.65m outlet drop and is a moderate priority for replacement. Downstream of Highway 16, chinook have historically spawned at the confluence of Driscoll Creek and the Fraser River (Salmon Watersheds Program 2025), indicating that this stream has provided valuable spawning habitat. Additionally, modelling from bcfishpass indicates there is ~7km of potential chinook spawning habitat available upstream of the crossing. The habitat upstream of Highway 16 was rated as moderate value for spawning and rearing during the 2024 assessment, and fish sampling is recommended to further assess whether the crossing is inhibiting fish passage. Given the crossing's proximity to Chun T'oh Whudujut (Ancient Forest) Provincial Park and its location within the traditional territory of the Lheidli T'enneh, restoration efforts could align with broader conservation initiatives and community engagement, increasing the likelihood of funding and project momentum.

Figure 4.17: Left: Typical habitat upstream of PSCIS crossing 199267. Right: Typical habitat upstream of PSCIS crossing 199267.

Should restoration/maintenance activities proceed, replacement of the Highway 16 crossing (199267) with a bridge (15 m span) is recommended. At the time of reporting in 2025, the cost of the work is estimated at \$ 11,250,000.

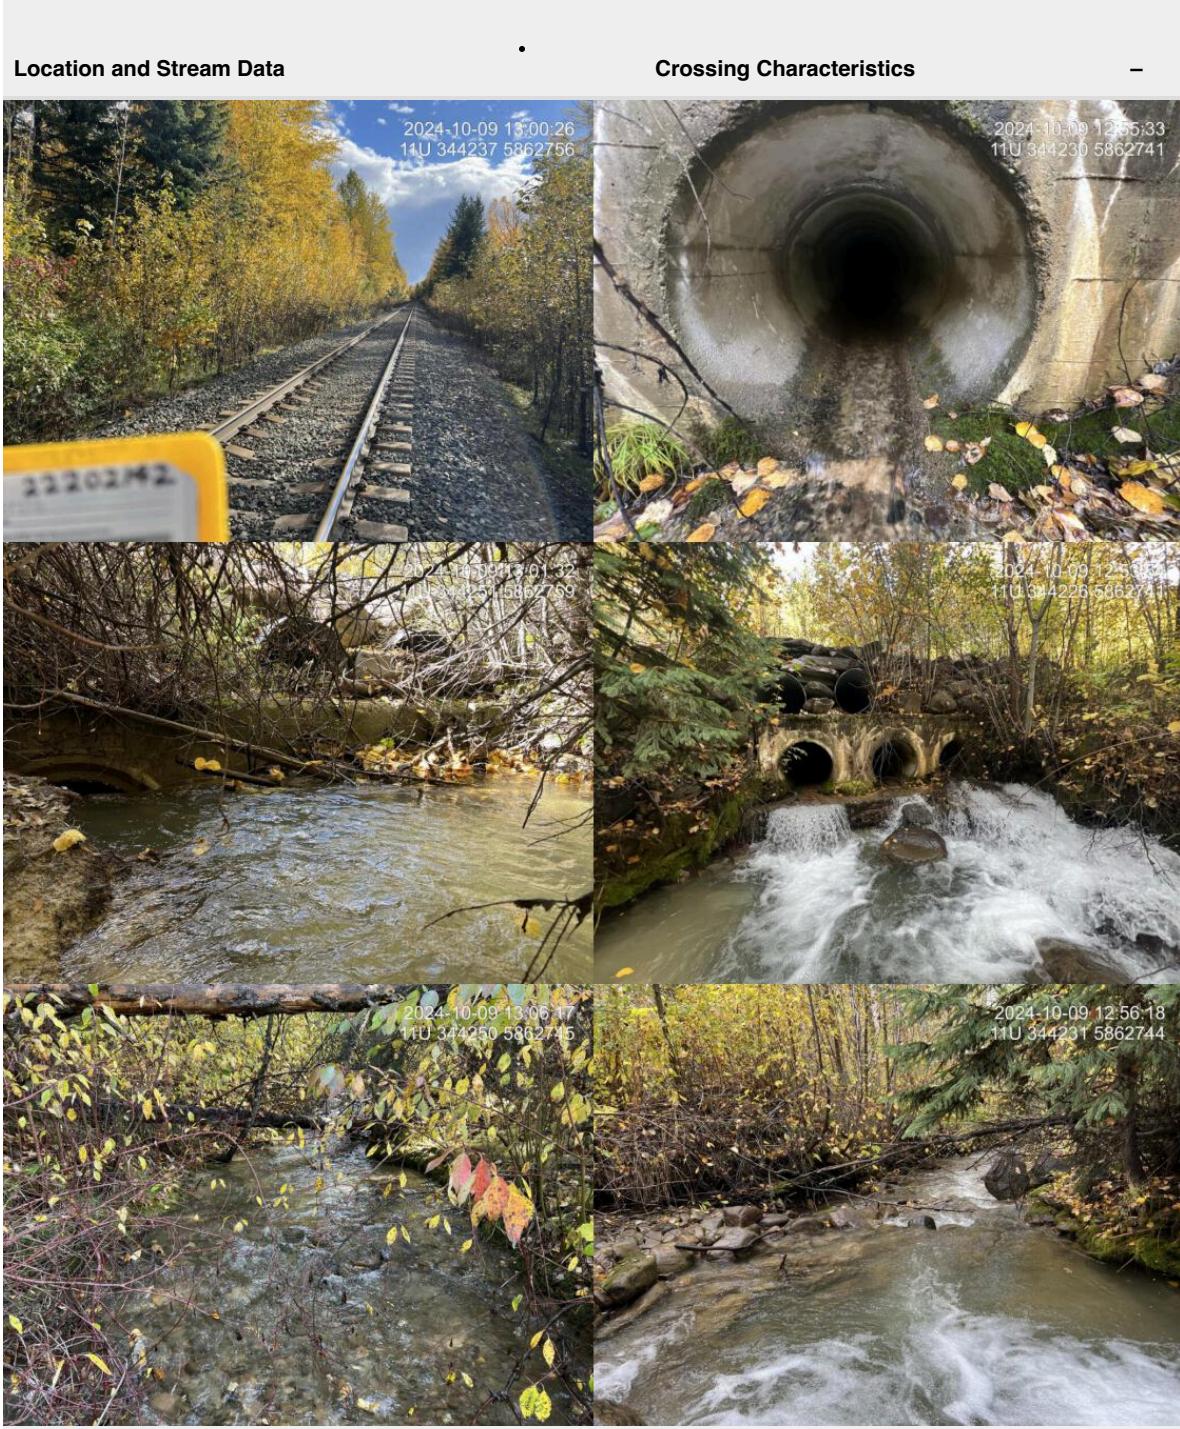
Location and Stream Data		Crossing Characteristics	
Date	2024-10-09	Crossing Sub Type	Round Culvert
PSCIS ID	203302	Diameter (m)	2.7
External ID	–	Length (m)	14
Crew	AI	Embedded	No
UTM Zone	11	Depth Embedded (m)	–
Easting	344222	Resemble Channel	No
Northing	5862742	Backwatered	No
Stream	Teepee Creek	Percent Backwatered	–
Road	Railway	Fill Depth (m)	2
Road Tenure	CN Rail	Outlet Drop (m)	0.75
Channel Width (m)	4.2	Outlet Pool Depth (m)	0.25
Stream Slope (%)	7	Inlet Drop	Yes
Beaver Activity	No	Slope (%)	6
Habitat Value	Medium	Valley Fill	Deep Fill
Final score	36	Barrier Result	Barrier
Fix type	Replace with New Open Bottom Structure	Fix Span / Diameter	15
Comments: Three concrete pipes, each 0.9m in diameter, were present, along with two 0.9m corrugated overflow pipes above. A stamp on the structure indicated it was built in 1944. All three concrete pipes were clogged at the inlet, ranging from 80% to 100% clogged with debris. This was a known fish-bearing stream, with a salmon point documented ~100m downstream in the FISS database. At this location, the stream was a mid-sized, steeper cobble-boulder step-pool system with only rare pockets of unembedded gravels. Deep pools were present, formed by boulder and large woody debris scour. Numerous small steps, ranging from 30-60cm, were present due to the steep, boulder-dominated nature of the stream. Downstream of the highway crossing, the stream had a lower gradient with frequent pools 0.3-0.5m deep, providing good overwintering habitat for fish and abundant gravels suitable for spawning.

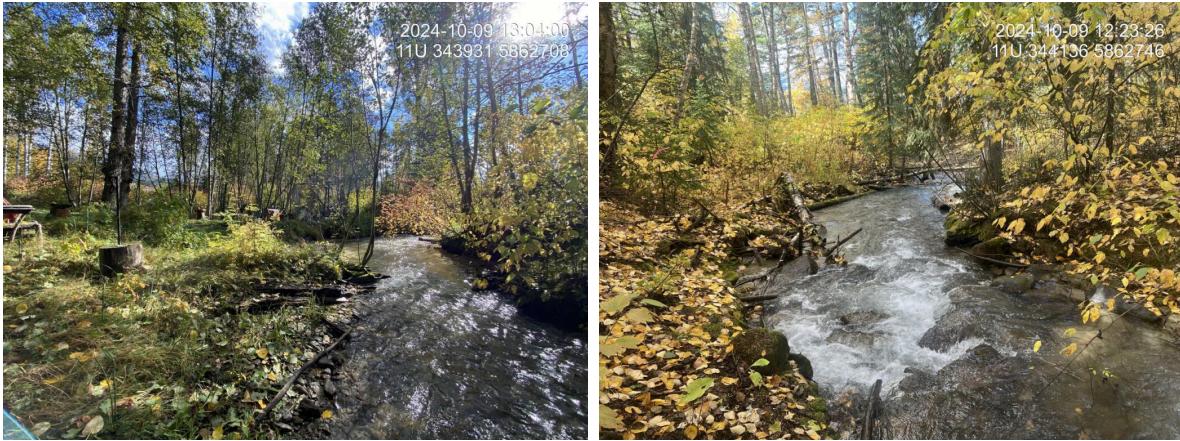
The stream was surveyed downstream from crossing 199278 for 150m (Figure 4.18).. The habitat was rated as high value, with frequent pools 0.3–0.5m deep suitable for overwintering fish and abundant gravels for spawning. Total cover amount was rated as abundant with large woody debris dominant. Cover was also present as small woody debris, undercut banks, and overhanging vegetation. The average channel width was 7.1m, the average wetted width was 4.5m, and the average gradient was 2.5%. The dominant substrate was cobbles with gravels sub-dominant.. Roughly 150m downstream of the culvert, several cattle pens crossed the stream and appeared to be set up to provide cattle access for drinking. These areas were visibly trampled, with significant loss of riparian vegetation.

The stream was surveyed upstream from crossing 199278 on Highway 5 to crossing 203302 on the CN Railway, a distance of approximately 300m (Figure 4.18). The habitat was rated as medium value for spawning and rearing, with frequent deep pools formed by boulders and large woody debris, but only limited pockets of unembedded gravels. Numerous small steps ranging from 30–60cm were present due to the steep, boulder-dominated nature of the stream. The average channel width was 5.3m, the average wetted width was 3.3m, and the average gradient was 7.2%. The dominant substrate was cobbles with boulders sub-dominant. Total cover amount was rated as moderate with boulders dominant. Cover was also present as large woody debris, undercut banks, and overhanging vegetation.

Figure 4.18: Left: Typical habitat downstream of PSCIS crossing 199278. Right: Typical habitat upstream of PSCIS crossing 199278 and downstream of PSCIS crossing 203302.

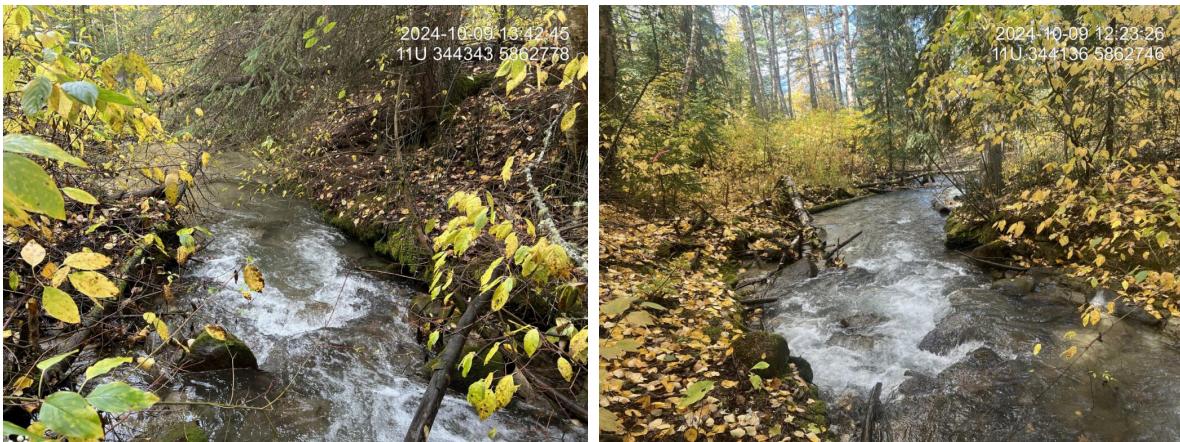
The stream was surveyed upstream from crossing 203302 for 600m (Figure 4.19). The habitat was rated as medium value for spawning and rearing, with few unembedded gravels; however, recent heavy rain caused slight turbidity making it difficult to assess the substrate. The dominant substrate was cobbles with boulders sub-dominant. The average channel width was 5.4m, the average wetted width was 3.9m, and the average gradient was 6.8%. Total cover amount was rated as moderate with boulders dominant. Cover was also present as . Approximately 100m before the end of the site, the stream showed signs of a large disturbance event that had incised the channel to a depth of 1.2–2m, with major areas of aggregation where the channel was widened and uniform.

Figure 4.19: Left: Typical habitat upstream of PSCIS crossing 203302. Right: Typical habitat upstream of PSCIS crossing 199278 and downstream of PSCIS crossing 203302.

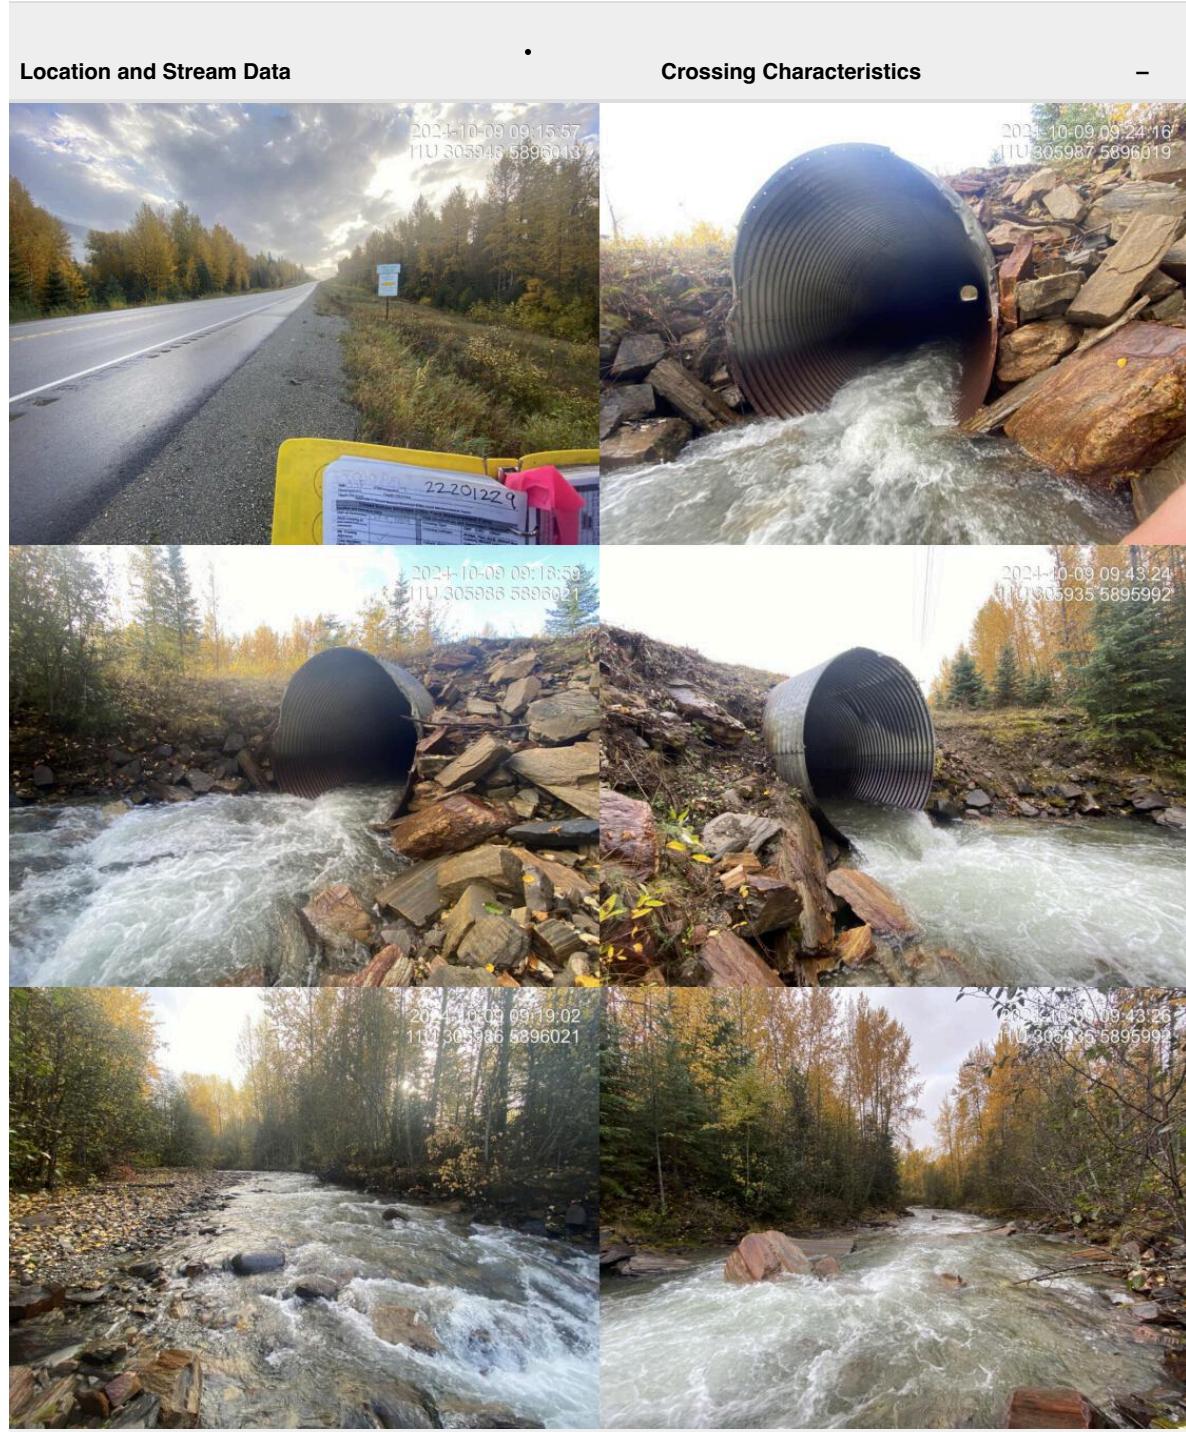
Location and Stream Data		Crossing Characteristics	
Date	2024-10-09	Crossing Sub Type	Round Culvert
PSCIS ID	199282	Diameter (m)	4
External ID	–	Length (m)	52
Crew	LS	Embedded	No
UTM Zone	11	Depth Embedded (m)	–
Easting	305946	Resemble Channel	No
Northing	5896010	Backwatered	No
Stream	Holiday Creek	Percent Backwatered	–
Road	Highway 16	Fill Depth (m)	2
Road Tenure	MOTI	Outlet Drop (m)	0.8
Channel Width (m)	16	Outlet Pool Depth (m)	0.5
Stream Slope (%)	3	Inlet Drop	No
Beaver Activity	No	Slope (%)	2
Habitat Value	High	Valley Fill	Deep Fill
Final score	37	Barrier Result	Barrier
Fix type	Replace with New Open Bottom Structure	Fix Span / Diameter	21
Comments: A significant outlet drop was present. Flow was high at the time of assessment, and at lower flows, the outlet drop would be even more substantial. Although the culvert was large, it was still likely undersized for the stream. The stream was a large glaciated system with a cobble-boulder substrate and an intact mixed riparian zone, primarily deciduous. Occasional large woody debris features created deep pool habitats and pockets of gravels were present suitable for spawning salmonids. A fish (~60mm) was observed during habitat confirmation. MoTi chris_hwy_structure_road_id: 29925
