## **Restoring Fish Passage in the Fraser Region - 2023**

**Prepared for  
Ministry of Transportation and Infrastructure**

**Prepared by  
Al Irvine, B.Sc., R.P.Bio. and Lucy Schick, B.Sc.  
New Graph Environment Ltd.**

**Version 0.0.1 2025-03-26**

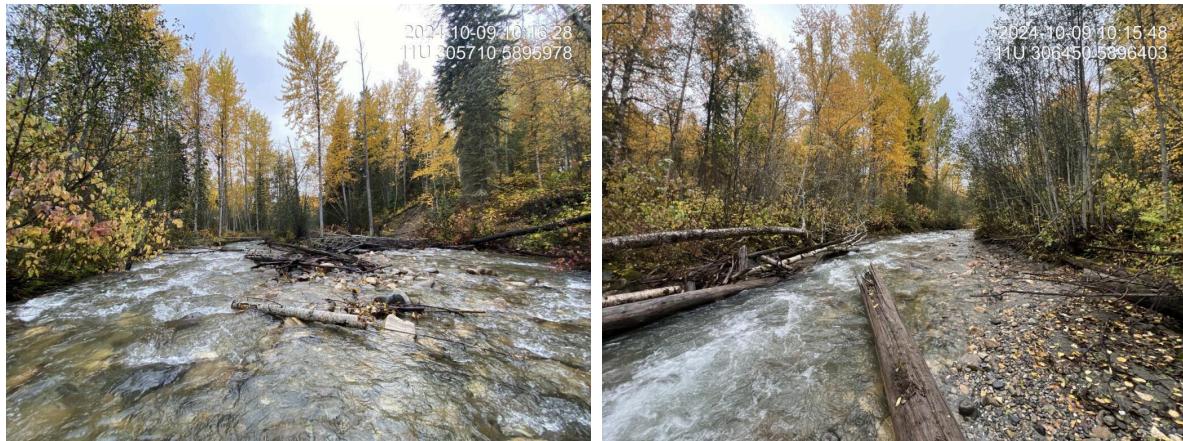
The stream was surveyed downstream from crossing 199282 for 350m (Figure [4.20](#)). The habitat was rated as high value with frequent gravels suitable for spawning and occasional pools available for overwintering. The average channel width was 16m, the average wetted width was 9.3m, and the average gradient was 2.8%. The dominant substrate was cobbles with boulders sub-dominant. Total cover amount was rated as abundant with large woody debris dominant. Cover was also present as boulders and undercut banks..

Figure 4.20: Left: Typical habitat downstream of PSCIS crossing 199282. Right: Typical habitat upstream of PSCIS crossing 199282.
