Restoring Fish Passage in the Fraser Region - 2023

**Prepared for
Ministry of Transportation and Infrastructure**

**Prepared by
Al Irvine, B.Sc., R.P.Bio. and Lucy Schick, B.Sc.
New Graph Environment Ltd.**

Version 0.0.1 2025-03-24

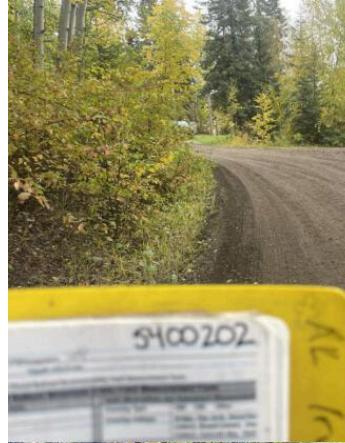
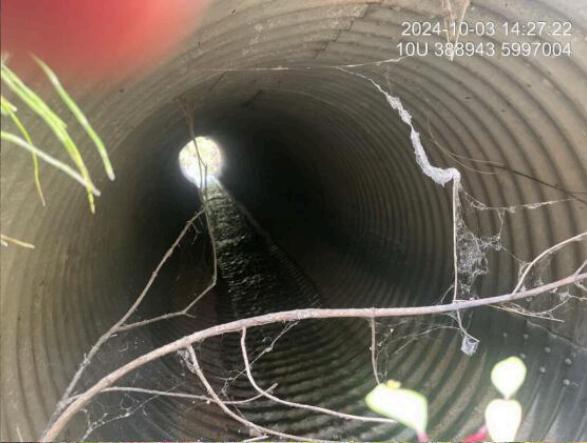
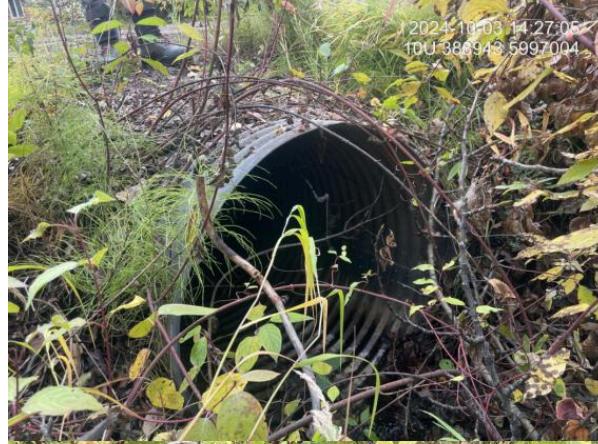
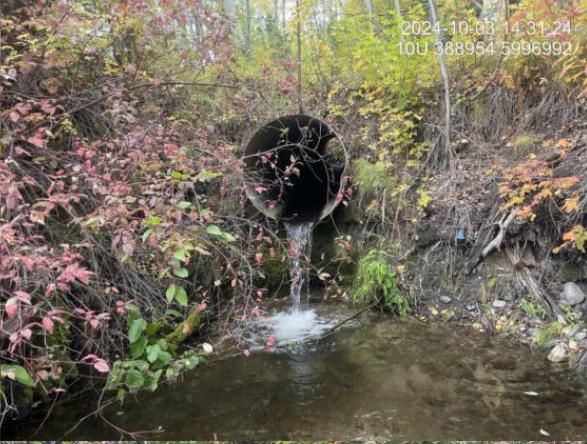
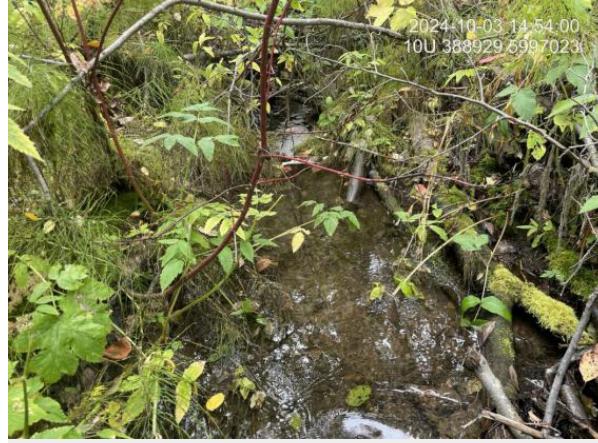
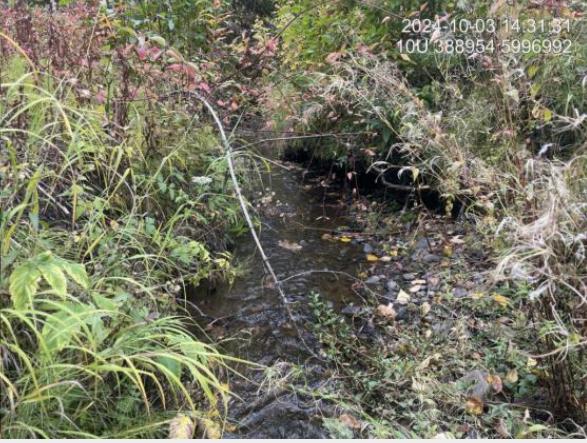
Location and Stream Data	Crossing Characteristics
<p>Comments: The local name of the stream is Burnt Cabin Creek. It had a large outlet drop and a heavily eroded outlet pool, indicating the culvert was undersized. The stream provided complex habitat for fish with abundant cover. The low-traffic dirt road had minimal road fill, making construction relatively straightforward.</p>	
<p>MoTi chris_culvert_id: 1790951</p>	
<p>Photos: From top left clockwise: Road/Site Card, Barrel, Outlet, Downstream, Upstream, Inlet.</p>

Should restoration/maintenance activities proceed, replacement of the Gala Bay Road crossing (199171) with a bridge (15 m span) is recommended. This culvert had a 0.9m outlet drop, likely inhibiting fish passage. At the time of reporting in 2025, the cost of the work is estimated at \$ 1,500,000.

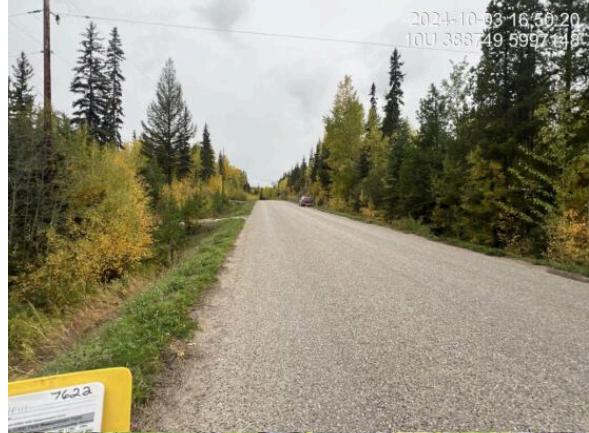
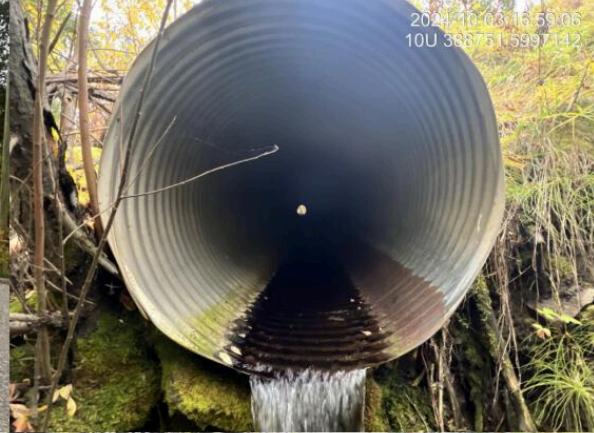
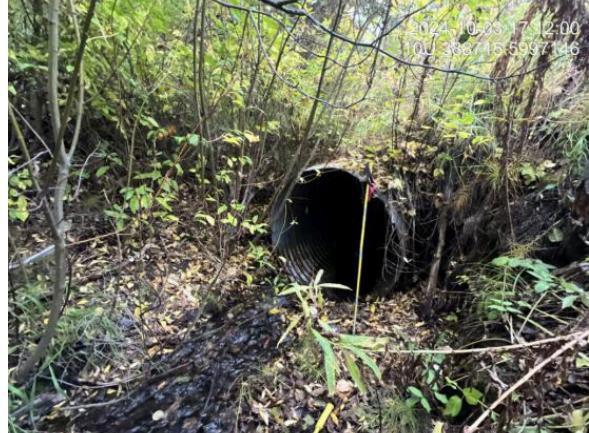
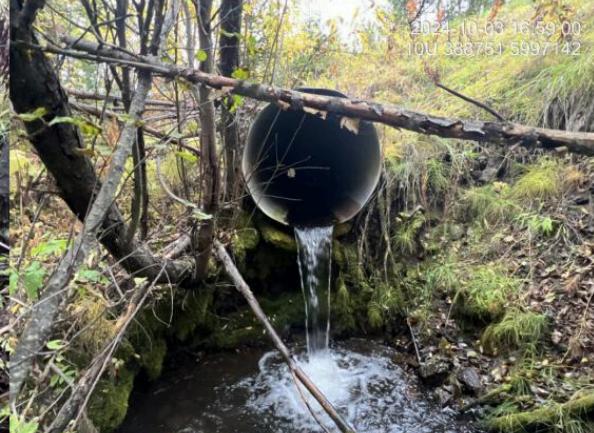
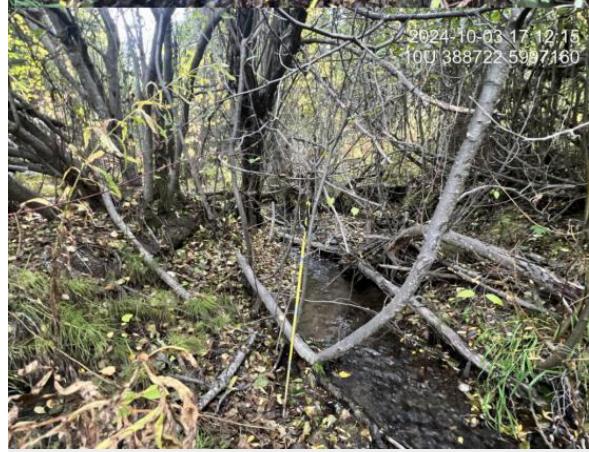
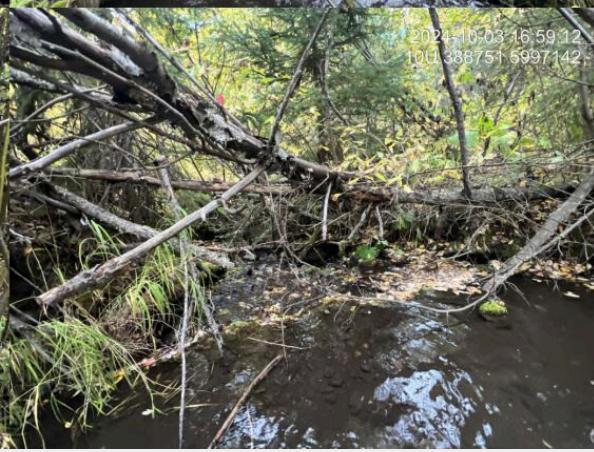
Location and Stream Data	Crossing Characteristics
<p>Comments: The culvert is undersized for current flow volumes, as indicated by a very large 1.15m outlet drop. Habitat confirmation was completed upstream, downstream, and below Gala Bay Road. MoTi chris_culvert_id: 1794196</p>	
<p>Photos: From top left clockwise: Road/Site Card, Barrel, Outlet, Downstream, Upstream, Inlet.</p>

Should restoration/maintenance activities proceed, replacement of the Stella Road crossing (7622) with a bridge (15 m span) is recommended. This culvert had a 1.15m outlet drop, very likely inhibiting fish passage. At the time of reporting in 2025, the cost of the work is estimated at \$ 3,000,000.

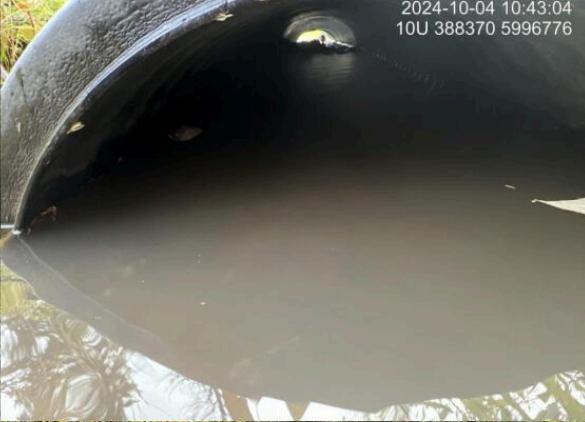
Location and Stream Data	Crossing Characteristics
<p>Comments: Two fully embedded PVC pipes, each 0.7m in diameter. One pipe was completely backwatered. Medium-value habitat was observed, with extensive gravels suitable for spawning upstream and downstream. A historic Chinook spawning point was recorded adjacent to the road. Habitat confirmations were conducted upstream, downstream, and above Stella Road. MoTi chris_culvert_id: 1790947</p>	
Photos: From top left clockwise: Road/Site Card, Barrel, Outlet, Downstream, Upstream, Inlet.

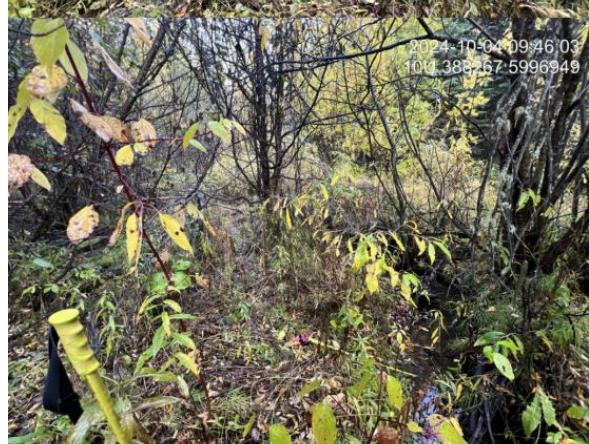
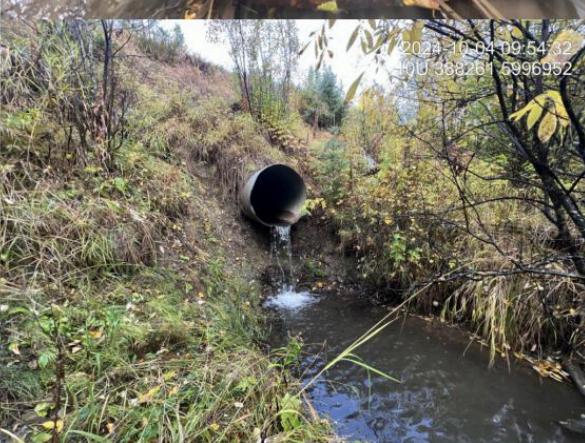
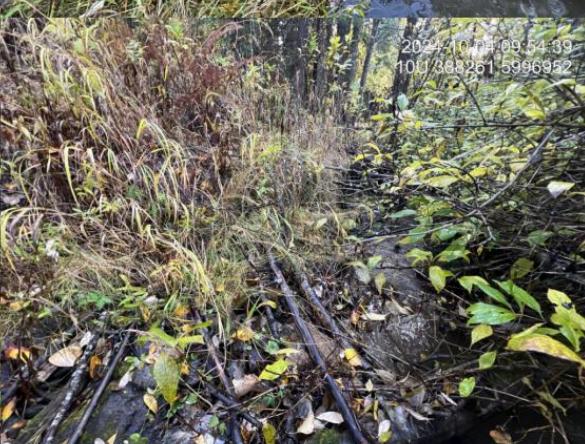
Table 4.16: Summary of fish passage assessment for PSCIS crossing 203297.

Location and Stream Data	Crossing Characteristics
<p>Comments: The culvert was very undersized for the stream, as evidenced by the large outlet drop. The stream had a good amount of flow for the time of year. Habitat was of medium value, with abundant large woody debris creating complex habitat and pools, providing ample cover for fish. Adjacent landowners reported that the stream was previously used as a water source for bottling and distribution across the province. Habitat confirmation was completed upstream and downstream. MoTi chris_culvert_id: 1794199</p> <p>Photos: From top left clockwise: Road/Site Card, Barrel, Outlet, Downstream, Upstream, Inlet.</p>

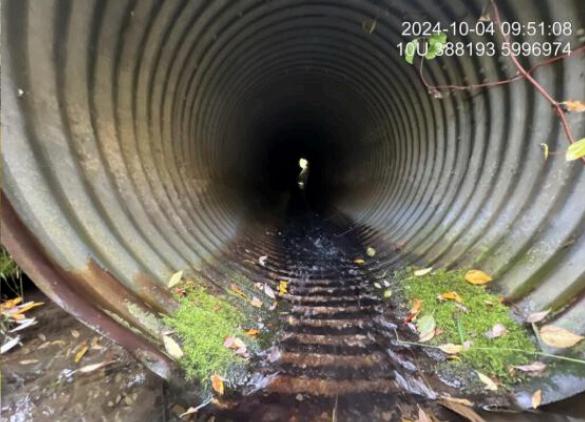
Location and Stream Data		Crossing Characteristics	
Date	2024-10-04	Crossing Sub Type	Round Culvert
PSCIS ID	203297	Diameter (m)	1.05
External ID	2024100450	Length (m)	8
Crew	LS	Embedded	No
UTM Zone	10	Depth Embedded (m)	—
Easting	388199	Resemble Channel	No
Northing	5997060	Backwatered	No
Stream	Scotch Creek	Percent Backwatered	—
Road	Private Driveway	Fill Depth (m)	2
Road Tenure	Private	Outlet Drop (m)	0.7
Channel Width (m)	2.5	Outlet Pool Depth (m)	0.55
Stream Slope (%)	4	Inlet Drop	No
Beaver Activity	No	Slope (%)	2
Habitat Value	Medium	Valley Fill	Deep Fill
Final score	31	Barrier Result	Barrier
Fix type	Replace with New Open Bottom Structure	Fix Span / Diameter	15
Comments: Two pipes, 0.6m and 0.45m in diameter, were present. There was a 0.7m outlet drop, and only the larger pipe conveyed flow. The inlet side of the road had completely eroded into the stream, obstructing the view of the inlet. No light was visible through the culverts from the outlet side, though water was still flowing. A landowner had placed a barricade across the road, likely to prevent access due to severe erosion of the road. The stream provided high-quality habitat with abundant large woody debris creating pools and gravels suitable for spawning. Just downstream, a functioning water intake shack was located in the middle of the stream, likely supplying the adjacent landowner's property. Plastic pipes extended from the intake shack downstream to the lower Stella Road crossing. The heavily overgrown and collapsing road appeared to be private access and would be a good candidate for removal. Due to inlet erosion, culvert length and slope were estimated as the inlet could not be located.

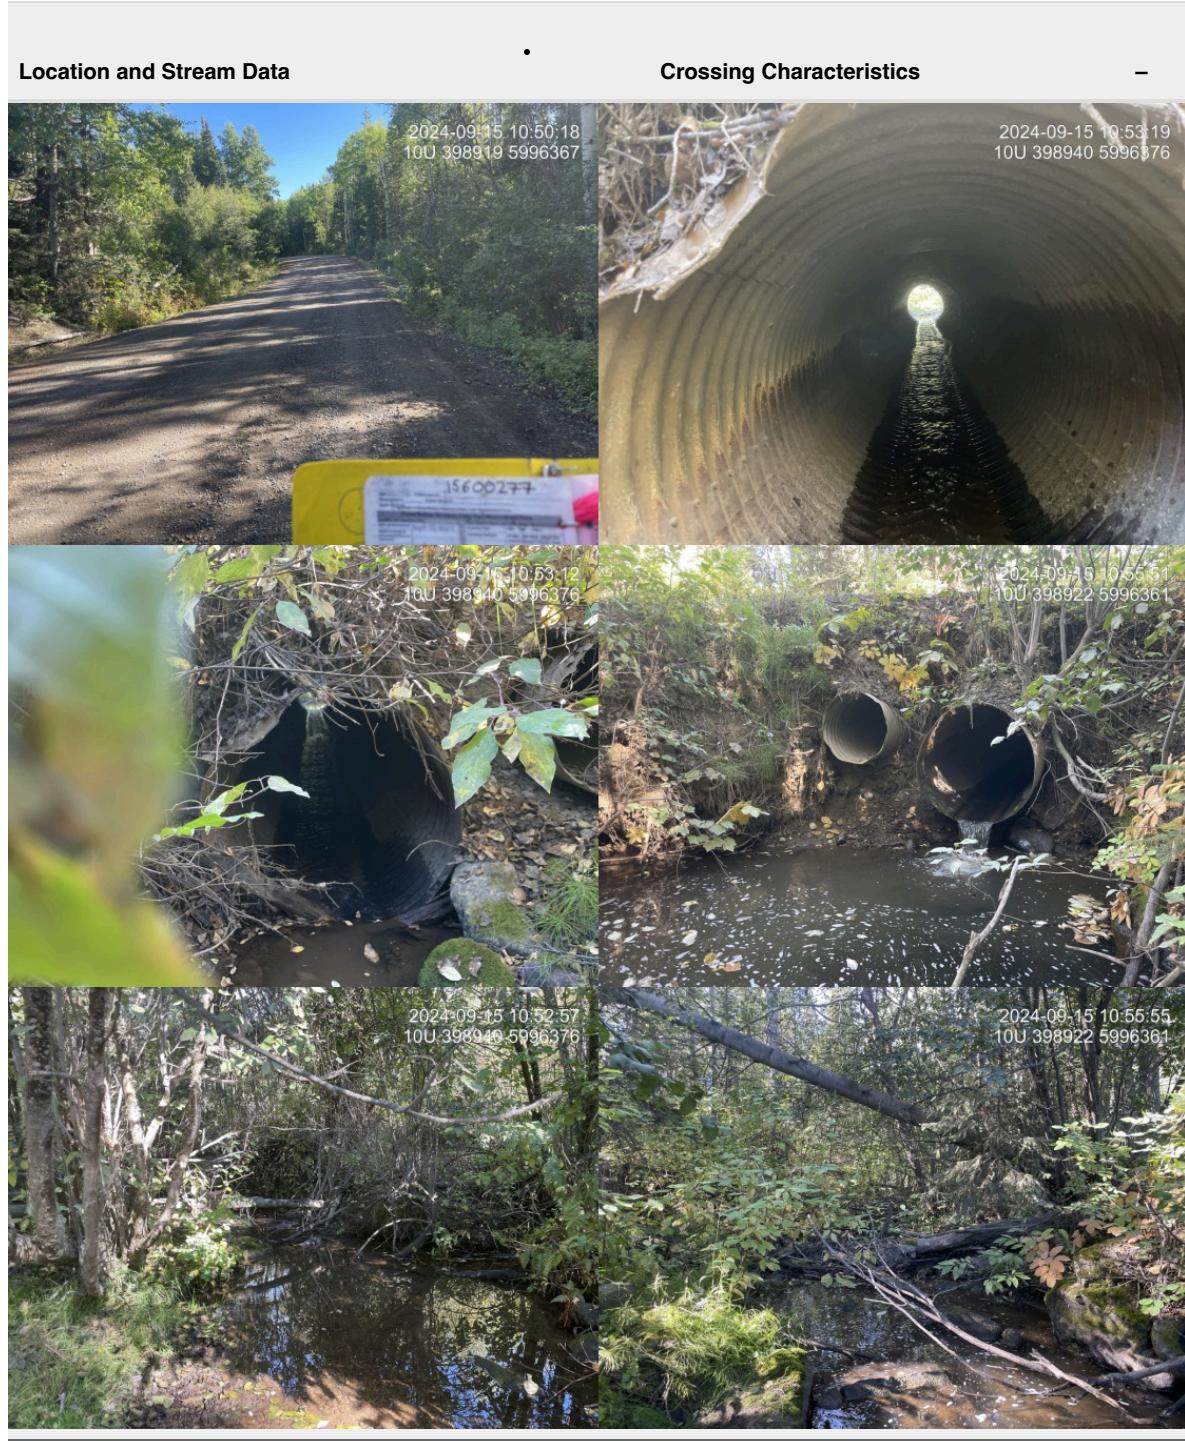
Location and Stream Data		Crossing Characteristics	
Date	2024-09-15	Crossing Sub Type	Round Culvert
PSCIS ID	199173	Diameter (m)	0.9
External ID	–	Length (m)	10
Crew	LS, AI	Embedded	No
UTM Zone	10	Depth Embedded (m)	–
Easting	398923	Resemble Channel	No
Northing	5996362	Backwatered	No
Stream	Tributary To Nechako River	Percent Backwatered	–
Road	Dog Creek Road	Fill Depth (m)	1
Road Tenure	MOTI	Outlet Drop (m)	0.35
Channel Width (m)	3	Outlet Pool Depth (m)	0.7
Stream Slope (%)	4	Inlet Drop	No
Beaver Activity	Yes	Slope (%)	2.5
Habitat Value	Medium	Valley Fill	Deep Fill
Final score	31	Barrier Result	Barrier
Fix type	Replace with New Open Bottom Structure	Fix Span / Diameter	15
Comments: The culvert had a moderate outlet drop with some erosion around the pipe at the outlet. The pipe was in good condition. The stream provided excellent habitat, with several pools and abundant undercut banks. Fish were observed during the assessment (~40-90mm in length). Upstream of the crossing, the stream was channelized with some pockets of gravel suitable for rearing rainbow trout and potentially Chinook. It then transitioned into beaver-impounded wetland areas storing large quantities of water, likely sustaining year-round stream flow at this crossing. Photos: From top left clockwise: Road/Site Card, Barrel, Outlet, Downstream, Upstream, Inlet.

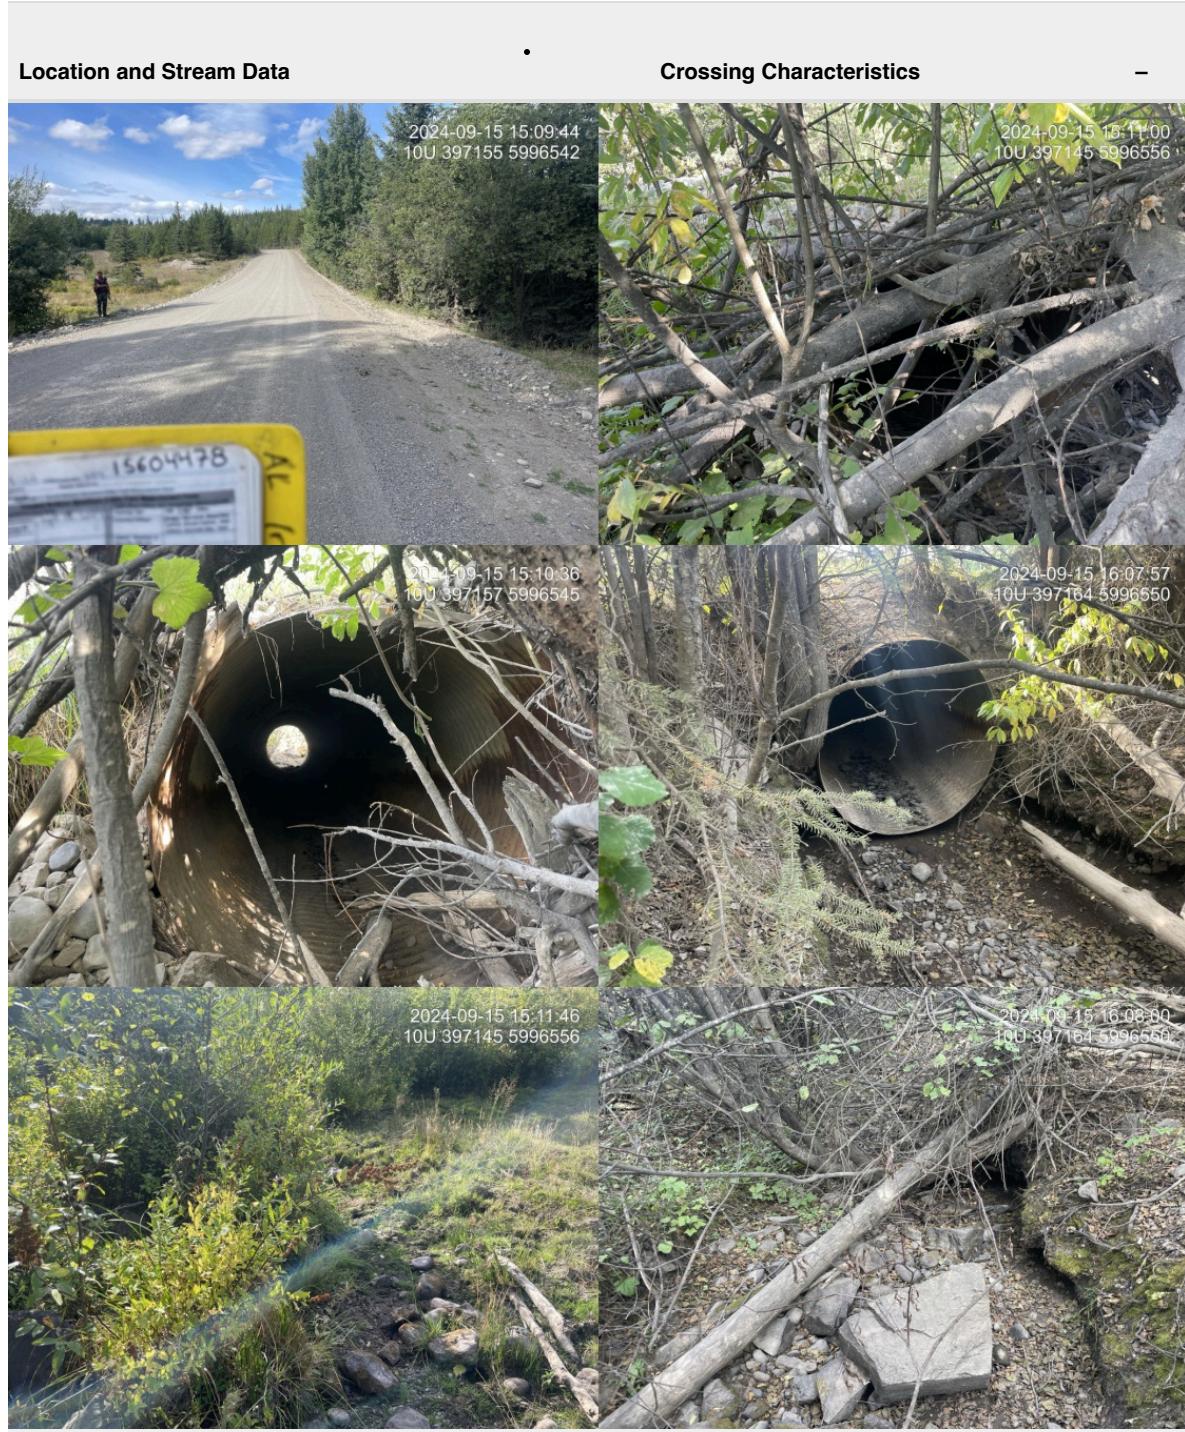
Location and Stream Data		Crossing Characteristics	
Date	2024-09-15	Crossing Sub Type	Round Culvert
PSCIS ID	199174	Diameter (m)	1.5
External ID	–	Length (m)	15
Crew	LS	Embedded	No
UTM Zone	10	Depth Embedded (m)	–
Easting	397160	Resemble Channel	No
Northing	5996574	Backwatered	No
Stream	Tributary To Nechako River	Percent Backwatered	–
Road	Sutherland FSR	Fill Depth (m)	0.4
Road Tenure	MoF	Outlet Drop (m)	0
Channel Width (m)	2.5	Outlet Pool Depth (m)	0
Stream Slope (%)	1.2	Inlet Drop	No
Beaver Activity	No	Slope (%)	1
Habitat Value	–	Valley Fill	Deep Fill
Final score	24	Barrier Result	Barrier
Fix type	Replace with New Open Bottom Structure	Fix Span / Diameter	15
<p>Comments: At the time of assessment, the stream was dry at the crossing; however, it contained medium-value habitat. Upstream of the culvert, the stream was primarily dry for the first 300m, then intermittent pools began to appear, associated with beaver activity. Approximately 450-500m upstream, the stream became nearly fully watered, with pools up to 40cm deep. Downstream of the crossing was dominated by beaver-impounded wetland areas, which were storing large quantities of water, likely sustaining year-round stream flow at the downstream crossing on Dog Creek Road. Further downstream, approximately 300m upstream of the crossing on Dog Creek Road, the stream transitioned to a channelized system with some pockets of gravel suitable for rearing rainbow trout and potentially Chinook. However, heavy cattle impacts were observed at both this crossing and the downstream crossing on Dog Creek Road.</p> <p>Photos: From top left clockwise: Road/Site Card, Barrel, Outlet, Downstream, Upstream, Inlet.</p>

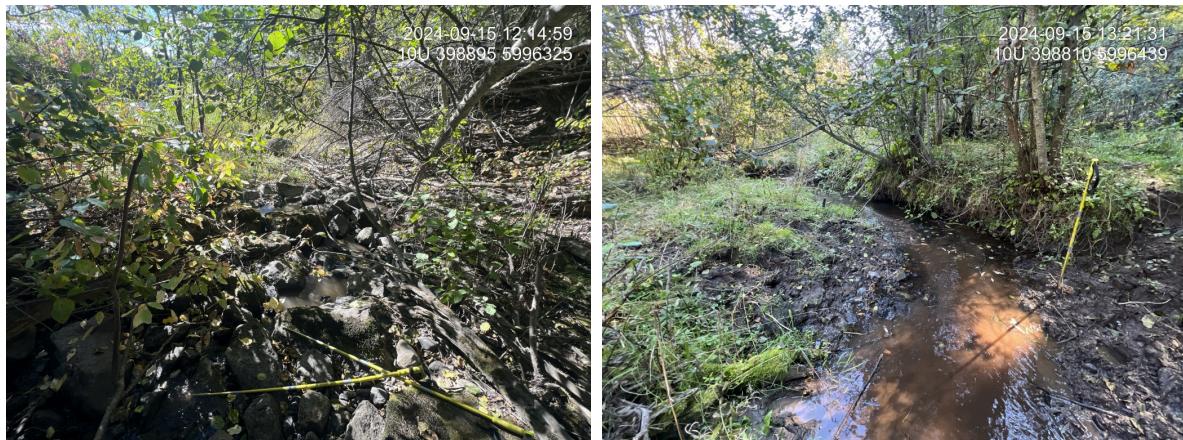
Figure 4.6: Left: Typical habitat downstream of PSCIS crossing 199173. Right: Typical habitat upstream of PSCIS crossing 199173.

The stream was surveyed downstream from crossing 199173 for 115m (Figure 4.6). The habitat was rated as medium value, with undercut banks suitable for juvenile chinook and rainbow trout rearing. No natural or man-made barriers were present between Dog Creek Road and the Nechako River. Fish (~40–90mm in length) were observed during the assessment. The dominant substrate was cobbles with fines sub-dominant. The average channel width was 3.5m, the average wetted width was 1.3m, and the average gradient was 6%. Total cover amount was rated as moderate with undercut banks dominant. Cover was also present as small woody debris and boulders.

The stream was surveyed upstream from crossing 199173 for 575m (Figure 4.6). The habitat was rated as medium with pockets of gravels suitable for rainbow trout and potentially chinook rearing, and fish were observed throughout the survey area. Heavy cattle impacts were evident, particularly in low-gradient sections with easily accessible banks. Fencing intended to restrict cattle access was present but had been breached. Approximately 300–350m upstream, the stream transitioned from a channelized section to a beaver-impounded wetland, with over three mature dams—some up to 1.5m high—vegetated and well-developed. These dams impounded large volumes of water, likely sustaining year-round stream flow downstream at the Dog Creek Road crossing. Total cover amount was rated as moderate with small woody debris dominant. Cover was also present as large woody debris, deep pools, and overhanging vegetation. The average channel width was 3m, the average wetted width was 1.5m, and the average gradient was 2.4%.

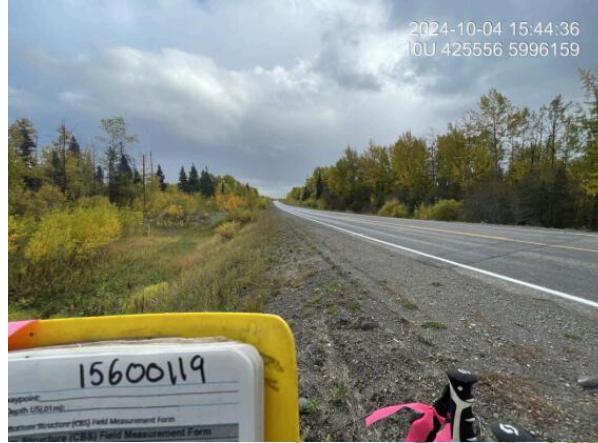
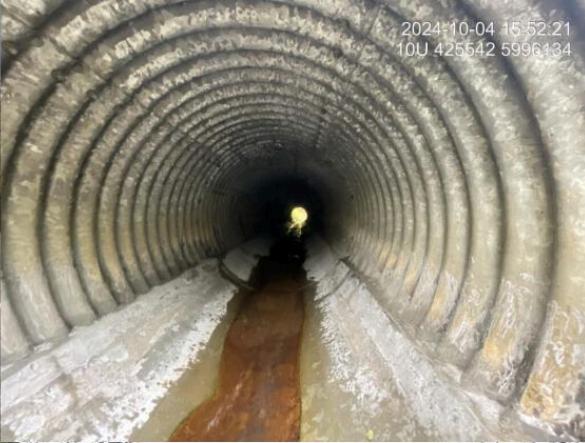
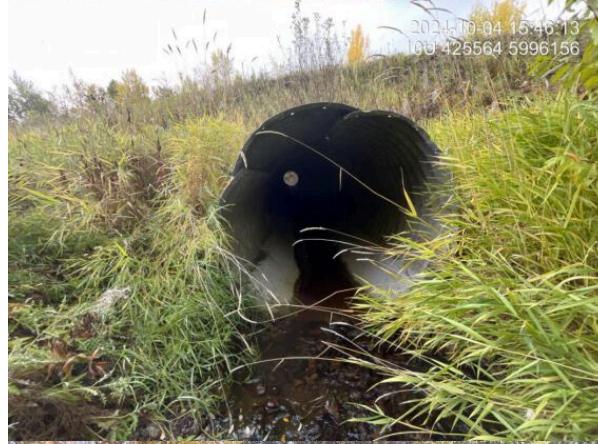
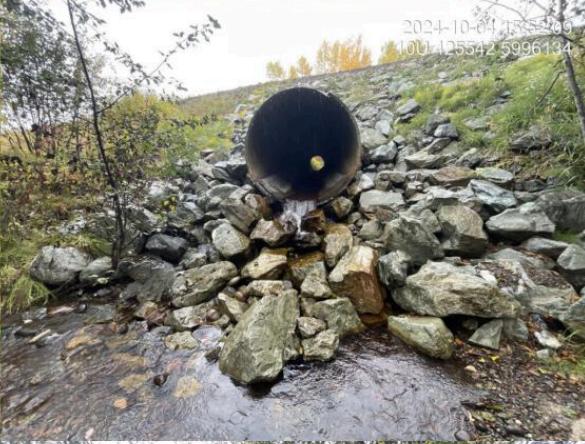
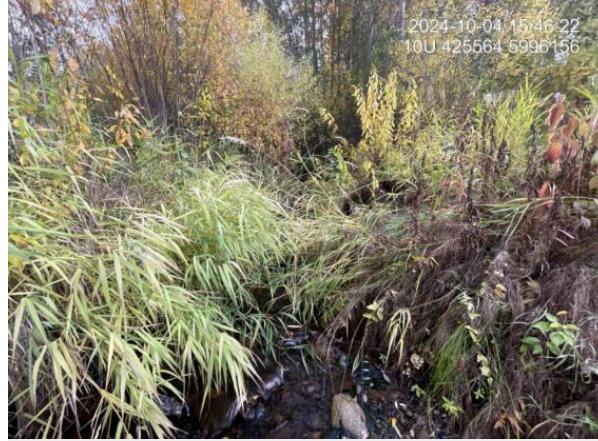
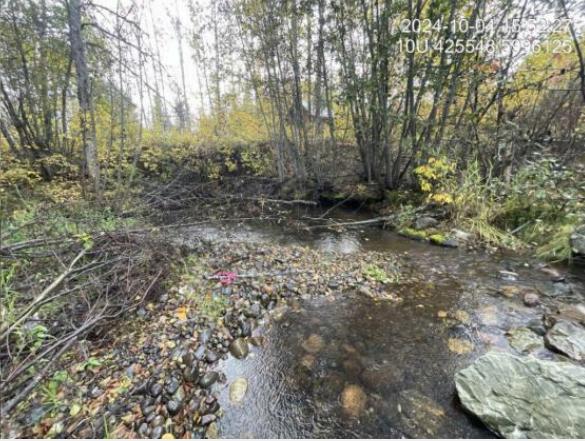
Location and Stream Data	Crossing Characteristics
<p>Comments: The bottom of the culvert had been reinforced with concrete, likely to address holes noted in the previous assessment. A large pile of riprap was placed at the outlet, possibly to reduce the outlet drop, though its placement appeared unusual and could inhibit fish passage. The habitat was high quality, with a large pool just downstream of the culvert and abundant gravels suitable for spawning fish. MoTi chris_culvert_id: 1806163</p>	
<p>Photos: From top left clockwise: Road/Site Card, Barrel, Outlet, Downstream, Upstream, Inlet.</p>

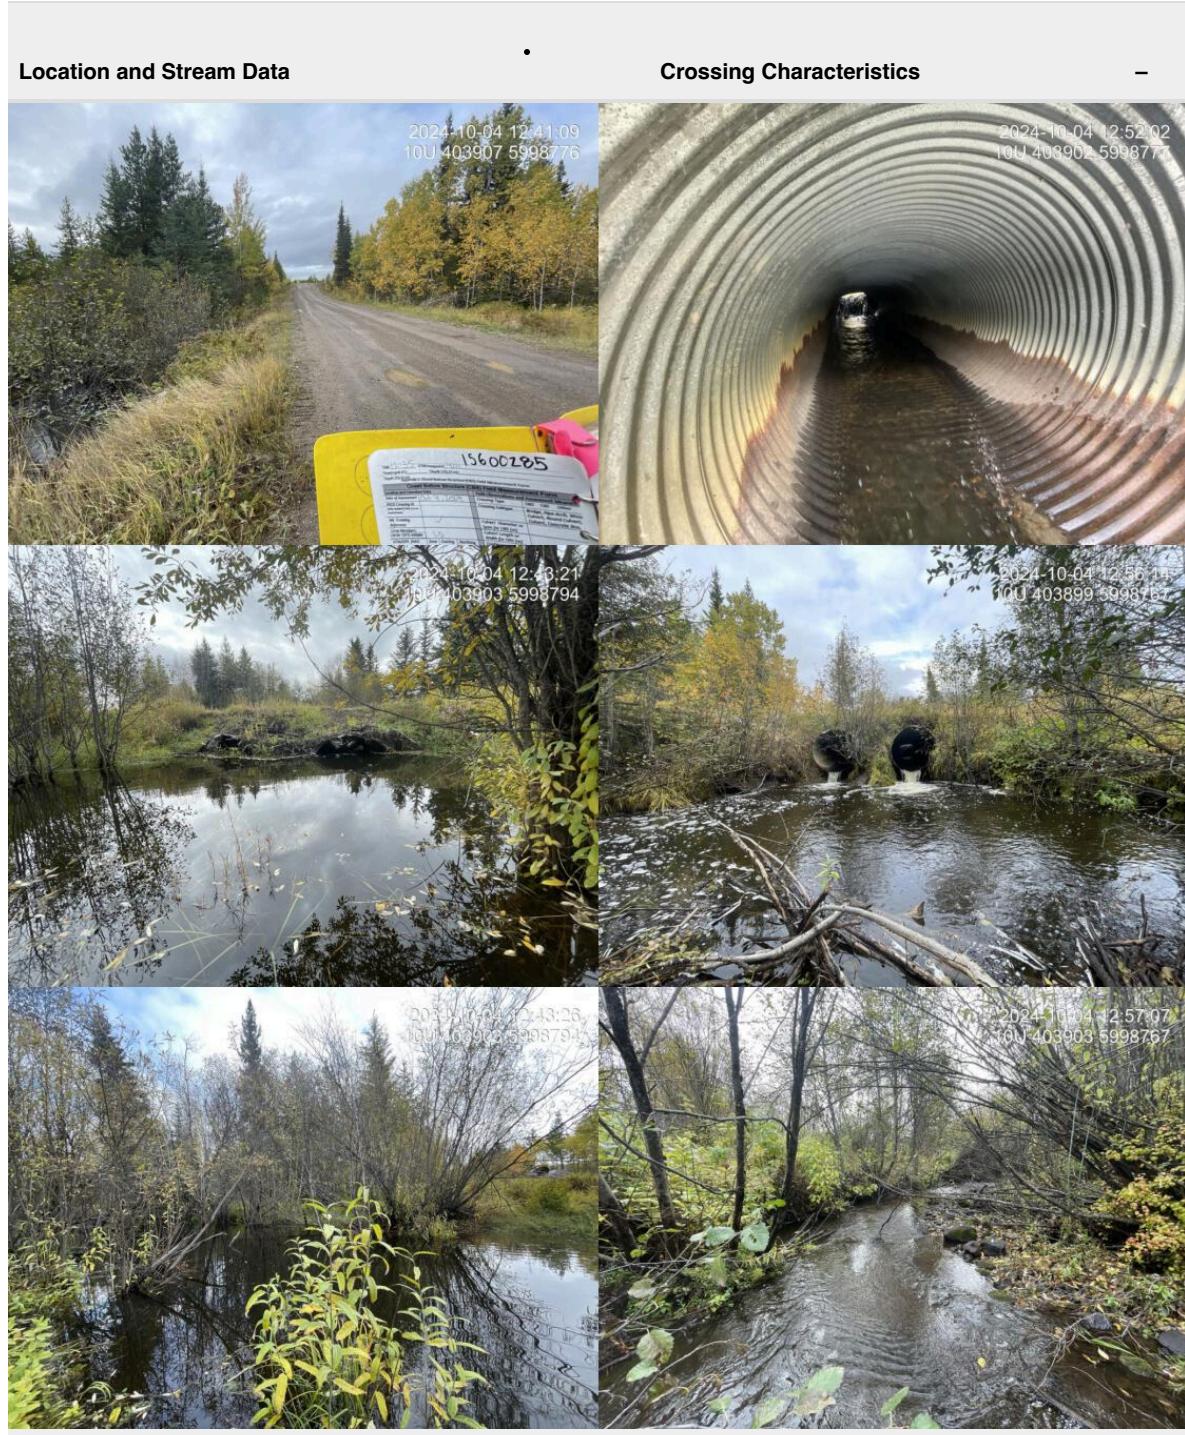
Location and Stream Data		Crossing Characteristics	
Date	2024-10-04	Crossing Sub Type	Round Culvert
PSCIS ID	199204	Diameter (m)	3.2
External ID	–	Length (m)	12
Crew	LS	Embedded	No
UTM Zone	10	Depth Embedded (m)	–
Easting	403906	Resemble Channel	No
Northing	5998777	Backwatered	No
Stream	Nine Mile Creek	Percent Backwatered	–
Road	Settlement Road	Fill Depth (m)	0.5
Road Tenure	MOTI	Outlet Drop (m)	0.5
Channel Width (m)	5.5	Outlet Pool Depth (m)	1.4
Stream Slope (%)	0.5	Inlet Drop	No
Beaver Activity	Yes	Slope (%)	2
Habitat Value	Medium	Valley Fill	Deep Fill
Final score	31	Barrier Result	Barrier
Fix type	Replace with New Open Bottom Structure	Fix Span / Diameter	15
Comments: The inlets of both culverts were dammed by a beaver, backing up water to most of the culverts' height. Two pipes, each 1.6m in diameter, were present. A large outlet pool indicated the pipes were likely undersized for the stream. Another beaver dam was being constructed at the outlet of the pool. The dirt road had minimal road fill, making construction relatively straightforward. The road appeared to be used for pipeline access. Outlet pool depth was estimated as it was too deep to wade. Fish approximately 40mm in length were observed downstream during habitat confirmation. MoTi chris_culvert_id: 1793923

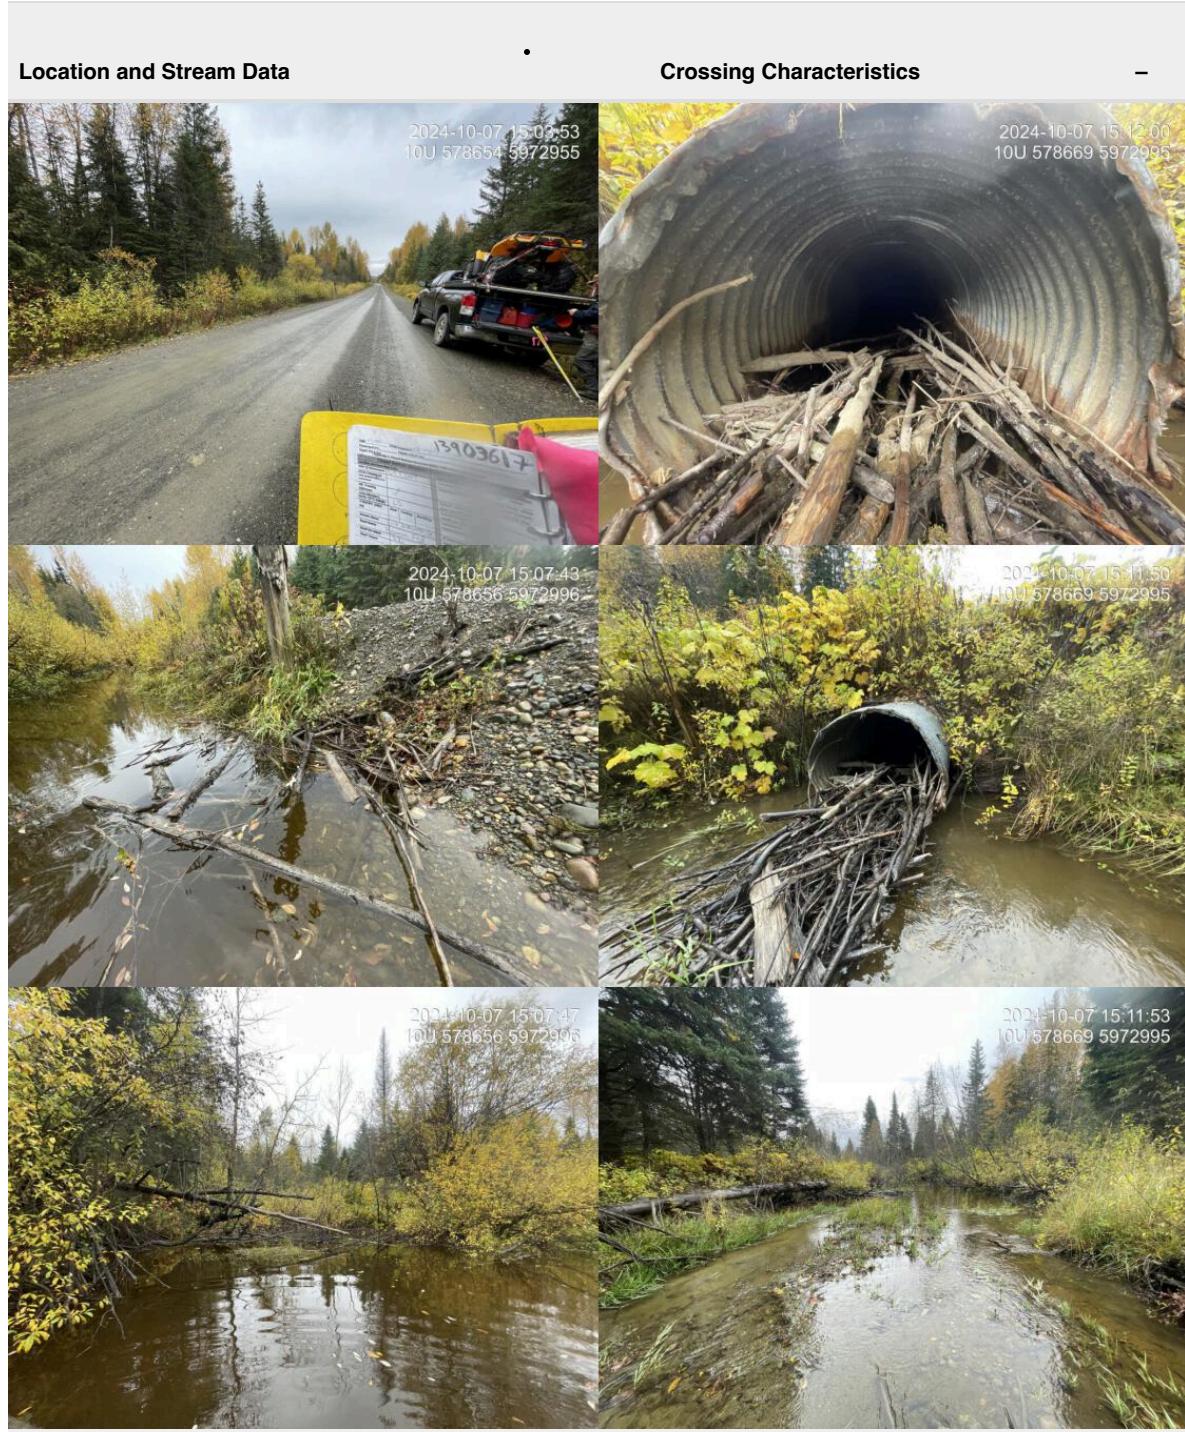
Table 4.41: Summary of fish passage assessment for PSCIS crossing 199255.

Location and Stream Data		Crossing Characteristics	
Date	2024-10-07	Crossing Sub Type	Round Culvert
PSCIS ID	199255	Diameter (m)	1.1
External ID	–	Length (m)	13
Crew	LS	Embedded	No
UTM Zone	10	Depth Embedded (m)	–
Easting	578664	Resemble Channel	No
Northing	5972996	Backwatered	No
Stream	Tributary To Kenneth Creek	Percent Backwatered	–
Road	Bowron FSR	Fill Depth (m)	1.5
Road Tenure	MoF	Outlet Drop (m)	0
Channel Width (m)	10.5	Outlet Pool Depth (m)	0.25
Stream Slope (%)	0.5	Inlet Drop	No
Beaver Activity	Yes	Slope (%)	1.5
Habitat Value	Medium	Valley Fill	Deep Fill
Final score	21	Barrier Result	Barrier
Fix type	Replace with New Open Bottom Structure	Fix Span / Diameter	15
<p>Comments: The inlet of the culvert was completely submerged, with a large beaver pond area just upstream. The outlet was plugged with beaver sticks, and it appeared the beaver had dammed the culvert entirely, creating a large pool at the inlet. Despite this, the culvert still had flow. A beaver dam approximately 0.7m in height was located about 40m downstream. A new culvert had been installed 60m north on the FSR, with flow from that crossing entering the outlet pool from the north. Downstream of the culvert, the stream flowed through the forest with minimal defined channel. Where a defined channel was present, it ranged from 13m wide, but most of the area consisted of 15-17m of wetted forest with some flow. Culvert slope was estimated due to the submerged inlet. Habitat confirmations were conducted upstream and downstream.</p> <p>Photos: From top left clockwise: Road/Site Card, Barrel, Outlet, Downstream, Upstream, Inlet.</p>

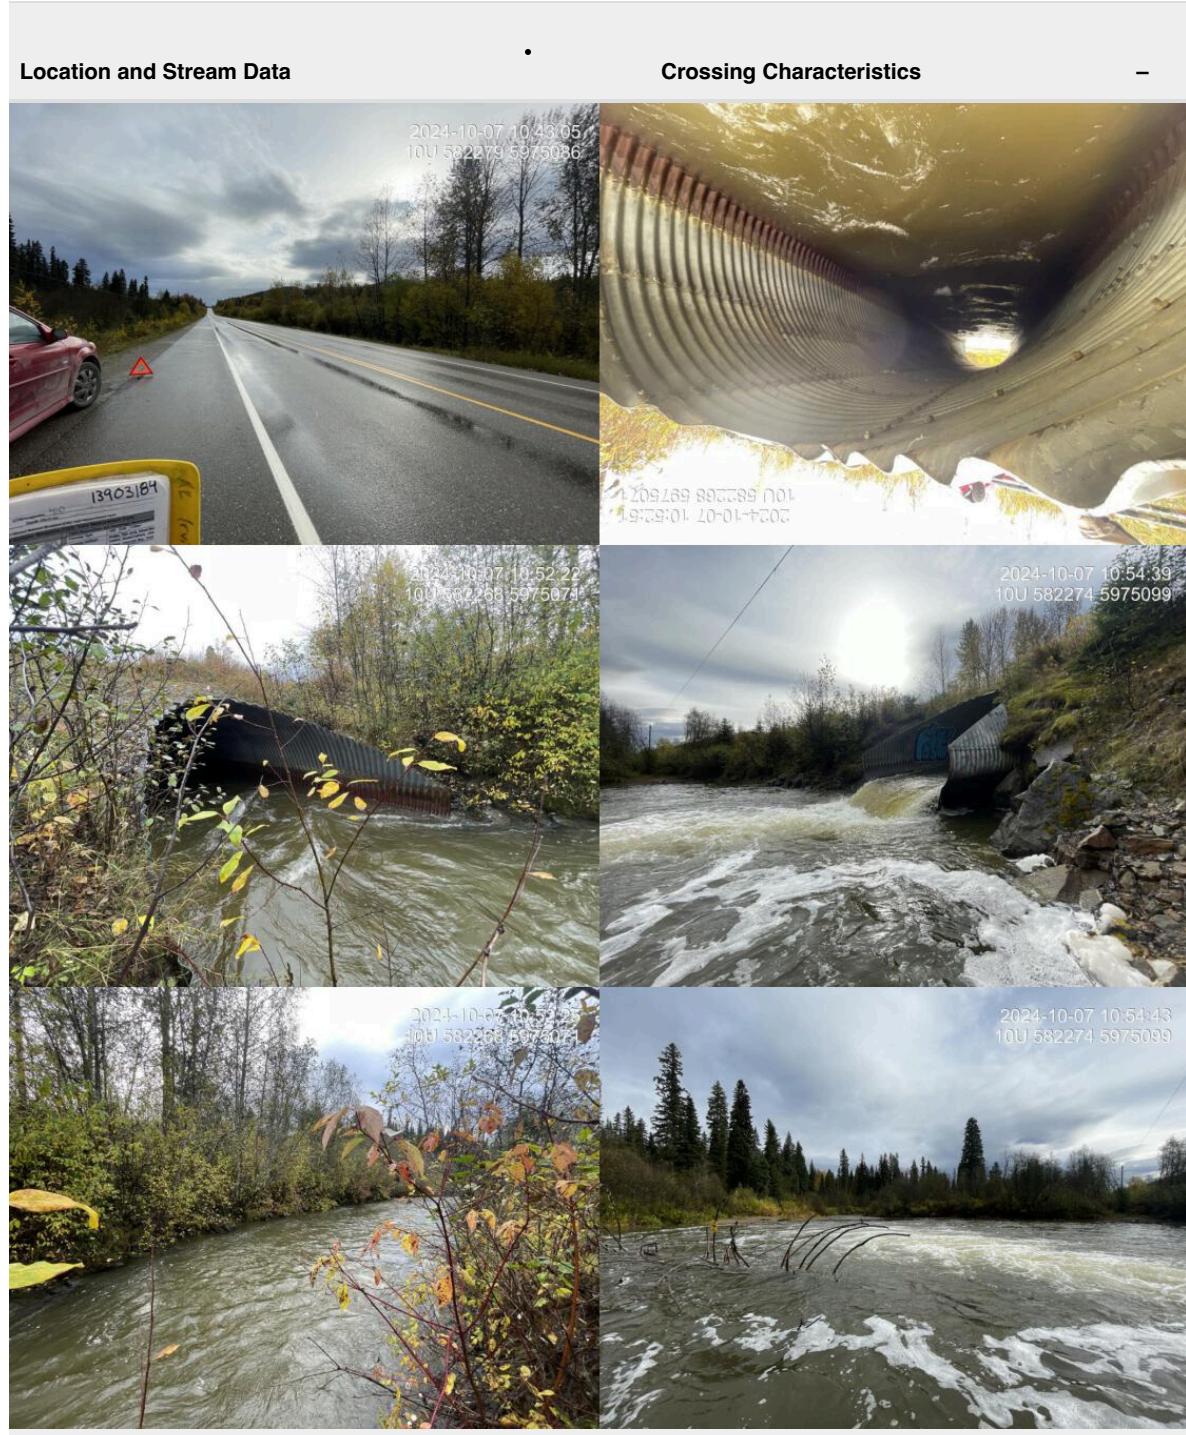
Location and Stream Data		Crossing Characteristics	
Date	2024-10-07	Crossing Sub Type	Oval Culvert
PSCIS ID	199256	Diameter (m)	5.5
External ID	–	Length (m)	30
Crew	LS	Embedded	No
UTM Zone	10	Depth Embedded (m)	–
Easting	582279	Resemble Channel	No
Northing	5975090	Backwatered	No
Stream	Kenneth Creek	Percent Backwatered	–
Road	Highway 16	Fill Depth (m)	1.5
Road Tenure	MOTI	Outlet Drop (m)	0.7
Channel Width (m)	19	Outlet Pool Depth (m)	2
Stream Slope (%)	0.5	Inlet Drop	No
Beaver Activity	No	Slope (%)	1
Habitat Value	High	Valley Fill	Deep Fill
Final score	37	Barrier Result	Barrier
Fix type	Replace with New Open Bottom Structure	Fix Span / Diameter	24
Comments: Large multi-plate oval culvert with a substantial 50m-wide outlet pool. The stream had high flow at the time of assessment. Culvert slope and outlet pool depth were estimated as the pool was too deep to wade. Deep pools over 1m, formed by functional large woody debris, provided good overwintering habitat for fish of all ages. Gravels suitable for spawning were present. Downstream of the culvert, the stream ran parallel to the highway with banks reinforced by riprap and large wood secured with metal wiring to create habitat and reduce flow. MoTi chris_hwy_structure_road_id: 3750

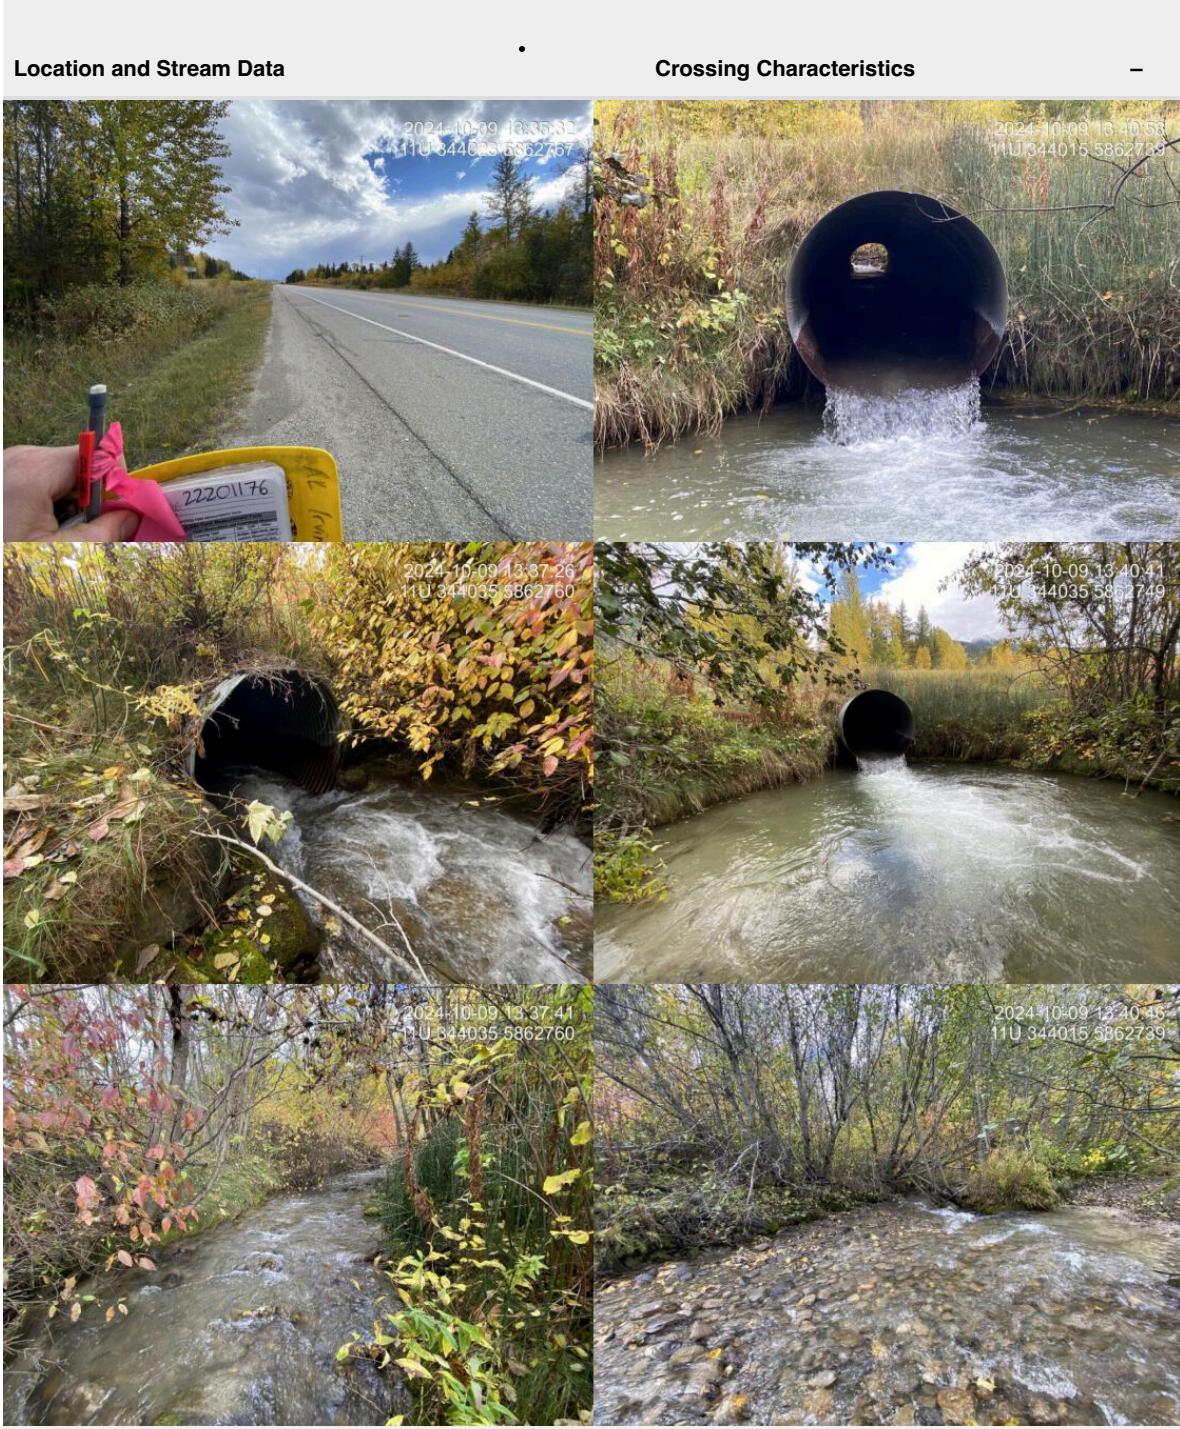
Location and Stream Data		Crossing Characteristics	
Date	2024-10-09	Crossing Sub Type	Round Culvert
PSCIS ID	199278	Diameter (m)	1.4
External ID	–	Length (m)	22
Crew	LS	Embedded	No
UTM Zone	11	Depth Embedded (m)	–
Easting	344031	Resemble Channel	No
Northing	5862744	Backwatered	No
Stream	Teepee Creek	Percent Backwatered	–
Road	Highway 5	Fill Depth (m)	0.7
Road Tenure	MOTI	Outlet Drop (m)	0.4
Channel Width (m)	7	Outlet Pool Depth (m)	1
Stream Slope (%)	2.5	Inlet Drop	No
Beaver Activity	No	Slope (%)	2
Habitat Value	High	Valley Fill	Deep Fill
Final score	34	Barrier Result	Barrier
Fix type	Replace with New Open Bottom Structure	Fix Span / Diameter	15
Comments: A moderate outlet drop was present and would be substantial at lower flows. Flow was steady at the time of assessment. The culvert was in good condition. A large, deep outlet pool indicated the culvert was likely undersized for the stream. Additionally, minimal road fill made this crossing a significant flood hazard, which could wash out Highway 5. Downstream, the stream had frequent pools 0.3-0.5m deep, providing good overwintering habitat for fish, and abundant gravels suitable for spawning. Roughly 150m downstream of the culvert, several cattle pens crossed the stream and appeared to be set up to provide cattle access for drinking. These areas were visibly trampled, with significant loss of riparian vegetation. Upstream, the stream was relatively confined, with only rare pockets of unembedded gravels. Deep pools were present, formed by boulder and large woody debris scour. A salmon point was noted near the pipeline location in FISS. Numerous small steps, ranging from 30-60cm, were present due to the steep, boulder-dominated nature of the stream. Electrofishing would be beneficial for further assessment. The site was a highway crossing, making replacement difficult. A small ford was located approximately 5m downstream of the culvert outlet. MoTi chris_culvert_id: 1467202

PSCIS crossing 199278 on Highway 5 had a moderate 0.4m outlet drop that could be substantial at lower flows. A large, deep outlet pool indicated the culvert was likely undersized for the stream, and minimal road fill made this crossing a significant flood hazard, which could wash out Highway 5. The crossing is a high priority for replacement. Further upstream, PSCIS crossing 203302 on the CN Railway had a significant 0.75m outlet drop, likely inhibiting fish passage. This crossing is a moderate priority for replacement.

Should restoration/maintenance activities proceed, replacement of the Highway 5 crossing (199278) with a bridge (15 m span) is recommended. At the time of reporting in 2025, the cost of the work is estimated at \$ 11,250,000.
