Restoring Fish Passage in the Fraser Region - 2023

**Prepared for
Ministry of Transportation and Infrastructure**

**Prepared by
Al Irvine, B.Sc., R.P.Bio. and Lucy Schick, B.Sc.
New Graph Environment Ltd.**

Version 0.0.1 2025-03-24

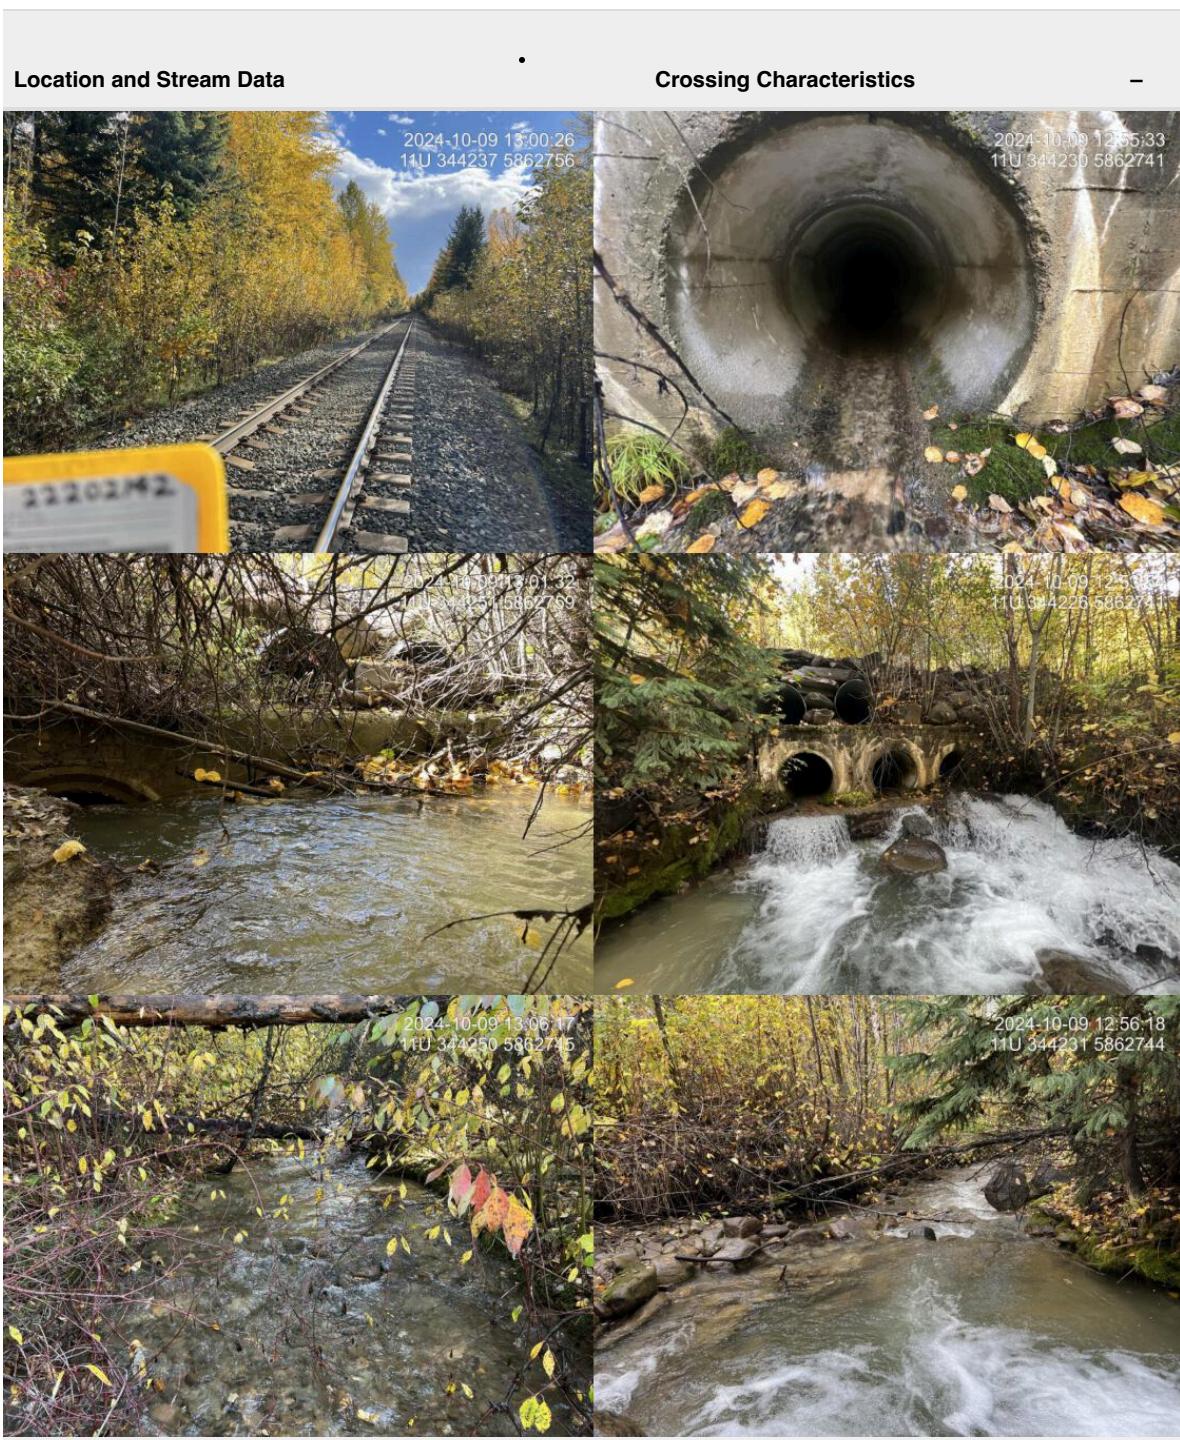
Location and Stream Data		Crossing Characteristics	
Date	2024-10-09	Crossing Sub Type	Round Culvert
PSCIS ID	203302	Diameter (m)	2.7
External ID	–	Length (m)	14
Crew	AI	Embedded	No
UTM Zone	11	Depth Embedded (m)	–
Easting	344222	Resemble Channel	No
Northing	5862742	Backwatered	No
Stream	Teepee Creek	Percent Backwatered	–
Road	Railway	Fill Depth (m)	2
Road Tenure	CN Rail	Outlet Drop (m)	0.75
Channel Width (m)	4.2	Outlet Pool Depth (m)	0.25
Stream Slope (%)	7	Inlet Drop	Yes
Beaver Activity	No	Slope (%)	6
Habitat Value	Medium	Valley Fill	Deep Fill
Final score	36	Barrier Result	Barrier
Fix type	Replace with New Open Bottom Structure	Fix Span / Diameter	15
Comments: Three concrete pipes, each 0.9m in diameter, were present, along with two 0.9m corrugated overflow pipes above. A stamp on the structure indicated it was built in 1944. All three concrete pipes were clogged at the inlet, ranging from 80% to 100% clogged with debris. This was a known fish-bearing stream, with a salmon point documented ~100m downstream in the FISS database. At this location, the stream was a mid-sized, steeper cobble-boulder step-pool system with only rare pockets of unembedded gravels. Deep pools were present, formed by boulder and large woody debris scour. Numerous small steps, ranging from 30-60cm, were present due to the steep, boulder-dominated nature of the stream. Downstream of the highway crossing, the stream had a lower gradient with frequent pools 0.3-0.5m deep, providing good overwintering habitat for fish and abundant gravels suitable for spawning.

Should restoration/maintenance activities proceed, replacement of the Railway crossing (203302) with a bridge (15 m span) is recommended. At the time of reporting in 2025, the cost of the work is estimated at \$ 11,250,000.

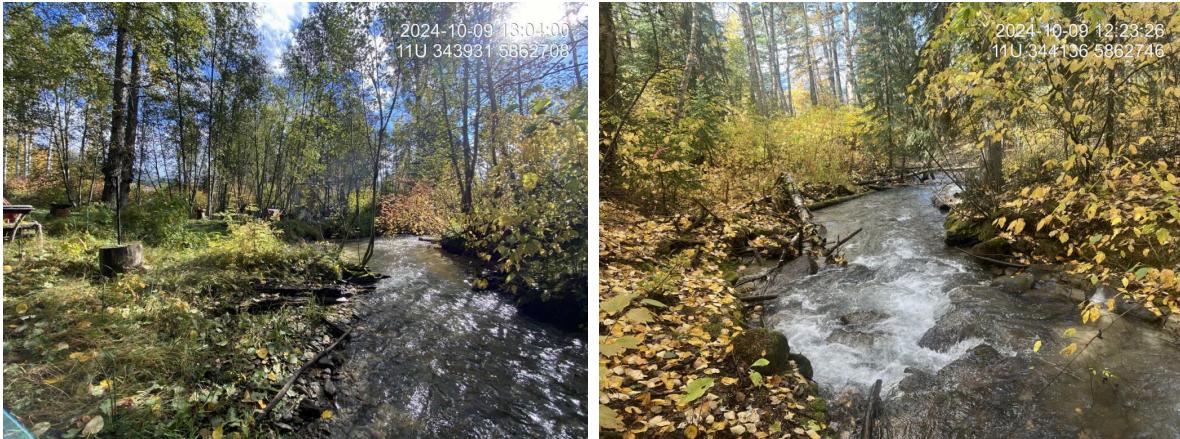
The stream was surveyed downstream from crossing 199278 for 150m (Figure 4.18).. The habitat was rated as high value, with frequent pools 0.3–0.5m deep suitable for overwintering fish and abundant gravels for spawning. The average channel width was 7.1m, the average wetted width was 4.5m, and the average gradient was 2.5%. Total cover amount was rated as abundant with large woody debris dominant. Cover was also present as small woody debris, undercut banks, and overhanging vegetation. The dominant substrate was cobbles with gravels sub-dominant.. Roughly 150m downstream of the culvert, several cattle pens crossed the stream and appeared to be set up to provide cattle access for drinking. These areas were visibly trampled, with significant loss of riparian vegetation.

The stream was surveyed upstream from crossing 199278 on Highway 5 to crossing 203302 on the CN Railway, a distance of approximately 300m (Figure 4.18). The habitat was rated as medium value for spawning and rearing, with frequent deep pools formed by boulders and large woody debris, but only limited pockets of unembedded gravels. Numerous small steps ranging from 30–60cm were present due to the steep, boulder-dominated nature of the stream. The dominant substrate was cobbles with boulders sub-dominant. The average channel width was 5.3m, the average wetted width was 3.3m, and the average gradient was 7.2%. Total cover amount was rated as moderate with boulders dominant. Cover was also present as large woody debris, undercut banks, and overhanging vegetation.

Figure 4.18: Left: Typical habitat downstream of PSCIS crossing 199278. Right: Typical habitat upstream of PSCIS crossing 199278 and downstream of PSCIS crossing 203302.

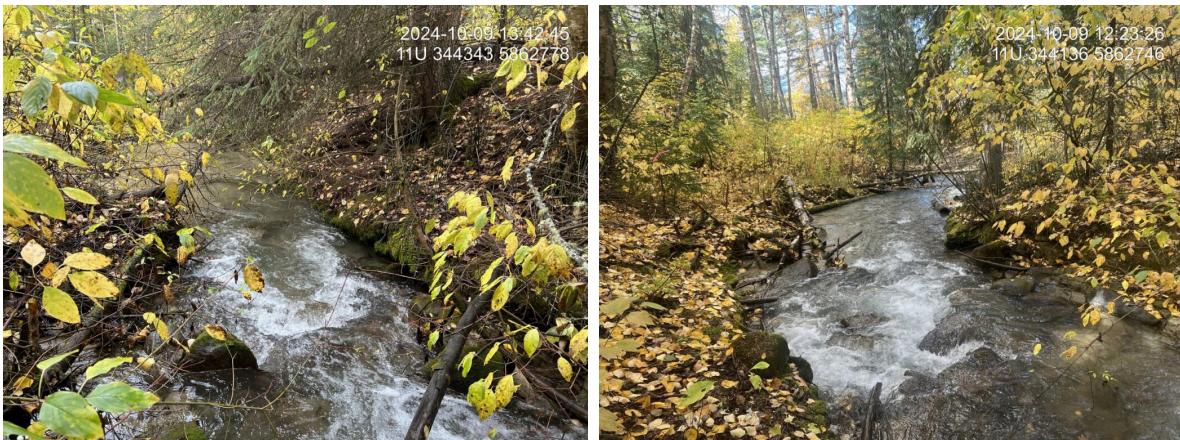
The stream was surveyed upstream from crossing 203302 for 600m (Figure 4.19). The habitat was rated as medium value for spawning and rearing, with few unembedded gravels; however, recent heavy rain caused slight turbidity making it difficult to assess the substrate. The dominant substrate was cobbles with boulders sub-dominant. The average channel width was 5.4m, the average wetted width was 3.9m, and the average gradient was 6.8%. Total cover amount was rated as moderate with boulders dominant. Cover was also present as . Approximately 100m before the end of the site, the stream showed signs of a large disturbance event that had incised the channel to a depth of 1.2–2m, with major areas of aggregation where the channel was widened and uniform.

Figure 4.19: Left: Typical habitat upstream of PSCIS crossing 203302. Right: Typical habitat upstream of PSCIS crossing 199278 and downstream of PSCIS crossing 203302.

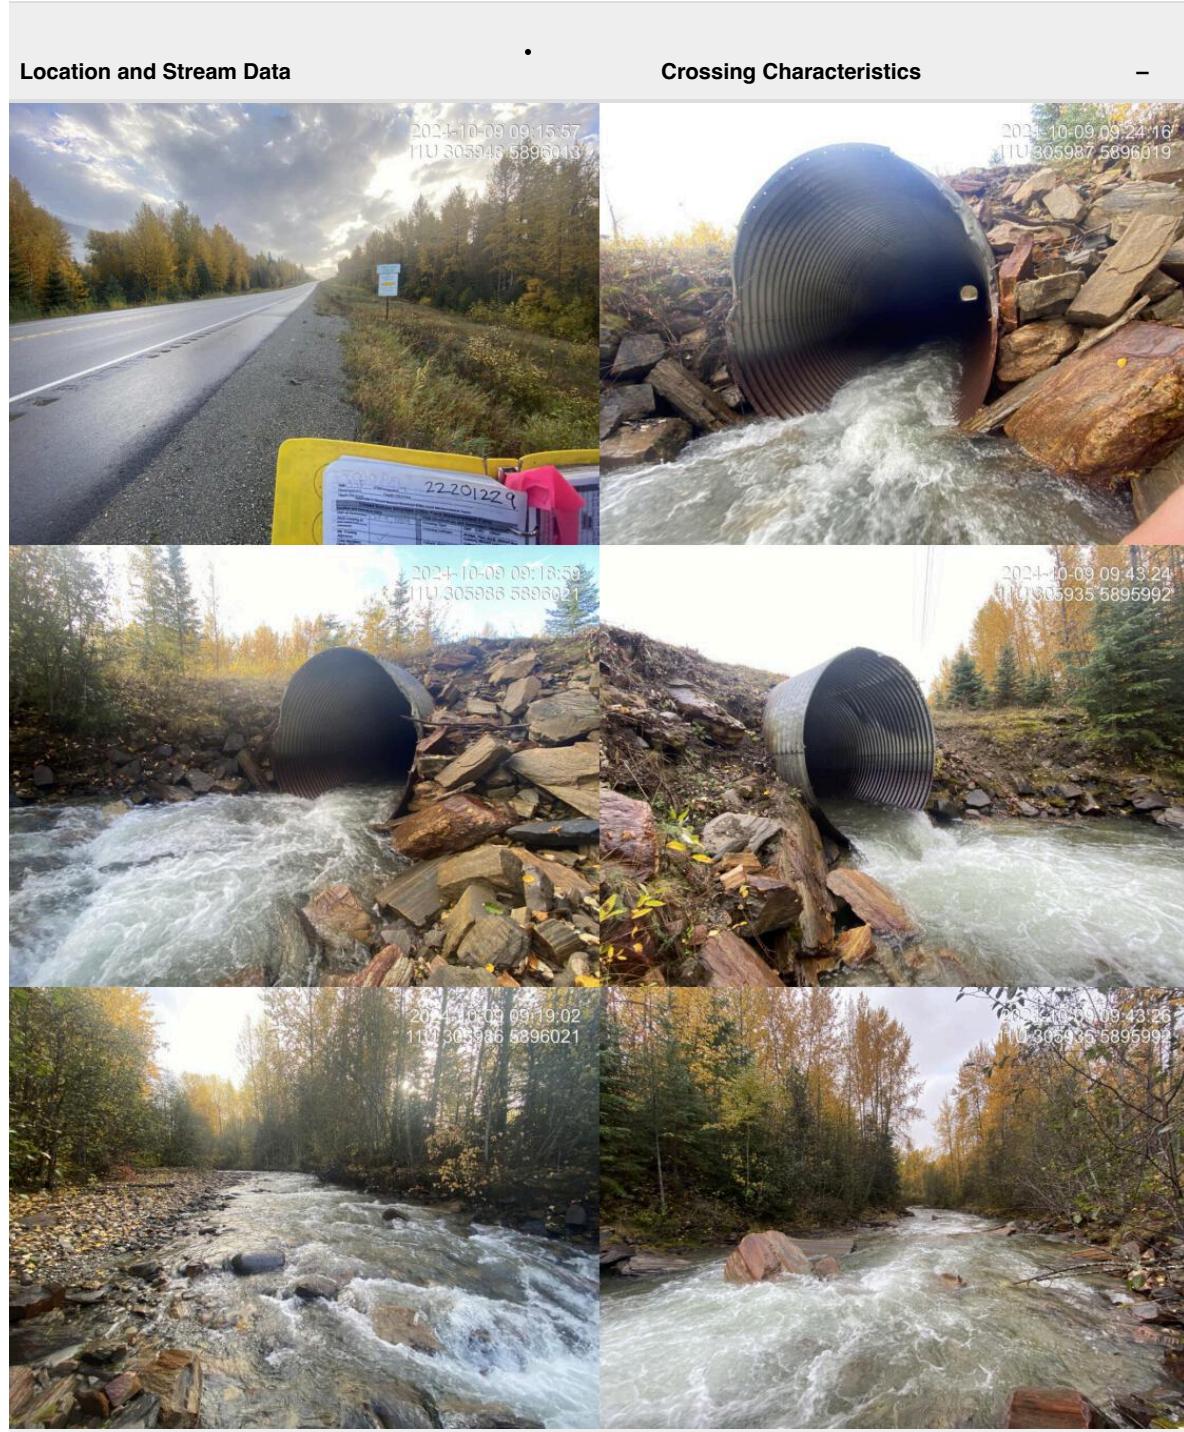
Location and Stream Data		Crossing Characteristics	
Date	2024-10-09	Crossing Sub Type	Round Culvert
PSCIS ID	199282	Diameter (m)	4
External ID	–	Length (m)	52
Crew	LS	Embedded	No
UTM Zone	11	Depth Embedded (m)	–
Easting	305946	Resemble Channel	No
Northing	5896010	Backwatered	No
Stream	Holiday Creek	Percent Backwatered	–
Road	Highway 16	Fill Depth (m)	2
Road Tenure	MOTI	Outlet Drop (m)	0.8
Channel Width (m)	16	Outlet Pool Depth (m)	0.5
Stream Slope (%)	3	Inlet Drop	No
Beaver Activity	No	Slope (%)	2
Habitat Value	High	Valley Fill	Deep Fill
Final score	37	Barrier Result	Barrier
Fix type	Replace with New Open Bottom Structure	Fix Span / Diameter	21
Comments: A significant outlet drop was present. Flow was high at the time of assessment, and at lower flows, the outlet drop would be even more substantial. Although the culvert was large, it was still likely undersized for the stream. The stream was a large glaciated system with a cobble-boulder substrate and an intact mixed riparian zone, primarily deciduous. Occasional large woody debris features created deep pool habitats and pockets of gravels were present suitable for spawning salmonids. A fish (~60mm) was observed during habitat confirmation. MoTi chris_hwy_structure_road_id: 29925
