Appendix - Phase 1 Fish Passage Assessment Data and Photos

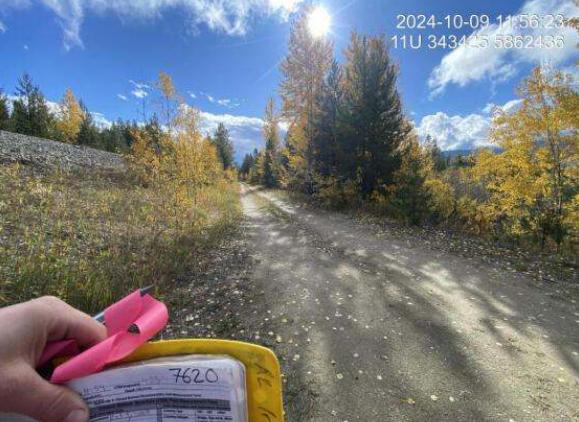
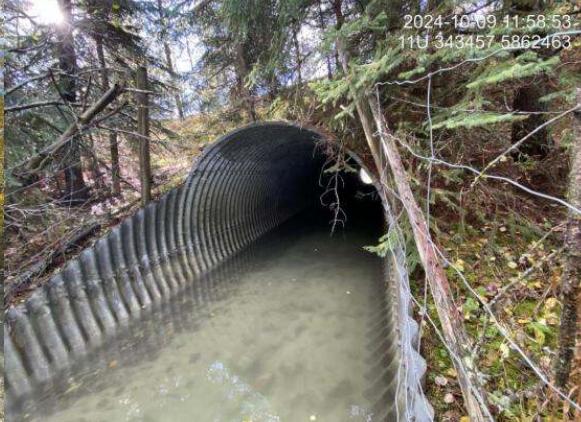
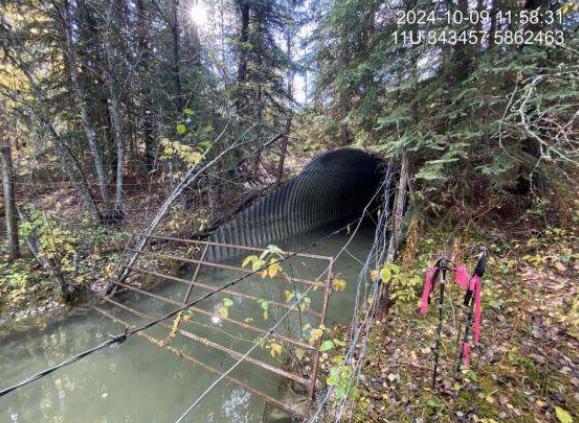
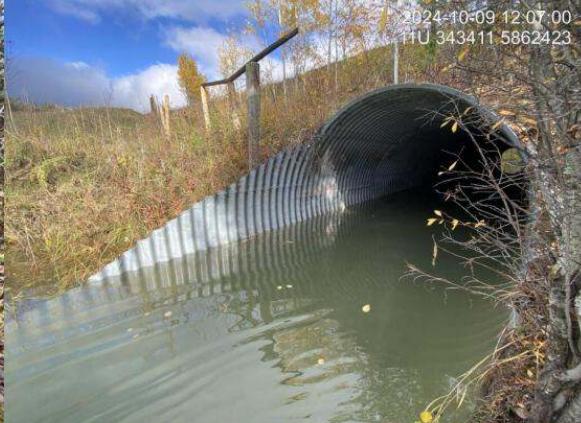
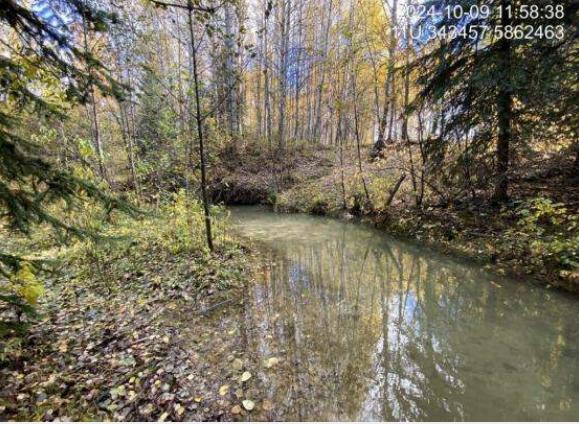
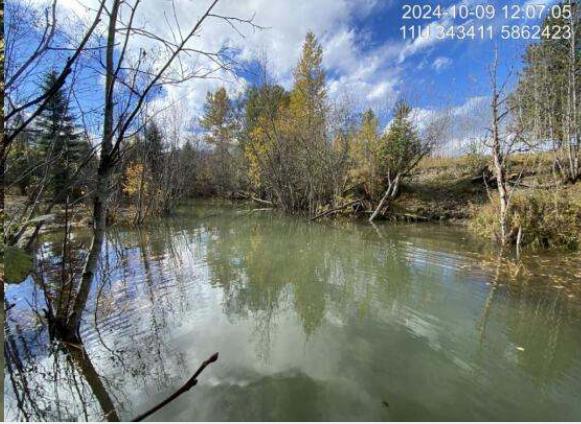
Photos: PSCIS ID 7620. From top left clockwise: Road/Site Card, Barrel, Outlet, Downstream, Upstream, Inlet.

Comments: Long culvert which passed under the CN railway and a dirt road. A beaver dam located 50m downstream of the outlet created a larger beaver pond which was backwatering the culvert . Below the beaver dam, the stream had low gradients and provided good fish habitat. A gate across the inlet functioned as a beaver grate. The stream was fenced perpendicular to the channel both upstream and downstream, likely for cattle management. Signs of cattle accessing the stream were observed near the outlet.

Location and Stream Data		Crossing Characteristics	
Date	2024-10-09	Crossing Sub Type	Round Culvert
PSCIS ID	7620	Diameter (m)	2.6
External ID	–	Length (m)	52
Crew	LS	Embedded	Yes
UTM Zone	11	Depth Embedded (m)	0.1
Easting	343425	Resemble Channel	Yes
Northing	5862437	Backwatered	Yes
Stream	Teepee Creek	Percent Backwatered	100
Road	Railway	Fill Depth (m)	7
Road Tenure	CN Rail	Outlet Drop (m)	0
Channel Width (m)	7.5	Outlet Pool Depth (m)	1
Stream Slope (%)	1	Inlet Drop	No
Beaver Activity	Yes	Slope (%)	1.5
Habitat Value	Medium	Valley Fill	Deep Fill
Final score	22	Barrier Result	Barrier
Fix type	Replace with New Open Bottom Structure	Fix Span / Diameter	27

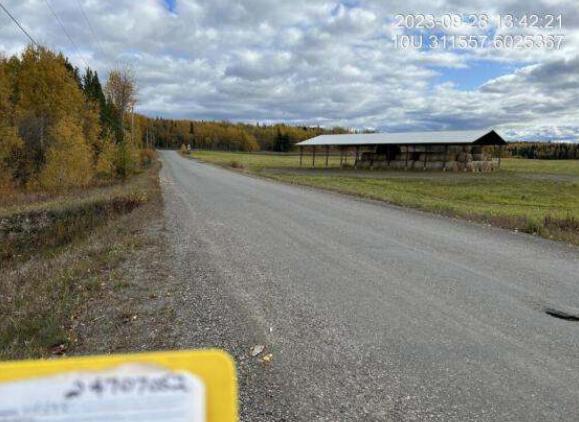
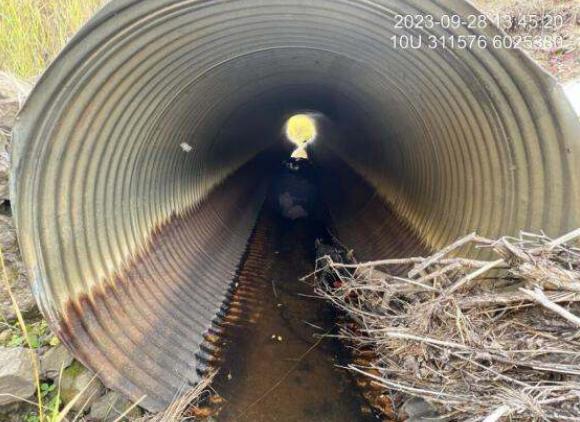
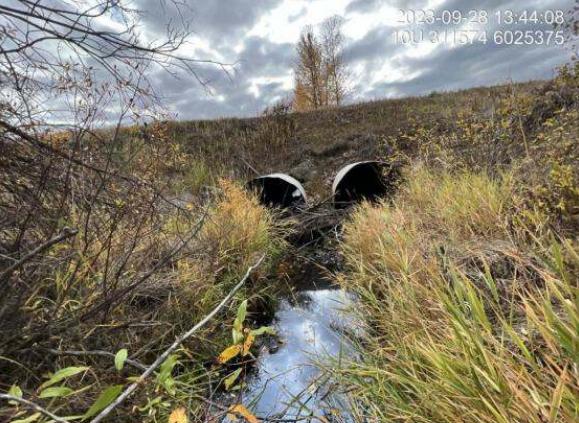
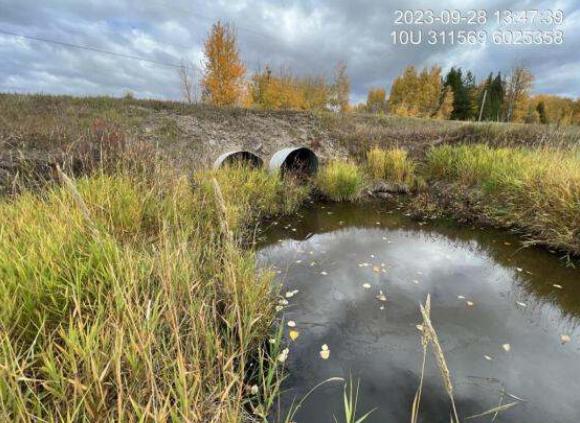
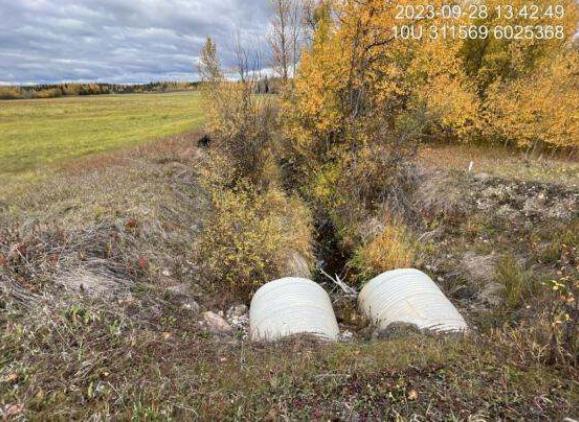
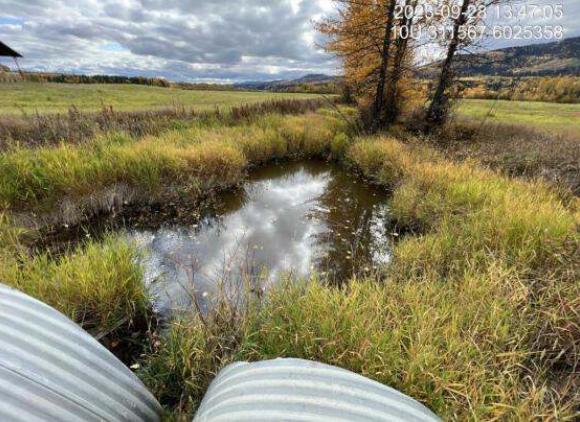
Photos: PSCIS ID 24707052. From top left clockwise: Road/Site Card, Barrel, Outlet, Downstream, Upstream, Inlet.

Comments: Was modelled as open bottom structure, has now been changed to CBS. Larger drainage with agricultural fields both upstream and downstream. Heavily impacted riparian with primarily field on either side upstream and downstream. Channel choked out with agronomic grasses. Mostly dewatered except for intermittent stagnant pools. Unassessed railway crossing downstream. MoTi chris_culvert_id: 2077140, 2077139. 13:48:59

Location and Stream Data		Crossing Characteristics	
Date	2023-09-28	Crossing Sub Type	Round Culvert
PSCIS ID	199164	Diameter (m)	3.6
External ID	24707052	Length (m)	22
Crew	AI	Embedded	No
UTM Zone	10	Depth Embedded (m)	—
Easting	311577	Resemble Channel	No
Northing	6025364	Backwatered	No
Stream	Tributary to Endako River	Percent Backwatered	—
Road	West Decker Road	Fill Depth (m)	2
Road Tenure	MOTI	Outlet Drop (m)	0
Channel Width (m)	4	Outlet Pool Depth (m)	0.6
Stream Slope (%)	0.5	Inlet Drop	No
Beaver Activity	No	Slope (%)	0
Habitat Value	Medium	Valley Fill	Deep Fill
Final score	16	Barrier Result	Potential
Fix type	Replace with New Open Bottom Structure	Fix Span / Diameter	15

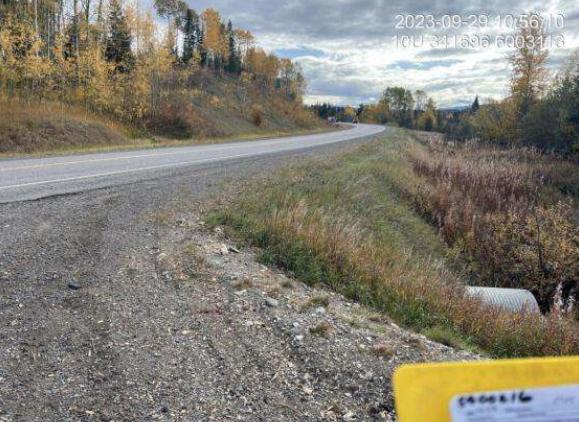
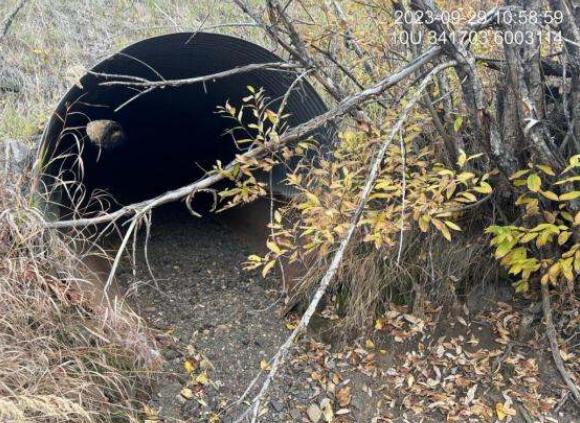
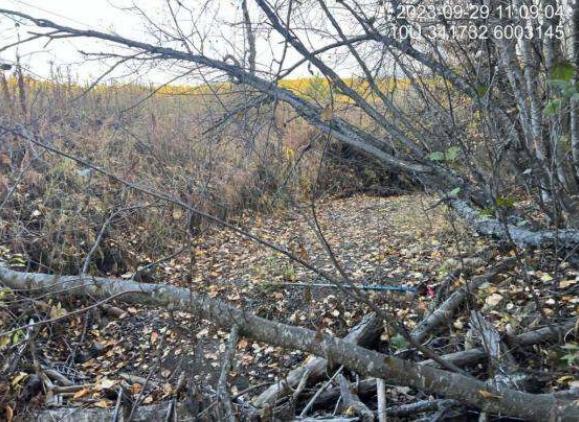
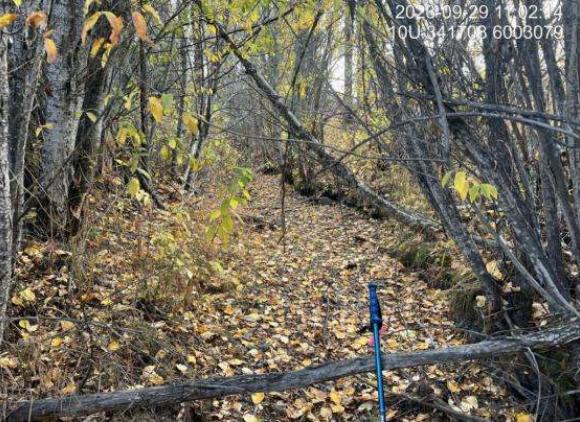
Photos: PSCIS ID 5400216. From top left clockwise: Road/Site Card, Barrel, Outlet, Downstream, Upstream, Inlet.

Comments: Dry at time of survey. Abundant gravels throughout. Crossing on railway downstream still unassessed. Modelled crossing below. First 5 m of pipe is rusted through on the bottom side. Deeply incised banks upstream indicate the stream has a lot of flow at sometimes in the year with a decent amount of power. 9m falls ~1km upstream. Upstream Co-op Lake stocked with KO from 2017-2023 and EB from 1963-2023. MoTi chris_culvert_id: 2069497. 10:56:54

Location and Stream Data		Crossing Characteristics	
Date	2023-09-29	Crossing Sub Type	Round Culvert
PSCIS ID	199165	Diameter (m)	1.8
External ID	5400216	Length (m)	25
Crew	AI	Embedded	No
UTM Zone	10	Depth Embedded (m)	—
Easting	341709	Resemble Channel	Yes
Northing	6003118	Backwatered	No
Stream	Tributary to Endako River	Percent Backwatered	—
Road	Highway 16	Fill Depth (m)	2
Road Tenure	MOTI	Outlet Drop (m)	0
Channel Width (m)	2.6	Outlet Pool Depth (m)	0.3
Stream Slope (%)	1	Inlet Drop	No
Beaver Activity	No	Slope (%)	2
Habitat Value	Medium	Valley Fill	Deep Fill
Final score	24	Barrier Result	Barrier
Fix type	Replace with New Open Bottom Structure	Fix Span / Diameter	15

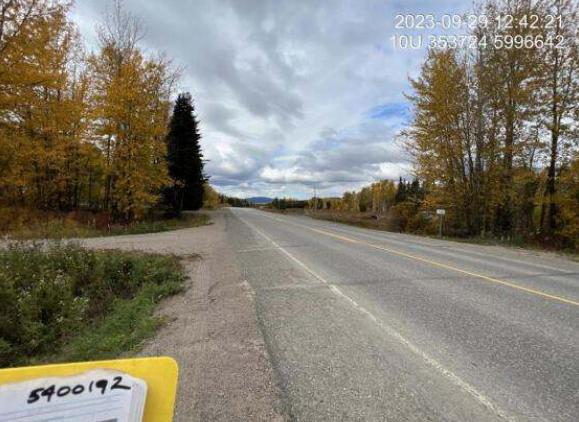
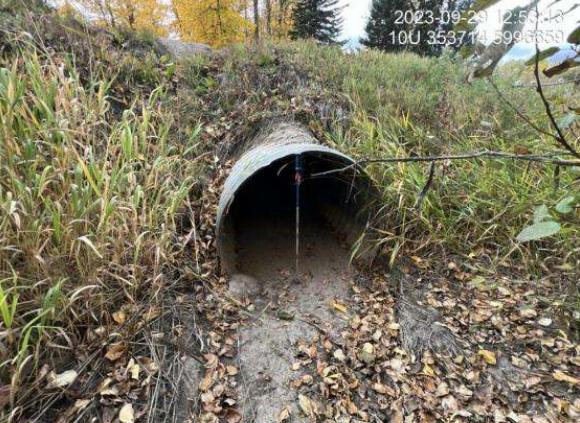
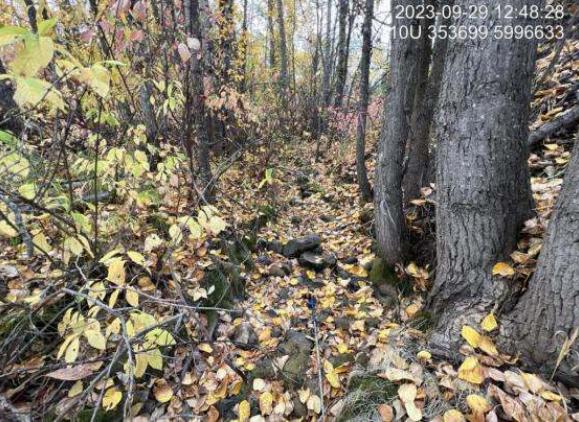
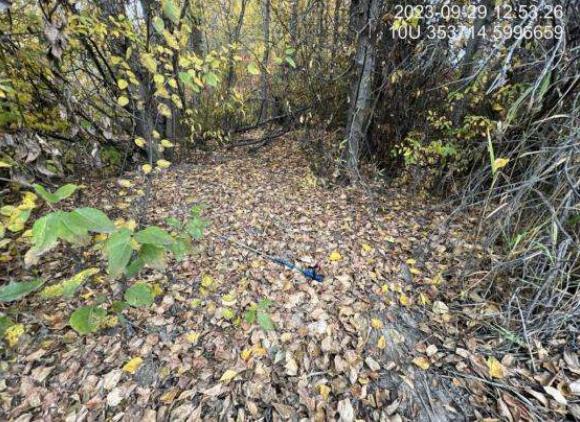
Photos: PSCIS ID 5400192. From top left clockwise: Road/Site Card, Barrel, Outlet, Downstream, Upstream, Inlet.

Comments: Dry at time of survey. Stream may be channelized upstream due to driveways to private properties on either side of the stream. Appears to have narrow, but decently healthy cottonwood dominated riparian, which could help dissipate flows and floods and runoff. Crack in Highway at culvert with minor erosion of road prism on downstream side. Stream labelled as Ross creek on sign. MoTi chris_culvert_id: 1793864. 12:42:58

Location and Stream Data	.	Crossing Characteristics	–
Date	2023-09-29	Crossing Sub Type	Round Culvert
PSCIS ID	199167	Diameter (m)	1.55
External ID	5400192	Length (m)	23
Crew	AI	Embedded	No
UTM Zone	10	Depth Embedded (m)	–
Easting	353705	Resemble Channel	No
Northing	5996651	Backwatered	No
Stream	Sam Ross Creek	Percent Backwatered	–
Road	Highway 16	Fill Depth (m)	1.8
Road Tenure	MOTI	Outlet Drop (m)	0
Channel Width (m)	1.6	Outlet Pool Depth (m)	0
Stream Slope (%)	2.5	Inlet Drop	No
Beaver Activity	No	Slope (%)	1
Habitat Value	Medium	Valley Fill	Deep Fill
Final score	21	Barrier Result	Barrier
Fix type	Replace Structure with Streambed Simulation CBS	Fix Span / Diameter	3

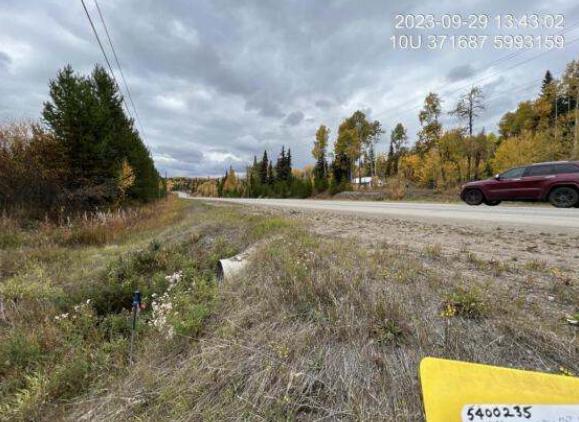
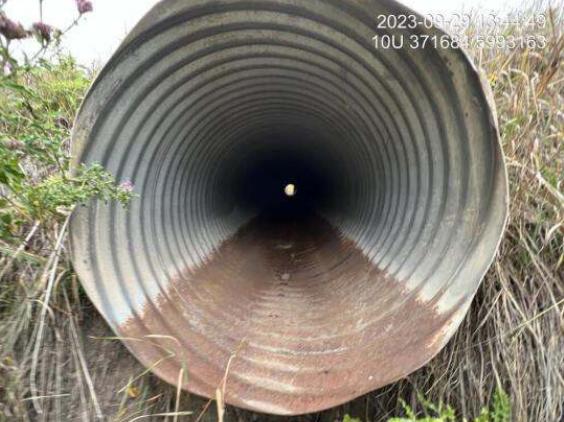
Photos: PSCIS ID 5400235. From top left clockwise: Road/Site Card, Barrel, Outlet, Downstream, Upstream, Inlet.

Comments: Dry with very poorly defined channel upstream and downstream. Seems very unlikely that this system could support fish. Pipe is rusted right through at the inlet for ~1m. Pipe is in very bad shape. MoTi chris_culvert_id: 1793794. 13:41:54

Location and Stream Data	.	Crossing Characteristics	–
Date	2023-09-29	Crossing Sub Type	Round Culvert
PSCIS ID	199168	Diameter (m)	0.9
External ID	5400235	Length (m)	20
Crew	AI	Embedded	No
UTM Zone	10	Depth Embedded (m)	–
Easting	371691	Resemble Channel	No
Northing	5993173	Backwatered	No
Stream	Alf Creek	Percent Backwatered	–
Road	Highway 16	Fill Depth (m)	0.7
Road Tenure	MOTI	Outlet Drop (m)	1.2
Channel Width (m)	1	Outlet Pool Depth (m)	0.4
Stream Slope (%)	3	Inlet Drop	No
Beaver Activity	No	Slope (%)	2
Habitat Value	Low	Valley Fill	Deep Fill
Final score	31	Barrier Result	Barrier
Fix type	Replace Structure with Streambed Simulation CBS	Fix Span / Diameter	3

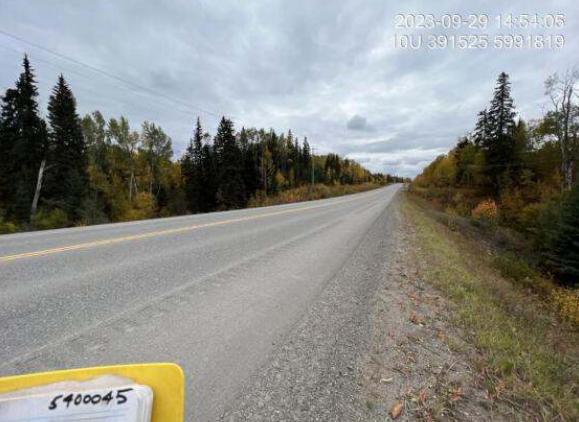
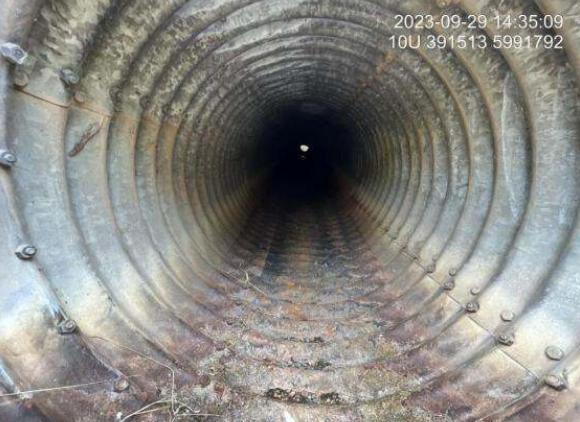
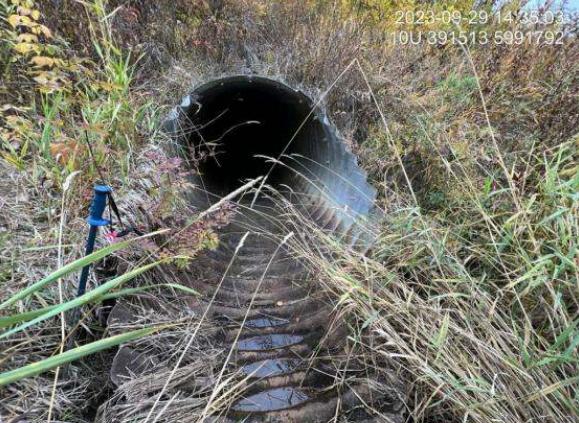
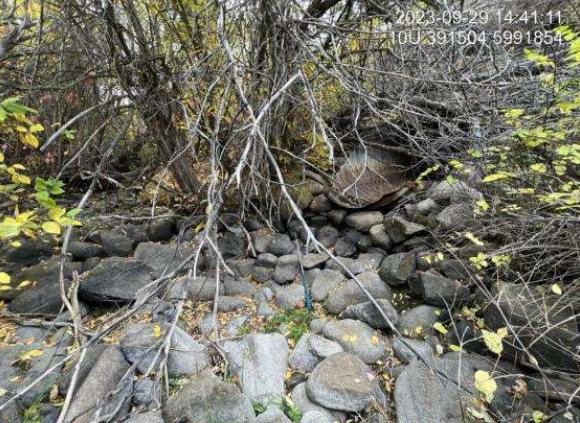
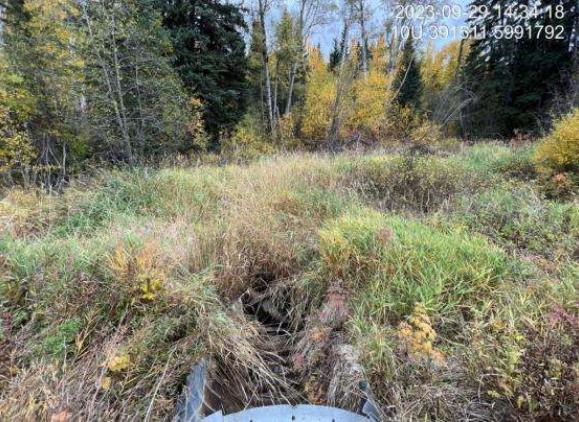
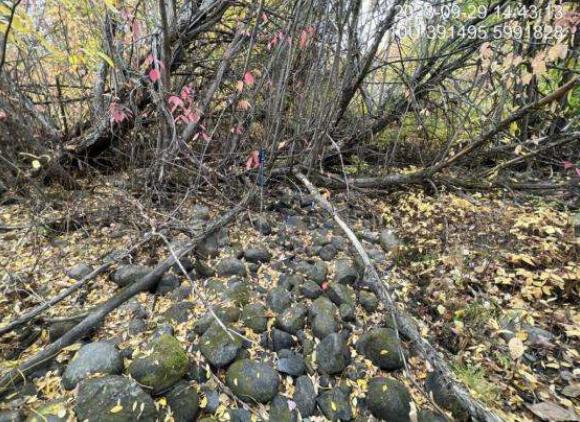
Photos: PSCIS ID 5400045. From top left clockwise: Road/Site Card, Barrel, Outlet, Downstream, Upstream, Inlet.

Location and Stream Data		Crossing Characteristics	
Date	2023-09-29	Crossing Sub Type	Round Culvert
PSCIS ID	199169	Diameter (m)	1.5
External ID	5400045	Length (m)	50
Crew	AI	Embedded	No
UTM Zone	10	Depth Embedded (m)	—
Easting	391513	Resemble Channel	No
Northing	5991795	Backwatered	No
Stream	Tributary to Fraser Lake	Percent Backwatered	—
Road	Highway 16	Fill Depth (m)	9.9
Road Tenure	MOTI	Outlet Drop (m)	0.4
Channel Width (m)	4	Outlet Pool Depth (m)	0.5
Stream Slope (%)	2	Inlet Drop	No
Beaver Activity	No	Slope (%)	0.5
Habitat Value	Medium	Valley Fill	Deep Fill
Final score	32	Barrier Result	Barrier
Fix type	Replace with New Open Bottom Structure	Fix Span / Diameter	35.5

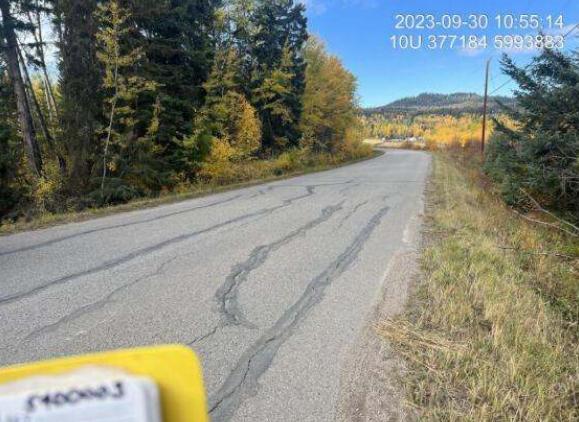
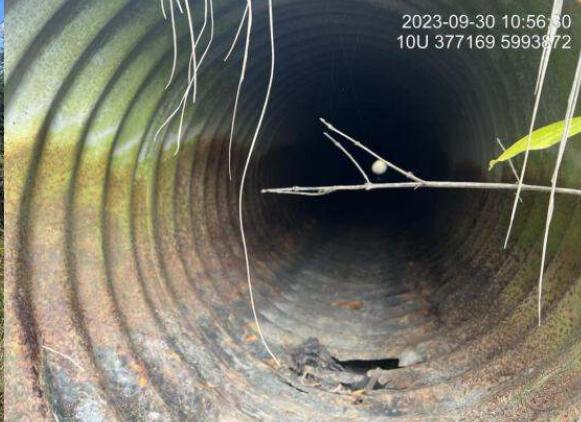
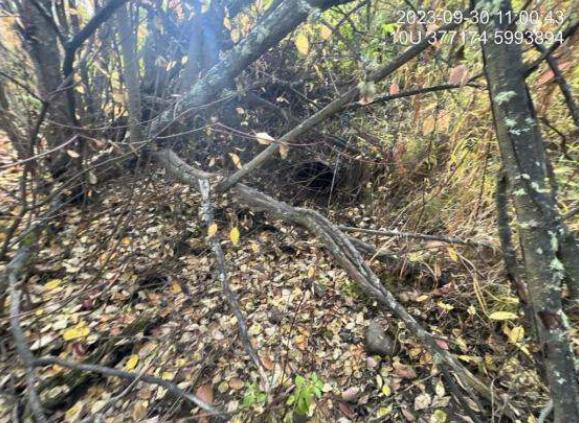
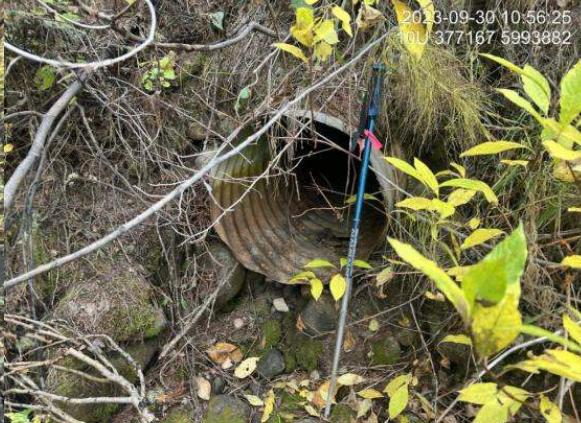
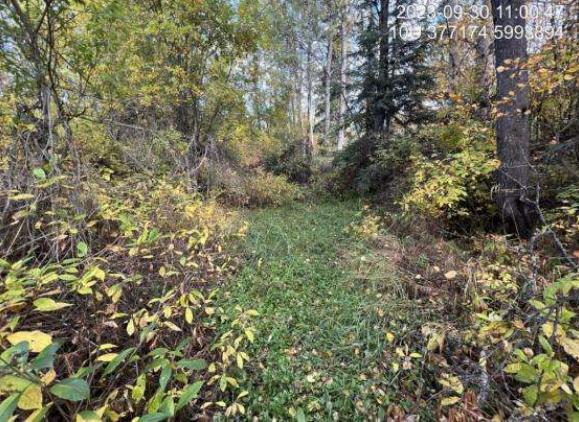
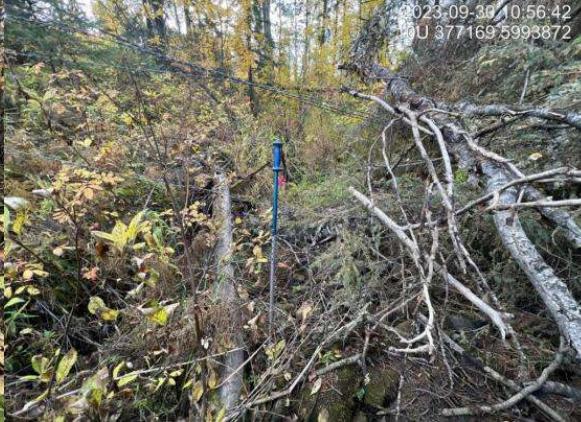
Photos: PSCIS ID 5400003. From top left clockwise: Road/Site Card, Barrel, Outlet, Downstream, Upstream, Inlet.

Location and Stream Data		Crossing Characteristics	
Date	2023-09-30	Crossing Sub Type	Round Culvert
PSCIS ID	199170	Diameter (m)	0.6
External ID	5400003	Length (m)	23
Crew	AI	Embedded	No
UTM Zone	10	Depth Embedded (m)	—
Easting	377178	Resemble Channel	No
Northing	5993874	Backwatered	No
Stream	Perry Creek	Percent Backwatered	—
Road	Stella Road	Fill Depth (m)	4
Road Tenure	MOTI	Outlet Drop (m)	0.3
Channel Width (m)	1	Outlet Pool Depth (m)	0
Stream Slope (%)	2	Inlet Drop	No
Beaver Activity	No	Slope (%)	1
Habitat Value	Low	Valley Fill	Deep Fill
Final score	34	Barrier Result	Barrier
Fix type	Replace Structure with Streambed Simulation CBS	Fix Span / Diameter	3

Culvert rusting at inlet. MoTi chris_culvert_id: 1794274. 10:53:44

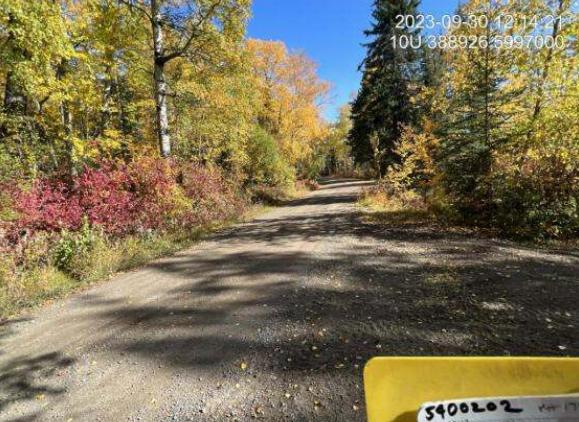
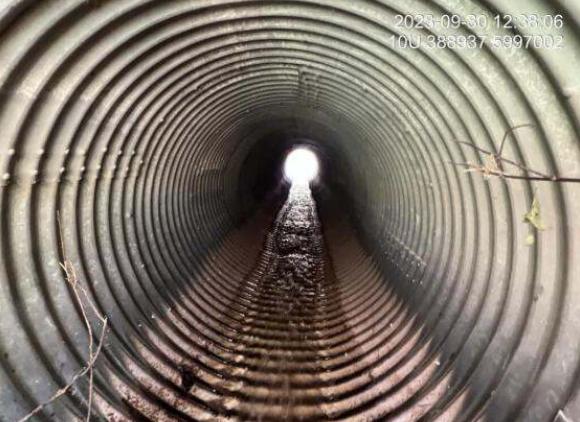
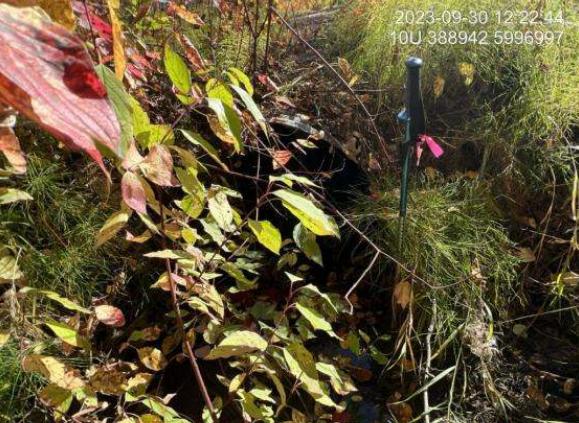
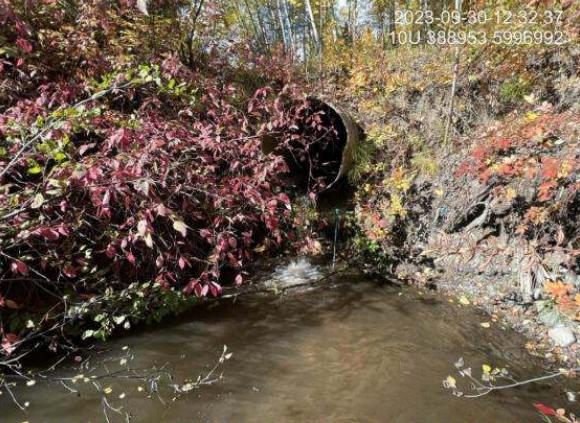
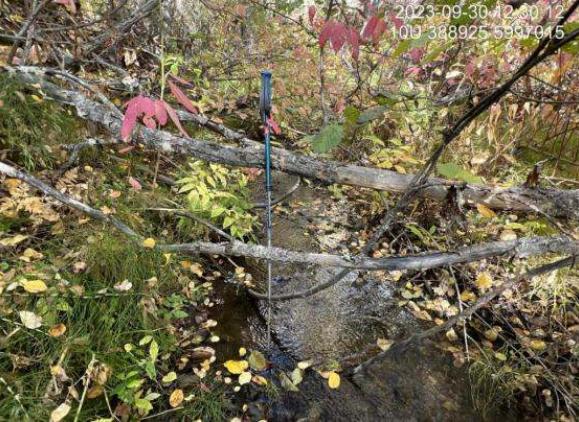
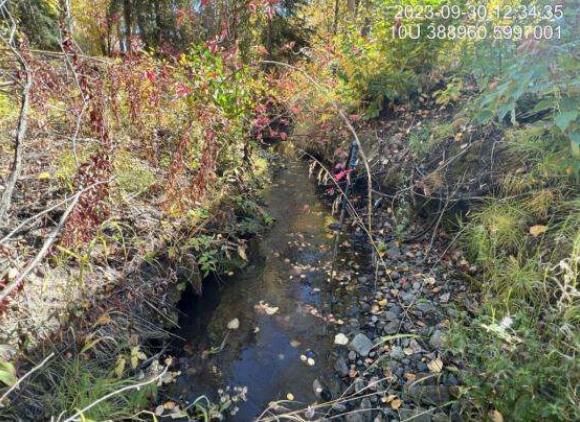
Photos: PSCIS ID 5400202. From top left clockwise: Road/Site Card, Barrel, Outlet, Downstream, Upstream, Inlet.

Location and Stream Data	.	Crossing Characteristics	-
Date	2023-09-30	Crossing Sub Type	Round Culvert
PSCIS ID	199171	Diameter (m)	1
External ID	5400202	Length (m)	13
Crew	AI	Embedded	No
UTM Zone	10	Depth Embedded (m)	-
Easting	388944	Resemble Channel	No
Northing	5997002	Backwatered	No
Stream	Tributary to Fraser Lake	Percent Backwatered	-
Road	Gala Bay Road	Fill Depth (m)	1
Road Tenure	MOTI Local	Outlet Drop (m)	0.8
Channel Width (m)	1.7	Outlet Pool Depth (m)	0.6
Stream Slope (%)	2	Inlet Drop	No
Beaver Activity	No	Slope (%)	4.5
Habitat Value	High	Valley Fill	Deep Fill
Final score	36	Barrier Result	Barrier
Fix type	Replace Structure with Streambed Simulation CBS	Fix Span / Diameter	3

Comments: Very nice stream with good flow and abundant gravels upstream and downstream. Landowner indicated sockeye spotted along shoreline years ago. Massive outlet drop. Deserves habitat confirmation and consideration for replacement if no natural barriers upstream. There is a PSCIS assessed site (assessment_id = 7622) upstream that is a barrier. MoTi chris_culvert_id: 1790951. 12:12:56

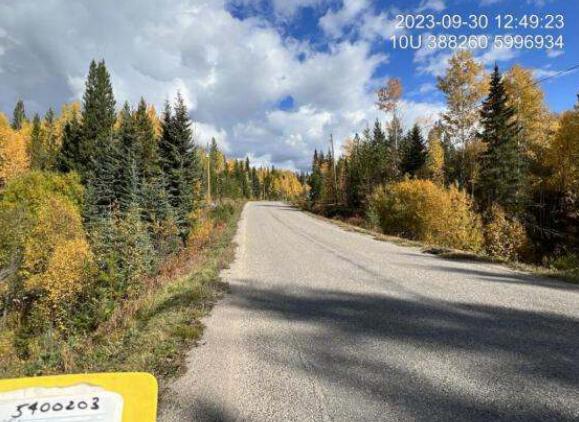
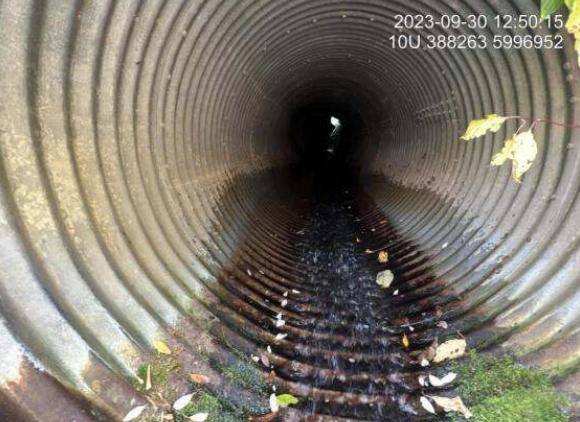
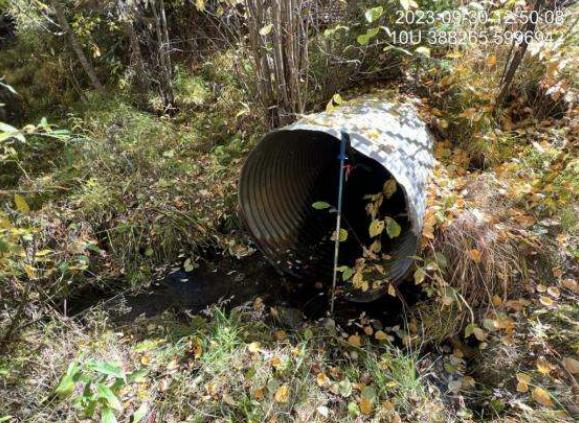
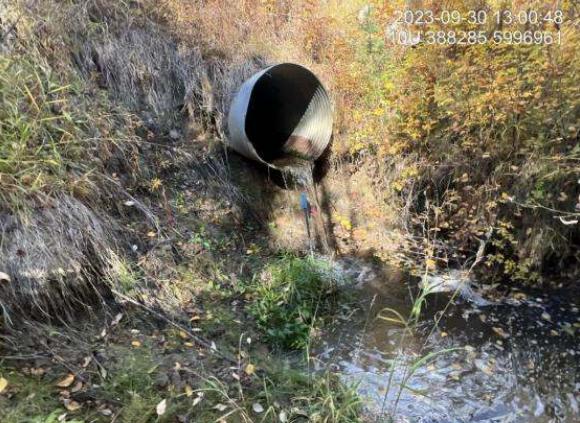
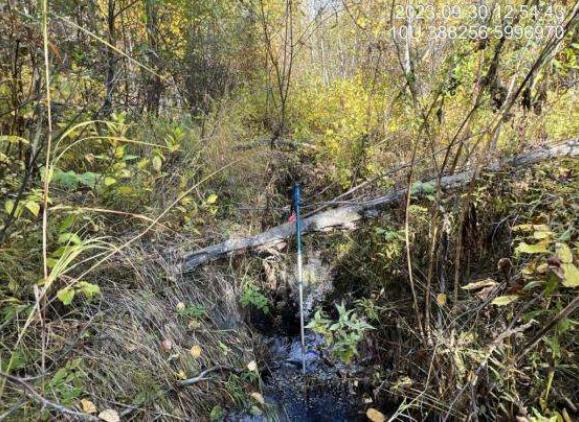
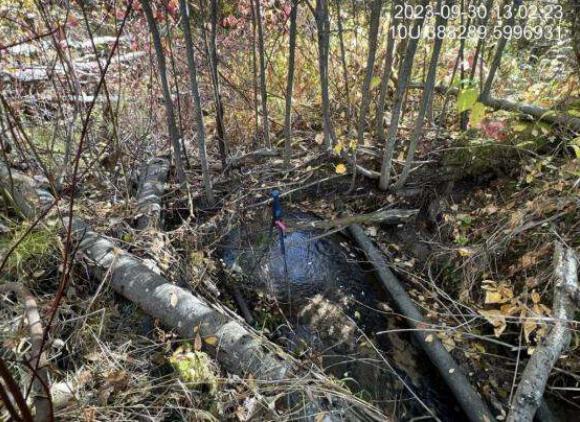
Photos: PSCIS ID 5400203. From top left clockwise: Road/Site Card, Barrel, Outlet, Downstream, Upstream, Inlet.

Location and Stream Data		Crossing Characteristics	
Date	2023-09-30	Crossing Sub Type	Round Culvert
PSCIS ID	199172	Diameter (m)	1.1
External ID	5400203	Length (m)	25
Crew	AI	Embedded	No
UTM Zone	10	Depth Embedded (m)	—
Easting	388270	Resemble Channel	No
Northing	5996949	Backwatered	No
Stream	Scotch Creek	Percent Backwatered	—
Road	Stella Road	Fill Depth (m)	5
Road Tenure	MOTI	Outlet Drop (m)	1.4
Channel Width (m)	2.6	Outlet Pool Depth (m)	0.2
Stream Slope (%)	2	Inlet Drop	No
Beaver Activity	No	Slope (%)	4.5
Habitat Value	High	Valley Fill	Deep Fill
Final score	39	Barrier Result	Barrier
Fix type	Replace with New Open Bottom Structure	Fix Span / Diameter	21

Comments: Very nice little stream with excellent flow for this time of year on a dry year. Crossing downstream on Gala Bay Road was fully embedded and passible at the time of the assessment. There is a historic chinook observation within this stream. This could be valuable Chinook rearing habitat and connectivity within the system should be restored, should no natural barriers be observed on a habitat confirmation assessment. MoTi chris_culvert_id: 1794198, 1794199. 12:47:26

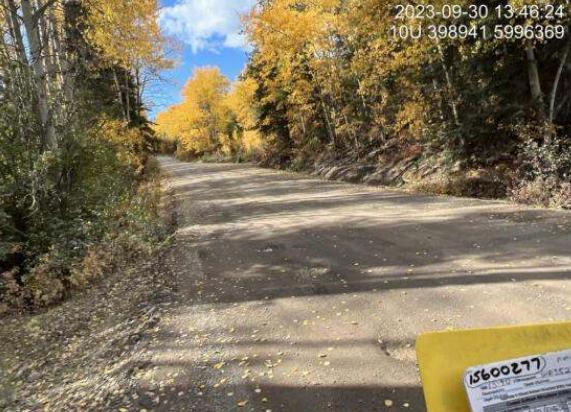
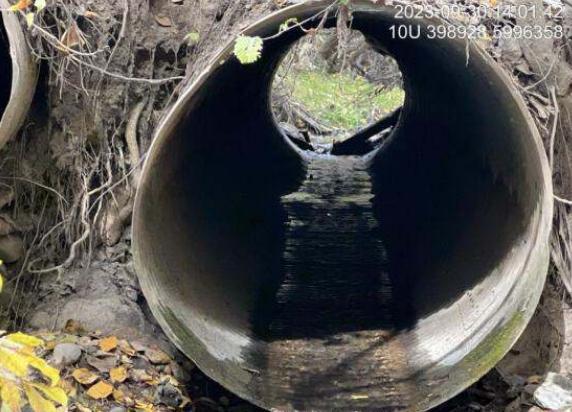
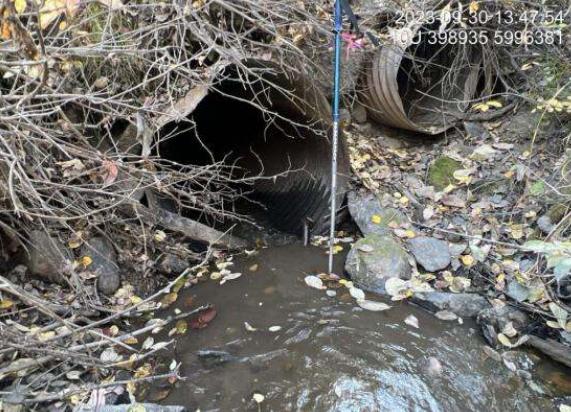
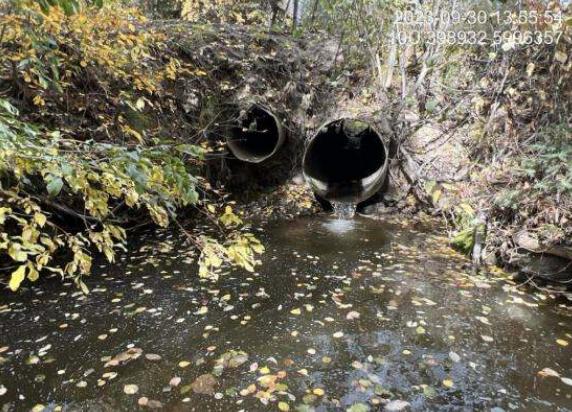
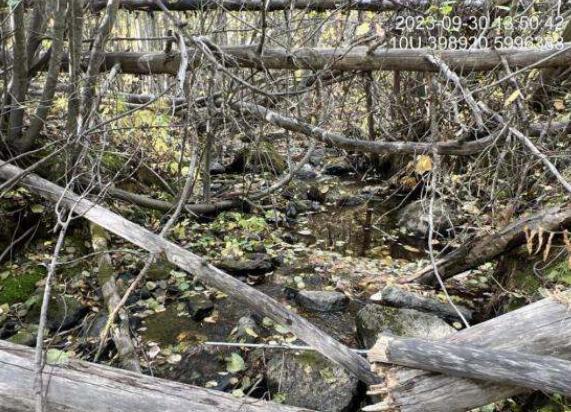
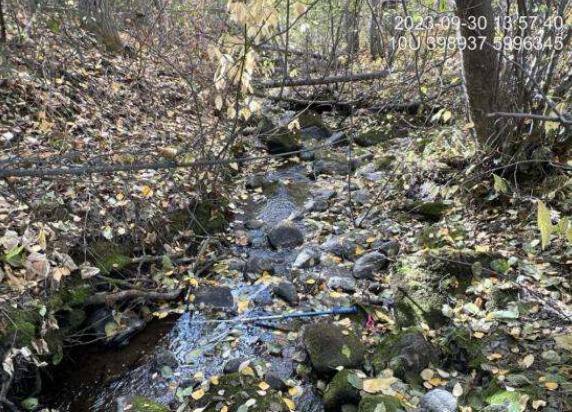
Photos: PSCIS ID 15600277. From top left clockwise: Road/Site Card, Barrel, Outlet, Downstream, Upstream, Inlet.

Location and Stream Data		Crossing Characteristics	
Date	2023-09-30	Crossing Sub Type	Round Culvert
PSCIS ID	199173	Diameter (m)	0.95
External ID	15600277	Length (m)	12
Crew	AI	Embedded	No
UTM Zone	10	Depth Embedded (m)	—
Easting	398933	Resemble Channel	No
Northing	5996365	Backwatered	No
Stream	Tributary to Nechako River	Percent Backwatered	—
Road	Dog Creek Road	Fill Depth (m)	1.5
Road Tenure	MOTI	Outlet Drop (m)	0.4
Channel Width (m)	2.7	Outlet Pool Depth (m)	1
Stream Slope (%)	3	Inlet Drop	No
Beaver Activity	Yes	Slope (%)	3
Habitat Value	High	Valley Fill	Deep Fill
Final score	36	Barrier Result	Barrier
Fix type	Replace with New Open Bottom Structure	Fix Span / Diameter	15

Comments: Very nice stream with excellent flow for this time of year on a dry year. Very large deep outlet pool with extensive erosion undercutting the main pipe and 0.6 m overflow. Locally known as Dog Creek. Chinook captured upstream and downstream of Dog Creek FSR in 2021, 2022, and 2023 reported here <https://a100.gov.bc.ca/pub/acat/public/viewReport.do?reportId=62942>. Connected to the Nechako River with observed chinook points downstream adjacent to the confluence. Road edge is failing at the culvert and eroding into stream. Highly degraded site upstream that would be a good candidate for restoration. MoTi chris_culvert_id: 1794340. 13:43:26

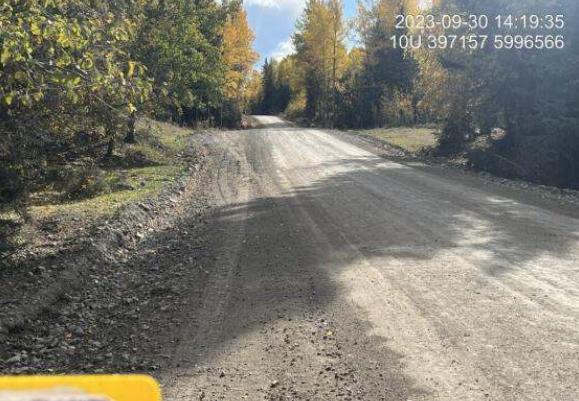
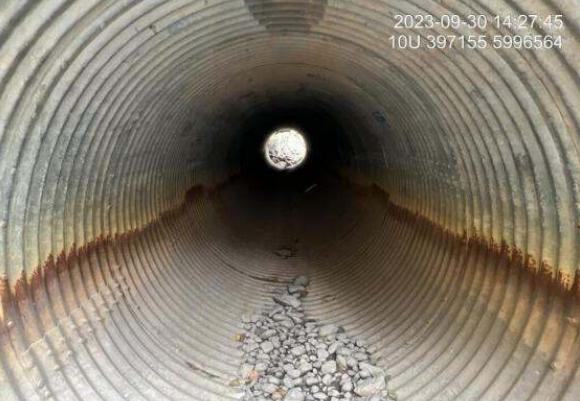
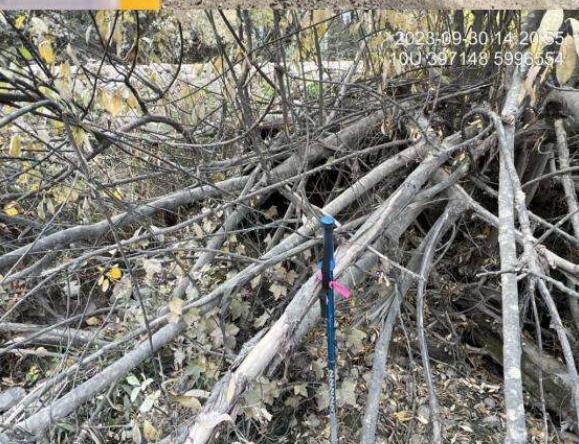
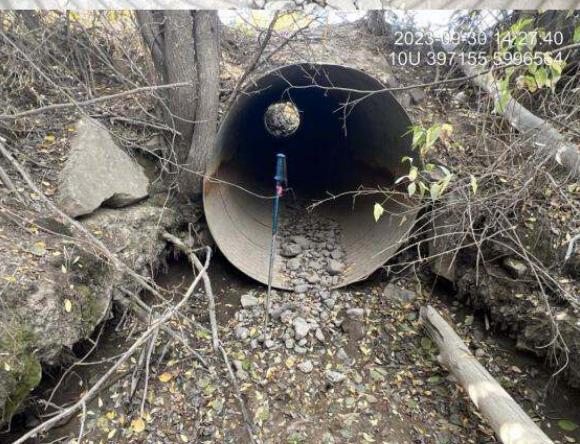
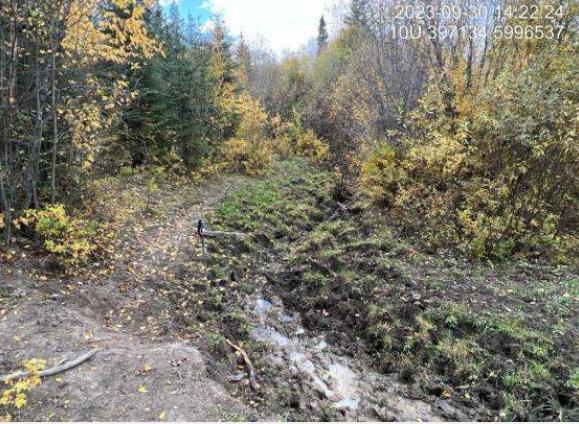
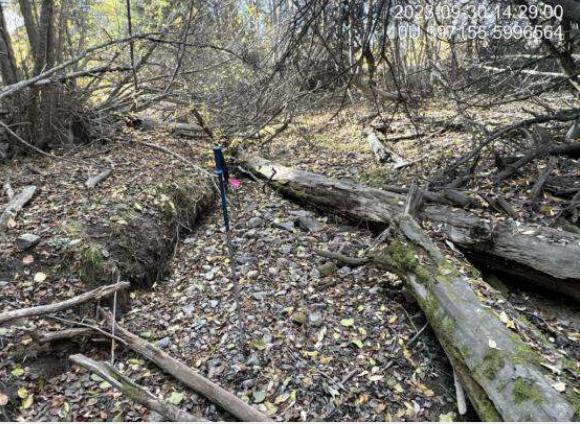
Photos: PSCIS ID 15604478. From top left clockwise: Road/Site Card, Barrel, Outlet, Downstream, Upstream, Inlet.

Location and Stream Data		Crossing Characteristics	
Date	2023-09-30	Crossing Sub Type	Round Culvert
PSCIS ID	199174	Diameter (m)	1.45
External ID	15604478	Length (m)	16
Crew	AI	Embedded	No
UTM Zone	10	Depth Embedded (m)	—
Easting	397160	Resemble Channel	No
Northing	5996558	Backwatered	No
Stream	Tributary to Nechako River	Percent Backwatered	—
Road	Sutherland FSR	Fill Depth (m)	0.5
Road Tenure	West Fraser R09194 SE	Outlet Drop (m)	0
Channel Width (m)	2.5	Outlet Pool Depth (m)	0.2
Stream Slope (%)	0.5	Inlet Drop	Yes
Beaver Activity	No	Slope (%)	2
Habitat Value	Medium	Valley Fill	Deep Fill
Final score	24	Barrier Result	Barrier
Fix type	Replace with New Open Bottom Structure	Fix Span / Diameter	15

Comments: Extreme negative impacts due to cattle, particularly upstream of the FSR. Extensive trampling of the channel and banks, along with heavy grazing and removal of riparian. Dry at the time of assessment besides a small wallowing hole upstream of the inlet. Riparian exclusion fencing is required along with repairing vegetation, restoration irrigation, and monitoring. This is a fish bearing stream with high habitat values less than 2 km down the stream where it crosses Dog Creek Road.. 14:17:41

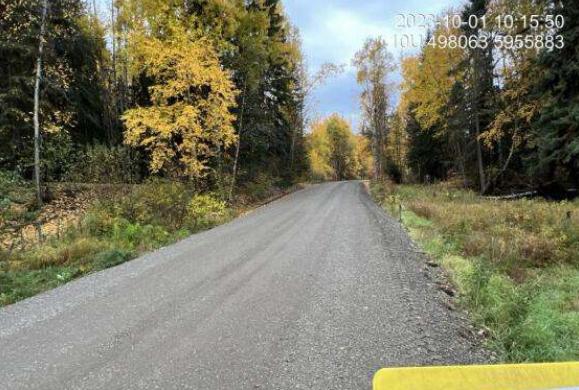
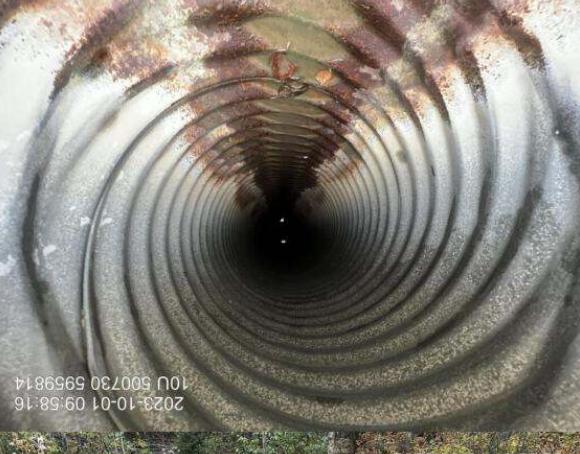
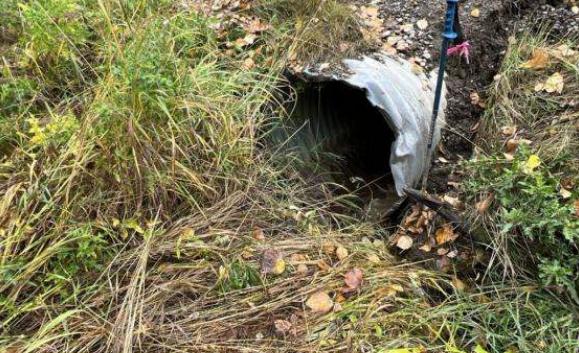
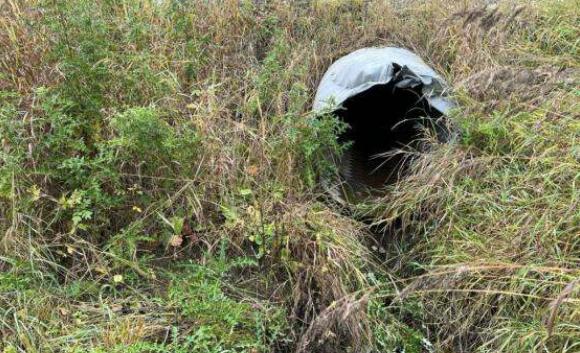
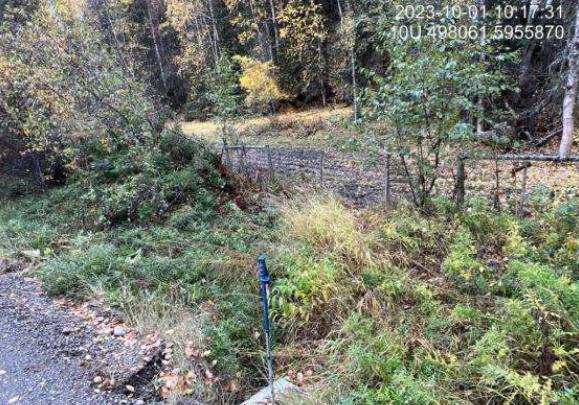
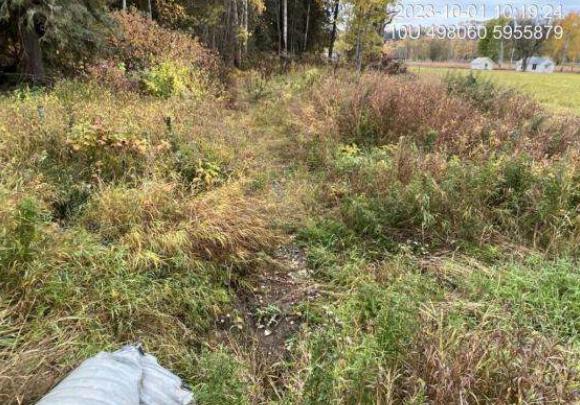
Agricultural field on right back downstream. Some scouring of the channel downstream, but primarily choked with grasses indicating stream does not flow for much of the year lately. MoTi chris_culvert_id: 1975651. 10:20:58			
Photos: PSCIS ID 9901826. From top left clockwise: Road/Site Card, Barrel, Outlet, Downstream, Upstream, Inlet.

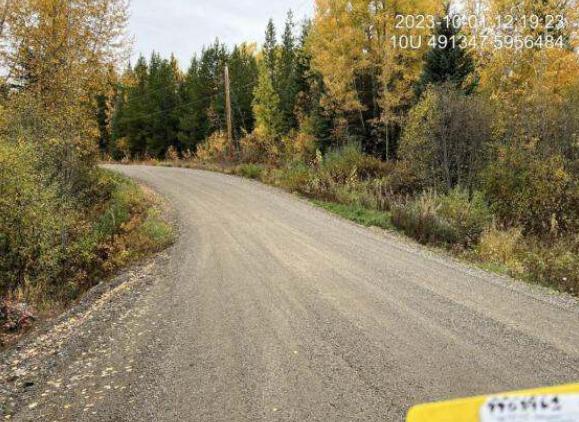
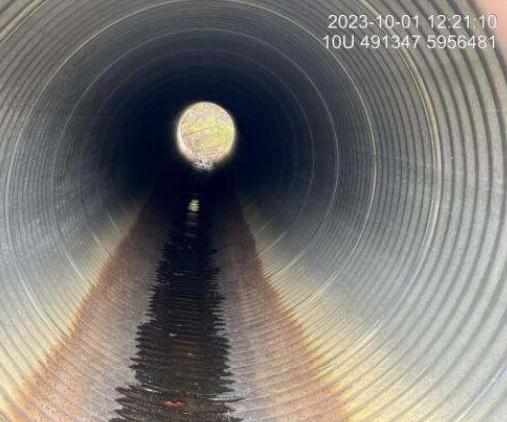
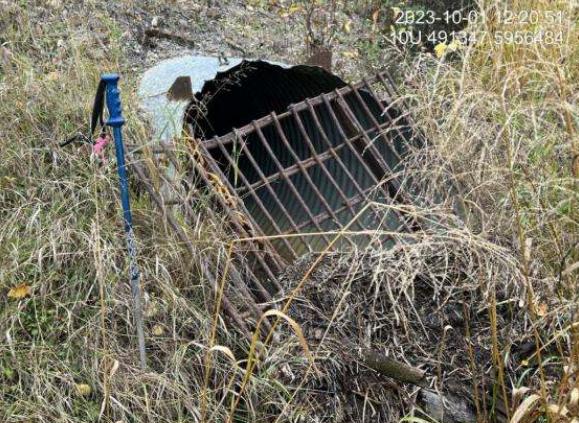
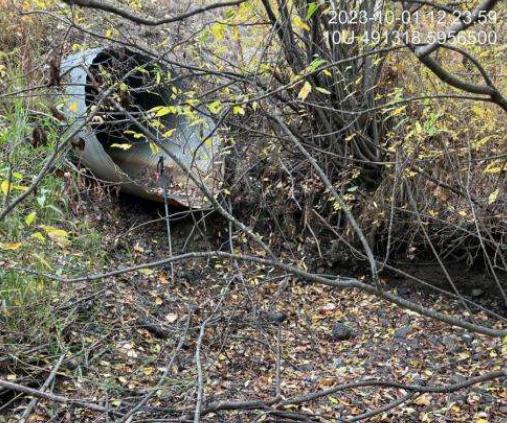
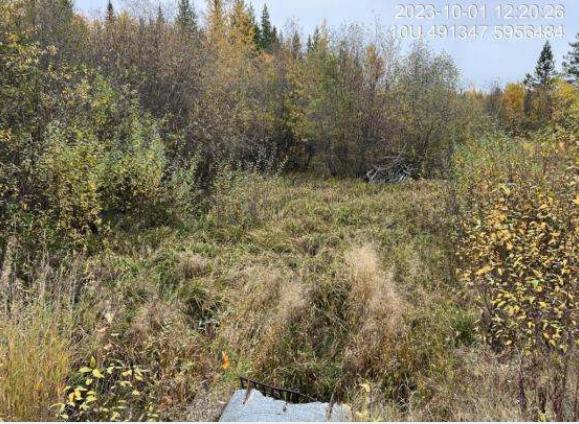
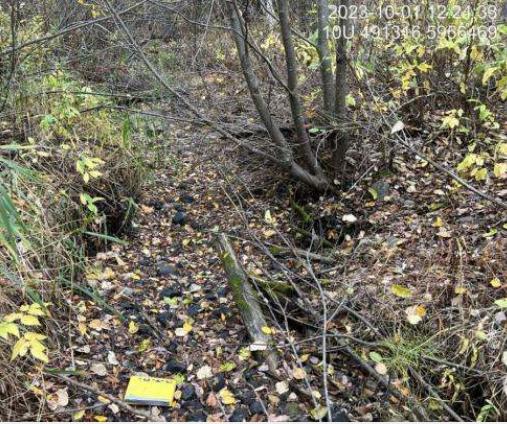
Photos: PSCIS ID 9903963. From top left clockwise: Road/Site Card, Barrel, Outlet, Downstream, Upstream, Inlet.

Location and Stream Data	.	Crossing Characteristics	–
Date	2023-10-01	Crossing Sub Type	Round Culvert
PSCIS ID	199177	Diameter (m)	1.5
External ID	9903963	Length (m)	16
Crew	AI	Embedded	No
UTM Zone	10	Depth Embedded (m)	–
Easting	491332	Resemble Channel	No
Northing	5956490	Backwatered	No
Stream	Tributary to Chelako River	Percent Backwatered	–
Road	McBride Timber Road	Fill Depth (m)	1.5
Road Tenure	MOTI	Outlet Drop (m)	0.75
Channel Width (m)	1.7	Outlet Pool Depth (m)	0.5
Stream Slope (%)	1	Inlet Drop	No
Beaver Activity	Yes	Slope (%)	3
Habitat Value	Low	Valley Fill	Deep Fill
Final score	36	Barrier Result	Barrier
Fix type	Replace Structure with Streambed Simulation CBS	Fix Span / Diameter	3

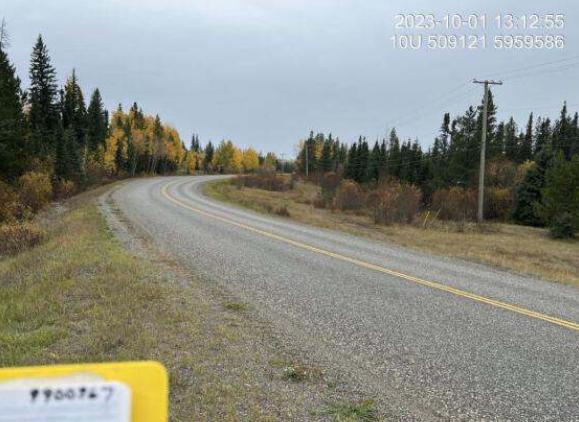
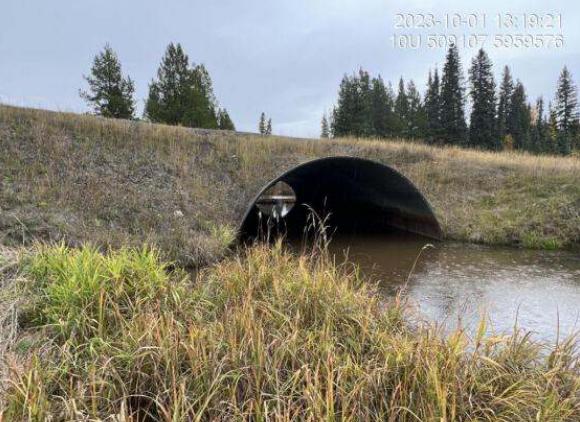
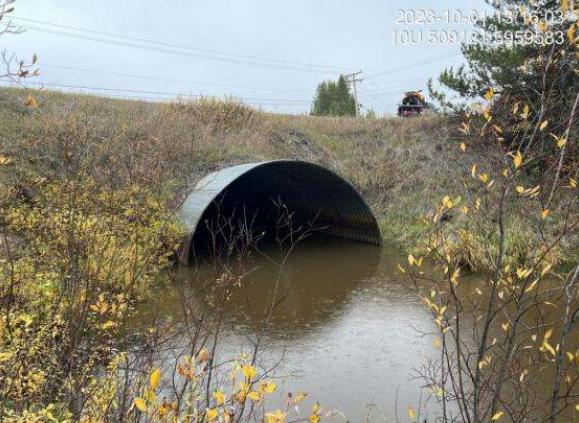
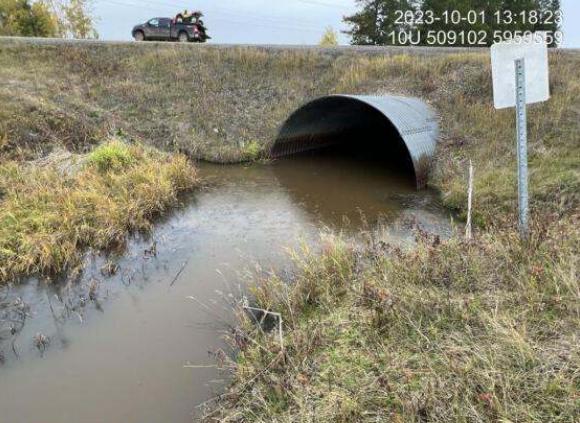
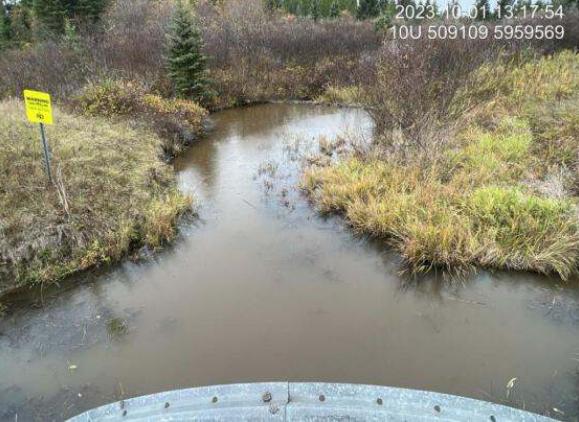
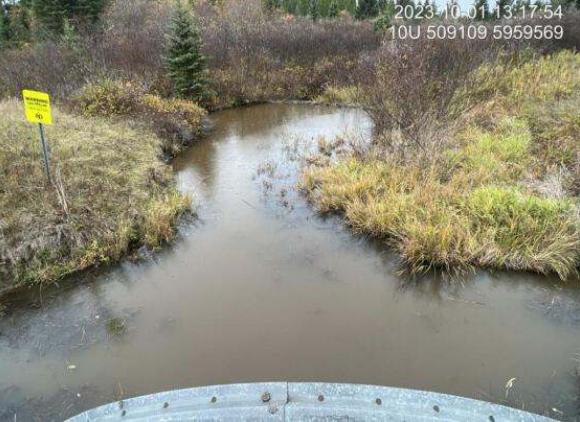
Location and Stream Data		Crossing Characteristics	
Date	2023-10-01	Crossing Sub Type	Round Culvert
PSCIS ID	199178	Diameter (m)	4.5
External ID	9900367	Length (m)	33
Crew	AI	Embedded	No
UTM Zone	10	Depth Embedded (m)	–
Easting	509128	Resemble Channel	No
Northing	5959562	Backwatered	No
Stream	Beaverley Creek	Percent Backwatered	–
Road	Blackwater Road	Fill Depth (m)	2
Road Tenure	MOTI	Outlet Drop (m)	0
Channel Width (m)	5	Outlet Pool Depth (m)	1
Stream Slope (%)	0	Inlet Drop	No
Beaver Activity	Yes	Slope (%)	0
Habitat Value	High	Valley Fill	Deep Fill
Final score	19	Barrier Result	Potential
Fix type	Replace with New Open Bottom Structure	Fix Span / Diameter	15
