Appendix - Phase 1 Fish Passage Assessment Data and Photos

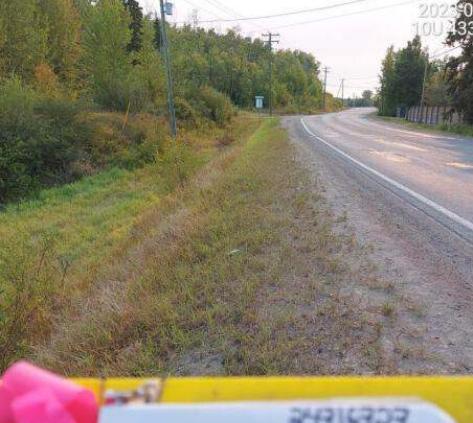
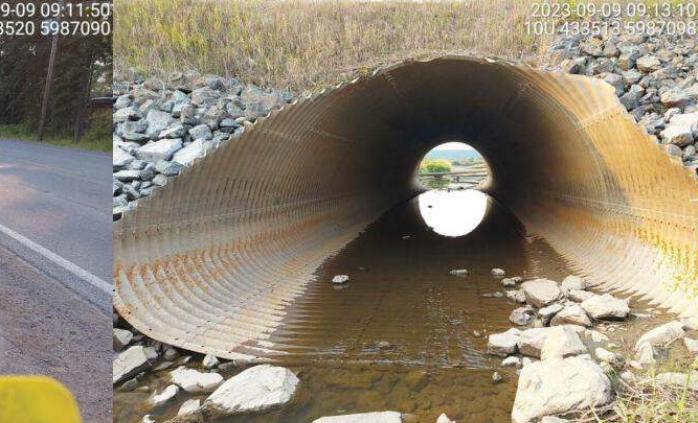
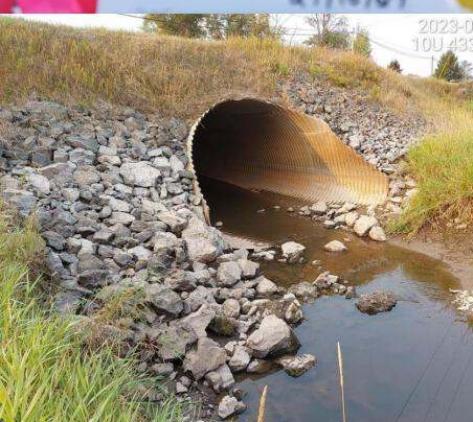
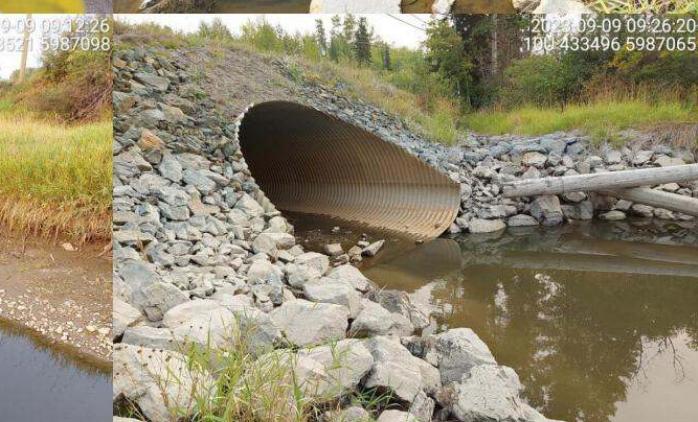
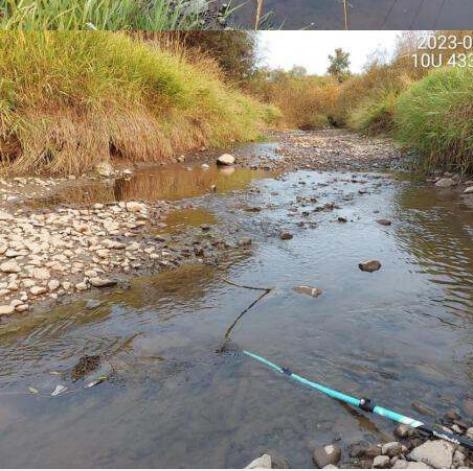
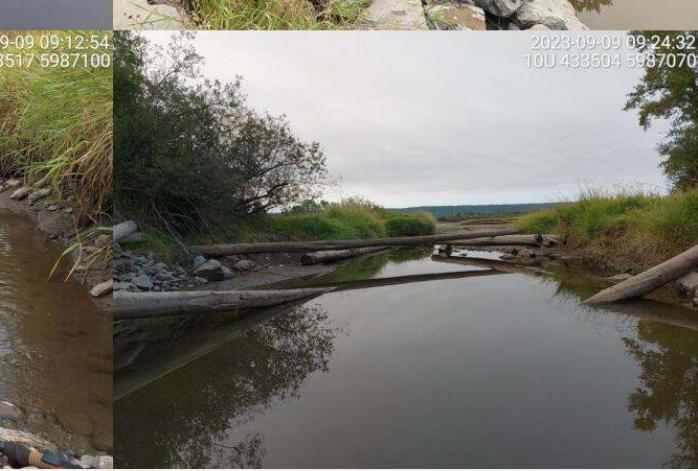
Photos: PSCIS ID 24716727. From top left clockwise: Road/Site Card, Barrel, Outlet, Downstream, Upstream, Inlet.

Location and Stream Data		Crossing Characteristics	
Date	2023-09-09	Crossing Sub Type	Round Culvert
PSCIS ID	199179	Diameter (m)	5
External ID	24716727	Length (m)	25
Crew	MW	Embedded	No
UTM Zone	10	Depth Embedded (m)	—
Easting	433506	Resemble Channel	No
Northing	5987089	Backwatered	No
Stream	Murray Creek	Percent Backwatered	—
Road	Loop Rd	Fill Depth (m)	1.5
Road Tenure	Vanderhoof	Outlet Drop (m)	0
Channel Width (m)	6.2	Outlet Pool Depth (m)	1.5
Stream Slope (%)	1	Inlet Drop	No
Beaver Activity	No	Slope (%)	1.5
Habitat Value	High	Valley Fill	Deep Fill
Final score	21	Barrier Result	Barrier
Fix type	Replace with New Open Bottom Structure	Fix Span / Diameter	15

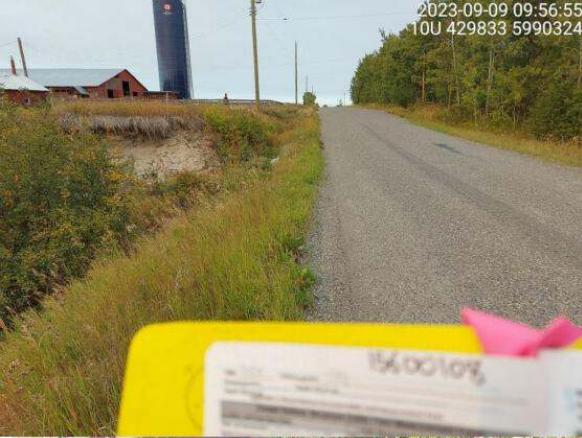
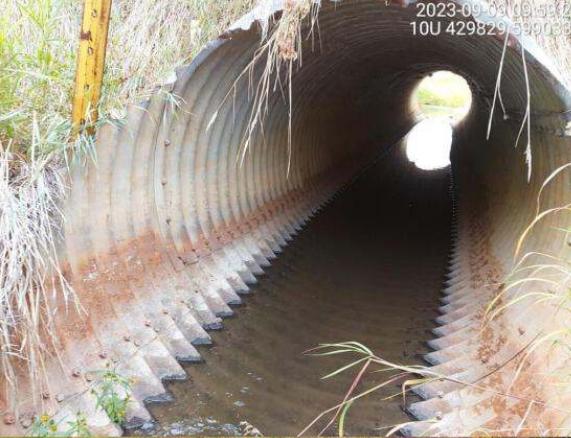
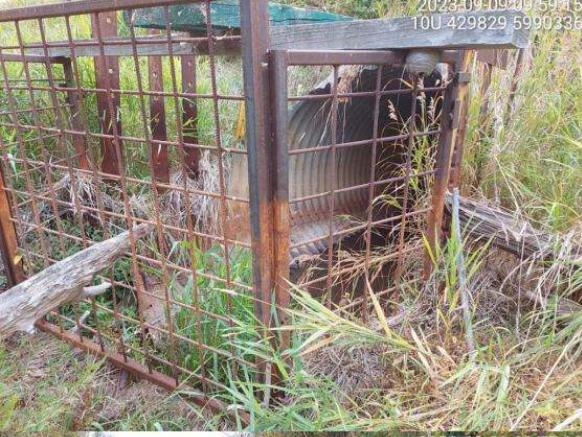
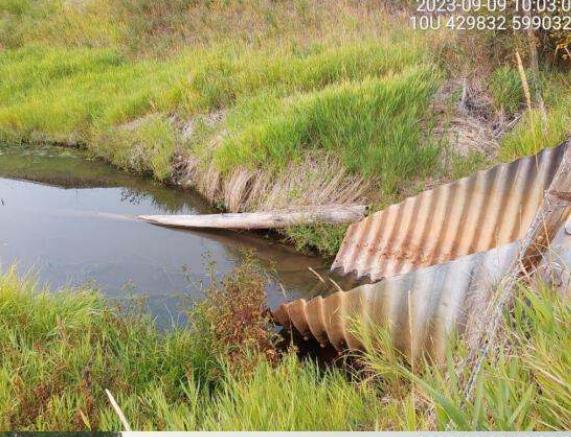
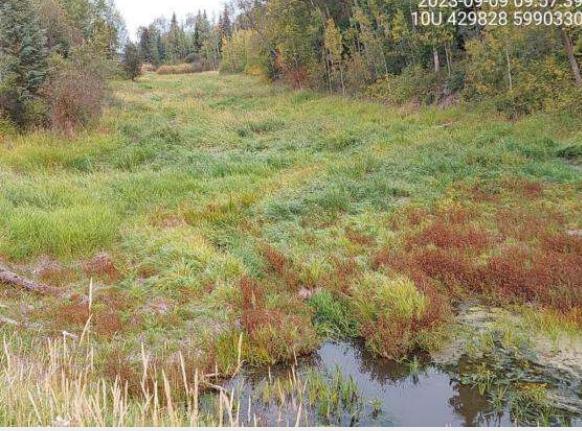
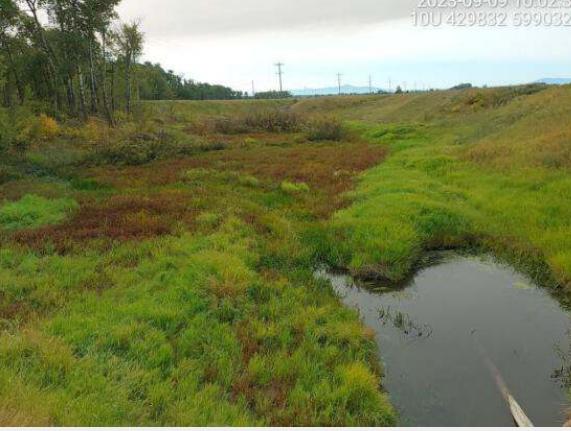
Location and Stream Data		•	Crossing Characteristics	–
Date	2023-09-09	Crossing Sub Type	Round Culvert	
PSCIS ID	199180	Diameter (m)	2.2	
External ID	15600108	Length (m)	15	
Crew	MW	Embedded	No	
UTM Zone	10	Depth Embedded (m)	–	
Easting	429831	Resemble Channel	No	
Northing	5990320	Backwatered	No	
Stream	Murray Creek	Percent Backwatered	–	
Road	Snell Rd E	Fill Depth (m)	2	
Road Tenure	MOTI	Outlet Drop (m)	0	
Channel Width (m)	2.1	Outlet Pool Depth (m)	0.4	
Stream Slope (%)	1	Inlet Drop	No	
Beaver Activity	No	Slope (%)	0.5	
Habitat Value	Medium	Valley Fill	Deep Fill	
Final score	13	Barrier Result	Passable	
Fix type	–	Fix Span / Diameter	–	
Comments: Grassy wetland habitat upstream and downstream. Culvert diameter used as channel width and stream slope estimated. Beaver grate present at inlet. Some flow in culvert. MoTi chris_culvert_id: 1808533. 09:55:51				
Photos: PSCIS ID 15600108. From top left clockwise: Road/Site Card, Barrel, Outlet, Downstream, Upstream, Inlet.

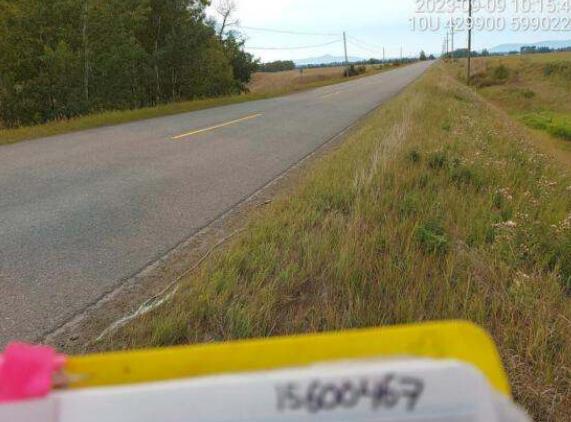
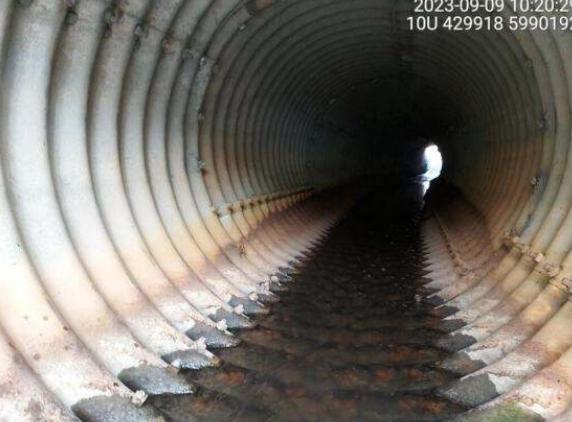
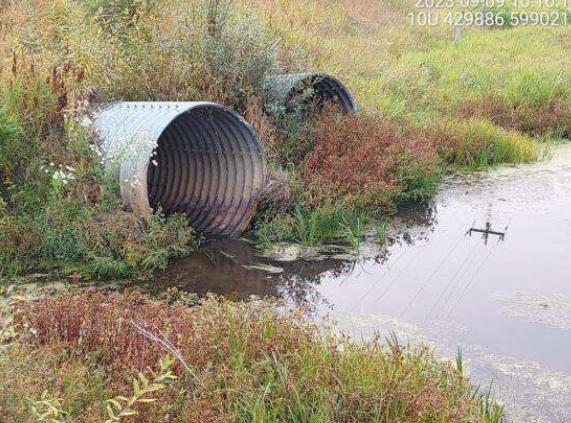
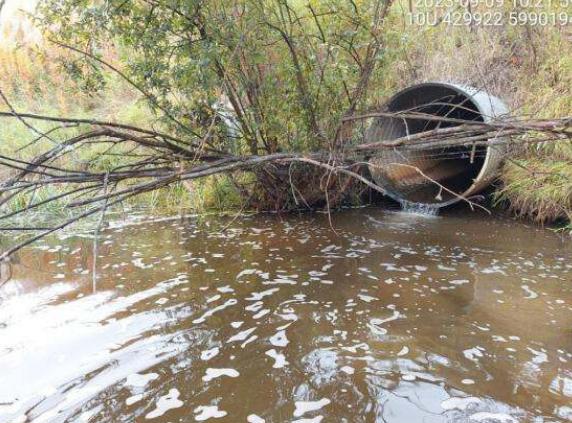
Photos: PSCIS ID 15600467. From top left clockwise: Road/Site Card, Barrel, Outlet, Downstream, Upstream, Inlet.

Location and Stream Data		Crossing Characteristics	
Date	2023-09-09	Crossing Sub Type	Round Culvert
PSCIS ID	199181	Diameter (m)	3.2
External ID	15600467	Length (m)	16
Crew	MW	Embedded	No
UTM Zone	10	Depth Embedded (m)	—
Easting	429905	Resemble Channel	No
Northing	5990198	Backwatered	No
Stream	Murray Creek	Percent Backwatered	—
Road	Loop Road	Fill Depth (m)	4
Road Tenure	MOTI Local	Outlet Drop (m)	0.3
Channel Width (m)	2.2	Outlet Pool Depth (m)	1
Stream Slope (%)	1	Inlet Drop	No
Beaver Activity	No	Slope (%)	2
Habitat Value	Medium	Valley Fill	Deep Fill
Final score	28	Barrier Result	Barrier
Fix type	Replace with New Open Bottom Structure	Fix Span / Diameter	18

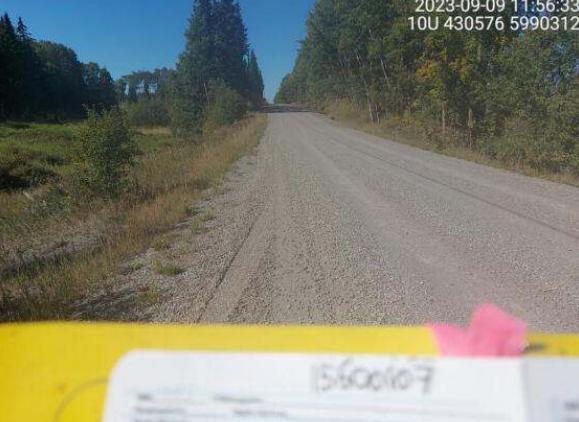
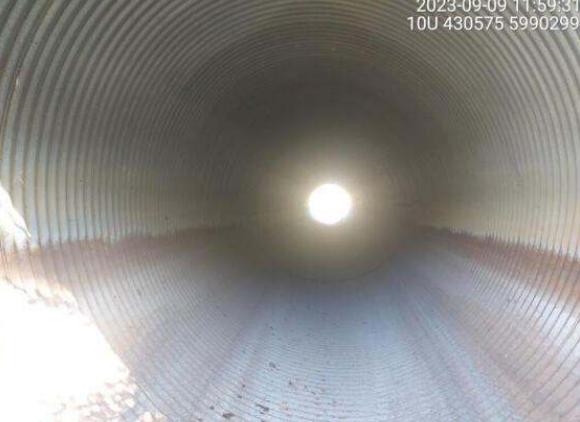
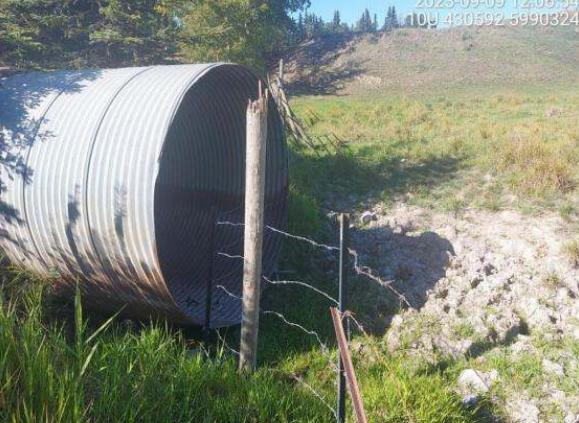
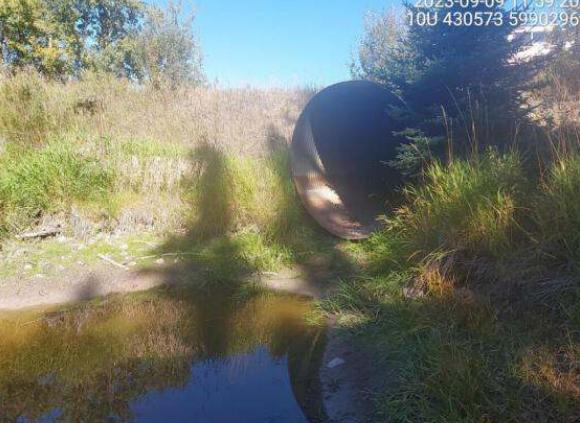
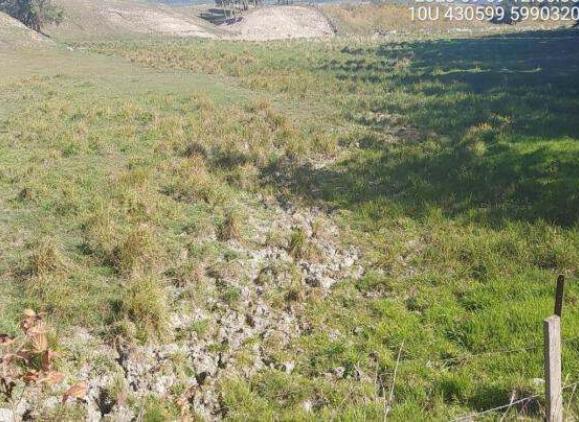
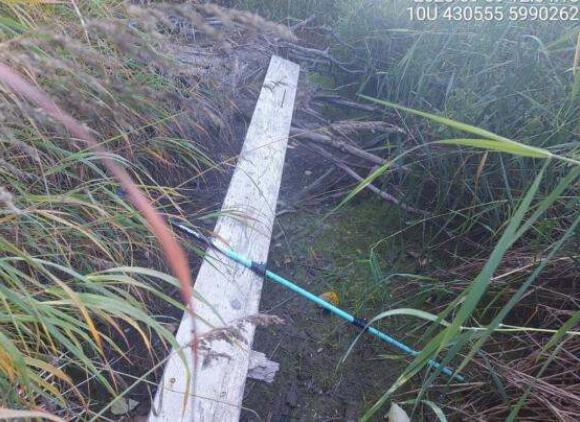
Location and Stream Data	.	Crossing Characteristics	–
Date	2023-09-09	Crossing Sub Type	Round Culvert
PSCIS ID	199182	Diameter (m)	2.5
External ID	15600107	Length (m)	22
Crew	MW	Embedded	No
UTM Zone	10	Depth Embedded (m)	–
Easting	430580	Resemble Channel	No
Northing	5990313	Backwatered	No
Stream	East Murray Creek	Percent Backwatered	–
Road	Snell Rd E	Fill Depth (m)	0.5
Road Tenure	MOTI Local	Outlet Drop (m)	0
Channel Width (m)	1.7	Outlet Pool Depth (m)	0.5
Stream Slope (%)	1	Inlet Drop	No
Beaver Activity	No	Slope (%)	1
Habitat Value	Low	Valley Fill	Deep Fill
Final score	18	Barrier Result	Potential
Fix type	Replace Structure with Streambed Simulation CBS	Fix Span / Diameter	3

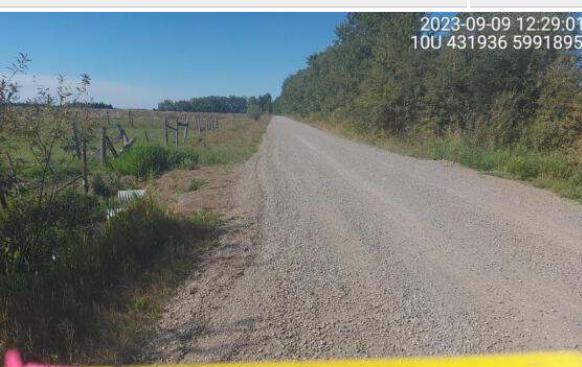
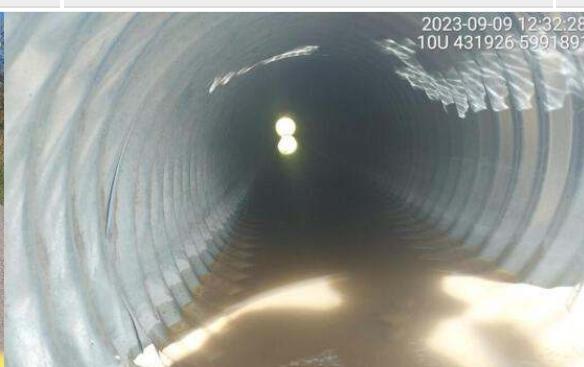
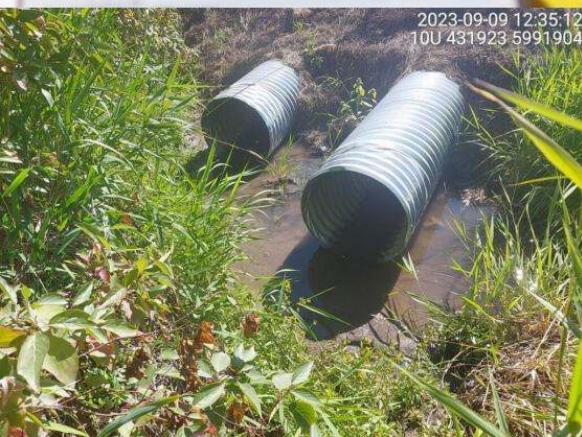
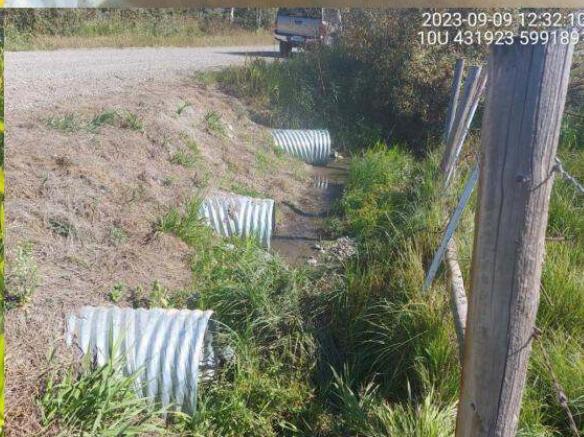
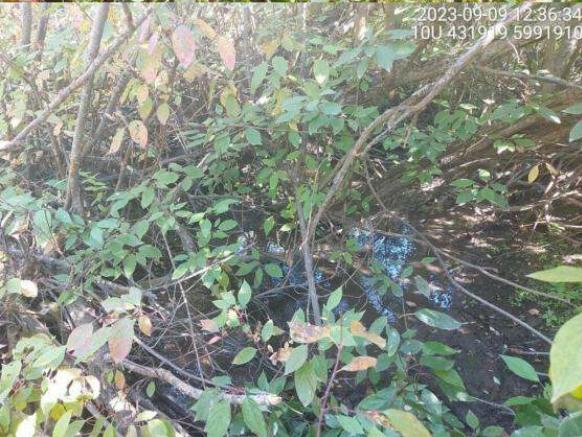
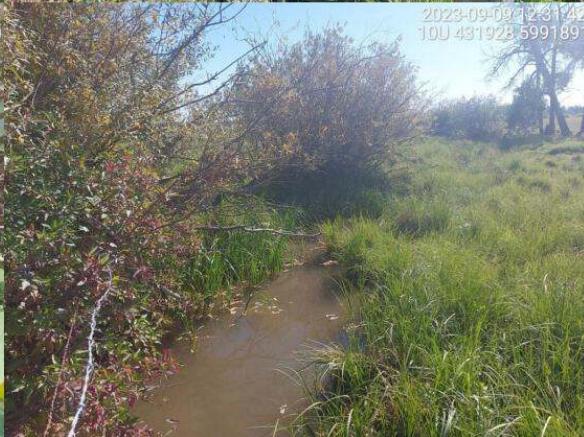
Photos: PSCIS ID 15600190. From top left clockwise: Road/Site Card, Barrel, Outlet, Downstream, Upstream, Inlet.

Location and Stream Data	.	Crossing Characteristics	-
Date	2023-09-09	Crossing Sub Type	Round Culvert
PSCIS ID	199183	Diameter (m)	1.8
External ID	15600190	Length (m)	12
Crew	MW	Embedded	No
UTM Zone	10	Depth Embedded (m)	-
Easting	431924	Resemble Channel	No
Northing	5991893	Backwatered	No
Stream	McIntosh Creek	Percent Backwatered	-
Road	Mcleod Pit Rd	Fill Depth (m)	0.5
Road Tenure	MOTI Local	Outlet Drop (m)	0
Channel Width (m)	1.6	Outlet Pool Depth (m)	0.3
Stream Slope (%)	1	Inlet Drop	No
Beaver Activity	No	Slope (%)	1
Habitat Value	Low	Valley Fill	Deep Fill
Final score	15	Barrier Result	Potential
Fix type	Replace Structure with Streambed Simulation CBS	Fix Span / Diameter	3

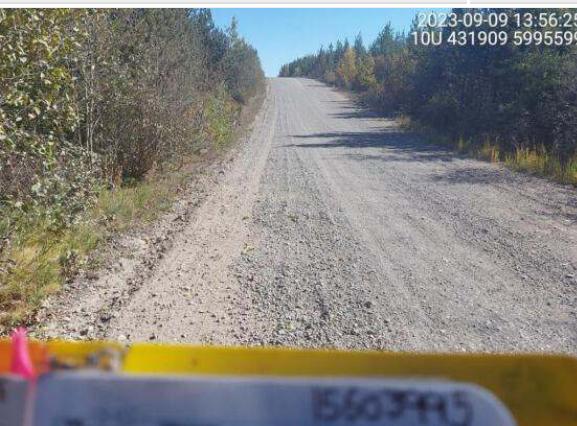
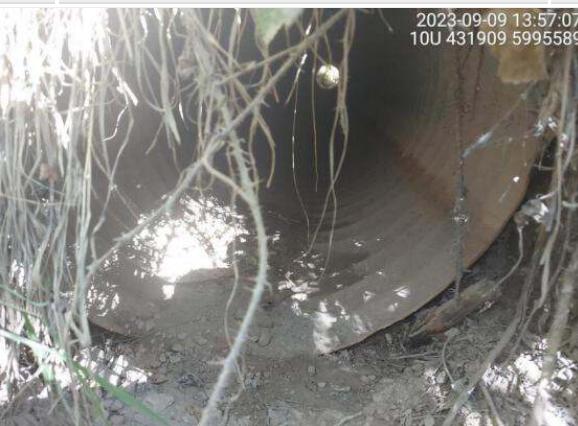
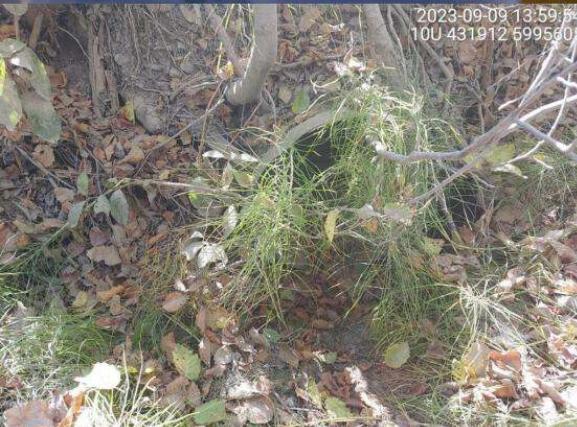
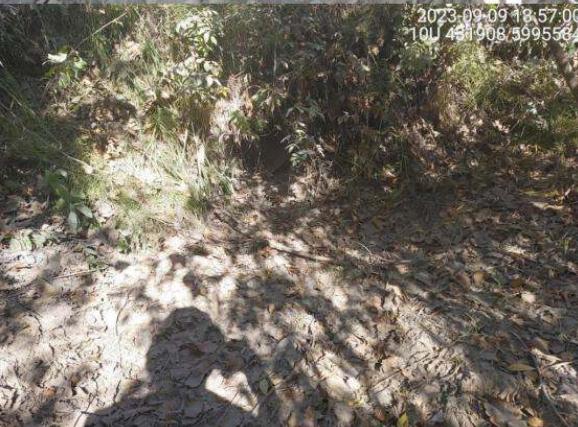
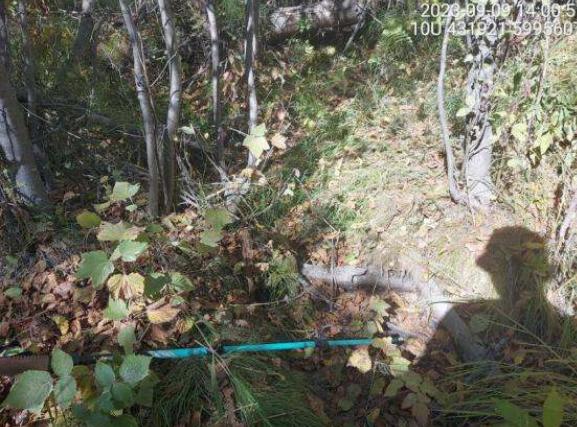
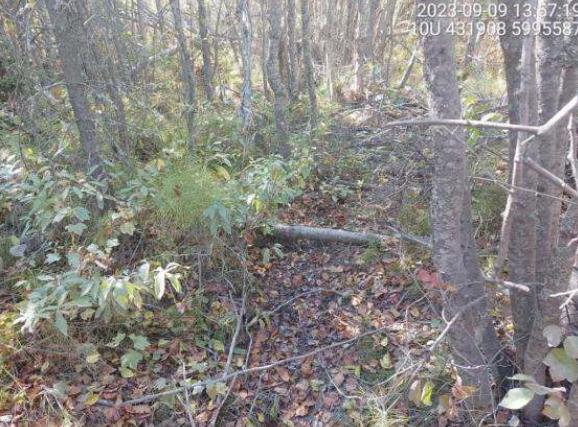
Photos: PSCIS ID 15603995. From top left clockwise: Road/Site Card, Barrel, Outlet, Downstream, Upstream, Inlet.

Location and Stream Data		Crossing Characteristics	
Date	2023-09-09	Crossing Sub Type	Round Culvert
PSCIS ID	199184	Diameter (m)	0.5
External ID	15603995	Length (m)	10
Crew	MW	Embedded	No
UTM Zone	10	Depth Embedded (m)	—
Easting	431910	Resemble Channel	No
Northing	5995592	Backwatered	No
Stream	McIntosh Creek	Percent Backwatered	—
Road	Stringer Rd	Fill Depth (m)	1
Road Tenure	MOTI Local	Outlet Drop (m)	0
Channel Width (m)	0.7	Outlet Pool Depth (m)	0
Stream Slope (%)	1.5	Inlet Drop	No
Beaver Activity	No	Slope (%)	1
Habitat Value	Low	Valley Fill	Deep Fill
Final score	21	Barrier Result	Barrier
Fix type	Replace Structure with Streambed Simulation CBS	Fix Span / Diameter	3

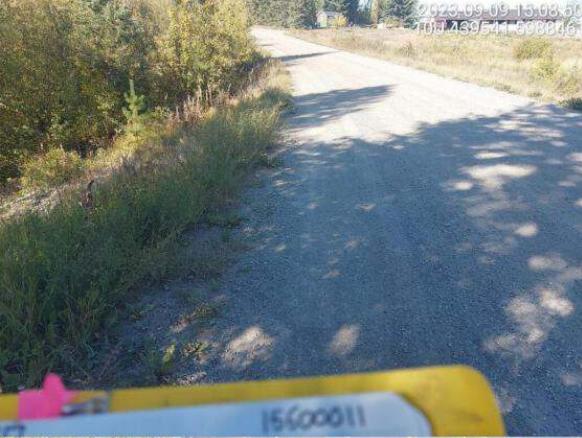
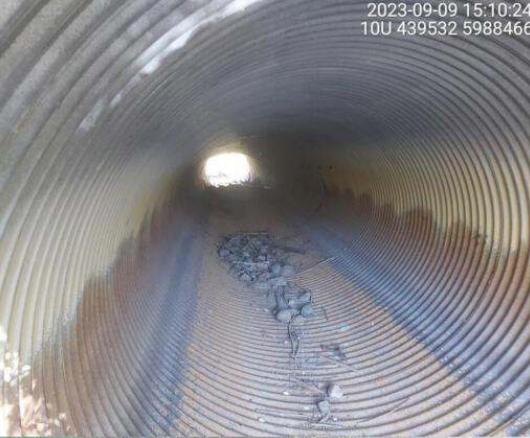
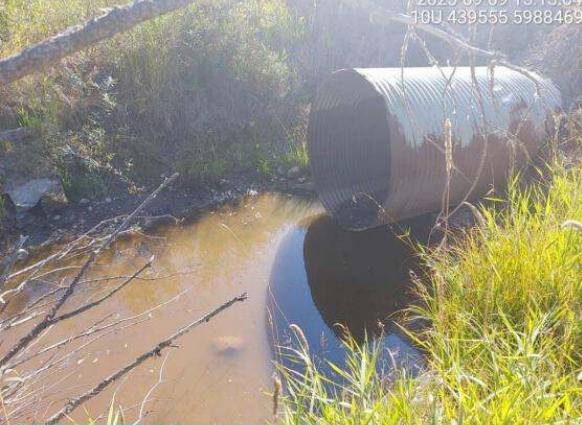
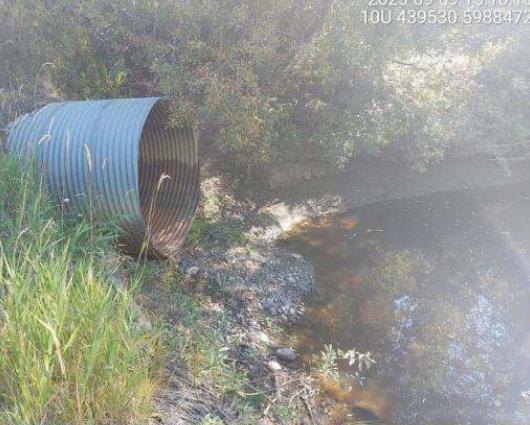
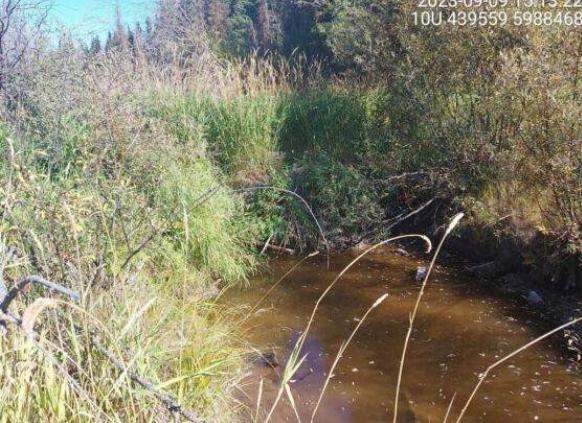
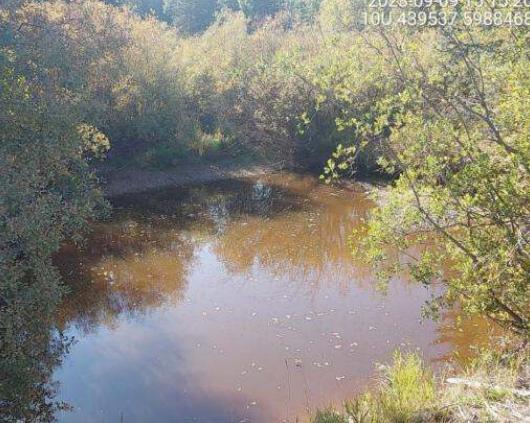
Location and Stream Data		Crossing Characteristics	
Date	2023-09-09	Crossing Sub Type	Round Culvert
PSCIS ID	199185	Diameter (m)	1.7
External ID	15600011	Length (m)	14
Crew	MW	Embedded	No
UTM Zone	10	Depth Embedded (m)	—
Easting	439543	Resemble Channel	No
Northing	5988470	Backwatered	No
Stream	Knight Creek	Percent Backwatered	—
Road	Gulbranson Rd	Fill Depth (m)	1.5
Road Tenure	MOTI Local	Outlet Drop (m)	0
Channel Width (m)	1.7	Outlet Pool Depth (m)	2
Stream Slope (%)	1.5	Inlet Drop	No
Beaver Activity	No	Slope (%)	1
Habitat Value	Medium	Valley Fill	Deep Fill
Final score	18	Barrier Result	Potential
Fix type	Replace Structure with Streambed Simulation CBS	Fix Span / Diameter	3
Comments: Huge outlet pool, but no outlet drop. No water in pipe and no flowing water in stream. MoTi chris_culvert_id: 1803926. 15:09:18			
Photos: PSCIS ID 15600011. From top left clockwise: Road/Site Card, Barrel, Outlet, Downstream, Upstream, Inlet.

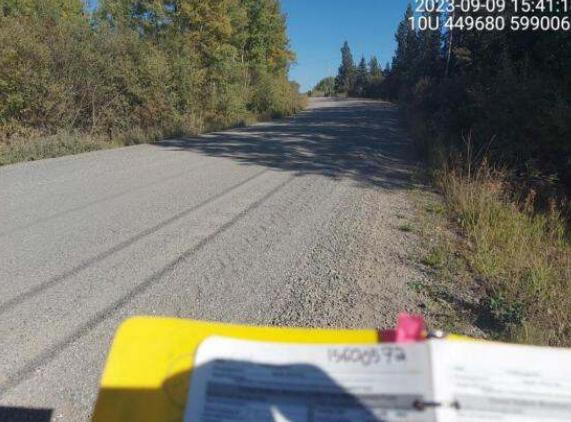
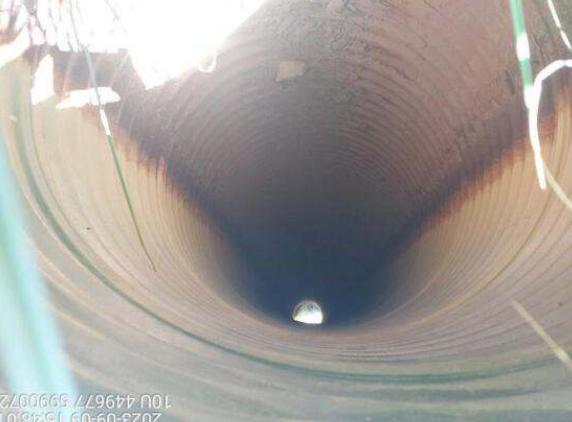
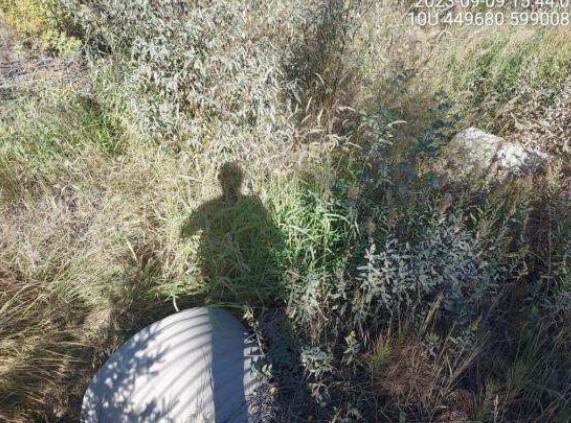
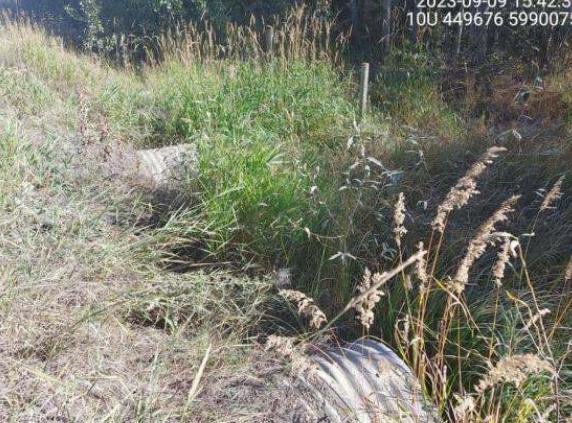
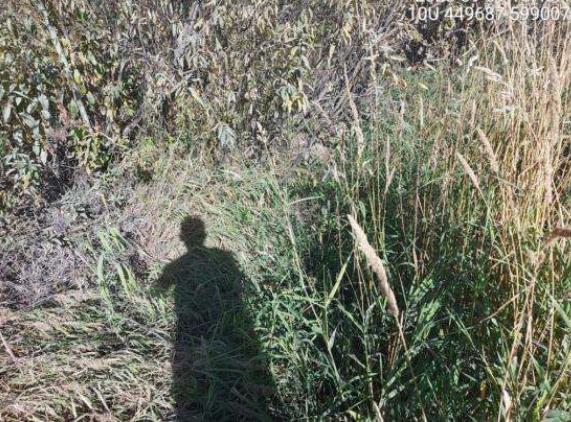
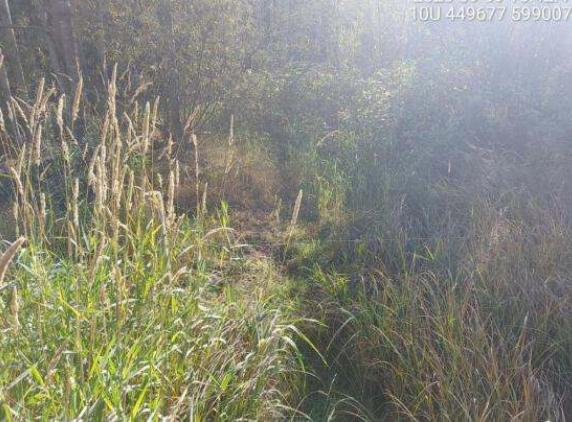
Location and Stream Data		.	Crossing Characteristics	-
Date	2023-09-09		Crossing Sub Type	Round Culvert
PSCIS ID	199186		Diameter (m)	3
External ID	15600572		Length (m)	16
Crew	MW		Embedded	No
UTM Zone	10		Depth Embedded (m)	-
Easting	449681		Resemble Channel	No
Northing	5990078		Backwatered	No
Stream	Tributary to Tritt Creek		Percent Backwatered	-
Road	Sturgeon Pt Rd		Fill Depth (m)	1
Road Tenure	MOTI		Outlet Drop (m)	0
Channel Width (m)	3		Outlet Pool Depth (m)	0
Stream Slope (%)	1		Inlet Drop	No
Beaver Activity	No		Slope (%)	1.5
Habitat Value	Low		Valley Fill	Deep Fill
Final score	21		Barrier Result	Barrier
Fix type	Replace with New Open Bottom Structure		Fix Span / Diameter	15
Comments: Dewatered. Vegetated stream channel. Three culverts, diameter totaled. MoTi chris_culvert_id: 1801577, 1801578. 15:44:14				
Photos: PSCIS ID 15600572. From top left clockwise: Road/Site Card, Barrel, Outlet, Downstream, Upstream, Inlet.

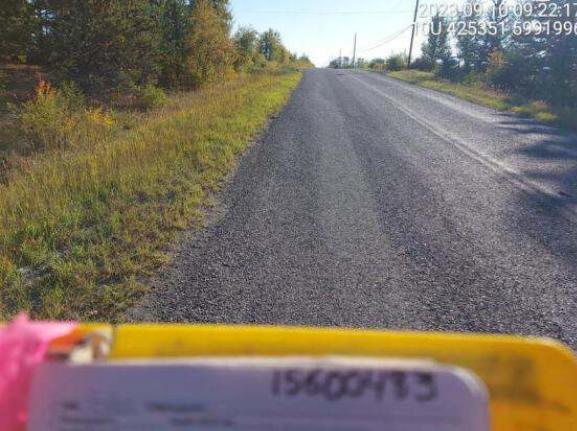
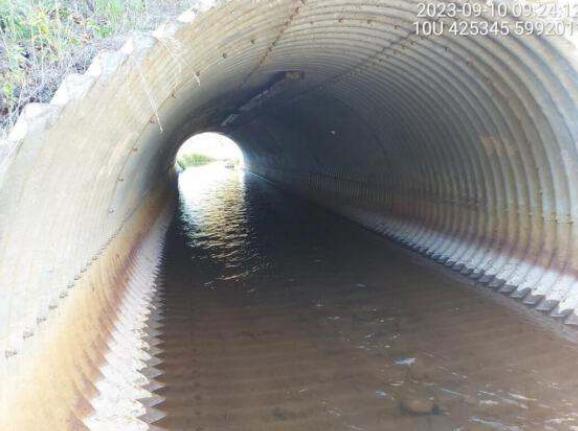
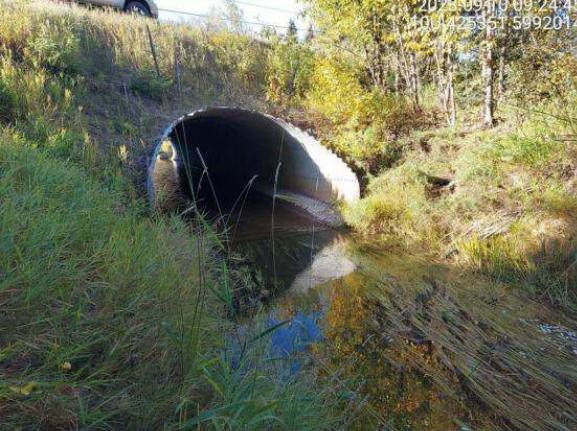
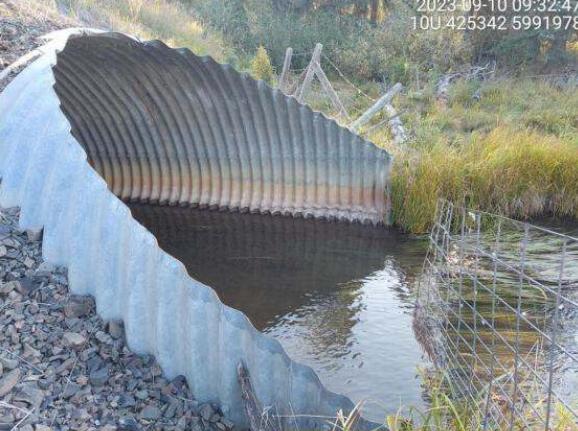
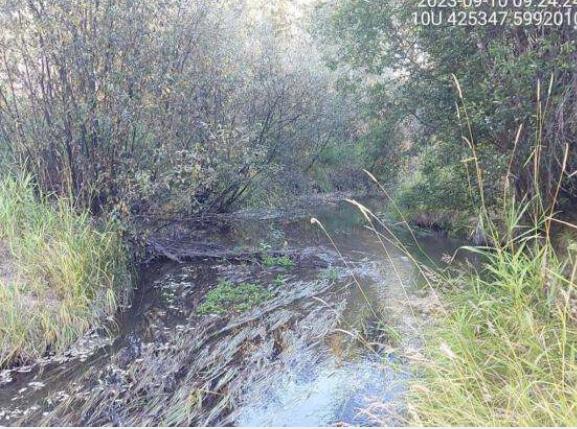
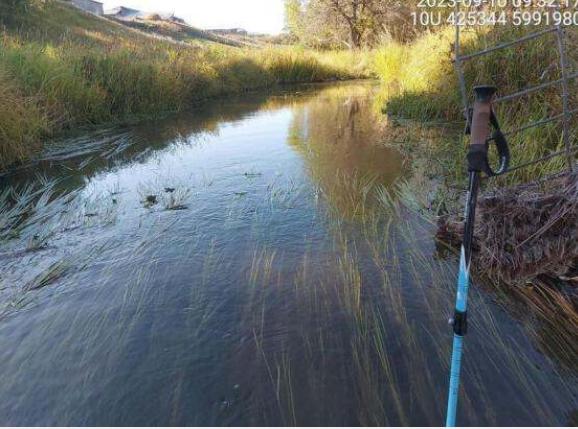
Photos: PSCIS ID 15600483. From top left clockwise: Road/Site Card, Barrel, Outlet, Downstream, Upstream, Inlet.

Location and Stream Data		.	Crossing Characteristics	-
Date	2023-09-10		Crossing Sub Type	Oval Culvert
PSCIS ID	199187		Diameter (m)	3.9
External ID	15600483		Length (m)	17
Crew	MW		Embedded	No
UTM Zone	10		Depth Embedded (m)	-
Easting	425343		Resemble Channel	No
Northing	5991993		Backwatered	No
Stream	Clear Creek		Percent Backwatered	-
Road	Braeside Rd		Fill Depth (m)	2
Road Tenure	MOTI		Outlet Drop (m)	0
Channel Width (m)	4.7		Outlet Pool Depth (m)	0.6
Stream Slope (%)	0.5		Inlet Drop	No
Beaver Activity	No		Slope (%)	1.5
Habitat Value	High		Valley Fill	Deep Fill
Final score	21		Barrier Result	Barrier
Fix type	Replace with New Open Bottom Structure		Fix Span / Diameter	15

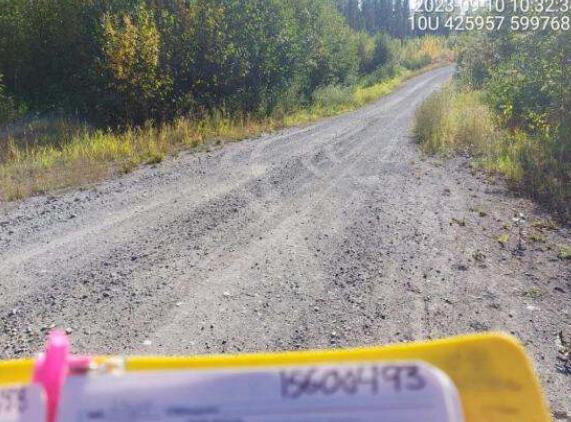
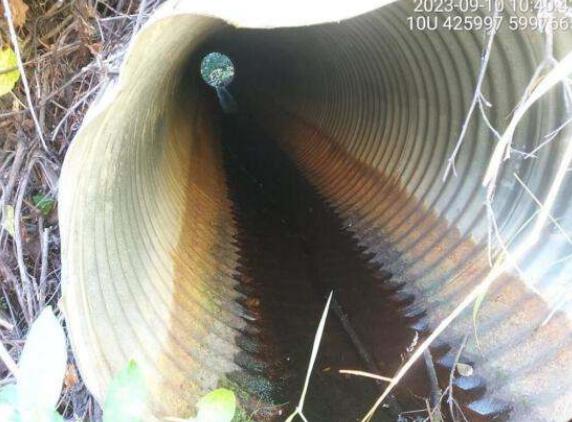
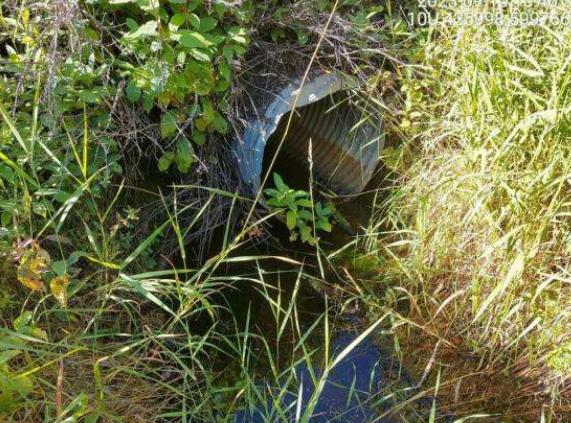
Photos: PSCIS ID 15600493. From top left clockwise: Road/Site Card, Barrel, Outlet, Downstream, Upstream, Inlet.

Location and Stream Data		Crossing Characteristics	
Date	2023-09-10	Crossing Sub Type	Round Culvert
PSCIS ID	199188	Diameter (m)	0.95
External ID	15600493	Length (m)	10
Crew	MW	Embedded	No
UTM Zone	10	Depth Embedded (m)	–
Easting	425987	Resemble Channel	No
Northing	5997655	Backwatered	No
Stream	Tributary to Clear Creek	Percent Backwatered	–
Road	Blue Mountain Road	Fill Depth (m)	1
Road Tenure	MOTI Local	Outlet Drop (m)	0.7
Channel Width (m)	1.1	Outlet Pool Depth (m)	0.7
Stream Slope (%)	4	Inlet Drop	No
Beaver Activity	No	Slope (%)	1
Habitat Value	Medium	Valley Fill	Deep Fill
Final score	28	Barrier Result	Barrier
Fix type	Replace Structure with Streambed Simulation CBS	Fix Span / Diameter	3

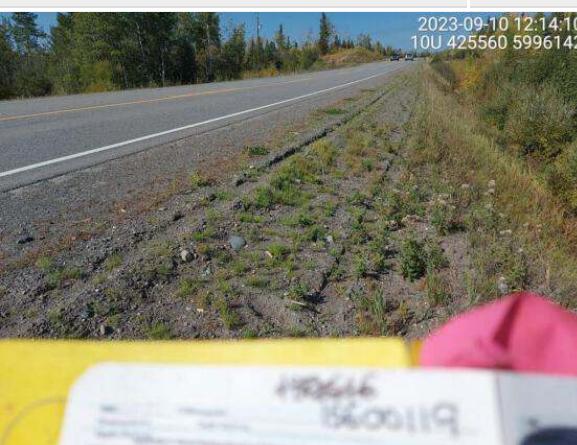
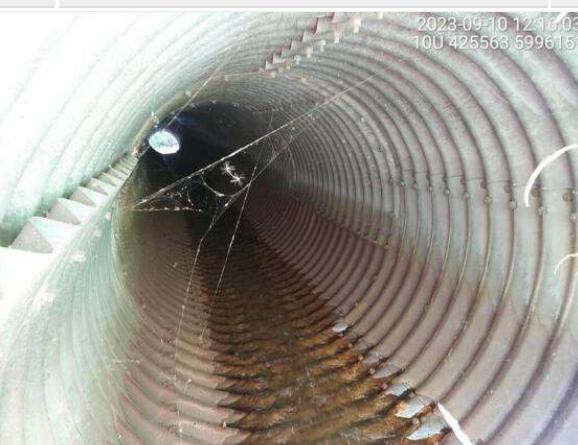
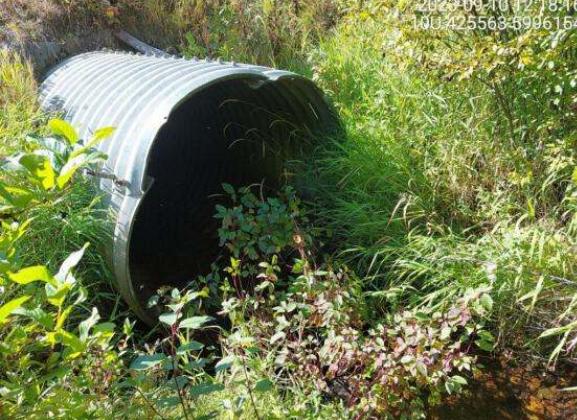
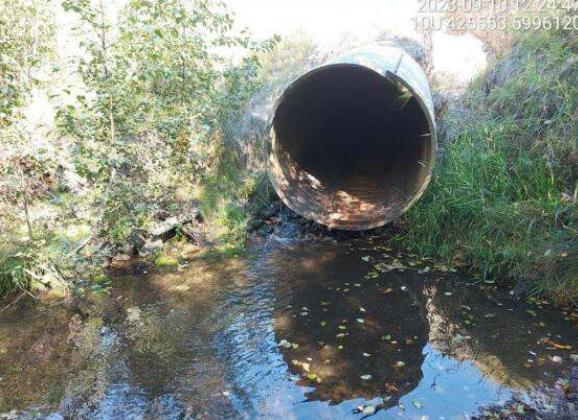
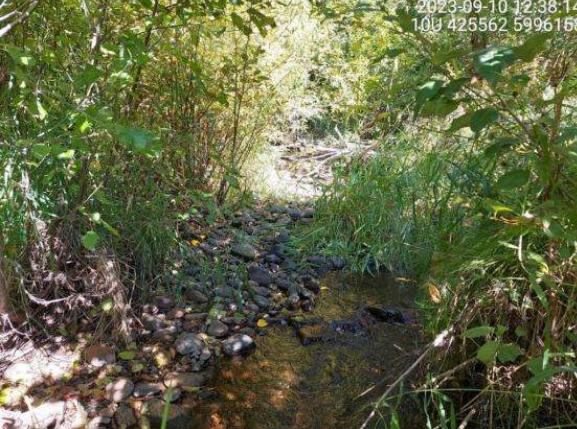
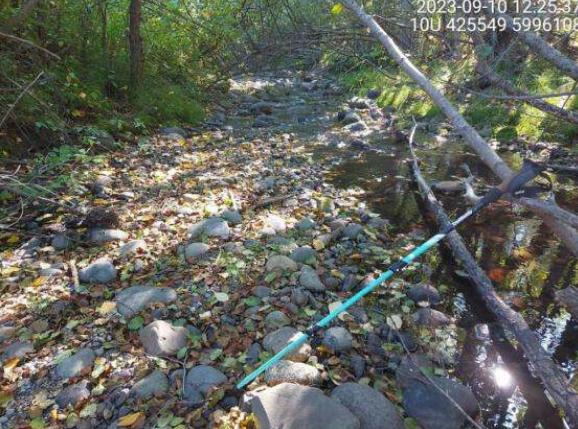
Photos: PSCIS ID 15600119. From top left clockwise: Road/Site Card, Barrel, Outlet, Downstream, Upstream, Inlet.

Comments: High value habitat, wide channel with good flow and gravels. Known chinook system downstream. Culvert is very damaged near outlet. There are holes on bottom of pipe about 5m from outlet where water is running through and under the pipe. Culvert is angled down near outlet. Good candidate for replacement. MoTi chris_culvert_id: 1806163.
12:15:10

Location and Stream Data		Crossing Characteristics	
Date	2023-09-10	Crossing Sub Type	Round Culvert
PSCIS ID	199190	Diameter (m)	1.7
External ID	15600119	Length (m)	22
Crew	MW	Embedded	No
UTM Zone	10	Depth Embedded (m)	—
Easting	425557	Resemble Channel	No
Northing	5996141	Backwatered	No
Stream	Clear Creek	Percent Backwatered	—
Road	Highway 27 S	Fill Depth (m)	2.5
Road Tenure	MOTI	Outlet Drop (m)	0.3
Channel Width (m)	2.5	Outlet Pool Depth (m)	0.4
Stream Slope (%)	5	Inlet Drop	No
Beaver Activity	No	Slope (%)	7
Habitat Value	High	Valley Fill	Deep Fill
Final score	39	Barrier Result	Barrier
Fix type	Replace with New Open Bottom Structure	Fix Span / Diameter	15

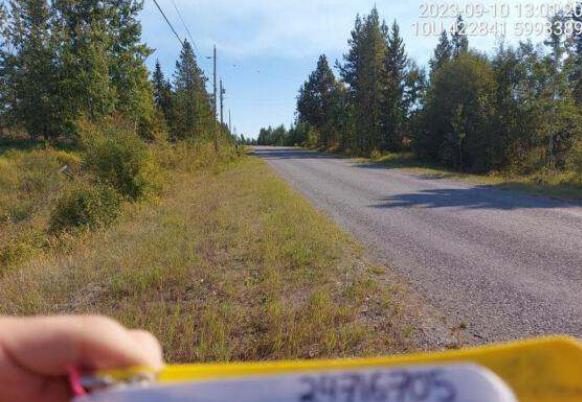
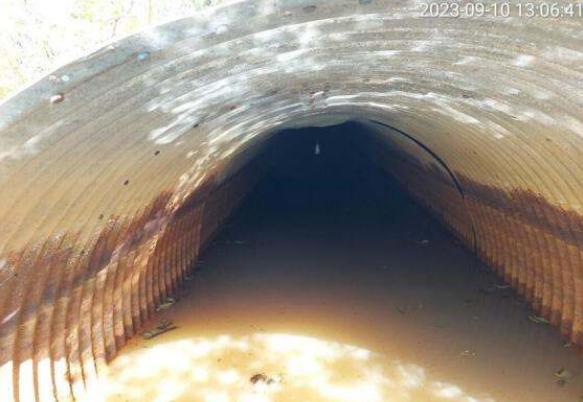
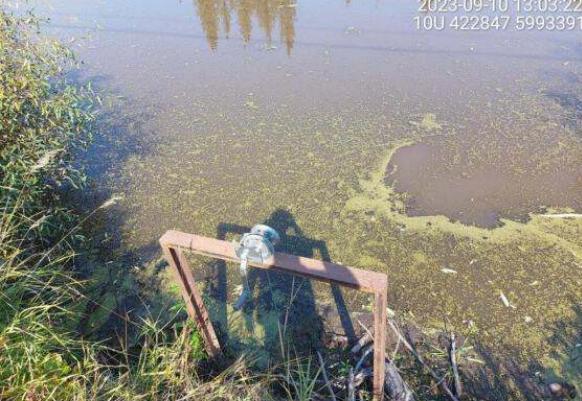
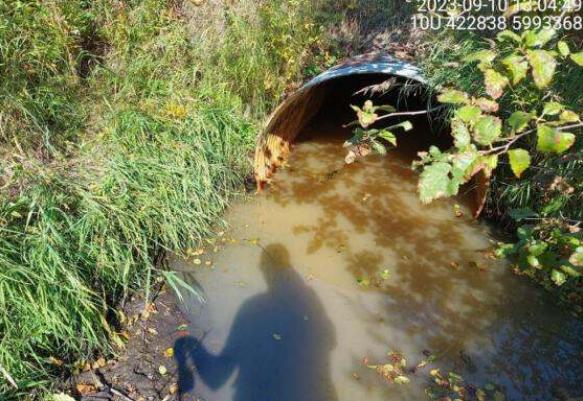
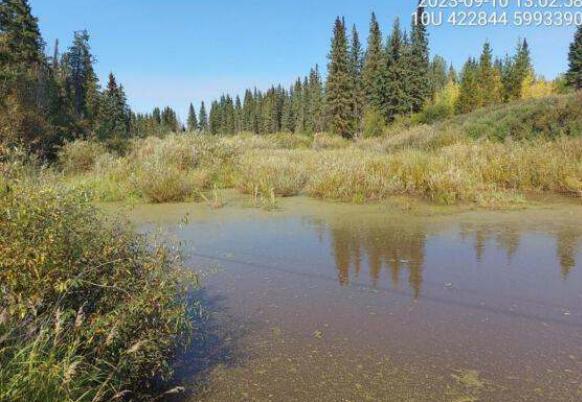
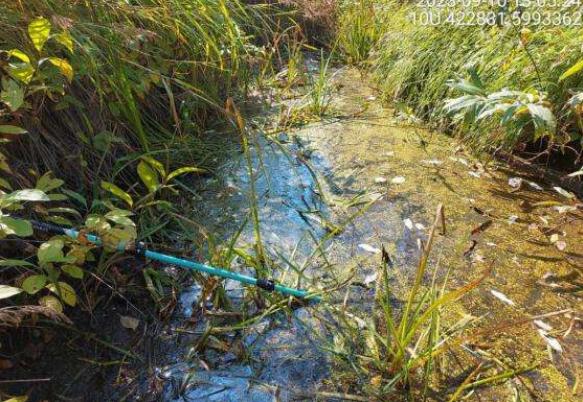
Photos: PSCIS ID 24716705. From top left clockwise: Road/Site Card, Barrel, Outlet, Downstream, Upstream, Inlet.

Comments: Inlet almost completely blocked by debris and wood. Wetland upstream. Beaver dam blocking most of water just downstream of outlet pool. Chinook observations noted downstream MoTi chris_culvert_id: 1804629. 13:01:50

Location and Stream Data		Crossing Characteristics	
Date	2023-09-10	Crossing Sub Type	Round Culvert
PSCIS ID	199191	Diameter (m)	1.6
External ID	24716705	Length (m)	18
Crew	MW	Embedded	No
UTM Zone	10	Depth Embedded (m)	–
Easting	422841	Resemble Channel	No
Northing	5993387	Backwatered	No
Stream	Moss Creek	Percent Backwatered	–
Road	Braeside Rd	Fill Depth (m)	2.5
Road Tenure	MOTI	Outlet Drop (m)	0
Channel Width (m)	2.2	Outlet Pool Depth (m)	0.2
Stream Slope (%)	1	Inlet Drop	No
Beaver Activity	Yes	Slope (%)	1
Habitat Value	Medium	Valley Fill	Deep Fill
Final score	24	Barrier Result	Barrier
Fix type	Replace with New Open Bottom Structure	Fix Span / Diameter	15

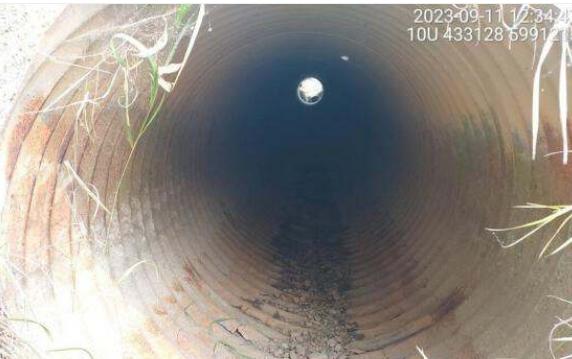
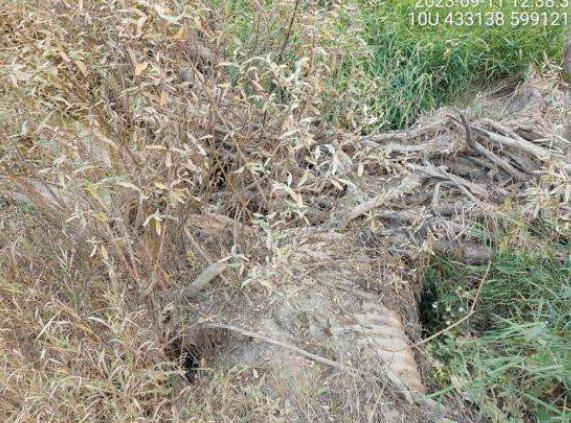
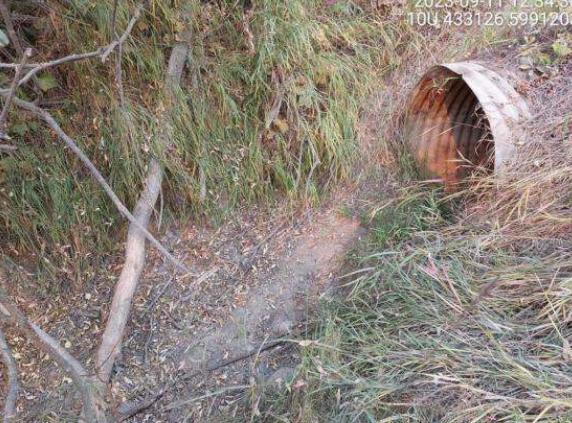
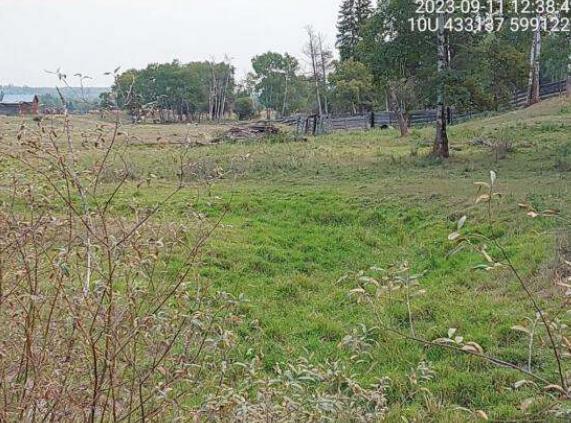
Comments: Very big outlet drop and deep outlet pool. Trickle of water flowing through culvert. Dewatered downstream of outlet pool and dewatered upstream of culvert. Channel width taken upstream but channel is wider downstream of crossing. Culvert is warped and a little corroded. Channel primarily vegetated.. 13:09:19

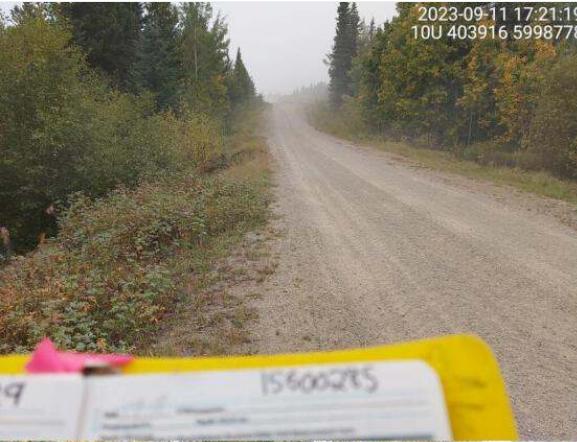
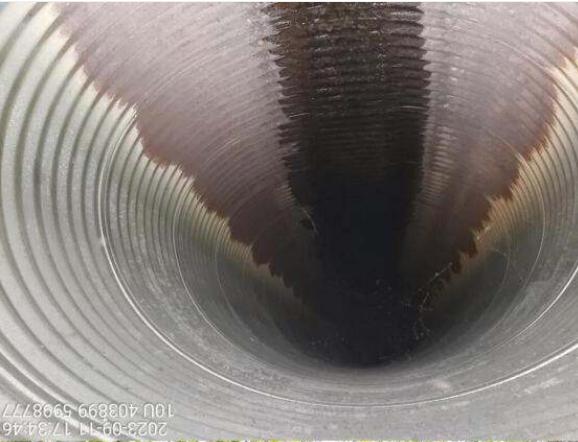
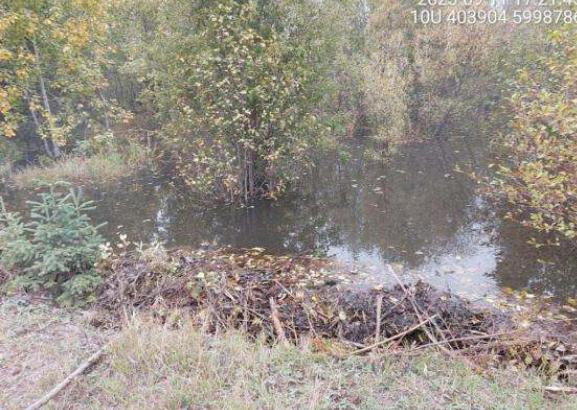
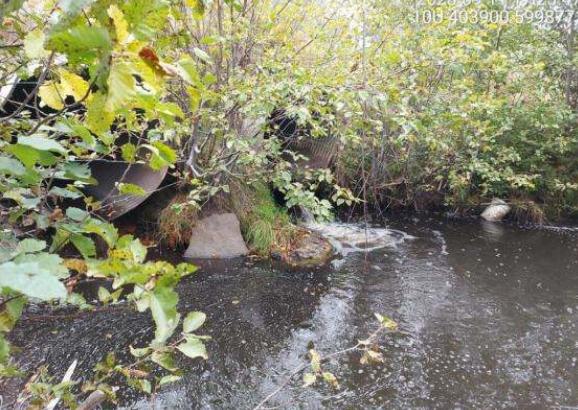
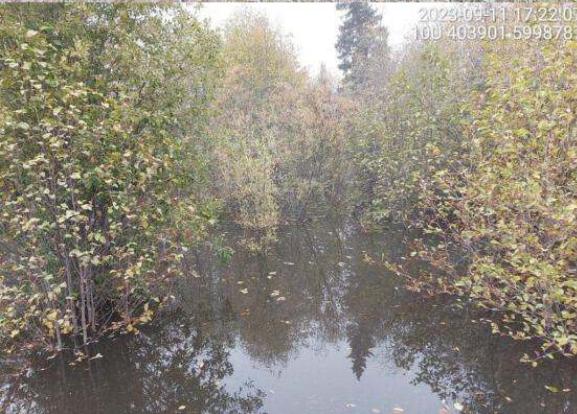
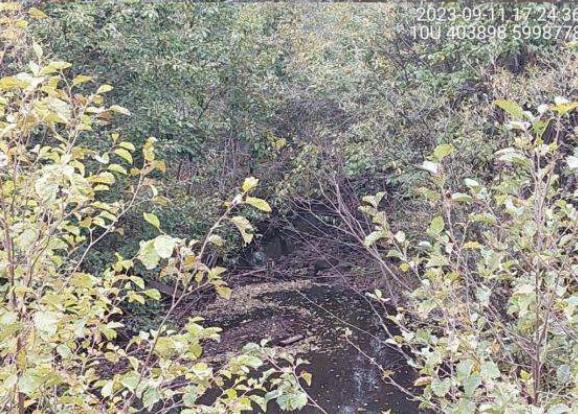
Photos: PSCIS ID 15600285. From top left clockwise: Road/Site Card, Barrel, Outlet, Downstream, Upstream, Inlet.

Comments: Two pipes (one at 1.8m, one at 1.5m), both with similar outlet drops. Inlet side has extensive beaver activity. Beaver dams are covering the inlet and culverts are not visible. Huge wetland upstream. Very big outlet pool so depth was estimated. Chinook were captured downstream of Settlement Road culvert in 2021 (<https://a100.gov.bc.ca/pub/acat/public/viewReport.do?reportId=61991>) and Rainbow Trout observed in stream from 2021-2023 (<https://a100.gov.bc.ca/pub/acat/public/viewReport.do?reportId=61202> and <https://a100.gov.bc.ca/pub/acat/public/viewReport.do?reportId=62942>). Culverts should be replaced and beaver activity managed. Habitat looks good downstream. High habitat value at crossing upstream. MoTi chris_culvert_id: 1793922, 1793923. 17:26:25

Location and Stream Data		Crossing Characteristics	
Date	2023-09-11	Crossing Sub Type	Round Culvert
PSCIS ID	199204	Diameter (m)	3
External ID	15600285	Length (m)	9
Crew	MW	Embedded	No
UTM Zone	10	Depth Embedded (m)	—
Easting	403897	Resemble Channel	No
Northing	5998780	Backwatered	No
Stream	Nine Mile Creek	Percent Backwatered	—
Road	Settlement Rd	Fill Depth (m)	0.5
Road Tenure	MOTI Local	Outlet Drop (m)	0.5
Channel Width (m)	3	Outlet Pool Depth (m)	2
Stream Slope (%)	2	Inlet Drop	No
Beaver Activity	Yes	Slope (%)	1
Habitat Value	Medium	Valley Fill	Deep Fill
Final score	28	Barrier Result	Barrier
Fix type	Replace with New Open Bottom Structure	Fix Span / Diameter	15
