Appendix - Phase 1 Fish Passage Assessment Data and Photos

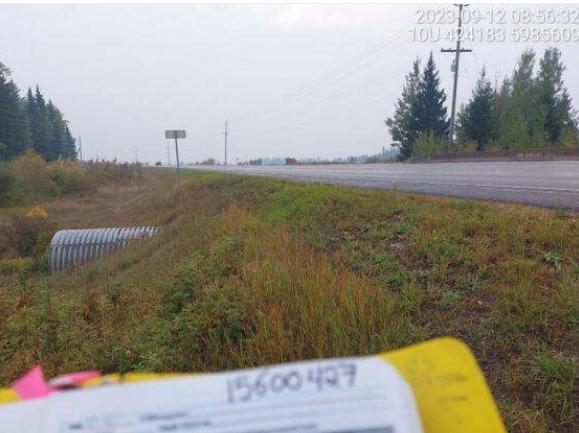
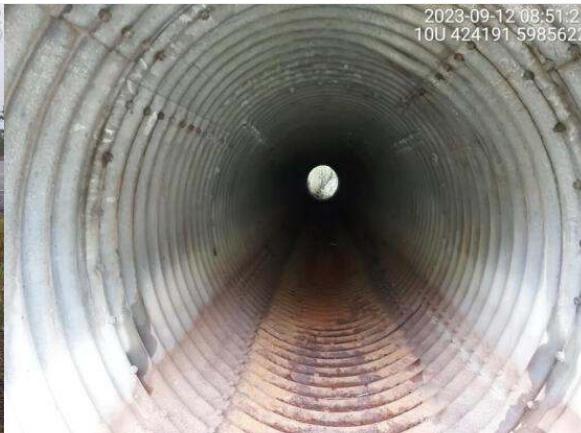
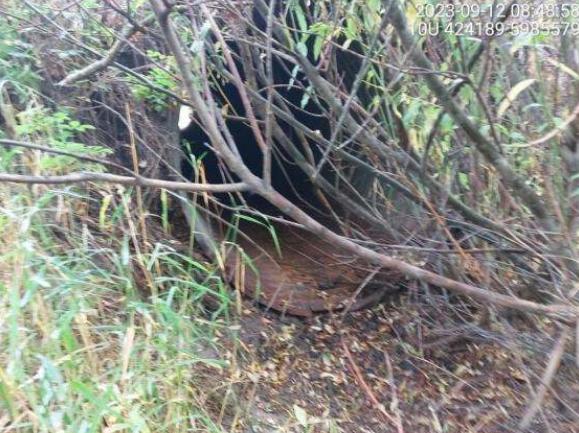
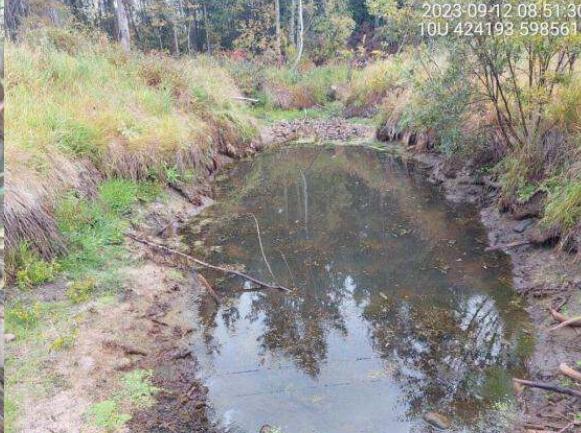
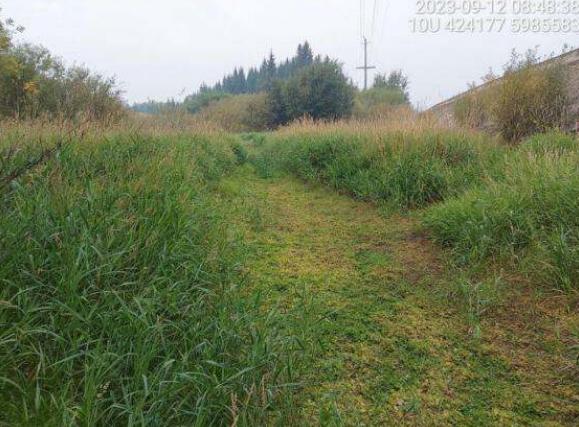
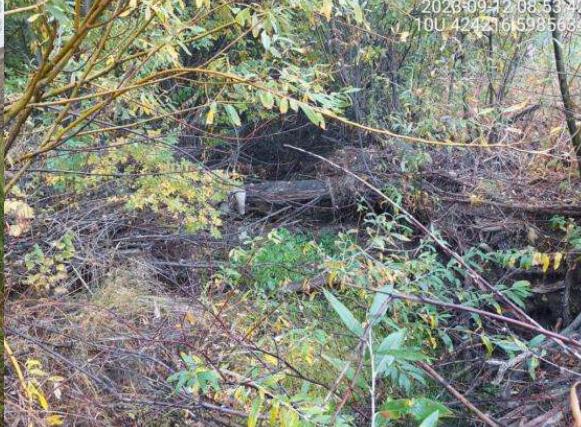
Photos: PSCIS ID 15600427. From top left clockwise: Road/Site Card, Barrel, Outlet, Downstream, Upstream, Inlet.

Comments: Dewatered stream. Large outlet pool. Pipe very corroded on outlet side. Wide stream channel upstream. Grassy channel downstream. Fully backwatered at time of assessment. MoTi chris_culvert_id: 3738843. 08:55:03

Location and Stream Data		Crossing Characteristics	
Date	2023-09-12	Crossing Sub Type	Round Culvert
PSCIS ID	199205	Diameter (m)	2
External ID	15600427	Length (m)	26
Crew	MW	Embedded	No
UTM Zone	10	Depth Embedded (m)	–
Easting	424186	Resemble Channel	No
Northing	5985604	Backwatered	No
Stream	Goldie Creek	Percent Backwatered	–
Road	Highway 16 W	Fill Depth (m)	1
Road Tenure	MOTI	Outlet Drop (m)	0
Channel Width (m)	3.1	Outlet Pool Depth (m)	0.4
Stream Slope (%)	0.5	Inlet Drop	No
Beaver Activity	No	Slope (%)	2
Habitat Value	Medium	Valley Fill	Deep Fill
Final score	24	Barrier Result	Barrier
Fix type	Replace with New Open Bottom Structure	Fix Span / Diameter	15

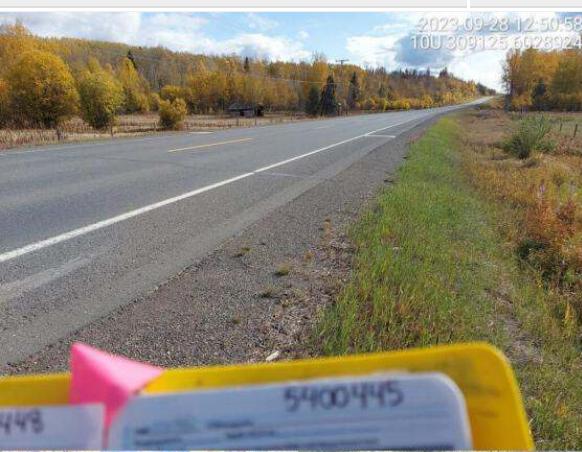
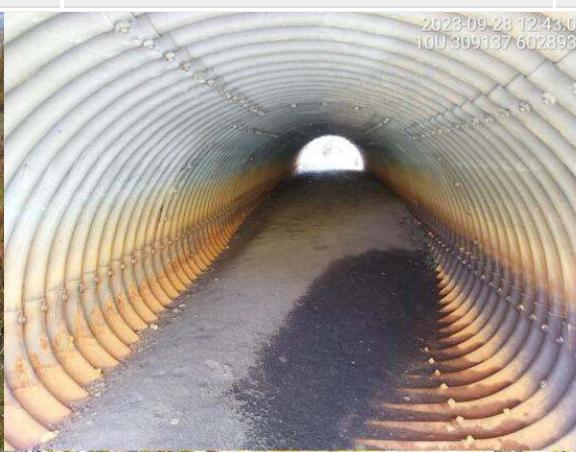
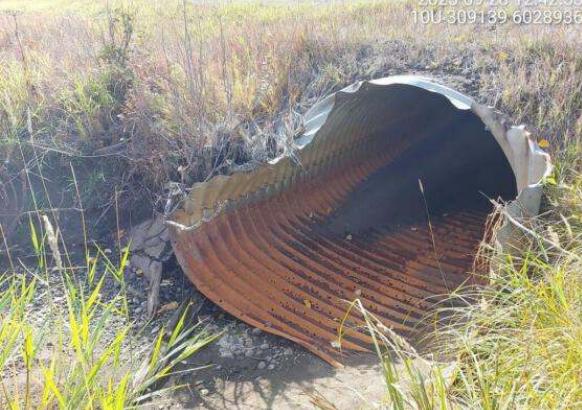
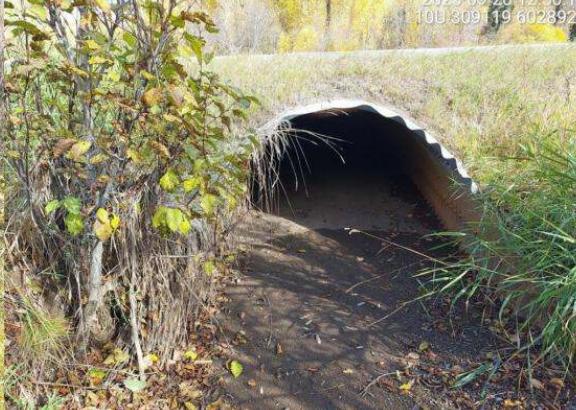
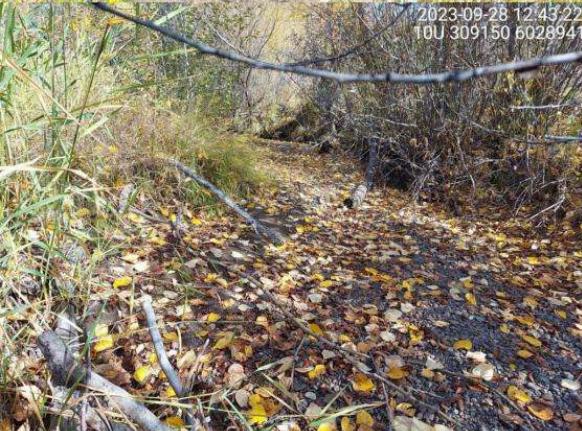
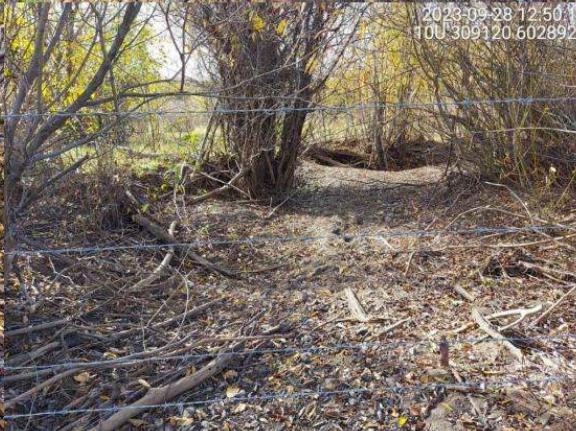
Photos: PSCIS ID 5400445. From top left clockwise: Road/Site Card, Barrel, Outlet, Downstream, Upstream, Inlet.

Comments: Dewatered at time of assessment. Wide channel, private land on both sides. Culvert looks old and corroded, abundant fill in barrel. MoTi chris_culvert_id: 2076438. 12:44:04

Location and Stream Data	.	Crossing Characteristics	—
Date	2023-09-28	Crossing Sub Type	Oval Culvert
PSCIS ID	199208	Diameter (m)	2.6
External ID	5400445	Length (m)	16
Crew	MW	Embedded	No
UTM Zone	10	Depth Embedded (m)	—
Easting	309133	Resemble Channel	No
Northing	6028926	Backwatered	No
Stream	Allen Creek	Percent Backwatered	—
Road	Highway 16 W	Fill Depth (m)	0.4
Road Tenure	MOTI	Outlet Drop (m)	0
Channel Width (m)	3.4	Outlet Pool Depth (m)	0
Stream Slope (%)	1	Inlet Drop	No
Beaver Activity	No	Slope (%)	3
Habitat Value	Medium	Valley Fill	Deep Fill
Final score	29	Barrier Result	Barrier
Fix type	Replace with New Open Bottom Structure	Fix Span / Diameter	15

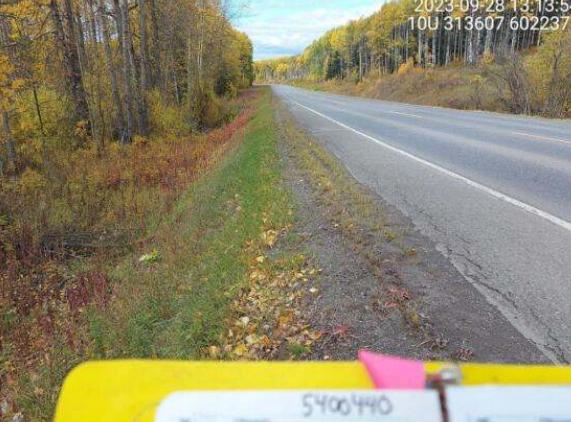
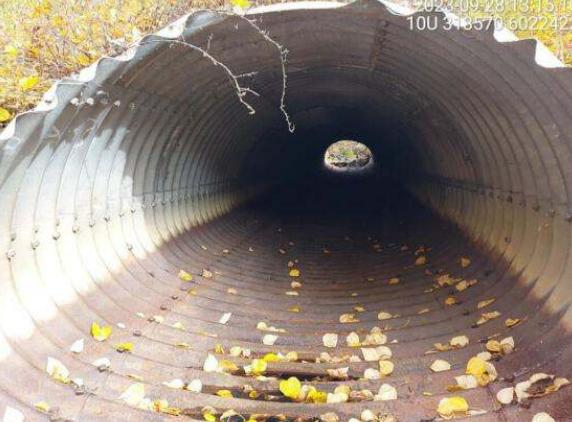
Photos: PSCIS ID 5400440. From top left clockwise: Road/Site Card, Barrel, Outlet, Downstream, Upstream, Inlet.

Comments: Dewatered at time of assessment. Small pool near outlet. Rainbow confirmed in past upstream. Two 3m falls noted 450m upstream. in FISS. Culvert is very old, corroded and has holes in bottom. MoTi chris_culvert_id: 2076418. 13:18:49

Location and Stream Data		Crossing Characteristics	
Date	2023-09-28	Crossing Sub Type	Oval Culvert
PSCIS ID	199209	Diameter (m)	2.3
External ID	5400440	Length (m)	20
Crew	MW	Embedded	No
UTM Zone	10	Depth Embedded (m)	–
Easting	313583	Resemble Channel	No
Northing	6022421	Backwatered	No
Stream	Powder House Creek	Percent Backwatered	–
Road	Highway 16 W	Fill Depth (m)	1
Road Tenure	MOTI	Outlet Drop (m)	0.2
Channel Width (m)	3.5	Outlet Pool Depth (m)	0
Stream Slope (%)	4	Inlet Drop	Yes
Beaver Activity	No	Slope (%)	5
Habitat Value	Medium	Valley Fill	Deep Fill
Final score	34	Barrier Result	Barrier
Fix type	Replace with New Open Bottom Structure	Fix Span / Diameter	15

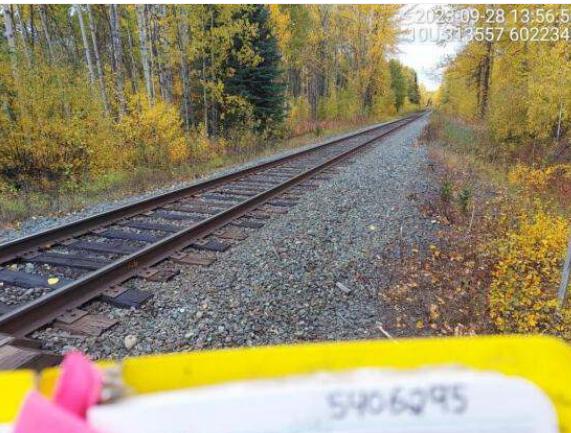
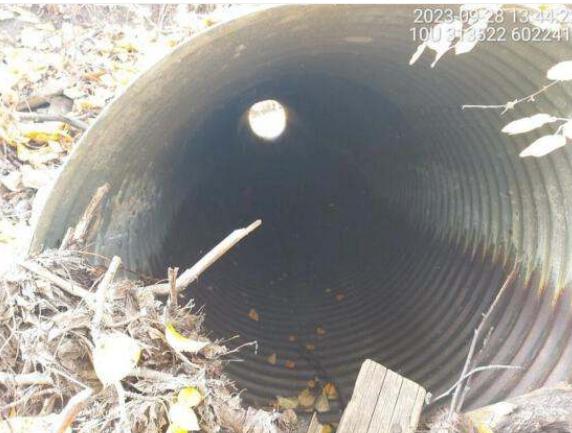
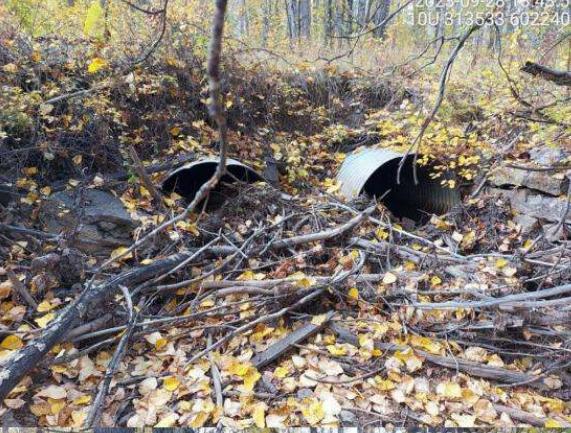
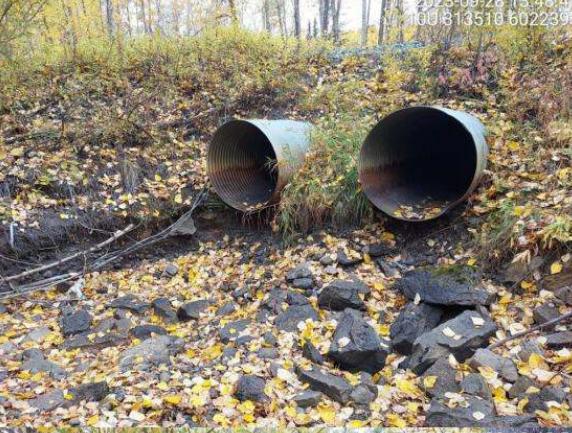
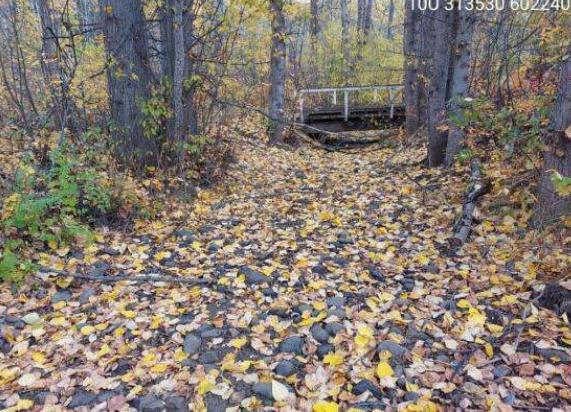
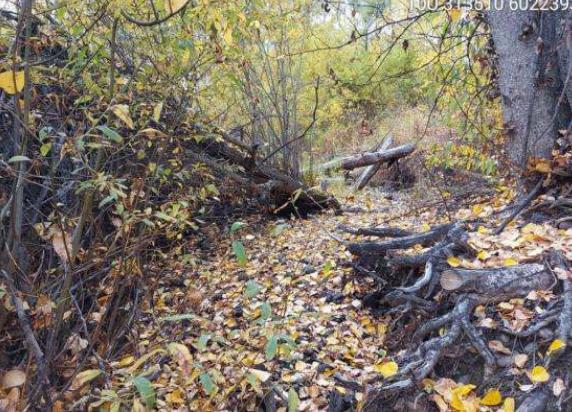
Photos: PSCIS ID 5406295. From top left clockwise: Road/Site Card, Barrel, Outlet, Downstream, Upstream, Inlet.

Location and Stream Data		Crossing Characteristics	
Date	2023-09-28	Crossing Sub Type	Round Culvert
PSCIS ID	199210	Diameter (m)	2.2
External ID	5406295	Length (m)	12
Crew	MW	Embedded	No
UTM Zone	10	Depth Embedded (m)	—
Easting	313514	Resemble Channel	No
Northing	6022401	Backwatered	No
Stream	Powder House Creek	Percent Backwatered	—
Road	Rail	Fill Depth (m)	1.2
Road Tenure	CN Rail	Outlet Drop (m)	0.5
Channel Width (m)	4.1	Outlet Pool Depth (m)	0
Stream Slope (%)	2	Inlet Drop	No
Beaver Activity	No	Slope (%)	5
Habitat Value	Medium	Valley Fill	Deep Fill
Final score	36	Barrier Result	Barrier
Fix type	Replace with New Open Bottom Structure	Fix Span / Diameter	15
Comments: Two pipes at 1.1m diameter each. Debris jam blocking majority of inlet on both pipes. Large channel dewatered at time of assessment. Significant outlet drop on both culverts. Two 3m high falls documented in FISS at ~500-600m upstream. Rainbow trout historically captured upstream. RB have historically been captured upstream. 13:50:33

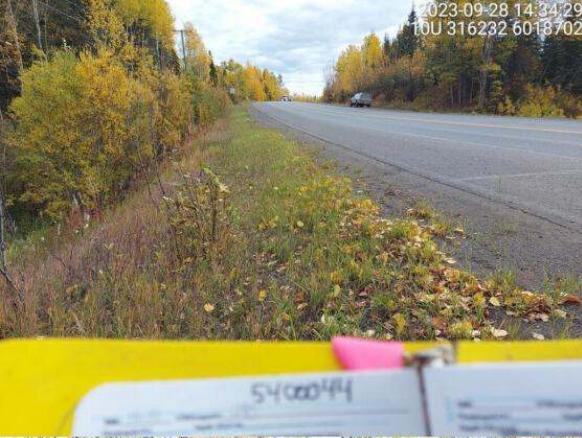
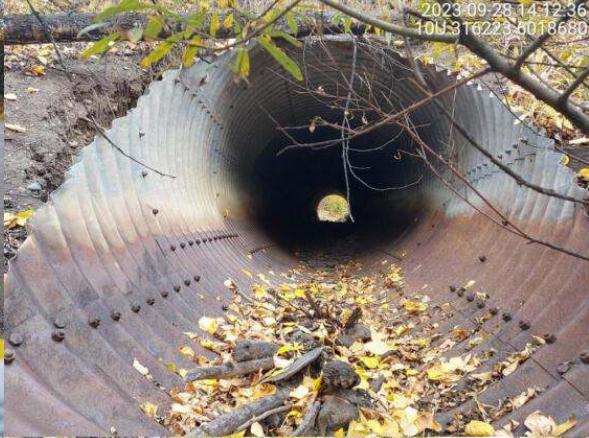
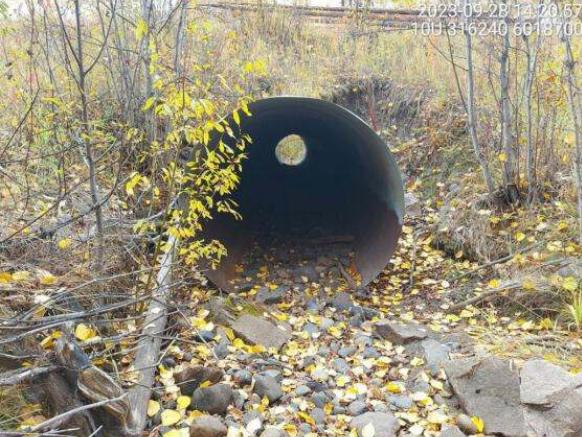
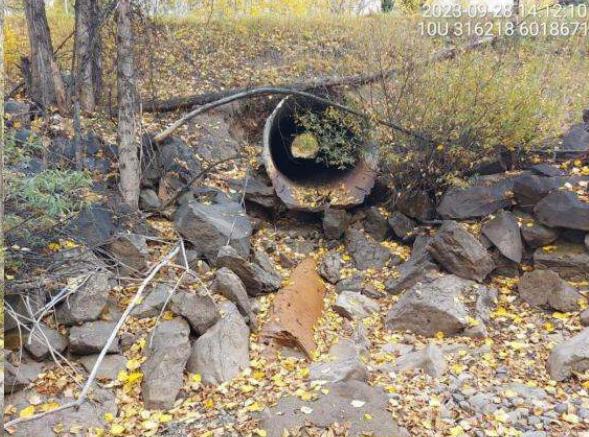
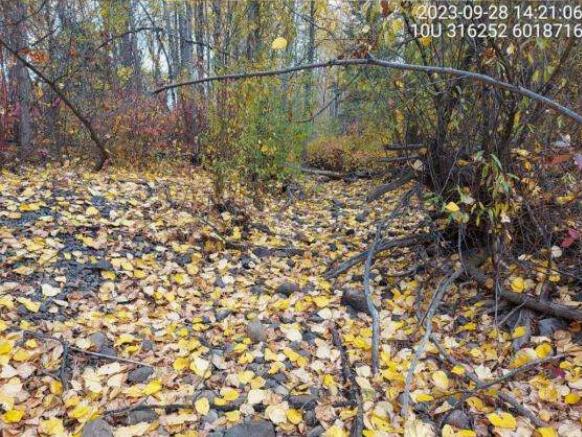
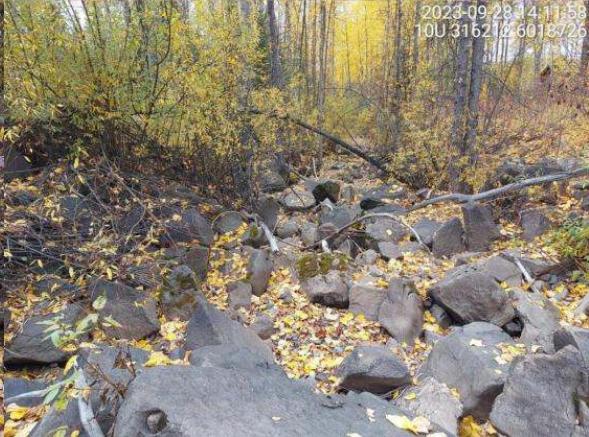
Photos: PSCIS ID 5400044. From top left clockwise: Road/Site Card, Barrel, Outlet, Downstream, Upstream, Inlet.

Comments: Dewatered stream at time of survey. Wide channel, abundant boulders downstream of crossing. Rainbow confirmed upstream in past. Culvert is old and corroded badly on outlet side. Stream most likely flows under culvert near outlet during high flow. MoTi chris_culvert_id: 2076407. 14:15:04

Location and Stream Data		Crossing Characteristics	
Date	2023-09-28	Crossing Sub Type	Round Culvert
PSCIS ID	199211	Diameter (m)	2.6
External ID	5400044	Length (m)	32
Crew	MW	Embedded	No
UTM Zone	10	Depth Embedded (m)	–
Easting	316235	Resemble Channel	No
Northing	6018694	Backwatered	No
Stream	Decker Creek	Percent Backwatered	–
Road	Highway 16 W	Fill Depth (m)	1.3
Road Tenure	MOTI	Outlet Drop (m)	0.6
Channel Width (m)	4.3	Outlet Pool Depth (m)	0
Stream Slope (%)	4	Inlet Drop	No
Beaver Activity	No	Slope (%)	2
Habitat Value	Medium	Valley Fill	Deep Fill
Final score	37	Barrier Result	Barrier
Fix type	Replace with New Open Bottom Structure	Fix Span / Diameter	15

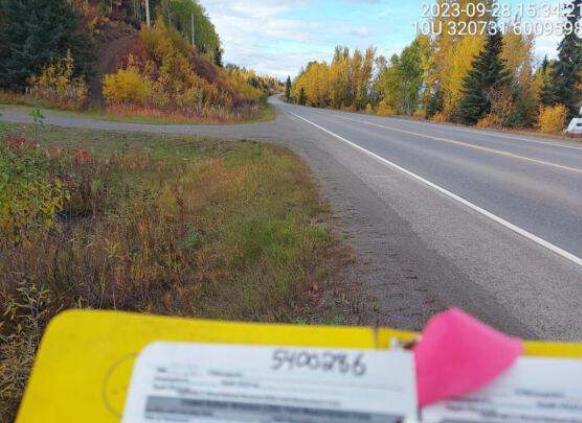
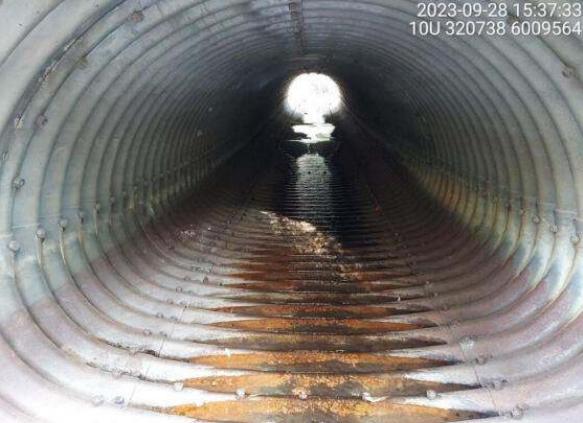
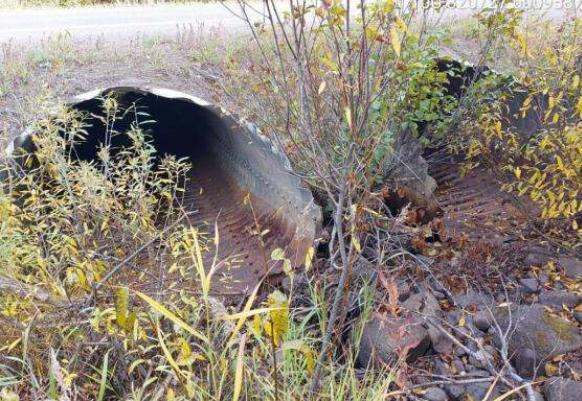
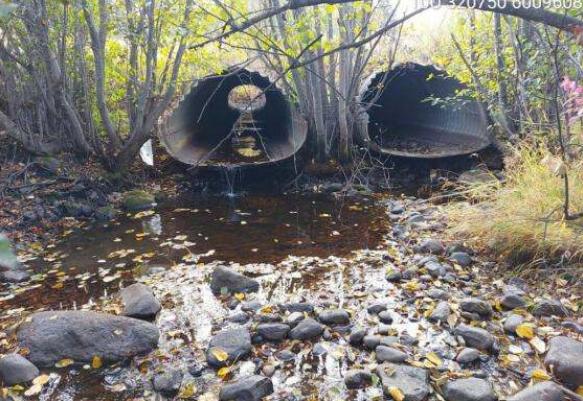
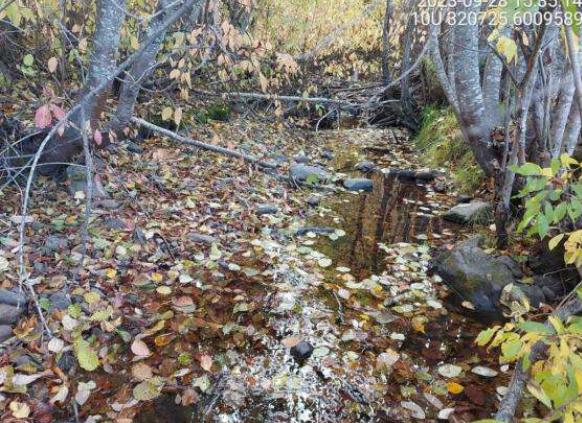
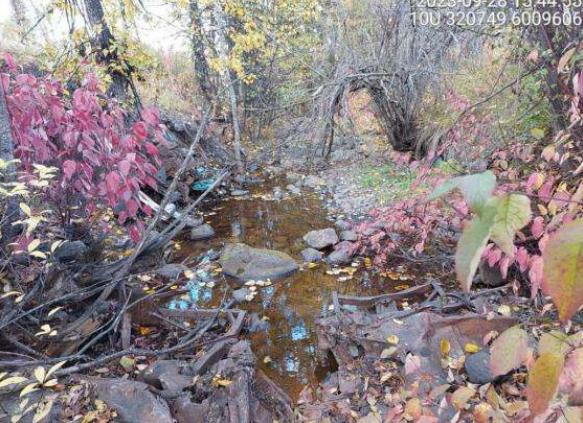
Photos: PSCIS ID 5400286. From top left clockwise: Road/Site Card, Barrel, Outlet, Downstream, Upstream, Inlet.

Comments: Small fry spotted in culvert and in outlet pool. Two pipes, both old and corroded with large outlet drops.

Small holes in both pipes causing some water to flow under pipe. Very low fill depth, culverts almost at highway. Near Burns Lake, in residential area. Habitat looks good upstream. RB and LSU upstream in Guyishton Lake. MoTi chris_culvert_id: 2070299, 2070298. 15:48:58

Location and Stream Data		.	Crossing Characteristics	-
Date	2023-09-28		Crossing Sub Type	Oval Culvert
PSCIS ID	199213		Diameter (m)	4
External ID	5400286		Length (m)	22
Crew	MW		Embedded	No
UTM Zone	10		Depth Embedded (m)	-
Easting	320733		Resemble Channel	No
Northing	6009596		Backwatered	No
Stream	Guyishton Creek		Percent Backwatered	-
Road	Highway 35		Fill Depth (m)	0.1
Road Tenure	MOTI		Outlet Drop (m)	0.6
Channel Width (m)	2.8		Outlet Pool Depth (m)	0.5
Stream Slope (%)	3		Inlet Drop	No
Beaver Activity	No		Slope (%)	2
Habitat Value	High		Valley Fill	Deep Fill
Final score	28		Barrier Result	Barrier
Fix type	Replace with New Open Bottom Structure		Fix Span / Diameter	15

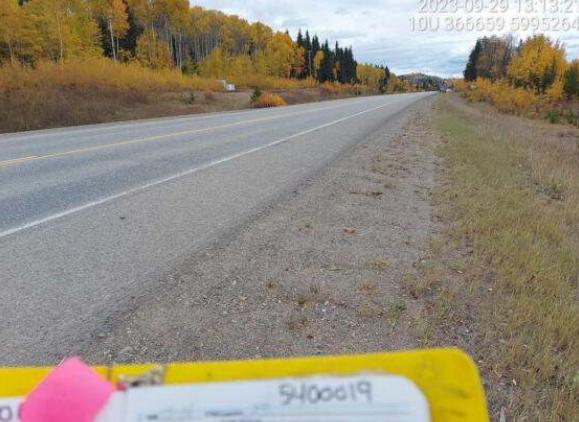
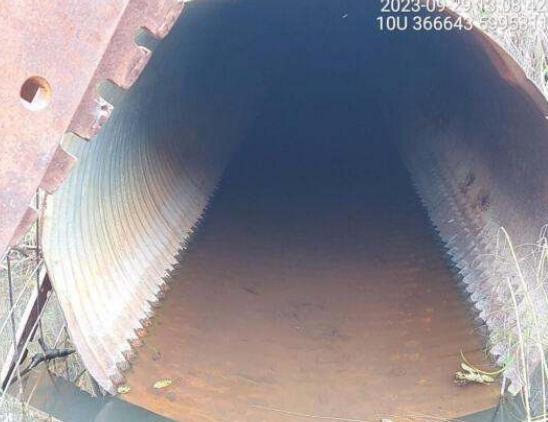
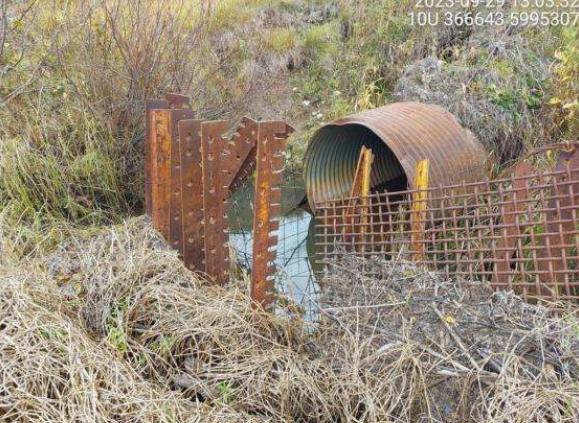
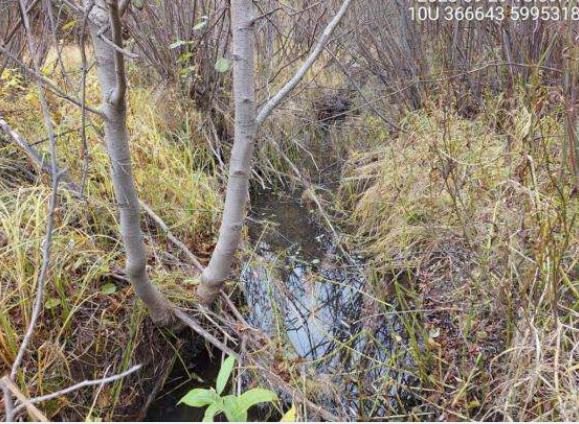
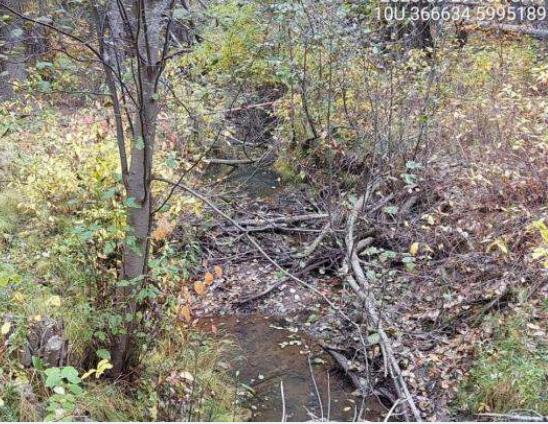
Photos: PSCIS ID 5400019. From top left clockwise: Road/Site Card, Barrel, Outlet, Downstream, Upstream, Inlet.

Comments: Culverts runs underneath highway and railway. Outlet could not be located Creek found below railway and flows to the Endako confluence. Beaver grate on inlet side. MoTi chris_culvert_id: 1793819. 13:07:39

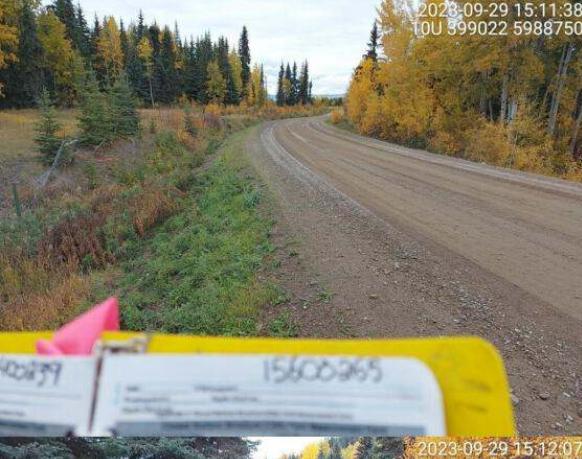
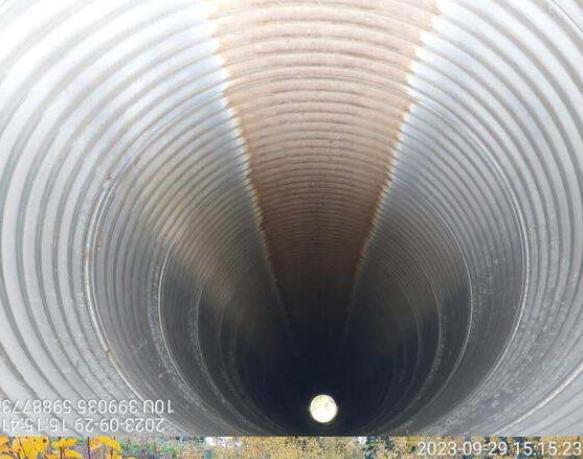
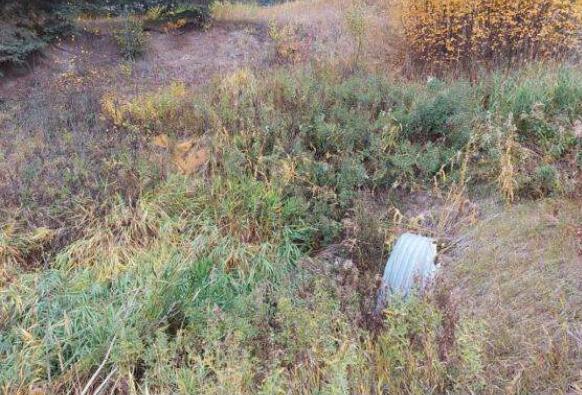
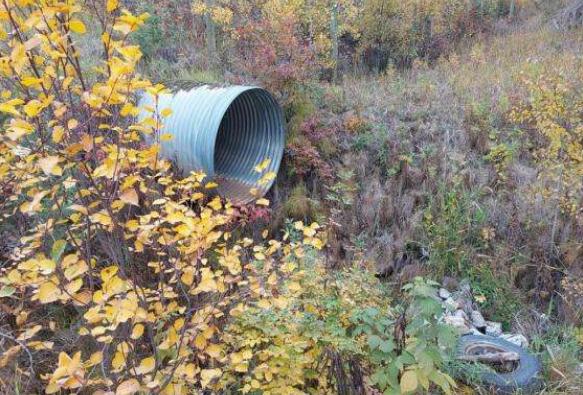
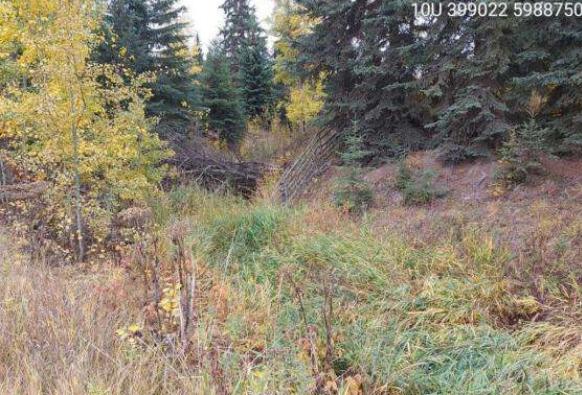
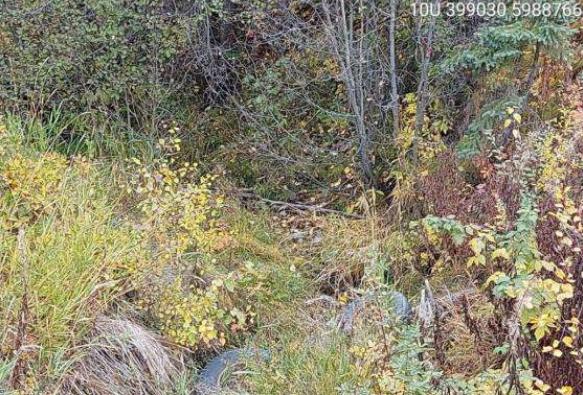
Photos: PSCIS ID 15600265. From top left clockwise: Road/Site Card, Barrel, Outlet, Downstream, Upstream, Inlet.

Comments: Dewatered at time of assessment. Fenced off private land on both sides. Small outlet drop. MoTi chris_culvert_id: 3343582. 15:19:42

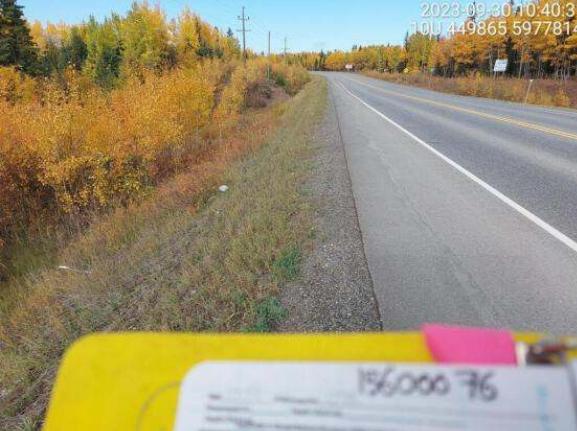
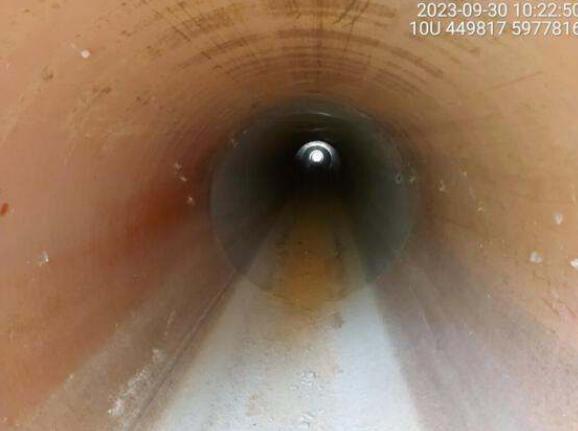
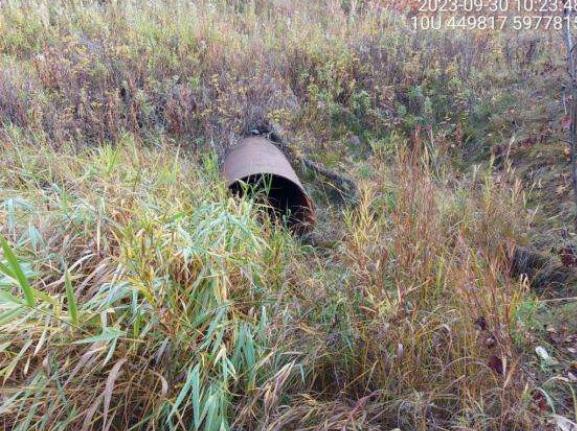
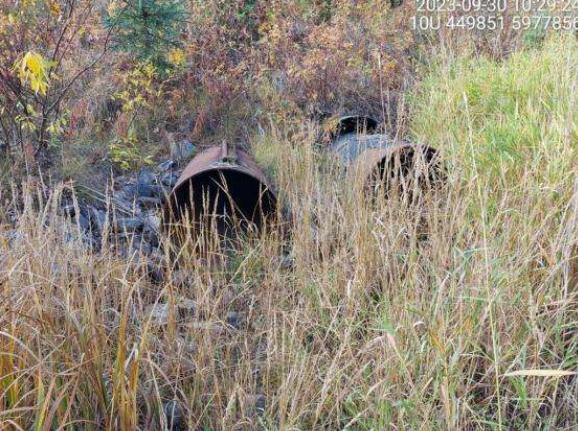
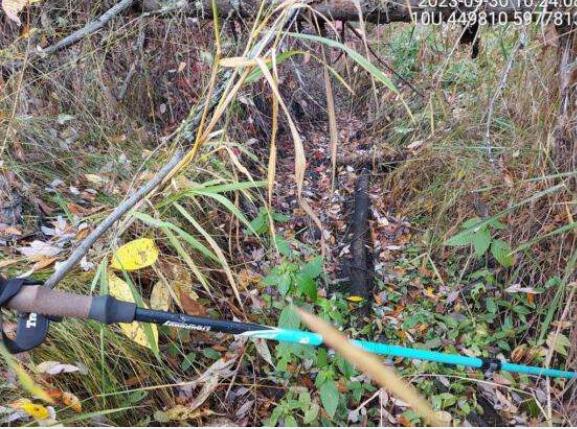
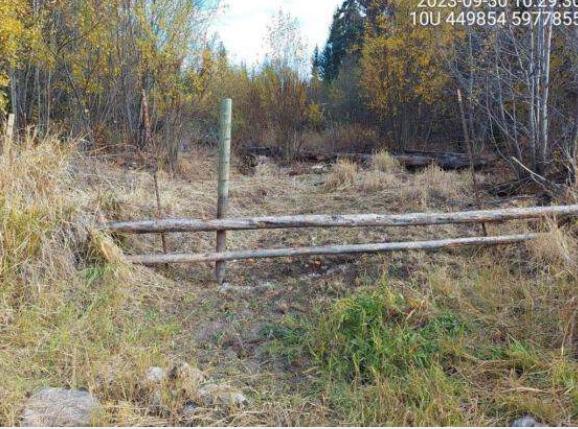
Photos: PSCIS ID 15600076. From top left clockwise: Road/Site Card, Barrel, Outlet, Downstream, Upstream, Inlet.

Location and Stream Data	.	Crossing Characteristics	–
Date	2023-09-30	Crossing Sub Type	Round Culvert
PSCIS ID	199224	Diameter (m)	1.8
External ID	15600076	Length (m)	48
Crew	MW	Embedded	No
UTM Zone	10	Depth Embedded (m)	–
Easting	449834	Resemble Channel	No
Northing	5977830	Backwatered	No
Stream	Tributary to Hulatt Creek	Percent Backwatered	–
Road	Highway 16	Fill Depth (m)	5
Road Tenure	MOTI	Outlet Drop (m)	0
Channel Width (m)	1.2	Outlet Pool Depth (m)	0
Stream Slope (%)	1	Inlet Drop	No
Beaver Activity	No	Slope (%)	1
Habitat Value	Low	Valley Fill	Deep Fill
Final score	21	Barrier Result	Barrier
Fix type	Replace Structure with Streambed Simulation CBS	Fix Span / Diameter	3

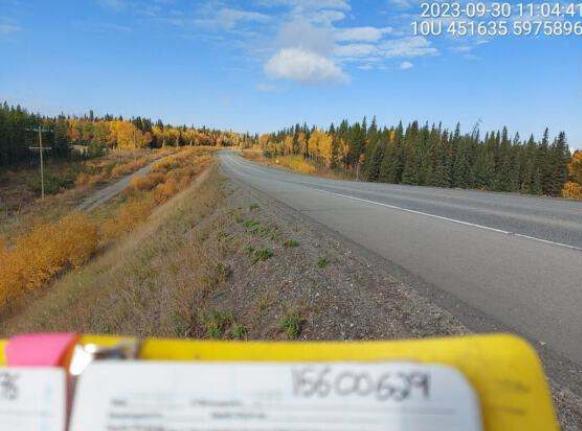
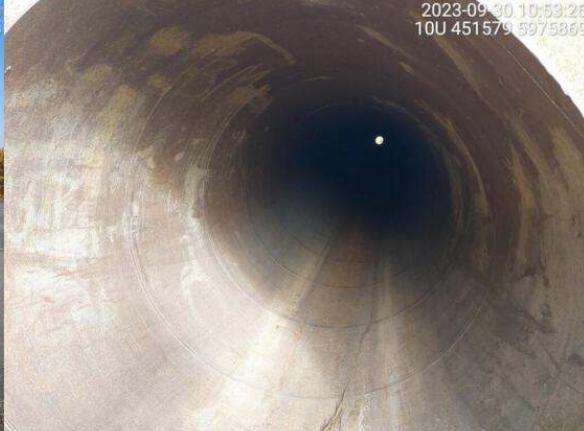
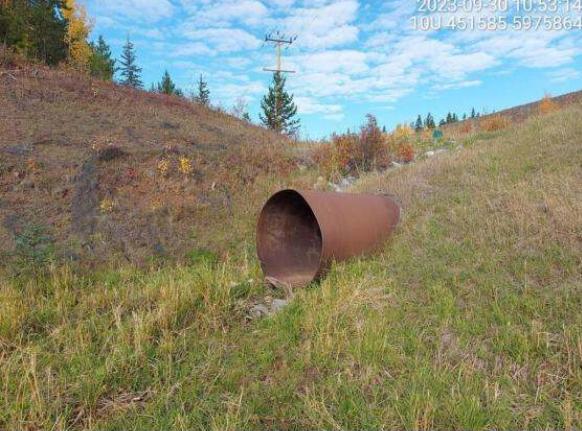
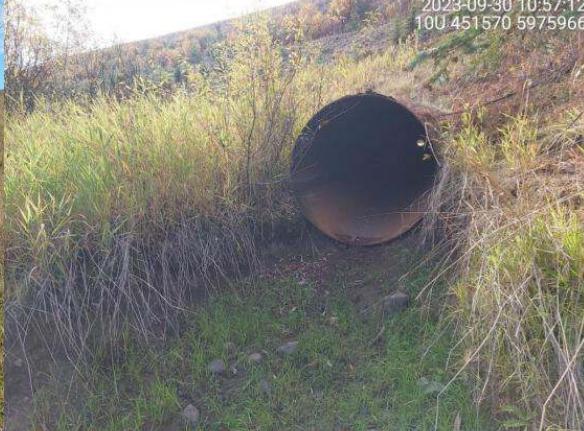
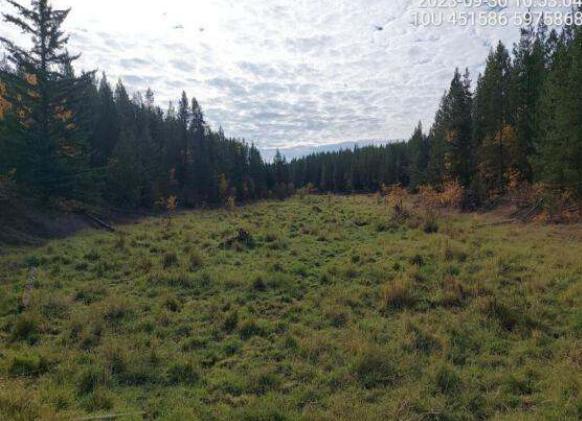
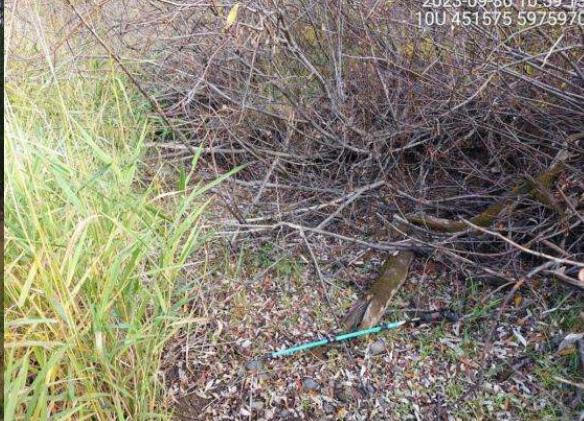
Photos: PSCIS ID 15600629. From top left clockwise: Road/Site Card, Barrel, Outlet, Downstream, Upstream, Inlet.

Location and Stream Data	.	Crossing Characteristics	–
Date	2023-09-30	Crossing Sub Type	Round Culvert
PSCIS ID	199225	Diameter (m)	1.5
External ID	15600629	Length (m)	90
Crew	MW	Embedded	No
UTM Zone	10	Depth Embedded (m)	–
Easting	451599	Resemble Channel	No
Northing	5975913	Backwatered	No
Stream	Hulatt Creek	Percent Backwatered	–
Road	Highway 16	Fill Depth (m)	8
Road Tenure	MOTI	Outlet Drop (m)	0
Channel Width (m)	3.3	Outlet Pool Depth (m)	0
Stream Slope (%)	2	Inlet Drop	No
Beaver Activity	No	Slope (%)	3
Habitat Value	Low	Valley Fill	Deep Fill
Final score	32	Barrier Result	Barrier
Fix type	Replace Structure with Streambed Simulation CBS	Fix Span / Diameter	4.5

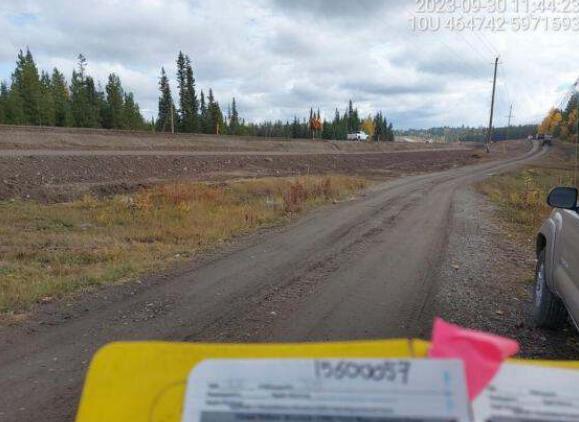
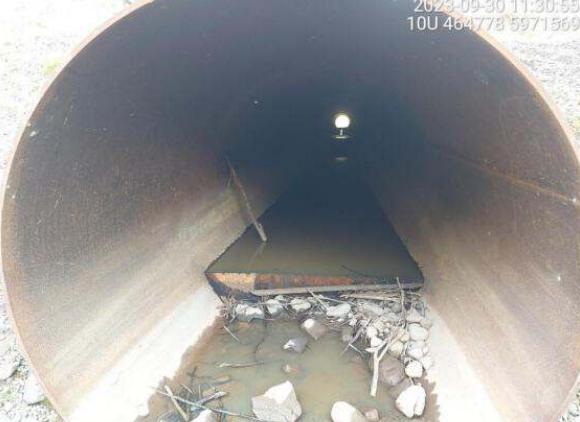
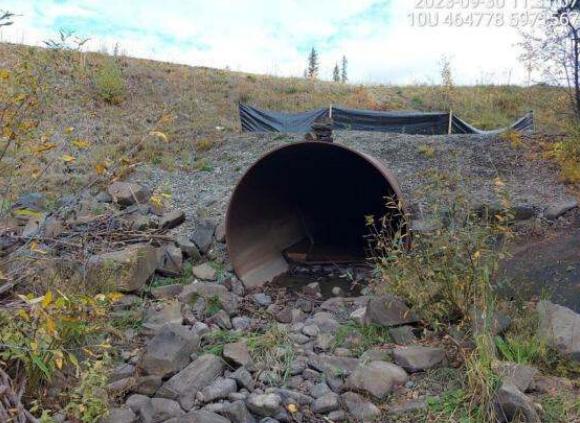
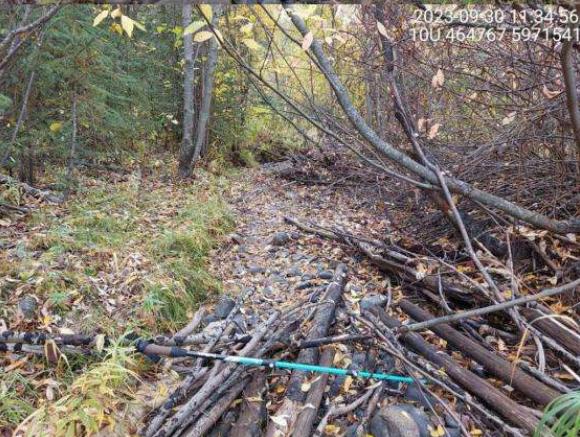
Photos: PSCIS ID 15600057. From top left clockwise: Road/Site Card, Barrel, Outlet, Downstream, Upstream, Inlet.

Location and Stream Data		Crossing Characteristics	
Date	2023-09-30	Crossing Sub Type	Round Culvert
PSCIS ID	199226	Diameter (m)	2.4
External ID	15600057	Length (m)	66
Crew	MW	Embedded	No
UTM Zone	10	Depth Embedded (m)	—
Easting	464822	Resemble Channel	No
Northing	5971609	Backwatered	No
Stream	Tributary to Cluculz Lake	Percent Backwatered	—
Road	Highway 16	Fill Depth (m)	5
Road Tenure	MOTI	Outlet Drop (m)	0
Channel Width (m)	2.6	Outlet Pool Depth (m)	0
Stream Slope (%)	0	Inlet Drop	No
Beaver Activity	No	Slope (%)	1
Habitat Value	Medium	Valley Fill	Deep Fill
Final score	24	Barrier Result	Barrier
Fix type	Replace with New Open Bottom Structure	Fix Span / Diameter	21
Comments: Culvert runs under active highway construction site. Inlet could not be accessed. Looks like they are excavating near inlet. Possible bridge construction? Stream is mostly dewatered but there is some stagnant water in culvert. Baffles in pipe. Habitat downstream looks good, with abundant woody debris and healthy riparian. MoTi chris_culvert_id: 1804902. 11:33:26

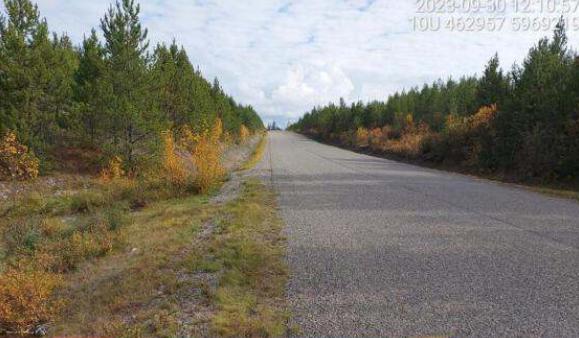
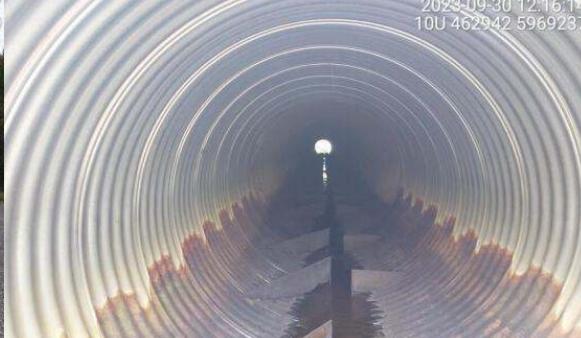
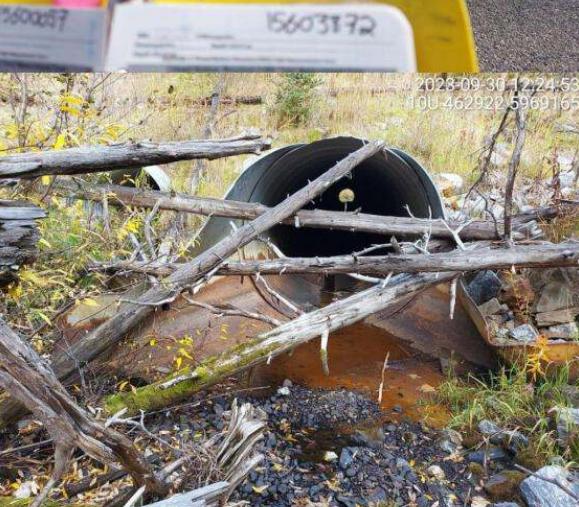
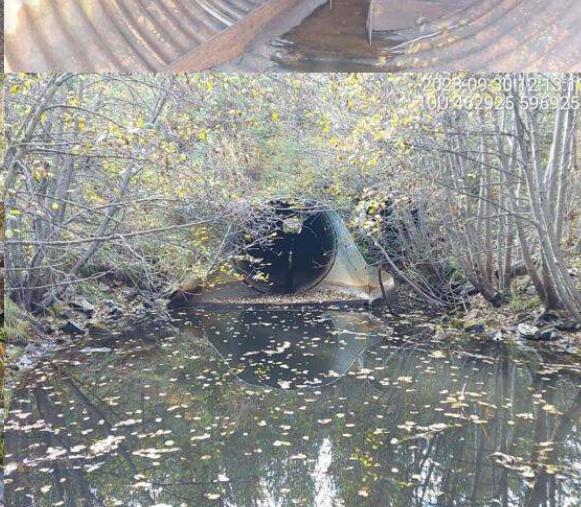
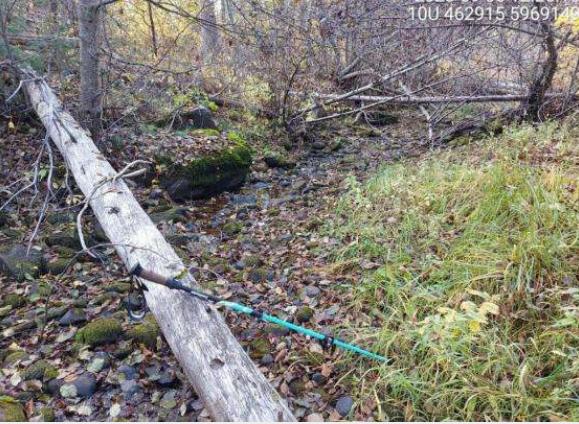
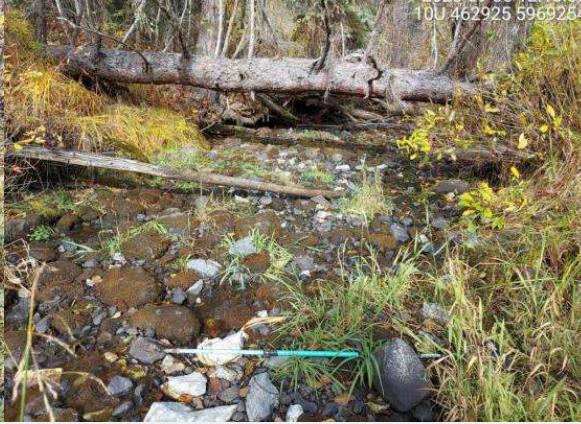
Photos: PSCIS ID 15603872. From top left clockwise: Road/Site Card, Barrel, Outlet, Downstream, Upstream, Inlet.

Location and Stream Data		Crossing Characteristics	
Date	2023-09-30	Crossing Sub Type	Round Culvert
PSCIS ID	199227	Diameter (m)	2.5
External ID	15603872	Length (m)	78
Crew	MW	Embedded	No
UTM Zone	10	Depth Embedded (m)	—
Easting	462928	Resemble Channel	No
Northing	5969213	Backwatered	No
Stream	Norman Creek	Percent Backwatered	—
Road	Lloyd Dr	Fill Depth (m)	5
Road Tenure	MOTI Local	Outlet Drop (m)	0
Channel Width (m)	3.1	Outlet Pool Depth (m)	0.3
Stream Slope (%)	3	Inlet Drop	No
Beaver Activity	No	Slope (%)	0
Habitat Value	Medium	Valley Fill	Deep Fill
Final score	19	Barrier Result	Potential
Fix type	Replace with New Open Bottom Structure	Fix Span / Diameter	21

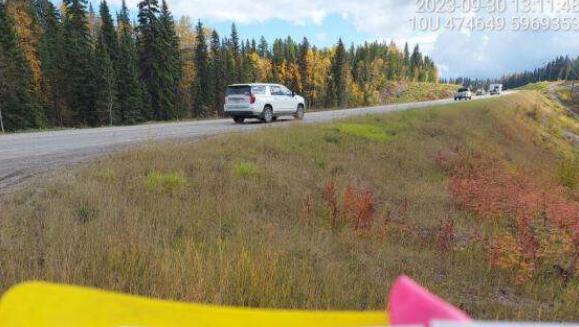
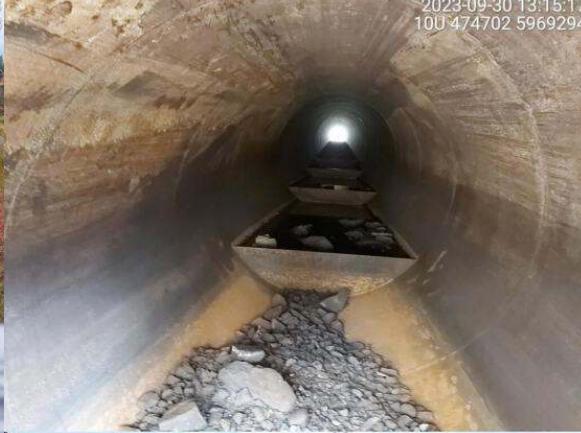
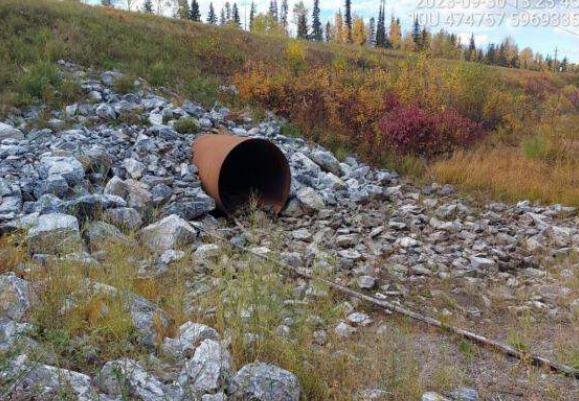
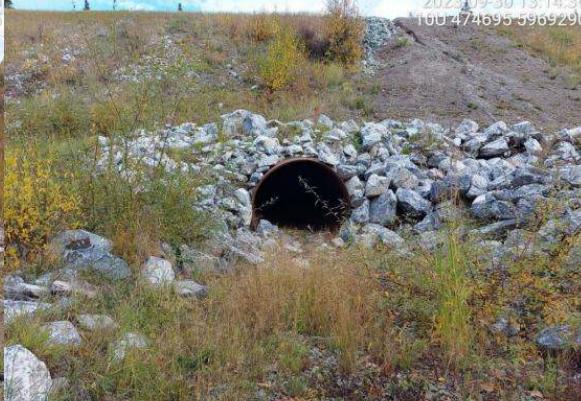
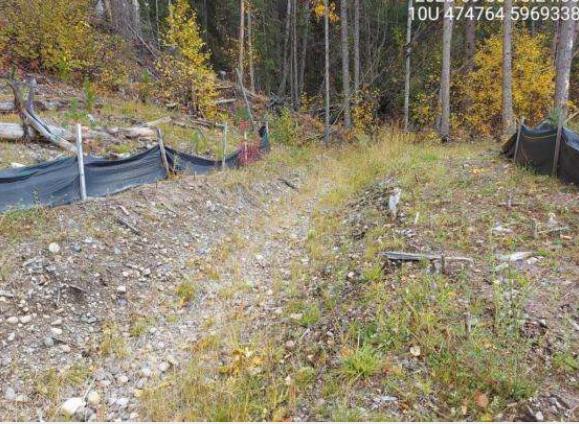
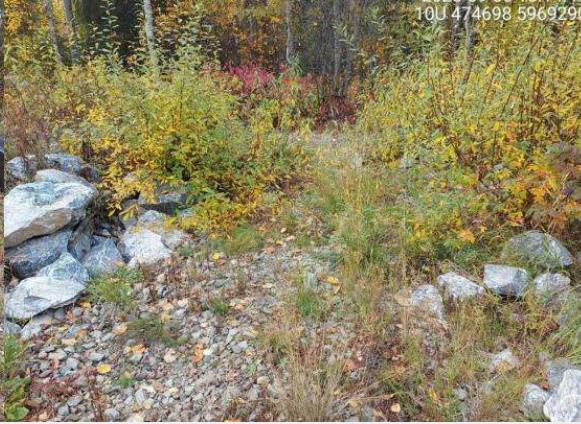
Photos: PSCIS ID 9902601. From top left clockwise: Road/Site Card, Barrel, Outlet, Downstream, Upstream, Inlet.

Location and Stream Data	.	Crossing Characteristics	-
Date	2023-09-30	Crossing Sub Type	Round Culvert
PSCIS ID	199228	Diameter (m)	2
External ID	9902601	Length (m)	60
Crew	MW	Embedded	No
UTM Zone	10	Depth Embedded (m)	-
Easting	474705	Resemble Channel	No
Northing	5969325	Backwatered	No
Stream	Tributary to Bednesti Lake	Percent Backwatered	-
Road	Highway 16	Fill Depth (m)	8
Road Tenure	MOTI	Outlet Drop (m)	0
Channel Width (m)	1.7	Outlet Pool Depth (m)	0
Stream Slope (%)	6	Inlet Drop	No
Beaver Activity	No	Slope (%)	3.5
Habitat Value	Medium	Valley Fill	Deep Fill
Final score	26	Barrier Result	Barrier
Fix type	Replace Structure with Streambed Simulation CBS	Fix Span / Diameter	3

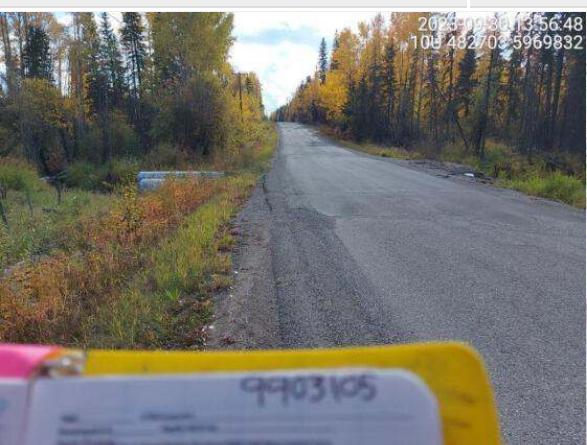
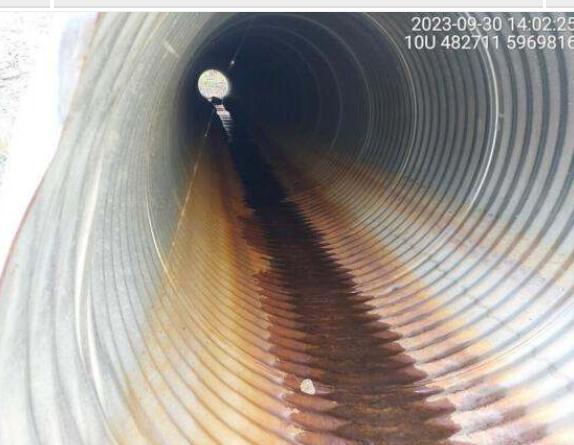
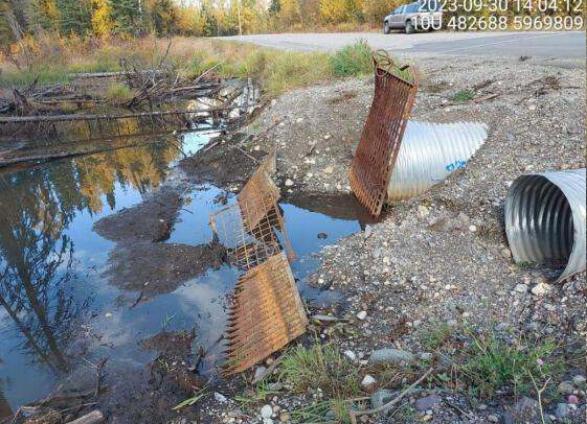
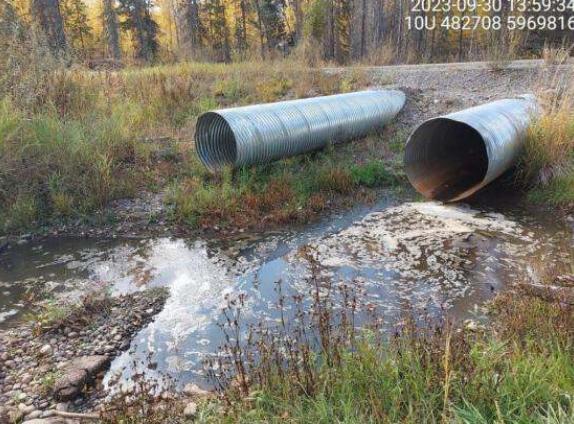
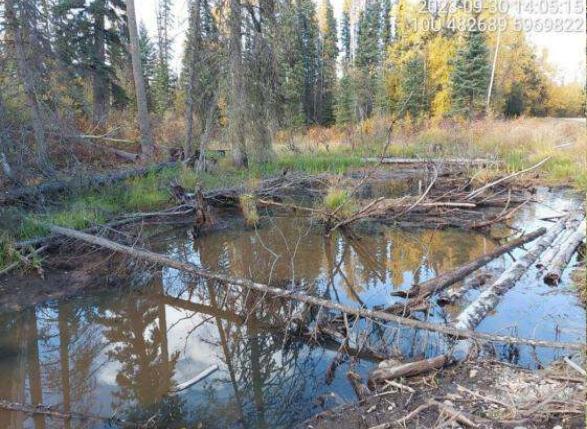
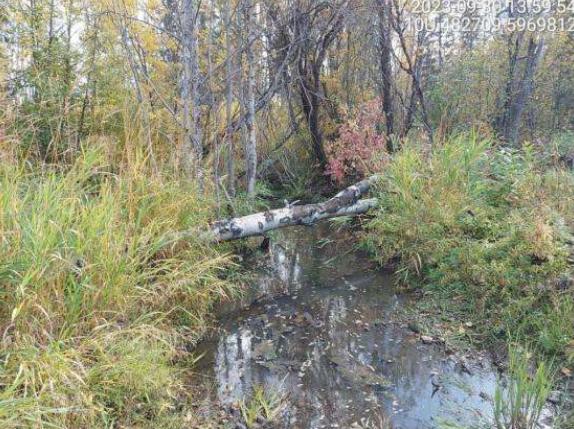
Photos: PSCIS ID 9903105. From top left clockwise: Road/Site Card, Barrel, Outlet, Downstream, Upstream, Inlet.

Location and Stream Data		Crossing Characteristics	
Date	2023-09-30	Crossing Sub Type	Round Culvert
PSCIS ID	199229	Diameter (m)	2.2
External ID	9903105	Length (m)	16
Crew	MW	Embedded	No
UTM Zone	10	Depth Embedded (m)	—
Easting	482695	Resemble Channel	No
Northing	5969819	Backwatered	No
Stream	Zelkwas Creek	Percent Backwatered	—
Road	Isle Pierre Rd	Fill Depth (m)	0.7
Road Tenure	MOTI Local	Outlet Drop (m)	0.1
Channel Width (m)	2.2	Outlet Pool Depth (m)	0.3
Stream Slope (%)	2	Inlet Drop	No
Beaver Activity	No	Slope (%)	1
Habitat Value	Medium	Valley Fill	Deep Fill
Final score	21	Barrier Result	Barrier
Fix type	Replace with New Open Bottom Structure	Fix Span / Diameter	15
