Appendix - Phase 1 Fish Passage Assessment Data and Photos

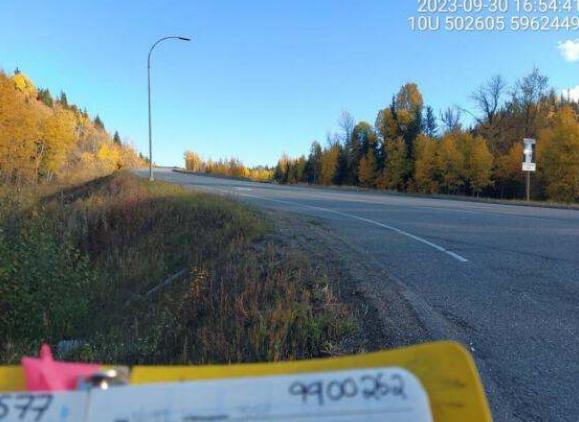
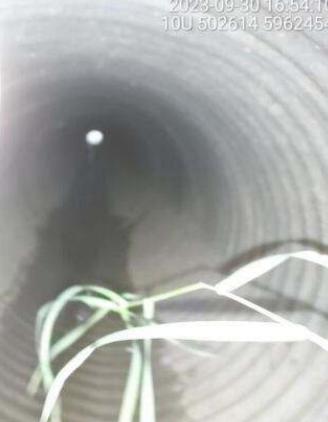
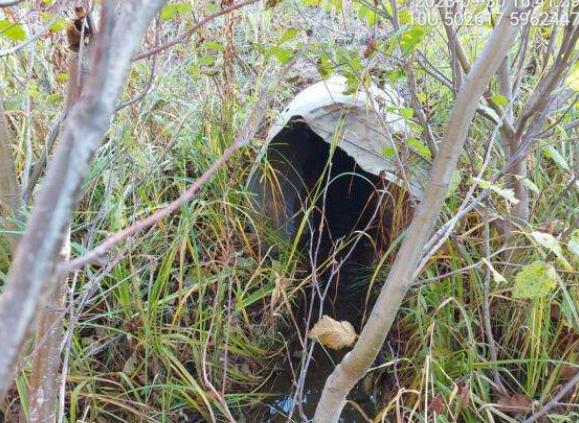
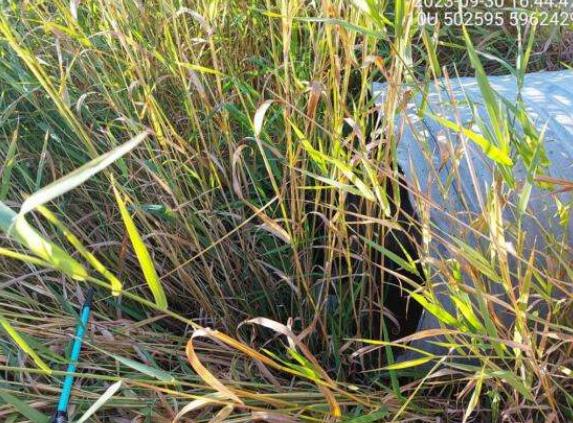
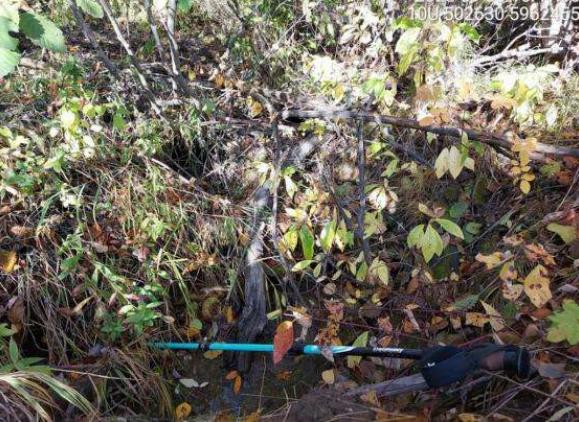
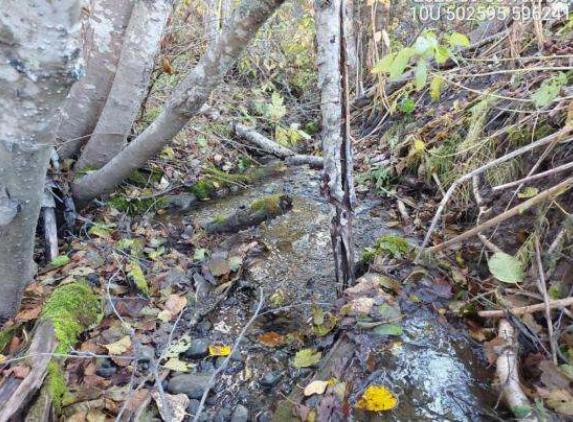
Photos: PSCIS ID 9900262. From top left clockwise: Road/Site Card, Barrel, Outlet, Downstream, Upstream, Inlet.

Comments: Two pipes but only one is functioning and has small amount of flow through it. Very small channel.
 Observed chinook in FISS downstream of confluence with Beaverley Creek at ~100m from the crossing and ~30m from the confluence. MoTi chris_culvert_id: 1975199. 16:46:37

Location and Stream Data	.	Crossing Characteristics	–
Date	2023-09-30	Crossing Sub Type	Round Culvert
PSCIS ID	199233	Diameter (m)	0.9
External ID	9900262	Length (m)	32
Crew	MW	Embedded	No
UTM Zone	10	Depth Embedded (m)	–
Easting	502603	Resemble Channel	No
Northing	5962435	Backwatered	No
Stream	Little Beaverley Creek	Percent Backwatered	–
Road	Highway 16	Fill Depth (m)	2.5
Road Tenure	MOTI	Outlet Drop (m)	0
Channel Width (m)	0.8	Outlet Pool Depth (m)	0
Stream Slope (%)	2	Inlet Drop	No
Beaver Activity	No	Slope (%)	2
Habitat Value	Medium	Valley Fill	Deep Fill
Final score	21	Barrier Result	Barrier
Fix type	Replace Structure with Streambed Simulation CBS	Fix Span / Diameter	3

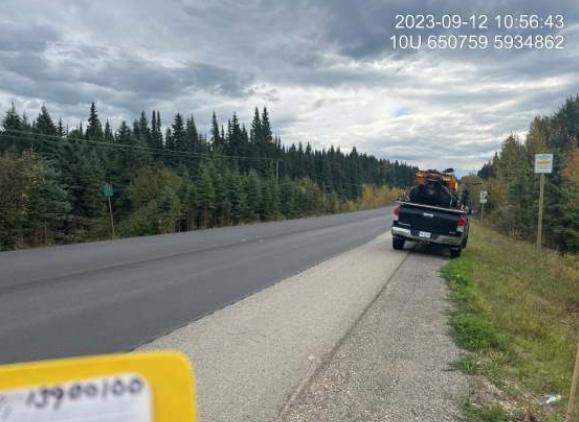
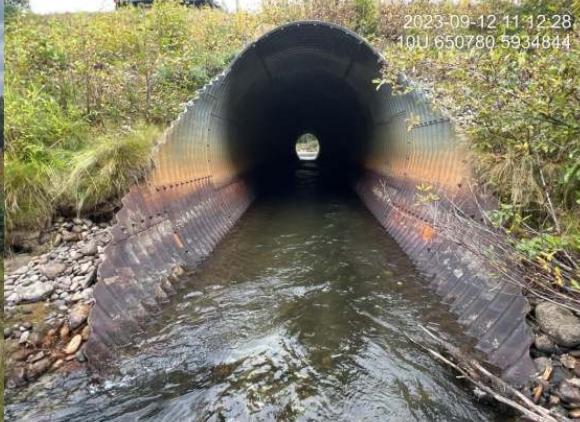
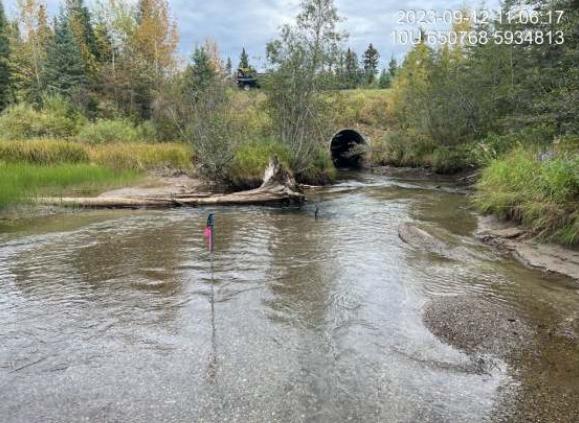
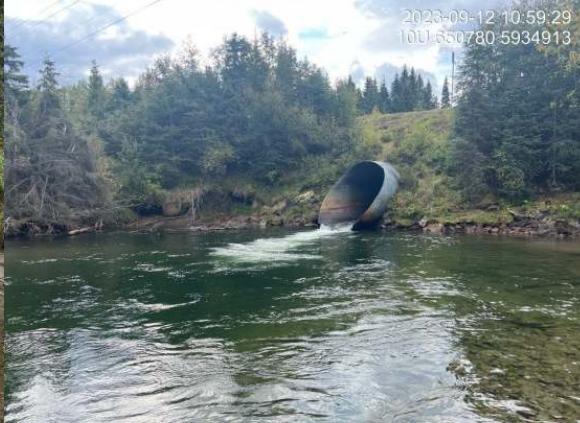
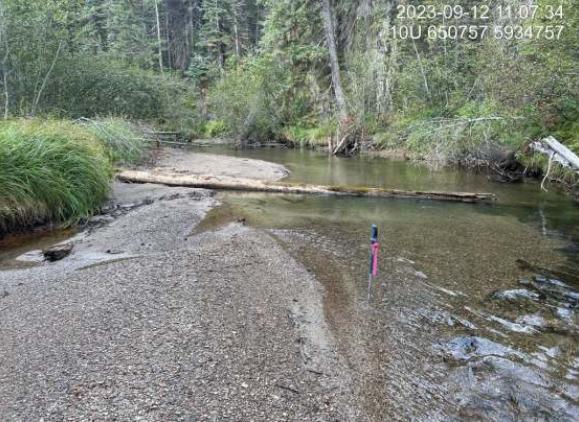
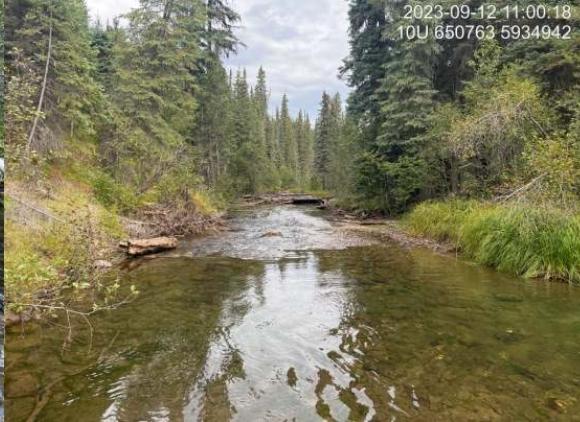
Photos: PSCIS ID 13900100. From top left clockwise: Road/Site Card, Barrel, Outlet, Downstream, Upstream, Inlet.

Location and Stream Data		Crossing Characteristics	
Date	2023-09-12	Crossing Sub Type	Oval Culvert
PSCIS ID	199237	Diameter (m)	3.1
External ID	13900100	Length (m)	44
Crew	AI	Embedded	No
UTM Zone	10	Depth Embedded (m)	—
Easting	650774	Resemble Channel	No
Northing	5934861	Backwatered	No
Stream	Snowshoe Creek	Percent Backwatered	—
Road	Highway 16a	Fill Depth (m)	4.5
Road Tenure	MOTI	Outlet Drop (m)	0.35
Channel Width (m)	15	Outlet Pool Depth (m)	2
Stream Slope (%)	0.5	Inlet Drop	No
Beaver Activity	No	Slope (%)	2
Habitat Value	High	Valley Fill	Deep Fill
Final score	37	Barrier Result	Barrier
Fix type	Replace with New Open Bottom Structure	Fix Span / Diameter	19.5

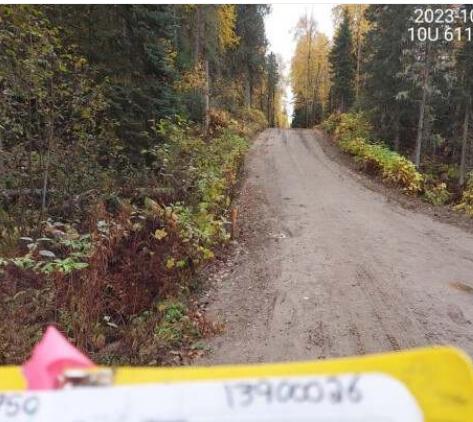
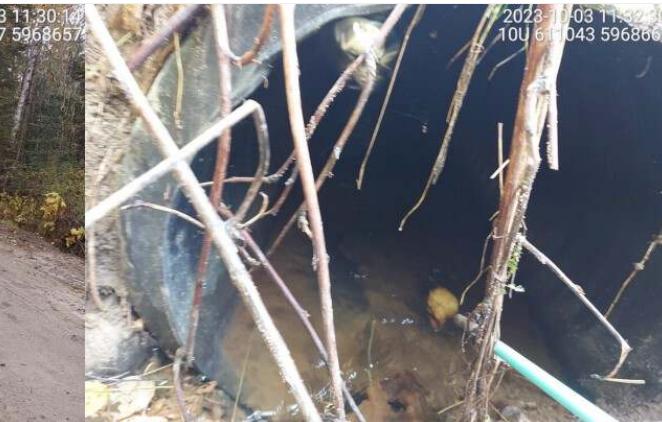
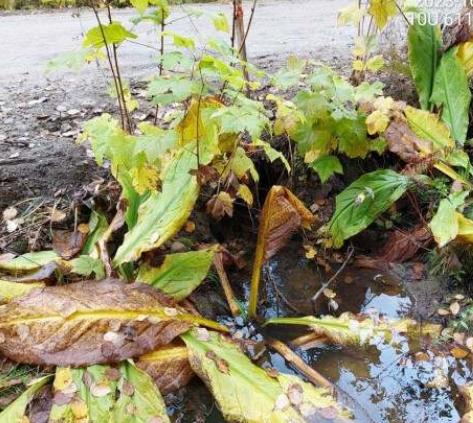
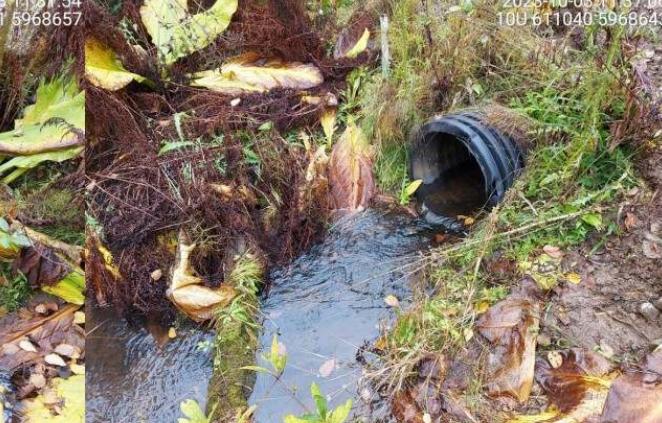
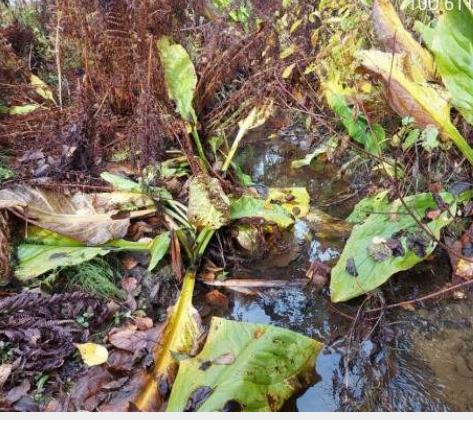
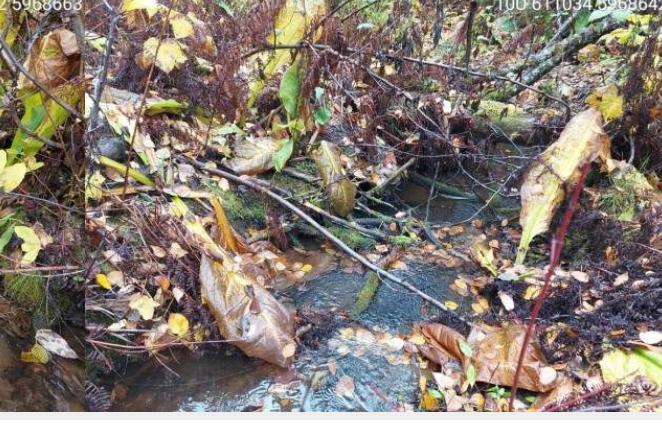
Photos: PSCIS ID 13900026. From top left clockwise: Road/Site Card, Barrel, Outlet, Downstream, Upstream, Inlet.

Location and Stream Data	.	Crossing Characteristics	–
Date	2023-10-03	Crossing Sub Type	Round Culvert
PSCIS ID	199238	Diameter (m)	0.6
External ID	13900026	Length (m)	10
Crew	MW	Embedded	No
UTM Zone	10	Depth Embedded (m)	–
Easting	611035	Resemble Channel	No
Northing	5968655	Backwatered	No
Stream	Tributary to Fraser River	Percent Backwatered	–
Road	Penny Rd	Fill Depth (m)	0.8
Road Tenure	Unknown	Outlet Drop (m)	0
Channel Width (m)	1.4	Outlet Pool Depth (m)	0
Stream Slope (%)	2	Inlet Drop	No
Beaver Activity	No	Slope (%)	3
Habitat Value	Medium	Valley Fill	Deep Fill
Final score	26	Barrier Result	Barrier
Fix type	Replace Structure with Streambed Simulation CBS	Fix Span / Diameter	3

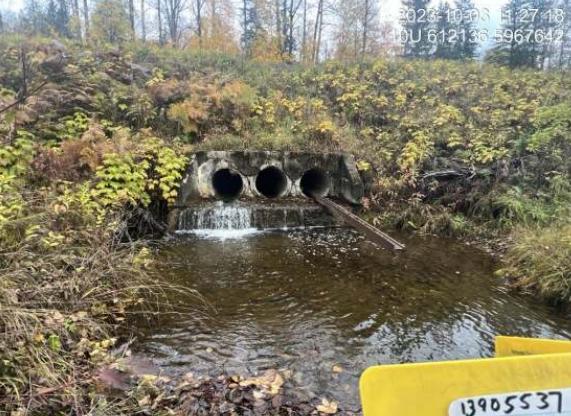
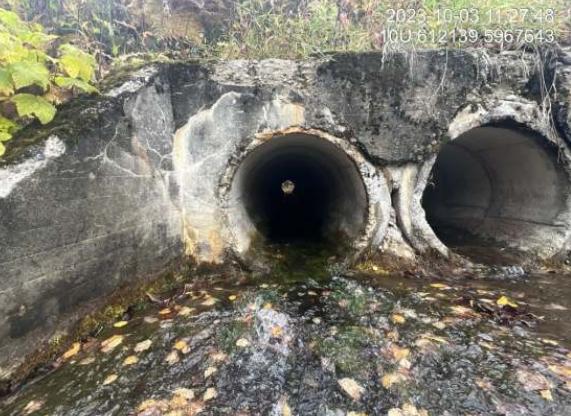
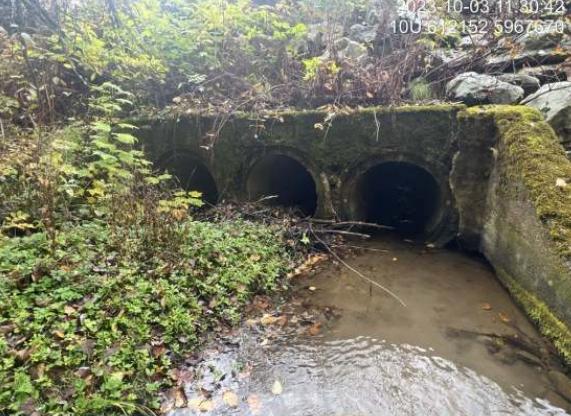
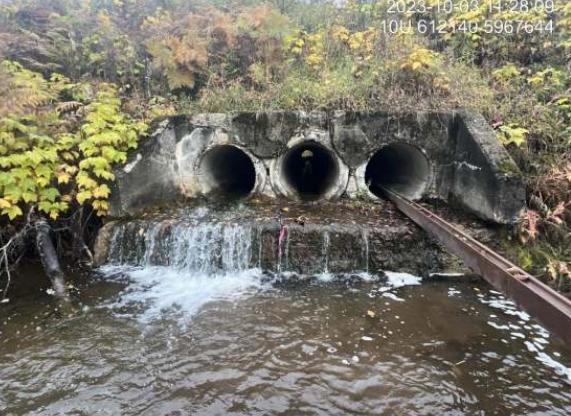
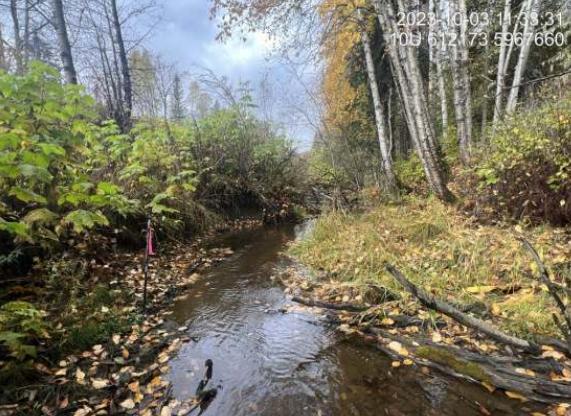
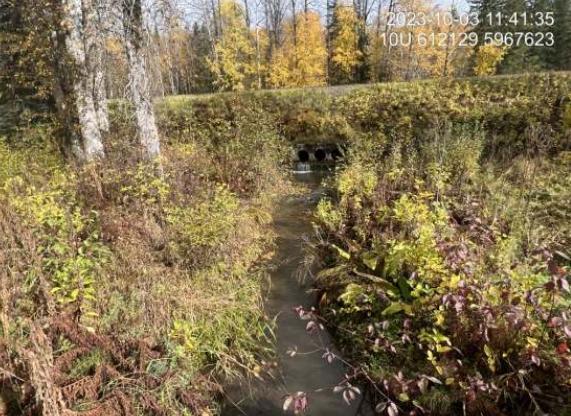
Photos: PSCIS ID 13905537. From top left clockwise: Road/Site Card, Barrel, Outlet, Downstream, Upstream, Inlet.

Location and Stream Data	.	Crossing Characteristics	–
Date	2023-10-03	Crossing Sub Type	Round Culvert
PSCIS ID	199239	Diameter (m)	2.7
External ID	13905537	Length (m)	20
Crew	AI	Embedded	No
UTM Zone	10	Depth Embedded (m)	–
Easting	612146	Resemble Channel	No
Northing	5967655	Backwatered	No
Stream	Tributary to Fraser River	Percent Backwatered	–
Road	Railway	Fill Depth (m)	7
Road Tenure	CN Rail	Outlet Drop (m)	0.5
Channel Width (m)	3.3	Outlet Pool Depth (m)	0.3
Stream Slope (%)	0.5	Inlet Drop	No
Beaver Activity	No	Slope (%)	2.5
Habitat Value	Medium	Valley Fill	Deep Fill
Final score	31	Barrier Result	Barrier
Fix type	Replace Structure with Streambed Simulation CBS	Fix Span / Diameter	4.5

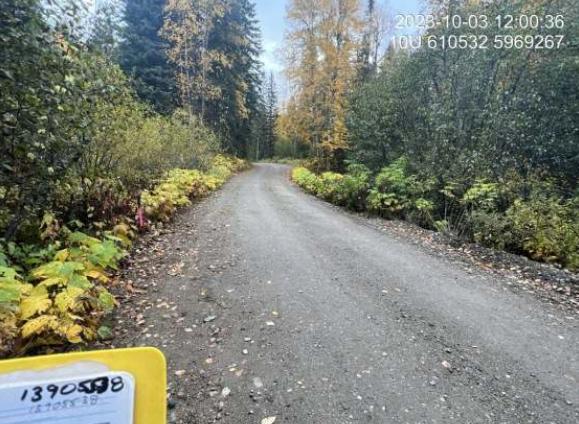
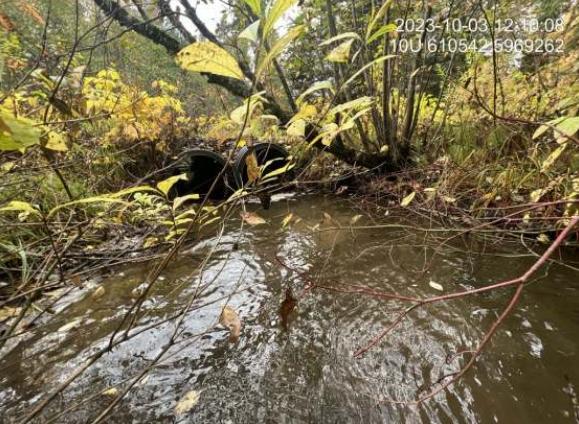
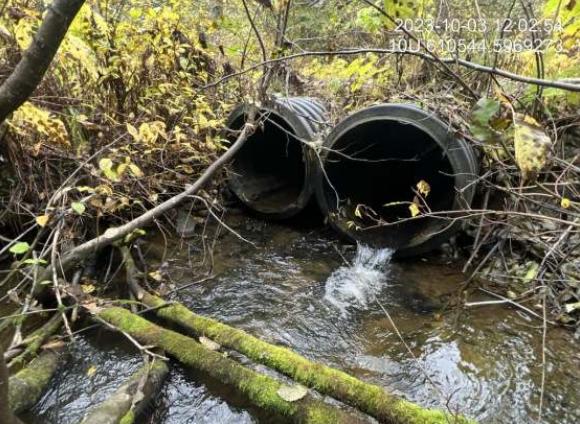
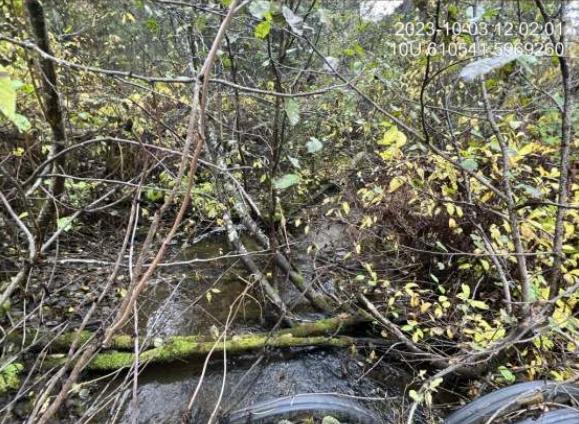
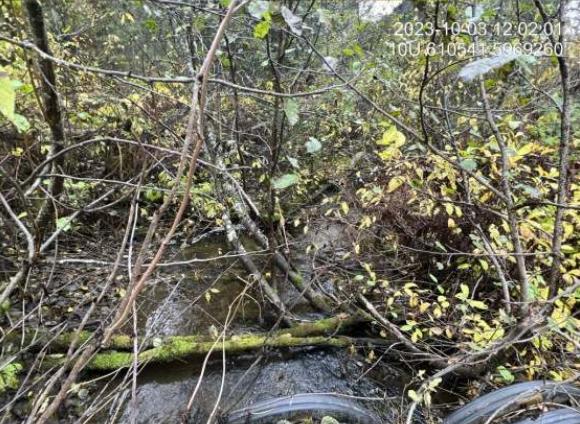
Photos: PSCIS ID 13900027. From top left clockwise: Road/Site Card, Barrel, Outlet, Downstream, Upstream, Inlet.

Location and Stream Data		Crossing Characteristics	
Date	2023-10-03	Crossing Sub Type	Round Culvert
PSCIS ID	199240	Diameter (m)	1.8
External ID	13900027	Length (m)	10
Crew	AI	Embedded	No
UTM Zone	10	Depth Embedded (m)	—
Easting	610540	Resemble Channel	No
Northing	5969263	Backwatered	No
Stream	72 Mile Creek	Percent Backwatered	—
Road	Penny Rd	Fill Depth (m)	0.3
Road Tenure	Unknown	Outlet Drop (m)	0.2
Channel Width (m)	3.1	Outlet Pool Depth (m)	0.2
Stream Slope (%)	1	Inlet Drop	No
Beaver Activity	No	Slope (%)	1
Habitat Value	Medium	Valley Fill	Deep Fill
Final score	26	Barrier Result	Barrier
Fix type	Replace with New Open Bottom Structure	Fix Span / Diameter	15

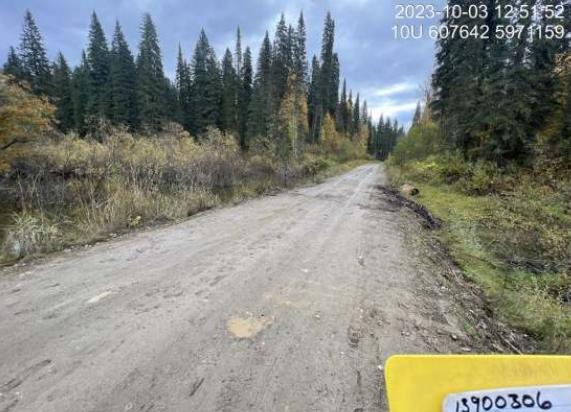
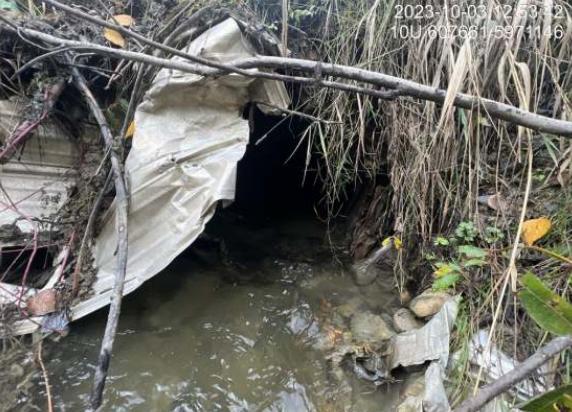
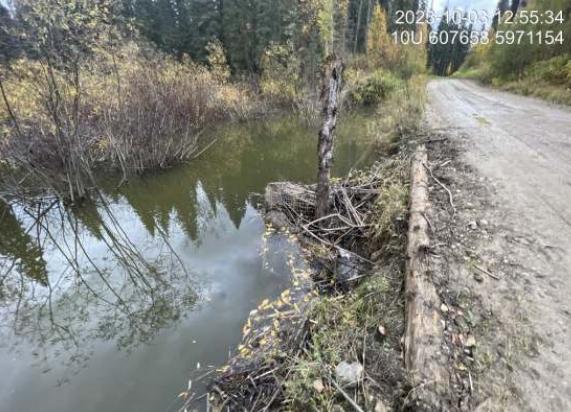
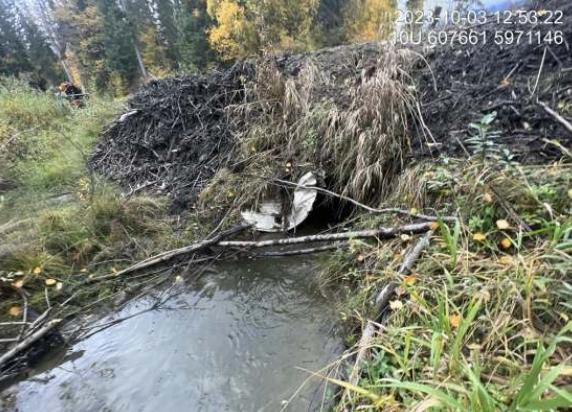
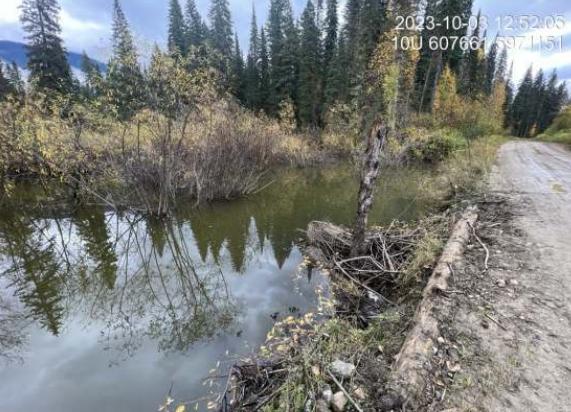
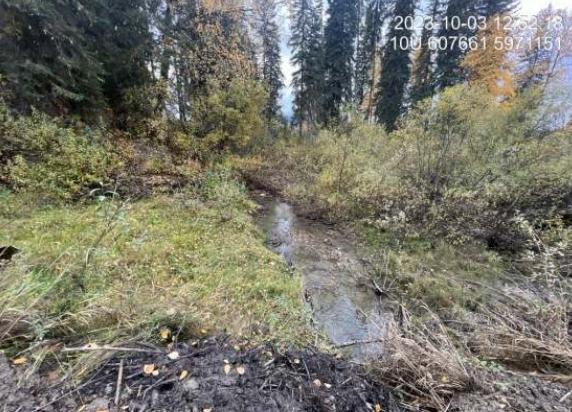
Photos: PSCIS ID 13900306. From top left clockwise: Road/Site Card, Barrel, Outlet, Downstream, Upstream, Inlet.

Location and Stream Data		Crossing Characteristics	
Date	2023-10-03	Crossing Sub Type	Round Culvert
PSCIS ID	199243	Diameter (m)	0.9
External ID	13900306	Length (m)	8
Crew	AI	Embedded	No
UTM Zone	10	Depth Embedded (m)	—
Easting	607661	Resemble Channel	No
Northing	5971153	Backwatered	No
Stream	Tributary to Fraser River	Percent Backwatered	—
Road	Penny Rd	Fill Depth (m)	2
Road Tenure	Unknown	Outlet Drop (m)	0
Channel Width (m)	3	Outlet Pool Depth (m)	0.7
Stream Slope (%)	0	Inlet Drop	Yes
Beaver Activity	Yes	Slope (%)	1
Habitat Value	Medium	Valley Fill	Deep Fill
Final score	21	Barrier Result	Barrier
Fix type	Replace with New Open Bottom Structure	Fix Span / Diameter	15

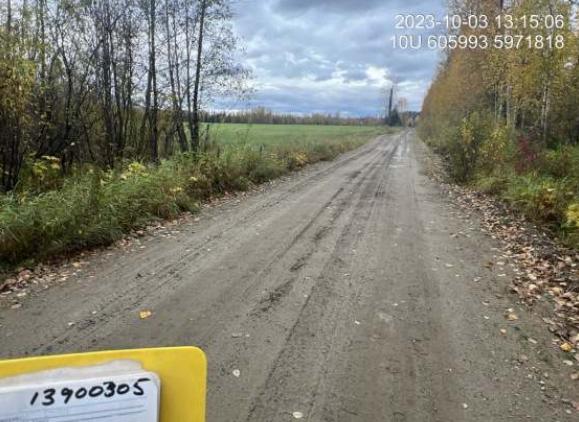
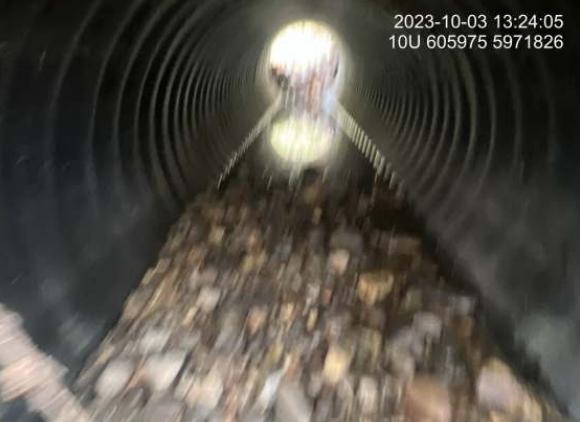
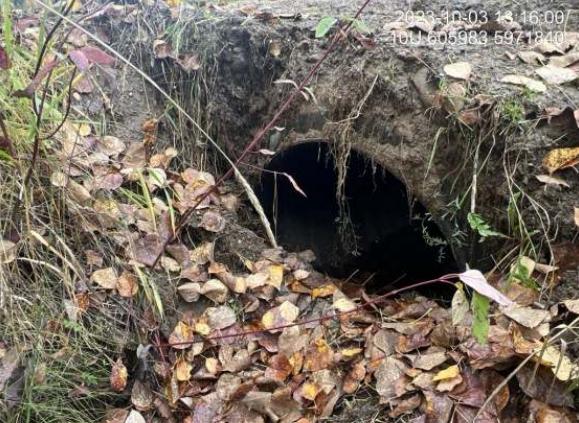
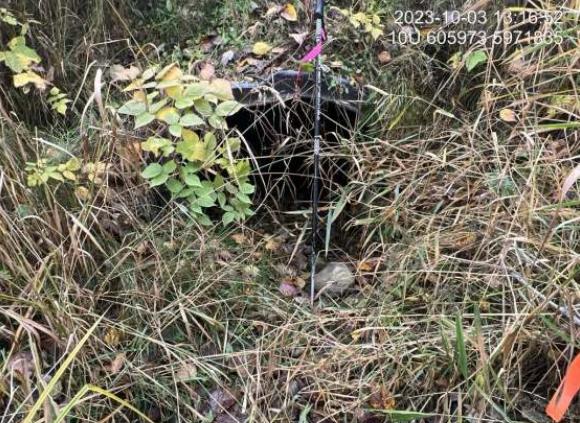
Photos: PSCIS ID 13900305. From top left clockwise: Road/Site Card, Barrel, Outlet, Downstream, Upstream, Inlet.

Location and Stream Data		Crossing Characteristics	
Date	2023-10-03	Crossing Sub Type	Round Culvert
PSCIS ID	199244	Diameter (m)	0.9
External ID	13900305	Length (m)	6
Crew	AI	Embedded	No
UTM Zone	10	Depth Embedded (m)	—
Easting	605976	Resemble Channel	No
Northing	5971827	Backwatered	No
Stream	Tributary to Fraser River	Percent Backwatered	—
Road	Penny Rd	Fill Depth (m)	0.5
Road Tenure	Carrier R07924	Outlet Drop (m)	0
Channel Width (m)	2.2	Outlet Pool Depth (m)	0
Stream Slope (%)	2	Inlet Drop	Yes
Beaver Activity	No	Slope (%)	1
Habitat Value	Low	Valley Fill	Deep Fill
Final score	21	Barrier Result	Barrier
Fix type	Replace with New Open Bottom Structure	Fix Span / Diameter	15

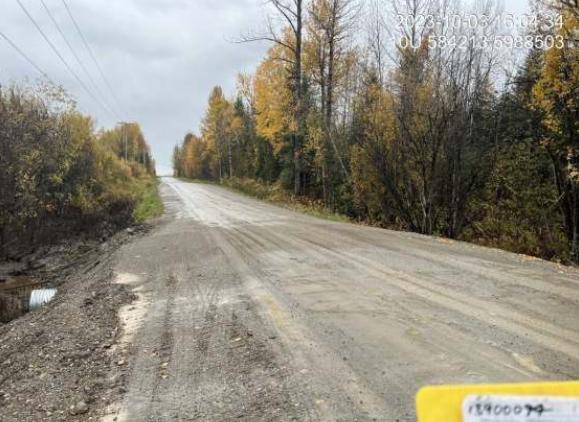
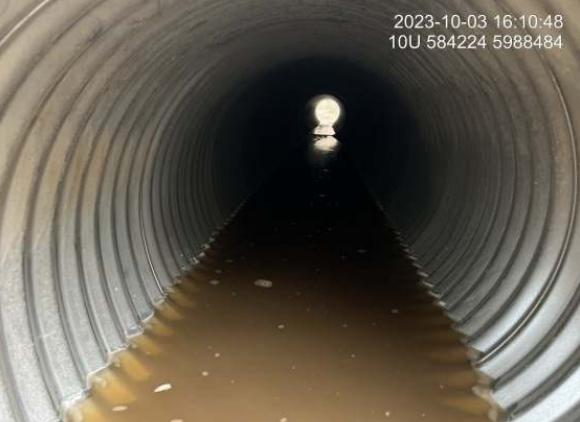
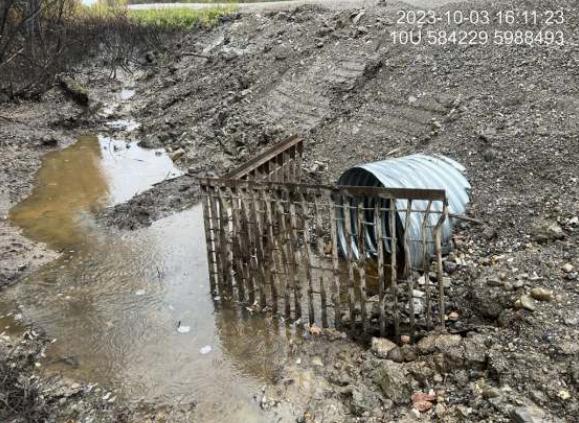
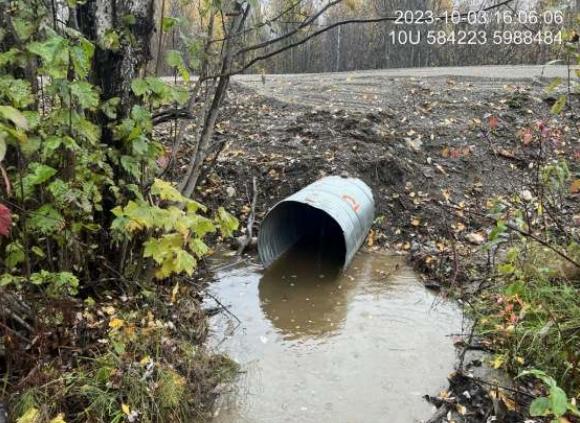
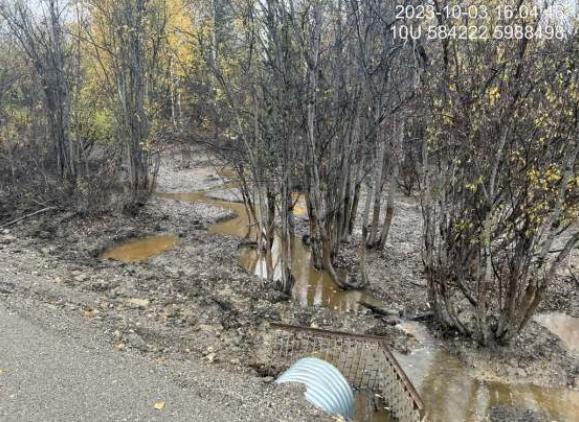
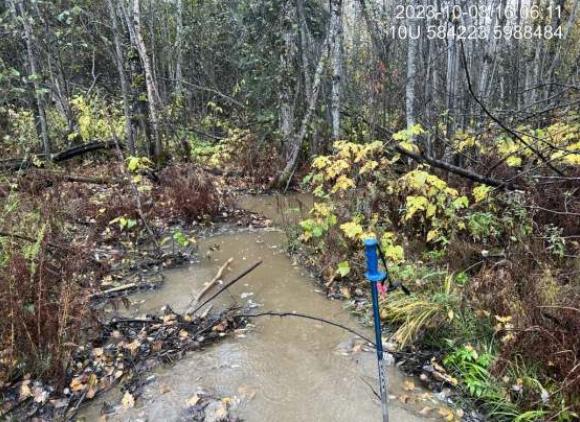
Photos: PSCIS ID 13900094. From top left clockwise: Road/Site Card, Barrel, Outlet, Downstream, Upstream, Inlet.

Location and Stream Data		Crossing Characteristics	
Date	2023-10-03	Crossing Sub Type	Round Culvert
PSCIS ID	199252	Diameter (m)	0.8
External ID	13900094	Length (m)	20
Crew	AI	Embedded	No
UTM Zone	10	Depth Embedded (m)	—
Easting	584227	Resemble Channel	No
Northing	5988493	Backwatered	No
Stream	Tributary to Fraser River	Percent Backwatered	—
Road	Upper Fraser Road	Fill Depth (m)	1.2
Road Tenure	MOTI	Outlet Drop (m)	0
Channel Width (m)	1.8	Outlet Pool Depth (m)	0.2
Stream Slope (%)	4.5	Inlet Drop	No
Beaver Activity	Yes	Slope (%)	2
Habitat Value	Medium	Valley Fill	Deep Fill
Final score	24	Barrier Result	Barrier
Fix type	Replace Structure with Streambed Simulation CBS	Fix Span / Diameter	3

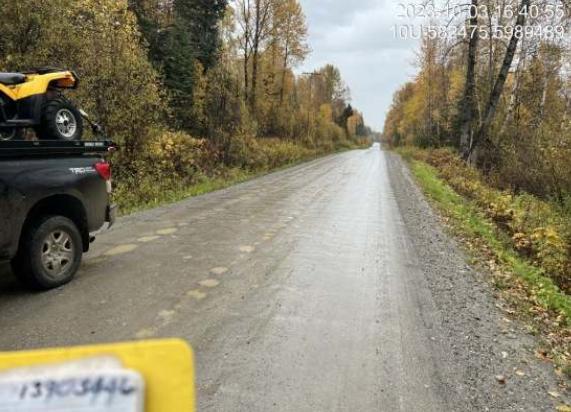
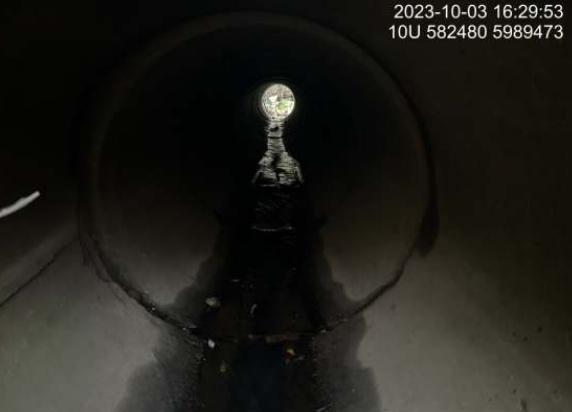
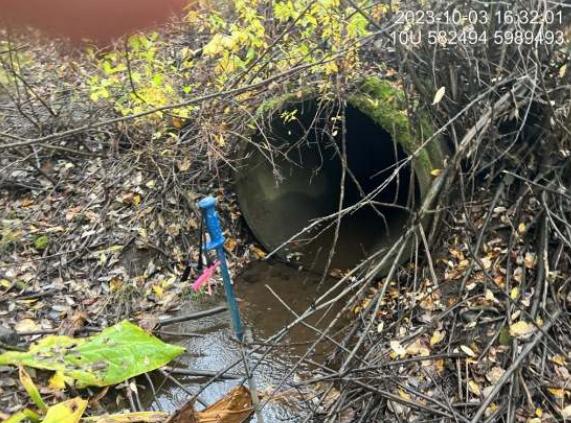
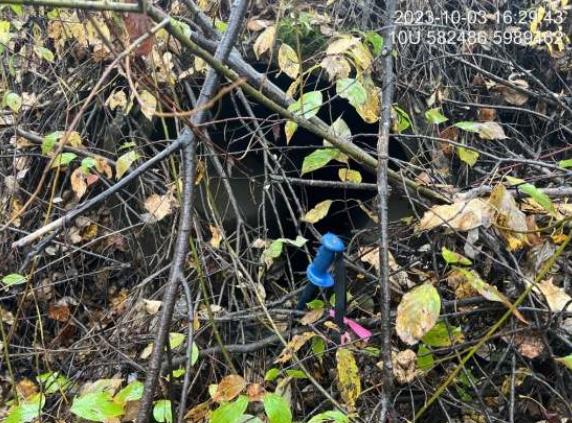
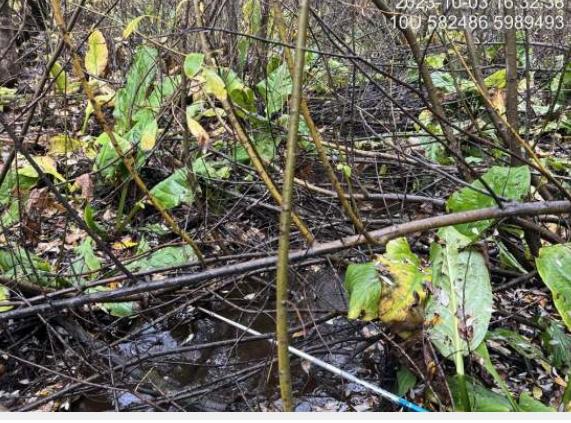
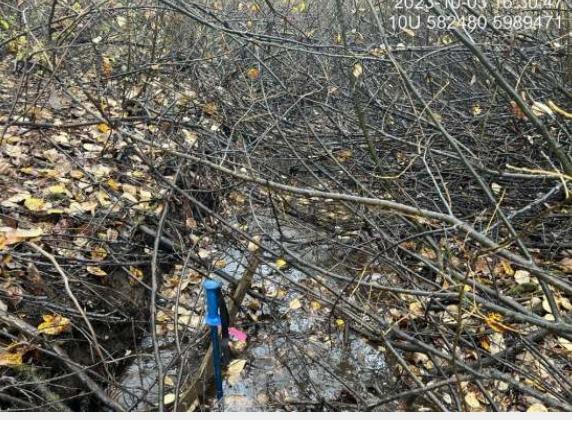
Photos: PSCIS ID 13903446. From top left clockwise: Road/Site Card, Barrel, Outlet, Downstream, Upstream, Inlet.

Location and Stream Data		Crossing Characteristics	
Date	2023-10-03	Crossing Sub Type	Round Culvert
PSCIS ID	199253	Diameter (m)	1.05
External ID	13903446	Length (m)	17
Crew	AI	Embedded	No
UTM Zone	10	Depth Embedded (m)	—
Easting	582480	Resemble Channel	No
Northing	5989487	Backwatered	No
Stream	Tributary to Fraser River	Percent Backwatered	—
Road	Upper Fraser Road	Fill Depth (m)	1.6
Road Tenure	MOTI	Outlet Drop (m)	0.05
Channel Width (m)	2	Outlet Pool Depth (m)	0.2
Stream Slope (%)	1	Inlet Drop	No
Beaver Activity	No	Slope (%)	2.5
Habitat Value	Medium	Valley Fill	Deep Fill
Final score	24	Barrier Result	Barrier
Fix type	Replace with New Open Bottom Structure	Fix Span / Diameter	15

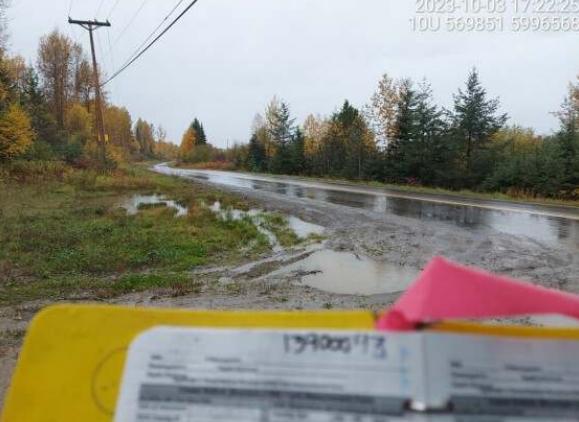
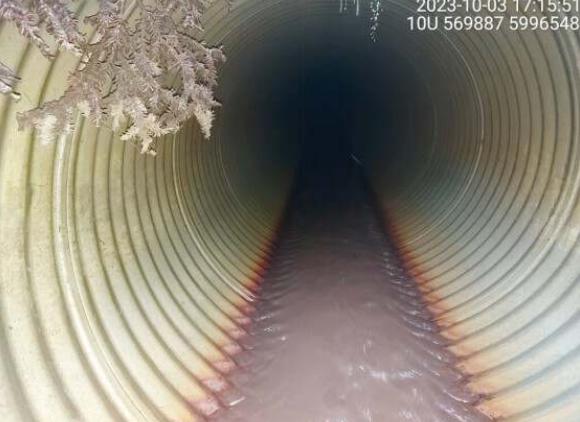
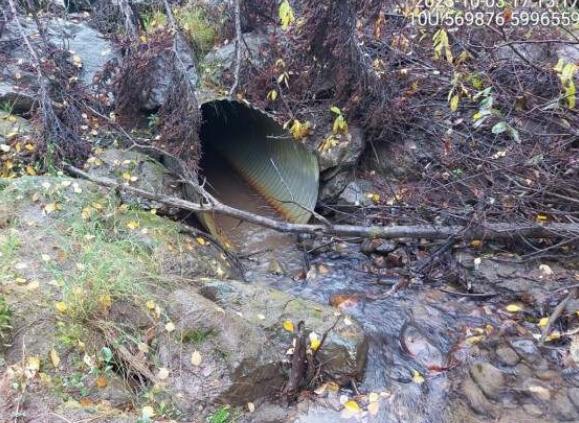
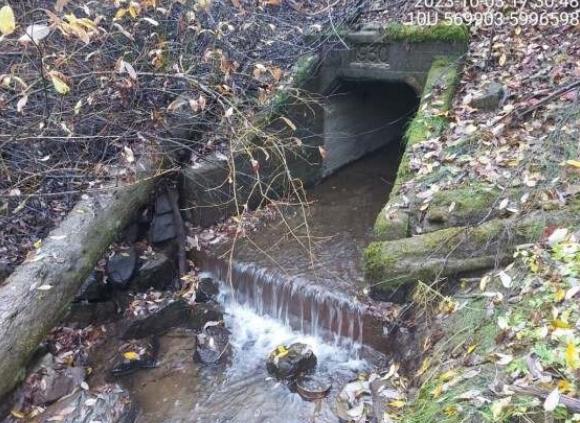
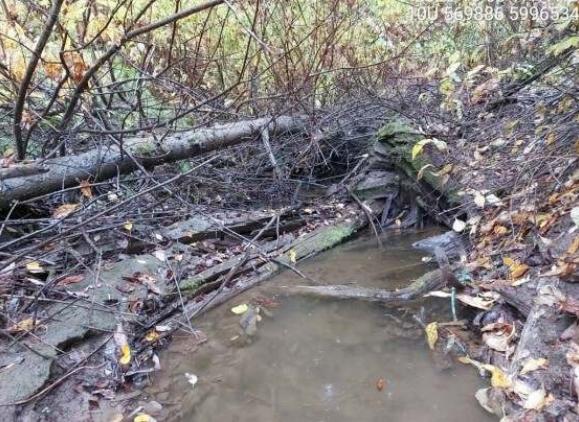
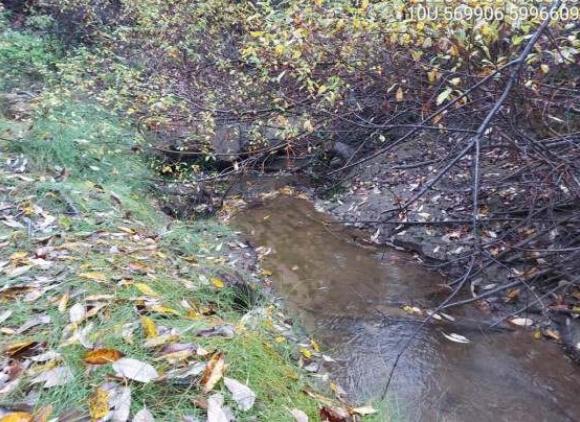
Photos: PSCIS ID 13900043. From top left clockwise: Road/Site Card, Barrel, Outlet, Downstream, Upstream, Inlet.

Location and Stream Data		Crossing Characteristics	
Date	2023-10-03	Crossing Sub Type	Round Culvert
PSCIS ID	199254	Diameter (m)	0.95
External ID	13900043	Length (m)	54
Crew	MW	Embedded	No
UTM Zone	10	Depth Embedded (m)	—
Easting	569895	Resemble Channel	No
Northing	5996572	Backwatered	No
Stream	Tributary to Fraser River	Percent Backwatered	—
Road	Upper Fraser Rd	Fill Depth (m)	4
Road Tenure	MOTI	Outlet Drop (m)	0.6
Channel Width (m)	2.3	Outlet Pool Depth (m)	0.2
Stream Slope (%)	4	Inlet Drop	No
Beaver Activity	No	Slope (%)	2
Habitat Value	Medium	Valley Fill	Deep Fill
Final score	37	Barrier Result	Barrier
Fix type	Replace with New Open Bottom Structure	Fix Span / Diameter	18

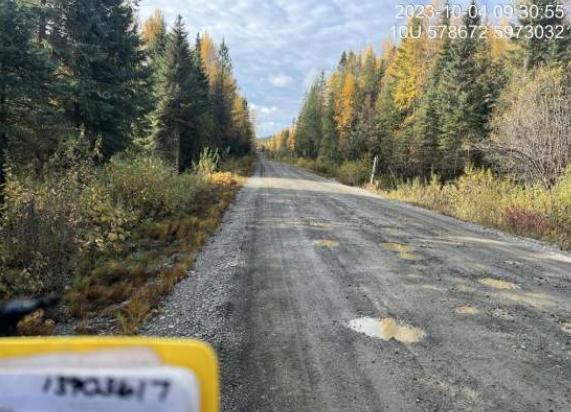
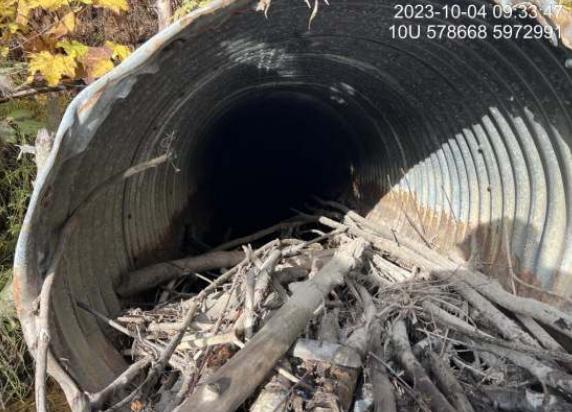
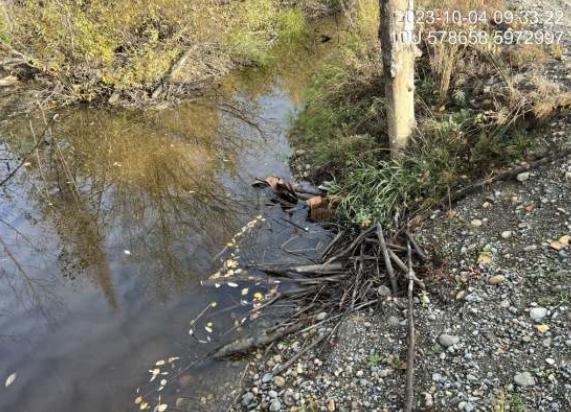
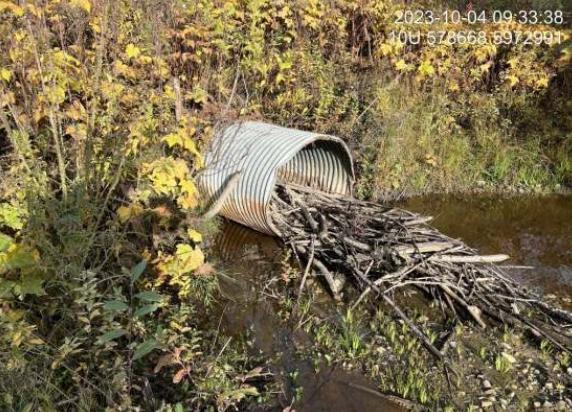
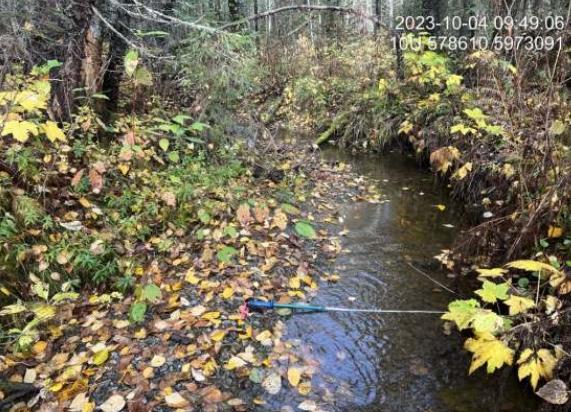
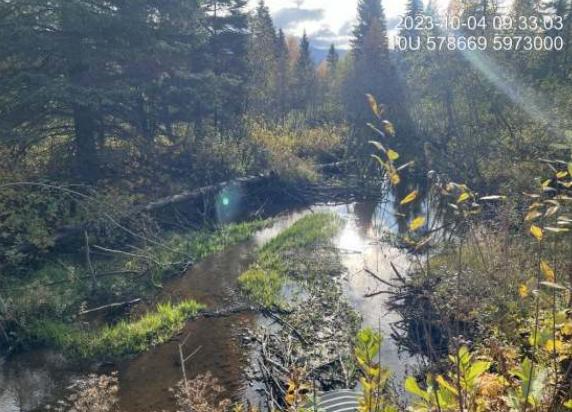
Photos: PSCIS ID 13903617. From top left clockwise: Road/Site Card, Barrel, Outlet, Downstream, Upstream, Inlet.

Location and Stream Data		Crossing Characteristics	
Date	2023-10-04	Crossing Sub Type	Round Culvert
PSCIS ID	199255	Diameter (m)	1.1
External ID	13903617	Length (m)	17
Crew	AI	Embedded	No
UTM Zone	10	Depth Embedded (m)	—
Easting	578670	Resemble Channel	No
Northing	5973004	Backwatered	No
Stream	Tributary to Kenneth Creek	Percent Backwatered	—
Road	Bowron FSR	Fill Depth (m)	1.3
Road Tenure	MOF	Outlet Drop (m)	0.05
Channel Width (m)	2.6	Outlet Pool Depth (m)	0.05
Stream Slope (%)	2	Inlet Drop	Yes
Beaver Activity	Yes	Slope (%)	3
Habitat Value	Medium	Valley Fill	Deep Fill
Final score	29	Barrier Result	Barrier
Fix type	Replace with New Open Bottom Structure	Fix Span / Diameter	15

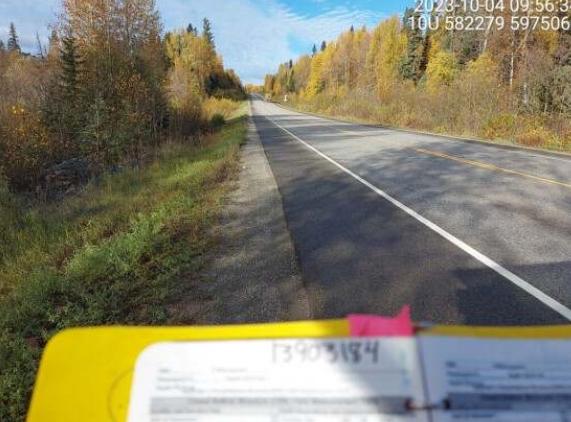
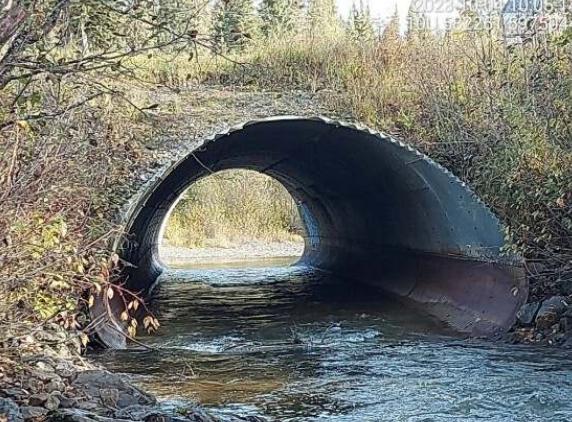
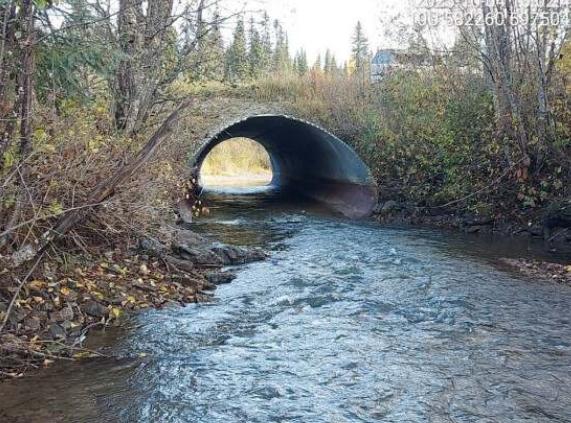
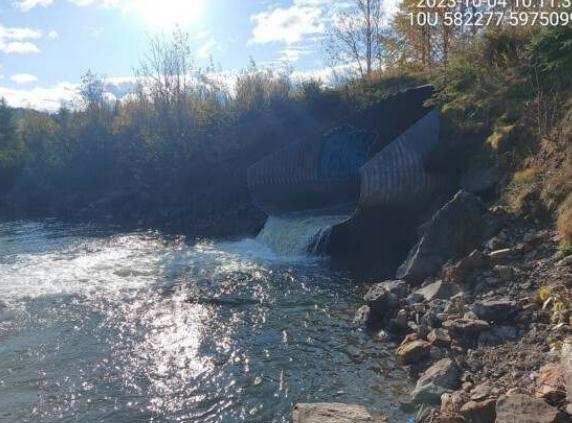
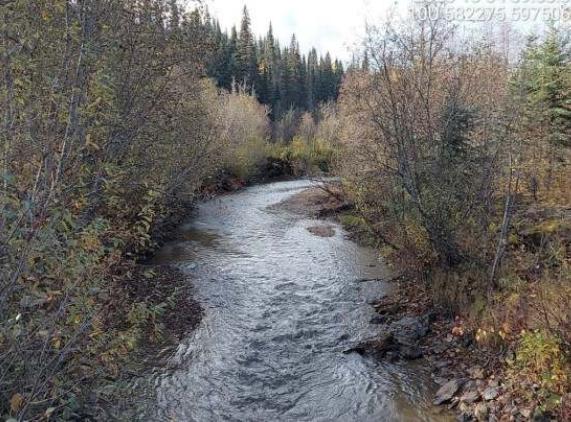
Photos: PSCIS ID 13903184. From top left clockwise: Road/Site Card, Barrel, Outlet, Downstream, Upstream, Inlet.

Location and Stream Data		Crossing Characteristics	
Date	2023-10-04	Crossing Sub Type	Oval Culvert
PSCIS ID	199256	Diameter (m)	4.7
External ID	13903184	Length (m)	33
Crew	MW	Embedded	No
UTM Zone	10	Depth Embedded (m)	—
Easting	582276	Resemble Channel	No
Northing	5975078	Backwatered	No
Stream	Kenneth Creek	Percent Backwatered	—
Road	Highway 16	Fill Depth (m)	1
Road Tenure	MOTI	Outlet Drop (m)	1
Channel Width (m)	9.4	Outlet Pool Depth (m)	2.4
Stream Slope (%)	1	Inlet Drop	No
Beaver Activity	No	Slope (%)	1.5
Habitat Value	High	Valley Fill	Deep Fill
Final score	37	Barrier Result	Barrier
Fix type	Replace with New Open Bottom Structure	Fix Span / Diameter	15

Comments: Very wide stream with high flow. Velocity is high in culvert. Very deep and big outlet pool, depth estimated. Known salmon spawning location. Chinook confirmed with carcass noted just upstream in 2022 by same field team.
MoTi chris_hwy_structure_road_id: 3750. 10:13:57

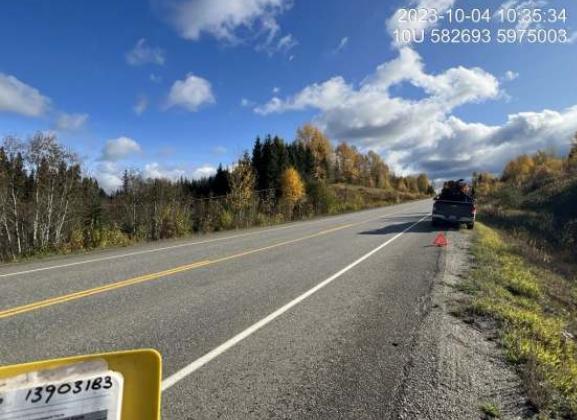
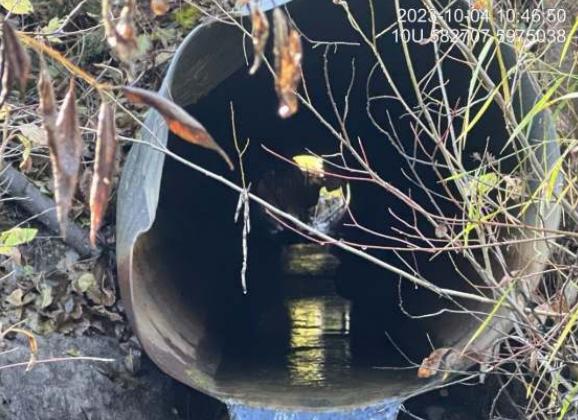
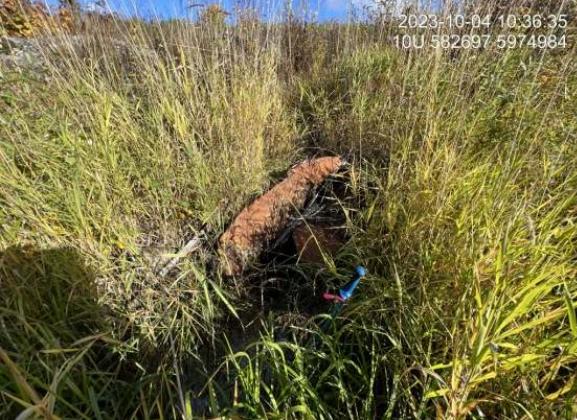
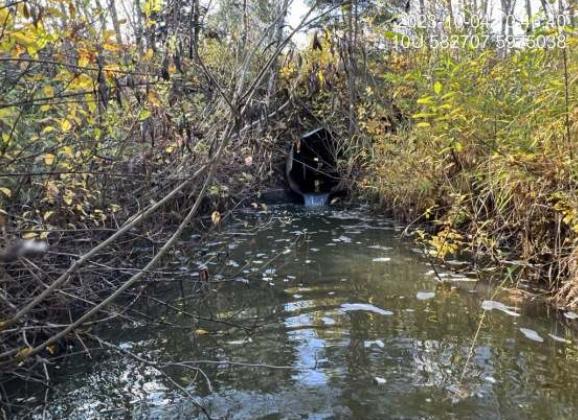
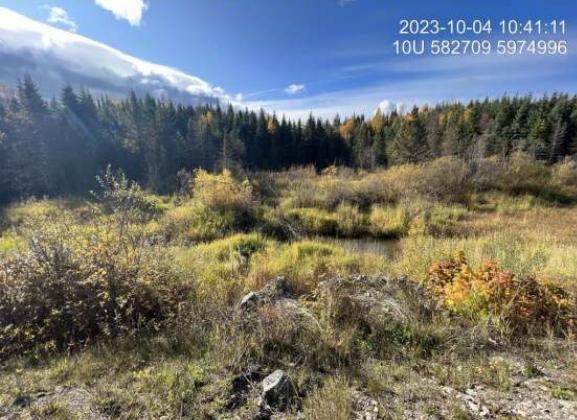
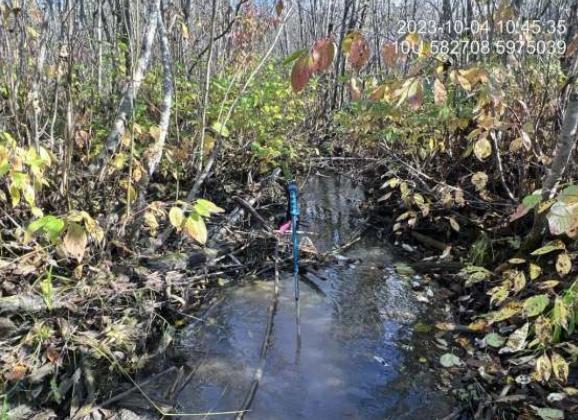
Photos: PSCIS ID 13903183. From top left clockwise: Road/Site Card, Barrel, Outlet, Downstream, Upstream, Inlet.

Location and Stream Data		Crossing Characteristics	
Date	2023-10-04	Crossing Sub Type	Round Culvert
PSCIS ID	199257	Diameter (m)	1.2
External ID	13903183	Length (m)	30
Crew	AI	Embedded	No
UTM Zone	10	Depth Embedded (m)	–
Easting	582694	Resemble Channel	No
Northing	5975012	Backwatered	No
Stream	Tributary to Kenneth Creek	Percent Backwatered	–
Road	Highway 16	Fill Depth (m)	3.5
Road Tenure	MOTI	Outlet Drop (m)	0.35
Channel Width (m)	2.2	Outlet Pool Depth (m)	0.7
Stream Slope (%)	1.5	Inlet Drop	Yes
Beaver Activity	Yes	Slope (%)	1.5
Habitat Value	Medium	Valley Fill	Deep Fill
Final score	37	Barrier Result	Barrier
Fix type	Replace with New Open Bottom Structure	Fix Span / Diameter	16.5

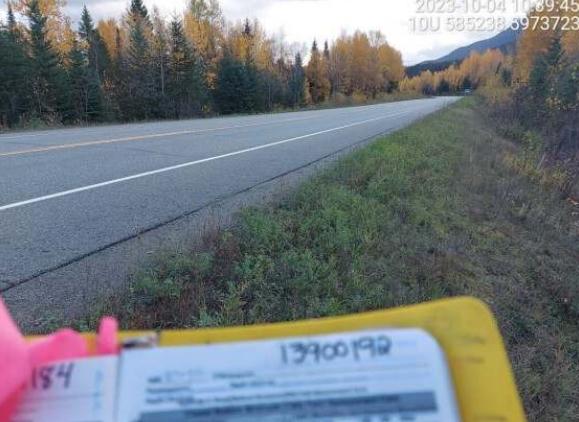
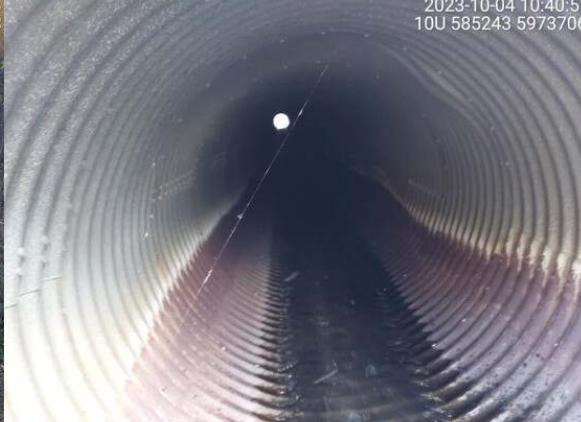
Photos: PSCIS ID 13900192. From top left clockwise: Road/Site Card, Barrel, Outlet, Downstream, Upstream, Inlet.

Location and Stream Data		Crossing Characteristics	
Date	2023-10-04	Crossing Sub Type	Round Culvert
PSCIS ID	199258	Diameter (m)	1.2
External ID	13900192	Length (m)	31
Crew	MW	Embedded	No
UTM Zone	10	Depth Embedded (m)	–
Easting	585255	Resemble Channel	No
Northing	5973726	Backwatered	No
Stream	Tributary to Kenneth Creek	Percent Backwatered	–
Road	Highway 16	Fill Depth (m)	2
Road Tenure	MOTI	Outlet Drop (m)	1.7
Channel Width (m)	2.3	Outlet Pool Depth (m)	0.6
Stream Slope (%)	4.5	Inlet Drop	No
Beaver Activity	No	Slope (%)	5
Habitat Value	High	Valley Fill	Deep Fill
Final score	42	Barrier Result	Barrier
Fix type	Replace with New Open Bottom Structure	Fix Span / Diameter	15
