Appendix - Phase 1 Fish Passage Assessment Data and Photos

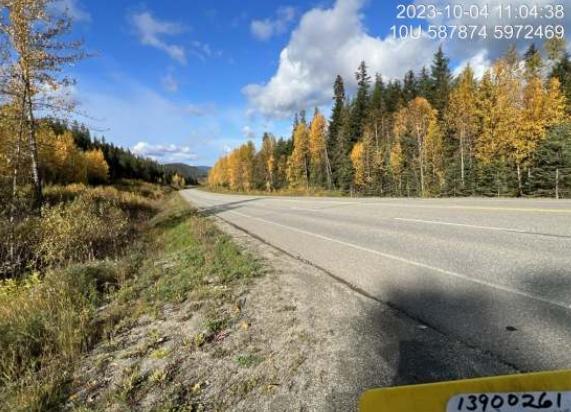
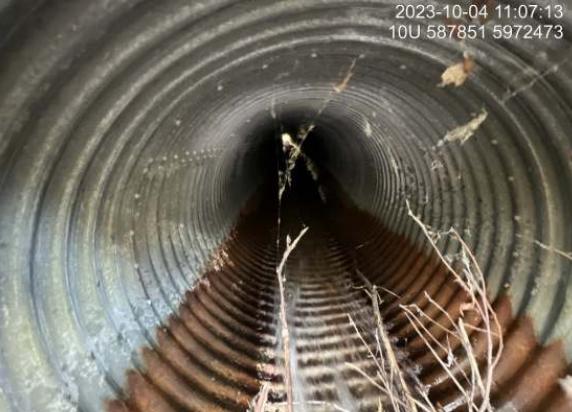
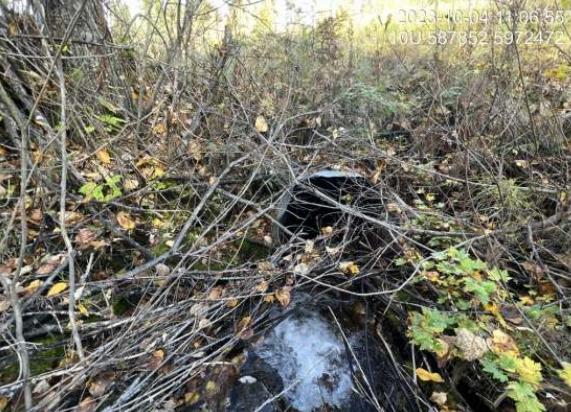
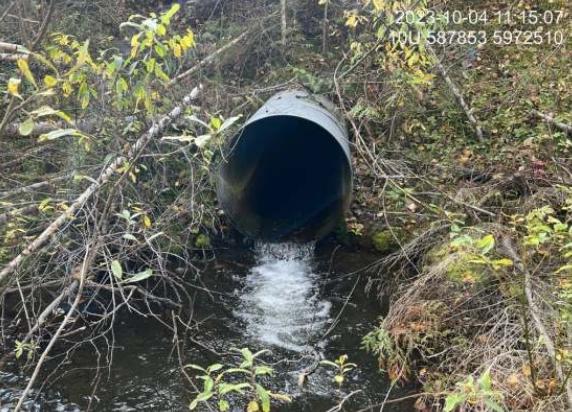
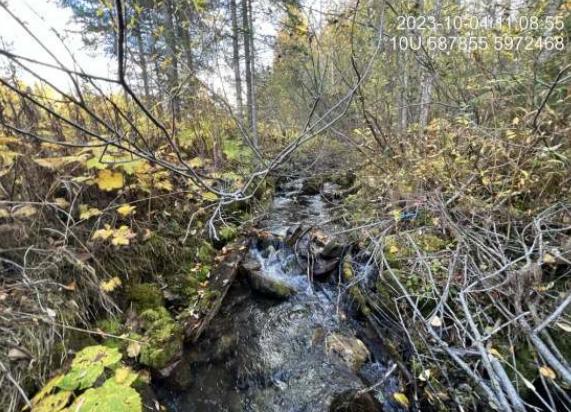
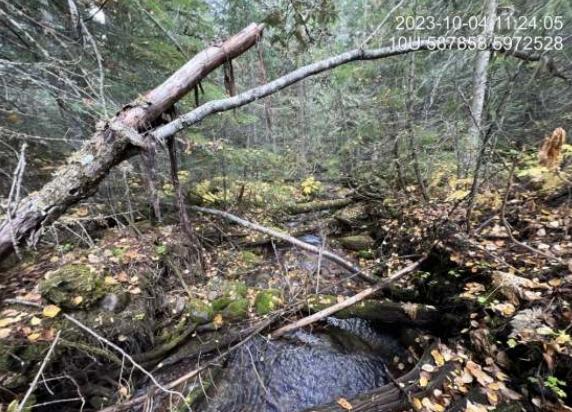
Photos: PSCIS ID 13900261. From top left clockwise: Road/Site Card, Barrel, Outlet, Downstream, Upstream, Inlet.

Location and Stream Data	.	Crossing Characteristics	-
Date	2023-10-04	Crossing Sub Type	Round Culvert
PSCIS ID	199259	Diameter (m)	1.1
External ID	13900261	Length (m)	42
Crew	AI	Embedded	No
UTM Zone	10	Depth Embedded (m)	-
Easting	587876	Resemble Channel	No
Northing	5972476	Backwatered	No
Stream	Tributary to Sugarbowl Creek	Percent Backwatered	-
Road	Highway 16	Fill Depth (m)	7
Road Tenure	MOTI	Outlet Drop (m)	0.2
Channel Width (m)	2.5	Outlet Pool Depth (m)	0.7
Stream Slope (%)	9	Inlet Drop	Yes
Beaver Activity	No	Slope (%)	12
Habitat Value	Medium	Valley Fill	Deep Fill
Final score	37	Barrier Result	Barrier
Fix type	Replace Structure with Streambed Simulation CBS	Fix Span / Diameter	4.5

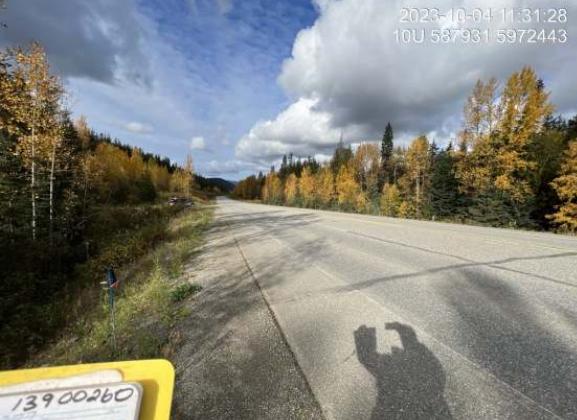
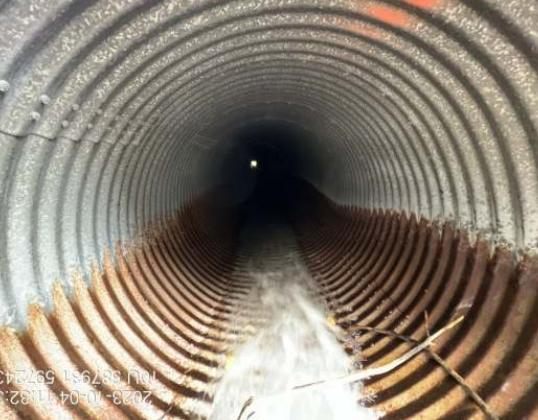
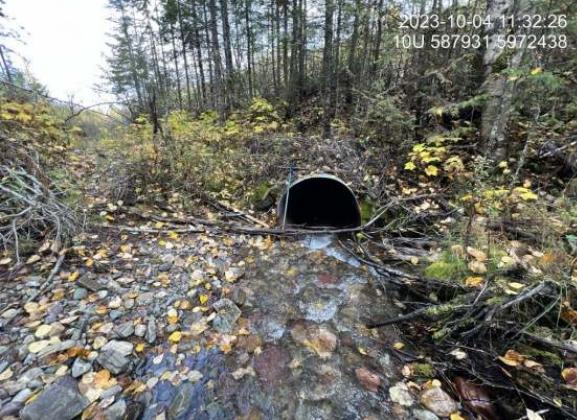
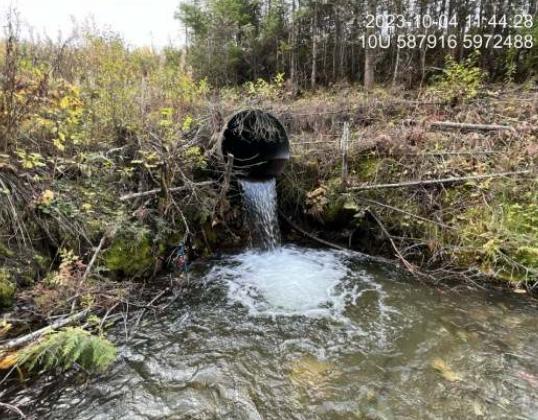
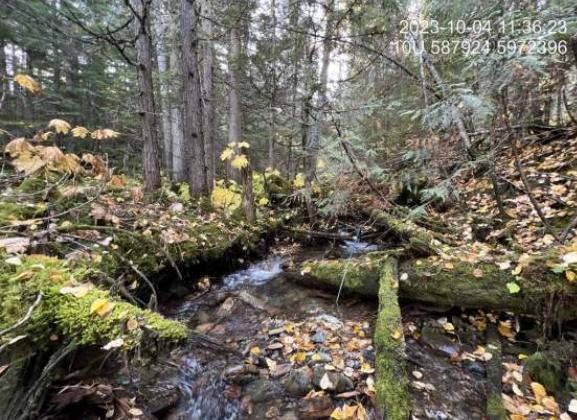
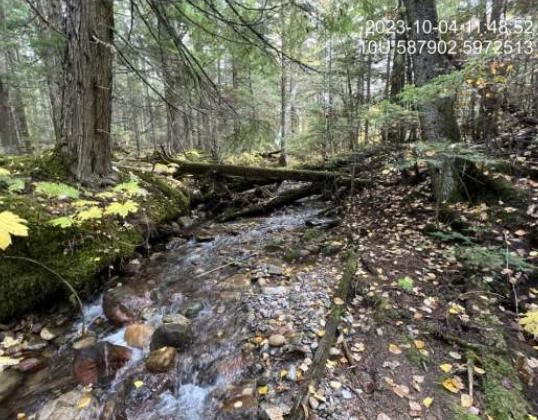
Photos: PSCIS ID 13900260. From top left clockwise: Road/Site Card, Barrel, Outlet, Downstream, Upstream, Inlet.

Comments: Large stream with abundant gravels present upstream suitable for spawning. Massive outlet drop with powerline riparian cleared downstream of the highway. Old growth cedar hemlock riparian within Sugar bowl grizzly den provincial park. Follow up with habitat confirmation recommended. MoTi chris_culvert_id: 1992815. 11:30:20

Location and Stream Data		Crossing Characteristics	
Date	2023-10-04	Crossing Sub Type	Round Culvert
PSCIS ID	199260	Diameter (m)	1.2
External ID	13900260	Length (m)	38
Crew	AI	Embedded	No
UTM Zone	10	Depth Embedded (m)	—
Easting	587936	Resemble Channel	No
Northing	5972452	Backwatered	No
Stream	Tributary to Sugarbowl Creek	Percent Backwatered	—
Road	Highway 16	Fill Depth (m)	8
Road Tenure	MOTI	Outlet Drop (m)	1.15
Channel Width (m)	5.2	Outlet Pool Depth (m)	0.8
Stream Slope (%)	9	Inlet Drop	Yes
Beaver Activity	No	Slope (%)	7
Habitat Value	High	Valley Fill	Deep Fill
Final score	42	Barrier Result	Barrier
Fix type	Replace with New Open Bottom Structure	Fix Span / Diameter	30

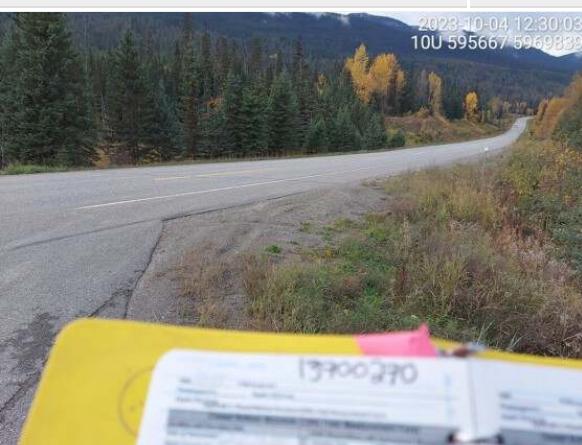
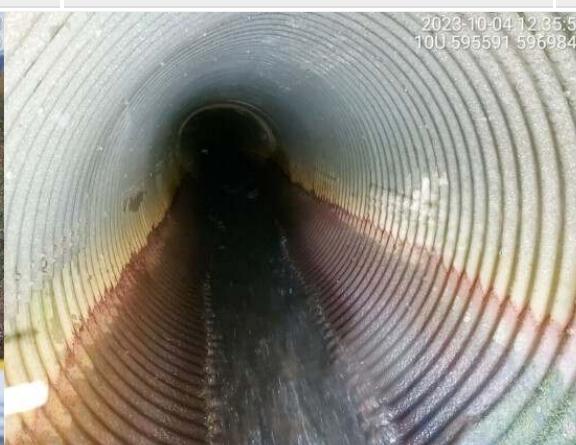
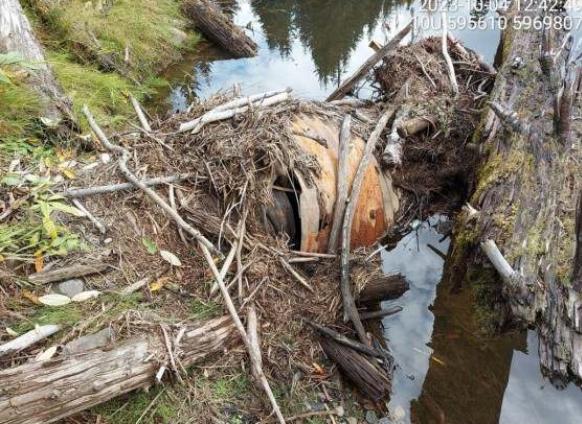
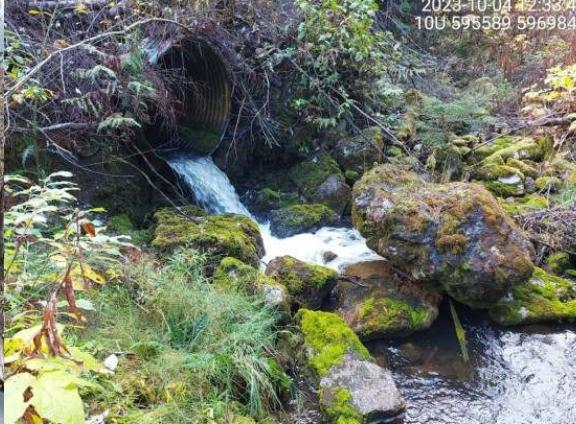
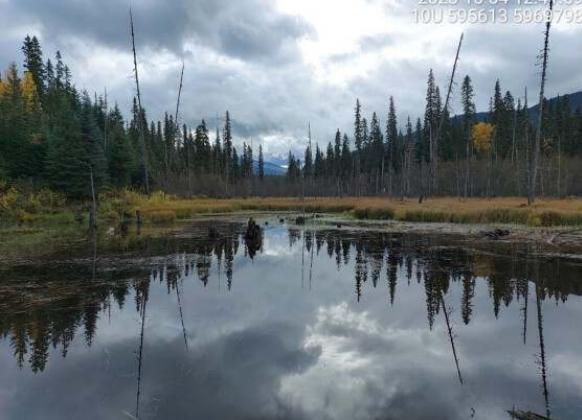
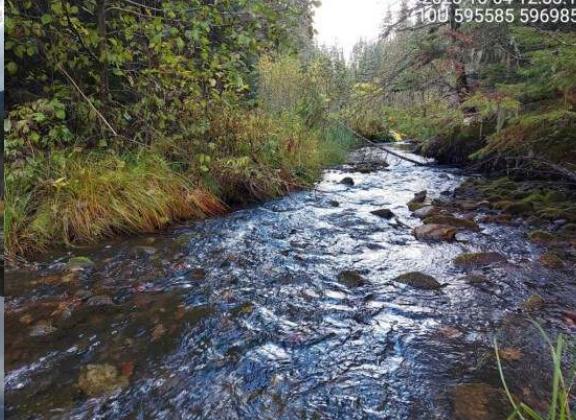
Photos: PSCIS ID 13900270. From top left clockwise: Road/Site Card, Barrel, Outlet, Downstream, Upstream, Inlet.

Comments: Culvert very old. Big wetland complex upstream. Inlet barely visible, covered in woody debris and rusty metal. Culvert slope estimated. High velocity coming out of outlet with moderate drop. Habitat looks good downstream, wide channel with high flow. Crossing is within the Sugarbowl grizzly den provincial park. MoTi chris_culvert_id: 1992569. 12:49:05

Location and Stream Data		Crossing Characteristics	
Date	2023-10-04	Crossing Sub Type	Round Culvert
PSCIS ID	199261	Diameter (m)	1.2
External ID	13900270	Length (m)	56
Crew	MW	Embedded	No
UTM Zone	10	Depth Embedded (m)	—
Easting	595602	Resemble Channel	No
Northing	5969818	Backwatered	No
Stream	Tributary to Sugarbowl Creek	Percent Backwatered	—
Road	Highway 16	Fill Depth (m)	6
Road Tenure	MOTI	Outlet Drop (m)	0.9
Channel Width (m)	3.7	Outlet Pool Depth (m)	0.4
Stream Slope (%)	4	Inlet Drop	No
Beaver Activity	Yes	Slope (%)	3
Habitat Value	Medium	Valley Fill	Deep Fill
Final score	42	Barrier Result	Barrier
Fix type	Replace with New Open Bottom Structure	Fix Span / Diameter	24

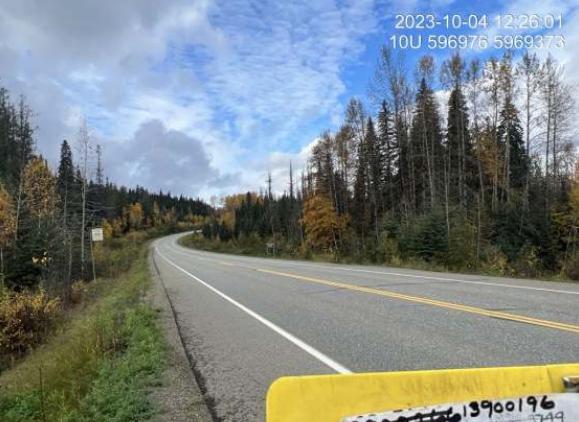
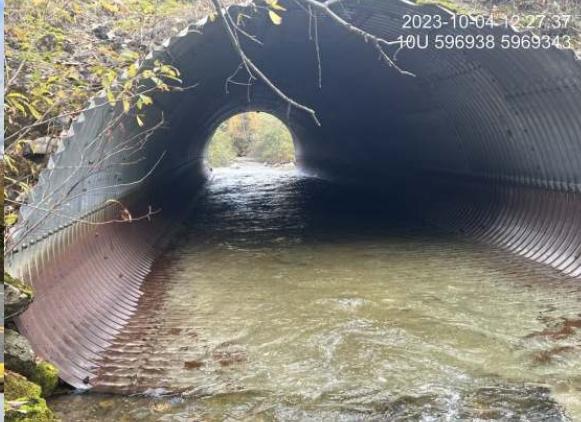
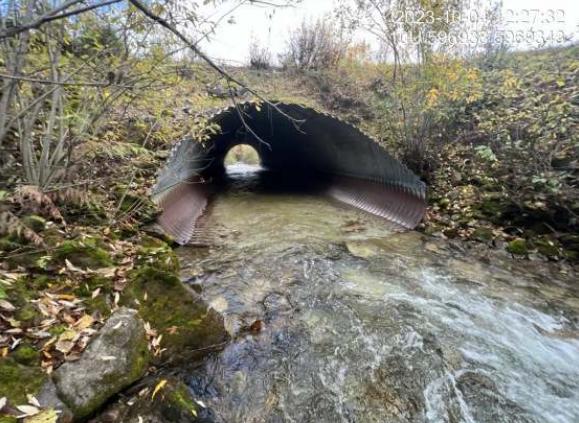
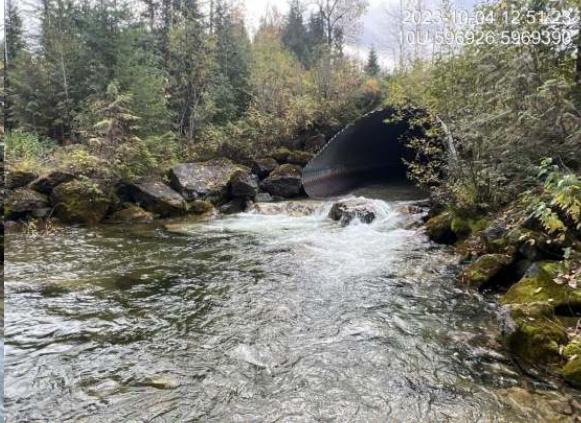
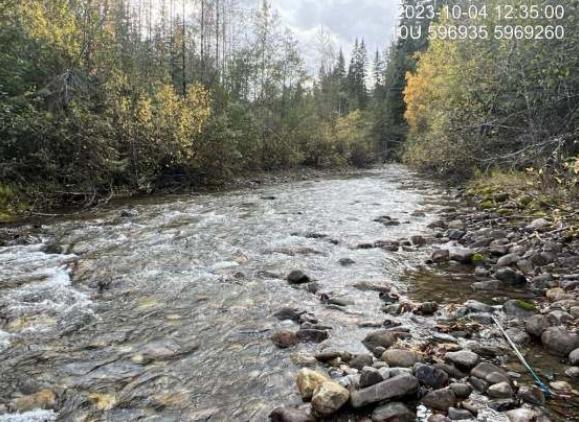
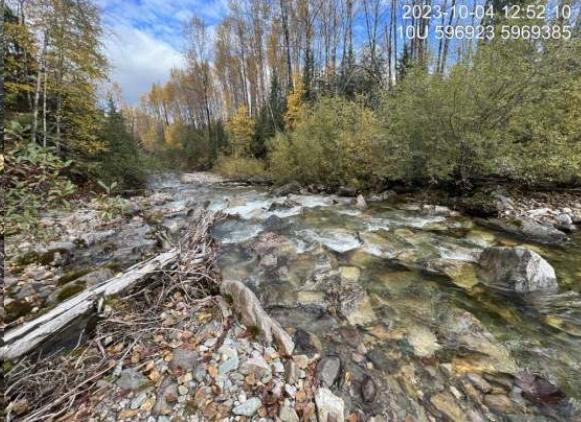
Photos: PSCIS ID 13900196. From top left clockwise: Road/Site Card, Barrel, Outlet, Downstream, Upstream, Inlet.

Location and Stream Data		.	Crossing Characteristics	-
Date	2023-10-04		Crossing Sub Type	Oval Culvert
PSCIS ID	199262		Diameter (m)	5
External ID	13900196		Length (m)	31
Crew	AI		Embedded	No
UTM Zone	10		Depth Embedded (m)	-
Easting	596934		Resemble Channel	No
Northing	5969359		Backwatered	No
Stream	Hungary Creek		Percent Backwatered	-
Road	Highway 16		Fill Depth (m)	2
Road Tenure	MOTI		Outlet Drop (m)	0.5
Channel Width (m)	11.6		Outlet Pool Depth (m)	1.4
Stream Slope (%)	1		Inlet Drop	No
Beaver Activity	No		Slope (%)	1
Habitat Value	High		Valley Fill	Deep Fill
Final score	37		Barrier Result	Barrier
Fix type	Replace with New Open Bottom Structure		Fix Span / Diameter	16.5

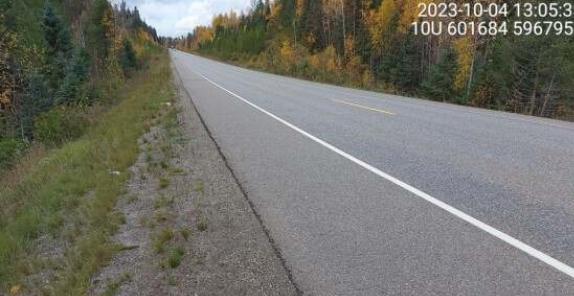
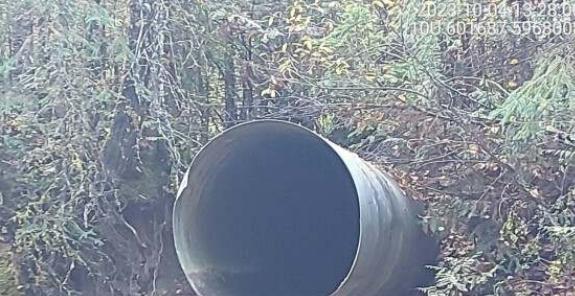
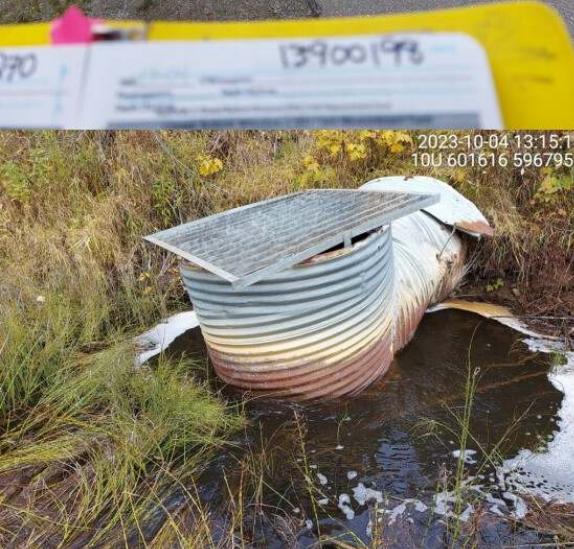
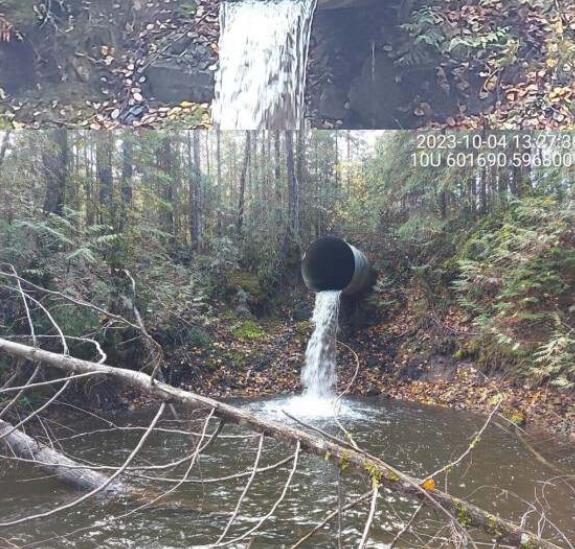
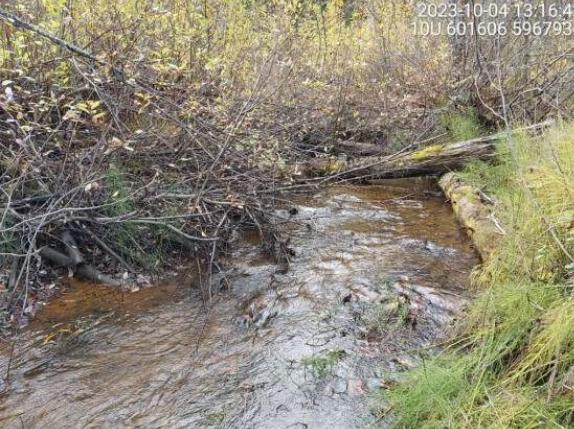
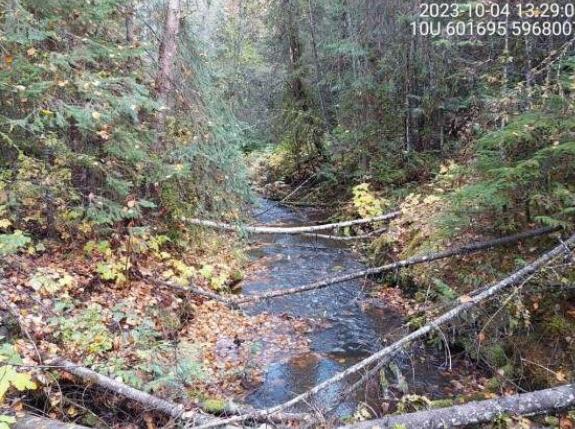
Photos: PSCIS ID 13900198. From top left clockwise: Road/Site Card, Barrel, Outlet, Downstream, Upstream, Inlet.

Location and Stream Data		Crossing Characteristics	
Date	2023-10-04	Crossing Sub Type	Round Culvert
PSCIS ID	199263	Diameter (m)	1.2
External ID	13900198	Length (m)	82
Crew	MW	Embedded	No
UTM Zone	10	Depth Embedded (m)	—
Easting	601647	Resemble Channel	No
Northing	5967974	Backwatered	No
Stream	Lunate Creek	Percent Backwatered	—
Road	Highway 16	Fill Depth (m)	8
Road Tenure	MOTI	Outlet Drop (m)	2.8
Channel Width (m)	2.4	Outlet Pool Depth (m)	2
Stream Slope (%)	3	Inlet Drop	No
Beaver Activity	Yes	Slope (%)	2
Habitat Value	Medium	Valley Fill	Deep Fill
Final score	37	Barrier Result	Barrier
Fix type	Replace Structure with Streambed Simulation CBS	Fix Span / Diameter	4.5

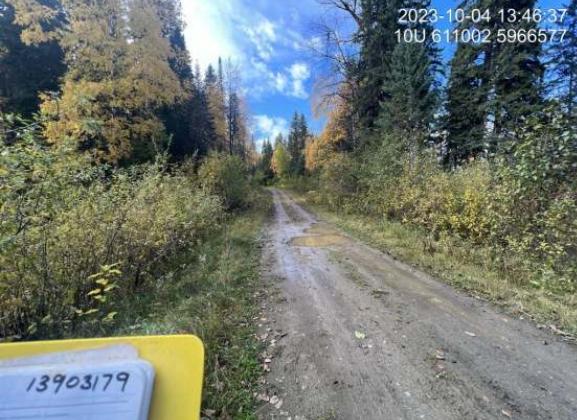
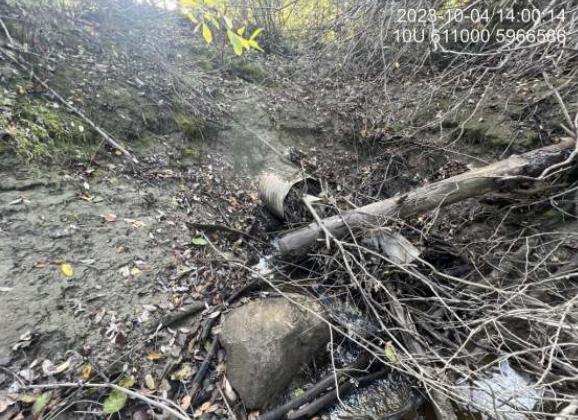
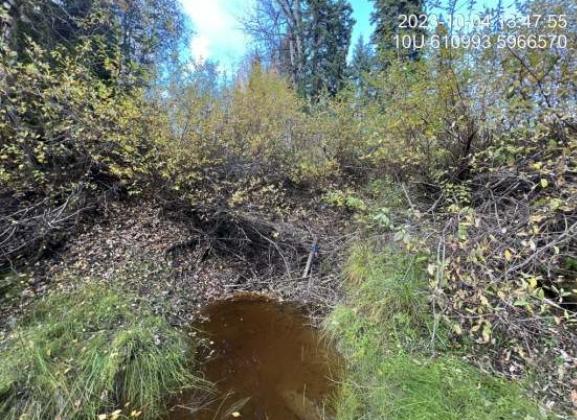
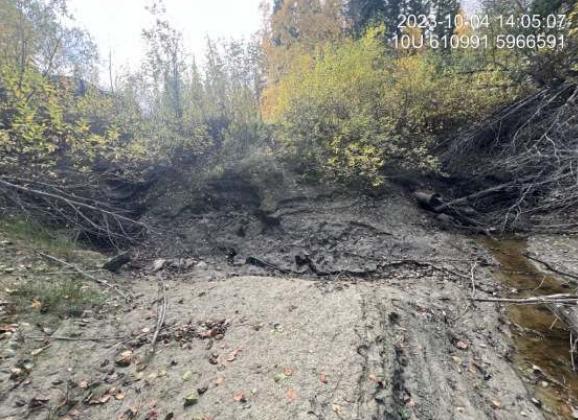
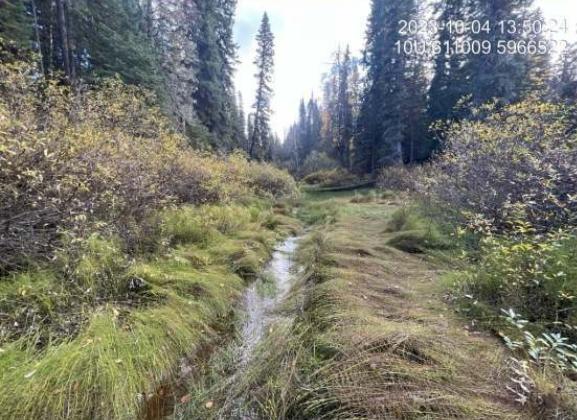
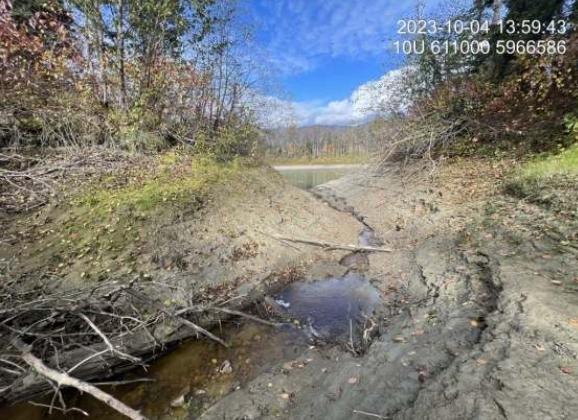
Photos: PSCIS ID 13903179. From top left clockwise: Road/Site Card, Barrel, Outlet, Downstream, Upstream, Inlet.

Location and Stream Data	.	Crossing Characteristics	–
Date	2023-10-04	Crossing Sub Type	Round Culvert
PSCIS ID	199264	Diameter (m)	0.6
External ID	13903179	Length (m)	20
Crew	AI	Embedded	No
UTM Zone	10	Depth Embedded (m)	–
Easting	610990	Resemble Channel	No
Northing	5966577	Backwatered	No
Stream	Tributary to Fraser River	Percent Backwatered	–
Road	Penny Access Road	Fill Depth (m)	3
Road Tenure	MOTI	Outlet Drop (m)	0.2
Channel Width (m)	1.6	Outlet Pool Depth (m)	0.2
Stream Slope (%)	0.25	Inlet Drop	Yes
Beaver Activity	Yes	Slope (%)	3
Habitat Value	Medium	Valley Fill	Deep Fill
Final score	34	Barrier Result	Barrier
Fix type	Replace Structure with Streambed Simulation CBS	Fix Span / Diameter	3

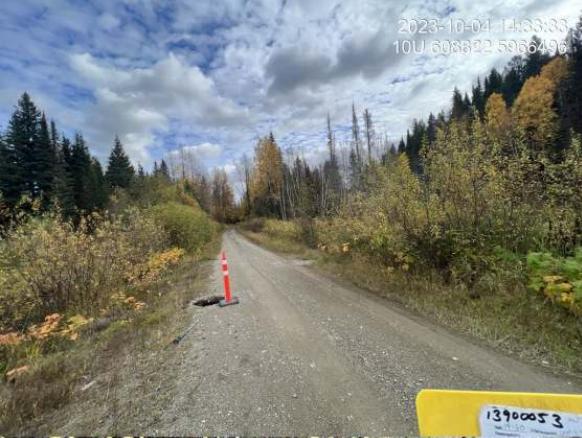
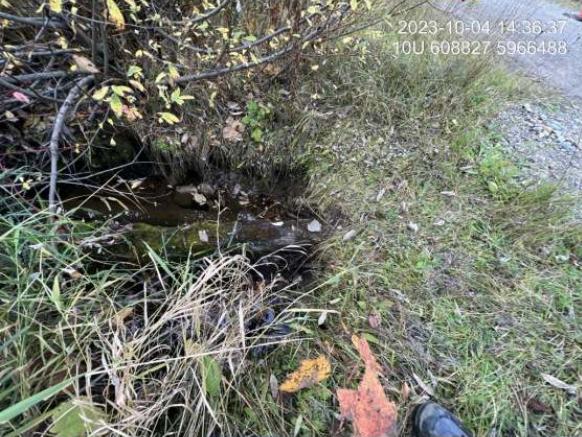
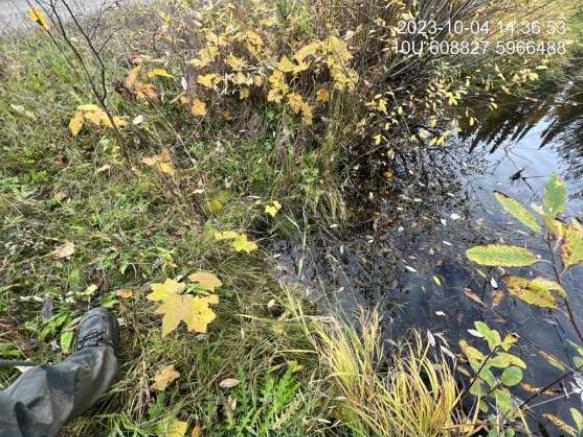
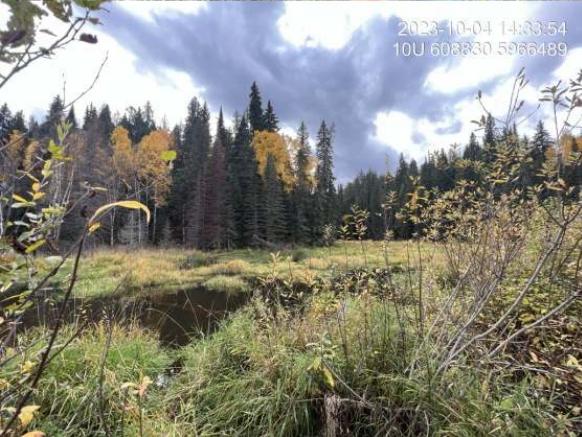
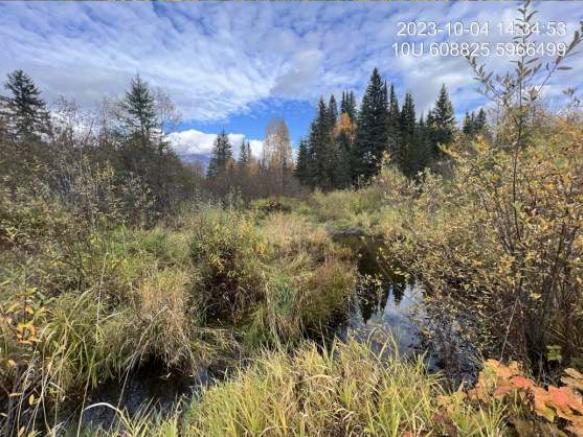
Photos: PSCIS ID 13900053. From top left clockwise: Road/Site Card, Barrel, Outlet, Downstream, Upstream, Inlet.

Comments: Could not locate pipe as it is underwater at both inlet and outlet. There appears to be a bunch of logs under the road so suspect that there may be no structure at all as the drainage may have been put in with logs - although MOT culvert layer says 0.6 m galvanized pipe.. Road is failing with 3 foot deep and 2 foot wide hole in the road marked with a pilon. MoTi chris_culvert_id: 1993428. 14:32:19

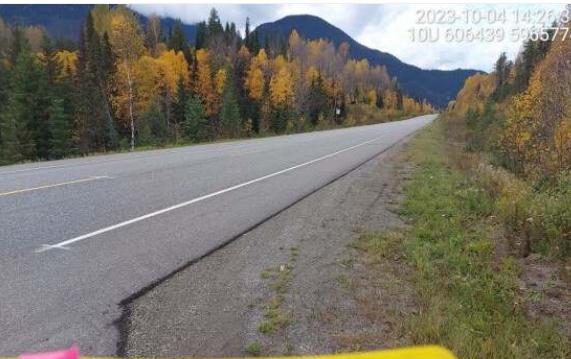
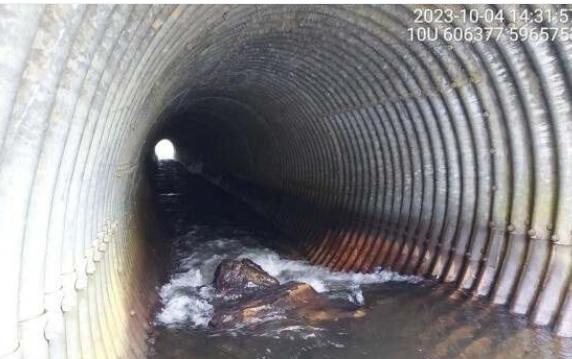
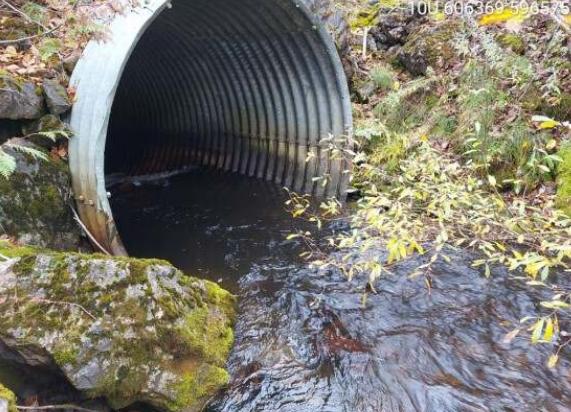
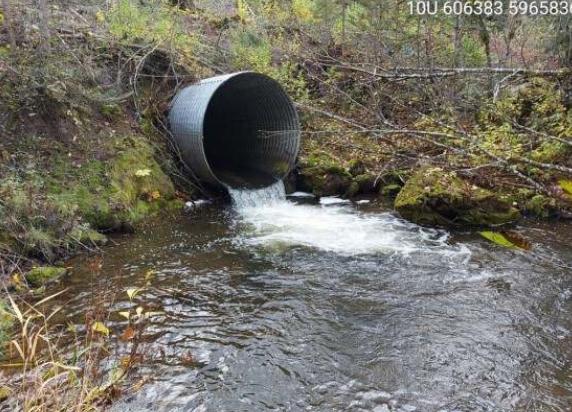
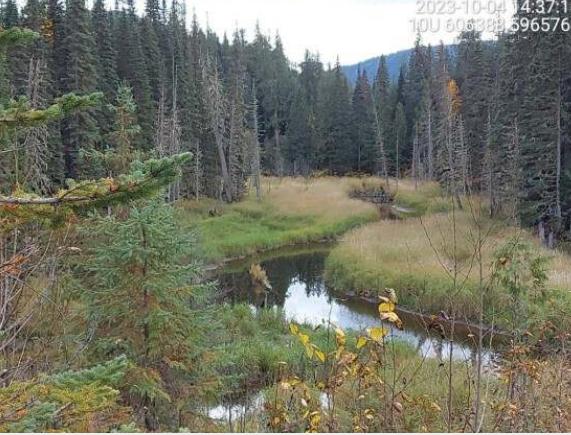
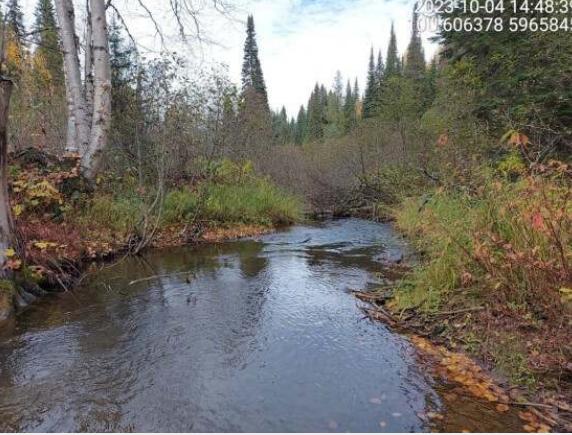
Photos: PSCIS ID 13900201. From top left clockwise: Road/Site Card, Barrel, Outlet, Downstream, Upstream, Inlet.

Comments: Big beaver dam near inlet of culvert spanning across whole channel approx 1.2m high. Boulders in pipe near inlet creating small drop and increasing velocity. Channel widens downstream, high value habitat. RB and CCG confirmed upstream and downstream with chinook observed way downstream at mouth. Low gradient upstream and downstream with decent outlet drop so resampling to determine chinook presence could be insightful. MoTi chris_culvert_id: 1992674. 14:54:00

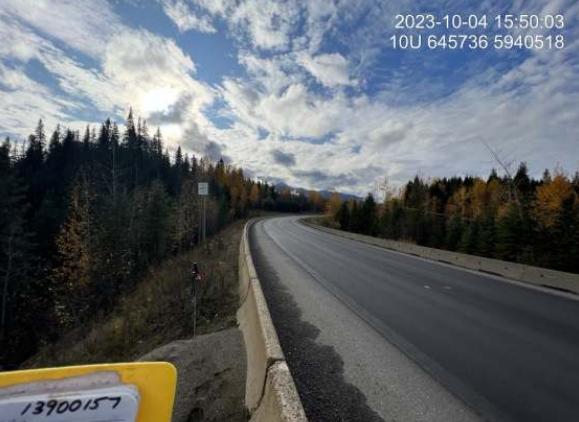
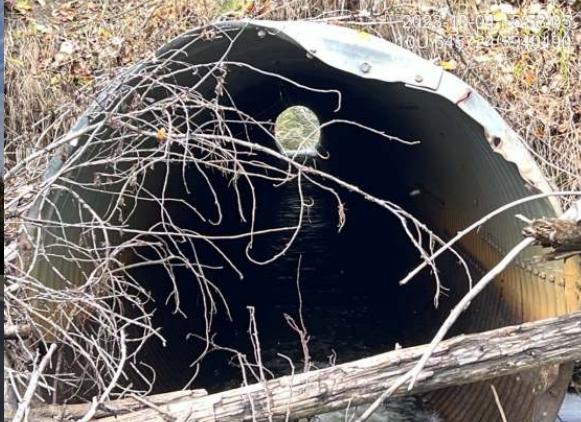
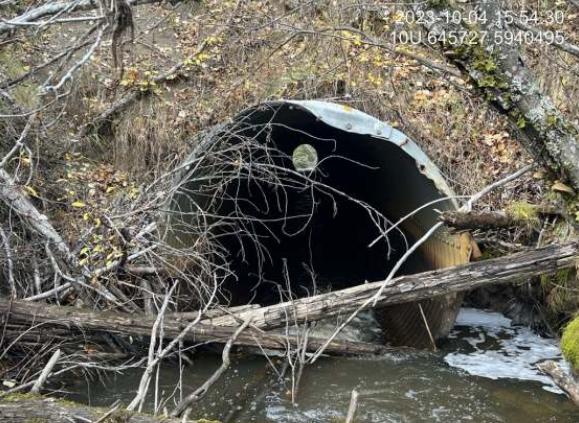
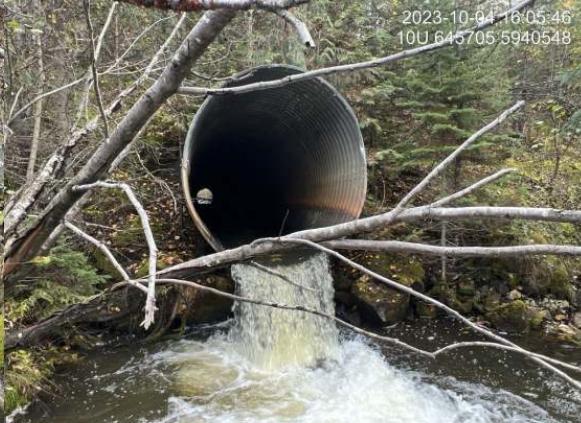
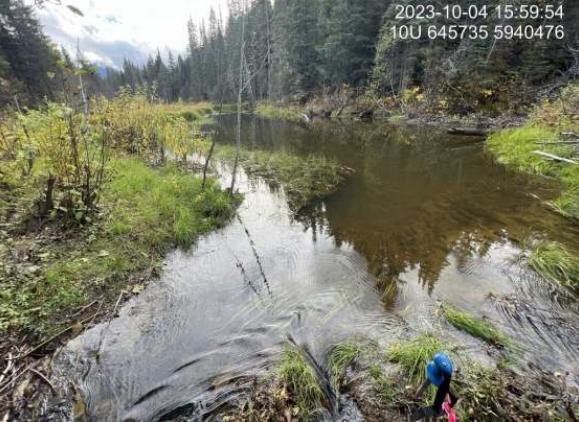
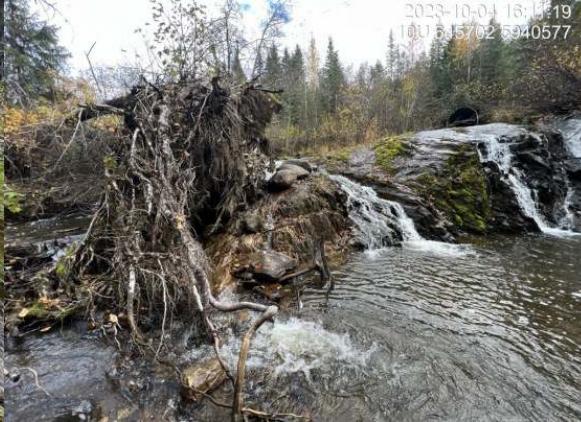
Photos: PSCIS ID 13900157. From top left clockwise: Road/Site Card, Barrel, Outlet, Downstream, Upstream, Inlet.

Comments: Very large system with beaver complex upstream, including a large beaver dam approximately 1.3m high located 25m upstream of the inlet. Approximately 20m downstream of the outlet is a rock chute that is over 30% gradient but only for 5m with a total height of 1.7m. There are two other falls noted as FISS obstacles between this crossing and the Fraser River downstream. There is significant erosion of the road prism on the upstream side above the culvert. Culvert is located on the bend of Highway 16 under 10m of road fill. Noted falls and lack of fish observations indicated access issues downstream. MoTi chris_culvert_id: 1992752. 16:16:08

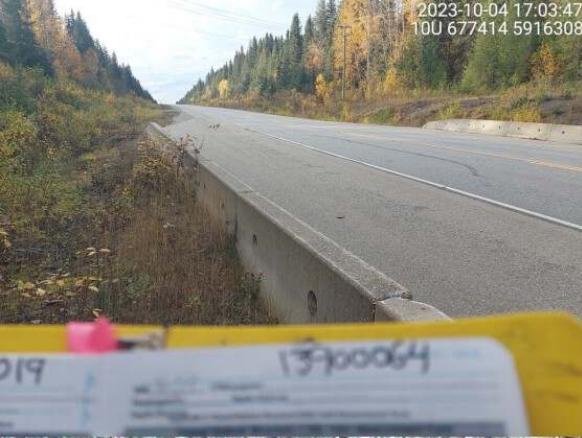
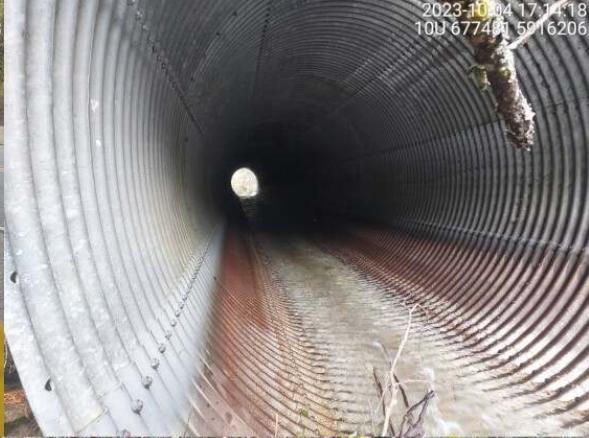
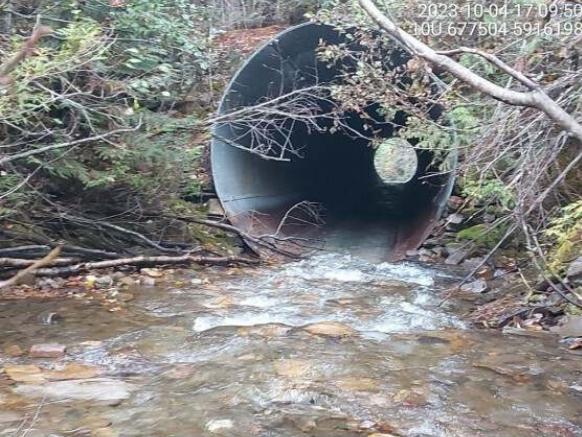
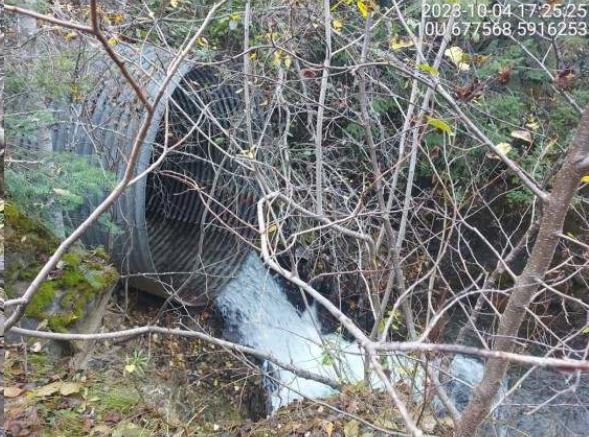
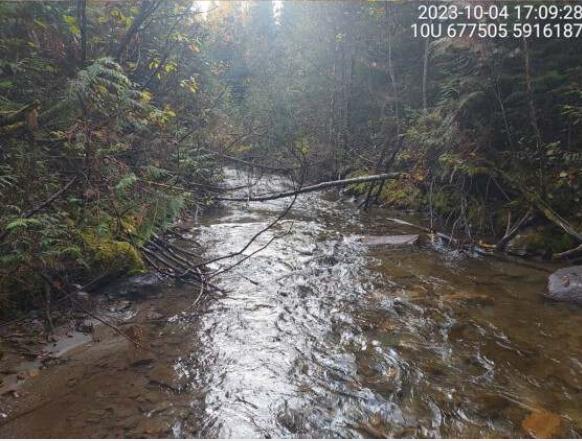
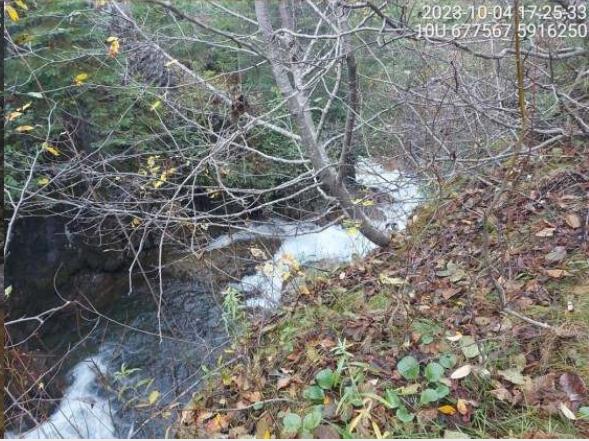
Photos: PSCIS ID 13900064. From top left clockwise: Road/Site Card, Barrel, Outlet, Downstream, Upstream, Inlet.

Comments: Deep canyon and high waterfall directly downstream of crossing which is a definite barrier to all fish. Rough estimate 20m height. Outlet drop and pool estimated because it was unsafe to get near stream due to steep embankment. RB confirmed upstream of crossing in 2017 and 2020, but the falls downstream is a definite barrier. MoTi chris_hwy_structure_road_id: 30367. 17:27:23

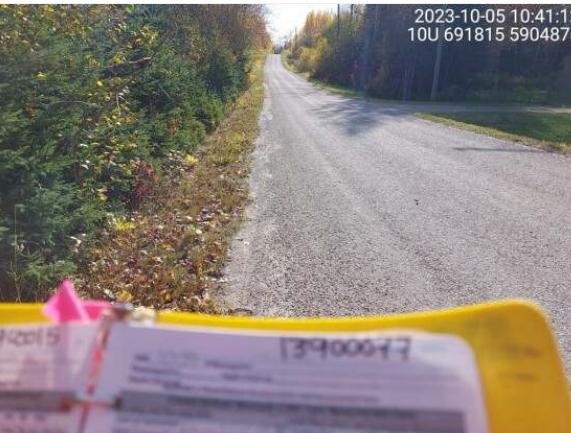
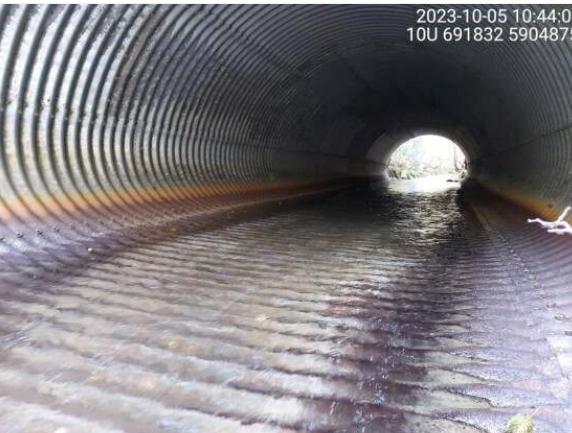
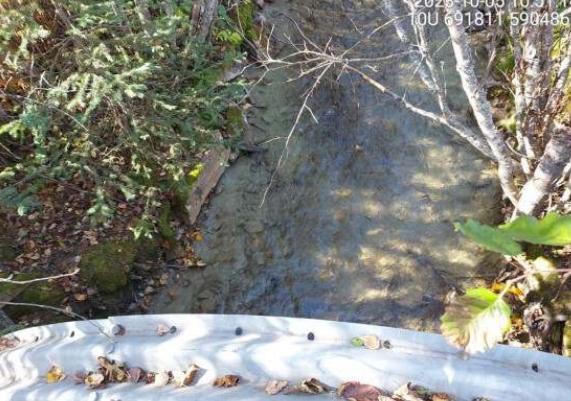
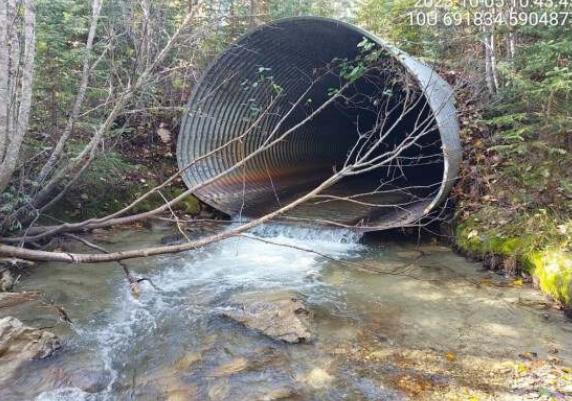
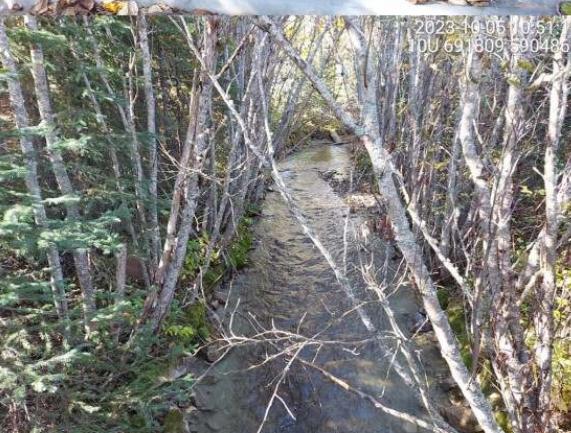
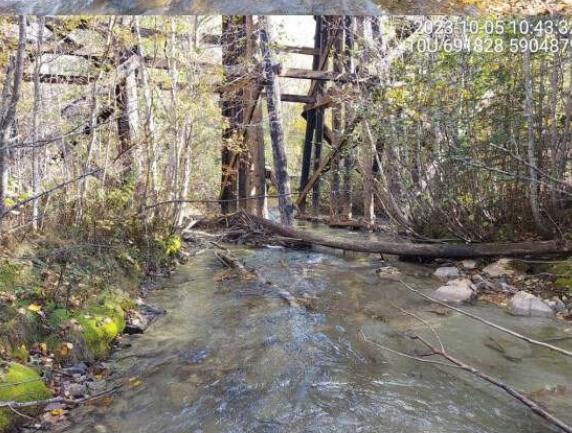
Photos: PSCIS ID 13900077. From top left clockwise: Road/Site Card, Barrel, Outlet, Downstream, Upstream, Inlet.

Comments: Wide channel and high flowing stream. Small outlet drop and high velocity in pipe with shallow flows over unembedded pipe. Chinook confirmed downstream near Fraser River confluence in the past. Railway bridge downstream seen in photos. MoTi chris_hwy_structure_road_id: 30365. 10:49:31

Location and Stream Data		Crossing Characteristics	
Date	2023-10-05	Crossing Sub Type	Oval Culvert
PSCIS ID	199273	Diameter (m)	4.5
External ID	13900077	Length (m)	28
Crew	MW	Embedded	No
UTM Zone	10	Depth Embedded (m)	–
Easting	691822	Resemble Channel	No
Northing	5904863	Backwatered	No
Stream	Hankins Creek	Percent Backwatered	–
Road	Eddy Rd	Fill Depth (m)	1.5
Road Tenure	MOTI Local	Outlet Drop (m)	0.3
Channel Width (m)	6.7	Outlet Pool Depth (m)	0.2
Stream Slope (%)	1.5	Inlet Drop	No
Beaver Activity	No	Slope (%)	0.5
Habitat Value	High	Valley Fill	Deep Fill
Final score	29	Barrier Result	Barrier
Fix type	Replace with New Open Bottom Structure	Fix Span / Diameter	15

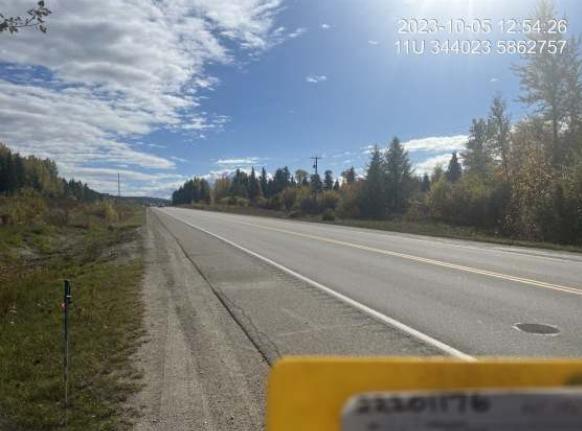
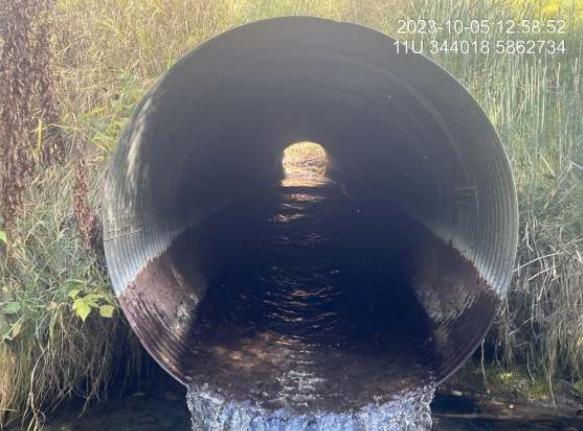
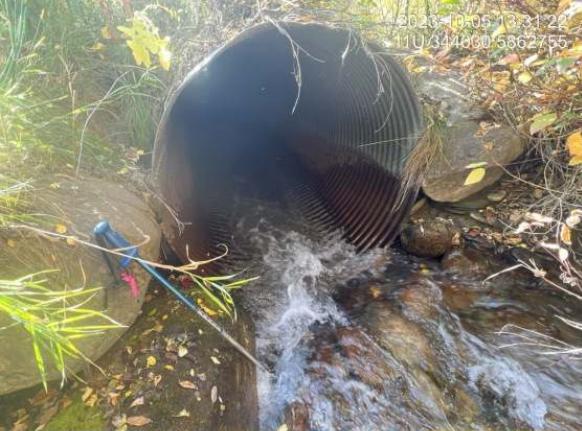
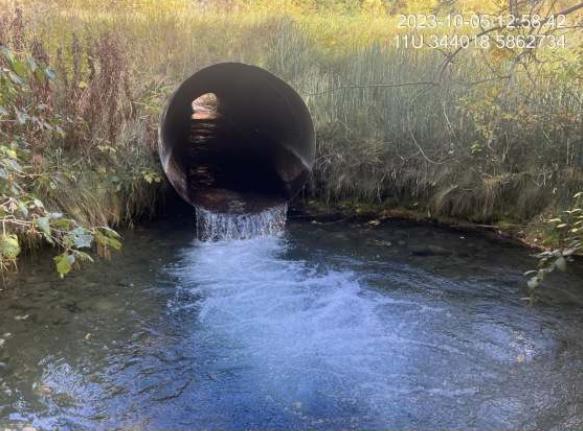
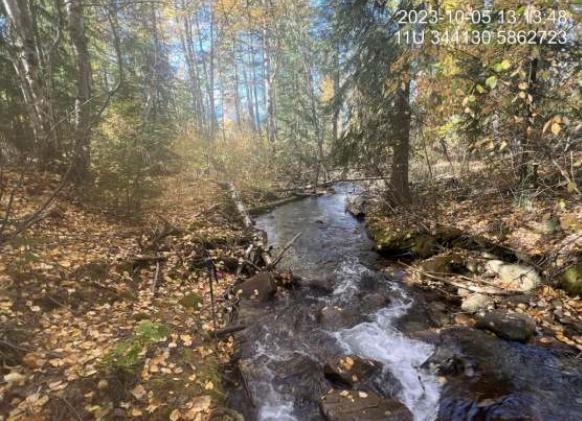
Photos: PSCIS ID 22201176. From top left clockwise: Road/Site Card, Barrel, Outlet, Downstream, Upstream, Inlet.

Comments: Very nice stream with salmon point in FISS located upstream. Very good flow with some pools present to 80cm deep upstream. Unassessed railway crossing approximately 200m upstream. There is no crossing at the pipeline but construction activities have resulted in a small cascade of boulders at the pipe which is similar to the natural cascade section observed approximately 50m upstream. Railway crossing downstream which is ranked as a barrier.
MoTi chris_culvert_id: 1467202. 12:56:09

Location and Stream Data		Crossing Characteristics	
Date	2023-10-05	Crossing Sub Type	Round Culvert
PSCIS ID	199278	Diameter (m)	1.5
External ID	22201176	Length (m)	26
Crew	MW	Embedded	No
UTM Zone	11	Depth Embedded (m)	—
Easting	344016	Resemble Channel	No
Northing	5862741	Backwatered	No
Stream	Teepee Creek	Percent Backwatered	—
Road	Highway 5	Fill Depth (m)	1.5
Road Tenure	MOTI	Outlet Drop (m)	0.4
Channel Width (m)	4.5	Outlet Pool Depth (m)	1
Stream Slope (%)	3.5	Inlet Drop	Yes
Beaver Activity	No	Slope (%)	1.5
Habitat Value	High	Valley Fill	Deep Fill
Final score	34	Barrier Result	Barrier
Fix type	Replace with New Open Bottom Structure	Fix Span / Diameter	15

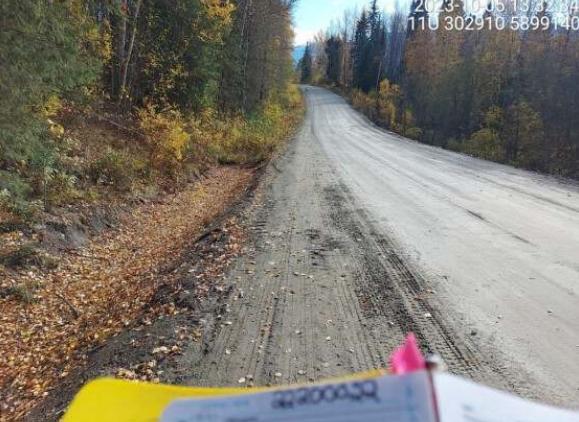
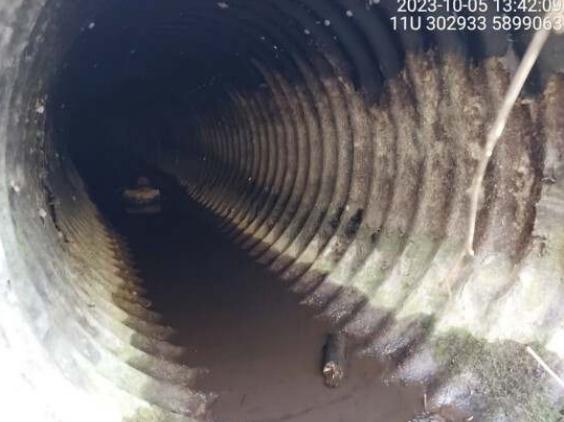
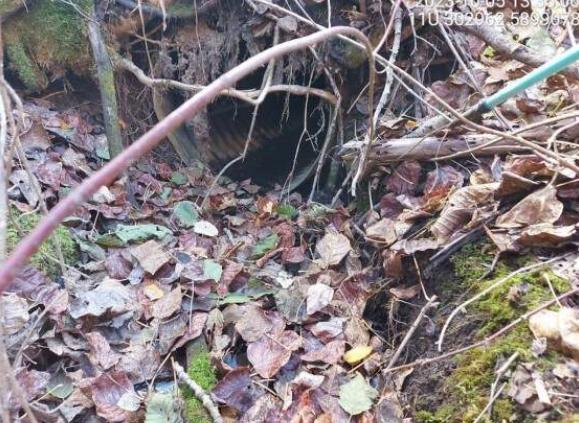
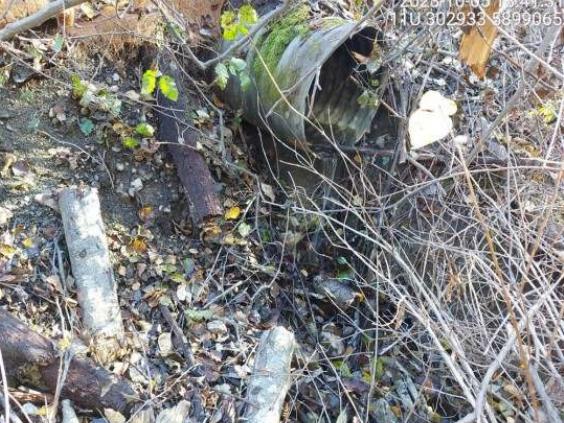
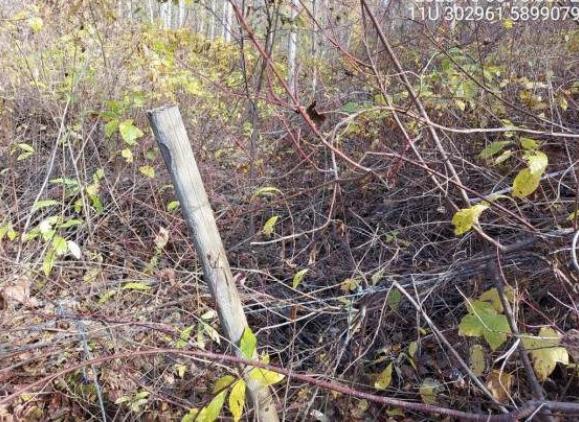
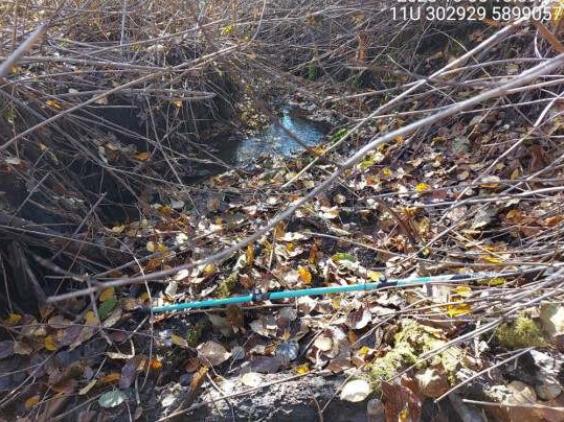
Photos: PSCIS ID 22200022. From top left clockwise: Road/Site Card, Barrel, Outlet, Downstream, Upstream, Inlet.

Location and Stream Data		Crossing Characteristics	
Date	2023-10-05	Crossing Sub Type	Round Culvert
PSCIS ID	199279	Diameter (m)	0.6
External ID	22200022	Length (m)	20
Crew	MW	Embedded	No
UTM Zone	11	Depth Embedded (m)	—
Easting	302951	Resemble Channel	No
Northing	5899072	Backwatered	No
Stream	Tributary to Fraser river	Percent Backwatered	—
Road	Hinkelman Rd	Fill Depth (m)	5
Road Tenure	MOTI Local	Outlet Drop (m)	0.7
Channel Width (m)	1.4	Outlet Pool Depth (m)	0
Stream Slope (%)	3	Inlet Drop	No
Beaver Activity	No	Slope (%)	1
Habitat Value	Low	Valley Fill	Deep Fill
Final score	34	Barrier Result	Barrier
Fix type	Replace Structure with Streambed Simulation CBS	Fix Span / Diameter	3
