Appendix - Phase 1 Fish Passage Assessment Data and Photos

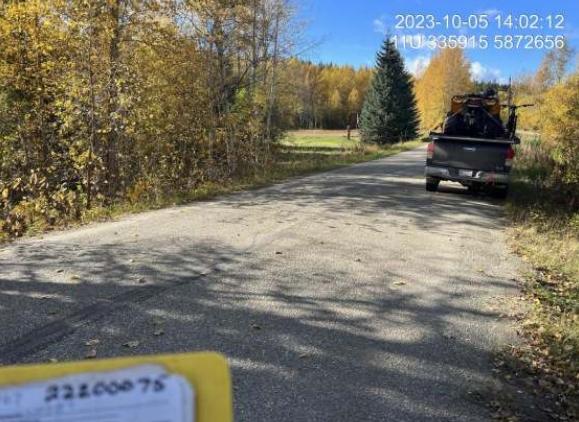
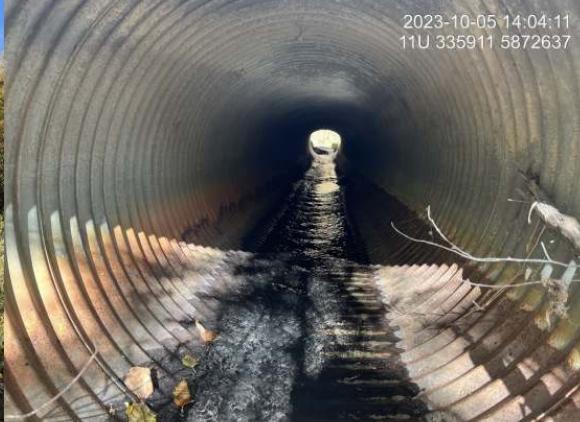
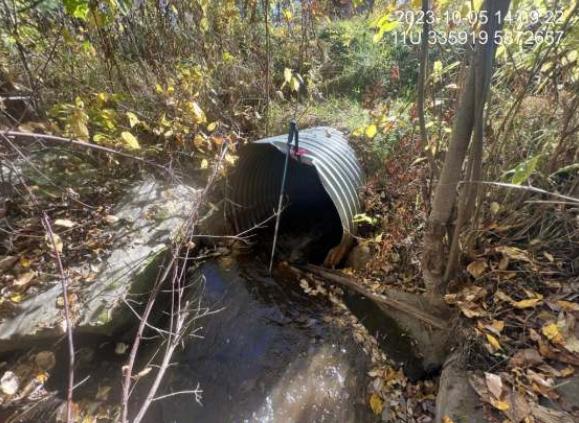
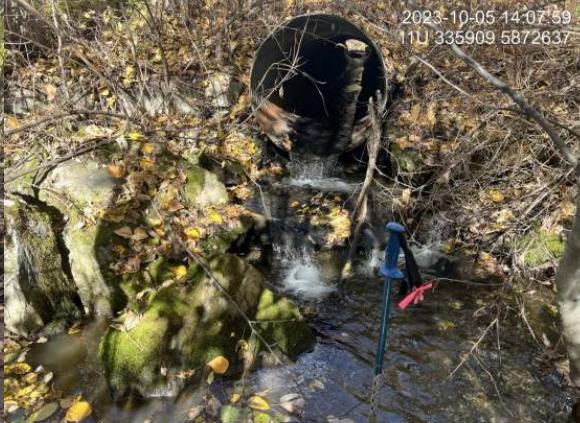
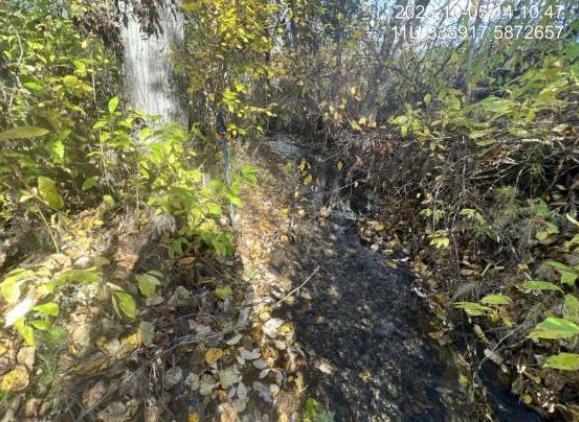
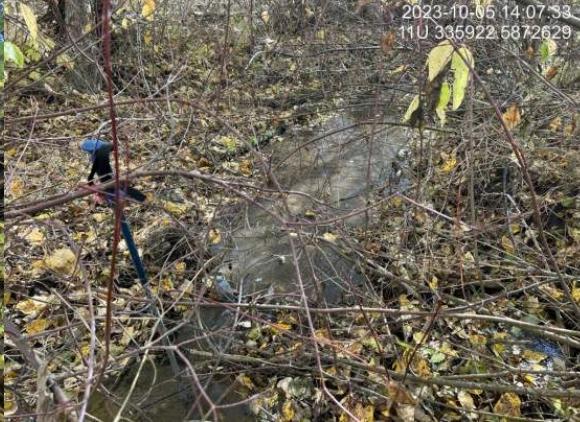
Photos: PSCIS ID 22200075. From top left clockwise: Road/Site Card, Barrel, Outlet, Downstream, Upstream, Inlet.

Location and Stream Data	•	Crossing Characteristics	–
Date	2023-10-05	Crossing Sub Type	Round Culvert
PSCIS ID	199280	Diameter (m)	1.05
External ID	22200075	Length (m)	19
Crew	MW	Embedded	No
UTM Zone	11	Depth Embedded (m)	–
Easting	335908	Resemble Channel	No
Northing	5872652	Backwatered	No
Stream	L'Esrange Creek	Percent Backwatered	–
Road	L'heureux Road	Fill Depth (m)	1.8
Road Tenure	MOTI	Outlet Drop (m)	0.5
Channel Width (m)	2.2	Outlet Pool Depth (m)	0.4
Stream Slope (%)	2	Inlet Drop	No
Beaver Activity	No	Slope (%)	3
Habitat Value	Medium	Valley Fill	Deep Fill
Final score	39	Barrier Result	Barrier
Fix type	Replace with New Open Bottom Structure	Fix Span / Diameter	15
Comments: Nice little stream with good flow and abundant small gravel's upstream. There may be crossings downstream on private land. Significant amount of large riprap placed around inlet and outlet to protect the crossing. Outlet is placed on large piece of riprap, so 0.3m was added to the 0.2m outlet drop to account for the additional distance from the stream to the outlet. RB observed upstream. MoTi chris_culvert_id: 1466467. 14:00:15

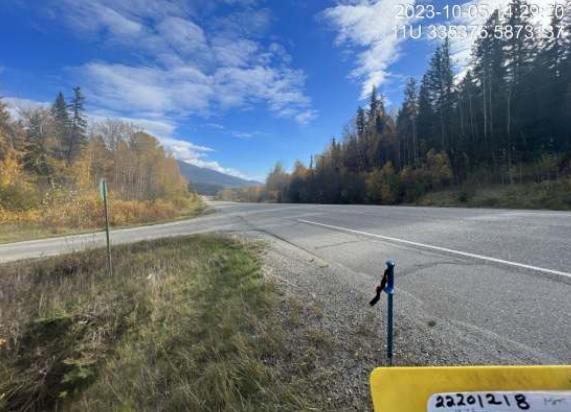
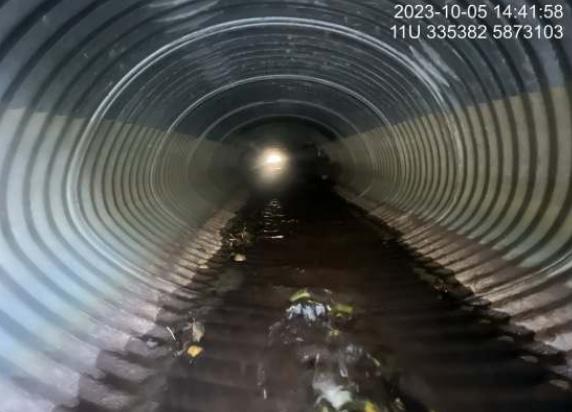
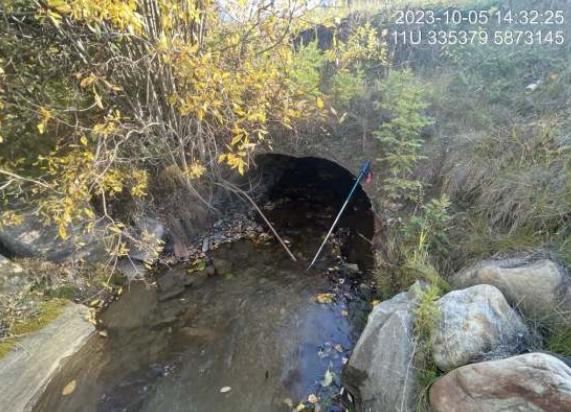
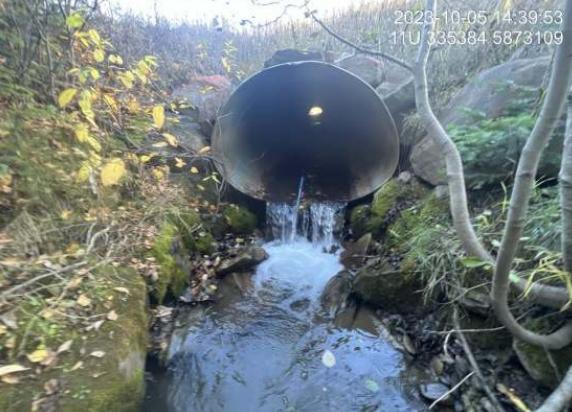
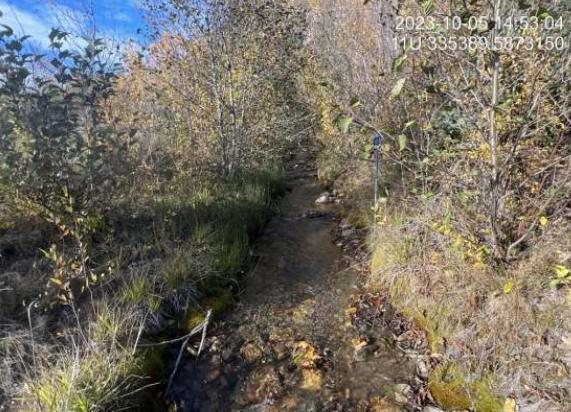
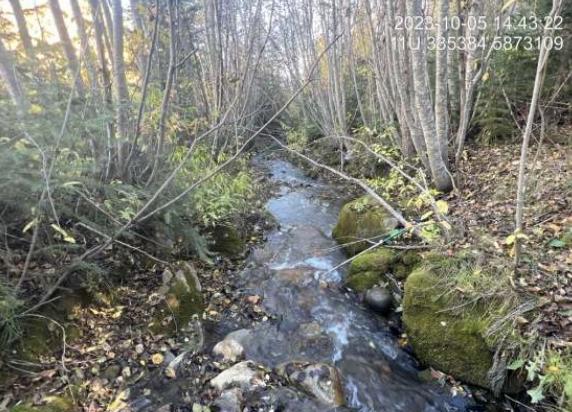
Photos: PSCIS ID 22201218. From top left clockwise: Road/Site Card, Barrel, Outlet, Downstream, Upstream, Inlet.

Location and Stream Data	.	Crossing Characteristics	–
Date	2023-10-05	Crossing Sub Type	Oval Culvert
PSCIS ID	199281	Diameter (m)	1.7
External ID	22201218	Length (m)	35
Crew	MW	Embedded	No
UTM Zone	11	Depth Embedded (m)	–
Easting	335375	Resemble Channel	No
Northing	5873132	Backwatered	No
Stream	Goslin Creek	Percent Backwatered	–
Road	Highway 16	Fill Depth (m)	2
Road Tenure	MOTI	Outlet Drop (m)	0.4
Channel Width (m)	1	Outlet Pool Depth (m)	0.4
Stream Slope (%)	0	Inlet Drop	No
Beaver Activity	No	Slope (%)	2
Habitat Value	Medium	Valley Fill	Deep Fill
Final score	31	Barrier Result	Barrier
Fix type	Replace Structure with Streambed Simulation CBS	Fix Span / Diameter	3

Comments: Very nice stream with good flow and abundant gravels upstream. Pipe is an extremely bad shape with extensive corrosion inside of the pipe particularly at the downstream end - see photos. Likely at least one crossing downstream on private land. Transmission line corridor is located immediately upstream and the channel appears to be modified in this location to be straighter and narrower than its natural state. No crossing immediately upstream on Goslin Road (no road - crossing should be removed as potential barrier in bcfishpass) MoTi chris_culvert_id: 1465295.
14:28:28

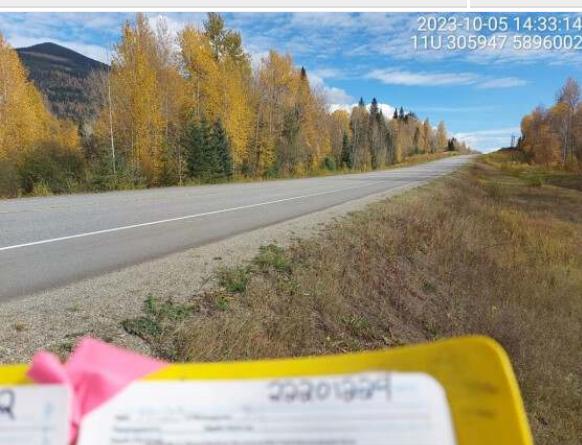
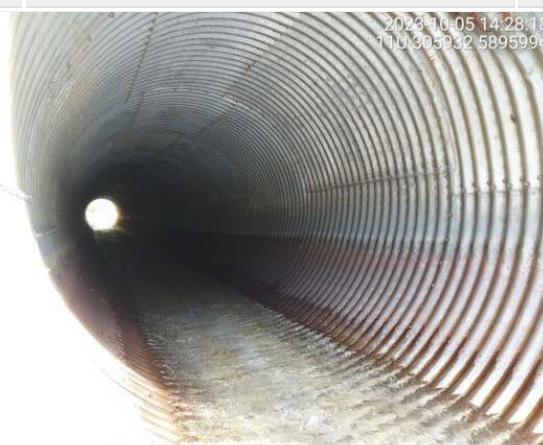
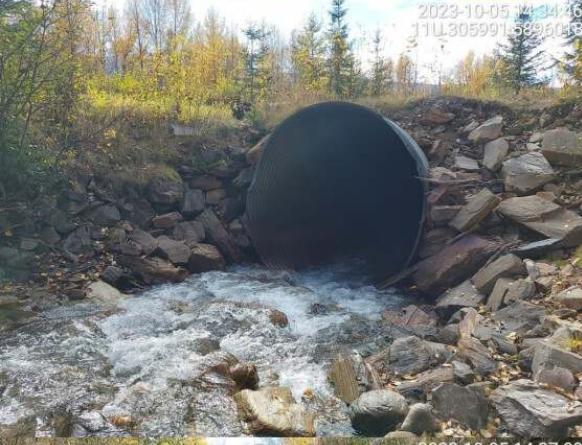
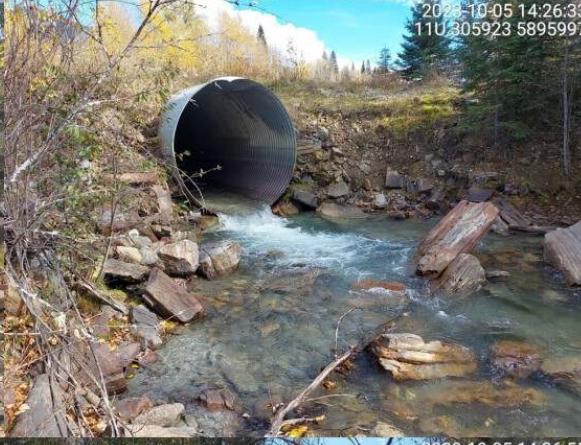
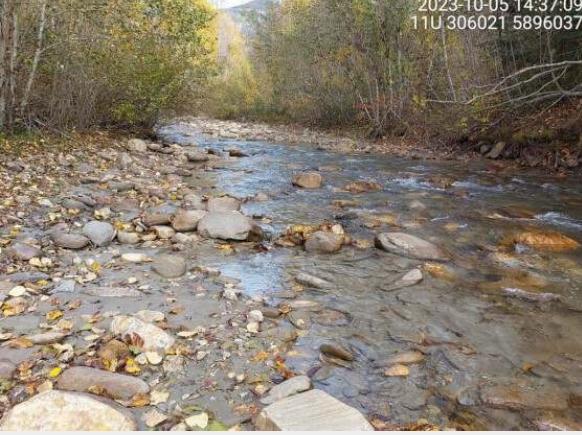
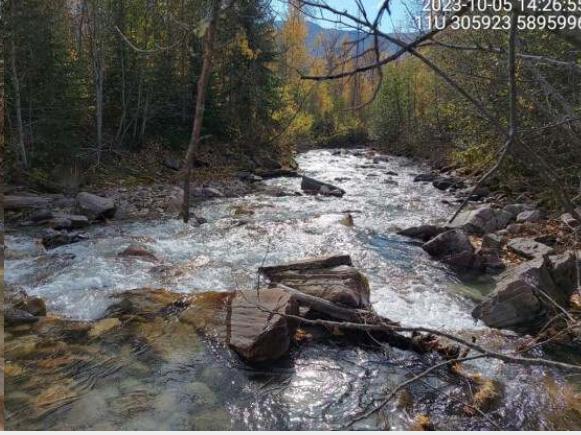
Photos: PSCIS ID 22201229. From top left clockwise: Road/Site Card, Barrel, Outlet, Downstream, Upstream, Inlet.

Location and Stream Data		Crossing Characteristics	
Date	2023-10-05	Crossing Sub Type	Round Culvert
PSCIS ID	199282	Diameter (m)	2.5
External ID	22201229	Length (m)	56
Crew	MW	Embedded	No
UTM Zone	11	Depth Embedded (m)	–
Easting	305965	Resemble Channel	No
Northing	5896000	Backwatered	No
Stream	Holliday Creek	Percent Backwatered	–
Road	Highway 16	Fill Depth (m)	2.3
Road Tenure	MOTI	Outlet Drop (m)	0.4
Channel Width (m)	10.8	Outlet Pool Depth (m)	0.3
Stream Slope (%)	5	Inlet Drop	No
Beaver Activity	No	Slope (%)	2
Habitat Value	High	Valley Fill	Deep Fill
Final score	37	Barrier Result	Barrier
Fix type	Replace with New Open Bottom Structure	Fix Span / Diameter	15

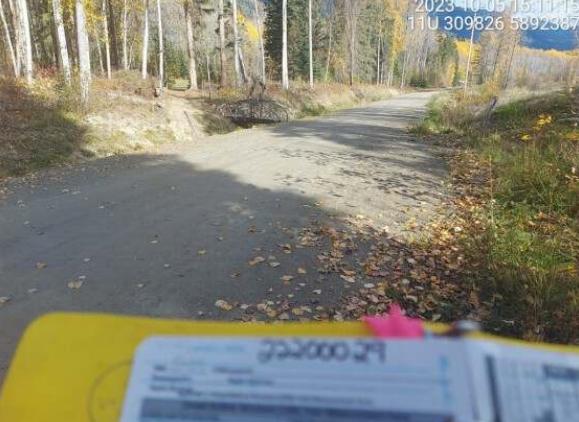
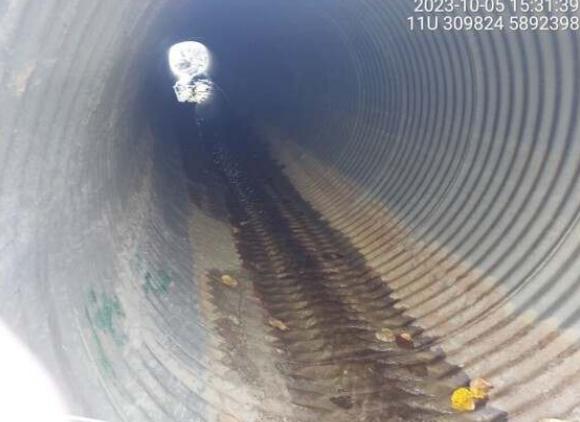
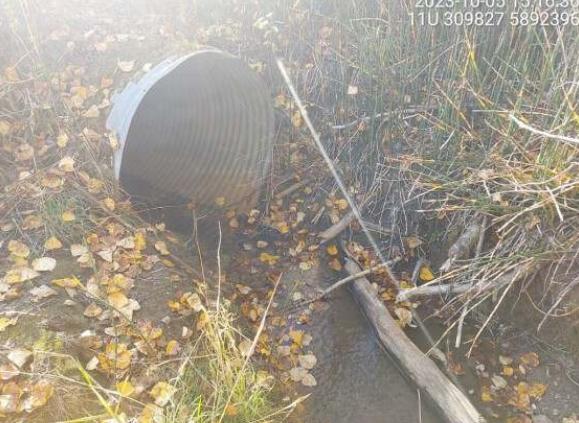
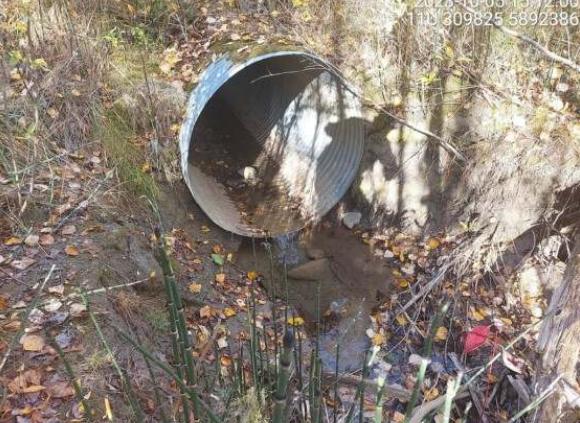
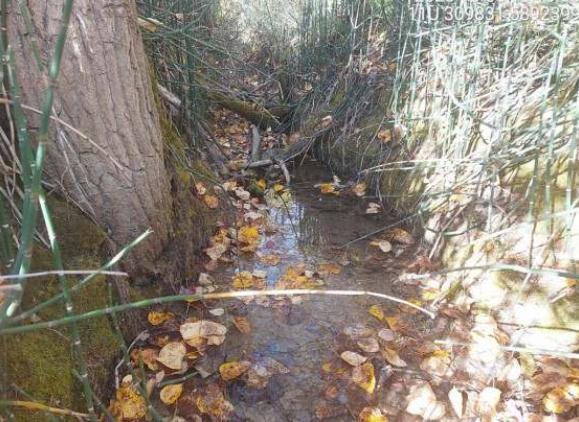
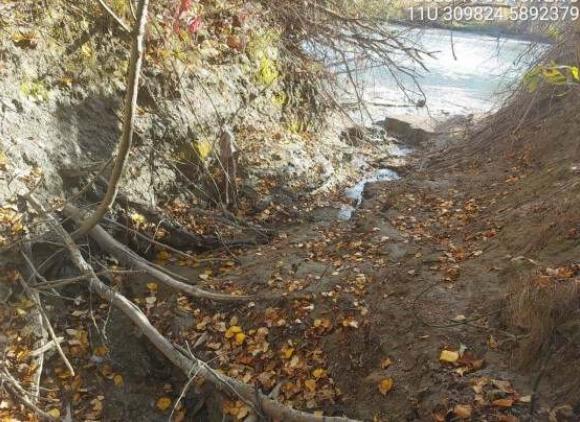
Photos: PSCIS ID 22200029. From top left clockwise: Road/Site Card, Barrel, Outlet, Downstream, Upstream, Inlet.

Location and Stream Data		Crossing Characteristics	
Date	2023-10-05	Crossing Sub Type	Round Culvert
PSCIS ID	199283	Diameter (m)	1.4
External ID	22200029	Length (m)	19
Crew	MW	Embedded	No
UTM Zone	11	Depth Embedded (m)	–
Easting	309830	Resemble Channel	No
Northing	5892394	Backwatered	No
Stream	Tributary to Fraser River	Percent Backwatered	–
Road	River Rd	Fill Depth (m)	2.2
Road Tenure	MOTI Local	Outlet Drop (m)	0.2
Channel Width (m)	1.2	Outlet Pool Depth (m)	0.2
Stream Slope (%)	3.5	Inlet Drop	No
Beaver Activity	No	Slope (%)	0
Habitat Value	Low	Valley Fill	Deep Fill
Final score	18	Barrier Result	Potential
Fix type	Replace Structure with Streambed Simulation CBS	Fix Span / Diameter	3

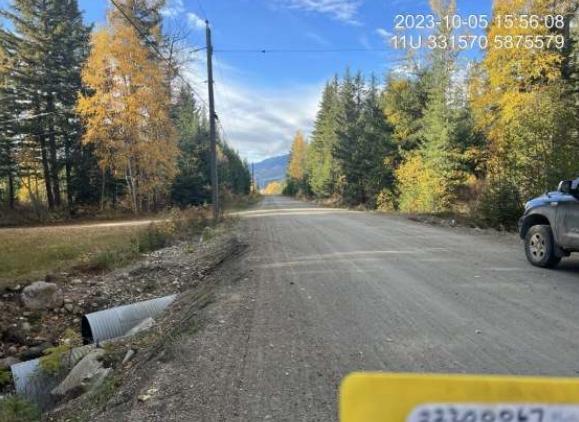
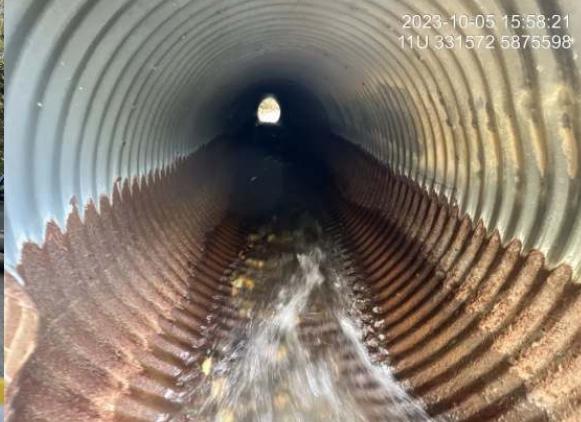
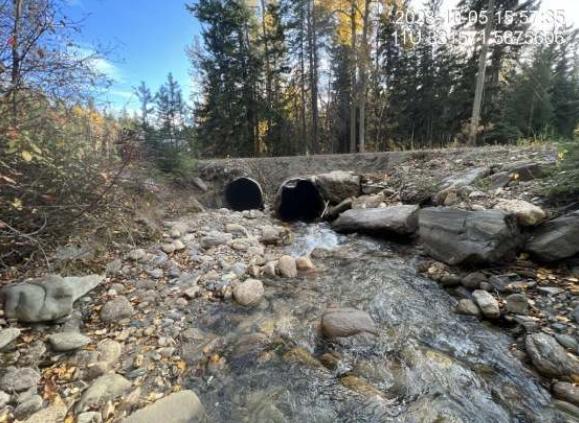
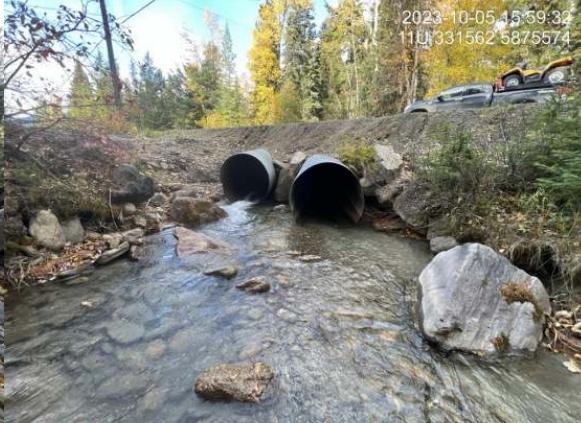
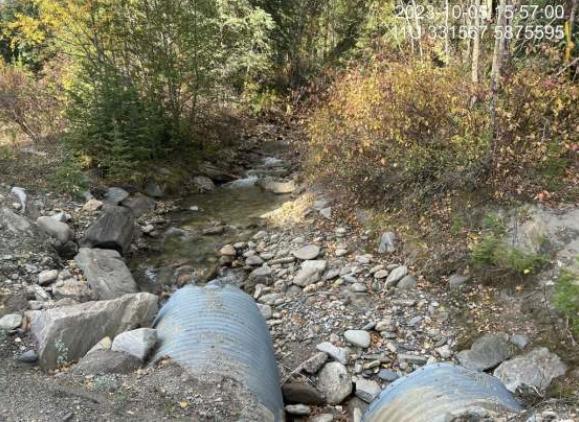
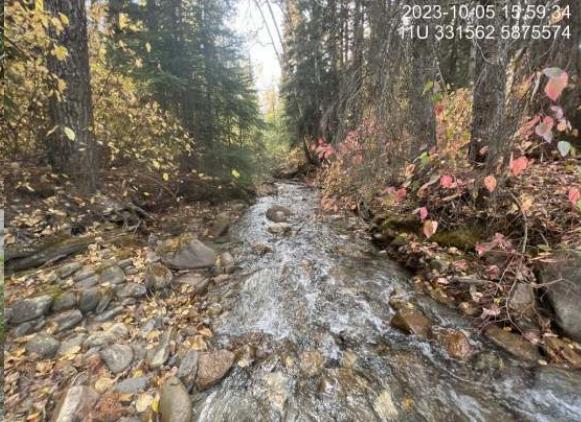
Photos: PSCIS ID 22200067. From top left clockwise: Road/Site Card, Barrel, Outlet, Downstream, Upstream, Inlet.

Location and Stream Data		Crossing Characteristics	
Date	2023-10-05	Crossing Sub Type	Round Culvert
PSCIS ID	199284	Diameter (m)	2.6
External ID	22200067	Length (m)	18
Crew	MW	Embedded	No
UTM Zone	11	Depth Embedded (m)	—
Easting	331575	Resemble Channel	No
Northing	5875589	Backwatered	No
Stream	Spittal Creek	Percent Backwatered	—
Road	Care Road	Fill Depth (m)	1.5
Road Tenure	MOTI	Outlet Drop (m)	0
Channel Width (m)	5.8	Outlet Pool Depth (m)	0.4
Stream Slope (%)	6	Inlet Drop	Yes
Beaver Activity	No	Slope (%)	5
Habitat Value	High	Valley Fill	Deep Fill
Final score	29	Barrier Result	Barrier
Fix type	Replace with New Open Bottom Structure	Fix Span / Diameter	15

Comments: Pipes and road are in extremely poor condition with evidence of embankment failure and pipes rusted all the way through on the bottom side in places. Small side road parallel to Highway 16 with residences that could be accessed from either side. Removal of crossing could perhaps be considered. Large high value system suitable for bulltrout rearing. Culvert upstream is relatively new concrete box culvert on the highway which is over half embedded and 3.7m wide. MoTi chris_culvert_id: 1466350. 15:53:19

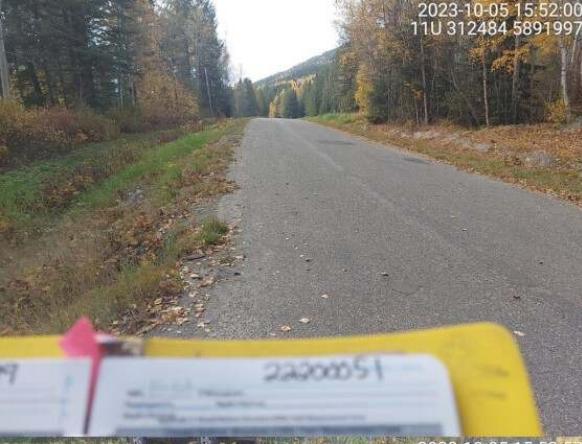
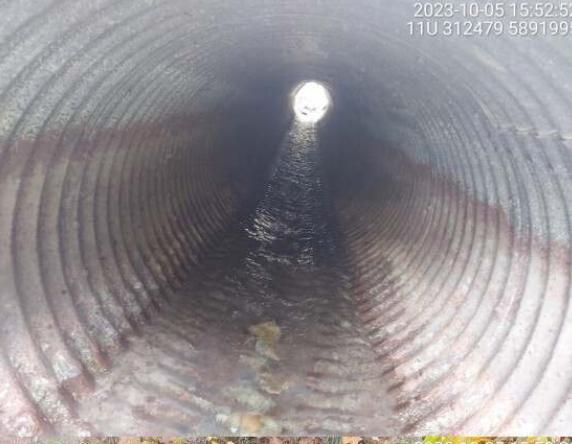
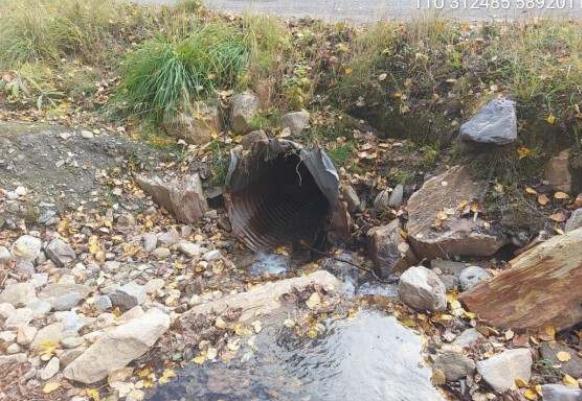
Photos: PSCIS ID 22200051. From top left clockwise: Road/Site Card, Barrel, Outlet, Downstream, Upstream, Inlet.

Location and Stream Data		Crossing Characteristics	
Date	2023-10-05	Crossing Sub Type	Round Culvert
PSCIS ID	199285	Diameter (m)	1.1
External ID	22200051	Length (m)	8
Crew	MW	Embedded	No
UTM Zone	11	Depth Embedded (m)	–
Easting	312484	Resemble Channel	No
Northing	5892004	Backwatered	No
Stream	Tributary to Fraser River	Percent Backwatered	–
Road	Read Rd	Fill Depth (m)	1
Road Tenure	MOTI Local	Outlet Drop (m)	0
Channel Width (m)	2.5	Outlet Pool Depth (m)	0
Stream Slope (%)	4.5	Inlet Drop	No
Beaver Activity	No	Slope (%)	5
Habitat Value	Medium	Valley Fill	Deep Fill
Final score	26	Barrier Result	Barrier
Fix type	Replace with New Open Bottom Structure	Fix Span / Diameter	15

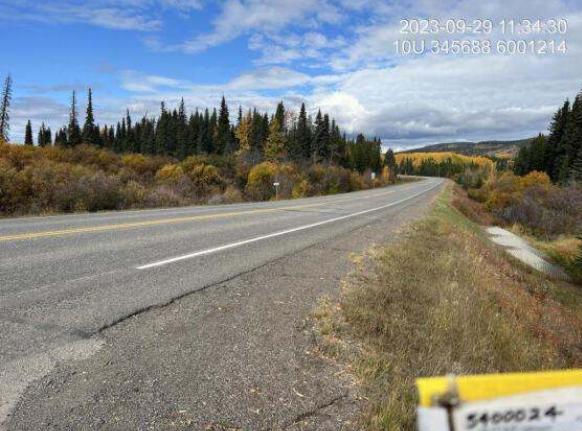
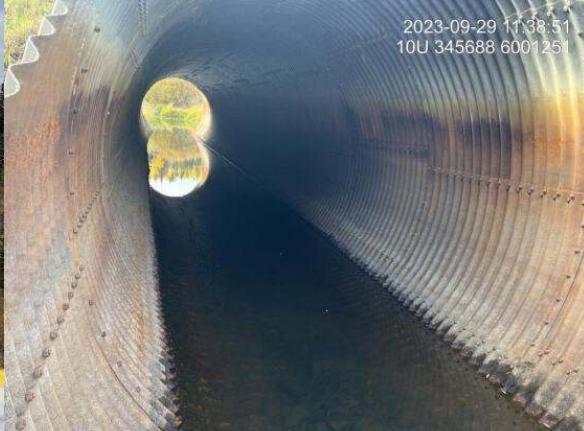
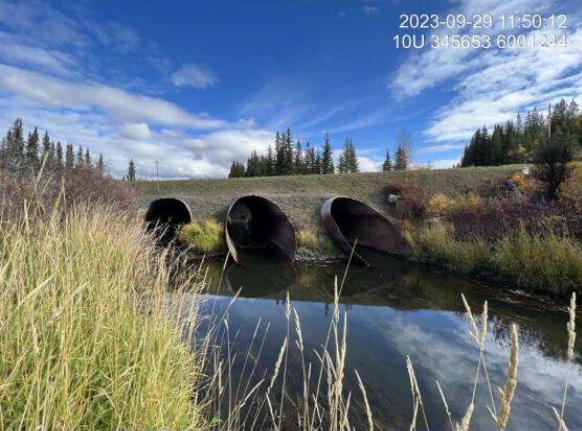
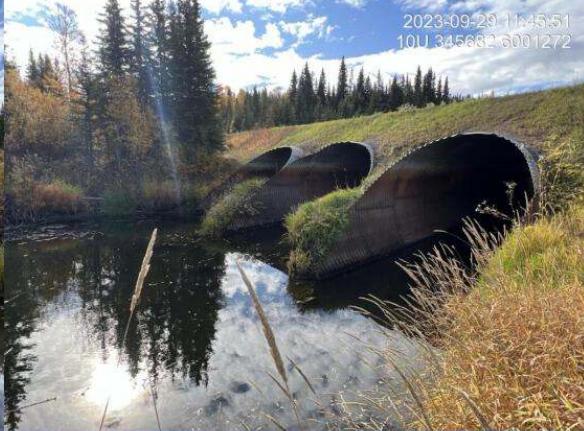
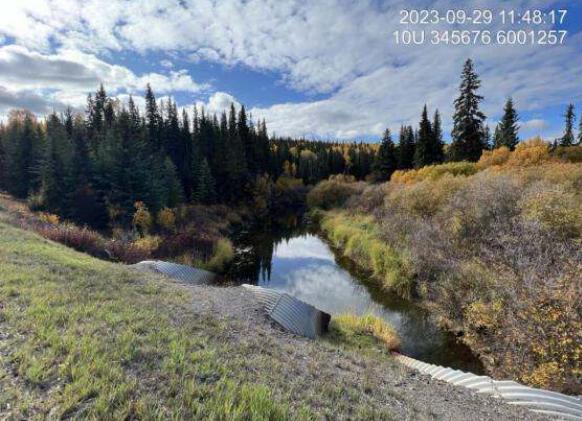
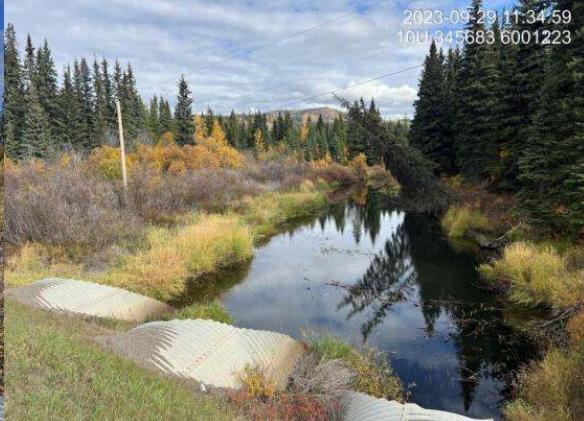
Photos: PSCIS ID 5400024. From top left clockwise: Road/Site Card, Barrel, Outlet, Downstream, Upstream, Inlet.

Comments: Three 4 m diameter pipes. All three pipes are 100% backwatered, and passable. Road prism and pipes appear to be in good condition. Extensive beaver activity upstream and downstream. Diameter changed from 12m to 9.99m to meet spreadsheet requirements. MoTi chris_hwy_structure_road_id: 3812. 11:35:39

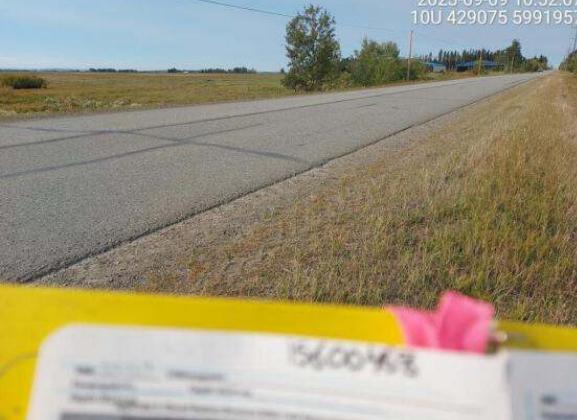
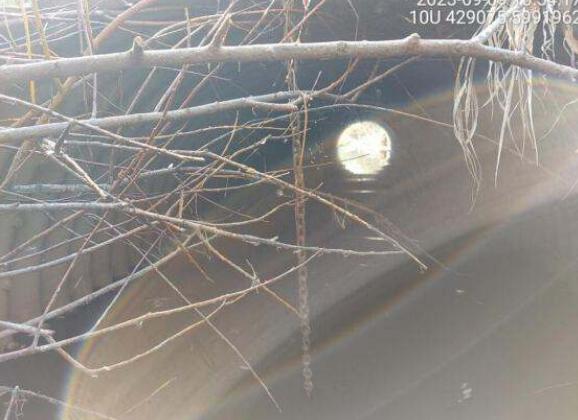
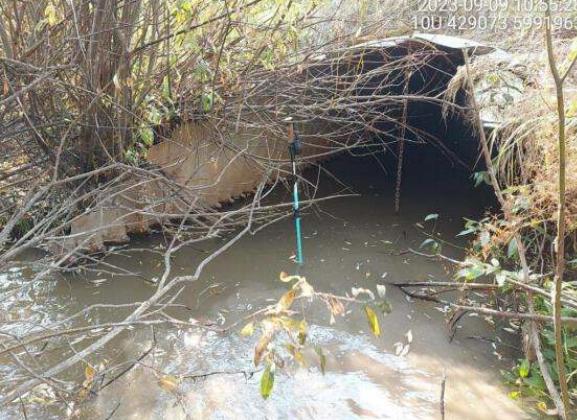
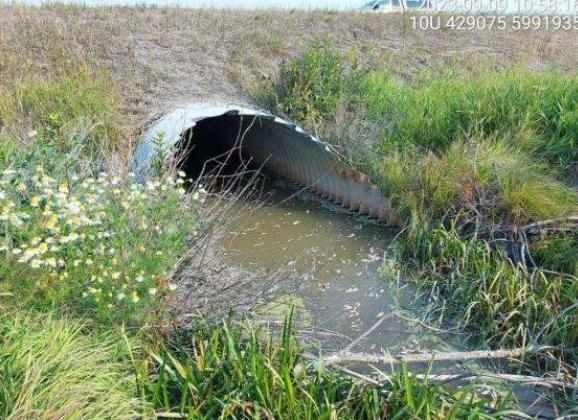
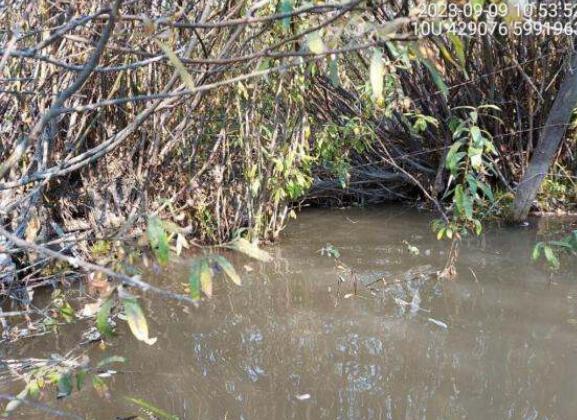
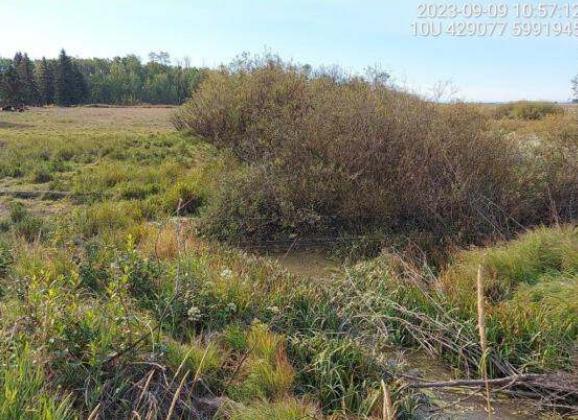
Location and Stream Data		•	Crossing Characteristics	–
Date	2023-09-09	Crossing Sub Type	Round Culvert	
PSCIS ID	199293	Diameter (m)	2.2	
External ID	15600468	Length (m)	14	
Crew	MW	Embedded	No	
UTM Zone	10	Depth Embedded (m)	–	
Easting	429073	Resemble Channel	No	
Northing	5991955	Backwatered	Yes	
Stream	Murray Creek	Percent Backwatered	100	
Road	Northside Rd	Fill Depth (m)	1.5	
Road Tenure	MOTI	Outlet Drop (m)	0	
Channel Width (m)	2.7	Outlet Pool Depth (m)	0.5	
Stream Slope (%)	0	Inlet Drop	No	
Beaver Activity	No	Slope (%)	0.5	
Habitat Value	Medium	Valley Fill	Deep Fill	
Final score	13	Barrier Result	Passable	
Fix type	–	Fix Span / Diameter	–	
Comments: Agricultural land on both sides and cow pasture downstream. Fully backwatered culvert with no flowing water. Cows seen intruding into the stream channel at time of survey. MoTi chris_culvert_id: 1799951. 10:55:03				
Photos: PSCIS ID 15600468. From top left clockwise: Road/Site Card, Barrel, Outlet, Downstream, Upstream, Inlet.

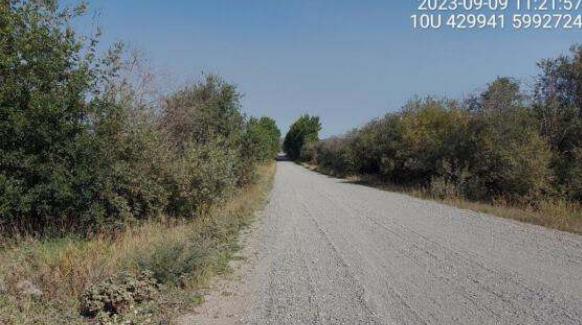
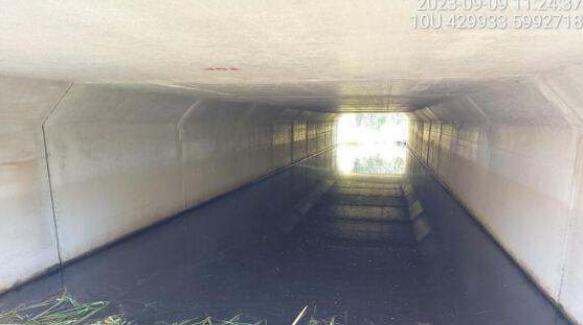
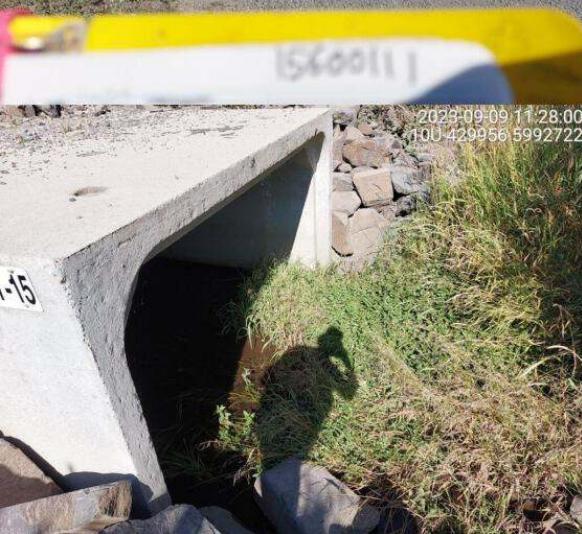
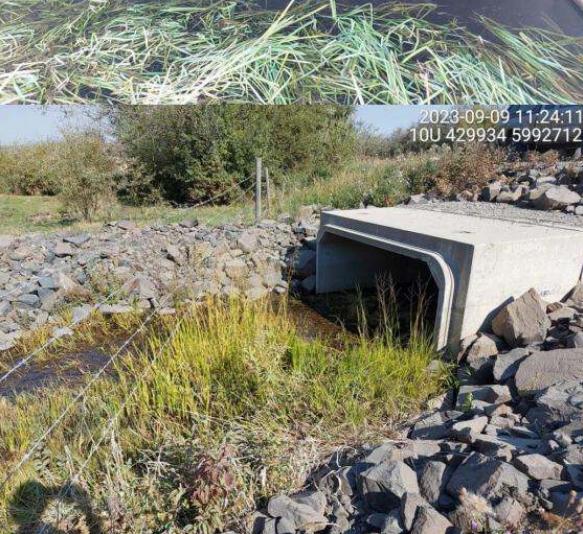
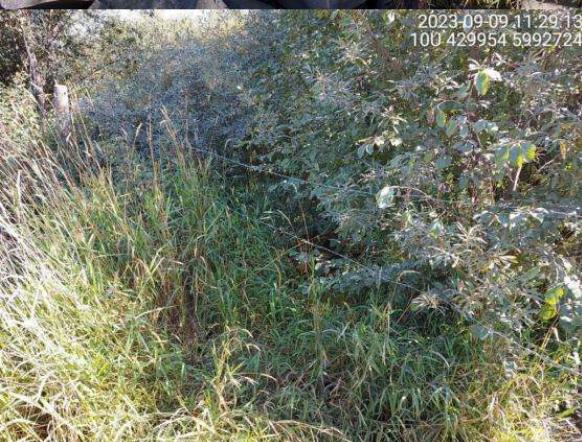
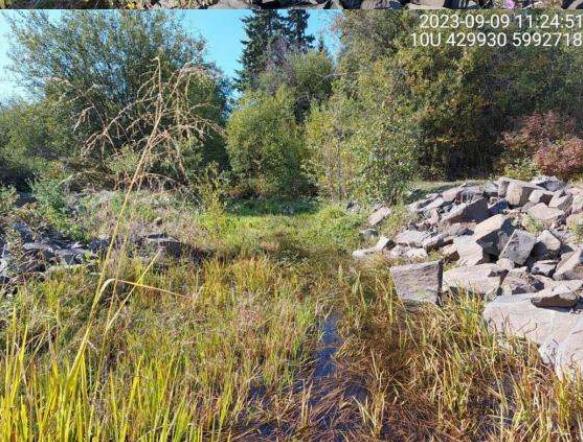
Location and Stream Data		•	Crossing Characteristics	–
Date	2023-09-09	Crossing Sub Type	Concrete Box	–
PSCIS ID	199294	Diameter (m)	3.1	–
External ID	15600111	Length (m)	16	–
Crew	MW	Embedded	No	–
UTM Zone	10	Depth Embedded (m)	–	–
Easting	429944	Resemble Channel	No	–
Northing	5992722	Backwatered	Yes	–
Stream	Murray Creek	Percent Backwatered	100	–
Road	Larson Road	Fill Depth (m)	0.5	–
Road Tenure	MOTI Local	Outlet Drop (m)	0	–
Channel Width (m)	2.7	Outlet Pool Depth (m)	0.1	–
Stream Slope (%)	0.5	Inlet Drop	No	–
Beaver Activity	No	Slope (%)	0	–
Habitat Value	High	Valley Fill	Deep Fill	–
Final score	13	Barrier Result	Passable	–
Fix type	–	Fix Span / Diameter	–	–
Comments: Stream section is part of rehab project. New - fully backwatered structure likely passable to all life stages and species at time of assessment. MoTi chris_hwy_structure_road_id: 26621. 11:25:02				
Photos: PSCIS ID 15600111. From top left clockwise: Road/Site Card, Barrel, Outlet, Downstream, Upstream, Inlet.

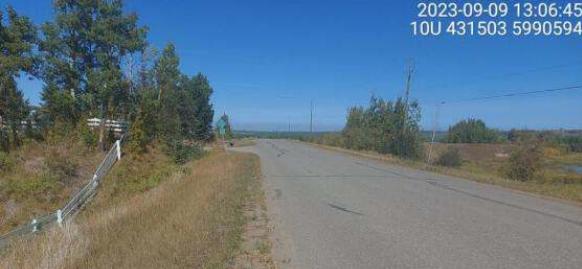
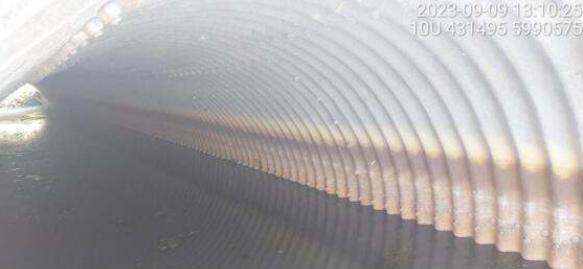
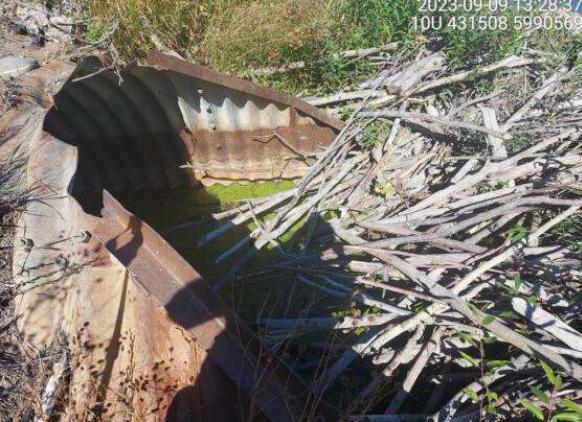
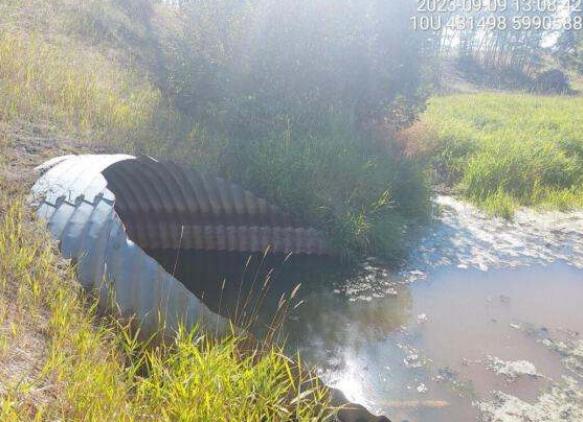
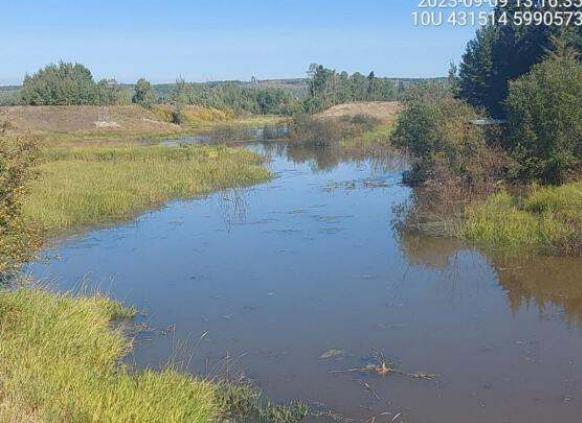
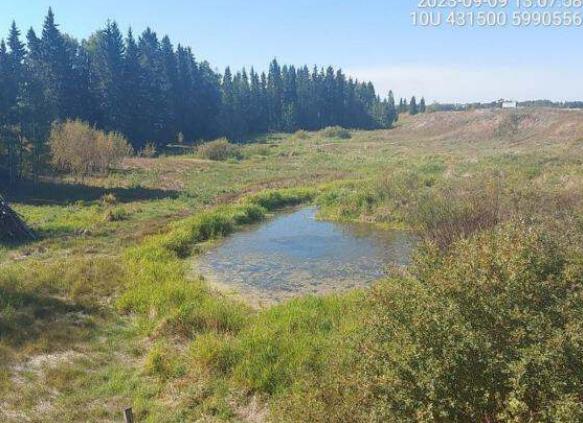
Photos: PSCIS ID 15600106. From top left clockwise: Road/Site Card, Barrel, Outlet, Downstream, Upstream, Inlet.

Location and Stream Data		Crossing Characteristics	
Date	2023-09-09	Crossing Sub Type	Round Culvert
PSCIS ID	199295	Diameter (m)	2.5
External ID	15600106	Length (m)	18
Crew	MW	Embedded	No
UTM Zone	10	Depth Embedded (m)	–
Easting	431487	Resemble Channel	No
Northing	5990586	Backwatered	Yes
Stream	East Murray Creek	Percent Backwatered	100
Road	Northside Rd	Fill Depth (m)	3
Road Tenure	MOTI	Outlet Drop (m)	0
Channel Width (m)	2.5	Outlet Pool Depth (m)	1.5
Stream Slope (%)	1	Inlet Drop	Yes
Beaver Activity	Yes	Slope (%)	1
Habitat Value	Low	Valley Fill	Deep Fill
Final score	21	Barrier Result	Barrier
Fix type	Replace with New Open Bottom Structure	Fix Span / Diameter	15

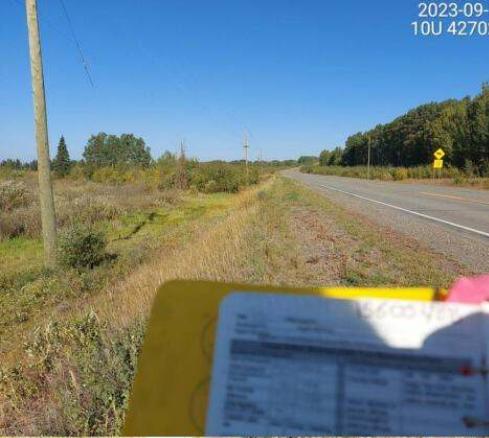
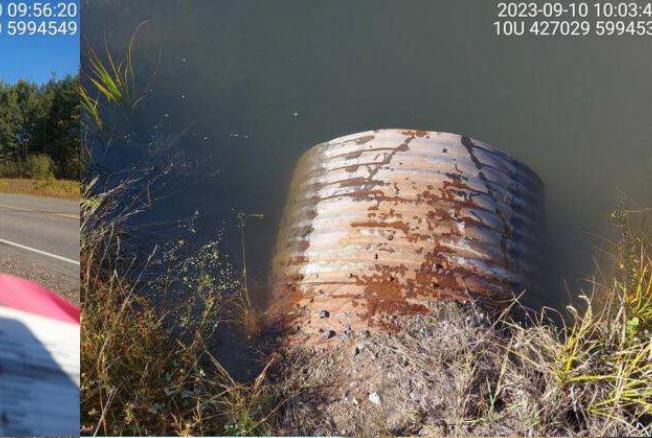
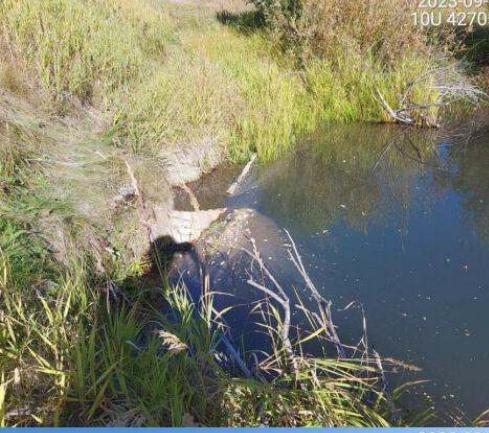
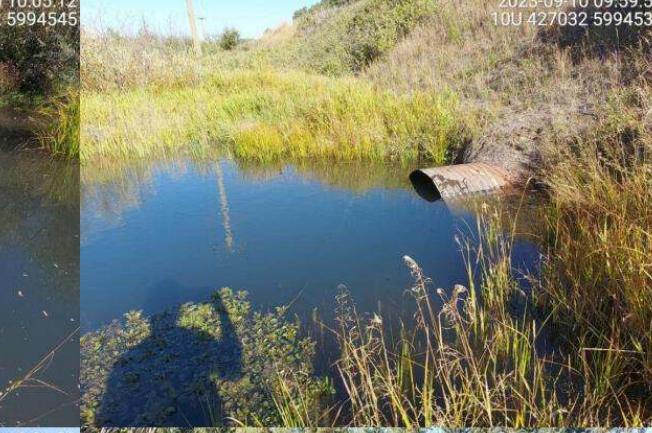
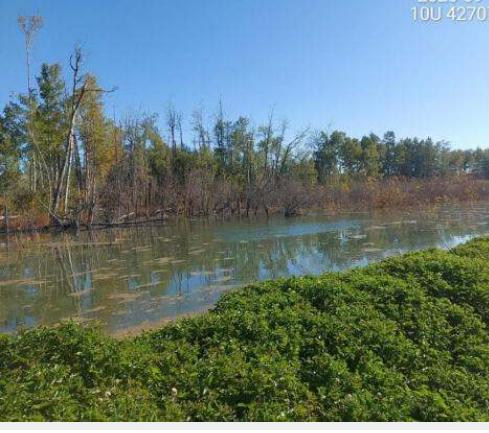
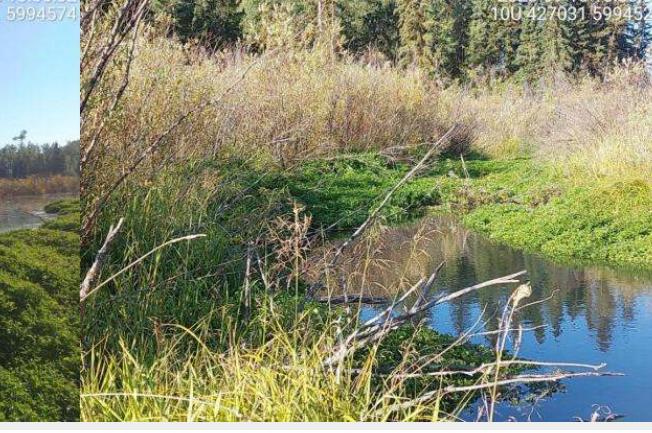
Photos: PSCIS ID 15600488. From top left clockwise: Road/Site Card, Barrel, Outlet, Downstream, Upstream, Inlet.

Location and Stream Data	.	Crossing Characteristics	–
Date	2023-09-10	Crossing Sub Type	Round Culvert
PSCIS ID	199296	Diameter (m)	1.3
External ID	15600488	Length (m)	20
Crew	MW	Embedded	No
UTM Zone	10	Depth Embedded (m)	–
Easting	427033	Resemble Channel	No
Northing	5994538	Backwatered	Yes
Stream	Tributary to Clear Creek	Percent Backwatered	100
Road	Highway 27S	Fill Depth (m)	2.5
Road Tenure	MOTI	Outlet Drop (m)	0
Channel Width (m)	1.3	Outlet Pool Depth (m)	0.8
Stream Slope (%)	1	Inlet Drop	No
Beaver Activity	Yes	Slope (%)	1
Habitat Value	Medium	Valley Fill	Deep Fill
Final score	21	Barrier Result	Barrier
Fix type	Replace Structure with Streambed Simulation CBS	Fix Span / Diameter	3

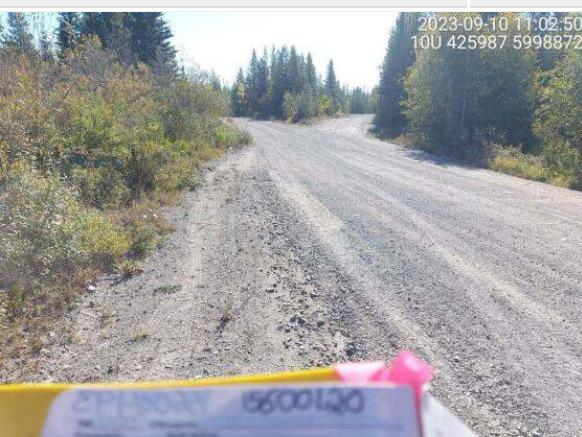
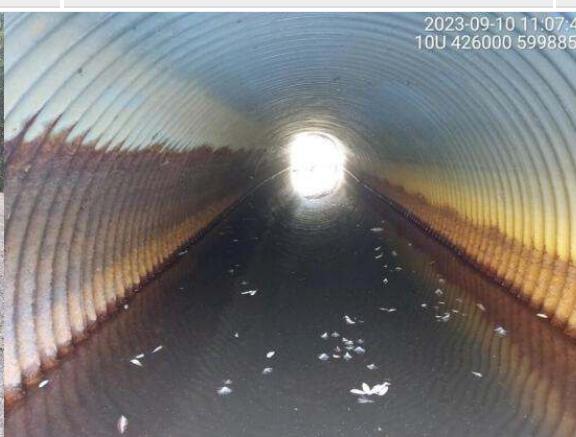
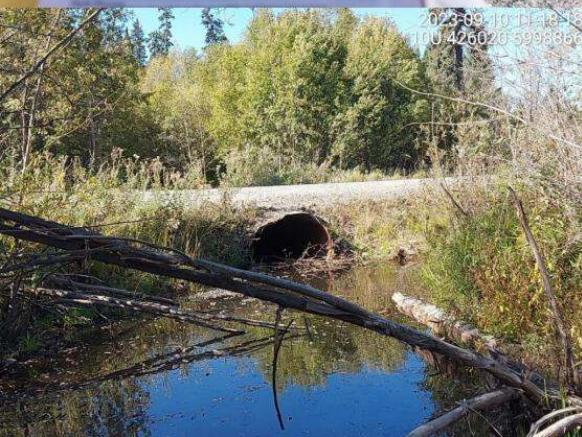
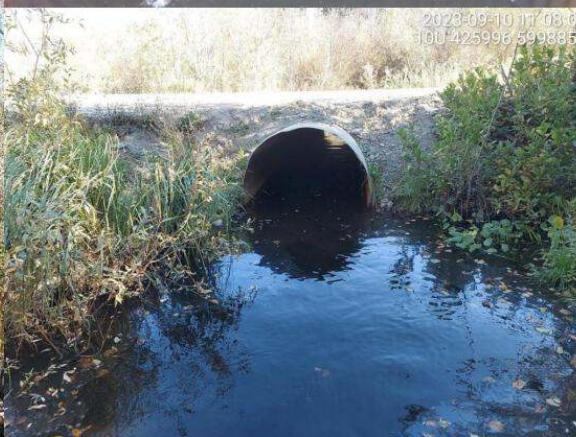
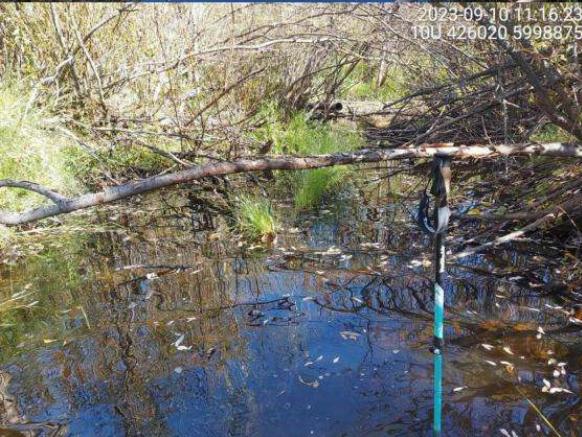
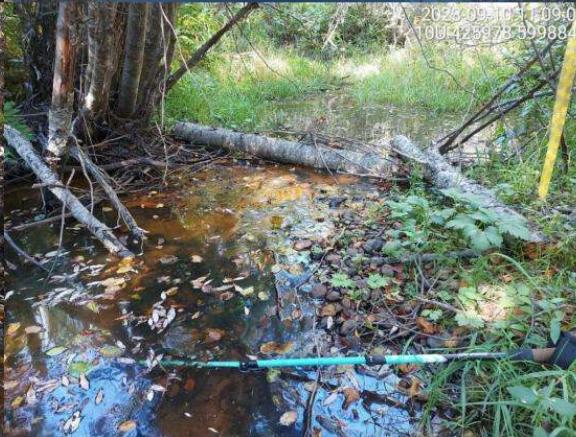
Photos: PSCIS ID 15600120. From top left clockwise: Road/Site Card, Barrel, Outlet, Downstream, Upstream, Inlet.

Location and Stream Data		.	Crossing Characteristics	-
Date	2023-09-10		Crossing Sub Type	Round Culvert
PSCIS ID	199297		Diameter (m)	2.35
External ID	15600120		Length (m)	10
Crew	MW		Embedded	No
UTM Zone	10		Depth Embedded (m)	-
Easting	426006		Resemble Channel	No
Northing	5998858		Backwatered	Yes
Stream	Clear Creek		Percent Backwatered	100
Road	Fourteen Mile Rd		Fill Depth (m)	0.3
Road Tenure	MOTI Local		Outlet Drop (m)	0
Channel Width (m)	2.5		Outlet Pool Depth (m)	0.4
Stream Slope (%)	4		Inlet Drop	No
Beaver Activity	Yes		Slope (%)	1
Habitat Value	Medium		Valley Fill	Deep Fill
Final score	18		Barrier Result	Potential
Fix type	Replace with New Open Bottom Structure		Fix Span / Diameter	15

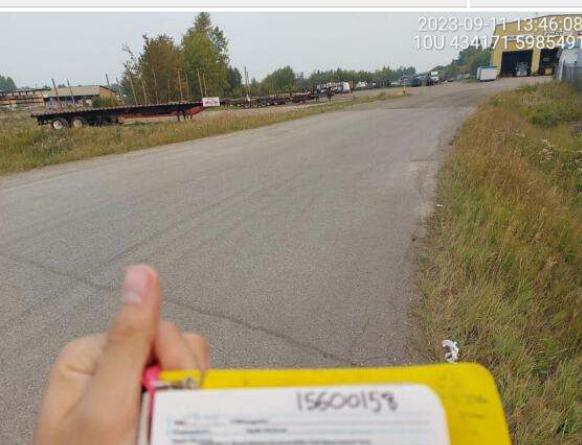
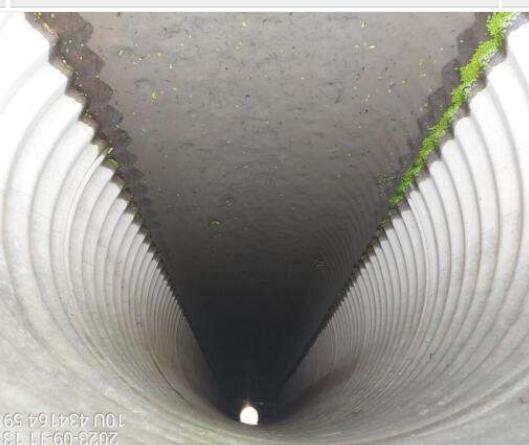
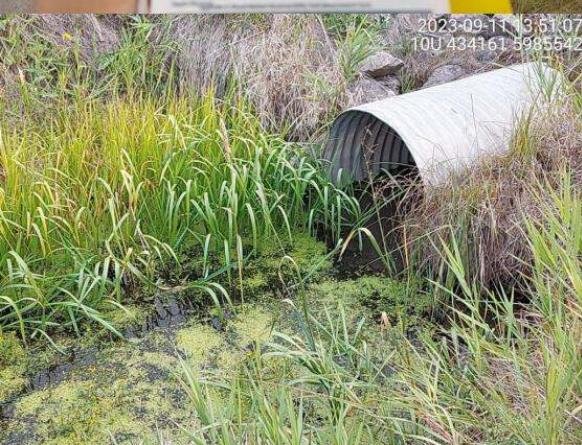
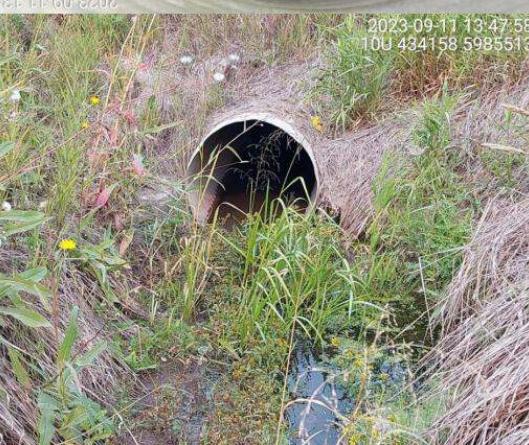
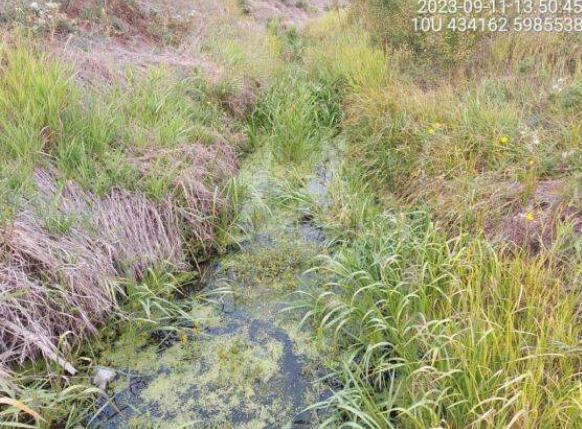
Photos: PSCIS ID 15600158. From top left clockwise: Road/Site Card, Barrel, Outlet, Downstream, Upstream, Inlet.

Location and Stream Data	.	Crossing Characteristics	–
Date	2023-09-11	Crossing Sub Type	Round Culvert
PSCIS ID	199298	Diameter (m)	0.8
External ID	15600158	Length (m)	16
Crew	MW	Embedded	No
UTM Zone	10	Depth Embedded (m)	–
Easting	434160	Resemble Channel	No
Northing	5985531	Backwatered	Yes
Stream	Tributary to Nechako River	Percent Backwatered	100
Road	Chilco Ave	Fill Depth (m)	2
Road Tenure	Vanderhoof	Outlet Drop (m)	0
Channel Width (m)	1.5	Outlet Pool Depth (m)	0
Stream Slope (%)	1	Inlet Drop	No
Beaver Activity	No	Slope (%)	0
Habitat Value	Medium	Valley Fill	Deep Fill
Final score	19	Barrier Result	Potential
Fix type	Replace Structure with Streambed Simulation CBS	Fix Span / Diameter	3
