Appendix - Phase 1 Fish Passage Assessment Data and Photos

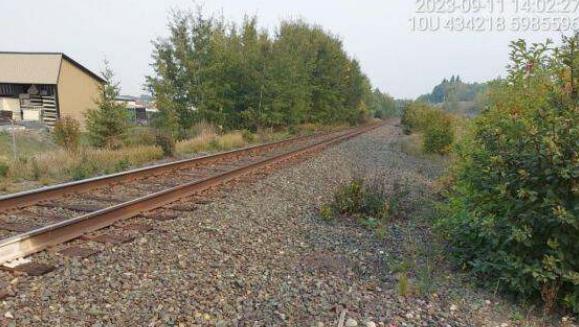
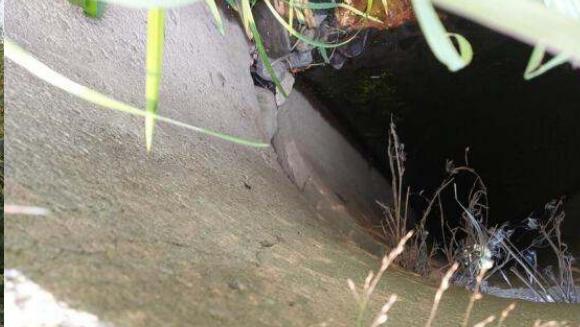
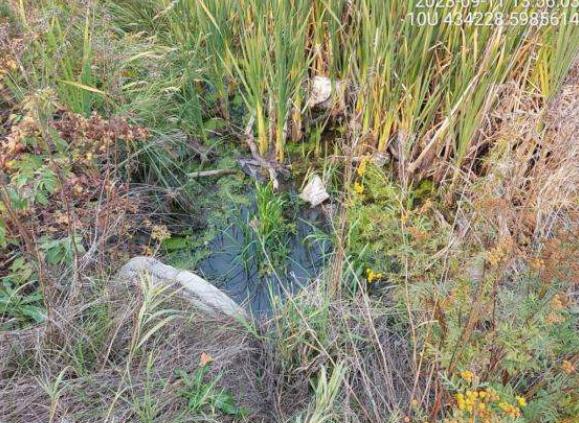
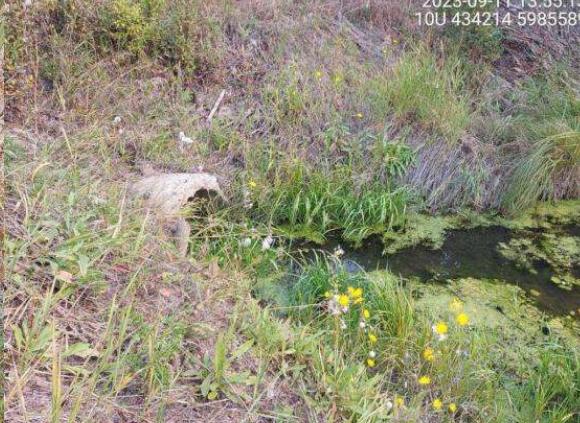
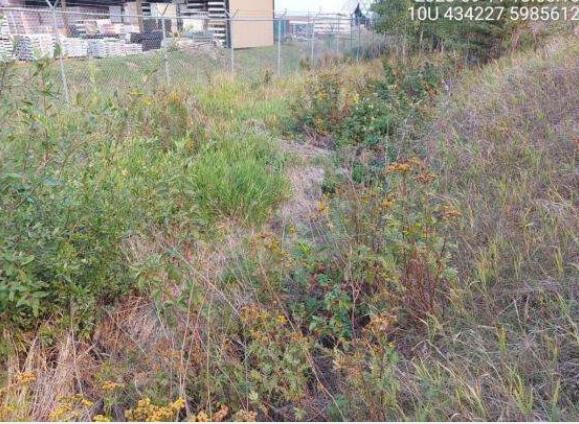
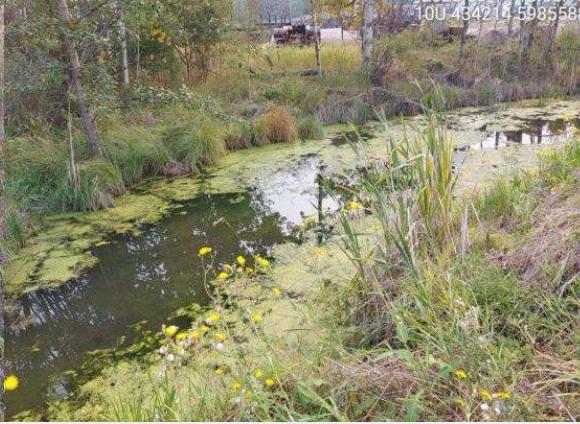
Location and Stream Data		Crossing Characteristics	
Date	2023-09-11	Crossing Sub Type	Round Culvert
PSCIS ID	199299	Diameter (m)	0.9
External ID	15605366	Length (m)	18
Crew	MW	Embedded	No
UTM Zone	10	Depth Embedded (m)	–
Easting	434208	Resemble Channel	No
Northing	5985603	Backwatered	Yes
Stream	Tributary to Nechako River	Percent Backwatered	100
Road	Rail	Fill Depth (m)	2
Road Tenure	CN Rail	Outlet Drop (m)	0
Channel Width (m)	1.3	Outlet Pool Depth (m)	0.5
Stream Slope (%)	0	Inlet Drop	No
Beaver Activity	No	Slope (%)	0
Habitat Value	Low	Valley Fill	Deep Fill
Final score	19	Barrier Result	Potential
Fix type	Replace Structure with Streambed Simulation CBS	Fix Span / Diameter	3
Comments: Wetland downstream. Vegetated channel upstream. Several unassessed crossings downstream.. 13:56:33			
Photos: PSCIS ID 15605366. From top left clockwise: Road/Site Card, Barrel, Outlet, Downstream, Upstream, Inlet.

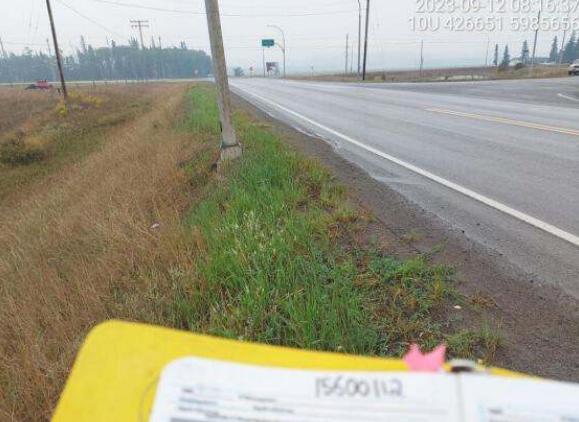
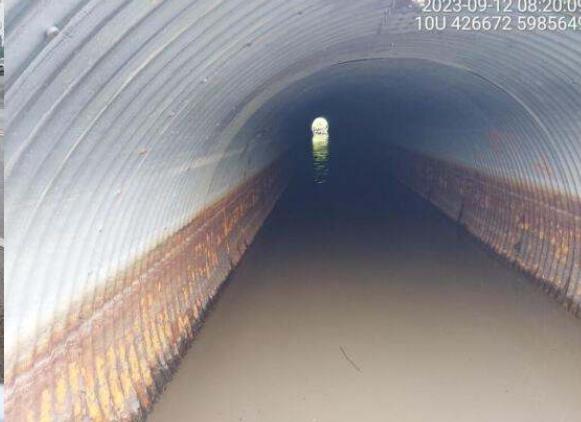
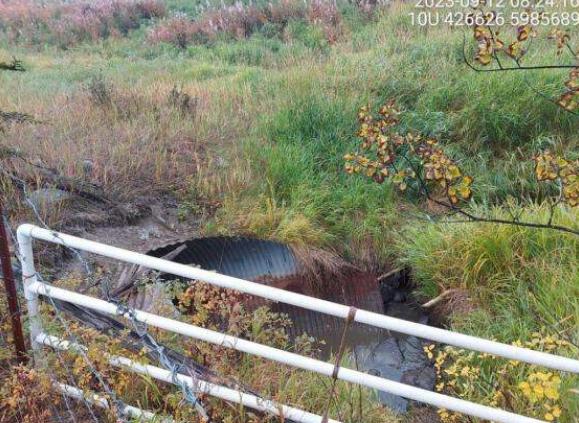
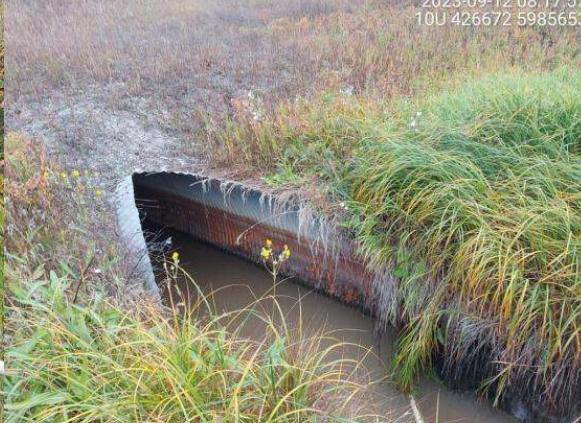
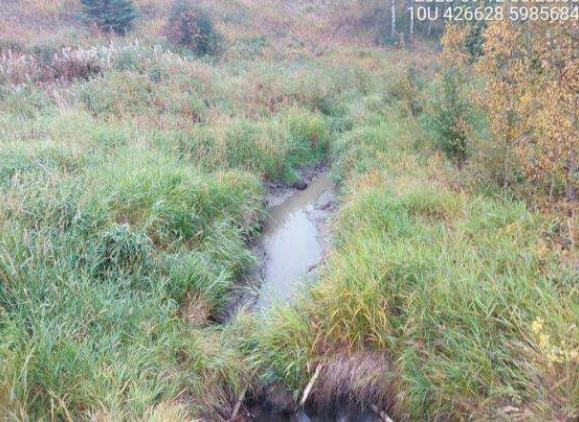
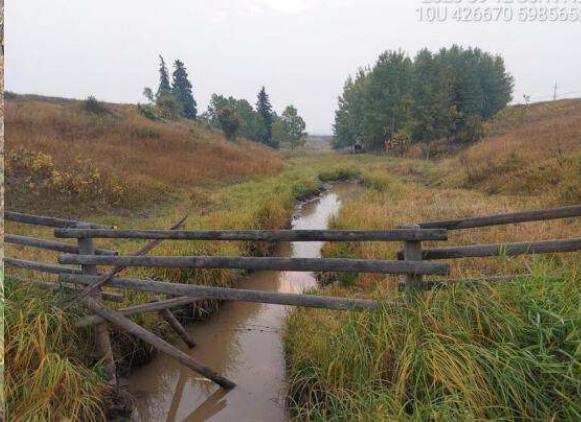
Photos: PSCIS ID 15600112. From top left clockwise: Road/Site Card, Barrel, Outlet, Downstream, Upstream, Inlet.

Location and Stream Data		Crossing Characteristics	
Date	2023-09-12	Crossing Sub Type	Round Culvert
PSCIS ID	199300	Diameter (m)	2.2
External ID	15600112	Length (m)	30
Crew	MW	Embedded	No
UTM Zone	10	Depth Embedded (m)	—
Easting	426644	Resemble Channel	No
Northing	5985671	Backwatered	Yes
Stream	Goldie Creek	Percent Backwatered	100
Road	Highway 27 S	Fill Depth (m)	4
Road Tenure	MOTI	Outlet Drop (m)	0
Channel Width (m)	2.2	Outlet Pool Depth (m)	0.5
Stream Slope (%)	1.5	Inlet Drop	No
Beaver Activity	No	Slope (%)	1
Habitat Value	Medium	Valley Fill	Deep Fill
Final score	24	Barrier Result	Barrier
Fix type	Replace with New Open Bottom Structure	Fix Span / Diameter	18

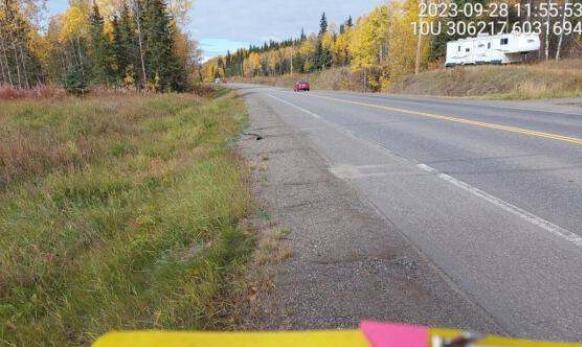
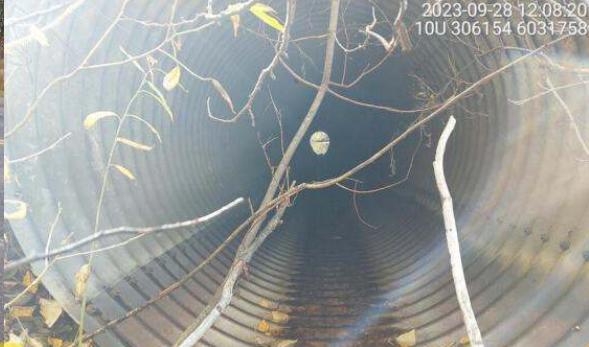
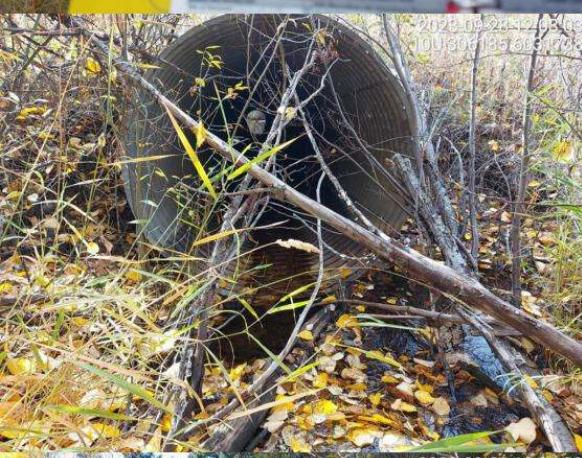
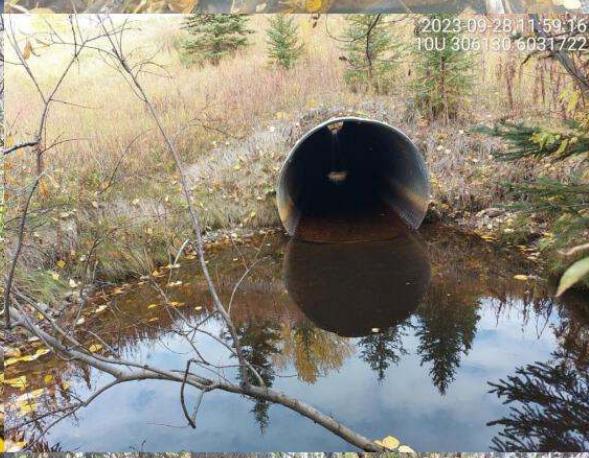
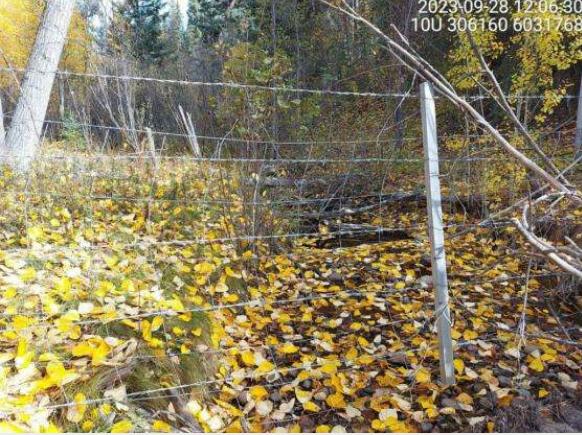
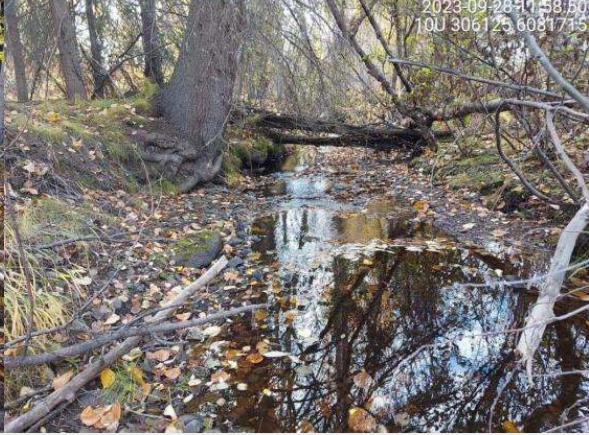
Location and Stream Data		Crossing Characteristics	
Date	2023-09-28	Crossing Sub Type	Round Culvert
PSCIS ID	199301	Diameter (m)	2.1
External ID	5400448	Length (m)	44
Crew	MW	Embedded	No
UTM Zone	10	Depth Embedded (m)	–
Easting	306137	Resemble Channel	No
Northing	6031749	Backwatered	Yes
Stream	Relief Creek	Percent Backwatered	25
Road	Highway 16 W	Fill Depth (m)	4
Road Tenure	MOTI	Outlet Drop (m)	0
Channel Width (m)	2.4	Outlet Pool Depth (m)	0.5
Stream Slope (%)	3	Inlet Drop	No
Beaver Activity	No	Slope (%)	3
Habitat Value	High	Valley Fill	Deep Fill
Final score	29	Barrier Result	Barrier
Fix type	Replace with New Open Bottom Structure	Fix Span / Diameter	18
Comments: Long pipe, no outlet drop but culvert is partially backwatered at outlet. Small fish spotted in outlet pool. Upstream goes into private land and is fenced off. MoTi chris_culvert_id: 2076443. 12:13:13			
Photos: PSCIS ID 5400448. From top left clockwise: Road/Site Card, Barrel, Outlet, Downstream, Upstream, Inlet.

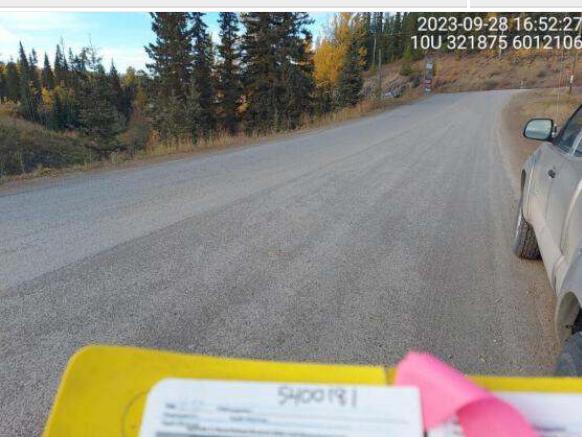
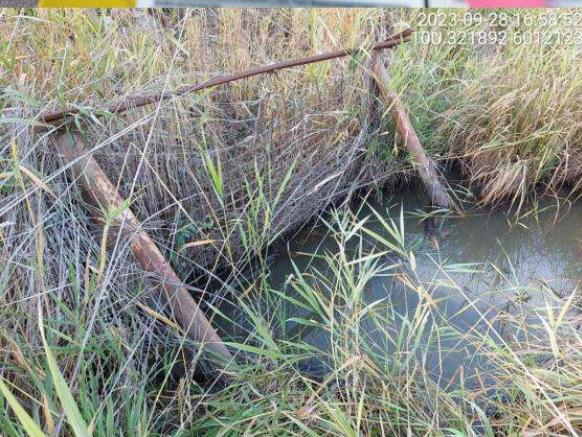
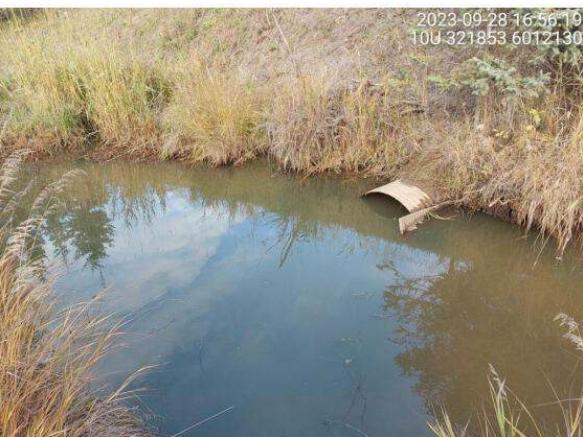
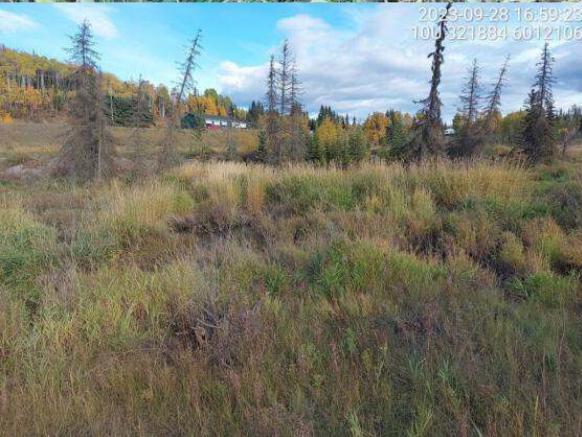
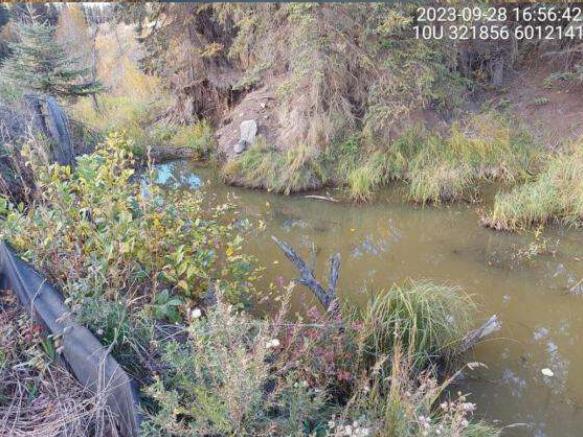
Photos: PSCIS ID 5400181. From top left clockwise: Road/Site Card, Barrel, Outlet, Downstream, Upstream, Inlet.

Location and Stream Data	.	Crossing Characteristics	-
Date	2023-09-28	Crossing Sub Type	Round Culvert
PSCIS ID	199302	Diameter (m)	0.8
External ID	5400181	Length (m)	28
Crew	MW	Embedded	No
UTM Zone	10	Depth Embedded (m)	-
Easting	321873	Resemble Channel	No
Northing	6012125	Backwatered	Yes
Stream	Wardrop Creek	Percent Backwatered	100
Road	Roumieu drive	Fill Depth (m)	3
Road Tenure	Burns Lake	Outlet Drop (m)	0
Channel Width (m)	0.8	Outlet Pool Depth (m)	0.5
Stream Slope (%)	1	Inlet Drop	No
Beaver Activity	Yes	Slope (%)	2
Habitat Value	Medium	Valley Fill	Deep Fill
Final score	21	Barrier Result	Barrier
Fix type	Replace Structure with Streambed Simulation CBS	Fix Span / Diameter	3

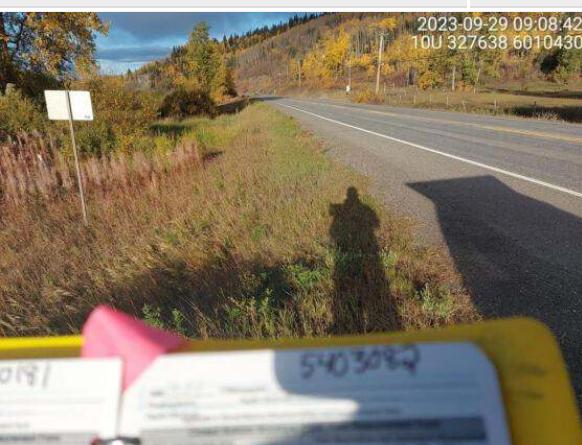
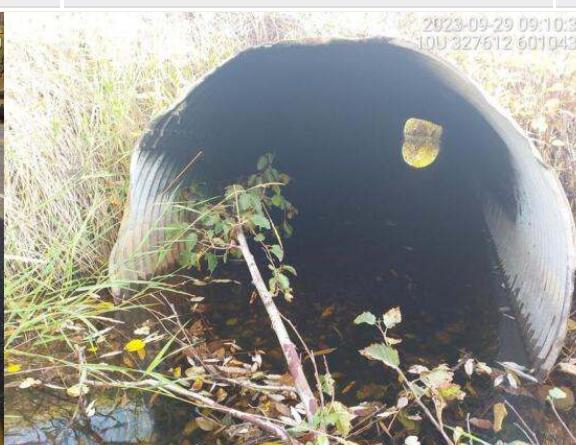
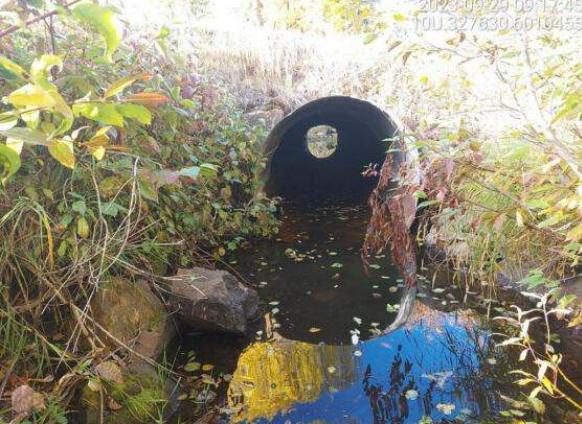
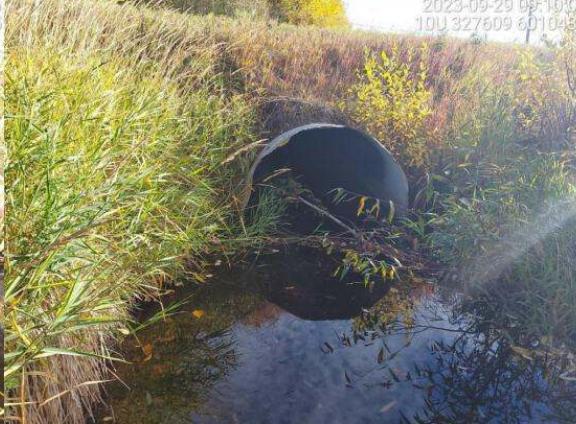
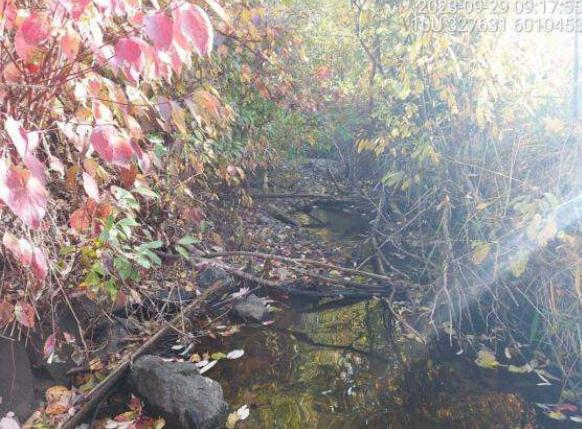
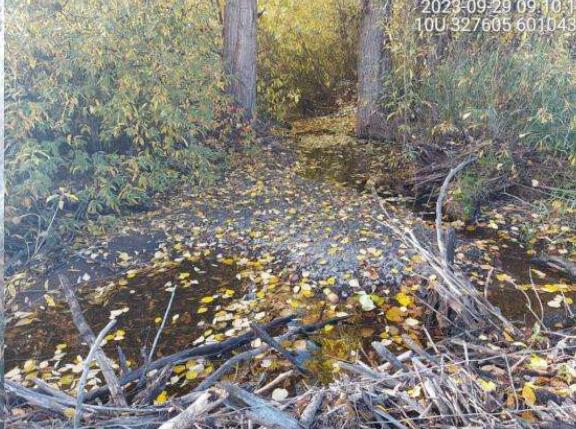
Photos: PSCIS ID 5403082. From top left clockwise: Road/Site Card, Barrel, Outlet, Downstream, Upstream, Inlet.

Location and Stream Data		Crossing Characteristics	
Date	2023-09-29	Crossing Sub Type	Round Culvert
PSCIS ID	199303	Diameter (m)	1.7
External ID	5403082	Length (m)	22
Crew	MW	Embedded	No
UTM Zone	10	Depth Embedded (m)	–
Easting	327620	Resemble Channel	No
Northing	6010443	Backwatered	Yes
Stream	Stearns Creek	Percent Backwatered	100
Road	Highway 16	Fill Depth (m)	1.8
Road Tenure	MOTI	Outlet Drop (m)	0
Channel Width (m)	3.1	Outlet Pool Depth (m)	0
Stream Slope (%)	2	Inlet Drop	No
Beaver Activity	No	Slope (%)	2.5
Habitat Value	High	Valley Fill	Deep Fill
Final score	24	Barrier Result	Barrier
Fix type	Replace with New Open Bottom Structure	Fix Span / Diameter	15

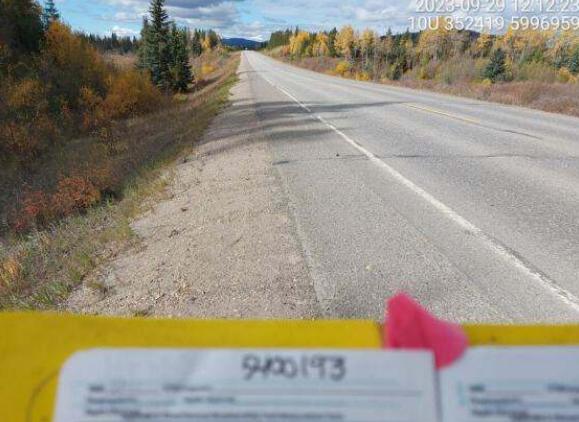
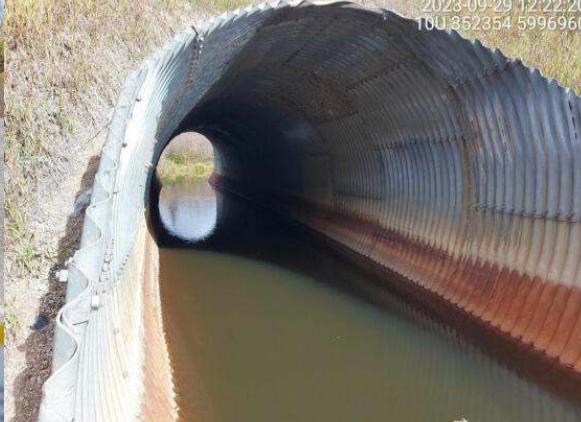
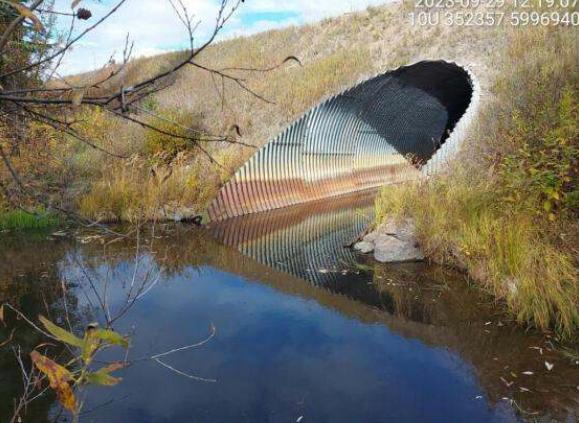
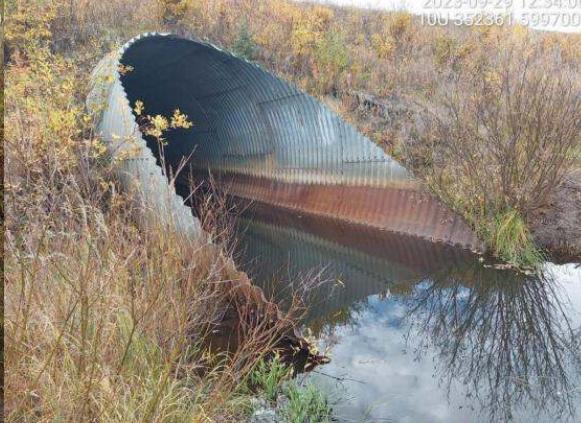
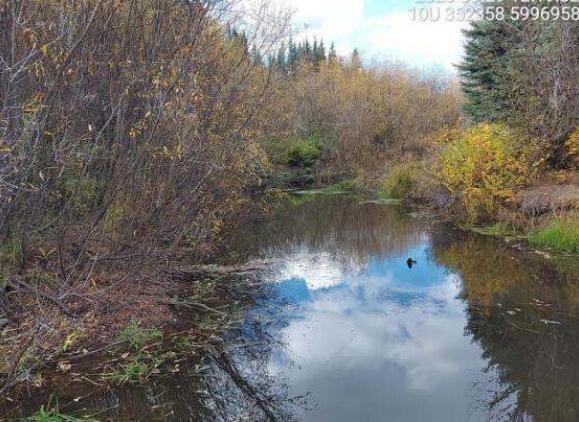
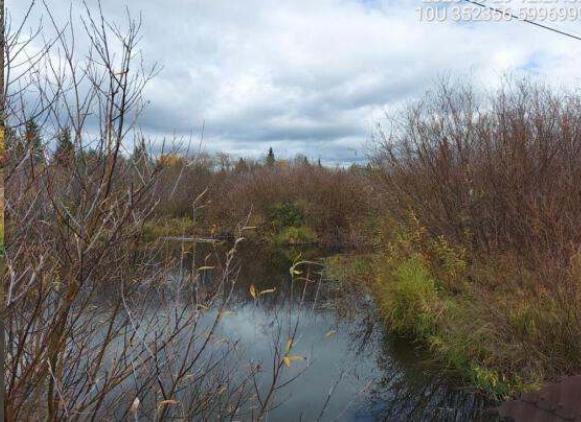
Photos: PSCIS ID 5400193. From top left clockwise: Road/Site Card, Barrel, Outlet, Downstream, Upstream, Inlet.

Location and Stream Data		Crossing Characteristics	
Date	2023-09-29	Crossing Sub Type	Round Culvert
PSCIS ID	199304	Diameter (m)	4
External ID	5400193	Length (m)	32
Crew	MW	Embedded	No
UTM Zone	10	Depth Embedded (m)	–
Easting	352357	Resemble Channel	No
Northing	5996976	Backwatered	Yes
Stream	Tchesinkut Creek	Percent Backwatered	100
Road	Highway 16	Fill Depth (m)	2.2
Road Tenure	MOTI	Outlet Drop (m)	0
Channel Width (m)	8.4	Outlet Pool Depth (m)	0
Stream Slope (%)	1	Inlet Drop	No
Beaver Activity	No	Slope (%)	1
Habitat Value	Medium	Valley Fill	Deep Fill
Final score	27	Barrier Result	Barrier
Fix type	Replace with New Open Bottom Structure	Fix Span / Diameter	15

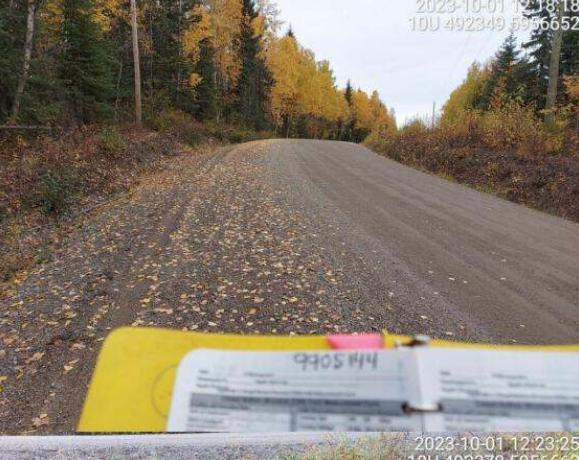
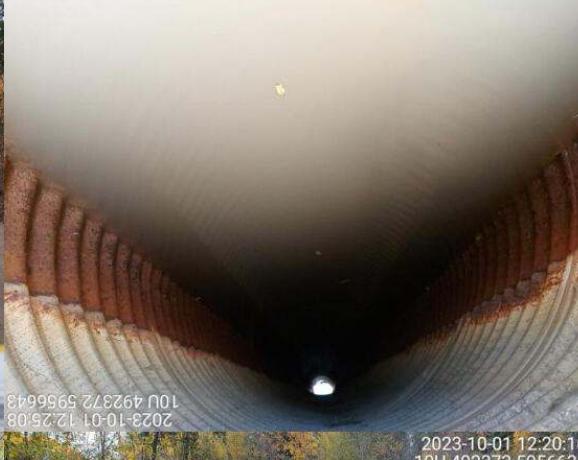
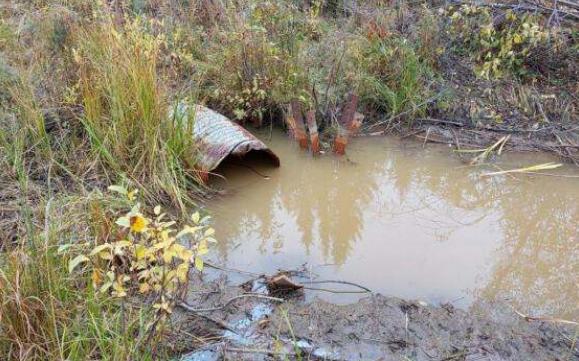
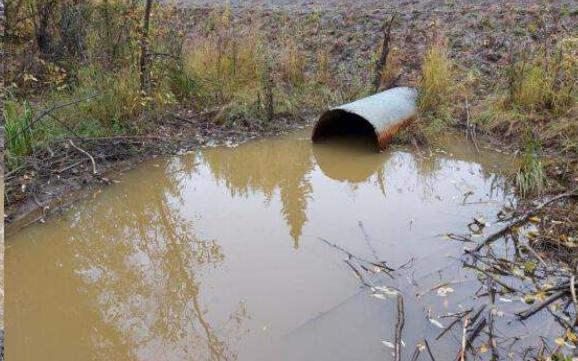
Photos: PSCIS ID 9905144. From top left clockwise: Road/Site Card, Barrel, Outlet, Downstream, Upstream, Inlet.

Location and Stream Data		Crossing Characteristics	
Date	2023-10-01	Crossing Sub Type	Round Culvert
PSCIS ID	199305	Diameter (m)	0.9
External ID	9905144	Length (m)	16
Crew	MW	Embedded	No
UTM Zone	10	Depth Embedded (m)	—
Easting	492375	Resemble Channel	No
Northing	5956652	Backwatered	Yes
Stream	Tributary to Chilako River	Percent Backwatered	100
Road	Gregg FSR	Fill Depth (m)	1.6
Road Tenure	MOTI Local	Outlet Drop (m)	0
Channel Width (m)	1	Outlet Pool Depth (m)	0.5
Stream Slope (%)	1	Inlet Drop	No
Beaver Activity	Yes	Slope (%)	1.5
Habitat Value	Low	Valley Fill	Deep Fill
Final score	21	Barrier Result	Barrier
Fix type	Replace Structure with Streambed Simulation CBS	Fix Span / Diameter	3

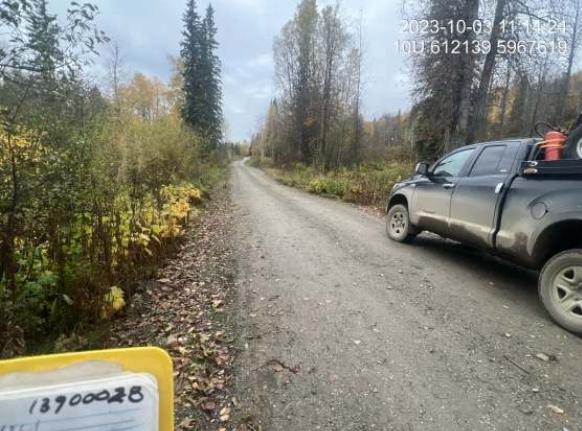
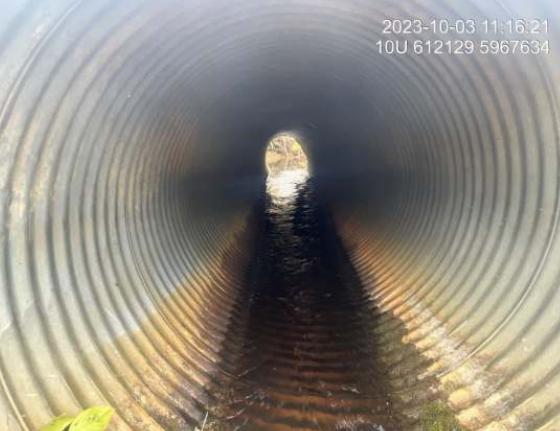
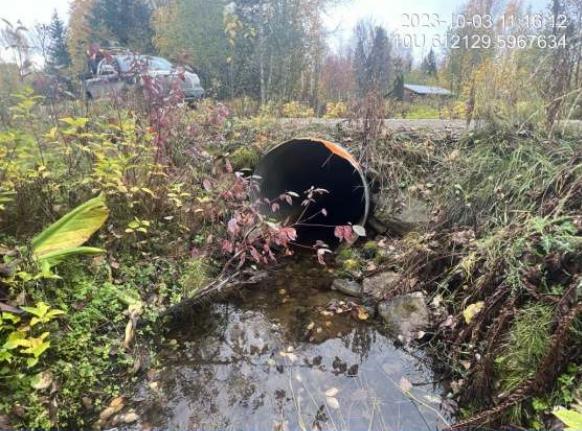
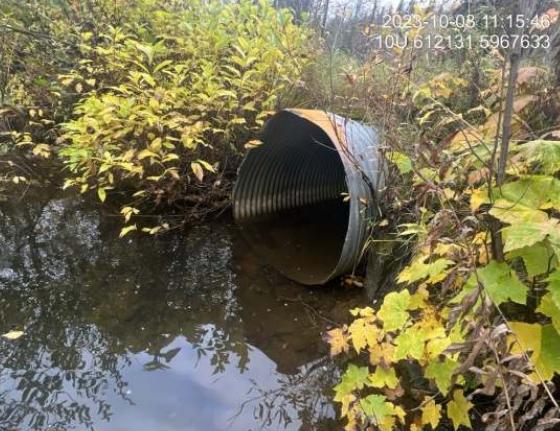
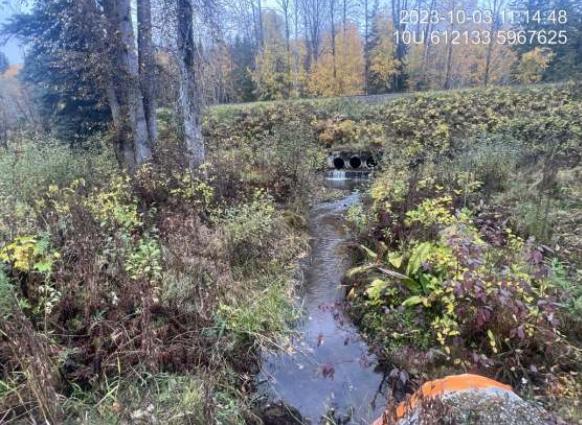
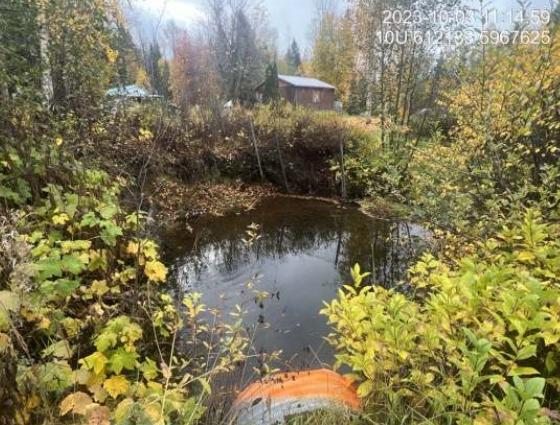
Location and Stream Data		Crossing Characteristics	
Date	2023-10-03	Crossing Sub Type	Round Culvert
PSCIS ID	199306	Diameter (m)	1.4
External ID	13900028	Length (m)	10
Crew	AI	Embedded	No
UTM Zone	10	Depth Embedded (m)	–
Easting	612135	Resemble Channel	No
Northing	5967623	Backwatered	Yes
Stream	Tributary to Fraser River	Percent Backwatered	40
Road	Penny street	Fill Depth (m)	0.3
Road Tenure	Northwood R02900	Outlet Drop (m)	0
Channel Width (m)	3.4	Outlet Pool Depth (m)	1
Stream Slope (%)	3	Inlet Drop	No
Beaver Activity	No	Slope (%)	1.5
Habitat Value	Medium	Valley Fill	Deep Fill
Final score	21	Barrier Result	Barrier
Fix type	Replace with New Open Bottom Structure	Fix Span / Diameter	15
Comments: Nice stream with good flow. Railway crossings approximately 30 m upstream are much more of a barrier than the crossing on Penny Street.. 11:19:24			
Photos: PSCIS ID 13900028. From top left clockwise: Road/Site Card, Barrel, Outlet, Downstream, Upstream, Inlet.

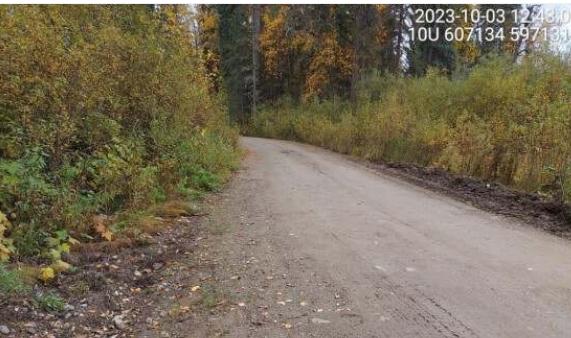
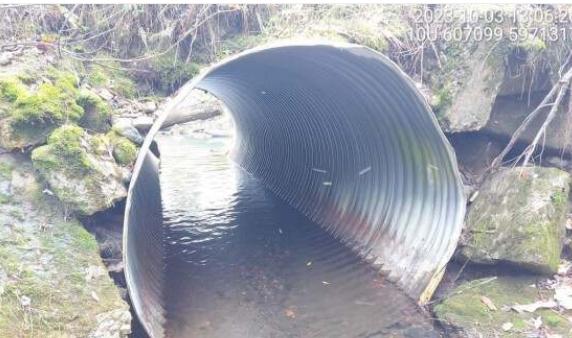
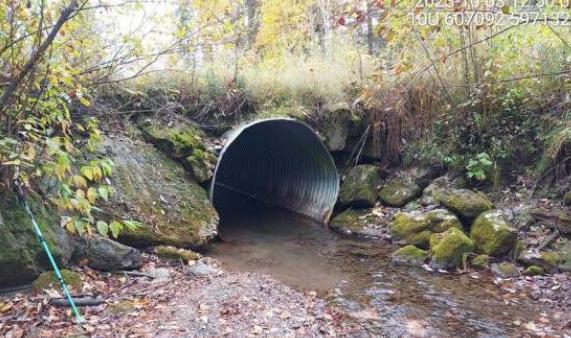
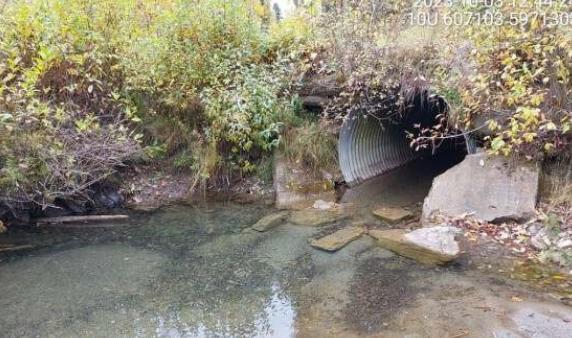
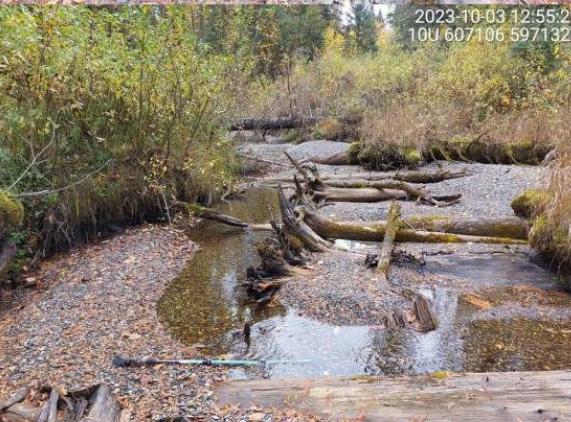
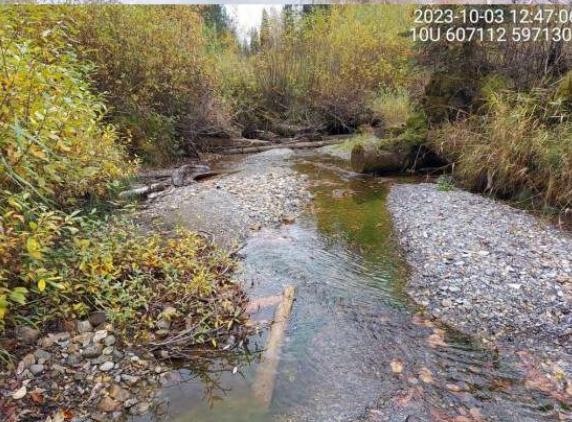
Photos: PSCIS ID 13900308. From top left clockwise: Road/Site Card, Barrel, Outlet, Downstream, Upstream, Inlet.

Location and Stream Data		Crossing Characteristics	
Date	2023-10-03	Crossing Sub Type	Round Culvert
PSCIS ID	199307	Diameter (m)	2
External ID	13900308	Length (m)	8
Crew	MW	Embedded	No
UTM Zone	10	Depth Embedded (m)	—
Easting	607110	Resemble Channel	No
Northing	5971294	Backwatered	Yes
Stream	Tributary to Fraser River	Percent Backwatered	100
Road	Penny Rd	Fill Depth (m)	0.7
Road Tenure	Unknown	Outlet Drop (m)	0
Channel Width (m)	5.9	Outlet Pool Depth (m)	0.6
Stream Slope (%)	3	Inlet Drop	No
Beaver Activity	No	Slope (%)	0
Habitat Value	High	Valley Fill	Deep Fill
Final score	16	Barrier Result	Potential
Fix type	Replace with New Open Bottom Structure	Fix Span / Diameter	15

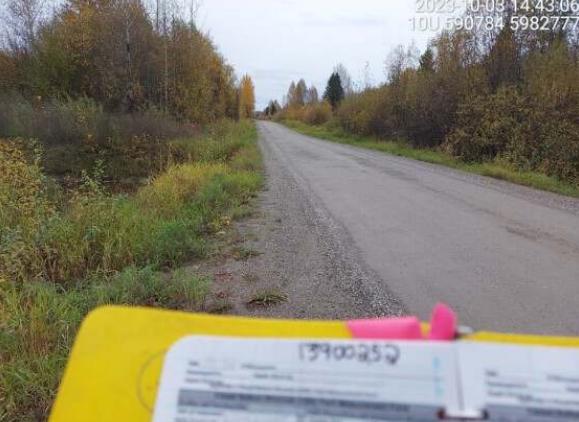
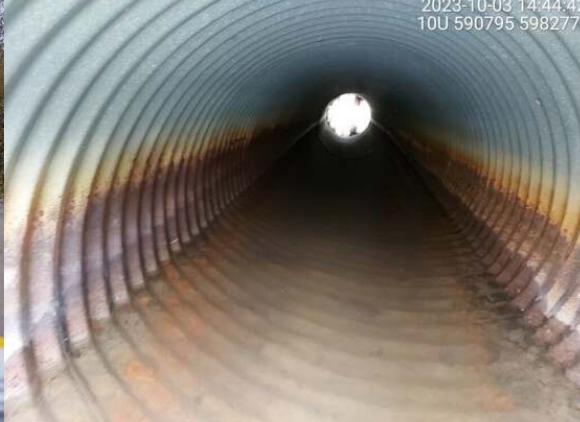
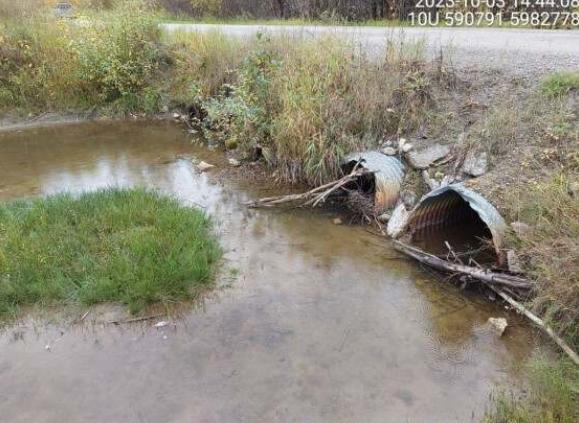
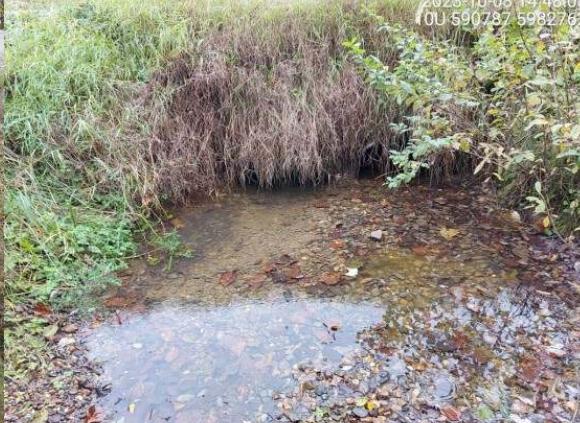
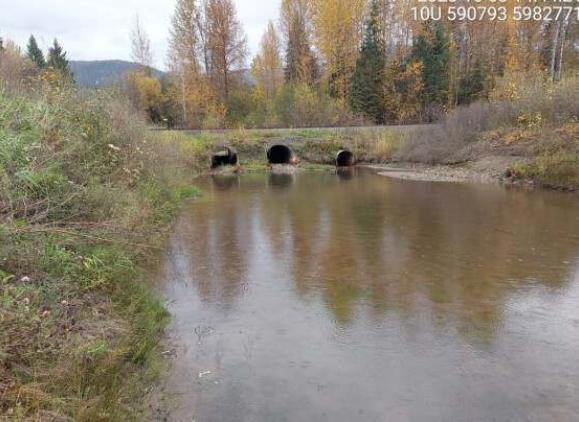
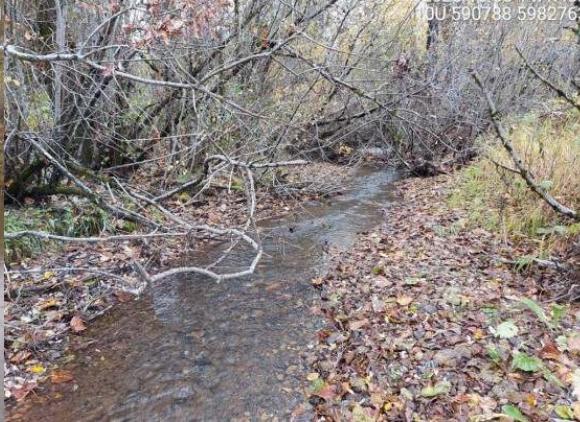
Comments: Wide channel with four culverts. Culvert diameter totaled for all 4 culverts. Two are in good condition, other two are bent and look older. Railway crossing just upstream which consists of three culverts and appears likely passable for most species at most flows. Abundant gravels present downstream of road. This road is the only to access the town of Penny. MoTi chris_culvert_id: 1994890, 1994893, 1994894. 14:48:37

Location and Stream Data		Crossing Characteristics	
Date	2023-10-03	Crossing Sub Type	Round Culvert
PSCIS ID	199308	Diameter (m)	3.3
External ID	13900252	Length (m)	7
Crew	MW	Embedded	No
UTM Zone	10	Depth Embedded (m)	—
Easting	590794	Resemble Channel	No
Northing	5982763	Backwatered	Yes
Stream	Wolfe Creek	Percent Backwatered	100
Road	Upper Fraser Rd	Fill Depth (m)	1
Road Tenure	MOTI	Outlet Drop (m)	0
Channel Width (m)	4.1	Outlet Pool Depth (m)	0
Stream Slope (%)	2	Inlet Drop	No
Beaver Activity	No	Slope (%)	1
Habitat Value	High	Valley Fill	Deep Fill
Final score	18	Barrier Result	Potential
Fix type	Replace with New Open Bottom Structure	Fix Span / Diameter	15

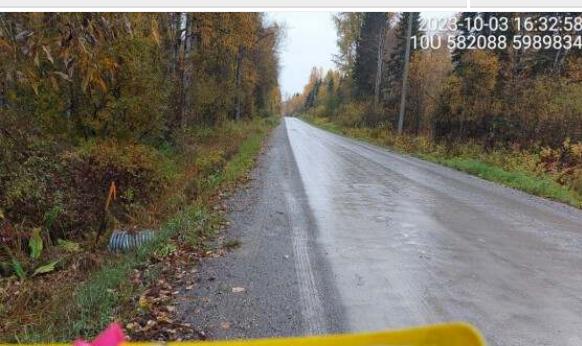
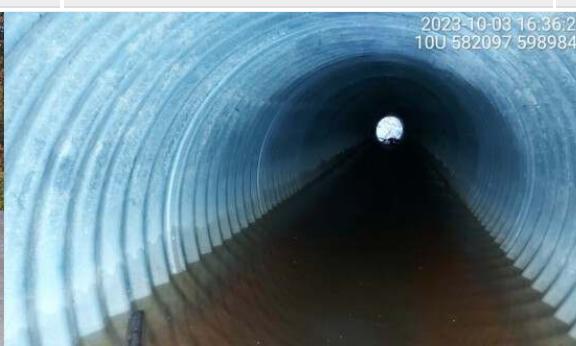
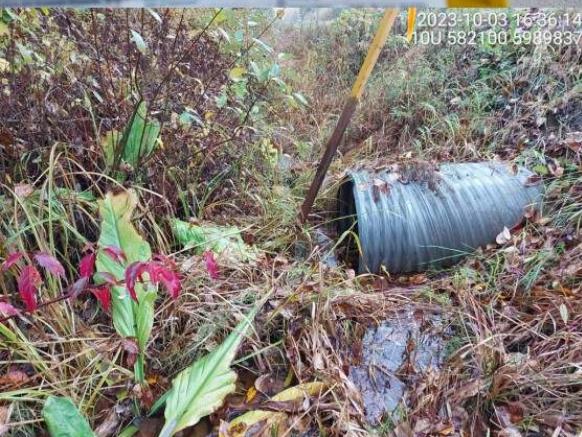
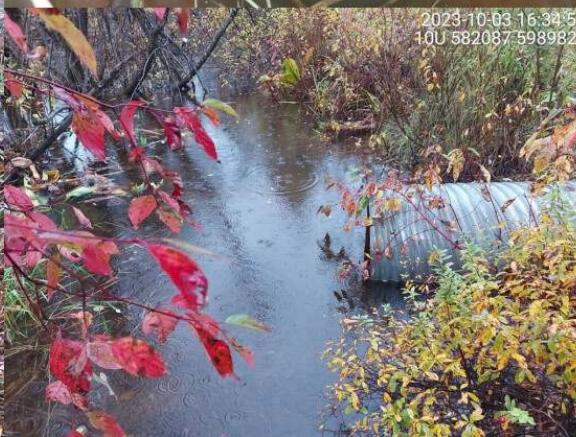
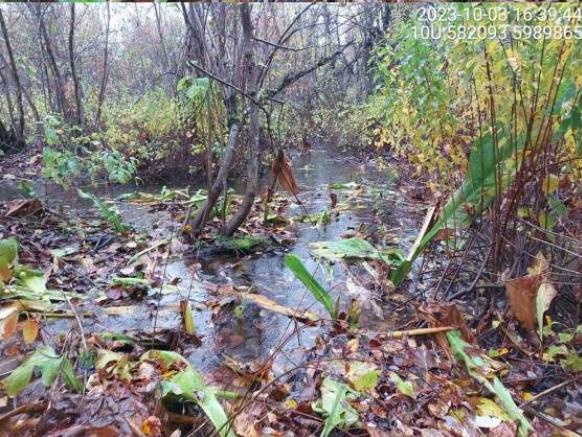
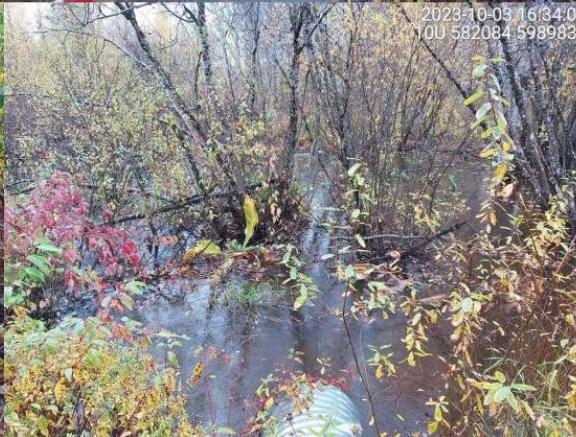
Photos: PSCIS ID 13900050. From top left clockwise: Road/Site Card, Barrel, Outlet, Downstream, Upstream, Inlet.

Comments: No well defined stream channel visible. Flooded wetland area downstream, surveyed during heavy rain.
Backwatered pipe. MoTi chris_culvert_id: 1994950. 16:43:39

Location and Stream Data	.	Crossing Characteristics	–
Date	2023-10-03	Crossing Sub Type	Round Culvert
PSCIS ID	199309	Diameter (m)	0.8
External ID	13900050	Length (m)	12
Crew	MW	Embedded	No
UTM Zone	10	Depth Embedded (m)	–
Easting	582105	Resemble Channel	No
Northing	5989825	Backwatered	Yes
Stream	Tributary to Fraser River	Percent Backwatered	100
Road	Upper Fraser Rd	Fill Depth (m)	1.2
Road Tenure	MOTI	Outlet Drop (m)	0
Channel Width (m)	1.2	Outlet Pool Depth (m)	0
Stream Slope (%)	1.5	Inlet Drop	No
Beaver Activity	No	Slope (%)	2
Habitat Value	Low	Valley Fill	Deep Fill
Final score	21	Barrier Result	Barrier
Fix type	Replace Structure with Streambed Simulation CBS	Fix Span / Diameter	3

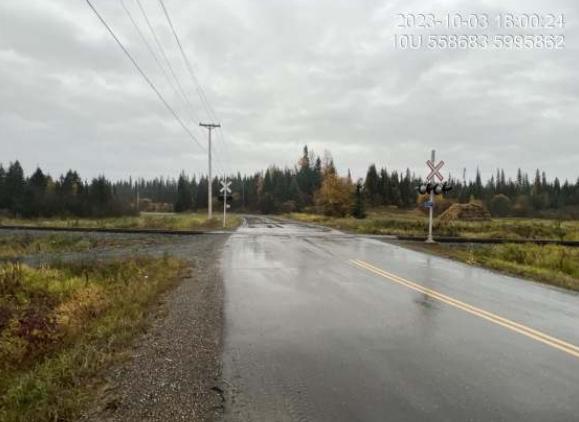
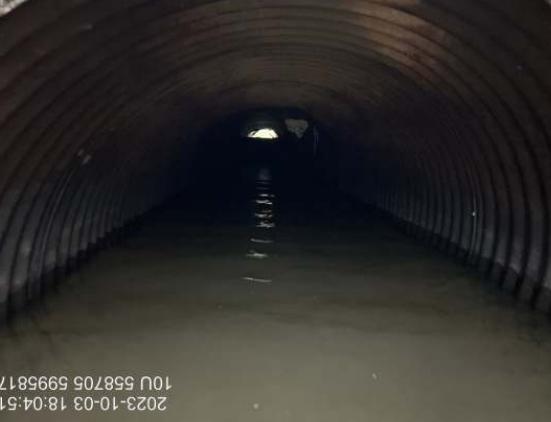
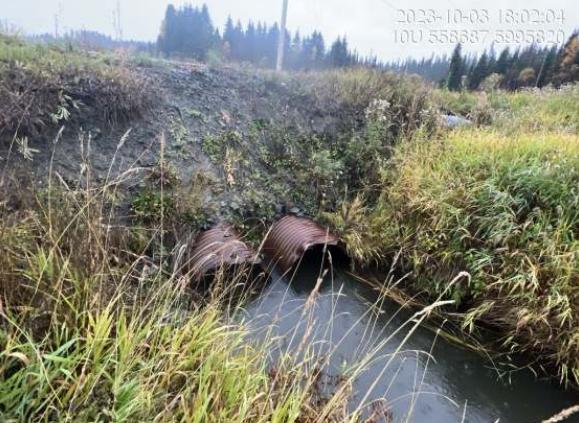
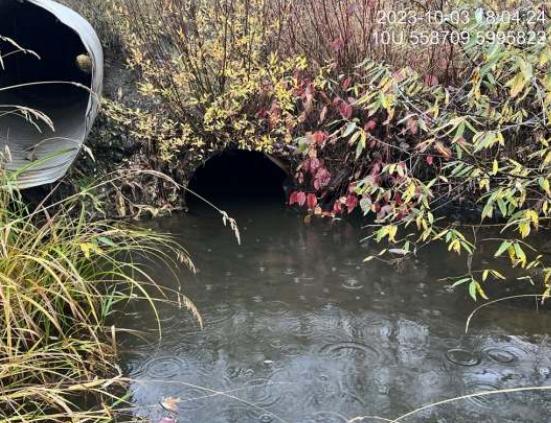
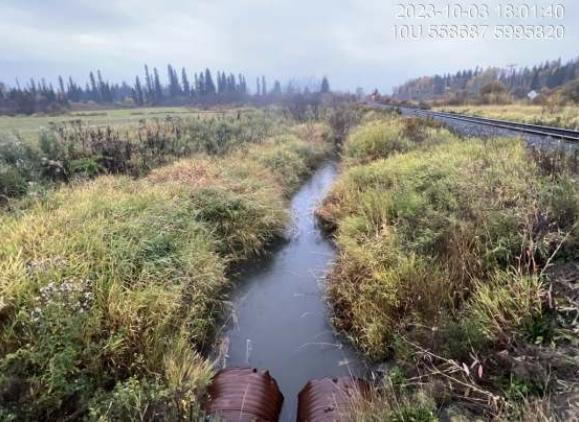
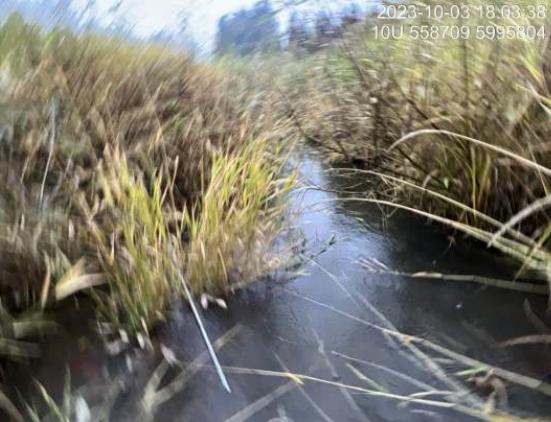
Photos: PSCIS ID 13900283. From top left clockwise: Road/Site Card, Barrel, Outlet, Downstream, Upstream, Inlet.

Location and Stream Data		.	Crossing Characteristics	–
Date	2023-10-03	Crossing Sub Type	Round Culvert	
PSCIS ID	199310	Diameter (m)	2	
External ID	13900283	Length (m)	14	
Crew	AI	Embedded	No	
UTM Zone	10	Depth Embedded (m)	–	
Easting	558697	Resemble Channel	No	
Northing	5995816	Backwatered	Yes	
Stream	Tributary to Aleza Lake	Percent Backwatered	100	
Road	Upper Fraser Rd	Fill Depth (m)	2.5	
Road Tenure	MOTI	Outlet Drop (m)	0	
Channel Width (m)	2.5	Outlet Pool Depth (m)	0.7	
Stream Slope (%)	0	Inlet Drop	No	
Beaver Activity	Yes	Slope (%)	0	
Habitat Value	Medium	Valley Fill	Deep Fill	
Final score	13	Barrier Result	Passable	
Fix type	–	Fix Span / Diameter	–	
Comments: Two pipes each with 1m diameter on the south side of the railway. It is not clear where the stream crosses under the railway upstream, this crossing still needs to be assessed. Agricultural field located upstream with what appears to be very minimal riparian buffer. Stream has been channelized beside the railway. A 1m overflow pipe has been installed above the level of the other 2 pipes. MoTi chris_culvert_id: 1994283, 1994682, 1994683. 18:08:11

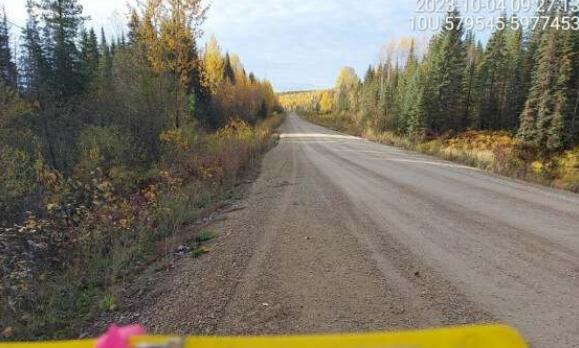
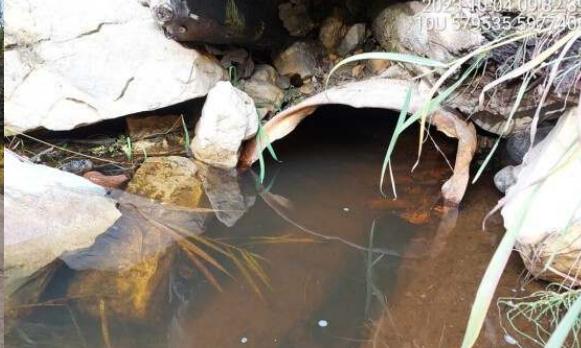
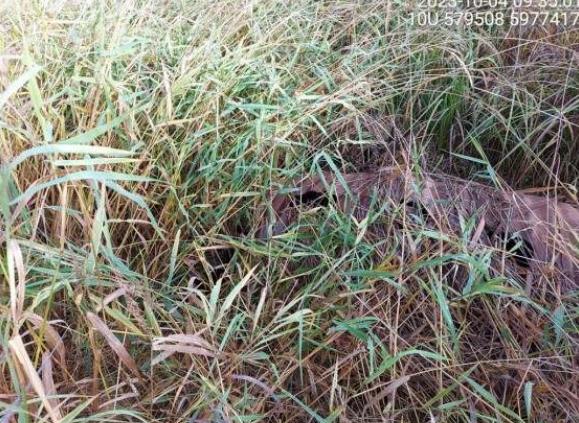
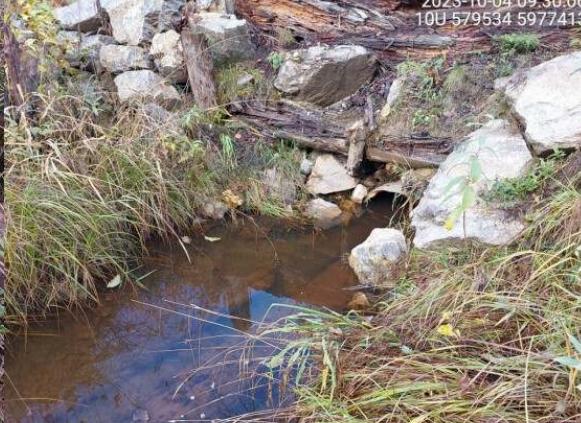
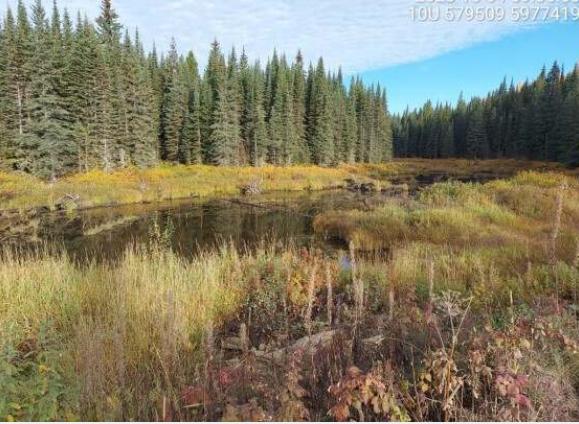
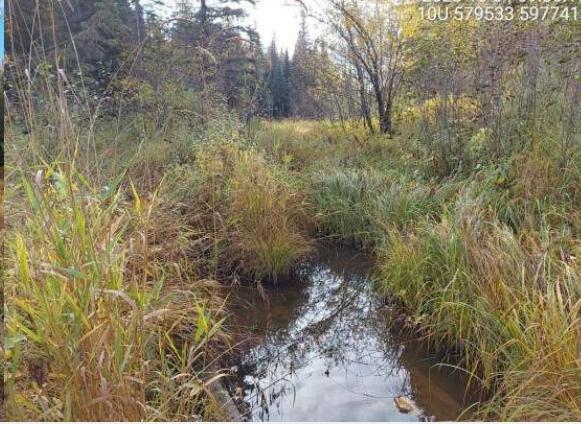
Photos: PSCIS ID 13903627. From top left clockwise: Road/Site Card, Barrel, Outlet, Downstream, Upstream, Inlet.

Location and Stream Data		.	Crossing Characteristics	-
Date	2023-10-04		Crossing Sub Type	Round Culvert
PSCIS ID	199311		Diameter (m)	0.7
External ID	13903627		Length (m)	16
Crew	MW		Embedded	No
UTM Zone	10		Depth Embedded (m)	-
Easting	579525		Resemble Channel	No
Northing	5977412		Backwatered	Yes
Stream	Tributary to Kenneth Creek		Percent Backwatered	100
Road	Bowron FSR		Fill Depth (m)	1.5
Road Tenure	MOF 7141		Outlet Drop (m)	0
Channel Width (m)	2.1		Outlet Pool Depth (m)	0
Stream Slope (%)	0		Inlet Drop	No
Beaver Activity	No		Slope (%)	1
Habitat Value	Low		Valley Fill	Deep Fill
Final score	24		Barrier Result	Barrier
Fix type	Replace with New Open Bottom Structure		Fix Span / Diameter	15

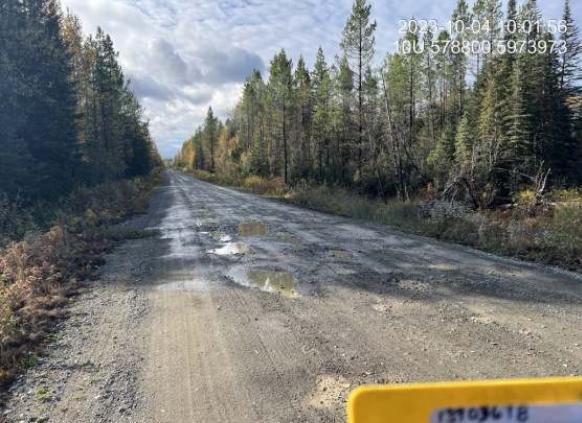
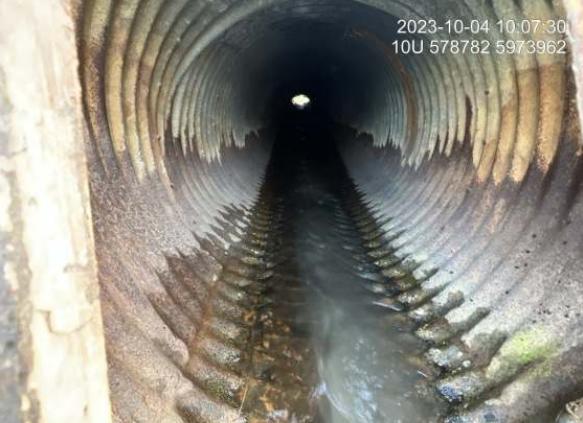
Photos: PSCIS ID 13903618. From top left clockwise: Road/Site Card, Barrel, Outlet, Downstream, Upstream, Inlet.

Comments: Wetland lake area upstream with small channels threaded through it. Beaver grate on culvert inlet and pipe is in poor shape as it is rusted and bent out of shape. Outlet backwater for 40%. Small stream with some flow.. 10:14:44

Location and Stream Data		Crossing Characteristics	
Date	2023-10-04	Crossing Sub Type	Round Culvert
PSCIS ID	199312	Diameter (m)	0.9
External ID	13903618	Length (m)	18
Crew	AI	Embedded	No
UTM Zone	10	Depth Embedded (m)	—
Easting	578804	Resemble Channel	No
Northing	5973956	Backwatered	Yes
Stream	Tributary to Kenneth Creek	Percent Backwatered	50
Road	Bowron FSR	Fill Depth (m)	1.4
Road Tenure	MOF 7141	Outlet Drop (m)	0
Channel Width (m)	1.8	Outlet Pool Depth (m)	0.5
Stream Slope (%)	1.5	Inlet Drop	No
Beaver Activity	Yes	Slope (%)	4
Habitat Value	Medium	Valley Fill	Deep Fill
Final score	29	Barrier Result	Barrier
Fix type	Replace Structure with Streambed Simulation CBS	Fix Span / Diameter	3
