Appendix - Phase 1 Fish Passage Assessment Data and Photos

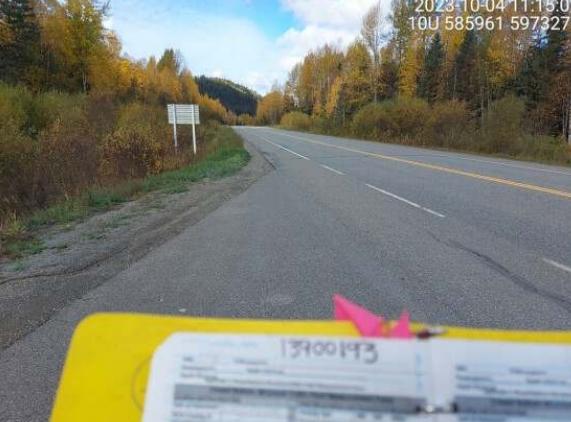
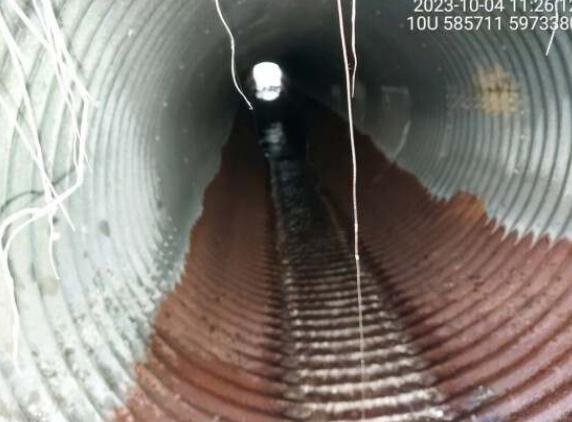
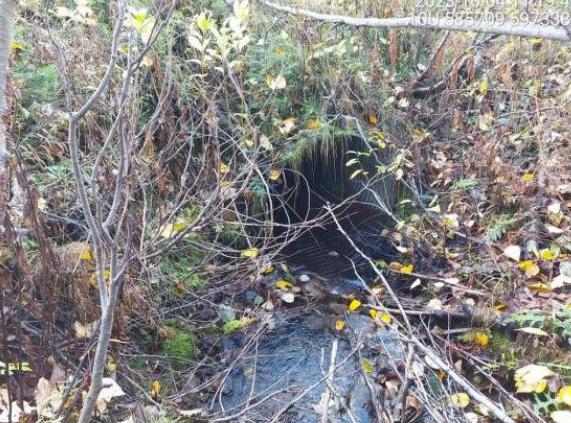
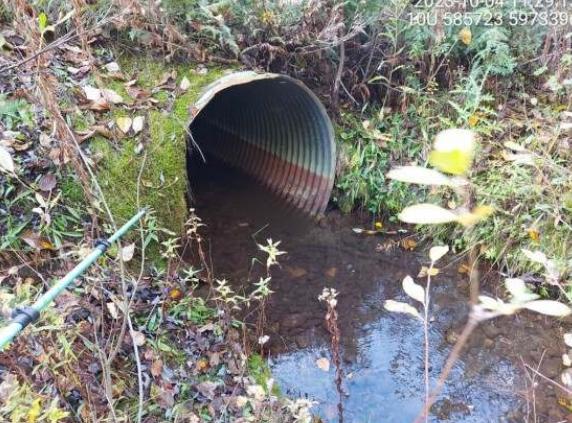
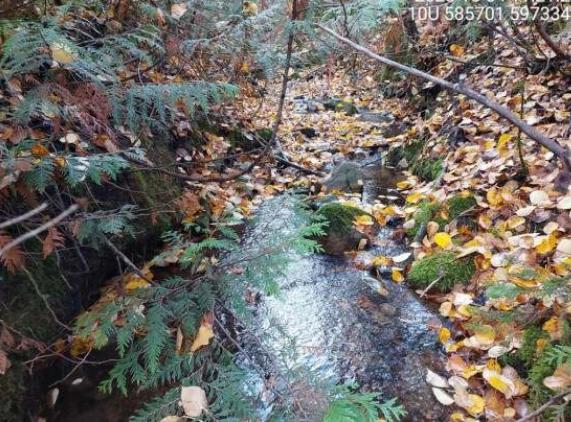
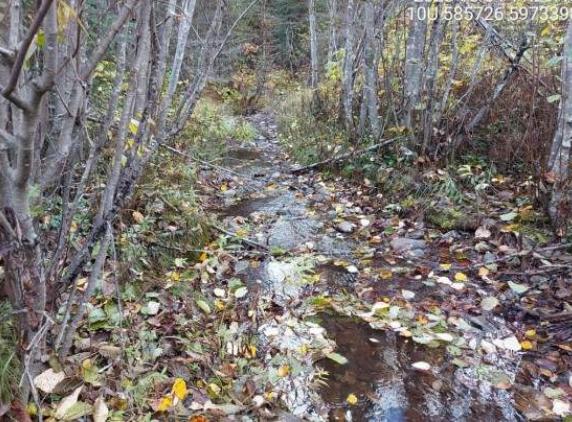
Photos: PSCIS ID 13900193. From top left clockwise: Road/Site Card, Barrel, Outlet, Downstream, Upstream, Inlet.

Location and Stream Data		Crossing Characteristics	
Date	2023-10-04	Crossing Sub Type	Round Culvert
PSCIS ID	199313	Diameter (m)	1.2
External ID	13900193	Length (m)	21
Crew	MW	Embedded	No
UTM Zone	10	Depth Embedded (m)	–
Easting	585722	Resemble Channel	No
Northing	5973394	Backwatered	Yes
Stream	Tributary to Kenneth Creek	Percent Backwatered	–
Road	Highway 16	Fill Depth (m)	1.2
Road Tenure	MOTI	Outlet Drop (m)	0
Channel Width (m)	2.1	Outlet Pool Depth (m)	0
Stream Slope (%)	5	Inlet Drop	Yes
Beaver Activity	No	Slope (%)	4
Habitat Value	High	Valley Fill	Deep Fill
Final score	29	Barrier Result	Barrier
Fix type	Replace with New Open Bottom Structure	Fix Span / Diameter	15

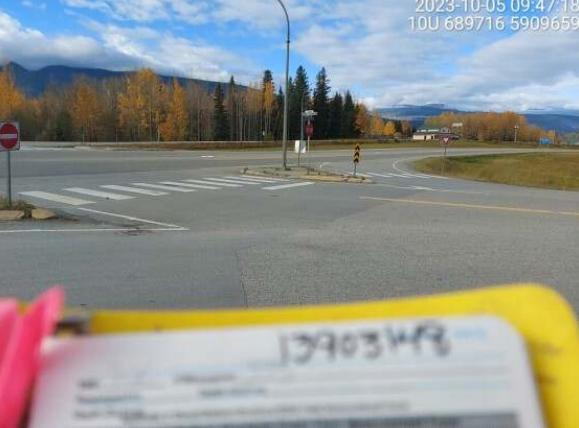
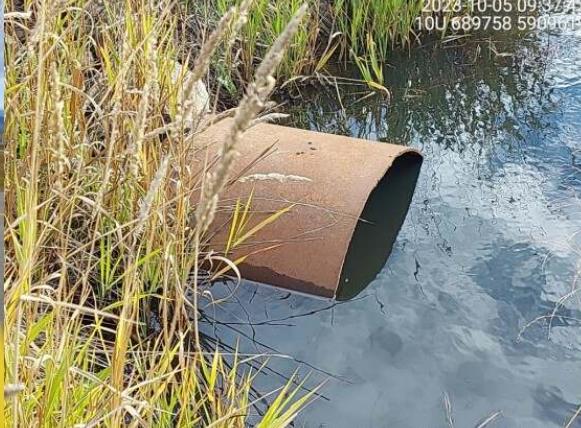
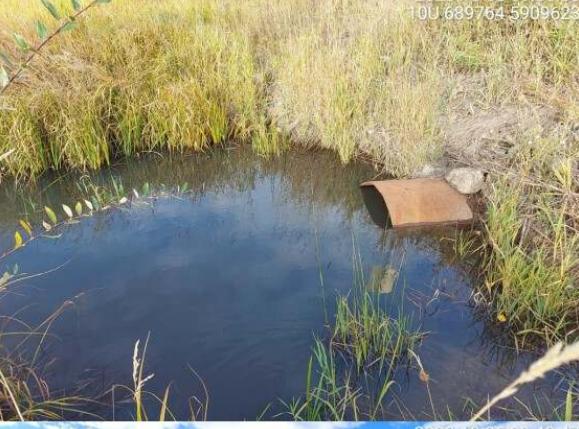
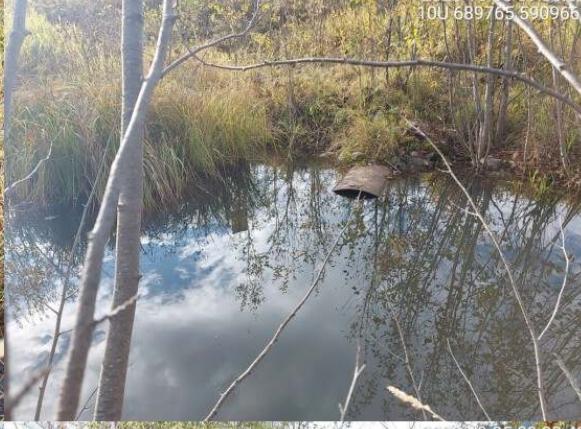
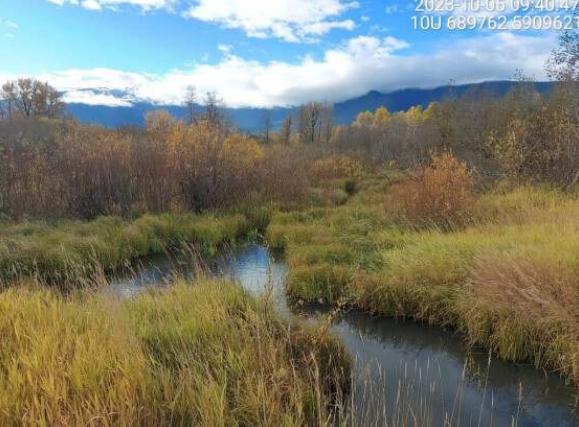
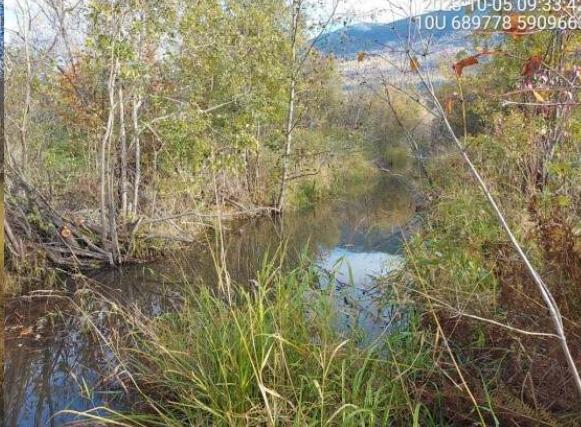
Photos: PSCIS ID 13903148. From top left clockwise: Road/Site Card, Barrel, Outlet, Downstream, Upstream, Inlet.

Location and Stream Data		Crossing Characteristics	
Date	2023-10-05	Crossing Sub Type	Round Culvert
PSCIS ID	199314	Diameter (m)	1.05
External ID	13903148	Length (m)	32
Crew	MW	Embedded	No
UTM Zone	10	Depth Embedded (m)	–
Easting	689760	Resemble Channel	No
Northing	5909638	Backwatered	Yes
Stream	Dominion Creek	Percent Backwatered	100
Road	Highway 16	Fill Depth (m)	1.3
Road Tenure	MOTI	Outlet Drop (m)	0
Channel Width (m)	2.9	Outlet Pool Depth (m)	0
Stream Slope (%)	0	Inlet Drop	No
Beaver Activity	No	Slope (%)	0
Habitat Value	Low	Valley Fill	Deep Fill
Final score	22	Barrier Result	Barrier
Fix type	Replace with New Open Bottom Structure	Fix Span / Diameter	15

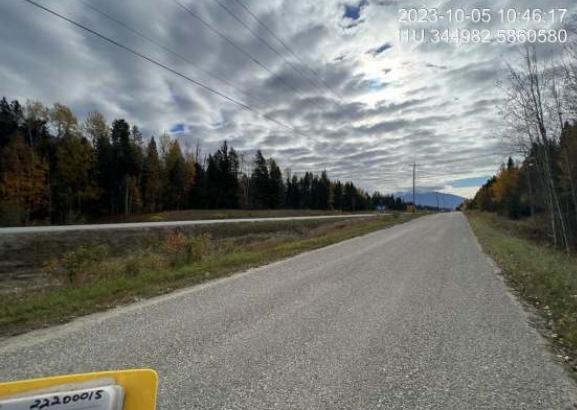
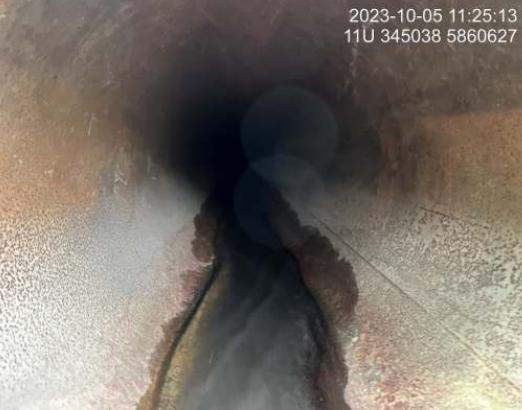
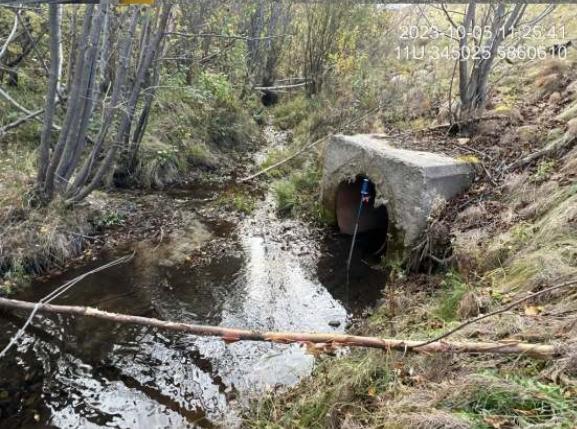
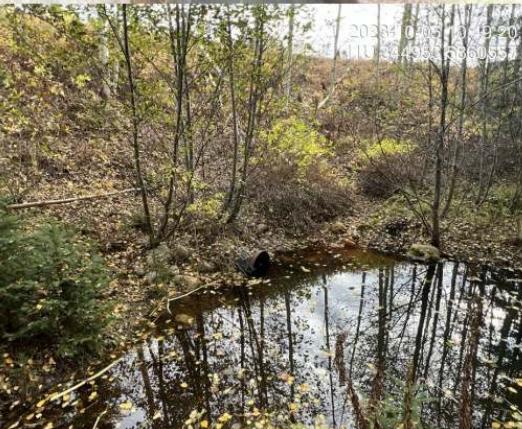
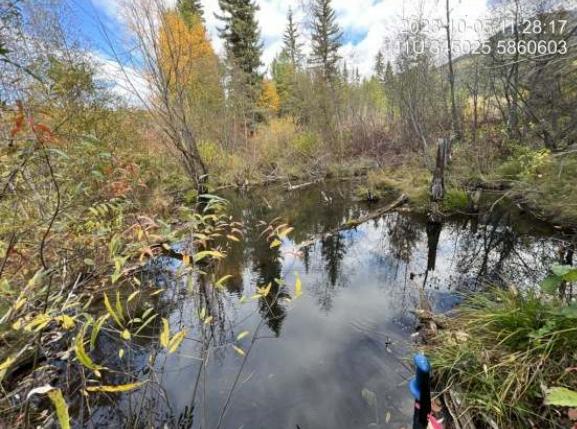
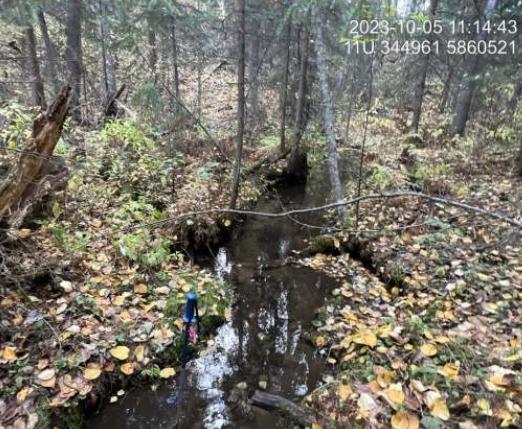
Photos: PSCIS ID 22200015. From top left clockwise: Road/Site Card, Barrel, Outlet, Downstream, Upstream, Inlet.

Location and Stream Data	.	Crossing Characteristics	-
Date	2023-10-05	Crossing Sub Type	Round Culvert
PSCIS ID	199315	Diameter (m)	0.9
External ID	22200015	Length (m)	67
Crew	AI	Embedded	No
UTM Zone	11	Depth Embedded (m)	-
Easting	345011	Resemble Channel	No
Northing	5860593	Backwatered	Yes
Stream	Crooked Creek	Percent Backwatered	10
Road	Highway 5	Fill Depth (m)	7.5
Road Tenure	MOTI	Outlet Drop (m)	0
Channel Width (m)	1.8	Outlet Pool Depth (m)	1
Stream Slope (%)	1.5	Inlet Drop	No
Beaver Activity	Yes	Slope (%)	3
Habitat Value	Medium	Valley Fill	Deep Fill
Final score	32	Barrier Result	Barrier
Fix type	Replace Structure with Streambed Simulation CBS	Fix Span / Diameter	3

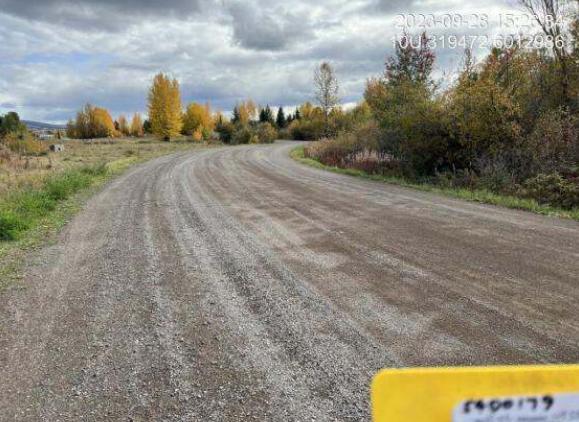
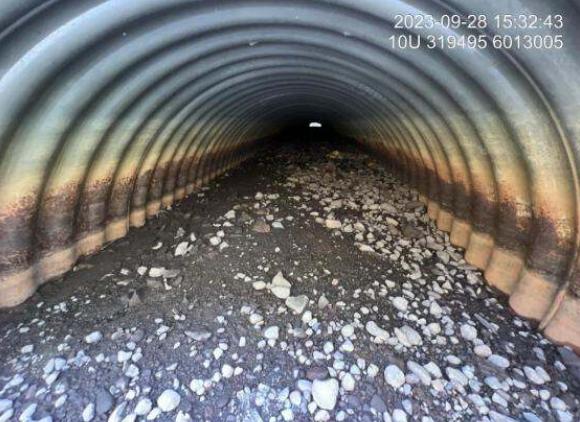
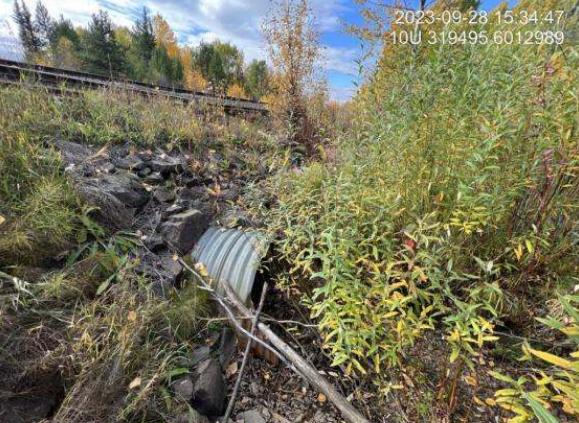
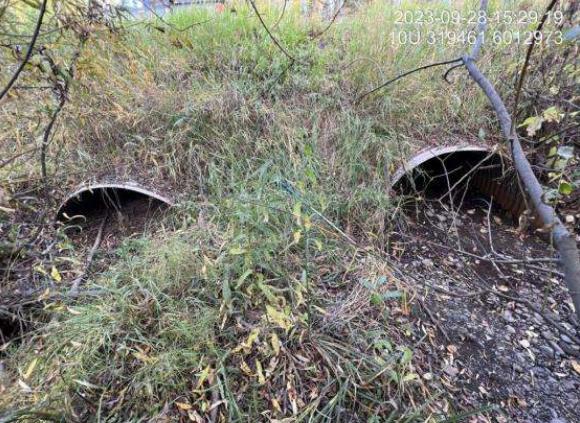
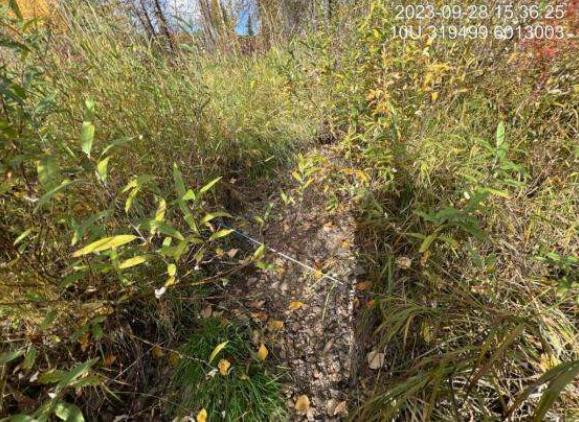
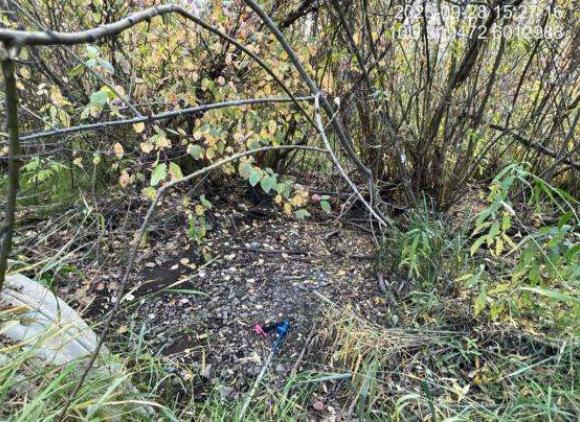
Photos: PSCIS ID 5400179. From top left clockwise: Road/Site Card, Barrel, Outlet, Downstream, Upstream, Inlet.

Location and Stream Data		•	Crossing Characteristics	–
Date	2023-09-28	Crossing Sub Type	Round Culvert	
PSCIS ID	199316	Diameter (m)	4.5	
External ID	5400179	Length (m)	38	
Crew	AI	Embedded	Yes	
UTM Zone	10	Depth Embedded (m)	0.75	
Easting	319471	Resemble Channel	Yes	
Northing	6012988	Backwatered	No	
Stream	Sauls Creek	Percent Backwatered	–	
Road	Railway Avenue	Fill Depth (m)	1.5	
Road Tenure	Burns Lake	Outlet Drop (m)	0	
Channel Width (m)	2.8	Outlet Pool Depth (m)	0	
Stream Slope (%)	0	Inlet Drop	No	
Beaver Activity	Yes	Slope (%)	0	
Habitat Value	Medium	Valley Fill	Deep Fill	
Final score	11	Barrier Result	Passable	
Fix type	–	Fix Span / Diameter	–	
Comments: There are three 1.5m pipes located under Railway Avenue continuing all the way under the railway line. Pipes are embedded at or more than 50% of their depth. Stream was dry at the time of assessment and scoured channels indicate a fairly small system.. 15:25:25

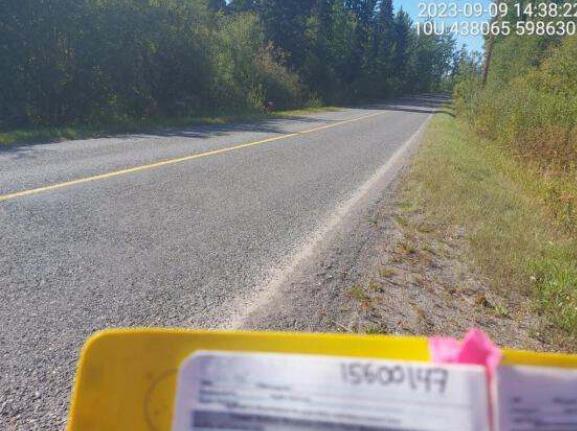
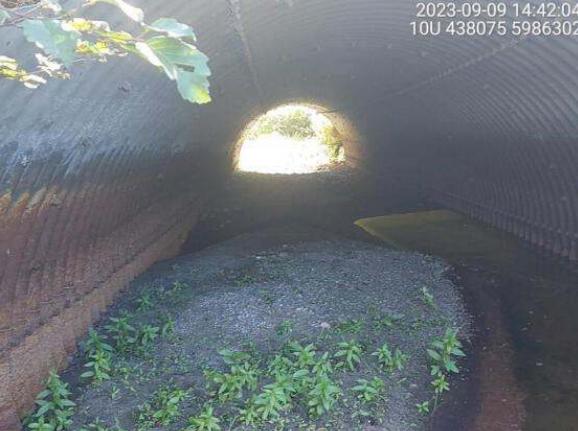
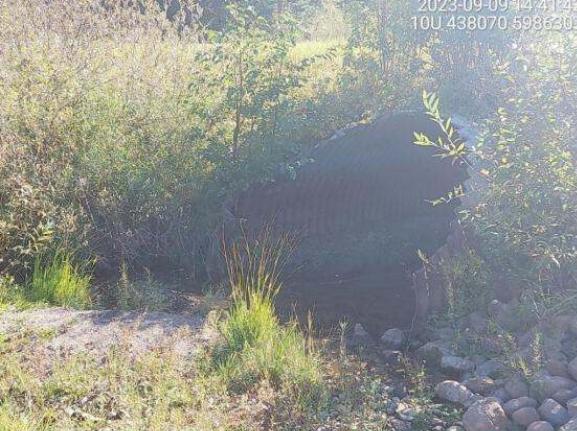
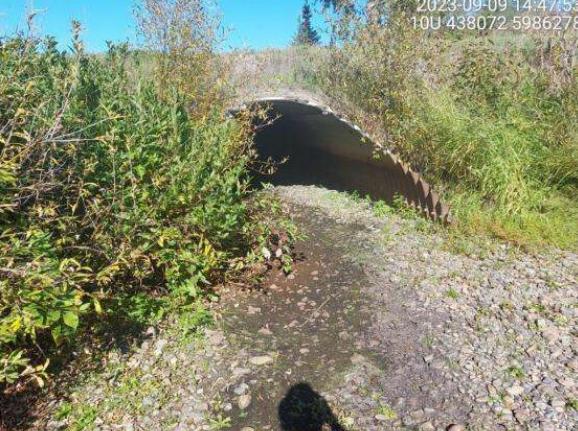
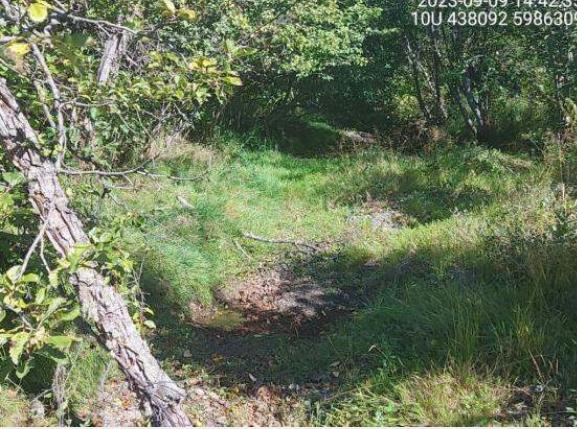
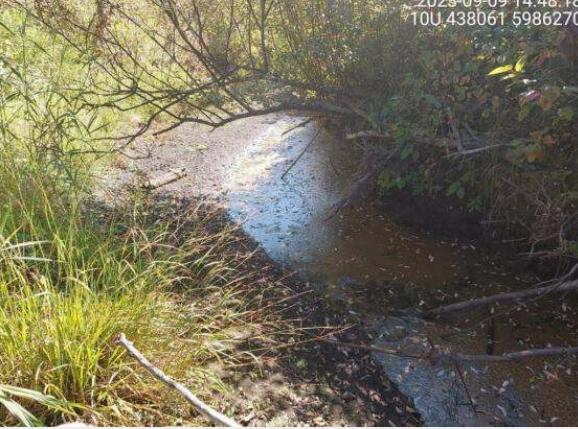
Photos: PSCIS ID 15600147. From top left clockwise: Road/Site Card, Barrel, Outlet, Downstream, Upstream, Inlet.

Location and Stream Data		.	Crossing Characteristics	–
Date	2023-09-09	Crossing Sub Type	Round Culvert	
PSCIS ID	199317	Diameter (m)	2.7	
External ID	15600147	Length (m)	16	
Crew	MW	Embedded	Yes	
UTM Zone	10	Depth Embedded (m)	0.3	
Easting	438071	Resemble Channel	No	
Northing	5986296	Backwatered	No	
Stream	Knight Creek	Percent Backwatered	–	
Road	Sickness Road	Fill Depth (m)	0.5	
Road Tenure	Vanderhoof	Outlet Drop (m)	0	
Channel Width (m)	1.9	Outlet Pool Depth (m)	0	
Stream Slope (%)	2	Inlet Drop	No	
Beaver Activity	No	Slope (%)	1	
Habitat Value	Medium	Valley Fill	Deep Fill	
Final score	13	Barrier Result	Passable	
Fix type	–	Fix Span / Diameter	–	
Comments: No water in pipe. Periodic pools of standing water upstream and downstream but no flowing water. NEWWS has completed restoration work for this site with sign posted at this location. Culvert appears fully embedded in photos so have changed inputs to reflect this.. 14:51:44

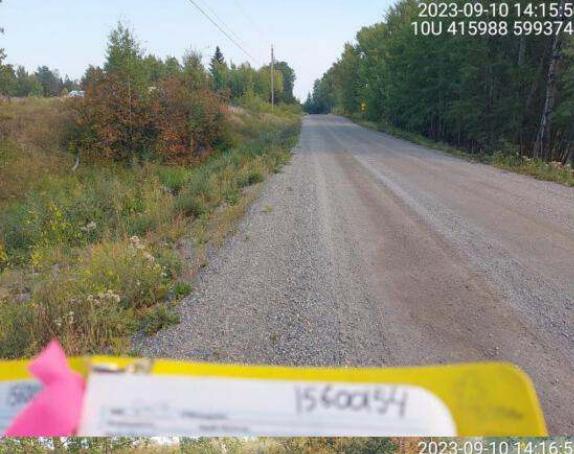
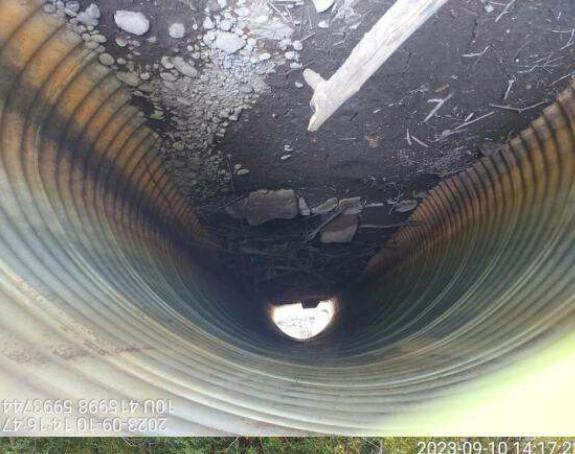
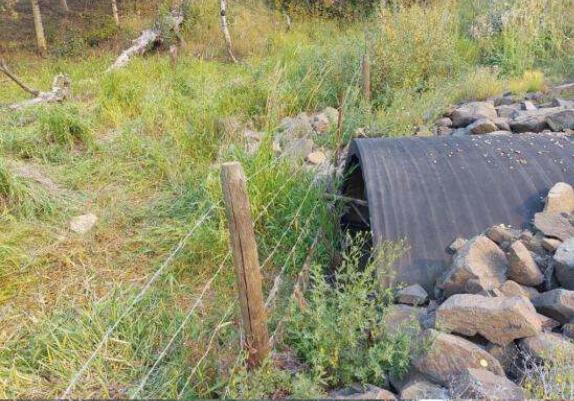
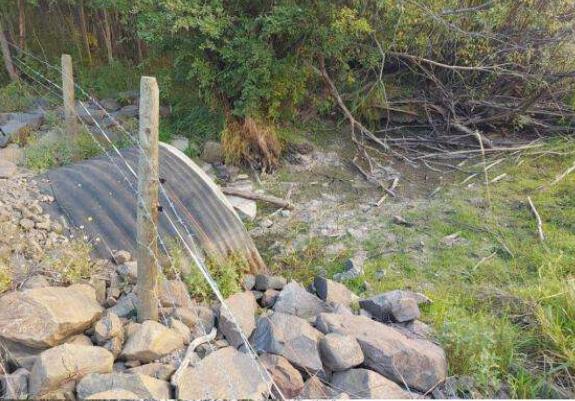
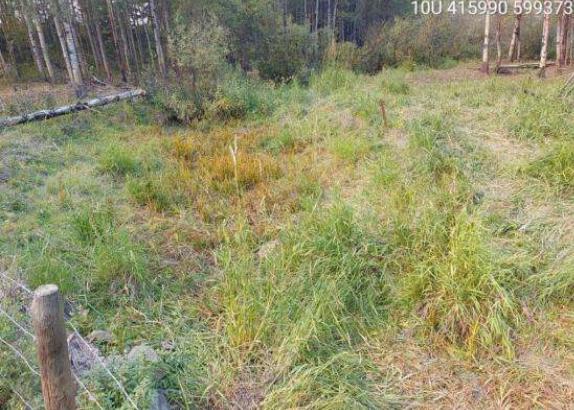
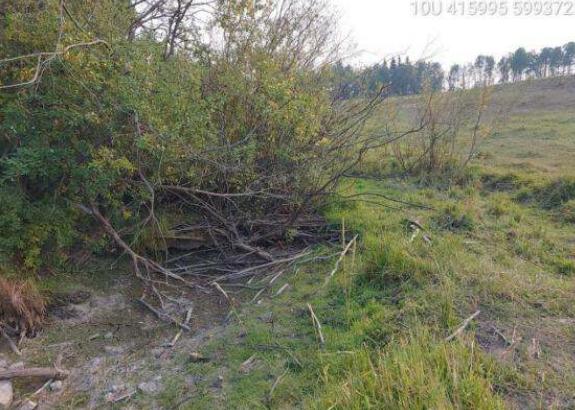
Photos: PSCIS ID 15600154. From top left clockwise: Road/Site Card, Barrel, Outlet, Downstream, Upstream, Inlet.

Location and Stream Data		Crossing Characteristics	
Date	2023-09-10	Crossing Sub Type	Round Culvert
PSCIS ID	199318	Diameter (m)	1
External ID	15600154	Length (m)	16
Crew	MW	Embedded	Yes
UTM Zone	10	Depth Embedded (m)	0.1
Easting	416009	Resemble Channel	No
Northing	5993732	Backwatered	No
Stream	Trankle Creek	Percent Backwatered	-
Road	Braeside Rd	Fill Depth (m)	1
Road Tenure	MOTI	Outlet Drop (m)	0
Channel Width (m)	1	Outlet Pool Depth (m)	0
Stream Slope (%)	2	Inlet Drop	No
Beaver Activity	No	Slope (%)	1
Habitat Value	Low	Valley Fill	Deep Fill
Final score	16	Barrier Result	Potential
Fix type	Replace Structure with Streambed Simulation CBS	Fix Span / Diameter	3

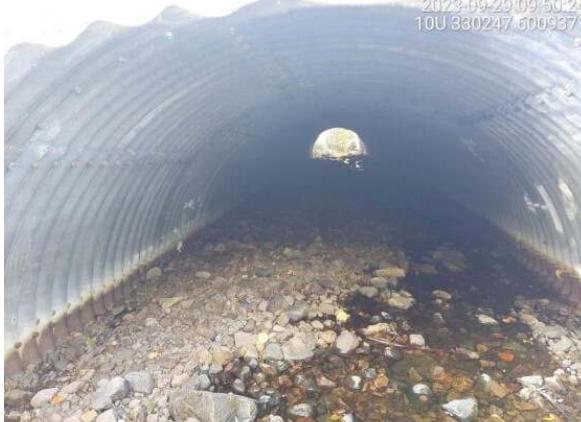
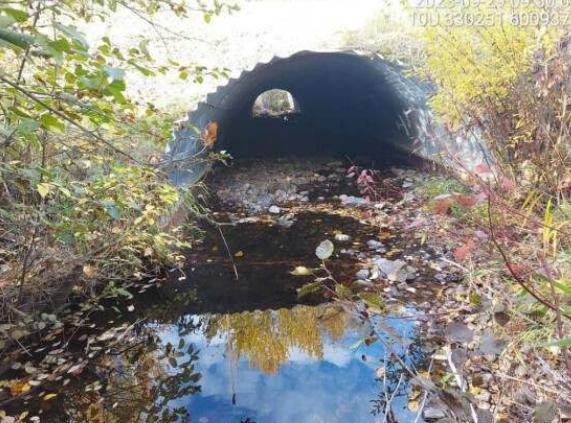
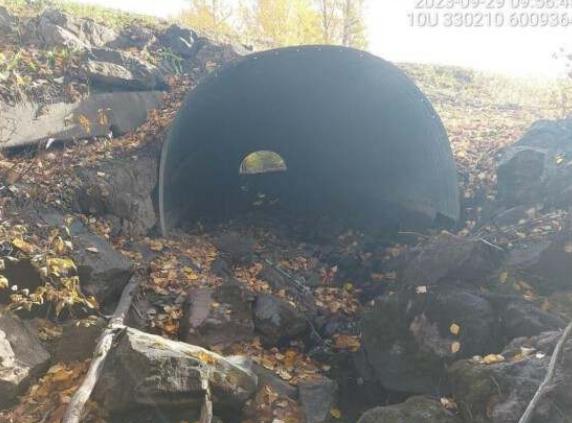
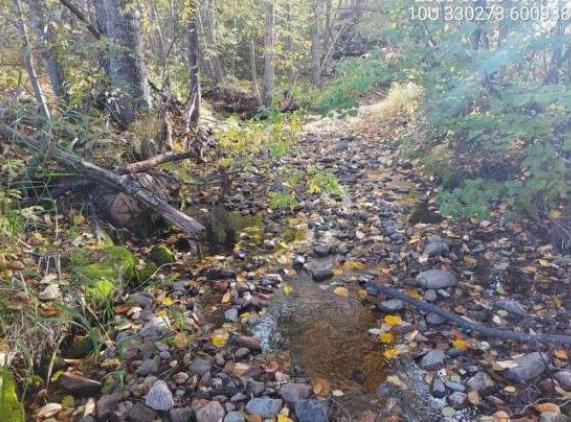
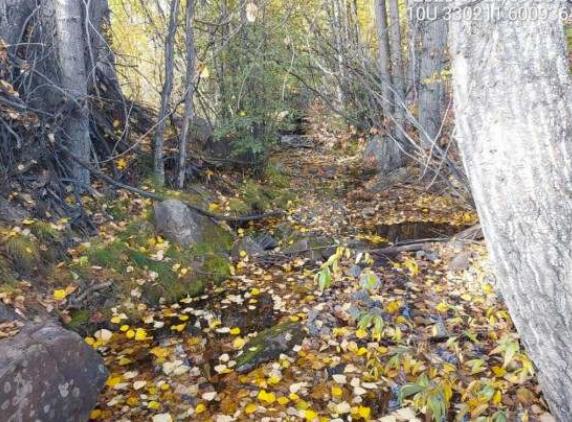
Photos: PSCIS ID 5400028. From top left clockwise: Road/Site Card, Barrel, Outlet, Downstream, Upstream, Inlet.

Comments: Wide channel, nicely installed moti major structure that appears passable as fully embedded. 3m falls noted in FISS as 1.3 km upstream. Railway crossing just downstream noted as passable in bcfishpass. MoTi chris_hwy_structure_road_id: 3811. 09:56:11

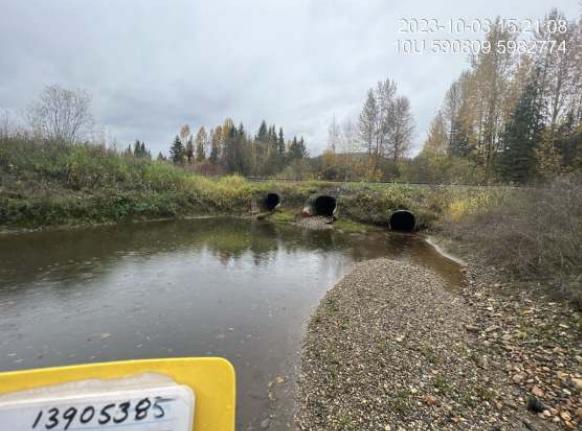
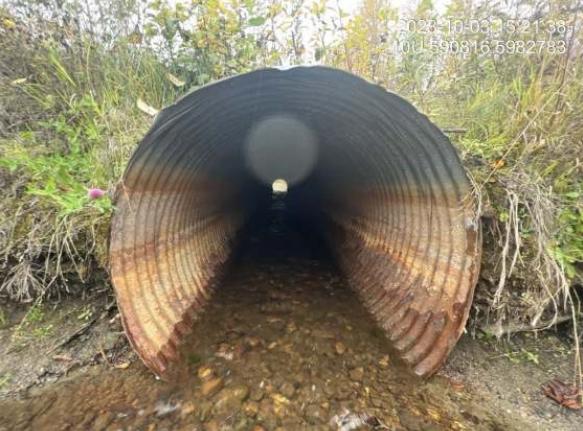
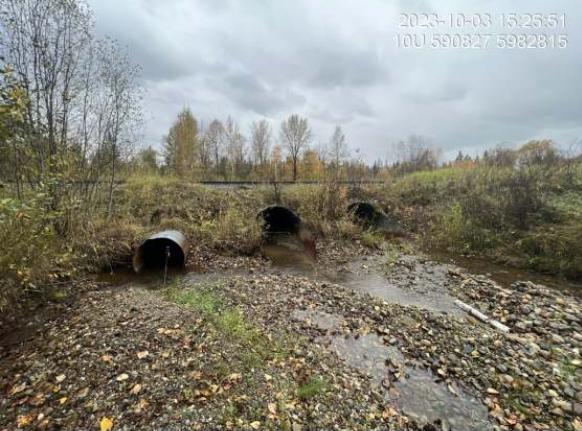
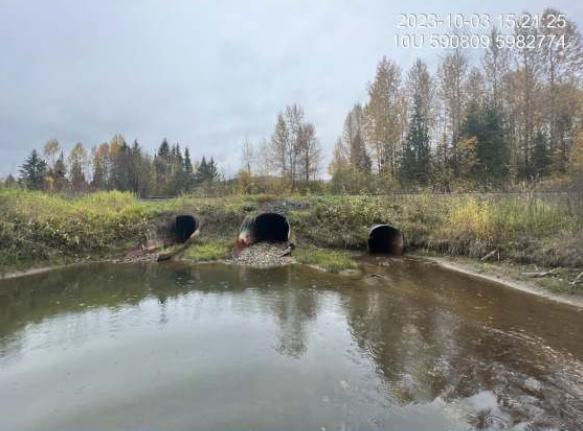
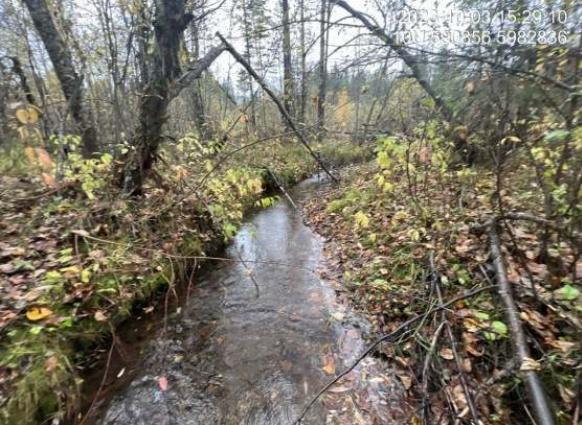
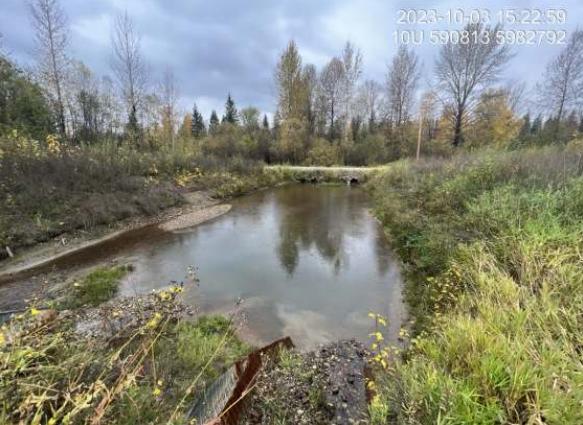
Location and Stream Data		•	Crossing Characteristics	–
Date	2023-10-03	Crossing Sub Type	Round Culvert	
PSCIS ID	199320	Diameter (m)	4.8	
External ID	13905385	Length (m)	18	
Crew	AI	Embedded	Yes	
UTM Zone	10	Depth Embedded (m)	0.25	
Easting	590814	Resemble Channel	Yes	
Northing	5982800	Backwatered	No	
Stream	Wolfe Creek	Percent Backwatered	–	
Road	Railway	Fill Depth (m)	2	
Road Tenure	CN Rail	Outlet Drop (m)	0	
Channel Width (m)	3.3	Outlet Pool Depth (m)	0.1	
Stream Slope (%)	1.5	Inlet Drop	No	
Beaver Activity	Yes	Slope (%)	0	
Habitat Value	High	Valley Fill	Deep Fill	
Final score	8	Barrier Result	Passable	
Fix type	–	Fix Span / Diameter	–	
Comments: Fully embedded pipes. Three pipes total, with two at 1.8 m and one at 1.2m in diameter. Nice habitat upstream with abundant gravels, some deeper pools and deeply undercut banks.. 15:31:23				
Photos: PSCIS ID 13905385. From top left clockwise: Road/Site Card, Barrel, Outlet, Downstream, Upstream, Inlet.

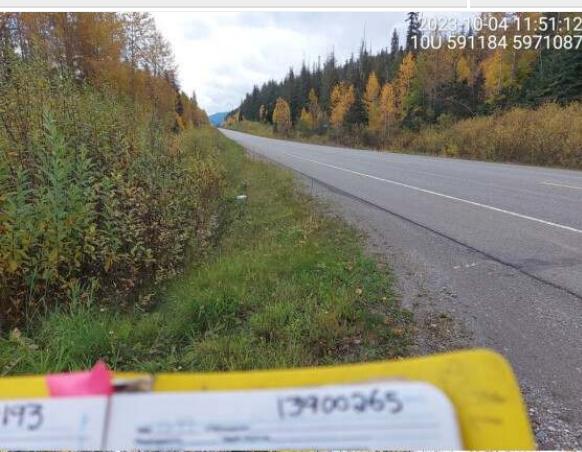
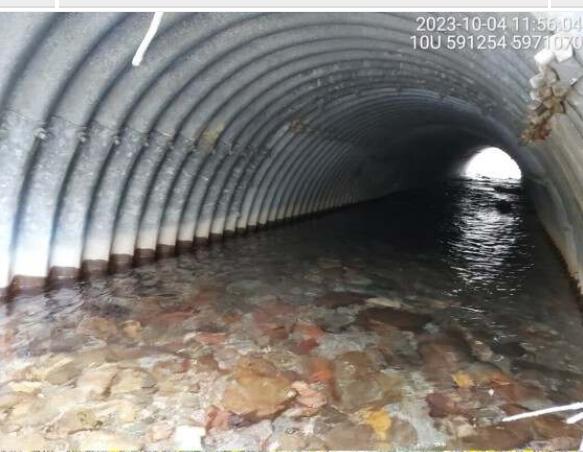
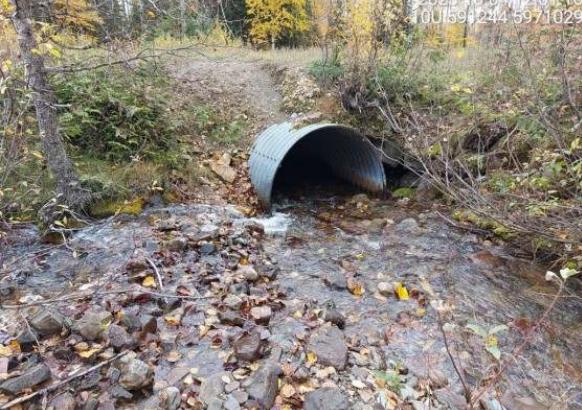
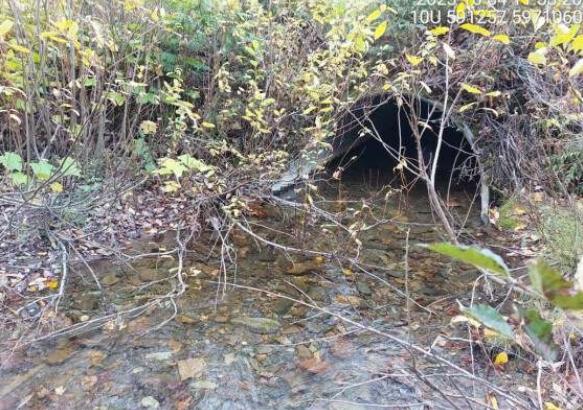
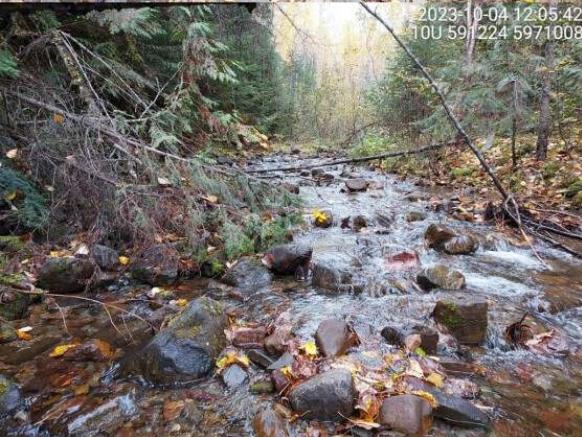
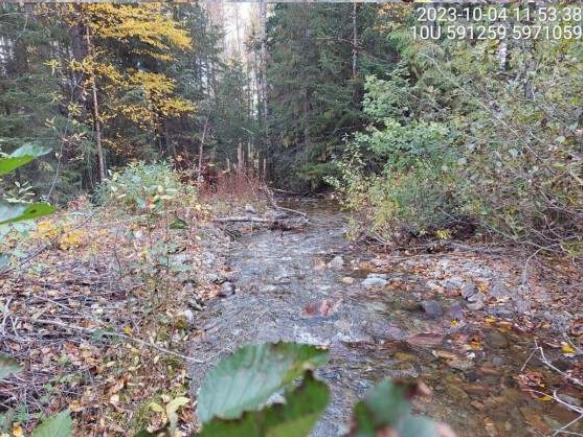
Photos: PSCIS ID 13900265. From top left clockwise: Road/Site Card, Barrel, Outlet, Downstream, Upstream, Inlet.

Location and Stream Data		Crossing Characteristics	
Date	2023-10-04	Crossing Sub Type	Round Culvert
PSCIS ID	199321	Diameter (m)	2
External ID	13900265	Length (m)	22
Crew	MW	Embedded	Yes
UTM Zone	10	Depth Embedded (m)	0.25
Easting	591253	Resemble Channel	No
Northing	5971048	Backwatered	No
Stream	Sugarbowl Creek	Percent Backwatered	—
Road	Highway 16	Fill Depth (m)	0.8
Road Tenure	MOTI	Outlet Drop (m)	0
Channel Width (m)	6.2	Outlet Pool Depth (m)	0
Stream Slope (%)	5.5	Inlet Drop	No
Beaver Activity	No	Slope (%)	1
Habitat Value	High	Valley Fill	Deep Fill
Final score	19	Barrier Result	Potential
Fix type	Replace with New Open Bottom Structure	Fix Span / Diameter	15

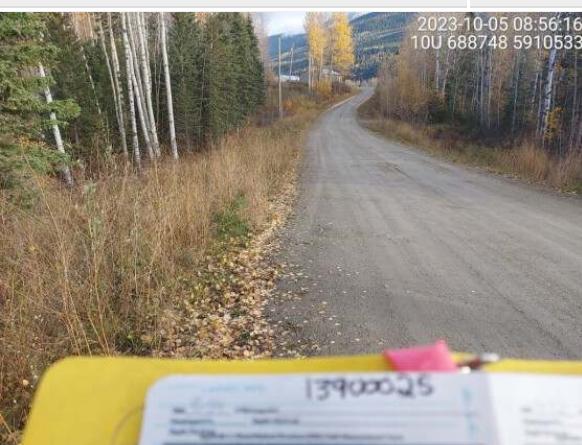
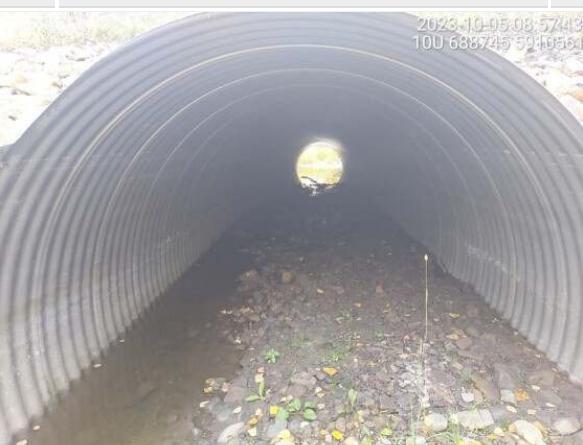
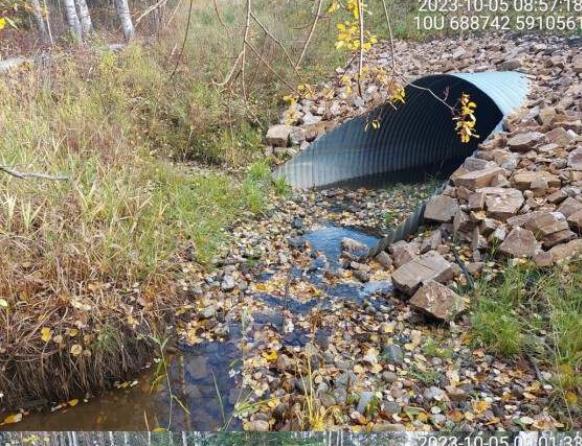
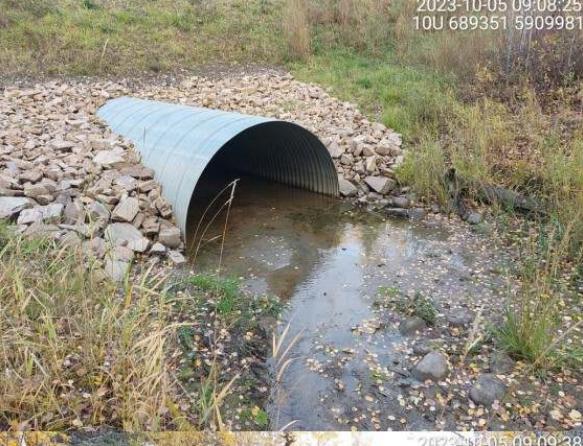
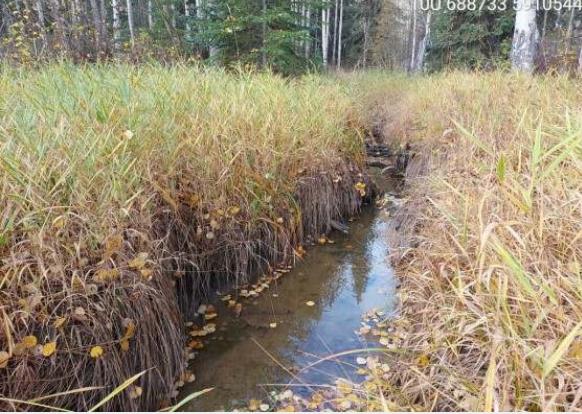
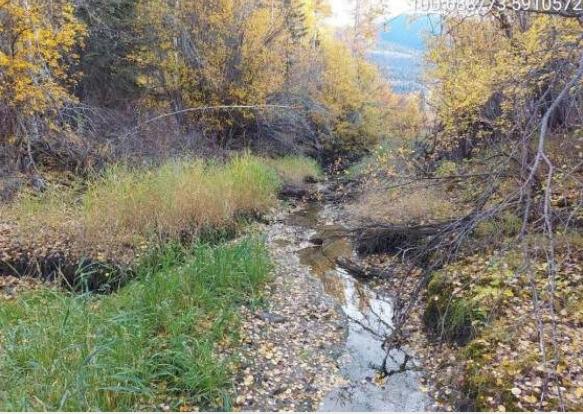
Photos: PSCIS ID 13900025. From top left clockwise: Road/Site Card, Barrel, Outlet, Downstream, Upstream, Inlet.

Location and Stream Data	.	Crossing Characteristics	—
Date	2023-10-05	Crossing Sub Type	Round Culvert
PSCIS ID	199322	Diameter (m)	3
External ID	13900025	Length (m)	27
Crew	MW	Embedded	Yes
UTM Zone	10	Depth Embedded (m)	0.15
Easting	688754	Resemble Channel	No
Northing	5910557	Backwatered	No
Stream	Shelby Creek	Percent Backwatered	—
Road	Airport Rd	Fill Depth (m)	2.2
Road Tenure	McBride	Outlet Drop (m)	0
Channel Width (m)	1.4	Outlet Pool Depth (m)	0
Stream Slope (%)	2	Inlet Drop	No
Beaver Activity	No	Slope (%)	3
Habitat Value	Medium	Valley Fill	Deep Fill
Final score	18	Barrier Result	Potential
Fix type	Replace Structure with Streambed Simulation CBS	Fix Span / Diameter	3

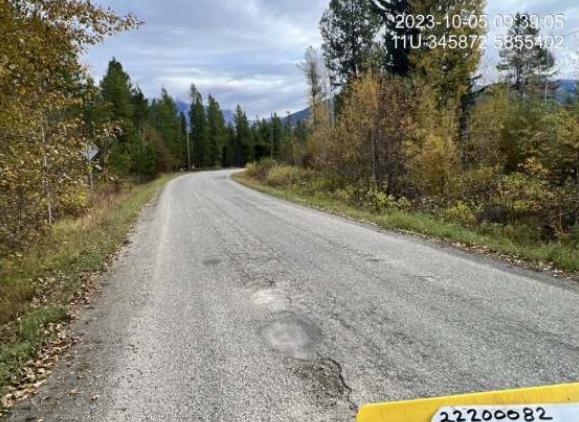
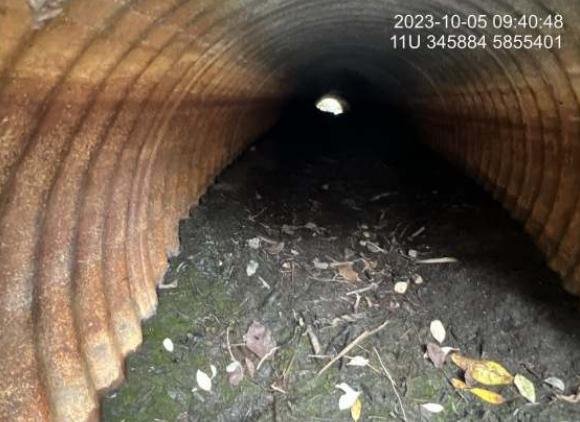
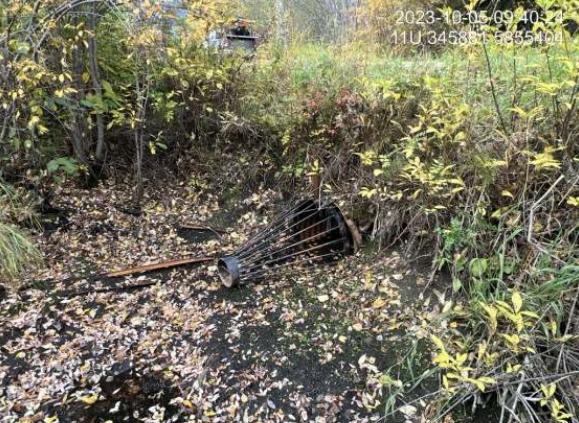
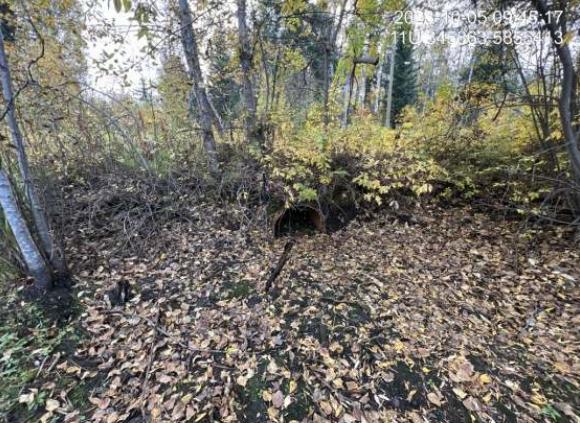
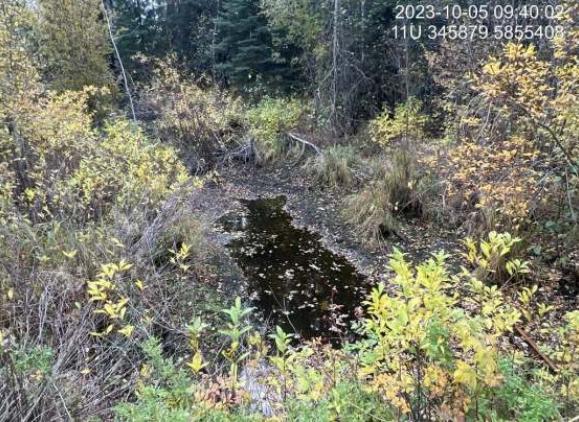
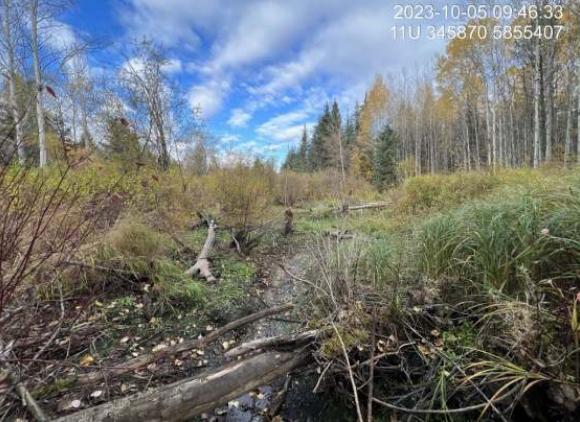
Photos: PSCIS ID 22200082. From top left clockwise: Road/Site Card, Barrel, Outlet, Downstream, Upstream, Inlet.

Location and Stream Data		•	Crossing Characteristics	–
Date	2023-10-05		Crossing Sub Type	Round Culvert
PSCIS ID	199323		Diameter (m)	0.75
External ID	22200082		Length (m)	12
Crew	AI		Embedded	Yes
UTM Zone	11		Depth Embedded (m)	0.18
Easting	345873		Resemble Channel	Yes
Northing	5855411		Backwatered	No
Stream	Cranberry Creek		Percent Backwatered	–
Road	Cranberry Lake Road		Fill Depth (m)	1
Road Tenure	MOTI		Outlet Drop (m)	0
Channel Width (m)	4		Outlet Pool Depth (m)	0
Stream Slope (%)	0		Inlet Drop	No
Beaver Activity	Yes		Slope (%)	0
Habitat Value	Medium		Valley Fill	Deep Fill
Final score	11		Barrier Result	Passable
Fix type	–		Fix Span / Diameter	–
Comments: Stream is mostly dewatered. Large beaver dam (1.7m high) located approximately 30m upstream. Fully embedded pipe with beaver grate on the inlet. Unassessed crossing on private driveway upstream from here. Adjacent landowner has concerns about the recent lack of water and says it is un-characteristic for the section of stream. They have concerns that recent pipeline construction just upstream of this crossing has potentially influenced beaver populations and water flow.. 09:47:05

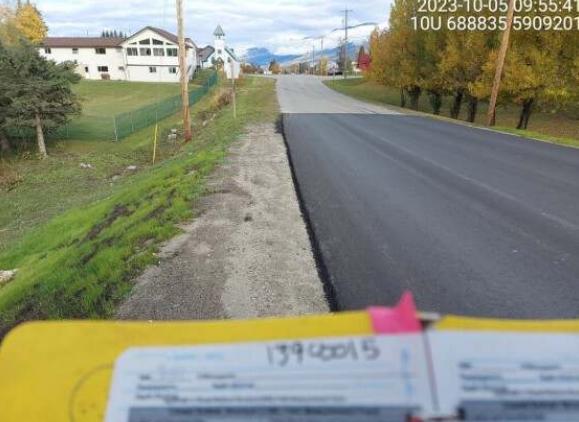
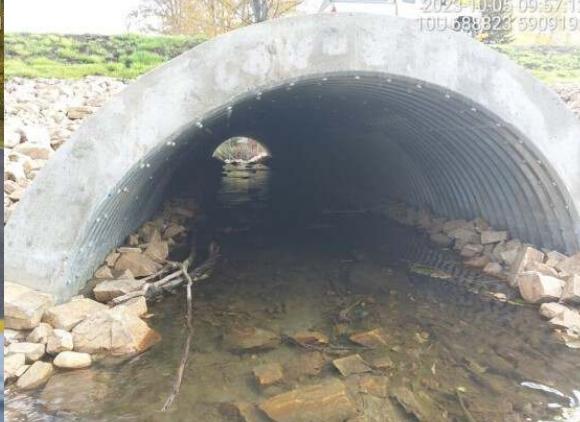
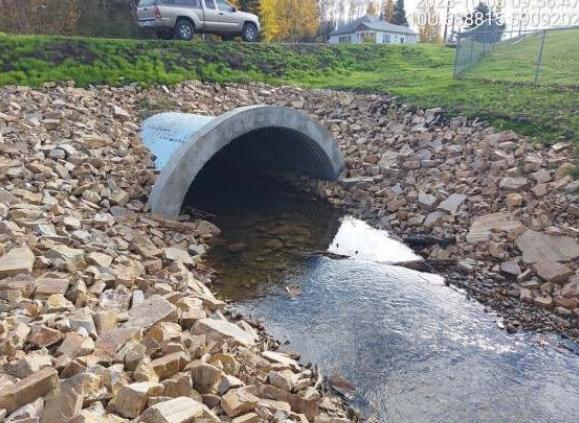
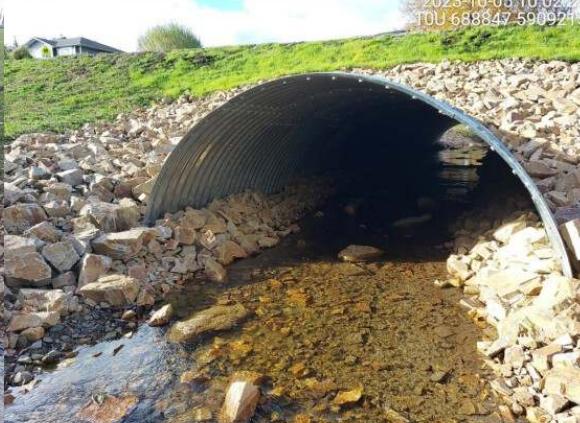
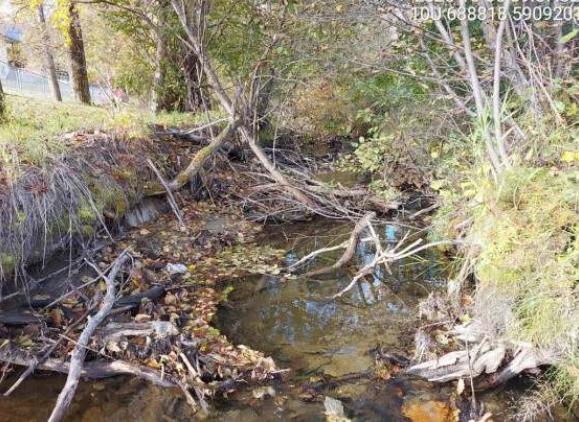
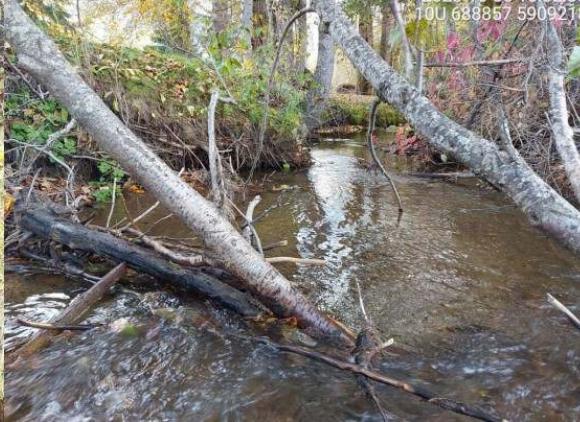
Location and Stream Data		Crossing Characteristics	
Date	2023-10-05	Crossing Sub Type	Round Culvert
PSCIS ID	199324	Diameter (m)	3.7
External ID	13900015	Length (m)	30
Crew	MW	Embedded	Yes
UTM Zone	10	Depth Embedded (m)	0.2
Easting	688844	Resemble Channel	Yes
Northing	5909209	Backwatered	No
Stream	Dominion Creek	Percent Backwatered	-
Road	2nd Ave	Fill Depth (m)	2
Road Tenure	McBride	Outlet Drop (m)	0
Channel Width (m)	3.4	Outlet Pool Depth (m)	0
Stream Slope (%)	0	Inlet Drop	No
Beaver Activity	No	Slope (%)	1
Habitat Value	High	Valley Fill	Deep Fill
Final score	16	Barrier Result	Potential
Fix type	Replace with New Open Bottom Structure	Fix Span / Diameter	15
Comments: Continuously embedded culvert. Wide channel with moderate flow. High value habitat. 10:09:03			
Photos: PSCIS ID 13900015. From top left clockwise: Road/Site Card, Barrel, Outlet, Downstream, Upstream, Inlet.

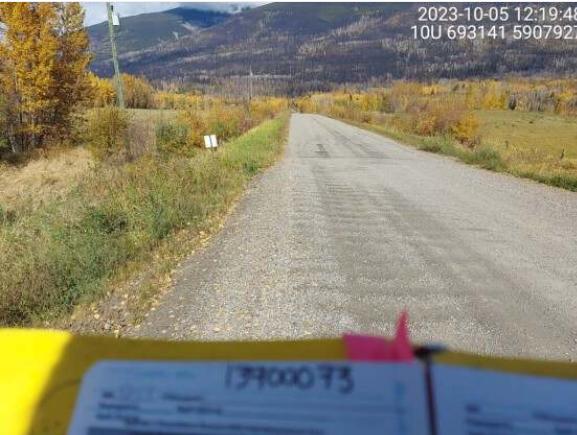
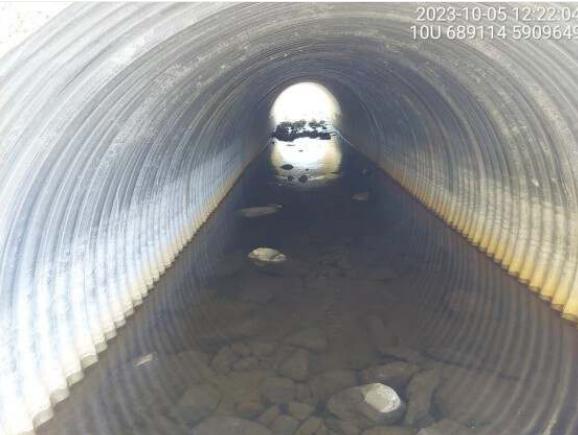
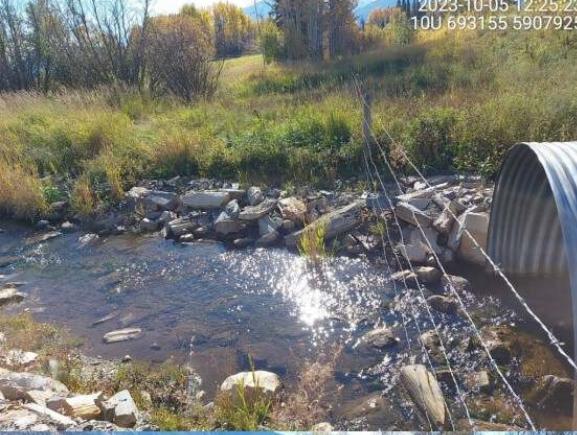
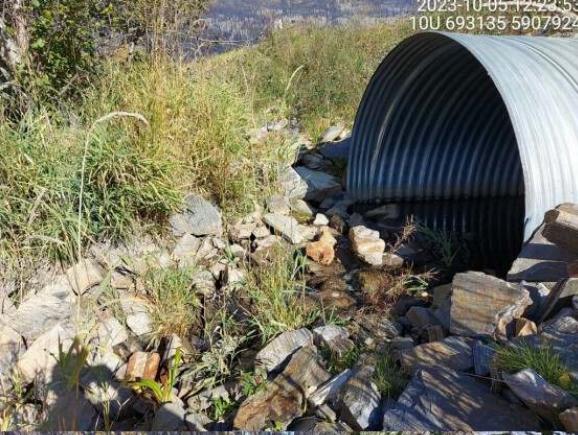
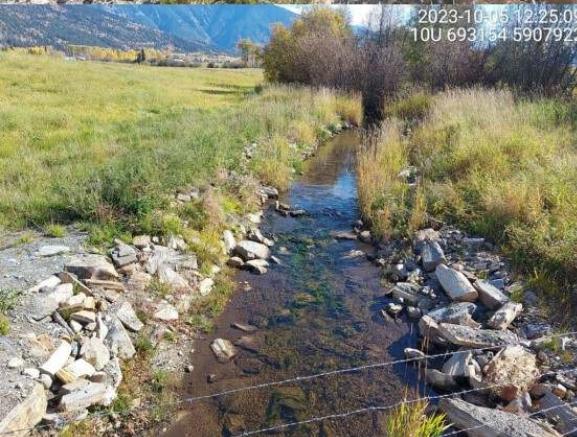
Photos: PSCIS ID 13900073. From top left clockwise: Road/Site Card, Barrel, Outlet, Downstream, Upstream, Inlet.

Location and Stream Data		Crossing Characteristics	
Date	2023-10-05	Crossing Sub Type	Round Culvert
PSCIS ID	199325	Diameter (m)	2.5
External ID	13900073	Length (m)	20
Crew	MW	Embedded	Yes
UTM Zone	10	Depth Embedded (m)	0.3
Easting	693145	Resemble Channel	Yes
Northing	5907919	Backwatered	No
Stream	Teare Creek	Percent Backwatered	—
Road	Jeck Rd	Fill Depth (m)	1.5
Road Tenure	MOTI Local	Outlet Drop (m)	0
Channel Width (m)	3.1	Outlet Pool Depth (m)	0.5
Stream Slope (%)	0	Inlet Drop	No
Beaver Activity	No	Slope (%)	1
Habitat Value	Medium	Valley Fill	Deep Fill
Final score	16	Barrier Result	Potential
Fix type	Replace with New Open Bottom Structure	Fix Span / Diameter	15
