Appendix - Phase 1 Fish Passage Assessment Data and Photos

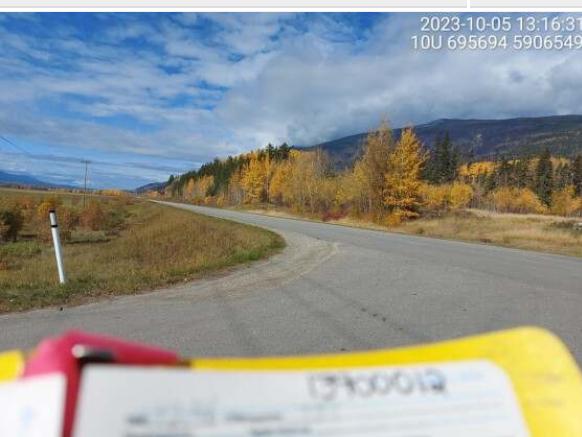
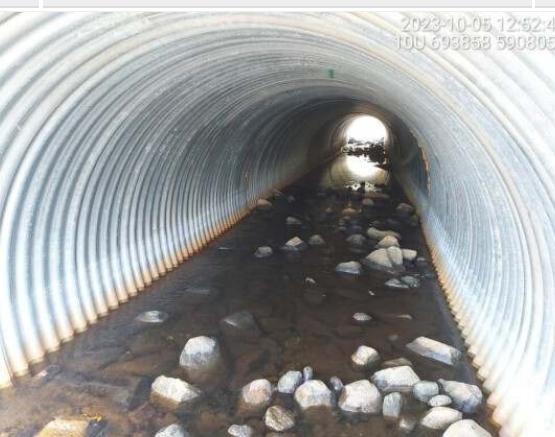
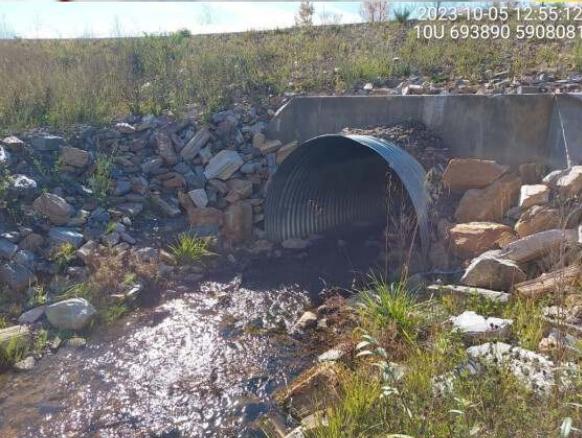
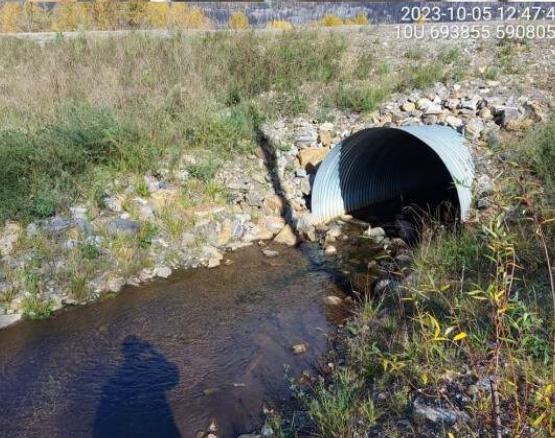
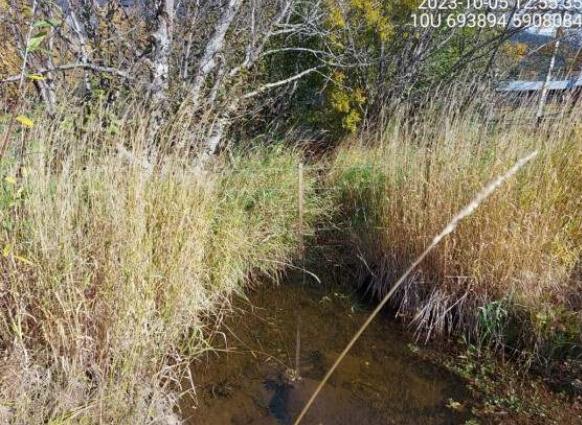
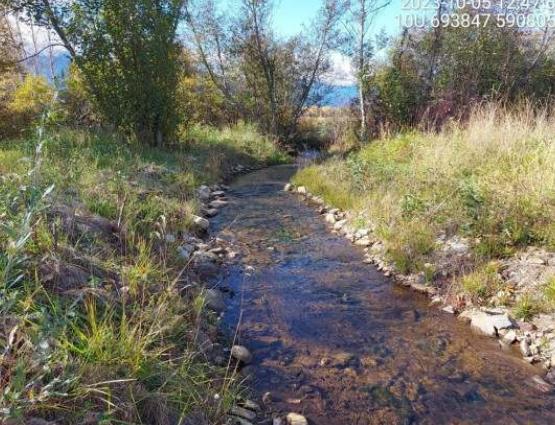
Photos: PSCIS ID 13900012. From top left clockwise: Road/Site Card, Barrel, Outlet, Downstream, Upstream, Inlet.

Location and Stream Data		Crossing Characteristics	
Date	2023-10-05	Crossing Sub Type	Round Culvert
PSCIS ID	199326	Diameter (m)	2.5
External ID	13900012	Length (m)	32
Crew	MW	Embedded	Yes
UTM Zone	10	Depth Embedded (m)	0.2
Easting	693878	Resemble Channel	Yes
Northing	5908064	Backwatered	No
Stream	Teare Creek	Percent Backwatered	—
Road	Highway 16	Fill Depth (m)	2.2
Road Tenure	MOTI	Outlet Drop (m)	0
Channel Width (m)	2.8	Outlet Pool Depth (m)	0
Stream Slope (%)	2	Inlet Drop	No
Beaver Activity	No	Slope (%)	1
Habitat Value	Medium	Valley Fill	Deep Fill
Final score	19	Barrier Result	Potential
Fix type	Replace with New Open Bottom Structure	Fix Span / Diameter	15

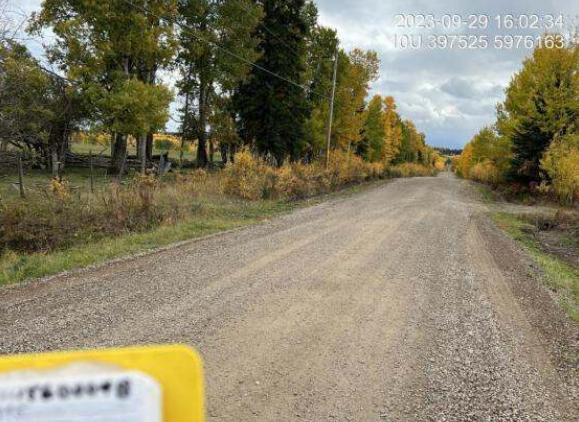
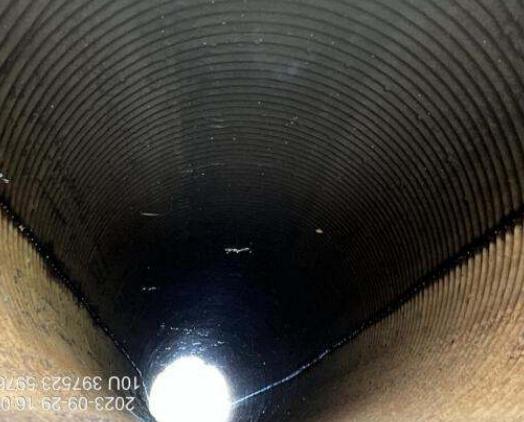
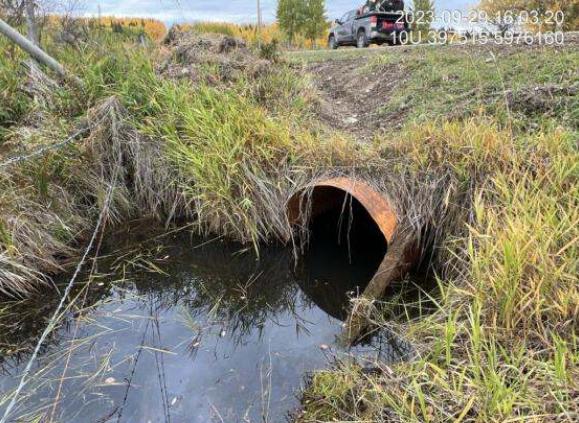
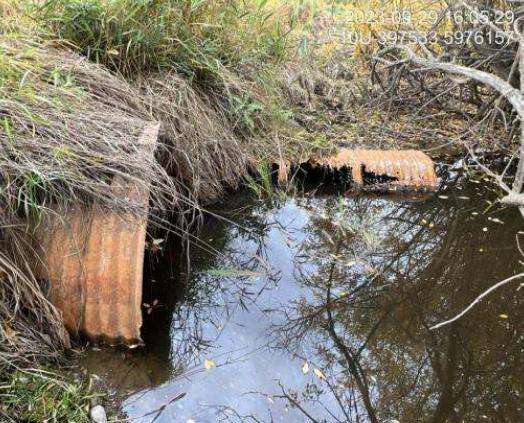
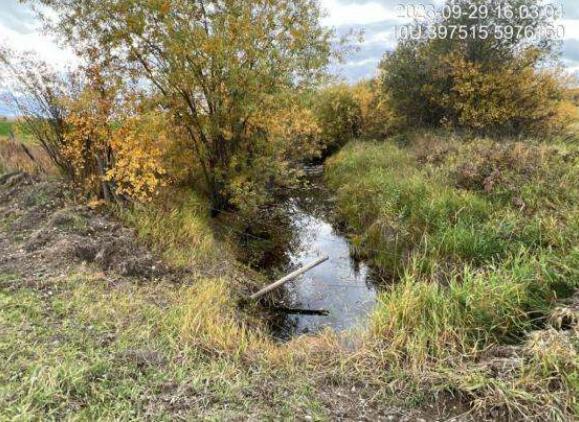
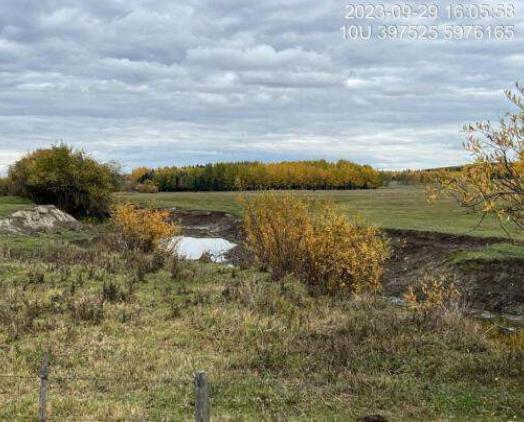
Photos: PSCIS ID 15600048. From top left clockwise: Road/Site Card, Barrel, Outlet, Downstream, Upstream, Inlet.

Location and Stream Data		•	Crossing Characteristics	–
Date	2023-09-29	Crossing Sub Type	Round Culvert	
PSCIS ID	199327	Diameter (m)	1.8	
External ID	15600048	Length (m)	17	
Crew	AI	Embedded	Yes	
UTM Zone	10	Depth Embedded (m)	0.2	
Easting	397528	Resemble Channel	Yes	
Northing	5976165	Backwatered	Yes	
Stream	Tahultzu Creek	Percent Backwatered	100	
Road	Lily Lake Road	Fill Depth (m)	1	
Road Tenure	MOTI	Outlet Drop (m)	0	
Channel Width (m)	3	Outlet Pool Depth (m)	0.3	
Stream Slope (%)	0	Inlet Drop	No	
Beaver Activity	No	Slope (%)	0	
Habitat Value	Medium	Valley Fill	Deep Fill	
Final score	14	Barrier Result	Passable	
Fix type	–	Fix Span / Diameter	–	
Comments: Two pipes (1.2m and 0.6m). 100% backwater. Guessing the pipes are embedded but cannot see due to poor water quality. This stream is extremely impacted by poor cattle ranching practices. There is no riparian fencing and cattle have completely trampled all the banks. There is no riparian vegetation and water quality is extremely poor. This stream could likely be very productive for chinook and other species if eventually restored. MoTi chris_culvert_id: 1795014, 1795015. 16:01:11

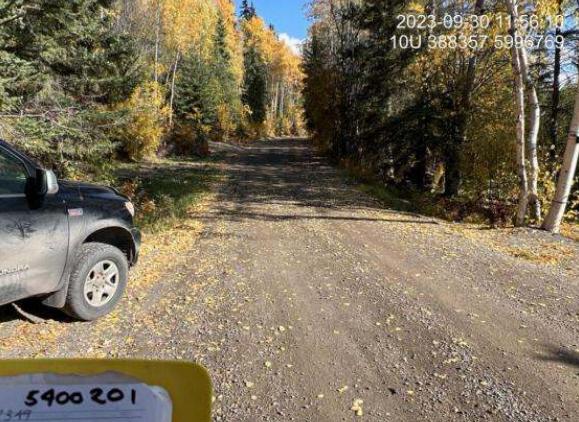
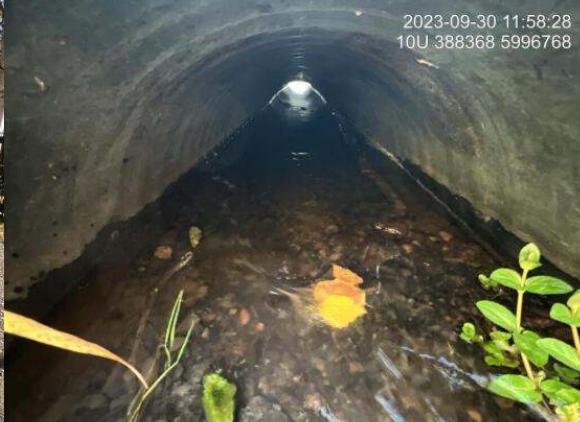
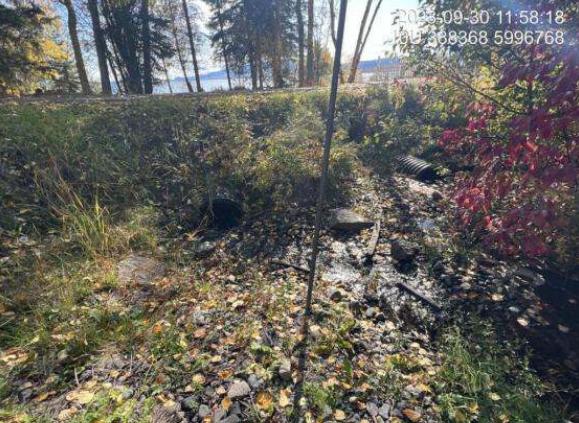
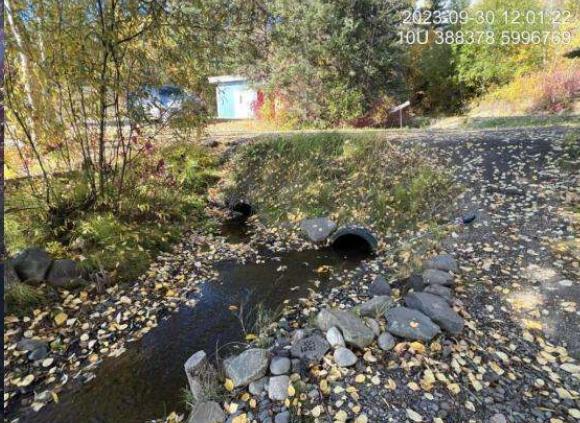
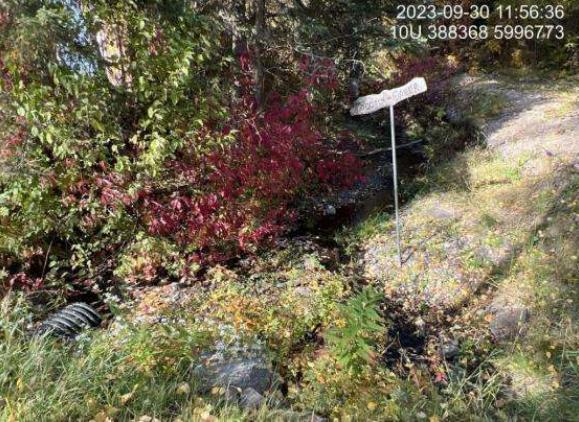
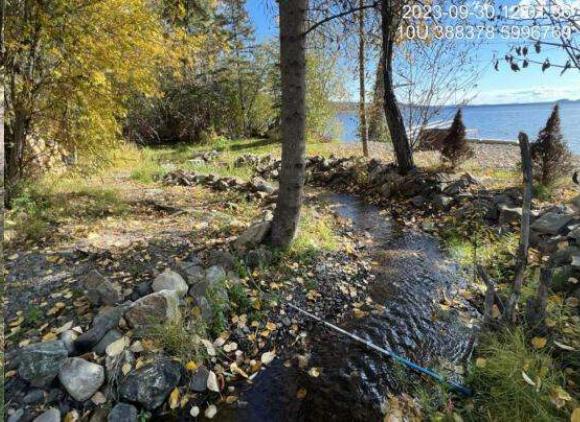
Photos: PSCIS ID 5400201. From top left clockwise: Road/Site Card, Barrel, Outlet, Downstream, Upstream, Inlet.

Location and Stream Data		•	Crossing Characteristics	–
Date	2023-09-30	Crossing Sub Type	Round Culvert	
PSCIS ID	199328	Diameter (m)	1.2	
External ID	5400201	Length (m)	11	
Crew	AI	Embedded	Yes	
UTM Zone	10	Depth Embedded (m)	0.5	
Easting	388367	Resemble Channel	Yes	
Northing	5996767	Backwatered	Yes	
Stream	Scotch Creek	Percent Backwatered	80	
Road	Gala Lake Road	Fill Depth (m)	1.5	
Road Tenure	MOTI	Outlet Drop (m)	0	
Channel Width (m)	1.7	Outlet Pool Depth (m)	0.05	
Stream Slope (%)	3	Inlet Drop	No	
Beaver Activity	No	Slope (%)	0.2	
Habitat Value	Medium	Valley Fill	Deep Fill	
Final score	6	Barrier Result	Passable	
Fix type	–	Fix Span / Diameter	–	
Comments: Good flow. Abundant gravel downstream and upstream. Pipes are both fully embedded with partial backwatering. Chinook point on the stream immediately adjacent to the site. Upstream left bank riparian has been cleared for what appears to be a parking space. Upstream crossing on Stella Road could be addressed by MoT. MoTi chris_culvert_id: 1790947, 3365573. 11:54:44

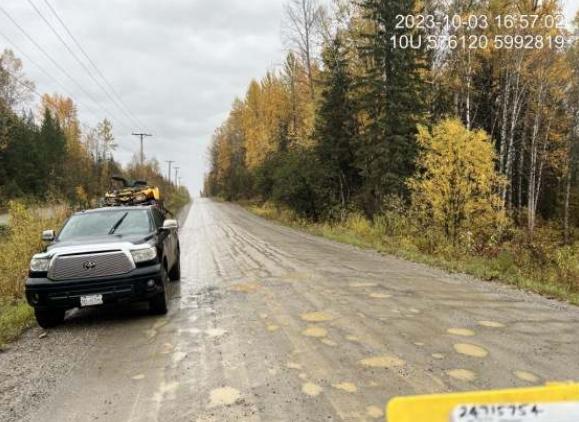
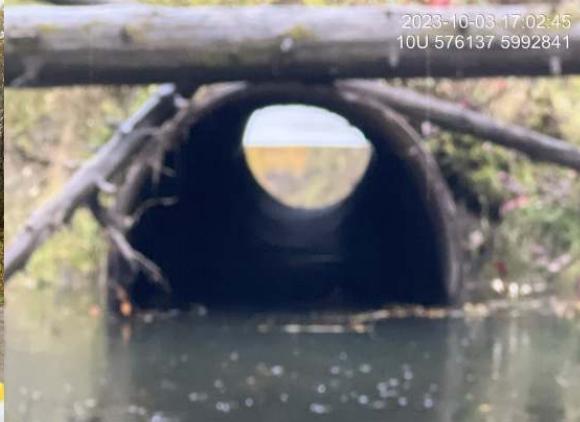
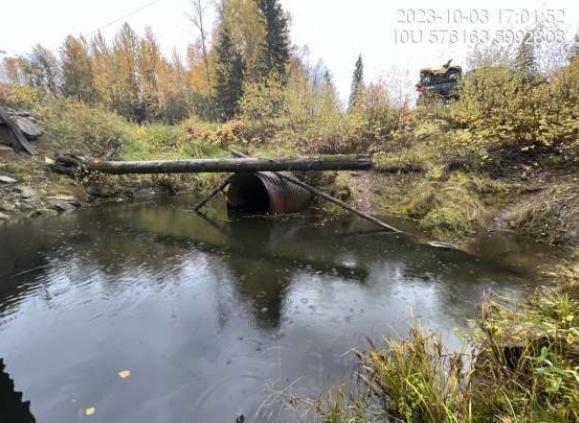
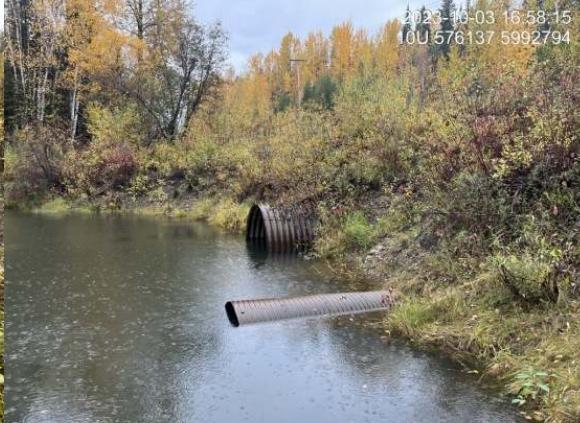
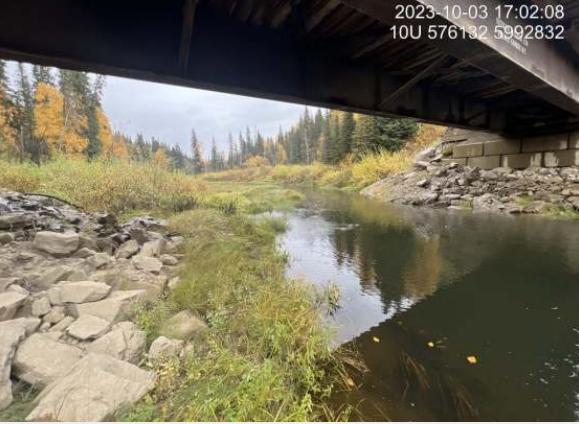
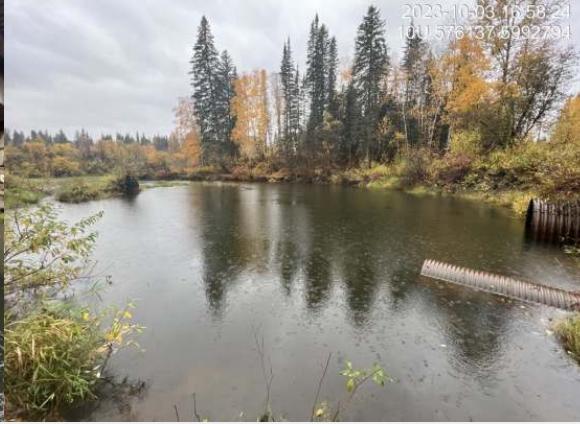
Photos: PSCIS ID 24715754. From top left clockwise: Road/Site Card, Barrel, Outlet, Downstream, Upstream, Inlet.

Location and Stream Data		•	Crossing Characteristics	–
Date	2023-10-03		Crossing Sub Type	Round Culvert
PSCIS ID	199329		Diameter (m)	4.4
External ID	24715754		Length (m)	35
Crew	AI		Embedded	Yes
UTM Zone	10		Depth Embedded (m)	1.3
Easting	576134		Resemble Channel	Yes
Northing	5992813		Backwatered	Yes
Stream	Tributary to Fraser River		Percent Backwatered	100
Road	Upper Fraser Road		Fill Depth (m)	2.5
Road Tenure	MOTI		Outlet Drop (m)	0
Channel Width (m)	12		Outlet Pool Depth (m)	2
Stream Slope (%)	0		Inlet Drop	No
Beaver Activity	Yes		Slope (%)	0
Habitat Value	High		Valley Fill	Deep Fill
Final score	12		Barrier Result	Passable
Fix type	–		Fix Span / Diameter	–
Comments: Three pipes total, two at 1.2m diameter which were completely submerged underwater and one at 2m diameter which was 100% backwatered. Assuming embedded due to the depth of the backwatering. Bridge located just upstream on River Road. Unassessed railway crossing located downstream which, based off satellite imagery, leads to a wetland area, but no modelled crossing present. There is a second unassessed crossing (24715896) downstream which should be assessed. Multiple non-salmonid FISS observations downstream. Chinook and sockeye salmon have been observed just upstream of the confluence of this creek with the Fraser River, roughly 1km downstream of the crossing. MoTi chris_culvert_id: 1994579, 1994580, 1994581. 17:04:42

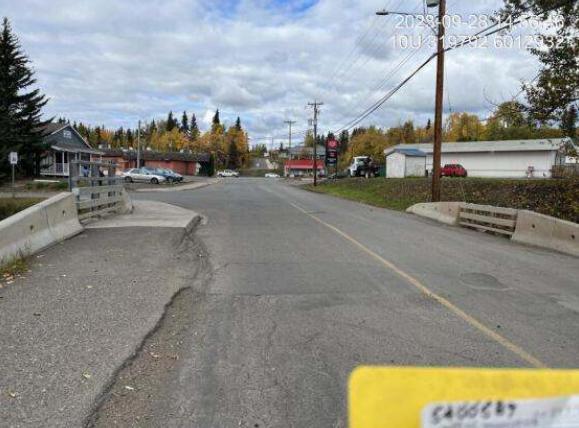
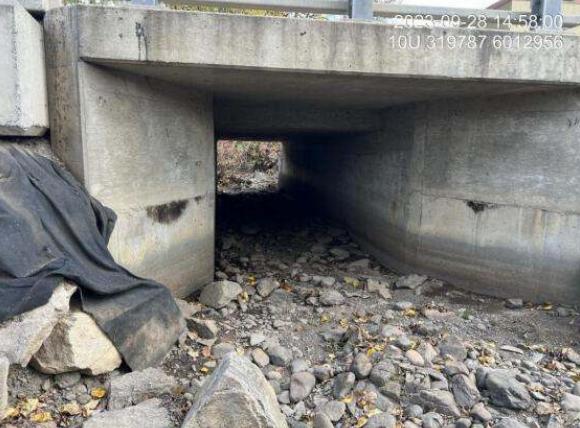
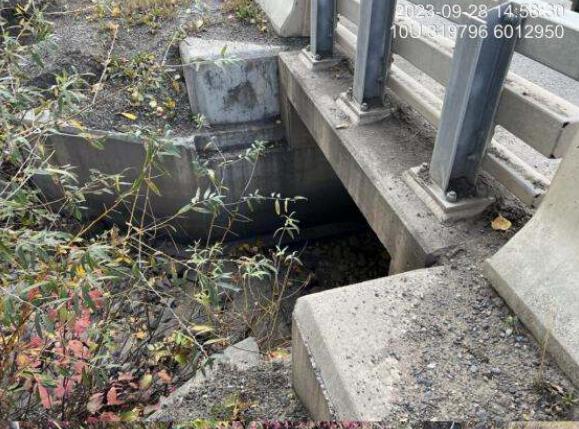
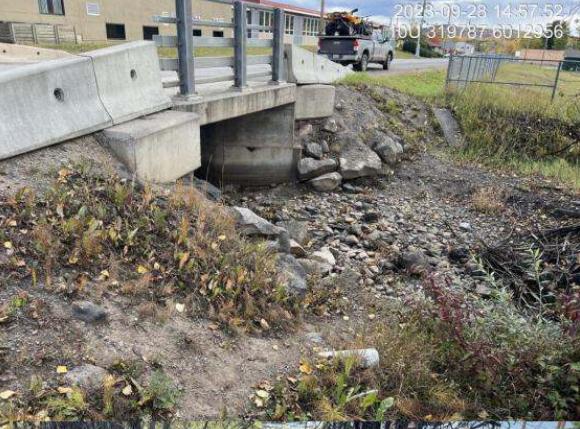
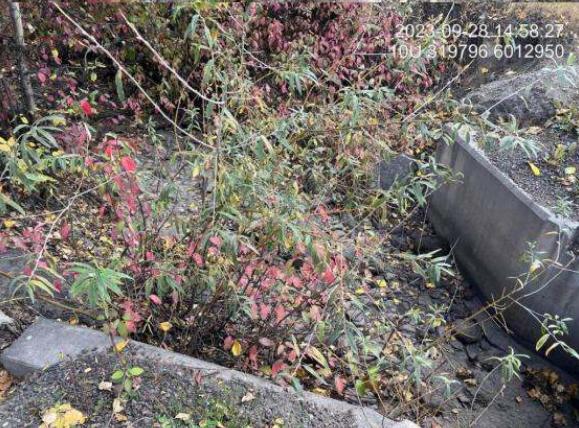
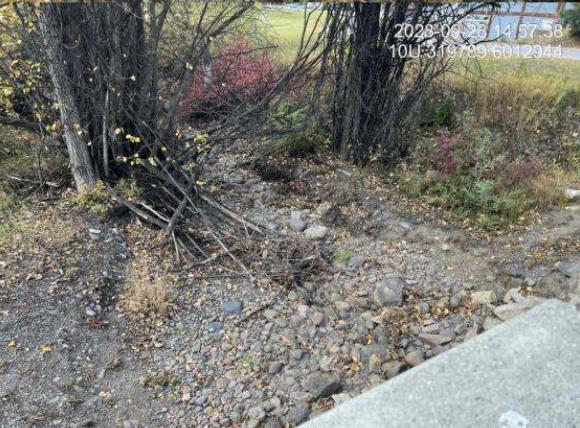
Location and Stream Data		.	Crossing Characteristics	-
Date	2023-09-28	Crossing Sub Type	Bridge	
PSCIS ID	199330	Diameter (m)	4	
External ID	5400159	Length (m)	11	
Crew	AI	Embedded	-	
UTM Zone	10	Depth Embedded (m)	-	
Easting	319797	Resemble Channel	-	
Northing	6012952	Backwatered	-	
Stream	Sauls Creek	Percent Backwatered	-	
Road	Government Rd	Fill Depth (m)	-	
Road Tenure	Burns Lake	Outlet Drop (m)	-	
Channel Width (m)	-	Outlet Pool Depth (m)	-	
Stream Slope (%)	-	Inlet Drop	-	
Beaver Activity	-	Slope (%)	-	
Habitat Value	-	Valley Fill	-	
Final score	0	Barrier Result	Passable	
Fix type	-	Fix Span / Diameter	-	
Comments: Dry channel. Bridge.. 14:56:53				
Photos: PSCIS ID 5400159. From top left clockwise: Road/Site Card, Barrel, Outlet, Downstream, Upstream, Inlet.

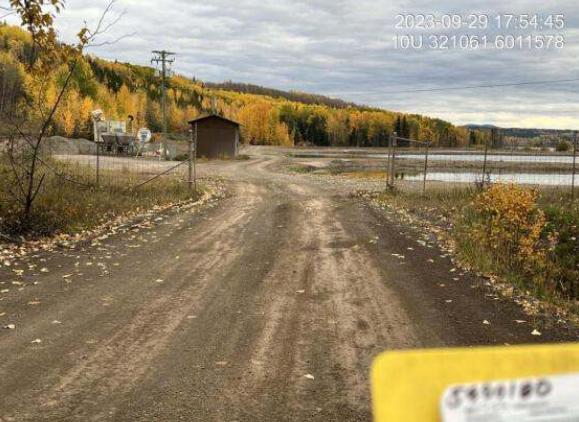
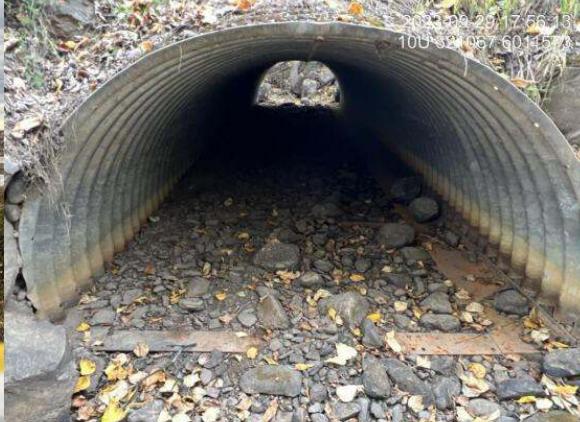
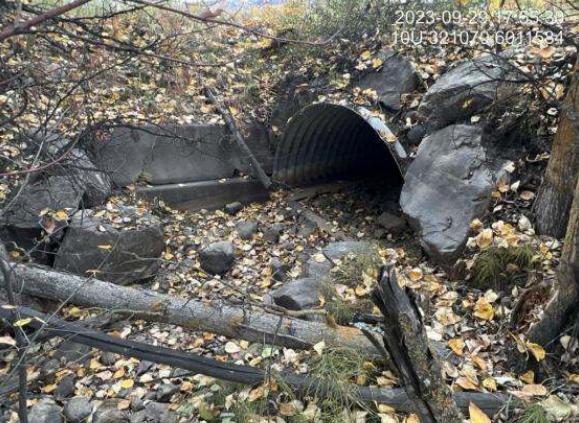
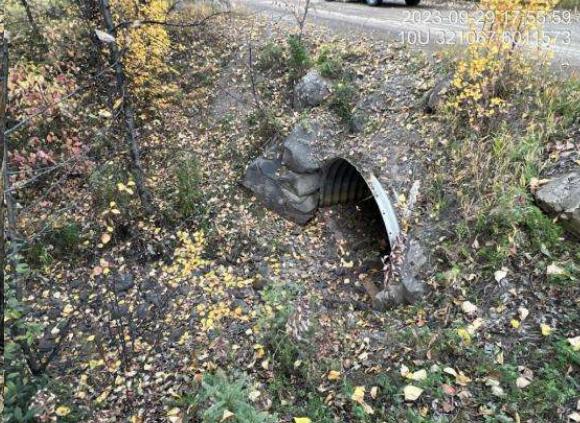
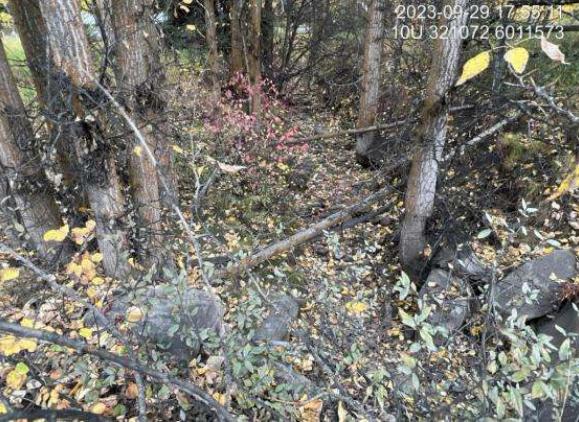
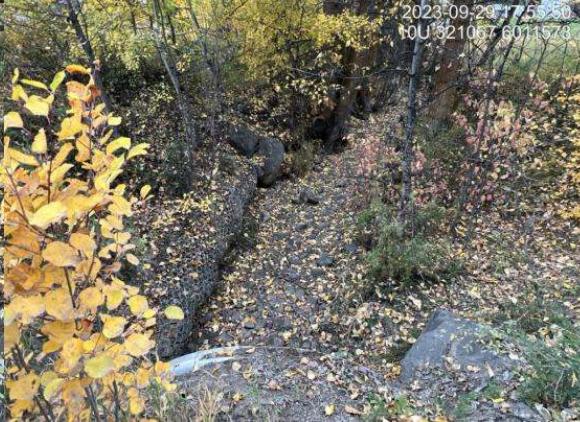
Location and Stream Data		.	Crossing Characteristics	-
Date	2023-09-29	Crossing Sub Type	Pipe Arch	
PSCIS ID	199331	Diameter (m)	2.65	
External ID	5400180	Length (m)	12	
Crew	AI	Embedded	-	
UTM Zone	10	Depth Embedded (m)	-	
Easting	321069	Resemble Channel	-	
Northing	6011579	Backwatered	-	
Stream	Wardrop Creek	Percent Backwatered	-	
Road	Glans Drive	Fill Depth (m)	-	
Road Tenure	Burns Lake	Outlet Drop (m)	-	
Channel Width (m)	-	Outlet Pool Depth (m)	-	
Stream Slope (%)	-	Inlet Drop	-	
Beaver Activity	-	Slope (%)	-	
Habitat Value	-	Valley Fill	-	
Final score	0	Barrier Result	Passable	
Fix type	-	Fix Span / Diameter	-	
Comments: Pipe arch. Passable. Modelled crossings 5406290 and 5400675 downstream adjacent to Burn's Lake shoreline have not been assessed.. 17:53:31				
Photos: PSCIS ID 5400180. From top left clockwise: Road/Site Card, Barrel, Outlet, Downstream, Upstream, Inlet.

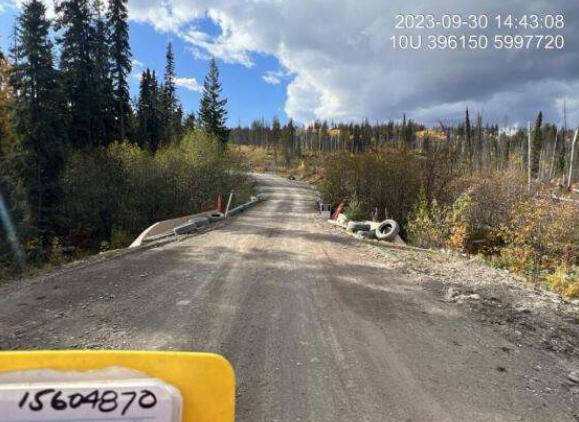
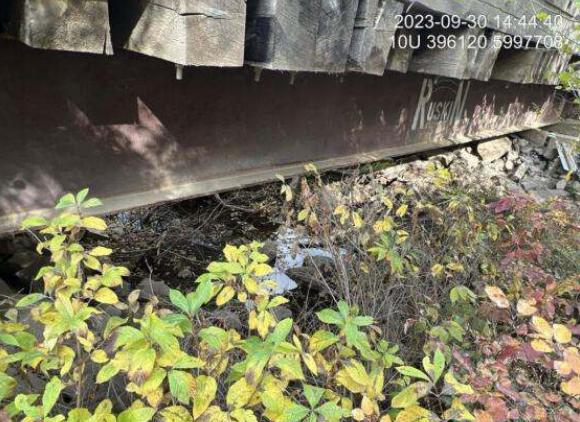
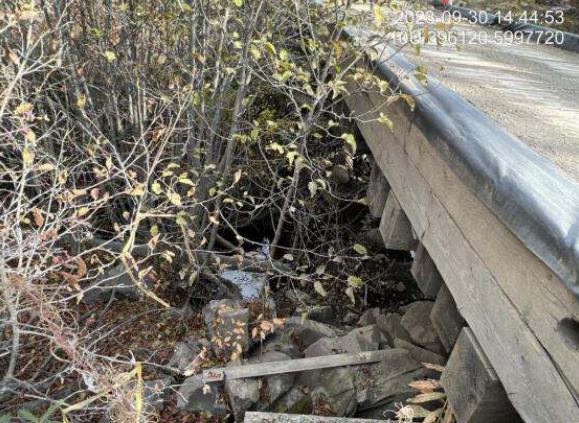
Location and Stream Data		•	Crossing Characteristics	–
Date	2023-09-30		Crossing Sub Type	Bridge
PSCIS ID	199332		Diameter (m)	13
External ID	15604870		Length (m)	5
Crew	AI		Embedded	–
UTM Zone	10		Depth Embedded (m)	–
Easting	396140		Resemble Channel	–
Northing	5997722		Backwatered	–
Stream	Tributary to Nechako River		Percent Backwatered	–
Road	Williams FSR		Fill Depth (m)	–
Road Tenure	West Fraser R09194 SE		Outlet Drop (m)	–
Channel Width (m)	–		Outlet Pool Depth (m)	–
Stream Slope (%)	–		Inlet Drop	–
Beaver Activity	–		Slope (%)	–
Habitat Value	–		Valley Fill	–
Final score	0		Barrier Result	Passable
Fix type	–		Fix Span / Diameter	–
Comments: Bridge with sign from Fraser lake sawmills. Extensive cattle trampling underneath the bridge, but some decent amount of water at this location.. 14:46:03				
Photos: PSCIS ID 15604870. From top left clockwise: Road/Site Card, Barrel, Outlet, Downstream, Upstream, Inlet.

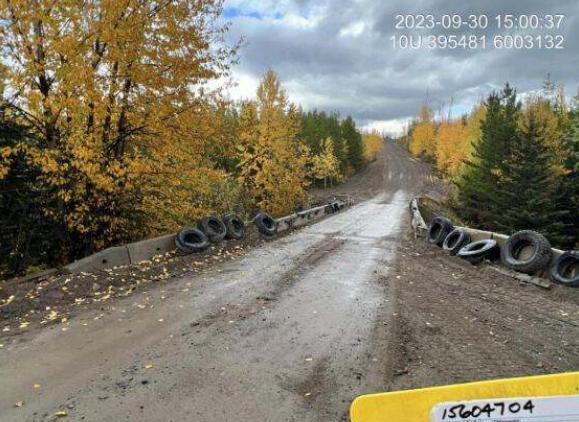
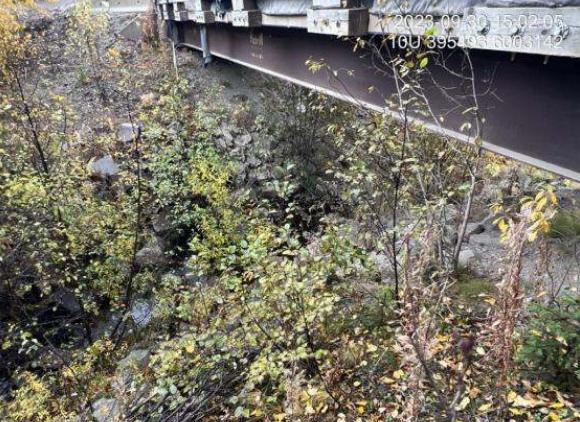
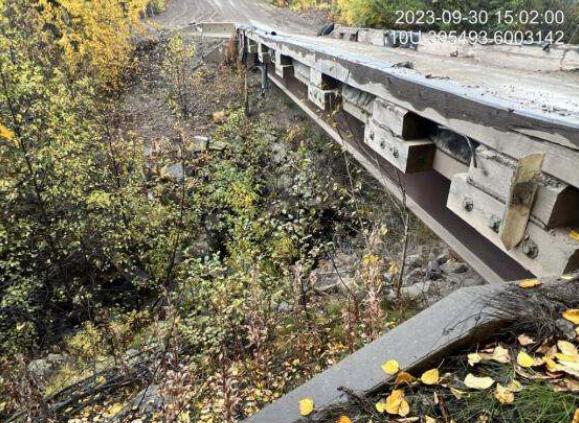
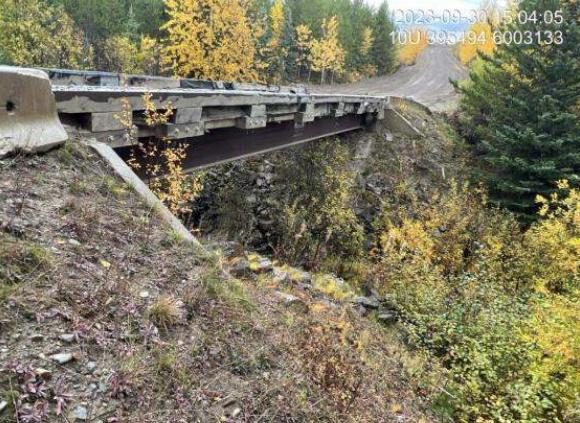
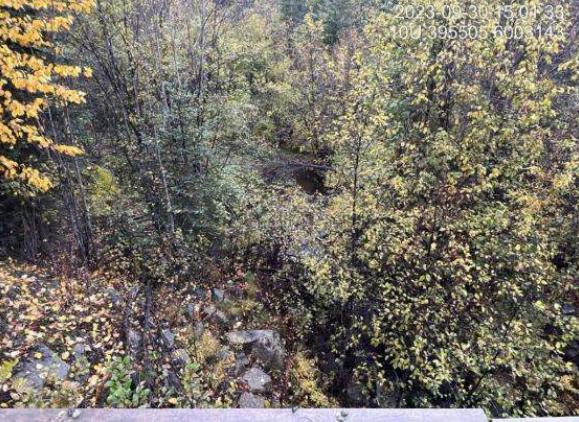
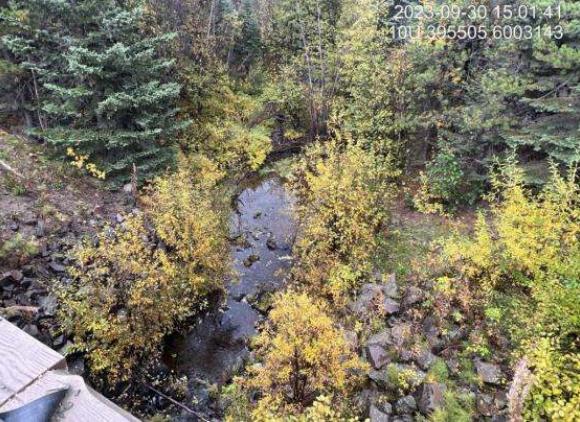
Location and Stream Data		.	Crossing Characteristics	-
Date	2023-09-30		Crossing Sub Type	Bridge
PSCIS ID	199333		Diameter (m)	20
External ID	15604704		Length (m)	5
Crew	AI		Embedded	-
UTM Zone	10		Depth Embedded (m)	-
Easting	395496		Resemble Channel	-
Northing	6003141		Backwatered	-
Stream	Tatsutnai Creek		Percent Backwatered	-
Road	Barlow FSR		Fill Depth (m)	-
Road Tenure	Canfor R11286		Outlet Drop (m)	-
Channel Width (m)	-		Outlet Pool Depth (m)	-
Stream Slope (%)	-		Inlet Drop	-
Beaver Activity	-		Slope (%)	-
Habitat Value	-		Valley Fill	-
Final score	0		Barrier Result	Passable
Fix type	-		Fix Span / Diameter	-
Comments: Bridge. Good flow. 15:02:17				
Photos: PSCIS ID 15604704. From top left clockwise: Road/Site Card, Barrel, Outlet, Downstream, Upstream, Inlet.

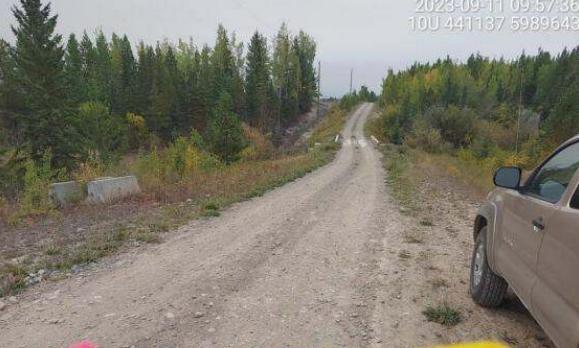
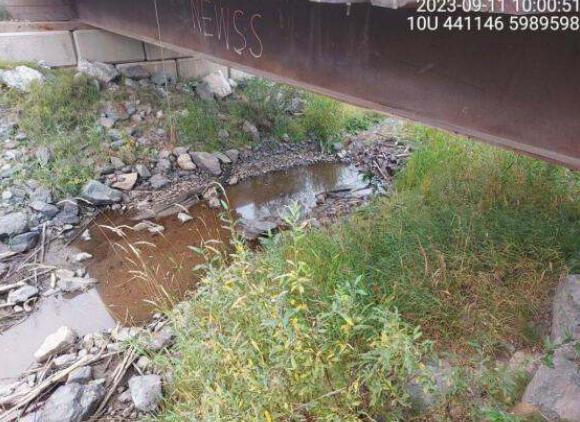
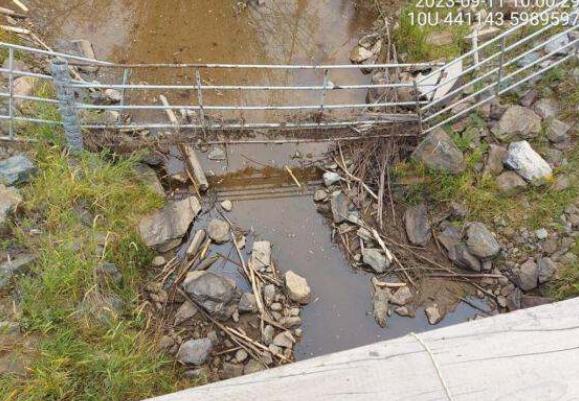
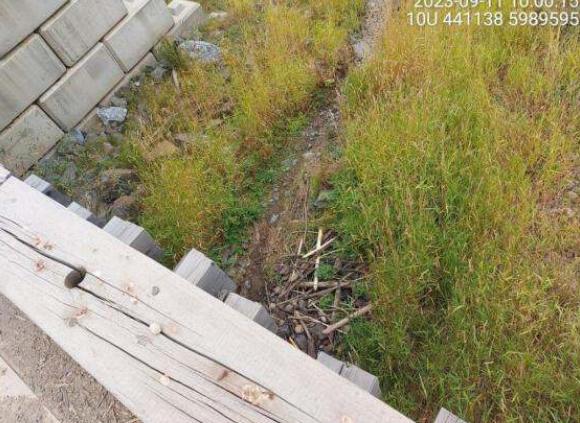
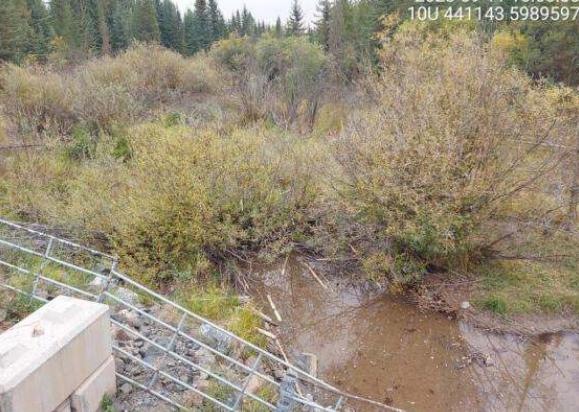
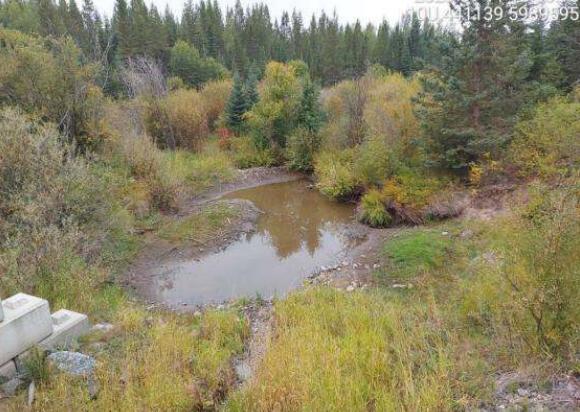
Location and Stream Data		•	Crossing Characteristics	-
Date	2023-09-11	Crossing Sub Type	Bridge	
PSCIS ID	199334	Diameter (m)	13	
External ID	15600065	Length (m)	4	
Crew	MW	Embedded	-	
UTM Zone	10	Depth Embedded (m)	-	
Easting	441140	Resemble Channel	-	
Northing	5989596	Backwatered	-	
Stream	Knight Creek	Percent Backwatered	-	
Road	Spur	Fill Depth (m)	-	
Road Tenure	MOTI Local	Outlet Drop (m)	-	
Channel Width (m)	-	Outlet Pool Depth (m)	-	
Stream Slope (%)	-	Inlet Drop	-	
Beaver Activity	-	Slope (%)	-	
Habitat Value	-	Valley Fill	-	
Final score	0	Barrier Result	Passable	
Fix type	-	Fix Span / Diameter	-	
Comments: Restoration work conducted at this crossing. No flowing water at time of survey. Livestock field upstream. Goats seen trampling through stream channel.. 09:59:33				
Photos: PSCIS ID 15600065. From top left clockwise: Road/Site Card, Barrel, Outlet, Downstream, Upstream, Inlet.

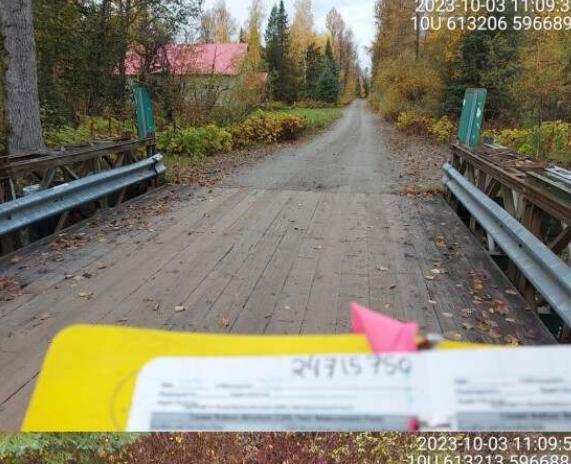
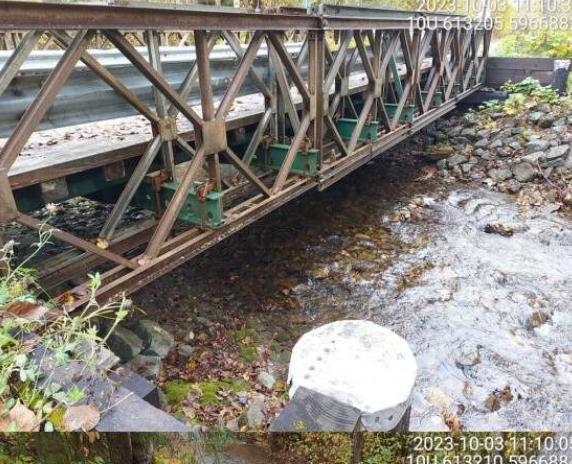
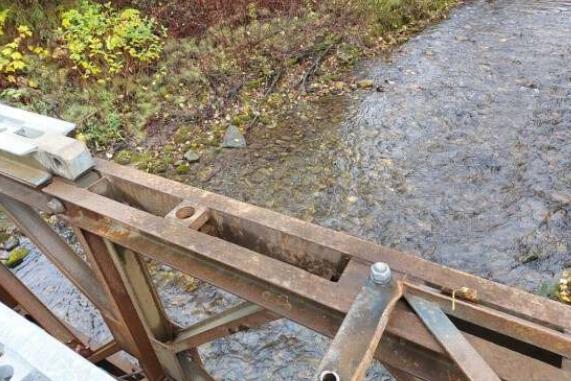
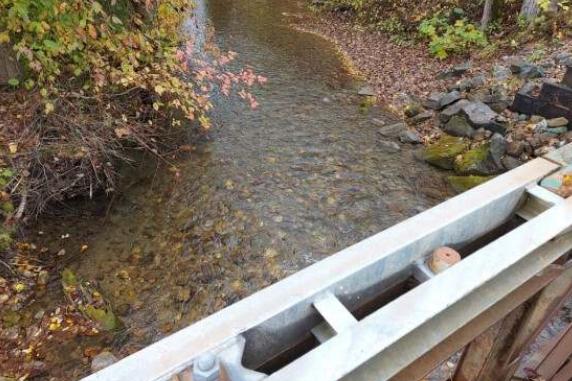
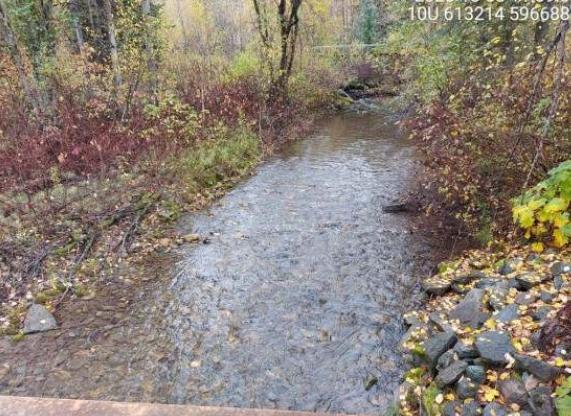
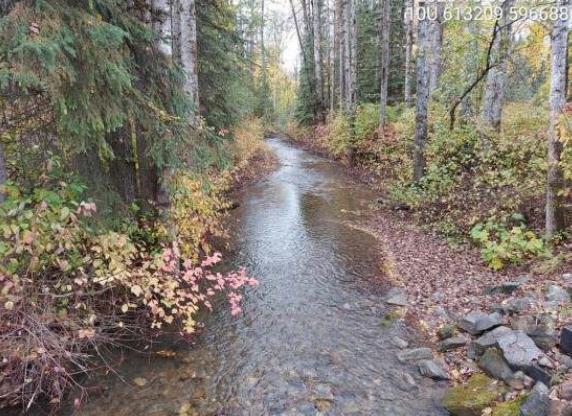
Location and Stream Data		•	Crossing Characteristics	–
Date	2023-10-03	Crossing Sub Type	Bridge	
PSCIS ID	199335	Diameter (m)	12	
External ID	24715750	Length (m)	5	
Crew	MW	Embedded	–	
UTM Zone	10	Depth Embedded (m)	–	
Easting	613206	Resemble Channel	–	
Northing	5966880	Backwatered	–	
Stream	Redmountain Creek	Percent Backwatered	–	
Road	Penny St	Fill Depth (m)	–	
Road Tenure	MOTI Local	Outlet Drop (m)	–	
Channel Width (m)	–	Outlet Pool Depth (m)	–	
Stream Slope (%)	–	Inlet Drop	–	
Beaver Activity	–	Slope (%)	–	
Habitat Value	–	Valley Fill	–	
Final score	0	Barrier Result	Passable	
Fix type	–	Fix Span / Diameter	–	
Comments: Wide stream with high flows and good habitat. Bridge on railway just upstream. Major moti structure was in the wrong spot on the map. MoTi chris_hwy_structure_road_id: 3626. 11:13:09				
Photos: PSCIS ID 24715750. From top left clockwise: Road/Site Card, Barrel, Outlet, Downstream, Upstream, Inlet.

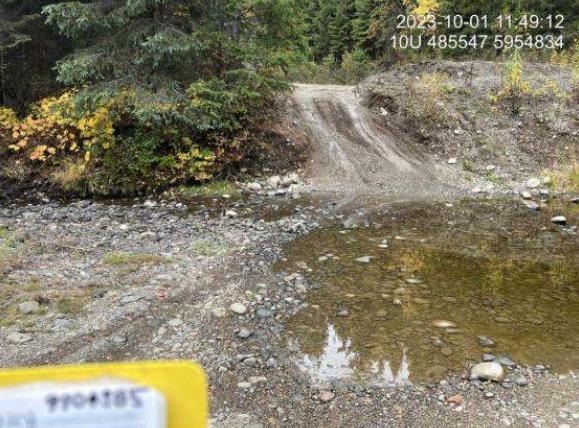
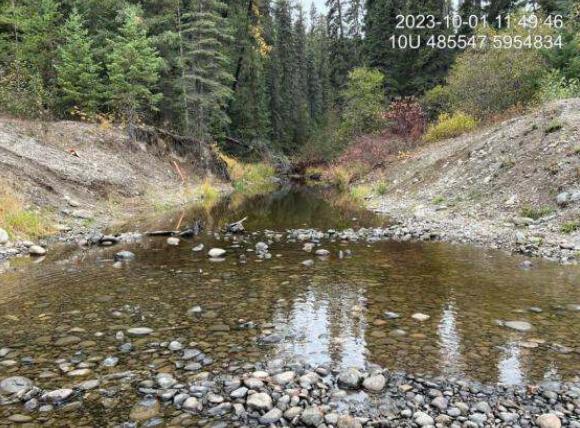
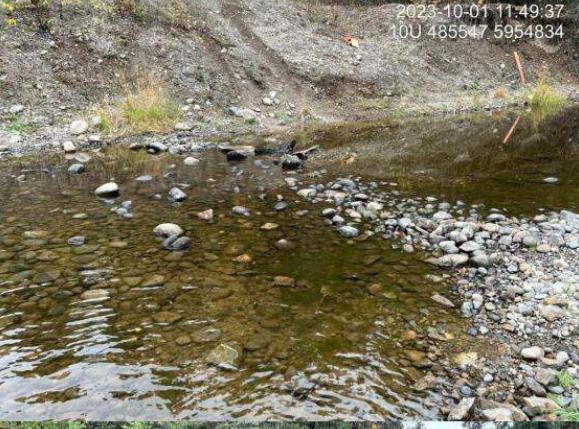
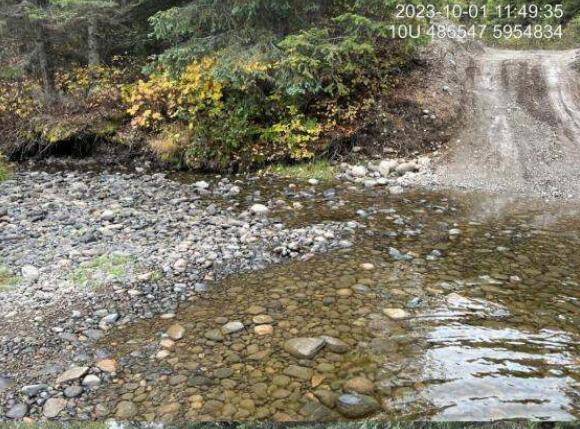
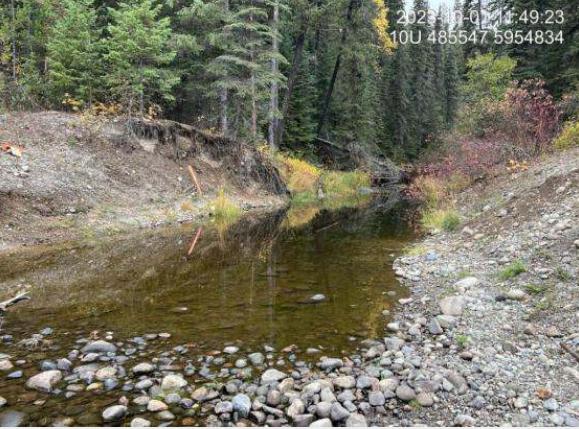
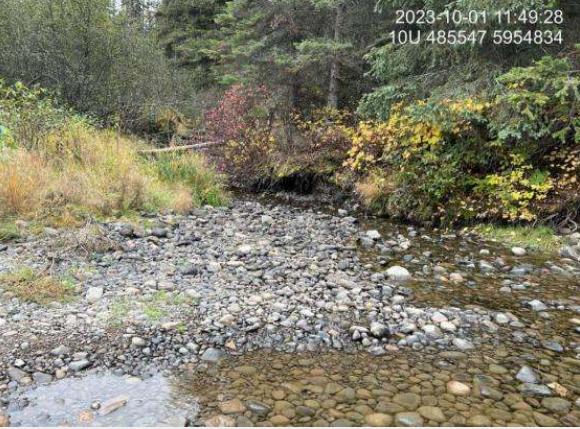
Location and Stream Data		•	Crossing Characteristics	–
Date	2023-10-01	Crossing Sub Type	Ford	–
PSCIS ID	199336	Diameter (m)	–	–
External ID	9904385	Length (m)	–	–
Crew	AI MW	Embedded	–	–
UTM Zone	10	Depth Embedded (m)	–	–
Easting	485546	Resemble Channel	–	–
Northing	5954833	Backwatered	–	–
Stream	Dahl Creek	Percent Backwatered	–	–
Road	Gregg Creek FSR	Fill Depth (m)	–	–
Road Tenure	MOF 5416	Outlet Drop (m)	–	–
Channel Width (m)	–	Outlet Pool Depth (m)	–	–
Stream Slope (%)	–	Inlet Drop	–	–
Beaver Activity	–	Slope (%)	–	–
Habitat Value	–	Valley Fill	–	–
Final score	0	Barrier Result	Unknown	–
Fix type	–	Fix Span / Diameter	–	–
Comments: Deactivated road. Ford passable by 4x4 vehicles. 11:50:24				
Photos: PSCIS ID 9904385. From top left clockwise: Road/Site Card, Barrel, Outlet, Downstream, Upstream, Inlet.

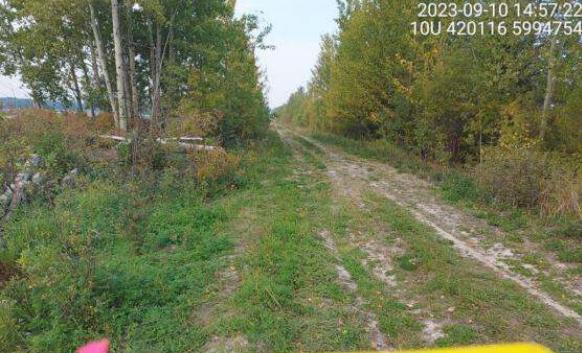
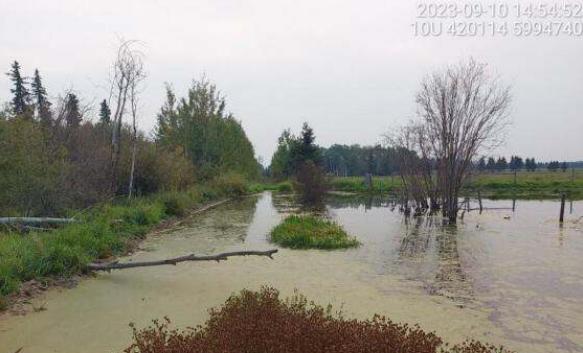
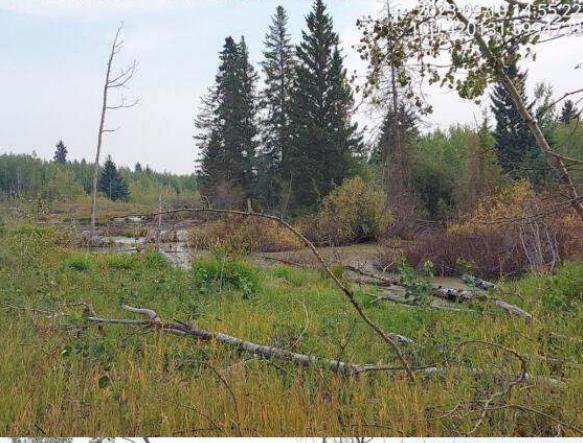
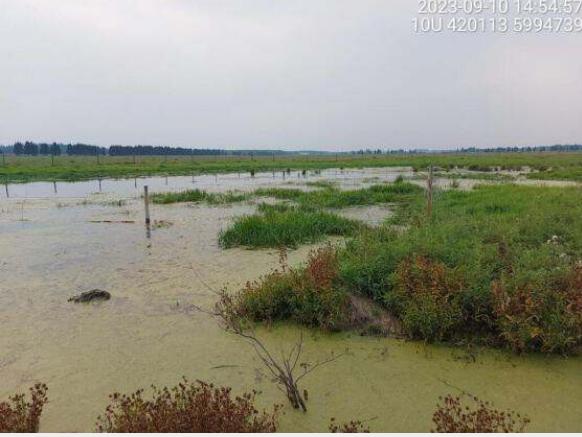
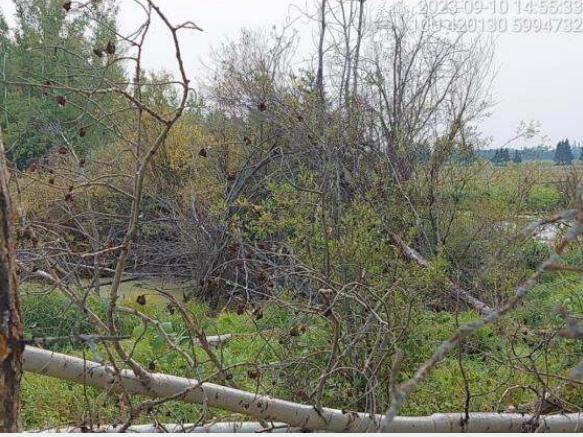
Location and Stream Data		•	Crossing Characteristics	–
Date	2023-09-10		Crossing Sub Type	Ford
PSCIS ID	199337		Diameter (m)	–
External ID	15600486		Length (m)	–
Crew	MW		Embedded	–
UTM Zone	10		Depth Embedded (m)	–
Easting	420111		Resemble Channel	–
Northing	5994723		Backwatered	–
Stream	Redmond Creek		Percent Backwatered	–
Road	Spur		Fill Depth (m)	–
Road Tenure	Unclassified		Outlet Drop (m)	–
Channel Width (m)	–		Outlet Pool Depth (m)	–
Stream Slope (%)	–		Inlet Drop	–
Beaver Activity	–		Slope (%)	–
Habitat Value	–		Valley Fill	–
Final score	0		Barrier Result	Unknown
Fix type	–		Fix Span / Diameter	–
Comments: NA. 14:54:00				
Photos: PSCIS ID 15600486. From top left clockwise: Road/Site Card, Barrel, Outlet, Downstream, Upstream, Inlet.

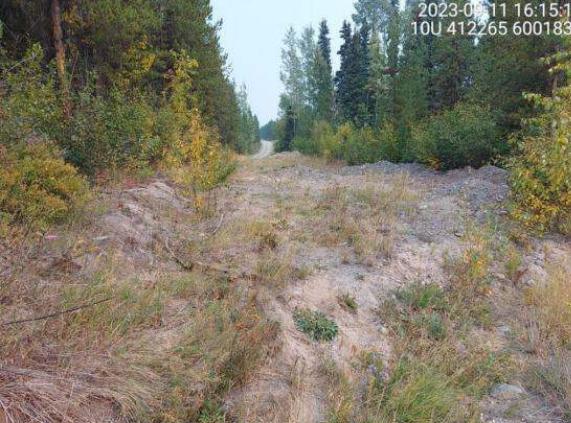
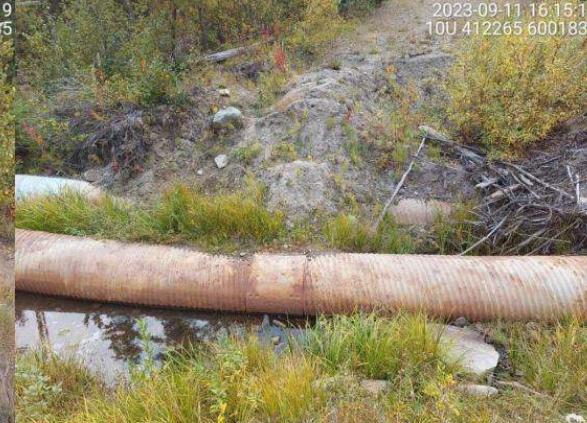
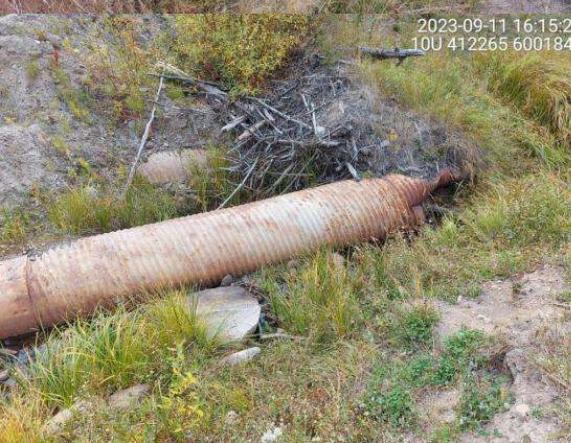
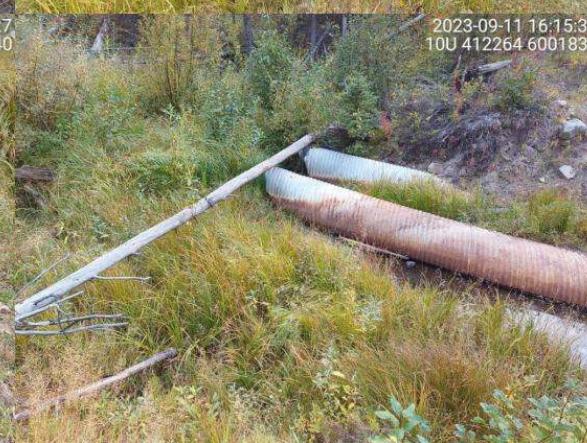
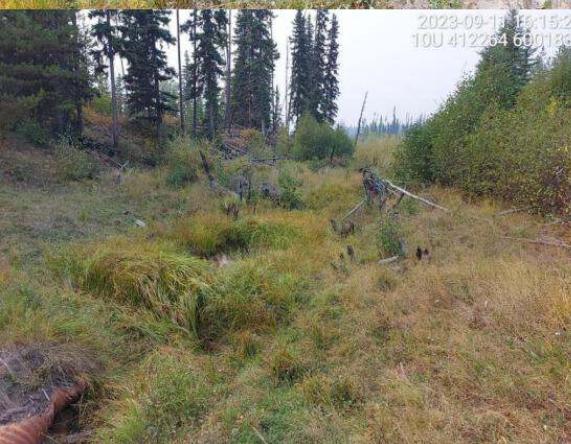
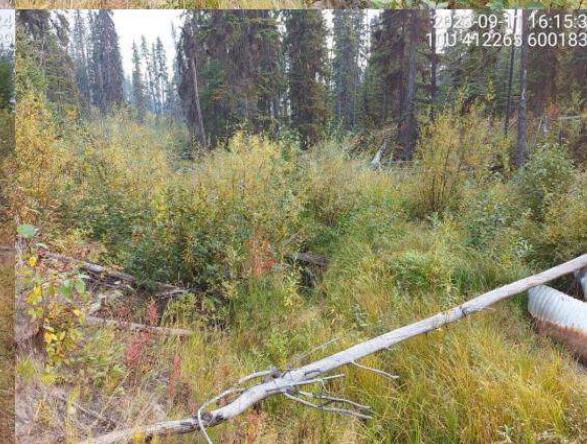
Location and Stream Data		.	Crossing Characteristics	-
Date	2023-09-11	Crossing Sub Type	Ford	
PSCIS ID	199338	Diameter (m)	-	
External ID	15604176	Length (m)	-	
Crew	MW	Embedded	-	
UTM Zone	10	Depth Embedded (m)	-	
Easting	412266	Resemble Channel	-	
Northing	6001835	Backwatered	-	
Stream	Tributary to Nechako River	Percent Backwatered	-	
Road	Spur	Fill Depth (m)	-	
Road Tenure	Canfor R09185	Outlet Drop (m)	-	
Channel Width (m)	-	Outlet Pool Depth (m)	-	
Stream Slope (%)	-	Inlet Drop	-	
Beaver Activity	-	Slope (%)	-	
Habitat Value	-	Valley Fill	-	
Final score	0	Barrier Result	Unknown	
Fix type	-	Fix Span / Diameter	-	
Comments: Deactivated road. Old culverts seen in pictures, now a ford.. 16:15:48				
Photos: PSCIS ID 15604176. From top left clockwise: Road/Site Card, Barrel, Outlet, Downstream, Upstream, Inlet.
