Appendix - Phase 1 Fish Passage Assessment Data and Photos

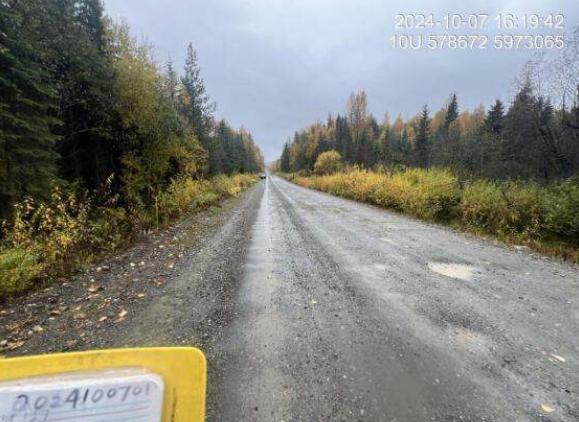
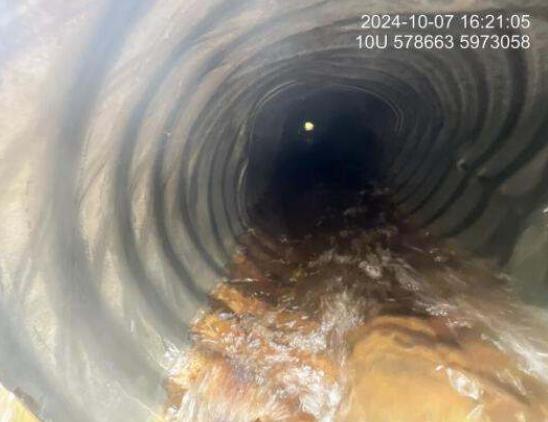
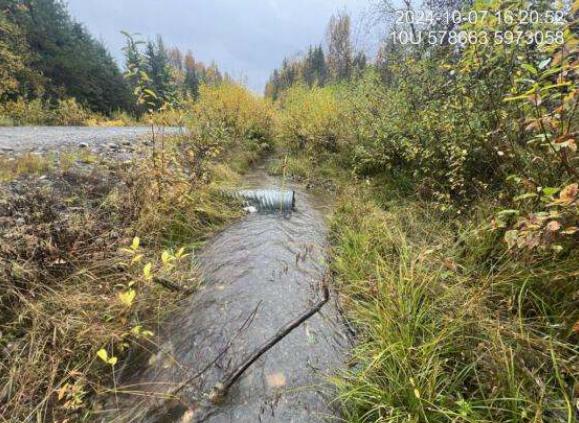
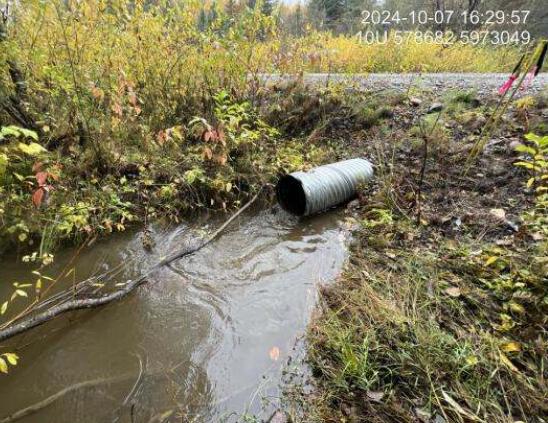
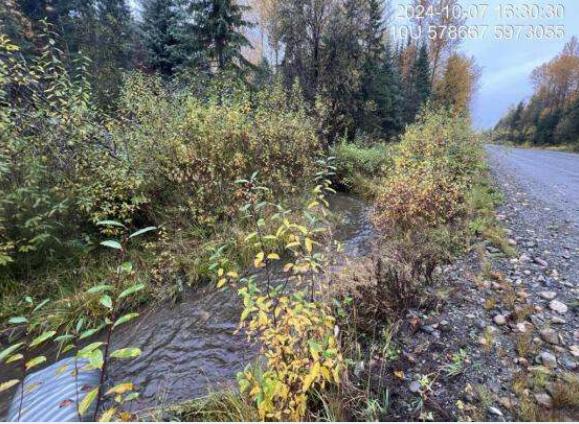
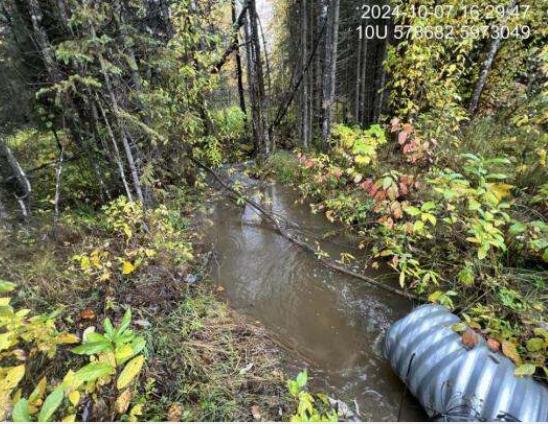
Photos: PSCIS ID 2024100701. From top left clockwise: Road/Site Card, Barrel, Outlet, Downstream, Upstream, Inlet.

Location and Stream Data	.	Crossing Characteristics	-
Date	2024-10-07	Crossing Sub Type	Round Culvert
PSCIS ID	203296	Diameter (m)	0.5
External ID	2024100701	Length (m)	20
Crew	AI	Embedded	No
UTM Zone	10	Depth Embedded (m)	-
Easting	578677	Resemble Channel	No
Northing	5973049	Backwatered	No
Stream	Tributary To Kenneth Creek	Percent Backwatered	-
Road	Bowron FSR	Fill Depth (m)	1
Road Tenure	MoF	Outlet Drop (m)	0.1
Channel Width (m)	0	Outlet Pool Depth (m)	0.15
Stream Slope (%)	0	Inlet Drop	No
Beaver Activity	No	Slope (%)	3
Habitat Value	Medium	Valley Fill	Deep Fill
Final score	23	Barrier Result	Barrier
Fix type	Replace Structure with Streambed Simulation CBS	Fix Span / Diameter	3

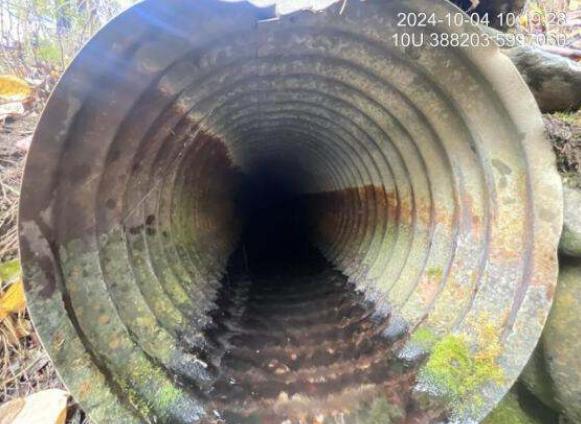
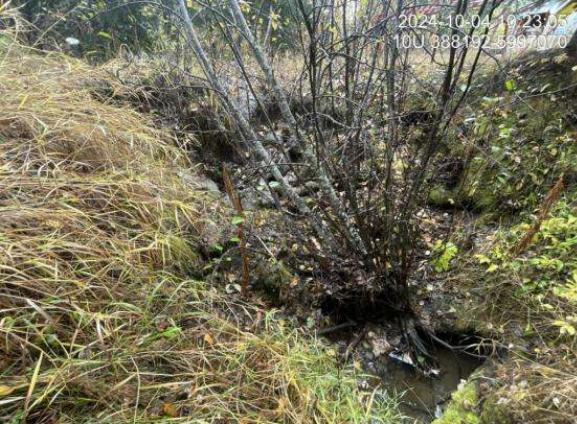
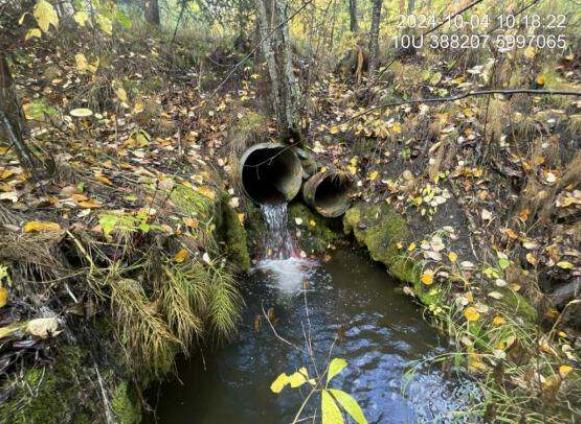
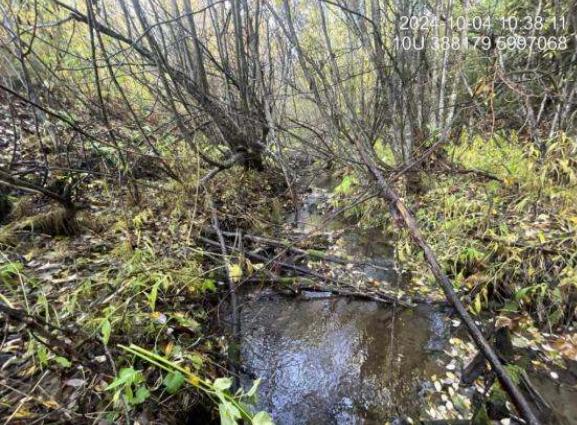
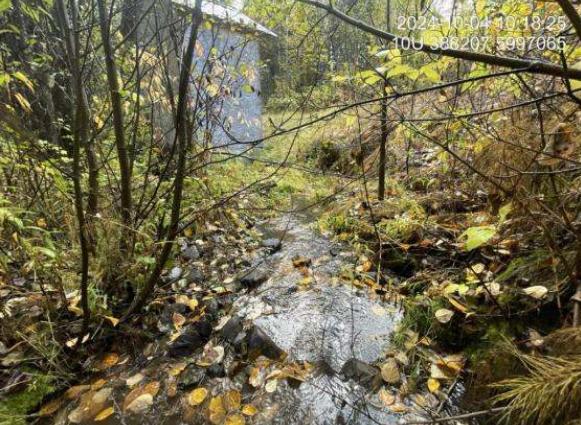
Location and Stream Data		Crossing Characteristics	
Date	2024-10-04	Crossing Sub Type	Round Culvert
PSCIS ID	203297	Diameter (m)	1.05
External ID	2024100450	Length (m)	8
Crew	LS	Embedded	No
UTM Zone	10	Depth Embedded (m)	—
Easting	388199	Resemble Channel	No
Northing	5997060	Backwatered	No
Stream	Scotch Creek	Percent Backwatered	—
Road	Private Driveway	Fill Depth (m)	2
Road Tenure	Private	Outlet Drop (m)	0.7
Channel Width (m)	2.5	Outlet Pool Depth (m)	0.55
Stream Slope (%)	4	Inlet Drop	No
Beaver Activity	No	Slope (%)	2
Habitat Value	Medium	Valley Fill	Deep Fill
Final score	31	Barrier Result	Barrier
Fix type	Replace with New Open Bottom Structure	Fix Span / Diameter	15

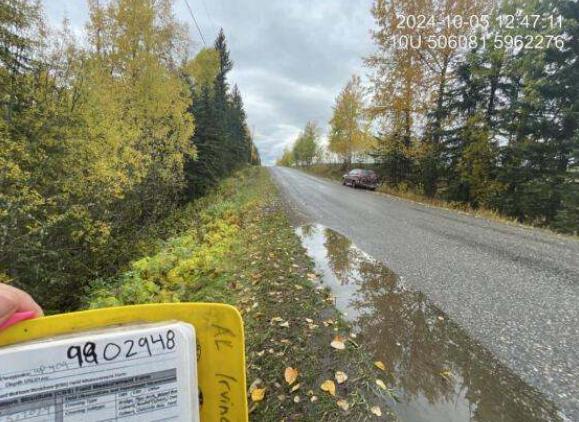
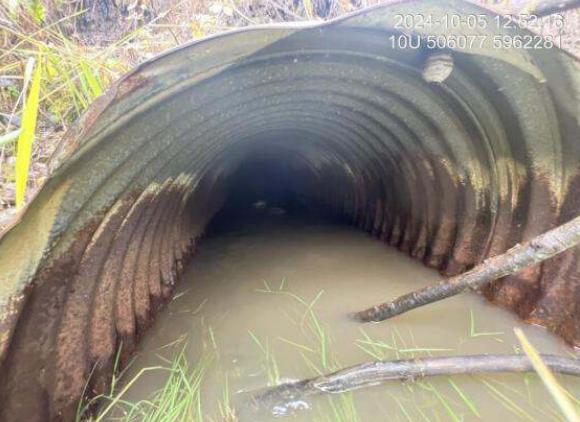
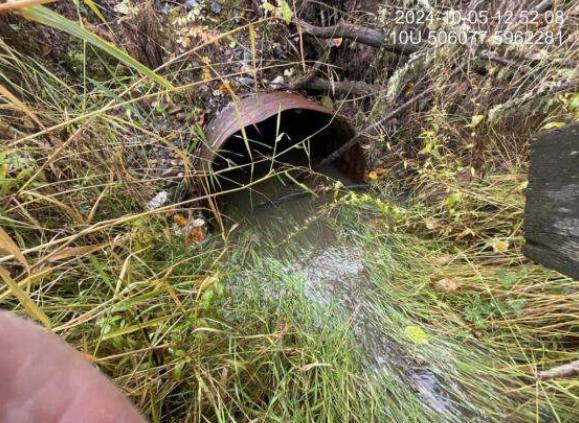
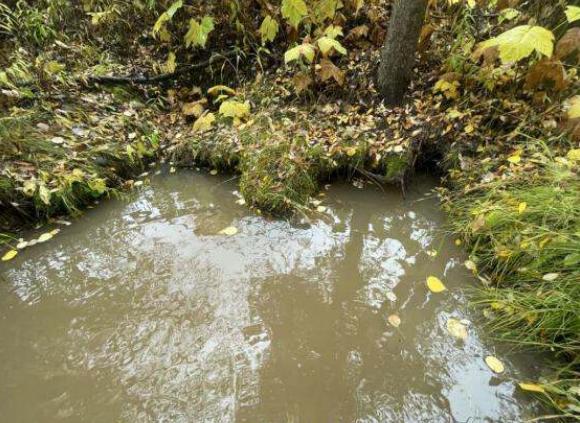
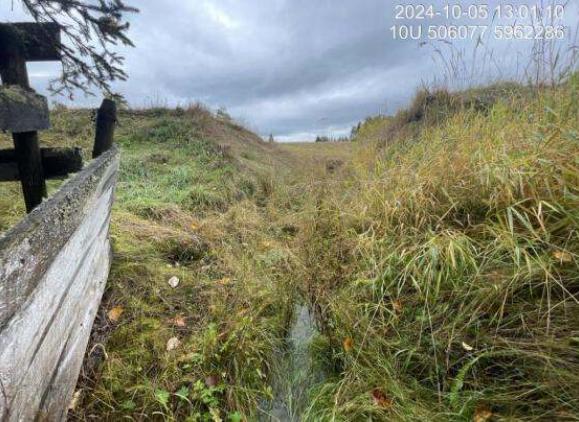
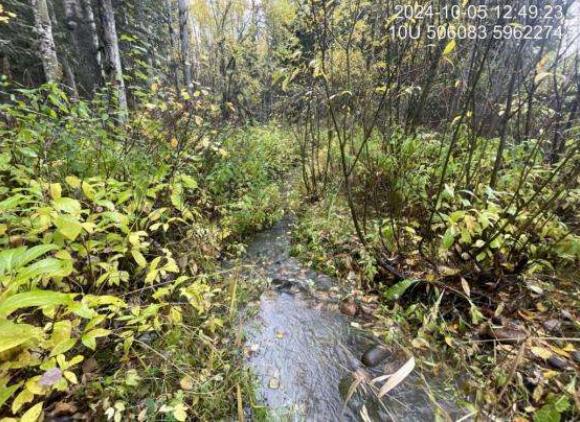
Photos: PSCIS ID 9902948. From top left clockwise: Road/Site Card, Barrel, Outlet, Downstream, Upstream, Inlet.

Location and Stream Data		Crossing Characteristics	
Date	2024-10-05	Crossing Sub Type	Round Culvert
PSCIS ID	203298	Diameter (m)	0.8
External ID	9902948	Length (m)	17
Crew	LS	Embedded	Yes
UTM Zone	10	Depth Embedded (m)	0.1
Easting	506082	Resemble Channel	Yes
Northing	5962275	Backwatered	Yes
Stream	Tributary To Beaverley Creek	Percent Backwatered	100
Road	Muralt Road	Fill Depth (m)	7
Road Tenure	MOTI	Outlet Drop (m)	0
Channel Width (m)	1.8	Outlet Pool Depth (m)	0.5
Stream Slope (%)	3	Inlet Drop	No
Beaver Activity	No	Slope (%)	1
Habitat Value	Low	Valley Fill	Deep Fill
Final score	19	Barrier Result	Potential
Fix type	Replace Structure with Streambed Simulation CBS	Fix Span / Diameter	27

Comments: The culvert was fully backwatered, with the outlet completely submerged. The stream flowed through a grassy valley on private property upstream. The road column on the inlet side was eroding significantly. A V-shaped fence was positioned in front of the inlet for unknown reasons. Culvert slope and length were estimated, as the inlet was completely submerged and not visible. The culvert was embedded at the inlet and assumed to be fully embedded, though this could not be confirmed due to the submerged outlet. Just upstream of the inlet, remnants of a possible old dam were observed, with large piles of dirt on both sides and a dugout middle section allowing stream flow. See photos for details. MoTi chris_culvert_id: 1976182

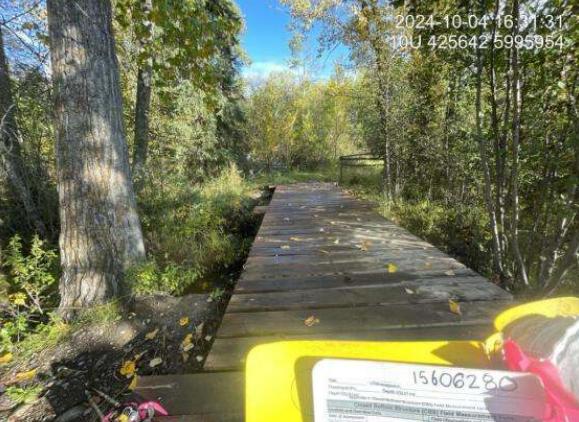
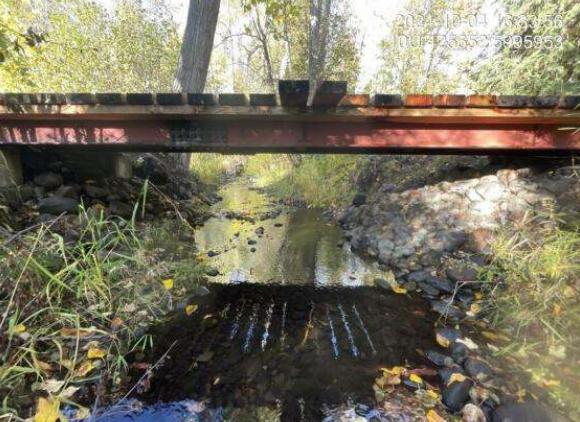
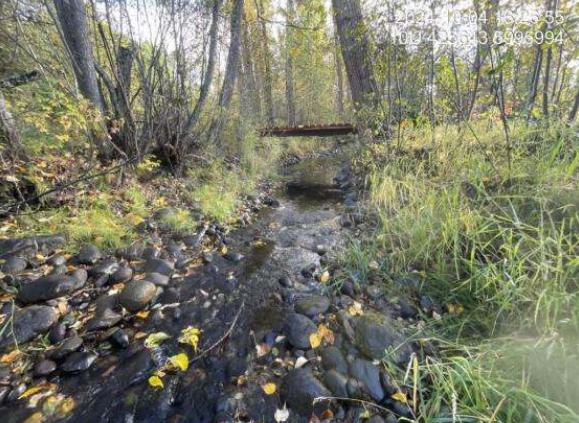
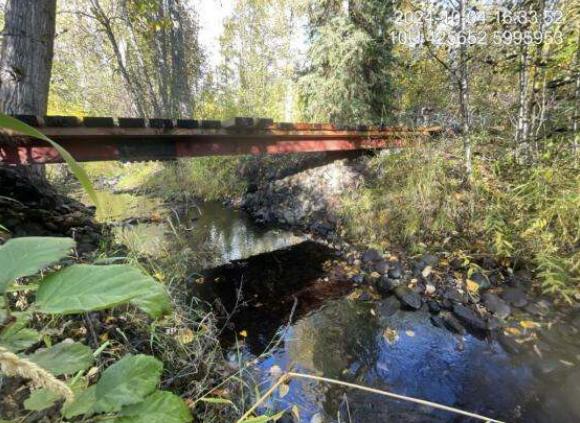
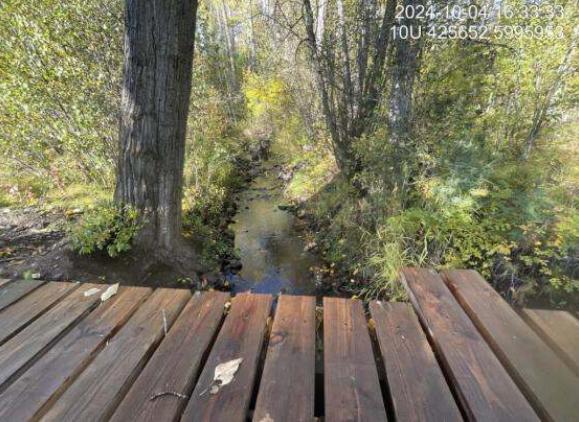
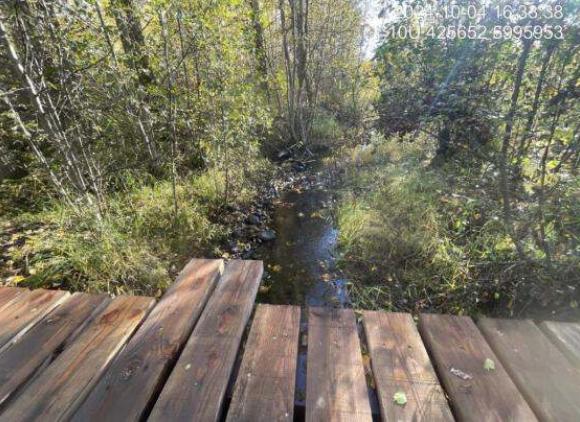
Location and Stream Data		.	Crossing Characteristics	-
Date	2024-10-04	Crossing Sub Type	Bridge	
PSCIS ID	203299	Diameter (m)	10	
External ID	15606280	Length (m)	2	
Crew	LS	Embedded	-	
UTM Zone	10	Depth Embedded (m)	-	
Easting	425644	Resemble Channel	-	
Northing	5995962	Backwatered	-	
Stream	Clear Creek	Percent Backwatered	-	
Road	Private Drive	Fill Depth (m)	-	
Road Tenure	Private	Outlet Drop (m)	-	
Channel Width (m)	-	Outlet Pool Depth (m)	-	
Stream Slope (%)	-	Inlet Drop	-	
Beaver Activity	No	Slope (%)	-	
Habitat Value	-	Valley Fill	-	
Final score	0	Barrier Result	Passable	
Fix type	-	Fix Span / Diameter	-	
Comments: The bridge crosses Clear Creek and appeared to provide access to private land.				
Photos: PSCIS ID 15606280. From top left clockwise: Road/Site Card, Barrel, Outlet, Downstream, Upstream, Inlet.

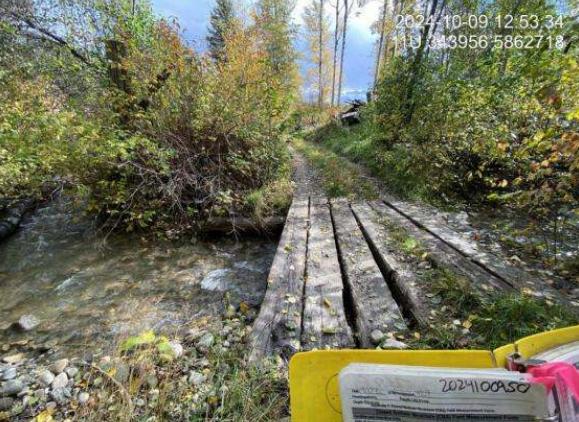
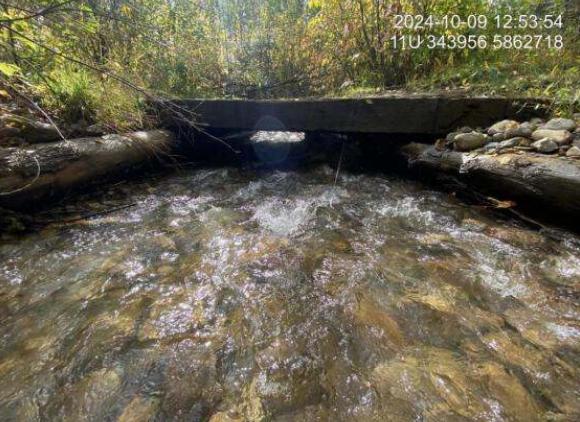
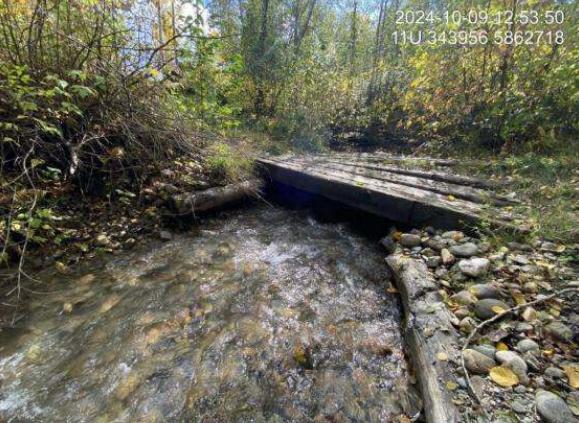
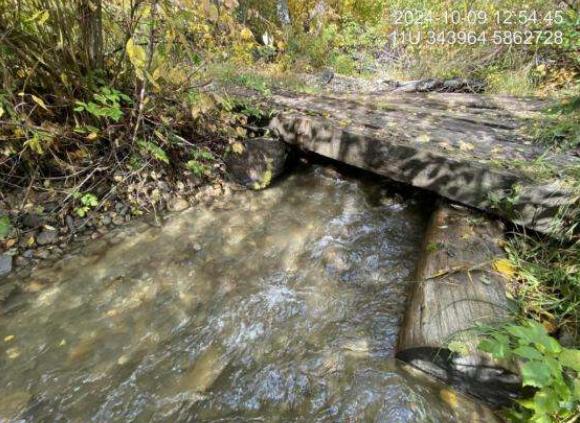
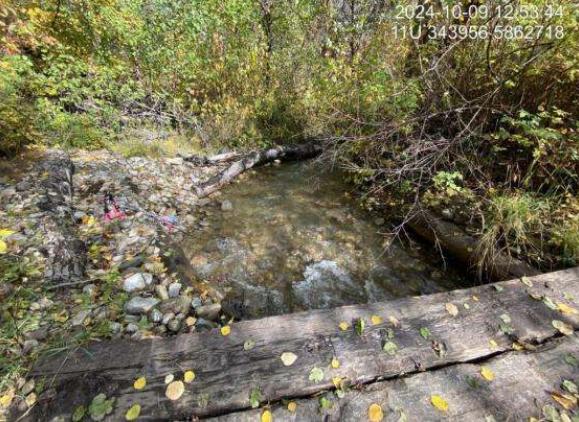
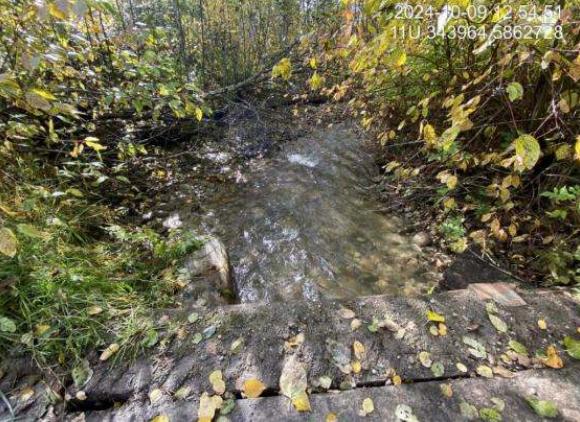
Location and Stream Data		•	Crossing Characteristics	-
Date	2024-10-09	Crossing Sub Type	Bridge	
PSCIS ID	203300	Diameter (m)	4	
External ID	2024100950	Length (m)	2	
Crew	LS	Embedded	-	
UTM Zone	11	Depth Embedded (m)	-	
Easting	343964	Resemble Channel	-	
Northing	5862720	Backwatered	-	
Stream	Teepee Creek	Percent Backwatered	-	
Road	Private Road	Fill Depth (m)	-	
Road Tenure	Private	Outlet Drop (m)	-	
Channel Width (m)	-	Outlet Pool Depth (m)	-	
Stream Slope (%)	-	Inlet Drop	-	
Beaver Activity	No	Slope (%)	-	
Habitat Value	-	Valley Fill	-	
Final score	0	Barrier Result	Passable	
Fix type	-	Fix Span / Diameter	-	
Comments: A small wooden bridge crossed Teepee Creek on private land.				
Photos: PSCIS ID 2024100950. From top left clockwise: Road/Site Card, Barrel, Outlet, Downstream, Upstream, Inlet.

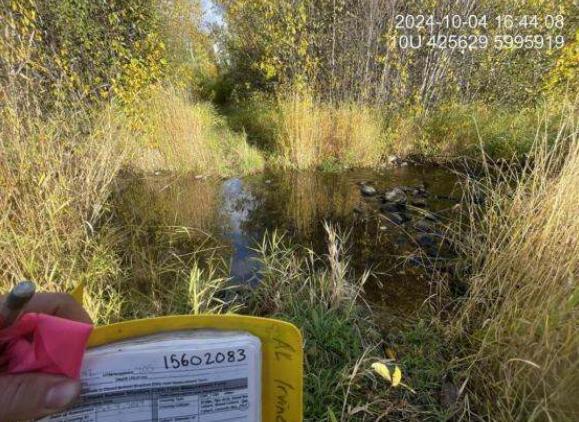
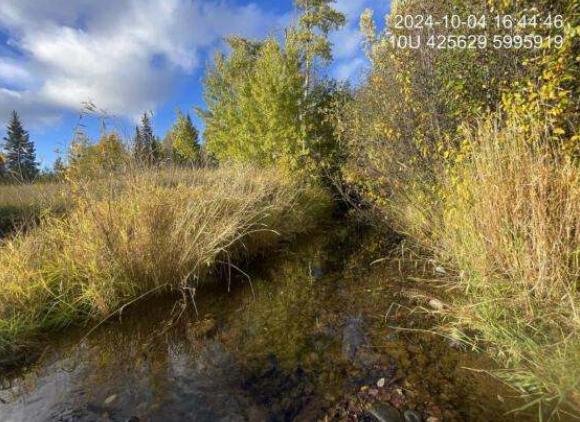
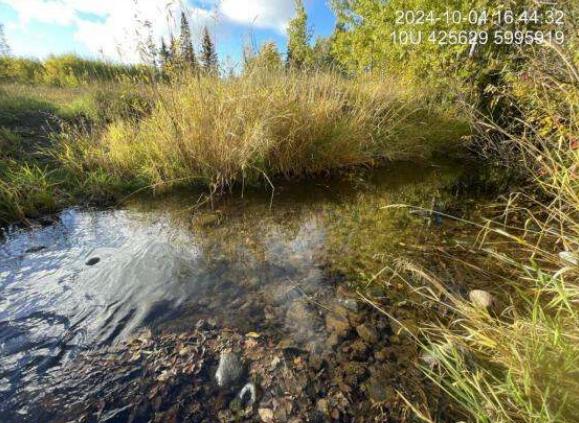
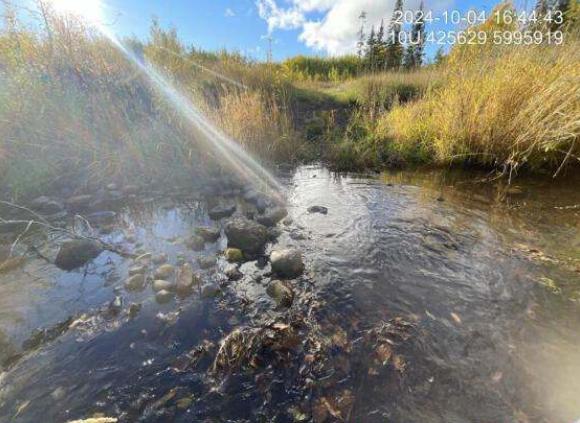
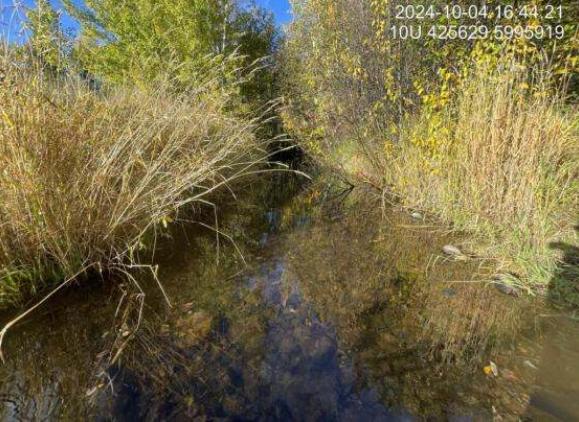
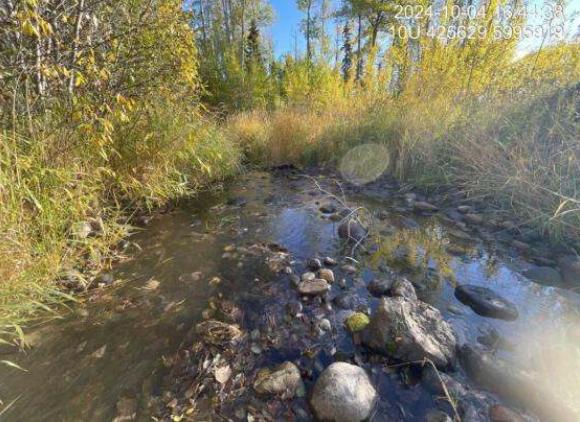
Location and Stream Data		.	Crossing Characteristics	-
Date	2024-10-04	Crossing Sub Type	Ford	
PSCIS ID	203301	Diameter (m)	-	
External ID	15602083	Length (m)	-	
Crew	LS	Embedded	-	
UTM Zone	10	Depth Embedded (m)	-	
Easting	425630	Resemble Channel	-	
Northing	5995920	Backwatered	-	
Stream	Clear Creek	Percent Backwatered	-	
Road	Private Road	Fill Depth (m)	-	
Road Tenure	Private	Outlet Drop (m)	-	
Channel Width (m)	-	Outlet Pool Depth (m)	-	
Stream Slope (%)	-	Inlet Drop	-	
Beaver Activity	No	Slope (%)	-	
Habitat Value	-	Valley Fill	-	
Final score	0	Barrier Result	Unknown	
Fix type	-	Fix Span / Diameter	-	
Comments: Ford crossing over Clear Creek on private land.				
Photos: PSCIS ID 15602083. From top left clockwise: Road/Site Card, Barrel, Outlet, Downstream, Upstream, Inlet.
