Restoring Fish Passage in the Fraser Region - 2023

Prepared for
Ministry of Transportation and Infrastructure

Prepared by
Al Irvine, B.Sc., R.P.Bio. and Lucy Schick, B.Sc.
New Graph Environment Ltd.

Version 0.0.1 2025-04-15

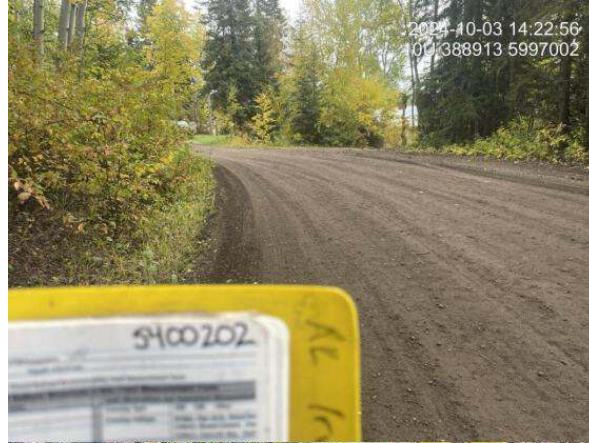
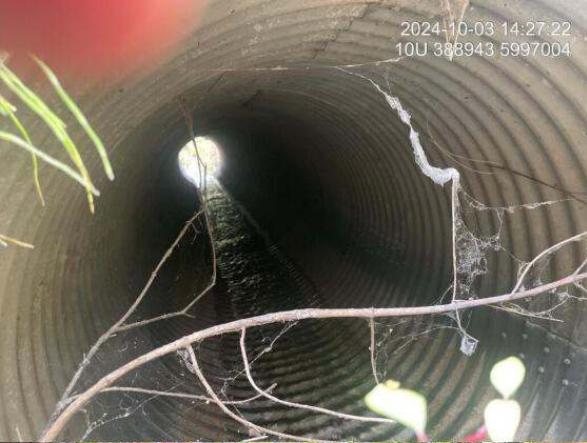
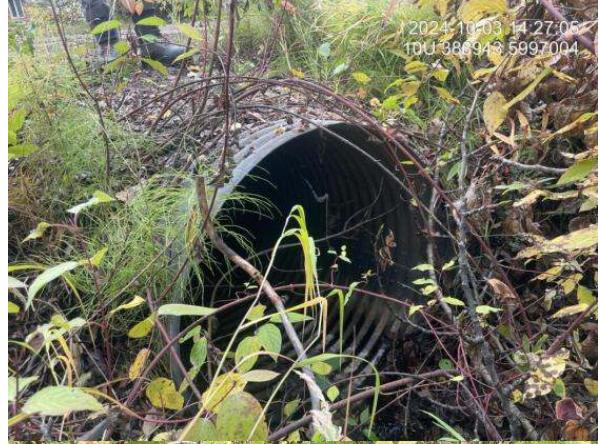
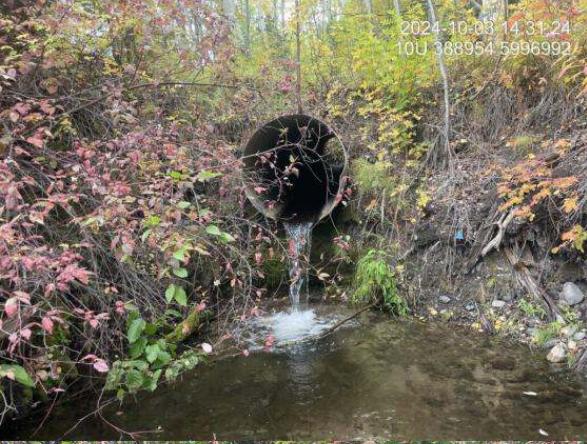
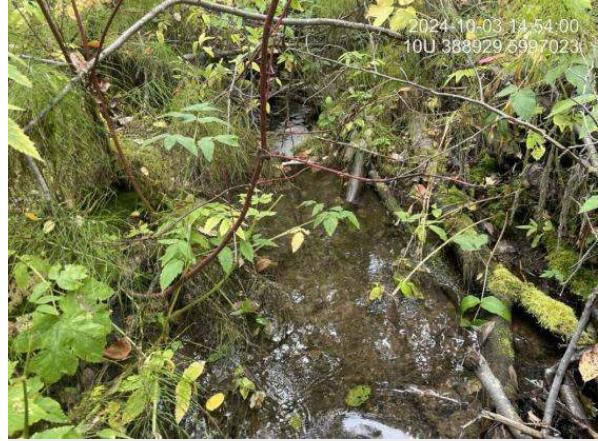
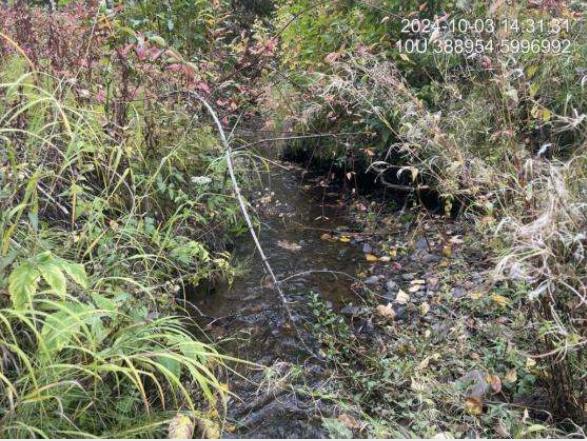
Location and Stream Data	Crossing Characteristics
<p>Comments: The local name of the stream is Burnt Cabin Creek. It had a large outlet drop and a heavily eroded outlet pool, indicating the culvert was undersized. The stream provided complex habitat for fish with abundant cover. The low-traffic dirt road had minimal road fill, making construction relatively straightforward.</p>	
<p>MoTi chris_culvert_id: 1790951</p>	
<p>Photos: From top left clockwise: Road/Site Card, Barrel, Outlet, Downstream, Upstream, Inlet.</p>

- Coordinate with the Ministry of Transportation to pursue funding for engineering designs at the following crossings:
 - PSCIS crossing 199171 on Burnt Cabin Creek along Gala Bay Road, in the Francois Lake watershed group.

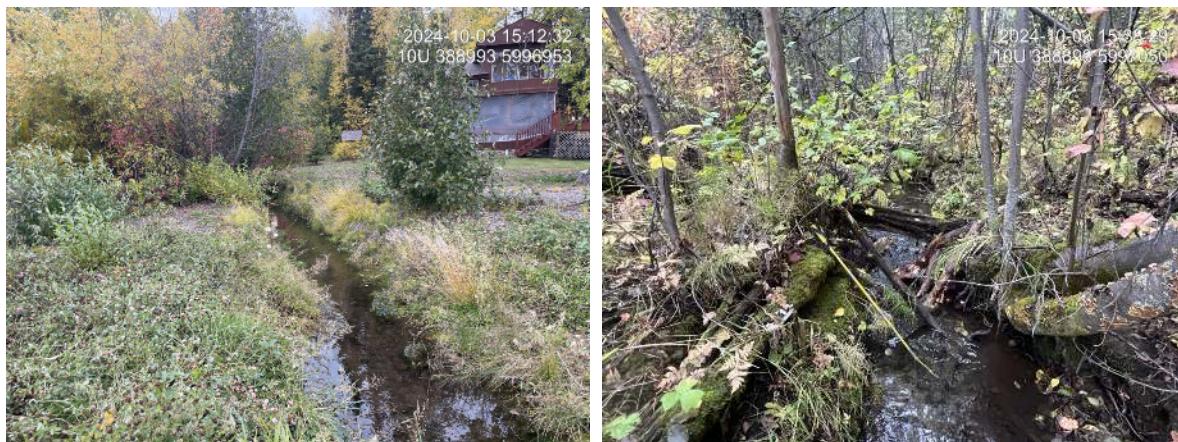
The stream was surveyed downstream from crossing 199171 for 50m (Figure 4.2). The stream was highly channelized due to residential properties on both sides. The habitat was rated as medium with minimal cover and few pools suitable for fish, but gravels were present for spawning. Anecdotal information from a neighboring landowner suggested the stream below Gala Bay Road had been diverted to accommodate a driveway for a recreational property. The average channel width was 2.4m, the average wetted width was 1.4m, and the average gradient was 1.3%. Total cover amount was rated as moderate with overhanging vegetation dominant. Cover was also present as small woody debris and undercut banks. The dominant substrate was gravels with fines sub-dominant.

The stream was surveyed upstream from crossing 199171 for 275m , all the way to crossing 7622 on Stella Road (Figure 4.2) The habitat was rated as medium value, with good flow and abundant gravels, flowing through several private properties with newly established quad and foot traffic trails. Pools were limited and predominantly shallow. The dominant substrate was gravels with cobbles sub-dominant. The average channel width was 2.4m, the average wetted width was 1.2m, and the average gradient was 4.5%. Total cover amount was rated as moderate with small woody debris dominant. Cover was also present as large woody debris, undercut banks, and overhanging vegetation.

Figure 4.2: Left: Typical habitat downstream of PSCIS crossing 199171. Right: Typical habitat upstream of PSCIS crossing 199171 and downstream of PSCIS crossing 7622.

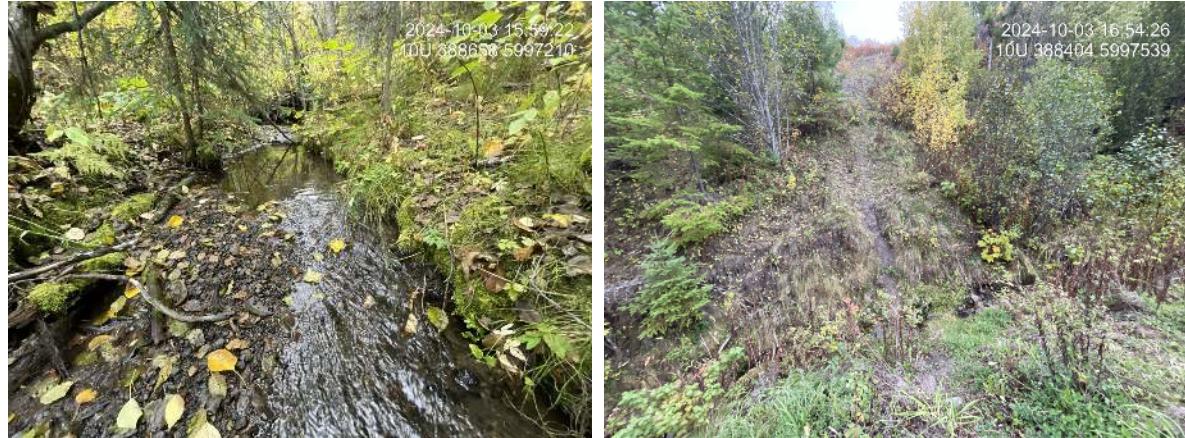
Figure 4.3: Left: Typical habitat upstream of PSCIS crossing 7622. Right: Bank erosion and riparian removal at the pipeline upstream of crossing 7622.

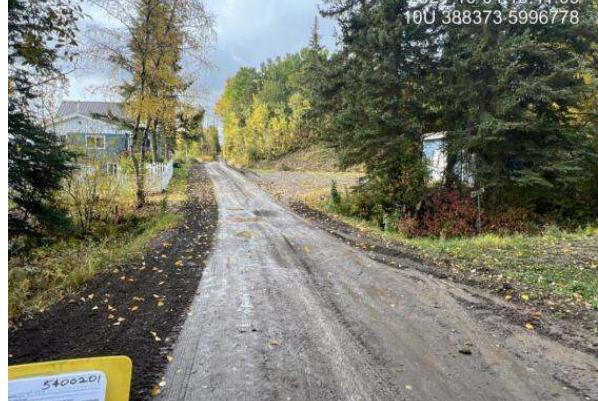
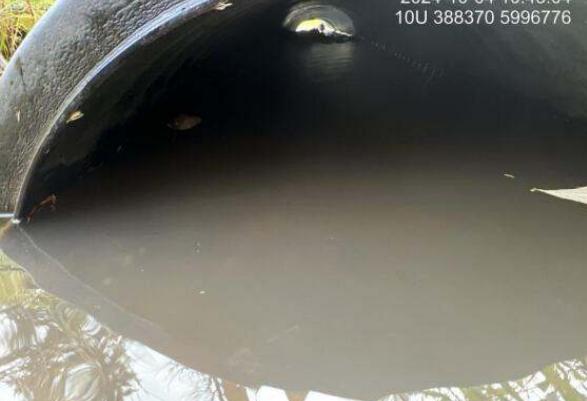
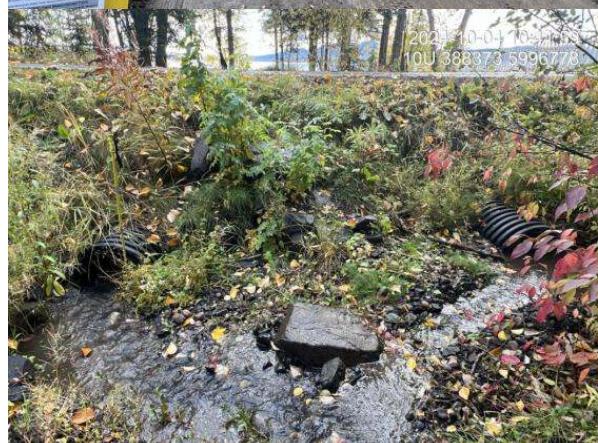
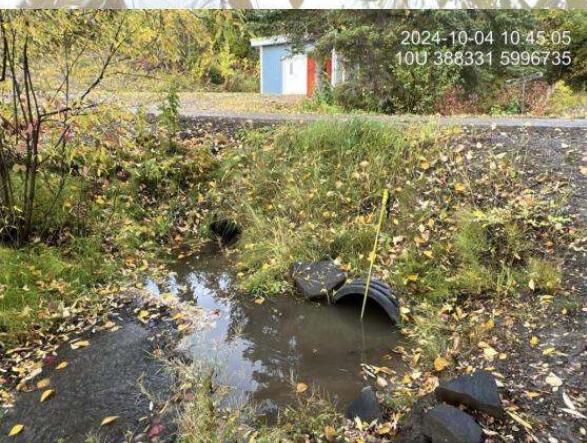
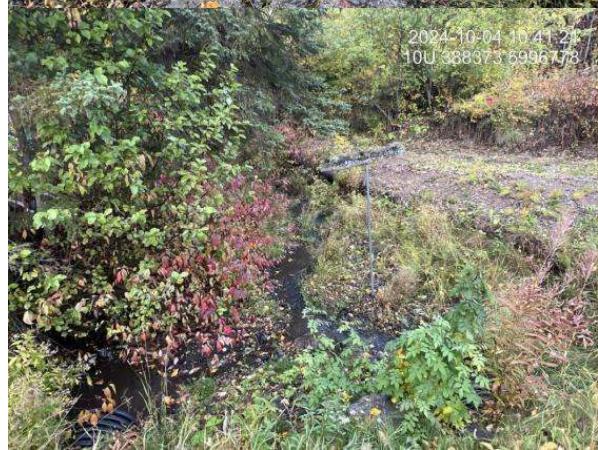
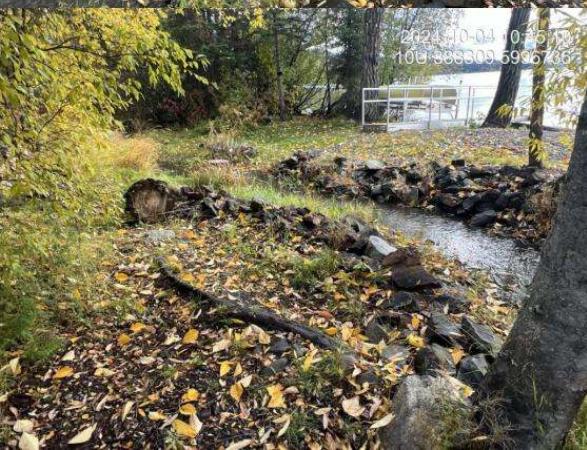
Location and Stream Data	Crossing Characteristics
<p>Comments: Two fully embedded PVC pipes, each 0.7m in diameter. One pipe was completely backwatered. Medium-value habitat was observed, with extensive gravels suitable for spawning upstream and downstream. A historic Chinook spawning point was recorded adjacent to the road. Habitat confirmations were conducted upstream, downstream, and above Stella Road. MoTi chris_culvert_id: 1790947</p>	
Photos: From top left clockwise: Road/Site Card, Barrel, Outlet, Downstream, Upstream, Inlet.

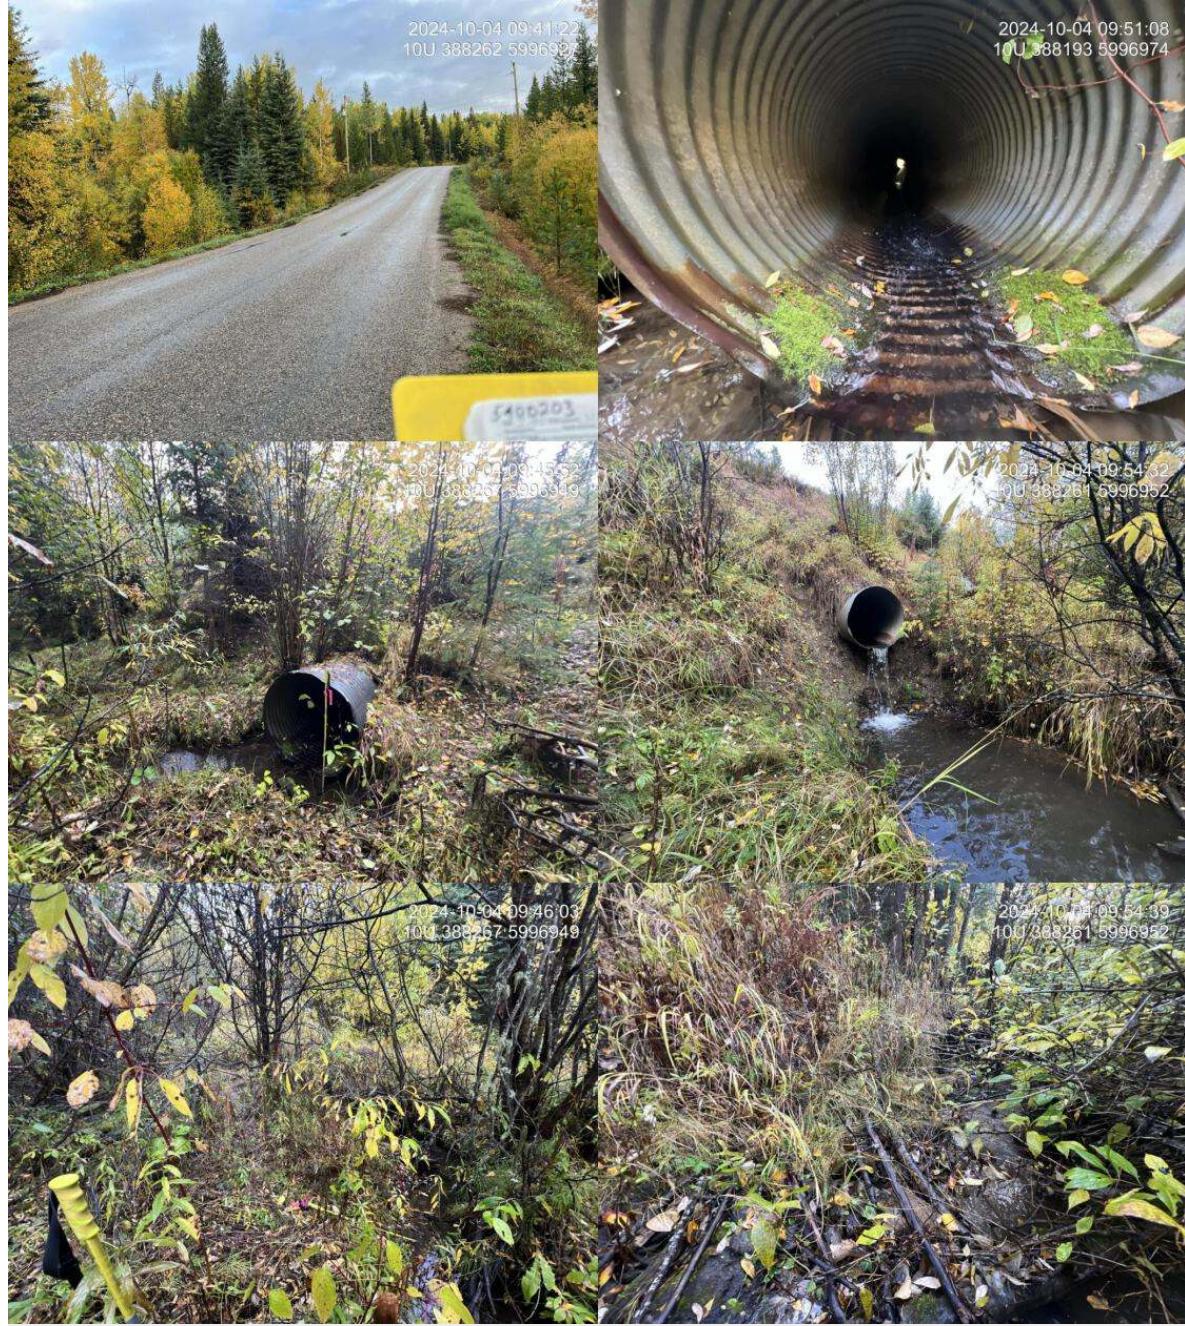
Location and Stream Data	Crossing Characteristics
<p>Comments: The culvert was very undersized for the stream, as evidenced by the large outlet drop. The stream had a good amount of flow for the time of year. Habitat was of medium value, with abundant large woody debris creating complex habitat and pools, providing ample cover for fish. Adjacent landowners reported that the stream was previously used as a water source for bottling and distribution across the province. Habitat confirmation was completed upstream and downstream. MoTi chris_culvert_id: 1794199</p> <p>Photos: From top left clockwise: Road/Site Card, Barrel, Outlet, Downstream, Upstream, Inlet.</p>

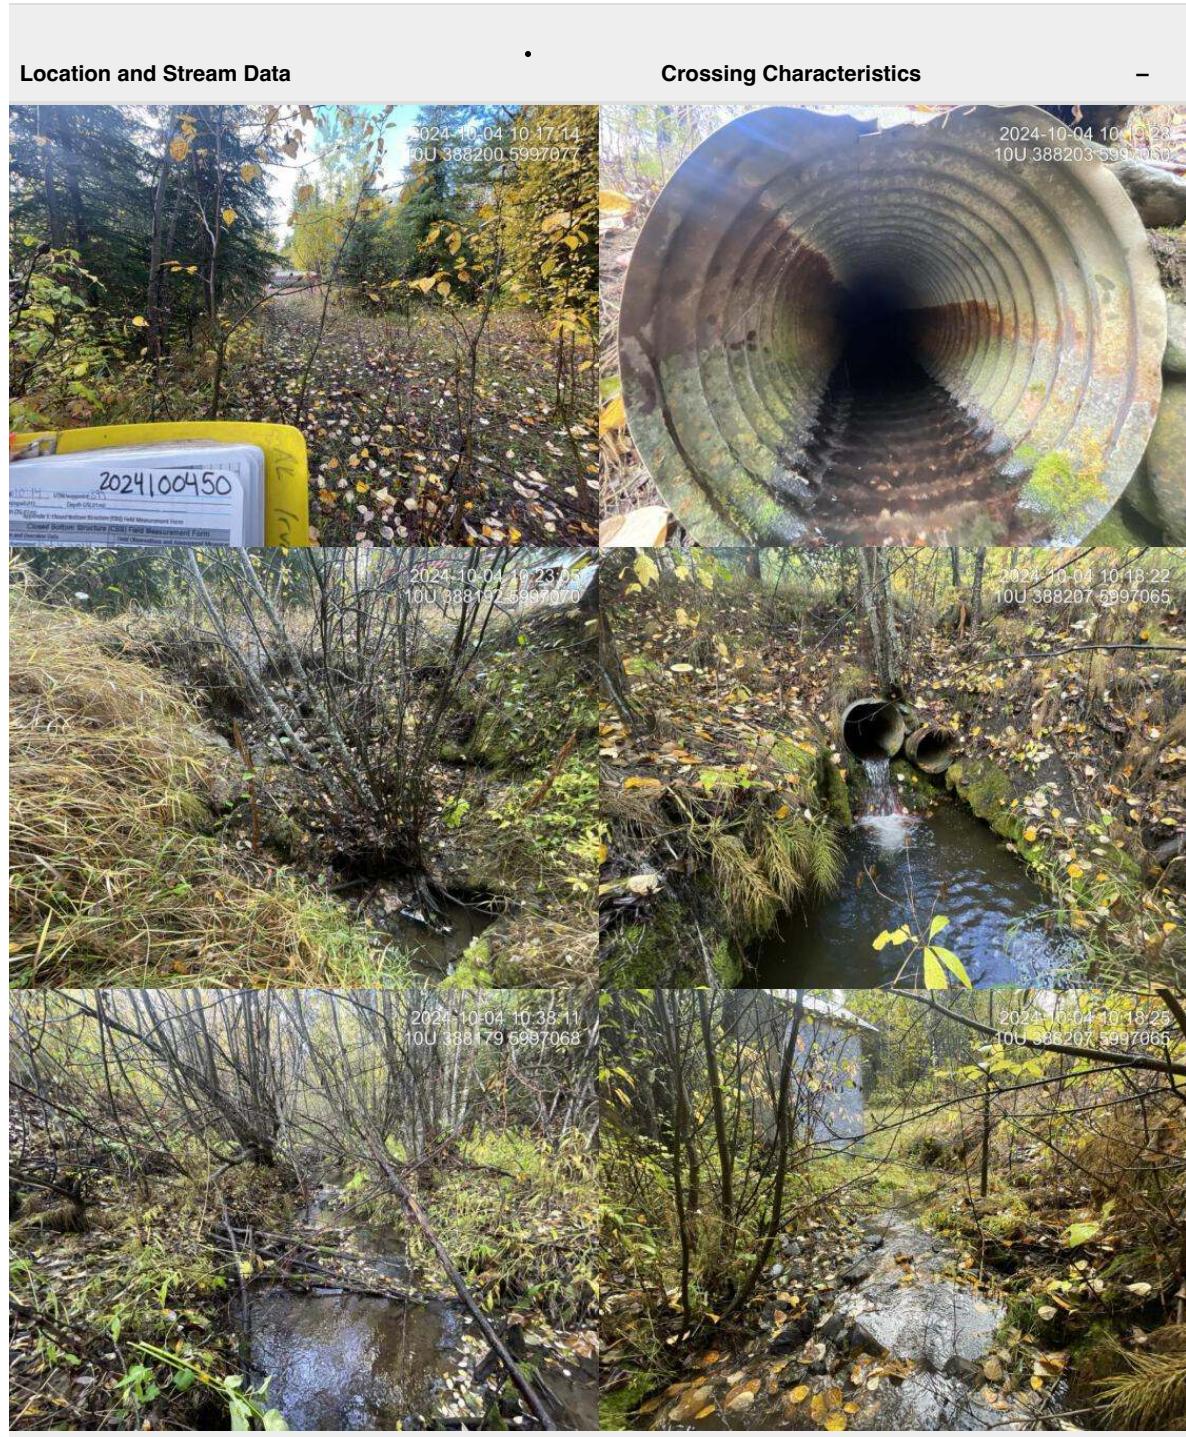
Comments: Two pipes, 0.6m and 0.45m in diameter, were present. There was a 0.7m outlet drop, and only the larger pipe conveyed flow. The inlet side of the road had completely eroded into the stream, obstructing the view of the inlet. No light was visible through the culverts from the outlet side, though water was still flowing. A landowner had placed a barricade across the road, likely to prevent access due to severe erosion of the road. The stream provided high-quality habitat with abundant large woody debris creating pools and gravels suitable for spawning. Just downstream, a functioning water intake shack was located in the middle of the stream, likely supplying the adjacent landowner's property. Plastic pipes extended from the intake shack downstream to the lower Stella Road crossing. The heavily overgrown and collapsing road appeared to be private access and would be a good candidate for removal. Due to inlet erosion, culvert length and slope were estimated as the inlet could not be located.

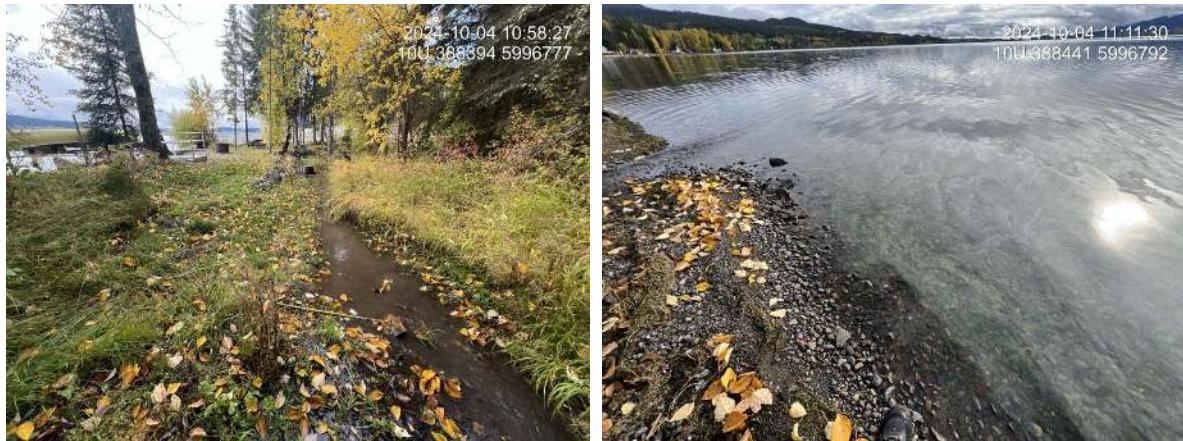
Figure 4.5: Left: Typical habitat downstream of PSCIS crossing 199328. Right: Algal bloom observed downstream of PSCIS crossing 199328 in Fraser Lake.

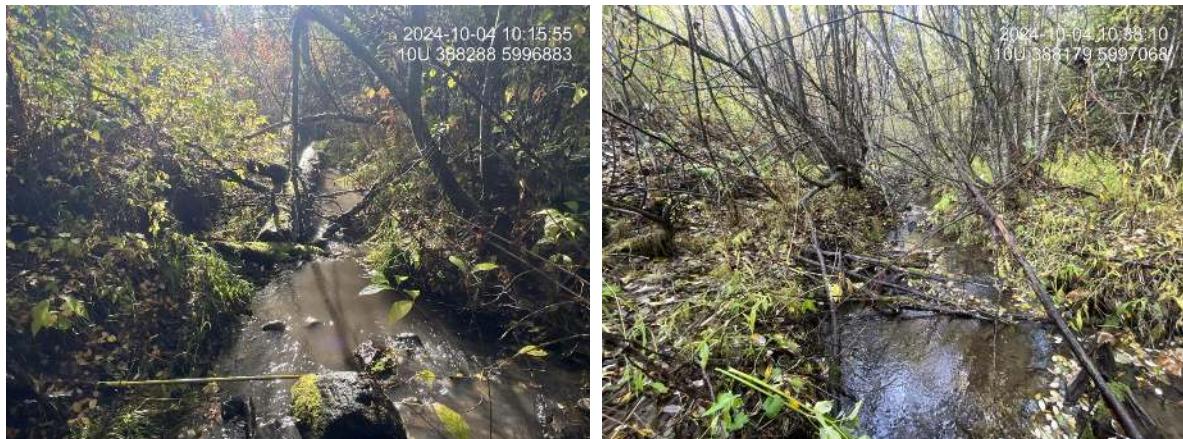
The stream was surveyed from Gala Bay Road upstream to Stella Road, a distance of approximately 270m (Figure 4.6) The habitat was rated as medium value, with limited pools; however, abundant overhanging vegetation and small woody debris provided cover, and gravels suitable for resident salmonid spawning were present. Incision was evident, beginning with a deep cut at the culvert outlet under Stella Road and continuing downstream to Gala Bay Road. The riparian area was generally intact through most of the survey, except for the downstream 75m, where private land development on the north side had resulted in a lawn and riparian vegetation removal up to the channel edge. Total cover amount was rated as moderate with overhanging vegetation dominant. Cover was also present as small woody debris and undercut banks. The average channel width was 2.1m, the average wetted width was 1.3m, and the average gradient was 3%. The dominant substrate was gravels with cobbles sub-dominant.

The stream was surveyed upstream from crossing 199172 for 550m (Figure 4.6). The habitat was rated as medium value, with abundant functional large woody debris creating pools 20–30cm deep, suitable for overwintering juvenile fish. Overhead cover was extensive, and occasional gravels were suitable for spawning. Approximately 400m upstream of Stella Road, the stream transitioned into a beaver-impounded area with four consecutive dams (1–1.5m high) impounding a large volume of water. Flow was maintained over or under the dams and the impounded area extended to the upper end of the surveyed area. A fish (~40mm) was observed after the second dam. The dominant substrate was gravels with fines sub-dominant. Total cover amount was rated as abundant with large woody debris dominant. Cover was also present as small woody debris, undercut banks, and overhanging vegetation. The average channel width was 2.6m, the average wetted width was 1.5m, and the average gradient was 4.3%.

Figure 4.6: Left: Typical habitat upstream of PSCIS crossing 199328 and downstream of PSCIS crossing 199172. Right: Typical habitat upstream of PSCIS crossing 199172.

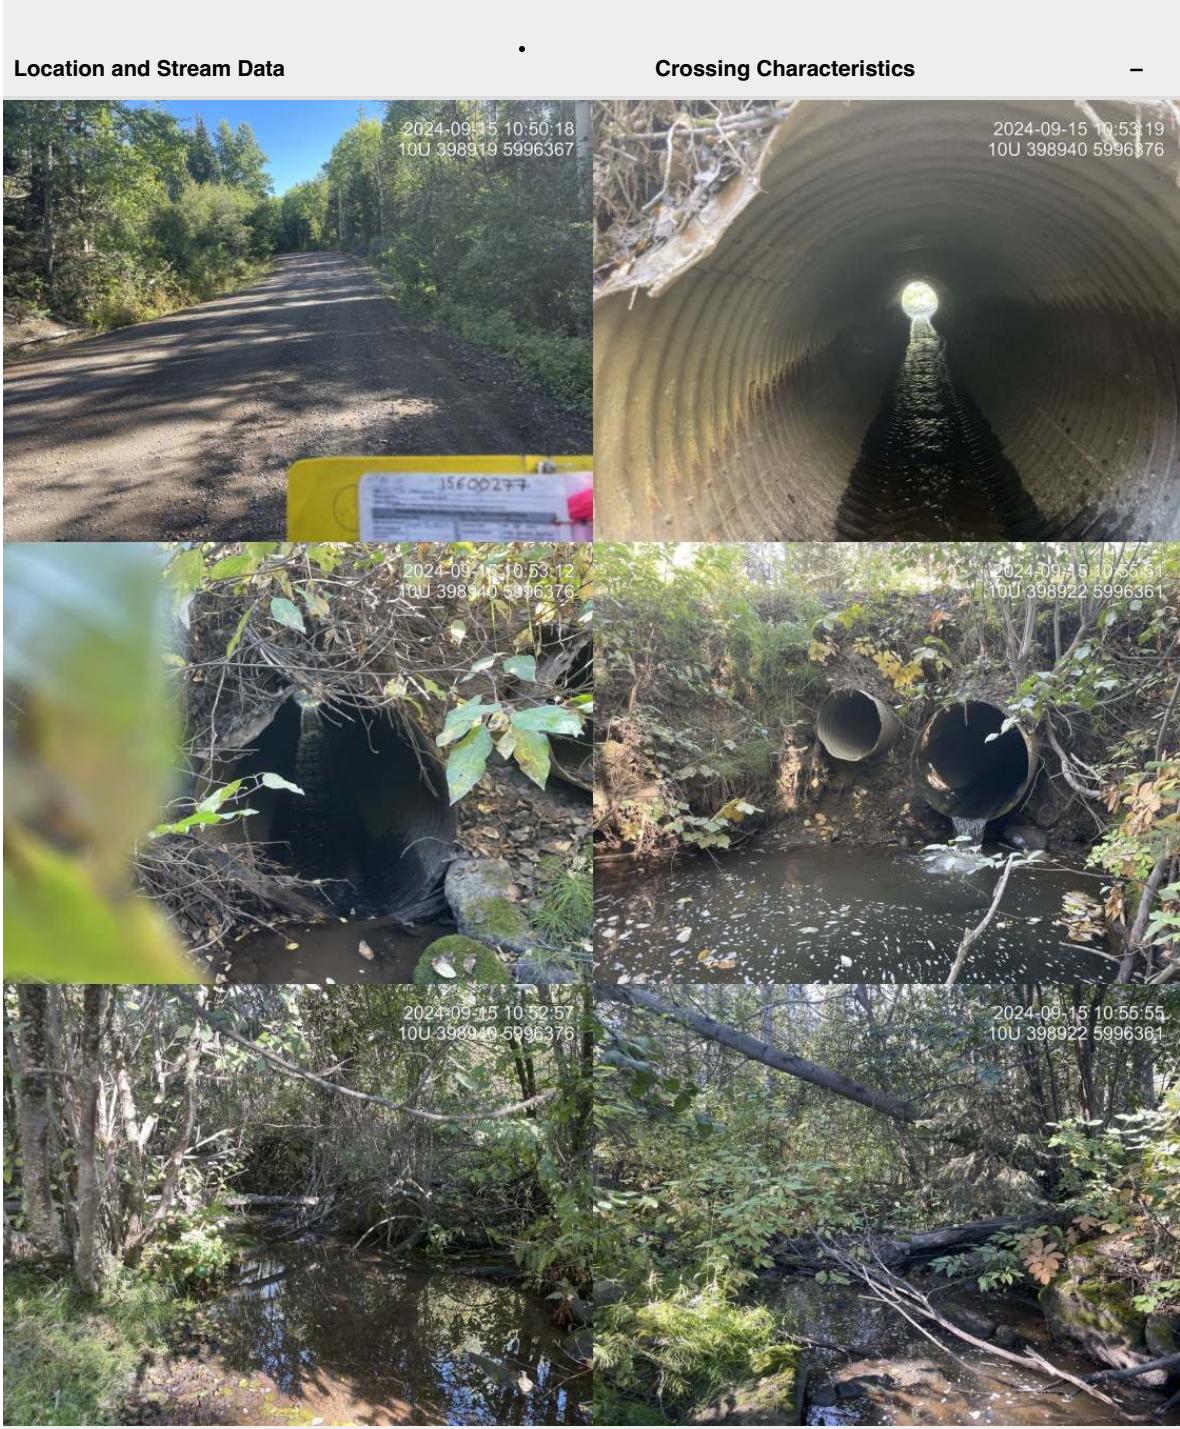
Tributary To Nechako River - 199173 ...

Location and Stream Data		Crossing Characteristics	
Date	2024-09-15	Crossing Sub Type	Round Culvert
PSCIS ID	199173	Diameter (m)	0.9
External ID	–	Length (m)	10
Crew	LS, AI	Embedded	No
UTM Zone	10	Depth Embedded (m)	–
Easting	398923	Resemble Channel	No
Northing	5996362	Backwatered	No
Stream	Tributary To Nechako River	Percent Backwatered	–
Road	Dog Creek Road	Fill Depth (m)	1
Road Tenure	MOTI	Outlet Drop (m)	0.35
Channel Width (m)	3	Outlet Pool Depth (m)	0.7
Stream Slope (%)	4	Inlet Drop	No
Beaver Activity	Yes	Slope (%)	2.5
Habitat Value	Medium	Valley Fill	Deep Fill
Final score	31	Barrier Result	Barrier
Fix type	Replace with New Open Bottom Structure	Fix Span / Diameter	15
Comments: The culvert had a moderate outlet drop with some erosion around the pipe at the outlet. The pipe was in good condition. The stream provided excellent habitat, with several pools and abundant undercut banks. Fish were observed during the assessment (~40-90mm in length). Upstream of the crossing, the stream was channelized with some pockets of gravel suitable for rearing rainbow trout and potentially Chinook. It then transitioned into beaver-impounded wetland areas storing large quantities of water, likely sustaining year-round stream flow at this crossing. Photos: From top left clockwise: Road/Site Card, Barrel, Outlet, Downstream, Upstream, Inlet.

Should restoration/maintenance activities proceed, replacement of the Dog Creek Road crossing (199173) with a bridge (15 m span) is recommended. At the time of reporting in 2025, the cost of the work is estimated at \$ 1,500,000.

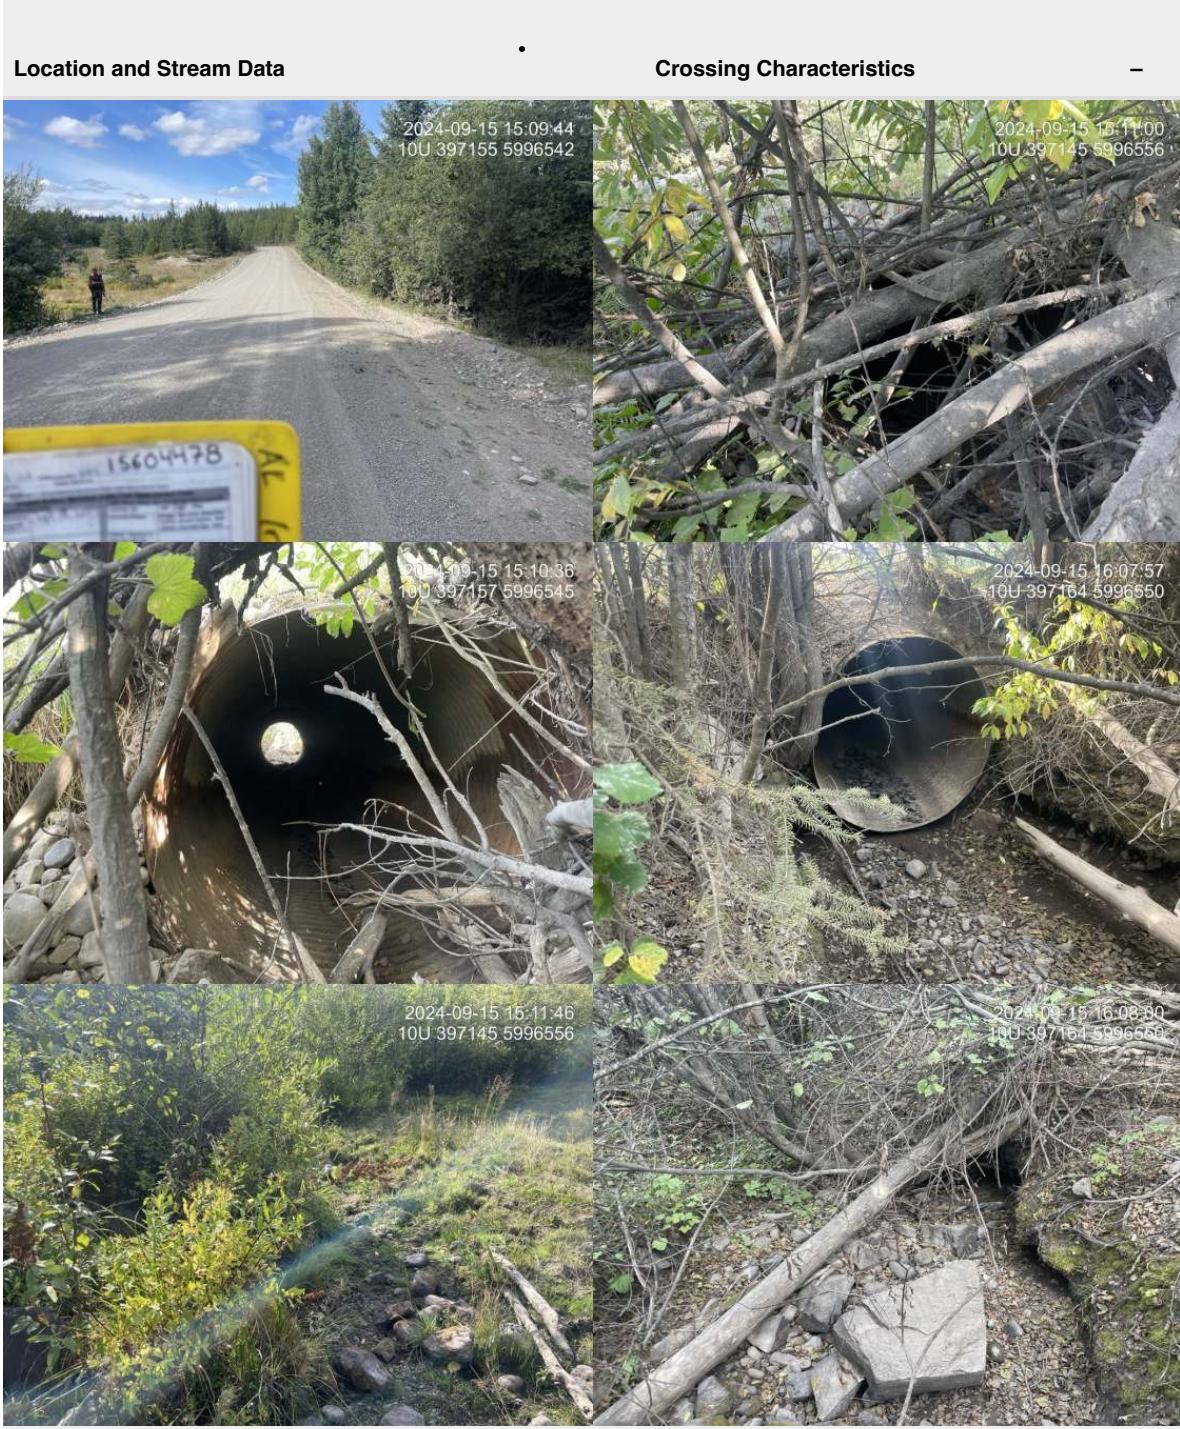
Location and Stream Data		Crossing Characteristics	
Date	2024-09-15	Crossing Sub Type	Round Culvert
PSCIS ID	199174	Diameter (m)	1.5
External ID	–	Length (m)	15
Crew	LS	Embedded	No
UTM Zone	10	Depth Embedded (m)	–
Easting	397160	Resemble Channel	No
Northing	5996574	Backwatered	No
Stream	Tributary To Nechako River	Percent Backwatered	–
Road	Sutherland FSR	Fill Depth (m)	0.4
Road Tenure	MoF	Outlet Drop (m)	0
Channel Width (m)	2.5	Outlet Pool Depth (m)	0
Stream Slope (%)	1.2	Inlet Drop	No
Beaver Activity	No	Slope (%)	1
Habitat Value	–	Valley Fill	Deep Fill
Final score	24	Barrier Result	Barrier
Fix type	Replace with New Open Bottom Structure	Fix Span / Diameter	15

At the time of assessment, the upstream crossing on Sutherland FSR was unlikely a barrier to fish passage, and restoration efforts should prioritize the downstream crossing on Dog Creek Road. However, should restoration activities proceed at crossing 199174, replacement with a bridge spanning 15 m is recommended. At the time of reporting in 2025, the estimated cost for the replacement is \$ 450,000.

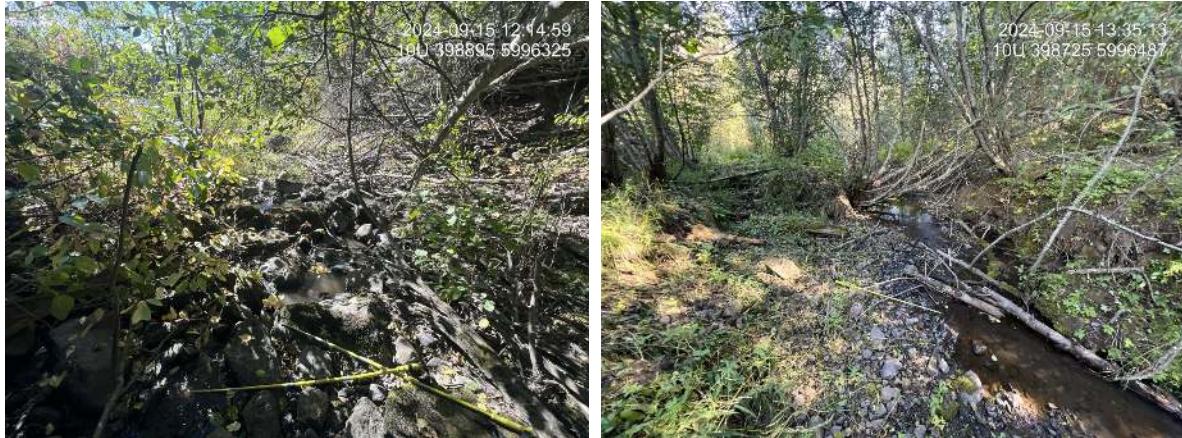
The stream was surveyed downstream from crossing 199173 for 115m (Figure 4.8). The habitat was rated as medium value, with undercut banks suitable for juvenile chinook and rainbow trout rearing. No natural or man-made barriers were present between Dog Creek Road and the Nechako River. Fish (~40–90mm in length) were observed during the assessment. Total cover amount was rated as moderate with undercut banks dominant. Cover was also present as small woody debris and boulders. The dominant substrate was cobbles with fines sub-dominant. The average channel width was 3.5m, the average wetted width was 1.3m, and the average gradient was 6%.

The stream was surveyed upstream from crossing 199173 for 575m (Figure 4.8). The habitat was rated as medium with pockets of gravels suitable for rainbow trout and potentially chinook rearing, and fish were observed throughout the survey area. Heavy cattle impacts were evident, particularly in low-gradient sections with easily accessible banks. Fencing intended to restrict cattle access was present but had been breached. Approximately 300–350m upstream, the stream transitioned from a channelized section to a beaver-impounded wetland, with over three mature dams—some up to 1.5m high—vegetated and well-developed. These dams impounded large volumes of water, likely sustaining year-round stream flow downstream at the Dog Creek Road crossing. Total cover amount was rated as moderate with small woody debris dominant. Cover was also present as large woody debris, deep pools, and overhanging vegetation. The average channel width was 3m, the average wetted width was 1.5m, and the average gradient was 2.4%.

Figure 4.8: Left: Typical habitat downstream of PSCIS crossing 199173. Right: Typical habitat upstream of PSCIS crossing 199173.

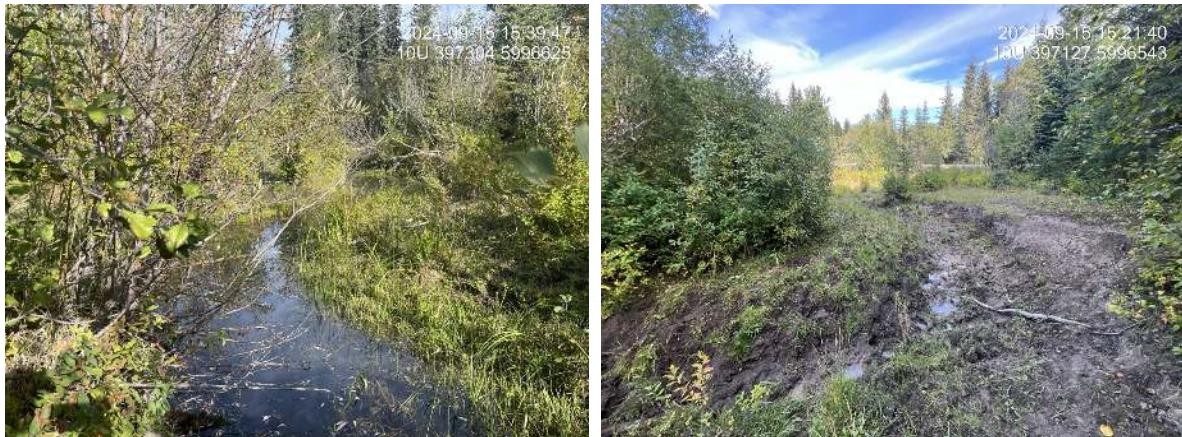
The stream was surveyed downstream from crossing 199174 for 300m (Figure 4.9). The stream was intermittent for the first ~70m before transitioning into a beaver-impacted wetland area. Approximately 250m downstream of Sutherland FSR, several large, mature, consecutive beaver dams were present and appeared to continue as far as the area surveyed. Signs of cattle trampling were observed throughout the stream, and the channel frequently split into several smaller channels. The habitat was rated as medium value, with few gravels for spawning but abundant pools created by beaver dams. The average channel width was 2m, the average wetted width was 1m, and the average gradient was 1.2%. Total cover amount was rated as abundant with small woody debris dominant. Cover was also present as large woody debris, undercut banks, deep pools, and overhanging vegetation. The dominant substrate was fines with gravels sub-dominant.

The stream was surveyed upstream from crossing 199174 for 650m (Figure 4.9). The habitat was rated as medium value and had been heavily impacted by cattle, with evidence of bank trampling and extensive low-gradient muddy sections. Upstream of the culvert, the stream was primarily dry for the first 300m, with young forest and shrubs. At this point, intermittent pools began to appear,

Figure 4.9: Left: Typical habitat downstream of PSCIS crossing 199174. Right: Typical habitat upstream of PSCIS crossing 199174.

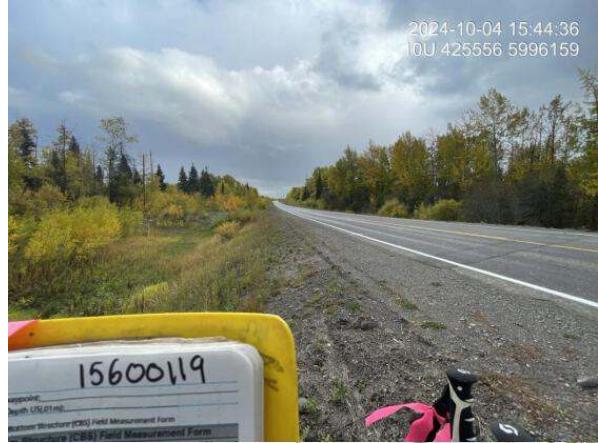
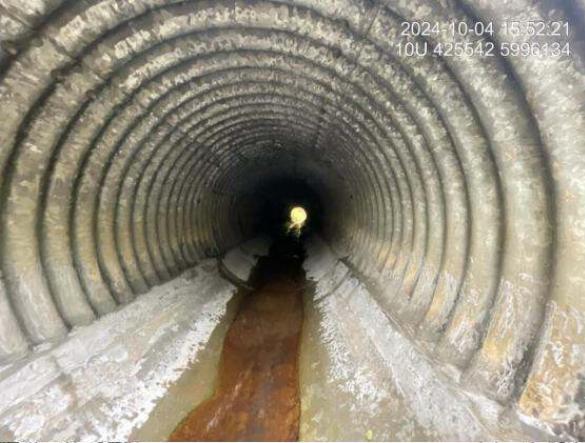
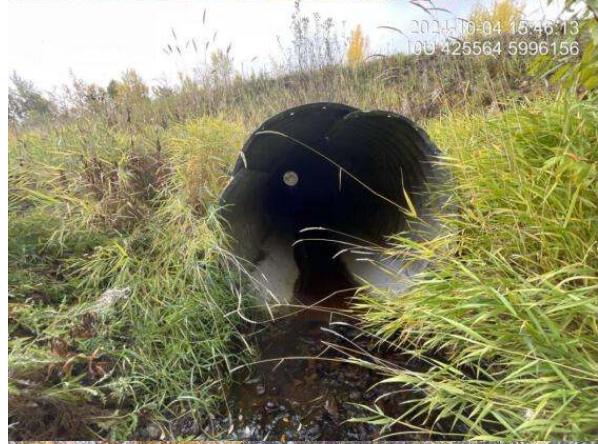
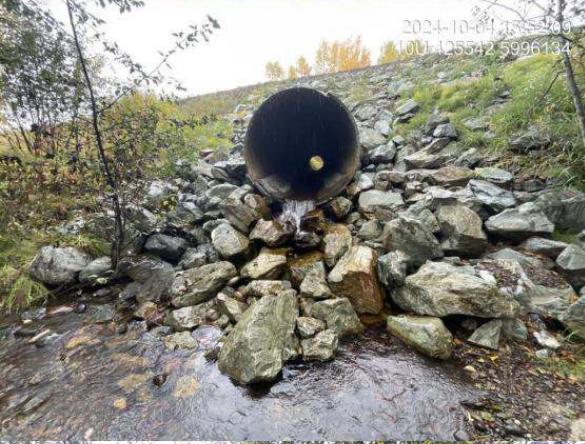
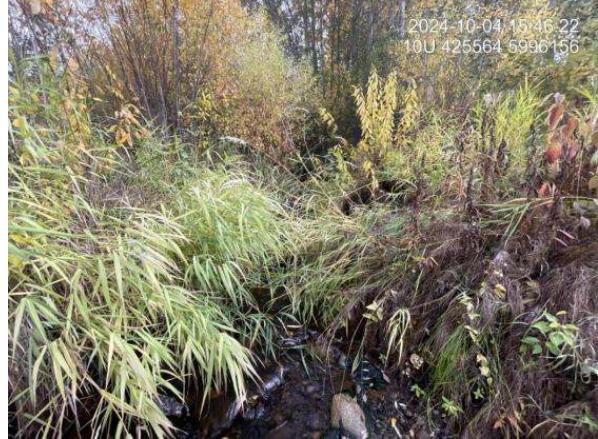
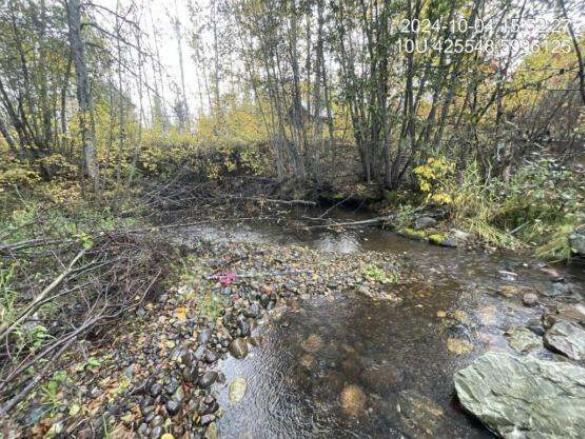
Stream Characteristics at Crossing 19...

Location and Stream Data	Crossing Characteristics
<p>Comments: The bottom of the culvert had been reinforced with concrete, likely to address holes noted in the previous assessment. A large pile of riprap was placed at the outlet, possibly to reduce the outlet drop, though its placement appeared unusual and could inhibit fish passage. The habitat was high quality, with a large pool just downstream of the culvert and abundant gravels suitable for spawning fish. MoTi chris_culvert_id: 1806163</p>	
Photos: From top left clockwise: Road/Site Card, Barrel, Outlet, Downstream, Upstream, Inlet.

Should restoration/maintenance activities proceed, replacement of the Highway 27 crossing (199190) with a bridge (15 m span) is recommended. At the time of reporting in 2025, the cost of the work is estimated at \$ 11,250,000.

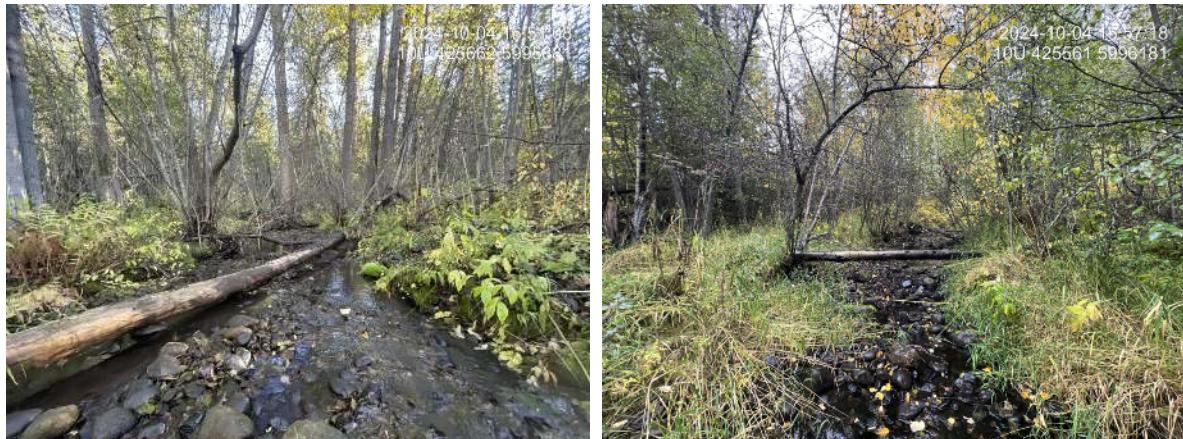
The stream was surveyed downstream from crossing 199190 for 335m (Figure 4.11). The habitat was rated as high value for salmonid spawning and rearing. The stream contained frequent pools suitable for overwintering fish, with abundant cobbles but limited gravels. Evidence of extreme seasonal flows was observed, including large eroding banks, extensive gravel deposits from channel widening (20–30m), and significant log jams. Total cover amount was rated as abundant with large woody debris dominant. Cover was also present as small woody debris and undercut banks. The average channel width was 5.4m, the average wetted width was 4m, and the average gradient was 1.2%. The dominant substrate was cobbles with fines sub-dominant.

The stream was surveyed upstream from crossing 199190 for 550m (Figure 4.11). The habitat was rated as low value. The stream had good flow and provided high-quality habitat for the first 100m before transitioning to subsurface flow. Approximately 200m upstream of the highway, adjacent to a quarry, the stream was fully dewatered to the top of the surveyed reach. The channel was highly confined, lacked complexity, and consisted primarily of a straight, coarse cobble and boulder substrate. While some small and large woody debris were present, they did not appear to contribute to habitat formation during periods of flow. The dominant substrate was cobbles with boulders sub-dominant. The average channel width was 5.2m, the average wetted width was 3.1m, and the average gradient was 1.3%. Total cover amount was rated as trace with boulders dominant. Cover was also present as overhanging vegetation.

Figure 4.11: Left: Typical habitat downstream of PSCIS crossing 199190. Right: Typical habitat upstream of PSCIS crossing 199190.

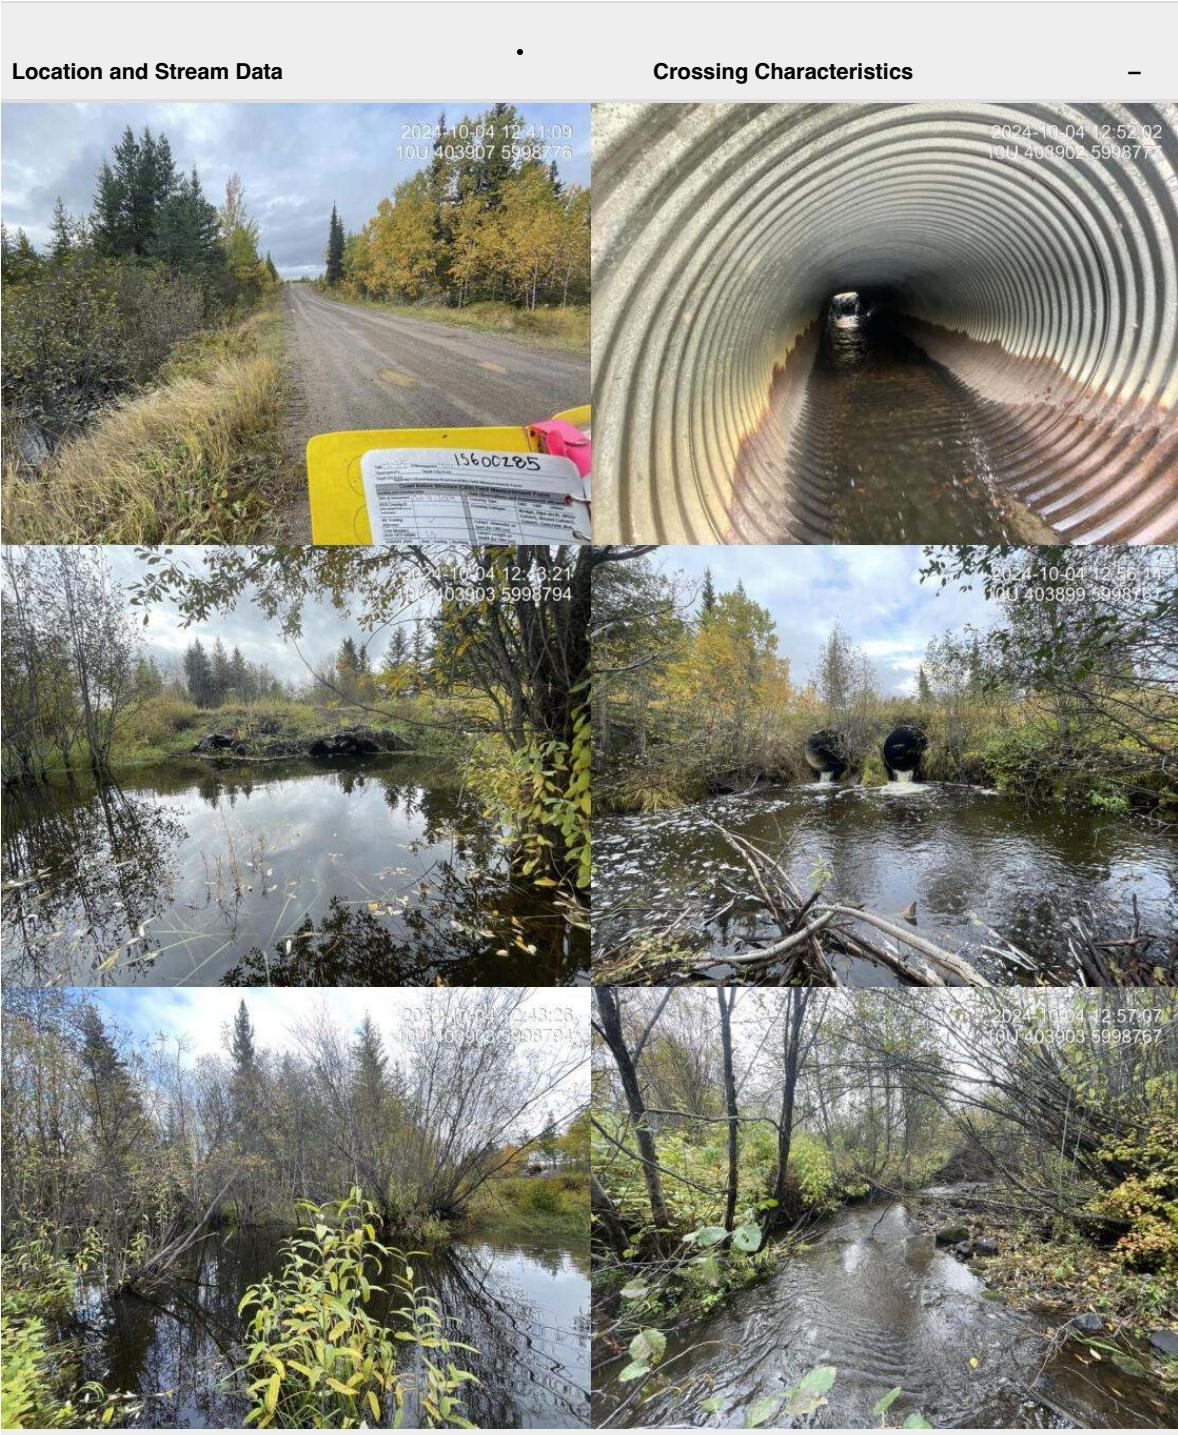
Stream Characteristics at Crossing 19...

Location and Stream Data		Crossing Characteristics	
Road	Settlement Road	Fill Depth (m)	0.5
Road Tenure	MOTI	Outlet Drop (m)	0.5
Channel Width (m)	5.5	Outlet Pool Depth (m)	1.4
Stream Slope (%)	0.5	Inlet Drop	No
Beaver Activity	Yes	Slope (%)	2
Habitat Value	Medium	Valley Fill	Deep Fill
Final score	31	Barrier Result	Barrier
Fix type	Replace with New Open Bottom Structure	Fix Span / Diameter	15
Comments: The inlets of both culverts were dammed by a beaver, backing up water to most of the culverts' height. Two pipes, each 1.6m in diameter, were present. A large outlet pool indicated the pipes were likely undersized for the stream. Another beaver dam was being constructed at the outlet of the pool. The dirt road had minimal road fill, making construction relatively straightforward. The road appeared to be used for pipeline access. Outlet pool depth was estimated as it was too deep to wade. Fish approximately 40mm in length were observed downstream during habitat confirmation. MoTi chris_culvert_id: 1793923

Should restoration/maintenance activities proceed, replacement of the Settlement Road crossing (199204) with a bridge (15 m span) is recommended. At the time of reporting in 2025, the cost of the work is estimated at \$ 1,500,000.

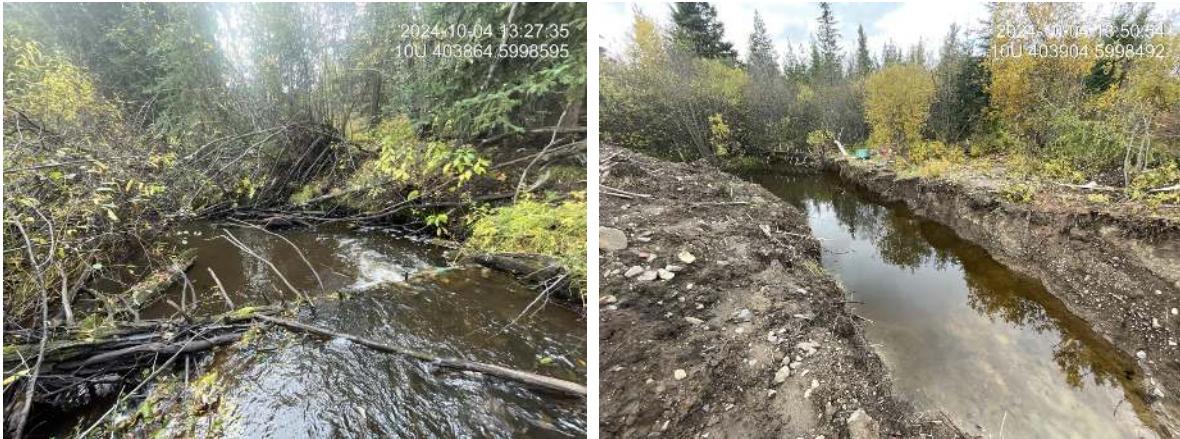
Figure 4.13: Left: Typical habitat downstream of PSCIS crossing 199204. Right: Large, artificially entrenched pool located ~300m downstream of PSCIS crossing 199204.
