Restoring Fish Passage in the Fraser Region - 2023

Prepared for
Ministry of Transportation and Infrastructure

Prepared by
Al Irvine, B.Sc., R.P.Bio. and Lucy Schick, B.Sc.
New Graph Environment Ltd.

Version 0.0.1 2025-04-15

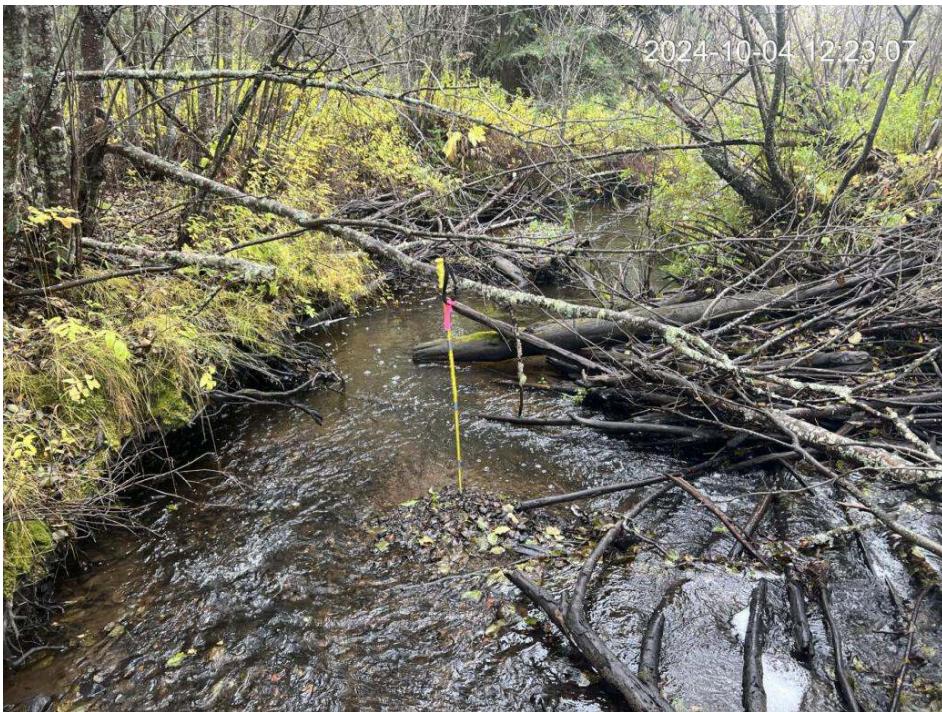
The stream was surveyed upstream from crossing 199204 for 425m (Figure 4.14). The habitat was rated as medium value for spawning and rearing. The stream was a larger system with significant beaver activity, creating impoundments behind dams ranging from 0.3 to 1.5m in height. Heavy cattle use was evident in riparian areas, with trampled banks, extensive browsing of riparian shrubs, and a significant amount of manure within seasonally inundated areas. Nutrient loading to the stream appeared high, with large amounts of algae present on the primarily gravel substrates in sections of the channel linking beaver-impounded areas. The dominant substrate was fines with gravels sub-dominant. The average channel width was 6.2m, the average wetted width was 4.4m, and the average gradient was 3%. Total cover amount was rated as moderate with deep pools dominant. Cover was also present as small woody debris, overhanging vegetation, and instream vegetation.

Figure 4.14: Typical habitat upstream of PSCIS crossing 199204.

Should restoration/maintenance activities proceed, replacement of the Settlement Road crossing (199204) with a bridge (15 m span) is recommended. At the time of reporting in 2025, the cost of the work is estimated at \$ 1,500,000.

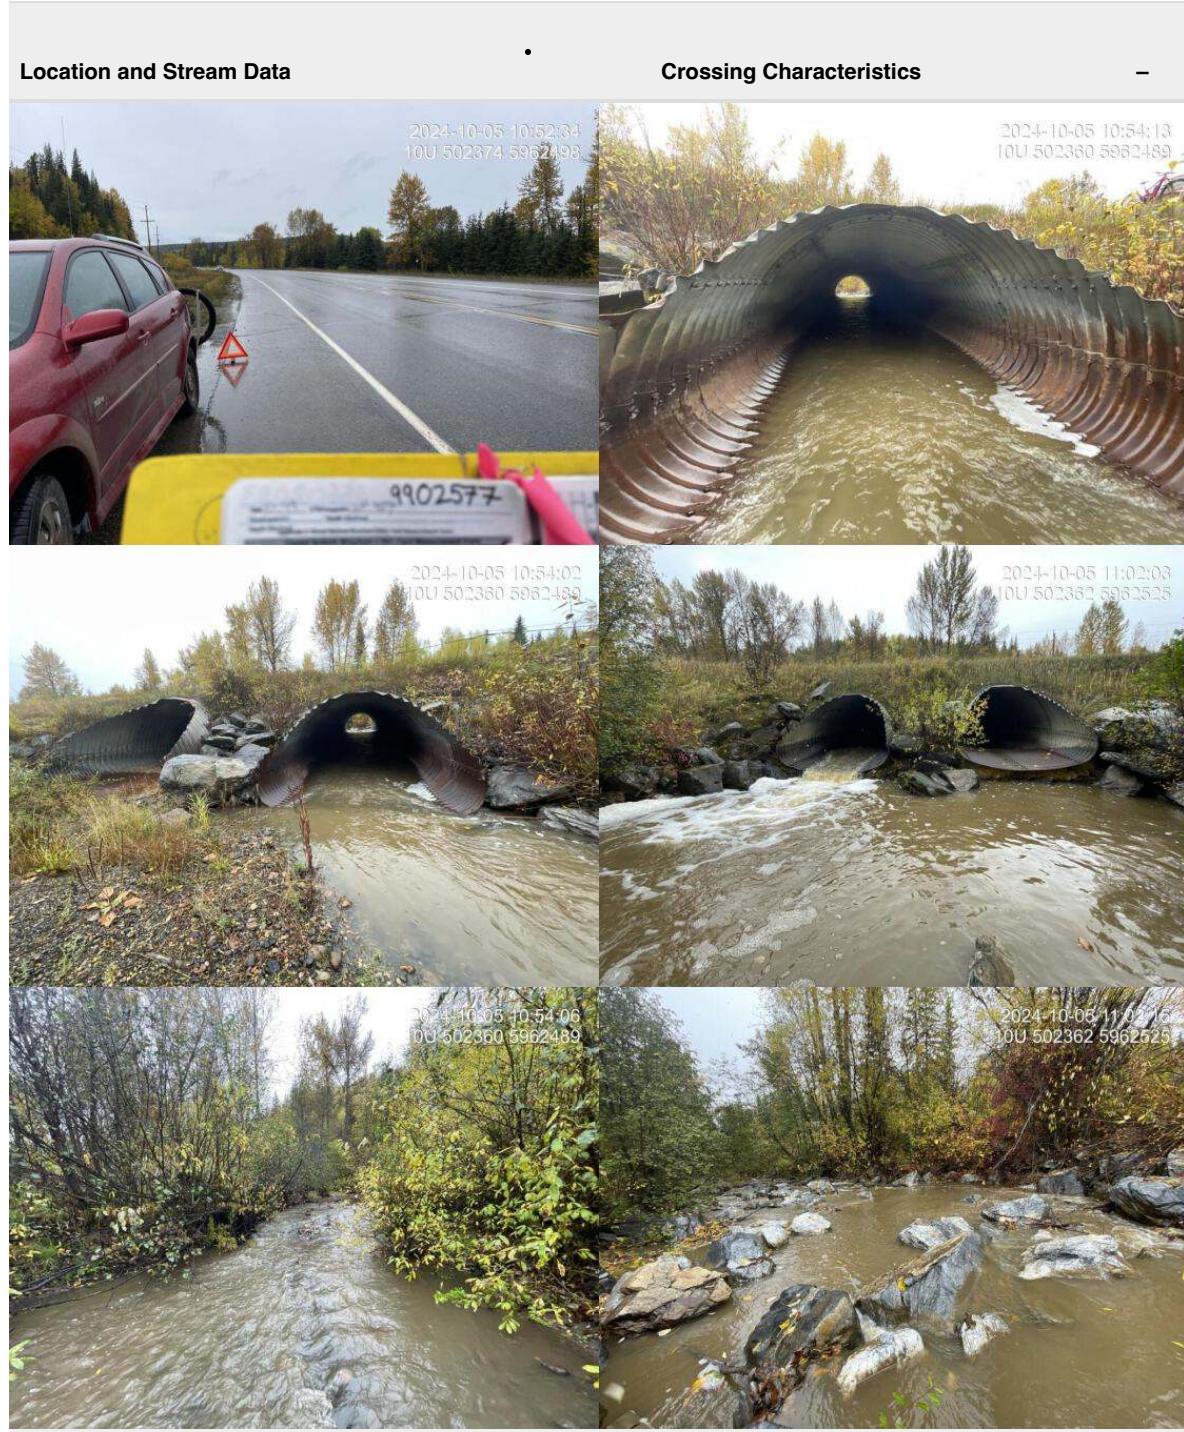
Stream Characteristics at Crossing 19...

At the time of the 2024 assessment, PSCIS crossing 199232 on Highway 16 was un-embedded, non-backwatered and ranked as barrier to upstream fish passage according to the provincial protocol (MoE 2011) (Table 4.25). Two 2.8m diameter pipes were present, with no flow observed in the more northern pipe. The culverts had a significant 1.05m outlet drop.

Should restoration/maintenance activities proceed, replacement of the Highway 16 crossing (199232) with a bridge (15 m span) is recommended. At the time of reporting in 2025, the cost of the work is estimated at \$ 11,250,000.

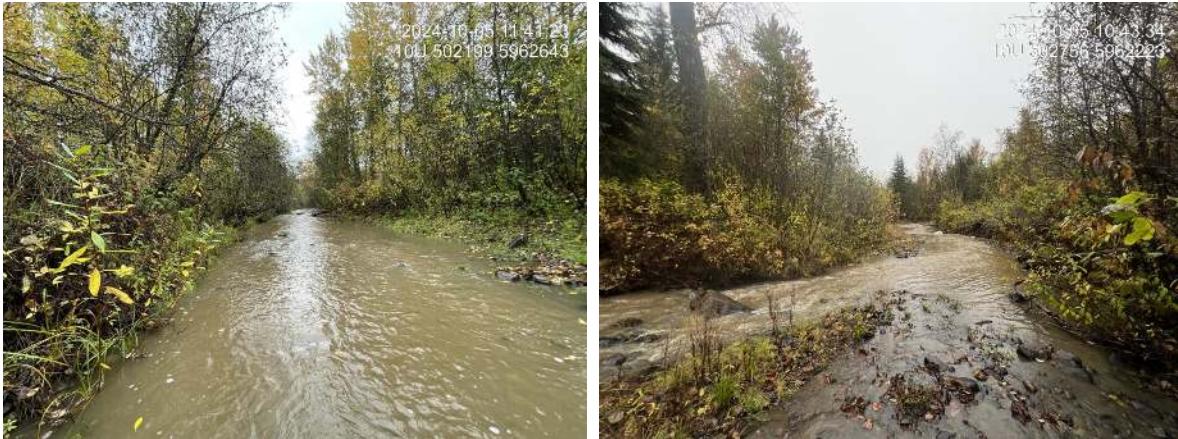
The stream was surveyed downstream from crossing 199232 for 300m (Figure 4.16). The habitat was rated as medium value due to sparse large woody debris, a lack of pools, and high turbidity from recent rainfall likely obscuring gravels. Below the outlet, large boulders were placed in rows to backwater the culvert, which was somewhat effective, though the culvert itself remained unbackwatered. This section had a steeper gradient (3–4%) before transitioning to ~0.5% for the remainder of the area surveyed. The upper section of the stream was somewhat channelized due to residences on both sides, while lower sections showed significant bank erosion. The dominant substrate was cobbles with gravels sub-dominant. Total cover amount was rated as moderate with large woody debris dominant. Cover was also present as boulders. The average channel width was 9.6m, the average wetted width was 6m, and the average gradient was 2%.

The stream was surveyed upstream from crossing 199232 for 725m (Figure 4.16). The habitat was rated as high value, with abundant gravels suitable for chinook spawning. Pools were infrequent, primarily located on outside bends and behind large woody debris. Some evidence of anthropogenic manipulation was observed, including cut cottonwood trees that had fallen into the channel. The riparian zone was in good condition, with mature shrub communities and old-growth cottonwood that should contribute to future habitat complexity. Water levels were elevated to moderate conditions due to heavy rainfall over the previous evening and preceding weeks. The average channel width was 11.9m, the average wetted width was 8m, and the average gradient was 0.6%. Total cover amount was rated as moderate with overhanging vegetation dominant. Cover was also present as small woody debris and boulders. The dominant substrate was gravels with cobbles sub-dominant.

Figure 4.16: Left: Typical habitat downstream of PSCIS crossing 199232. Right: Typical habitat upstream of PSCIS crossing 199232.

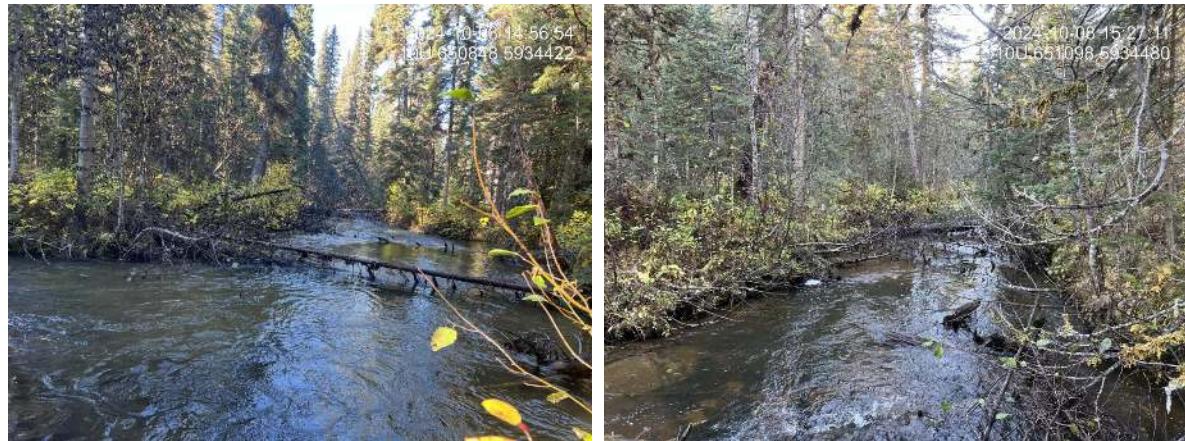
Figure 4.18: Left: Typical habitat upstream of PSCIS crossing 199237 on the west fork on Snowshoe Creek. Right: Typical habitat upstream of PSCIS crossing 199237 on the east fork on Snowshoe Creek.

Should restoration/maintenance activities proceed, replacement of the Highway 16 crossing with a bridge (19 m span) is recommended. At the time of reporting in 2025, the cost of the work is estimated at \$ 14,250,000.

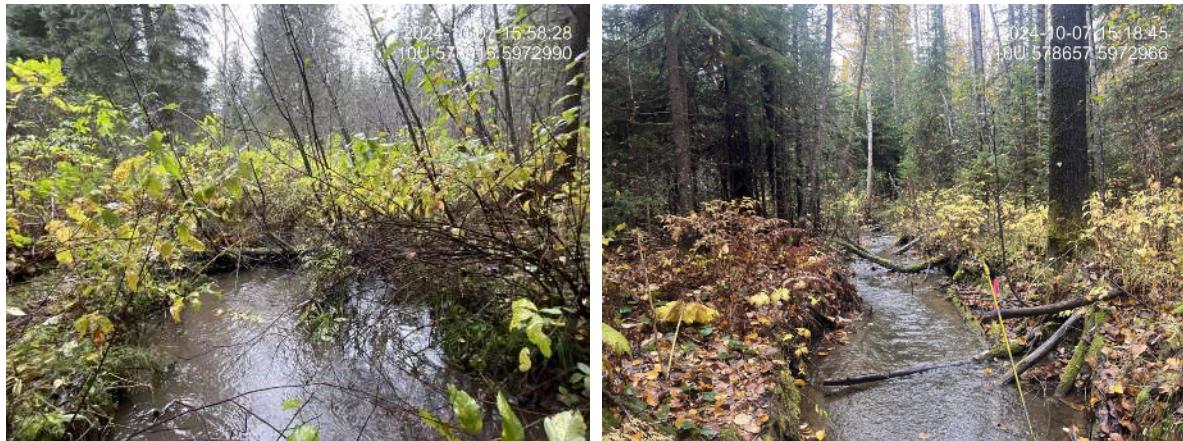
The stream was surveyed downstream from crossing 199255 for 270m (Figure 4.20). The habitat was rated as low value for spawning and rearing with no gravels or cobbles observed and the substrate consisting entirely of fine mud. Fish habitat was limited, with very few pools present. The first 130m of the stream was a beaver-affected area, with a beaver dam approximately 0.7m high located ~40m downstream of the culvert. The dam had flooded the surrounding forest, with no main channel observed. Occasional sections had a somewhat defined channel, but the majority of the surveyed area consisted of water flowing through a wet forest. The dominant substrate was fines with fines sub-dominant. The average channel width was 10.3m, the average wetted width was 7m, and the average gradient was 0.8%. Total cover amount was rated as moderate with overhanging vegetation dominant. Cover was also present as small woody debris, undercut banks, and instream vegetation..

The stream was surveyed upstream from crossing 199255 for 650m (Figure 4.20). The habitat was rated as medium value with good flow and abundant gravels suitable for bull trout and cutthroat trout spawning. Occasional shallow pools provided habitat for juvenile salmonid rearing. Banks were stable, with an intact mixed mature forest. The stream was small and had some short sections with gradients up to 5% but was primarily a low-gradient riffle-gravel system. The dominant substrate was gravels with cobbles sub-dominant. The average channel width was 3.4m, the average wetted width was 2.8m, and the average gradient was 2.8%. Total cover amount was rated as moderate with undercut banks dominant. Cover was also present as small woody debris, large woody debris, and overhanging vegetation.

Figure 4.20: Left: Typical habitat downstream of PSCIS crossing 199255. Right: Typical habitat upstream of PSCIS crossing 199255.

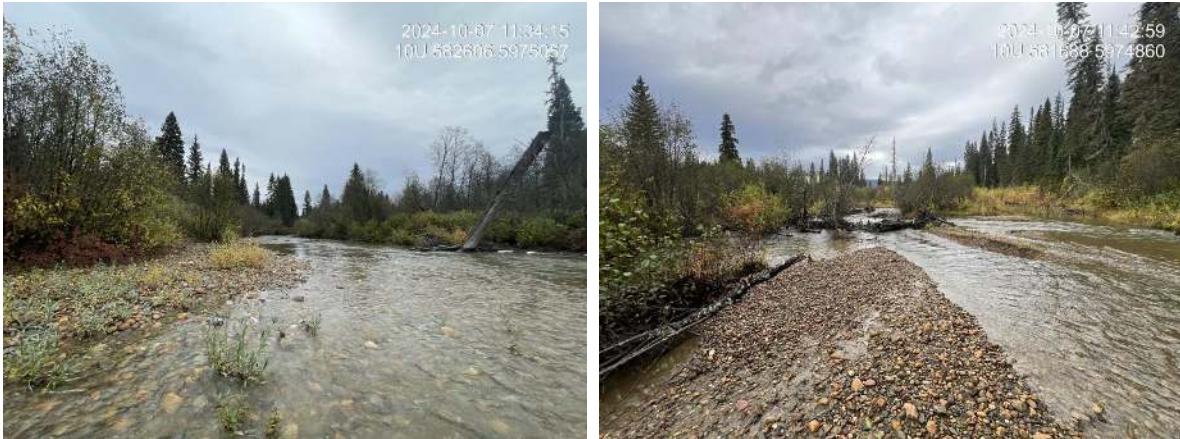
The stream was surveyed downstream from crossing 199256 for 370m (Figure 4.22). The habitat was rated as high value, with abundant spawning gravels and deep pools (>1m) formed by functional large woody debris, providing high-quality overwintering habitat for fish of all ages. Total cover amount was rated as abundant with large woody debris dominant. Cover was also present as small woody debris, deep pools, and overhanging vegetation. The dominant substrate was cobbles with gravels sub-dominant. The average channel width was 19m, the average wetted width was 16.1m, and the average gradient was 0.7%.

The stream was surveyed upstream from crossing 199256 for 950m (Figure 4.22). The habitat was rated as high value, with gravels suitable for chinook and resident salmonid spawning. The stream was large and gravel-dominated, with extensive deep runs, deep pools, large woody debris, and multiple channels throughout. The riparian area was intact throughout, consisting of a mix of shrub-dominated wetland areas and mature mixed forest. The dominant substrate was gravels with cobbles sub-dominant. The average channel width was 22.8m, the average wetted width was 16.7m, and the average gradient was 0.8%. Total cover amount was rated as moderate with deep pools dominant. Cover was also present as small woody debris, large woody debris, undercut banks, and overhanging vegetation.

Figure 4.22: Left: Typical habitat downstream of PSCIS crossing 199256. Right: Typical habitat upstream of PSCIS crossing 199256.

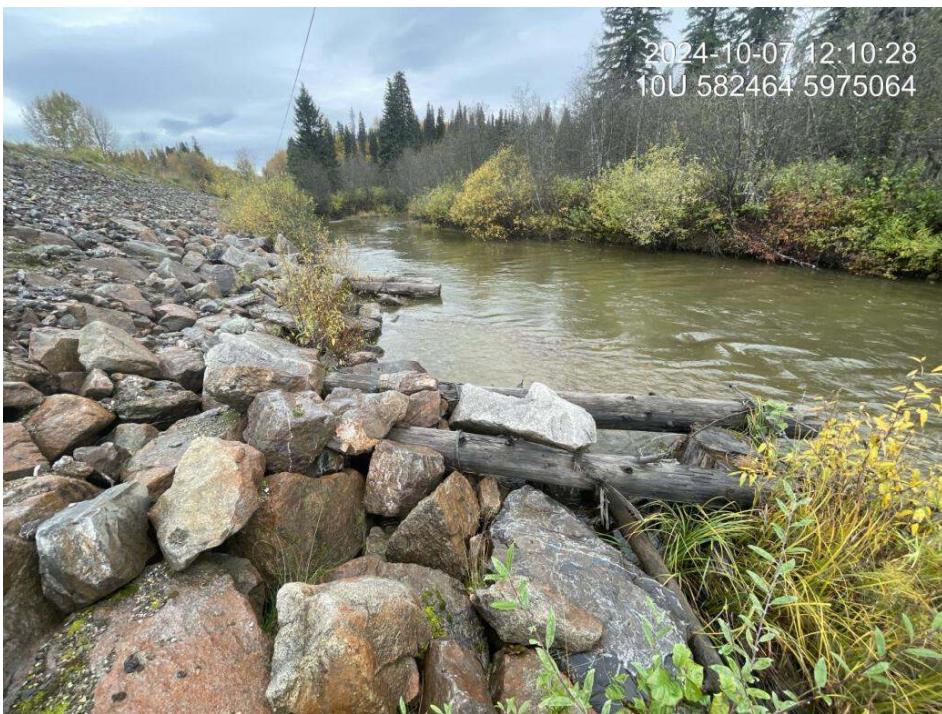
Figure 4.23: Ripwrapped banks and large wood structures secured with metal wiring located downstream of crossing 199256.

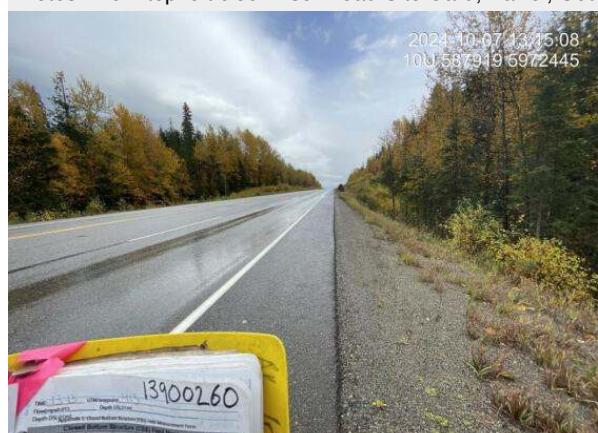
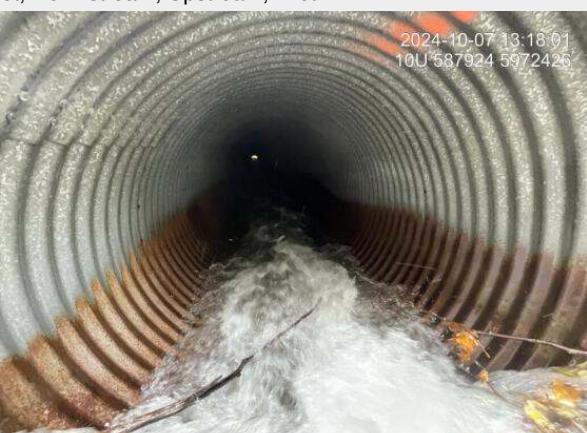
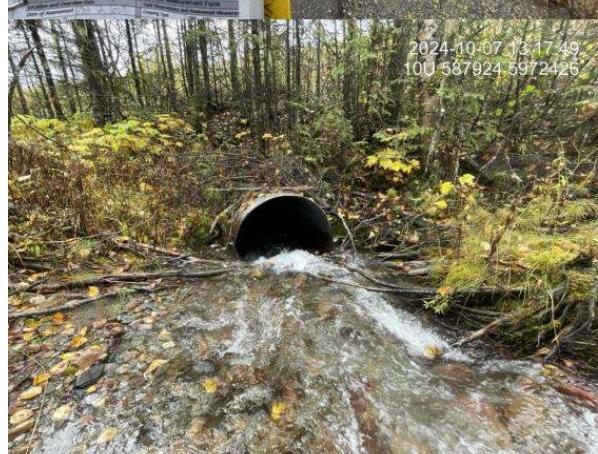
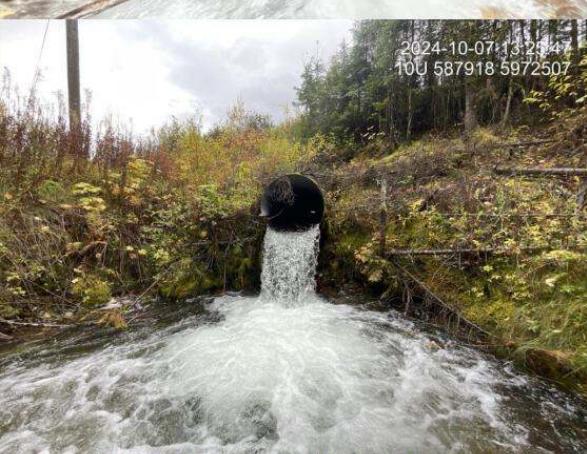
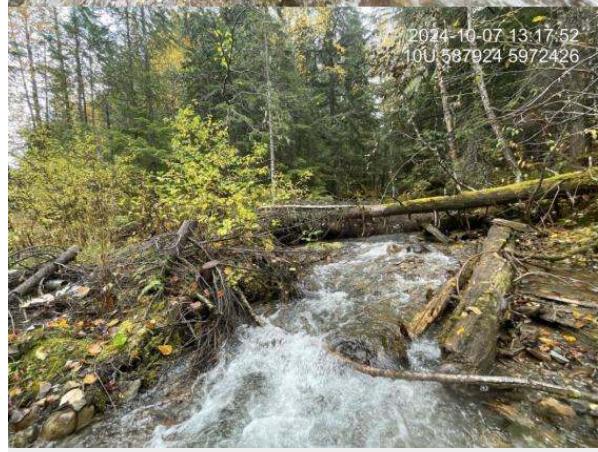
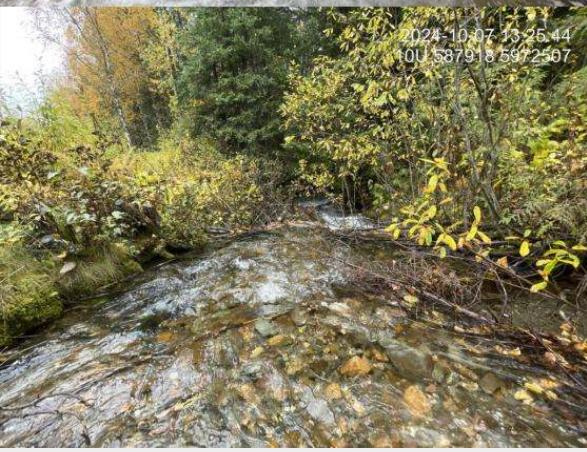
Tributary To Sugarbowl Creek - 19926...

Location and Stream Data	Crossing Characteristics
<p>Comments: The culvert had a significant 1.4m outlet drop, and inlet drop due to a small debris jam. The stream flowed through mature old-growth forest and provided high-quality habitat with steep gradients, step pools, and cascade pools, suggesting the potential presence of bull trout. The highway crossing had a large amount of road fill, making construction difficult and expensive. The site would be a good candidate for replacement if feasible. The riparian area at the outlet had been cleared due to overhead powerlines. MoTi chris_culvert_id: 1992815</p>	
<p>Photos: From top left clockwise: Road/Site Card, Barrel, Outlet, Downstream, Upstream, Inlet.</p>

Should restoration/maintenance activities proceed, replacement of the Highway 16 crossing (199260) with a bridge (33 m span) is recommended. At the time of reporting in 2025, the cost of the work is estimated at \$ 24,750,000.

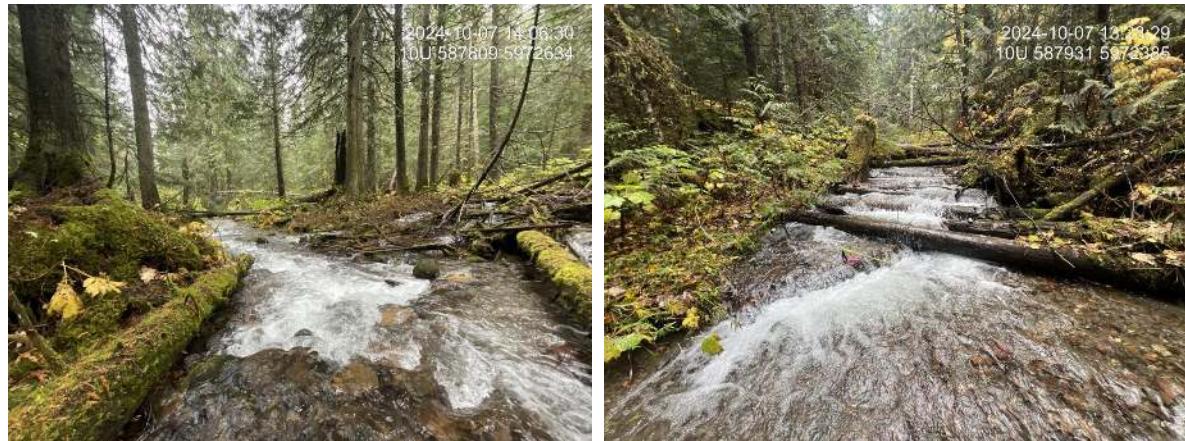
Figure 4.25: Left: Typical habitat downstream of PSCIS crossing 199260. Right: Typical habitat upstream of PSCIS crossing 199260.

The stream was surveyed downstream from crossing 199260 for 320m (Figure 4.25). The habitat was rated as high value, with gravels suitable for spawning and occasional pools ranging from 0.2–0.4m deep providing overwintering habitat. The stream flowed through a healthy, mature old-growth forest. The dominant substrate was cobbles with boulders sub-dominant. The average channel width was 7m, the average wetted width was 4.2m, and the average gradient was 5.3%. Total cover amount was rated as abundant with large woody debris dominant. Cover was also present as small woody debris and boulders.

The stream was surveyed upstream from crossing 199260 for 650m (Figure 4.25). The habitat was rated as medium value, and appeared suitable for large bull trout spawning and rearing. The stream was a larger, steeper system with intact, mature coniferous cedar-hemlock riparian cover, primarily stable banks, and abundant large woody debris throughout. A step-pool morphology was present, characterized by pools up to 80cm deep and debris jam steps ranging from 30–60cm. Total cover amount was rated as moderate with large woody debris dominant. Cover was also present as small woody debris, boulders, undercut banks, deep pools, and overhanging vegetation. The dominant substrate was cobbles with gravels sub-dominant. The average channel width was 6.1m, the average wetted width was 5.1m, and the average gradient was 7.1%.

PSCIS crossing 199260 had a substantial 1.4m outlet drop and is a high priority for replacement. Average gradients were generally above the maximum thresholds for chinook spawning and rearing (4.5% and 5.5%, respectively), but fell within the suitable range for bull trout spawning and rearing (5.5% and 10.5%, respectively). The habitat upstream was rated as medium value for bull trout spawning and rearing, with bcfishpass modeling indicating ~900m of potential bull trout rearing habitat upstream of the crossing. Given the crossings location within Sugarbowl-Grizzly Den Provincial Park and the park's ecological significance, restoration efforts could align with broader conservation initiatives and public engagement, increasing the likelihood of funding and project momentum.

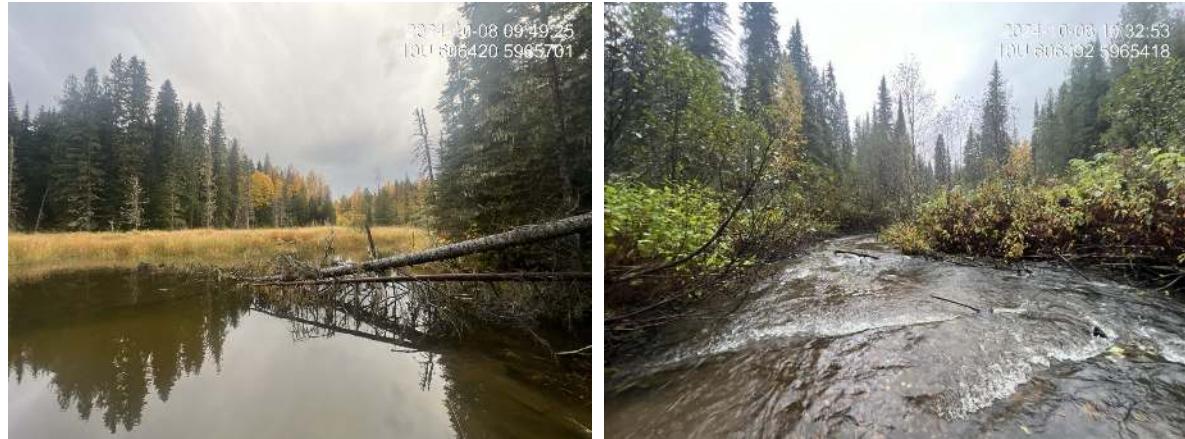
Figure 4.27: Left: Typical habitat upstream of PSCIS crossing 199267. Right: Typical habitat upstream of PSCIS crossing 199267.

The stream was surveyed upstream from crossing 199267 for 600m (Figure 4.27). The habitat was rated as high value for spawning and rearing. The stream was a low-gradient, gravel-dominated system with an extensive shrub-sedge wetland area and beaver activity in the lower 200m. Deep pools up to 1m were present throughout, influenced by abundant large woody debris contributed from the adjacent mature, primarily coniferous forest. Total cover amount was rated as moderate with large woody debris dominant. Cover was also present as small woody debris, undercut banks, deep pools, and overhanging vegetation.The dominant substrate was gravels with cobbles sub-dominant.The average channel width was 8.9m, the average wetted width was 8.7m, and the average gradient was 0.5%.

PSCIS crossing 199267 on Highway 16 had a significant 0.65m outlet drop and is a moderate priority for replacement. Downstream of Highway 16, chinook have historically spawned at the confluence of Driscoll Creek and the Fraser River (Salmon Watersheds Program 2025), indicating that this stream has provided valuable spawning habitat. Additionally, modelling from bcfishpass indicates there is ~7km of potential chinook spawning habitat available upstream of the crossing. The habitat upstream of Highway 16 was rated as moderate value for spawning and rearing during the 2024 assessment, and fish sampling is recommended to further assess whether the crossing is inhibiting fish passage. Given the crossing's proximity to Chun T'oh Whudujut (Ancient Forest) Provincial Park and its location within the traditional territory of the Lheidli T'enneh, restoration efforts could align with broader conservation initiatives and community engagement, increasing the likelihood of funding and project momentum.

Should restoration/maintenance activities proceed, replacement of the Highway 16 crossing (199267) with a bridge (15 m span) is recommended. At the time of reporting in 2025, the cost of the work is estimated at \$ 11,250,000.

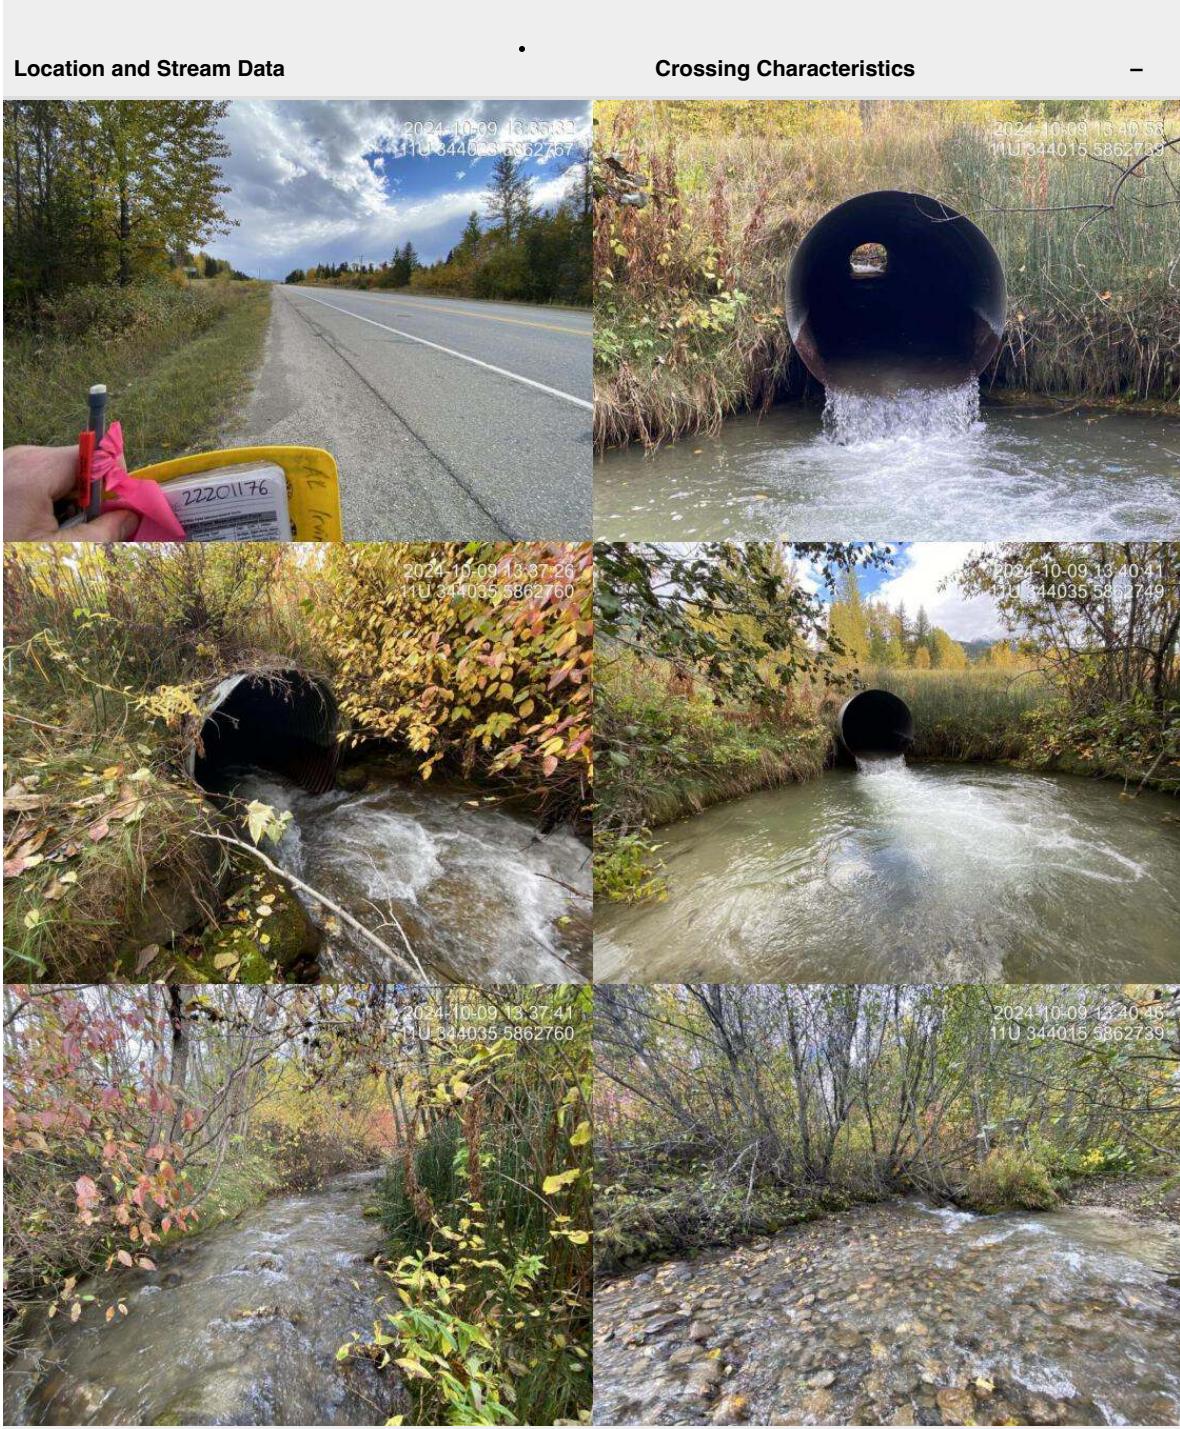
Location and Stream Data		Crossing Characteristics	
Date	2024-10-09	Crossing Sub Type	Round Culvert
PSCIS ID	199278	Diameter (m)	1.4
External ID	–	Length (m)	22
Crew	LS	Embedded	No
UTM Zone	11	Depth Embedded (m)	–
Easting	344031	Resemble Channel	No
Northing	5862744	Backwatered	No
Stream	Teepee Creek	Percent Backwatered	–
Road	Highway 5	Fill Depth (m)	0.7
Road Tenure	MOTI	Outlet Drop (m)	0.4
Channel Width (m)	7	Outlet Pool Depth (m)	1
Stream Slope (%)	2.5	Inlet Drop	No
Beaver Activity	No	Slope (%)	2
Habitat Value	High	Valley Fill	Deep Fill
Final score	34	Barrier Result	Barrier
Fix type	Replace with New Open Bottom Structure	Fix Span / Diameter	15

Comments: A moderate outlet drop was present and would be substantial at lower flows. Flow was steady at the time of assessment. The culvert was in good condition. A large, deep outlet pool indicated the culvert was likely undersized for the stream. Additionally, minimal road fill made this crossing a significant flood hazard, which could wash out Highway 5. Downstream, the stream had frequent pools 0.3-0.5m deep, providing good overwintering habitat for fish, and abundant gravels suitable for spawning. Roughly 150m downstream of the culvert, several cattle pens crossed the stream and appeared to be set up to provide cattle access for drinking. These areas were visibly trampled, with significant loss of riparian vegetation. Upstream, the stream was relatively confined, with only rare pockets of unembedded gravels. Deep pools were present, formed by boulder and large woody debris scour. A salmon point was noted near the pipeline location in FISS. Numerous small steps, ranging from 30-60cm, were present due to the steep, boulder-dominated nature of the stream. Electrofishing would be beneficial for further assessment. The site was a highway crossing, making replacement difficult. A small ford was located approximately 5m downstream of the culvert outlet. MoTi chris_culvert_id: 1467202

PSCIS crossing 199278 on Highway 5 had a moderate 0.4m outlet drop that could be substantial at lower flows. A large, deep outlet pool indicated the culvert was likely undersized for the stream, and minimal road fill made this crossing a significant flood hazard, which could wash out Highway 5. The crossing is a high priority for replacement. Further upstream, PSCIS crossing 203302 on the CN Railway had a significant 0.75m outlet drop, likely inhibiting fish passage. This crossing is a moderate priority for replacement.

Should restoration/maintenance activities proceed, replacement of the Highway 5 crossing (199278) with a bridge (15 m span) is recommended. At the time of reporting in 2025, the cost of the work is estimated at \$ 11,250,000.

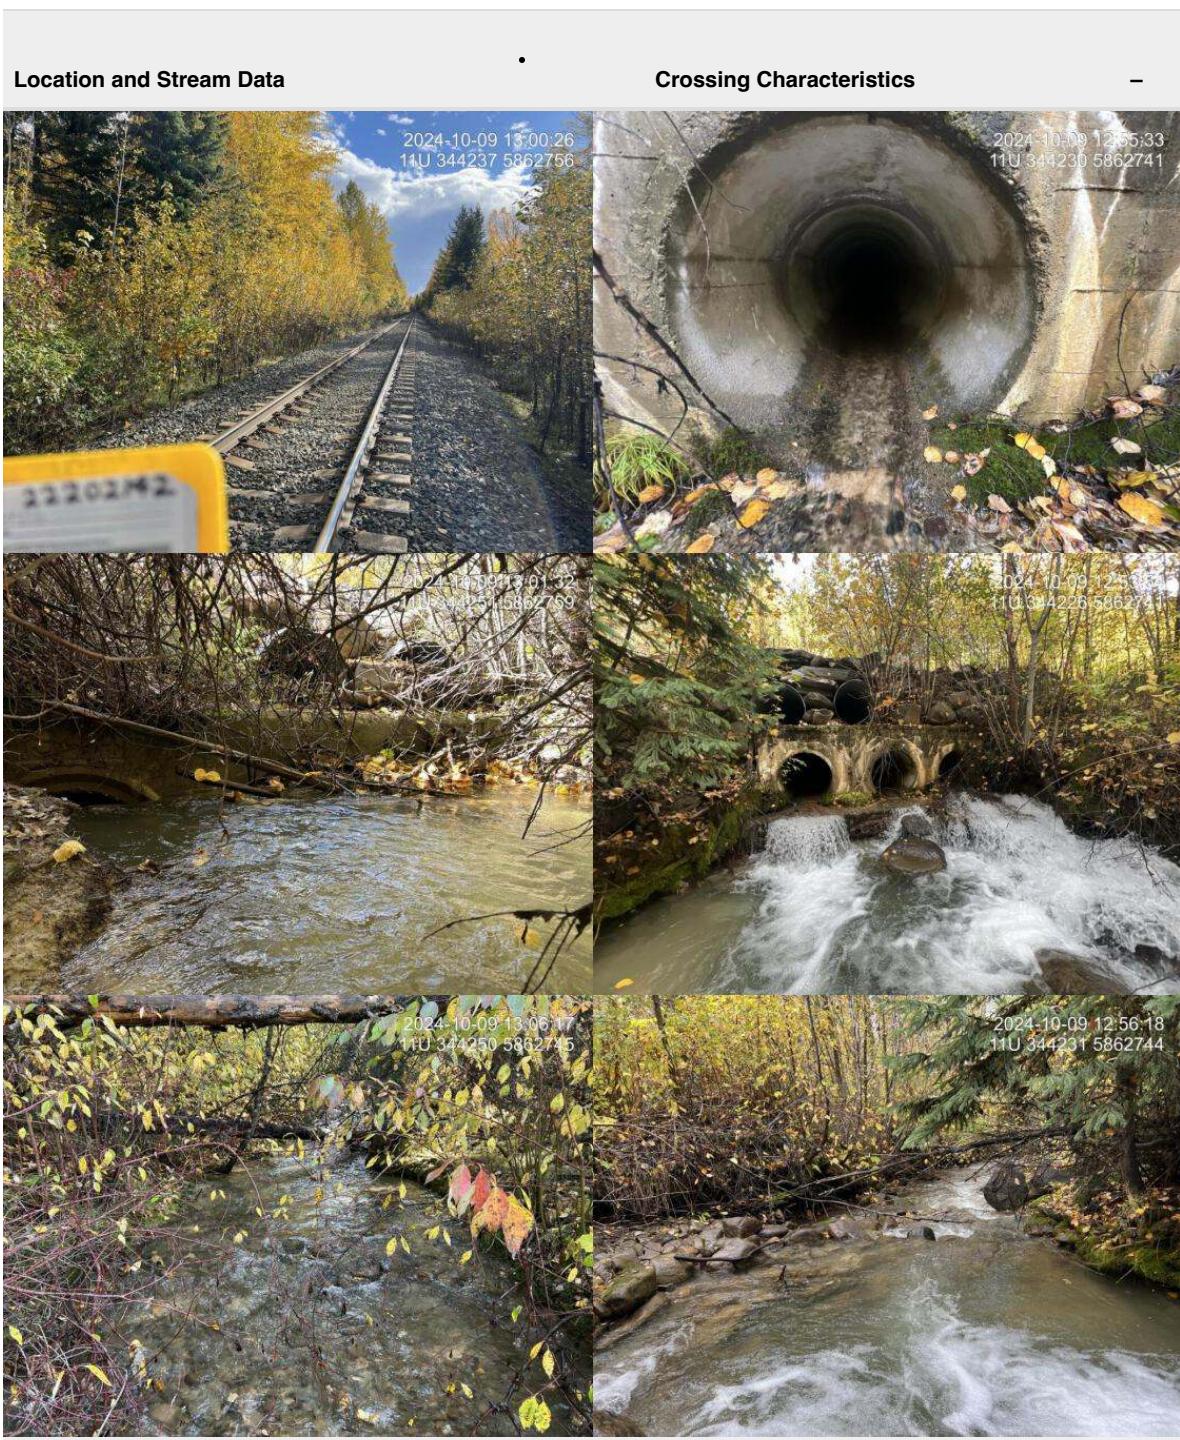
Location and Stream Data		Crossing Characteristics	
Date	2024-10-09	Crossing Sub Type	Round Culvert
PSCIS ID	203302	Diameter (m)	2.7
External ID	–	Length (m)	14
Crew	AI	Embedded	No
UTM Zone	11	Depth Embedded (m)	–
Easting	344222	Resemble Channel	No
Northing	5862742	Backwatered	No
Stream	Teepee Creek	Percent Backwatered	–
Road	Railway	Fill Depth (m)	2
Road Tenure	CN Rail	Outlet Drop (m)	0.75
Channel Width (m)	4.2	Outlet Pool Depth (m)	0.25
Stream Slope (%)	7	Inlet Drop	Yes
Beaver Activity	No	Slope (%)	6
Habitat Value	Medium	Valley Fill	Deep Fill
Final score	36	Barrier Result	Barrier
Fix type	Replace with New Open Bottom Structure	Fix Span / Diameter	15
Comments: Three concrete pipes, each 0.9m in diameter, were present, along with two 0.9m corrugated overflow pipes above. A stamp on the structure indicated it was built in 1944. All three concrete pipes were clogged at the inlet, ranging from 80% to 100% clogged with debris. This was a known fish-bearing stream, with a salmon point documented ~100m downstream in the FISS database. At this location, the stream was a mid-sized, steeper cobble-boulder step-pool system with only rare pockets of unembedded gravels. Deep pools were present, formed by boulder and large woody debris scour. Numerous small steps, ranging from 30-60cm, were present due to the steep, boulder-dominated nature of the stream. Downstream of the highway crossing, the stream had a lower gradient with frequent pools 0.3-0.5m deep, providing good overwintering habitat for fish and abundant gravels suitable for spawning.

Should restoration/maintenance activities proceed, replacement of the Railway crossing (203302) with a bridge (15 m span) is recommended. At the time of reporting in 2025, the cost of the work is estimated at \$ 11,250,000.

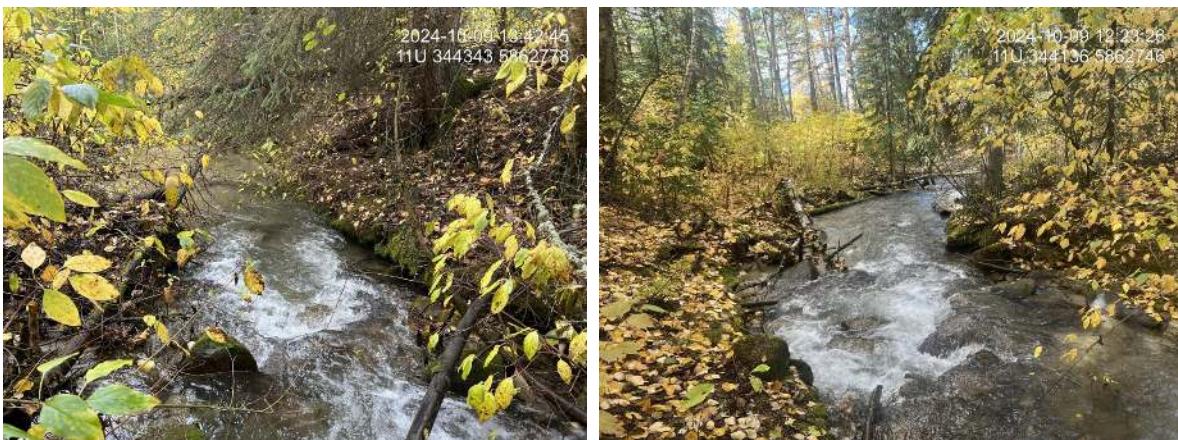
Figure 4.30: Left: Typical habitat upstream of PSCIS crossing 203302. Right: Typical habitat upstream of PSCIS crossing 199278 and downstream of PSCIS crossing 203302.

The stream was surveyed upstream from crossing 203302 for 600m (Figure 4.30). The habitat was rated as medium value for spawning and rearing, with few unembedded gravels; however, recent heavy rain caused slight turbidity making it difficult to assess the substrate. Total cover amount was rated as moderate with boulders dominant. Cover was also present as . The average channel width was 5.4m, the average wetted width was 3.9m, and the average gradient was 6.8%. The dominant substrate was cobbles with boulders sub-dominant. Approximately 100m before the end of the site, the stream showed signs of a large disturbance event that had incised the channel to a depth of 1.2–2m, with major areas of aggregation where the channel was widened and uniform.

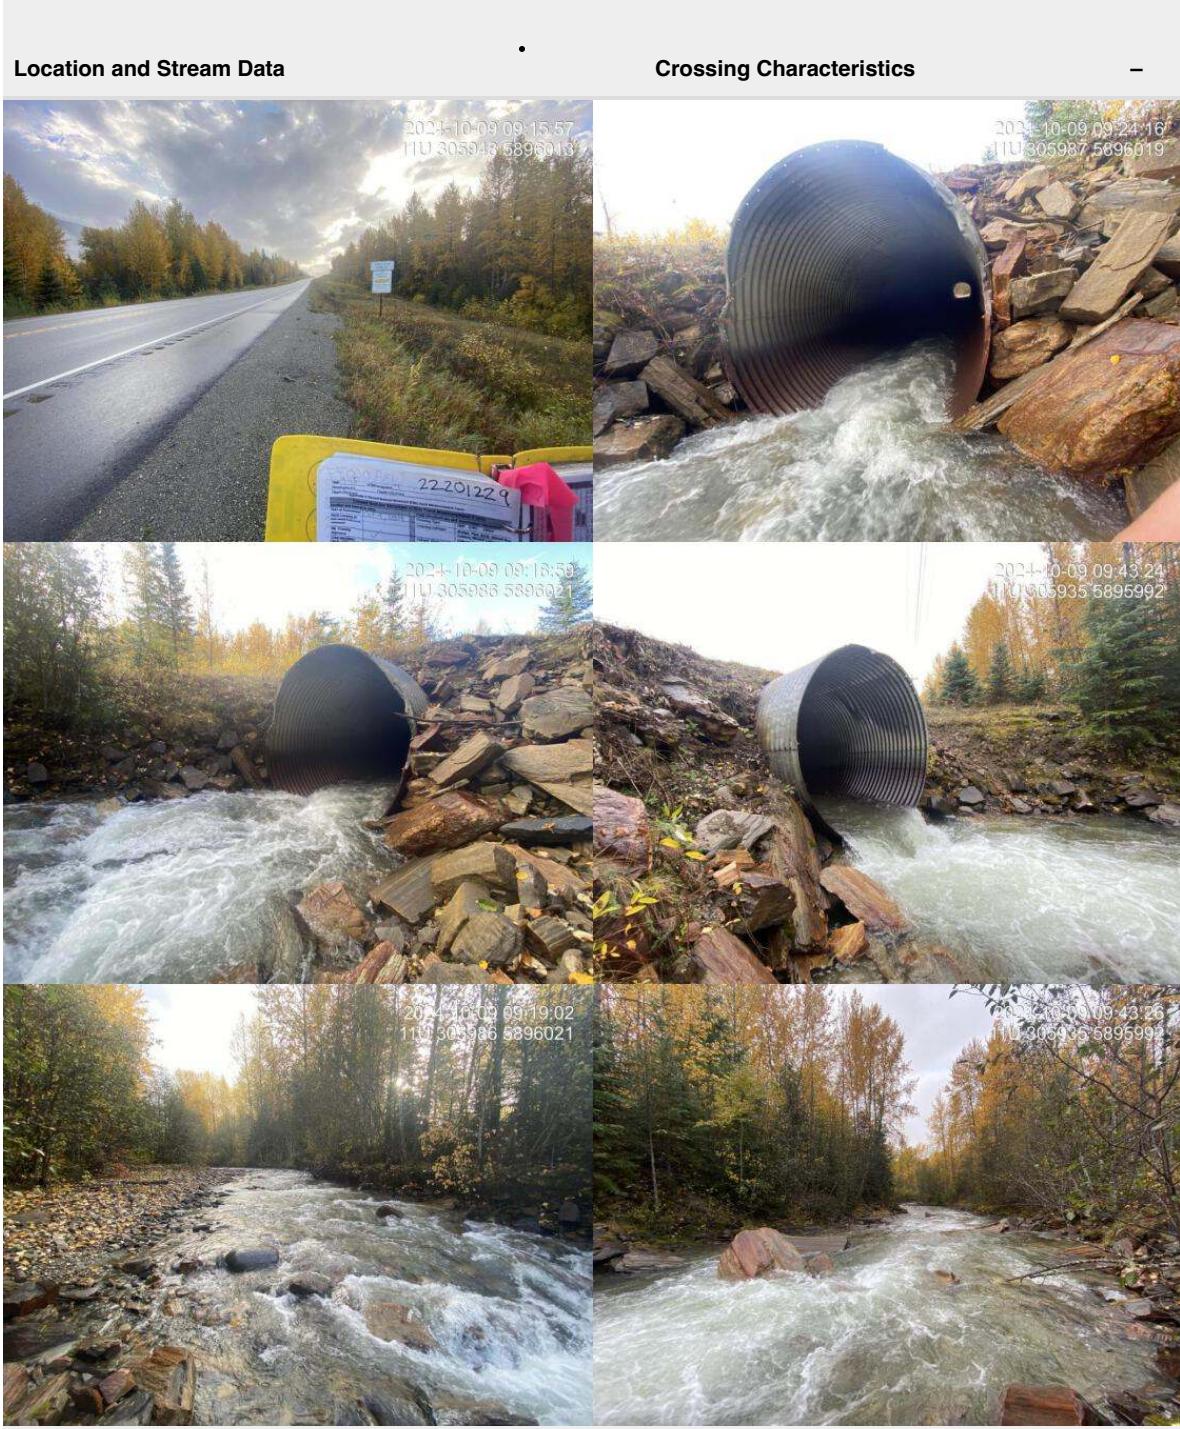
Location and Stream Data		Crossing Characteristics	
Date	2024-10-09	Crossing Sub Type	Round Culvert
PSCIS ID	199282	Diameter (m)	4
External ID	–	Length (m)	52
Crew	LS	Embedded	No
UTM Zone	11	Depth Embedded (m)	–
Easting	305946	Resemble Channel	No
Northing	5896010	Backwatered	No
Stream	Holliday Creek	Percent Backwatered	–
Road	Highway 16	Fill Depth (m)	2
Road Tenure	MOTI	Outlet Drop (m)	0.8
Channel Width (m)	16	Outlet Pool Depth (m)	0.5
Stream Slope (%)	3	Inlet Drop	No
Beaver Activity	No	Slope (%)	2
Habitat Value	High	Valley Fill	Deep Fill
Final score	37	Barrier Result	Barrier
Fix type	Replace with New Open Bottom Structure	Fix Span / Diameter	21
Comments: A significant outlet drop was present. Flow was high at the time of assessment, and at lower flows, the outlet drop would be even more substantial. Although the culvert was large, it was still likely undersized for the stream. The stream was a large glaciated system with a cobble-boulder substrate and an intact mixed riparian zone, primarily deciduous. Occasional large woody debris features created deep pool habitats and pockets of gravels were present suitable for spawning salmonids. A fish (~60mm) was observed during habitat confirmation. MoTi chris_hwy_structure_road_id: 29925

Should restoration/maintenance activities proceed, replacement of the Highway 16 crossing (PSCIS 199282) with a bridge (21 m span) is recommended. At the time of reporting in 2025, the cost of the work is estimated at \$ 15,750,000.

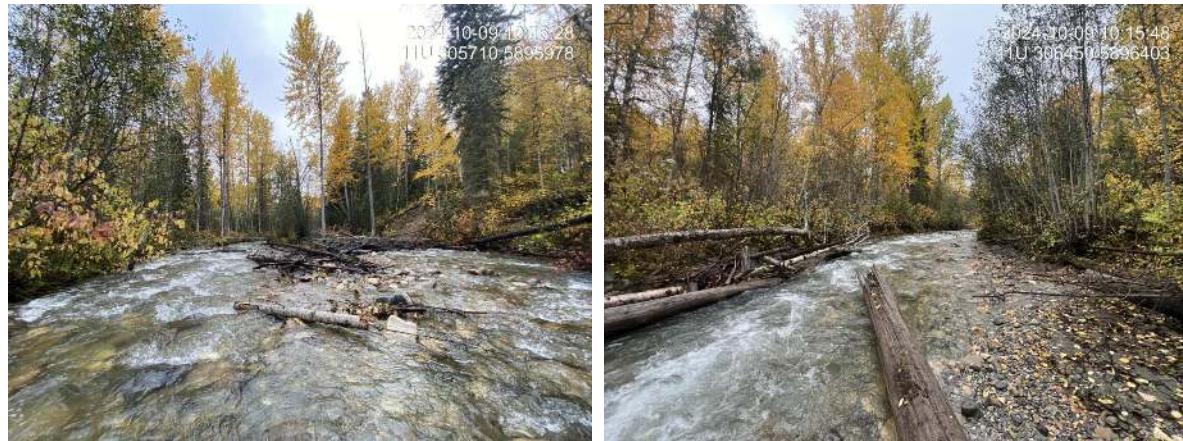
Figure 4.32: Left: Typical habitat downstream of PSCIS crossing 199282. Right: Typical habitat upstream of PSCIS crossing 199282.

The stream was surveyed downstream from crossing 199282 for 350m (Figure 4.32). The habitat was rated as high value with frequent gravels suitable for spawning and occasional pools available for overwintering. The dominant substrate was cobbles with boulders sub-dominant. The average channel width was 16m, the average wetted width was 9.3m, and the average gradient was 2.8%. Total cover amount was rated as abundant with large woody debris dominant. Cover was also present as boulders and undercut banks.

The stream was surveyed upstream from crossing 199282 for 800m (Figure 4.32). The habitat was rated as medium value for spawning and rearing. Occasional large woody debris features created deep pools, with pockets of gravels suitable for spawning. The dominant substrate was cobbles with boulders sub-dominant. Total cover amount was rated as moderate with boulders dominant. Cover was also present as . The average channel width was 11.8m, the average wetted width was 8.9m, and the average gradient was 2.5%.
