Restoring Fish Passage in the Fraser Region - 2023

**Prepared for
Ministry of Transportation and Infrastructure**

**Prepared by
Al Irvine, B.Sc., R.P.Bio. and Lucy Schick, B.Sc.
New Graph Environment Ltd.**

Version 0.0.1 2025-04-14

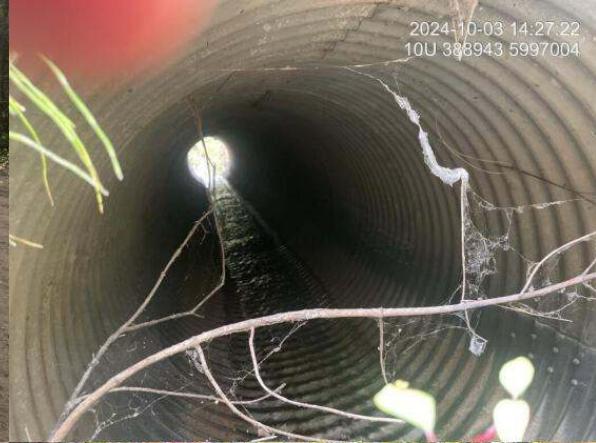
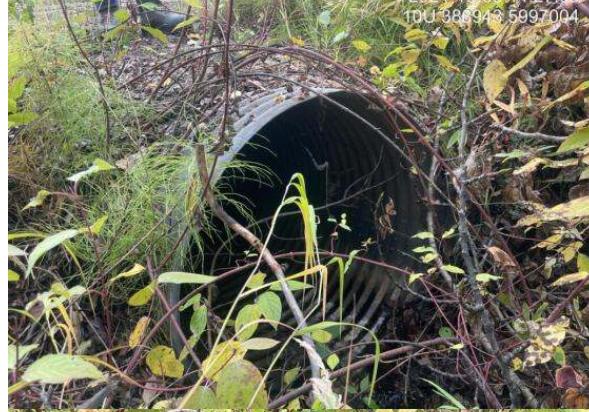
Location and Stream Data	Crossing Characteristics
<p>Comments: The local name of the stream is Burnt Cabin Creek. It had a large outlet drop and a heavily eroded outlet pool, indicating the culvert was undersized. The stream provided complex habitat for fish with abundant cover. The low-traffic dirt road had minimal road fill, making construction relatively straightforward.</p>	
<p>MoTi chris_culvert_id: 1790951</p>	
<p>Photos: From top left clockwise: Road/Site Card, Barrel, Outlet, Downstream, Upstream, Inlet.</p>

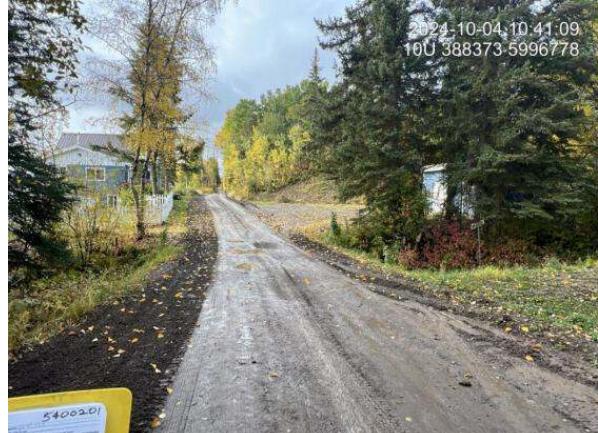
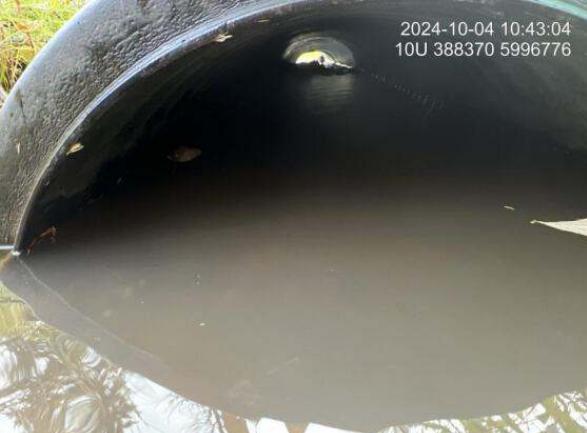
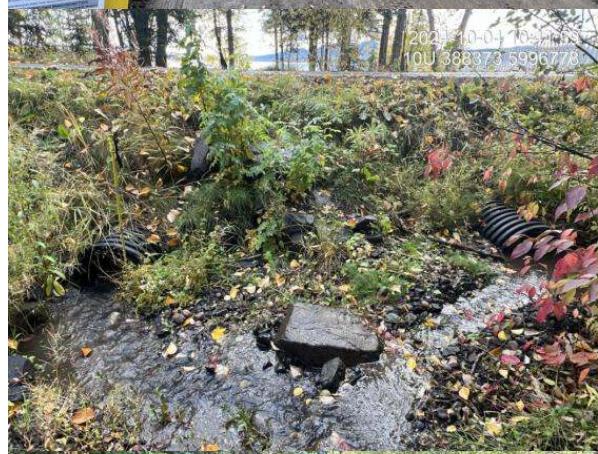
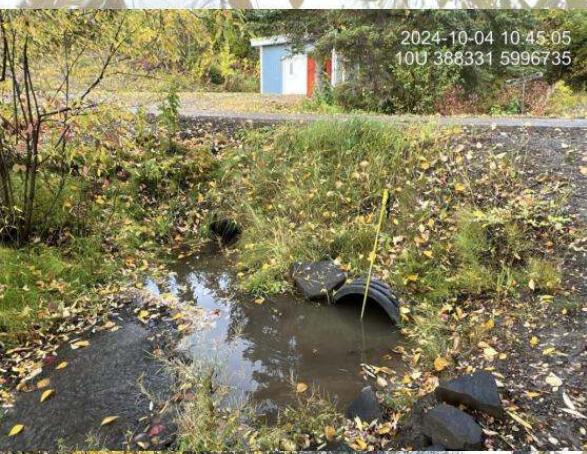
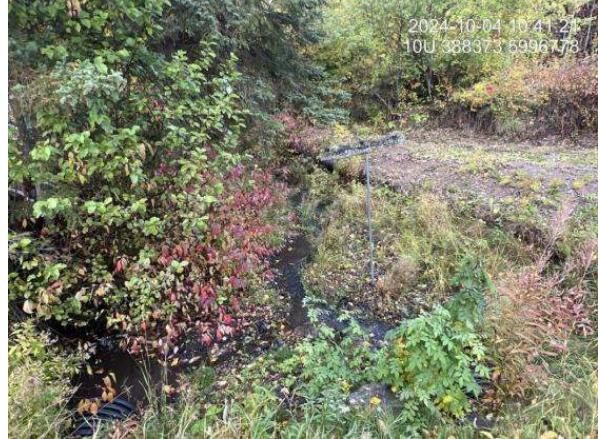
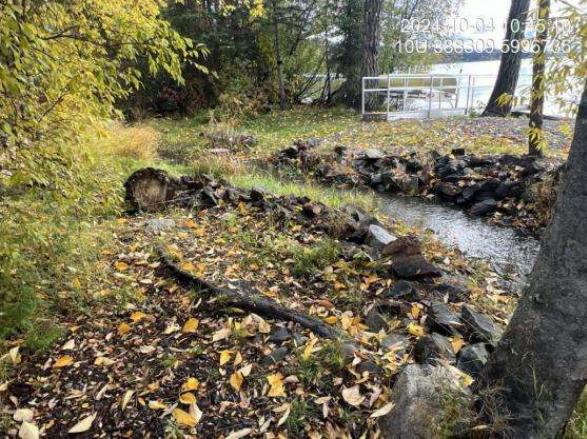
Location and Stream Data	Crossing Characteristics
<p>Comments: Two fully embedded PVC pipes, each 0.7m in diameter. One pipe was completely backwatered. Medium-value habitat was observed, with extensive gravels suitable for spawning upstream and downstream. A historic Chinook spawning point was recorded adjacent to the road. Habitat confirmations were conducted upstream, downstream, and above Stella Road. MoTi chris_culvert_id: 1790947</p>	
Photos: From top left clockwise: Road/Site Card, Barrel, Outlet, Downstream, Upstream, Inlet.

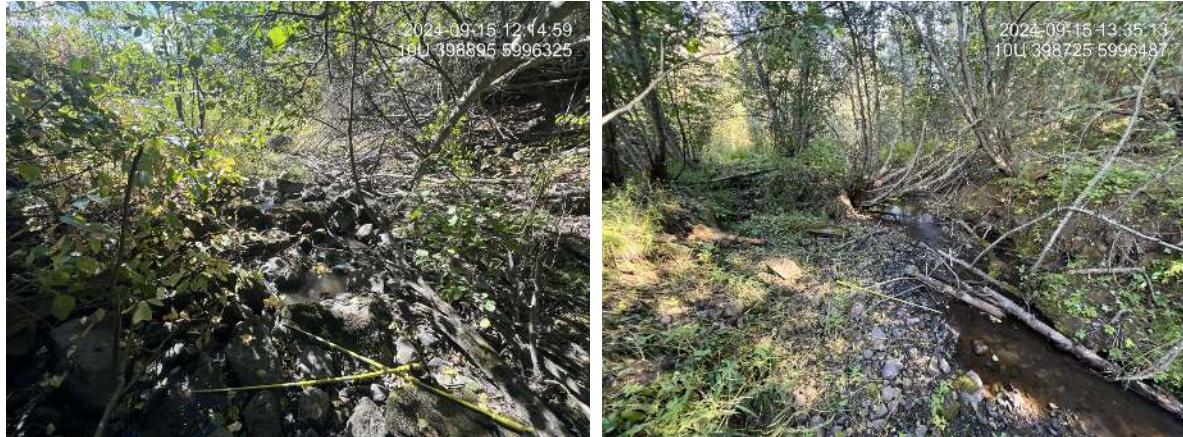
Figure 4.8: Left: Typical habitat downstream of PSCIS crossing 199173. Right: Typical habitat upstream of PSCIS crossing 199173.

The stream was surveyed downstream from crossing 199173 for 115m (Figure 4.8). The habitat was rated as medium value, with undercut banks suitable for juvenile chinook and rainbow trout rearing. No natural or man-made barriers were present between Dog Creek Road and the Nechako River. Fish (~40–90mm in length) were observed during the assessment. The average channel width was 3.5m, the average wetted width was 1.3m, and the average gradient was 6%. The dominant substrate was cobbles with fines sub-dominant. Total cover amount was rated as moderate with undercut banks dominant. Cover was also present as small woody debris and boulders.

The stream was surveyed upstream from crossing 199173 for 575m (Figure 4.8). The habitat was rated as medium with pockets of gravels suitable for rainbow trout and potentially chinook rearing, and fish were observed throughout the survey area. Heavy cattle impacts were evident, particularly in low-gradient sections with easily accessible banks. Fencing intended to restrict cattle access was present but had been breached. Approximately 300–350m upstream, the stream transitioned from a channelized section to a beaver-impounded wetland, with over three mature dams—some up to 1.5m high—vegetated and well-developed. These dams impounded large volumes of water, likely sustaining year-round stream flow downstream at the Dog Creek Road crossing. Total cover amount was rated as moderate with small woody debris dominant. Cover was also present as large woody debris, deep pools, and overhanging vegetation. The average channel width was 3m, the average wetted width was 1.5m, and the average gradient was 2.4%.

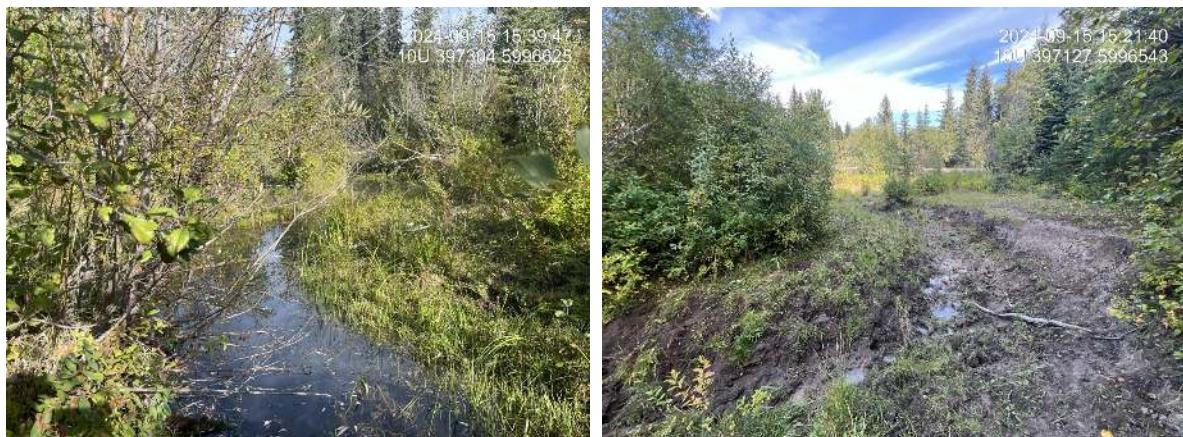
Figure 4.9: Left: Typical habitat downstream of PSCIS crossing 199174. Right: Typical habitat upstream of PSCIS crossing 199174.

The stream was surveyed downstream from crossing 199174 for 300m (Figure 4.9). The stream was intermittent for the first ~70m before transitioning into a beaver-impacted wetland area. Approximately 250m downstream of Sutherland FSR, several large, mature, consecutive beaver dams were present and appeared to continue as far as the area surveyed. Signs of cattle trampling were observed throughout the stream, and the channel frequently split into several smaller channels. The habitat was rated as medium value, with few gravels for spawning but abundant pools created by beaver dams. The average channel width was 2m, the average wetted width was 1m, and the average gradient was 1.2%. Total cover amount was rated as abundant with small woody debris dominant. Cover was also present as large woody debris, undercut banks, deep pools, and overhanging vegetation. The dominant substrate was fines with gravels sub-dominant.

The stream was surveyed upstream from crossing 199174 for 650m (Figure 4.9). The habitat was rated as medium value and had been heavily impacted by cattle, with evidence of bank trampling and extensive low-gradient muddy sections. Upstream of the culvert, the stream was primarily dry

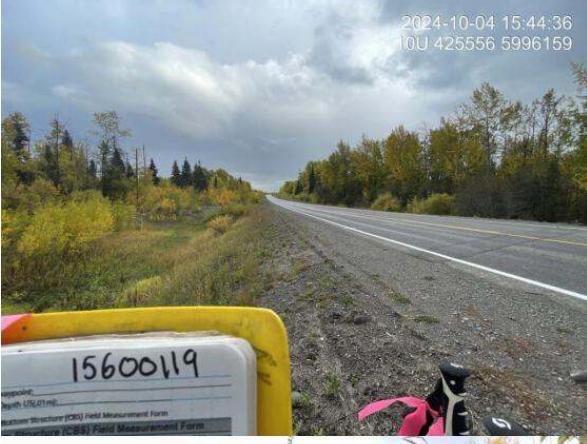
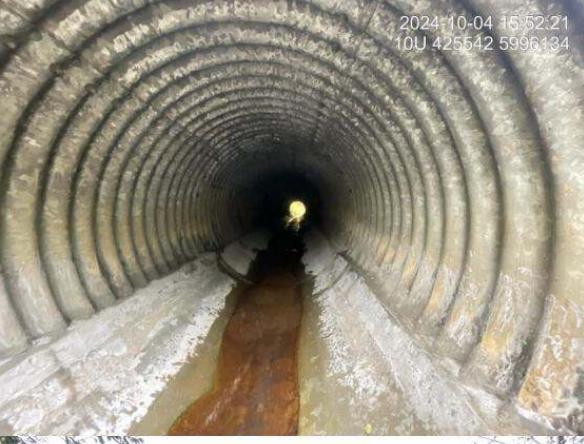
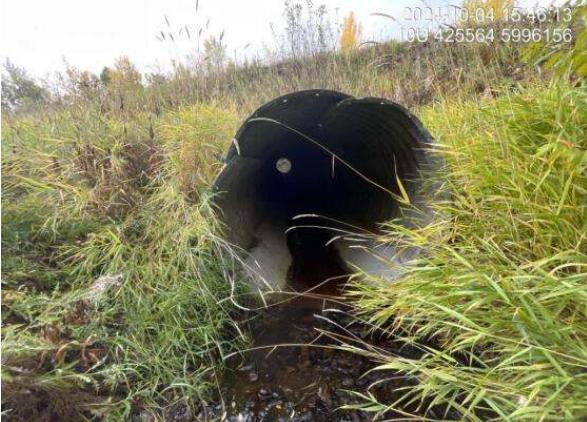
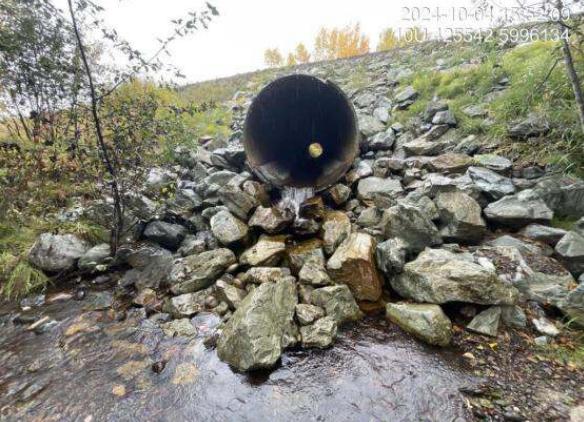
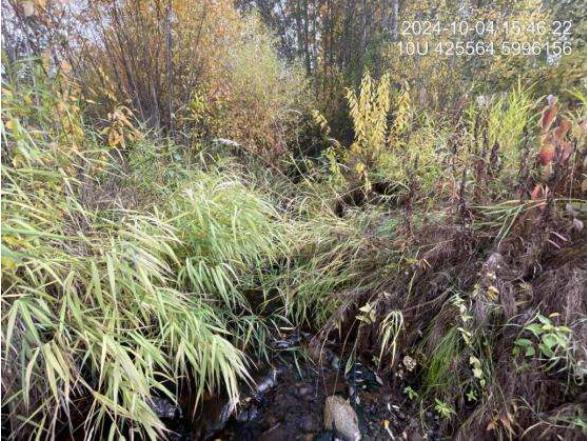
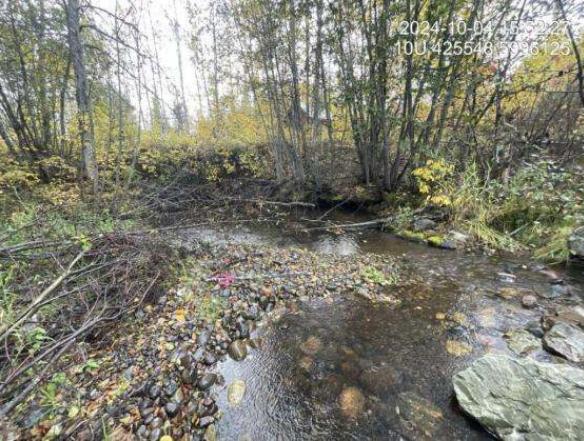
Location and Stream Data	Crossing Characteristics
Comments: The bottom of the culvert had been reinforced with concrete, likely to address holes noted in the previous assessment. A large pile of riprap was placed at the outlet, possibly to reduce the outlet drop, though its placement appeared unusual and could inhibit fish passage. The habitat was high quality, with a large pool just downstream of the culvert and abundant gravels suitable for spawning fish. MoTi chris_culvert_id: 1806163	-
Photos: From top left clockwise: Road/Site Card, Barrel, Outlet, Downstream, Upstream, Inlet.	-

Should restoration/maintenance activities proceed, replacement of the Highway 27 crossing (199190) with a bridge (15 m span) is recommended. At the time of reporting in 2025, the cost of the work is estimated at \$ 11,250,000.

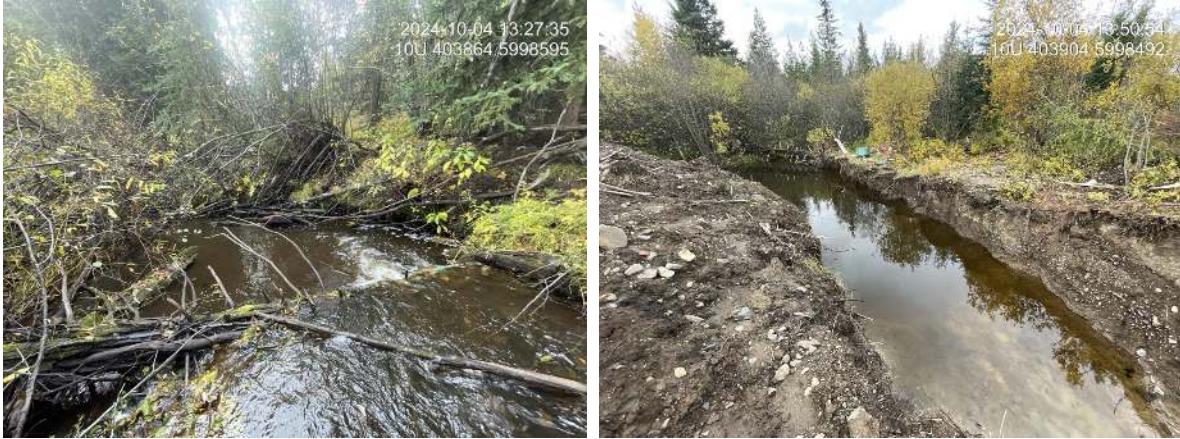
Figure 4.13: Left: Typical habitat downstream of PSCIS crossing 199204. Right: Large, artificially entrenched pool located ~300m downstream of PSCIS crossing 199204.

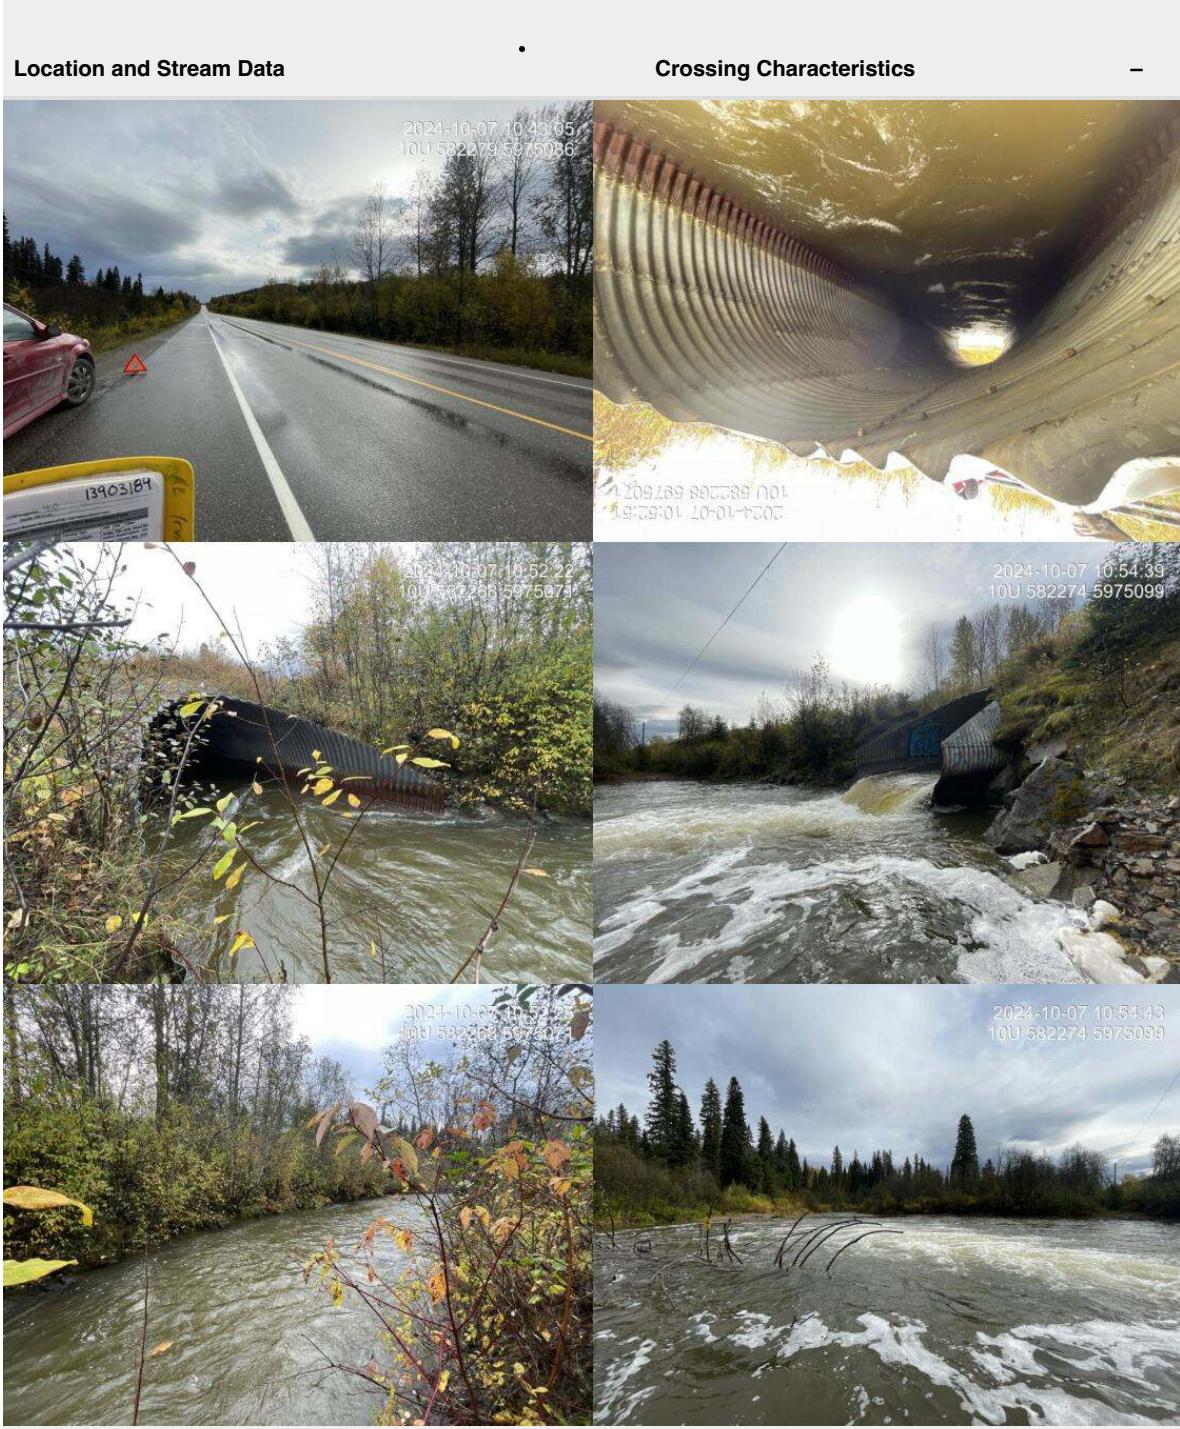
Stream Characteristics at Crossing 19...

modeling indicates nearly 50km of potential chinook spawning habitat upstream. The crossing is a moderate priority for replacement.

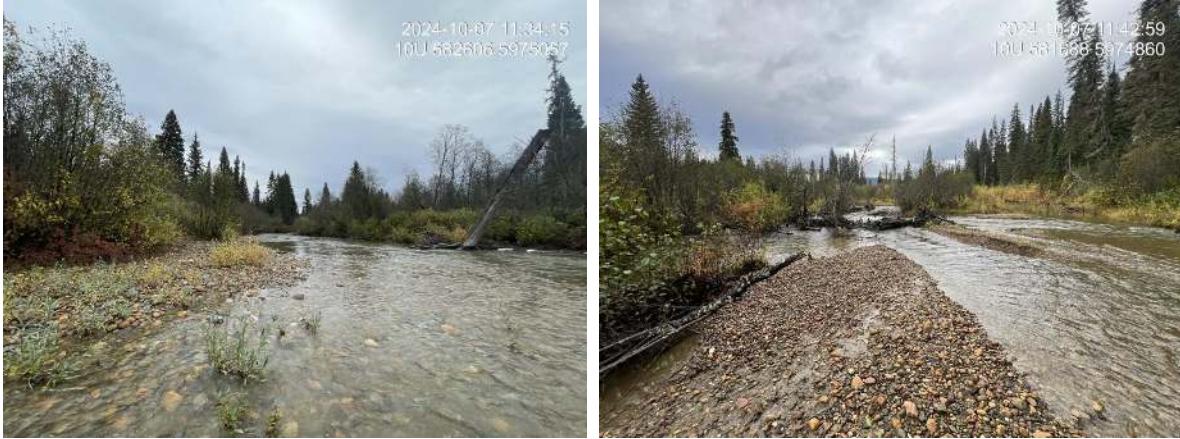
Figure 4.22: Left: Typical habitat downstream of PSCIS crossing 199256. Right: Typical habitat upstream of PSCIS crossing 199256.

The stream was surveyed downstream from crossing 199256 for 370m (Figure 4.22). The habitat was rated as high value, with abundant spawning gravels and deep pools (>1m) formed by functional large woody debris, providing high-quality overwintering habitat for fish of all ages. The dominant substrate was cobbles with gravels sub-dominant. Total cover amount was rated as abundant with large woody debris dominant. Cover was also present as small woody debris, deep pools, and overhanging vegetation. The average channel width was 19m, the average wetted width was 16.1m, and the average gradient was 0.7%.

Downstream of the culvert, the stream ran parallel to the highway, with banks reinforced by riprap. Large wood, secured with metal wiring, was placed to create habitat and reduce flow, arranged in three sets of two logs spaced approximately 5m apart (Figure 4.23). These structures were likely installed to mitigate habitat loss caused by the riprapped banks.

The stream was surveyed upstream from crossing 199256 for 950m (Figure 4.22). The habitat was rated as high value, with gravels suitable for chinook and resident salmonid spawning. The stream was large and gravel-dominated, with extensive deep runs, deep pools, large woody debris, and multiple channels throughout. The riparian area was intact throughout, consisting of a mix of shrub-dominated wetland areas and mature mixed forest. The average channel width was 22.8m, the average wetted width was 16.7m, and the average gradient was 0.8%. The dominant substrate was gravels with cobbles sub-dominant. Total cover amount was rated as moderate with deep pools dominant. Cover was also present as small woody debris, large woody debris, undercut banks, and overhanging vegetation.

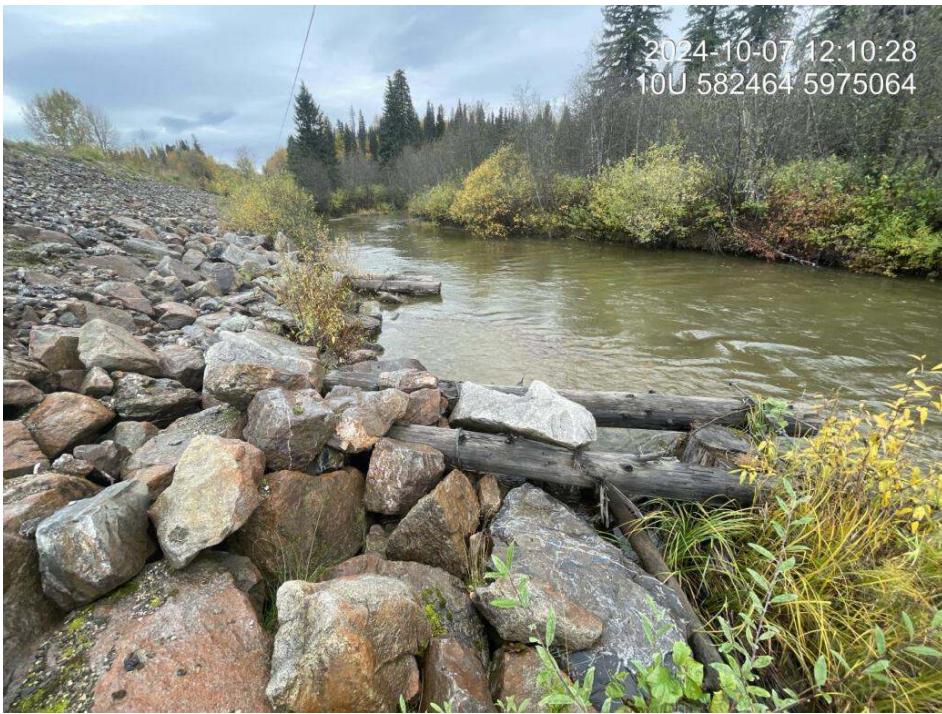
Figure 4.23: Ripwrapped banks and large wood structures secured with metal wiring located downstream of crossing 199256.

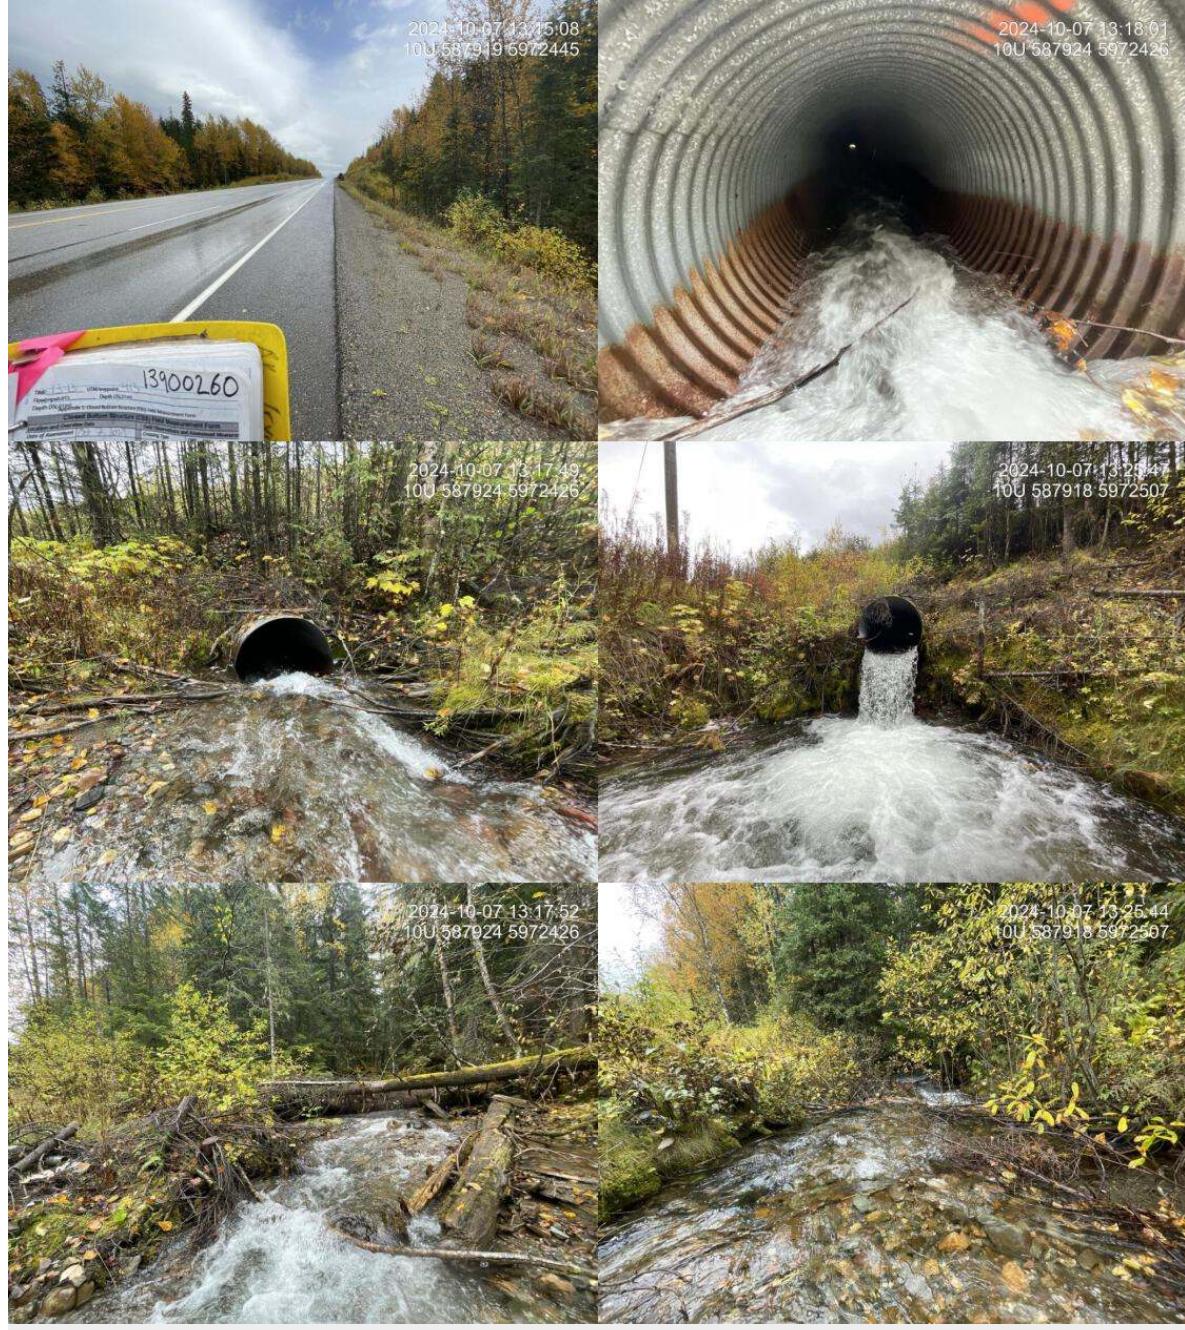
Tributary To Sugarbowl Creek - 19926...

Location and Stream Data	Crossing Characteristics
<p>Comments: The culvert had a significant 1.4m outlet drop, and inlet drop due to a small debris jam. The stream flowed through mature old-growth forest and provided high-quality habitat with steep gradients, step pools, and cascade pools, suggesting the potential presence of bull trout. The highway crossing had a large amount of road fill, making construction difficult and expensive. The site would be a good candidate for replacement if feasible. The riparian area at the outlet had been cleared due to overhead powerlines. MoTi chris_culvert_id: 1992815</p> <p>Photos: From top left clockwise: Road/Site Card, Barrel, Outlet, Downstream, Upstream, Inlet.</p>

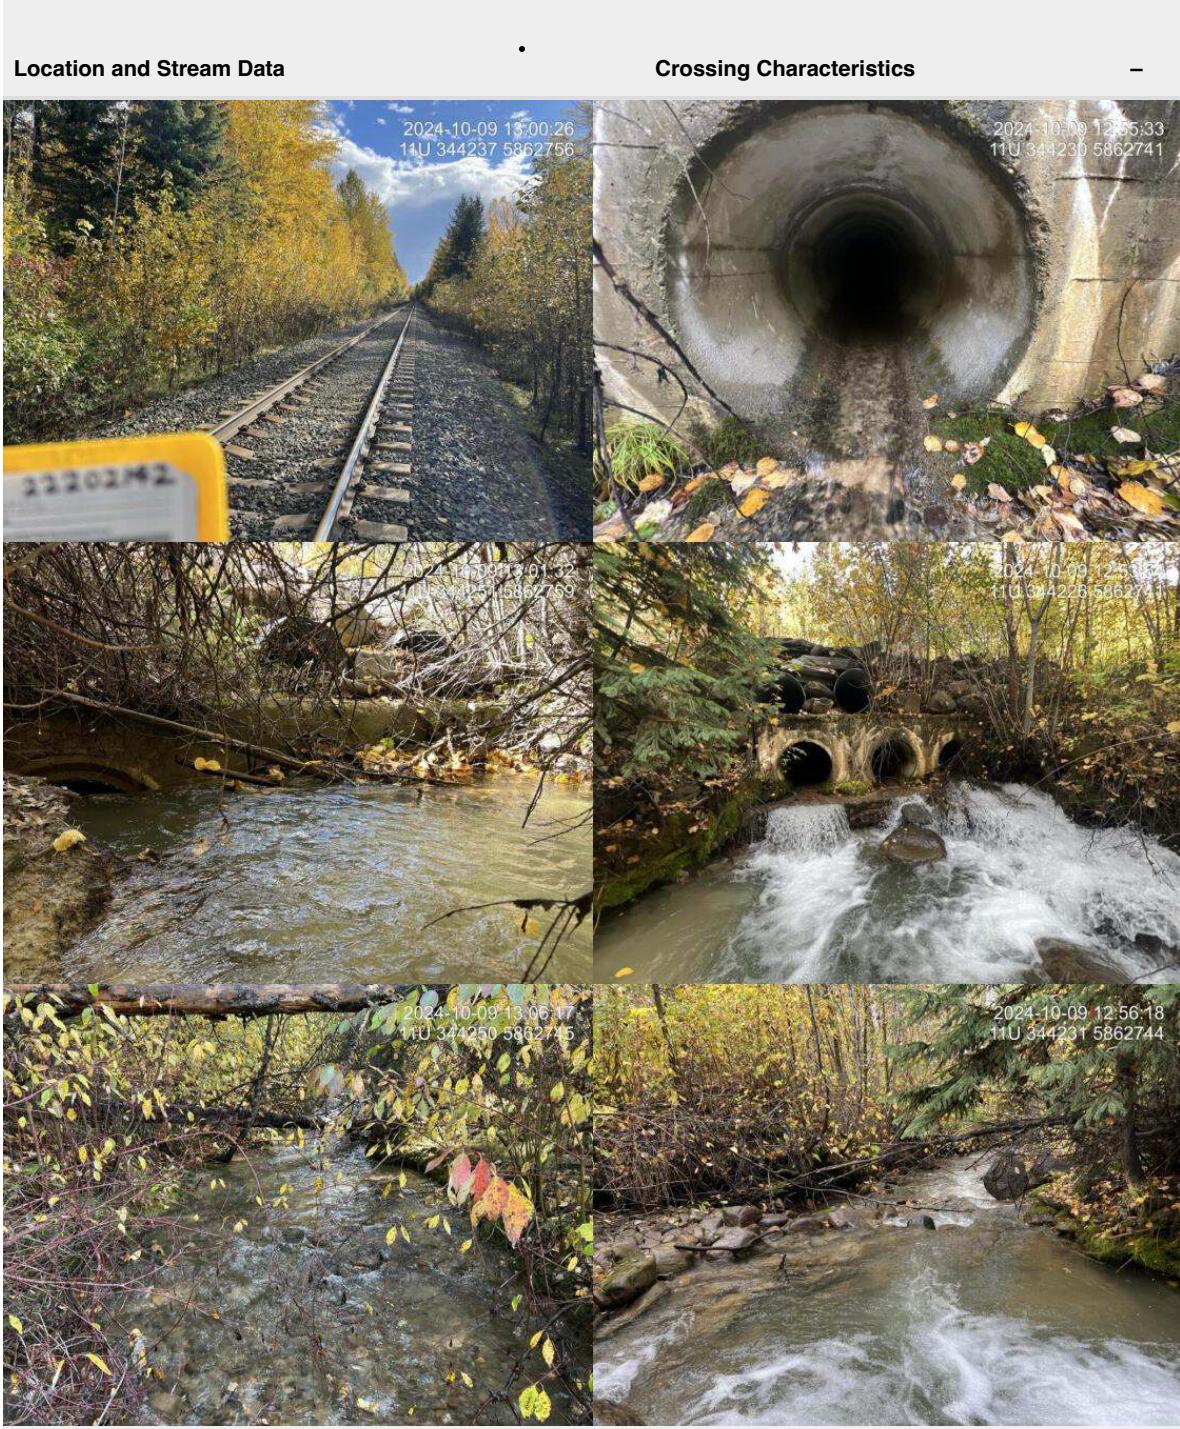
Location and Stream Data		Crossing Characteristics	
Date	2024-10-09	Crossing Sub Type	Round Culvert
PSCIS ID	203302	Diameter (m)	2.7
External ID	–	Length (m)	14
Crew	AI	Embedded	No
UTM Zone	11	Depth Embedded (m)	–
Easting	344222	Resemble Channel	No
Northing	5862742	Backwatered	No
Stream	Teepee Creek	Percent Backwatered	–
Road	Railway	Fill Depth (m)	2
Road Tenure	CN Rail	Outlet Drop (m)	0.75
Channel Width (m)	4.2	Outlet Pool Depth (m)	0.25
Stream Slope (%)	7	Inlet Drop	Yes
Beaver Activity	No	Slope (%)	6
Habitat Value	Medium	Valley Fill	Deep Fill
Final score	36	Barrier Result	Barrier
Fix type	Replace with New Open Bottom Structure	Fix Span / Diameter	15
Comments: Three concrete pipes, each 0.9m in diameter, were present, along with two 0.9m corrugated overflow pipes above. A stamp on the structure indicated it was built in 1944. All three concrete pipes were clogged at the inlet, ranging from 80% to 100% clogged with debris. This was a known fish-bearing stream, with a salmon point documented ~100m downstream in the FISS database. At this location, the stream was a mid-sized, steeper cobble-boulder step-pool system with only rare pockets of unembedded gravels. Deep pools were present, formed by boulder and large woody debris scour. Numerous small steps, ranging from 30-60cm, were present due to the steep, boulder-dominated nature of the stream. Downstream of the highway crossing, the stream had a lower gradient with frequent pools 0.3-0.5m deep, providing good overwintering habitat for fish and abundant gravels suitable for spawning.

Photos: From top left clockwise: Road/Site Card, Barrel, Outlet, Downstream, Upstream, Inlet.

Should restoration/maintenance activities proceed, replacement of the Railway crossing (203302) with a bridge (15 m span) is recommended. At the time of reporting in 2025, the cost of the work is estimated at \$ 11,250,000.

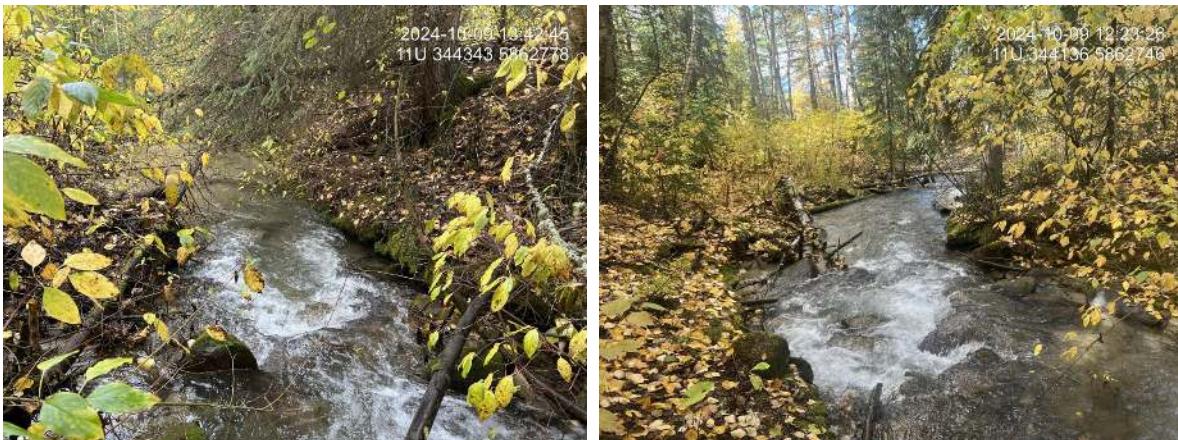
The stream was surveyed upstream from crossing 203302 for 600m (Figure 4.30). The habitat was rated as medium value for spawning and rearing, with few unembedded gravels; however, recent heavy rain caused slight turbidity making it difficult to assess the substrate. The average channel width was 5.4m, the average wetted width was 3.9m, and the average gradient was 6.8%.Total cover amount was rated as moderate with boulders dominant. Cover was also present as .The dominant substrate was cobbles with boulders sub-dominant. Approximately 100m before the end of the site, the stream showed signs of a large disturbance event that had incised the channel to a depth of 1.2–2m, with major areas of aggregation where the channel was widened and uniform.

Figure 4.30: Left: Typical habitat upstream of PSCIS crossing 203302. Right: Typical habitat upstream of PSCIS crossing 199278 and downstream of PSCIS crossing 203302.
