## **Restoring Fish Passage in the Fraser Region - 2023**

**Prepared for  
Ministry of Transportation and Infrastructure**

**Prepared by  
Al Irvine, B.Sc., R.P.Bio. and Lucy Schick, B.Sc.  
New Graph Environment Ltd.**

**Version 0.1.2 2025-07-14**

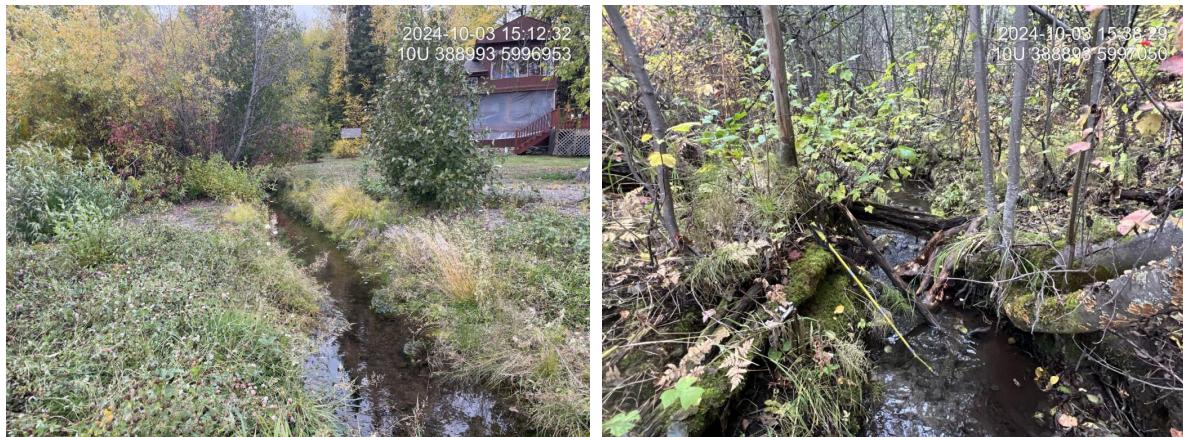
Figure 5.2: Left: Typical habitat downstream of PSCIS crossing 199171. Right: Typical habitat upstream of PSCIS crossing 199171 and downstream of PSCIS crossing 7622.

- Coordinate with the Ministry of Transportation to pursue funding for engineering designs at the following crossings:
  - PSCIS crossing 199171 on Burnt Cabin Creek along Gala Bay Road, in the Francois Lake watershed group.

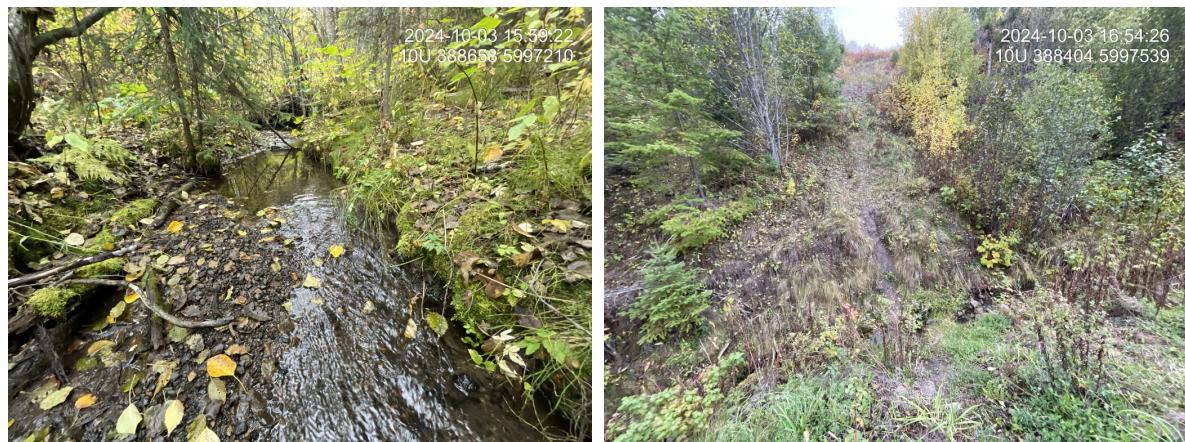
Figure 5.3: Left: Typical habitat upstream of PSCIS crossing 7622. Right: Bank erosion and riparian removal at the pipeline upstream of crossing 7622.

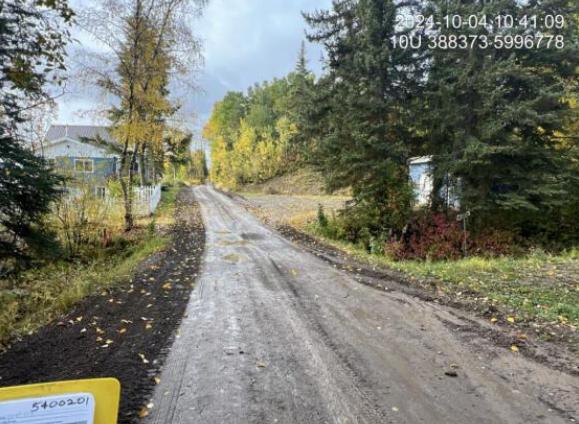
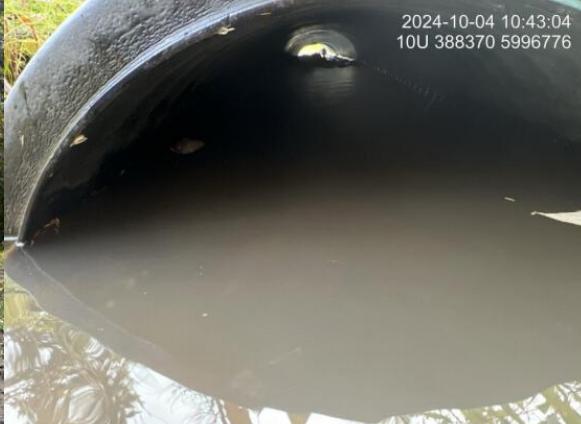
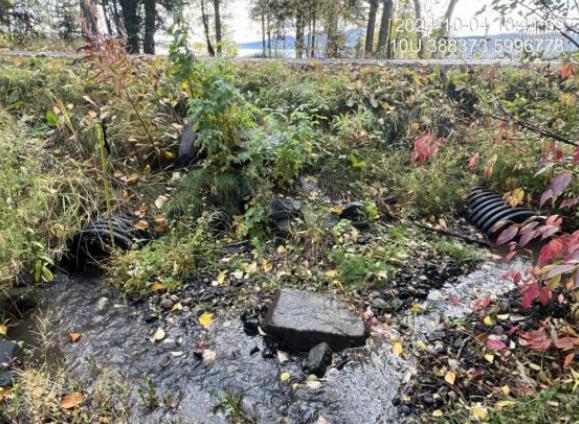
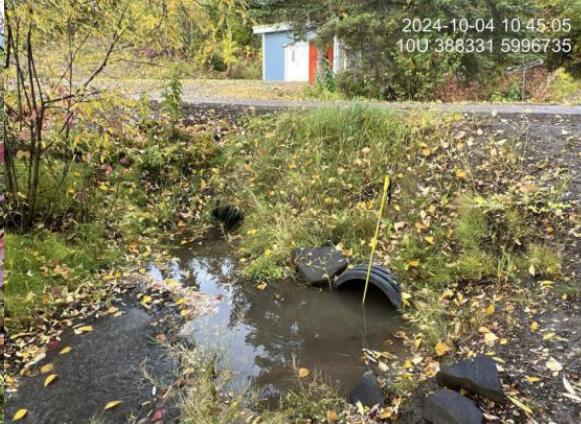
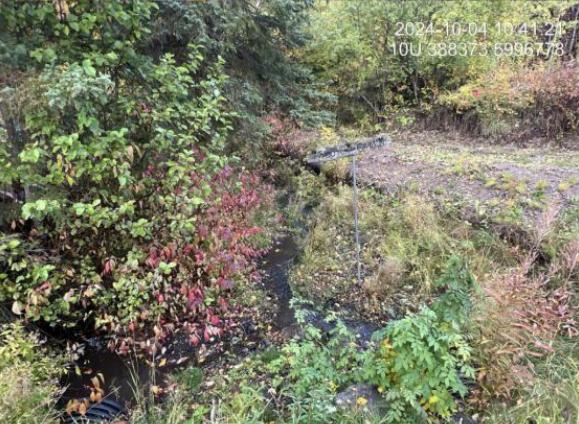
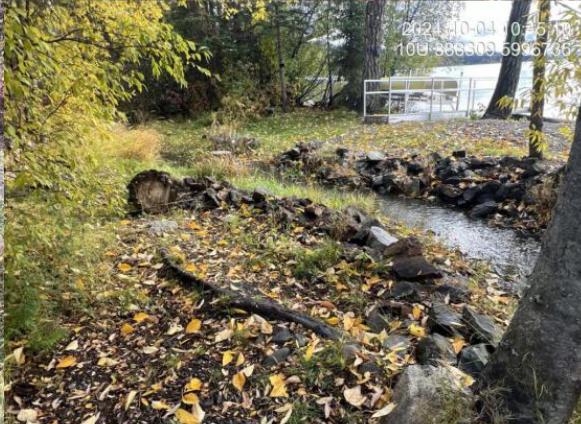
Location and Stream Data		Crossing Characteristics	
Date	2024-10-04	Crossing Sub Type	Round Culvert
PSCIS ID	199172	Diameter (m)	1.1
External ID	–	Length (m)	25
Crew	AI	Embedded	No
UTM Zone	10	Depth Embedded (m)	–
Easting	388269	Resemble Channel	No
Northing	5996948	Backwatered	No
Stream	Scotch Creek	Percent Backwatered	–
Road	Stella Road	Fill Depth (m)	4
Road Tenure	MoTi	Outlet Drop (m)	1.35
Channel Width (m)	2	Outlet Pool Depth (m)	0.28
Stream Slope (%)	0	Inlet Drop	No
Beaver Activity	No	Slope (%)	5
Habitat Value	Medium	Valley Fill	Deep Fill
Final score	39	Barrier Result	Barrier
Fix type	Replace with New Open Bottom Structure	Fix Span / Diameter	18

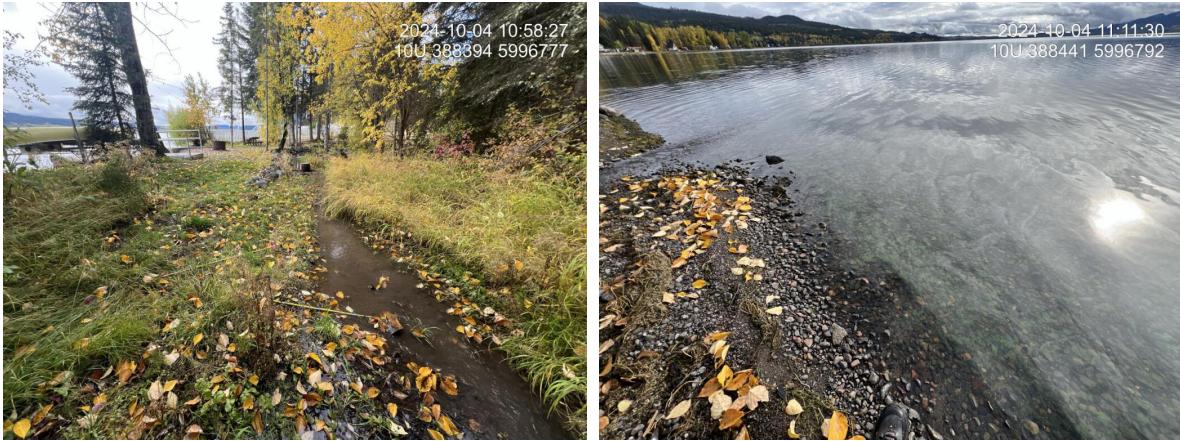
Figure 5.5: Left: Typical habitat downstream of PSCIS crossing 199328. Right: Algal bloom observed downstream of PSCIS crossing 199328 in Fraser Lake.

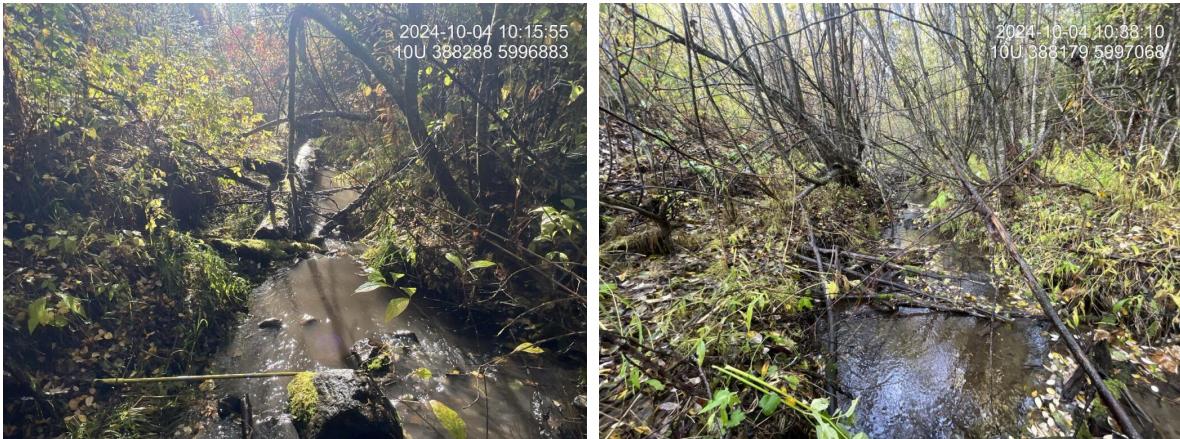
The stream was surveyed from Gala Bay Road upstream to Stella Road, a distance of approximately 270m (Figure 5.6) The habitat was rated as medium value, with limited pools; however, abundant overhanging vegetation and small woody debris provided cover, and gravels suitable for resident salmonid spawning were present. Incision was evident, beginning with a deep cut at the culvert outlet under Stella Road and continuing downstream to Gala Bay Road. The riparian area was generally intact through most of the survey, except for the downstream 75m, where private land development on the north side had resulted in a lawn and riparian vegetation removal up to the channel edge. The average channel width was 2.1m, the average wetted width was 1.3m, and the average gradient was 3%. Total cover amount was rated as moderate with overhanging vegetation dominant. Cover was also present as small woody debris and undercut banks. The dominant substrate was gravels with cobbles sub-dominant.

The stream was surveyed upstream from crossing 199172 for 550m (Figure 5.6). The habitat was rated as medium value, with abundant functional large woody debris creating pools 20 – 30cm deep, suitable for overwintering juvenile fish. Overhead cover was extensive, and occasional gravels were suitable for spawning. Approximately 400m upstream of Stella Road, the stream transitioned into a beaver-impounded area with four consecutive dams (1 – 1.5m high) impounding a large volume of water. Flow was maintained over or under the dams and the impounded area extended to the upper end of the surveyed area. A fish (~40mm) was observed after the second dam. The dominant substrate was gravels with fines sub-dominant. The average channel width was 2.6m, the average wetted width was 1.5m, and the average gradient was 4.3%. Total cover amount was rated as abundant with large woody debris dominant. Cover was also present as small woody debris, undercut banks, and overhanging vegetation.

Figure 5.6: Left: Typical habitat upstream of PSCIS crossing 199328 and downstream of PSCIS crossing 199172. Right: Typical habitat upstream of PSCIS crossing 199172.

Should restoration/maintenance activities proceed upstream, replacement of the Stella Road crossing (199172) with a bridge (18 m span) is recommended. This culvert had a 1.35m outlet drop, very likely inhibiting fish passage. At the time of reporting in 2025, the cost of the work is estimated at \$ 3,600,000.

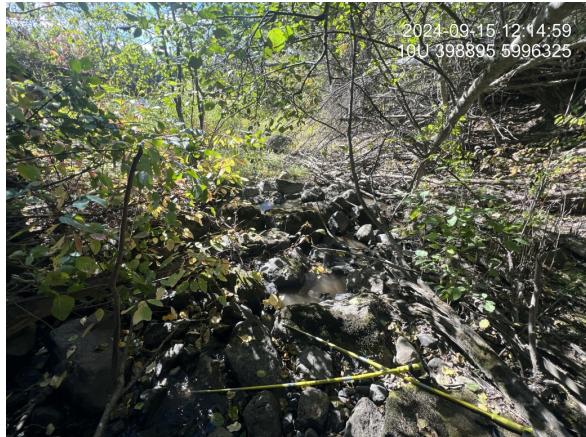
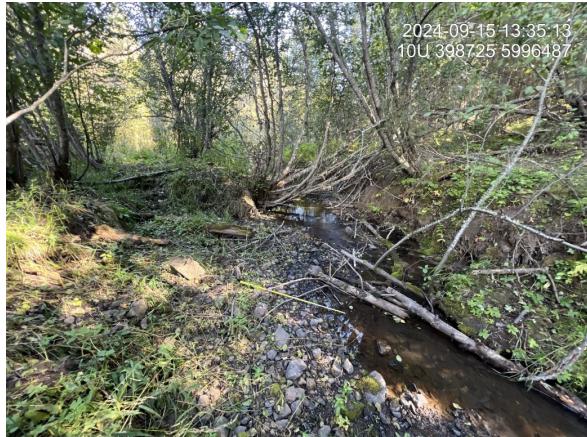
The stream was surveyed downstream from crossing 199173 for 115m (Figure 5.8). The habitat was rated as medium value, with undercut banks suitable for juvenile chinook and rainbow trout

rearing. No natural or man-made barriers were present between Dog Creek Road and the Nechako River. Fish (~40 – 90mm in length) were observed during the assessment. The dominant substrate was cobbles with fines sub-dominant. Total cover amount was rated as moderate with undercut banks dominant. Cover was also present as small woody debris and boulders. The average channel width was 3.5m, the average wetted width was 1.3m, and the average gradient was 6%.

The stream was surveyed upstream from crossing 199173 for 575m (Figure 5.8). The habitat was rated as medium with pockets of gravels suitable for rainbow trout and potentially chinook rearing, and fish were observed throughout the survey area. Heavy cattle impacts were evident, particularly in low-gradient sections with easily accessible banks. Fencing intended to restrict cattle access was present but had been breached. Approximately 300–350m upstream, the stream transitioned from a channelized section to a beaver-impounded wetland, with over three mature dams — some up to 1.5m high — vegetated and well-developed. These dams impounded large volumes of water, likely sustaining year-round stream flow downstream at the Dog Creek Road crossing. Total cover amount was rated as moderate with small woody debris dominant. Cover was also present as large woody debris, deep pools, and overhanging vegetation. The average channel width was 3m, the average wetted width was 1.5m, and the average gradient was 2.4%.

Figure 5.8: Left: Typical habitat downstream of PSCIS crossing 199173. Right: Typical habitat upstream of PSCIS crossing 199173.

Should restoration/maintenance activities proceed, replacement of the Dog Creek Road crossing (199173) with a bridge (15 m span) is recommended. At the time of reporting in 2025, the cost of the work is estimated at \$ 1,500,000.

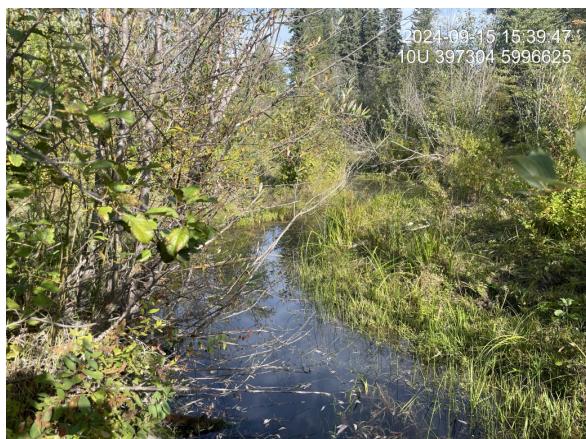
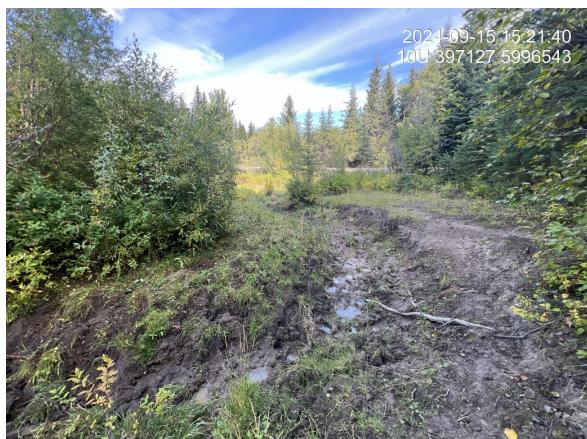
The stream was surveyed downstream from crossing 199174 for 300m (Figure 5.9). The stream was intermittent for the first ~70m before transitioning into a beaver-impacted wetland area.

Approximately 250m downstream of Sutherland FSR, several large, mature, consecutive beaver dams were present and appeared to continue as far as the area surveyed. Signs of cattle trampling were observed throughout the stream, and the channel frequently split into several smaller channels. The habitat was rated as medium value, with few gravels for spawning but abundant pools created by beaver dams. The average channel width was 2m, the average wetted width was 1m, and the average gradient was 1.2%. Total cover amount was rated as abundant with small woody debris dominant. Cover was also present as large woody debris, undercut banks, deep pools, and overhanging vegetation. The dominant substrate was fines with gravels sub-dominant.

The stream was surveyed upstream from crossing 199174 for 650m (Figure 5.9). The habitat was rated as medium value and had been heavily impacted by cattle, with evidence of bank trampling and extensive low-gradient muddy sections. Upstream of the culvert, the stream was primarily dry for the first 300m, with young forest and shrub riparian. At this point, intermittent pools began to appear, associated with beaver activity. At approximately 450 – 500m upstream, the stream became almost entirely watered, with pools up to 40cm deep. Many surveyed areas resembled wetland habitat, with spirea, willow, alder, and trembling aspen throughout. The average channel width was 2.5m, the average wetted width was 0.9m, and the average gradient was 1.2%. The dominant substrate was fines with gravels sub-dominant. Total cover amount was rated as moderate with

Figure 5.9: Left: Typical habitat downstream of PSCIS crossing 199174. Right: Typical habitat upstream of PSCIS crossing 199174.

At the time of assessment, the upstream crossing on Sutherland FSR was unlikely a barrier to fish passage, and restoration efforts should prioritize the downstream crossing on Dog Creek Road. However, should restoration activities proceed at crossing 199174, replacement with a bridge spanning 15 m is recommended. At the time of reporting in 2025, the estimated cost for the replacement is \$ 450,000.

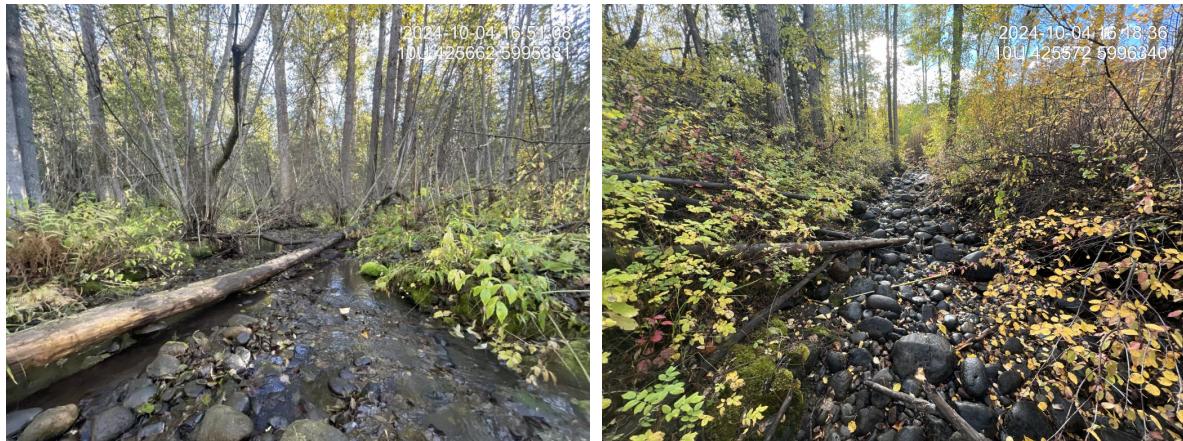
Figure 5.11: Left: Typical habitat downstream of PSCIS crossing 199190. Right: The stream went subsurface approximately 200m upstream of PSCIS crossing 199190.

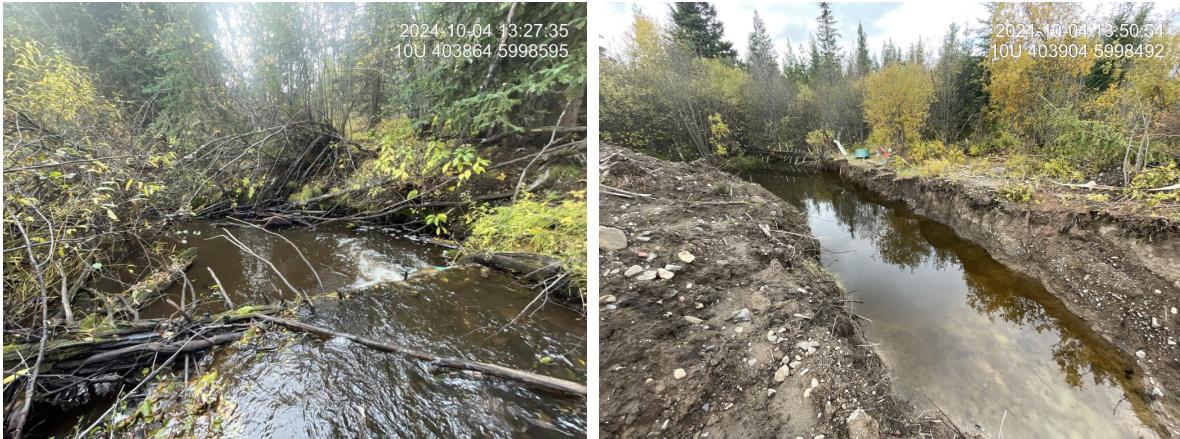
Figure 5.13: Left: Typical habitat downstream of PSCIS crossing 199204. Right: Large, artificially entrenched pool located ~300m downstream of PSCIS crossing 199204.

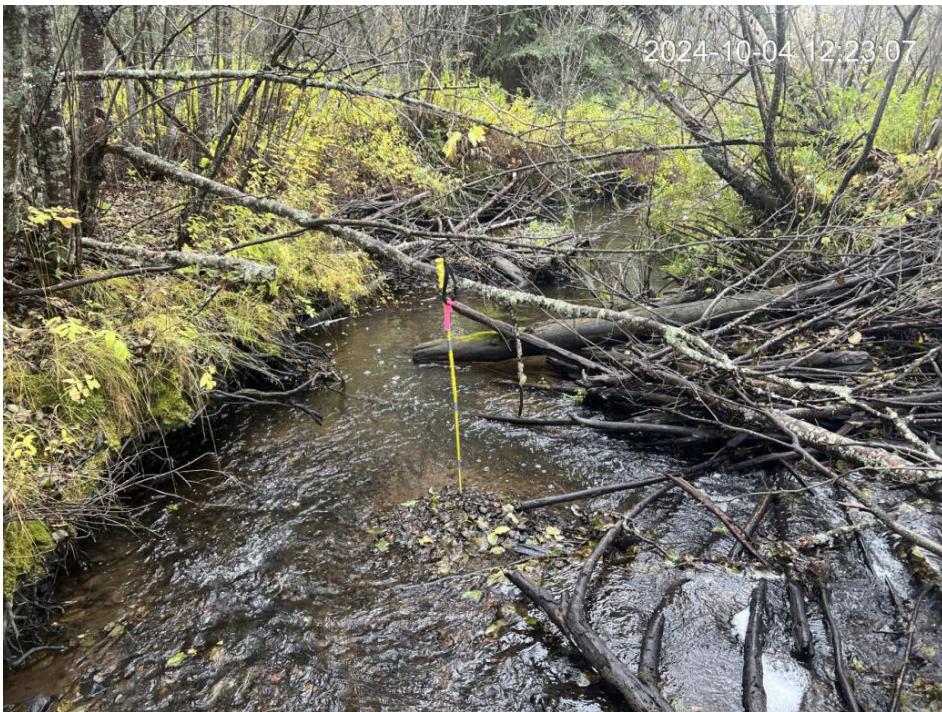
The stream was surveyed upstream from crossing 199204 for 425m (Figure 5.14). The habitat was rated as medium value for spawning and rearing. The stream was a larger system with significant beaver activity, creating impoundments behind dams ranging from 0.3 - 1.5m in height. Heavy cattle use was evident in riparian areas, with trampled banks, extensive browsing of riparian shrubs, and a significant amount of manure within seasonally inundated areas. Nutrient loading to the stream appeared high, with large amounts of algae present on the primarily gravel substrates in sections of the channel linking beaver-impounded areas. Total cover amount was rated as moderate with deep pools dominant. Cover was also present as small woody debris, overhanging vegetation, and instream vegetation. The dominant substrate was fines with gravels sub-dominant. The average channel width was 6.2m, the average wetted width was 4.4m, and the average gradient was 3%.

Figure 5.14: Typical habitat upstream of PSCIS crossing 199204.

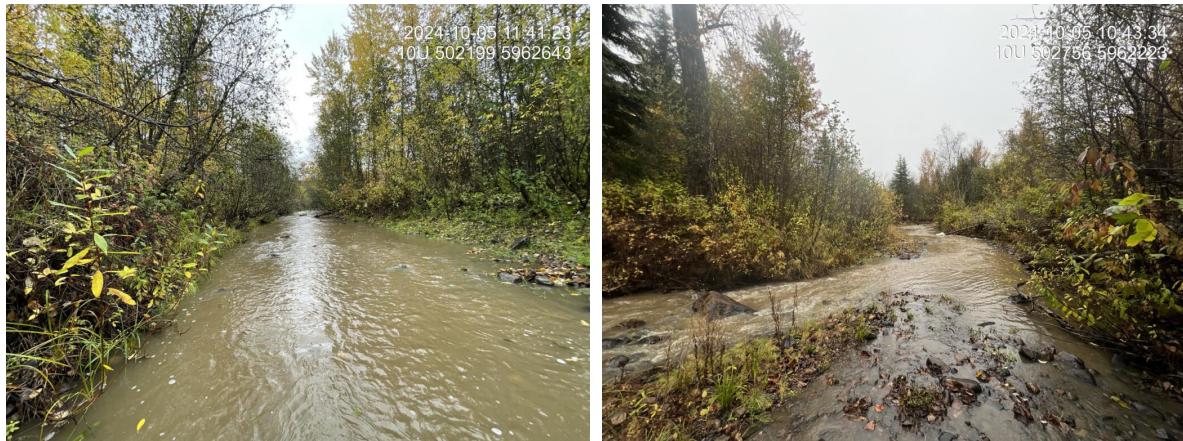
The stream was surveyed downstream from crossing 199232 for 300m (Figure 5.16). The habitat was rated as medium value due to sparse large woody debris, a lack of pools, and high turbidity

The stream was surveyed upstream from crossing 199232 for 725m (Figure 5.16). The habitat was rated as high value, with abundant gravels suitable for chinook spawning. Pools were infrequent, primarily located on outside bends and behind large woody debris. Some evidence of anthropogenic manipulation was observed, including cut cottonwood trees that had fallen into the channel. The riparian zone was in good condition, with mature shrub communities and old-growth cottonwood that should contribute to future habitat complexity. Water levels were elevated to moderate conditions due to heavy rainfall over the previous evening and preceding weeks. The dominant substrate was gravels with cobbles sub-dominant. Total cover amount was rated as moderate with overhanging vegetation dominant. Cover was also present as small woody debris and boulders. The average channel width was 11.9m, the average wetted width was 8m, and the average gradient was 0.6%.

Figure 5.16: Left: Typical habitat downstream of PSCIS crossing 199232. Right: Typical habitat upstream of PSCIS crossing 199232.

Should restoration/maintenance activities proceed, replacement of the Highway 16 crossing (199232) with a bridge (15 m span) is recommended. At the time of reporting in 2025, the cost of the work is estimated at \$ 11,250,000.

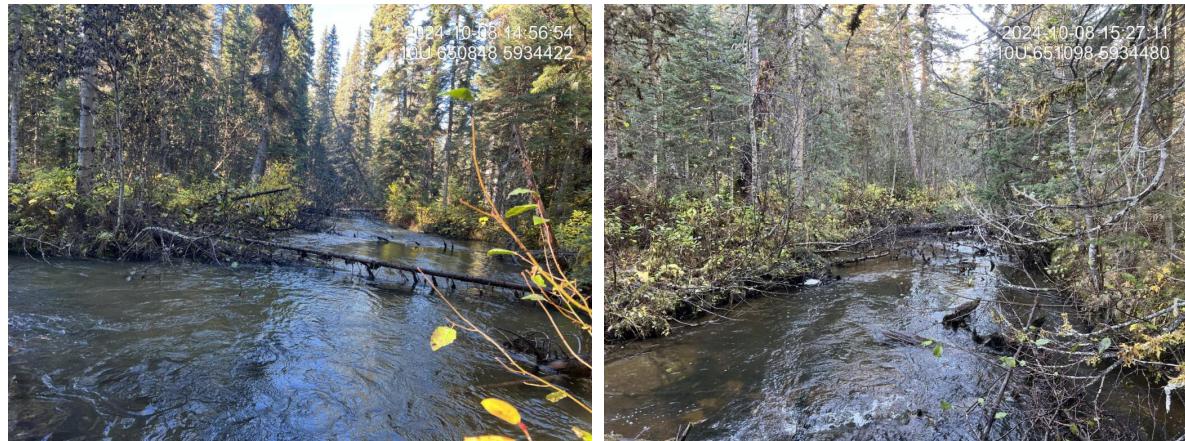
PSCIS crossing 199237 on Highway 16 had a significant outlet drop and is a moderate priority for replacement. Although the latest data on record appears to be from 2003, according to Fisheries and Oceans Canada (n.d.), chinook have historically spawned within Snowshoe Creek, indicating this stream has provided valuable chinook spawning habitat. Given that the habitat upstream of Highway 16 was rated as high value for spawning and rearing during the 2024 assessment, replacement of the crossing is considered a high priority. In the interim, fish sampling is recommended to further assess whether the crossing is inhibiting fish passage.

Figure 5.18: Left: Typical habitat upstream of PSCIS crossing 199237 on the west fork on Snowshoe Creek. Right: Typical habitat upstream of PSCIS crossing 199237 on the east fork on Snowshoe Creek.

Should restoration/maintenance activities proceed, replacement of the Highway 16 crossing with a bridge (19 m span) is recommended. At the time of reporting in 2025, the cost of the work is estimated at \$ 14,250,000.

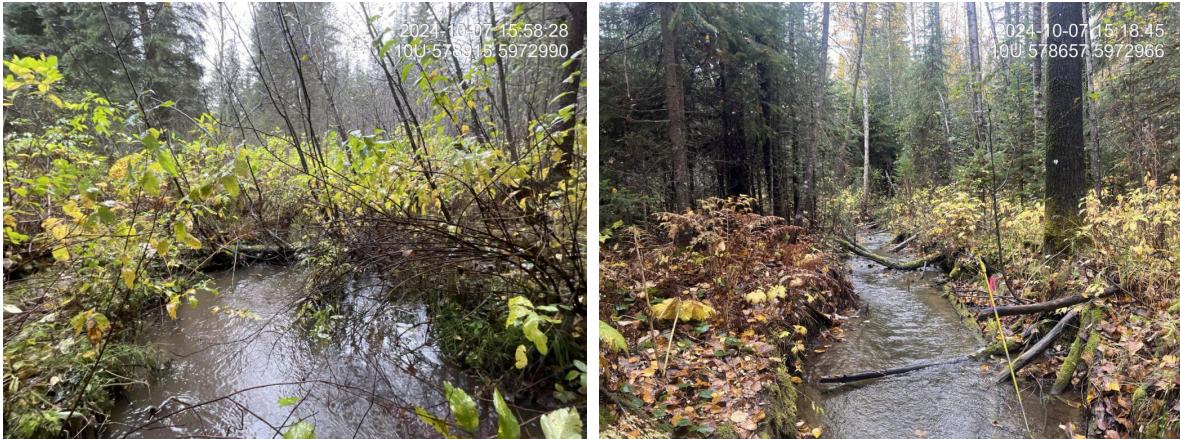
The stream was surveyed downstream from crossing 199255 for 270m (Figure 5.20). The habitat was rated as low value for spawning and rearing with no gravels or cobbles observed and the

substrate consisting entirely of fine mud. Fish habitat was limited, with very few pools present. The first 130m of the stream was a beaver-affected area, with a beaver dam approximately 0.7m high located ~40m downstream of the culvert. The dam had flooded the surrounding forest, with no main channel observed. Occasional sections had a somewhat defined channel, but the majority of the surveyed area consisted of water flowing through a wet forest. Total cover amount was rated as moderate with overhanging vegetation dominant. Cover was also present as small woody debris, undercut banks, and instream vegetation. The average channel width was 10.3m, the average wetted width was 7m, and the average gradient was 0.8%. The dominant substrate was fines with fines sub-dominant..

The stream was surveyed upstream from crossing 199255 for 650m (Figure 5.20). The habitat was rated as medium value with good flow and abundant gravels suitable for bull trout and cutthroat trout spawning. Occasional shallow pools provided habitat for juvenile salmonid rearing. Banks were stable, with an intact mixed mature forest. The stream was small and had some short sections with gradients up to 5% but was primarily a low-gradient riffle-gravel system. The average channel width was 3.4m, the average wetted width was 2.8m, and the average gradient was 2.8%. The dominant substrate was gravels with cobbles sub-dominant. Total cover amount was rated as moderate with undercut banks dominant. Cover was also present as small woody debris, large woody debris, and overhanging vegetation.

Figure 5.20: Left: Typical habitat downstream of PSCIS crossing 199255. Right: Typical habitat upstream of PSCIS crossing 199255.

Should restoration/maintenance activities proceed, replacement of the Bowron FSR crossing (199255) with a bridge (15 m span) is recommended. At the time of reporting in 2025, the cost of the work is estimated at \$ 450,000.

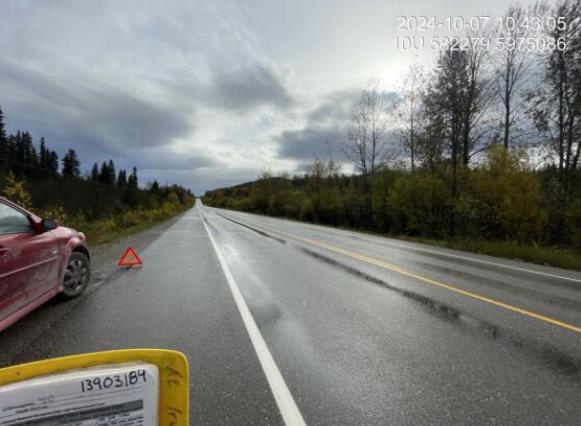
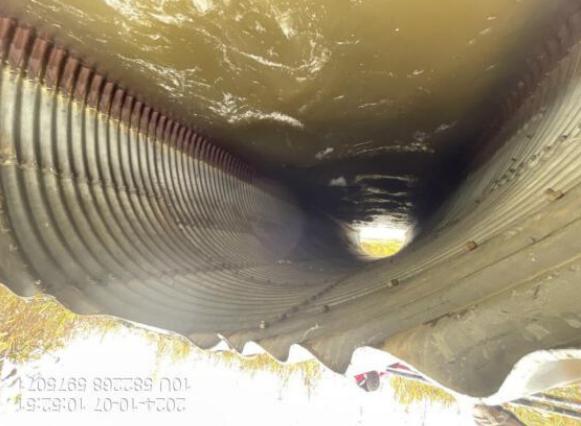
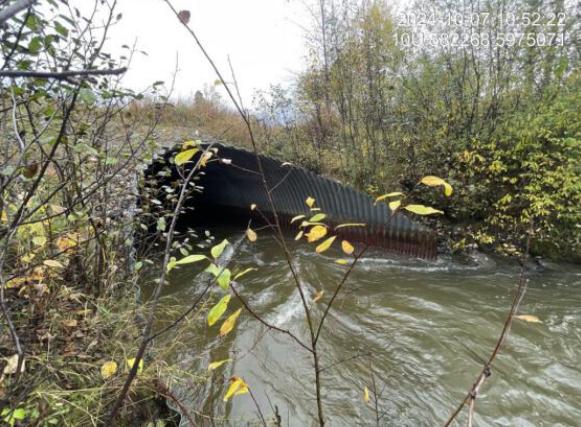
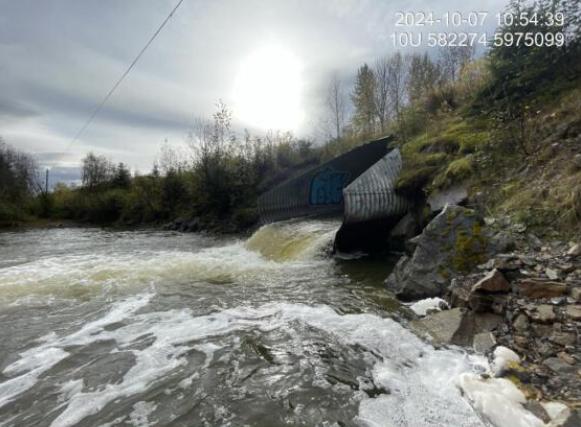
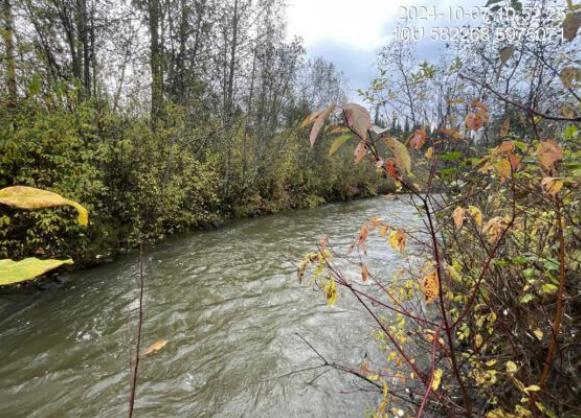
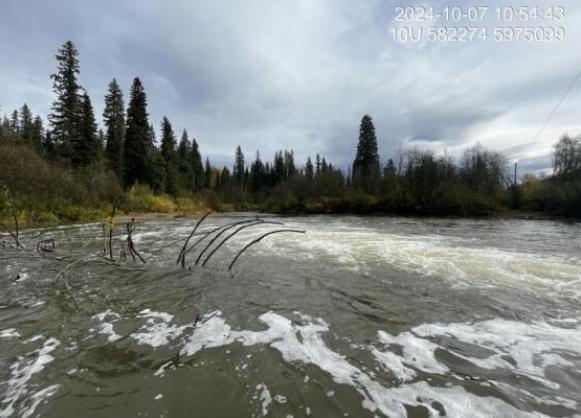
Comments: Large multi-plate oval culvert with a substantial 50m-wide outlet pool. Chinook, bull trout, and other species are documented upstream in the FISS database, and a dead chinook spawner was observed upstream of the crossing during an informal site visit in 2022. The stream had high flow at the time of assessment and the culvert slope and outlet pool depth were estimated as the pool was too deep to wade. Deep pools over 1m, formed by functional large woody debris, provided good overwintering habitat for fish of all ages. Gravels suitable for spawning were present. Downstream of the culvert, the stream ran parallel to the highway with banks reinforced by riprap and large wood secured with metal wiring to create habitat and reduce flow. The Kenneth Creek watershed was assessed in detail using Fish Habitat Assessment Procedures (FHAP) in 1997 by AquaFor Consulting Ltd., who identified the lower 15 reaches as extremely valuable chinook salmon habitat, also supporting bull trout and rainbow trout. MoTi chris\_hwy\_structure\_road\_id: 3750

Photos: From top left clockwise: Road/Site Card, Barrel, Outlet, Downstream, Upstream, Inlet.

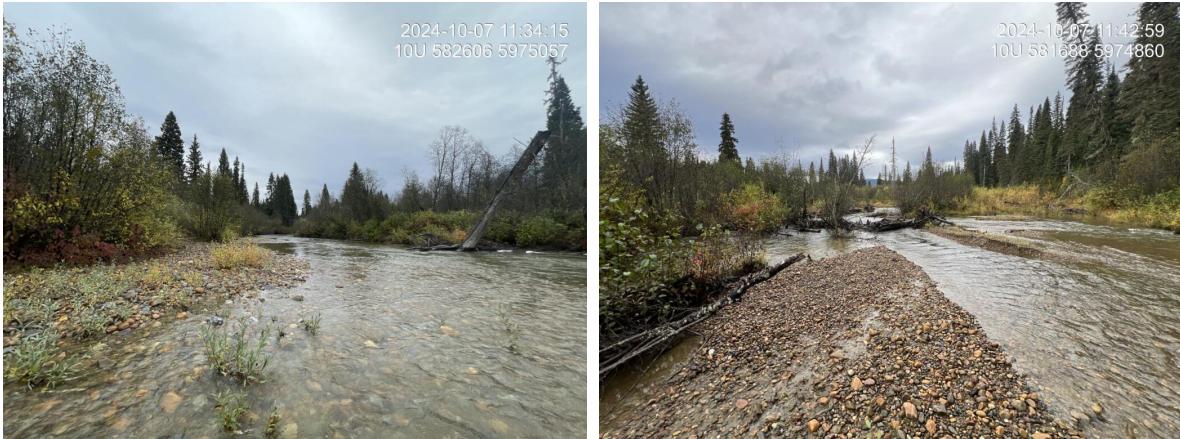
The stream was surveyed downstream from crossing 199256 for 370m (Figure 5.22). The habitat was rated as high value, with abundant spawning gravels and deep pools (>1m) formed by

Downstream of the culvert, the stream ran parallel to the highway, with banks reinforced by riprap. Large wood, secured with metal wiring, was placed to create habitat and reduce flow, arranged in three sets of two logs spaced approximately 5m apart (Figure 5.23). These structures were likely installed to mitigate habitat loss caused by the riprapped banks.

The stream was surveyed upstream from crossing 199256 for 950m (Figure 5.22). The habitat was rated as high value, with gravels suitable for chinook and resident salmonid spawning. The stream was large and gravel-dominated, with extensive deep runs, deep pools, large woody debris, and multiple channels throughout. The riparian area was intact throughout, consisting of a mix of shrub-dominated wetland areas and mature mixed forest. Total cover amount was rated as moderate with deep pools dominant. Cover was also present as small woody debris, large woody debris, undercut banks, and overhanging vegetation. The dominant substrate was gravels with cobbles sub-dominant. The average channel width was 22.8m, the average wetted width was 16.7m, and the average gradient was 0.8%.

Due to PSCIS crossing 199256 being located on highway 16, replacement of the crossing would be a large and expensive undertaking. Previous assessment by Hooft (2006) considered various mitigation options, including substrate placement, baffles, and downstream weirs, and concluded that replacement with a clear-spanning bridge or open-bottom structure is the only permanent solution to restore fish passage and address hydraulic concerns. The crossing is a high priority for replacement.

Figure 5.22: Left: Typical habitat downstream of PSCIS crossing 199256. Right: Typical habitat upstream of PSCIS crossing 199256.

Should restoration/maintenance activities proceed, replacement of the Highway 16 crossing (PSCIS 199256) with a bridge (24 m span) is recommended. At the time of reporting in 2025, the cost of the work is estimated at \$ 18,000,000.

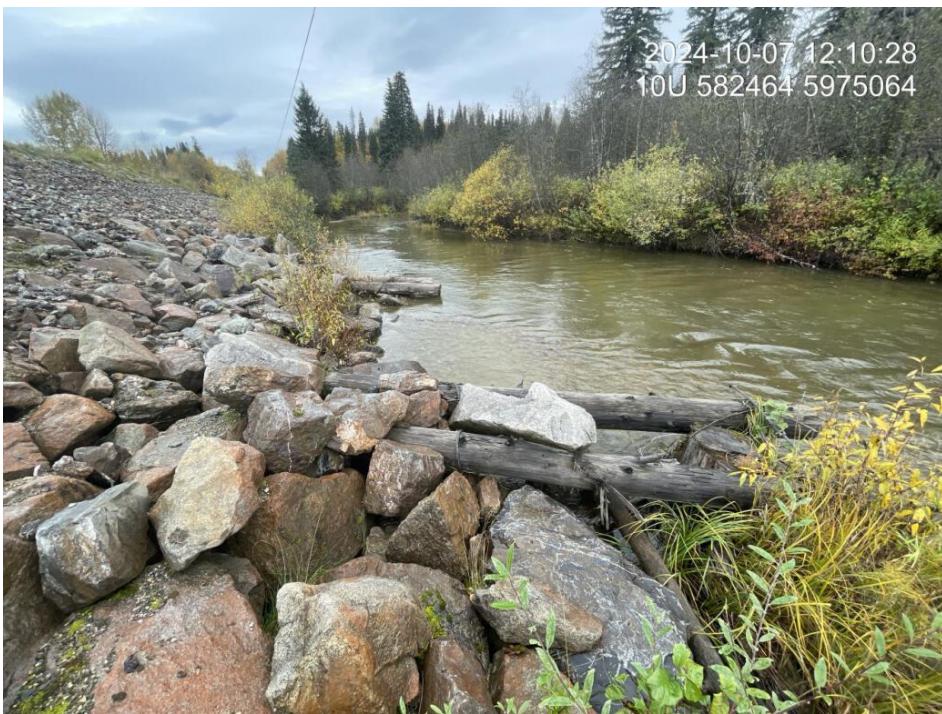
Figure 5.23: Ripwrapped banks and large wood structures secured with metal wiring located downstream of crossing 199256.

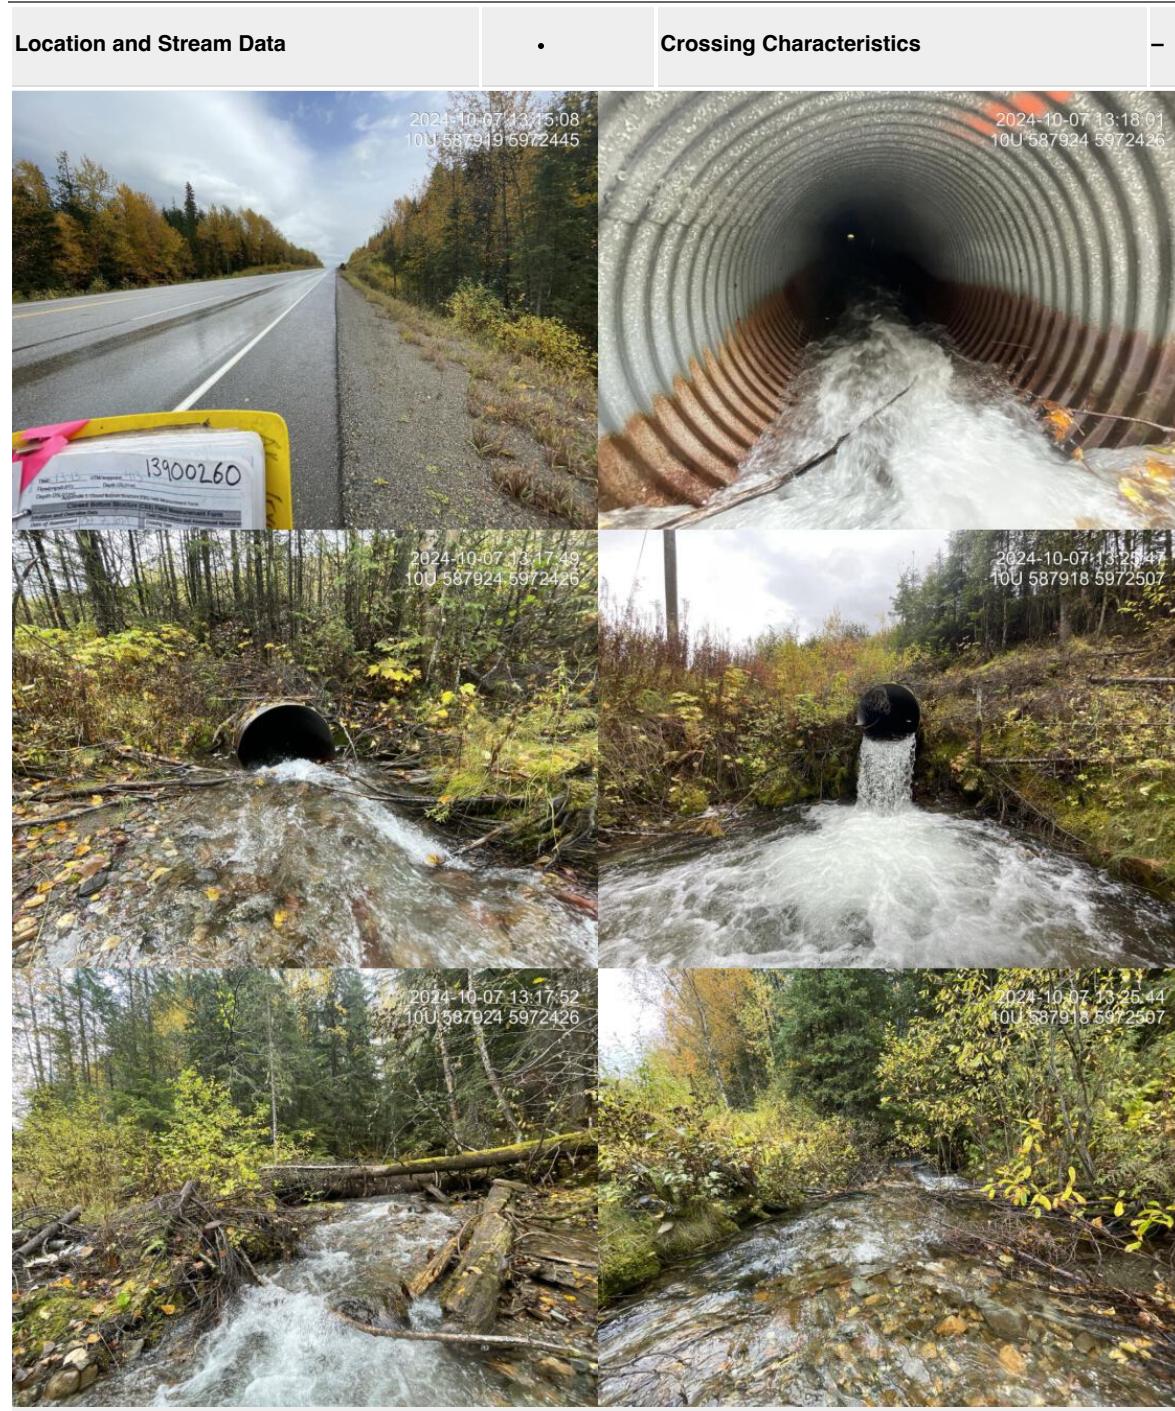
Comments: The culvert had a significant 1.4m outlet drop, and inlet drop due to a small debris jam. The stream flowed through mature old-growth forest and provided high-quality habitat with steep gradients, step pools, and cascade pools, suggesting the potential presence of bull trout. The highway crossing had a large amount of road fill, making construction difficult and expensive. The site would be a good candidate for replacement if feasible. The riparian area at the outlet had been cleared due to overhead powerlines. MoTi chris\_culvert\_id: 1992815

Photos: From top left clockwise: Road/Site Card, Barrel, Outlet, Downstream, Upstream, Inlet.

PSCIS crossing 199260 had a substantial outlet drop and is a high priority for replacement. Average gradients were generally above the maximum thresholds for chinook spawning and rearing (4.5% and 5.5%, respectively), but fell within the suitable range for bull trout spawning and rearing (5.5% and 10.5%, respectively). The habitat upstream was rated as medium value for bull trout spawning and rearing, with bcfishpass modeling indicating ~900m of potential bull trout rearing habitat upstream of the crossing. Given the crossings location within Sugarbowl-Grizzly Den Provincial Park and the park's ecological significance, restoration efforts could align with broader conservation initiatives and public engagement, increasing the likelihood of funding and project momentum.

Should restoration/maintenance activities proceed, replacement of the Highway 16 crossing (199260) with a bridge (33 m span) is recommended. At the time of reporting in 2025, the cost of the work is estimated at \$ 24,750,000.

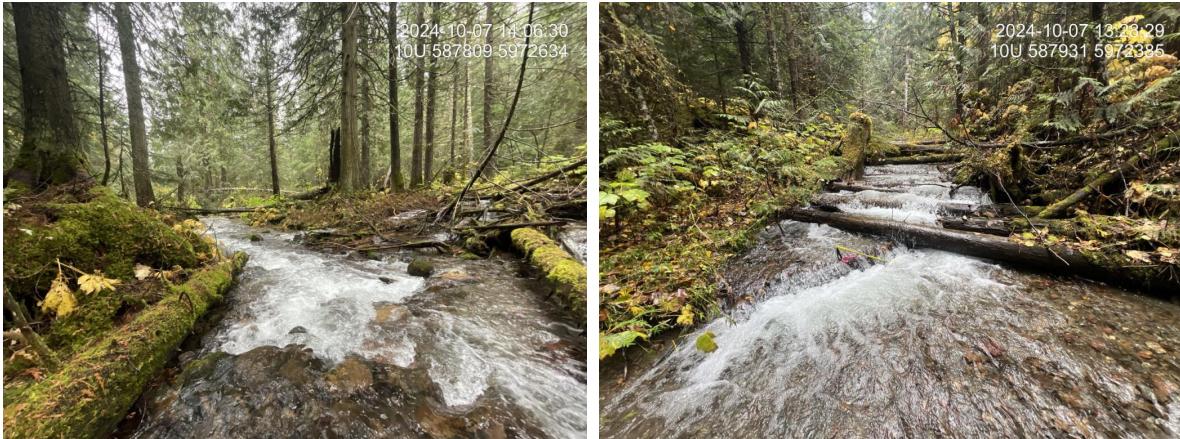
The stream was surveyed downstream from crossing 199260 for 320m (Figure 5.25). The habitat was rated as high value, with gravels suitable for spawning and occasional pools ranging from 0.2 –

The stream was surveyed upstream from crossing 199260 for 650m (Figure 5.25). The habitat was rated as medium value, and appeared suitable for large bull trout spawning and rearing. The stream was a larger, steeper system with intact, mature coniferous cedar-hemlock riparian cover, primarily stable banks, and abundant large woody debris throughout. A step-pool morphology was present, characterized by pools up to 80cm deep and debris jam steps ranging from 30 – 60cm. The average channel width was 6.1m, the average wetted width was 5.1m, and the average gradient was 7.1%. Total cover amount was rated as moderate with large woody debris dominant. Cover was also present as small woody debris, boulders, undercut banks, deep pools, and overhanging vegetation. The dominant substrate was cobbles with gravels sub-dominant.

Figure 5.25: Left: Typical habitat downstream of PSCIS crossing 199260. Right: Typical habitat upstream of PSCIS crossing 199260.

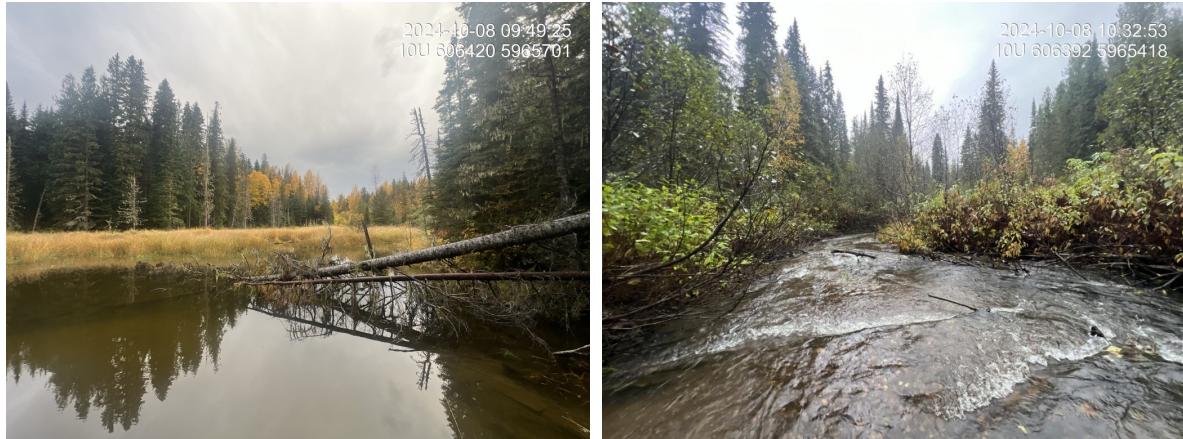
The stream was surveyed upstream from crossing 199267 for 600m (Figure 5.27). The habitat was rated as high value for spawning and rearing. The stream was a low-gradient, gravel-dominated system with an extensive shrub-sedge wetland area and beaver activity in the lower 200m. Deep pools up to 1m were present throughout, influenced by abundant large woody debris contributed from the adjacent mature, primarily coniferous forest. Total cover amount was rated as moderate with large woody debris dominant. Cover was also present as small woody debris, undercut banks, deep pools, and overhanging vegetation. The average channel width was 8.9m, the average wetted width was 8.7m, and the average gradient was 0.5%. The dominant substrate was gravels with cobbles sub-dominant.

Figure 5.27: Left: Typical habitat upstream of PSCIS crossing 199267. Right: Typical habitat upstream of PSCIS crossing 199267.

Should restoration/maintenance activities proceed, replacement of the Highway 16 crossing (199267) with a bridge (15 m span) is recommended. At the time of reporting in 2025, the cost of the work is estimated at \$ 11,250,000.

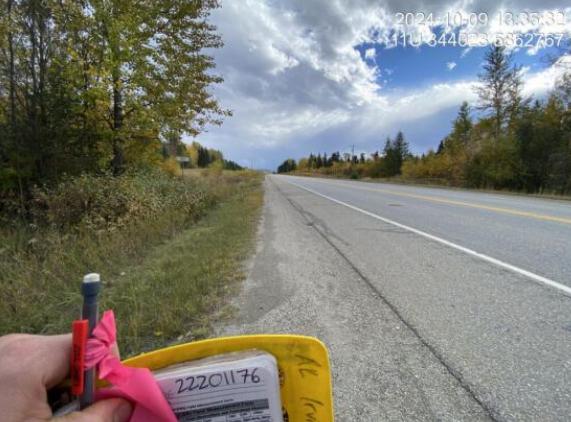
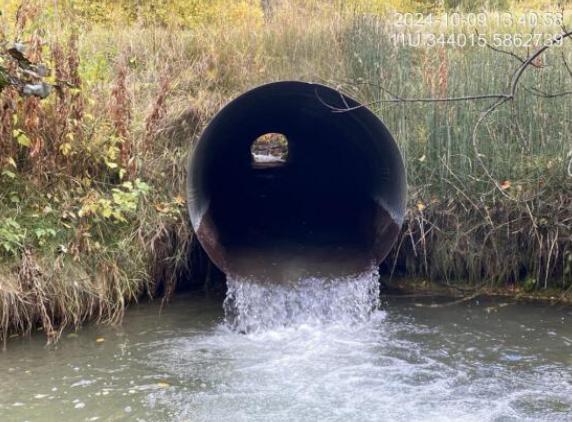
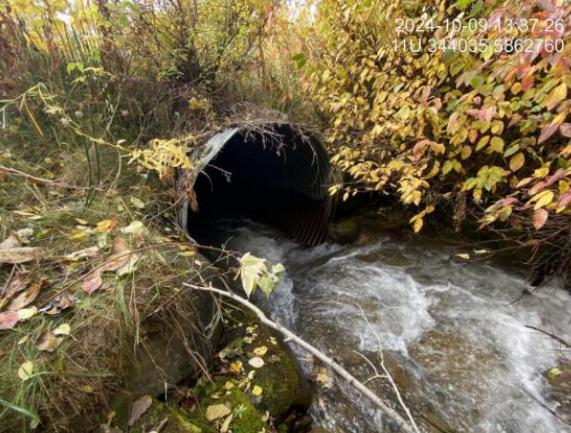
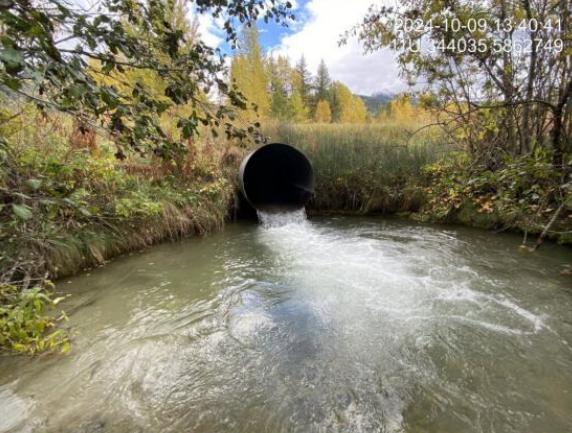
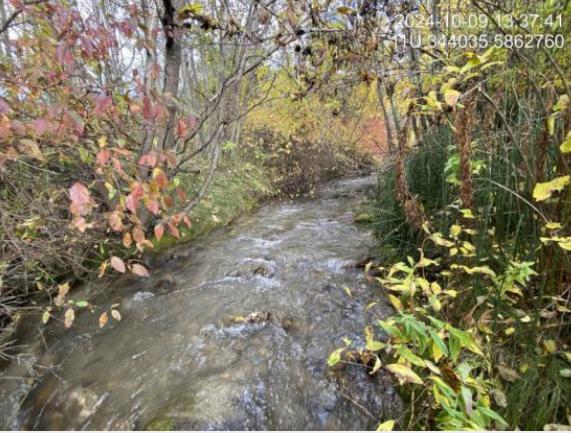
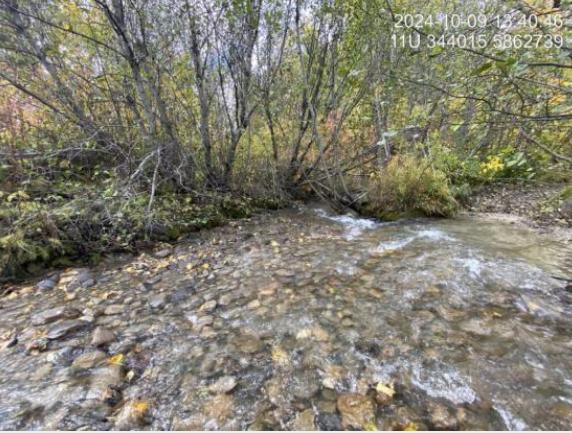
Photos: From top left clockwise: Road/Site Card, Barrel, Outlet, Downstream, Upstream, Inlet.
