## **Restoring Fish Passage in the Fraser Region - 2023**

**Prepared for  
Ministry of Transportation and Infrastructure**

**Prepared by  
Al Irvine, B.Sc., R.P.Bio. and Lucy Schick, B.Sc.  
New Graph Environment Ltd.**

**Version 0.1.2 2025-07-14**

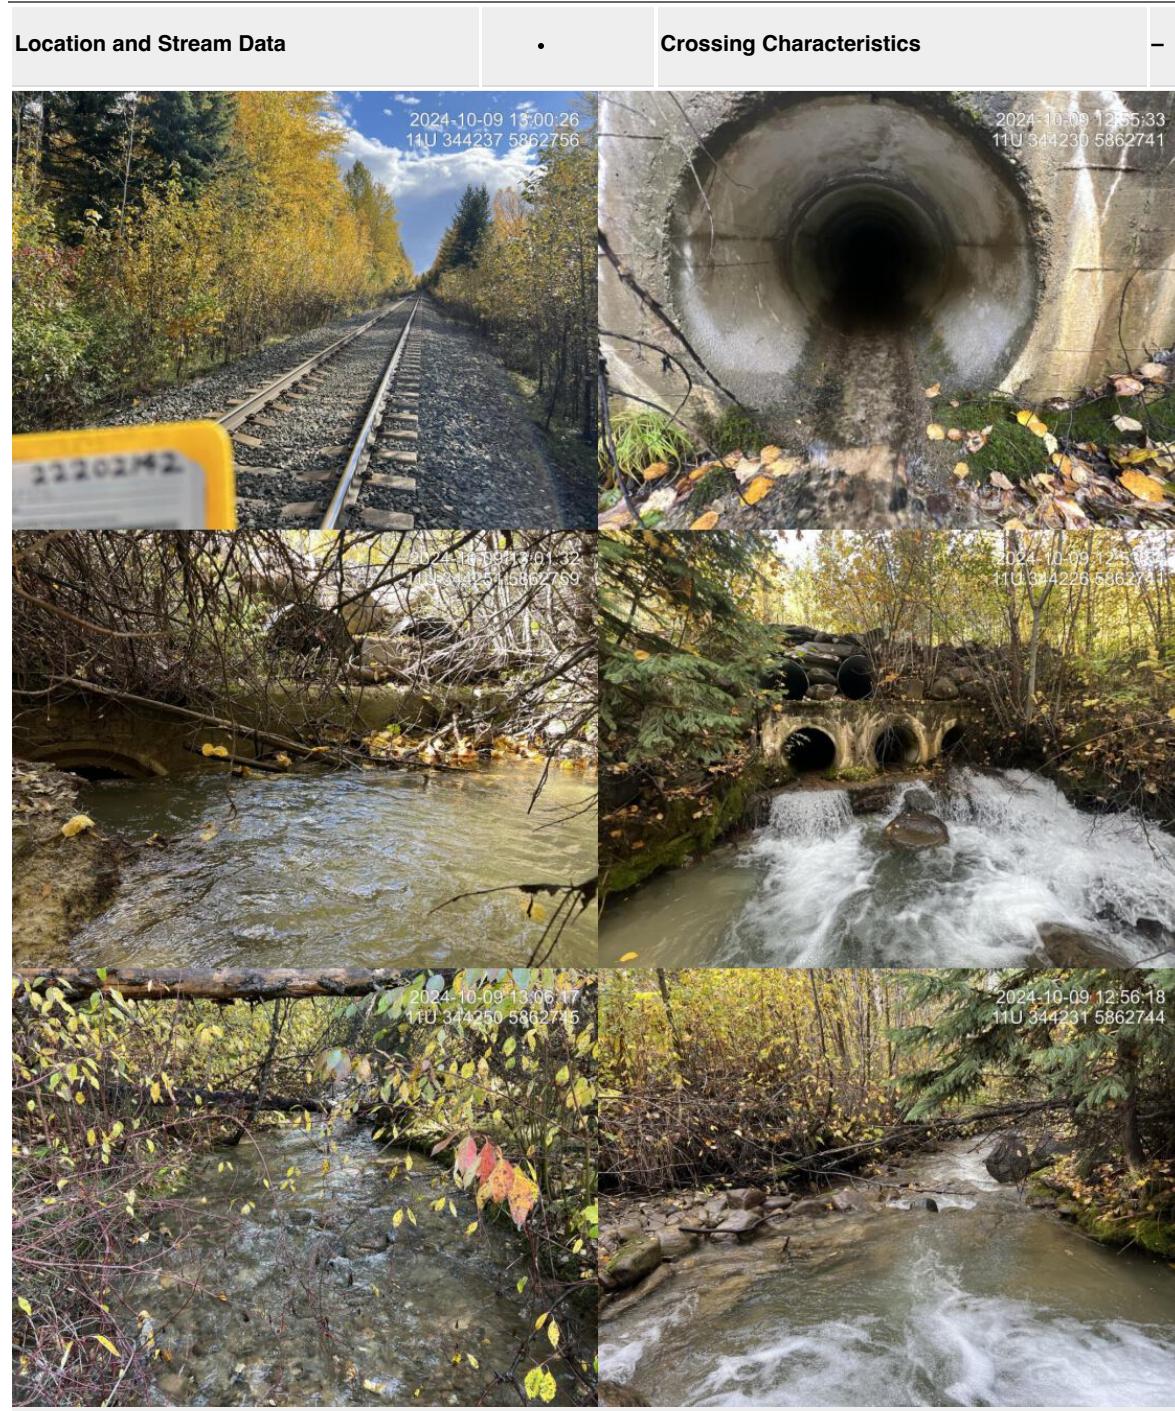
Comments: Three concrete pipes, each 0.9m in diameter, were present, along with two 0.9m corrugated overflow pipes above. A stamp on the structure indicated it was built in 1944. All three concrete pipes were clogged at the inlet, ranging from 80% to 100% clogged with debris. This is a known fish-bearing stream, with a salmon point documented ~100m downstream in the FISS database. At this location, the stream was a mid-sized, steeper cobble-boulder step-pool system with only rare pockets of unembedded gravels. Deep pools were present, formed by boulder and large woody debris scour. Numerous small steps, ranging from 30-60cm, were present due to the steep, boulder-dominated nature of the stream. Downstream of the highway crossing, the stream had a lower gradient with frequent pools 0.3-0.5m deep, providing good overwintering habitat for fish and abundant gravels suitable for spawning. Bull trout have previously been captured both upstream and downstream of the highway 5 crossing by Triton Environmental Consultants Ltd. Upstream of the Mount Tinsley Pit Road crossing, a hiking trail follows Teepee Creek and provides access to Mount Terry Fox Provincial Park.

Photos: From top left clockwise: Road/Site Card, Barrel, Outlet, Downstream, Upstream, Inlet.

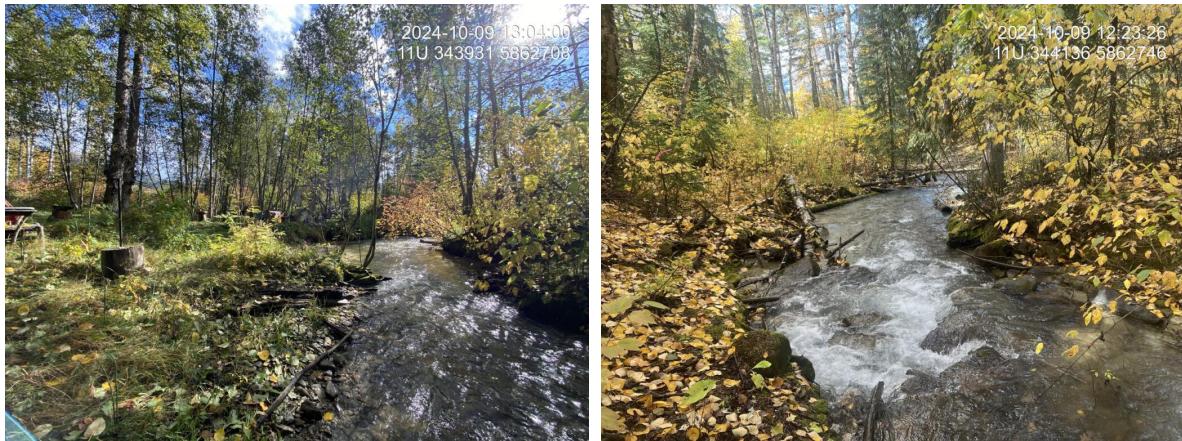
The stream was surveyed downstream from crossing 199278 for 150m (Figure 5.29). The habitat was rated as high value, with frequent pools 0.3 – 0.5m deep suitable for overwintering fish and

Figure 5.29: Left: Typical habitat downstream of PSCIS crossing 199278. Right: Typical habitat upstream of PSCIS crossing 199278 and downstream of PSCIS crossing 203302.

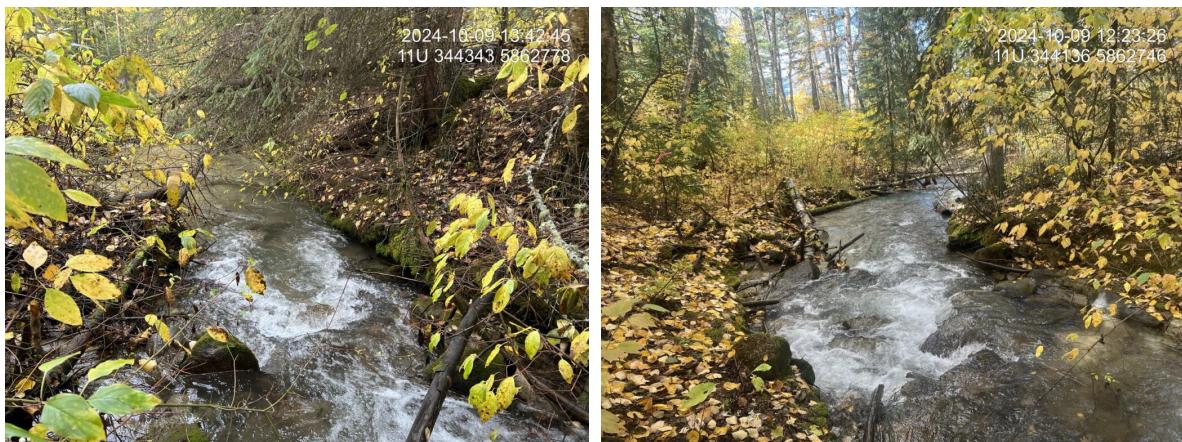
Figure 5.30: Left: Typical habitat upstream of PSCIS crossing 203302. Right: Typical habitat upstream of PSCIS crossing 199278 and downstream of PSCIS crossing 203302.

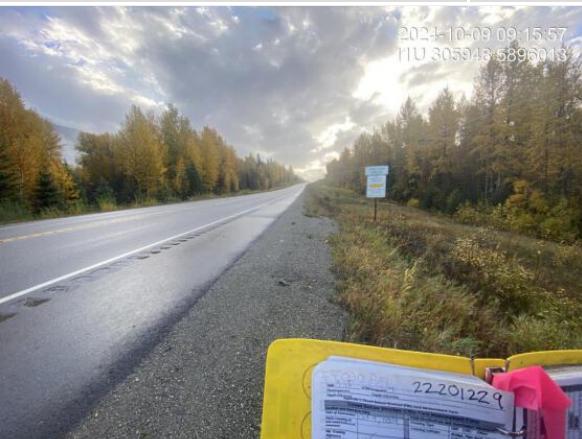
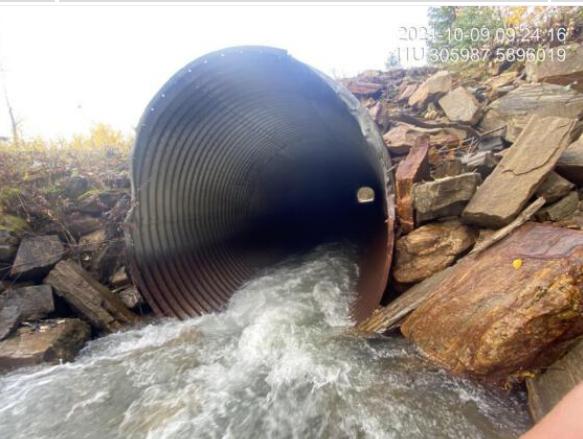
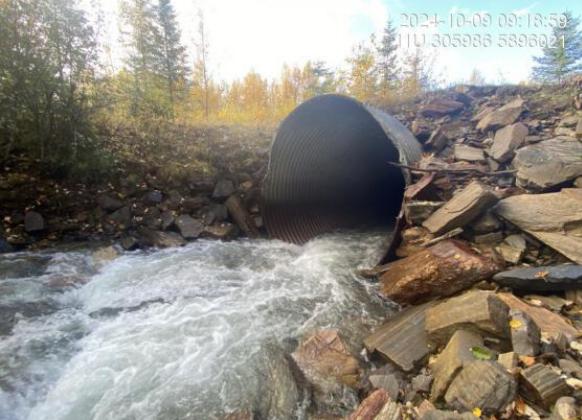
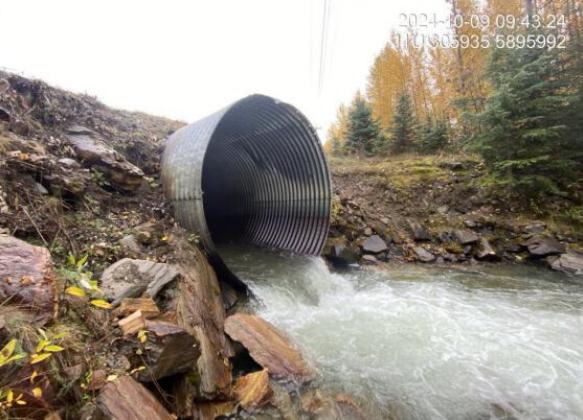
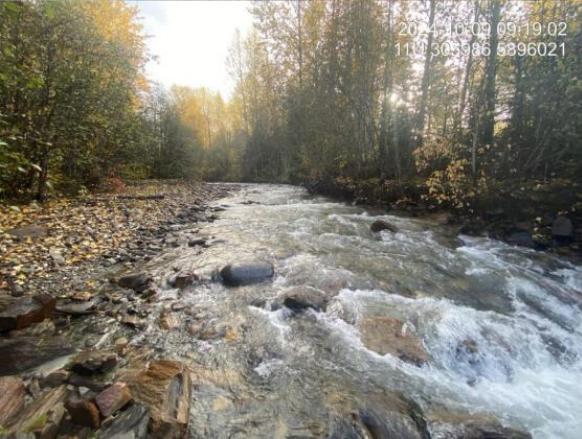
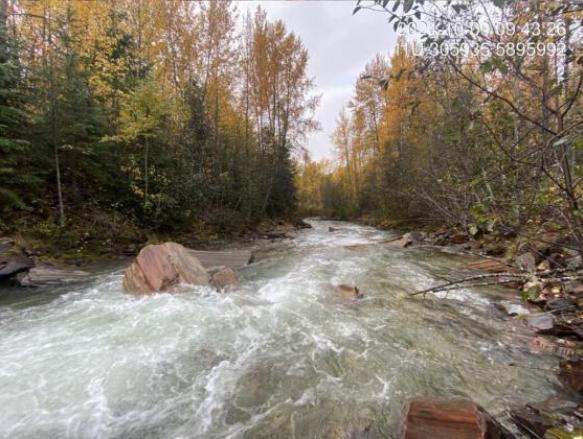
Comments: A significant outlet drop was present. Flow was high at the time of assessment, and at lower flows, the outlet drop would be even more substantial. Although the culvert was large, it was still likely undersized for the stream. The stream was a large glaciated system with a cobble-boulder substrate and an intact mixed riparian zone, primarily deciduous. Occasional large woody debris features created deep pool habitats and pockets of gravels were present suitable for spawning salmonids. A fish (~60mm) was observed during the habitat confirmation. Chinook and bull trout have been previously captured both upstream and downstream of the crossing by Triton Environmental Consultants Ltd. MoTi chris\_hwy\_structure\_road\_id: 29925

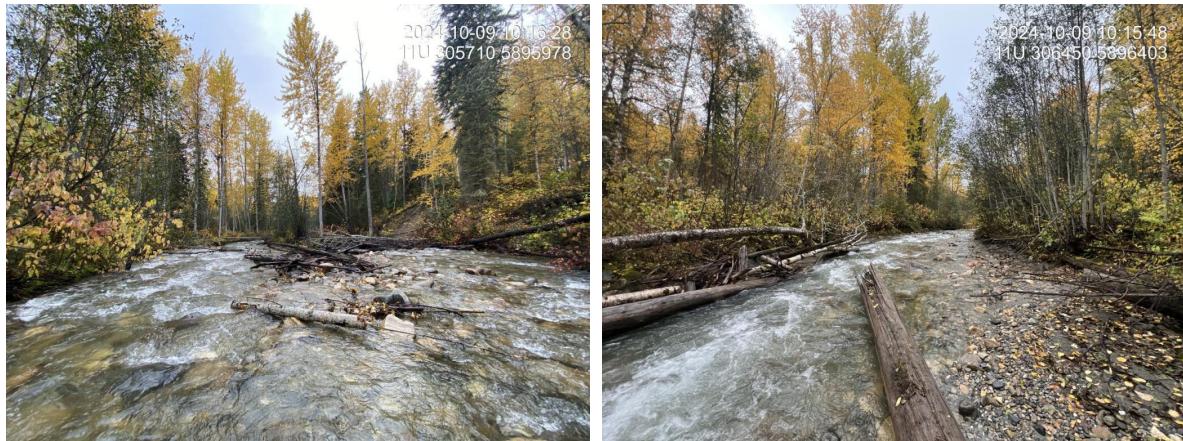
The stream was surveyed downstream from crossing 199282 for 350m (Figure 5.32). The habitat was rated as high value with frequent gravels suitable for spawning and occasional pools available

The stream was surveyed upstream from crossing 199282 for 800m (Figure 5.32). The habitat was rated as medium value for spawning and rearing. Occasional large woody debris features created deep pools, with pockets of gravels suitable for spawning. The average channel width was 11.8m, the average wetted width was 8.9m, and the average gradient was 2.5%. Total cover amount was rated as moderate with boulders dominant. Cover was also present as .The dominant substrate was cobbles with boulders sub-dominant.

Figure 5.32: Left: Typical habitat downstream of PSCIS crossing 199282. Right: Typical habitat upstream of PSCIS crossing 199282.

Should restoration/maintenance activities proceed, replacement of the Highway 16 crossing (PSCIS 199282) with a bridge (21 m span) is recommended. At the time of reporting in 2025, the cost of the work is estimated at \$ 15,750,000.
