Appendix - Phase 1 Fish Passage Assessment Data and Photos

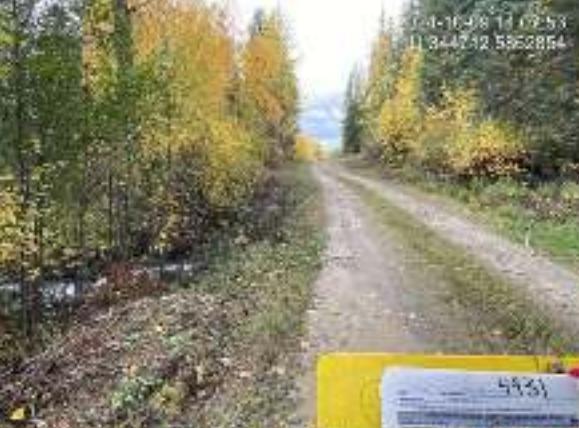
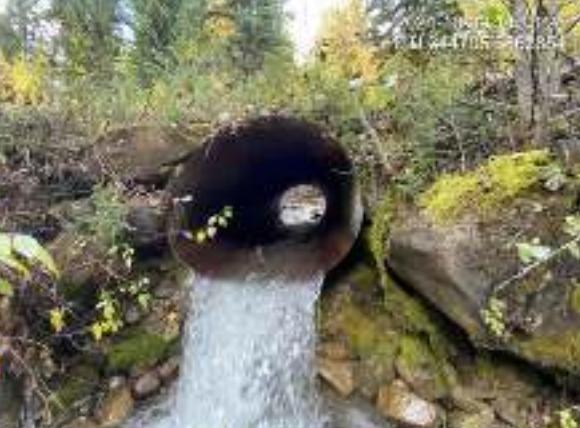
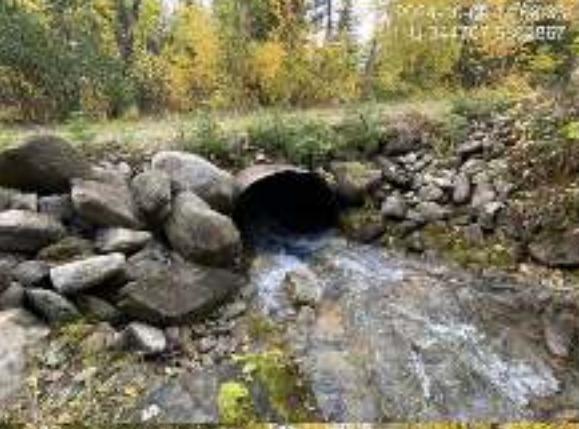
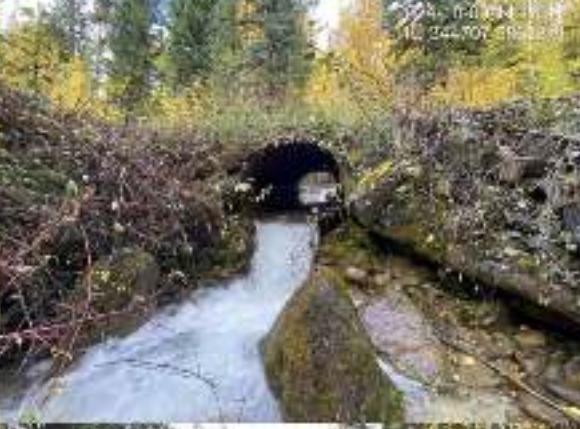
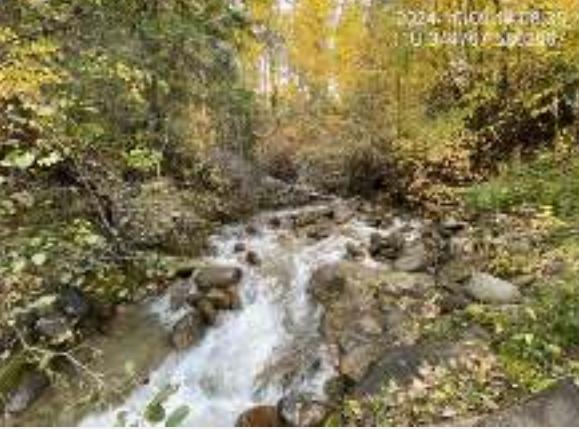
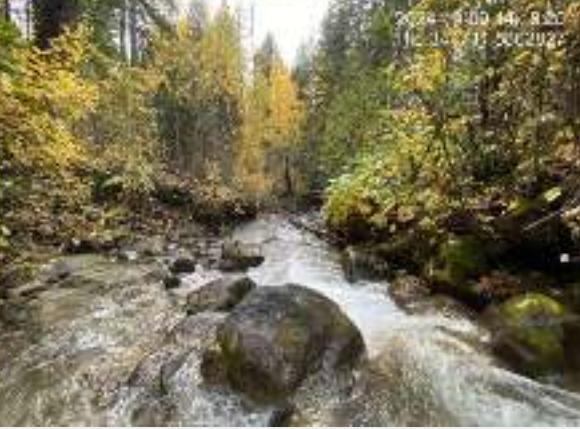
| Location and Stream Data | | Crossing Characteristics | |
|---|--|---|---|
| Photos: PSCIS ID 4931. From top left clockwise: Road/Site Card, Barrel, Outlet, Downstream, Upstream, Inlet. | | | |

| Location and Stream Data | | Crossing Characteristics | |
|---|--|---|---|
| Comments: A significant outlet drop was present. The pipe was in good condition, but there was erosion under the outlet and on the road column on the outlet side. The stream provided high-quality habitat with known fish in the system, including a salmon point downstream. The gradient was steep at this crossing, but the downstream highway crossing had lower gradients with abundant gravels. The road was a small dirt road with minimal road fill, making replacement relatively straightforward. | | | |

| Location and Stream Data | | Crossing Characteristics | |
|---|--|---|---|
| Fix type | Replace with New Open Bottom Structure | Fix Span / Diameter | 15 |

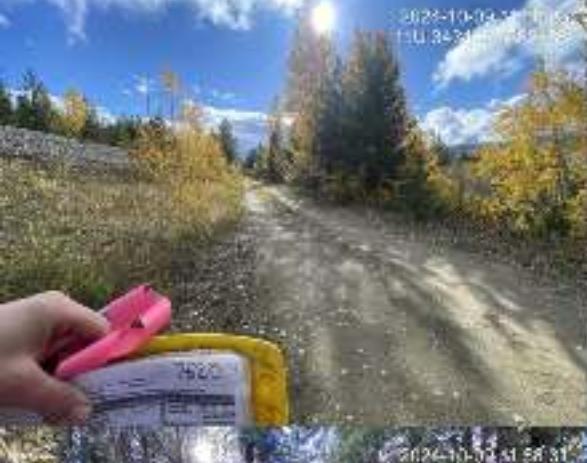
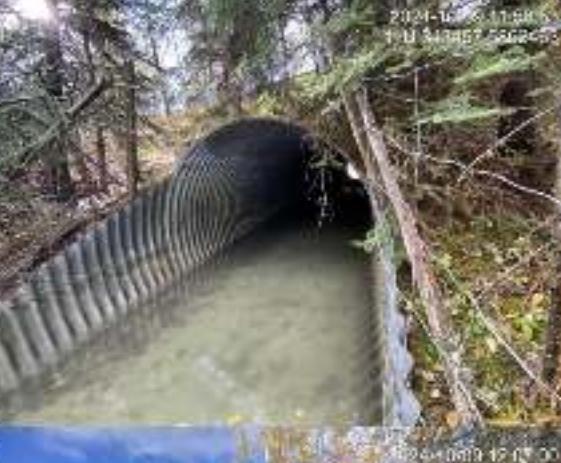
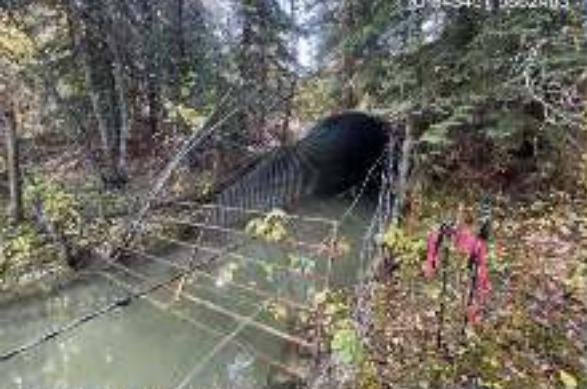
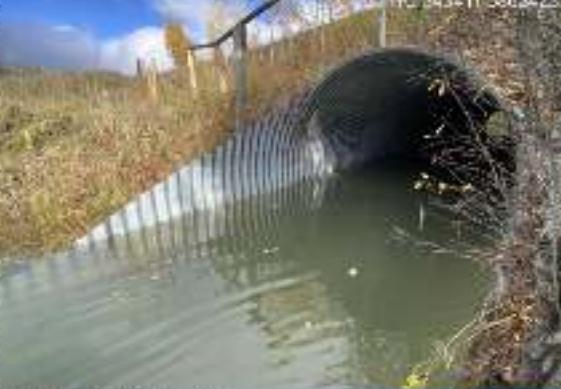
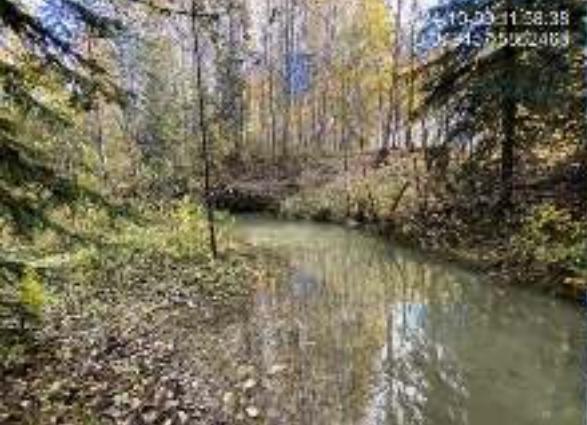
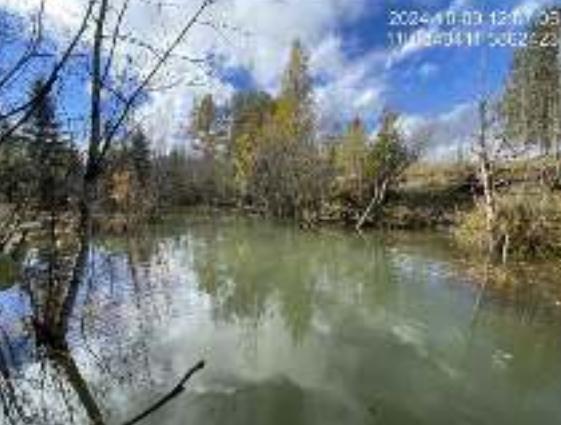
Photos: PSCIS ID 7620. From top left clockwise: Road/Site Card, Barrel, Outlet, Downstream, Upstream, Inlet.

Comments: Long culvert which passed under the CN railway and a dirt road. A beaver dam located 50m downstream of the outlet created a larger beaver pond which was backwatering the culvert . Below the beaver dam, the stream had low gradients and provided good fish habitat. A gate across the inlet functioned as a beaver grate. The stream was fenced perpendicular to the channel both upstream and downstream, likely for cattle management. Signs of cattle accessing the stream were observed near the outlet.

| Location and Stream Data | | Crossing Characteristics | |
|---|--|---|---|
| Fix type | Replace with New Open Bottom Structure | Fix Span / Diameter | 27 |

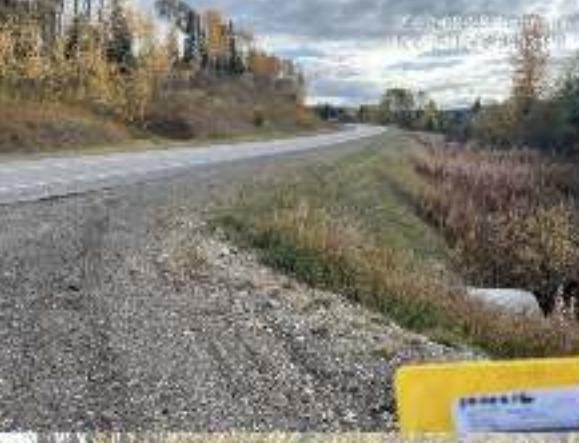
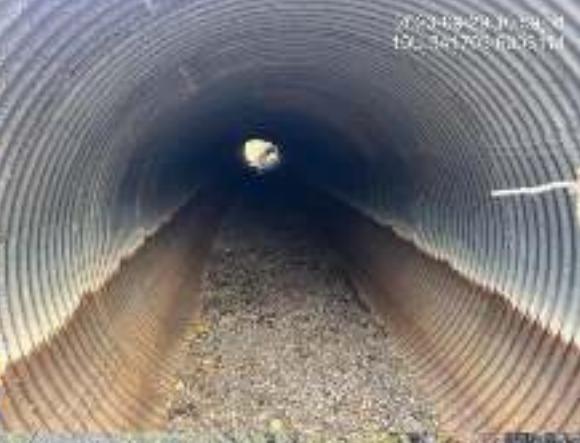
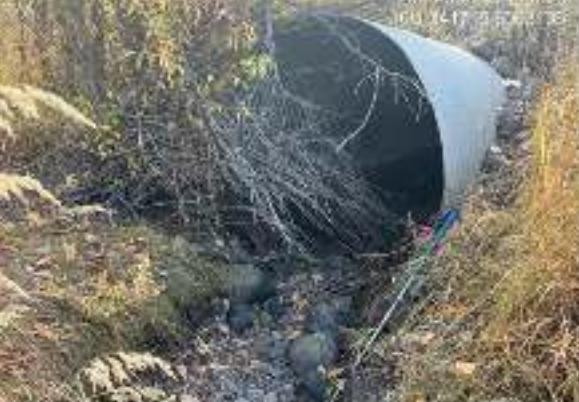
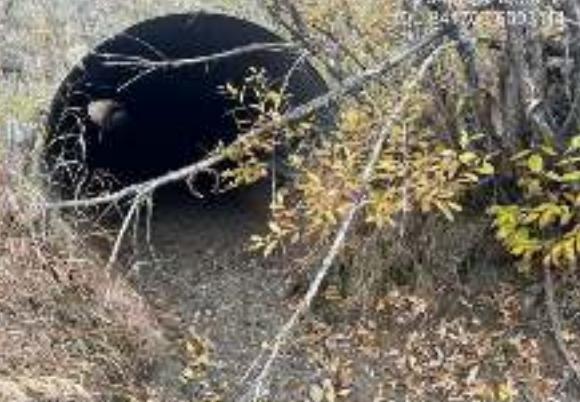
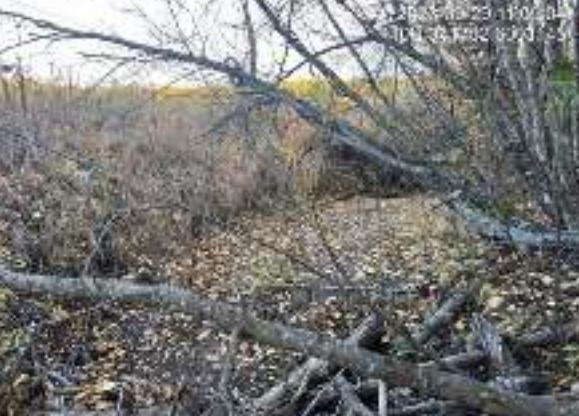
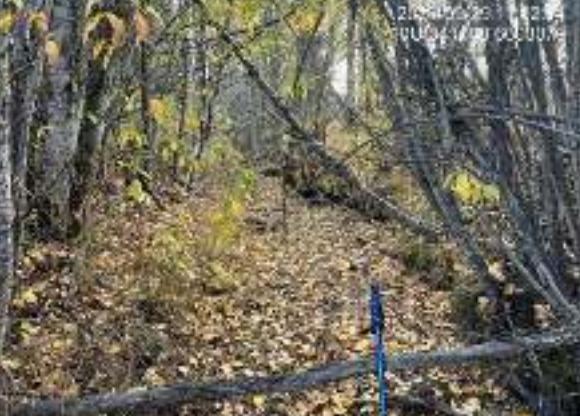
Photos: PSCIS ID 5400216. From top left clockwise: Road/Site Card, Barrel, Outlet, Downstream, Upstream, Inlet.

Comments: Dry at time of survey. Abundant gravels throughout. Crossing on railway downstream still unassessed. Modelled crossing below. First 5 m of pipe is rusted through on the bottom side. Deeply incised banks upstream indicate the stream has a lot of flow at sometimes in the year with a decent amount of power. 9m falls ~1km upstream. Upstream Co-op Lake stocked with KO from 2017-2023 and EB from 1963-2023. MoTi chris_culvert_id: 2069497. 10:56:54

| Location and Stream Data | | Crossing Characteristics | |
|---|--|---|---|
| Fix type | Replace with New Open Bottom Structure | Fix Span / Diameter | 15 |

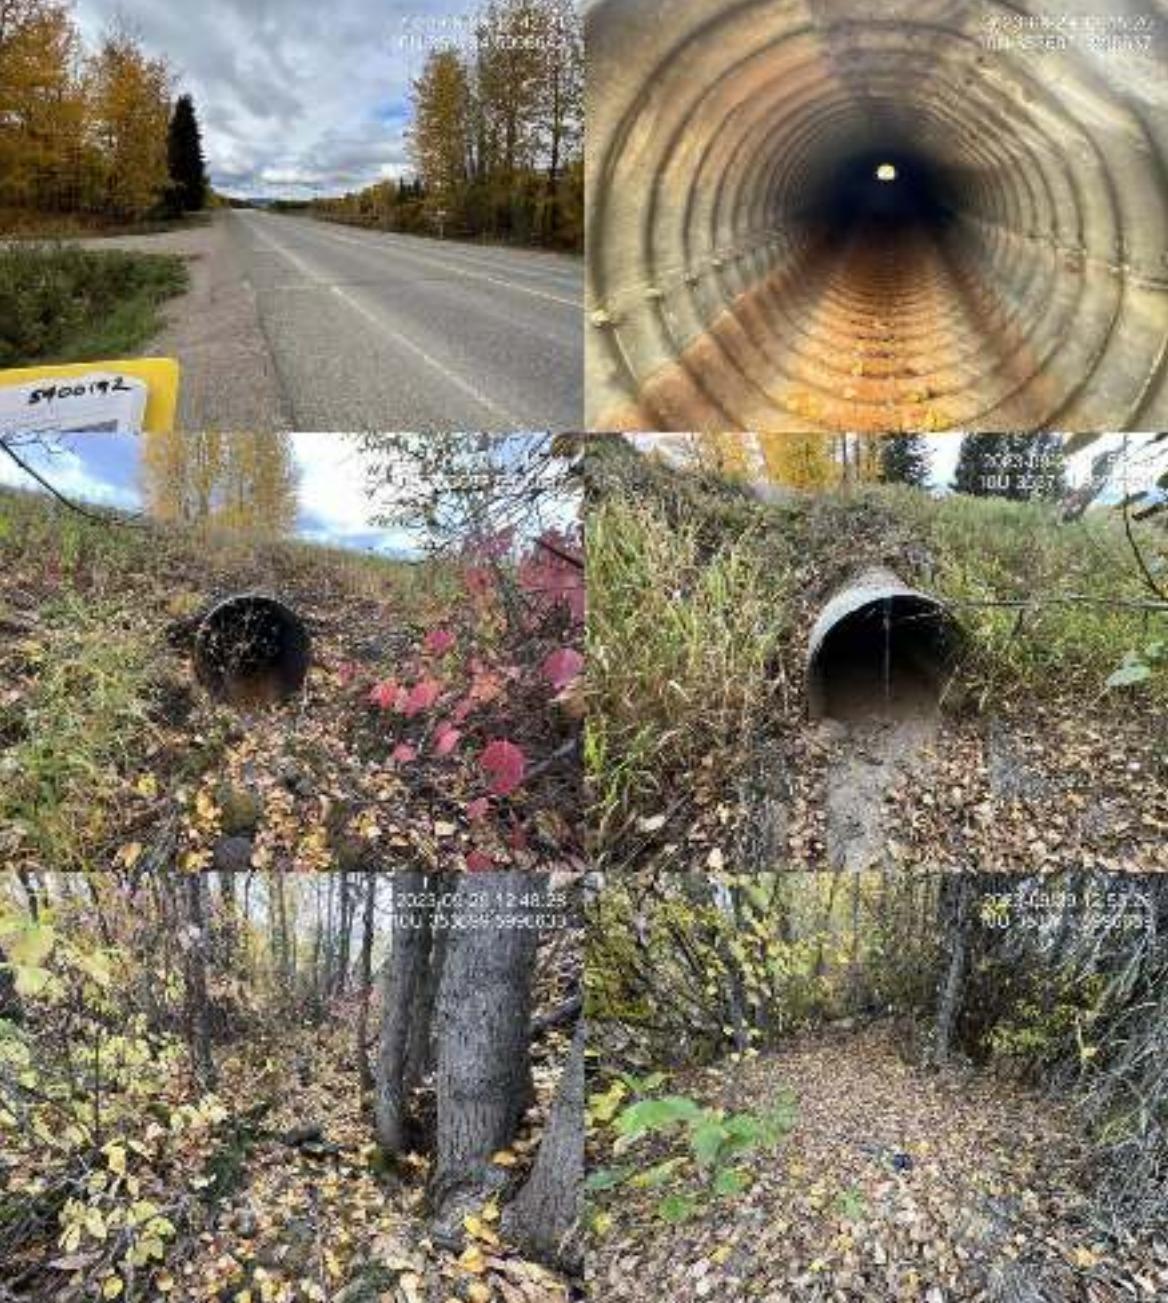
Photos: PSCIS ID 5400192. From top left clockwise: Road/Site Card, Barrel, Outlet, Downstream, Upstream, Inlet.

Comments: Dry at time of survey. Stream may be channelized upstream due to driveways to private properties on either side of the stream. Appears to have narrow, but decently healthy cottonwood dominated riparian, which could help dissipate flows and floods and runoff. Crack in Highway at culvert with minor erosion of road prism on downstream side. Stream labelled as Ross creek on sign. MoTi chris_culvert_id: 1793864. 12:42:58

| Location and Stream Data | . | Crossing Characteristics | – |
|---|---|---|---|
| Fix type | Replace Structure with Streambed Simulation CBS | Fix Span / Diameter | 3 |

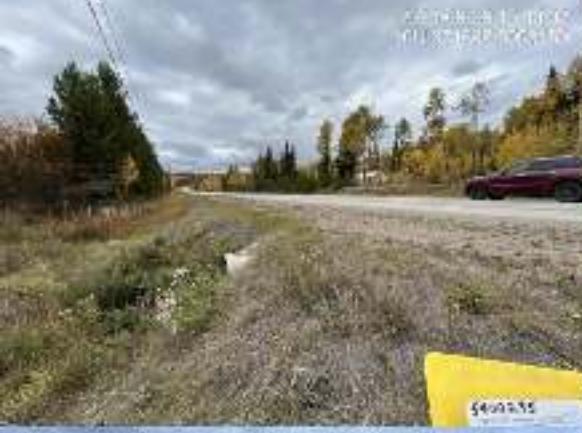
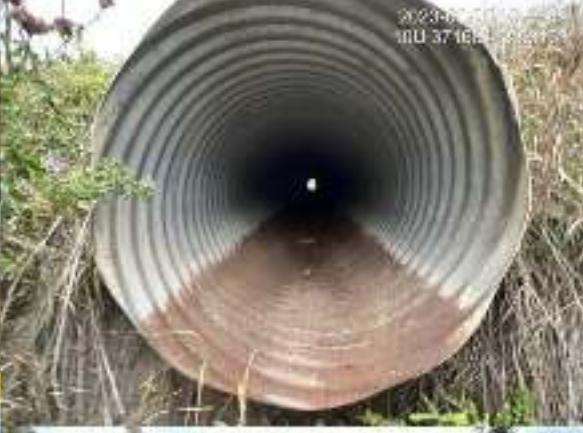
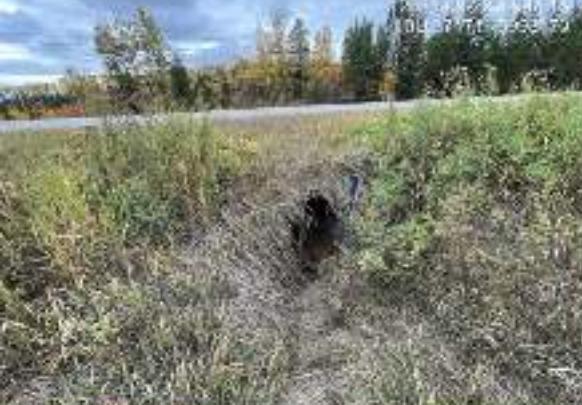
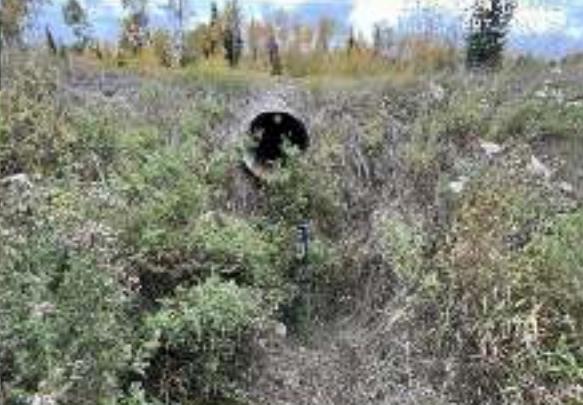
Photos: PSCIS ID 5400235. From top left clockwise: Road/Site Card, Barrel, Outlet, Downstream, Upstream, Inlet.

Comments: Dry with very poorly defined channel upstream and downstream. Seems very unlikely that this system could support fish. Pipe is rusted right through at the inlet for ~1m. Pipe is in very bad shape. MoTi chris_culvert_id: 1793794. 13:41:54

| Location and Stream Data | . | Crossing Characteristics | – |
|---|---|---|---|
| Fix type | Replace Structure with Streambed Simulation CBS | Fix Span / Diameter | 3 |

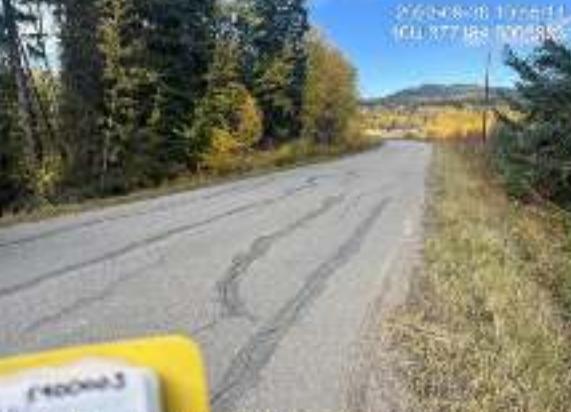
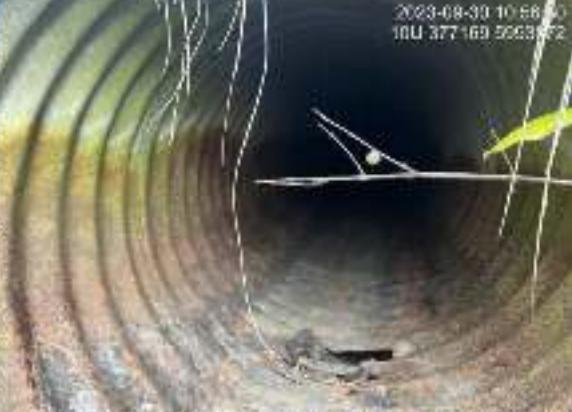
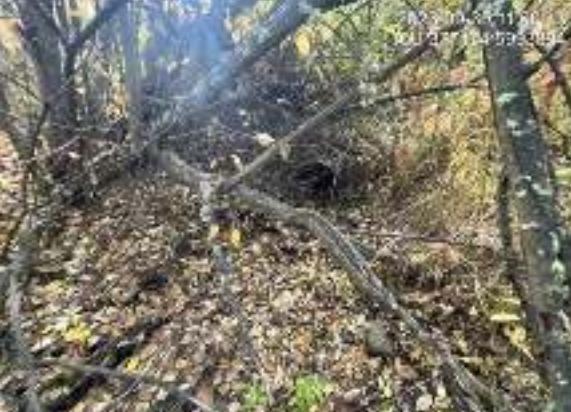
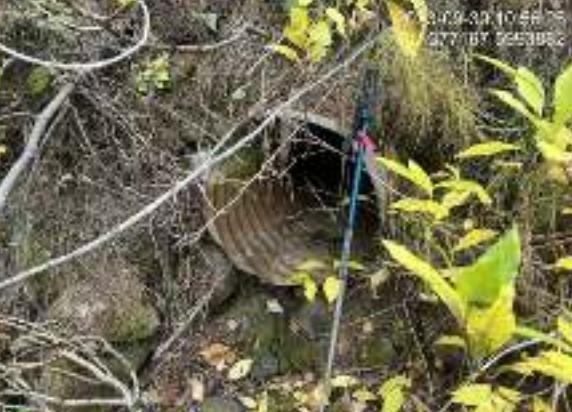
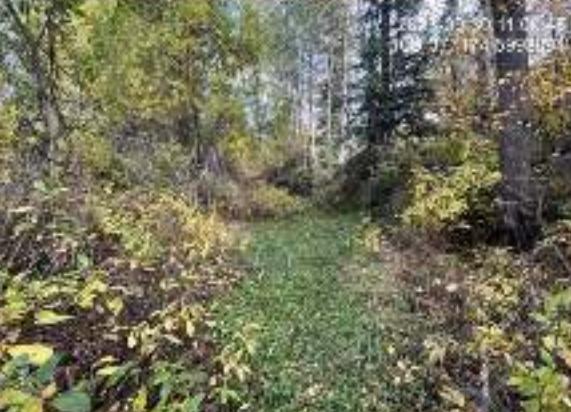
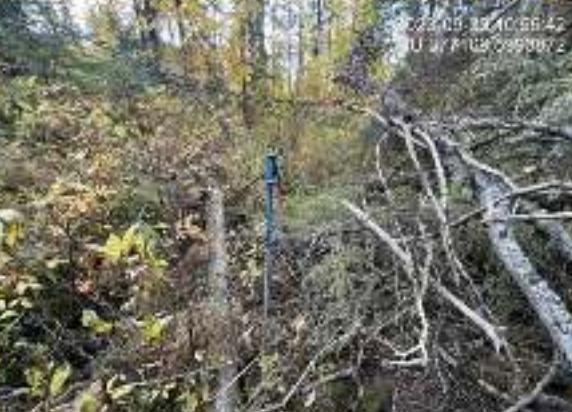
Photos: PSCIS ID 5400003. From top left clockwise: Road/Site Card, Barrel, Outlet, Downstream, Upstream, Inlet.

Culvert rusting at inlet. MoTi chris_culvert_id: 1794274. 10:53:44

| Location and Stream Data | | Crossing Characteristics | |
|---|--|---|---|
| Fix type | Replace Structure with Streambed Simulation CBS | Fix Span / Diameter | 3 |

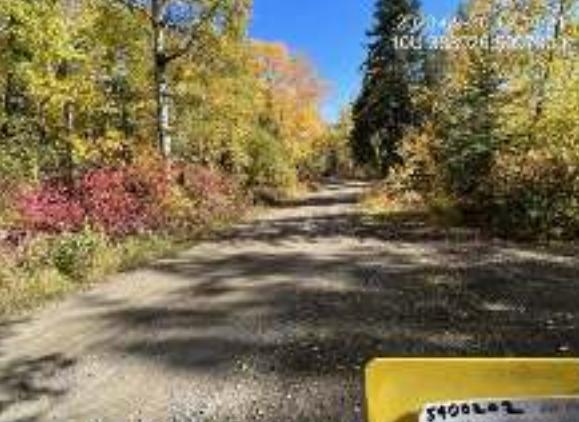
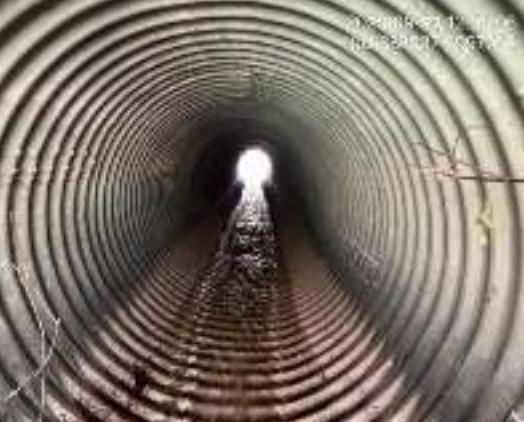
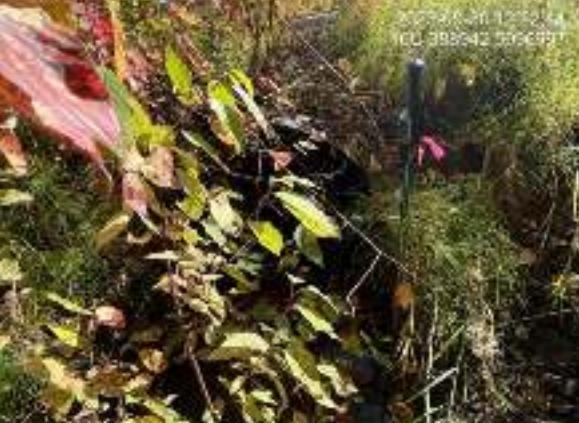
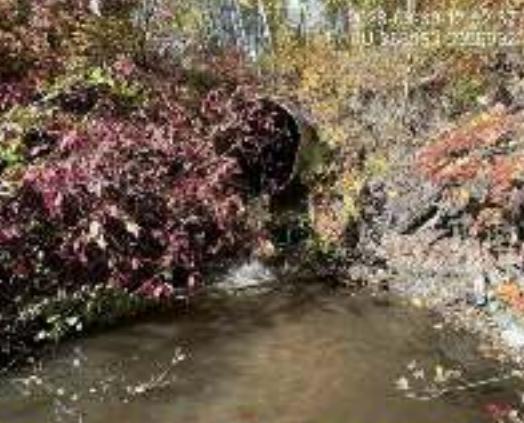
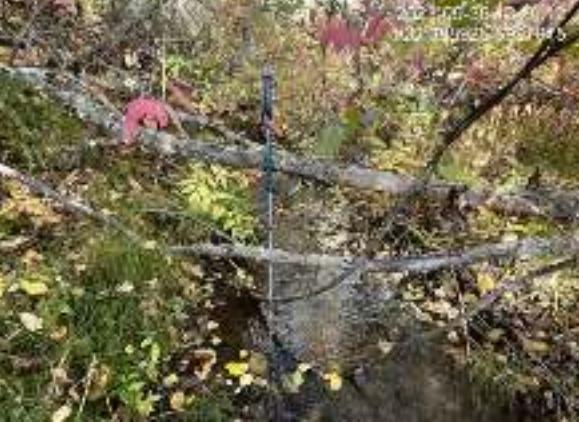
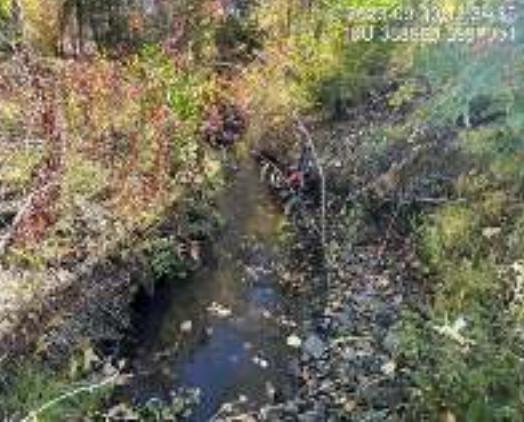
Photos: PSCIS ID 5400202. From top left clockwise: Road/Site Card, Barrel, Outlet, Downstream, Upstream, Inlet.

Comments: Very nice stream with good flow and abundant gravels upstream and downstream. Landowner indicated sockeye spotted along shoreline years ago. Massive outlet drop. Deserves habitat confirmation and consideration for replacement if no natural barriers upstream. There is a PSCIS assessed site (assessment_id = 7622) upstream that is a barrier. MoTi chris_culvert_id: 1790951. 12:12:56

| Location and Stream Data | . | Crossing Characteristics | - |
|---|---|---|---|
| Fix type | Replace Structure with Streambed Simulation CBS | Fix Span / Diameter | 3 |

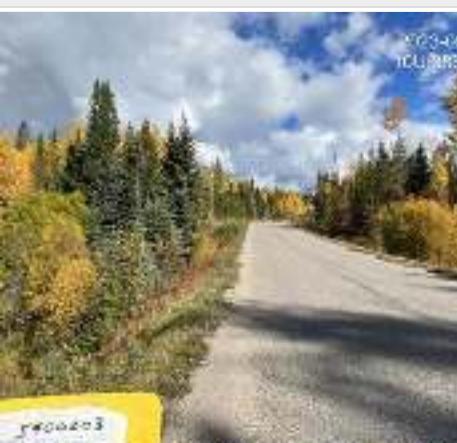
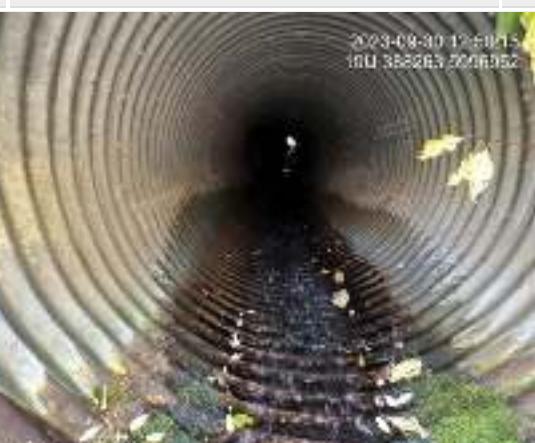
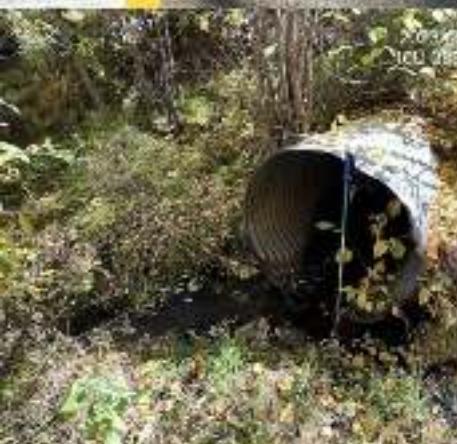
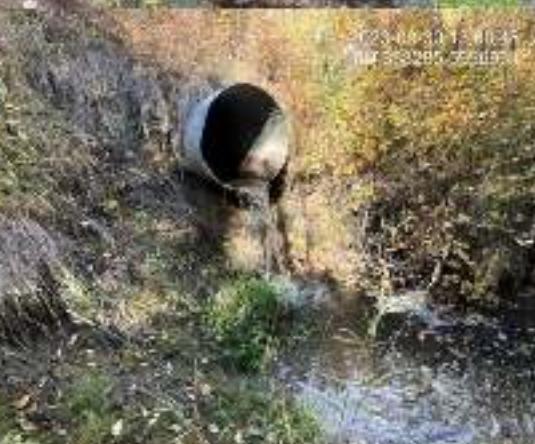
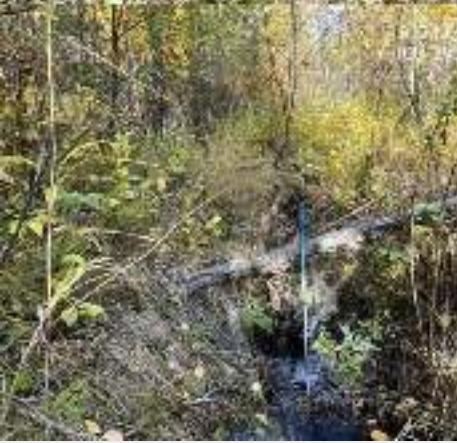
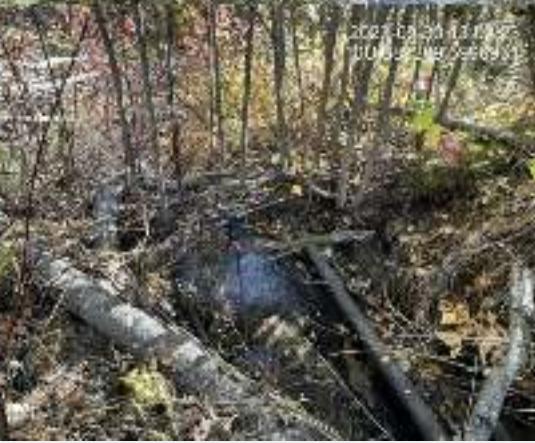
Photos: PSCIS ID 5400203. From top left clockwise: Road/Site Card, Barrel, Outlet, Downstream, Upstream, Inlet.

Comments: Very nice little stream with excellent flow for this time of year on a dry year. Crossing downstream on Gala Bay Road was fully embedded and passible at the time of the assessment. There is a historic chinook observation within this stream. This could be valuable Chinook rearing habitat and connectivity within the system should be restored, should no natural barriers be observed on a habitat confirmation assessment. MoTi chris_culvert_id: 1794198, 1794199. 12:47:26

| Location and Stream Data | | Crossing Characteristics | |
|---|--|---|---|
| Fix type | Replace with New Open Bottom Structure | Fix Span / Diameter | 21 |

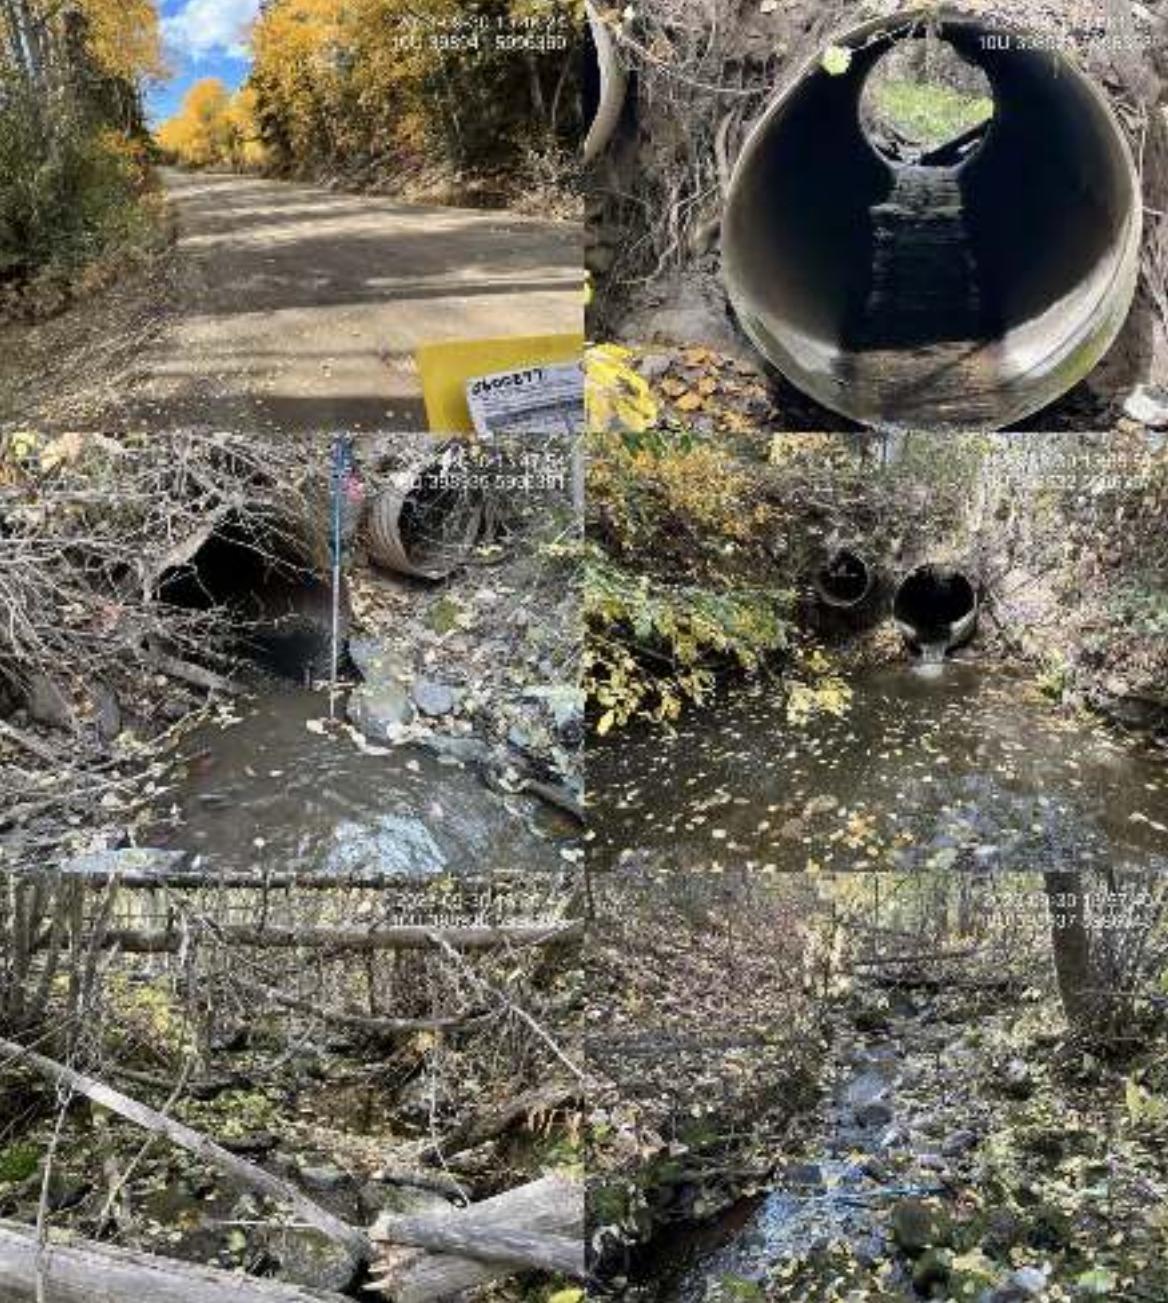
Photos: PSCIS ID 15600277. From top left clockwise: Road/Site Card, Barrel, Outlet, Downstream, Upstream, Inlet.

Comments: Very nice stream with excellent flow for this time of year on a dry year. Very large deep outlet pool with extensive erosion undercutting the main pipe and 0.6 m overflow. Locally known as Dog Creek. Chinook captured upstream and downstream of Dog Creek FSR in 2021, 2022, and 2023 reported here <https://a100.gov.bc.ca/pub/acat/public/viewReport.do?reportId=62942>. Connected to the Nechako River with observed chinook points downstream adjacent to the confluence. Road edge is failing at the culvert and eroding into stream. Highly degraded site upstream that would be a good candidate for restoration. MoTi chris_culvert_id: 1794340. 13:43:26

| Location and Stream Data | | Crossing Characteristics | |
|---|--|---|---|
| Fix type | Replace with New Open Bottom Structure | Fix Span / Diameter | 15 |

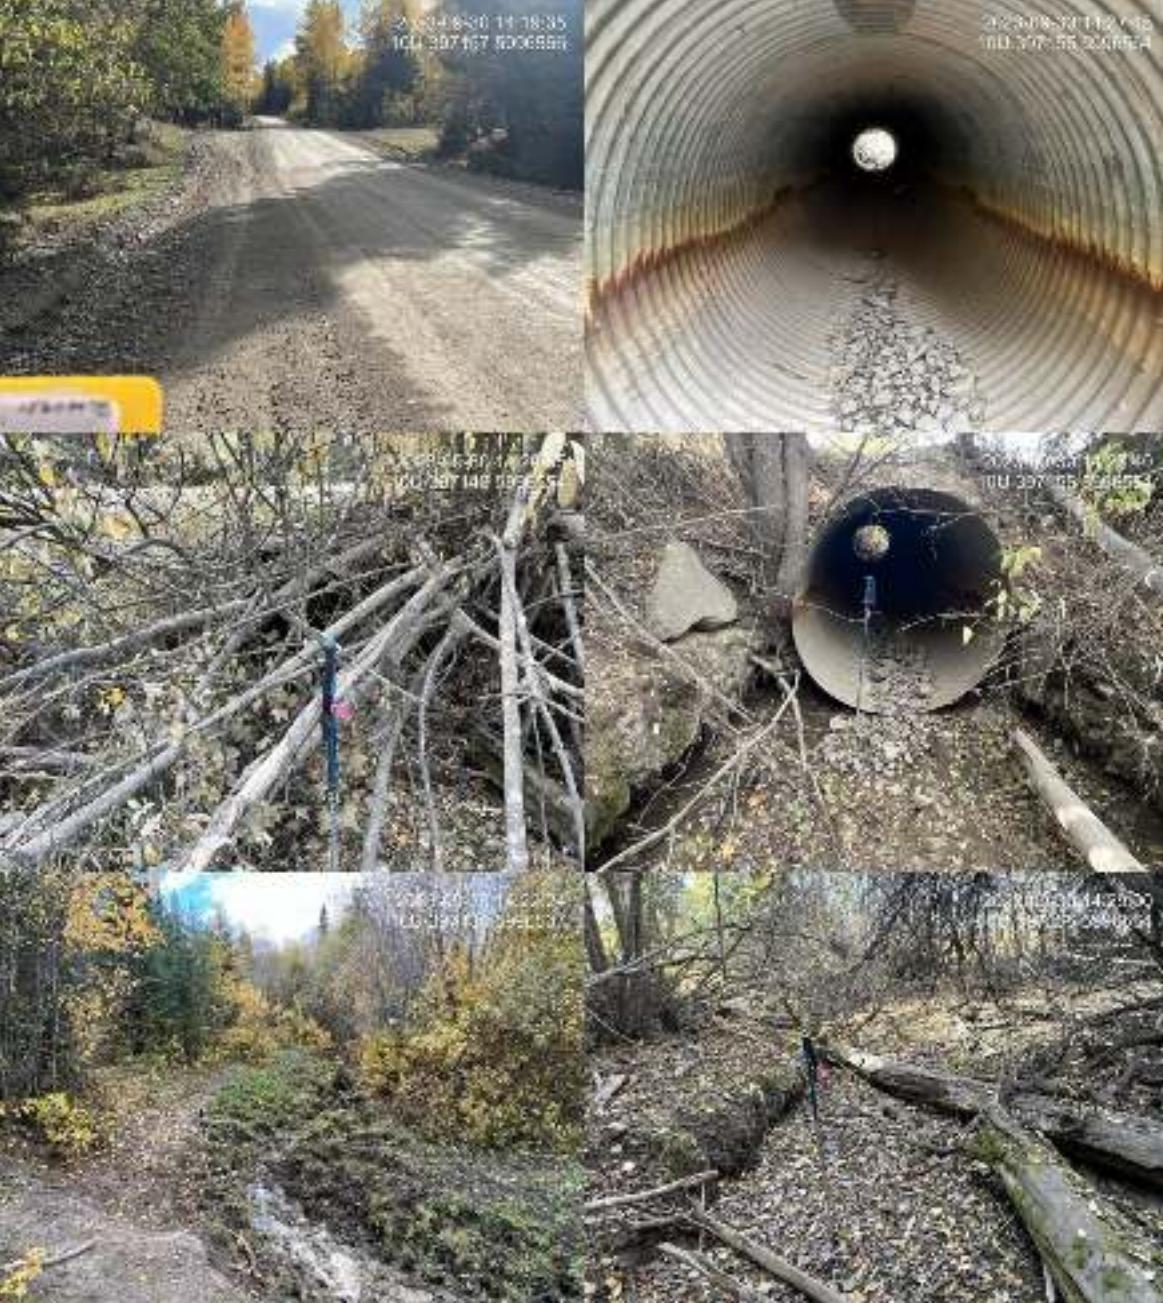
Photos: PSCIS ID 15604478. From top left clockwise: Road/Site Card, Barrel, Outlet, Downstream, Upstream, Inlet.

Comments: Extreme negative impacts due to cattle, particularly upstream of the FSR. Extensive trampling of the channel and banks, along with heavy grazing and removal of riparian. Dry at the time of assessment besides a small wallowing hole upstream of the inlet. Riparian exclusion fencing is required along with repairing vegetation, restoration irrigation, and monitoring. This is a fish bearing stream with high habitat values less than 2 km down the stream where it crosses Dog Creek Road.. 14:17:41

| Location and Stream Data | | Crossing Characteristics | |
|---|--|---|---|
| Fix type | Replace with New Open Bottom Structure | Fix Span / Diameter | 15 |

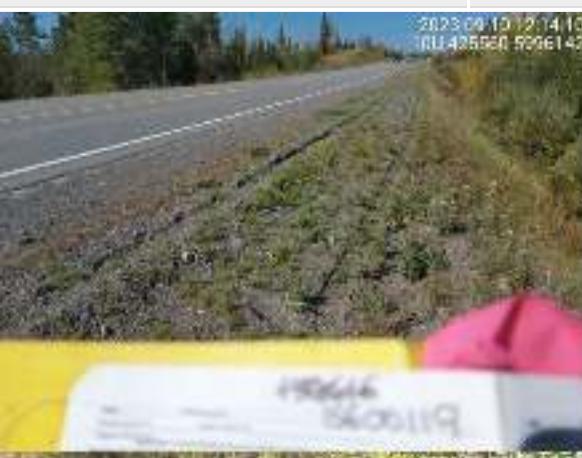
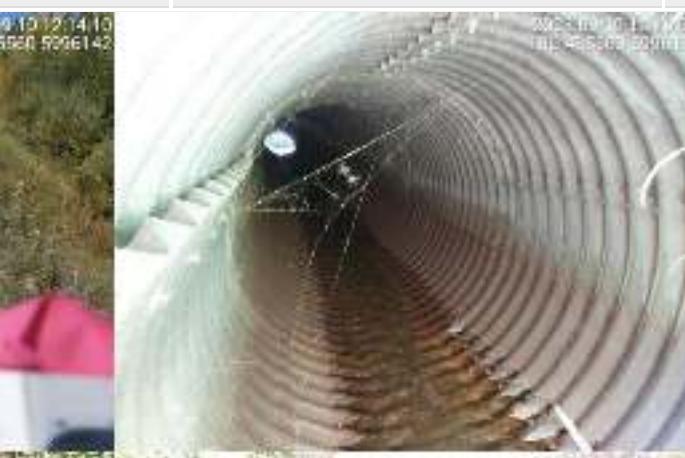
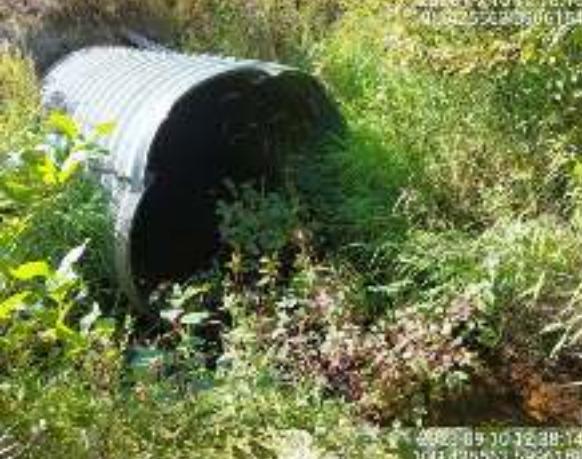
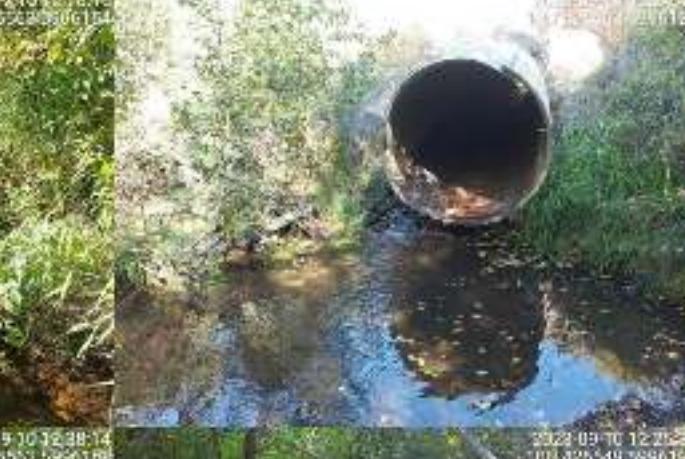
Photos: PSCIS ID 15600119. From top left clockwise: Road/Site Card, Barrel, Outlet, Downstream, Upstream, Inlet.

Comments: High value habitat, wide channel with good flow and gravels. Known chinook system downstream. Culvert is very damaged near outlet. There are holes on bottom of pipe about 5m from outlet where water is running through and under the pipe. Culvert is angled down near outlet. Good candidate for replacement. MoTi chris_culvert_id: 1806163.
12:15:10

| Location and Stream Data | | Crossing Characteristics | |
|---|--|---|---|
| Fix type | Replace with New Open Bottom Structure | Fix Span / Diameter | 15 |

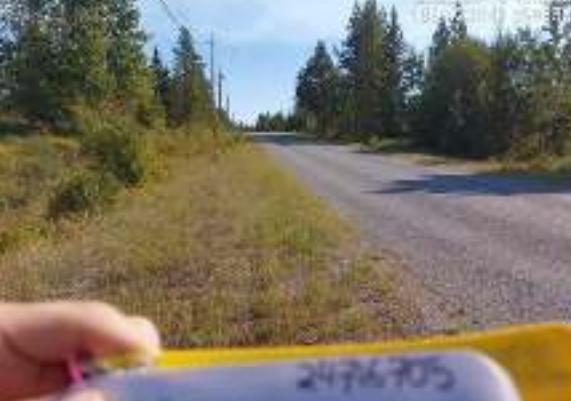
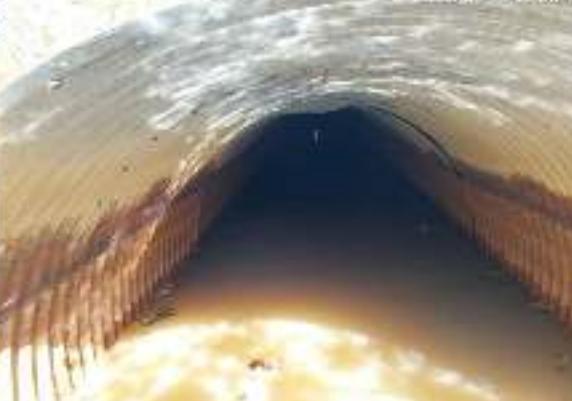
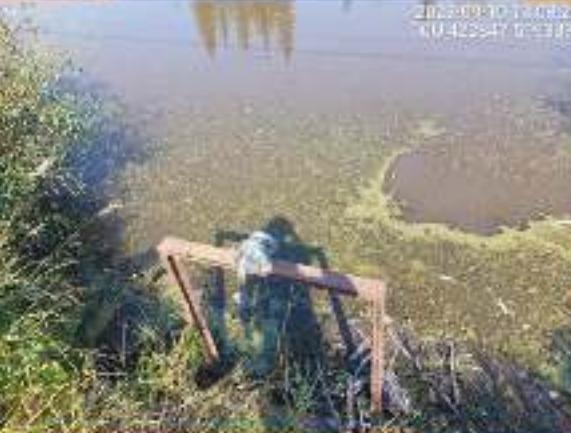
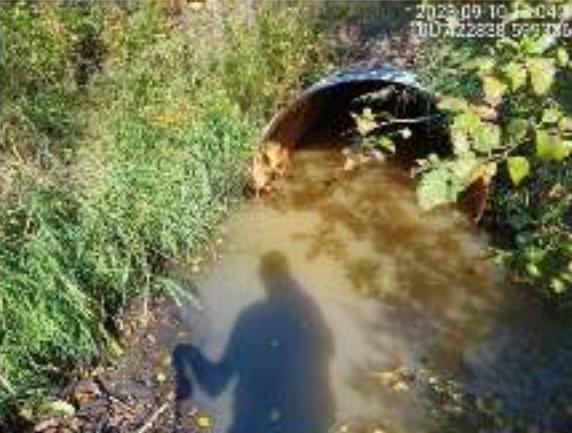
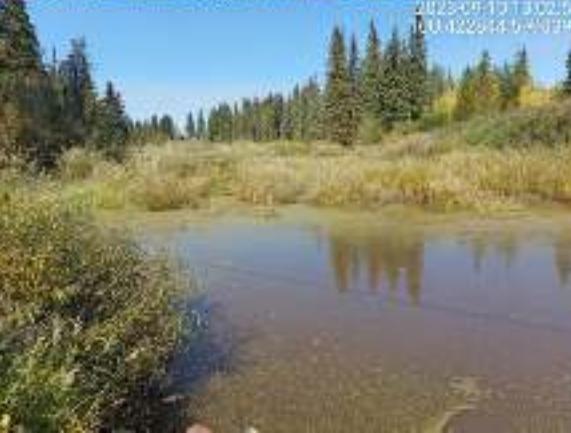
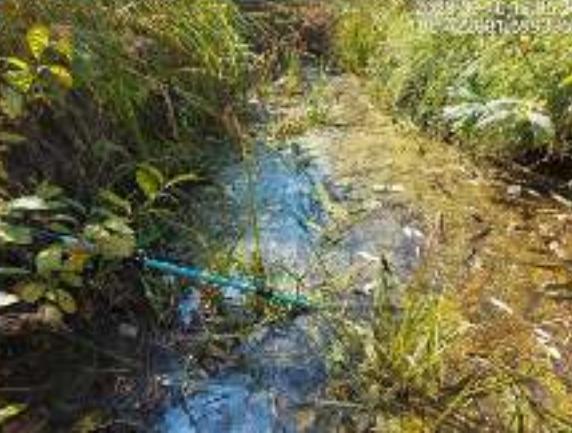
Photos: PSCIS ID 24716705. From top left clockwise: Road/Site Card, Barrel, Outlet, Downstream, Upstream, Inlet.

Comments: Inlet almost completely blocked by debris and wood. Wetland upstream. Beaver dam blocking most of water just downstream of outlet pool. Chinook observations noted downstream MoTi chris_culvert_id: 1804629. 13:01:50

| Location and Stream Data | | Crossing Characteristics | |
|---|--|---|---|
| Fix type | Replace with New Open Bottom Structure | Fix Span / Diameter | 15 |

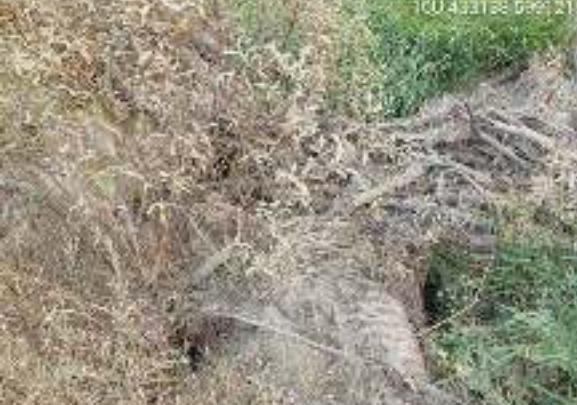
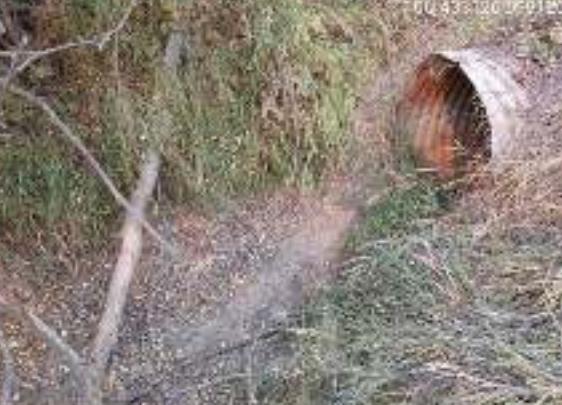
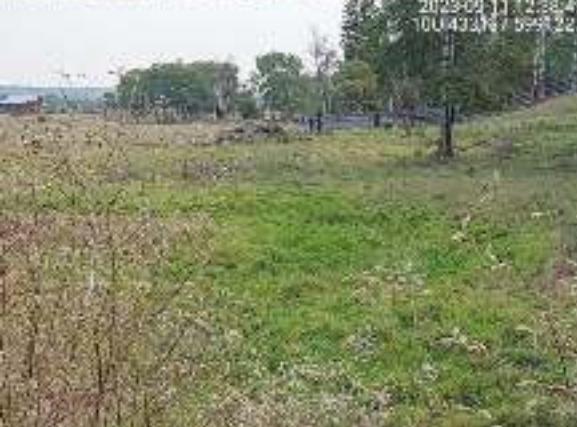
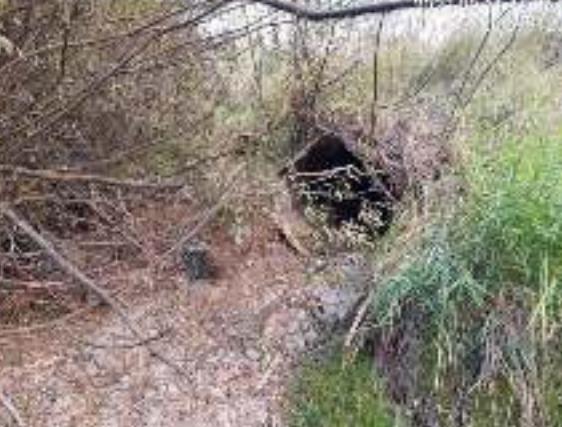
Photos: PSCIS ID 15600182. From top left clockwise: Road/Site Card, Barrel, Outlet, Downstream, Upstream, Inlet.

Comments: Very big outlet drop and deep outlet pool. Trickle of water flowing through culvert. Dewatered downstream of outlet pool and dewatered upstream of culvert. Channel width taken upstream but channel is wider downstream of crossing. Culvert is warped and a little corroded. Channel primarily vegetated.. 13:09:19

| Location and Stream Data | . | Crossing Characteristics | - |
|---|---|---|---|
| Fix type | Replace Structure with Streambed Simulation CBS | Fix Span / Diameter | 3 |

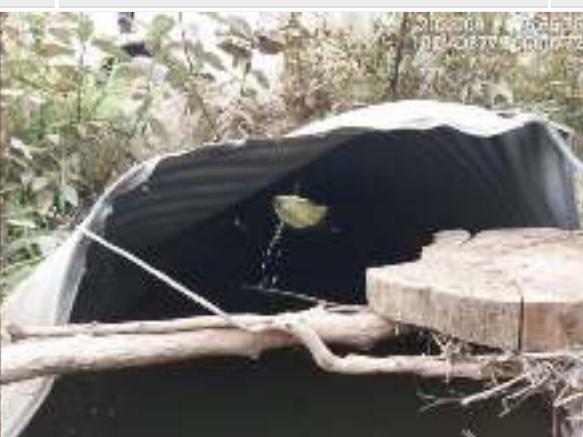
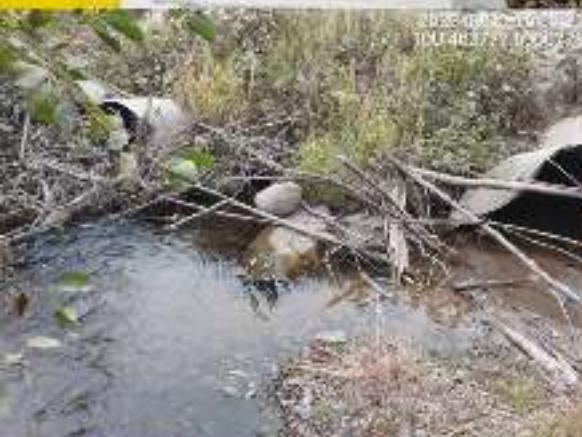
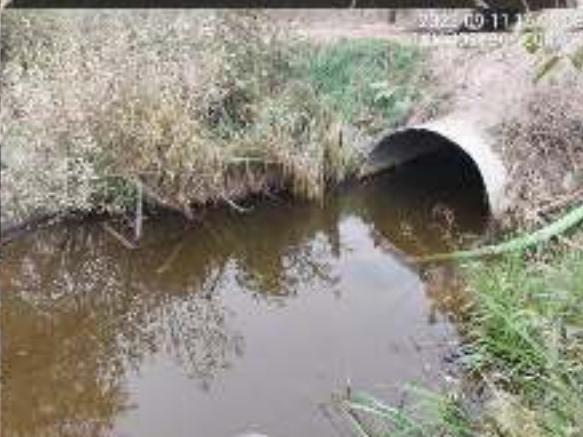
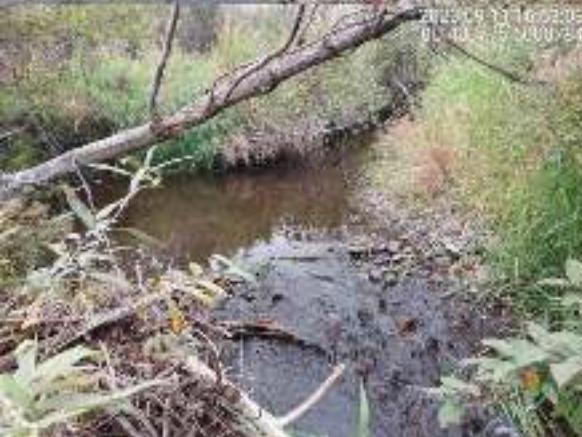
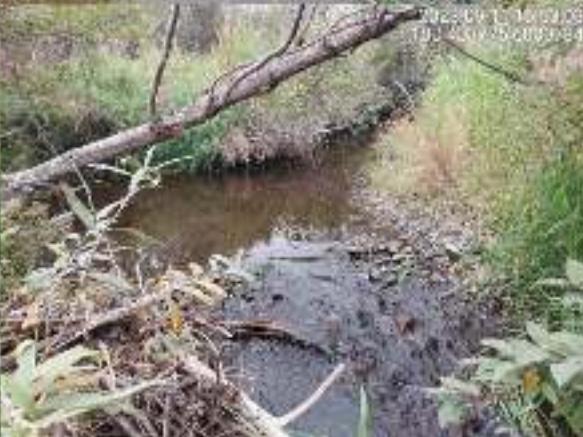
Photos: PSCIS ID 15600285. From top left clockwise: Road/Site Card, Barrel, Outlet, Downstream, Upstream, Inlet.

Comments: Two pipes (one at 1.8m, one at 1.5m), both with similar outlet drops. Inlet side has extensive beaver activity. Beaver dams are covering the inlet and culverts are not visible. Huge wetland upstream. Very big outlet pool so depth was estimated. Chinook were captured downstream of Settlement Road culvert in 2021 (<https://a100.gov.bc.ca/pub/acat/public/viewReport.do?reportId=61991>) and Rainbow Trout observed in stream from 2021-2023 (<https://a100.gov.bc.ca/pub/acat/public/viewReport.do?reportId=61202> and <https://a100.gov.bc.ca/pub/acat/public/viewReport.do?reportId=62942>). Culverts should be replaced and beaver activity managed. Habitat looks good downstream. High habitat value at crossing upstream. MoTi chris_culvert_id: 1793922, 1793923. 17:26:25

| Location and Stream Data | | Crossing Characteristics | |
|---|--|---|---|
| Fix type | Replace with New Open Bottom Structure | Fix Span / Diameter | 15 |
