Appendix - Phase 1 Fish Passage Assessment Data and Photos

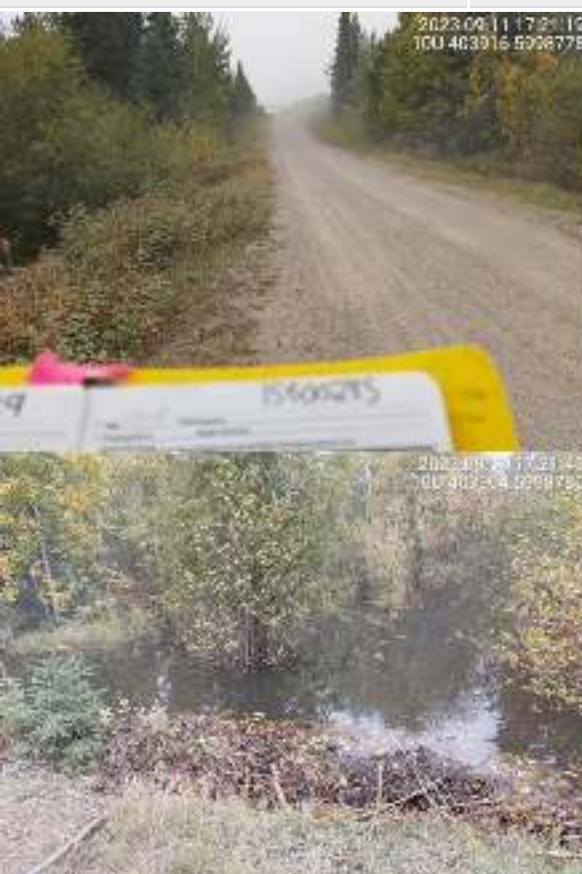
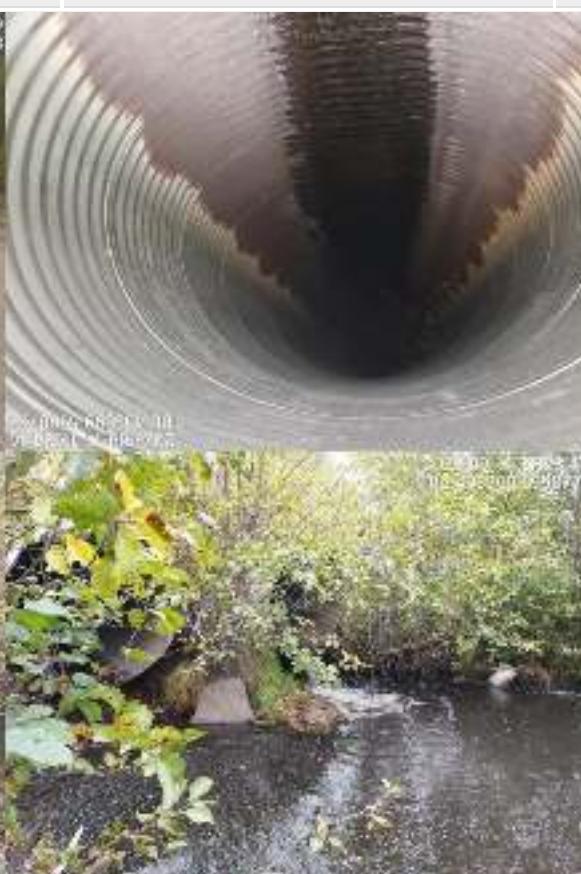
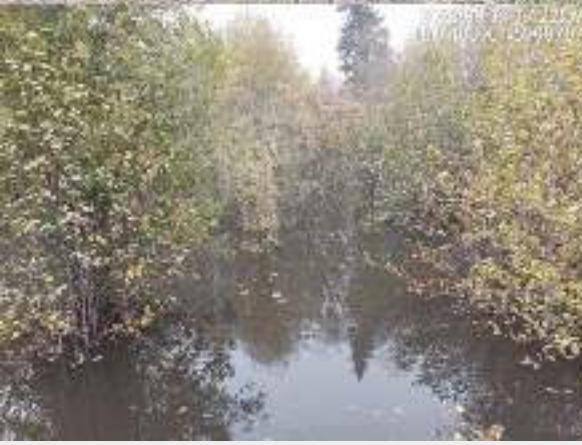
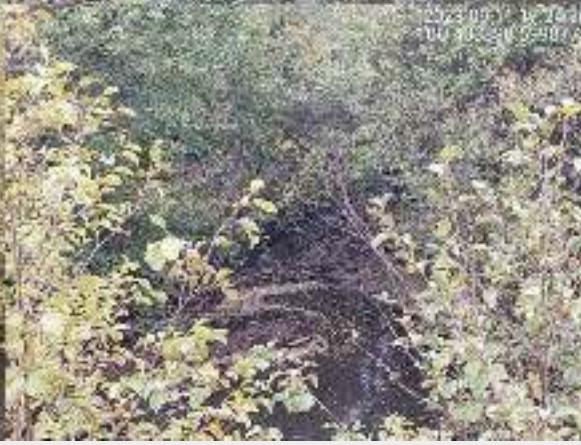
Photos: PSCIS ID 15600427. From top left clockwise: Road/Site Card, Barrel, Outlet, Downstream, Upstream, Inlet.

Comments: Dewatered stream. Large outlet pool. Pipe very corroded on outlet side. Wide stream channel upstream. Grassy channel downstream. Fully backwatered at time of assessment. MoTi chris_culvert_id: 3738843. 08:55:03

| Location and Stream Data | | Crossing Characteristics | |
|---|--|---|---|
| Fix type | Replace with New Open Bottom Structure | Fix Span / Diameter | 15 |

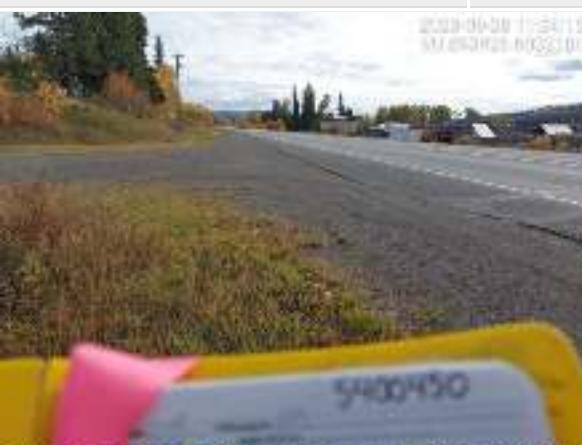
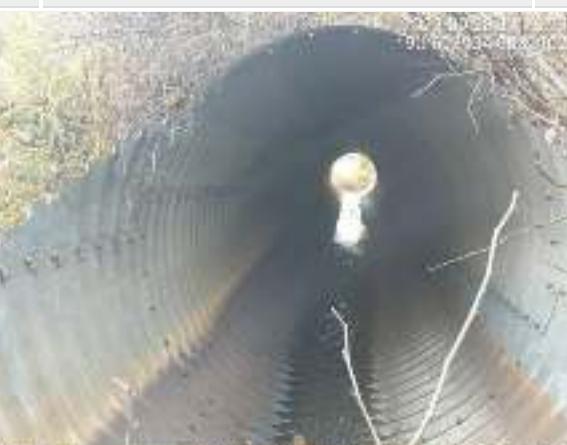
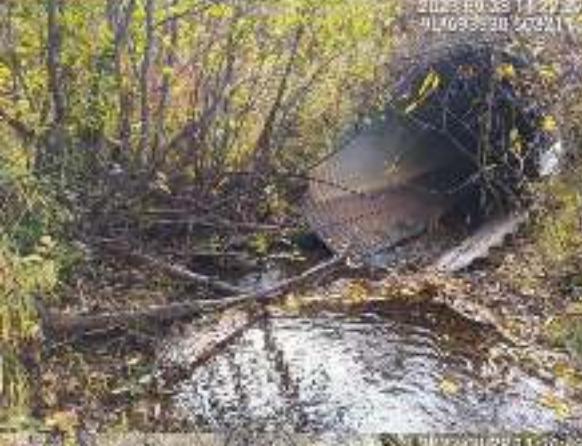
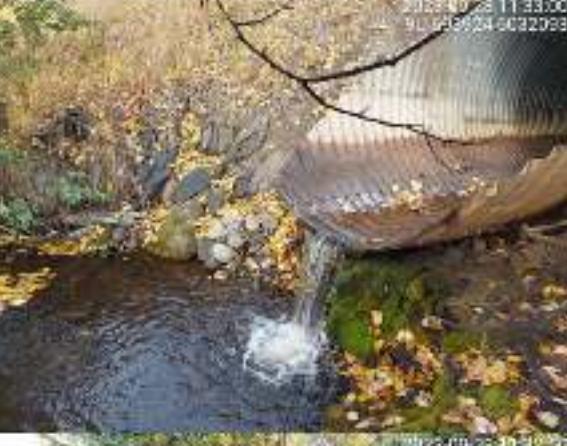
Comments: Dewatered at time of assessment. Wide channel, private land on both sides. Culvert looks old and corroded, abundant fill in barrel. MoTi chris_culvert_id: 2076438. 12:44:04

| Location and Stream Data | . | Crossing Characteristics | — |
|---|--|---|---|
| Fix type | Replace with New Open Bottom Structure | Fix Span / Diameter | 15 |

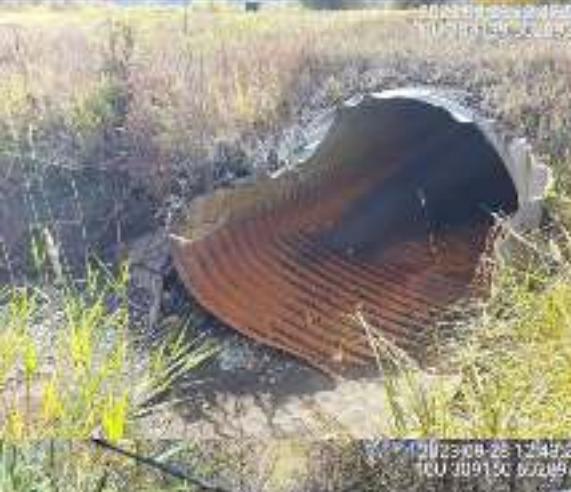
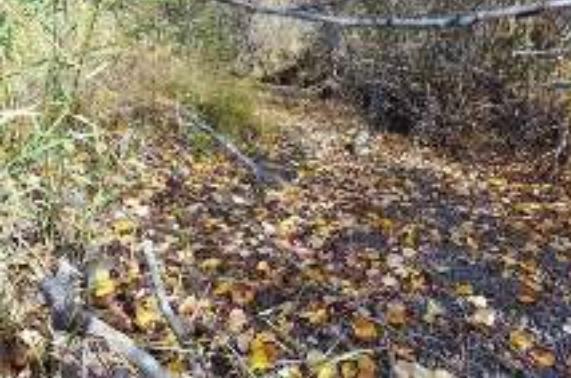
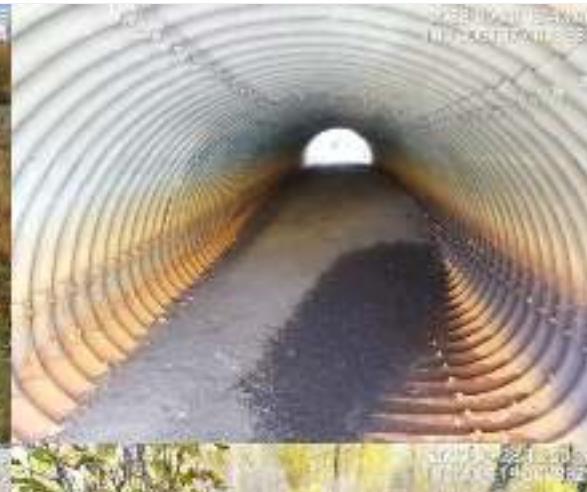
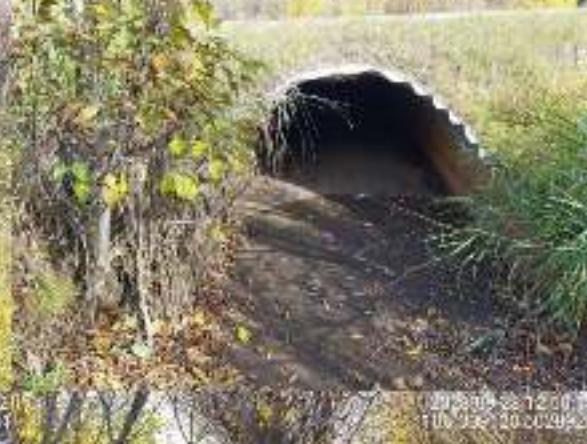
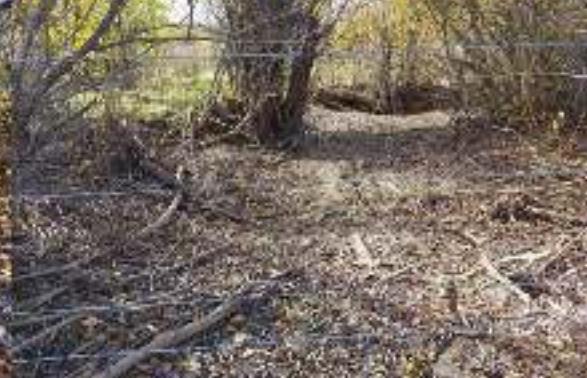
Photos: PSCIS ID 5400440. From top left clockwise: Road/Site Card, Barrel, Outlet, Downstream, Upstream, Inlet.

Comments: Dewatered at time of assessment. Small pool near outlet. Rainbow confirmed in past upstream. Two 3m falls noted 450m upstream. in FISS. Culvert is very old, corroded and has holes in bottom. MoTi chris_culvert_id: 2076418. 13:18:49

| Location and Stream Data | | Crossing Characteristics | |
|---|--|---|---|
| Fix type | Replace with New Open Bottom Structure | Fix Span / Diameter | 15 |

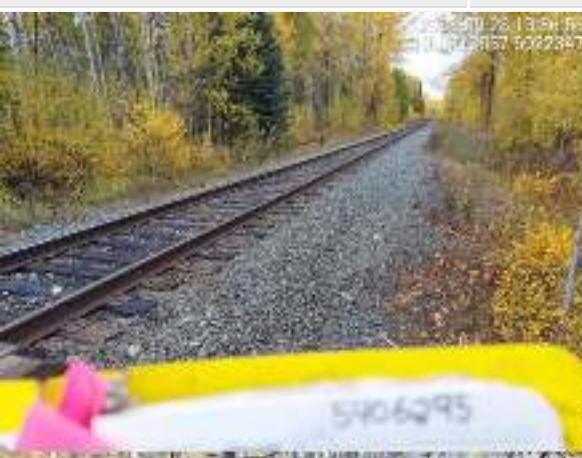
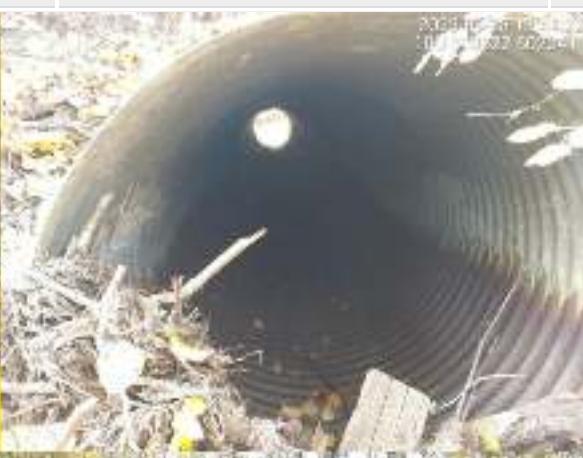
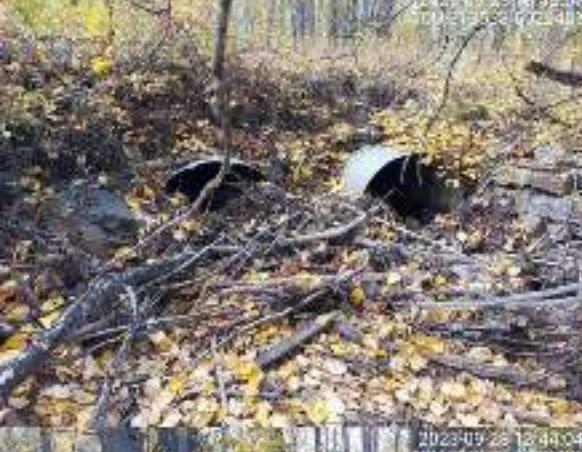
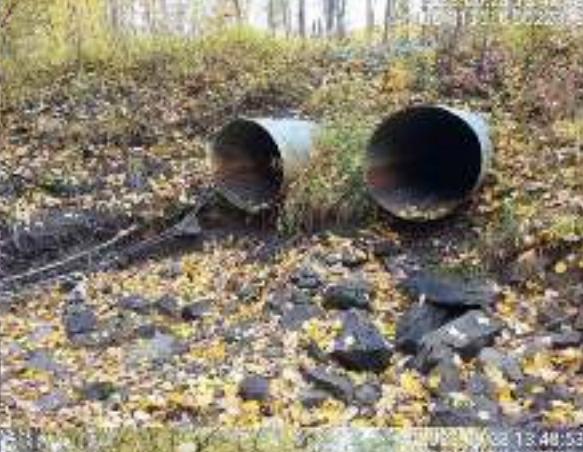
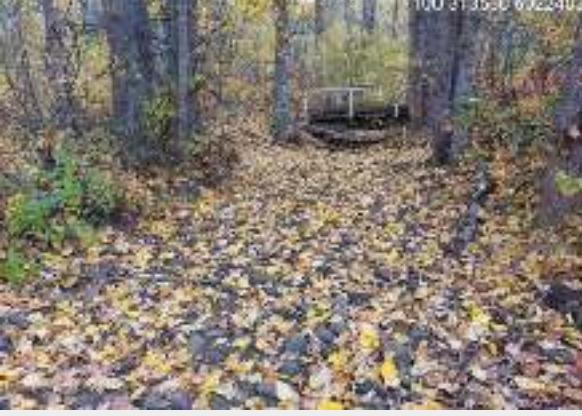
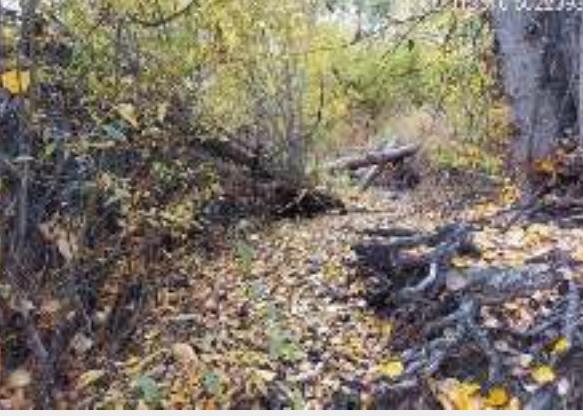
Photos: PSCIS ID 5400044. From top left clockwise: Road/Site Card, Barrel, Outlet, Downstream, Upstream, Inlet.

Comments: Dewatered stream at time of survey. Wide channel, abundant boulders downstream of crossing. Rainbow confirmed upstream in past. Culvert is old and corroded badly on outlet side. Stream most likely flows under culvert near outlet during high flow. MoTi chris_culvert_id: 2076407. 14:15:04

| Location and Stream Data | | Crossing Characteristics | |
|---|--|---|---|
| Fix type | Replace with New Open Bottom Structure | Fix Span / Diameter | 15 |

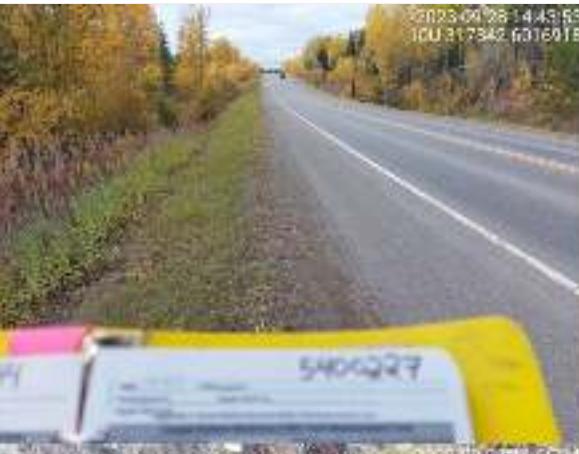
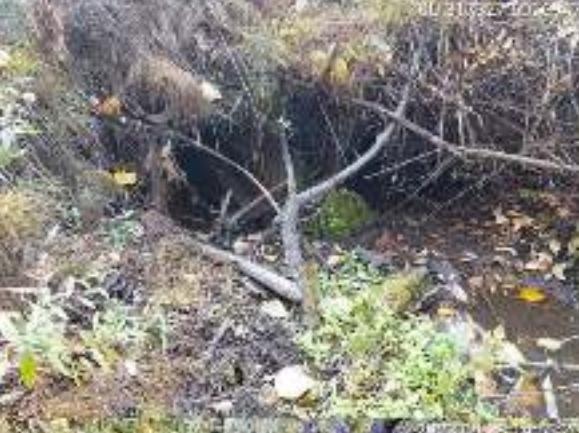
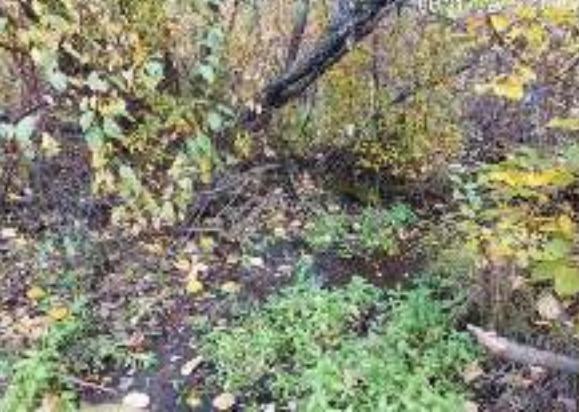
Photos: PSCIS ID 5400286. From top left clockwise: Road/Site Card, Barrel, Outlet, Downstream, Upstream, Inlet.

Comments: Small fry spotted in culvert and in outlet pool. Two pipes, both old and corroded with large outlet drops.

Small holes in both pipes causing some water to flow under pipe. Very low fill depth, culverts almost at highway. Near Burns Lake, in residential area. Habitat looks good upstream. RB and LSU upstream in Guyishton Lake. MoTi chris_culvert_id: 2070299, 2070298. 15:48:58

| Location and Stream Data | | . | Crossing Characteristics | - |
|---|--|---|---|---|
| Fix type | Replace with New Open Bottom Structure | | Fix Span / Diameter | 15 |

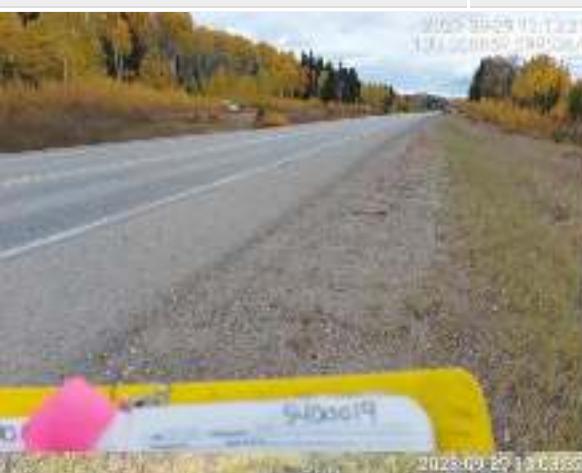
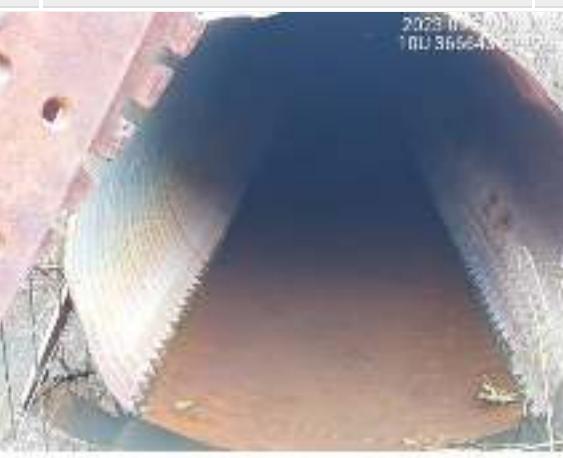
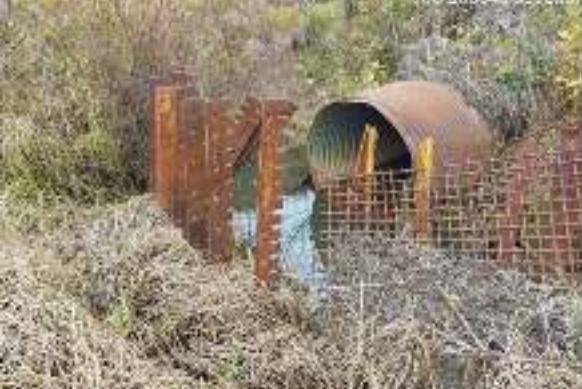
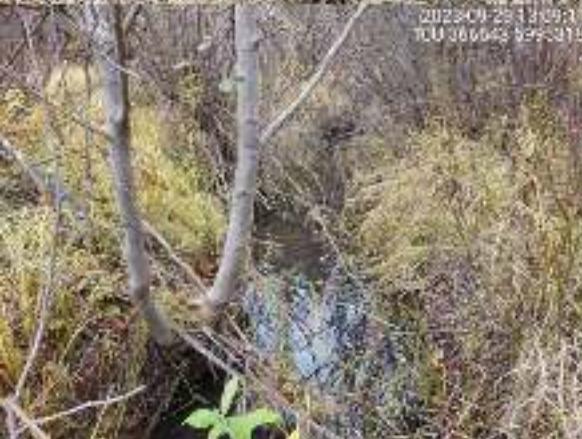
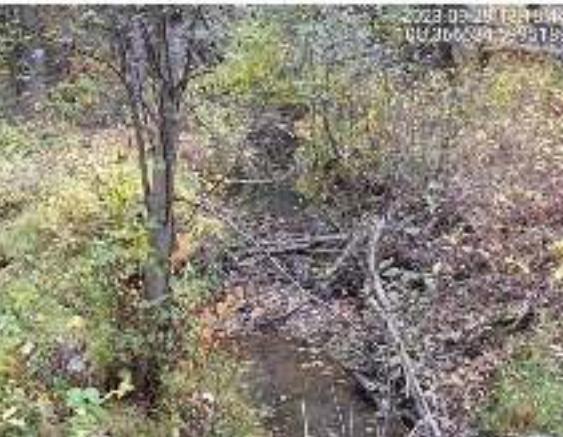
Photos: PSCIS ID 5400019. From top left clockwise: Road/Site Card, Barrel, Outlet, Downstream, Upstream, Inlet.

Comments: Culverts runs underneath highway and railway. Outlet could not be located Creek found below railway and flows to the Endako confluence. Beaver grate on inlet side. MoTi chris_culvert_id: 1793819. 13:07:39

| Location and Stream Data | | Crossing Characteristics | |
|---|---|---|---|
| Fix type | Replace Structure with Streambed Simulation CBS | Fix Span / Diameter | 3 |

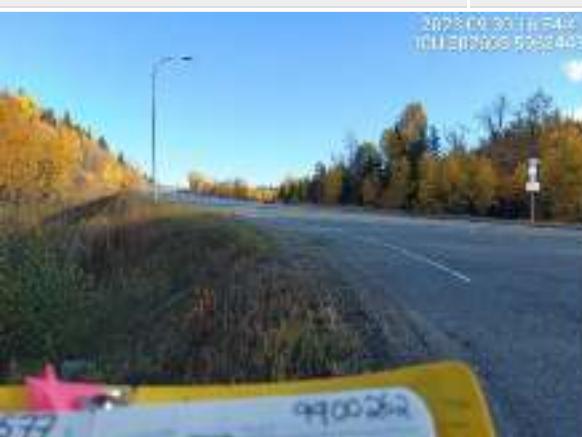
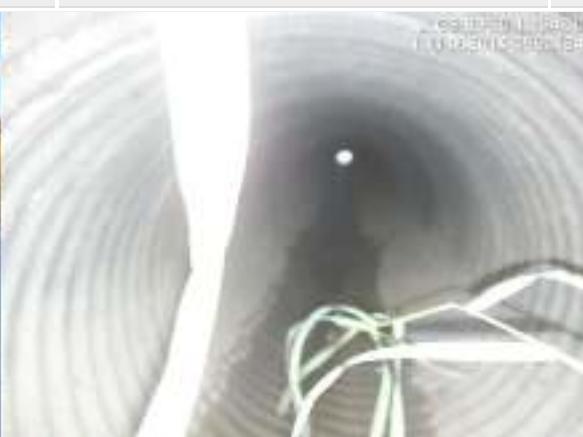
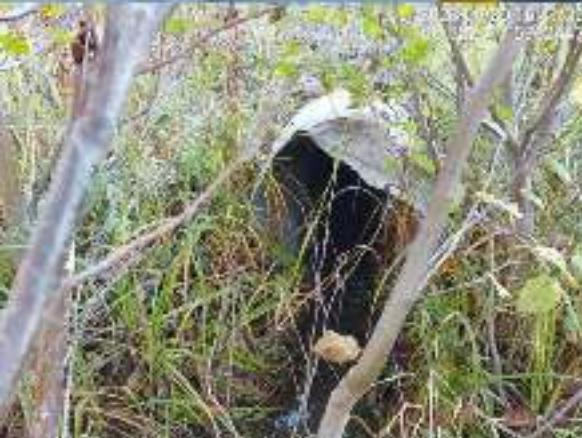
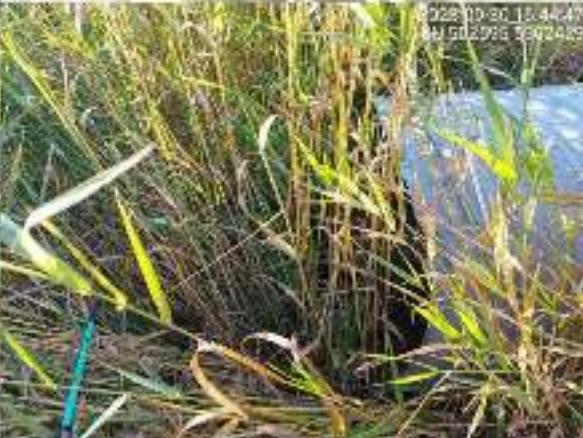
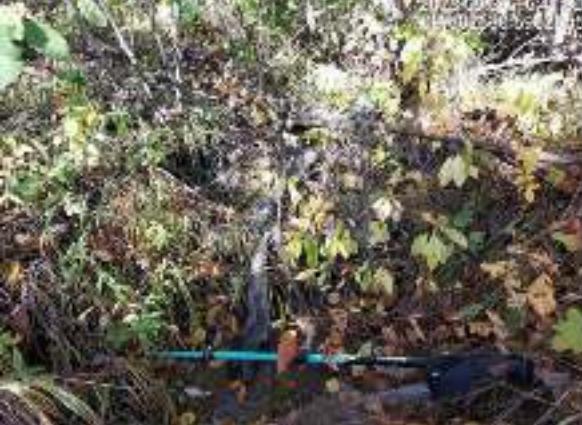
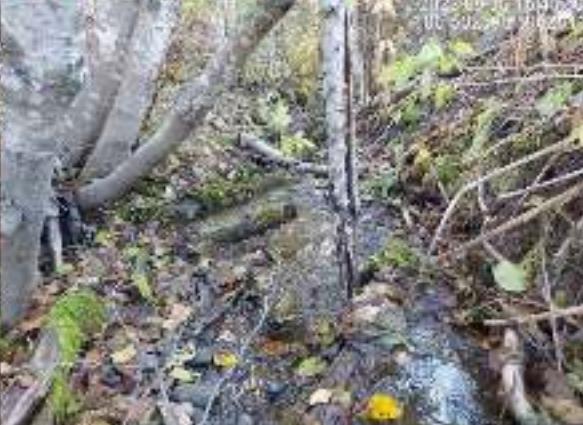
Photos: PSCIS ID 9900262. From top left clockwise: Road/Site Card, Barrel, Outlet, Downstream, Upstream, Inlet.

Comments: Two pipes but only one is functioning and has small amount of flow through it. Very small channel.
 Observed chinook in FISS downstream of confluence with Beaverley Creek at ~100m from the crossing and ~30m from the confluence. MoTi chris_culvert_id: 1975199. 16:46:37

| Location and Stream Data | . | Crossing Characteristics | – |
|---|---|---|---|
| Fix type | Replace Structure with Streambed Simulation CBS | Fix Span / Diameter | 3 |

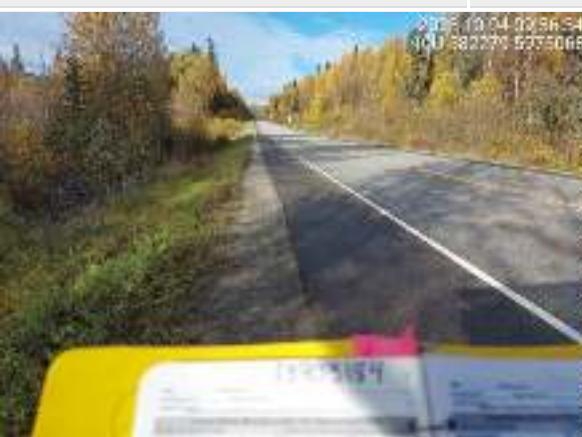
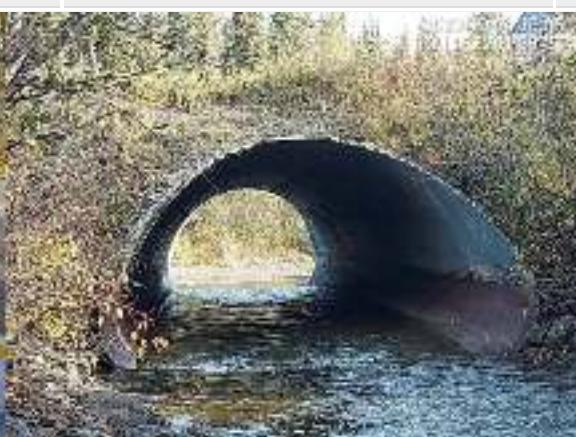
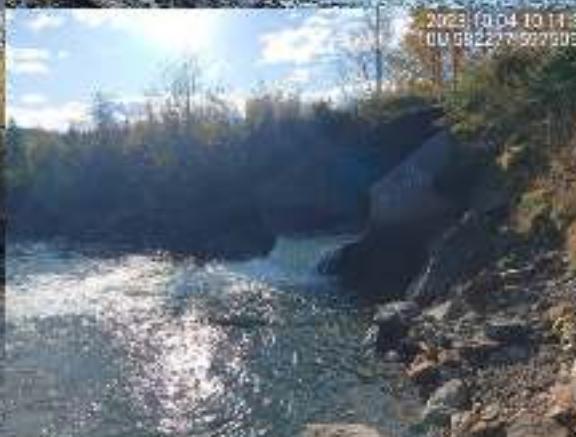
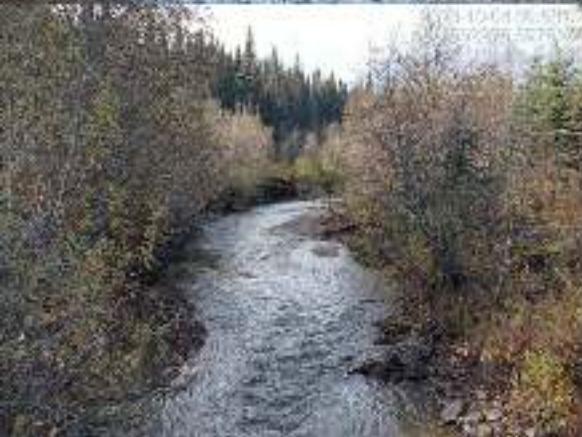
Photos: PSCIS ID 13903184. From top left clockwise: Road/Site Card, Barrel, Outlet, Downstream, Upstream, Inlet.

Comments: Very wide stream with high flow. Velocity is high in culvert. Very deep and big outlet pool, depth estimated. Known salmon spawning location. Chinook confirmed with carcass noted just upstream in 2022 by same field team.
MoTi chris_hwy_structure_road_id: 3750. 10:13:57

| Location and Stream Data | | Crossing Characteristics | |
|---|--|---|---|
| Fix type | Replace with New Open Bottom Structure | Fix Span / Diameter | 15 |

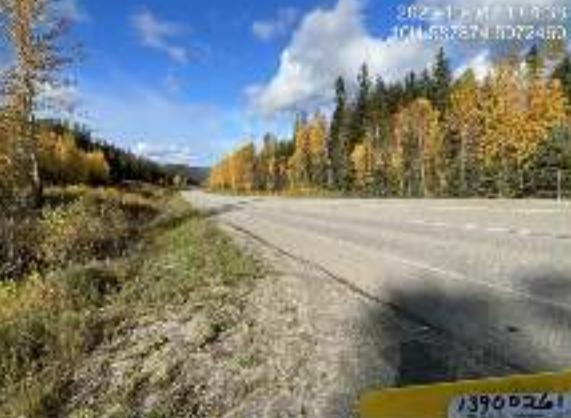
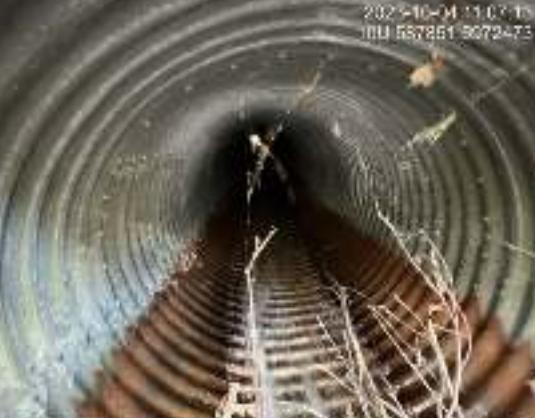
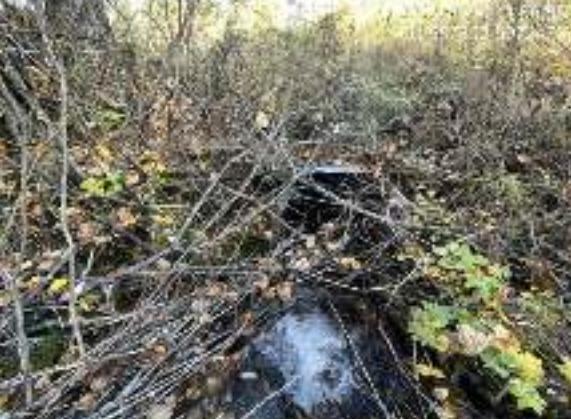
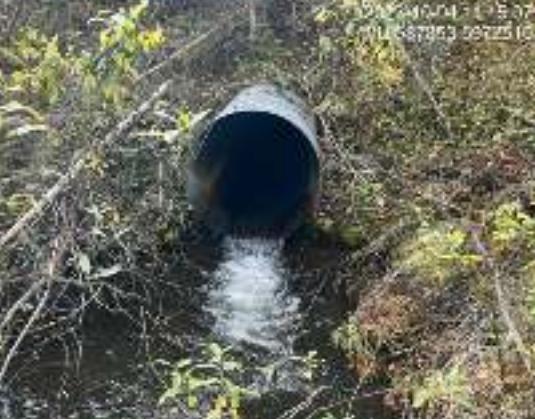
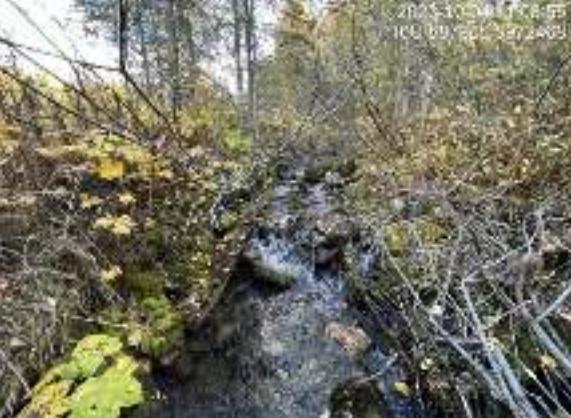
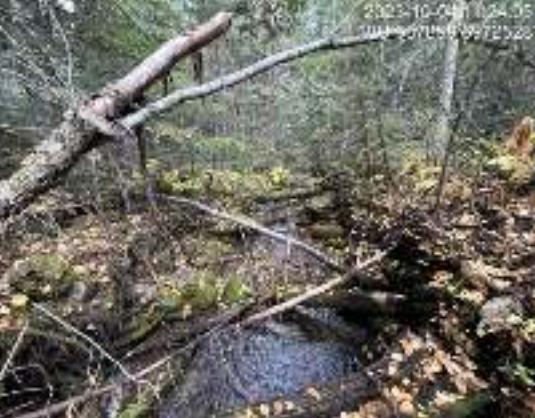
Photos: PSCIS ID 13900261. From top left clockwise: Road/Site Card, Barrel, Outlet, Downstream, Upstream, Inlet.

Comments: Large stream with abundant gravels present upstream suitable for spawning. Massive outlet drop with powerline riparian cleared downstream of the highway. Old growth cedar hemlock riparian within Sugar bowl grizzly den provincial park. Follow up with habitat confirmation recommended. MoTi chris_culvert_id: 1992815. 11:30:20

| Location and Stream Data | | Crossing Characteristics | |
|---|--|---|---|
| Fix type | Replace with New Open Bottom Structure | Fix Span / Diameter | 30 |

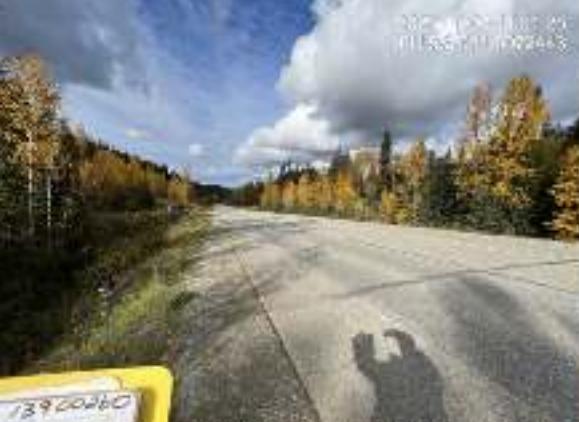
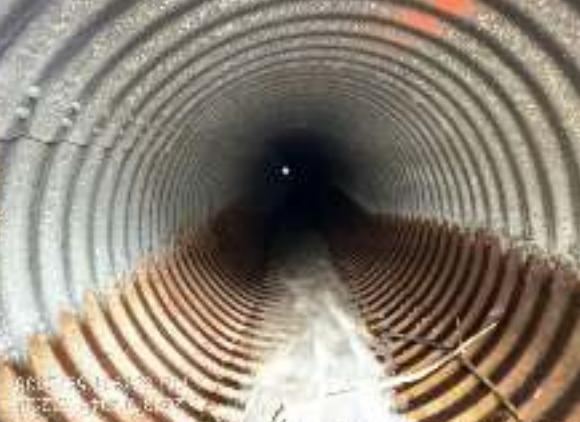
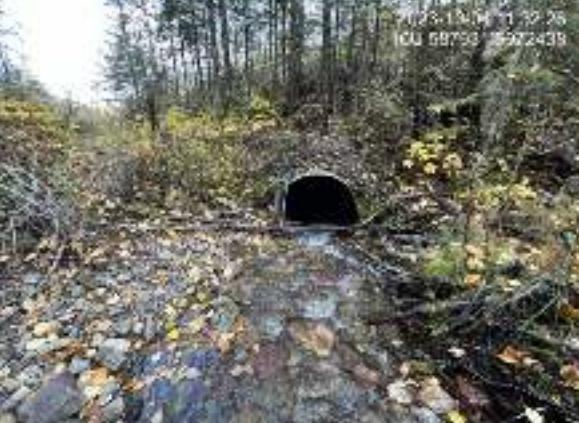
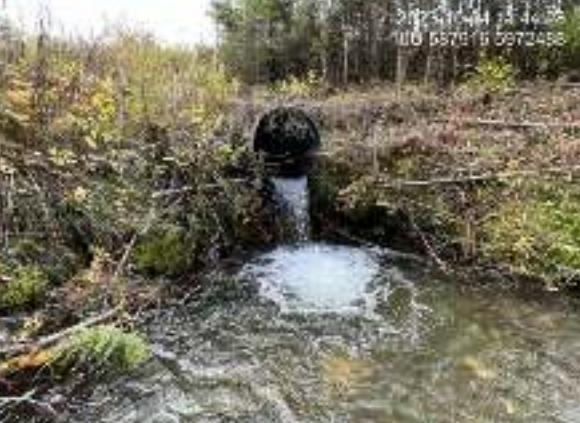
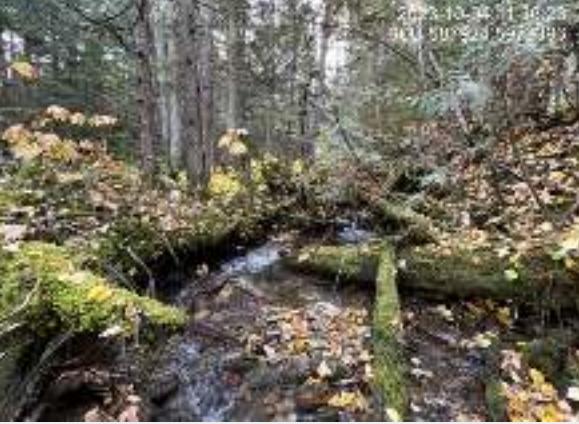
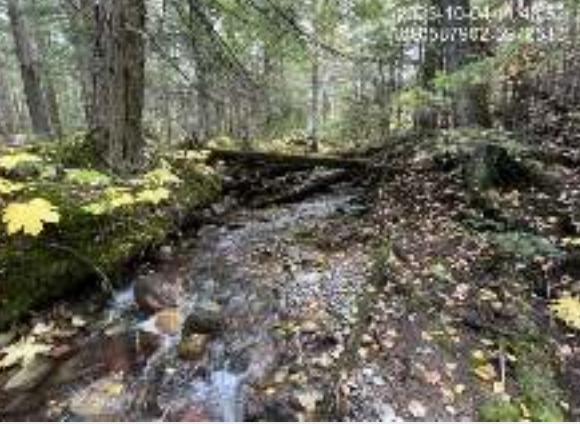
Photos: PSCIS ID 13900260. From top left clockwise: Road/Site Card, Barrel, Outlet, Downstream, Upstream, Inlet.

Comments: Culvert very old. Big wetland complex upstream. Inlet barely visible, covered in woody debris and rusty metal. Culvert slope estimated. High velocity coming out of outlet with moderate drop. Habitat looks good downstream, wide channel with high flow. Crossing is within the Sugarbowl grizzly den provincial park. MoTi chris_culvert_id: 1992569. 12:49:05

| Location and Stream Data | | Crossing Characteristics | |
|---|--|---|---|
| Fix type | Replace with New Open Bottom Structure | Fix Span / Diameter | 24 |

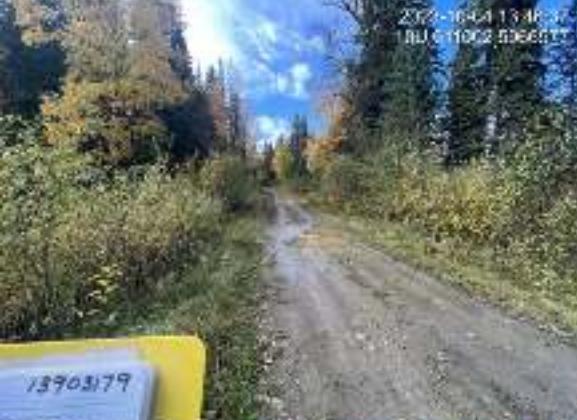
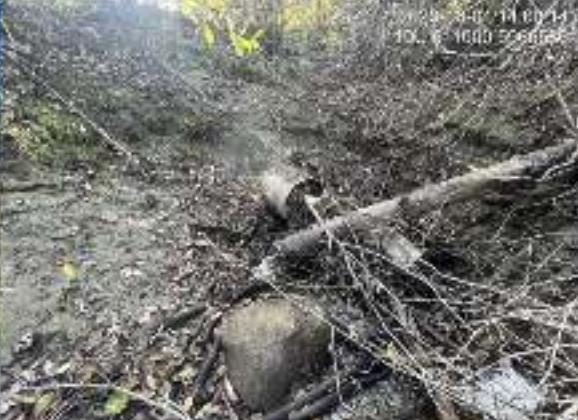
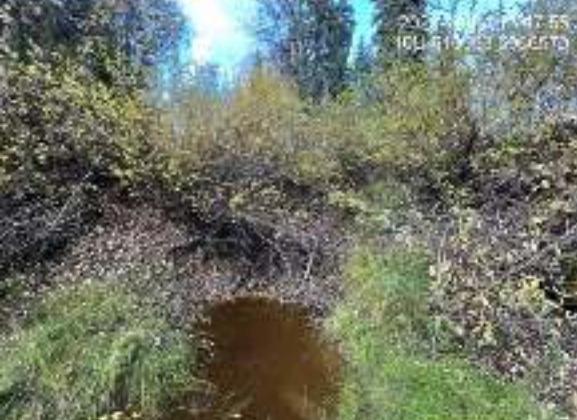
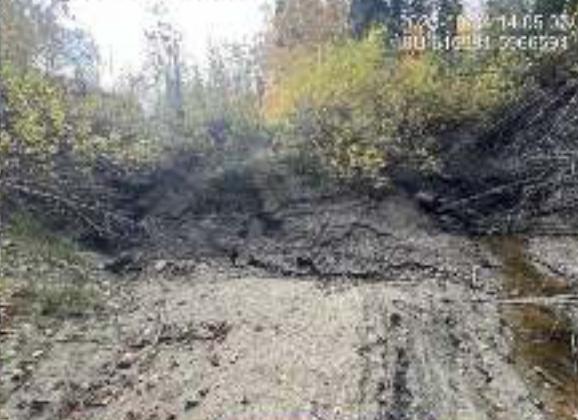
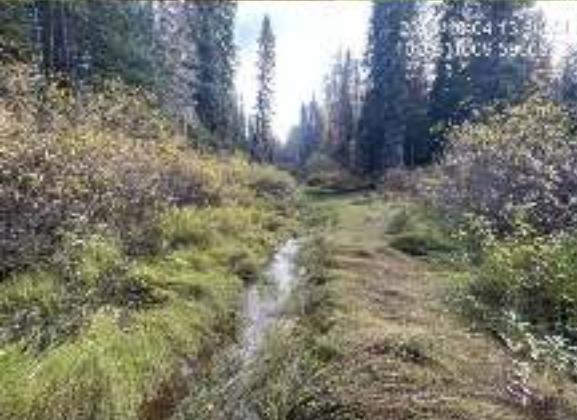
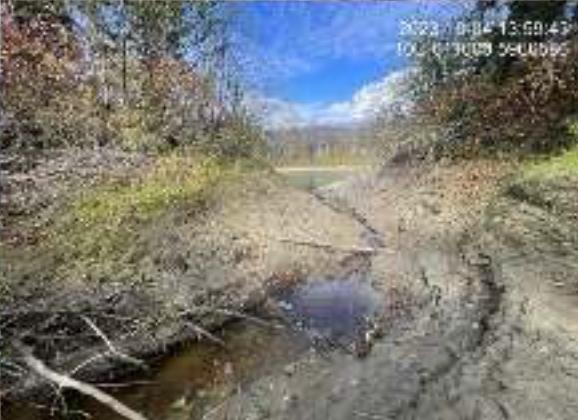
Photos: PSCIS ID 13903179. From top left clockwise: Road/Site Card, Barrel, Outlet, Downstream, Upstream, Inlet.

Comments: Big wetland upstream. Inlet could not be found, likely submerged. Small channel downstream, pipe looks old and in bad shape. Overflow pipe near first pipe but not functioning currently. MoTi chris_culvert_id: 1992855.

| Location and Stream Data | . | Crossing Characteristics | – |
|---|---|---|---|
| Fix type | Replace Structure with Streambed Simulation CBS | Fix Span / Diameter | 3 |

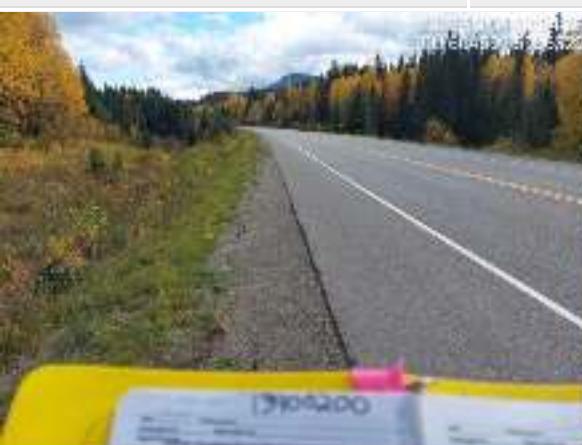
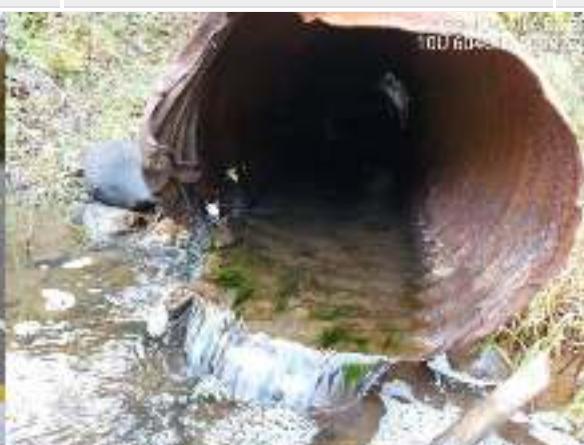
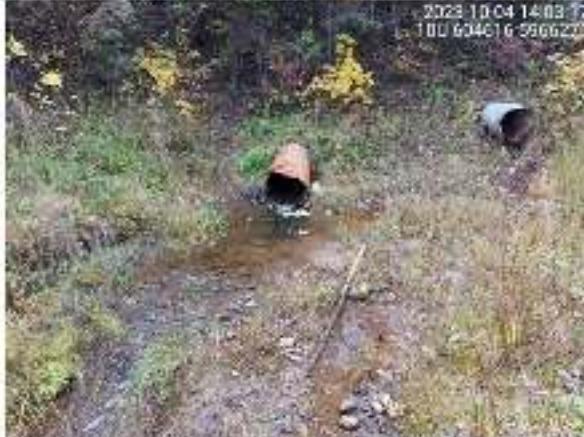
Photos: PSCIS ID 13900200. From top left clockwise: Road/Site Card, Barrel, Outlet, Downstream, Upstream, Inlet.

Comments: Could not locate pipe as it is underwater at both inlet and outlet. There appears to be a bunch of logs under the road so suspect that there may be no structure at all as the drainage may have been put in with logs - although MOT culvert layer says 0.6 m galvanized pipe.. Road is failing with 3 foot deep and 2 foot wide hole in the road marked with a pilon. MoTi chris_culvert_id: 1993428. 14:32:19

| Location and Stream Data | | Crossing Characteristics | |
|---|--|---|---|
| Fix type | Replace with New Open Bottom Structure | Fix Span / Diameter | 15 |

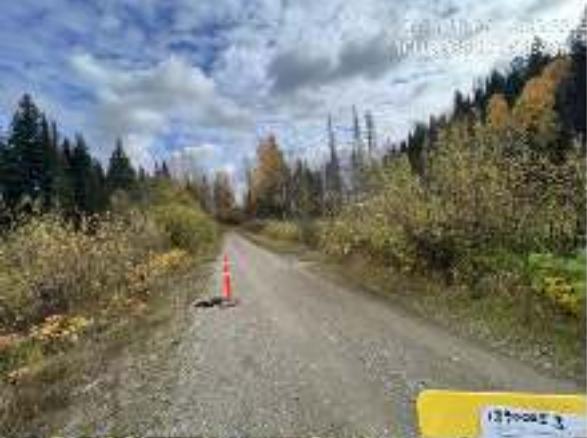
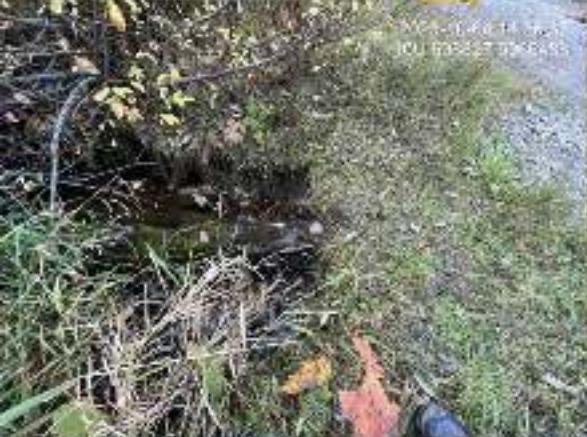
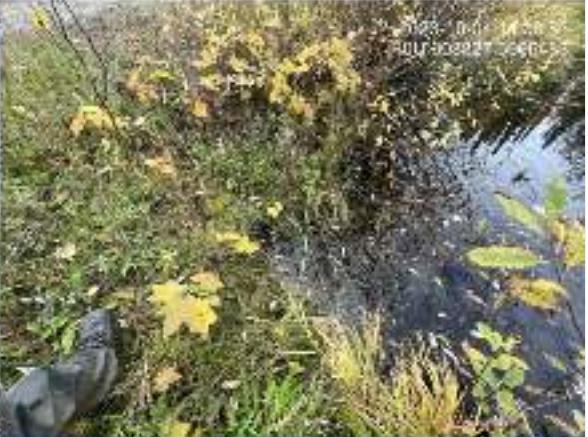
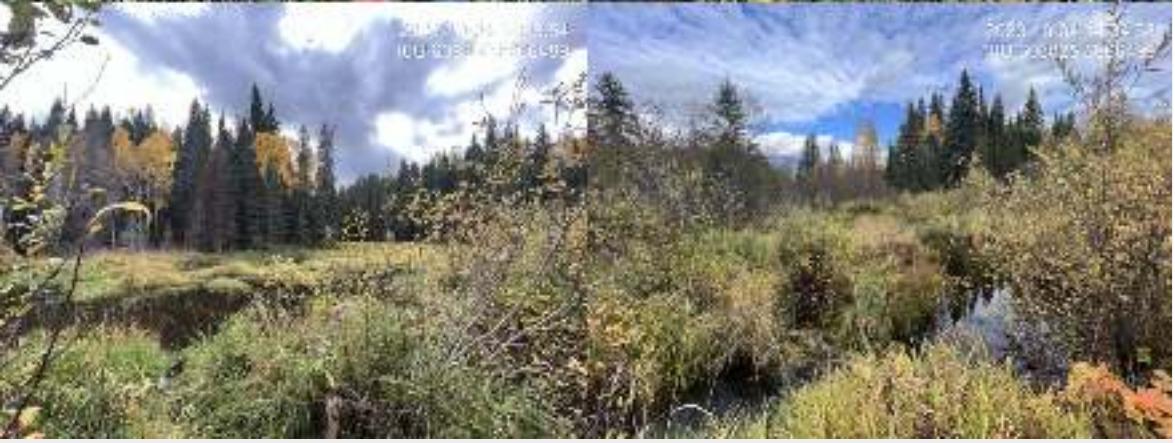
Photos: PSCIS ID 13900201. From top left clockwise: Road/Site Card, Barrel, Outlet, Downstream, Upstream, Inlet.

Comments: Big beaver dam near inlet of culvert spanning across whole channel approx 1.2m high. Boulders in pipe near inlet creating small drop and increasing velocity. Channel widens downstream, high value habitat. RB and CCG confirmed upstream and downstream with chinook observed way downstream at mouth. Low gradient upstream and downstream with decent outlet drop so resampling to determine chinook presence could be insightful. MoTi chris_culvert_id: 1992674. 14:54:00

| Location and Stream Data | | Crossing Characteristics | |
|---|--|---|---|
| Fix type | Replace with New Open Bottom Structure | Fix Span / Diameter | 16.5 |

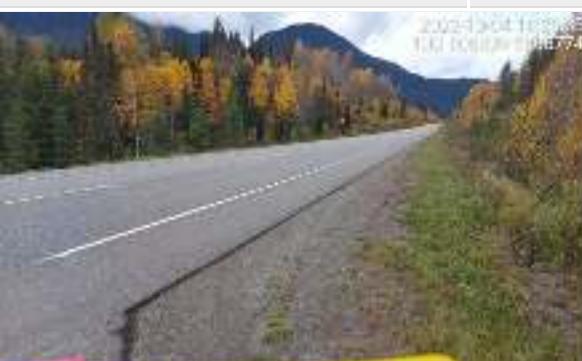
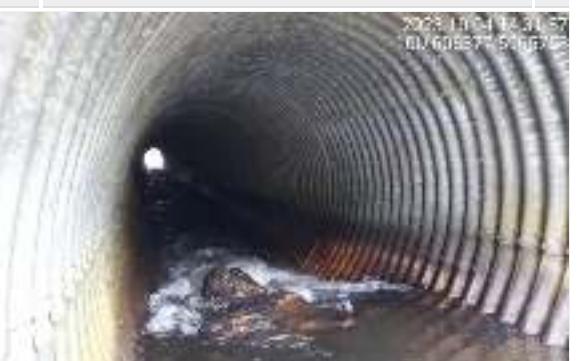
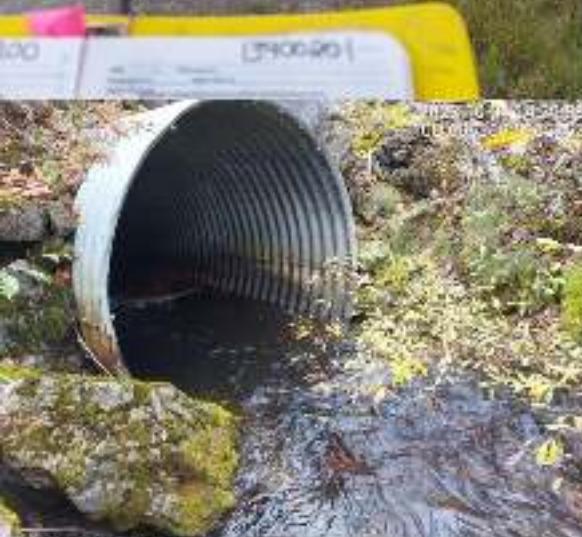
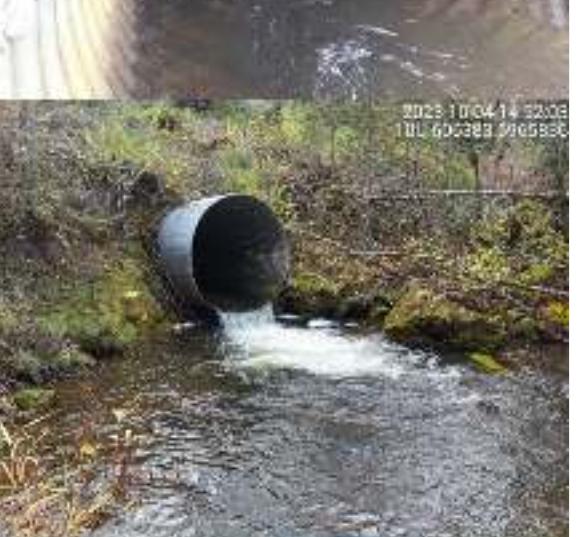
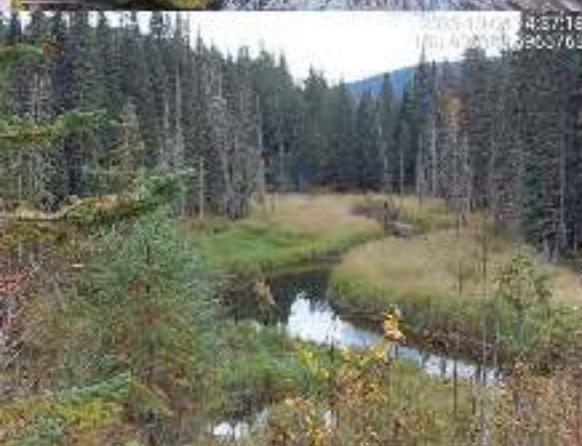
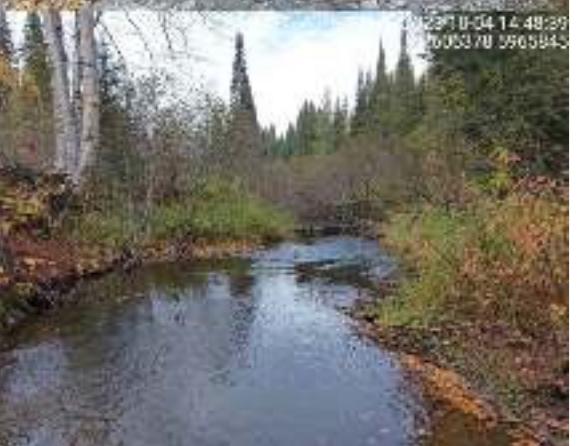
Photos: PSCIS ID 13900157. From top left clockwise: Road/Site Card, Barrel, Outlet, Downstream, Upstream, Inlet.

Comments: Very large system with beaver complex upstream, including a large beaver dam approximately 1.3m high located 25m upstream of the inlet. Approximately 20m downstream of the outlet is a rock chute that is over 30% gradient but only for 5m with a total height of 1.7m. There are two other falls noted as FISS obstacles between this crossing and the Fraser River downstream. There is significant erosion of the road prism on the upstream side above the culvert. Culvert is located on the bend of Highway 16 under 10m of road fill. Noted falls and lack of fish observations indicated access issues downstream. MoTi chris_culvert_id: 1992752. 16:16:08

| Location and Stream Data | | Crossing Characteristics | |
|---|--|---|---|
| Fix type | Replace with New Open Bottom Structure | Fix Span / Diameter | 35.5 |

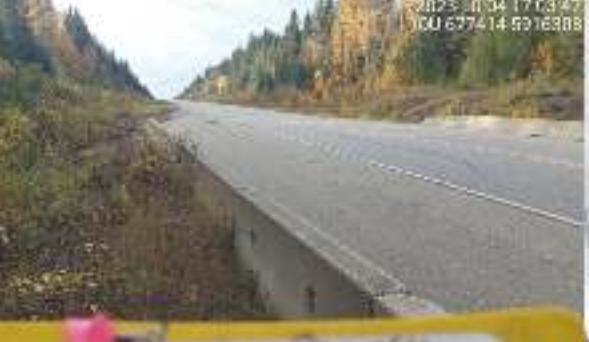
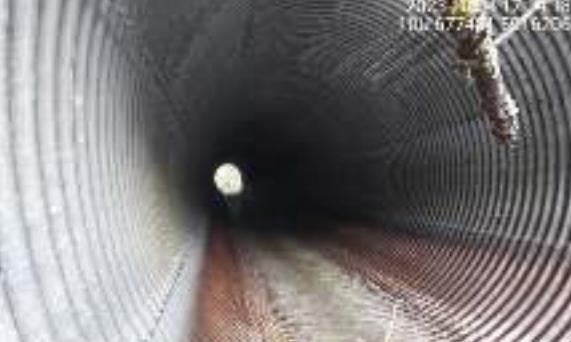
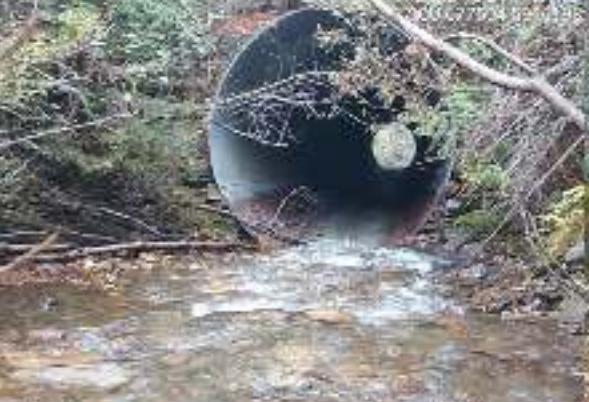
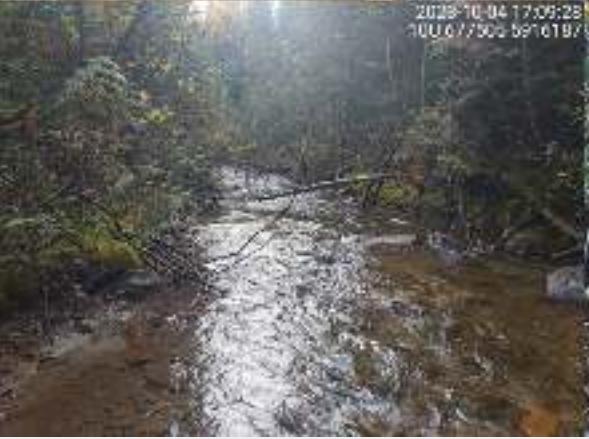
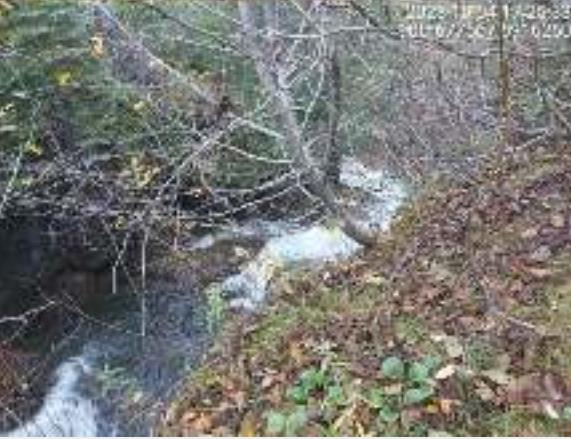
Photos: PSCIS ID 22200151. From top left clockwise: Road/Site Card, Barrel, Outlet, Downstream, Upstream, Inlet.

Comments: Deep canyon and high waterfall directly downstream of crossing which is a definite barrier to all fish. Rough estimate 20m height. Outlet drop and pool estimated because it was unsafe to get near stream due to steep embankment. RB confirmed upstream of crossing in 2017 and 2020, but the falls downstream is a definite barrier. MoTi chris_hwy_structure_road_id: 30367. 17:27:23

| Location and Stream Data | | Crossing Characteristics | |
|---|--|---|---|
| Fix type | Replace with New Open Bottom Structure | Fix Span / Diameter | 35.5 |

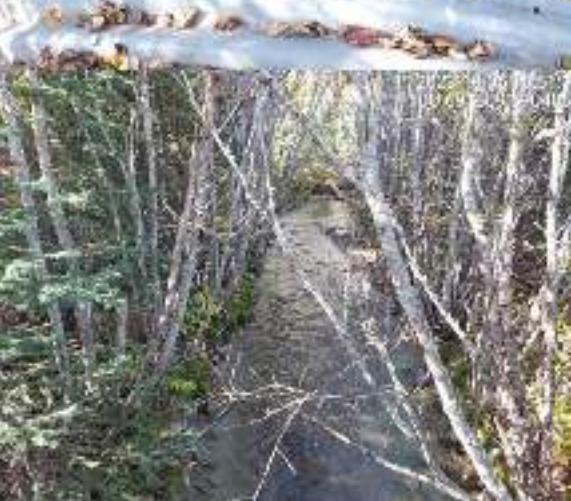
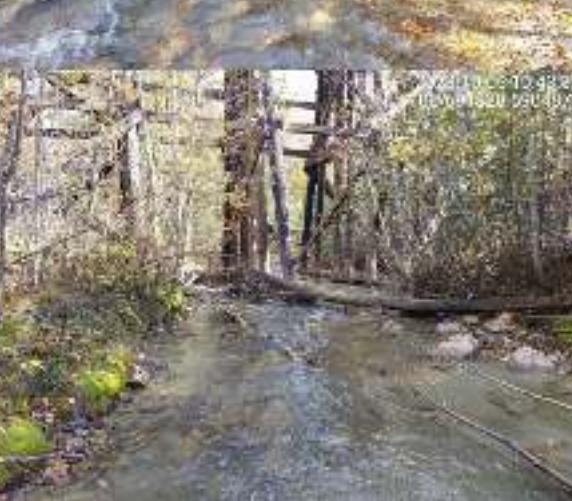
Photos: PSCIS ID 13900003. From top left clockwise: Road/Site Card, Barrel, Outlet, Downstream, Upstream, Inlet.

| Location and Stream Data | | . | Crossing Characteristics | - |
|---|--|---|---|---|
| Fix type | Replace with New Open Bottom Structure | | Fix Span / Diameter | 15 |
