Appendix - Phase 1 Fish Passage Assessment Data and Photos

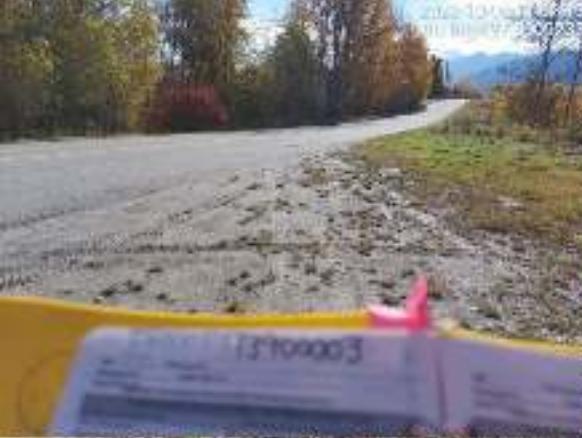
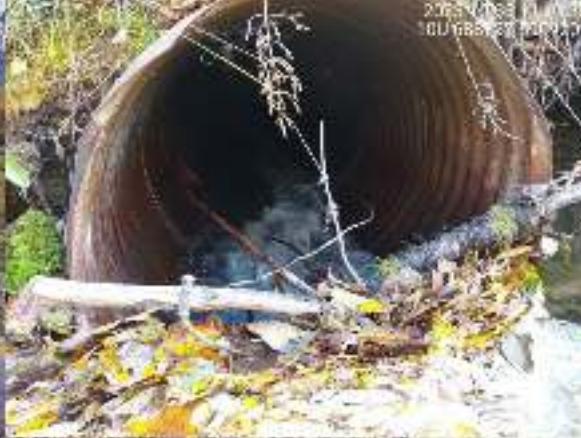
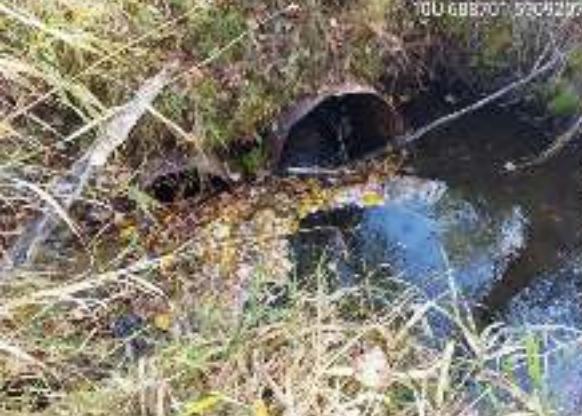
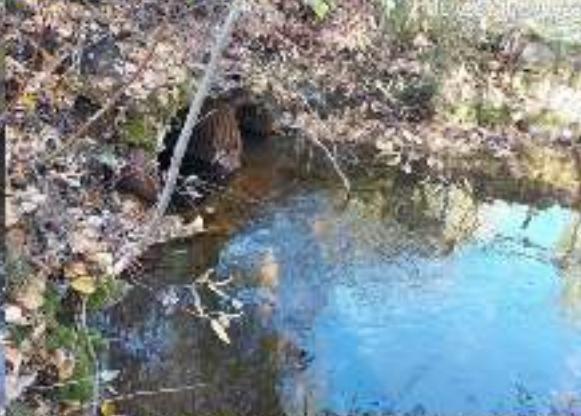
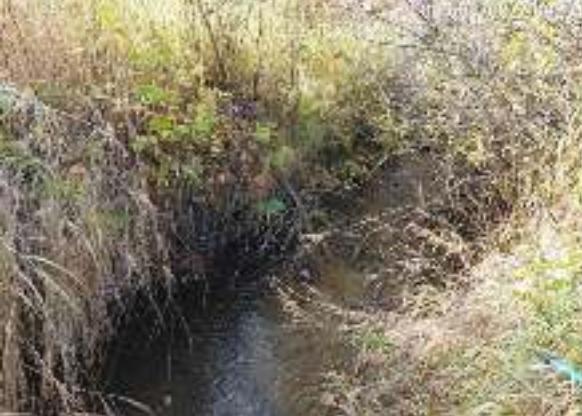
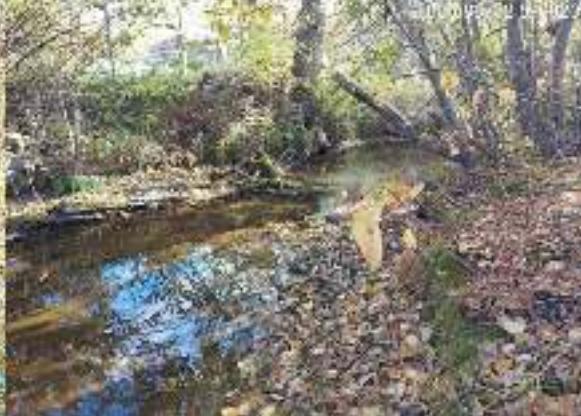
Photos: PSCIS ID 13900030. From top left clockwise: Road/Site Card, Barrel, Outlet, Downstream, Upstream, Inlet.

| Location and Stream Data | | Crossing Characteristics | |
|---|--|---|---|
| Fix type | Replace Structure with Streambed Simulation CBS | Fix Span / Diameter | 3 |

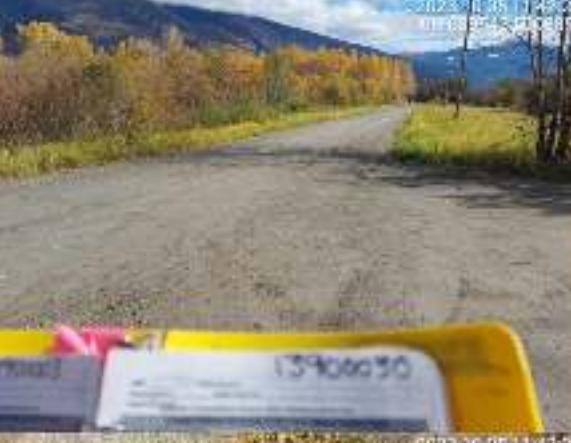
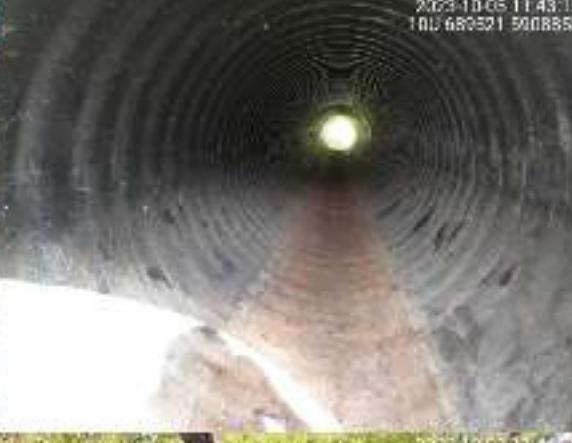
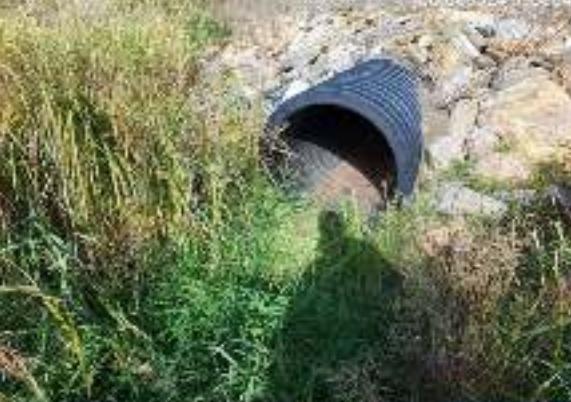
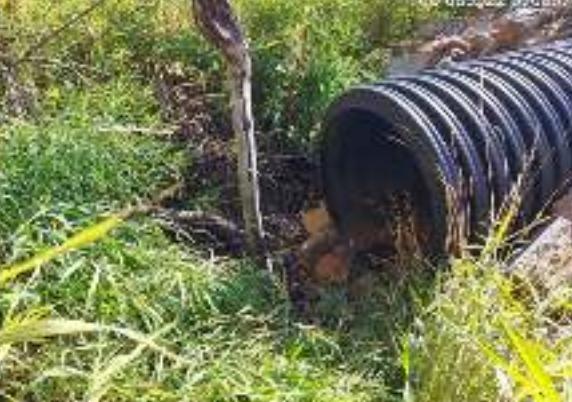
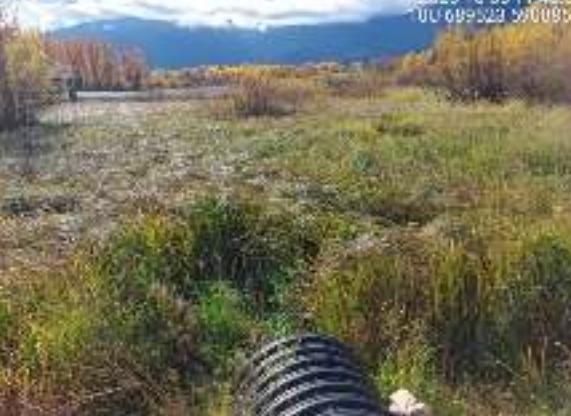
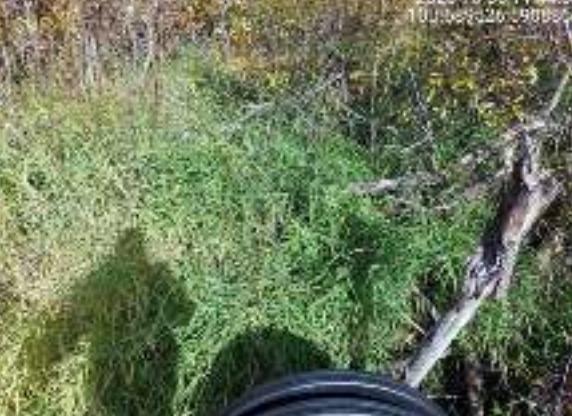
Photos: PSCIS ID 22200081. From top left clockwise: Road/Site Card, Barrel, Outlet, Downstream, Upstream, Inlet.

| Location and Stream Data | | . | Crossing Characteristics | - |
|---|--|---|---|---|
| Fix type | Replace with New Open Bottom Structure | | Fix Span / Diameter | 15 |

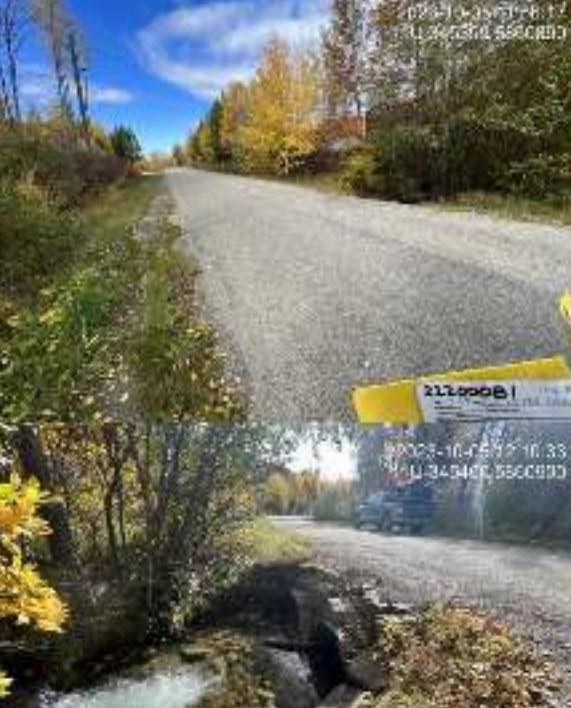
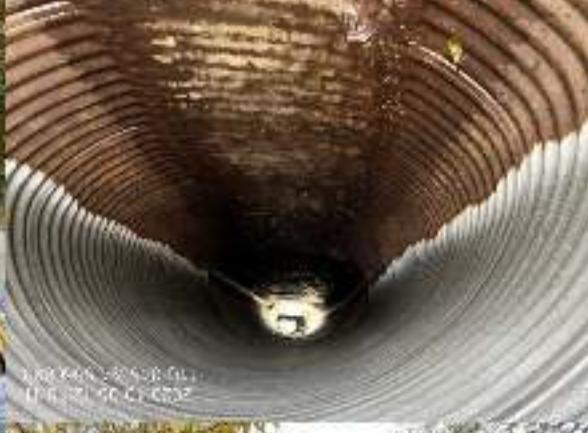
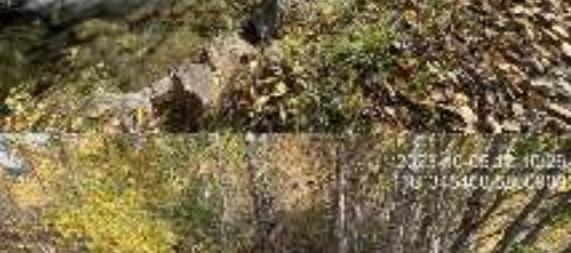
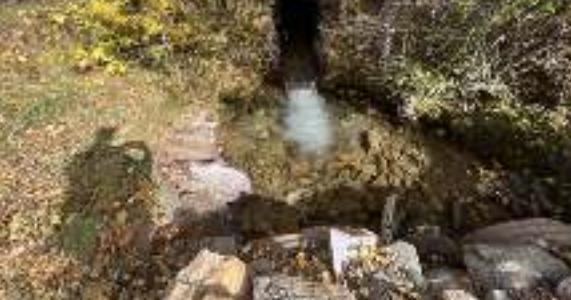
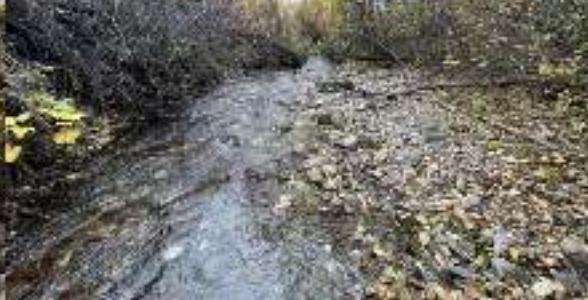
Photos: PSCIS ID 22201951. From top left clockwise: Road/Site Card, Barrel, Outlet, Downstream, Upstream, Inlet.

| Location and Stream Data | | Crossing Characteristics | |
|---|--|---|---|
| Fix type | Replace with New Open Bottom Structure | Fix Span / Diameter | 15 |

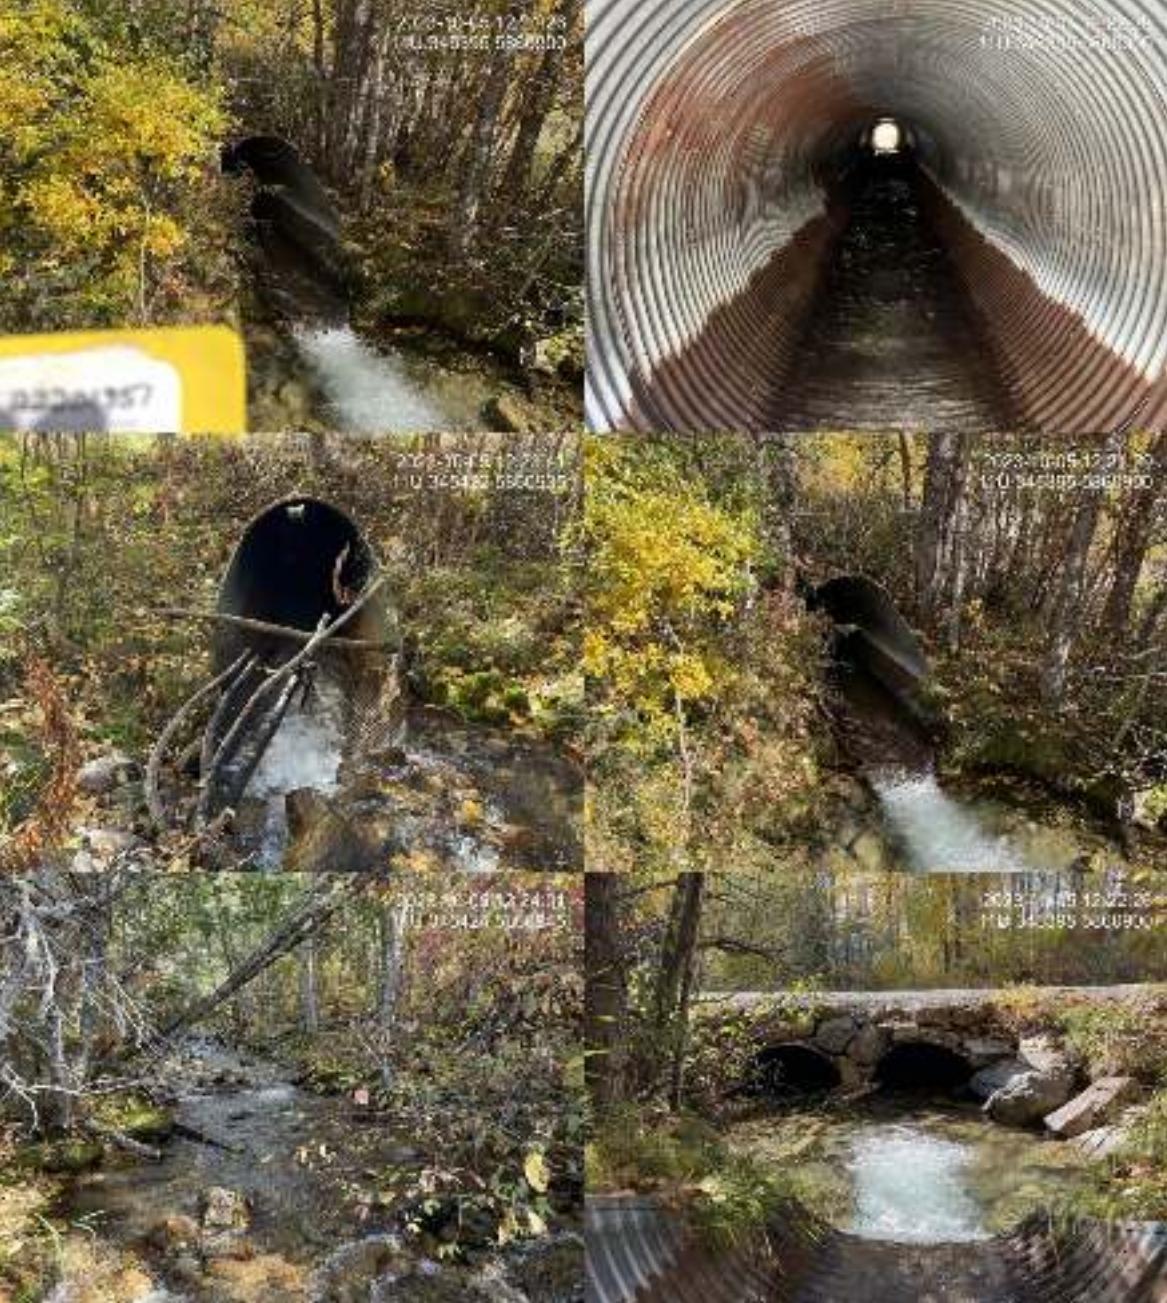
Photos: PSCIS ID 22201176. From top left clockwise: Road/Site Card, Barrel, Outlet, Downstream, Upstream, Inlet.

Comments: Very nice stream with salmon point in FISS located upstream. Very good flow with some pools present to 80cm deep upstream. Unassessed railway crossing approximately 200m upstream. There is no crossing at the pipeline but construction activities have resulted in a small cascade of boulders at the pipe which is similar to the natural cascade section observed approximately 50m upstream. Railway crossing downstream which is ranked as a barrier.
MoTi chris_culvert_id: 1467202. 12:56:09

| Location and Stream Data | | Crossing Characteristics | |
|---|--|---|---|
| Fix type | Replace with New Open Bottom Structure | Fix Span / Diameter | 15 |

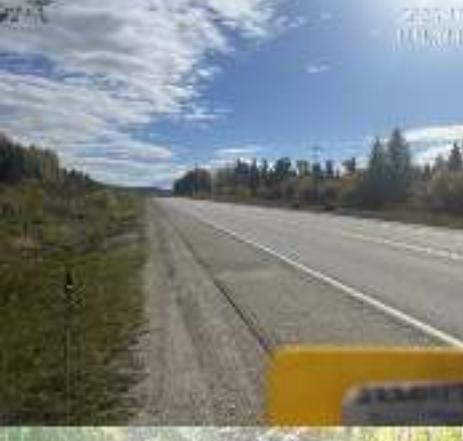
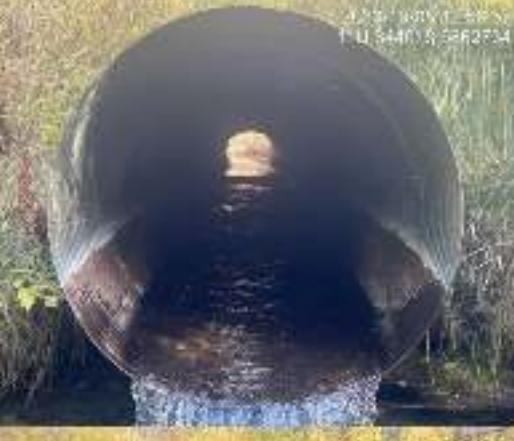
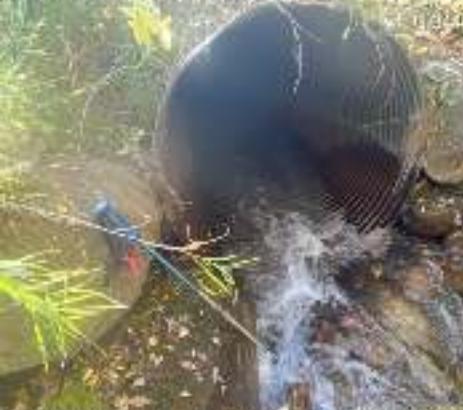
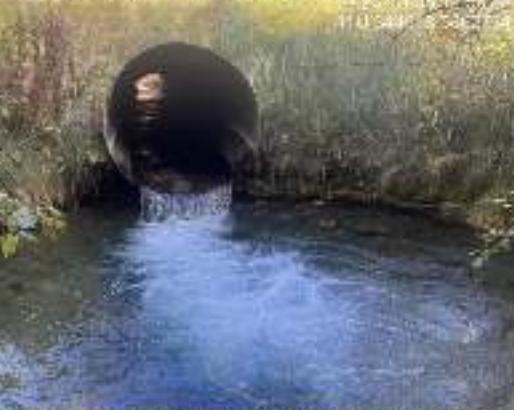
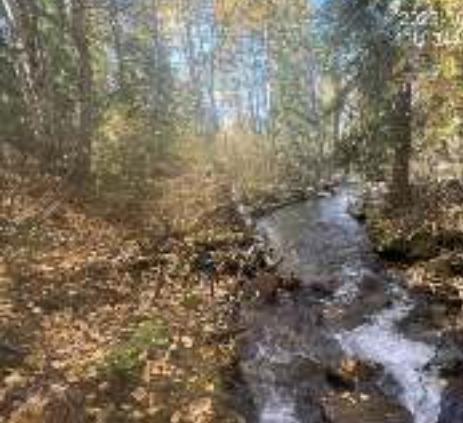
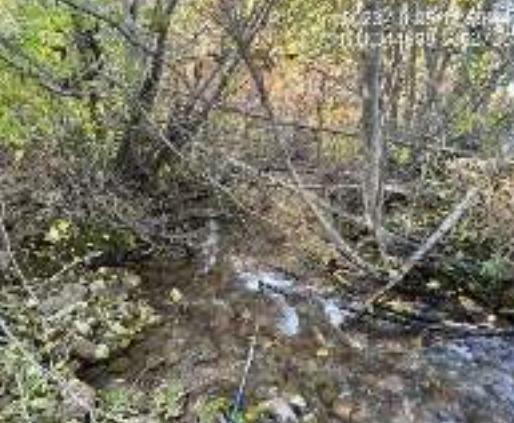
Photos: PSCIS ID 22200022. From top left clockwise: Road/Site Card, Barrel, Outlet, Downstream, Upstream, Inlet.

| Location and Stream Data | | Crossing Characteristics | |
|---|--|---|---|
| Fix type | Replace Structure with Streambed Simulation CBS | Fix Span / Diameter | 3 |

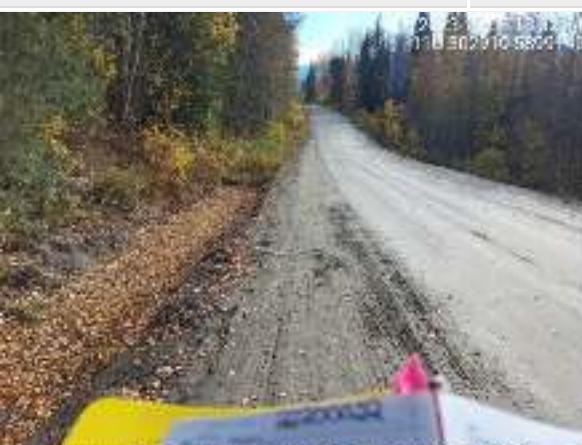
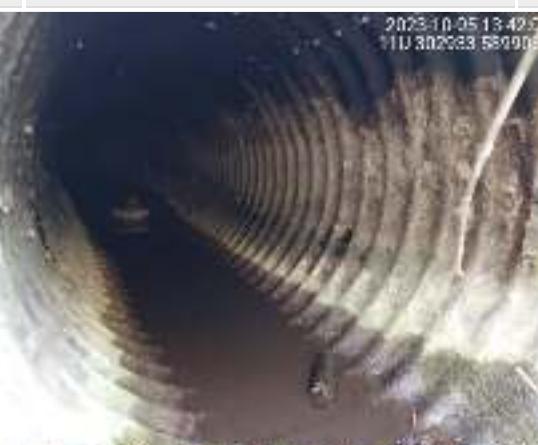
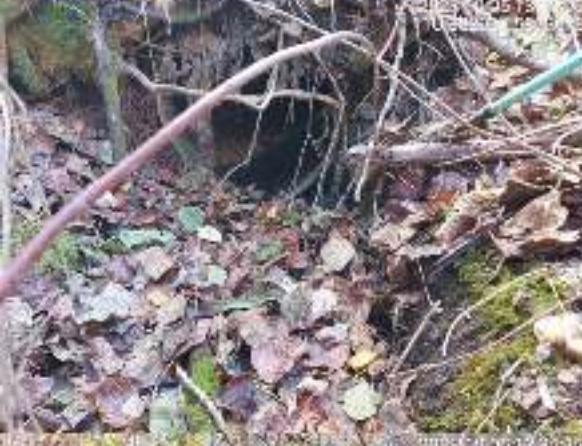
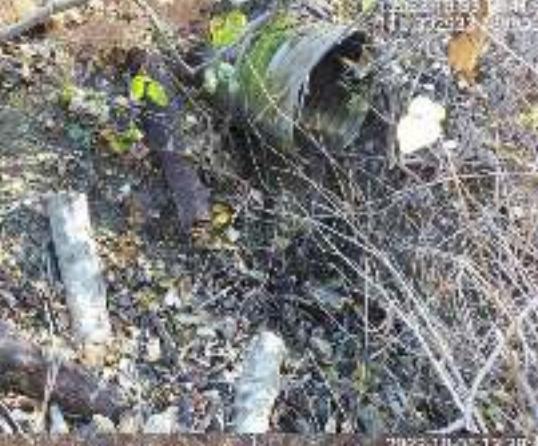
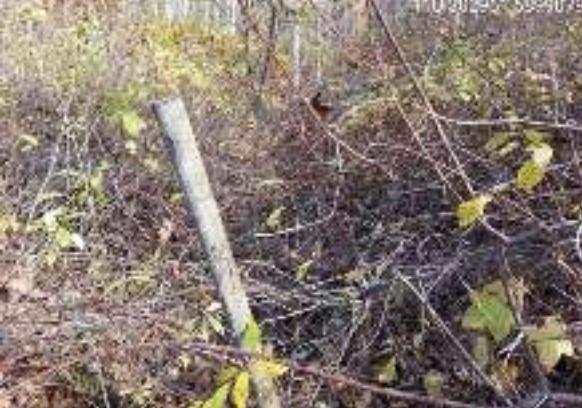
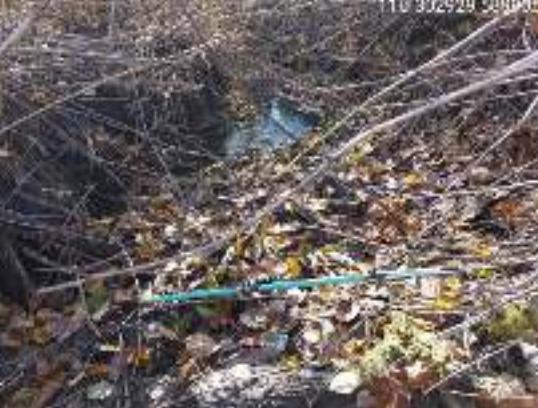
| Location and Stream Data | | Crossing Characteristics | |
|---|--|---|---|
| Photos: PSCIS ID 22200075. From top left clockwise: Road/Site Card, Barrel, Outlet, Downstream, Upstream, Inlet. | | | |

| Location and Stream Data | | Crossing Characteristics | |
|---|--|---|---|
| Comments: Nice little stream with good flow and abundant small gravel's upstream. There may be crossings downstream on private land. Significant amount of large riprap placed around inlet and outlet to protect the crossing. Outlet is placed on large piece of riprap, so 0.3m was added to the 0.2m outlet drop to account for the additional distance from the stream to the outlet. RB observed upstream. MoTi chris_culvert_id: 1466467. 14:00:15 | | | |

| Location and Stream Data | | Crossing Characteristics | |
|---|--|---|---|
| Fix type | Replace with New Open Bottom Structure | Fix Span / Diameter | 15 |

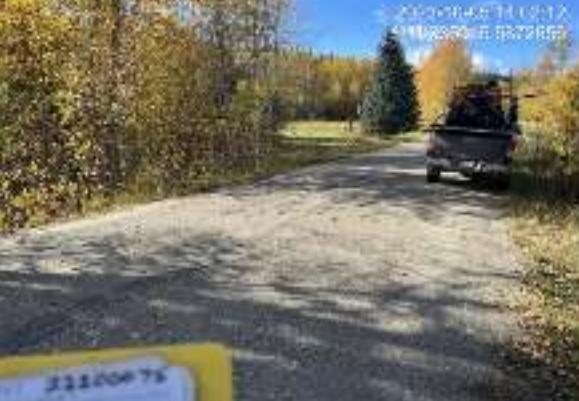
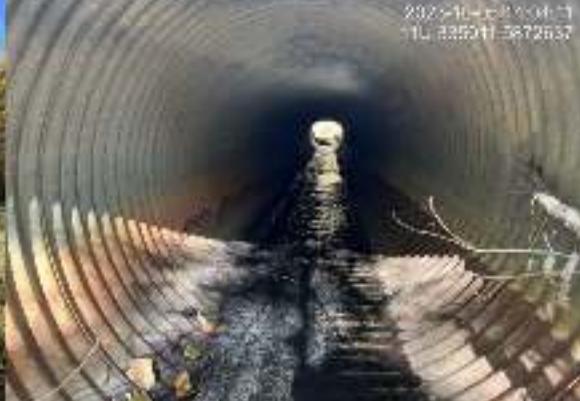
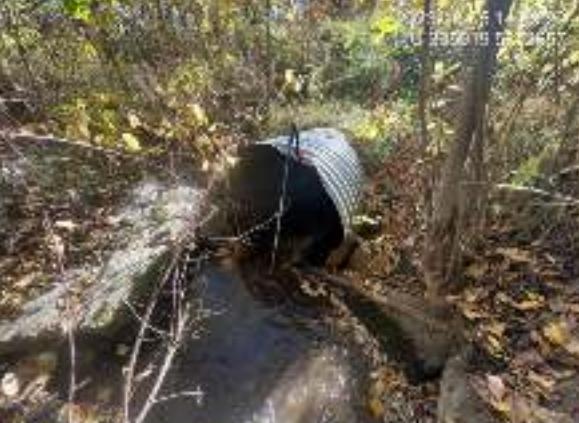
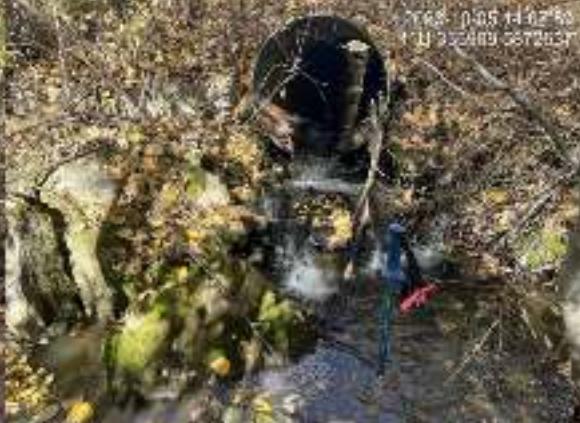
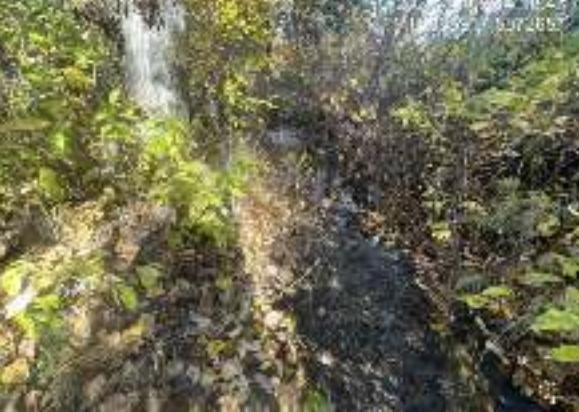
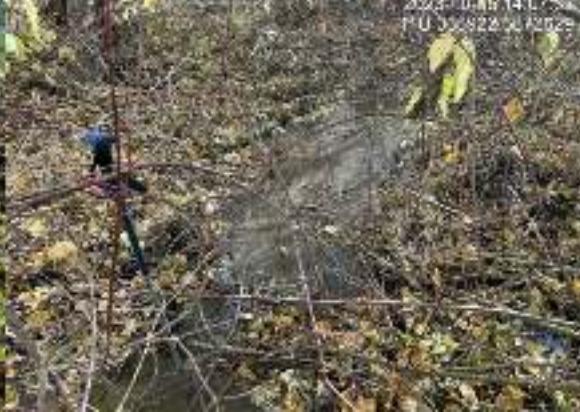
Photos: PSCIS ID 22201218. From top left clockwise: Road/Site Card, Barrel, Outlet, Downstream, Upstream, Inlet.

Comments: Very nice stream with good flow and abundant gravels upstream. Pipe is an extremely bad shape with extensive corrosion inside of the pipe particularly at the downstream end - see photos. Likely at least one crossing downstream on private land. Transmission line corridor is located immediately upstream and the channel appears to be modified in this location to be straighter and narrower than its natural state. No crossing immediately upstream on Goslin Road (no road - crossing should be removed as potential barrier in bcfishpass) MoTi chris_culvert_id: 1465295.
14:28:28

| Location and Stream Data | . | Crossing Characteristics | – |
|---|---|---|---|
| Fix type | Replace Structure with Streambed Simulation CBS | Fix Span / Diameter | 3 |

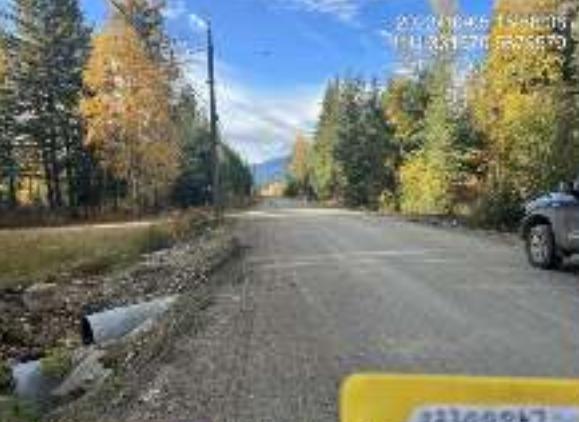
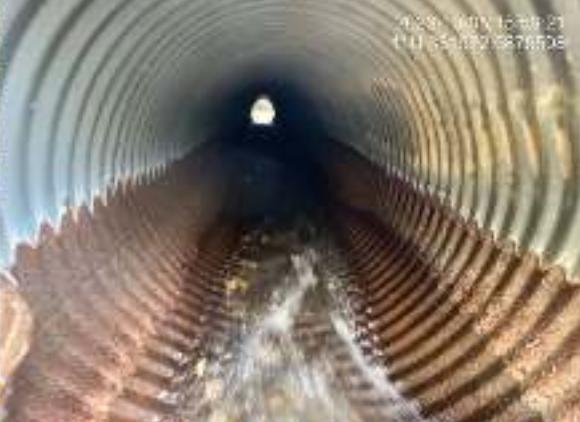
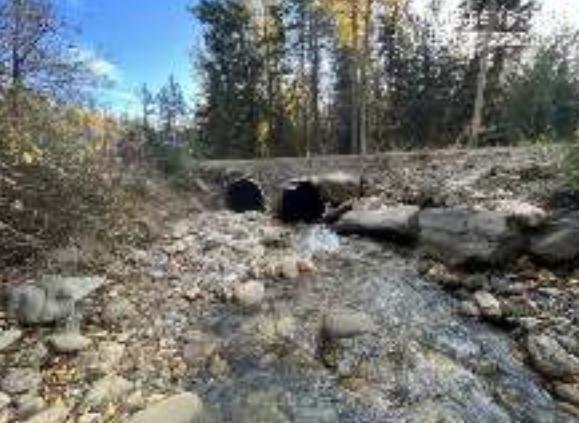
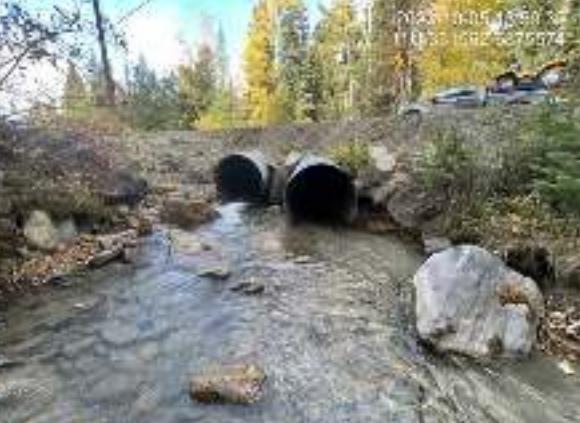
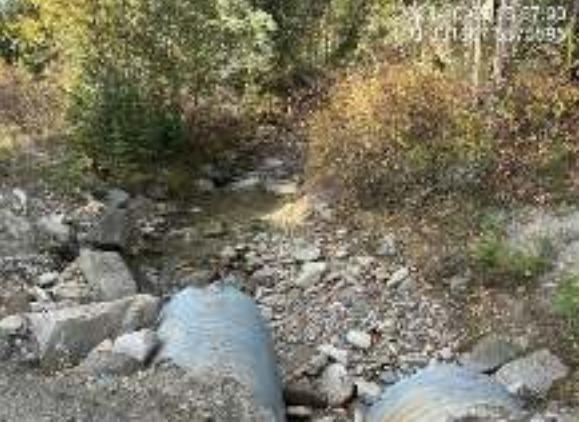
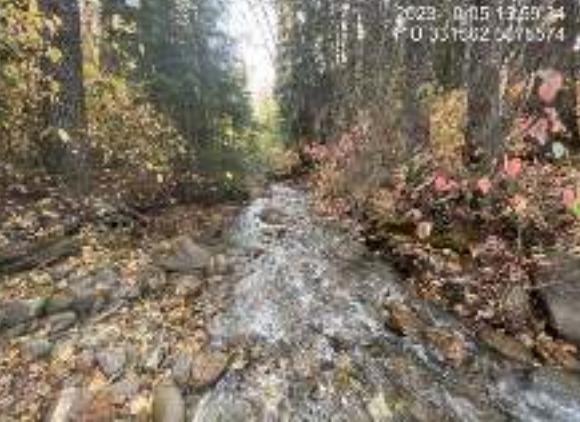
Photos: PSCIS ID 22200067. From top left clockwise: Road/Site Card, Barrel, Outlet, Downstream, Upstream, Inlet.

Comments: Pipes and road are in extremely poor condition with evidence of embankment failure and pipes rusted all the way through on the bottom side in places. Small side road parallel to Highway 16 with residences that could be accessed from either side. Removal of crossing could perhaps be considered. Large high value system suitable for bulltrout rearing. Culvert upstream is relatively new concrete box culvert on the highway which is over half embedded and 3.7m wide. MoTi chris_culvert_id: 1466350. 15:53:19

| Location and Stream Data | | Crossing Characteristics | |
|---|--|---|---|
| Fix type | Replace with New Open Bottom Structure | Fix Span / Diameter | 15 |

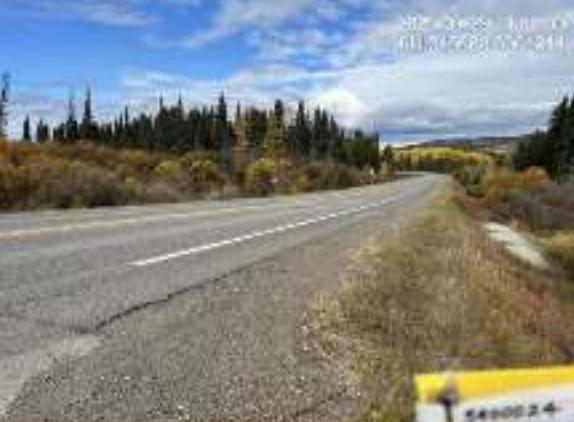
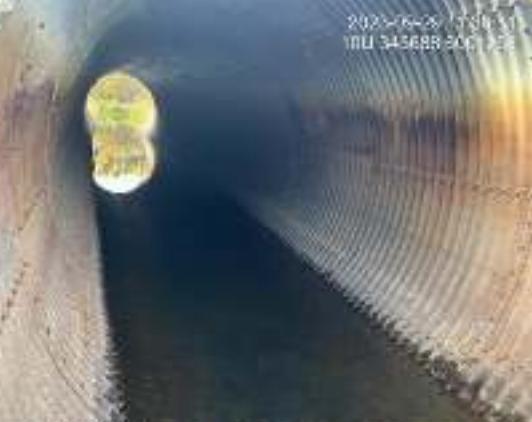
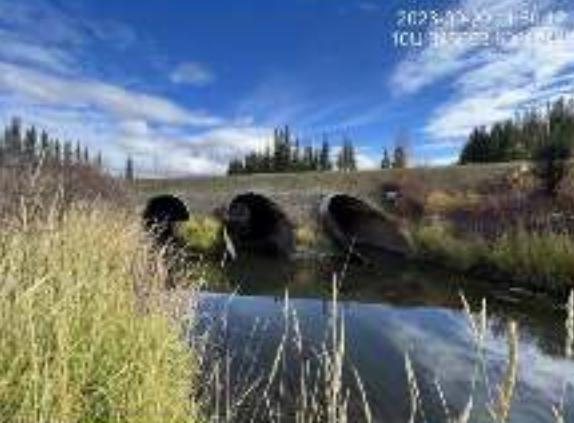
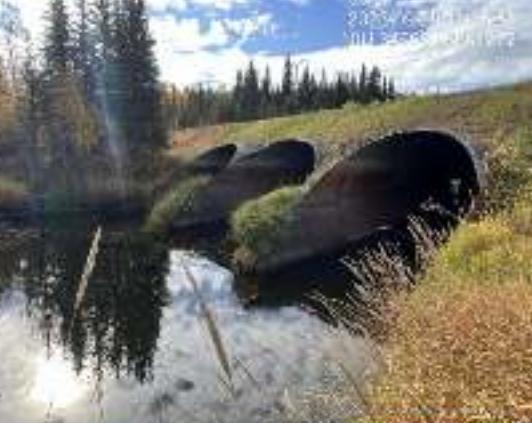
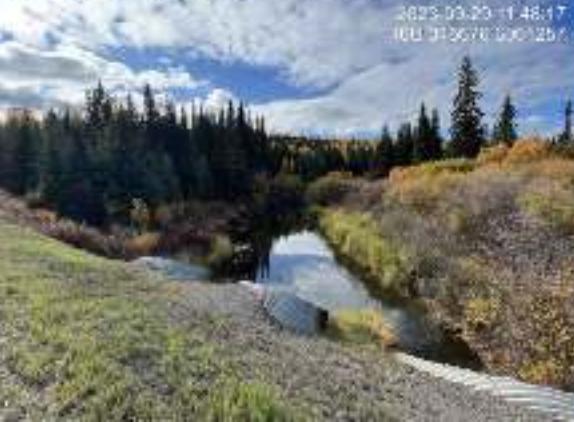
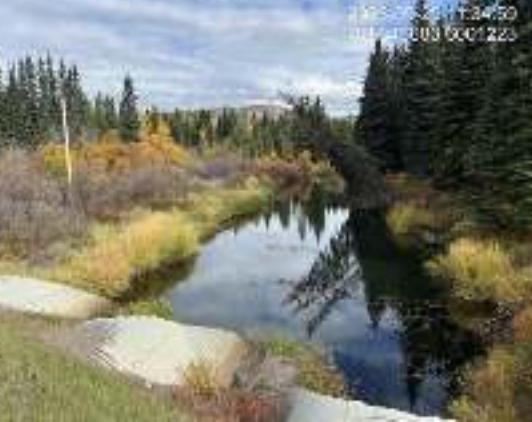
Photos: PSCIS ID 5400024. From top left clockwise: Road/Site Card, Barrel, Outlet, Downstream, Upstream, Inlet.

Comments: Three 4 m diameter pipes. All three pipes are 100% backwatered, and passable. Road prism and pipes appear to be in good condition. Extensive beaver activity upstream and downstream. Diameter changed from 12m to 9.99m to meet spreadsheet requirements. MoTi chris_hwy_structure_road_id: 3812. 11:35:39

| Location and Stream Data | | Crossing Characteristics | |
|---|--|---|---|
| Fix type | Replace with New Open Bottom Structure | Fix Span / Diameter | 22 |

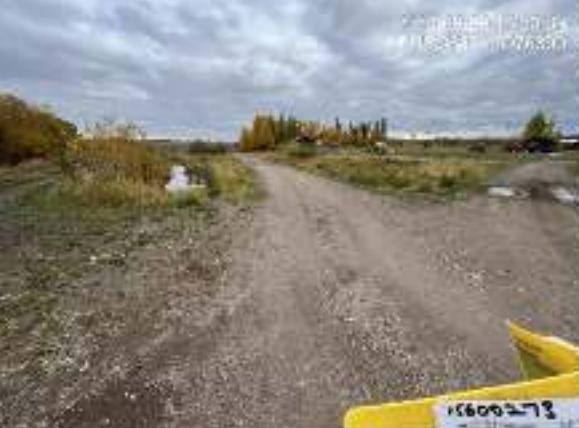
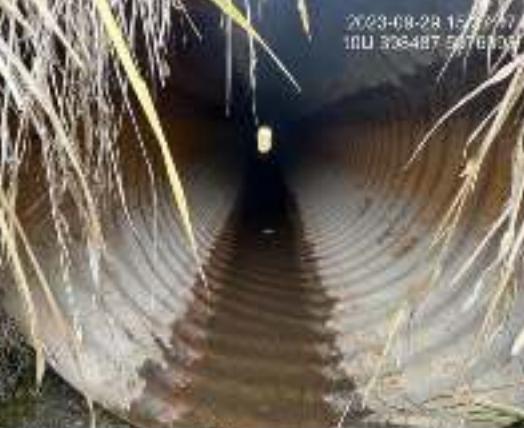
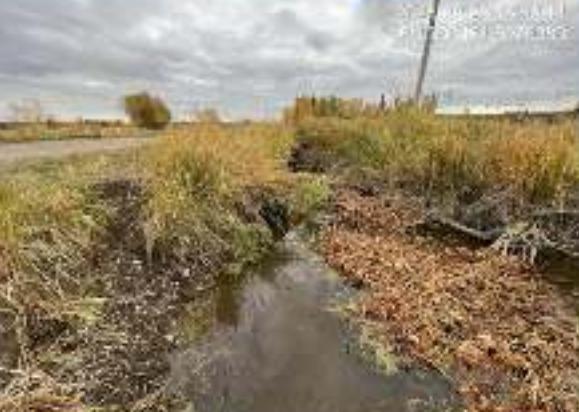
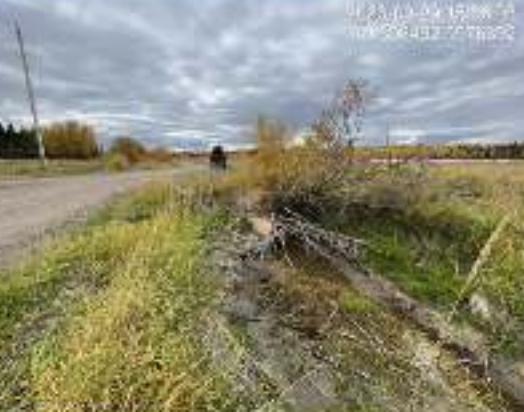
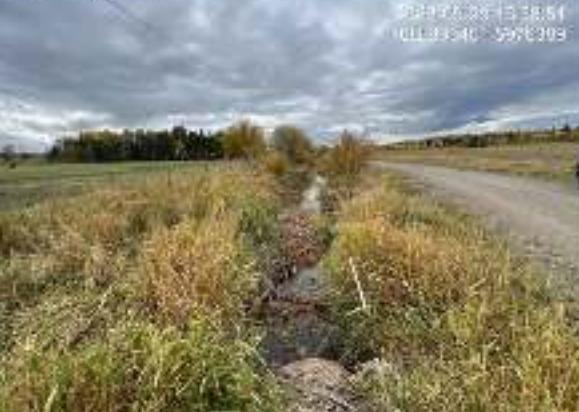
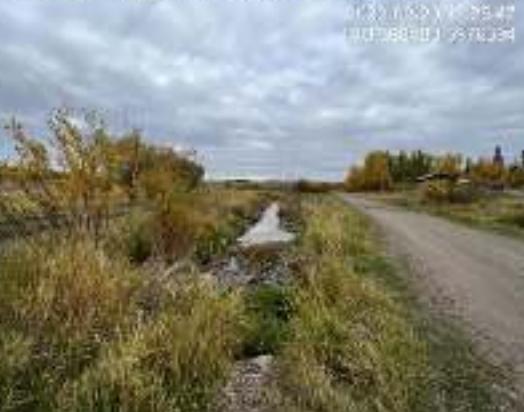
| Location and Stream Data | | Crossing Characteristics | |
|---|--|---|---|
| Photos: PSCIS ID 15600273. From top left clockwise: Road/Site Card, Barrel, Outlet, Downstream, Upstream, Inlet. | | | |

| Location and Stream Data | | Crossing Characteristics | |
|---|--|---|---|
| Comments: Stream is extremely impacted by cattle ranching. Banks eroded and trampled. Algae indicates nutrient inputs from cows are high. Pipes are old with a lot of rust. Habitat value is currently very poor, but historically would've been high. Still a good amount of flow for a dry year. 100% backwatered however, depth of the water is only approximately 1 cm. Absolutely no riparian vegetation or cattle exclusion fencing on the upstream side for as far as the eye can see (approximately 1 km.). MoTi chris_culvert_id: 1790770, 1790769. 15:33:57 | | | |

| Location and Stream Data | | Crossing Characteristics | |
|---|--|---|---|
| Fix type | Replace with New Open Bottom Structure | Fix Span / Diameter | 15 |

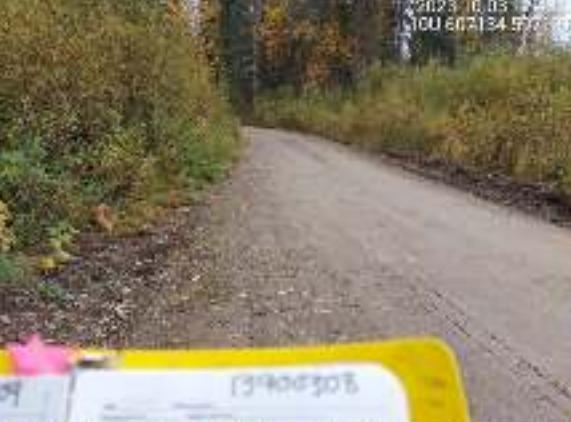
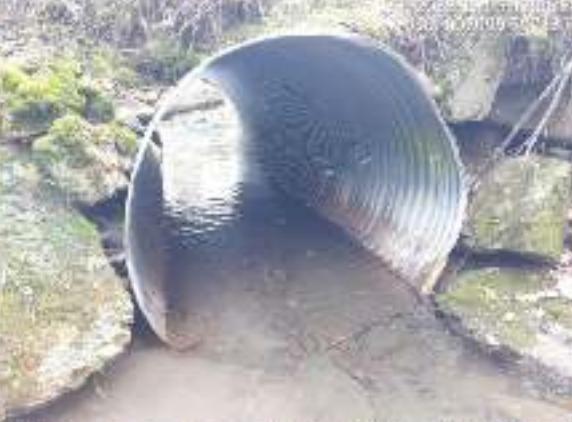
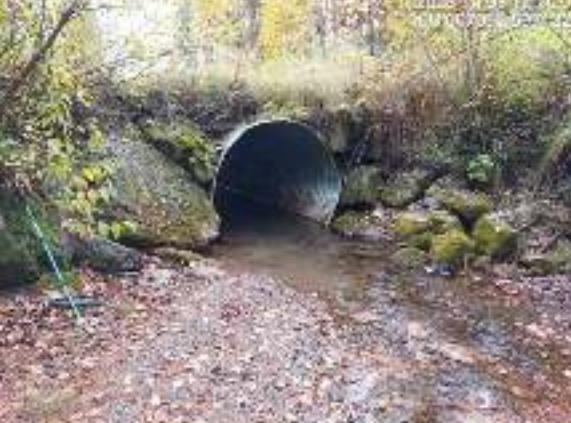
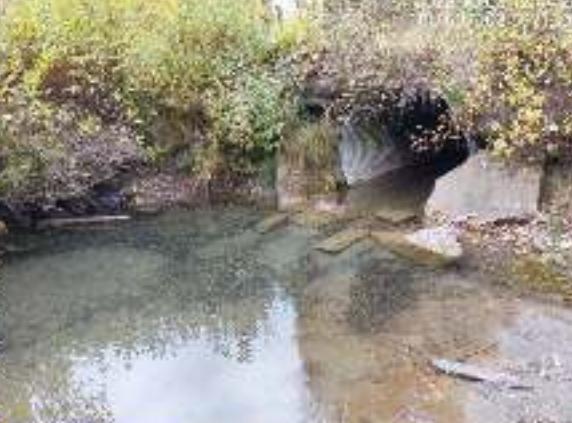
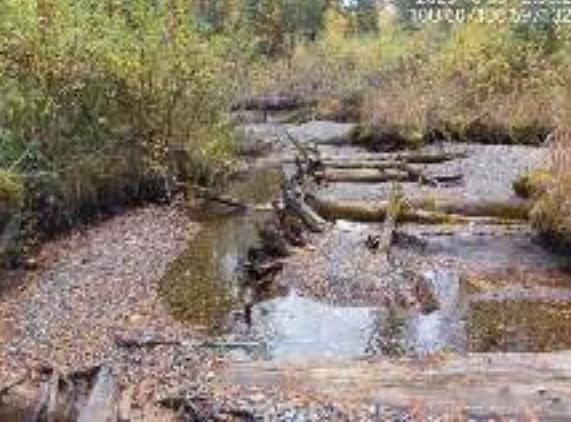
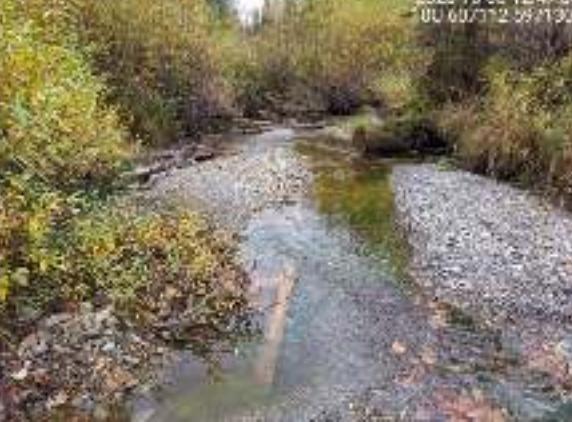
Photos: PSCIS ID 13900308. From top left clockwise: Road/Site Card, Barrel, Outlet, Downstream, Upstream, Inlet.

Comments: Wide channel with four culverts. Culvert diameter totaled for all 4 culverts. Two are in good condition, other two are bent and look older. Railway crossing just upstream which consists of three culverts and appears likely passable for most species at most flows. Abundant gravels present downstream of road. This road is the only to access the town of Penny. MoTi chris_culvert_id: 1994890, 1994893, 1994894. 14:48:37

| Location and Stream Data | | Crossing Characteristics | |
|---|--|---|---|
| Fix type | Replace with New Open Bottom Structure | Fix Span / Diameter | 15 |

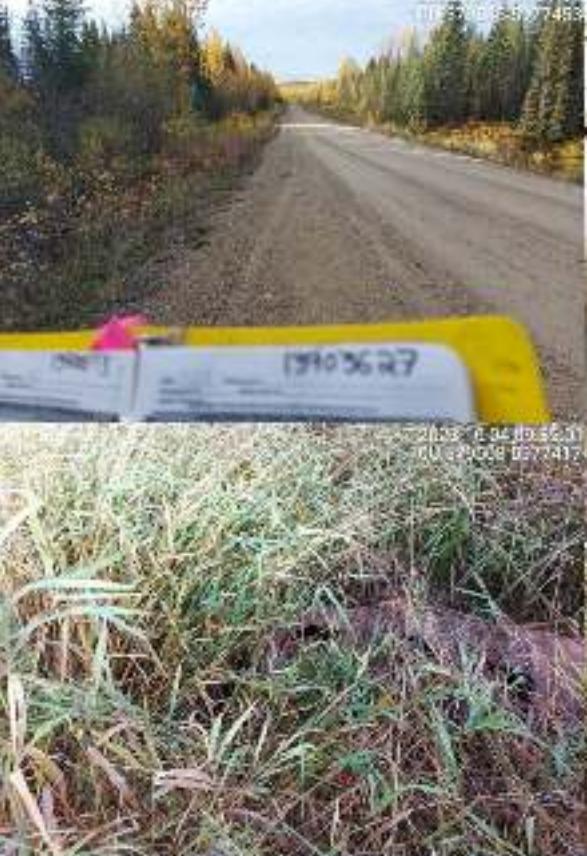
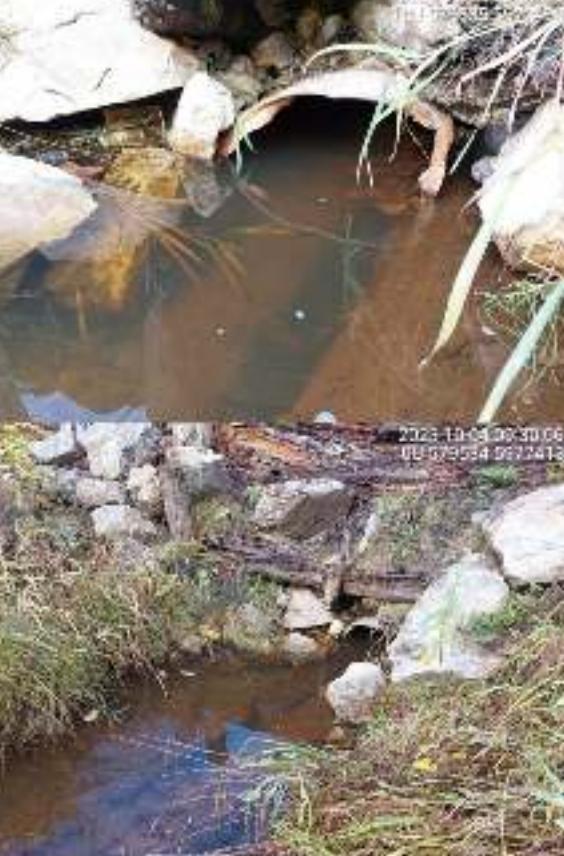
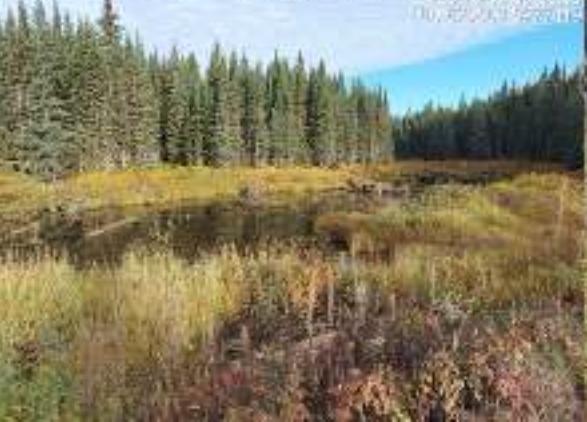
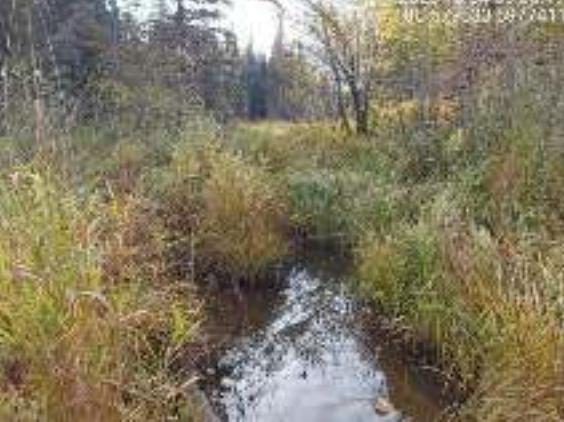
Photos: PSCIS ID 13903627. From top left clockwise: Road/Site Card, Barrel, Outlet, Downstream, Upstream, Inlet.

Comments: Wetland lake area upstream with small channels threaded through it. Beaver grate on culvert inlet and pipe is in poor shape as it is rusted and bent out of shape. Outlet backwater for 40%. Small stream with some flow.. 10:14:44

| Location and Stream Data | | Crossing Characteristics | |
|---|---|---|---|
| Fix type | Replace Structure with Streambed Simulation CBS | Fix Span / Diameter | 3 |

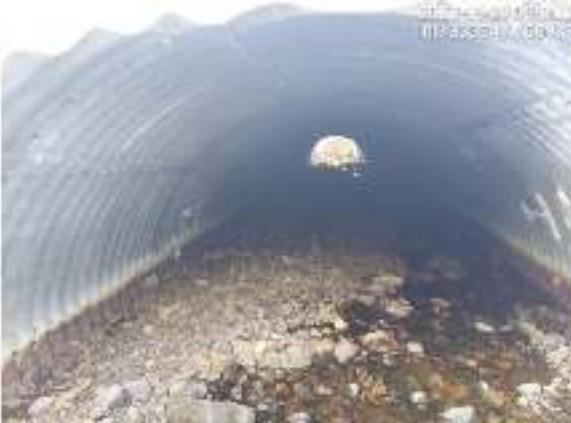
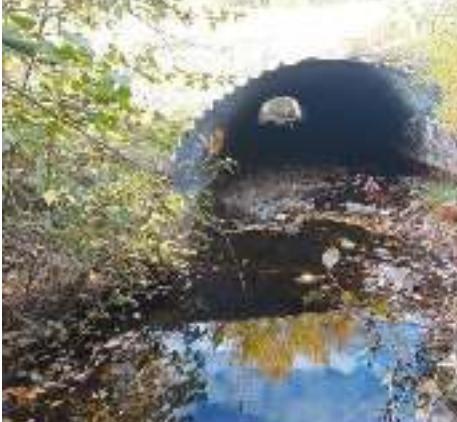
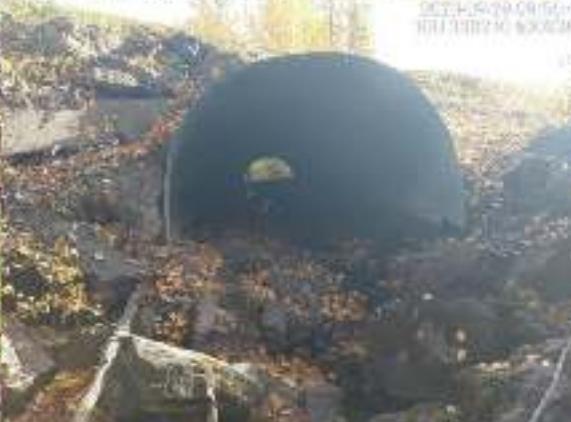
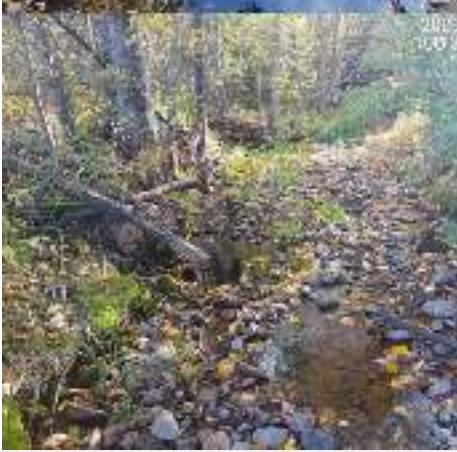
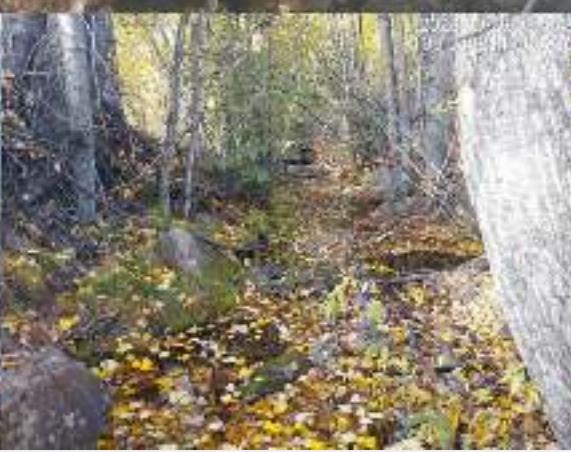
Photos: PSCIS ID 5400028. From top left clockwise: Road/Site Card, Barrel, Outlet, Downstream, Upstream, Inlet.

Comments: Wide channel, nicely installed moti major structure that appears passable as fully embedded. 3m falls noted in FISS as 1.3 km upstream. Railway crossing just downstream noted as passable in bcfishpass. MoTi chris_hwy_structure_road_id: 3811. 09:56:11

| Location and Stream Data | | Crossing Characteristics | |
|---|--|---|---|
| Fix type | Replace with New Open Bottom Structure | Fix Span / Diameter | 15 |

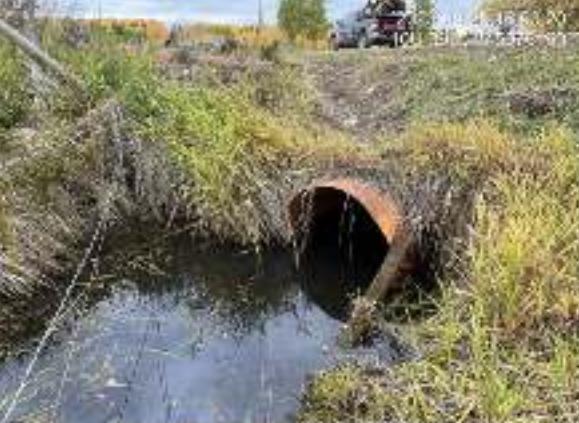
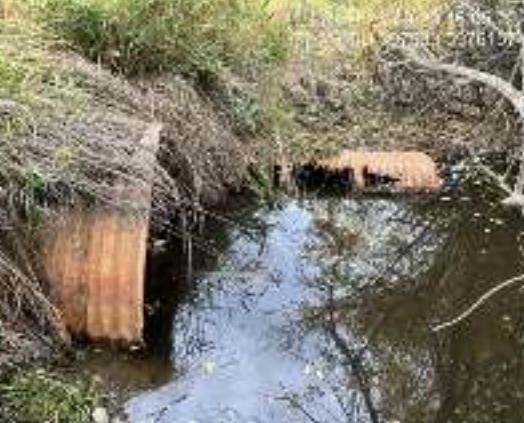
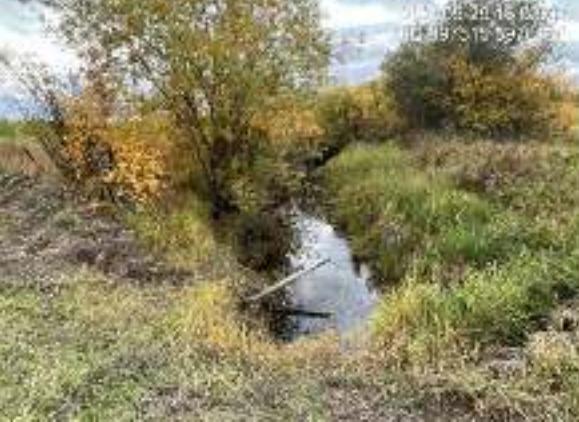
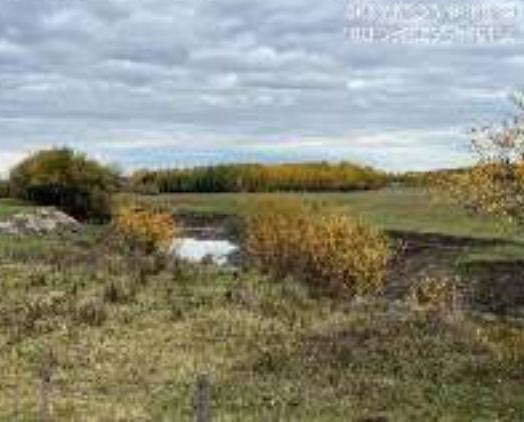
| Location and Stream Data | | • | Crossing Characteristics | – |
|---|---|---|---|---|
| Photos: PSCIS ID 5400201. From top left clockwise: Road/Site Card, Barrel, Outlet, Downstream, Upstream, Inlet. | | | | |

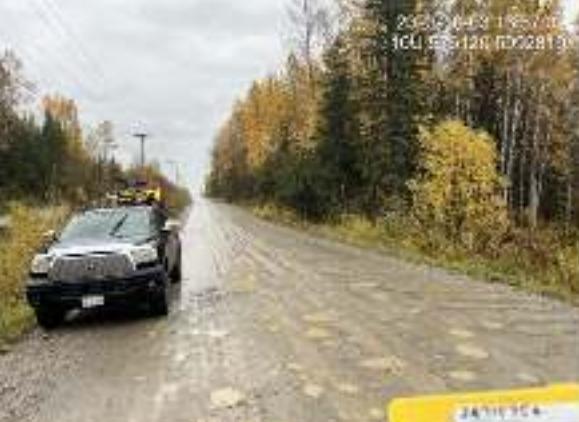
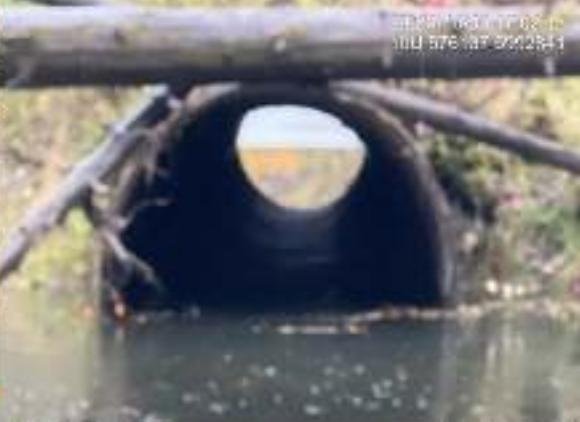
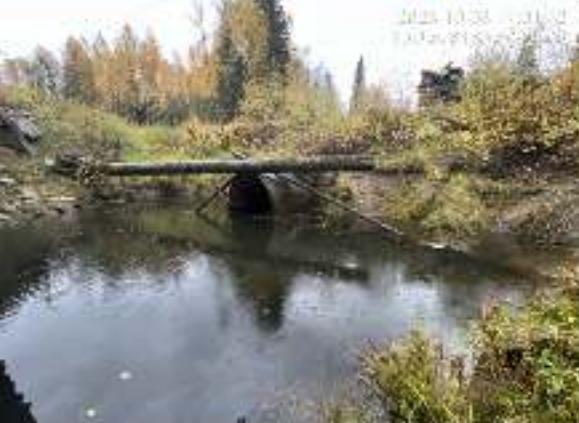
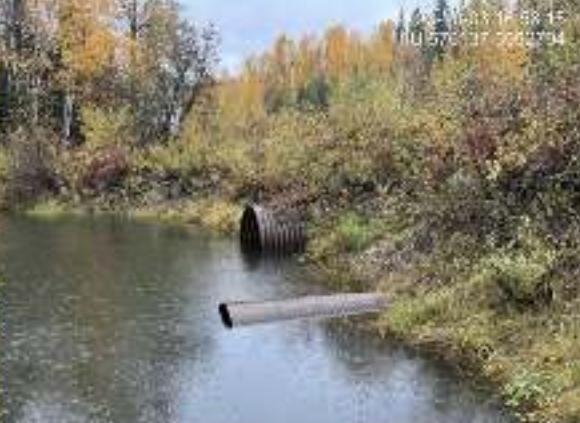
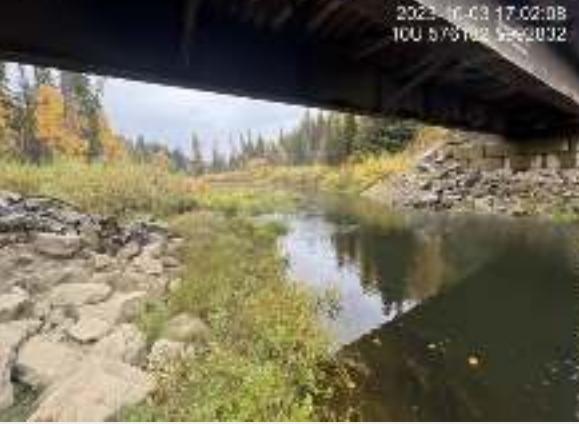
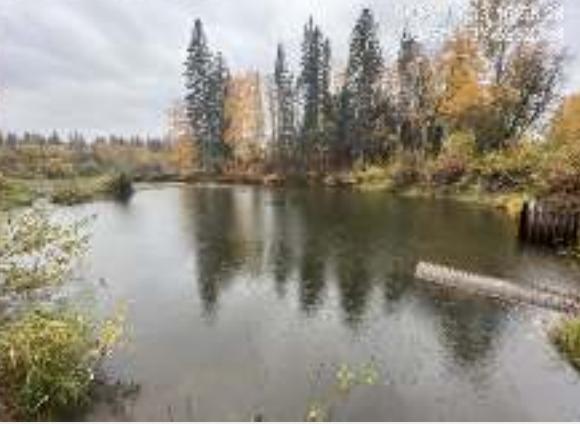
| Location and Stream Data | | . | Crossing Characteristics | - |
|---|---|---|---|---|
| Photos: PSCIS ID 5400159. From top left clockwise: Road/Site Card, Barrel, Outlet, Downstream, Upstream, Inlet. | | | | |
