Appendix - Phase 1 Fish Passage Assessment Data and Photos

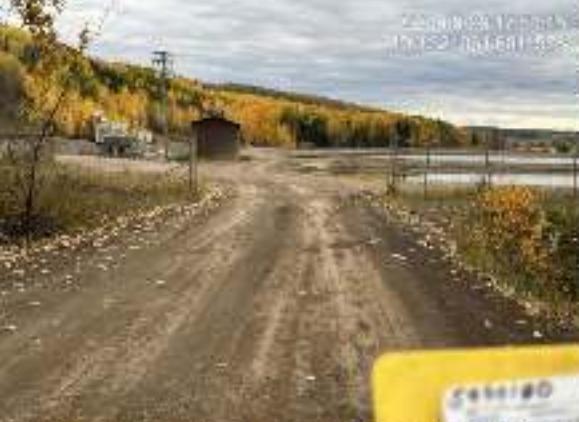
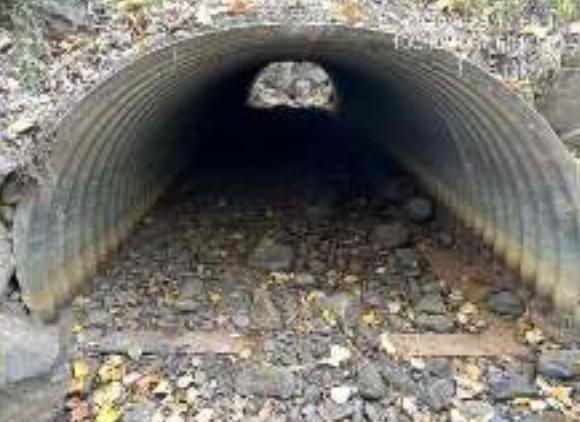
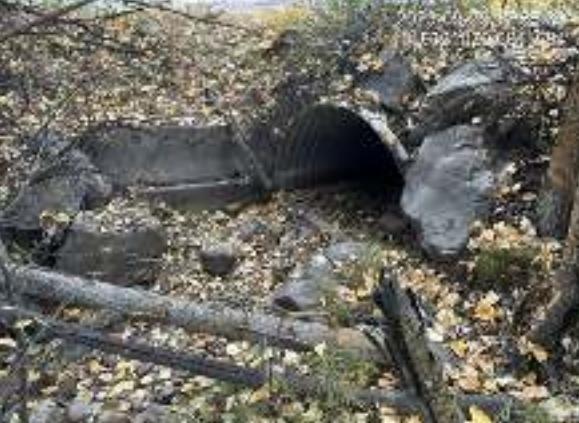
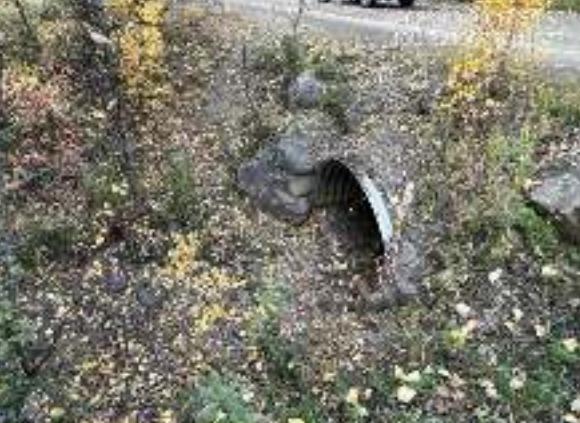
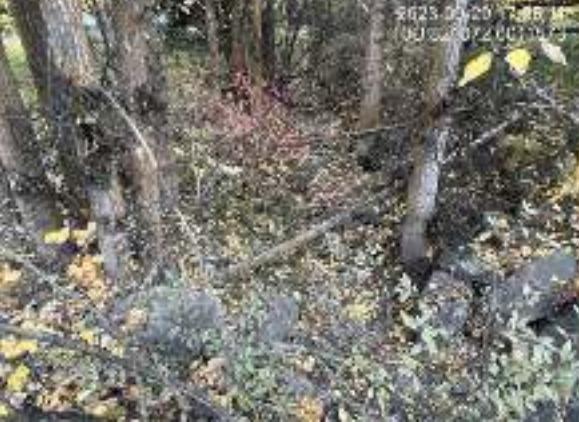
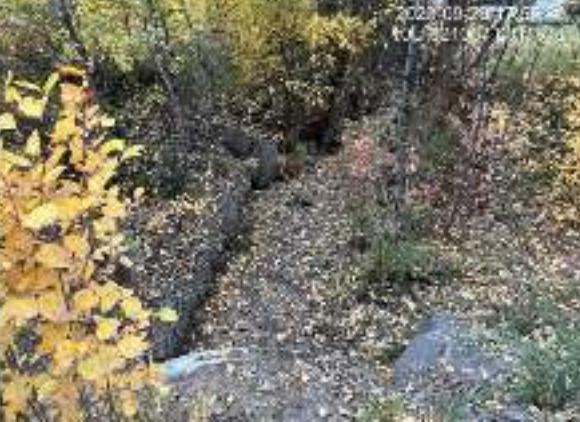
| Location and Stream Data | | • | Crossing Characteristics | – |
|---|---|---|---|---|
| Photos: PSCIS ID 15604870. From top left clockwise: Road/Site Card, Barrel, Outlet, Downstream, Upstream, Inlet. | | | | |

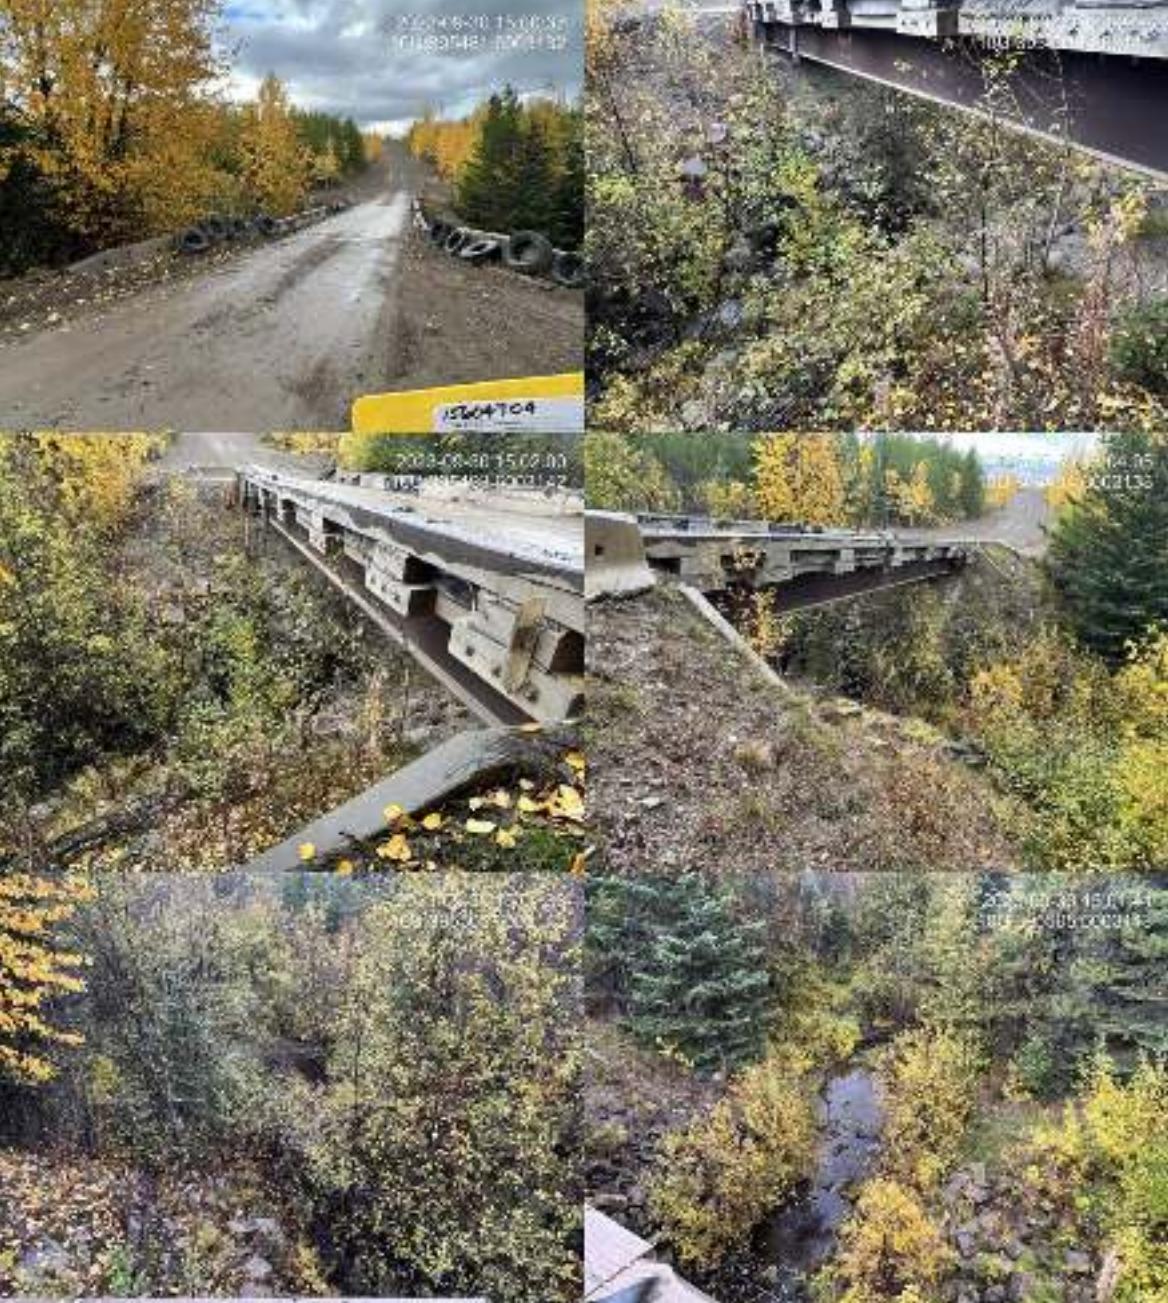
| Location and Stream Data | | • | Crossing Characteristics | – |
|--|---|---|---|---|
| Photos: PSCIS ID 24715750. From top left clockwise: Road/Site Card, Barrel, Outlet, Downstream, Upstream, Inlet. | | | | |

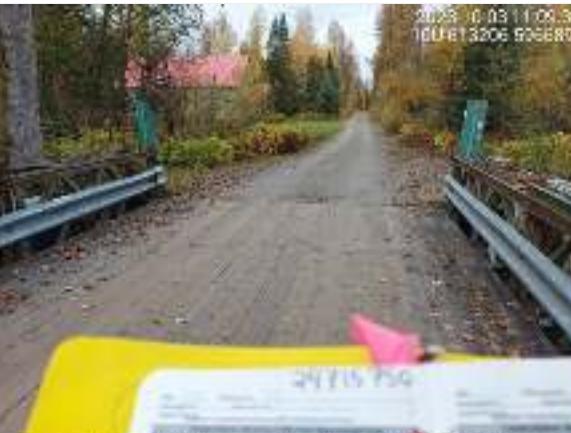
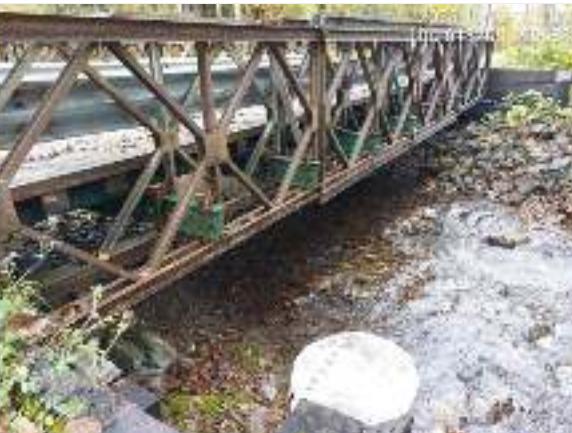
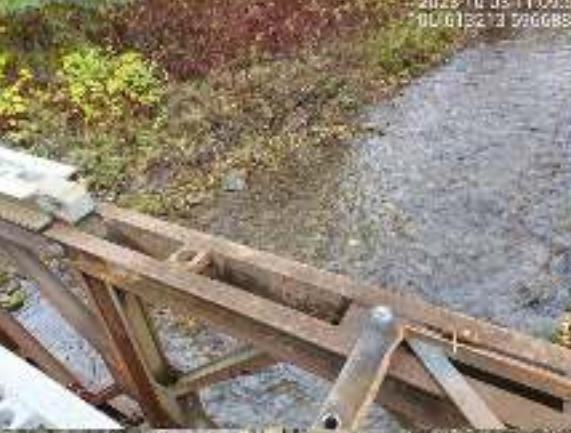
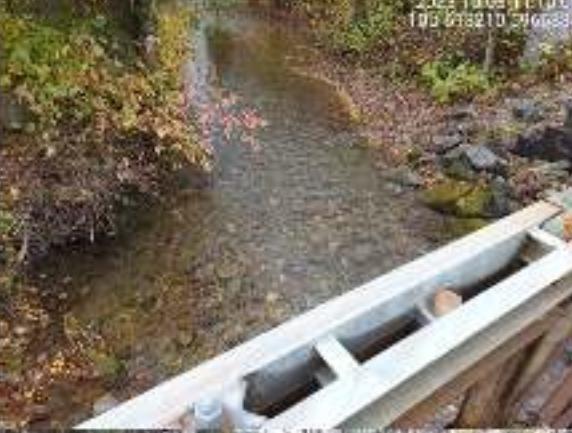
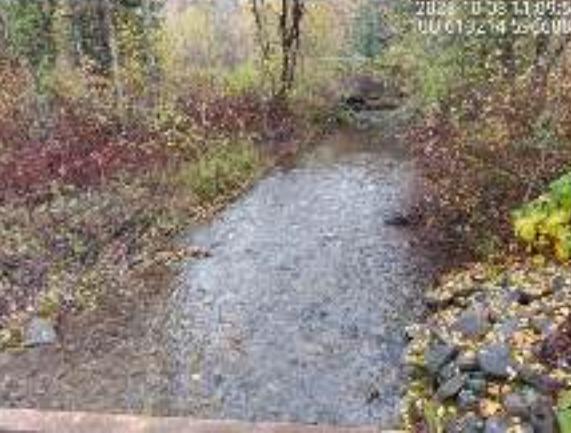
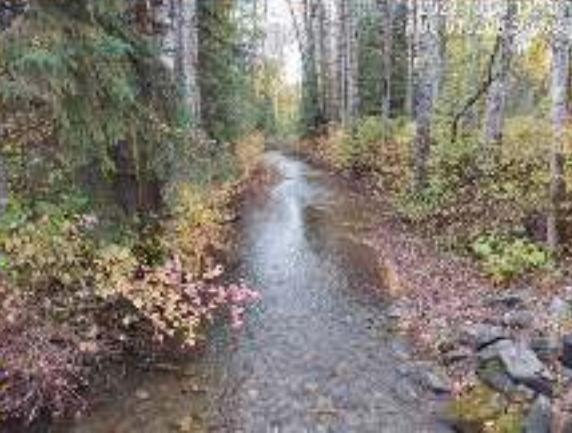
| Location and Stream Data | | • | Crossing Characteristics | – |
|---|---|---|---|---|
| Photos: PSCIS ID 9904385. From top left clockwise: Road/Site Card, Barrel, Outlet, Downstream, Upstream, Inlet. | | | | |

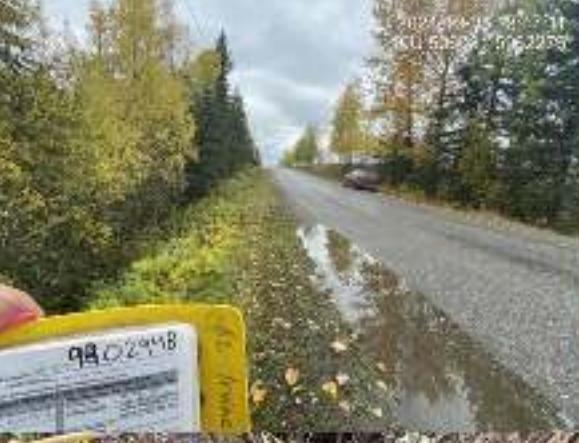
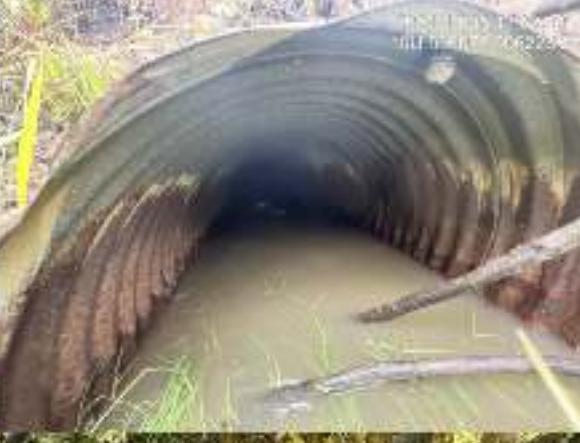
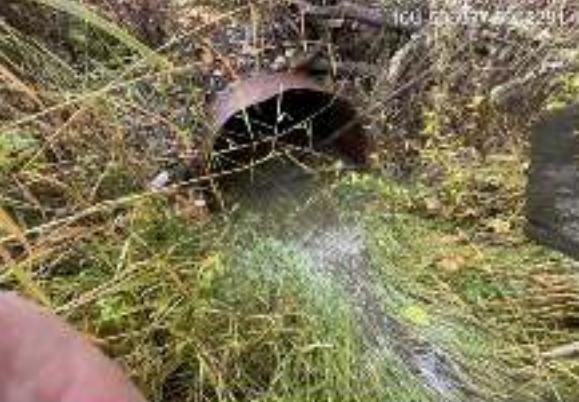
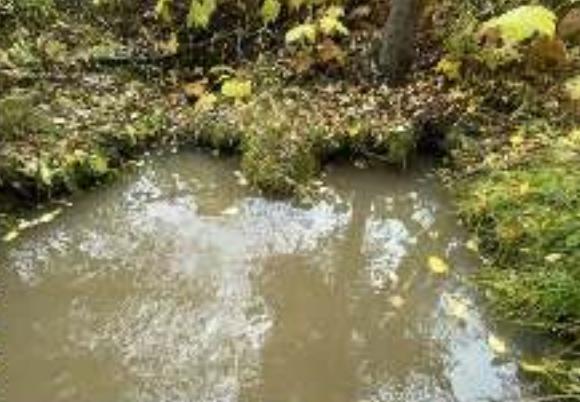
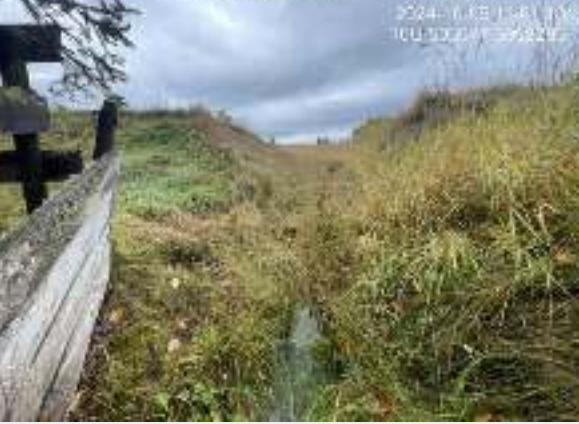
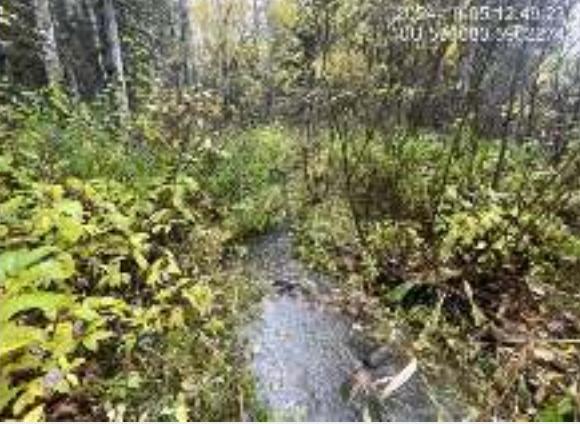
Photos: PSCIS ID 9902948. From top left clockwise: Road/Site Card, Barrel, Outlet, Downstream, Upstream, Inlet.

Comments: The culvert was fully backwatered, with the outlet completely submerged. The stream flowed through a grassy valley on private property upstream. The road column on the inlet side was eroding significantly. A V-shaped fence was positioned in front of the inlet for unknown reasons. Culvert slope and length were estimated, as the inlet was completely submerged and not visible. The culvert was embedded at the inlet and assumed to be fully embedded, though this could not be confirmed due to the submerged outlet. Just upstream of the inlet, remnants of a possible old dam were observed, with large piles of dirt on both sides and a dugout middle section allowing stream flow. See photos for details. MoTi chris_culvert_id: 1976182

| Location and Stream Data | | Crossing Characteristics | |
|---|---|---|---|
| Fix type | Replace Structure with Streambed Simulation CBS | Fix Span / Diameter | 27 |
