Restoring Fish Passage in the Fraser Region - 2023

**Prepared for
Ministry of Transportation and Infrastructure**

**Prepared by
Al Irvine, B.Sc., R.P.Bio. and Lucy Schick, B.Sc.
New Graph Environment Ltd.**

Version 0.1.1 DRAFT 2025-05-01

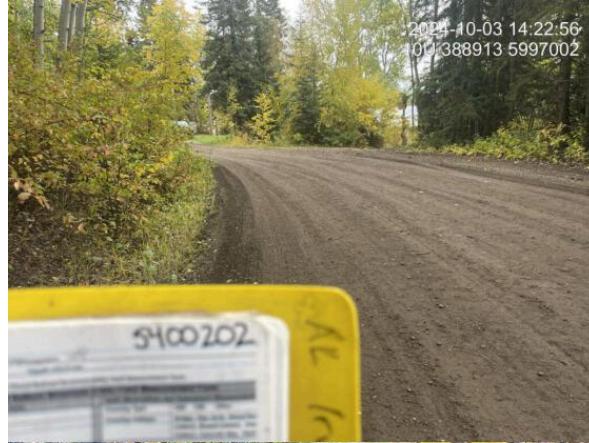
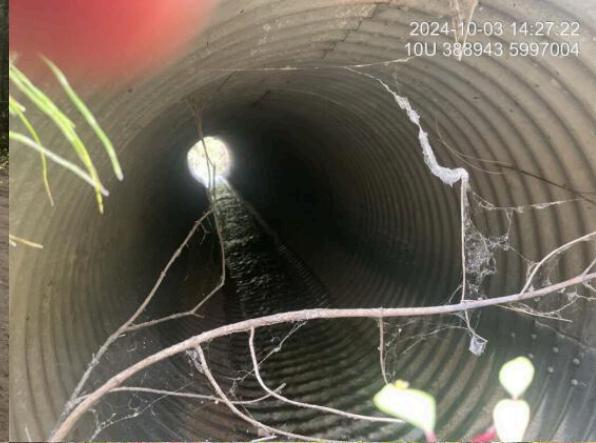
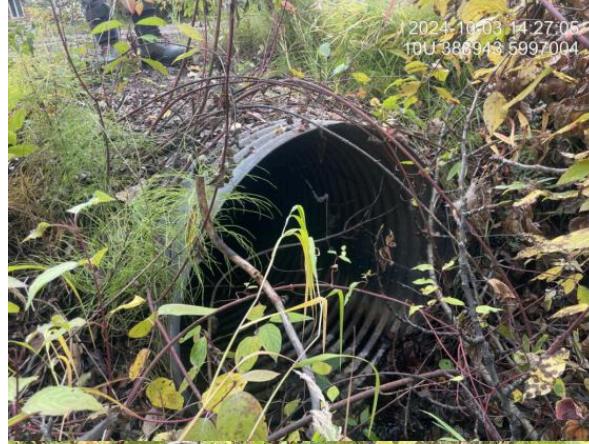
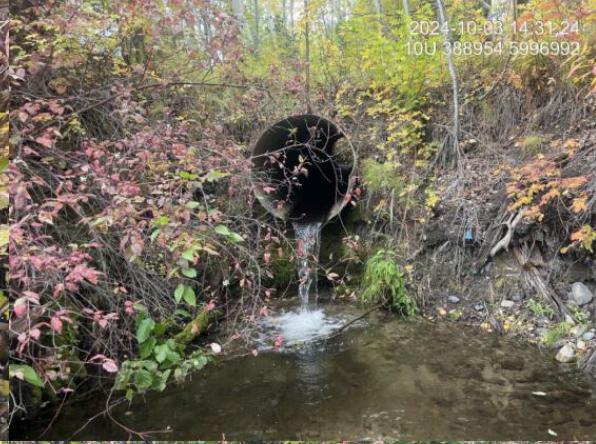
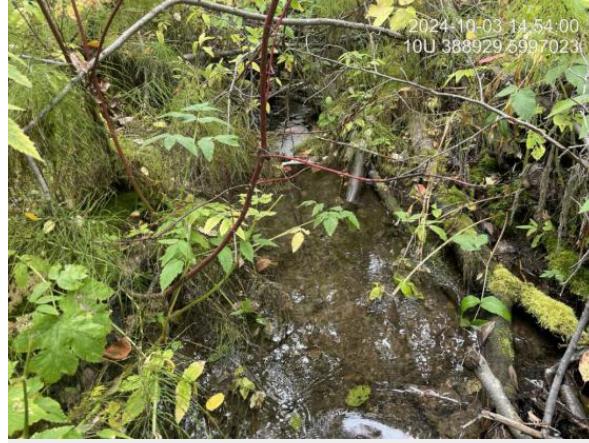
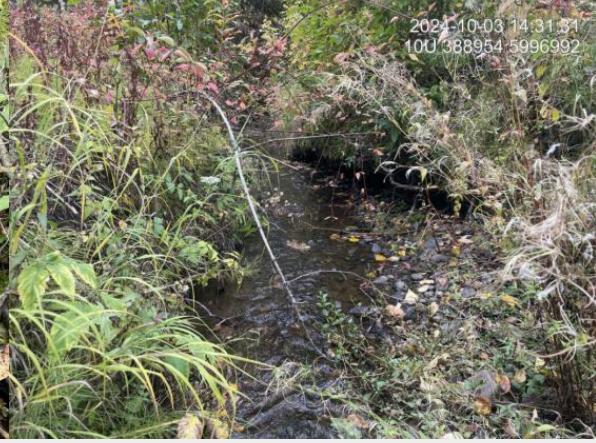
Table 5.4: Summary of fish passage assessment for PSCIS crossing 7622.

Location and Stream Data	Crossing Characteristics
<p>Comments: The local name of the stream is Burnt Cabin Creek. It had a large outlet drop and a heavily eroded outlet pool, indicating the culvert was undersized. The stream provided complex habitat for fish with abundant cover. The low-traffic dirt road had minimal road fill, making construction relatively straightforward.</p> <p>MoTi chris_culvert_id: 1790951</p> <p>Photos: From top left clockwise: Road/Site Card, Barrel, Outlet, Downstream, Upstream, Inlet.</p>

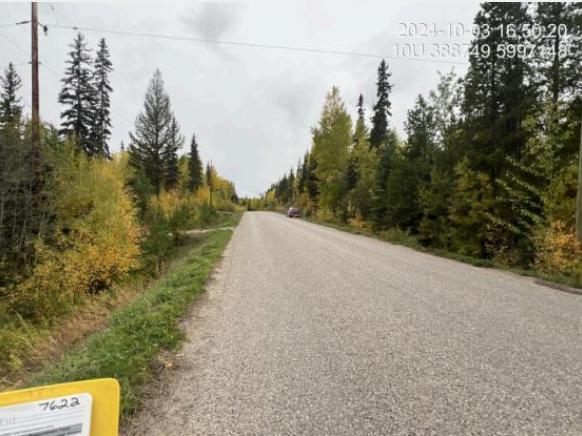
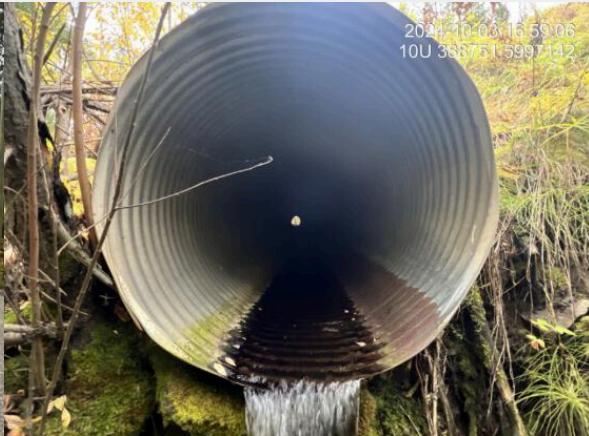
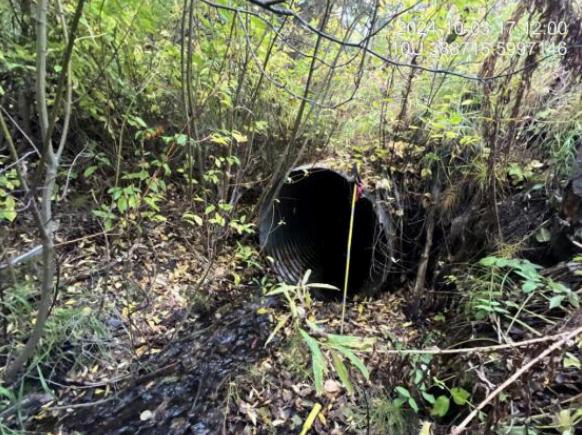
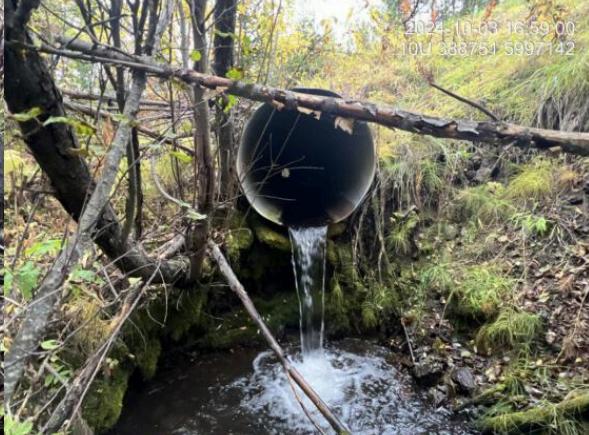
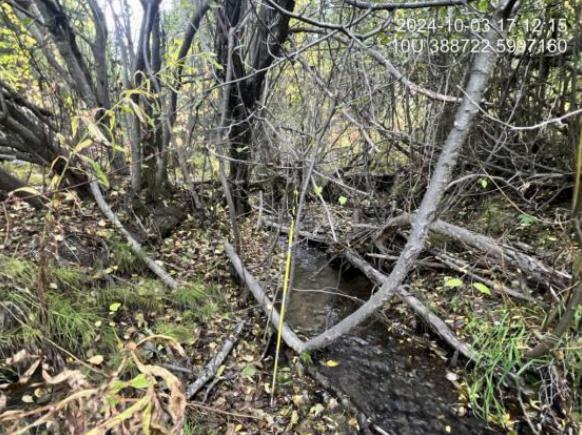
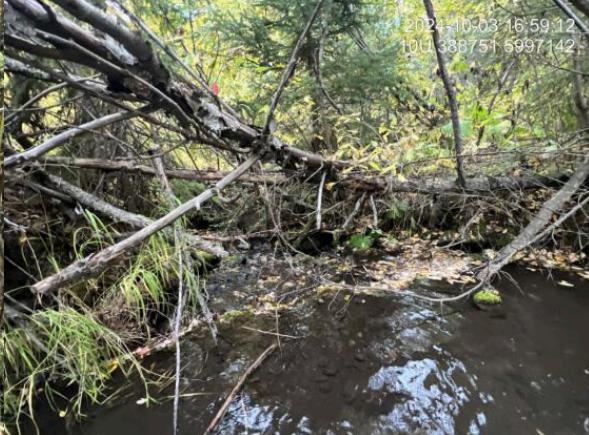
Location and Stream Data	Crossing Characteristics
Comments: The culvert is undersized for current flow volumes, as indicated by a very large 1.15m outlet drop. Habitat confirmation was completed upstream, downstream, and below Gala Bay Road. MoTi chris_culvert_id: 1794196	
Photos: From top left clockwise: Road/Site Card, Barrel, Outlet, Downstream, Upstream, Inlet.

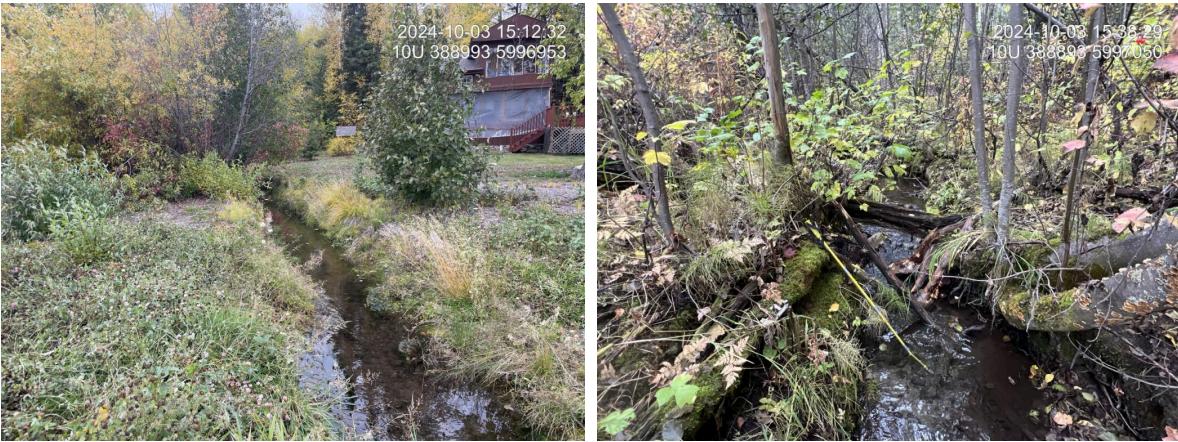
Figure 5.2: Left: Typical habitat downstream of PSCIS crossing 199171. Right: Typical habitat upstream of PSCIS crossing 199171 and downstream of PSCIS crossing 7622.

Site	Location	Length Surveyed (m)	Average		Average Pool Depth (m)	Average Gradient (%)	Total Cover	Habitat Value
			Channel Width (m)	Average Wetted Width (m)				
7622	Upstream	500	3.5	1.4	0.2	7.0	abundant	high
199171	Downstream	50	2.4	1.4	0.1	1.3	moderate	medium
199171	Upstream	275	2.4	1.2	0.1	4.5	moderate	medium

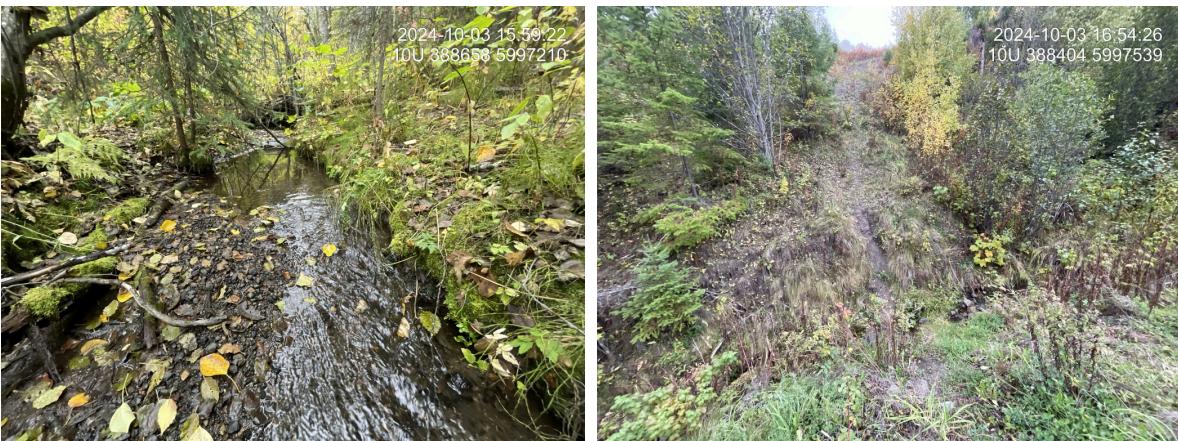
Figure 5.3: Left: Typical habitat upstream of PSCIS crossing 7622. Right: Bank erosion and riparian removal at the pipeline upstream of crossing 7622.

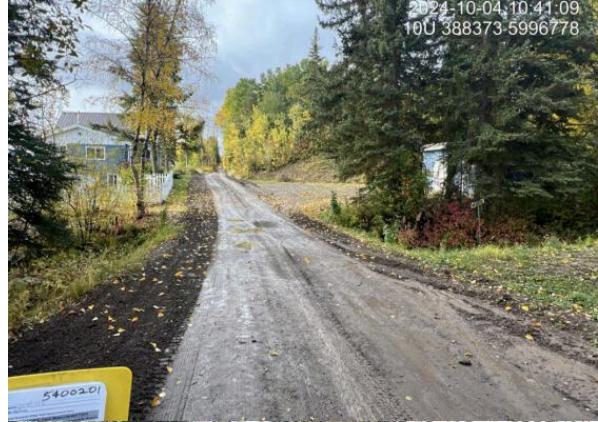
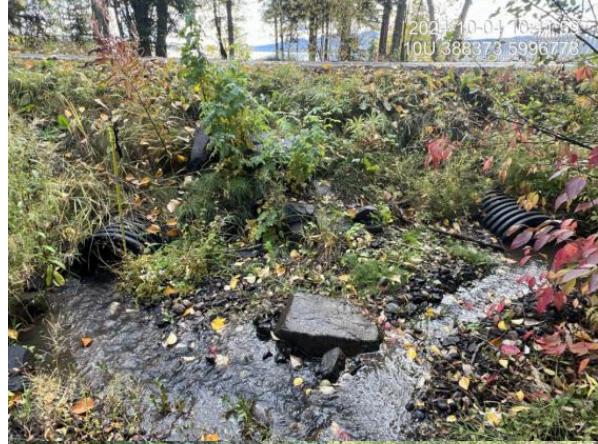
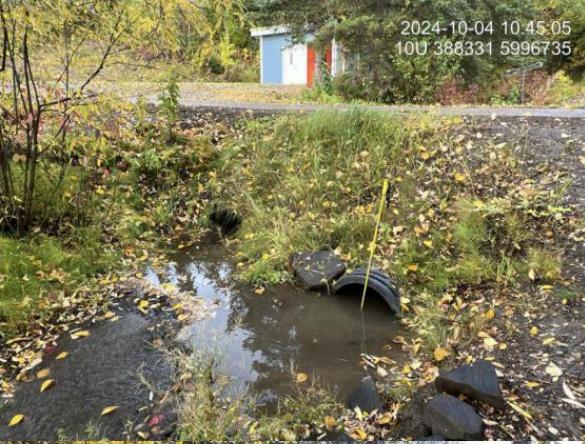
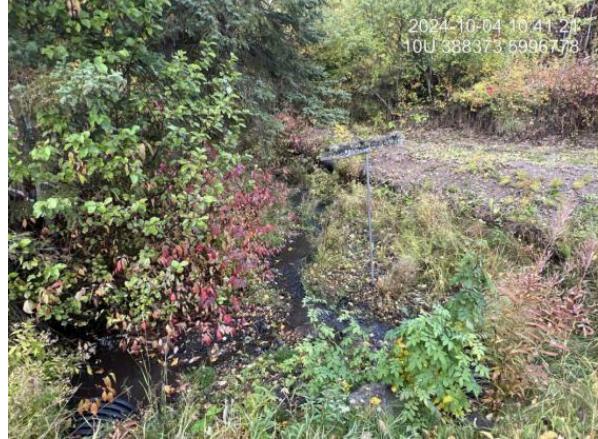
Location and Stream Data	Crossing Characteristics
<p>Comments: Two fully embedded PVC pipes, each 0.7m in diameter. One pipe was completely backwatered. Medium-value habitat was observed, with extensive gravels suitable for spawning upstream and downstream. A historic Chinook spawning point was recorded adjacent to the road. Habitat confirmations were conducted upstream, downstream, and above Stella Road. MoTi chris_culvert_id: 1790947</p>	
Photos: From top left clockwise: Road/Site Card, Barrel, Outlet, Downstream, Upstream, Inlet.

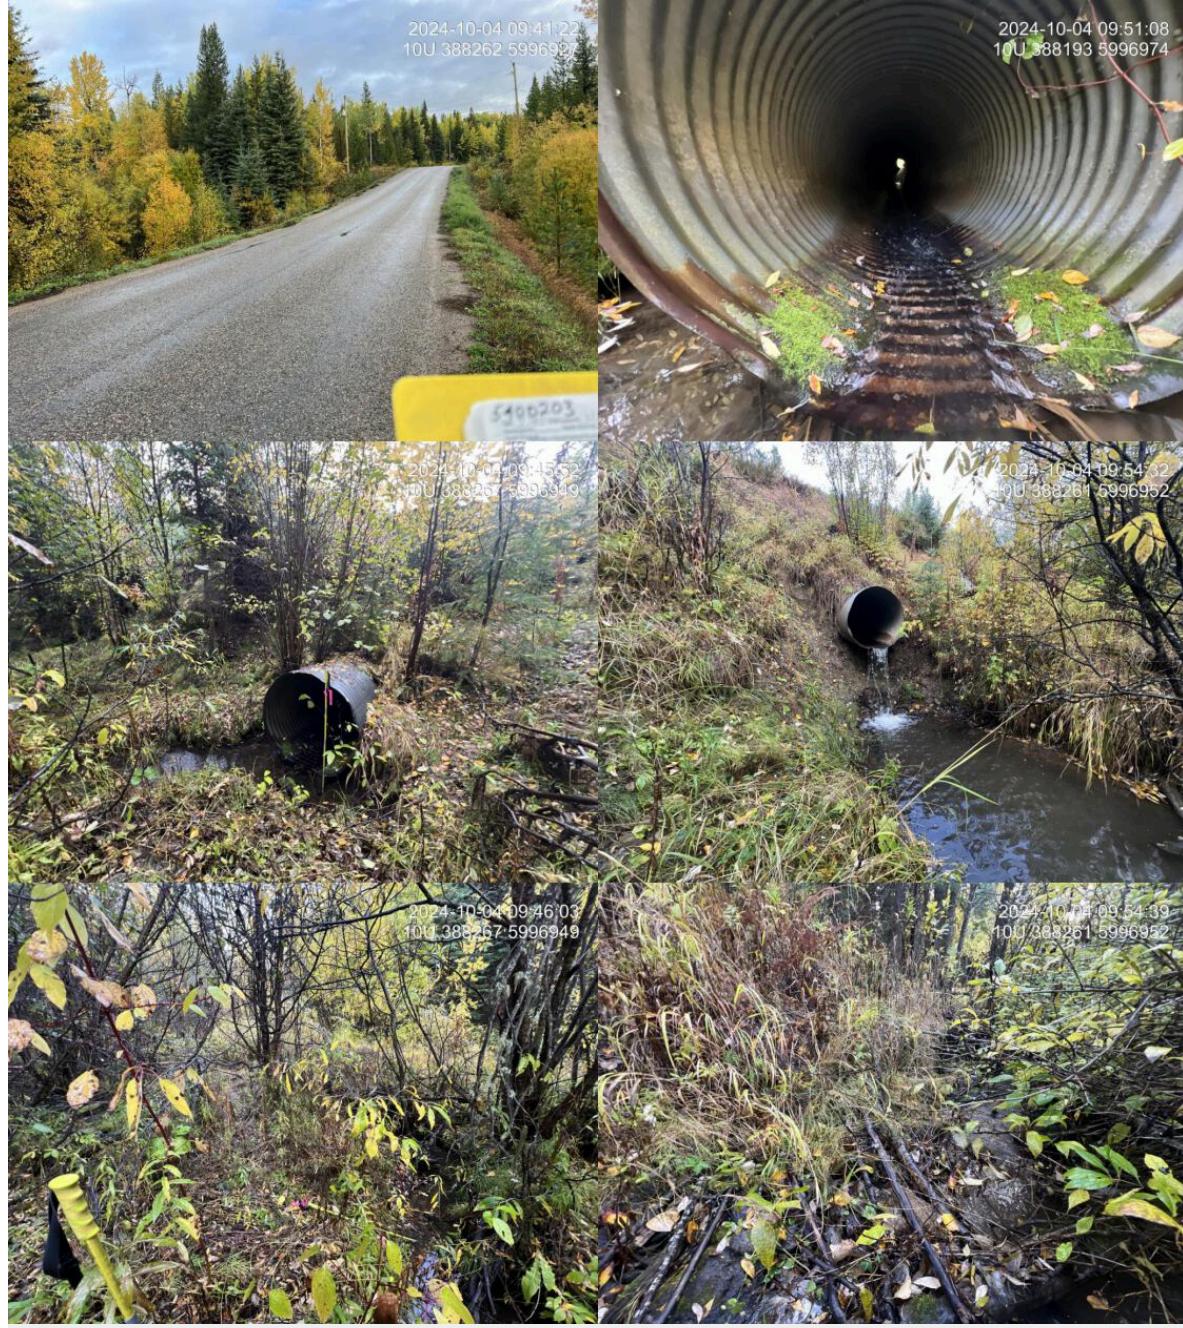
Location and Stream Data	Crossing Characteristics
<p>Comments: The culvert was very undersized for the stream, as evidenced by the large outlet drop. The stream had a good amount of flow for the time of year. Habitat was of medium value, with abundant large woody debris creating complex habitat and pools, providing ample cover for fish. Adjacent landowners reported that the stream was previously used as a water source for bottling and distribution across the province. Habitat confirmation was completed upstream and downstream. MoTi chris_culvert_id: 1794199</p> <p>Photos: From top left clockwise: Road/Site Card, Barrel, Outlet, Downstream, Upstream, Inlet.</p>

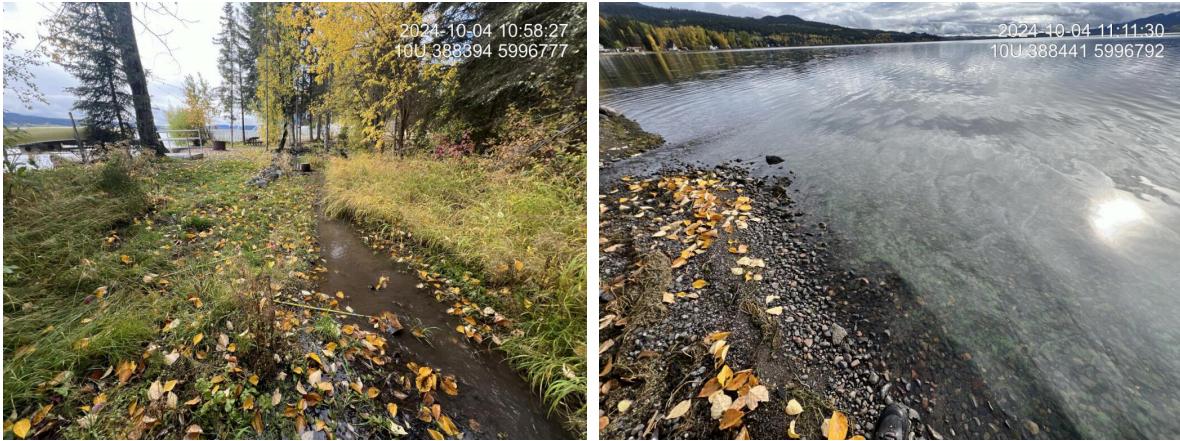
Figure 5.5: Left: Typical habitat downstream of PSCIS crossing 199328. Right: Algal bloom observed downstream of PSCIS crossing 199328 in Fraser Lake.

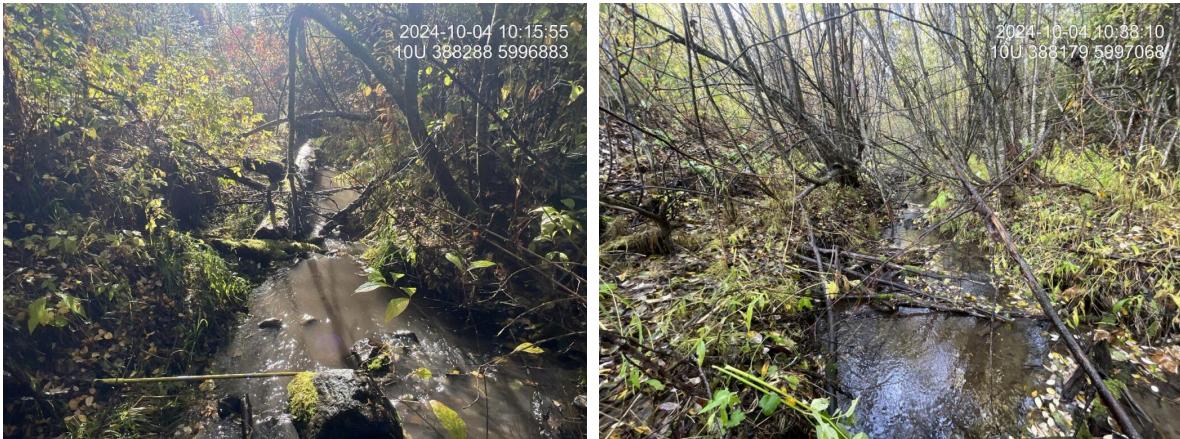
Figure 5.6: Left: Typical habitat upstream of PSCIS crossing 199328 and downstream of PSCIS crossing 199172. Right: Typical habitat upstream of PSCIS crossing 199172.

The stream was surveyed from Gala Bay Road upstream to Stella Road, a distance of approximately 270m (Figure 5.6) The habitat was rated as medium value, with limited pools; however, abundant overhanging vegetation and small woody debris provided cover, and gravels suitable for resident salmonid spawning were present. Incision was evident, beginning with a deep cut at the culvert outlet under Stella Road and continuing downstream to Gala Bay Road. The riparian area was generally intact through most of the survey, except for the downstream 75m, where private land development on the north side had resulted in a lawn and riparian vegetation removal up to the channel edge. Total cover amount was rated as moderate with overhanging vegetation dominant. Cover was also present as small woody debris and undercut banks. The average channel width was 2.1m, the average wetted width was 1.3m, and the average gradient was 3%. The dominant substrate was gravels with cobbles sub-dominant.

The stream was surveyed upstream from crossing 199172 for 550m (Figure 5.6). The habitat was rated as medium value, with abundant functional large woody debris creating pools 20 – 30cm deep, suitable for overwintering juvenile fish. Overhead cover was extensive, and occasional gravels were suitable for spawning. Approximately 400m upstream of Stella Road, the stream transitioned into a beaver-impounded area with four consecutive dams (1 – 1.5m high) impounding a large volume of water. Flow was maintained over or under the dams and the impounded area extended to the upper end of the surveyed area. A fish (~40mm) was observed after the second dam. The dominant substrate was gravels with fines sub-dominant. The average channel width was 2.6m, the average wetted width was 1.5m, and the average gradient was 4.3%. Total cover amount was rated as abundant with large woody debris dominant. Cover was also present as small woody debris, undercut banks, and overhanging vegetation.

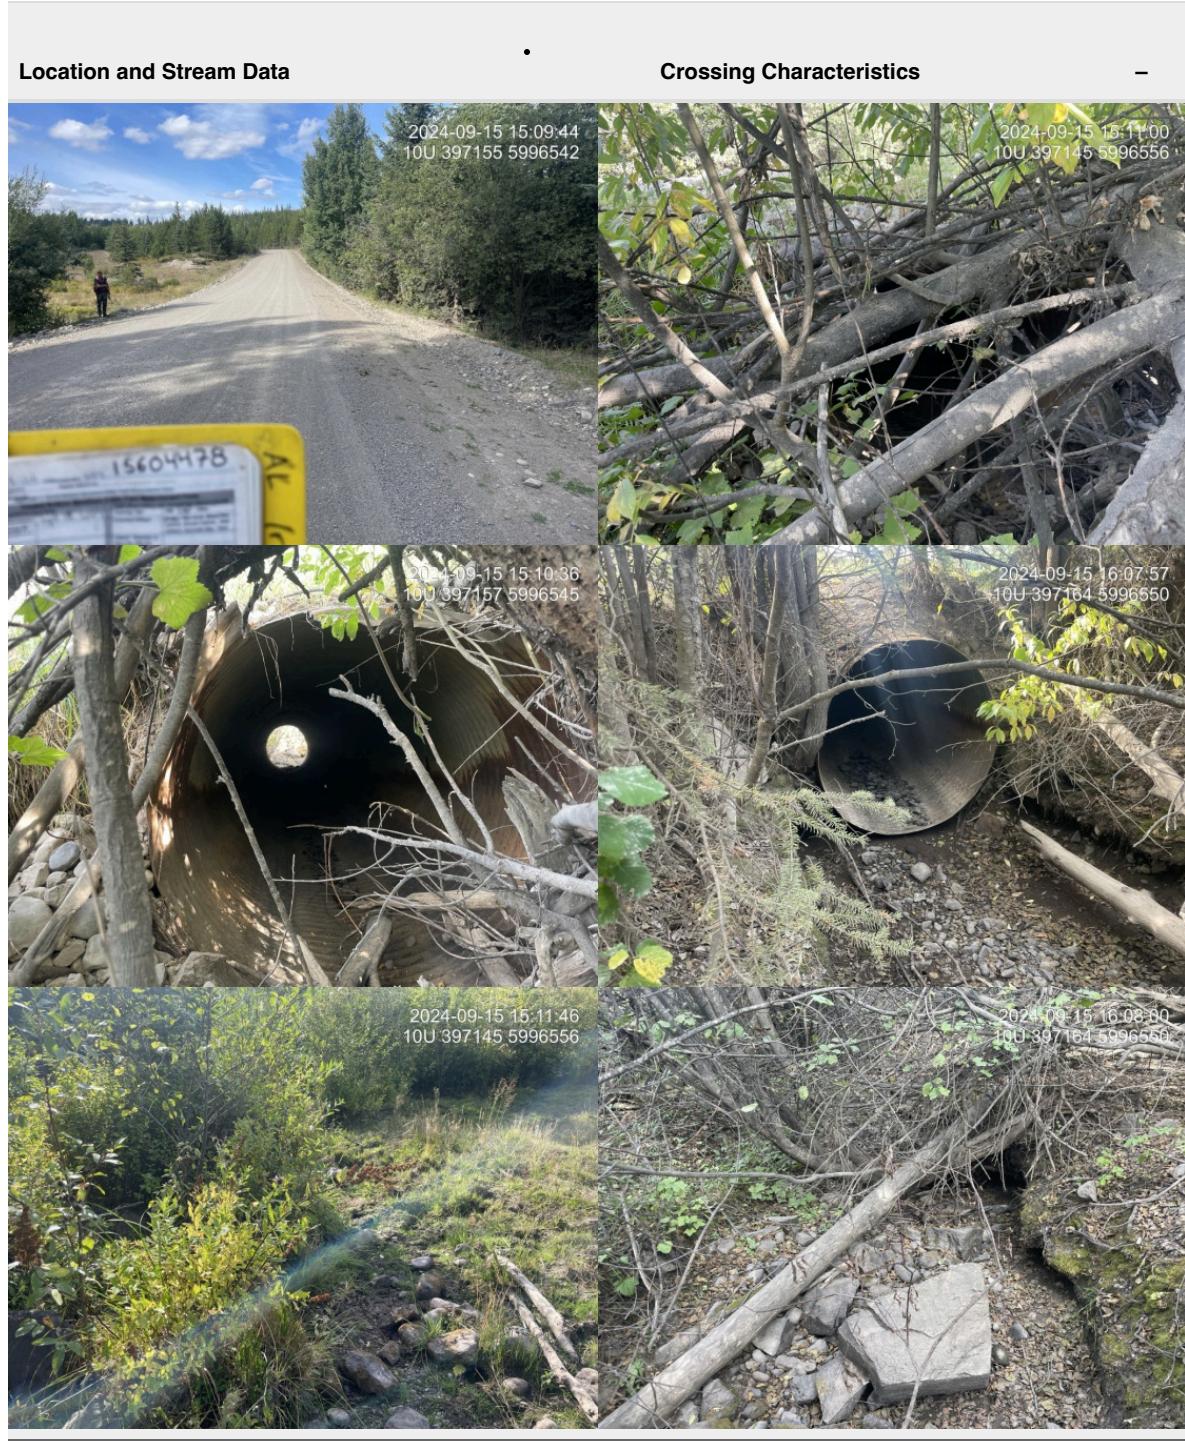
Location and Stream Data		Crossing Characteristics	
Date	2024-09-15	Crossing Sub Type	Round Culvert
PSCIS ID	199174	Diameter (m)	1.5
External ID	–	Length (m)	15
Crew	LS	Embedded	No
UTM Zone	10	Depth Embedded (m)	–
Easting	397160	Resemble Channel	No
Northing	5996574	Backwatered	No
Stream	Tributary To Nechako River	Percent Backwatered	–
Road	Sutherland FSR	Fill Depth (m)	0.4
Road Tenure	MoF	Outlet Drop (m)	0
Channel Width (m)	2.5	Outlet Pool Depth (m)	0
Stream Slope (%)	1.2	Inlet Drop	No
Beaver Activity	No	Slope (%)	1
Habitat Value	–	Valley Fill	Deep Fill
Final score	24	Barrier Result	Barrier
Fix type	Replace with New Open Bottom Structure	Fix Span / Diameter	15

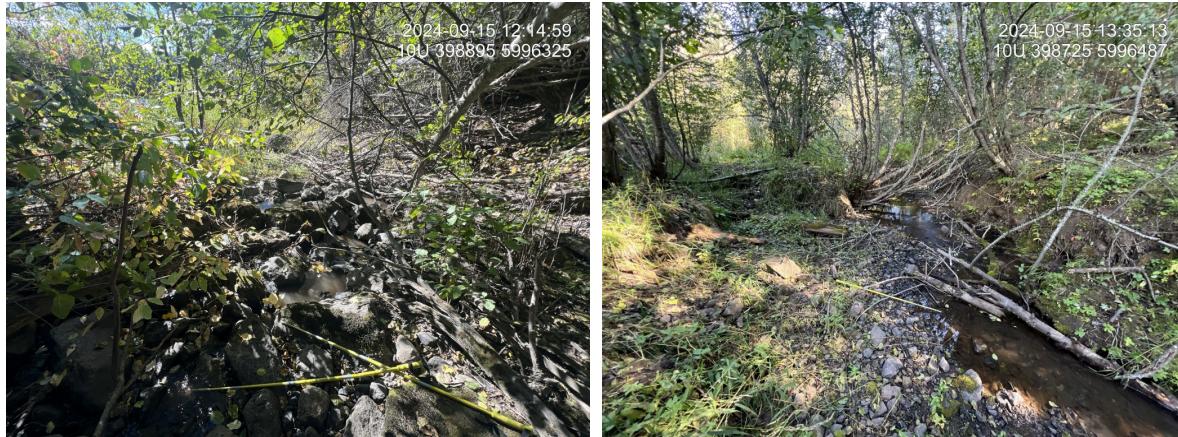
Figure 5.8: Left: Typical habitat downstream of PSCIS crossing 199173. Right: Typical habitat upstream of PSCIS crossing 199173.

The stream was surveyed downstream from crossing 199173 for 115m (Figure 5.8). The habitat was rated as medium value, with undercut banks suitable for juvenile chinook and rainbow trout rearing. No natural or man-made barriers were present between Dog Creek Road and the Nechako River. Fish (~40 – 90mm in length) were observed during the assessment. The dominant substrate was cobbles with fines sub-dominant. Total cover amount was rated as moderate with undercut banks dominant. Cover was also present as small woody debris and boulders. The average channel width was 3.5m, the average wetted width was 1.3m, and the average gradient was 6%.

The stream was surveyed upstream from crossing 199173 for 575m (Figure 5.8). The habitat was rated as medium with pockets of gravels suitable for rainbow trout and potentially chinook rearing, and fish were observed throughout the survey area. Heavy cattle impacts were evident, particularly in low-gradient sections with easily accessible banks. Fencing intended to restrict cattle access was present but had been breached. Approximately 300–350m upstream, the stream transitioned from a channelized section to a beaver-impounded wetland, with over three mature dams — some up to 1.5m high — vegetated and well-developed. These dams impounded large volumes of water, likely sustaining year-round stream flow downstream at the Dog Creek Road crossing. Total cover amount was rated as moderate with small woody debris dominant. Cover was also present as large woody debris, deep pools, and overhanging vegetation. The average channel width was 3m, the average wetted width was 1.5m, and the average gradient was 2.4%.

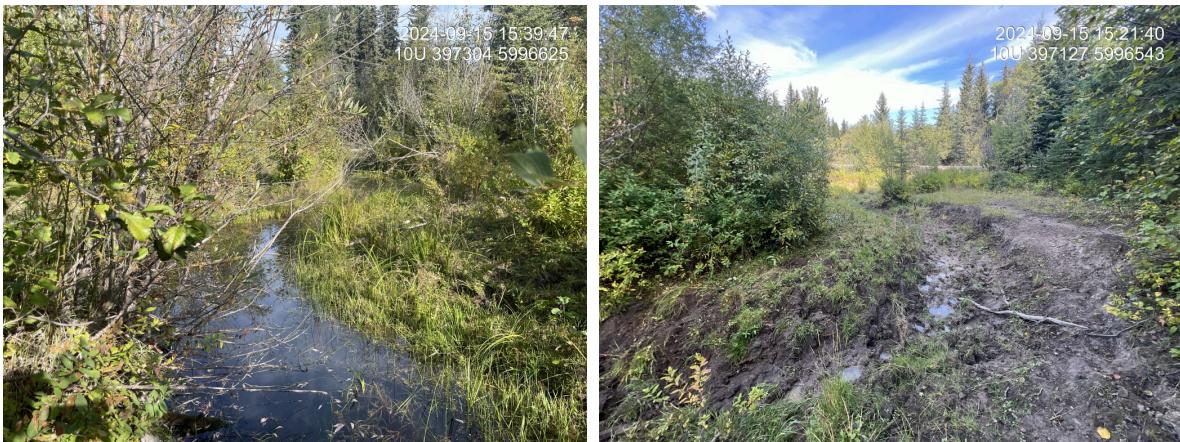
Figure 5.9: Left: Typical habitat downstream of PSCIS crossing 199174. Right: Typical habitat upstream of PSCIS crossing 199174.

The stream was surveyed downstream from crossing 199174 for 300m (Figure 5.9). The stream was intermittent for the first ~70m before transitioning into a beaver-impacted wetland area. Approximately 250m downstream of Sutherland FSR, several large, mature, consecutive beaver dams were present and appeared to continue as far as the area surveyed. Signs of cattle trampling were observed throughout the stream, and the channel frequently split into several smaller channels. The habitat was rated as medium value, with few gravels for spawning but abundant pools created by beaver dams. Total cover amount was rated as abundant with small woody debris dominant. Cover was also present as large woody debris, undercut banks, deep pools, and overhanging vegetation. The average channel width was 2m, the average wetted width was 1m, and the average gradient was 1.2%. The dominant substrate was fines with gravels sub-dominant.

The stream was surveyed upstream from crossing 199174 for 650m (Figure 5.9). The habitat was rated as medium value and had been heavily impacted by cattle, with evidence of bank trampling and extensive low-gradient muddy sections. Upstream of the culvert, the stream was primarily dry for the first 300m, with young forest and shrub riparian. At this point, intermittent pools began to

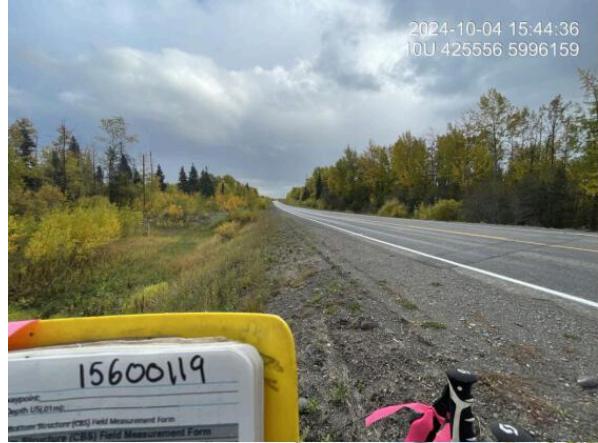
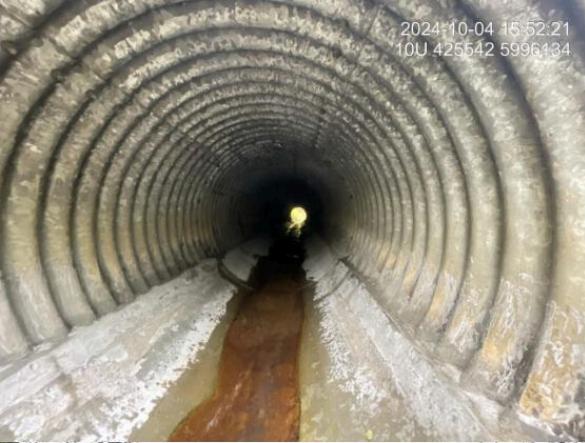
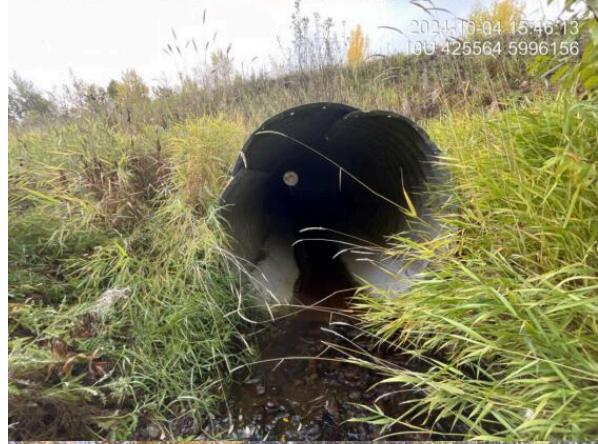
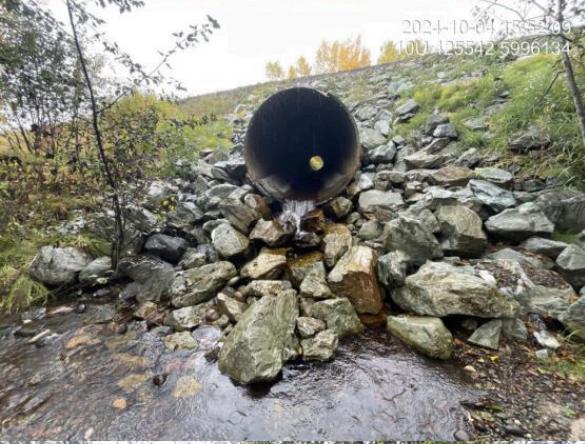
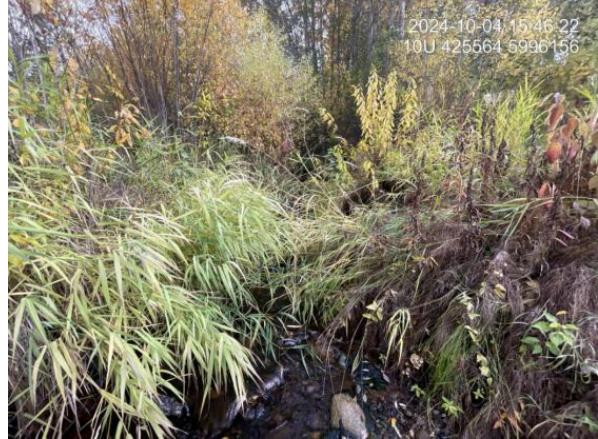
Location and Stream Data	Crossing Characteristics
<p>Comments: The bottom of the culvert had been reinforced with concrete, likely to address holes noted in the previous assessment. A large pile of riprap was placed at the outlet, possibly to reduce the outlet drop, though its placement appeared unusual and could inhibit fish passage. The habitat was high quality, with a large pool just downstream of the culvert and abundant gravels suitable for spawning fish. MoTi chris_culvert_id: 1806163</p>	
Photos: From top left clockwise: Road/Site Card, Barrel, Outlet, Downstream, Upstream, Inlet.

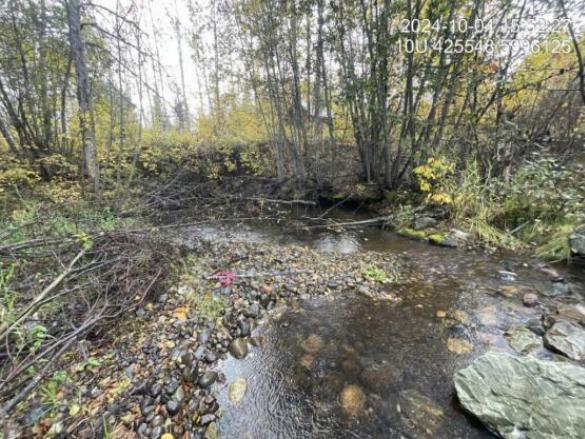
<p>2024-10-04 15:52:25 10U 425542 5996125</p> A photograph of a stream flowing through a rocky bed with fallen leaves, surrounded by trees and shrubs.

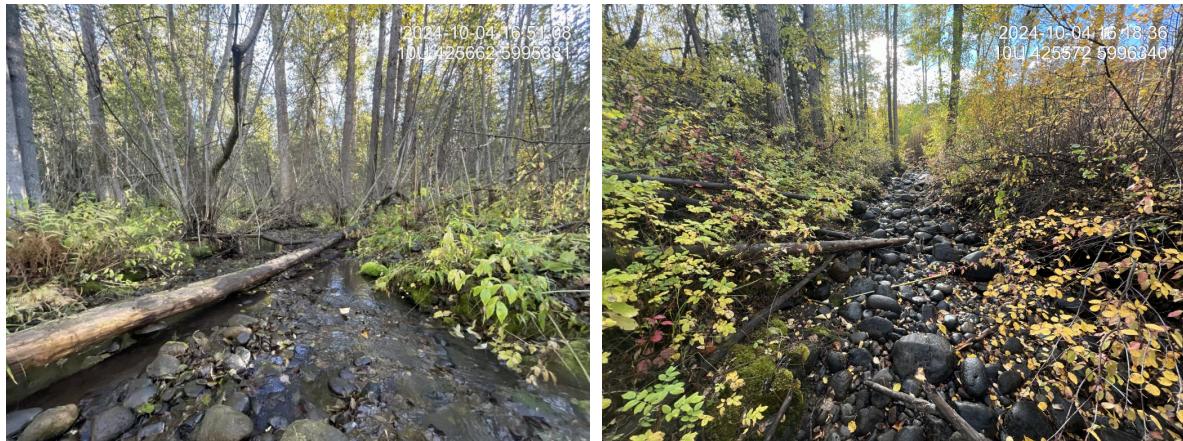
Figure 5.11: Left: Typical habitat downstream of PSCIS crossing 199190. Right: The stream went subsurface approximately 200m upstream of PSCIS crossing 199190.

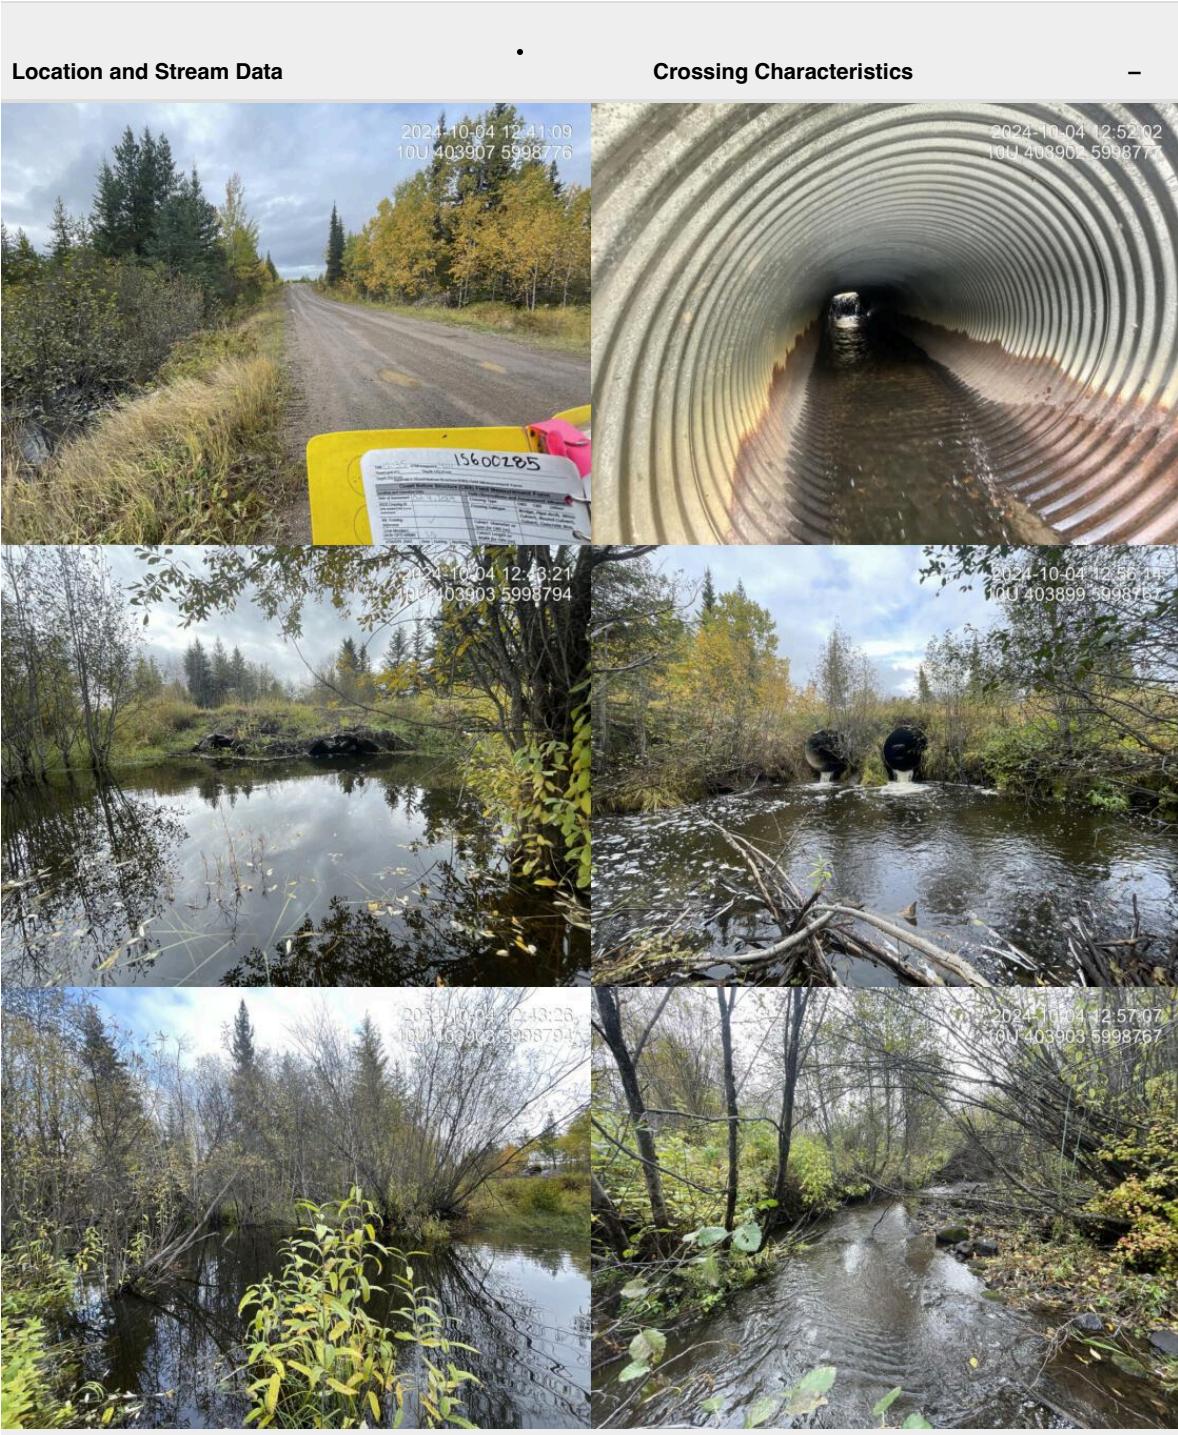
Stream Characteristics at Crossing 19...

Location and Stream Data		Crossing Characteristics	
Final score	31	Barrier Result	Barrier
Fix type	Replace with New Open Bottom Structure	Fix Span / Diameter	15
Comments: The inlets of both culverts were dammed by a beaver, backing up water to most of the culverts' height. Two pipes, each 1.6m in diameter, were present. A large outlet pool indicated the pipes were likely undersized for the stream. Another beaver dam was being constructed at the outlet of the pool. The dirt road had minimal road fill, making construction relatively straightforward. The road appeared to be used for pipeline access. Outlet pool depth was estimated as it was too deep to wade. Fish approximately 40mm in length were observed downstream during habitat confirmation. MoTi chris_culvert_id: 1793923			
Photos: From top left clockwise: Road/Site Card, Barrel, Outlet, Downstream, Upstream, Inlet.

Should restoration/maintenance activities proceed, replacement of the Settlement Road crossing (199204) with a bridge (15 m span) is recommended. At the time of reporting in 2025, the cost of the work is estimated at \$ 1,500,000.

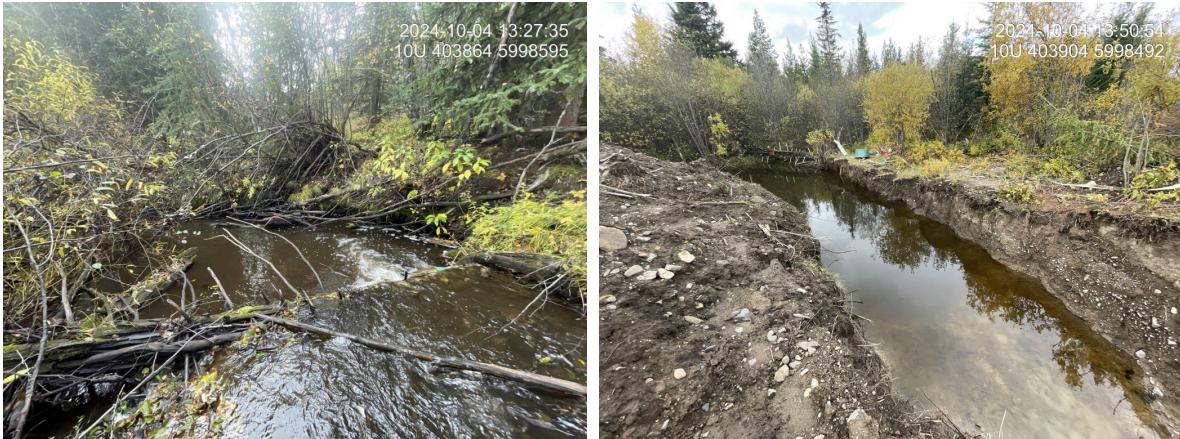
Figure 5.13: Left: Typical habitat downstream of PSCIS crossing 199204. Right: Large, artificially entrenched pool located ~300m downstream of PSCIS crossing 199204.

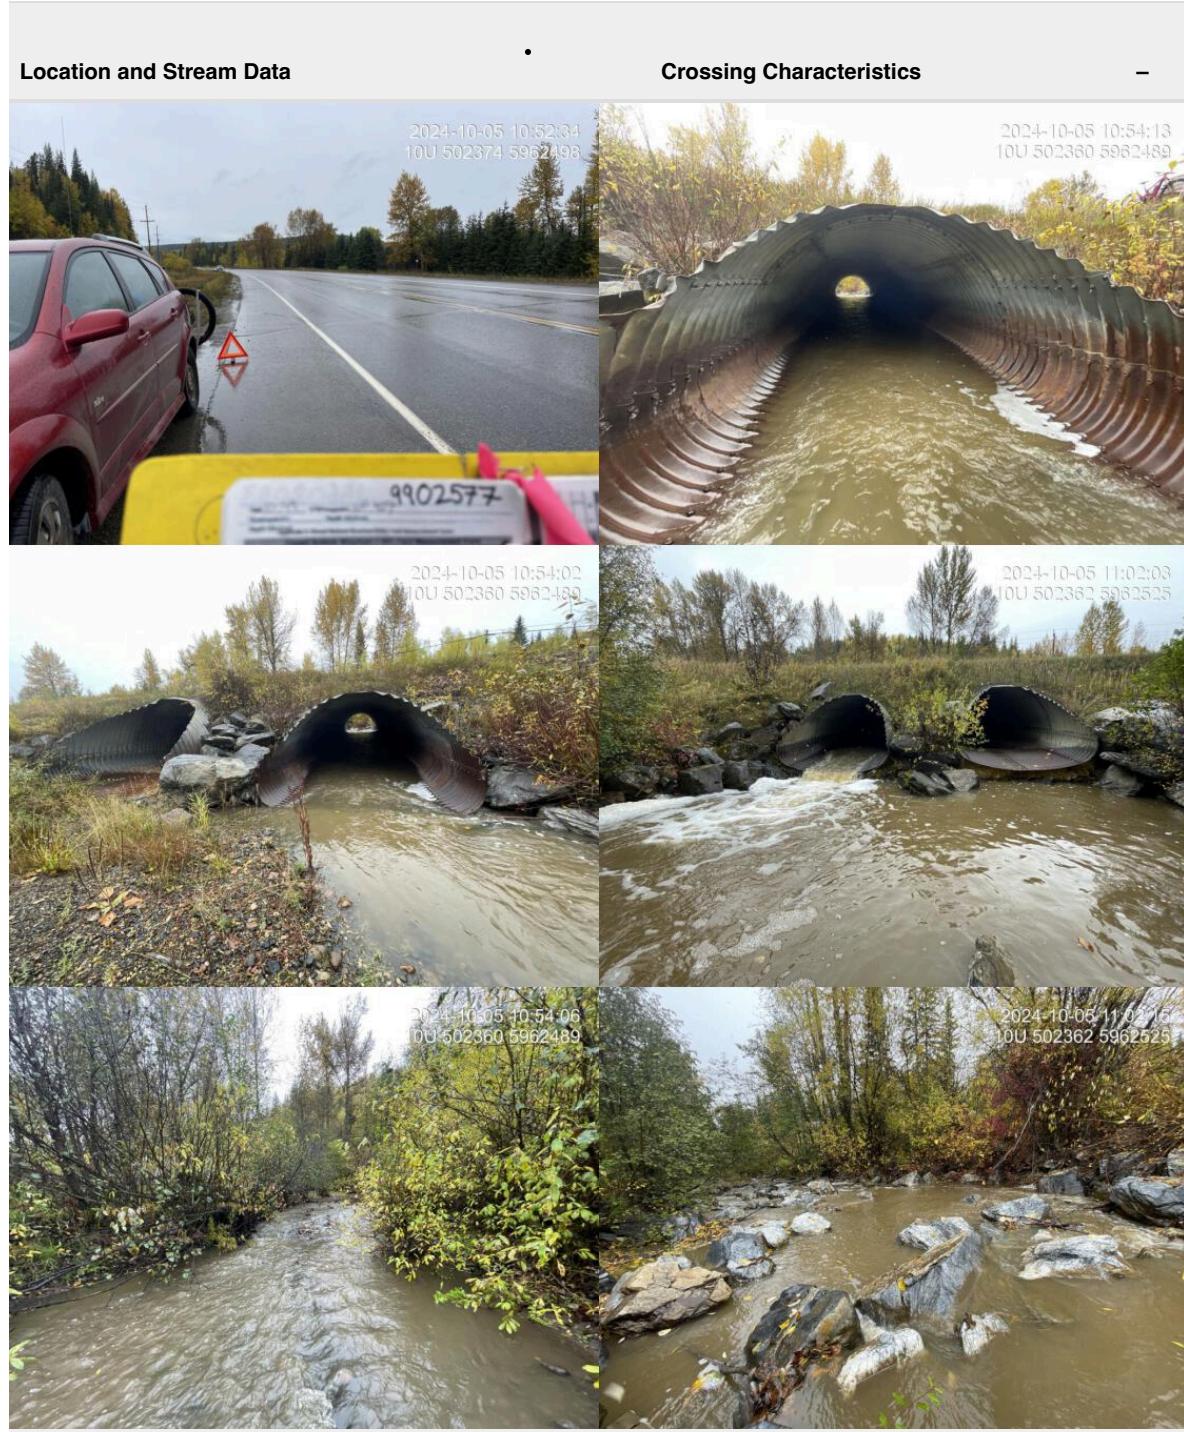
Stream Characteristics at Crossing 19...

At the time of the 2024 assessment, PSCIS crossing 199232 on Highway 16 was un-embedded, non-backwatered and ranked as barrier to upstream fish passage according to the provincial protocol (MoE 2011) (Table 5.27). Two 2.8m diameter pipes were present, with no flow observed in the more northern pipe. The culverts had a significant 1.05m outlet drop.

Should restoration/maintenance activities proceed, replacement of the Highway 16 crossing (199232) with a bridge (15 m span) is recommended. At the time of reporting in 2025, the cost of the work is estimated at \$ 11,250,000.

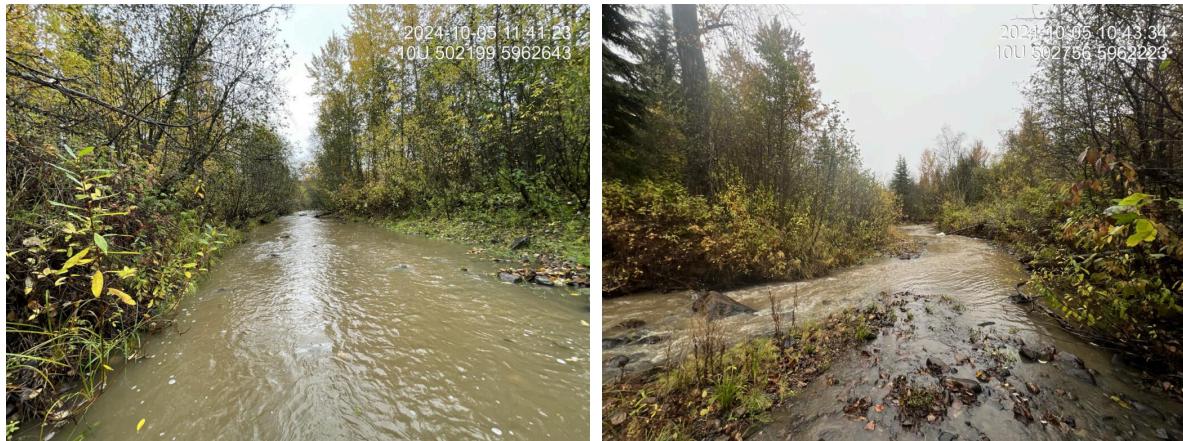
The stream was surveyed downstream from crossing 199232 for 300m (Figure [5.16](#)). The habitat was rated as medium value due to sparse large woody debris, a lack of pools, and high turbidity from recent rainfall likely obscuring gravels. Below the outlet, large boulders were placed in rows to backwater the culvert, which was somewhat effective, though the culvert itself remained unbackwatered. This section had a steeper gradient (3 – 4%) before transitioning to ~0.5% for the remainder of the area surveyed. The upper section of the stream was somewhat channelized due to residences on both sides, while lower sections showed significant bank erosion. Total cover amount was rated as moderate with large woody debris dominant. Cover was also present as boulders. The dominant substrate was cobbles with gravels sub-dominant. The average channel width was 9.6m, the average wetted width was 6m, and the average gradient was 2%.

The stream was surveyed upstream from crossing 199232 for 725m (Figure [5.16](#)). The habitat was rated as high value, with abundant gravels suitable for chinook spawning. Pools were infrequent, primarily located on outside bends and behind large woody debris. Some evidence of anthropogenic manipulation was observed, including cut cottonwood trees that had fallen into the channel. The riparian zone was in good condition, with mature shrub communities and old-growth cottonwood that should contribute to future habitat complexity. Water levels were elevated to moderate conditions due to heavy rainfall over the previous evening and preceding weeks. The average channel width was 11.9m, the average wetted width was 8m, and the average gradient was 0.6%. The dominant substrate was gravels with cobbles sub-dominant. Total cover amount was rated as moderate with overhanging vegetation dominant. Cover was also present as small woody debris and boulders.

Figure 5.16: Left: Typical habitat downstream of PSCIS crossing 199232. Right: Typical habitat upstream of PSCIS crossing 199232.

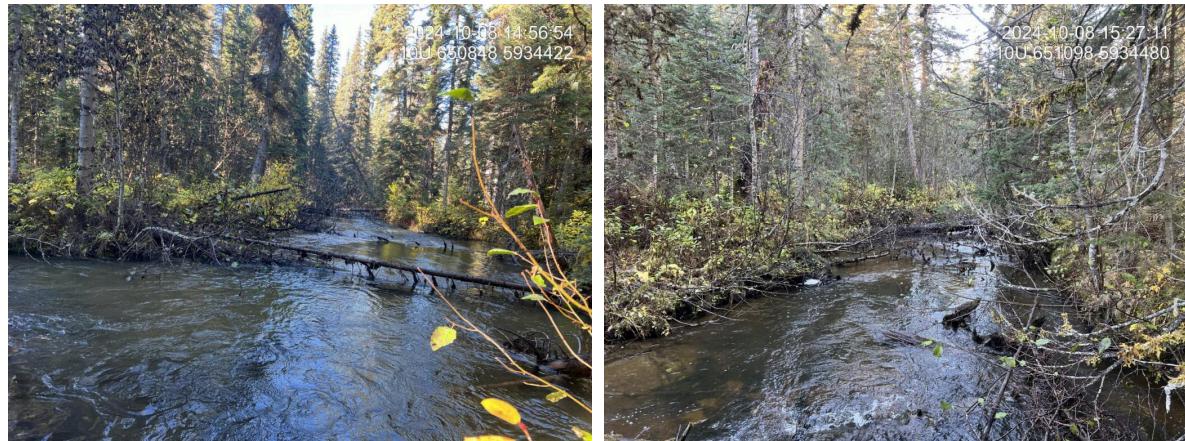
Figure 5.18: Left: Typical habitat upstream of PSCIS crossing 199237 on the west fork on Snowshoe Creek. Right: Typical habitat upstream of PSCIS crossing 199237 on the east fork on Snowshoe Creek.

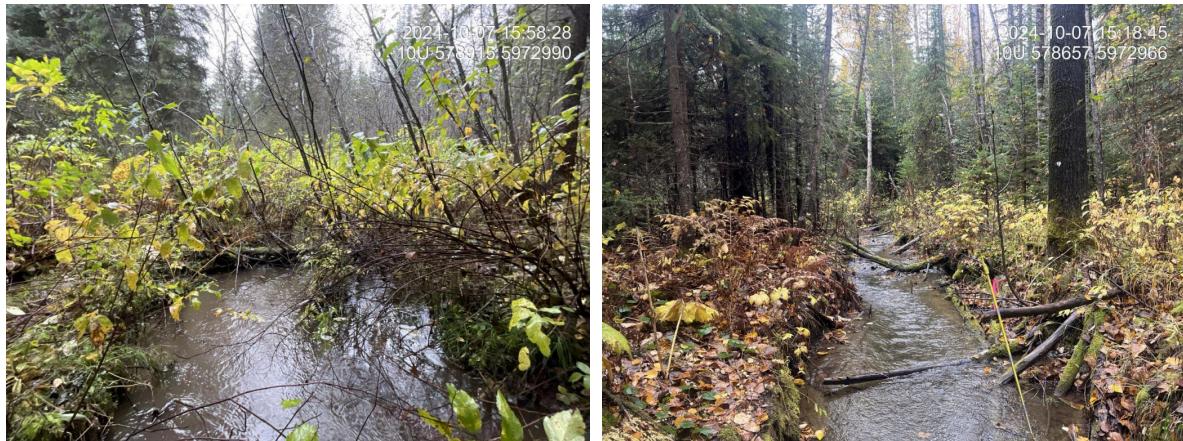
The stream was surveyed downstream from crossing 199255 for 270m (Figure [5.20](#)). The habitat was rated as low value for spawning and rearing with no gravels or cobbles observed and the substrate consisting entirely of fine mud. Fish habitat was limited, with very few pools present. The first 130m of the stream was a beaver-affected area, with a beaver dam approximately 0.7m high located ~40m downstream of the culvert. The dam had flooded the surrounding forest, with no main channel observed. Occasional sections had a somewhat defined channel, but the majority of the surveyed area consisted of water flowing through a wet forest. Total cover amount was rated as moderate with overhanging vegetation dominant. Cover was also present as small woody debris, undercut banks, and instream vegetation. The dominant substrate was fines with fines sub-dominant. The average channel width was 10.3m, the average wetted width was 7m, and the average gradient was 0.8%..

Figure 5.20: Left: Typical habitat downstream of PSCIS crossing 199255. Right: Typical habitat upstream of PSCIS crossing 199255.
