Restoring Fish Passage in the Fraser Region - 2023

**Prepared for
Ministry of Transportation and Infrastructure**

**Prepared by
Al Irvine, B.Sc., R.P.Bio. and Lucy Schick, B.Sc.
New Graph Environment Ltd.**

Version 0.1.1 DRAFT 2025-05-01

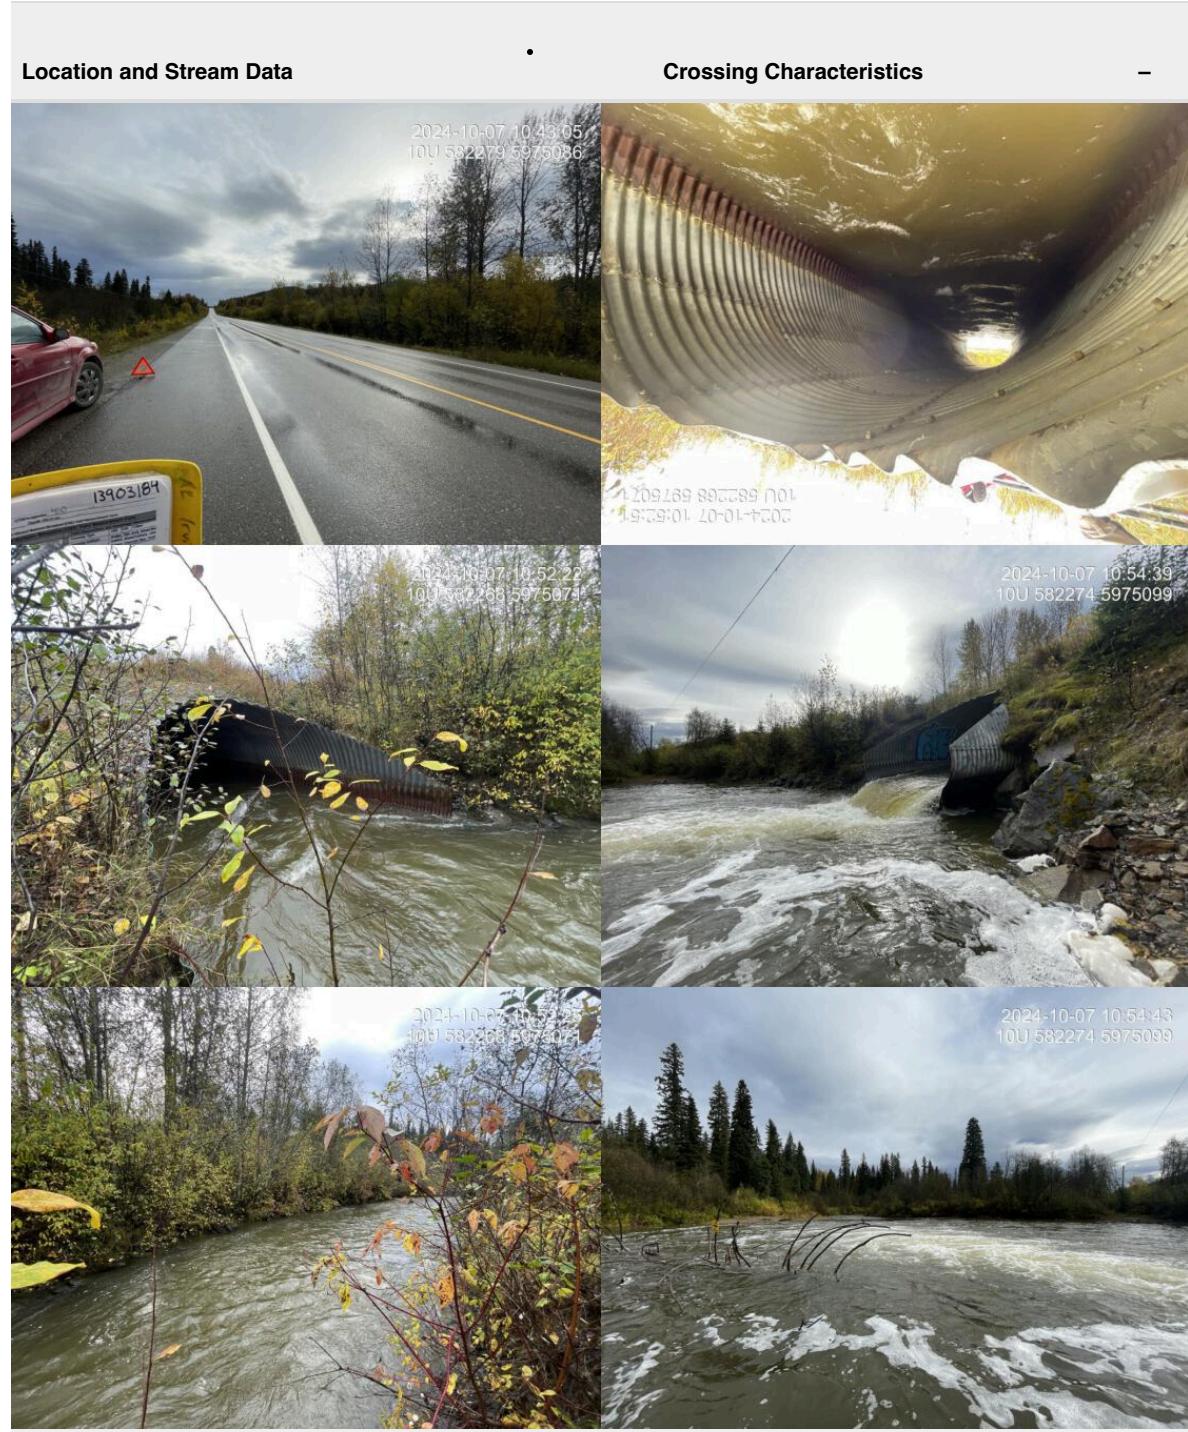
In 2006, PSCIS crossing 199256 on Highway 16 was assessed with a fish passage assessment by DWB Forestry Services Ltd. and documented as a partial barrier due to high water velocities and an 8cm outlet drop (Hooft 2006). The culvert constricted the channel to less than half its natural width; however, upstream habitat was noted as high value, with chinook captured both upstream and downstream of the crossing. Hooft (2006) noted that although adult chinook salmon and rainbow trout could ascend at the observed velocities, they were likely impeded during higher spring flows.

Location and Stream Data		Crossing Characteristics	
Date	2024-10-07	Crossing Sub Type	Oval Culvert
PSCIS ID	199256	Diameter (m)	5.5
External ID	–	Length (m)	30
Crew	LS	Embedded	No
UTM Zone	10	Depth Embedded (m)	–
Easting	582279	Resemble Channel	No
Northing	5975090	Backwatered	No
Stream	Kenneth Creek	Percent Backwatered	–
Road	Highway 16	Fill Depth (m)	1.5
Road Tenure	MOTI	Outlet Drop (m)	0.7
Channel Width (m)	19	Outlet Pool Depth (m)	2
Stream Slope (%)	0.5	Inlet Drop	No
Beaver Activity	No	Slope (%)	1
Habitat Value	High	Valley Fill	Deep Fill
Final score	37	Barrier Result	Barrier
Fix type	Replace with New Open Bottom Structure	Fix Span / Diameter	24
Comments: Large multi-plate oval culvert with a substantial 50m-wide outlet pool. The stream had high flow at the time of assessment. Culvert slope and outlet pool depth were estimated as the pool was too deep to wade. Deep pools over 1m, formed by functional large woody debris, provided good overwintering habitat for fish of all ages. Gravels suitable for spawning were present. Downstream of the culvert, the stream ran parallel to the highway with banks reinforced by riprap and large wood secured with metal wiring to create habitat and reduce flow. MoTi chris_hwy_structure_road_id: 3750

Should restoration/maintenance activities proceed, replacement of the Highway 16 crossing (PSCIS 199256) with a bridge (24 m span) is recommended. At the time of reporting in 2025, the cost of the work is estimated at \$ 18,000,000.

Due to PSCIS crossing 199256 being located on highway 16, replacement of the crossing would be a large and expensive undertaking. Previous assessment by Hooft (2006) considered various mitigation options, including substrate placement, baffles, and downstream weirs, and concluded that replacement with a clear-spanning bridge or open-bottom structure is the only permanent solution to restore fish passage and address hydraulic concerns. The crossing is a high priority for replacement.

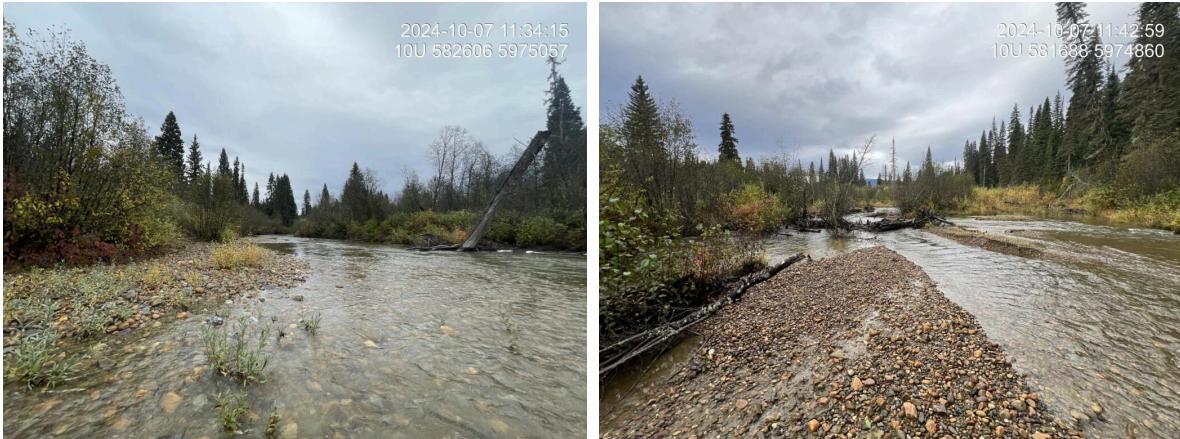
The stream was surveyed downstream from crossing 199256 for 370m (Figure [5.22](#)). The habitat was rated as high value, with abundant spawning gravels and deep pools (>1m) formed by functional large woody debris, providing high-quality overwintering habitat for fish of all ages. The average channel width was 19m, the average wetted width was 16.1m, and the average gradient was 0.7%. Total cover amount was rated as abundant with large woody debris dominant. Cover was also present as small woody debris, deep pools, and overhanging vegetation. The dominant substrate was cobbles with gravels sub-dominant.

Downstream of the culvert, the stream ran parallel to the highway, with banks reinforced by riprap. Large wood, secured with metal wiring, was placed to create habitat and reduce flow, arranged in three sets of two logs spaced approximately 5m apart (Figure [5.23](#)). These structures were likely installed to mitigate habitat loss caused by the riprapped banks.

Figure 5.22: Left: Typical habitat downstream of PSCIS crossing 199256. Right: Typical habitat upstream of PSCIS crossing 199256.

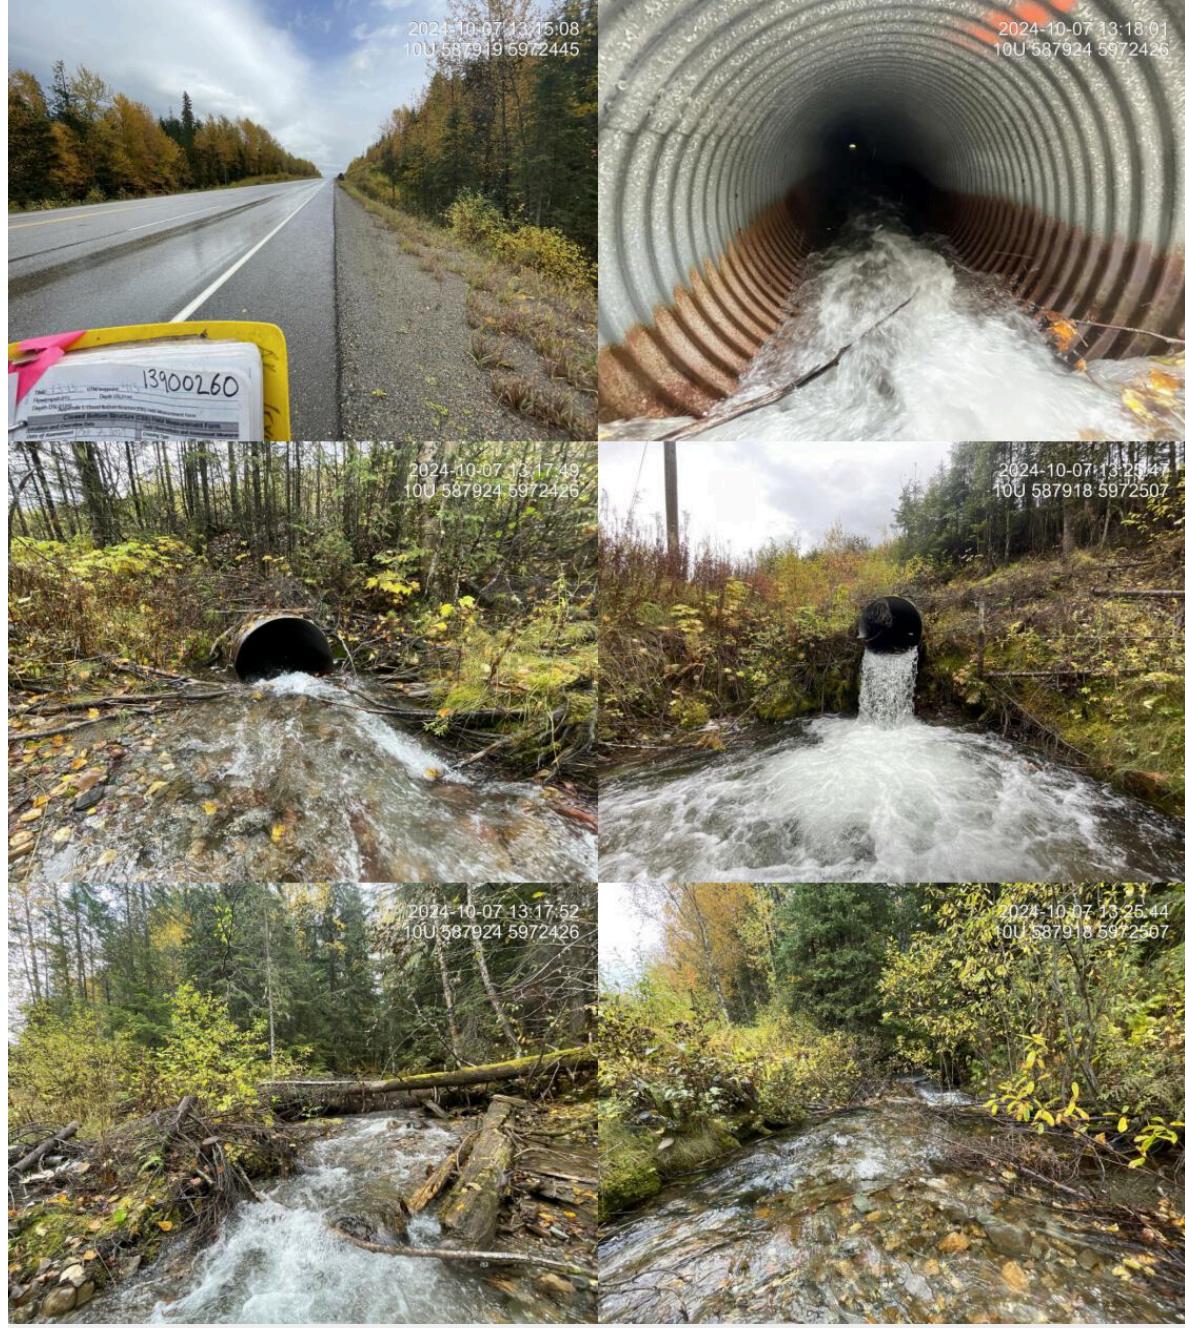
Stream Characteristics at Crossing 19...

Location and Stream Data	Crossing Characteristics
<p>Comments: The culvert had a significant 1.4m outlet drop, and inlet drop due to a small debris jam. The stream flowed through mature old-growth forest and provided high-quality habitat with steep gradients, step pools, and cascade pools, suggesting the potential presence of bull trout. The highway crossing had a large amount of road fill, making construction difficult and expensive. The site would be a good candidate for replacement if feasible. The riparian area at the outlet had been cleared due to overhead powerlines. MoTi chris_culvert_id: 1992815</p> <p>Photos: From top left clockwise: Road/Site Card, Barrel, Outlet, Downstream, Upstream, Inlet.</p>

PSCIS crossing 199260 had a substantial outlet drop and is a high priority for replacement. Average gradients were generally above the maximum thresholds for chinook spawning and rearing (4.5% and 5.5%, respectively), but fell within the suitable range for bull trout spawning and rearing (5.5% and 10.5%, respectively). The habitat upstream was rated as medium value for bull trout spawning and rearing, with bcfishpass modeling indicating ~900m of potential bull trout rearing habitat upstream of the crossing. Given the crossings location within Sugarbowl-Grizzly Den Provincial Park and the park's ecological significance, restoration efforts could align with broader conservation initiatives and public engagement, increasing the likelihood of funding and project momentum.

Should restoration/maintenance activities proceed, replacement of the Highway 16 crossing (199260) with a bridge (33 m span) is recommended. At the time of reporting in 2025, the cost of the work is estimated at \$ 24,750,000.

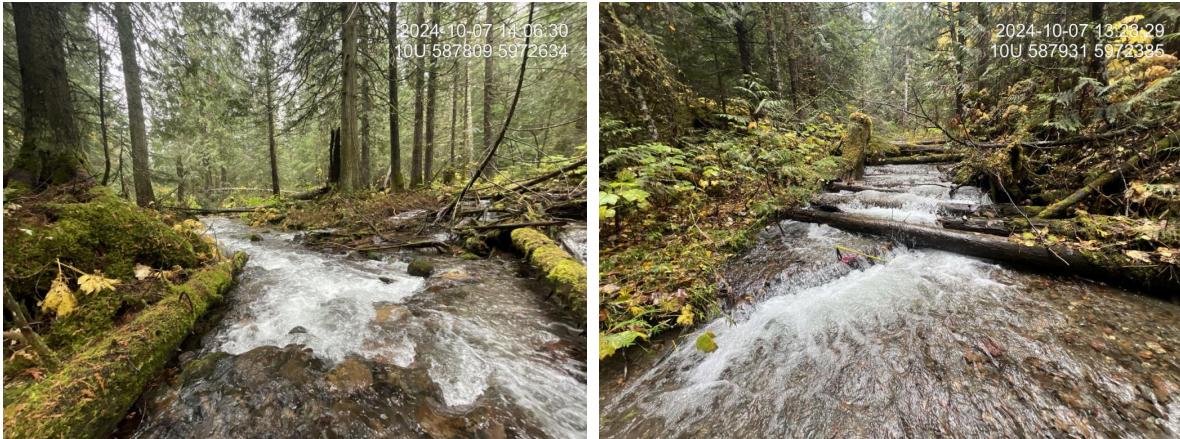
The stream was surveyed downstream from crossing 199260 for 320m (Figure 5.25). The habitat was rated as high value, with gravels suitable for spawning and occasional pools ranging from 0.2 – 0.4m deep providing overwintering habitat. The stream flowed through a healthy, mature old-growth forest. The average channel width was 7m, the average wetted width was 4.2m, and the average gradient was 5.3%. The dominant substrate was cobbles with boulders sub-dominant. Total cover amount was rated as abundant with large woody debris dominant. Cover was also present as small woody debris and boulders.

The stream was surveyed upstream from crossing 199260 for 650m (Figure 5.25). The habitat was rated as medium value, and appeared suitable for large bull trout spawning and rearing. The stream was a larger, steeper system with intact, mature coniferous cedar-hemlock riparian cover, primarily stable banks, and abundant large woody debris throughout. A step-pool morphology was present, characterized by pools up to 80cm deep and debris jam steps ranging from 30 – 60cm. The dominant substrate was cobbles with gravels sub-dominant. The average channel width was 6.1m, the average wetted width was 5.1m, and the average gradient was 7.1%. Total cover amount was rated as moderate with large woody debris dominant. Cover was also present as small woody debris, boulders, undercut banks, deep pools, and overhanging vegetation.

Figure 5.25: Left: Typical habitat downstream of PSCIS crossing 199260. Right: Typical habitat upstream of PSCIS crossing 199260.

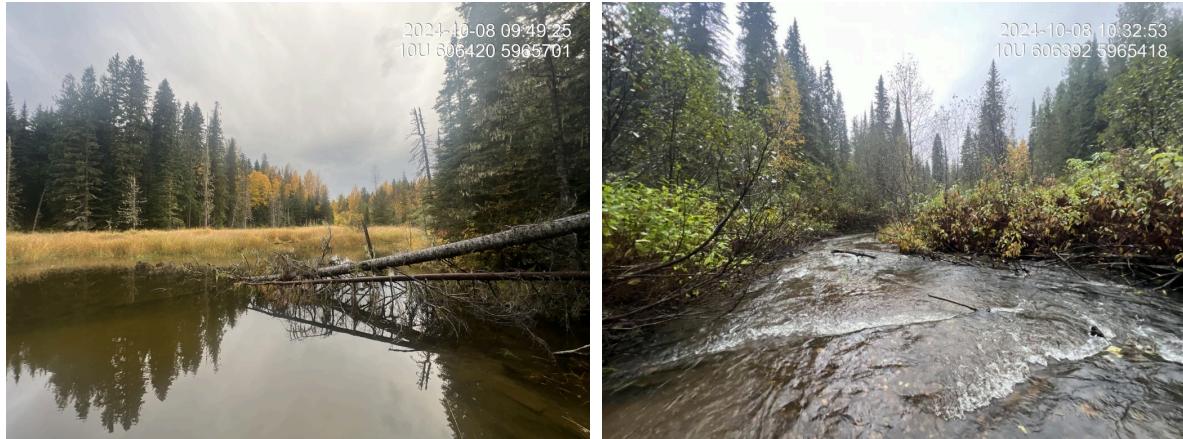
Figure 5.27: Left: Typical habitat upstream of PSCIS crossing 199267. Right: Typical habitat upstream of PSCIS crossing 199267.

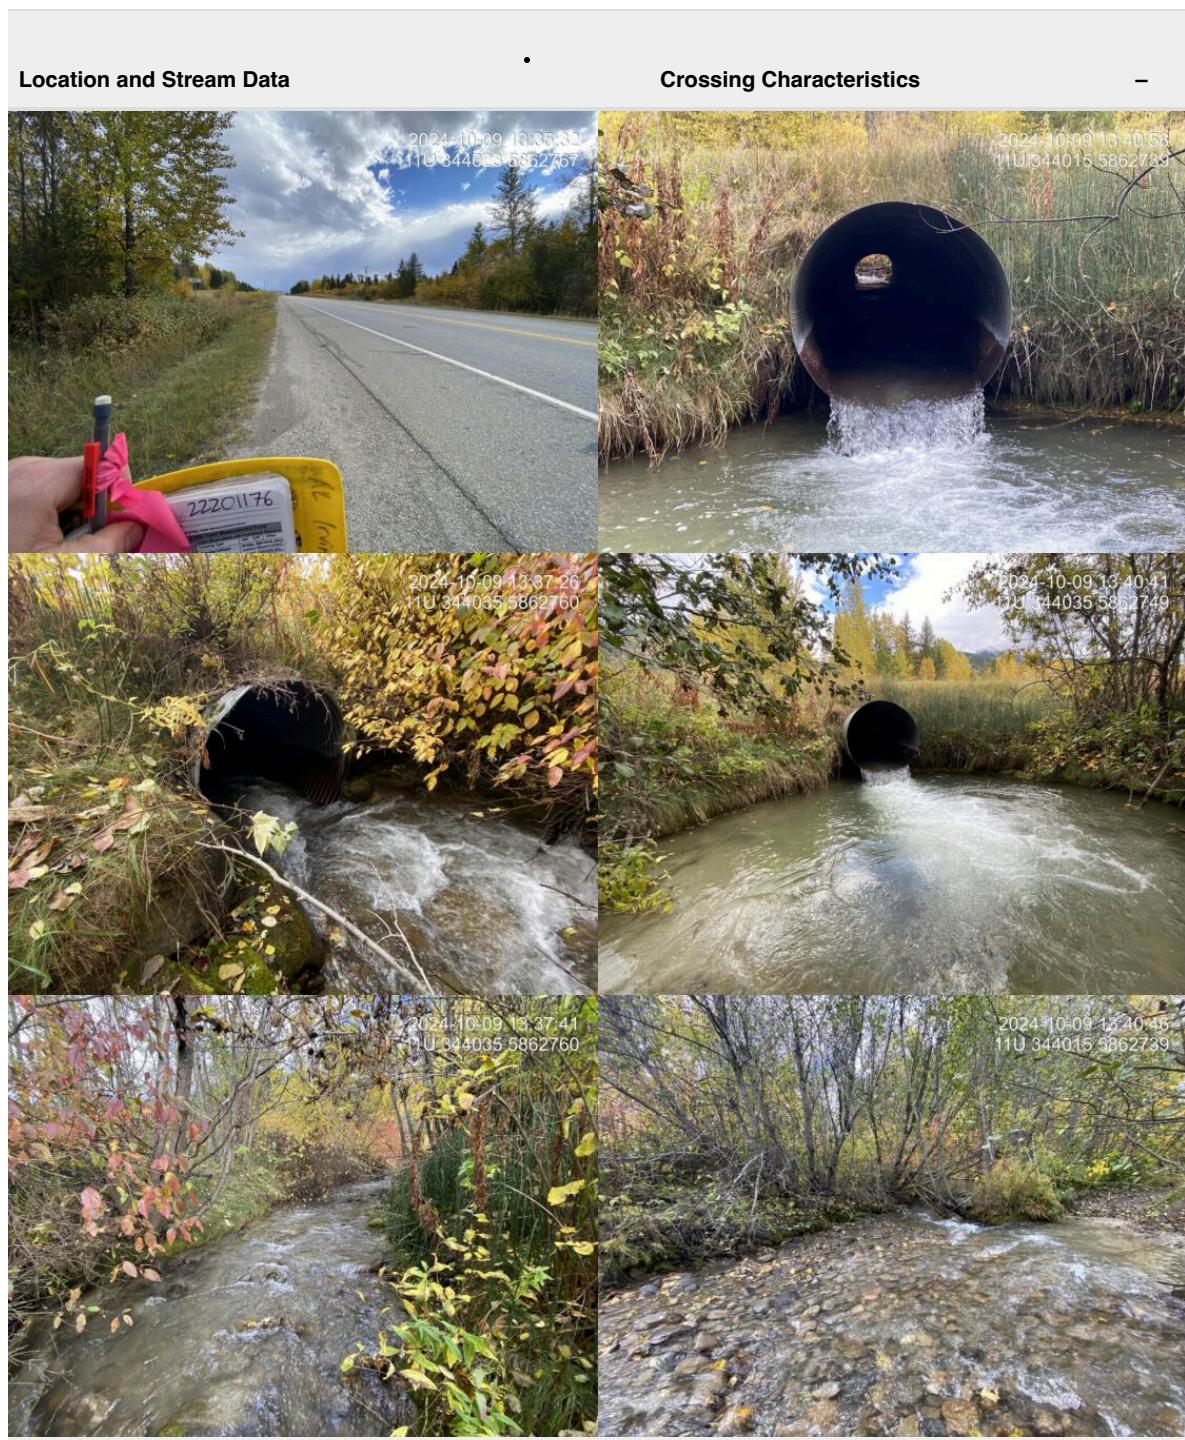
Location and Stream Data		Crossing Characteristics	
Date	2024-10-09	Crossing Sub Type	Round Culvert
PSCIS ID	199278	Diameter (m)	1.4
External ID	–	Length (m)	22
Crew	LS	Embedded	No
UTM Zone	11	Depth Embedded (m)	–
Easting	344031	Resemble Channel	No
Northing	5862744	Backwatered	No
Stream	Teepee Creek	Percent Backwatered	–
Road	Highway 5	Fill Depth (m)	0.7
Road Tenure	MOTI	Outlet Drop (m)	0.4
Channel Width (m)	7	Outlet Pool Depth (m)	1
Stream Slope (%)	2.5	Inlet Drop	No
Beaver Activity	No	Slope (%)	2
Habitat Value	High	Valley Fill	Deep Fill
Final score	34	Barrier Result	Barrier
Fix type	Replace with New Open Bottom Structure	Fix Span / Diameter	15

Comments: A moderate outlet drop was present and would be substantial at lower flows. Flow was steady at the time of assessment. The culvert was in good condition. A large, deep outlet pool indicated the culvert was likely undersized for the stream. Additionally, minimal road fill made this crossing a significant flood hazard, which could wash out Highway 5. Downstream, the stream had frequent pools 0.3-0.5m deep, providing good overwintering habitat for fish, and abundant gravels suitable for spawning. Roughly 150m downstream of the culvert, several cattle pens crossed the stream and appeared to be set up to provide cattle access for drinking. These areas were visibly trampled, with significant loss of riparian vegetation. Upstream, the stream was relatively confined, with only rare pockets of unembedded gravels. Deep pools were present, formed by boulder and large woody debris scour. A salmon point was noted near the pipeline location in FISS. Numerous small steps, ranging from 30-60cm, were present due to the steep, boulder-dominated nature of the stream. Electrofishing would be beneficial for further assessment. The site was a highway crossing, making replacement difficult. A small ford was located approximately 5m downstream of the culvert outlet. MoTi chris_culvert_id: 1467202

Photos: From top left clockwise: Road/Site Card, Barrel, Outlet, Downstream, Upstream, Inlet.

PSCIS crossing 199278 on Highway 5 had a moderate outlet drop that could be substantial at lower flows. A large, deep outlet pool indicated the culvert was likely undersized for the stream, and minimal road fill made this crossing a significant flood hazard which could wash out Highway 5, a major transportation route. The crossing is a high priority for replacement. A further 300m upstream, PSCIS crossing 203302 on the CN Railway had a substantial outlet drop, which may inhibit passage for younger life stages of salmonids. This crossing is a moderate priority for replacement. The documented fish observation recorded upstream of the Highway 5 crossing indicate that this stream has provided valuable fish habitat (Manson 2005; MoE 2024). Given the species present in the system and the outlet drops at both crossings, fish sampling is recommended to assess whether the culverts are impeding fish passage.

Should restoration/maintenance activities proceed, replacement of the Highway 5 crossing (199278) with a bridge (15 m span) is recommended. At the time of reporting in 2025, the cost of the work is estimated at \$ 11,250,000.

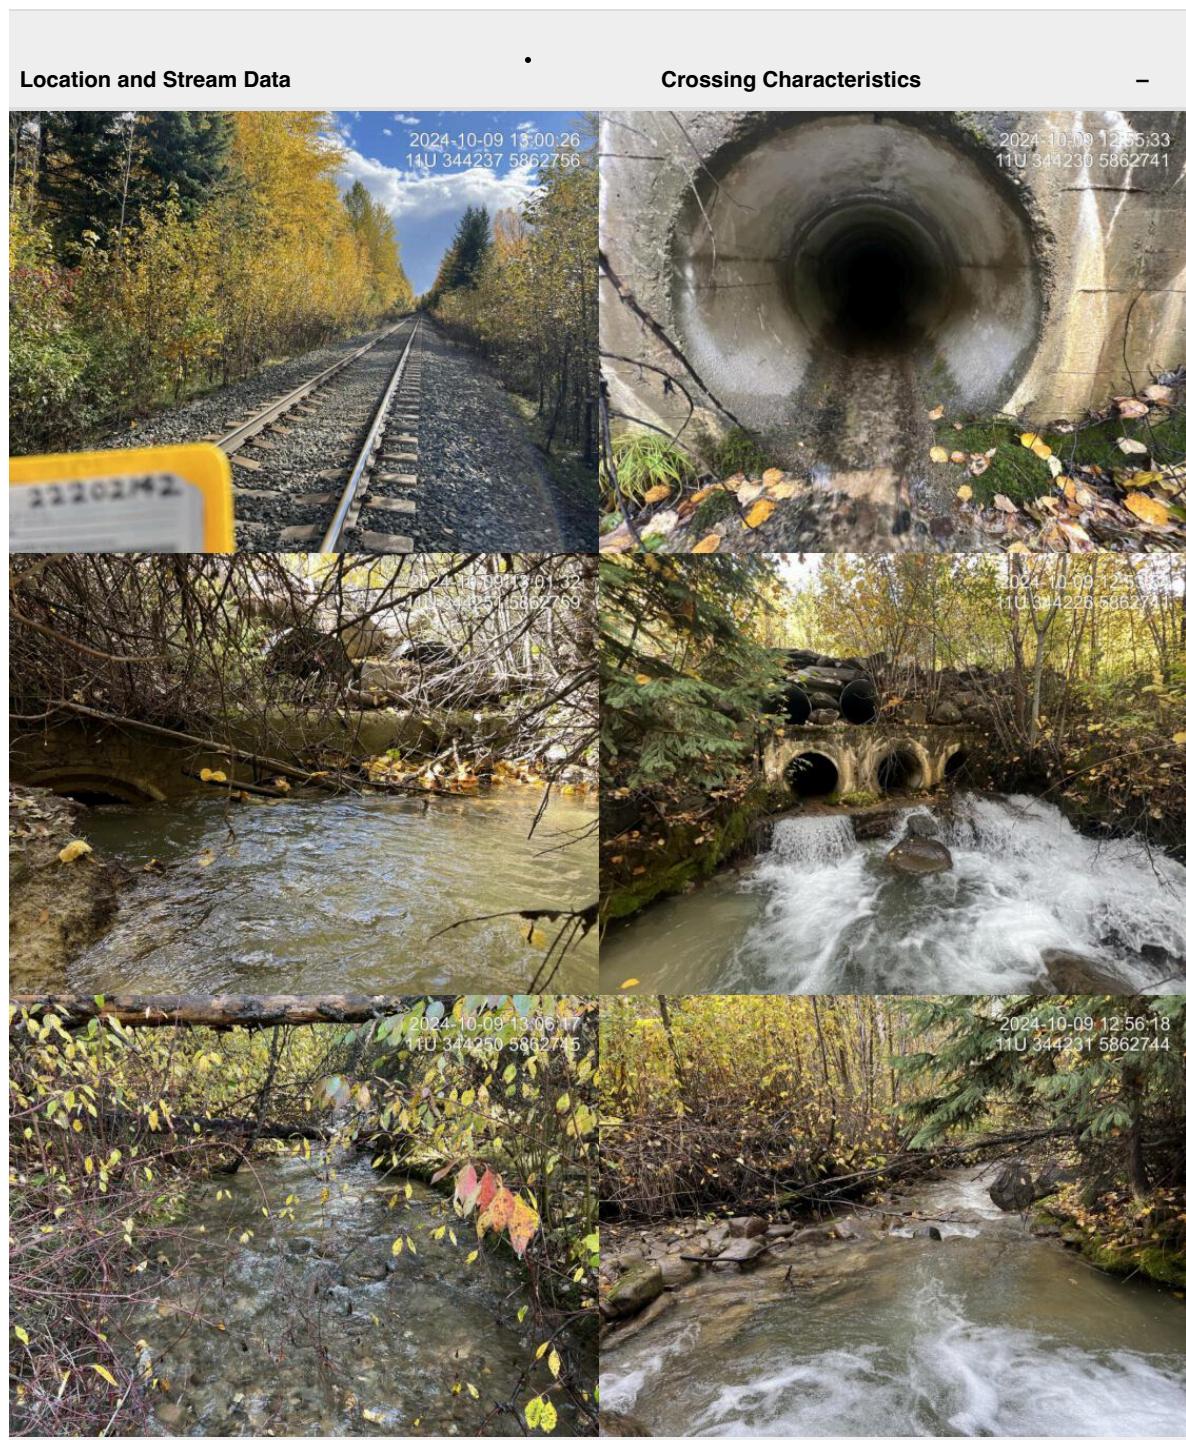
Stream Characteristics at Crossings 1...

Location and Stream Data		Crossing Characteristics	
Date	2024-10-09	Crossing Sub Type	Round Culvert
PSCIS ID	203302	Diameter (m)	2.7
External ID	–	Length (m)	14
Crew	AI	Embedded	No
UTM Zone	11	Depth Embedded (m)	–
Easting	344222	Resemble Channel	No
Northing	5862742	Backwatered	No
Stream	Teepee Creek	Percent Backwatered	–
Road	Railway	Fill Depth (m)	2
Road Tenure	CN Rail	Outlet Drop (m)	0.75
Channel Width (m)	4.2	Outlet Pool Depth (m)	0.25
Stream Slope (%)	7	Inlet Drop	Yes
Beaver Activity	No	Slope (%)	6
Habitat Value	Medium	Valley Fill	Deep Fill
Final score	36	Barrier Result	Barrier
Fix type	Replace with New Open Bottom Structure	Fix Span / Diameter	15
<p>Comments: Three concrete pipes, each 0.9m in diameter, were present, along with two 0.9m corrugated overflow pipes above. A stamp on the structure indicated it was built in 1944. All three concrete pipes were clogged at the inlet, ranging from 80% to 100% clogged with debris. This was a known fish-bearing stream, with a salmon point documented ~100m downstream in the FISS database. At this location, the stream was a mid-sized, steeper cobble-boulder step-pool system with only rare pockets of unembedded gravels. Deep pools were present, formed by boulder and large woody debris scour. Numerous small steps, ranging from 30-60cm, were present due to the steep, boulder-dominated nature of the stream. Downstream of the highway crossing, the stream had a lower gradient with frequent pools 0.3-0.5m deep, providing good overwintering habitat for fish and abundant gravels suitable for spawning.</p> <p>Photos: From top left clockwise: Road/Site Card, Barrel, Outlet, Downstream, Upstream, Inlet.</p>

Should restoration/maintenance activities proceed, replacement of the Railway crossing (203302) with a bridge (15 m span) is recommended. At the time of reporting in 2025, the cost of the work is estimated at \$ 11,250,000.

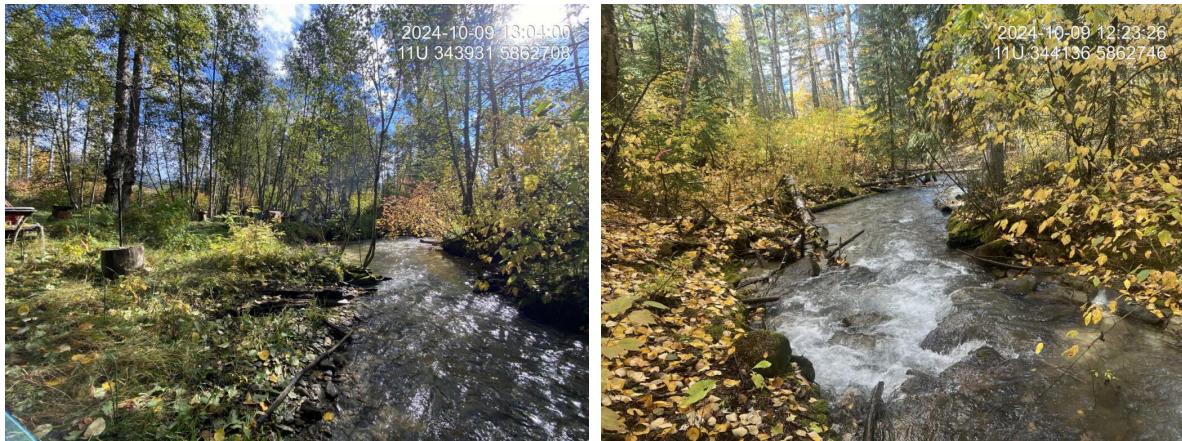
The stream was surveyed downstream from crossing 199278 for 150m (Figure [5.29](#)). The habitat was rated as high value, with frequent pools 0.3 – 0.5m deep suitable for overwintering fish and abundant gravels for spawning. The dominant substrate was cobbles with gravels sub-dominant. The average channel width was 7.1m, the average wetted width was 4.5m, and the average gradient was 2.5%. Total cover amount was rated as abundant with large woody debris dominant. Cover was also present as small woody debris, undercut banks, and overhanging vegetation. Roughly 150m downstream of the culvert, several cattle pens crossed the stream and appeared to be set up to provide cattle access for drinking. These areas were visibly trampled, with significant loss of riparian vegetation.

Downstream of PSCIS crossing 199278 on Highway 5, heavy cattle activity has resulted in visibly trampled streambanks and significant loss of riparian vegetation. Additional signs of cattle disturbance were observed further downstream near PSCIS crossing 7620. This lower section of Teepee Creek presents an opportunity for riparian restoration to exclude cattle from the stream through measures such as fencing and the installation of offsite watering systems. Given the stream's proximity to the Village of Valemount, landowner engagement through education and restoration initiatives should be explored. Furthermore, with Mount Terry Fox Provincial Park and the Teepee Creek trail network located upstream, crossing replacement and habitat restoration efforts could align with broader conservation goals and community initiatives, increasing the likelihood of funding and sustained project momentum.

Figure 5.29: Left: Typical habitat downstream of PSCIS crossing 199278. Right: Typical habitat upstream of PSCIS crossing 199278 and downstream of PSCIS crossing 203302.

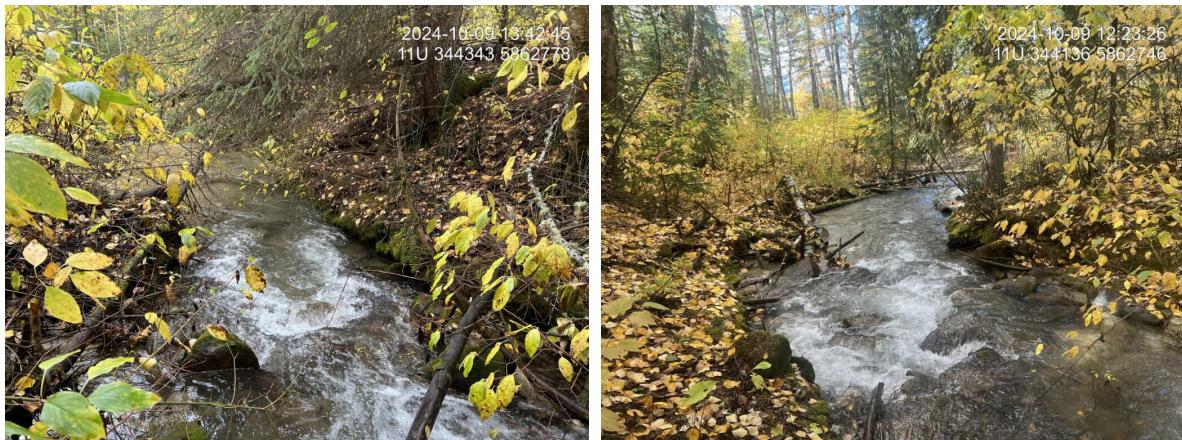
The stream was surveyed upstream from crossing 203302 for 600m (Figure [5.30](#)). The habitat was rated as medium value for spawning and rearing, with few unembedded gravels; however, recent heavy rain caused slight turbidity making it difficult to assess the substrate. The average channel width was 5.4m, the average wetted width was 3.9m, and the average gradient was 6.8%. The dominant substrate was cobbles with boulders sub-dominant. Total cover amount was rated as moderate with boulders dominant. Cover was also present as . Approximately 100m before the end of the site, the stream showed signs of a large disturbance event that had incised the channel to a depth of 1.2 – 2m, with major areas of aggregation where the channel was widened and uniform.

Figure 5.30: Left: Typical habitat upstream of PSCIS crossing 203302. Right: Typical habitat upstream of PSCIS crossing 199278 and downstream of PSCIS crossing 203302.

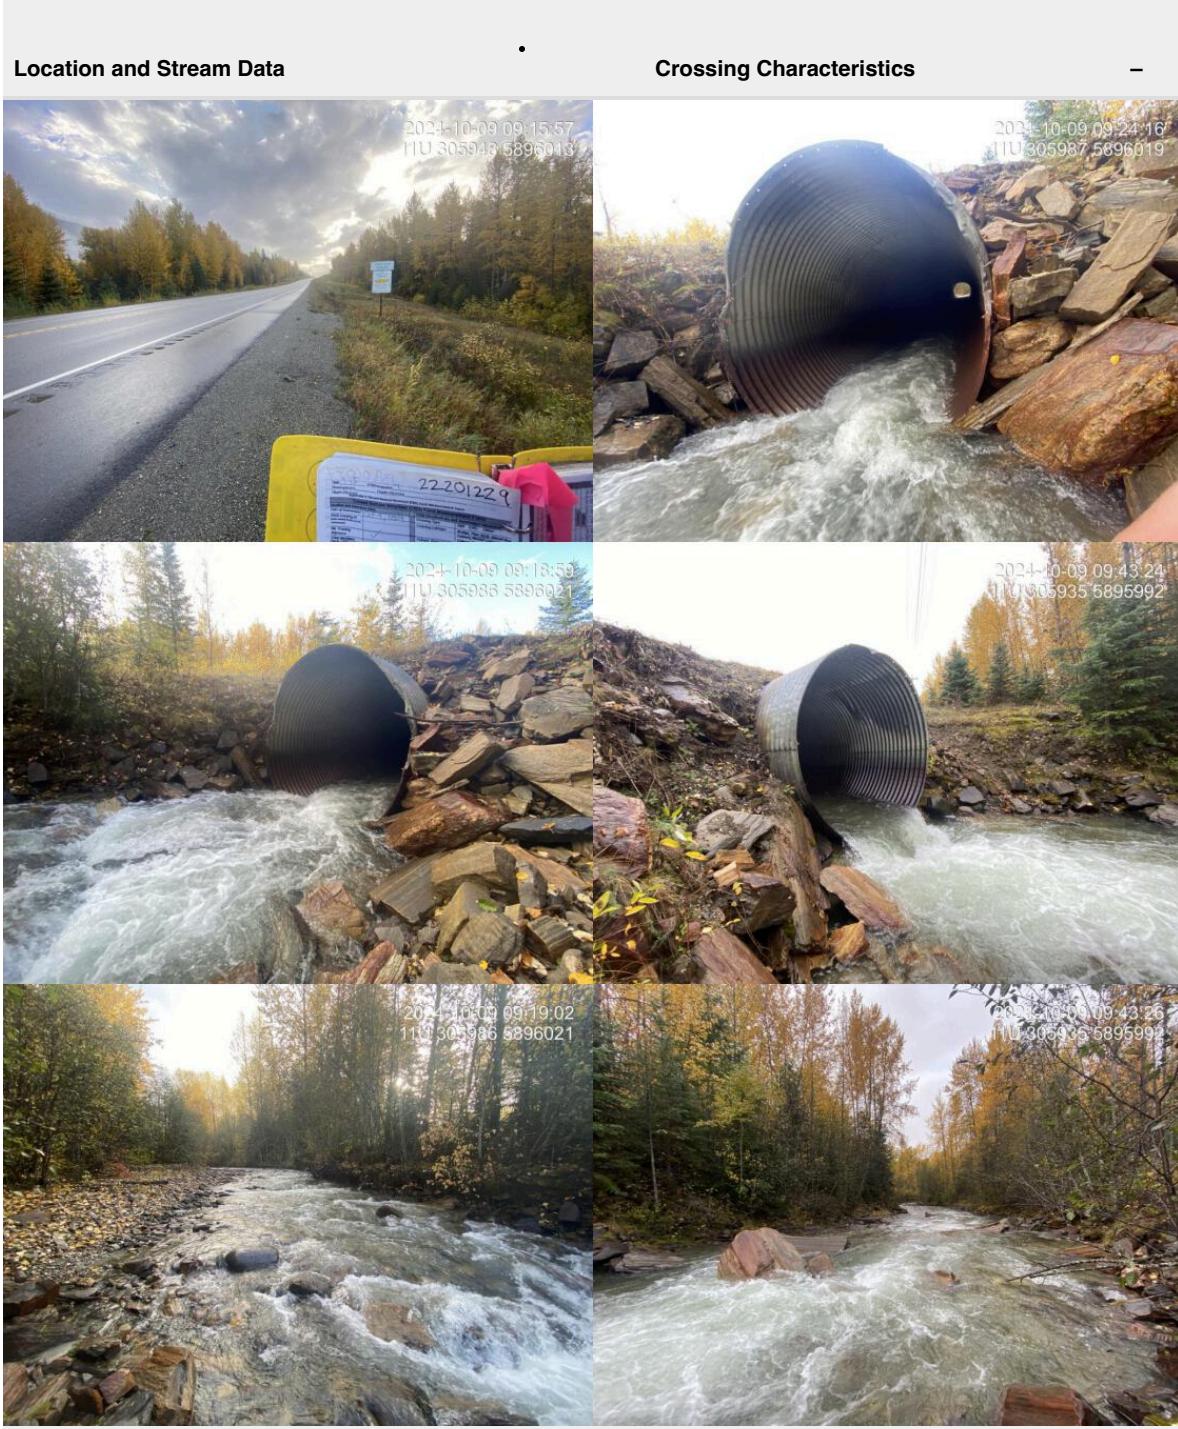
Stream Characteristics at Crossing 19...

Location and Stream Data		Crossing Characteristics	
Date	2024-10-09	Crossing Sub Type	Round Culvert
PSCIS ID	199282	Diameter (m)	4
External ID	–	Length (m)	52
Crew	LS	Embedded	No
UTM Zone	11	Depth Embedded (m)	–
Easting	305946	Resemble Channel	No
Northing	5896010	Backwatered	No
Stream	Holliday Creek	Percent Backwatered	–
Road	Highway 16	Fill Depth (m)	2
Road Tenure	MOTI	Outlet Drop (m)	0.8
Channel Width (m)	16	Outlet Pool Depth (m)	0.5
Stream Slope (%)	3	Inlet Drop	No
Beaver Activity	No	Slope (%)	2
Habitat Value	High	Valley Fill	Deep Fill
Final score	37	Barrier Result	Barrier
Fix type	Replace with New Open Bottom Structure	Fix Span / Diameter	21
Comments: A significant outlet drop was present. Flow was high at the time of assessment, and at lower flows, the outlet drop would be even more substantial. Although the culvert was large, it was still likely undersized for the stream. The stream was a large glaciated system with a cobble-boulder substrate and an intact mixed riparian zone, primarily deciduous. Occasional large woody debris features created deep pool habitats and pockets of gravels were present suitable for spawning salmonids. A fish (~60mm) was observed during habitat confirmation. MoTi chris_hwy_structure_road_id: 29925

Photos: From top left clockwise: Road/Site Card, Barrel, Outlet, Downstream, Upstream, Inlet.

Should restoration/maintenance activities proceed, replacement of the Highway 16 crossing (PSCIS 199282) with a bridge (21 m span) is recommended. At the time of reporting in 2025, the cost of the work is estimated at \$ 15,750,000.

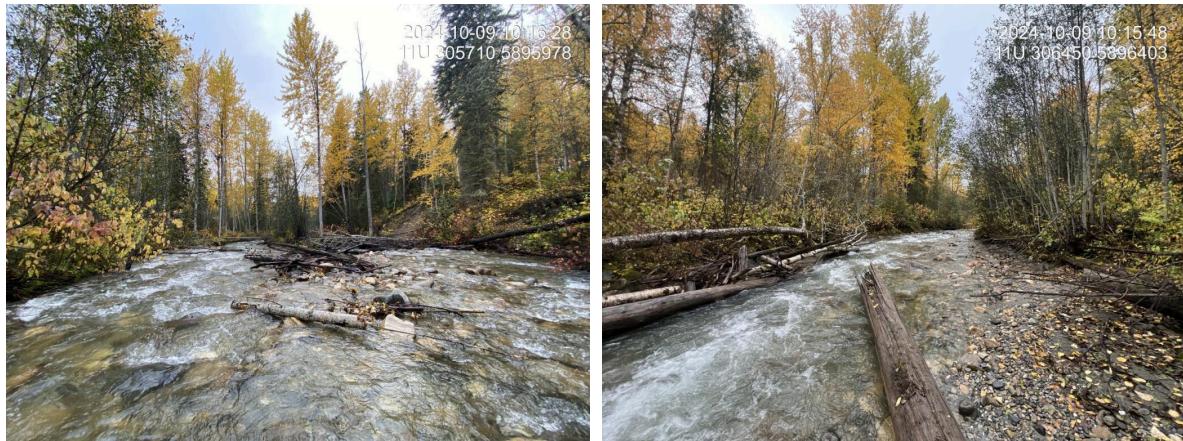
The stream was surveyed downstream from crossing 199282 for 350m (Figure 5.32). The habitat was rated as high value with frequent gravels suitable for spawning and occasional pools available for overwintering. The average channel width was 16m, the average wetted width was 9.3m, and the average gradient was 2.8%. Total cover amount was rated as abundant with large woody debris dominant. Cover was also present as boulders and undercut banks. The dominant substrate was cobbles with boulders sub-dominant.

The stream was surveyed upstream from crossing 199282 for 800m (Figure 5.32). The habitat was rated as medium value for spawning and rearing. Occasional large woody debris features created deep pools, with pockets of gravels suitable for spawning. The average channel width was 11.8m, the average wetted width was 8.9m, and the average gradient was 2.5%. The dominant substrate was cobbles with boulders sub-dominant. Total cover amount was rated as moderate with boulders dominant. Cover was also present as .

Figure 5.32: Left: Typical habitat downstream of PSCIS crossing 199282. Right: Typical habitat upstream of PSCIS crossing 199282.
