Restoring Fish Passage in the Fraser Region - 2023

**Prepared for
Ministry of Transportation and Infrastructure**

**Prepared by
Al Irvine, B.Sc., R.P.Bio. and Lucy Schick, B.Sc.
New Graph Environment Ltd.**

Version 0.1.2 2025-07-15

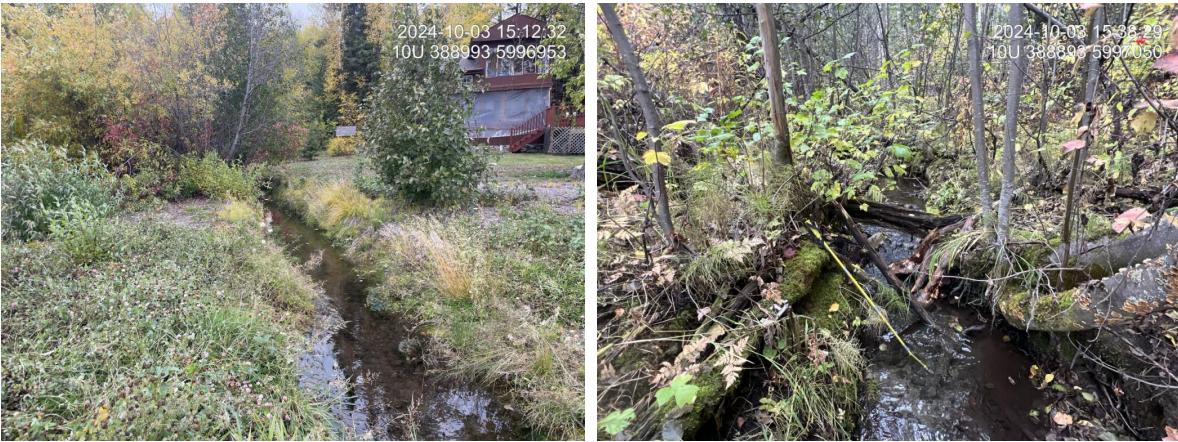
Figure 5.2: Left: Typical habitat downstream of PSCIS crossing 199171. Right: Typical habitat upstream of PSCIS crossing 199171 and downstream of PSCIS crossing 7622.

- Coordinate with the Ministry of Transportation to pursue funding for engineering designs at the following crossings:
 - PSCIS crossing 199171 on Burnt Cabin Creek along Gala Bay Road, in the Francois Lake watershed group.

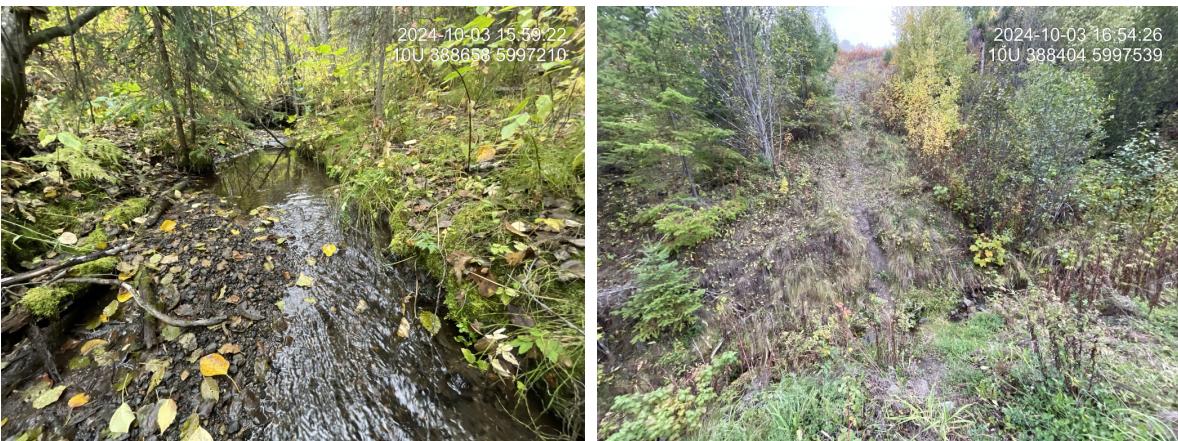
Figure 5.3: Left: Typical habitat upstream of PSCIS crossing 7622. Right: Bank erosion and riparian removal at the pipeline upstream of crossing 7622.

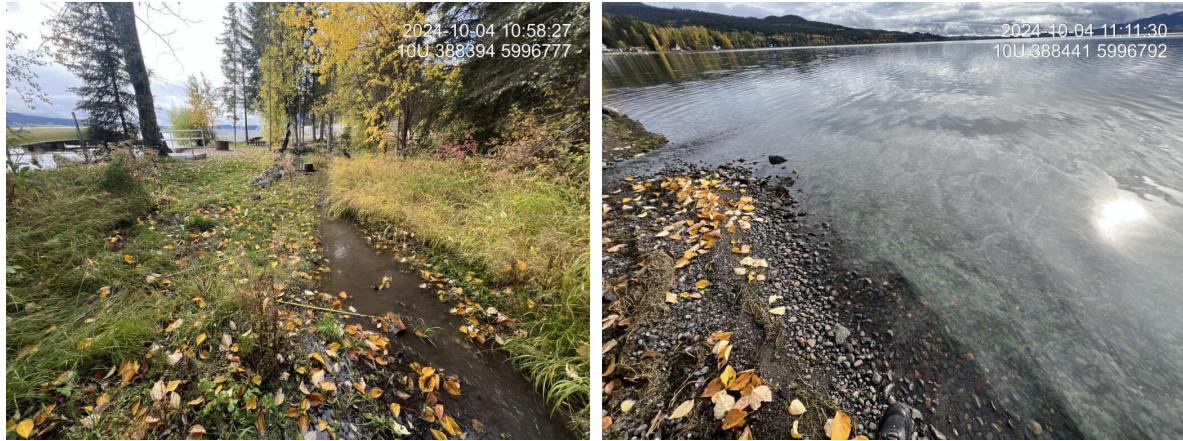
Figure 5.5: Left: Typical habitat downstream of PSCIS crossing 199328. Right: Algal bloom observed downstream of PSCIS crossing 199328 in Fraser Lake.

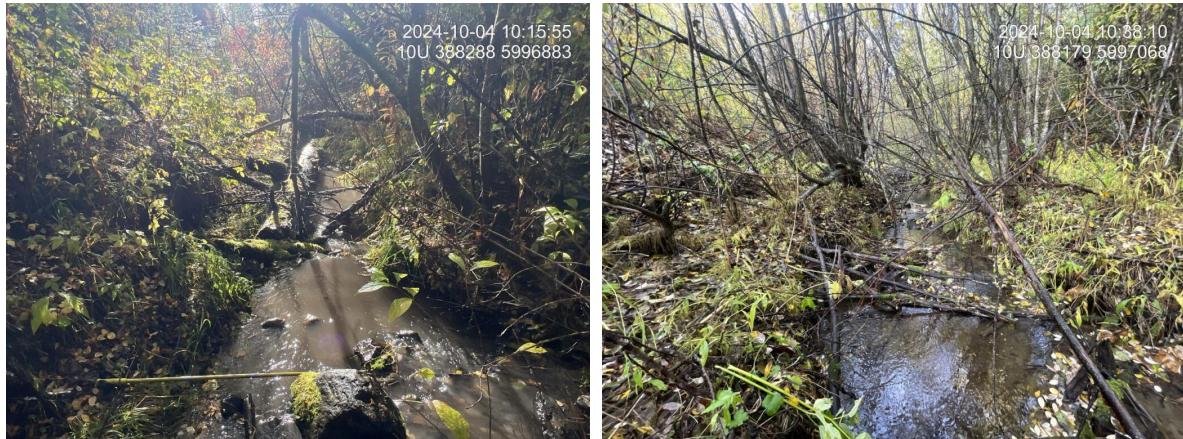
The stream was surveyed from Gala Bay Road upstream to Stella Road, a distance of approximately 270m (Figure 5.6) The habitat was rated as medium value, with limited pools; however, abundant overhanging vegetation and small woody debris provided cover, and gravels suitable for resident salmonid spawning were present. Incision was evident, beginning with a deep cut at the culvert outlet under Stella Road and continuing downstream to Gala Bay Road. The riparian area was generally intact through most of the survey, except for the downstream 75m, where private land development on the north side had resulted in a lawn and riparian vegetation removal up to the channel edge. The dominant substrate was gravels with cobbles sub-dominant.Total cover amount was rated as moderate with overhanging vegetation dominant. Cover was also present as small woody debris and undercut banks.The average channel width was 2.1m, the average wetted width was 1.3m, and the average gradient was 3%.

The stream was surveyed upstream from crossing 199172 for 550m (Figure 5.6). The habitat was rated as medium value, with abundant functional large woody debris creating pools 20 – 30cm deep, suitable for overwintering juvenile fish. Overhead cover was extensive, and occasional gravels were suitable for spawning. Approximately 400m upstream of Stella Road, the stream transitioned into a beaver-impounded area with four consecutive dams (1 – 1.5m high) impounding a large volume of water. Flow was maintained over or under the dams and the impounded area extended to the upper end of the surveyed area. A fish (~40mm) was observed after the second dam. Total cover amount was rated as abundant with large woody debris dominant. Cover was also present as small woody debris, undercut banks, and overhanging vegetation.The dominant substrate was gravels with fines sub-dominant.The average channel width was 2.6m, the average wetted width was 1.5m, and the average gradient was 4.3%.

Figure 5.6: Left: Typical habitat upstream of PSCIS crossing 199328 and downstream of PSCIS crossing 199172. Right: Typical habitat upstream of PSCIS crossing 199172.

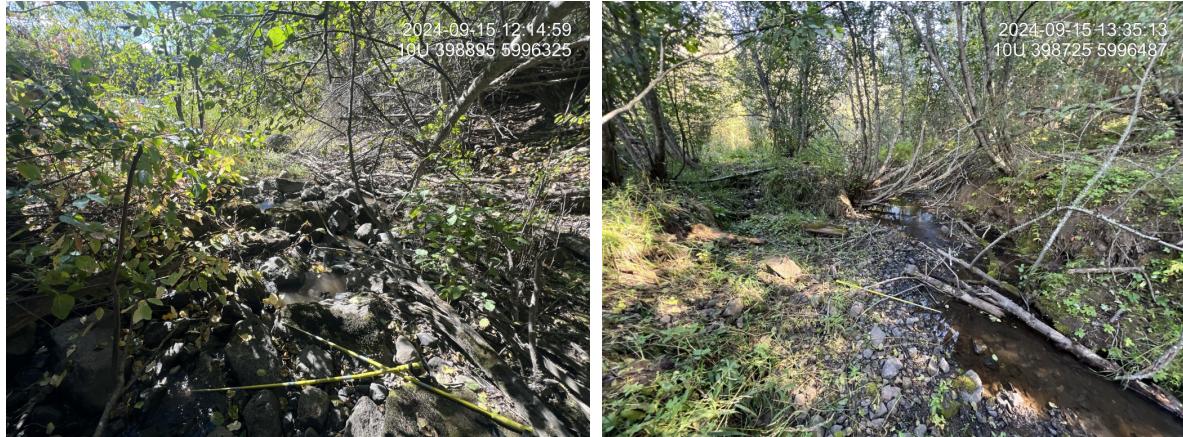
The stream was surveyed downstream from crossing 199173 for 115m (Figure 5.8). The habitat was rated as medium value, with undercut banks suitable for juvenile chinook and rainbow trout rearing. No natural or man-made barriers were present between Dog Creek Road and the Nechako River. Fish (~40 – 90mm in length) were observed during the assessment. The average channel width was 3.5m, the average wetted width was 1.3m, and the average gradient was 6%. Total cover amount was rated as moderate with undercut banks dominant. Cover was also present as small woody debris and boulders. The dominant substrate was cobbles with fines sub-dominant.

The stream was surveyed upstream from crossing 199173 for 575m (Figure 5.8). The habitat was rated as medium with pockets of gravels suitable for rainbow trout and potentially chinook rearing, and fish were observed throughout the survey area. Heavy cattle impacts were evident, particularly in low-gradient sections with easily accessible banks. Fencing intended to restrict cattle access was present but had been breached. Approximately 300–350m upstream, the stream transitioned from a channelized section to a beaver-impounded wetland, with over three mature dams — some up to 1.5m high — vegetated and well-developed. These dams impounded large volumes of water, likely sustaining year-round stream flow downstream at the Dog Creek Road crossing. Total cover amount was rated as moderate with small woody debris dominant. Cover was also present as large woody debris, deep pools, and overhanging vegetation. The average channel width was 3m, the average wetted width was 1.5m, and the average gradient was 2.4%.

Figure 5.8: Left: Typical habitat downstream of PSCIS crossing 199173. Right: Typical habitat upstream of PSCIS crossing 199173.

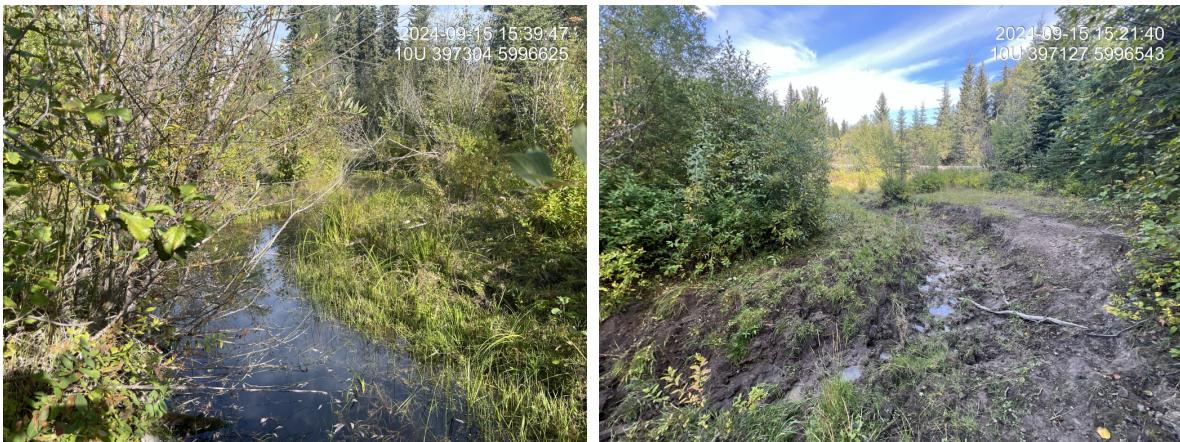
The stream was surveyed downstream from crossing 199174 for 300m (Figure 5.9). The stream was intermittent for the first ~70m before transitioning into a beaver-impacted wetland area. Approximately 250m downstream of Sutherland FSR, several large, mature, consecutive beaver dams were present and appeared to continue as far as the area surveyed. Signs of cattle trampling were observed throughout the stream, and the channel frequently split into several smaller channels. The habitat was rated as medium value, with few gravels for spawning but abundant pools created by beaver dams. Total cover amount was rated as abundant with small woody debris dominant. Cover was also present as large woody debris, undercut banks, deep pools, and overhanging vegetation. The average channel width was 2m, the average wetted width was 1m, and the average gradient was 1.2%. The dominant substrate was fines with gravels sub-dominant.

The stream was surveyed upstream from crossing 199174 for 650m (Figure 5.9). The habitat was rated as medium value and had been heavily impacted by cattle, with evidence of bank trampling and extensive low-gradient muddy sections. Upstream of the culvert, the stream was primarily dry for the first 300m, with young forest and shrub riparian. At this point, intermittent pools began to

Figure 5.9: Left: Typical habitat downstream of PSCIS crossing 199174. Right: Typical habitat upstream of PSCIS crossing 199174.

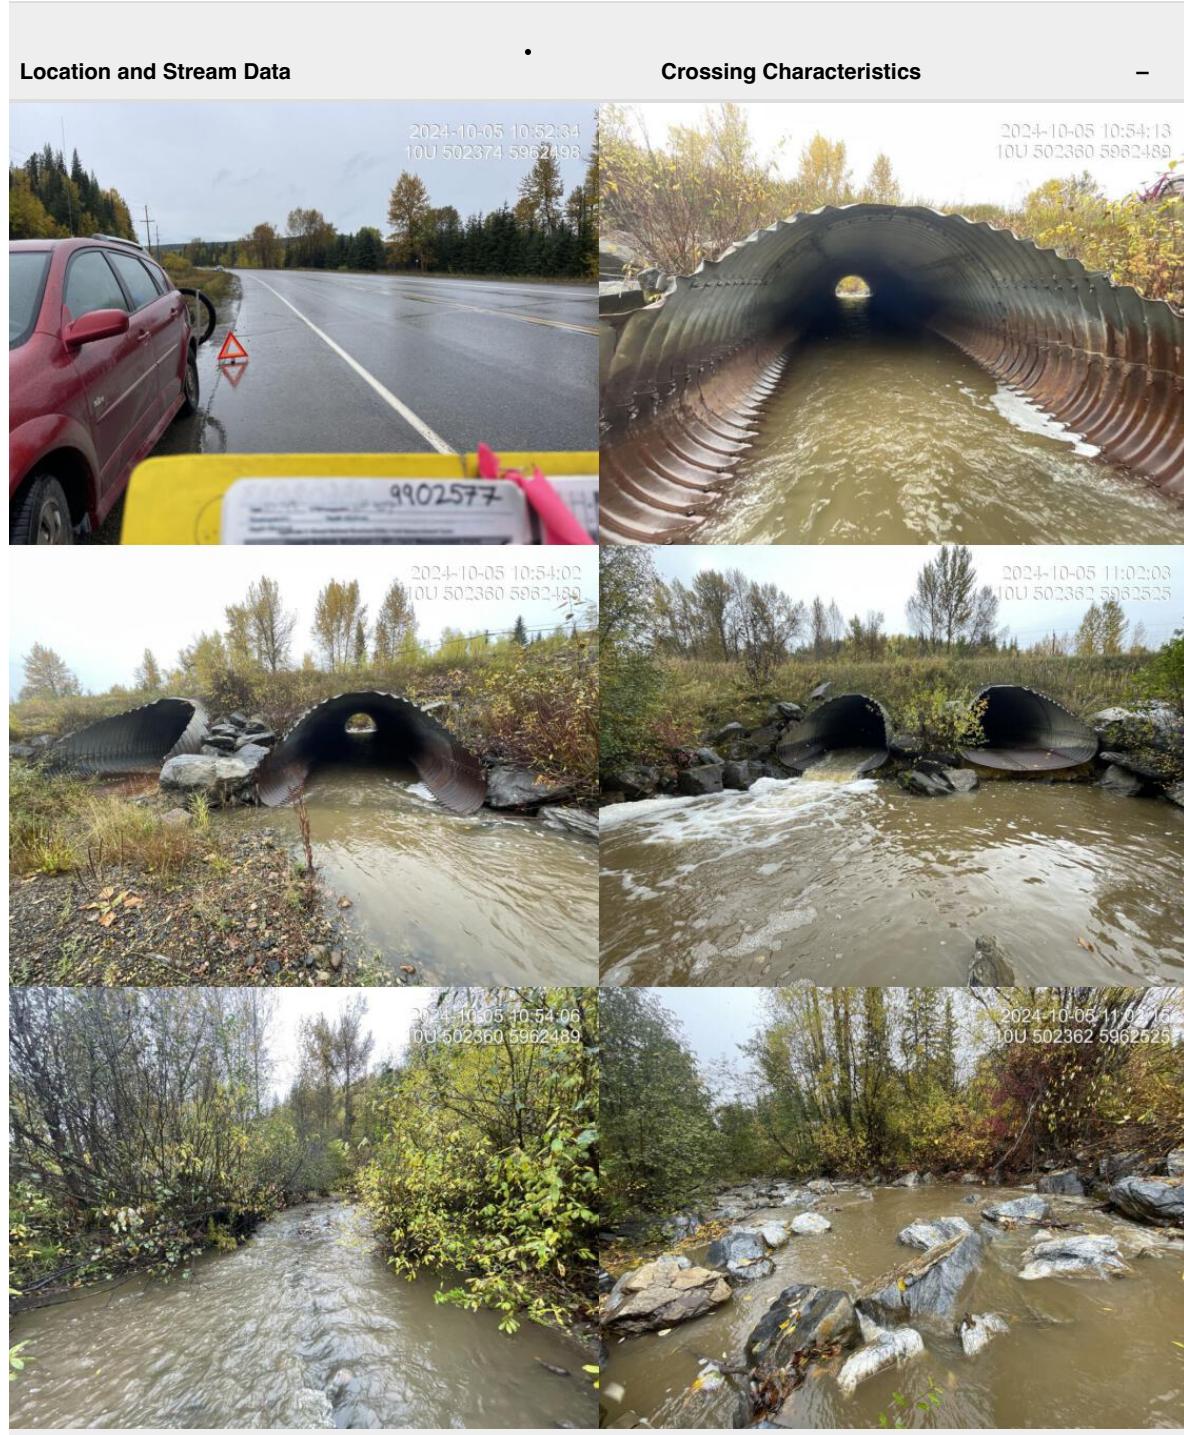
The stream was surveyed downstream from crossing 199232 for 300m (Figure 5.16). The habitat was rated as medium value due to sparse large woody debris, a lack of pools, and high turbidity from recent rainfall likely obscuring gravels. Below the outlet, large boulders were placed in rows to backwater the culvert, which was somewhat effective, though the culvert itself remained unbackwatered. This section had a steeper gradient (3 – 4%) before transitioning to ~0.5% for the remainder of the area surveyed. The upper section of the stream was somewhat channelized due to residences on both sides, while lower sections showed significant bank erosion. The dominant substrate was cobbles with gravels sub-dominant. Total cover amount was rated as moderate with large woody debris dominant. Cover was also present as boulders. The average channel width was 9.6m, the average wetted width was 6m, and the average gradient was 2%.

Should restoration/maintenance activities proceed, replacement of the Highway 16 crossing (199232) with a bridge (15 m span) is recommended. At the time of reporting in 2025, the cost of the work is estimated at \$ 11,250,000.

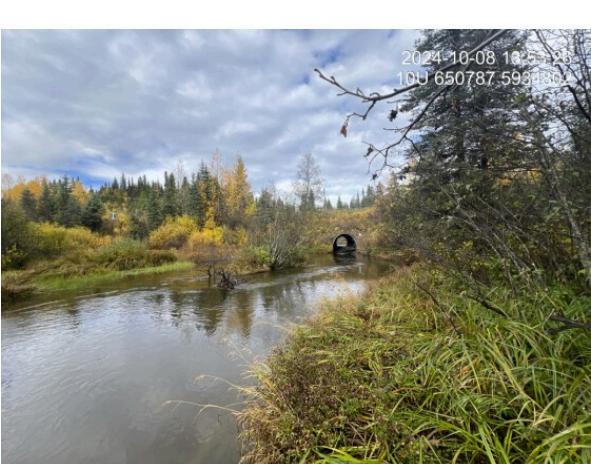
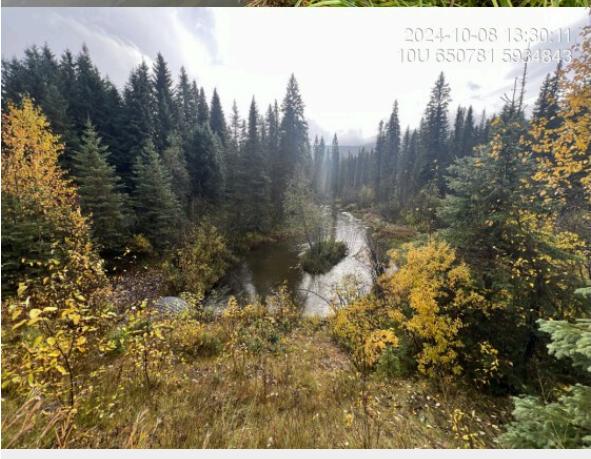
At the time of the 2024 assessment, PSCIS crossing 199237 on Highway 16 was un-embedded, non-backwatered and ranked as barrier to upstream fish passage according to the provincial protocol (MoE 2011) (Table [5.31](#)). The culvert had a significant 0.65m outlet drop. Photos from the 2024 assessment were limited due to the surveyor's phone falling in the river; however, photos from the 2023 assessment can be found in [Attachment - Phase 1 Data and Photos \(page 203\)](#).

The stream was surveyed downstream from crossing 199237 for 300m . The habitat was rated as high value. The dominant substrate was fines with gravels sub-dominant.The average channel width was 14m, the average wetted width was 12.4m, and the average gradient was 0.7%.Total cover amount was rated as moderate with large woody debris dominant. Cover was also present as small woody debris and overhanging vegetation. No photos were available due to the surveyor's phone falling in the river.

Should restoration/maintenance activities proceed, replacement of the Highway 16 crossing with a bridge (19 m span) is recommended. At the time of reporting in 2025, the cost of the work is estimated at \$ 14,250,000.

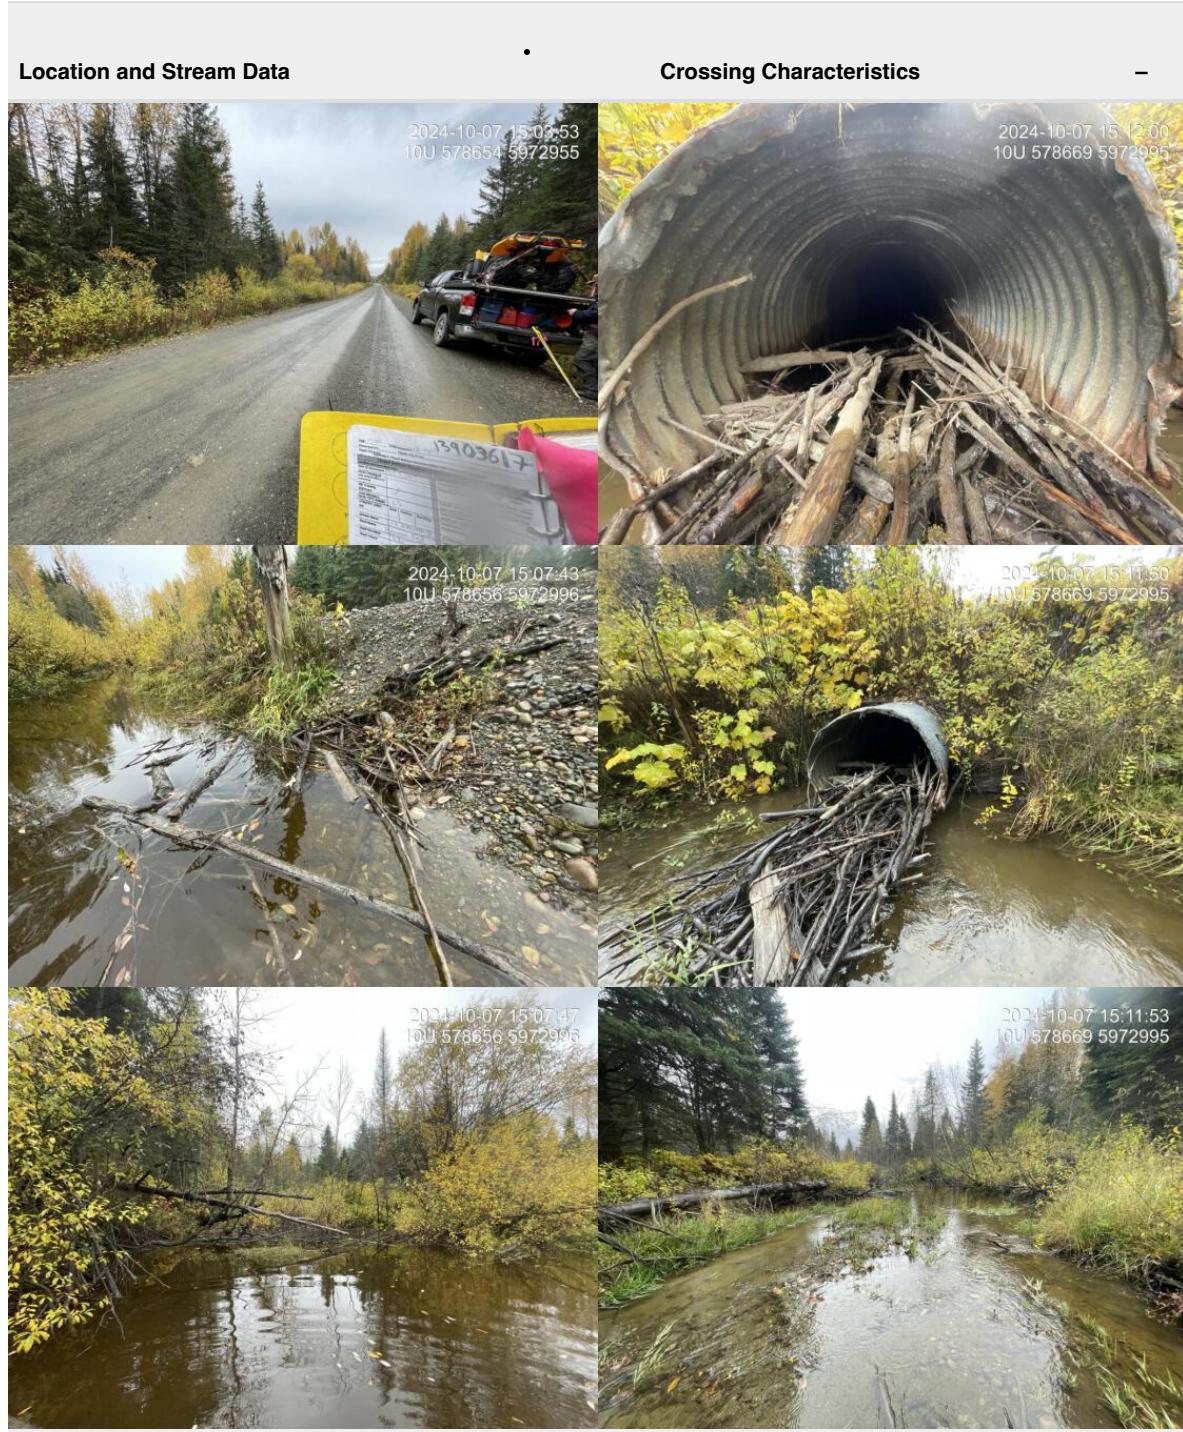
The stream was surveyed downstream from crossing 199255 for 270m (Figure [5.20](#)). The habitat was rated as low value for spawning and rearing with no gravels or cobbles observed and the substrate consisting entirely of fine mud. Fish habitat was limited, with very few pools present. The first 130m of the stream was a beaver-affected area, with a beaver dam approximately 0.7m high located ~40m downstream of the culvert. The dam had flooded the surrounding forest, with no main channel observed. Occasional sections had a somewhat defined channel, but the majority of the surveyed area consisted of water flowing through a wet forest. The dominant substrate was fines with fines sub-dominant. Total cover amount was rated as moderate with overhanging vegetation dominant. Cover was also present as small woody debris, undercut banks, and instream vegetation. The average channel width was 10.3m, the average wetted width was 7m, and the average gradient was 0.8%..

Should restoration/maintenance activities proceed, replacement of the Bowron FSR crossing (199255) with a bridge (15 m span) is recommended. At the time of reporting in 2025, the cost of the work is estimated at \$ 450,000.

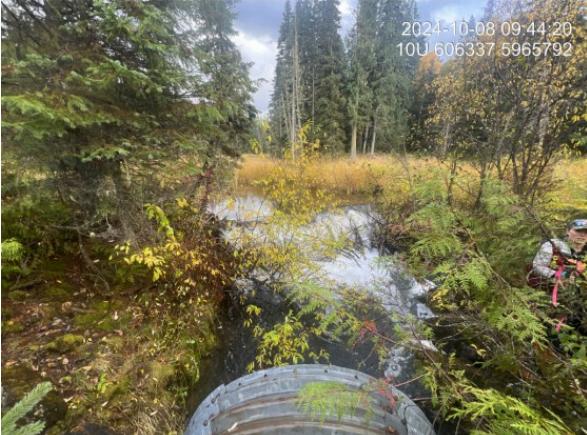
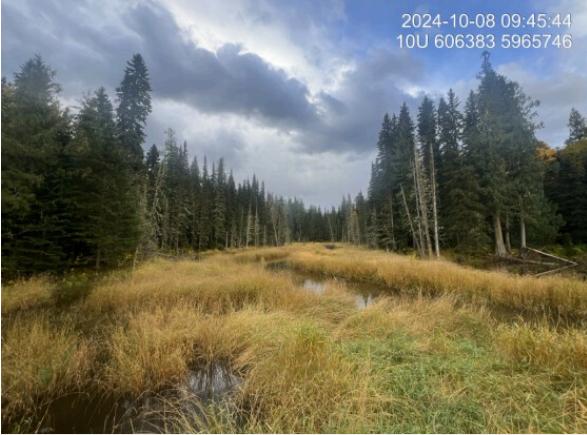
At the time of the 2024 assessment, PSCIS crossing 199267 on Highway 16 was un-embedded, non-backwatered and ranked as barrier to upstream fish passage according to the provincial protocol (MoE 2011) (Table [5.47](#)). The culvert had a significant 0.65m outlet drop. Photos from the 2024 assessment were limited due to the surveyor's phone falling in the river; however, photos from the 2023 assessment can be found in [Attachment - Phase 1 Data and Photos \(page 203\)](#).

The stream was surveyed downstream from crossing 199267 for 300m . The habitat was rated as high value for spawning and rearing. The surrounding riparian area consisted of a healthy old-growth forest on both sides of the stream. The dominant substrate was gravels with fines sub-dominant.Total cover amount was rated as moderate with large woody debris dominant. Cover was also present as small woody debris, undercut banks, and overhanging vegetation.The average channel width was 10.7m, the average wetted width was 7.5m, and the average gradient was 0.6%. Photos from the 2024 assessment were limited due to the surveyor's phone falling in the river; however, photos from the 2023 assessment can be found in [Attachment - Phase 1 Data and Photos \(page 203\)](#).

Should restoration/maintenance activities proceed, replacement of the Highway 16 crossing (199267) with a bridge (15 m span) is recommended. At the time of reporting in 2025, the cost of the work is estimated at \$ 11,250,000.

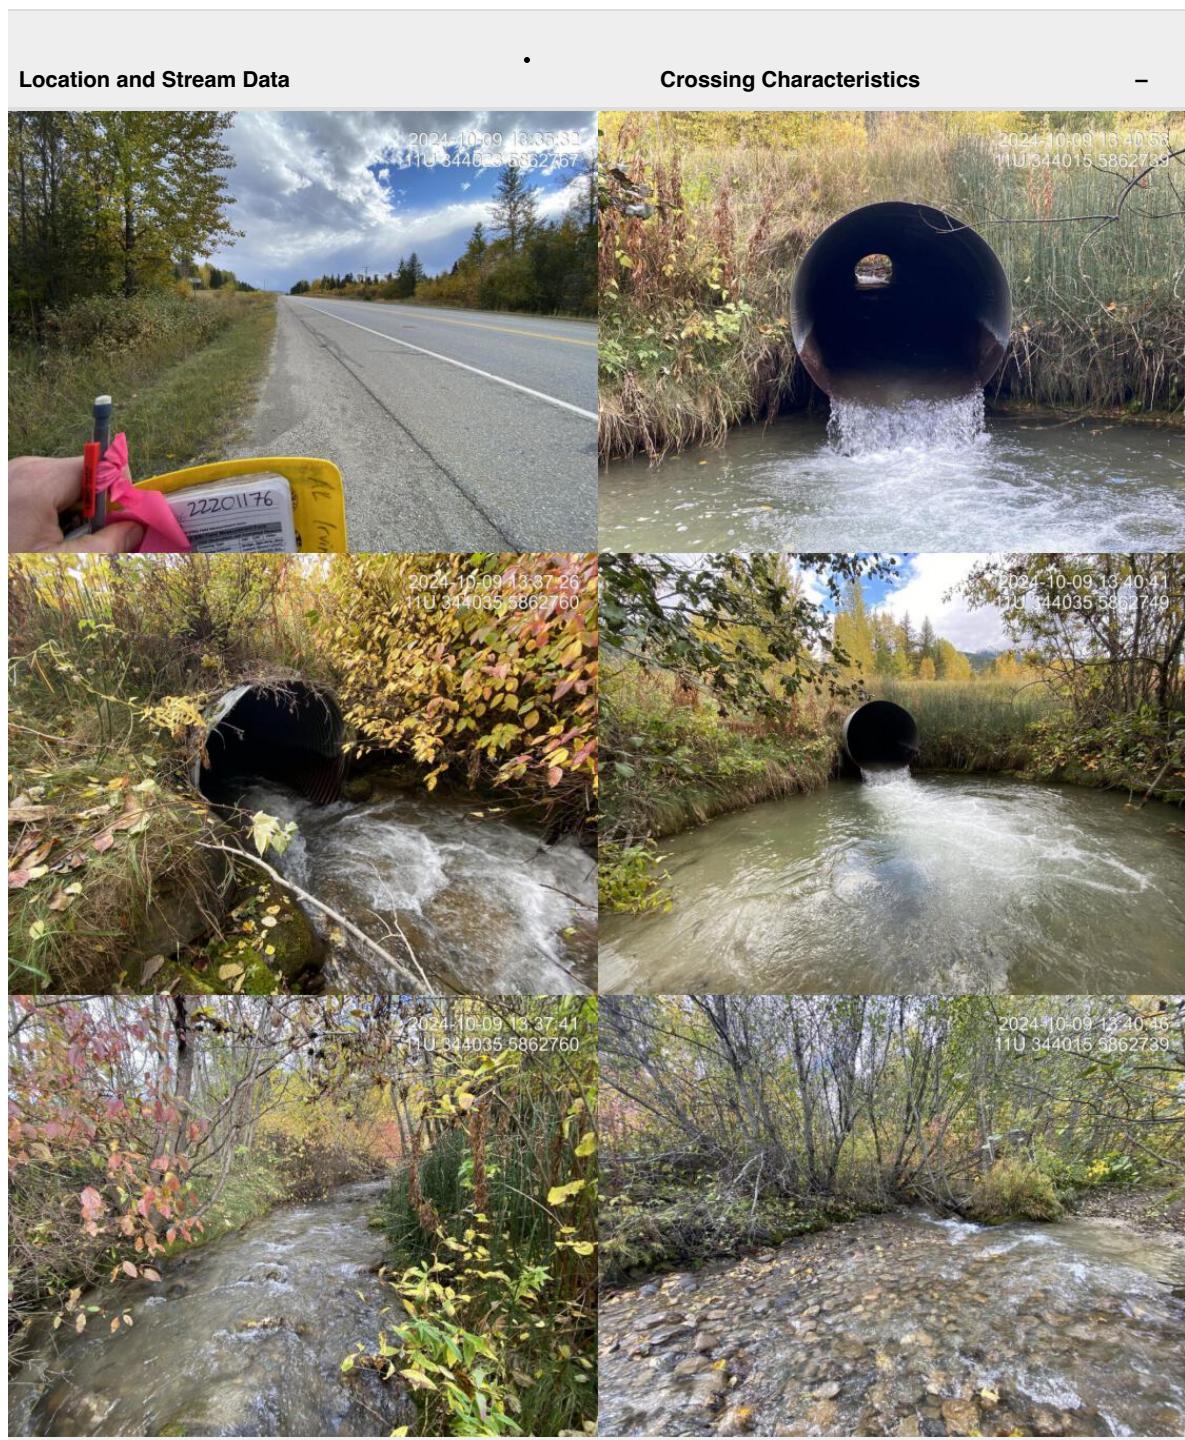
Comments: A moderate outlet drop was present and would be substantial at lower flows. Flow was steady at the time of assessment. The culvert was in good condition. A large, deep outlet pool indicated the culvert was likely undersized for the stream. Additionally, minimal road fill made this crossing a significant flood hazard, which could wash out Highway 5. Downstream, the stream had frequent pools 0.3-0.5m deep, providing good overwintering habitat for fish, and abundant gravels suitable for spawning. Roughly 150m downstream of the culvert, several cattle pens crossed the stream and appeared to be set up to provide cattle access for drinking. These areas were visibly trampled, with significant loss of riparian vegetation. Upstream, the stream was relatively confined, with only rare pockets of unembedded gravels. Deep pools were present, formed by boulder and large woody debris scour. Numerous small steps, ranging from 30-60cm, were present due to the steep, boulder-dominated nature of the stream. A salmon point was noted near the pipeline location in FISS. Bull trout have previously been captured both upstream and downstream of the highway crossing by Triton Environmental Consultants Ltd. Electrofishing would be beneficial for further assessment. The site was a highway crossing, making replacement difficult. Upstream of the Mount Tinsley Pit Road crossing, a hiking trail follows Teepee Creek and provides access to Mount Terry Fox Provincial Park. MoTi chris_culvert_id: 1467202

Should restoration/maintenance activities proceed, replacement of the Highway 5 crossing (199278) with a bridge (15 m span) is recommended. At the time of reporting in 2025, the cost of the work is estimated at \$ 11,250,000.

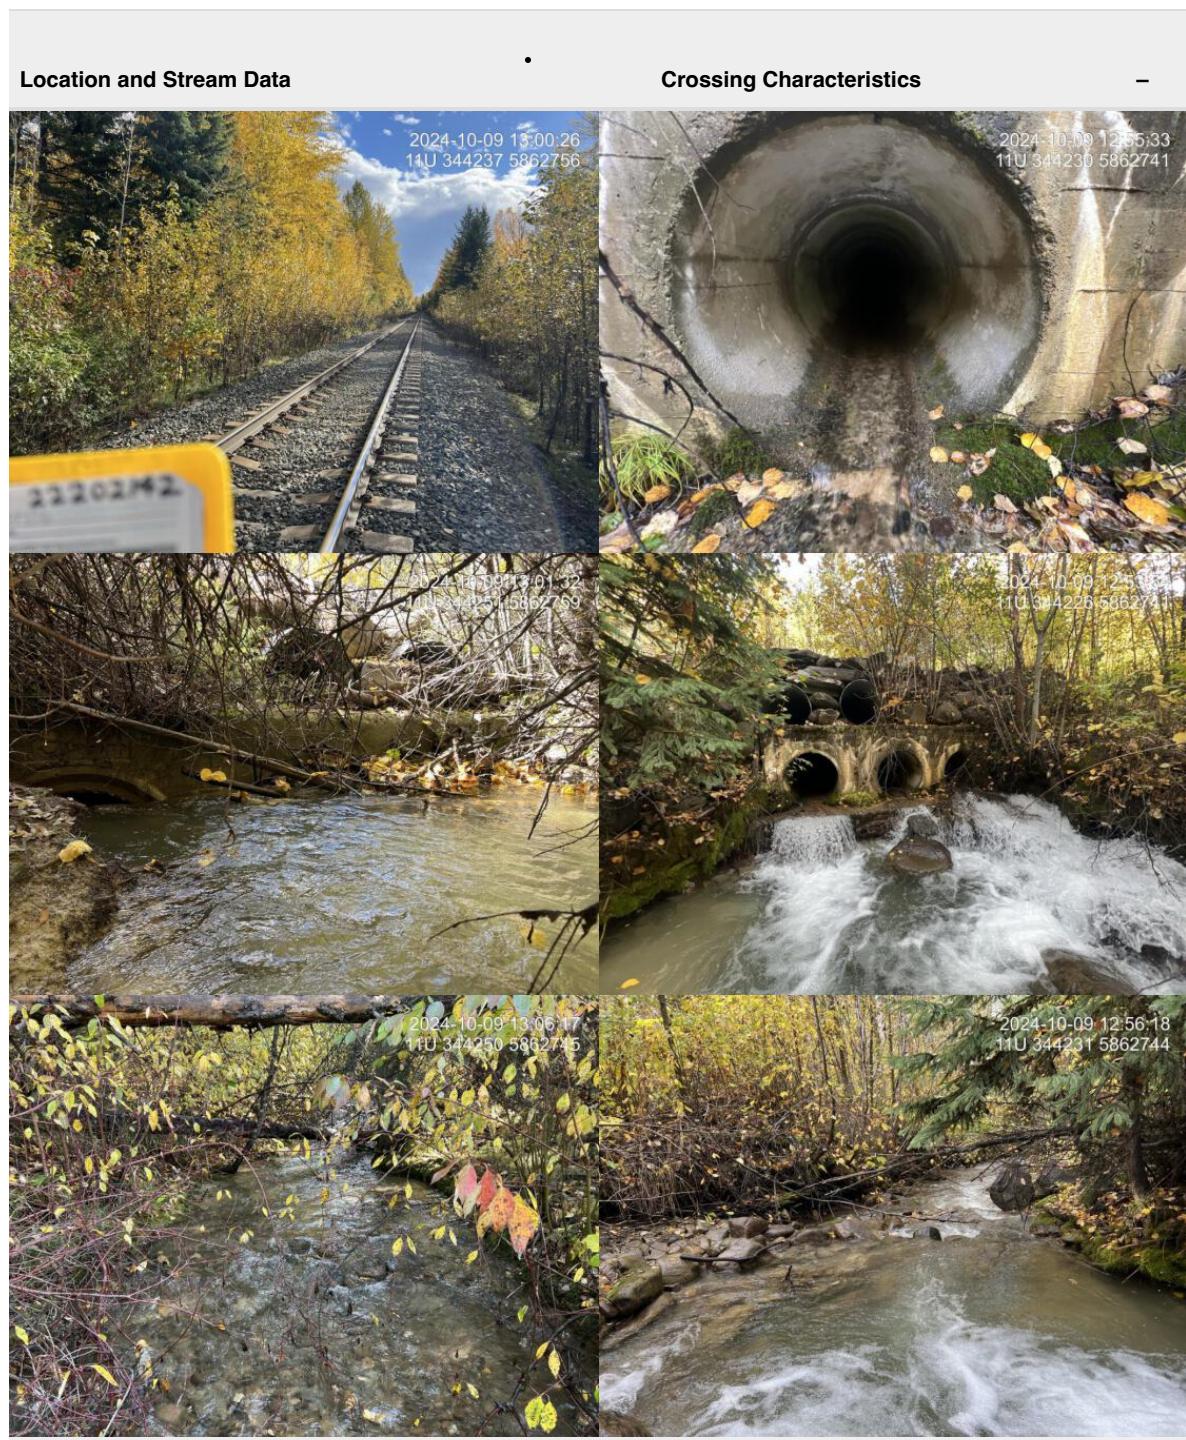
Comments: Three concrete pipes, each 0.9m in diameter, were present, along with two 0.9m corrugated overflow pipes above. A stamp on the structure indicated it was built in 1944. All three concrete pipes were clogged at the inlet, ranging from 80% to 100% clogged with debris. This is a known fish-bearing stream, with a salmon point documented ~100m downstream in the FISS database. At this location, the stream was a mid-sized, steeper cobble-boulder step-pool system with only rare pockets of unembedded gravels. Deep pools were present, formed by boulder and large woody debris scour. Numerous small steps, ranging from 30-60cm, were present due to the steep, boulder-dominated nature of the stream. Downstream of the highway crossing, the stream had a lower gradient with frequent pools 0.3-0.5m deep, providing good overwintering habitat for fish and abundant gravels suitable for spawning. Bull trout have previously been captured both upstream and downstream of the highway 5 crossing by Triton Environmental Consultants Ltd. Upstream of the Mount Tinsley Pit Road crossing, a hiking trail follows Teepee Creek and provides access to Mount Terry Fox Provincial Park.

Should restoration/maintenance activities proceed, replacement of the Railway crossing (203302) with a bridge (15 m span) is recommended. At the time of reporting in 2025, the cost of the work is estimated at \$ 11,250,000.

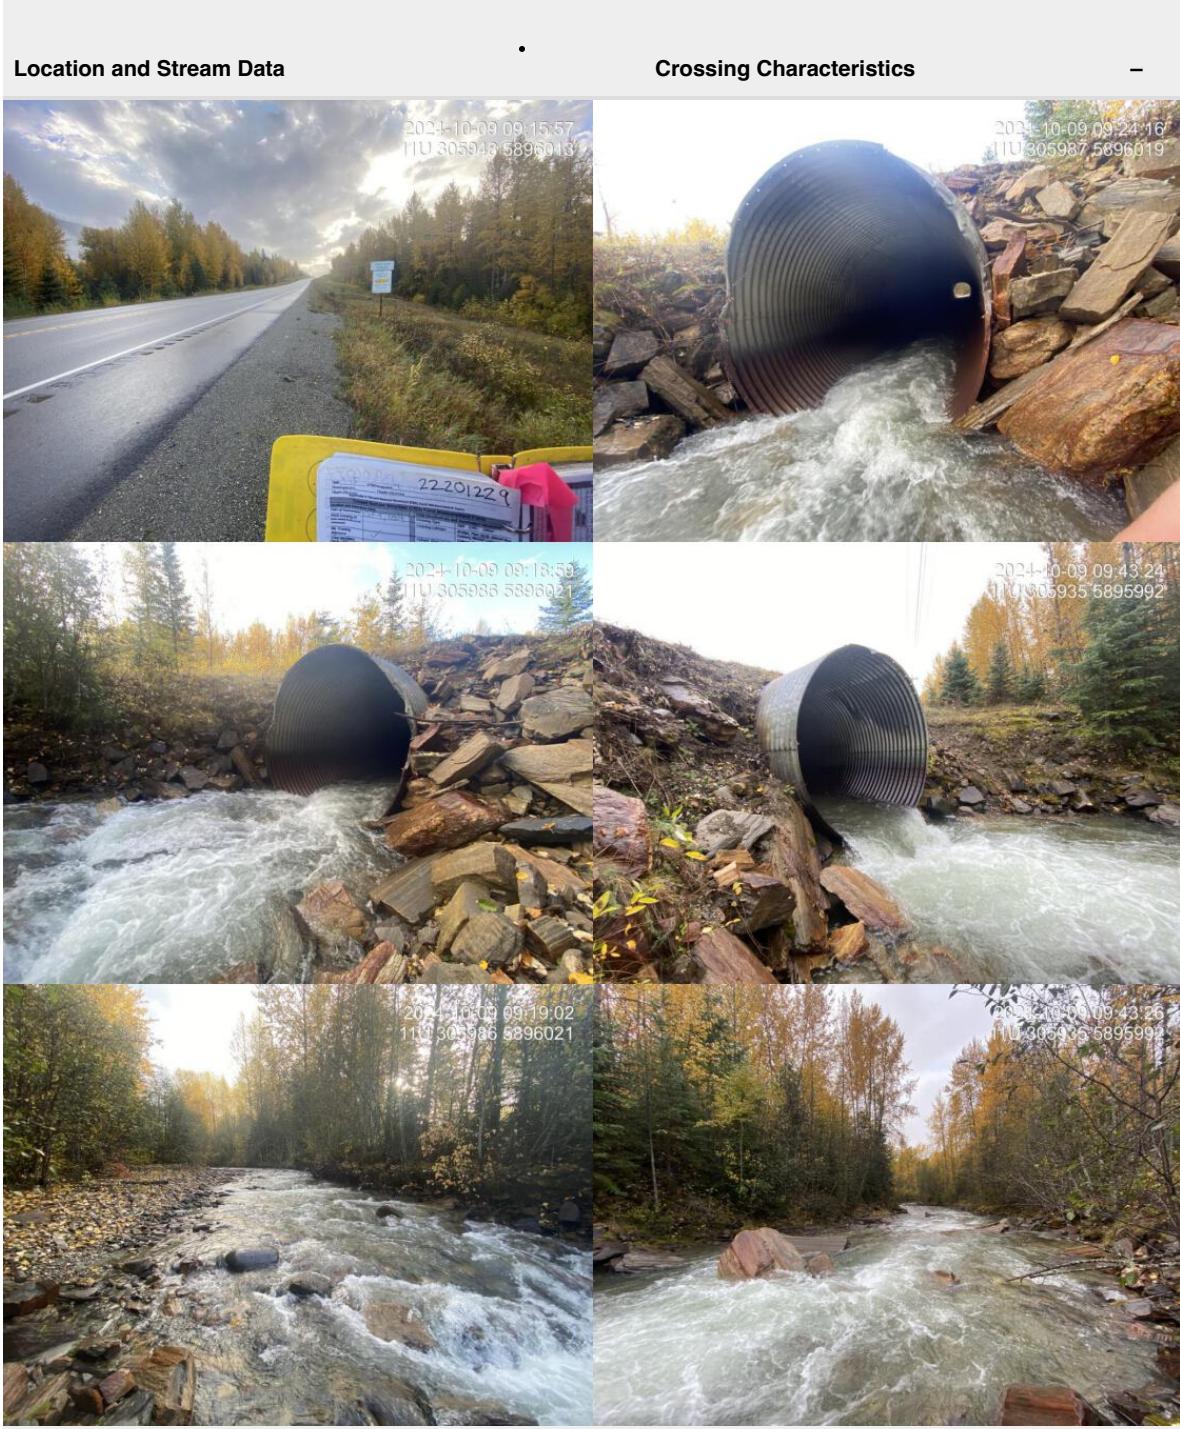
Comments: A significant outlet drop was present. Flow was high at the time of assessment, and at lower flows, the outlet drop would be even more substantial. Although the culvert was large, it was still likely undersized for the stream. The stream was a large glaciated system with a cobble-boulder substrate and an intact mixed riparian zone, primarily deciduous. Occasional large woody debris features created deep pool habitats and pockets of gravels were present suitable for spawning salmonids. A fish (~60mm) was observed during the habitat confirmation. Chinook and bull trout have been previously captured both upstream and downstream of the crossing by Triton Environmental Consultants Ltd. MoTi chris_hwy_structure_road_id: 29925

Photos: From top left clockwise: Road/Site Card, Barrel, Outlet, Downstream, Upstream, Inlet.

Should restoration/maintenance activities proceed, replacement of the Highway 16 crossing (PSCIS 199282) with a bridge (21 m span) is recommended. At the time of reporting in 2025, the cost of the work is estimated at \$ 15,750,000.
