Appendix - Phase 1 Fish Passage Assessment Data and Photos

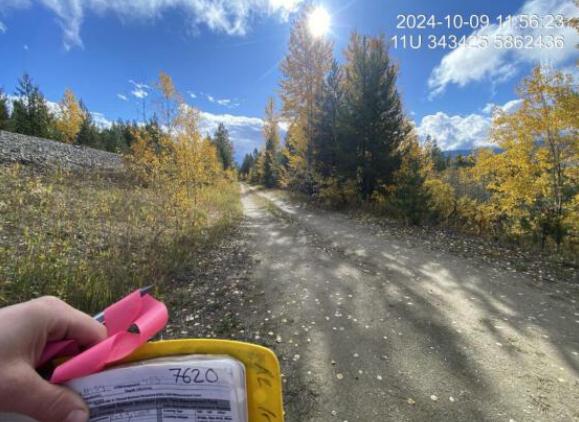
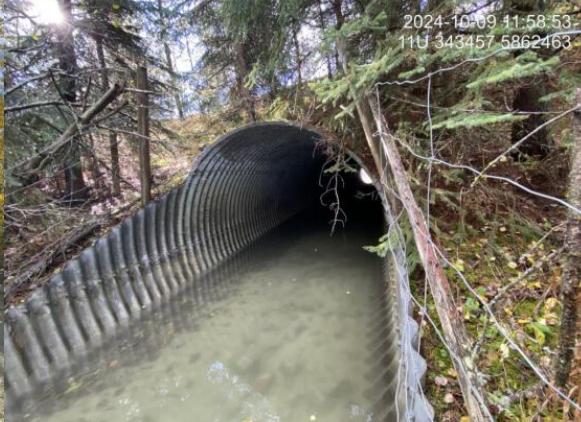
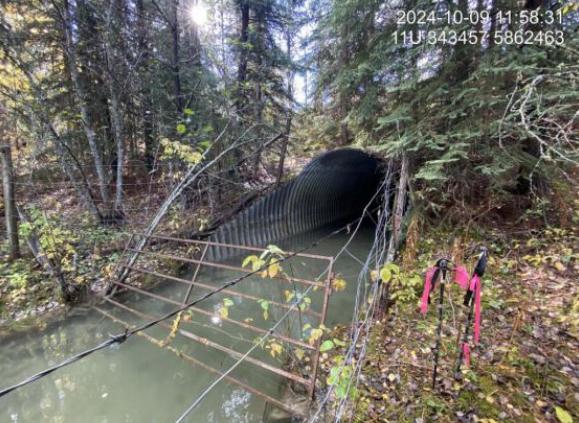
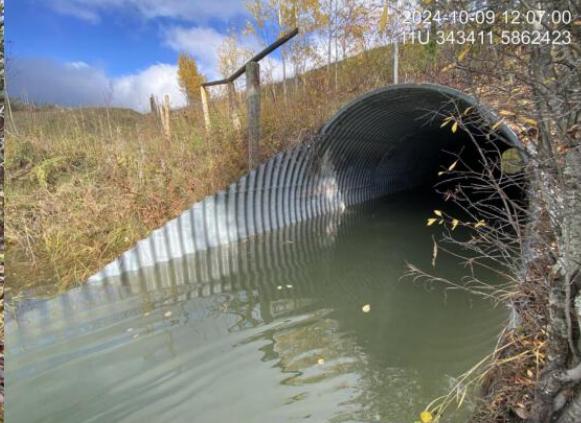
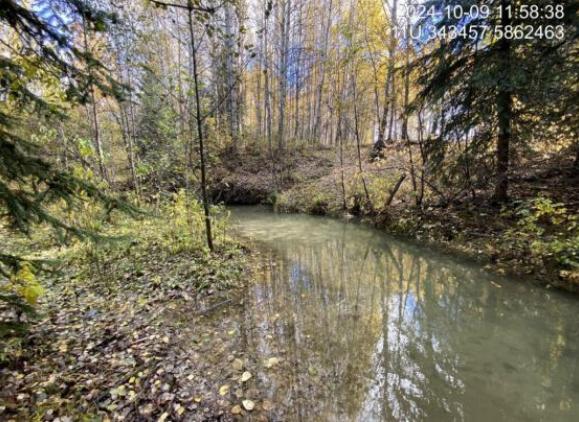
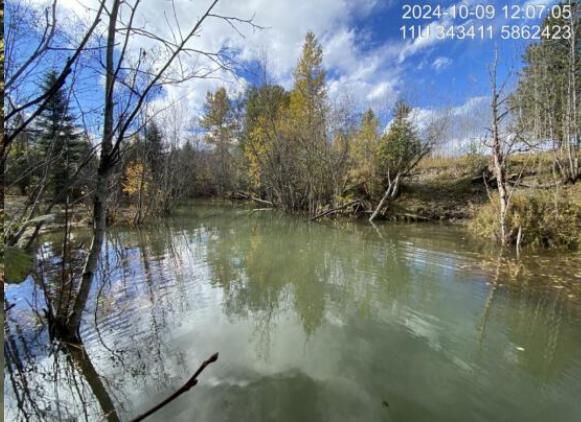
Photos: PSCIS ID 7620. From top left clockwise: Road/Site Card, Barrel, Outlet, Downstream, Upstream, Inlet.

Comments: Long culvert which passed under the CN railway and a dirt road. A beaver dam located 50m downstream of the outlet created a larger beaver pond which was backwatering the culvert . Below the beaver dam, the stream had low gradients and provided good fish habitat. A gate across the inlet functioned as a beaver grate. Signs of cattle accessing the stream were observed near the outlet.

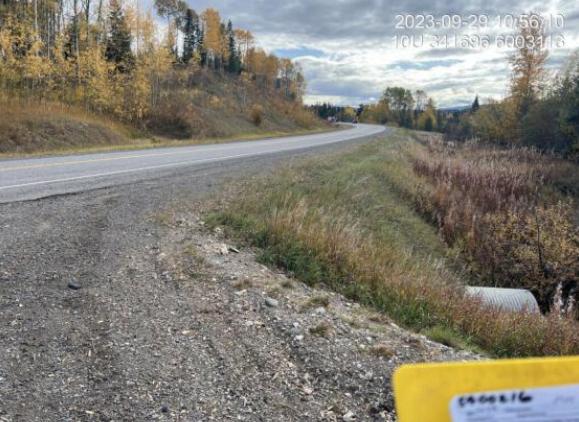
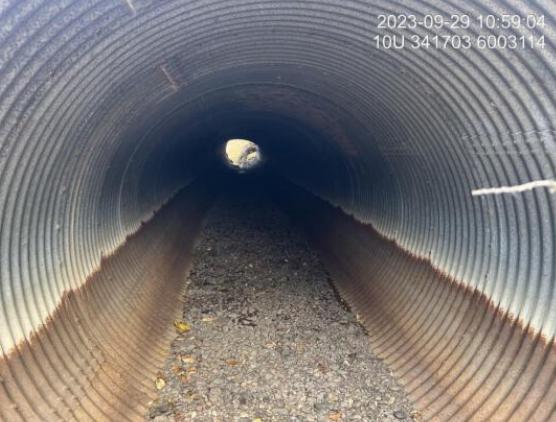
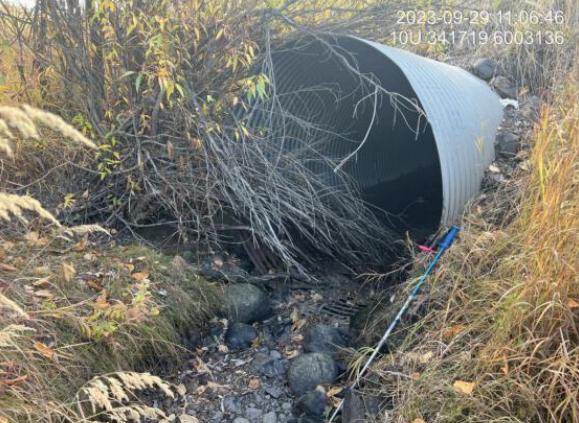
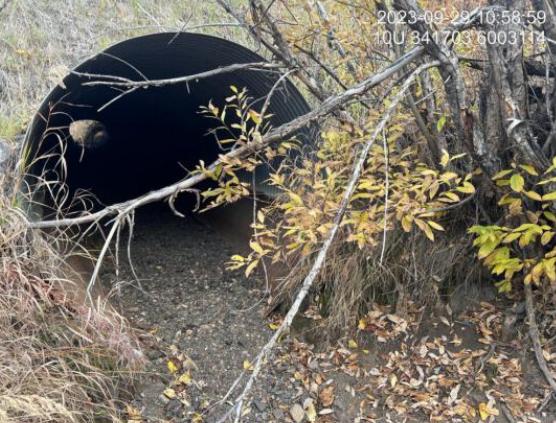
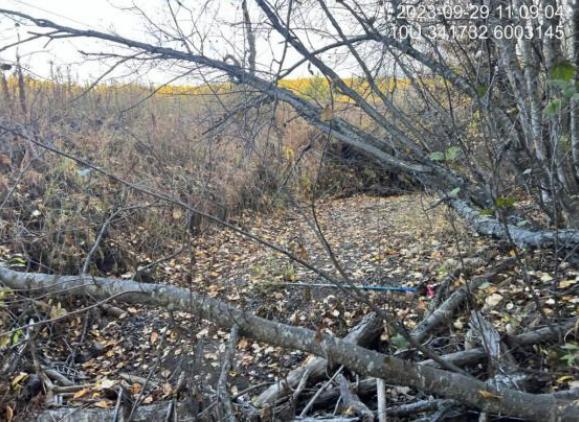
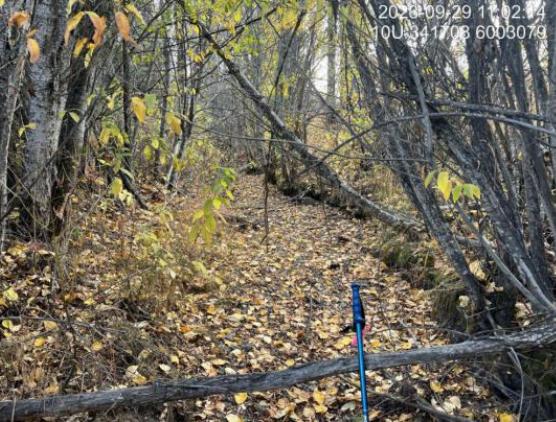
Photos: PSCIS ID 5400216. From top left clockwise: Road/Site Card, Barrel, Outlet, Downstream, Upstream, Inlet.

Comments: Dry at time of survey. Abundant gravels throughout. Crossing on railway downstream still unassessed. Modelled crossing below. First 5 m of pipe is rusted through on the bottom side. Deeply incised banks upstream indicate the stream has a lot of flow at sometimes in the year with a decent amount of power. 9m falls ~1km upstream. Upstream Co-op Lake stocked with KO from 2017-2023 and EB from 1963-2023. MoTi chris_culvert_id: 2069497. 10:56:54

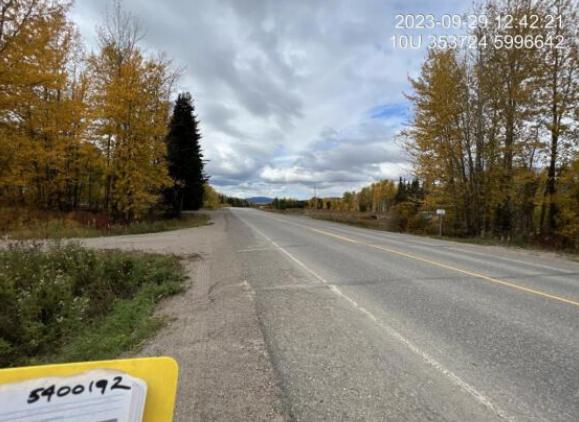
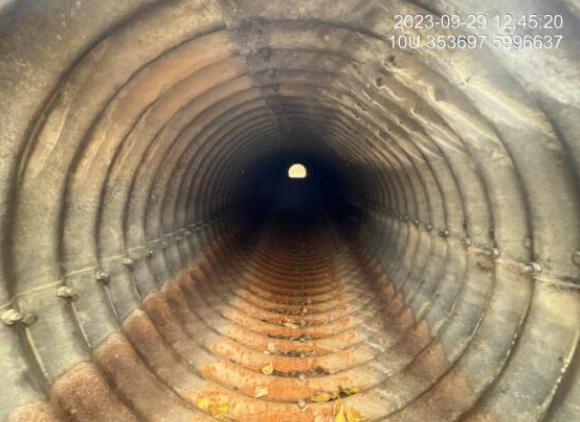
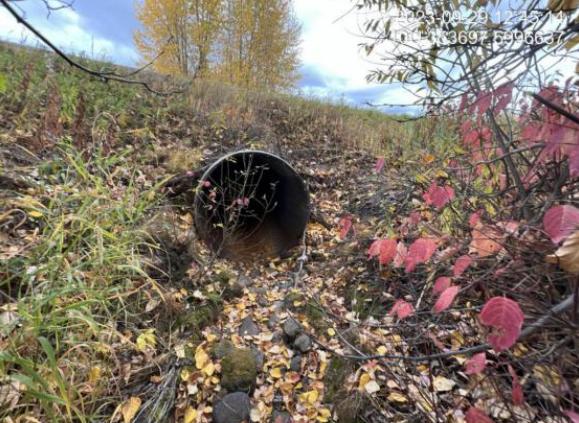
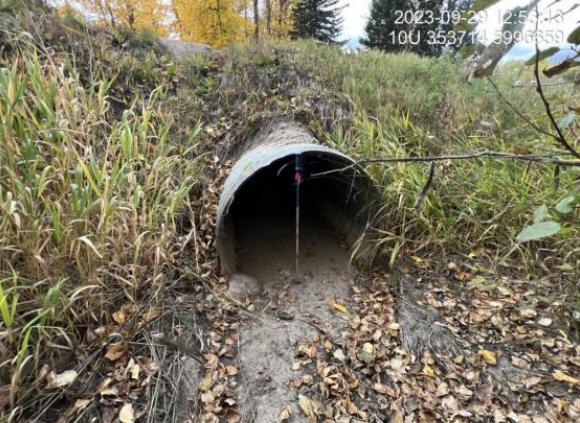
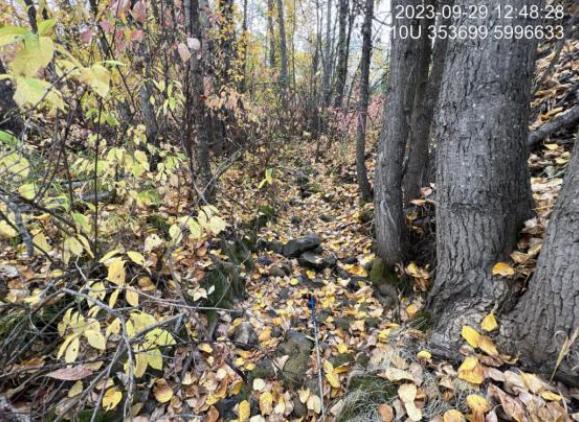
Photos: PSCIS ID 5400192. From top left clockwise: Road/Site Card, Barrel, Outlet, Downstream, Upstream, Inlet.

Comments: Dry at time of survey. Stream may be channelized upstream due to driveways to private properties on either side of the stream. Appears to have narrow, but decently healthy cottonwood dominated riparian, which could help dissipate flows and floods and runoff. Crack in Highway at culvert with minor erosion of road prism on downstream side. Stream labelled as Ross creek on sign. MoTi chris_culvert_id: 1793864. 12:42:58

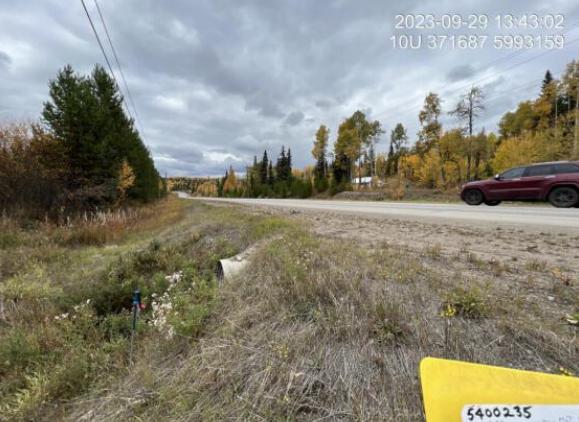
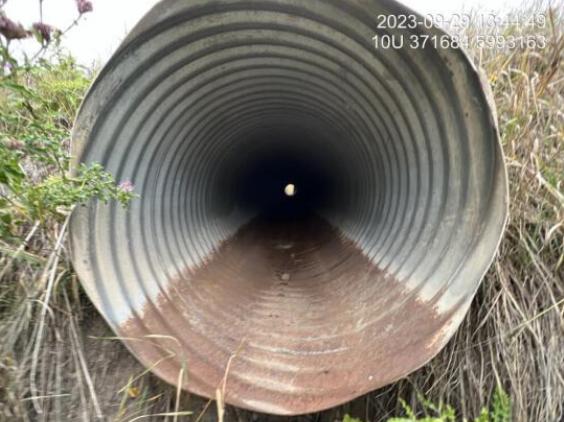
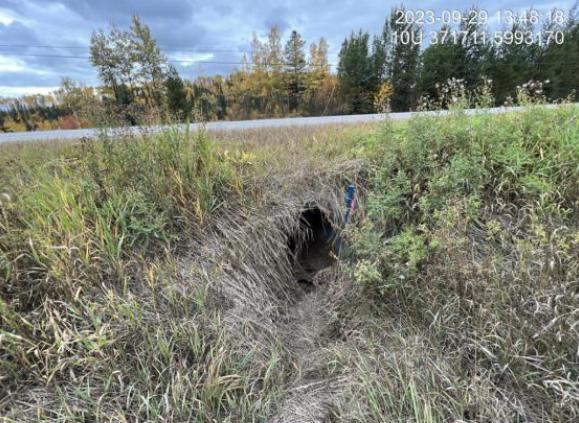
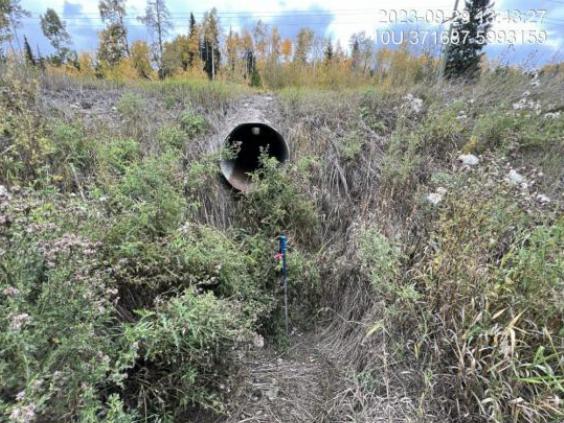
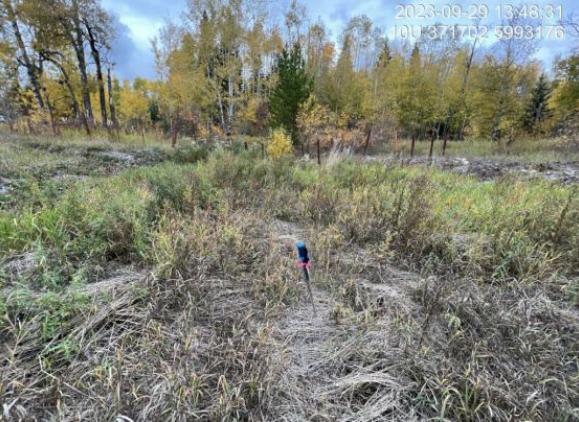
Photos: PSCIS ID 5400235. From top left clockwise: Road/Site Card, Barrel, Outlet, Downstream, Upstream, Inlet.

Location and Stream Data	.	Crossing Characteristics	–
Date	2023-09-29	Crossing Sub Type	Round Culvert
PSCIS ID	199168	Diameter (m)	0.9
External ID	5400235	Length (m)	20
Crew	AI	Embedded	No
UTM Zone	10	Depth Embedded (m)	–
Easting	371691	Resemble Channel	No
Northing	5993173	Backwatered	No
Stream	Alf Creek	Percent Backwatered	–
Road	Highway 16	Fill Depth (m)	0.7
Road Tenure	MOTI	Outlet Drop (m)	1.2
Channel Width (m)	1	Outlet Pool Depth (m)	0.4
Stream Slope (%)	3	Inlet Drop	No
Beaver Activity	No	Slope (%)	2
Habitat Value	Low	Valley Fill	Deep Fill
Final score	31	Barrier Result	Barrier
Fix type	Replace Structure with Streambed Simulation CBS	Fix Span / Diameter	3

Comments: Dry with very poorly defined channel upstream and downstream. Seems very unlikely that this system could support fish. Pipe is rusted right through at the inlet for ~1m. Pipe is in very bad shape. MoTi chris_culvert_id: 1793794. 13:41:54

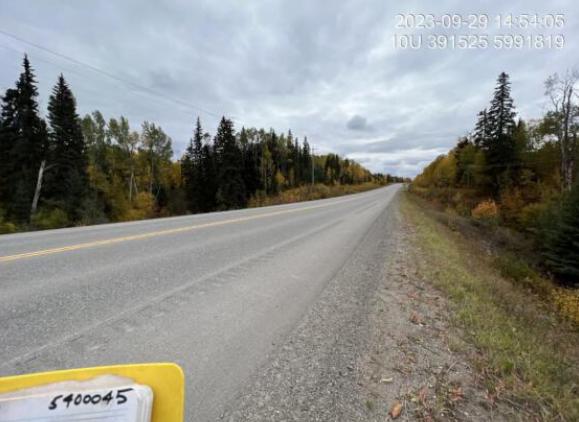
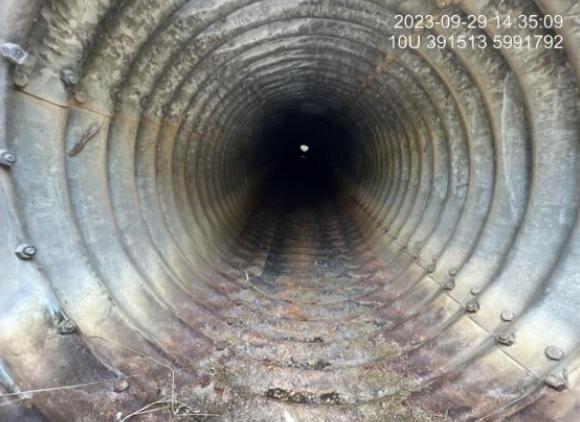
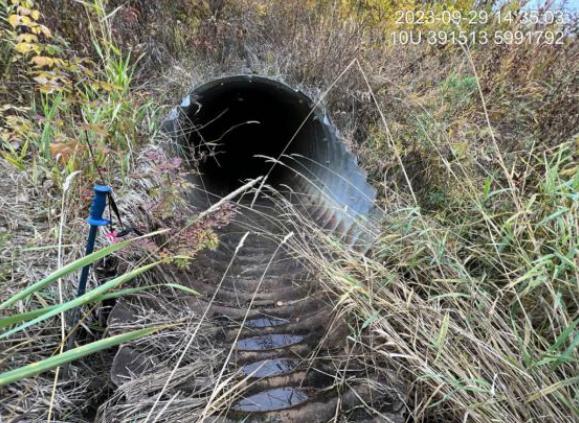
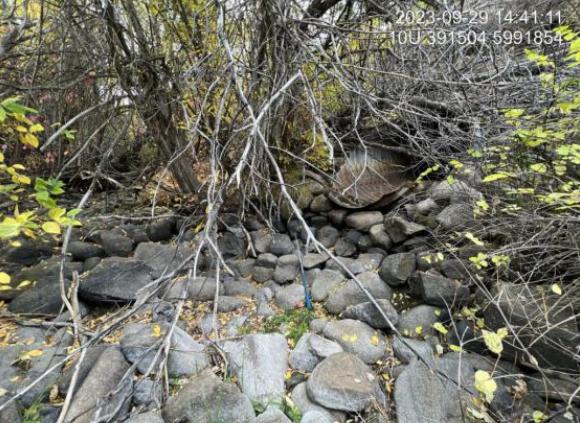
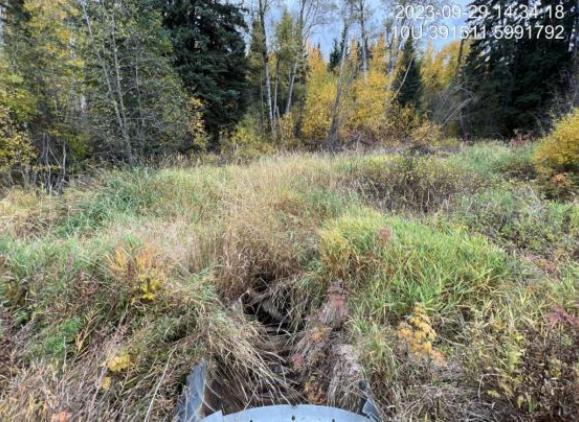
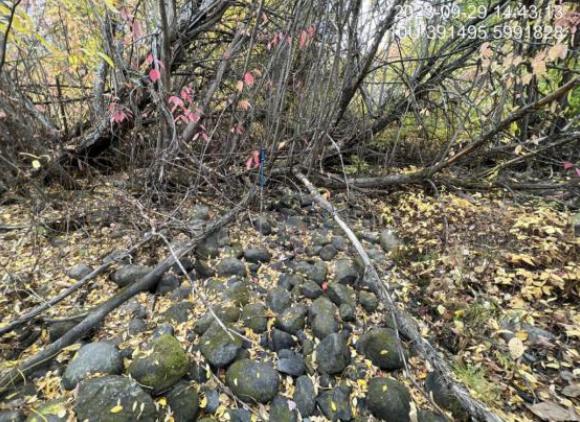
Photos: PSCIS ID 5400045. From top left clockwise: Road/Site Card, Barrel, Outlet, Downstream, Upstream, Inlet.

Location and Stream Data		Crossing Characteristics	
Date	2023-09-29	Crossing Sub Type	Round Culvert
PSCIS ID	199169	Diameter (m)	1.5
External ID	5400045	Length (m)	50
Crew	AI	Embedded	No
UTM Zone	10	Depth Embedded (m)	—
Easting	391513	Resemble Channel	No
Northing	5991795	Backwatered	No
Stream	Tributary to Fraser Lake	Percent Backwatered	—
Road	Highway 16	Fill Depth (m)	9.9
Road Tenure	MOTI	Outlet Drop (m)	0.4
Channel Width (m)	4	Outlet Pool Depth (m)	0.5
Stream Slope (%)	2	Inlet Drop	No
Beaver Activity	No	Slope (%)	0.5
Habitat Value	Medium	Valley Fill	Deep Fill
Final score	32	Barrier Result	Barrier
Fix type	Replace with New Open Bottom Structure	Fix Span / Diameter	35.5

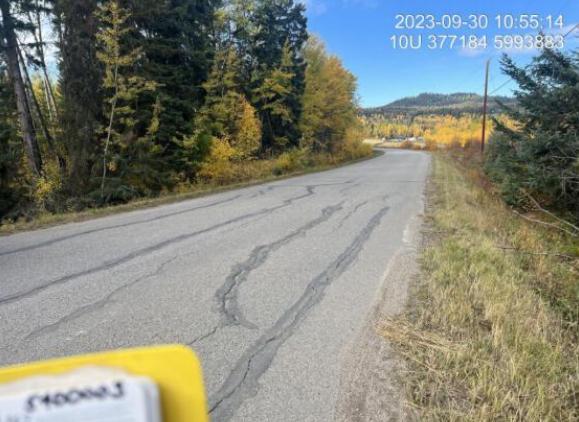
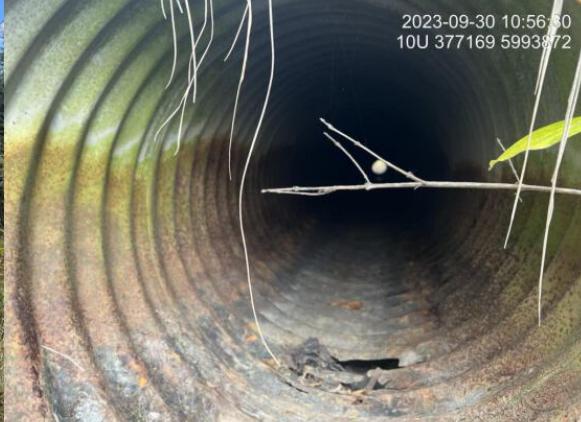
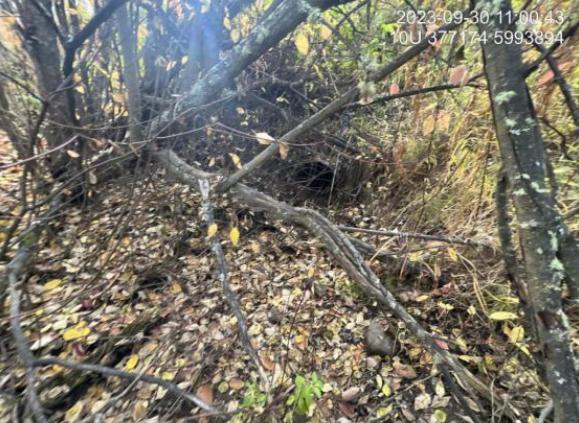
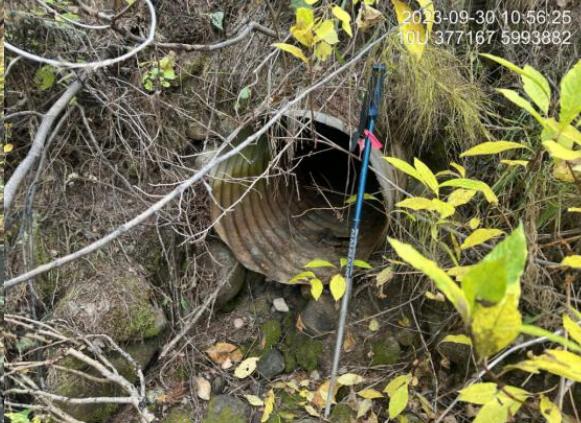
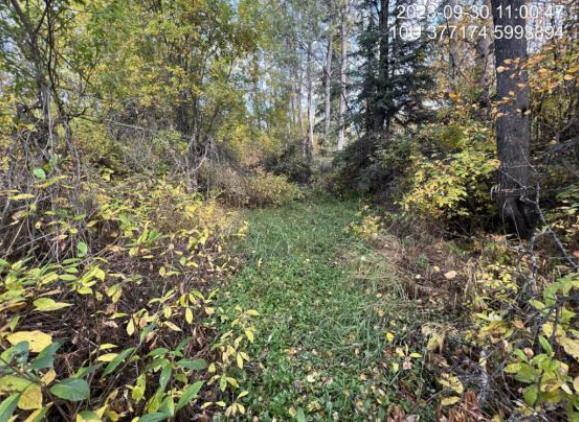
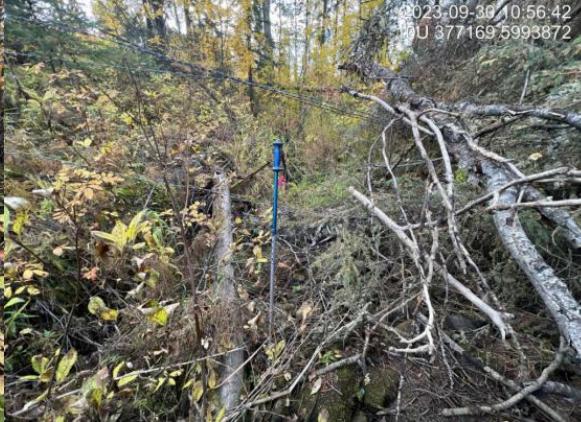
Photos: PSCIS ID 5400003. From top left clockwise: Road/Site Card, Barrel, Outlet, Downstream, Upstream, Inlet.

Location and Stream Data		Crossing Characteristics	
	.		-
Date	2023-09-30	Crossing Sub Type	Round Culvert
PSCIS ID	199170	Diameter (m)	0.6
External ID	5400003	Length (m)	23
Crew	AI	Embedded	No
UTM Zone	10	Depth Embedded (m)	-
Easting	377178	Resemble Channel	No
Northing	5993874	Backwatered	No
Stream	Perry Creek	Percent Backwatered	-
Road	Stella Road	Fill Depth (m)	4
Road Tenure	MOTI	Outlet Drop (m)	0.3
Channel Width (m)	1	Outlet Pool Depth (m)	0
Stream Slope (%)	2	Inlet Drop	No
Beaver Activity	No	Slope (%)	1
Habitat Value	Low	Valley Fill	Deep Fill
Final score	34	Barrier Result	Barrier
Fix type	Replace Structure with Streambed Simulation CBS	Fix Span / Diameter	3

Comments: Small drainage. Dry with primarily vegetated channel indicating does not much flow for most of the year.
Culvert rusting at inlet. MoTi chris_culvert_id: 1794274. 10:53:44

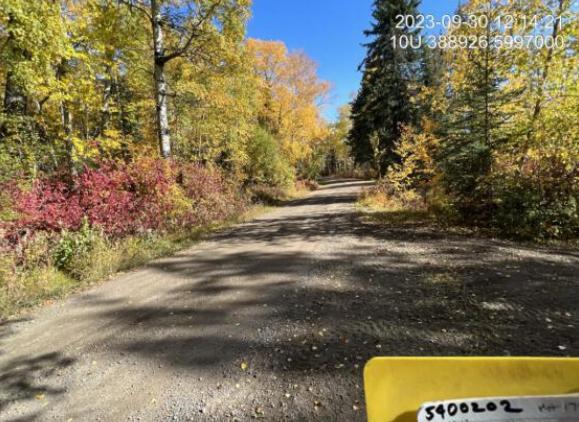
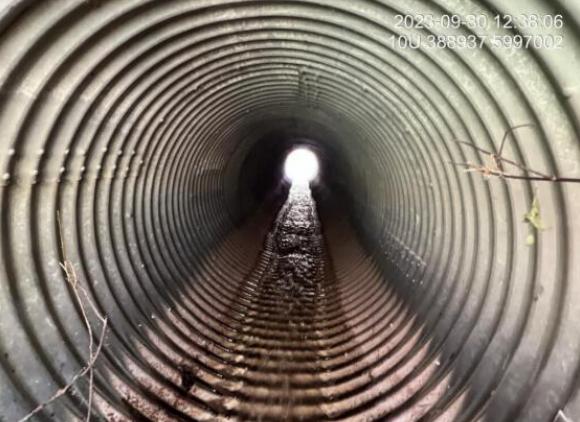
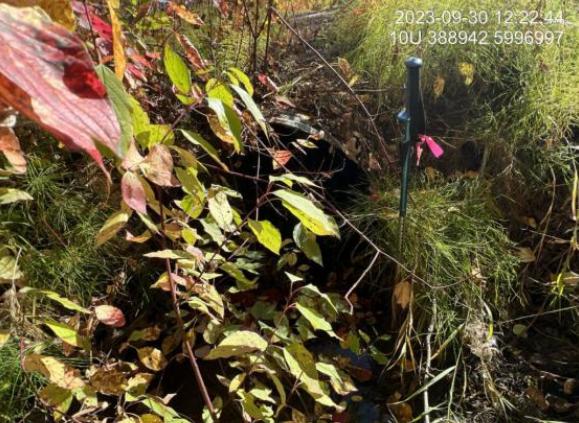
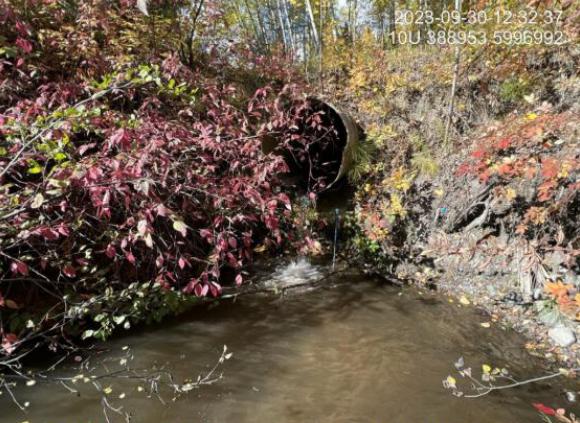
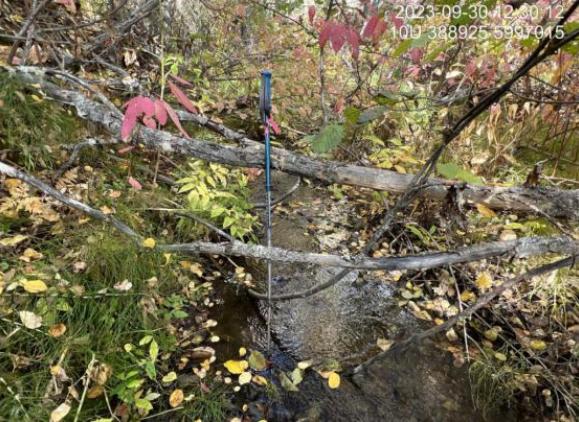
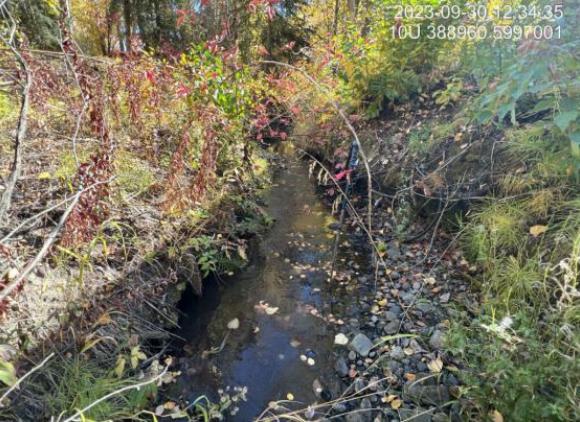
Photos: PSCIS ID 5400202. From top left clockwise: Road/Site Card, Barrel, Outlet, Downstream, Upstream, Inlet.

Location and Stream Data	.	Crossing Characteristics	–
Date	2023-09-30	Crossing Sub Type	Round Culvert
PSCIS ID	199171	Diameter (m)	1
External ID	5400202	Length (m)	13
Crew	AI	Embedded	No
UTM Zone	10	Depth Embedded (m)	–
Easting	388944	Resemble Channel	No
Northing	5997002	Backwatered	No
Stream	Tributary to Fraser Lake	Percent Backwatered	–
Road	Gala Bay Road	Fill Depth (m)	1
Road Tenure	MOTI Local	Outlet Drop (m)	0.8
Channel Width (m)	1.7	Outlet Pool Depth (m)	0.6
Stream Slope (%)	2	Inlet Drop	No
Beaver Activity	No	Slope (%)	4.5
Habitat Value	High	Valley Fill	Deep Fill
Final score	36	Barrier Result	Barrier
Fix type	Replace Structure with Streambed Simulation CBS	Fix Span / Diameter	3

Comments: Very nice stream with good flow and abundant gravels upstream and downstream. Landowner indicated sockeye spotted along shoreline years ago. Massive outlet drop. Deserves habitat confirmation and consideration for replacement if no natural barriers upstream. There is a PSCIS assessed site (assessment_id = 7622) upstream that is a barrier. MoTi chris_culvert_id: 1790951. 12:12:56

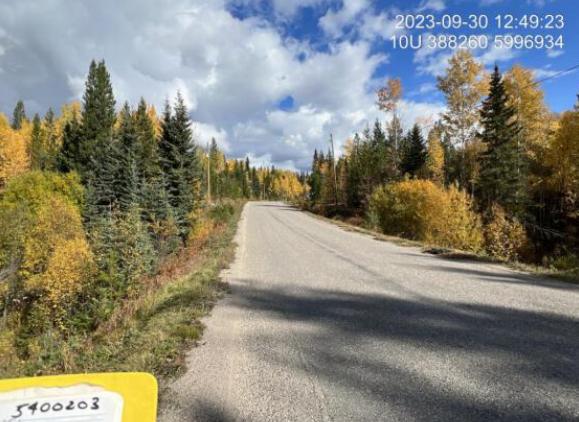
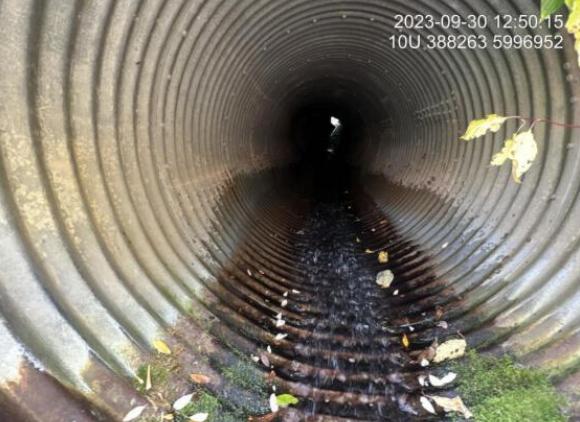
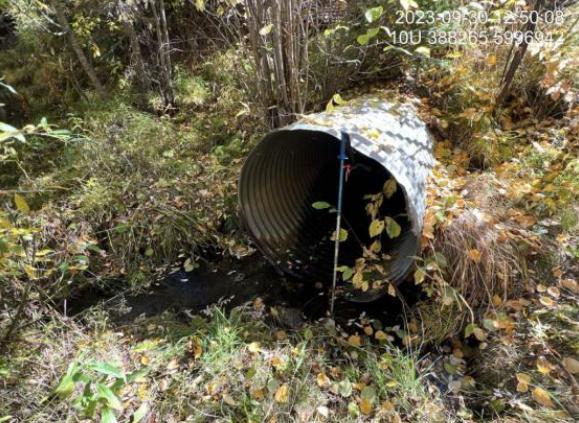
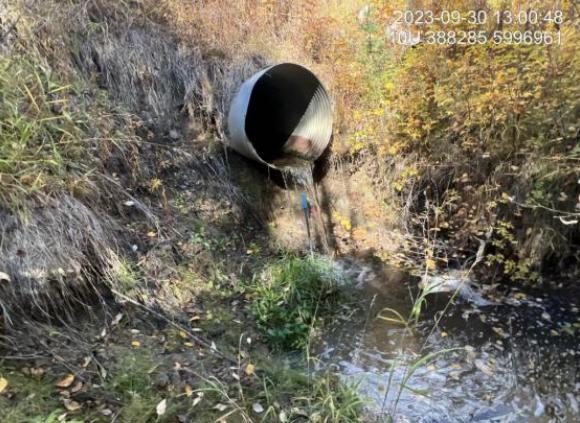
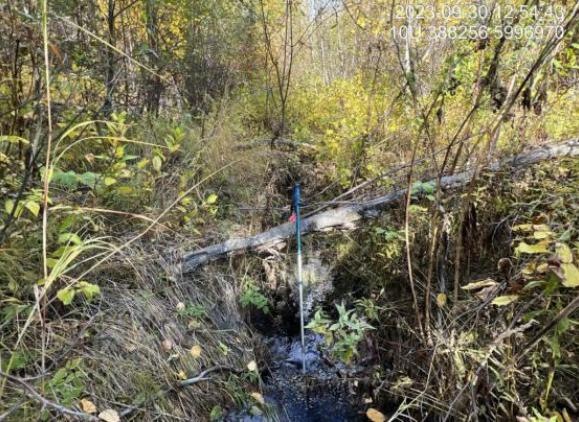
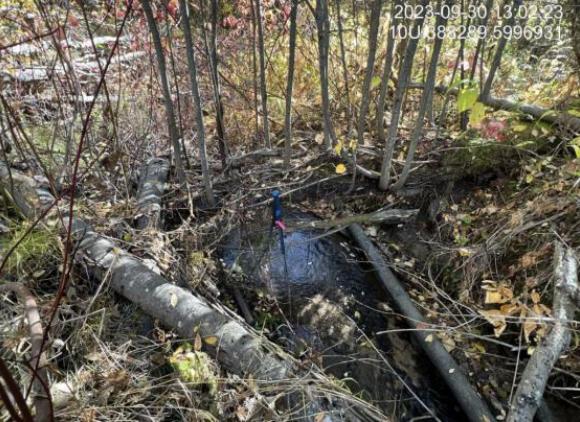
Photos: PSCIS ID 5400203. From top left clockwise: Road/Site Card, Barrel, Outlet, Downstream, Upstream, Inlet.

Location and Stream Data		Crossing Characteristics	
Date	2023-09-30	Crossing Sub Type	Round Culvert
PSCIS ID	199172	Diameter (m)	1.1
External ID	5400203	Length (m)	25
Crew	AI	Embedded	No
UTM Zone	10	Depth Embedded (m)	—
Easting	388270	Resemble Channel	No
Northing	5996949	Backwatered	No
Stream	Scotch Creek	Percent Backwatered	—
Road	Stella Road	Fill Depth (m)	5
Road Tenure	MOTI	Outlet Drop (m)	1.4
Channel Width (m)	2.6	Outlet Pool Depth (m)	0.2
Stream Slope (%)	2	Inlet Drop	No
Beaver Activity	No	Slope (%)	4.5
Habitat Value	High	Valley Fill	Deep Fill
Final score	39	Barrier Result	Barrier
Fix type	Replace with New Open Bottom Structure	Fix Span / Diameter	21

Comments: Very nice little stream with excellent flow for this time of year on a dry year. Crossing downstream on Gala Bay Road was fully embedded and passible at the time of the assessment. There is a historic chinook observation within this stream. This could be valuable Chinook rearing habitat and connectivity within the system should be restored, should no natural barriers be observed on a habitat confirmation assessment. MoTi chris_culvert_id: 1794198, 1794199. 12:47:26

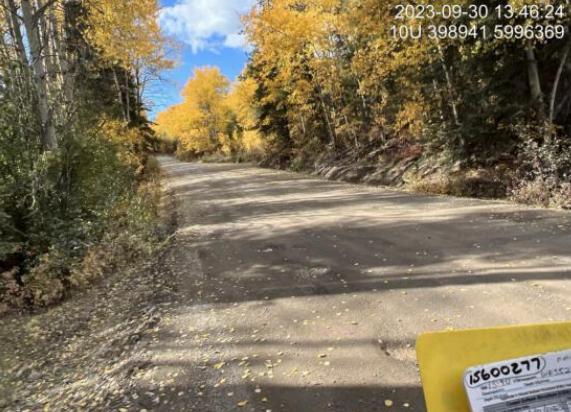
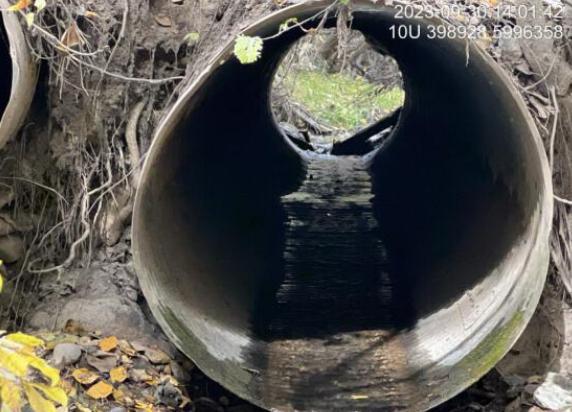
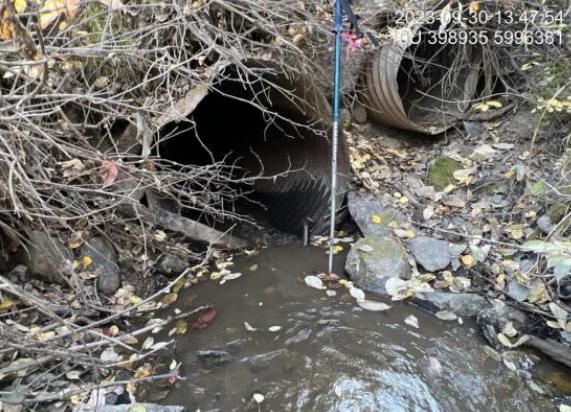
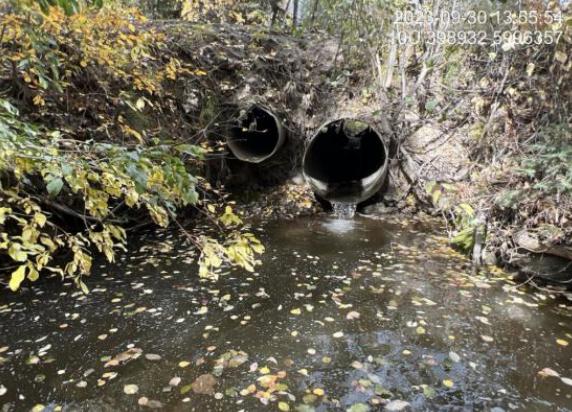
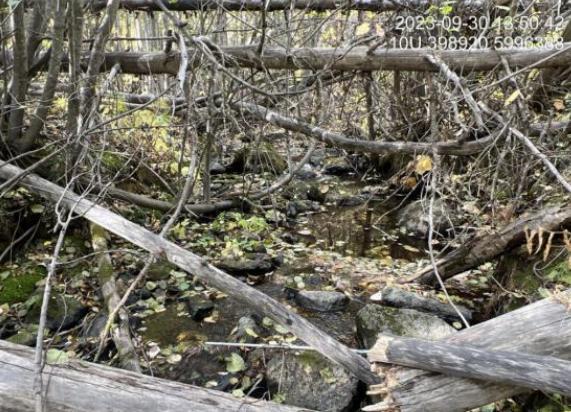
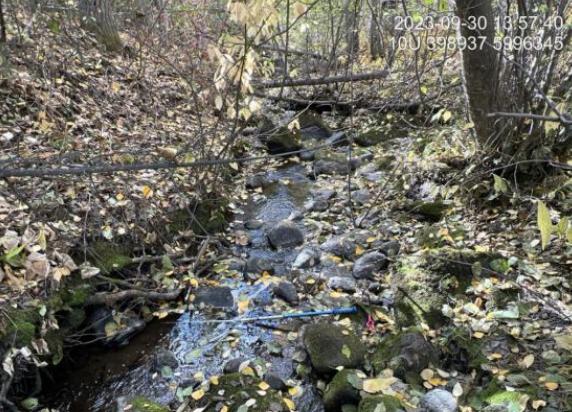
Photos: PSCIS ID 15600277. From top left clockwise: Road/Site Card, Barrel, Outlet, Downstream, Upstream, Inlet.

Location and Stream Data		Crossing Characteristics	
Date	2023-09-30	Crossing Sub Type	Round Culvert
PSCIS ID	199173	Diameter (m)	0.95
External ID	15600277	Length (m)	12
Crew	AI	Embedded	No
UTM Zone	10	Depth Embedded (m)	—
Easting	398933	Resemble Channel	No
Northing	5996365	Backwatered	No
Stream	Tributary to Nechako River	Percent Backwatered	—
Road	Dog Creek Road	Fill Depth (m)	1.5
Road Tenure	MOTI	Outlet Drop (m)	0.4
Channel Width (m)	2.7	Outlet Pool Depth (m)	1
Stream Slope (%)	3	Inlet Drop	No
Beaver Activity	Yes	Slope (%)	3
Habitat Value	High	Valley Fill	Deep Fill
Final score	36	Barrier Result	Barrier
Fix type	Replace with New Open Bottom Structure	Fix Span / Diameter	15

Comments: Very nice stream with excellent flow for this time of year on a dry year. Very large deep outlet pool with extensive erosion undercutting the main pipe and 0.6 m overflow. Locally known as Dog Creek. Chinook captured upstream and downstream of Dog Creek FSR in 2021, 2022, and 2023 reported here <https://a100.gov.bc.ca/pub/acat/public/viewReport.do?reportId=62942>. Connected to the Nechako River with observed chinook points downstream adjacent to the confluence. Road edge is failing at the culvert and eroding into stream. Highly degraded site upstream that would be a good candidate for restoration. MoTi chris_culvert_id: 1794340. 13:43:26

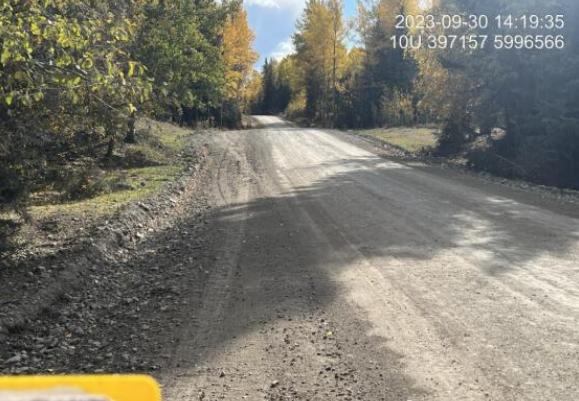
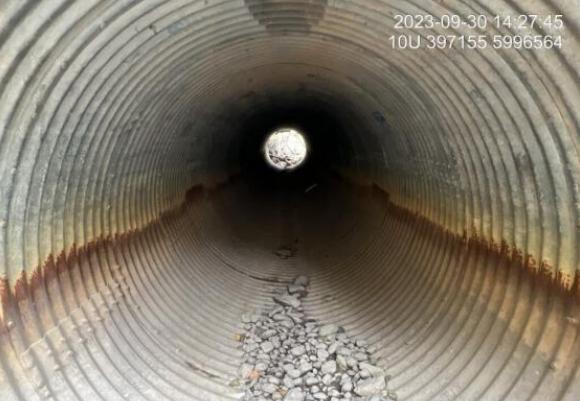
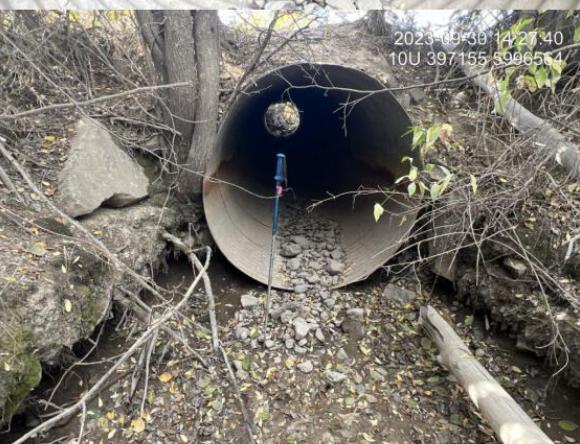
Photos: PSCIS ID 15604478. From top left clockwise: Road/Site Card, Barrel, Outlet, Downstream, Upstream, Inlet.

Location and Stream Data		Crossing Characteristics	
Date	2023-09-30	Crossing Sub Type	Round Culvert
PSCIS ID	199174	Diameter (m)	1.45
External ID	15604478	Length (m)	16
Crew	AI	Embedded	No
UTM Zone	10	Depth Embedded (m)	—
Easting	397160	Resemble Channel	No
Northing	5996558	Backwatered	No
Stream	Tributary to Nechako River	Percent Backwatered	—
Road	Sutherland FSR	Fill Depth (m)	0.5
Road Tenure	West Fraser R09194 SE	Outlet Drop (m)	0
Channel Width (m)	2.5	Outlet Pool Depth (m)	0.2
Stream Slope (%)	0.5	Inlet Drop	Yes
Beaver Activity	No	Slope (%)	2
Habitat Value	Medium	Valley Fill	Deep Fill
Final score	24	Barrier Result	Barrier
Fix type	Replace with New Open Bottom Structure	Fix Span / Diameter	15

Comments: Extreme negative impacts due to cattle, particularly upstream of the FSR. Extensive trampling of the channel and banks, along with heavy grazing and removal of riparian. Dry at the time of assessment besides a small wallowing hole upstream of the inlet. Riparian exclusion fencing is required along with repairing vegetation, restoration irrigation, and monitoring. This is a fish bearing stream with high habitat values less than 2 km down the stream where it crosses Dog Creek Road.. 14:17:41

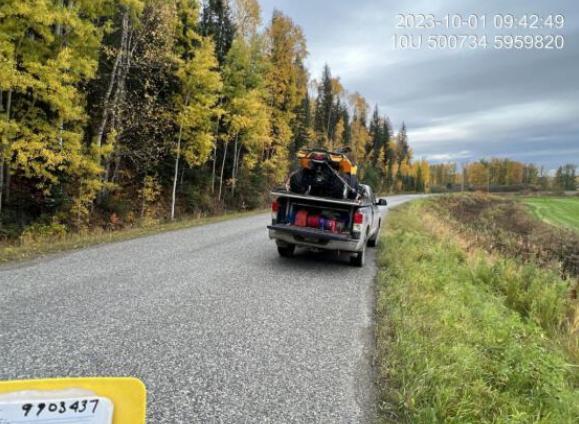
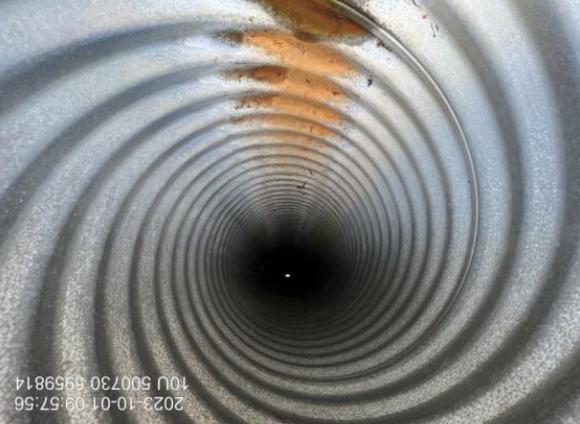
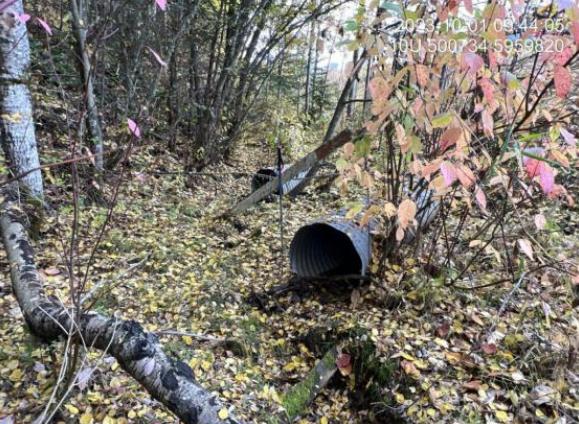
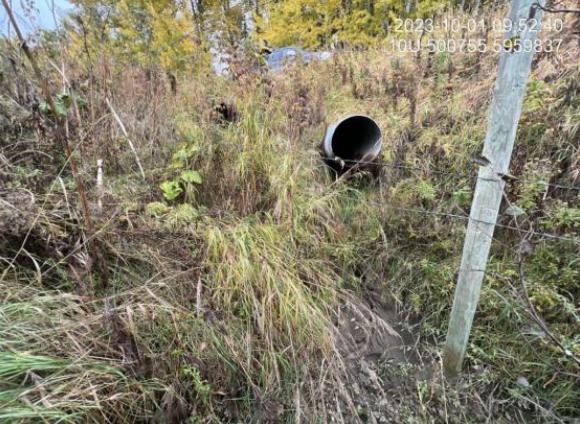
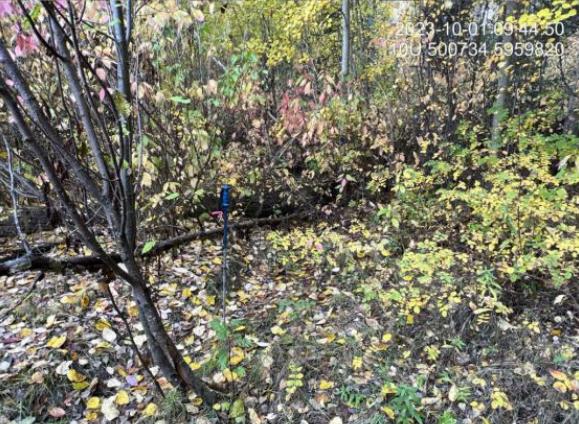
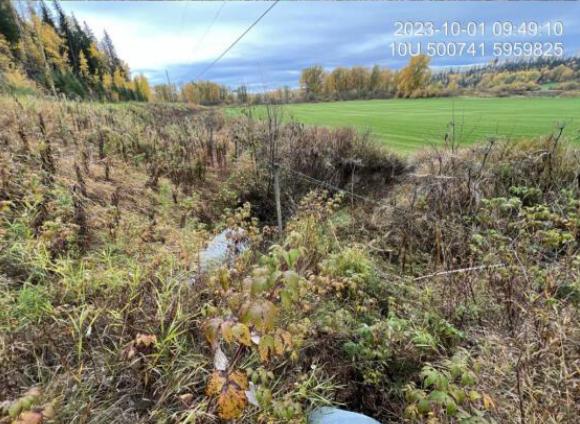
Photos: PSCIS ID 9903437. From top left clockwise: Road/Site Card, Barrel, Outlet, Downstream, Upstream, Inlet.

Location and Stream Data	.	Crossing Characteristics	-
Date	2023-10-01	Crossing Sub Type	Round Culvert
PSCIS ID	199175	Diameter (m)	1.2
External ID	9903437	Length (m)	29
Crew	AI	Embedded	No
UTM Zone	10	Depth Embedded (m)	-
Easting	500733	Resemble Channel	No
Northing	5959822	Backwatered	No
Stream	Aird Creek	Percent Backwatered	-
Road	Upper Mud River Road	Fill Depth (m)	2
Road Tenure	MOTI	Outlet Drop (m)	1.5
Channel Width (m)	1.2	Outlet Pool Depth (m)	0
Stream Slope (%)	3	Inlet Drop	No
Beaver Activity	No	Slope (%)	5
Habitat Value	Low	Valley Fill	Deep Fill
Final score	36	Barrier Result	Barrier
Fix type	Replace Structure with Streambed Simulation CBS	Fix Span / Diameter	3

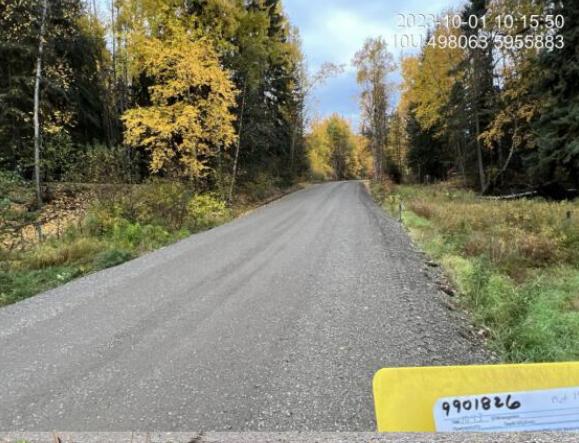
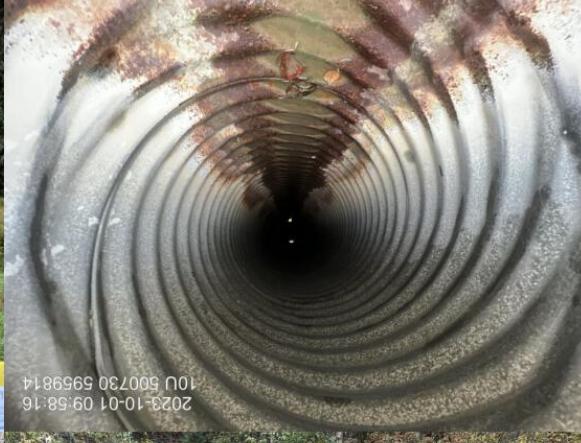
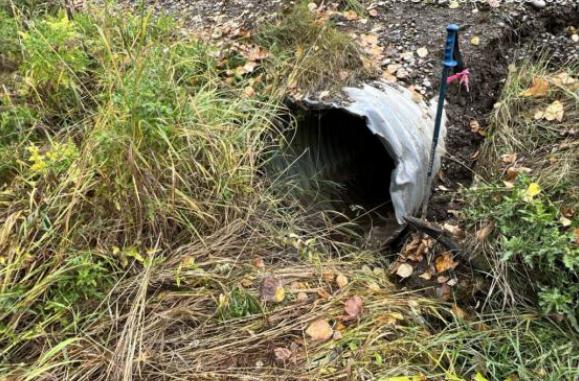
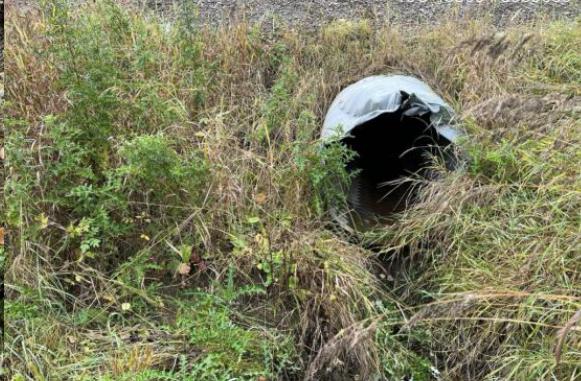
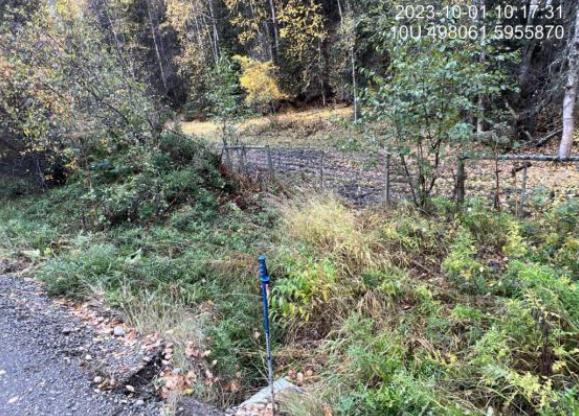
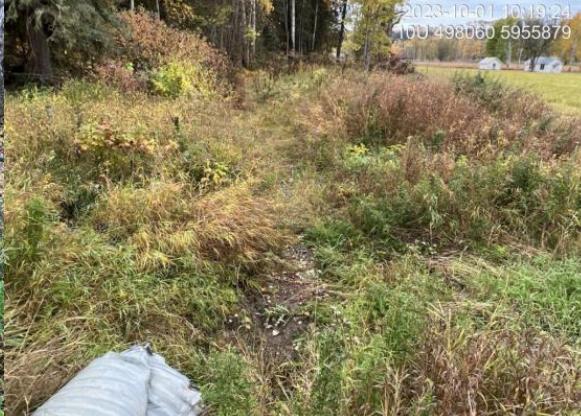
Location and Stream Data	.	Crossing Characteristics	–
Date	2023-10-01	Crossing Sub Type	Round Culvert
PSCIS ID	199176	Diameter (m)	0.9
External ID	9901826	Length (m)	10
Crew	AI	Embedded	No
UTM Zone	10	Depth Embedded (m)	–
Easting	498057	Resemble Channel	No
Northing	5955884	Backwatered	No
Stream	Chilako Creek	Percent Backwatered	–
Road	Upper Mud River Road	Fill Depth (m)	0.8
Road Tenure	MOTI	Outlet Drop (m)	0.25
Channel Width (m)	1.7	Outlet Pool Depth (m)	0.2
Stream Slope (%)	1	Inlet Drop	No
Beaver Activity	No	Slope (%)	3
Habitat Value	Low	Valley Fill	Deep Fill
Final score	31	Barrier Result	Barrier
Fix type	Replace Structure with Streambed Simulation CBS	Fix Span / Diameter	3
Comments: Dry at time of assessment. One assessed crossing on private driveway located downstream. Stream is completely trampled and barely recognizable upstream due to cattle trampling and riparian removal. Downstream is ditch like with just grass and shrub riparian before mix forest begins proximately 40 m downstream of the road.

Agricultural field on right back downstream. Some scouring of the channel downstream, but primarily choked with grasses indicating stream does not flow for much of the year lately. MoTi chris_culvert_id: 1975651. 10:20:58			
Photos: PSCIS ID 9901826. From top left clockwise: Road/Site Card, Barrel, Outlet, Downstream, Upstream, Inlet.

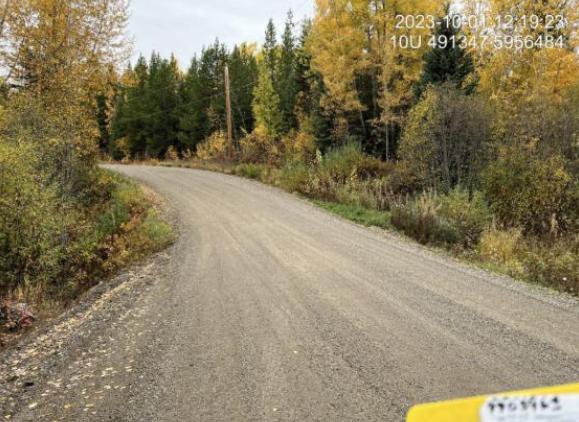
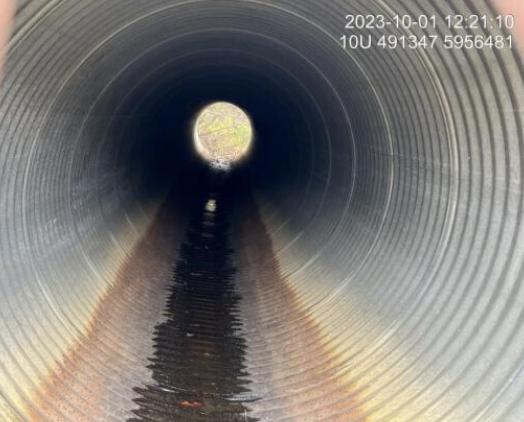
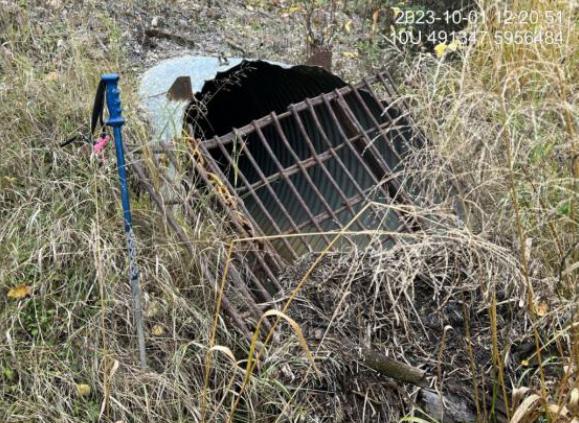
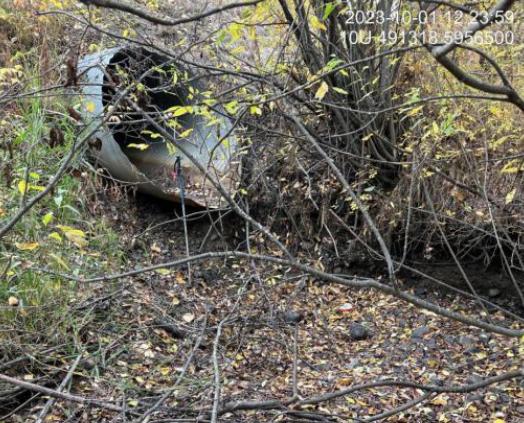
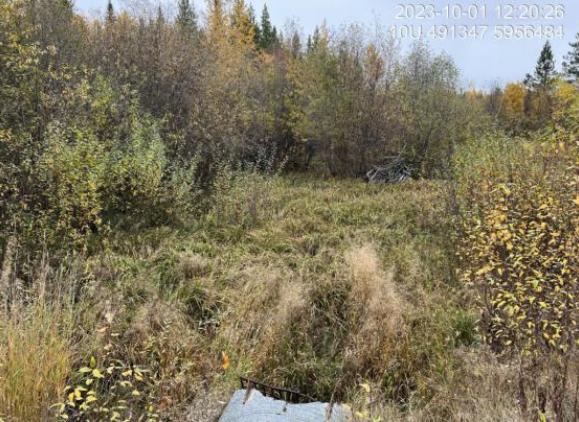
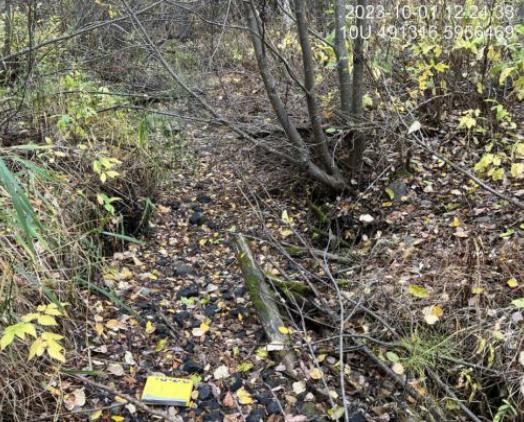
Photos: PSCIS ID 9903963. From top left clockwise: Road/Site Card, Barrel, Outlet, Downstream, Upstream, Inlet.

Location and Stream Data	.	Crossing Characteristics	–
Date	2023-10-01	Crossing Sub Type	Round Culvert
PSCIS ID	199177	Diameter (m)	1.5
External ID	9903963	Length (m)	16
Crew	AI	Embedded	No
UTM Zone	10	Depth Embedded (m)	–
Easting	491332	Resemble Channel	No
Northing	5956490	Backwatered	No
Stream	Tributary to Chelako River	Percent Backwatered	–
Road	McBride Timber Road	Fill Depth (m)	1.5
Road Tenure	MOTI	Outlet Drop (m)	0.75
Channel Width (m)	1.7	Outlet Pool Depth (m)	0.5
Stream Slope (%)	1	Inlet Drop	No
Beaver Activity	Yes	Slope (%)	3
Habitat Value	Low	Valley Fill	Deep Fill
Final score	36	Barrier Result	Barrier
Fix type	Replace Structure with Streambed Simulation CBS	Fix Span / Diameter	3

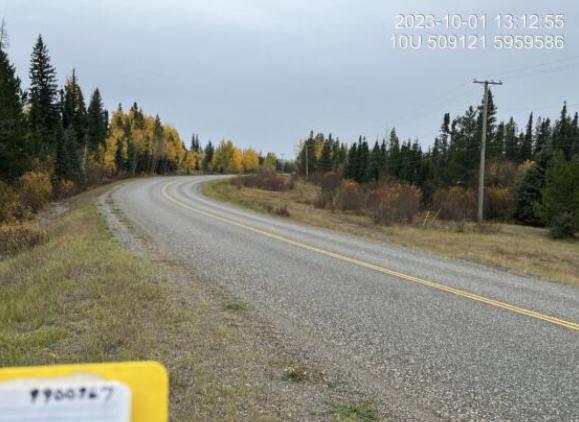
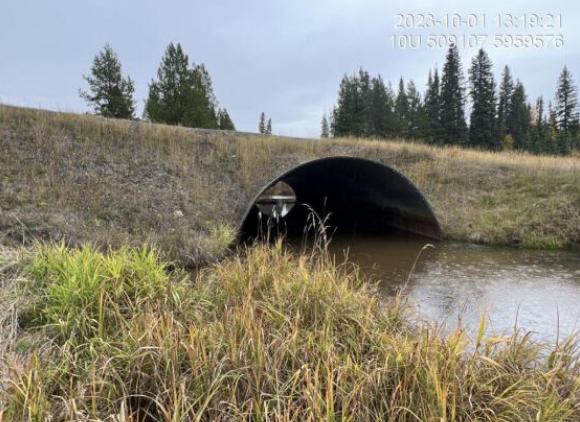
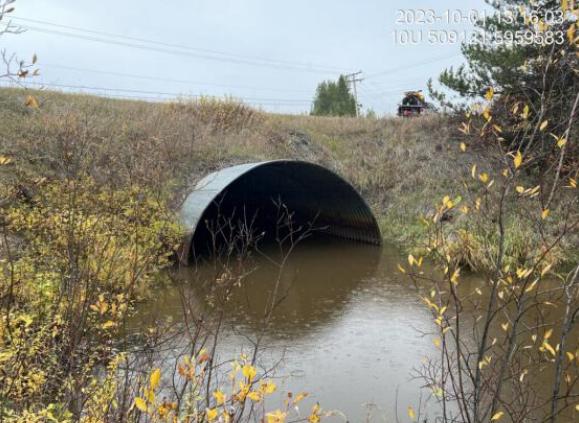
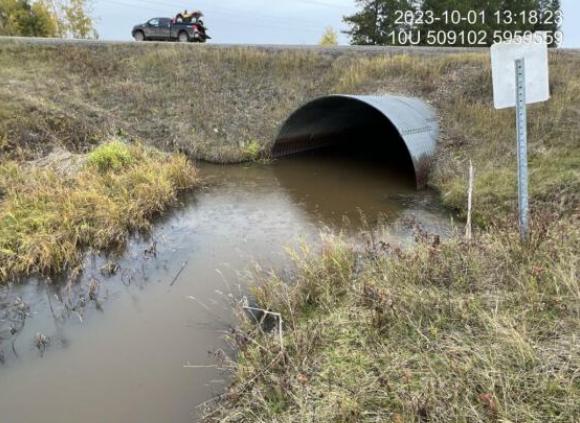
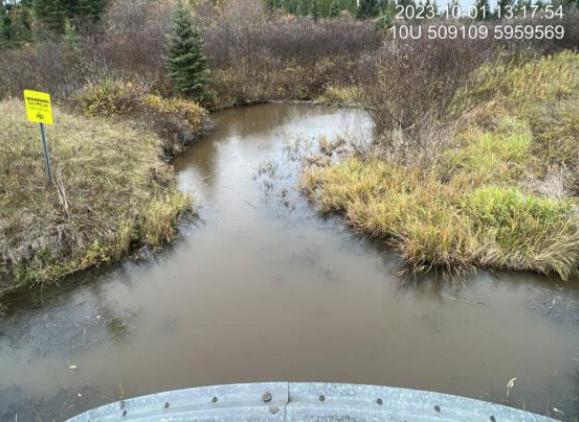
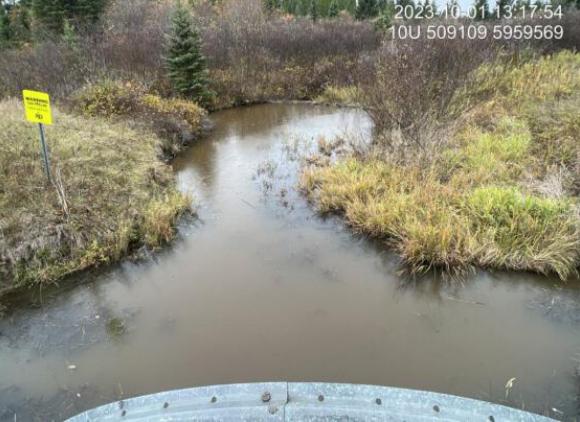
Location and Stream Data		Crossing Characteristics	
Date	2023-10-01	Crossing Sub Type	Round Culvert
PSCIS ID	199178	Diameter (m)	4.5
External ID	9900367	Length (m)	33
Crew	AI	Embedded	No
UTM Zone	10	Depth Embedded (m)	–
Easting	509128	Resemble Channel	No
Northing	5959562	Backwatered	No
Stream	Beaverley Creek	Percent Backwatered	–
Road	Blackwater Road	Fill Depth (m)	2
Road Tenure	MOTI	Outlet Drop (m)	0
Channel Width (m)	5	Outlet Pool Depth (m)	1
Stream Slope (%)	0	Inlet Drop	No
Beaver Activity	Yes	Slope (%)	0
Habitat Value	High	Valley Fill	Deep Fill
Final score	19	Barrier Result	Potential
Fix type	Replace with New Open Bottom Structure	Fix Span / Diameter	15
Comments: Moti major structure. Beaver dam located approximately 30 m downstream has backwatered the entire structure. MoTi chris_hwy_structure_road_id: 3755. 13:13:41			
Photos: PSCIS ID 9900367. From top left clockwise: Road/Site Card, Barrel, Outlet, Downstream, Upstream, Inlet.
