Appendix - Phase 1 Fish Passage Assessment Data and Photos

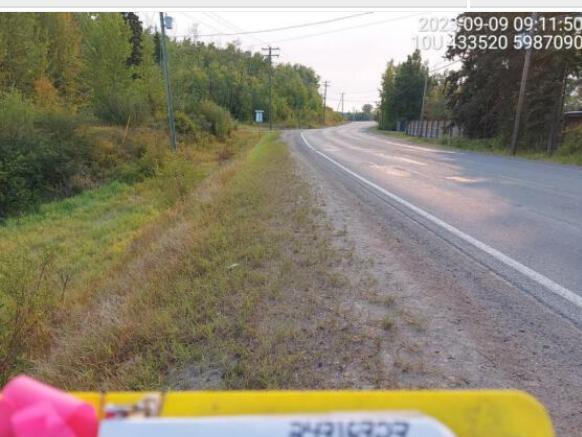
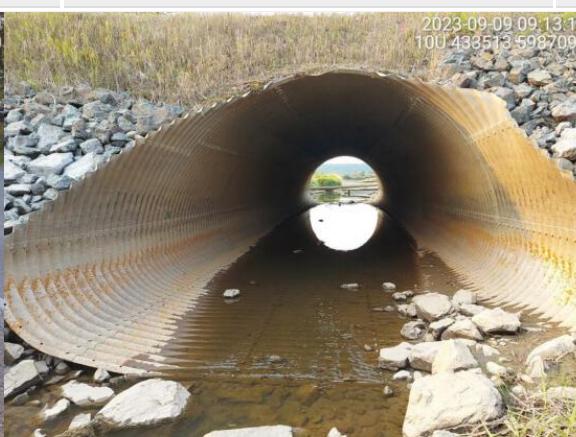
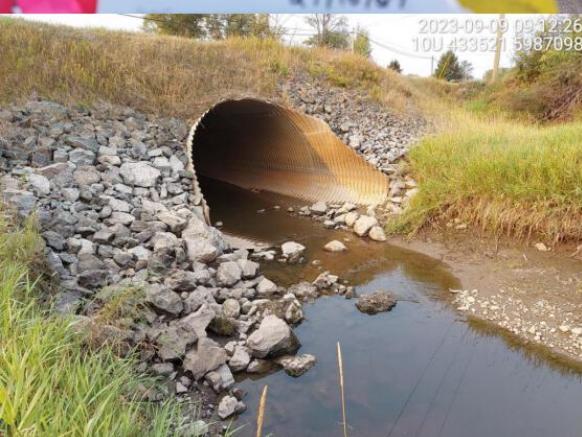
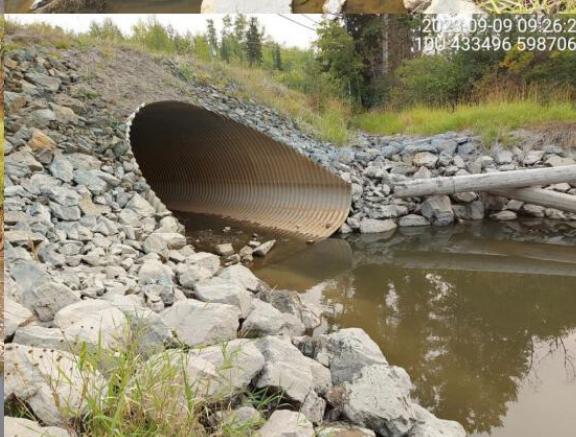
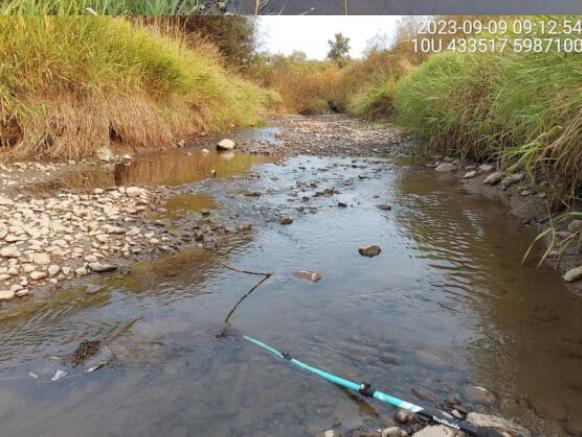
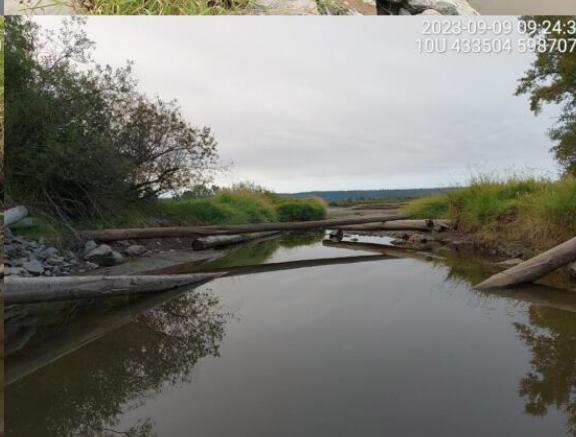
Photos: PSCIS ID 24716727. From top left clockwise: Road/Site Card, Barrel, Outlet, Downstream, Upstream, Inlet.

Location and Stream Data		Crossing Characteristics	
Date	2023-09-09	Crossing Sub Type	Round Culvert
PSCIS ID	199179	Diameter (m)	5
External ID	24716727	Length (m)	25
Crew	MW	Embedded	No
UTM Zone	10	Depth Embedded (m)	—
Easting	433506	Resemble Channel	No
Northing	5987089	Backwatered	No
Stream	Murray Creek	Percent Backwatered	—
Road	Loop Rd	Fill Depth (m)	1.5
Road Tenure	Vanderhoof	Outlet Drop (m)	0
Channel Width (m)	6.2	Outlet Pool Depth (m)	1.5
Stream Slope (%)	1	Inlet Drop	No
Beaver Activity	No	Slope (%)	1.5
Habitat Value	High	Valley Fill	Deep Fill
Final score	21	Barrier Result	Barrier
Fix type	Replace with New Open Bottom Structure	Fix Span / Diameter	15

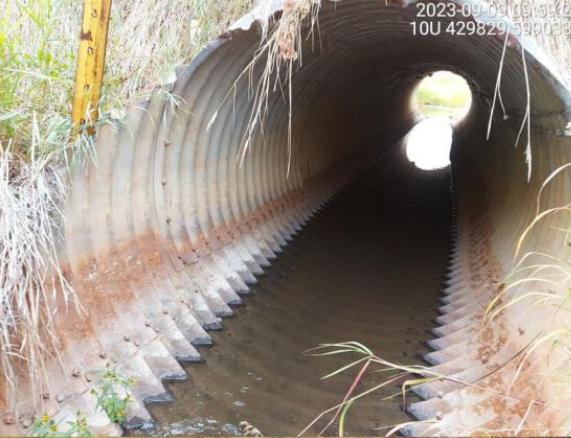
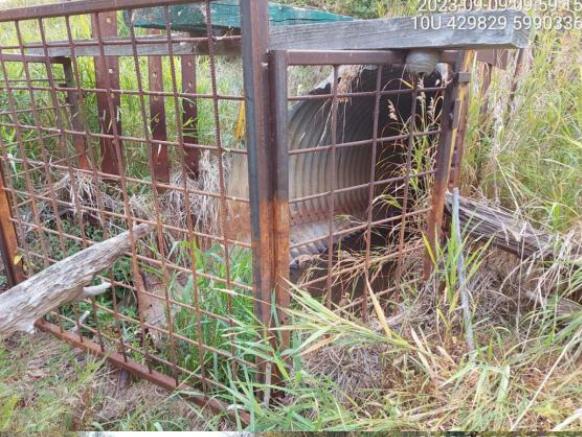
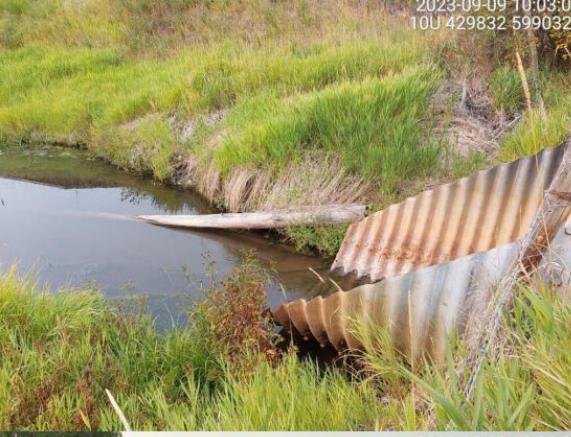
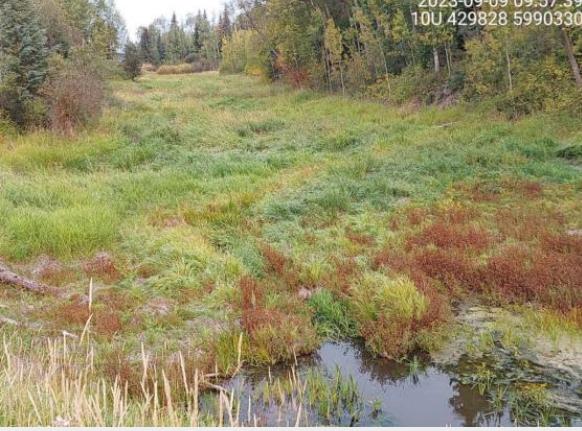
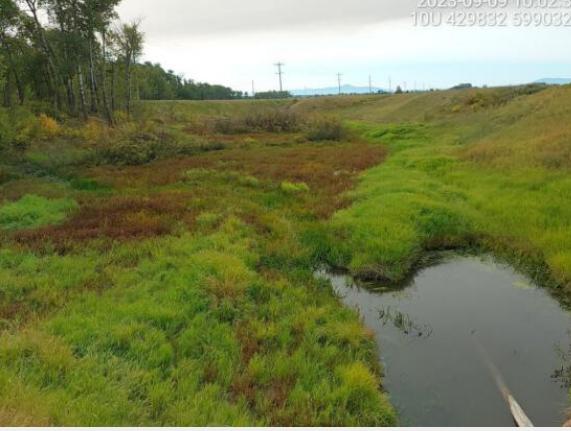
Location and Stream Data		•	Crossing Characteristics	–
Date	2023-09-09		Crossing Sub Type	Round Culvert
PSCIS ID	199180		Diameter (m)	2.2
External ID	15600108		Length (m)	15
Crew	MW		Embedded	No
UTM Zone	10		Depth Embedded (m)	–
Easting	429831		Resemble Channel	No
Northing	5990320		Backwatered	No
Stream	Murray Creek		Percent Backwatered	–
Road	Snell Rd E		Fill Depth (m)	2
Road Tenure	MOTI		Outlet Drop (m)	0
Channel Width (m)	2.1		Outlet Pool Depth (m)	0.4
Stream Slope (%)	1		Inlet Drop	No
Beaver Activity	No		Slope (%)	0.5
Habitat Value	Medium		Valley Fill	Deep Fill
Final score	13		Barrier Result	Passable
Fix type	–		Fix Span / Diameter	–
Comments: Grassy wetland habitat upstream and downstream. Culvert diameter used as channel width and stream slope estimated. Beaver grate present at inlet. Some flow in culvert. MoTi chris_culvert_id: 1808533. 09:55:51				
Photos: PSCIS ID 15600108. From top left clockwise: Road/Site Card, Barrel, Outlet, Downstream, Upstream, Inlet.

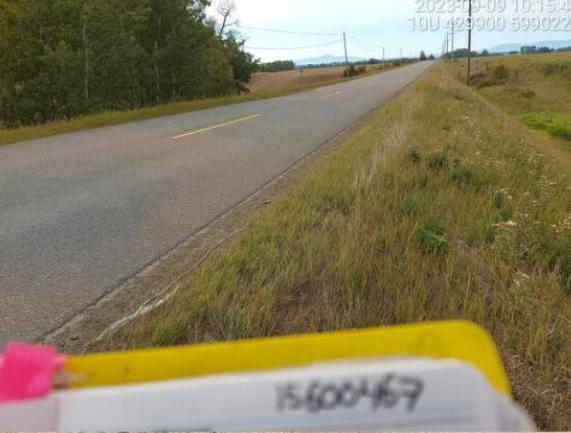
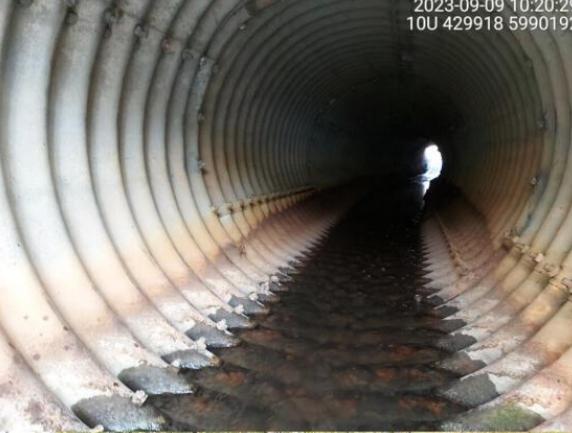
Photos: PSCIS ID 15600467. From top left clockwise: Road/Site Card, Barrel, Outlet, Downstream, Upstream, Inlet.

Location and Stream Data		Crossing Characteristics	
Date	2023-09-09	Crossing Sub Type	Round Culvert
PSCIS ID	199181	Diameter (m)	3.2
External ID	15600467	Length (m)	16
Crew	MW	Embedded	No
UTM Zone	10	Depth Embedded (m)	—
Easting	429905	Resemble Channel	No
Northing	5990198	Backwatered	No
Stream	Murray Creek	Percent Backwatered	—
Road	Loop Road	Fill Depth (m)	4
Road Tenure	MOTI Local	Outlet Drop (m)	0.3
Channel Width (m)	2.2	Outlet Pool Depth (m)	1
Stream Slope (%)	1	Inlet Drop	No
Beaver Activity	No	Slope (%)	2
Habitat Value	Medium	Valley Fill	Deep Fill
Final score	28	Barrier Result	Barrier
Fix type	Replace with New Open Bottom Structure	Fix Span / Diameter	18

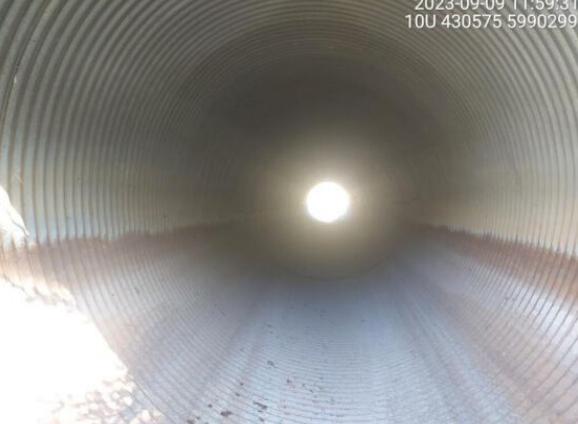
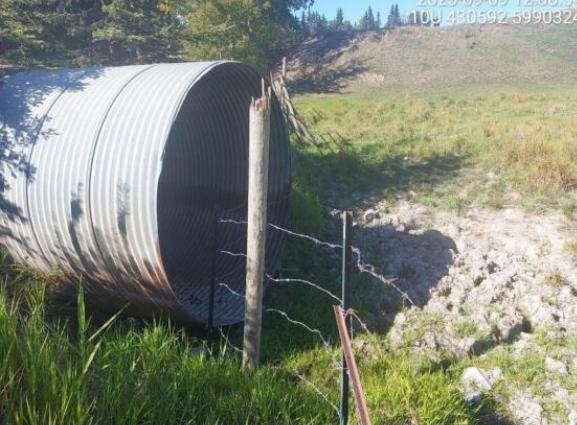
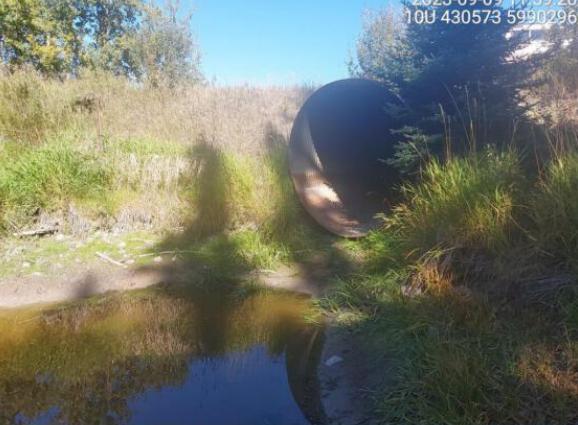
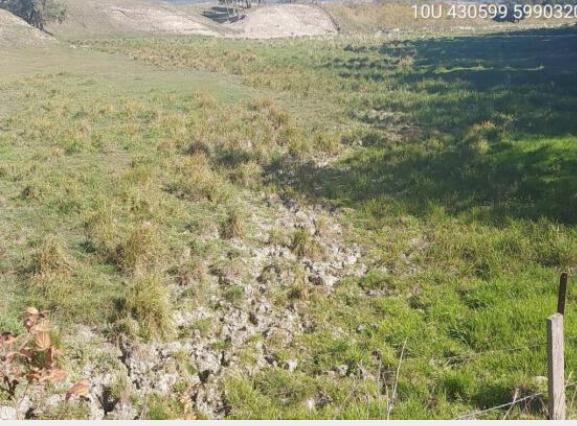
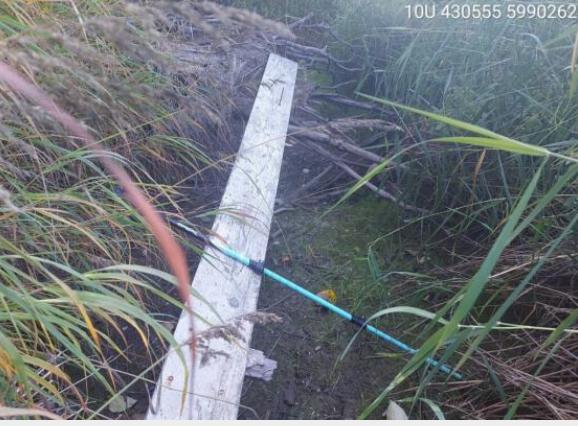
Location and Stream Data	.	Crossing Characteristics	–
Date	2023-09-09	Crossing Sub Type	Round Culvert
PSCIS ID	199182	Diameter (m)	2.5
External ID	15600107	Length (m)	22
Crew	MW	Embedded	No
UTM Zone	10	Depth Embedded (m)	–
Easting	430580	Resemble Channel	No
Northing	5990313	Backwatered	No
Stream	East Murray Creek	Percent Backwatered	–
Road	Snell Rd E	Fill Depth (m)	0.5
Road Tenure	MOTI Local	Outlet Drop (m)	0
Channel Width (m)	1.7	Outlet Pool Depth (m)	0.5
Stream Slope (%)	1	Inlet Drop	No
Beaver Activity	No	Slope (%)	1
Habitat Value	Low	Valley Fill	Deep Fill
Final score	18	Barrier Result	Potential
Fix type	Replace Structure with Streambed Simulation CBS	Fix Span / Diameter	3

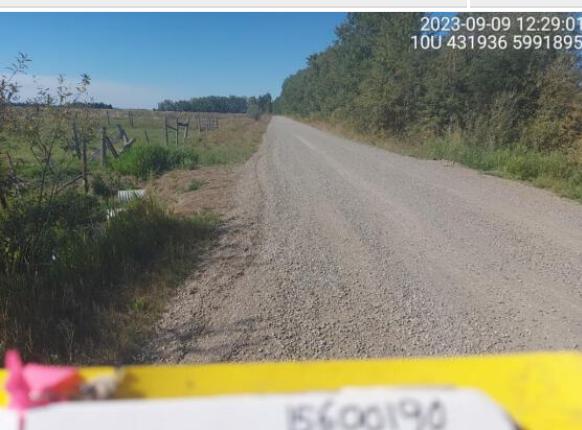
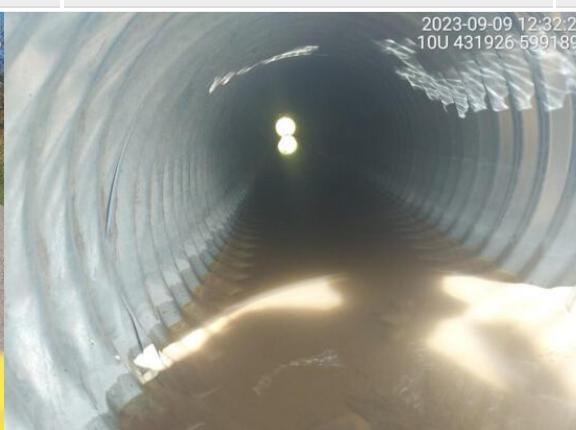
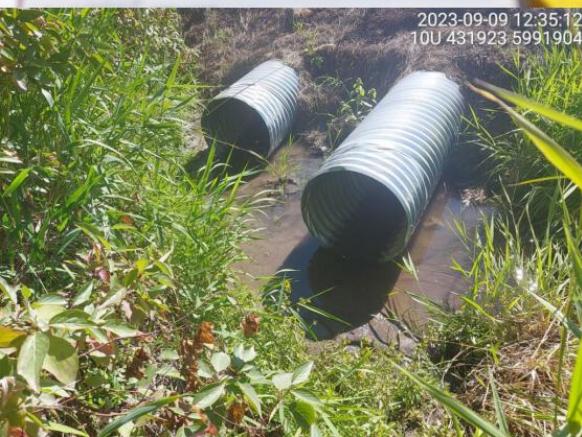
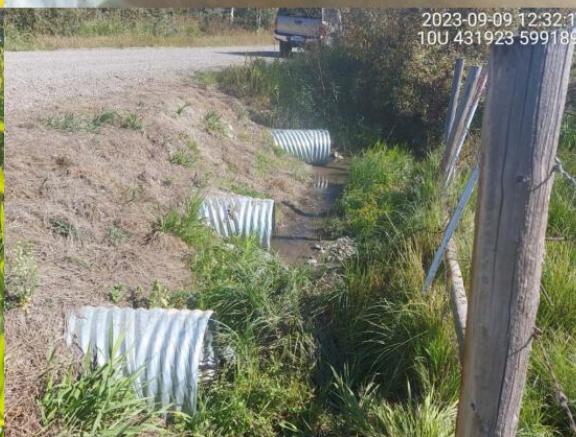
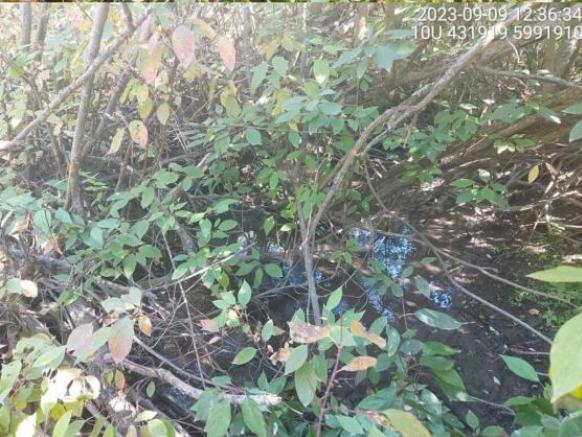
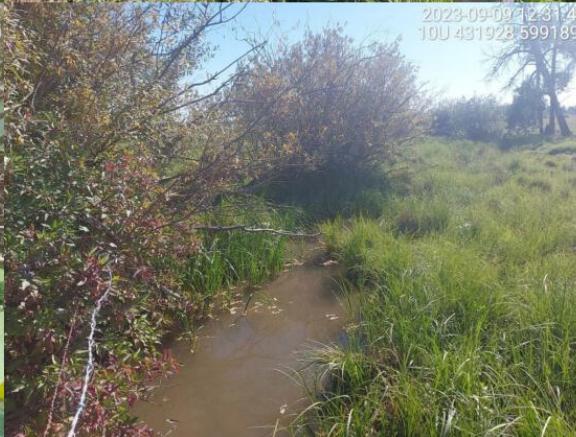
Photos: PSCIS ID 15600190. From top left clockwise: Road/Site Card, Barrel, Outlet, Downstream, Upstream, Inlet.

Location and Stream Data	.	Crossing Characteristics	-
Date	2023-09-09	Crossing Sub Type	Round Culvert
PSCIS ID	199183	Diameter (m)	1.8
External ID	15600190	Length (m)	12
Crew	MW	Embedded	No
UTM Zone	10	Depth Embedded (m)	-
Easting	431924	Resemble Channel	No
Northing	5991893	Backwatered	No
Stream	McIntosh Creek	Percent Backwatered	-
Road	Mcleod Pit Rd	Fill Depth (m)	0.5
Road Tenure	MOTI Local	Outlet Drop (m)	0
Channel Width (m)	1.6	Outlet Pool Depth (m)	0.3
Stream Slope (%)	1	Inlet Drop	No
Beaver Activity	No	Slope (%)	1
Habitat Value	Low	Valley Fill	Deep Fill
Final score	15	Barrier Result	Potential
Fix type	Replace Structure with Streambed Simulation CBS	Fix Span / Diameter	3

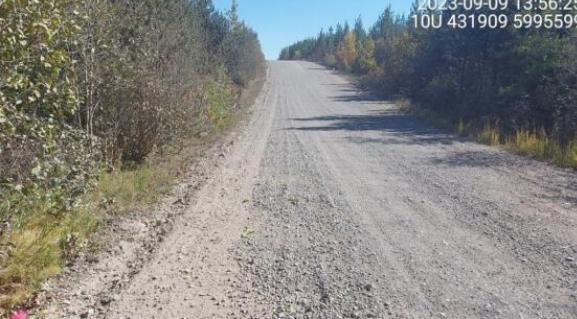
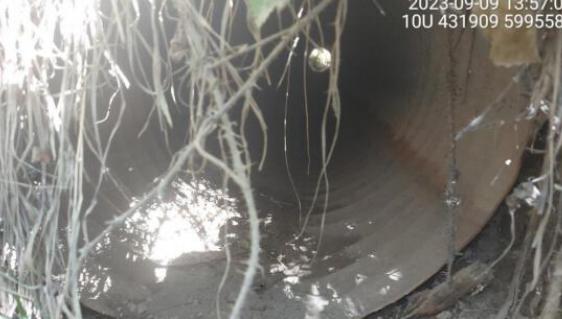
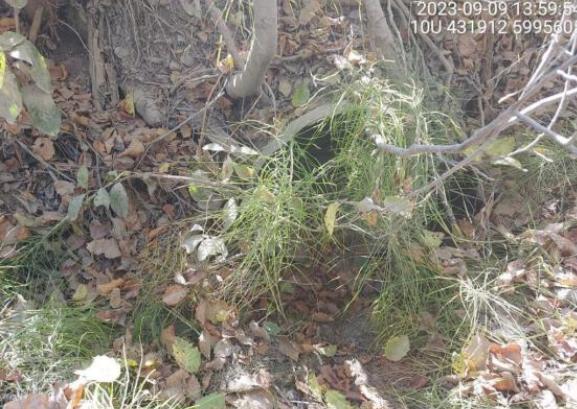
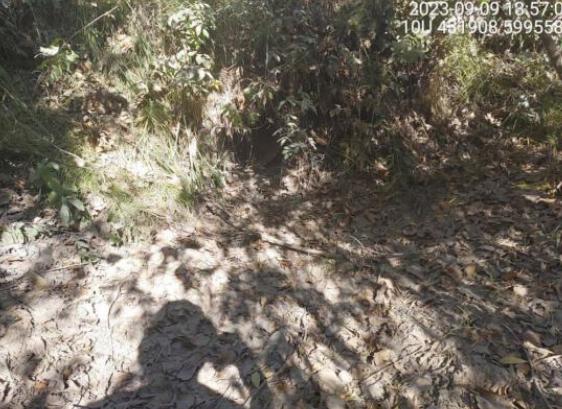
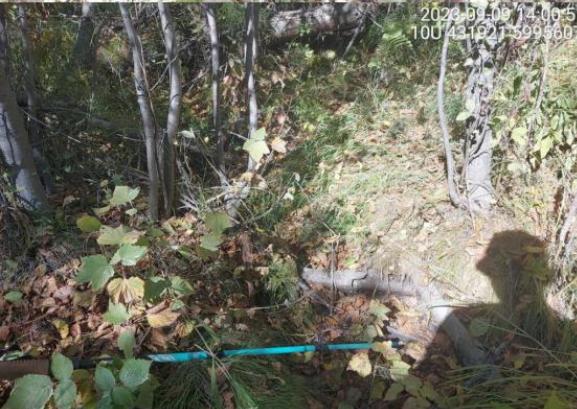
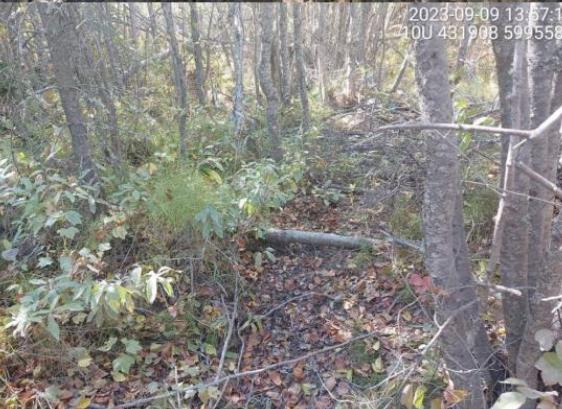
Photos: PSCIS ID 15603995. From top left clockwise: Road/Site Card, Barrel, Outlet, Downstream, Upstream, Inlet.

Location and Stream Data		Crossing Characteristics	
Date	2023-09-09	Crossing Sub Type	Round Culvert
PSCIS ID	199184	Diameter (m)	0.5
External ID	15603995	Length (m)	10
Crew	MW	Embedded	No
UTM Zone	10	Depth Embedded (m)	—
Easting	431910	Resemble Channel	No
Northing	5995592	Backwatered	No
Stream	McIntosh Creek	Percent Backwatered	—
Road	Stringer Rd	Fill Depth (m)	1
Road Tenure	MOTI Local	Outlet Drop (m)	0
Channel Width (m)	0.7	Outlet Pool Depth (m)	0
Stream Slope (%)	1.5	Inlet Drop	No
Beaver Activity	No	Slope (%)	1
Habitat Value	Low	Valley Fill	Deep Fill
Final score	21	Barrier Result	Barrier
Fix type	Replace Structure with Streambed Simulation CBS	Fix Span / Diameter	3

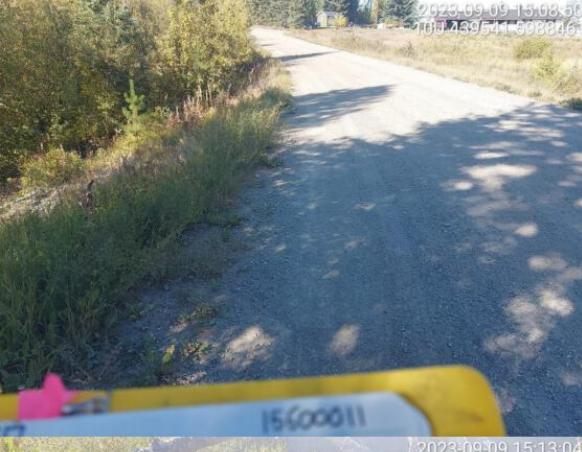
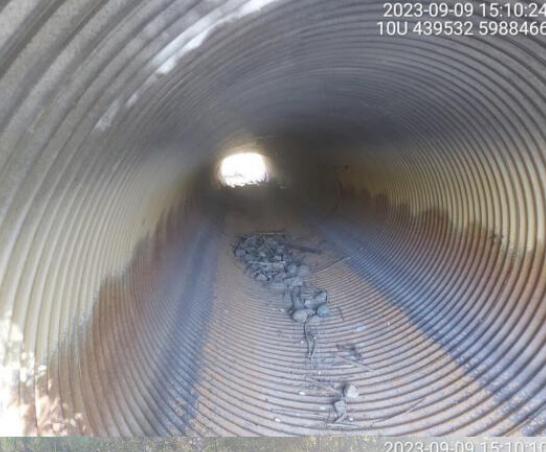
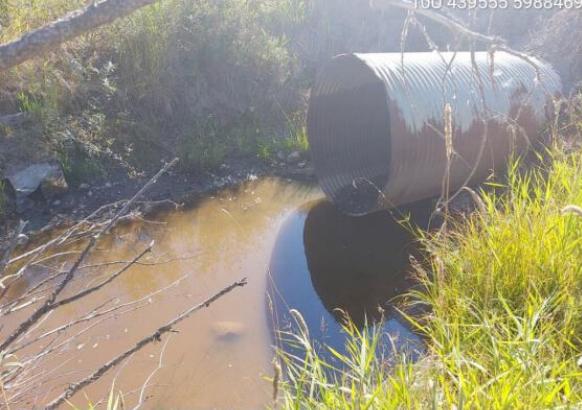
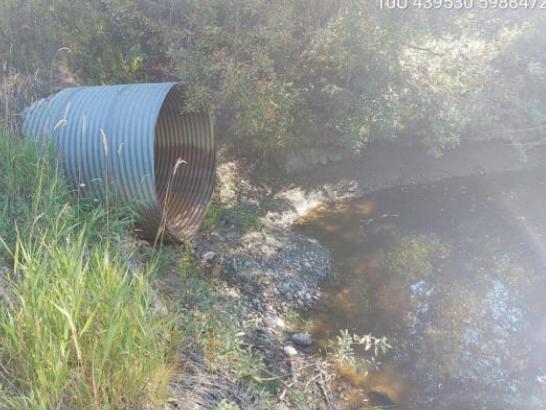
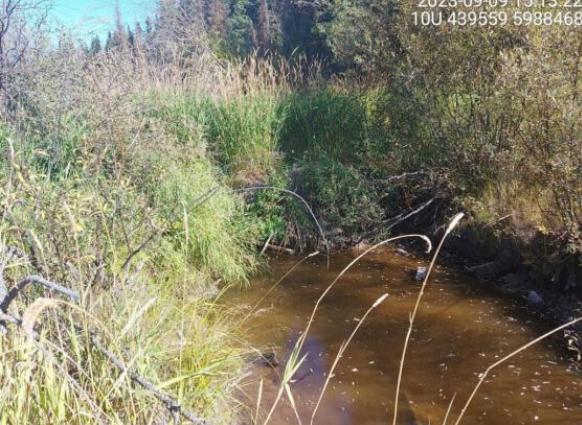
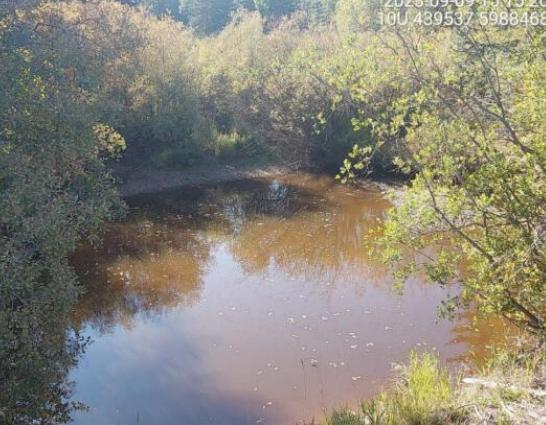
Location and Stream Data		Crossing Characteristics	
Date	2023-09-09	Crossing Sub Type	Round Culvert
PSCIS ID	199185	Diameter (m)	1.7
External ID	15600011	Length (m)	14
Crew	MW	Embedded	No
UTM Zone	10	Depth Embedded (m)	—
Easting	439543	Resemble Channel	No
Northing	5988470	Backwatered	No
Stream	Knight Creek	Percent Backwatered	—
Road	Gulbranson Rd	Fill Depth (m)	1.5
Road Tenure	MOTI Local	Outlet Drop (m)	0
Channel Width (m)	1.7	Outlet Pool Depth (m)	2
Stream Slope (%)	1.5	Inlet Drop	No
Beaver Activity	No	Slope (%)	1
Habitat Value	Medium	Valley Fill	Deep Fill
Final score	18	Barrier Result	Potential
Fix type	Replace Structure with Streambed Simulation CBS	Fix Span / Diameter	3
Comments: Huge outlet pool, but no outlet drop. No water in pipe and no flowing water in stream. MoTi chris_culvert_id: 1803926. 15:09:18			
Photos: PSCIS ID 15600011. From top left clockwise: Road/Site Card, Barrel, Outlet, Downstream, Upstream, Inlet.

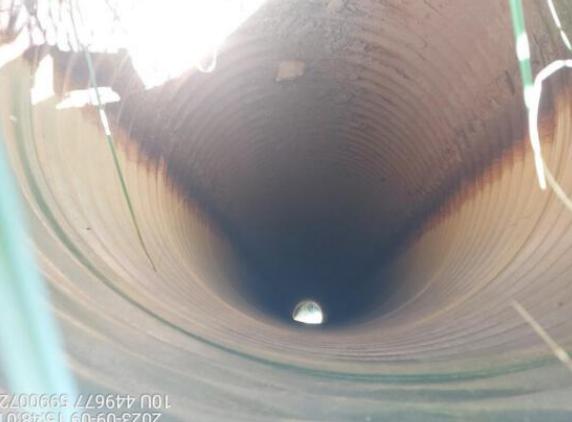
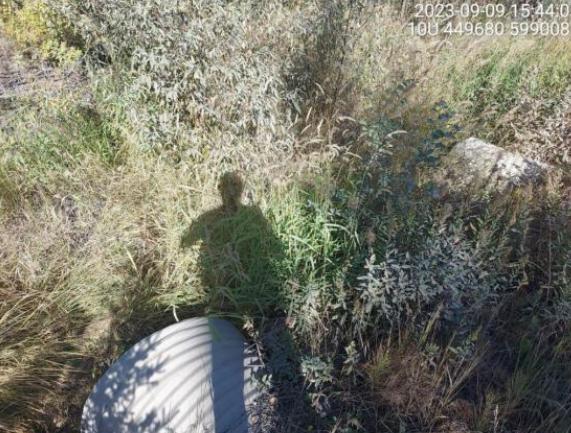
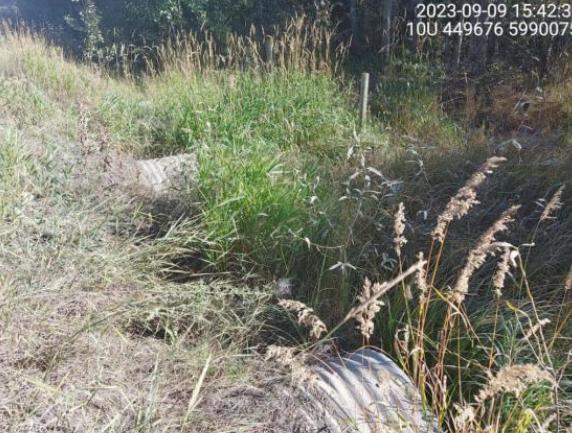
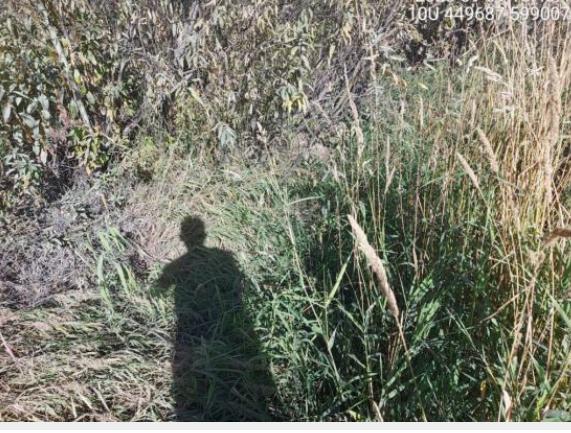
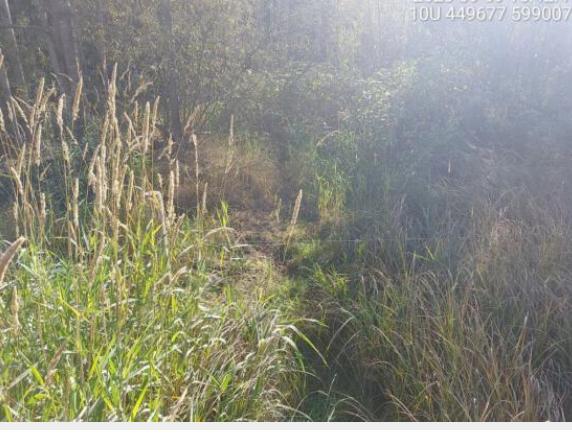
Location and Stream Data		.	Crossing Characteristics	-
Date	2023-09-09		Crossing Sub Type	Round Culvert
PSCIS ID	199186		Diameter (m)	3
External ID	15600572		Length (m)	16
Crew	MW		Embedded	No
UTM Zone	10		Depth Embedded (m)	-
Easting	449681		Resemble Channel	No
Northing	5990078		Backwatered	No
Stream	Tributary to Tritt Creek		Percent Backwatered	-
Road	Sturgeon Pt Rd		Fill Depth (m)	1
Road Tenure	MOTI		Outlet Drop (m)	0
Channel Width (m)	3		Outlet Pool Depth (m)	0
Stream Slope (%)	1		Inlet Drop	No
Beaver Activity	No		Slope (%)	1.5
Habitat Value	Low		Valley Fill	Deep Fill
Final score	21		Barrier Result	Barrier
Fix type	Replace with New Open Bottom Structure		Fix Span / Diameter	15
Comments: Dewatered. Vegetated stream channel. Three culverts, diameter totaled. MoTi chris_culvert_id: 1801577, 1801578. 15:44:14				
Photos: PSCIS ID 15600572. From top left clockwise: Road/Site Card, Barrel, Outlet, Downstream, Upstream, Inlet.

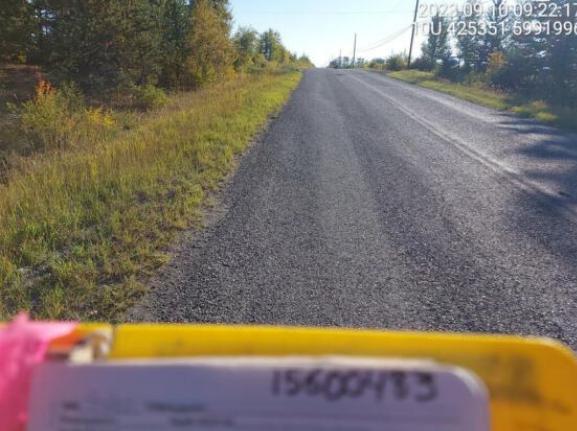
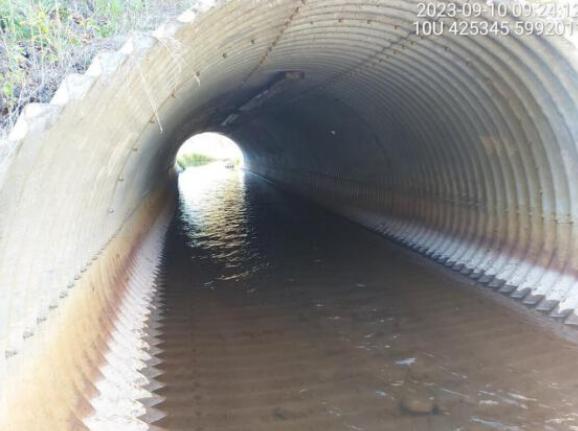
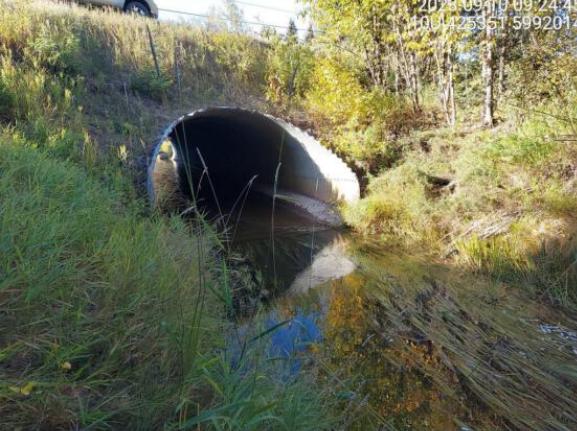
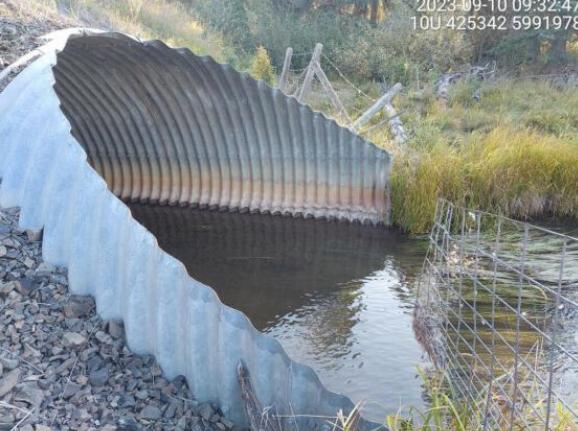
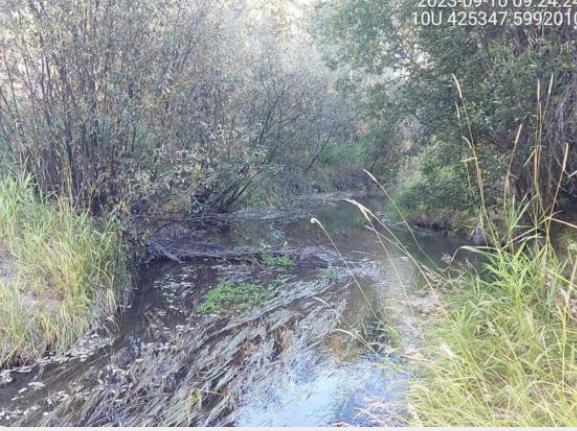
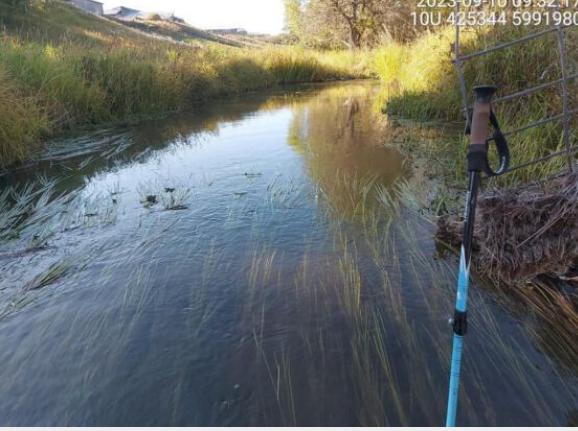
Photos: PSCIS ID 15600483. From top left clockwise: Road/Site Card, Barrel, Outlet, Downstream, Upstream, Inlet.

Location and Stream Data		.	Crossing Characteristics	-
Date	2023-09-10		Crossing Sub Type	Oval Culvert
PSCIS ID	199187		Diameter (m)	3.9
External ID	15600483		Length (m)	17
Crew	MW		Embedded	No
UTM Zone	10		Depth Embedded (m)	-
Easting	425343		Resemble Channel	No
Northing	5991993		Backwatered	No
Stream	Clear Creek		Percent Backwatered	-
Road	Braeside Rd		Fill Depth (m)	2
Road Tenure	MOTI		Outlet Drop (m)	0
Channel Width (m)	4.7		Outlet Pool Depth (m)	0.6
Stream Slope (%)	0.5		Inlet Drop	No
Beaver Activity	No		Slope (%)	1.5
Habitat Value	High		Valley Fill	Deep Fill
Final score	21		Barrier Result	Barrier
Fix type	Replace with New Open Bottom Structure		Fix Span / Diameter	15

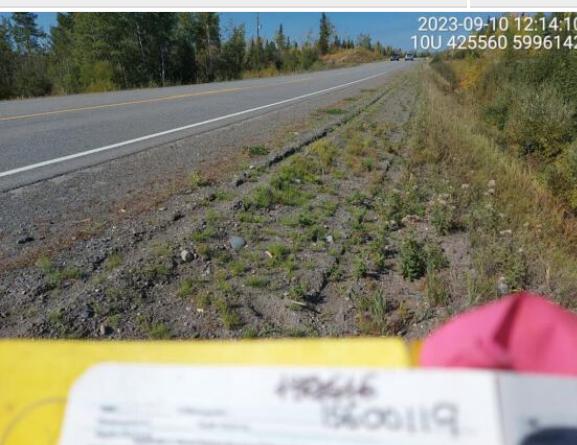
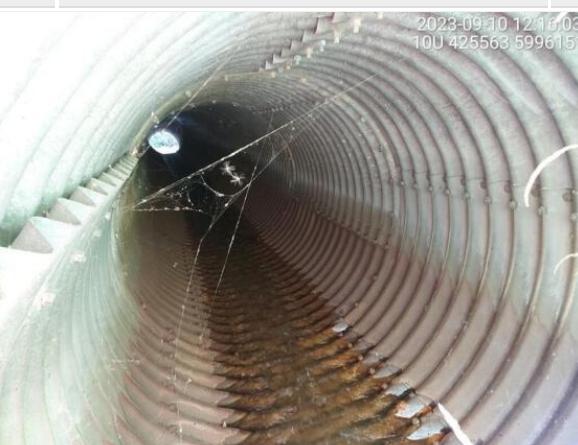
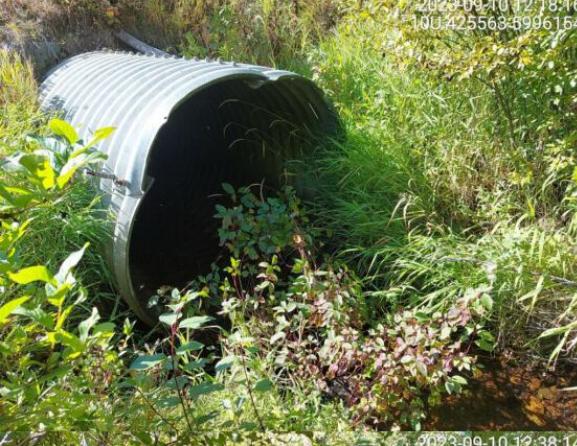
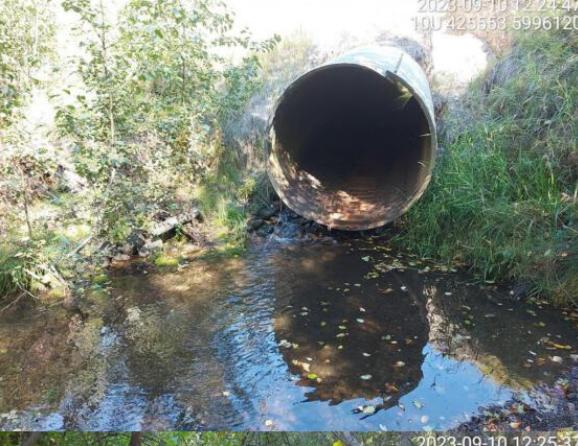
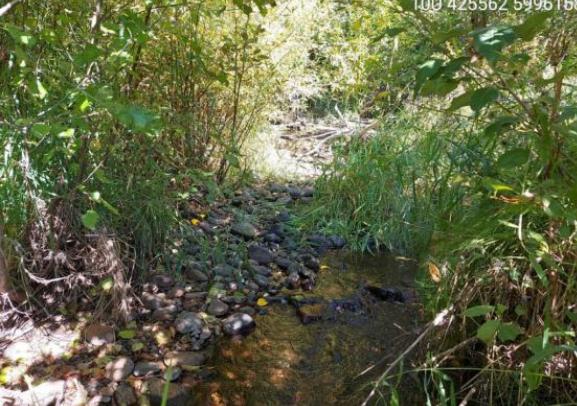
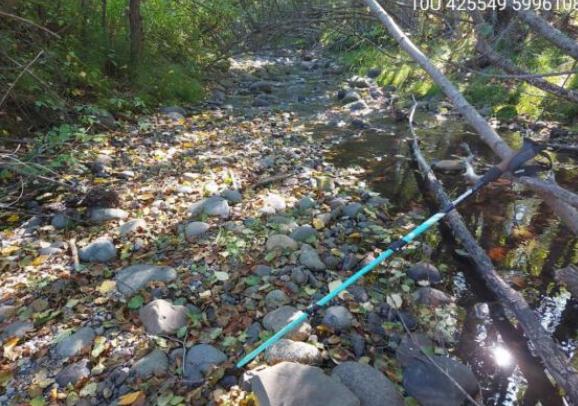
Photos: PSCIS ID 15600119. From top left clockwise: Road/Site Card, Barrel, Outlet, Downstream, Upstream, Inlet.

Comments: High value habitat, wide channel with good flow and gravels. Known chinook system downstream. Culvert is very damaged near outlet. There are holes on bottom of pipe about 5m from outlet where water is running through and under the pipe. Culvert is angled down near outlet. Good candidate for replacement. MoTi chris_culvert_id: 1806163.
12:15:10

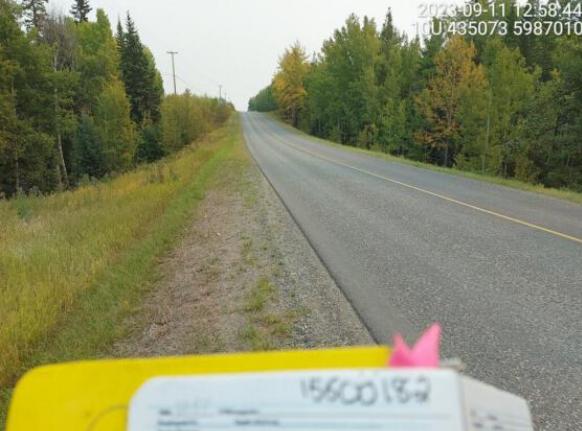
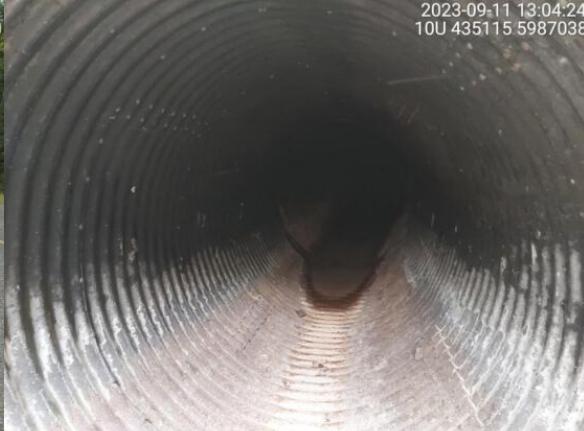
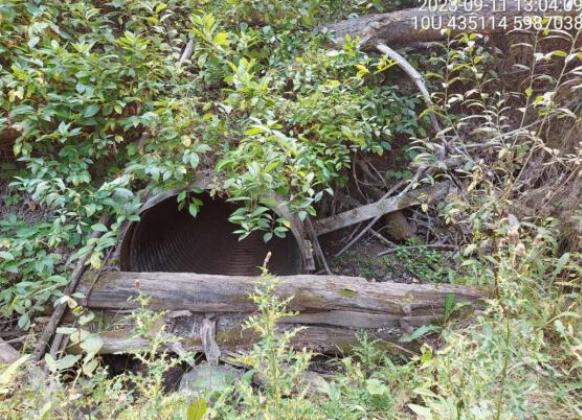
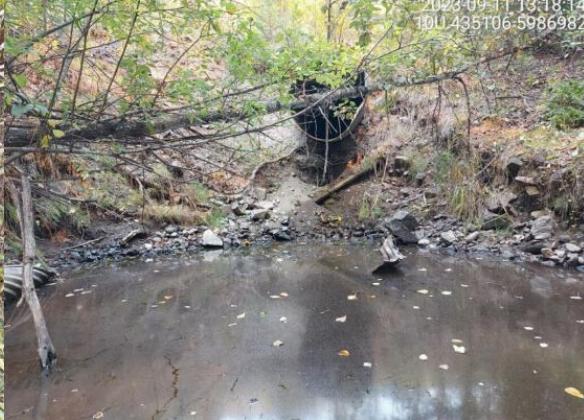
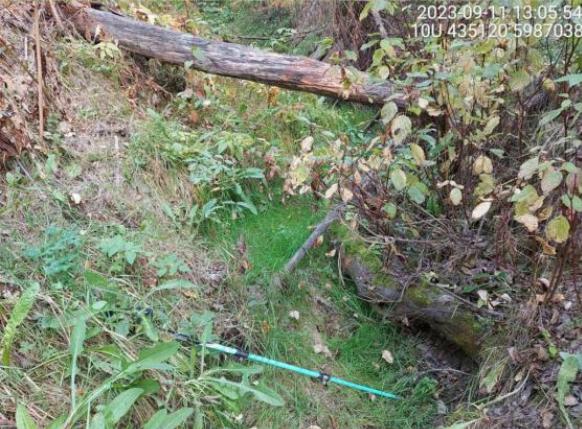
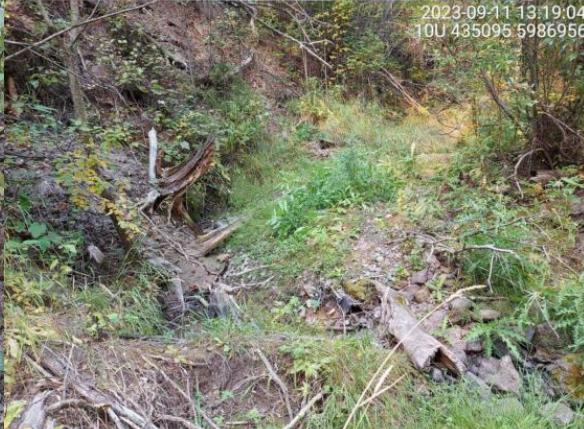
Photos: PSCIS ID 15600182. From top left clockwise: Road/Site Card, Barrel, Outlet, Downstream, Upstream, Inlet.

Comments: Very big outlet drop and deep outlet pool. Trickle of water flowing through culvert. Dewatered downstream of outlet pool and dewatered upstream of culvert. Channel width taken upstream but channel is wider downstream of crossing. Culvert is warped and a little corroded. Channel primarily vegetated.. 13:09:19

Location and Stream Data	.	Crossing Characteristics	-
Date	2023-09-11	Crossing Sub Type	Round Culvert
PSCIS ID	199201	Diameter (m)	1.2
External ID	15600182	Length (m)	30
Crew	MW	Embedded	No
UTM Zone	10	Depth Embedded (m)	-
Easting	435117	Resemble Channel	No
Northing	5987010	Backwatered	No
Stream	Tributary to Nechako River	Percent Backwatered	-
Road	Sackner Rd	Fill Depth (m)	9.9
Road Tenure	MOTI Local	Outlet Drop (m)	1.2
Channel Width (m)	1.3	Outlet Pool Depth (m)	1.6
Stream Slope (%)	3	Inlet Drop	No
Beaver Activity	No	Slope (%)	1
Habitat Value	Medium	Valley Fill	Deep Fill
Final score	34	Barrier Result	Barrier
Fix type	Replace Structure with Streambed Simulation CBS	Fix Span / Diameter	3

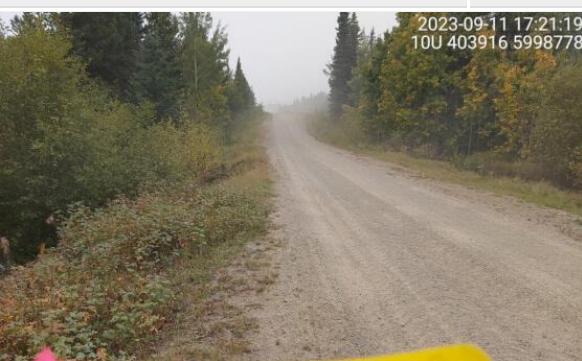
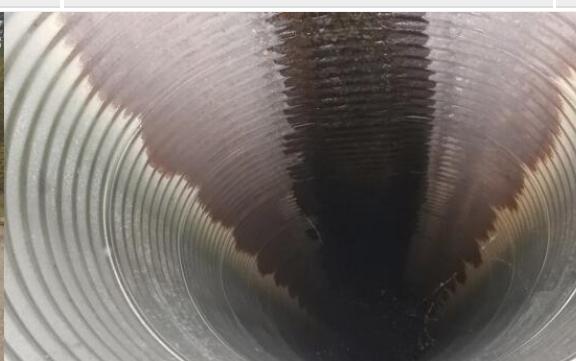
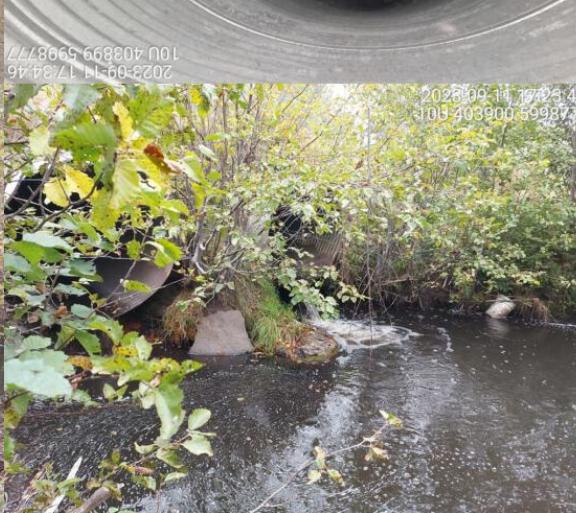
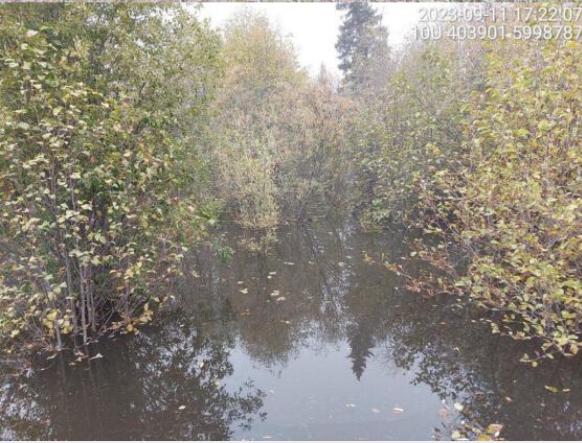
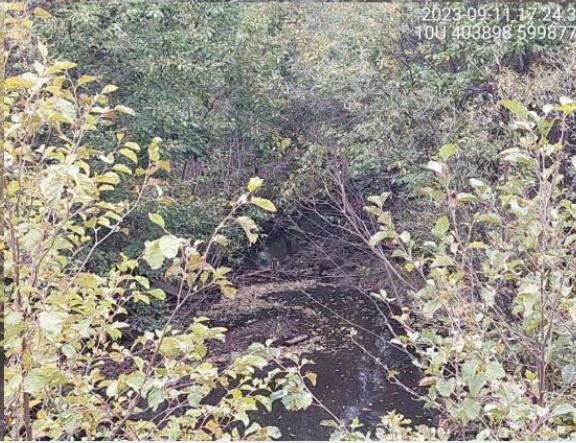
Photos: PSCIS ID 15600285. From top left clockwise: Road/Site Card, Barrel, Outlet, Downstream, Upstream, Inlet.

Comments: Two pipes (one at 1.8m, one at 1.5m), both with similar outlet drops. Inlet side has extensive beaver activity. Beaver dams are covering the inlet and culverts are not visible. Huge wetland upstream. Very big outlet pool so depth was estimated. Chinook were captured downstream of Settlement Road culvert in 2021 (<https://a100.gov.bc.ca/pub/acat/public/viewReport.do?reportId=61991>) and Rainbow Trout observed in stream from 2021-2023 (<https://a100.gov.bc.ca/pub/acat/public/viewReport.do?reportId=61202> and <https://a100.gov.bc.ca/pub/acat/public/viewReport.do?reportId=62942>). Culverts should be replaced and beaver activity managed. Habitat looks good downstream. High habitat value at crossing upstream. MoTi chris_culvert_id: 1793922, 1793923. 17:26:25

Location and Stream Data		Crossing Characteristics	
Date	2023-09-11	Crossing Sub Type	Round Culvert
PSCIS ID	199204	Diameter (m)	3
External ID	15600285	Length (m)	9
Crew	MW	Embedded	No
UTM Zone	10	Depth Embedded (m)	—
Easting	403897	Resemble Channel	No
Northing	5998780	Backwatered	No
Stream	Nine Mile Creek	Percent Backwatered	—
Road	Settlement Rd	Fill Depth (m)	0.5
Road Tenure	MOTI Local	Outlet Drop (m)	0.5
Channel Width (m)	3	Outlet Pool Depth (m)	2
Stream Slope (%)	2	Inlet Drop	No
Beaver Activity	Yes	Slope (%)	1
Habitat Value	Medium	Valley Fill	Deep Fill
Final score	28	Barrier Result	Barrier
Fix type	Replace with New Open Bottom Structure	Fix Span / Diameter	15

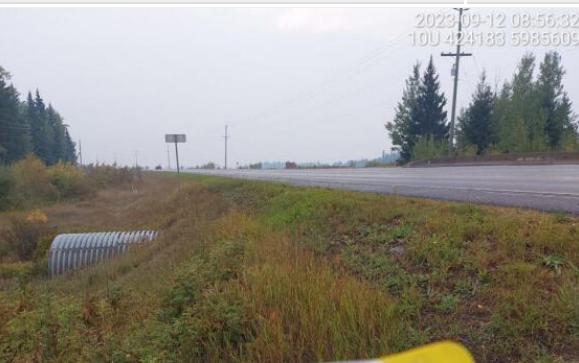
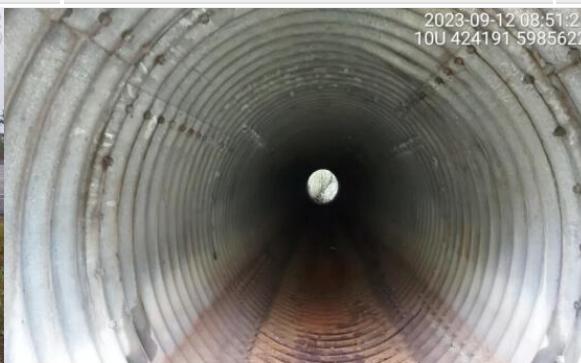
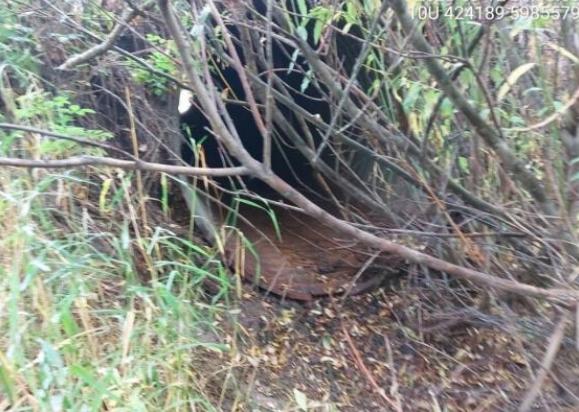
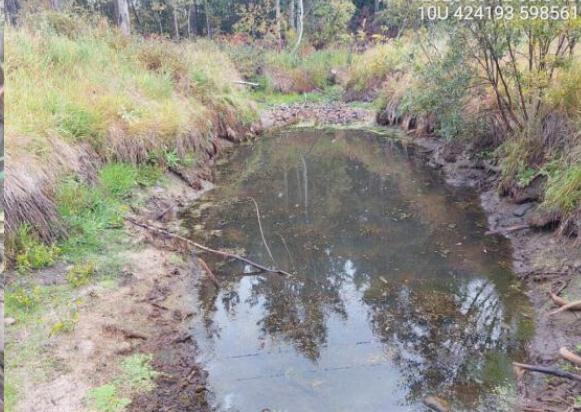
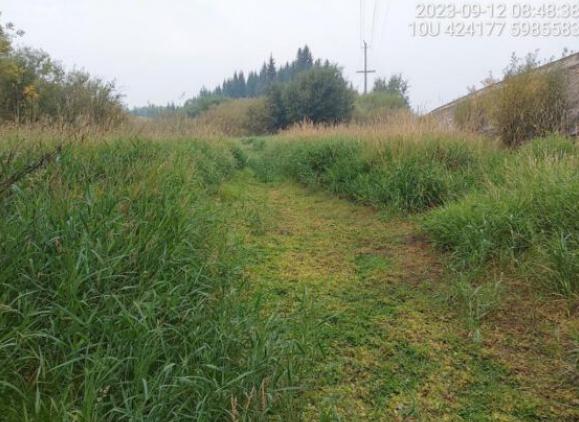
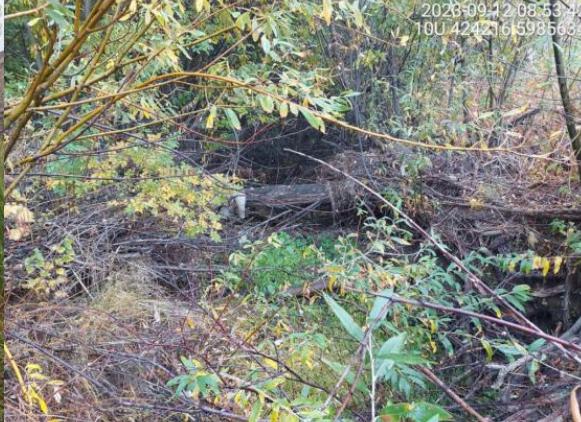
Photos: PSCIS ID 15600427. From top left clockwise: Road/Site Card, Barrel, Outlet, Downstream, Upstream, Inlet.

Comments: Dewatered stream. Large outlet pool. Pipe very corroded on outlet side. Wide stream channel upstream. Grassy channel downstream. Fully backwatered at time of assessment. MoTi chris_culvert_id: 3738843. 08:55:03

Location and Stream Data		Crossing Characteristics	
Date	2023-09-12	Crossing Sub Type	Round Culvert
PSCIS ID	199205	Diameter (m)	2
External ID	15600427	Length (m)	26
Crew	MW	Embedded	No
UTM Zone	10	Depth Embedded (m)	–
Easting	424186	Resemble Channel	No
Northing	5985604	Backwatered	No
Stream	Goldie Creek	Percent Backwatered	–
Road	Highway 16 W	Fill Depth (m)	1
Road Tenure	MOTI	Outlet Drop (m)	0
Channel Width (m)	3.1	Outlet Pool Depth (m)	0.4
Stream Slope (%)	0.5	Inlet Drop	No
Beaver Activity	No	Slope (%)	2
Habitat Value	Medium	Valley Fill	Deep Fill
Final score	24	Barrier Result	Barrier
Fix type	Replace with New Open Bottom Structure	Fix Span / Diameter	15

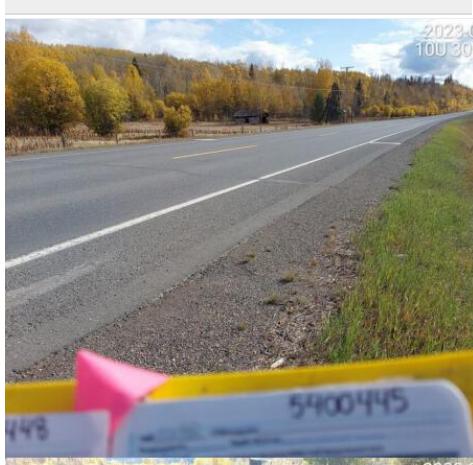
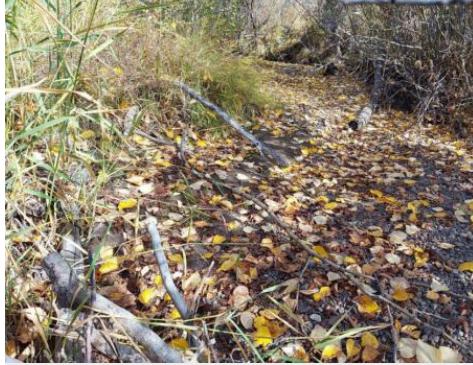
Photos: PSCIS ID 5400445. From top left clockwise: Road/Site Card, Barrel, Outlet, Downstream, Upstream, Inlet.

Comments: Dewatered at time of assessment. Wide channel, private land on both sides. Culvert looks old and corroded, abundant fill in barrel. MoTi chris_culvert_id: 2076438. 12:44:04

Location and Stream Data	.	Crossing Characteristics	—
Date	2023-09-28	Crossing Sub Type	Oval Culvert
PSCIS ID	199208	Diameter (m)	2.6
External ID	5400445	Length (m)	16
Crew	MW	Embedded	No
UTM Zone	10	Depth Embedded (m)	—
Easting	309133	Resemble Channel	No
Northing	6028926	Backwatered	No
Stream	Allen Creek	Percent Backwatered	—
Road	Highway 16 W	Fill Depth (m)	0.4
Road Tenure	MOTI	Outlet Drop (m)	0
Channel Width (m)	3.4	Outlet Pool Depth (m)	0
Stream Slope (%)	1	Inlet Drop	No
Beaver Activity	No	Slope (%)	3
Habitat Value	Medium	Valley Fill	Deep Fill
Final score	29	Barrier Result	Barrier
Fix type	Replace with New Open Bottom Structure	Fix Span / Diameter	15

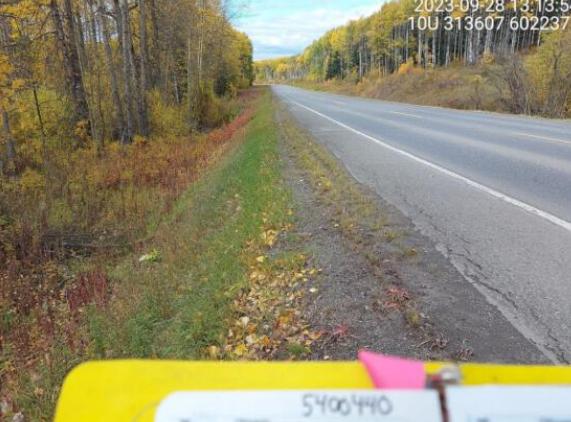
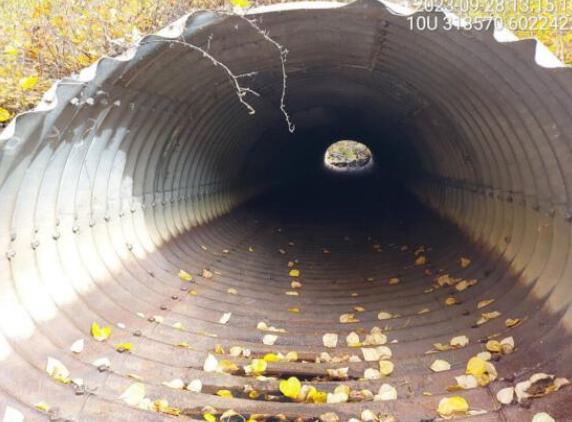
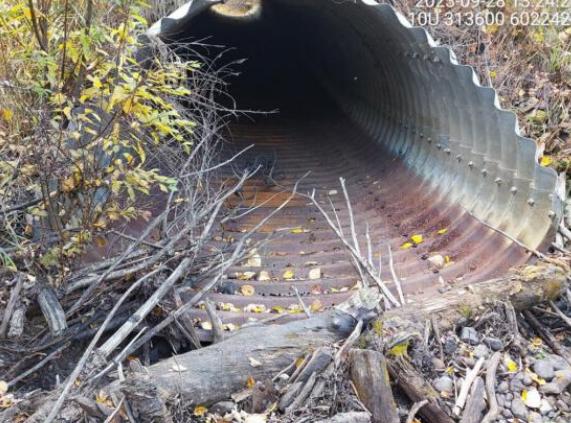
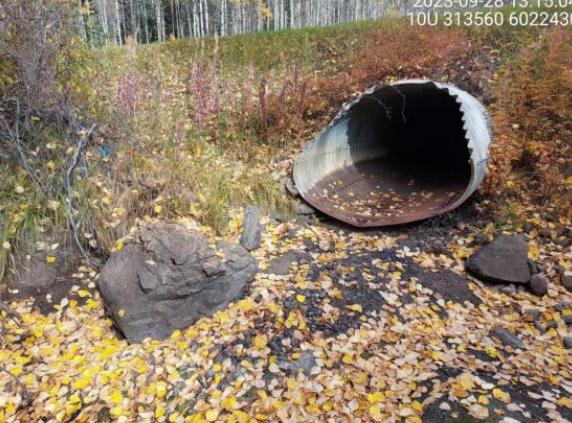
Photos: PSCIS ID 5400440. From top left clockwise: Road/Site Card, Barrel, Outlet, Downstream, Upstream, Inlet.

Comments: Dewatered at time of assessment. Small pool near outlet. Rainbow confirmed in past upstream. Two 3m falls noted 450m upstream. in FISS. Culvert is very old, corroded and has holes in bottom. MoTi chris_culvert_id: 2076418. 13:18:49
