Appendix - Phase 1 Fish Passage Assessment Data and Photos

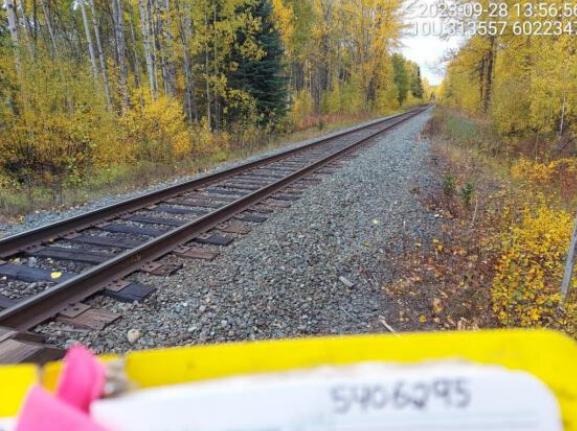
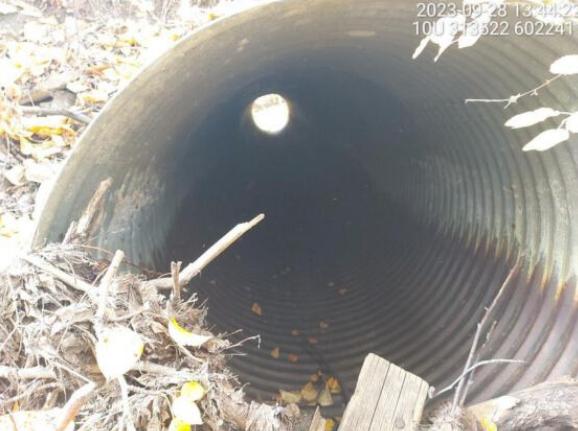
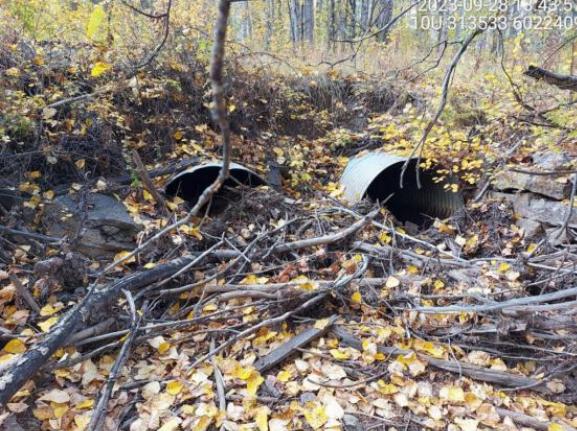
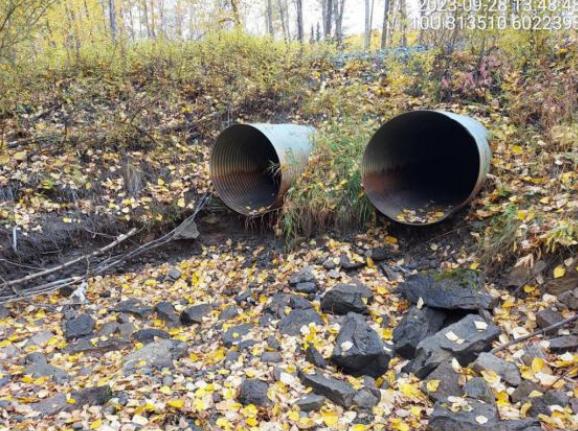
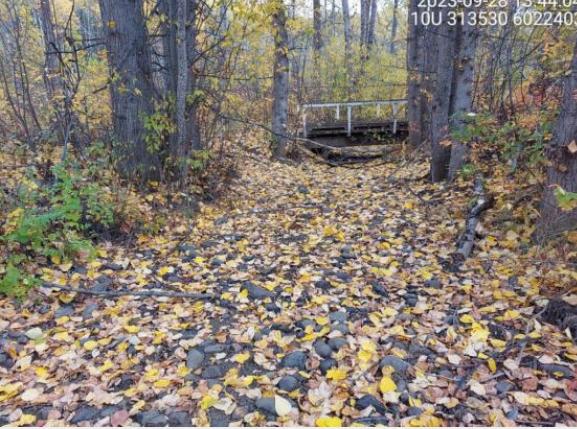
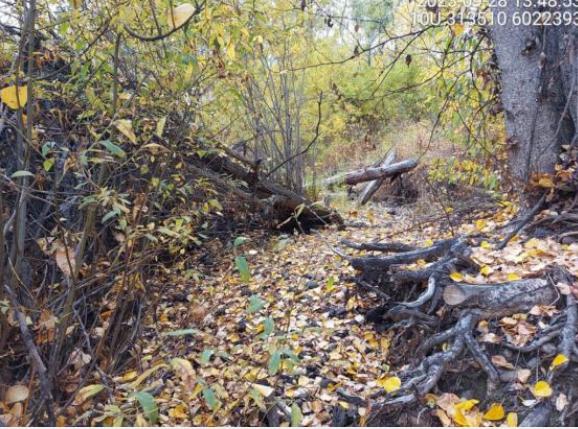
Photos: PSCIS ID 5406295. From top left clockwise: Road/Site Card, Barrel, Outlet, Downstream, Upstream, Inlet.

Location and Stream Data		Crossing Characteristics	
Date	2023-09-28	Crossing Sub Type	Round Culvert
PSCIS ID	199210	Diameter (m)	2.2
External ID	5406295	Length (m)	12
Crew	MW	Embedded	No
UTM Zone	10	Depth Embedded (m)	—
Easting	313514	Resemble Channel	No
Northing	6022401	Backwatered	No
Stream	Powder House Creek	Percent Backwatered	—
Road	Rail	Fill Depth (m)	1.2
Road Tenure	CN Rail	Outlet Drop (m)	0.5
Channel Width (m)	4.1	Outlet Pool Depth (m)	0
Stream Slope (%)	2	Inlet Drop	No
Beaver Activity	No	Slope (%)	5
Habitat Value	Medium	Valley Fill	Deep Fill
Final score	36	Barrier Result	Barrier
Fix type	Replace with New Open Bottom Structure	Fix Span / Diameter	15
Comments: Two pipes at 1.1m diameter each. Debris jam blocking majority of inlet on both pipes. Large channel dewatered at time of assessment. Significant outlet drop on both culverts. Two 3m high falls documented in FISS at ~500-600m upstream. Rainbow trout historically captured upstream. RB have historically been captured upstream. 13:50:33

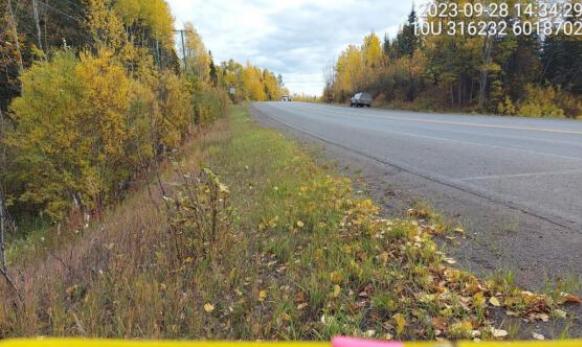
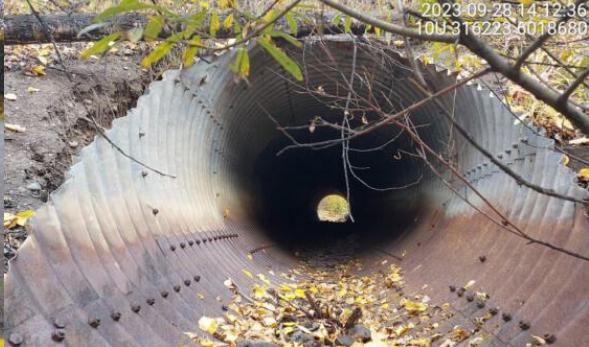
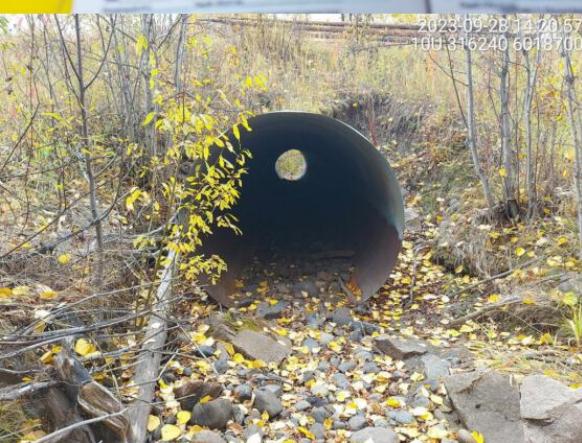
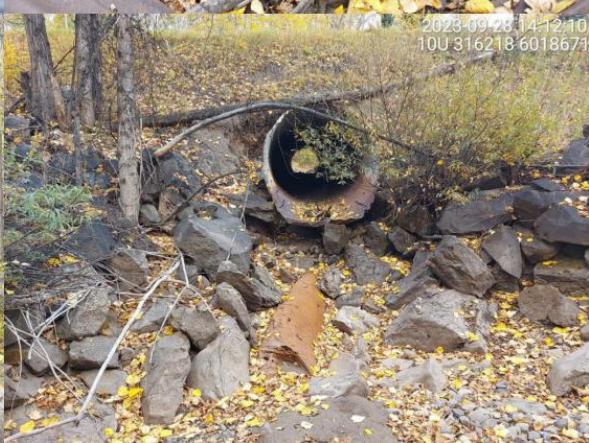
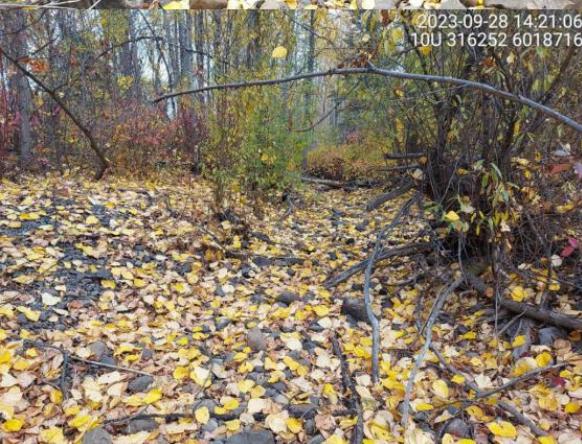
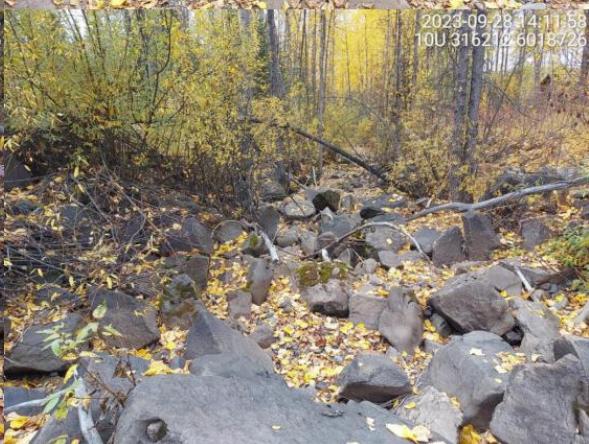
Photos: PSCIS ID 5400044. From top left clockwise: Road/Site Card, Barrel, Outlet, Downstream, Upstream, Inlet.

Comments: Dewatered stream at time of survey. Wide channel, abundant boulders downstream of crossing. Rainbow confirmed upstream in past. Culvert is old and corroded badly on outlet side. Stream most likely flows under culvert near outlet during high flow. MoTi chris_culvert_id: 2076407. 14:15:04

Location and Stream Data		Crossing Characteristics	
Date	2023-09-28	Crossing Sub Type	Round Culvert
PSCIS ID	199211	Diameter (m)	2.6
External ID	5400044	Length (m)	32
Crew	MW	Embedded	No
UTM Zone	10	Depth Embedded (m)	—
Easting	316235	Resemble Channel	No
Northing	6018694	Backwatered	No
Stream	Decker Creek	Percent Backwatered	—
Road	Highway 16 W	Fill Depth (m)	1.3
Road Tenure	MOTI	Outlet Drop (m)	0.6
Channel Width (m)	4.3	Outlet Pool Depth (m)	0
Stream Slope (%)	4	Inlet Drop	No
Beaver Activity	No	Slope (%)	2
Habitat Value	Medium	Valley Fill	Deep Fill
Final score	37	Barrier Result	Barrier
Fix type	Replace with New Open Bottom Structure	Fix Span / Diameter	15

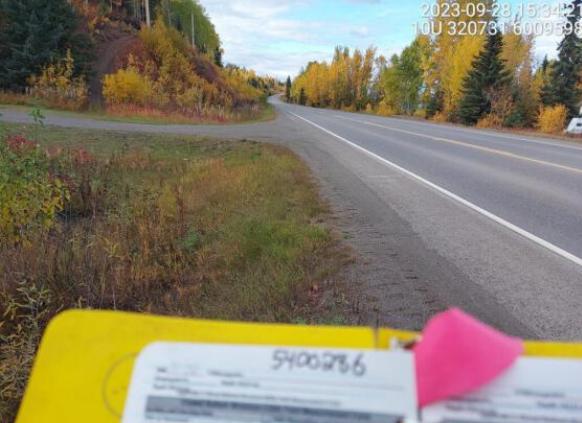
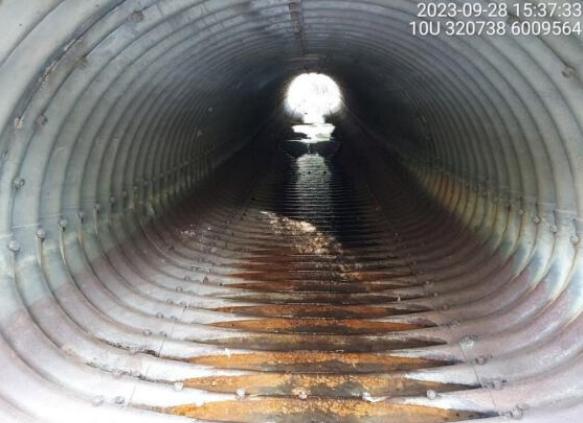
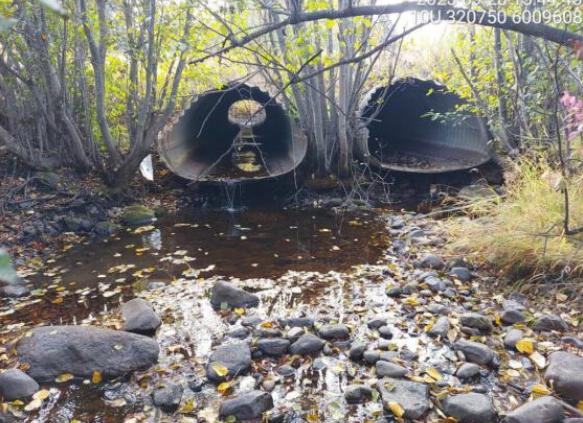
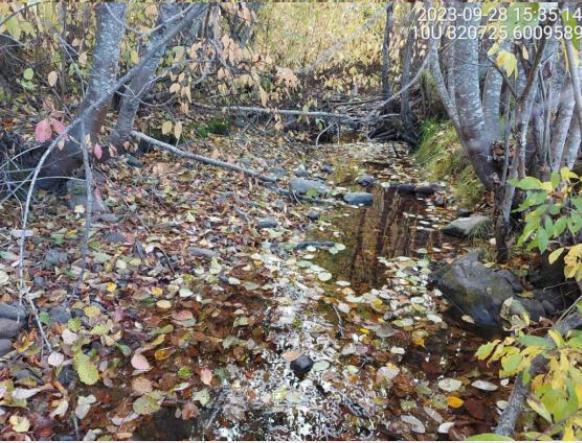
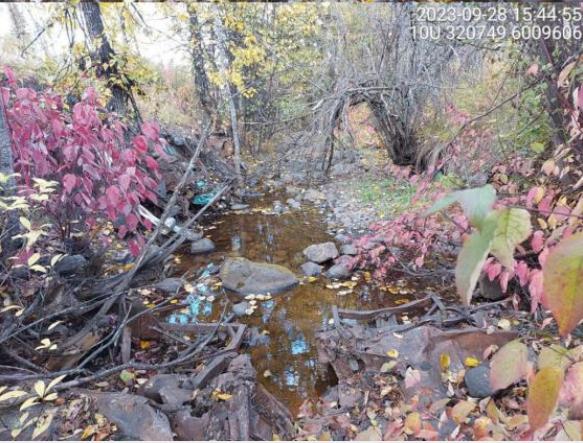
Photos: PSCIS ID 5400286. From top left clockwise: Road/Site Card, Barrel, Outlet, Downstream, Upstream, Inlet.

Comments: Small fry spotted in culvert and in outlet pool. Two pipes, both old and corroded with large outlet drops.

Small holes in both pipes causing some water to flow under pipe. Very low fill depth, culverts almost at highway. Near Burns Lake, in residential area. Habitat looks good upstream. RB and LSU upstream in Guyishton Lake. MoTi chris_culvert_id: 2070299, 2070298. 15:48:58

Location and Stream Data		.	Crossing Characteristics	-
Date	2023-09-28		Crossing Sub Type	Oval Culvert
PSCIS ID	199213		Diameter (m)	4
External ID	5400286		Length (m)	22
Crew	MW		Embedded	No
UTM Zone	10		Depth Embedded (m)	-
Easting	320733		Resemble Channel	No
Northing	6009596		Backwatered	No
Stream	Guyishton Creek		Percent Backwatered	-
Road	Highway 35		Fill Depth (m)	0.1
Road Tenure	MOTI		Outlet Drop (m)	0.6
Channel Width (m)	2.8		Outlet Pool Depth (m)	0.5
Stream Slope (%)	3		Inlet Drop	No
Beaver Activity	No		Slope (%)	2
Habitat Value	High		Valley Fill	Deep Fill
Final score	28		Barrier Result	Barrier
Fix type	Replace with New Open Bottom Structure		Fix Span / Diameter	15

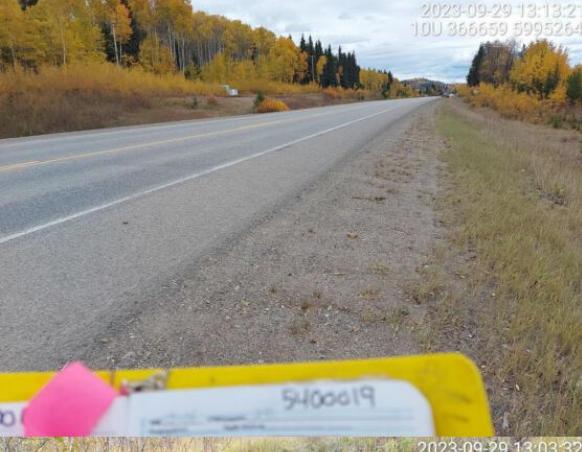
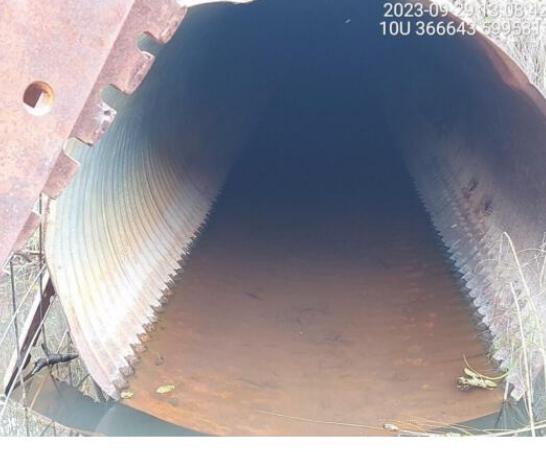
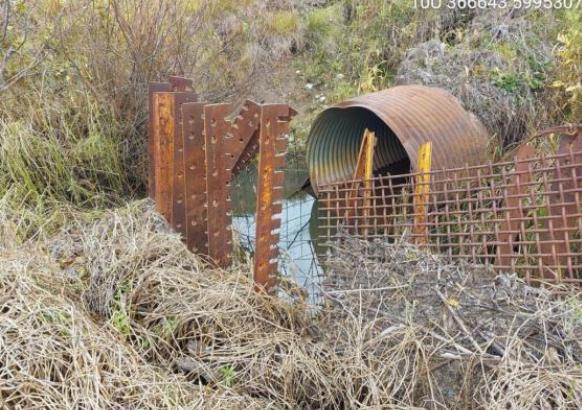
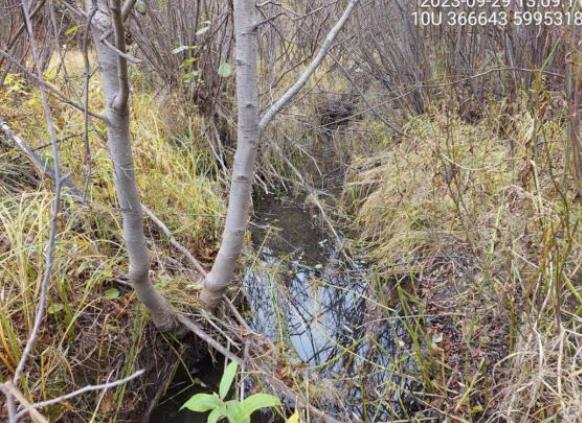
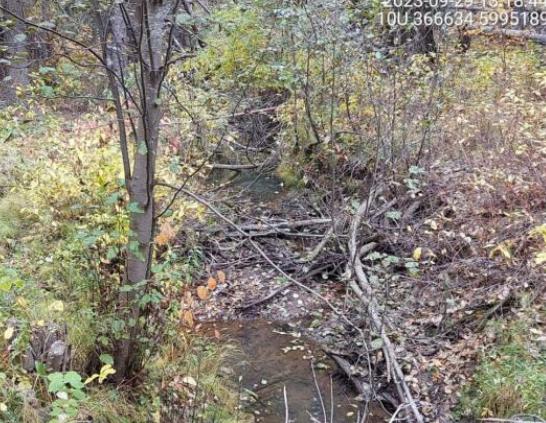
Photos: PSCIS ID 5400019. From top left clockwise: Road/Site Card, Barrel, Outlet, Downstream, Upstream, Inlet.

Comments: Culverts runs underneath highway and railway. Outlet could not be located Creek found below railway and flows to the Endako confluence. Beaver grate on inlet side. MoTi chris_culvert_id: 1793819. 13:07:39

Location and Stream Data	.	Crossing Characteristics	–
Date	2023-09-29	Crossing Sub Type	Round Culvert
PSCIS ID	199217	Diameter (m)	1.2
External ID	5400019	Length (m)	99
Crew	MW	Embedded	No
UTM Zone	10	Depth Embedded (m)	–
Easting	366638	Resemble Channel	No
Northing	5995282	Backwatered	No
Stream	Four Mile Creek	Percent Backwatered	–
Road	Highway 16	Fill Depth (m)	6
Road Tenure	MOTI	Outlet Drop (m)	0
Channel Width (m)	1.1	Outlet Pool Depth (m)	0
Stream Slope (%)	3	Inlet Drop	No
Beaver Activity	No	Slope (%)	1
Habitat Value	Low	Valley Fill	Deep Fill
Final score	21	Barrier Result	Barrier
Fix type	Replace Structure with Streambed Simulation CBS	Fix Span / Diameter	3

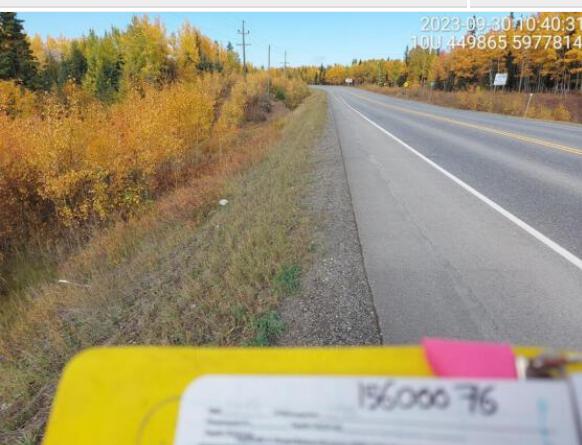
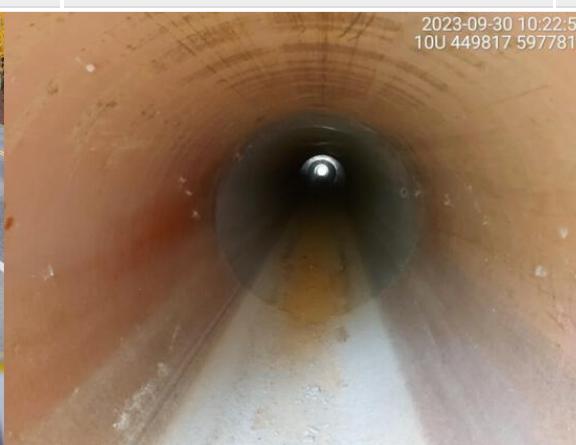
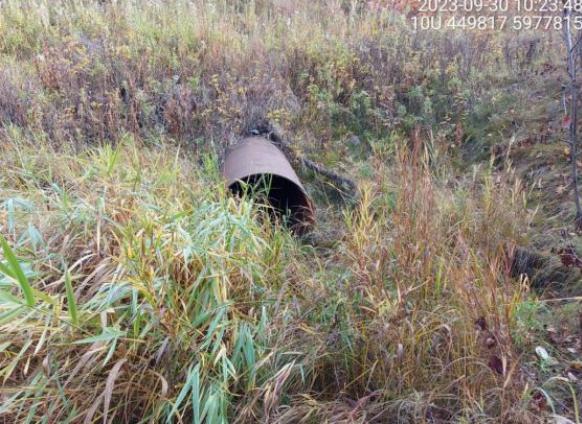
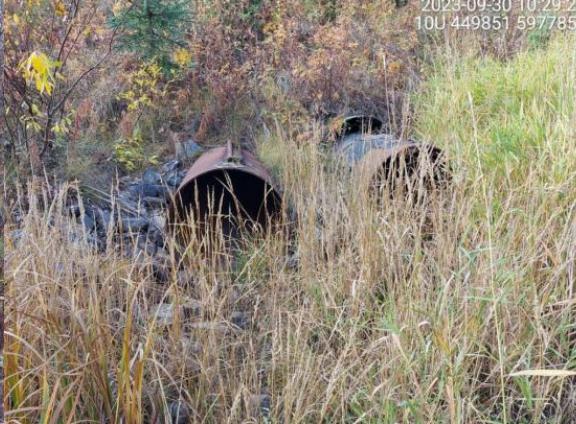
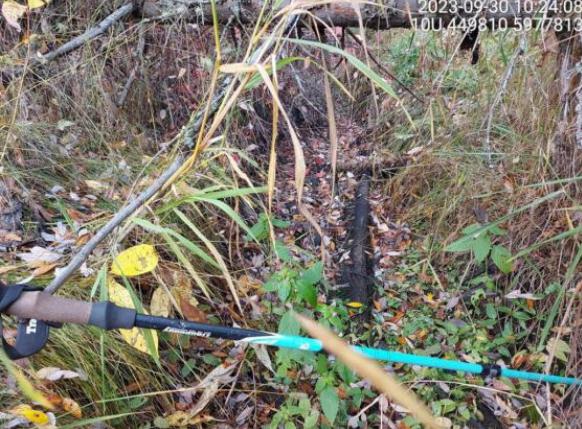
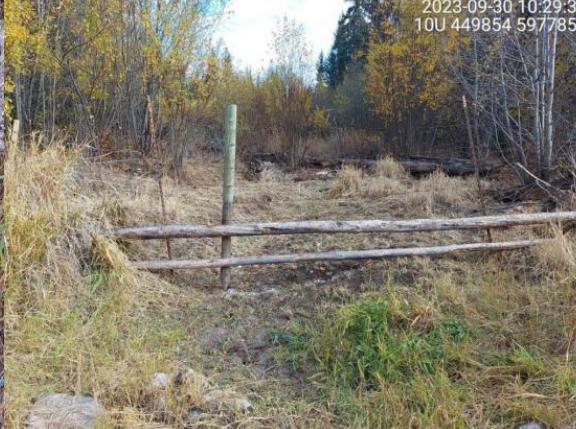
Photos: PSCIS ID 15600076. From top left clockwise: Road/Site Card, Barrel, Outlet, Downstream, Upstream, Inlet.

Location and Stream Data	.	Crossing Characteristics	–
Date	2023-09-30	Crossing Sub Type	Round Culvert
PSCIS ID	199224	Diameter (m)	1.8
External ID	15600076	Length (m)	48
Crew	MW	Embedded	No
UTM Zone	10	Depth Embedded (m)	–
Easting	449834	Resemble Channel	No
Northing	5977830	Backwatered	No
Stream	Tributary to Hulatt Creek	Percent Backwatered	–
Road	Highway 16	Fill Depth (m)	5
Road Tenure	MOTI	Outlet Drop (m)	0
Channel Width (m)	1.2	Outlet Pool Depth (m)	0
Stream Slope (%)	1	Inlet Drop	No
Beaver Activity	No	Slope (%)	1
Habitat Value	Low	Valley Fill	Deep Fill
Final score	21	Barrier Result	Barrier
Fix type	Replace Structure with Streambed Simulation CBS	Fix Span / Diameter	3

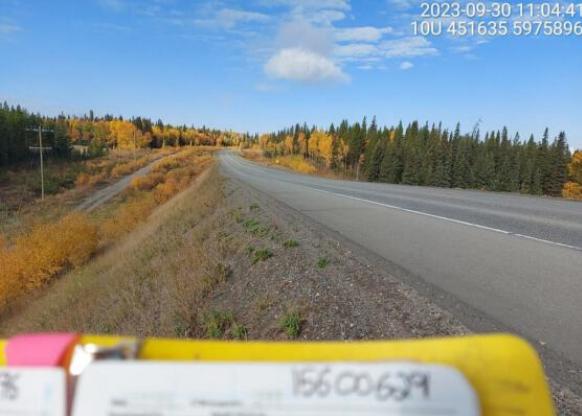
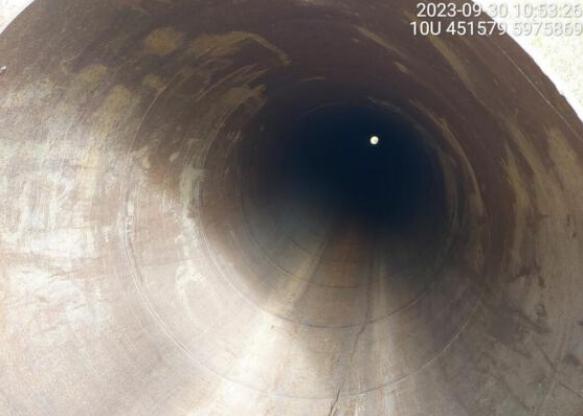
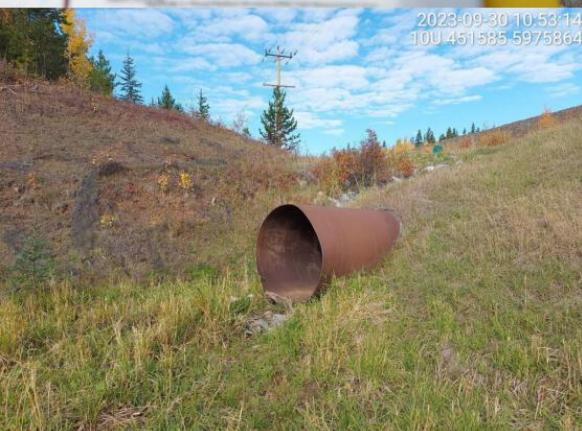
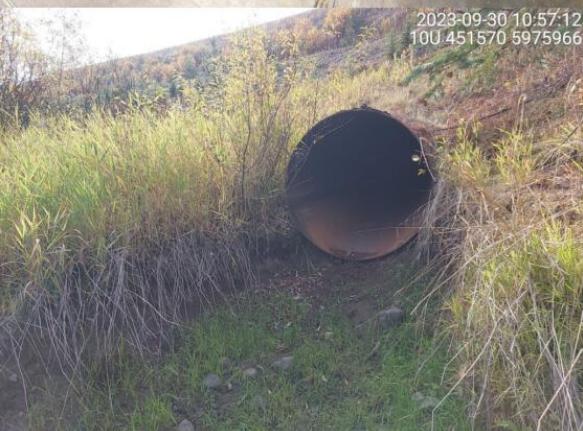
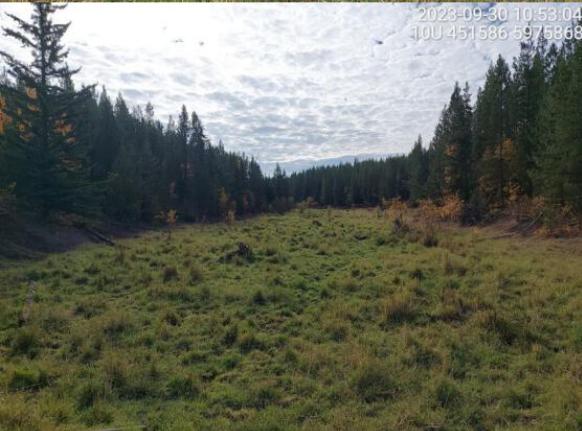
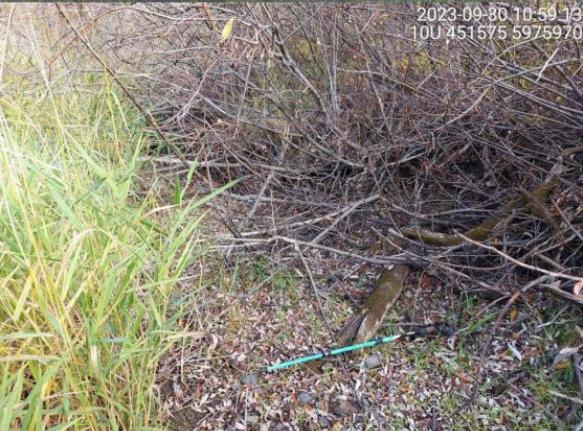
Photos: PSCIS ID 15600629. From top left clockwise: Road/Site Card, Barrel, Outlet, Downstream, Upstream, Inlet.

Location and Stream Data	.	Crossing Characteristics	–
Date	2023-09-30	Crossing Sub Type	Round Culvert
PSCIS ID	199225	Diameter (m)	1.5
External ID	15600629	Length (m)	90
Crew	MW	Embedded	No
UTM Zone	10	Depth Embedded (m)	–
Easting	451599	Resemble Channel	No
Northing	5975913	Backwatered	No
Stream	Hulatt Creek	Percent Backwatered	–
Road	Highway 16	Fill Depth (m)	8
Road Tenure	MOTI	Outlet Drop (m)	0
Channel Width (m)	3.3	Outlet Pool Depth (m)	0
Stream Slope (%)	2	Inlet Drop	No
Beaver Activity	No	Slope (%)	3
Habitat Value	Low	Valley Fill	Deep Fill
Final score	32	Barrier Result	Barrier
Fix type	Replace Structure with Streambed Simulation CBS	Fix Span / Diameter	4.5

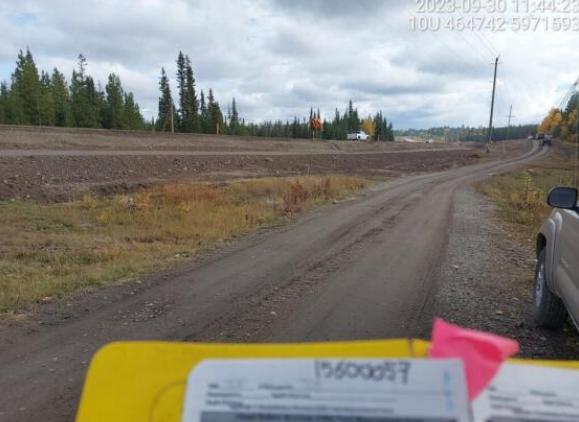
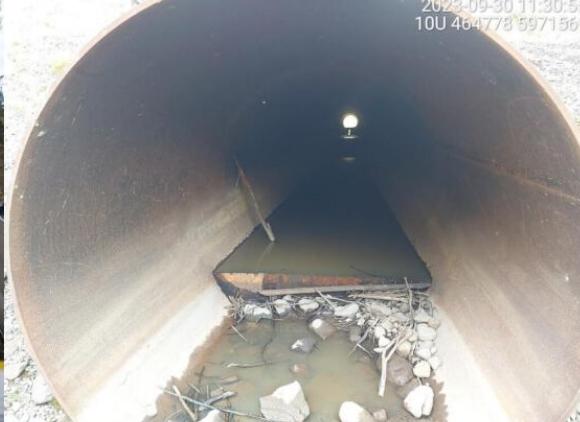
Photos: PSCIS ID 15600057. From top left clockwise: Road/Site Card, Barrel, Outlet, Downstream, Upstream, Inlet.

Location and Stream Data		Crossing Characteristics	
Date	2023-09-30	Crossing Sub Type	Round Culvert
PSCIS ID	199226	Diameter (m)	2.4
External ID	15600057	Length (m)	66
Crew	MW	Embedded	No
UTM Zone	10	Depth Embedded (m)	—
Easting	464822	Resemble Channel	No
Northing	5971609	Backwatered	No
Stream	Tributary to Cluculz Lake	Percent Backwatered	—
Road	Highway 16	Fill Depth (m)	5
Road Tenure	MOTI	Outlet Drop (m)	0
Channel Width (m)	2.6	Outlet Pool Depth (m)	0
Stream Slope (%)	0	Inlet Drop	No
Beaver Activity	No	Slope (%)	1
Habitat Value	Medium	Valley Fill	Deep Fill
Final score	24	Barrier Result	Barrier
Fix type	Replace with New Open Bottom Structure	Fix Span / Diameter	21
Comments: Culvert runs under active highway construction site. Inlet could not be accessed. Looks like they are excavating near inlet. Possible bridge construction? Stream is mostly dewatered but there is some stagnant water in culvert. Baffles in pipe. Habitat downstream looks good, with abundant woody debris and healthy riparian. MoTi chris_culvert_id: 1804902. 11:33:26

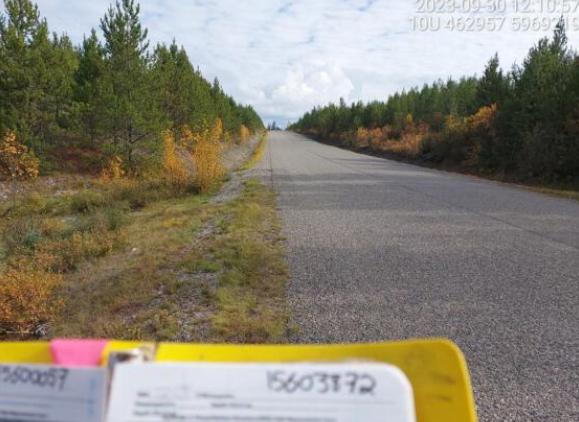
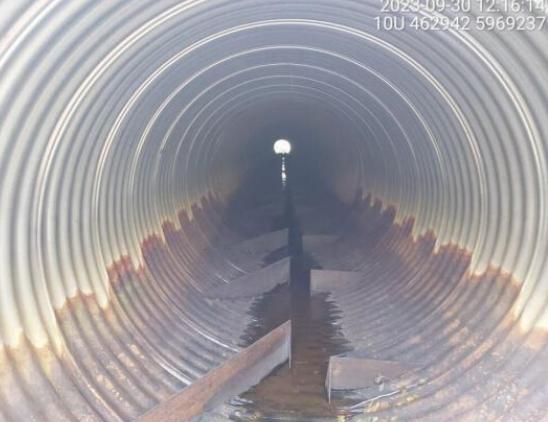
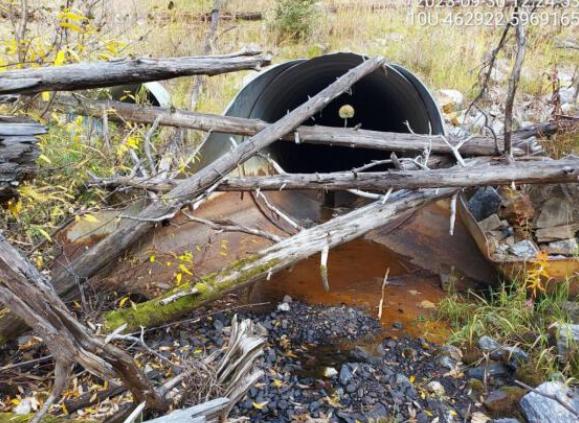
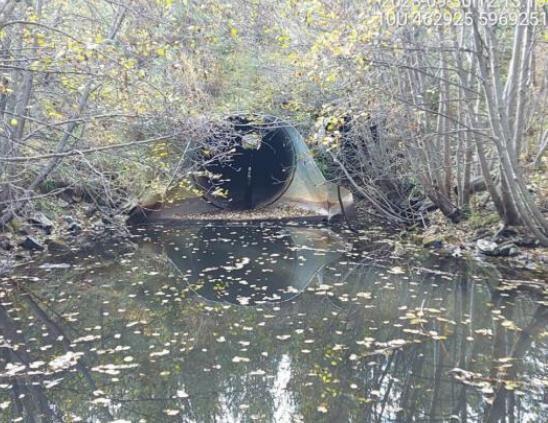
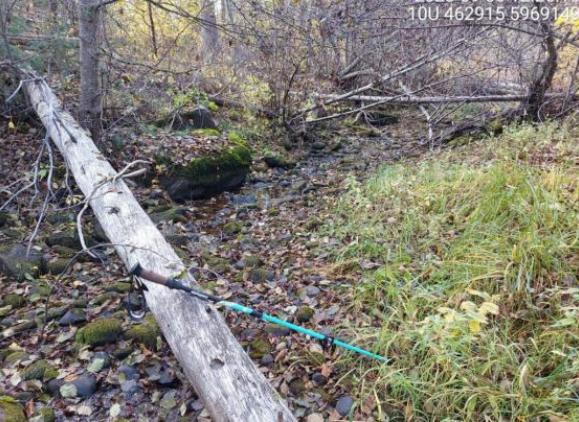
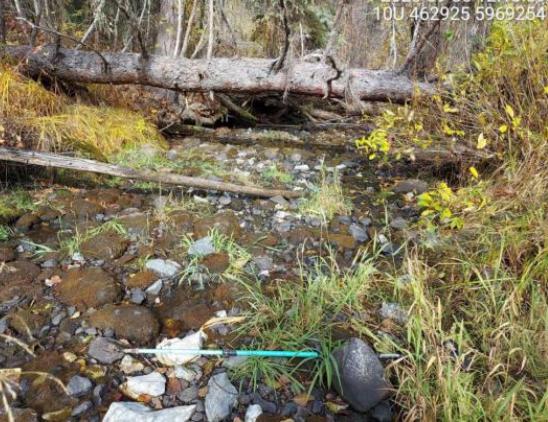
Photos: PSCIS ID 15603872. From top left clockwise: Road/Site Card, Barrel, Outlet, Downstream, Upstream, Inlet.

Location and Stream Data		Crossing Characteristics	
Date	2023-09-30	Crossing Sub Type	Round Culvert
PSCIS ID	199227	Diameter (m)	2.5
External ID	15603872	Length (m)	78
Crew	MW	Embedded	No
UTM Zone	10	Depth Embedded (m)	—
Easting	462928	Resemble Channel	No
Northing	5969213	Backwatered	No
Stream	Norman Creek	Percent Backwatered	—
Road	Lloyd Dr	Fill Depth (m)	5
Road Tenure	MOTI Local	Outlet Drop (m)	0
Channel Width (m)	3.1	Outlet Pool Depth (m)	0.3
Stream Slope (%)	3	Inlet Drop	No
Beaver Activity	No	Slope (%)	0
Habitat Value	Medium	Valley Fill	Deep Fill
Final score	19	Barrier Result	Potential
Fix type	Replace with New Open Bottom Structure	Fix Span / Diameter	21

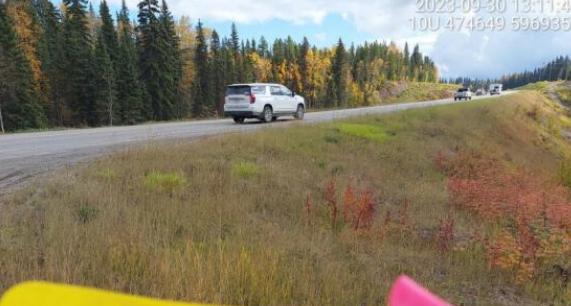
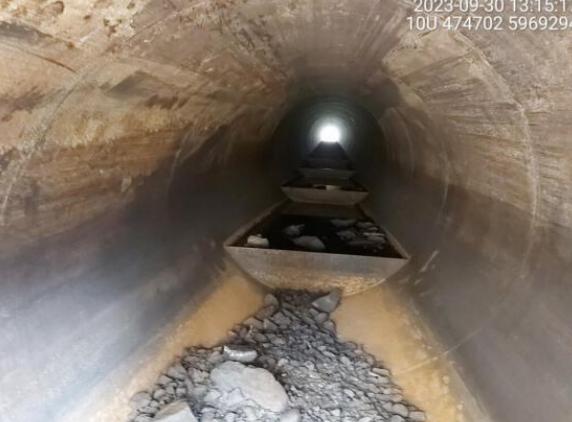
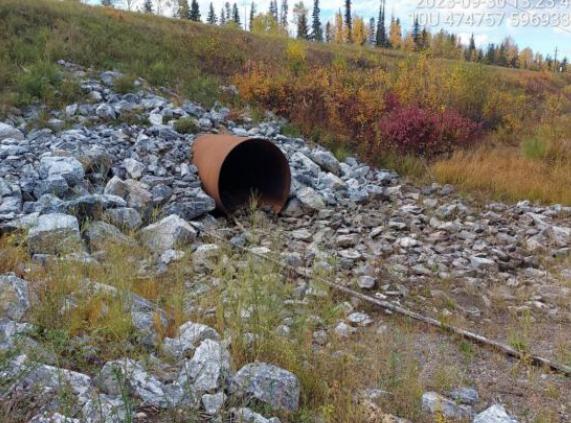
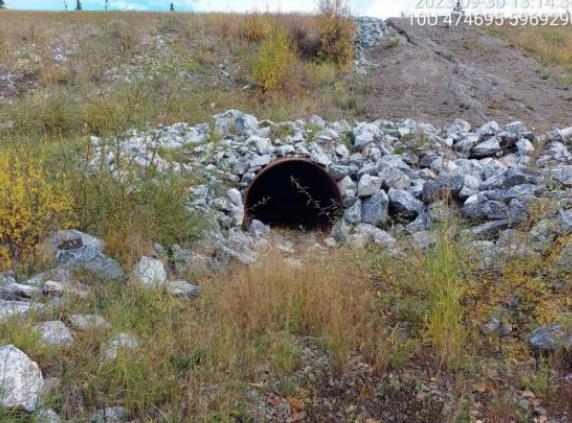
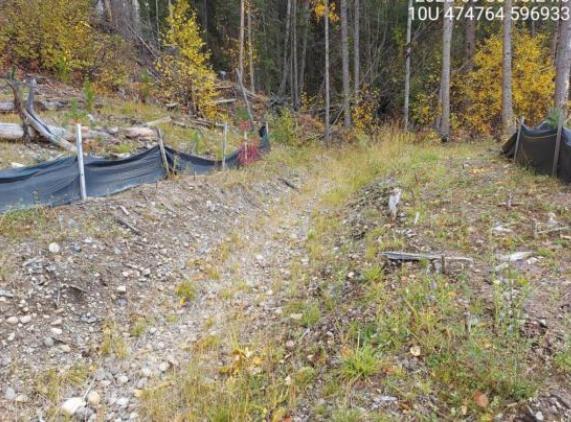
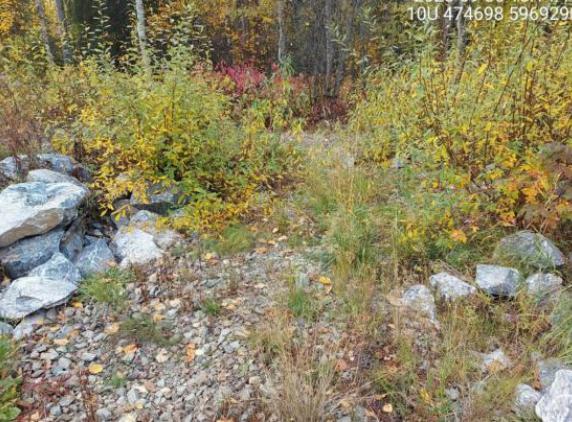
Photos: PSCIS ID 9902601. From top left clockwise: Road/Site Card, Barrel, Outlet, Downstream, Upstream, Inlet.

Location and Stream Data	.	Crossing Characteristics	–
Date	2023-09-30	Crossing Sub Type	Round Culvert
PSCIS ID	199228	Diameter (m)	2
External ID	9902601	Length (m)	60
Crew	MW	Embedded	No
UTM Zone	10	Depth Embedded (m)	–
Easting	474705	Resemble Channel	No
Northing	5969325	Backwatered	No
Stream	Tributary to Bednesti Lake	Percent Backwatered	–
Road	Highway 16	Fill Depth (m)	8
Road Tenure	MOTI	Outlet Drop (m)	0
Channel Width (m)	1.7	Outlet Pool Depth (m)	0
Stream Slope (%)	6	Inlet Drop	No
Beaver Activity	No	Slope (%)	3.5
Habitat Value	Medium	Valley Fill	Deep Fill
Final score	26	Barrier Result	Barrier
Fix type	Replace Structure with Streambed Simulation CBS	Fix Span / Diameter	3

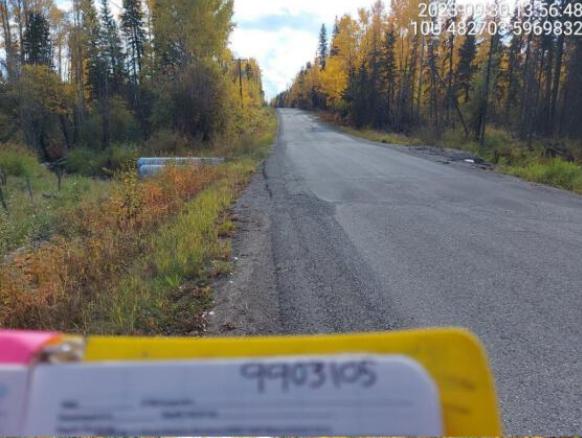
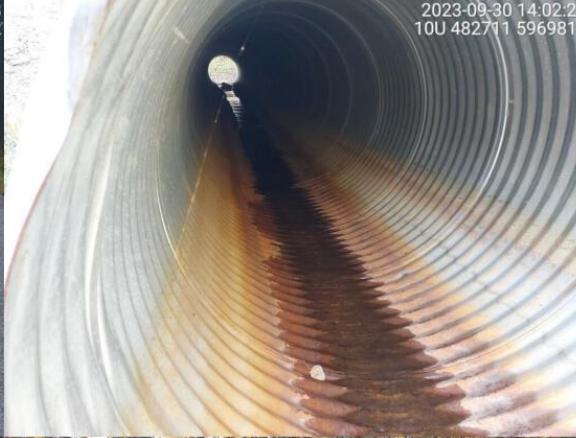
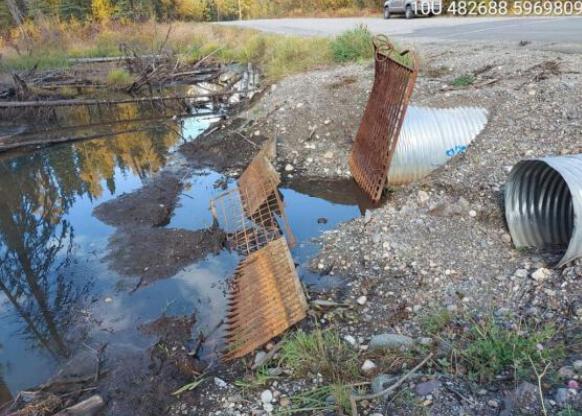
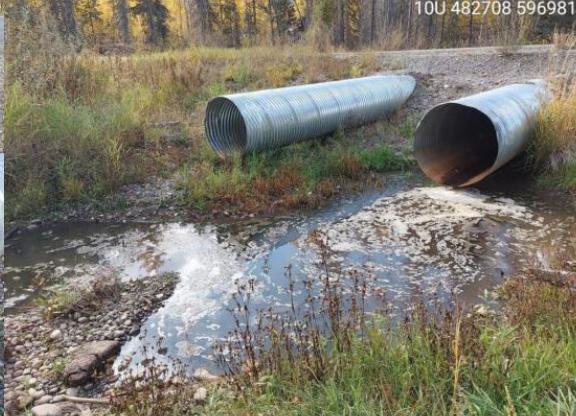
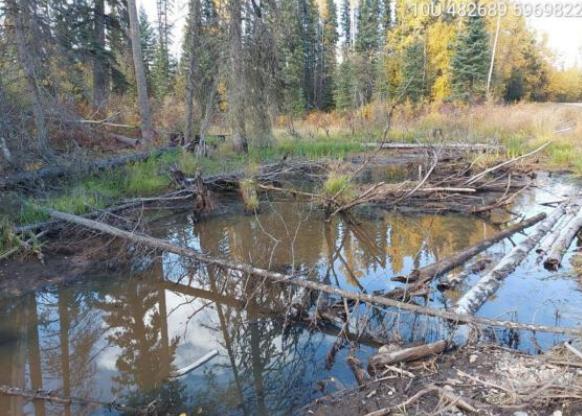
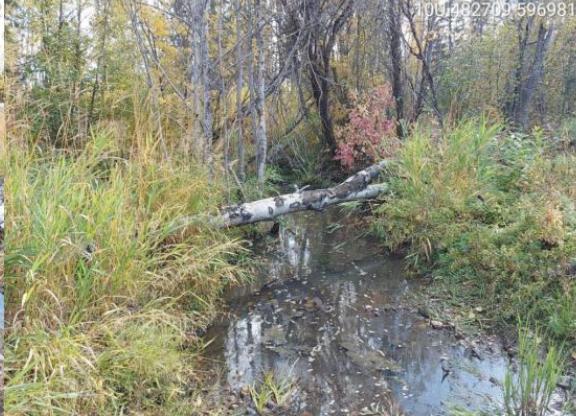
Photos: PSCIS ID 9903105. From top left clockwise: Road/Site Card, Barrel, Outlet, Downstream, Upstream, Inlet.

Location and Stream Data		Crossing Characteristics	
Date	2023-09-30	Crossing Sub Type	Round Culvert
PSCIS ID	199229	Diameter (m)	2.2
External ID	9903105	Length (m)	16
Crew	MW	Embedded	No
UTM Zone	10	Depth Embedded (m)	—
Easting	482695	Resemble Channel	No
Northing	5969819	Backwatered	No
Stream	Zelkwas Creek	Percent Backwatered	—
Road	Isle Pierre Rd	Fill Depth (m)	0.7
Road Tenure	MOTI Local	Outlet Drop (m)	0.1
Channel Width (m)	2.2	Outlet Pool Depth (m)	0.3
Stream Slope (%)	2	Inlet Drop	No
Beaver Activity	No	Slope (%)	1
Habitat Value	Medium	Valley Fill	Deep Fill
Final score	21	Barrier Result	Barrier
Fix type	Replace with New Open Bottom Structure	Fix Span / Diameter	15

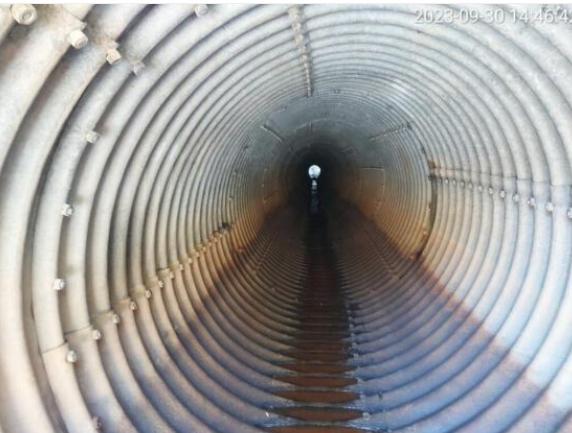
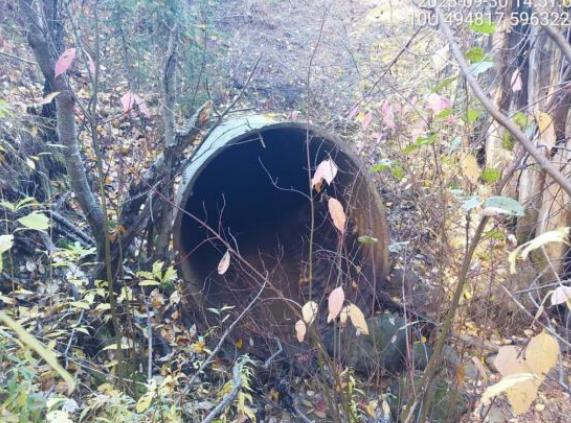
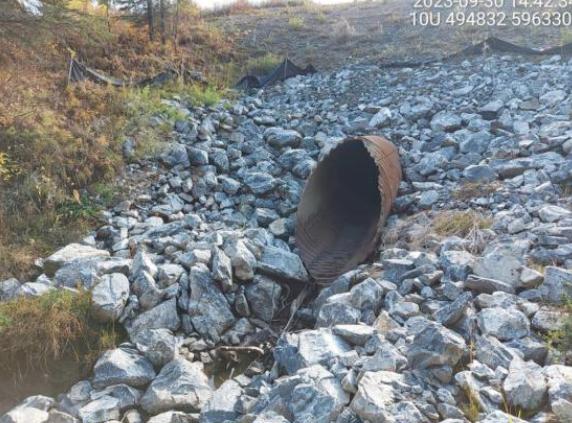
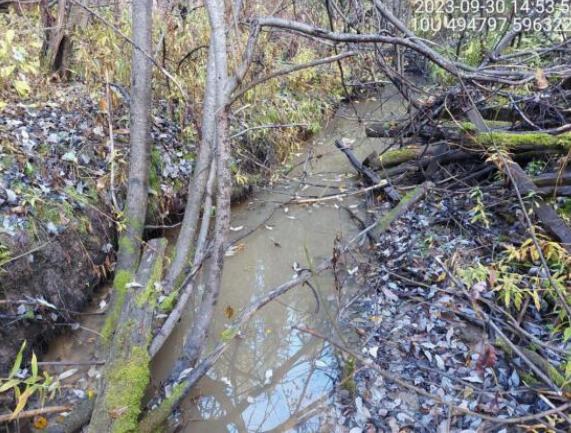
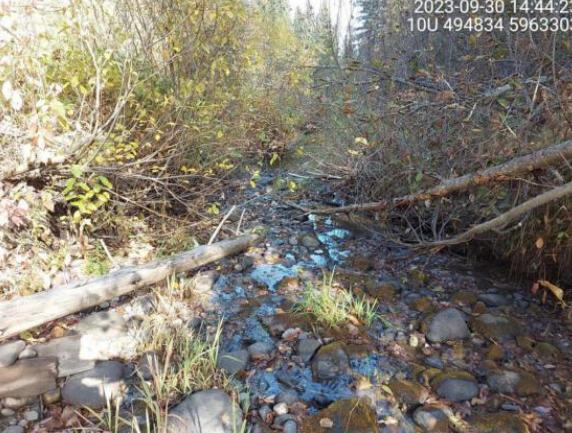
Photos: PSCIS ID 9900404. From top left clockwise: Road/Site Card, Barrel, Outlet, Downstream, Upstream, Inlet.

Location and Stream Data		Crossing Characteristics	
Date	2023-09-30	Crossing Sub Type	Round Culvert
PSCIS ID	199230	Diameter (m)	1.7
External ID	9900404	Length (m)	56
Crew	MW	Embedded	No
UTM Zone	10	Depth Embedded (m)	–
Easting	494827	Resemble Channel	No
Northing	5963256	Backwatered	No
Stream	Sweden Creek	Percent Backwatered	–
Road	Highway 16	Fill Depth (m)	6
Road Tenure	MOTI	Outlet Drop (m)	0.4
Channel Width (m)	2.2	Outlet Pool Depth (m)	0
Stream Slope (%)	1	Inlet Drop	No
Beaver Activity	No	Slope (%)	2
Habitat Value	Medium	Valley Fill	Deep Fill
Final score	34	Barrier Result	Barrier
Fix type	Replace Structure with Streambed Simulation CBS	Fix Span / Diameter	4.5

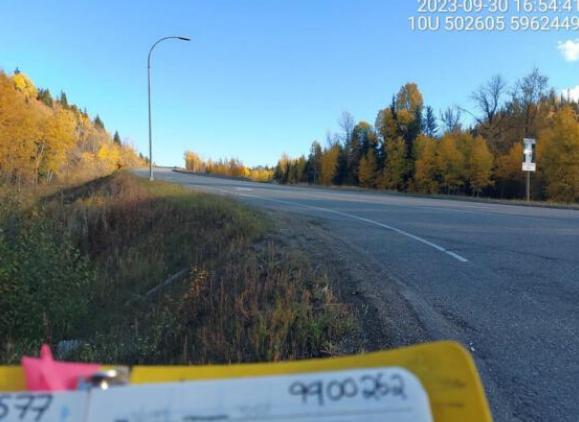
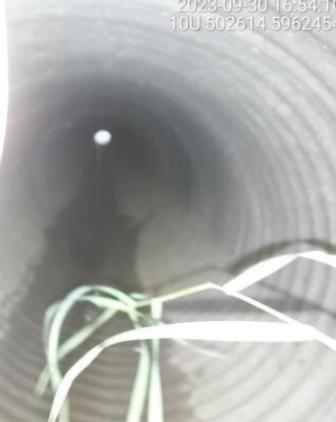
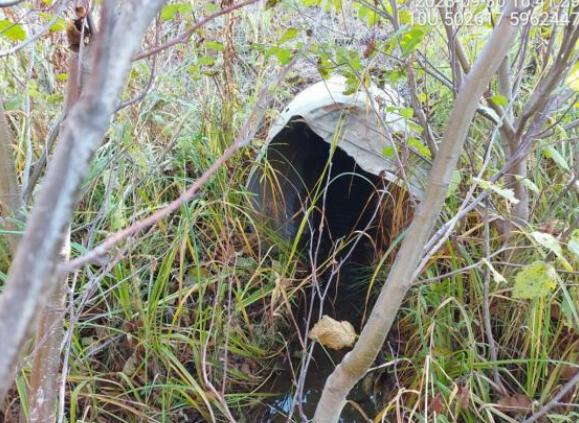
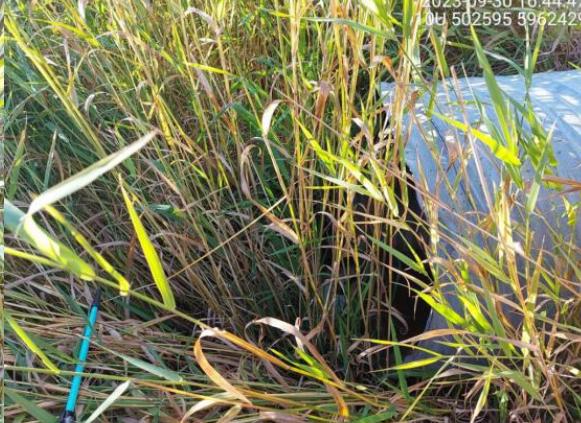
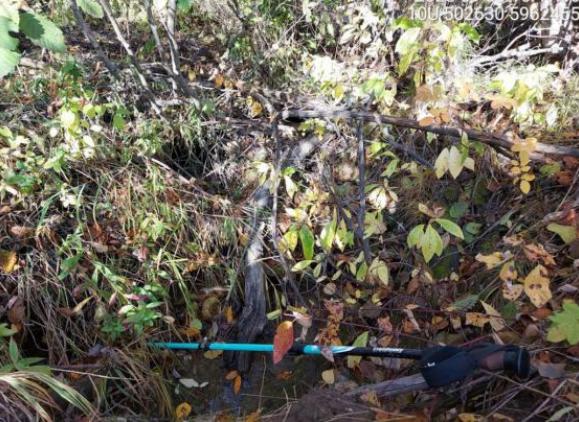
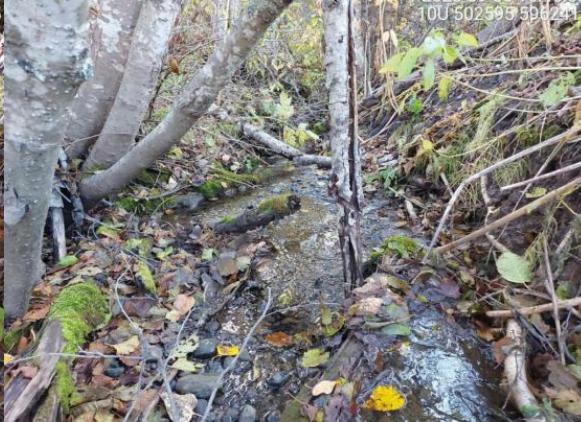
Photos: PSCIS ID 9900262. From top left clockwise: Road/Site Card, Barrel, Outlet, Downstream, Upstream, Inlet.

Comments: Two pipes but only one is functioning and has small amount of flow through it. Very small channel.
 Observed chinook in FISS downstream of confluence with Beaverley Creek at ~100m from the crossing and ~30m from the confluence. MoTi chris_culvert_id: 1975199. 16:46:37

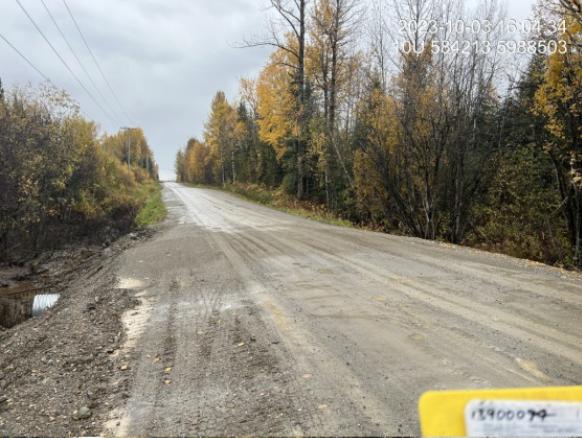
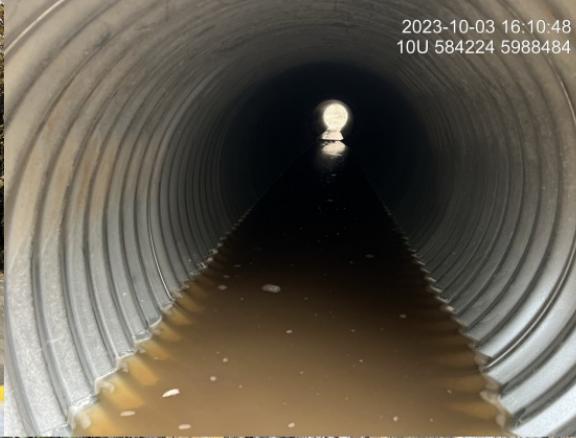
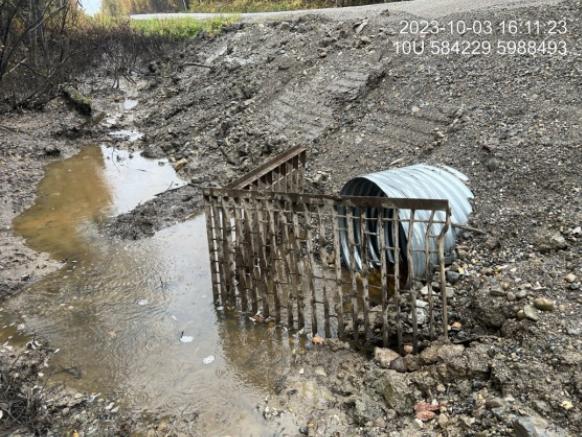
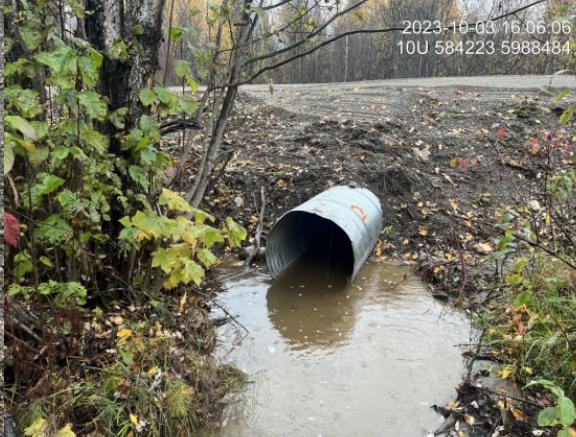
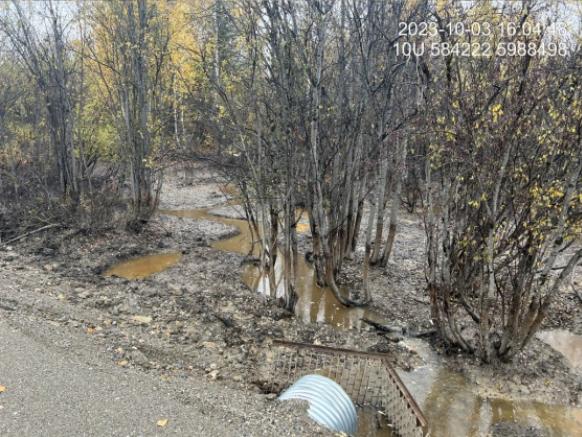
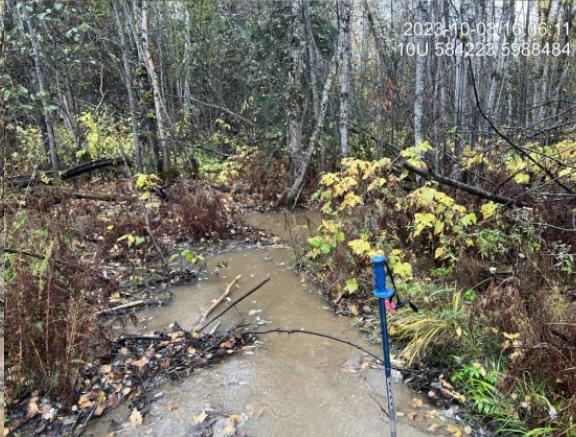
Photos: PSCIS ID 13900094. From top left clockwise: Road/Site Card, Barrel, Outlet, Downstream, Upstream, Inlet.

Location and Stream Data		Crossing Characteristics	
Date	2023-10-03	Crossing Sub Type	Round Culvert
PSCIS ID	199252	Diameter (m)	0.8
External ID	13900094	Length (m)	20
Crew	AI	Embedded	No
UTM Zone	10	Depth Embedded (m)	—
Easting	584227	Resemble Channel	No
Northing	5988493	Backwatered	No
Stream	Tributary to Fraser River	Percent Backwatered	—
Road	Upper Fraser Road	Fill Depth (m)	1.2
Road Tenure	MOTI	Outlet Drop (m)	0
Channel Width (m)	1.8	Outlet Pool Depth (m)	0.2
Stream Slope (%)	4.5	Inlet Drop	No
Beaver Activity	Yes	Slope (%)	2
Habitat Value	Medium	Valley Fill	Deep Fill
Final score	24	Barrier Result	Barrier
Fix type	Replace Structure with Streambed Simulation CBS	Fix Span / Diameter	3

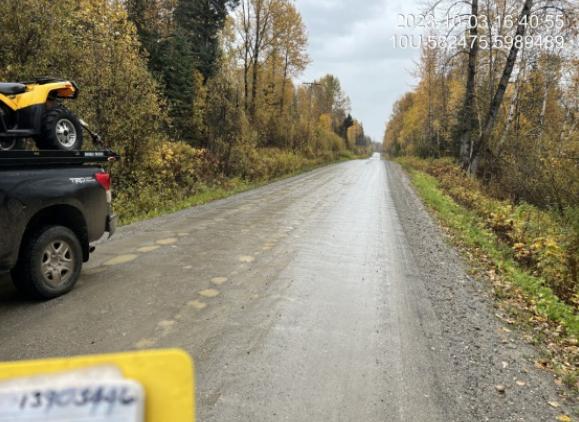
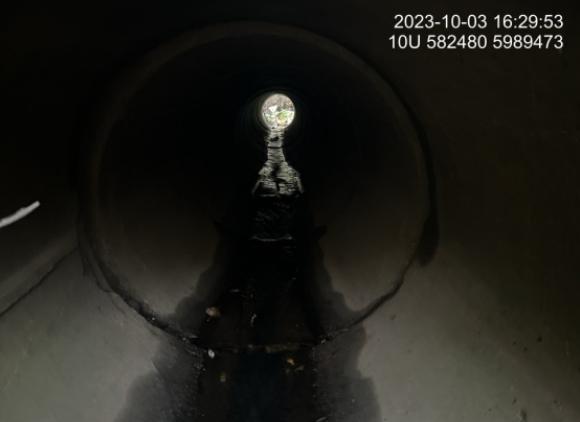
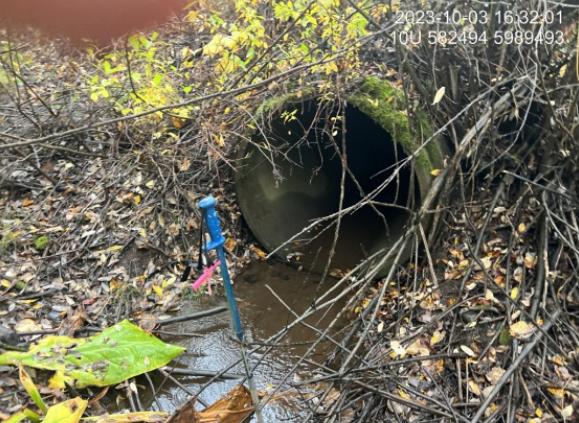
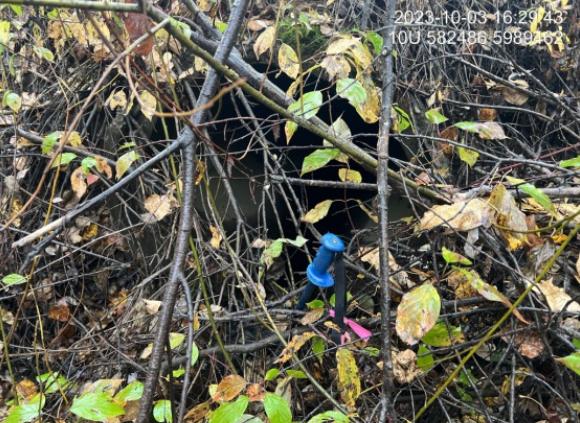
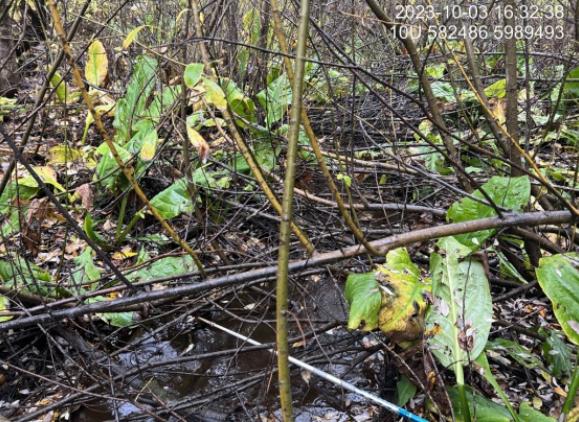
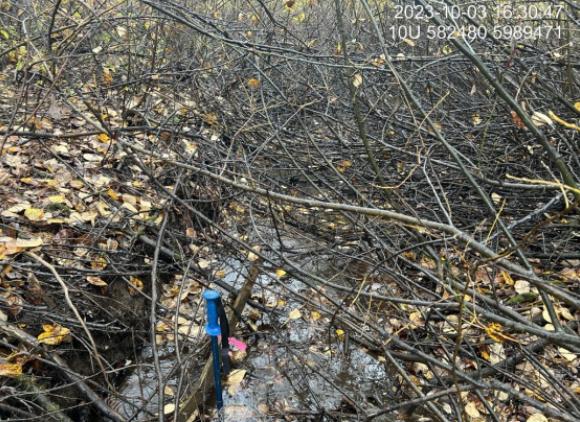
Photos: PSCIS ID 13903446. From top left clockwise: Road/Site Card, Barrel, Outlet, Downstream, Upstream, Inlet.

Location and Stream Data		Crossing Characteristics	
Date	2023-10-03	Crossing Sub Type	Round Culvert
PSCIS ID	199253	Diameter (m)	1.05
External ID	13903446	Length (m)	17
Crew	AI	Embedded	No
UTM Zone	10	Depth Embedded (m)	—
Easting	582480	Resemble Channel	No
Northing	5989487	Backwatered	No
Stream	Tributary to Fraser River	Percent Backwatered	—
Road	Upper Fraser Road	Fill Depth (m)	1.6
Road Tenure	MOTI	Outlet Drop (m)	0.05
Channel Width (m)	2	Outlet Pool Depth (m)	0.2
Stream Slope (%)	1	Inlet Drop	No
Beaver Activity	No	Slope (%)	2.5
Habitat Value	Medium	Valley Fill	Deep Fill
Final score	24	Barrier Result	Barrier
Fix type	Replace with New Open Bottom Structure	Fix Span / Diameter	15
