Appendix - Phase 1 Fish Passage Assessment Data and Photos

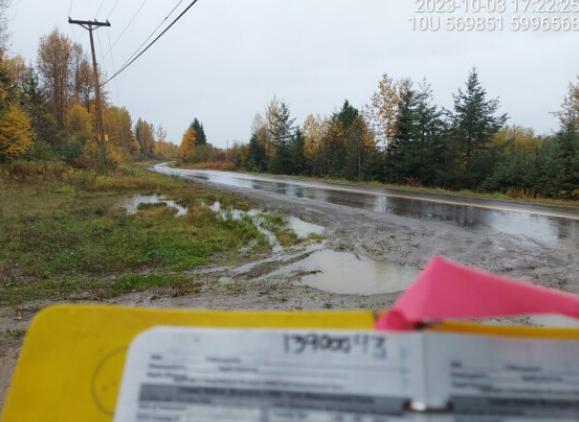
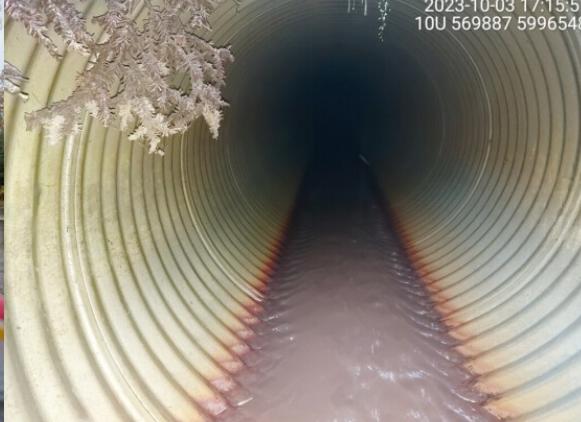
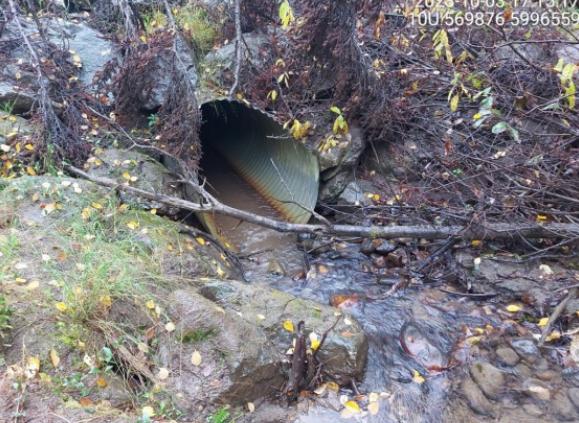
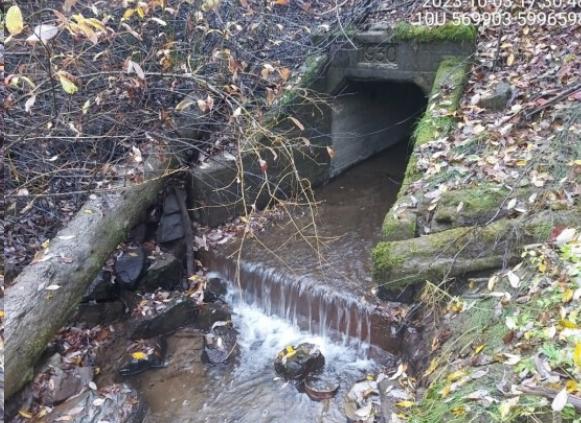
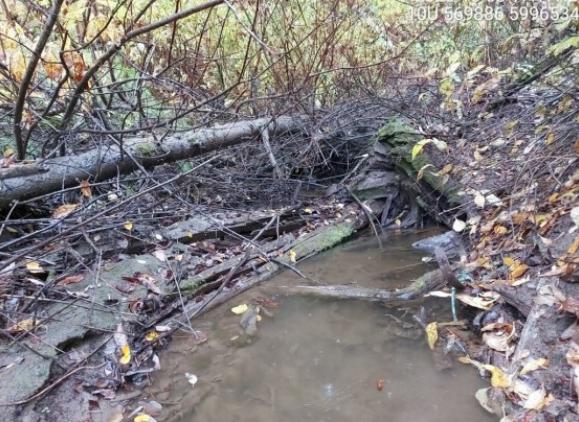
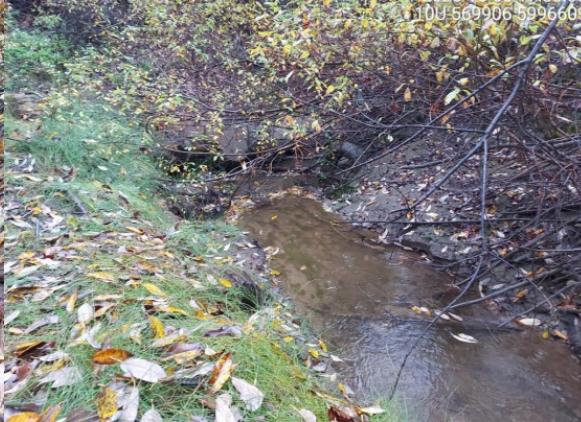
Photos: PSCIS ID 13900043. From top left clockwise: Road/Site Card, Barrel, Outlet, Downstream, Upstream, Inlet.

Location and Stream Data		Crossing Characteristics	
Date	2023-10-03	Crossing Sub Type	Round Culvert
PSCIS ID	199254	Diameter (m)	0.95
External ID	13900043	Length (m)	54
Crew	MW	Embedded	No
UTM Zone	10	Depth Embedded (m)	—
Easting	569895	Resemble Channel	No
Northing	5996572	Backwatered	No
Stream	Tributary to Fraser River	Percent Backwatered	—
Road	Upper Fraser Rd	Fill Depth (m)	4
Road Tenure	MOTI	Outlet Drop (m)	0.6
Channel Width (m)	2.3	Outlet Pool Depth (m)	0.2
Stream Slope (%)	4	Inlet Drop	No
Beaver Activity	No	Slope (%)	2
Habitat Value	Medium	Valley Fill	Deep Fill
Final score	37	Barrier Result	Barrier
Fix type	Replace with New Open Bottom Structure	Fix Span / Diameter	18

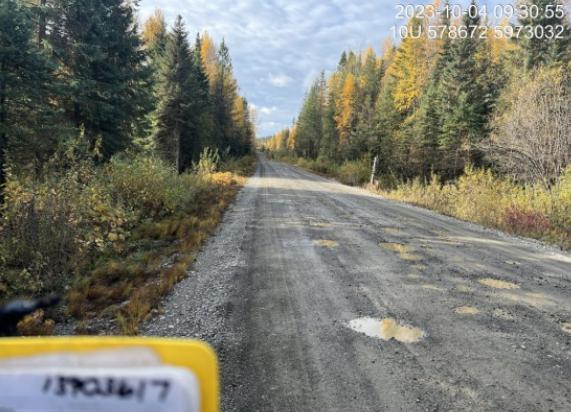
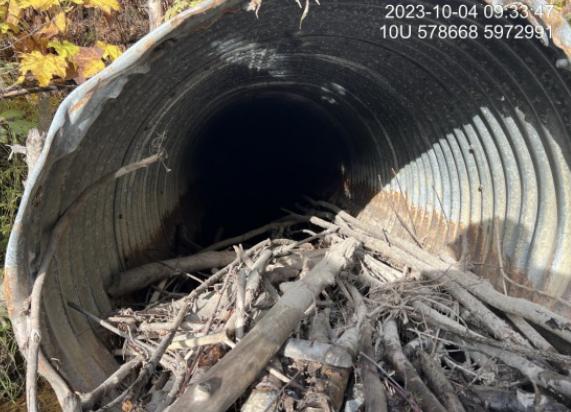
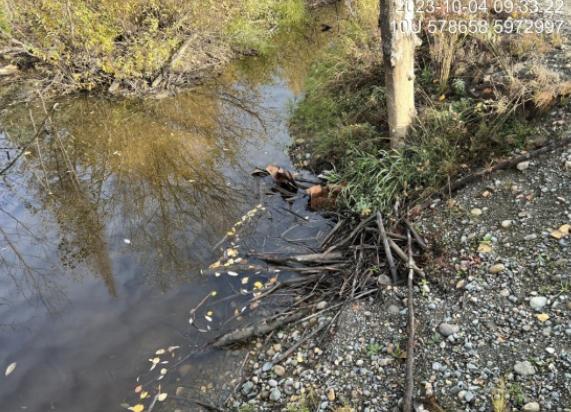
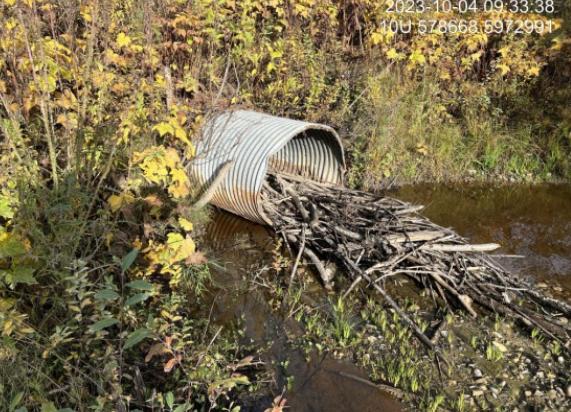
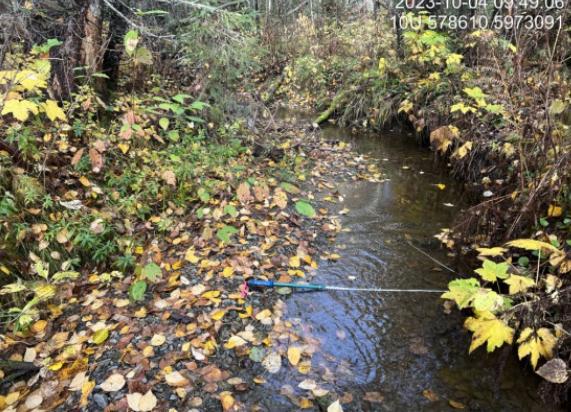
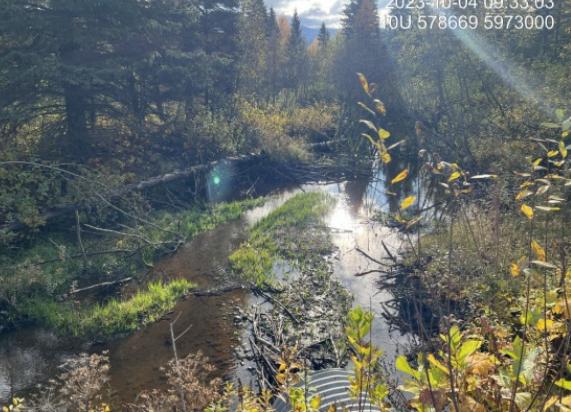
Photos: PSCIS ID 13903617. From top left clockwise: Road/Site Card, Barrel, Outlet, Downstream, Upstream, Inlet.

Location and Stream Data		Crossing Characteristics	
Date	2023-10-04	Crossing Sub Type	Round Culvert
PSCIS ID	199255	Diameter (m)	1.1
External ID	13903617	Length (m)	17
Crew	AI	Embedded	No
UTM Zone	10	Depth Embedded (m)	—
Easting	578670	Resemble Channel	No
Northing	5973004	Backwatered	No
Stream	Tributary to Kenneth Creek	Percent Backwatered	—
Road	Bowron FSR	Fill Depth (m)	1.3
Road Tenure	MOF	Outlet Drop (m)	0.05
Channel Width (m)	2.6	Outlet Pool Depth (m)	0.05
Stream Slope (%)	2	Inlet Drop	Yes
Beaver Activity	Yes	Slope (%)	3
Habitat Value	Medium	Valley Fill	Deep Fill
Final score	29	Barrier Result	Barrier
Fix type	Replace with New Open Bottom Structure	Fix Span / Diameter	15

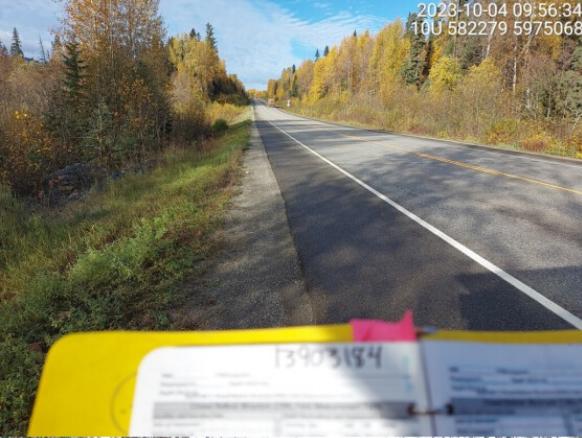
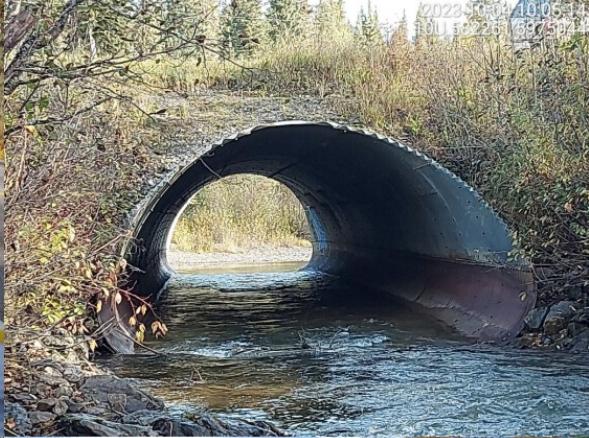
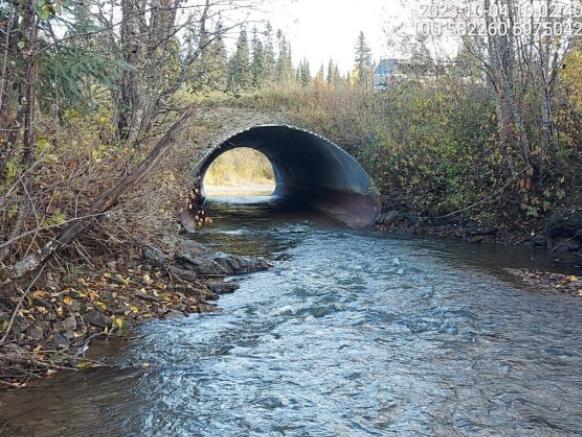
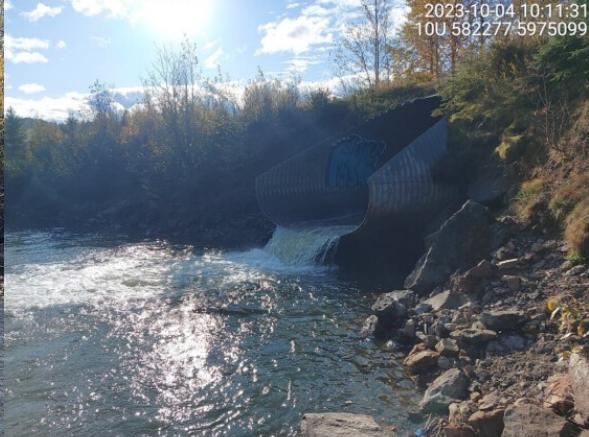
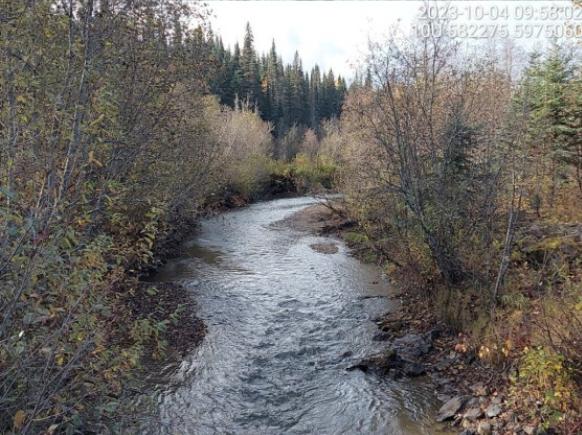
Photos: PSCIS ID 13903184. From top left clockwise: Road/Site Card, Barrel, Outlet, Downstream, Upstream, Inlet.

Comments: Very wide stream with high flow. Velocity is high in culvert. Very deep and big outlet pool, depth estimated. Known salmon spawning location. Chinook confirmed with carcass noted just upstream in 2022 by same field team.
MoTi chris_hwy_structure_road_id: 3750. 10:13:57

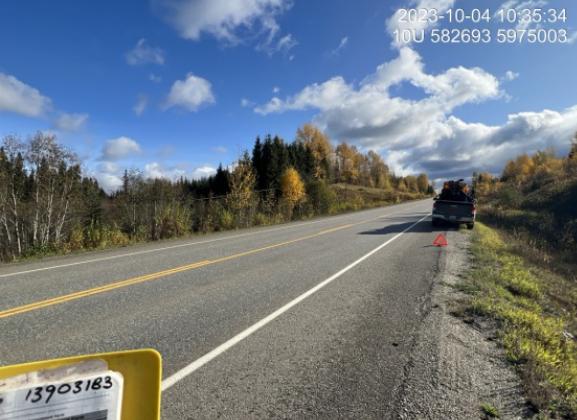
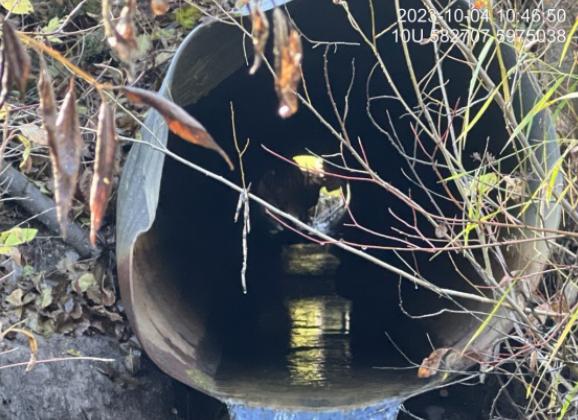
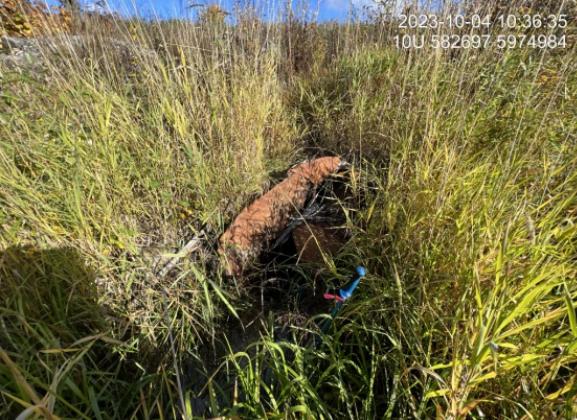
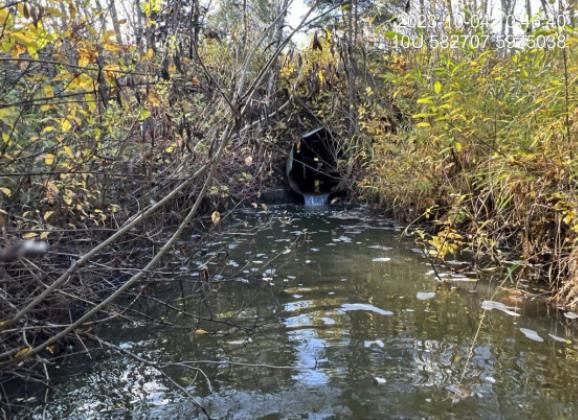
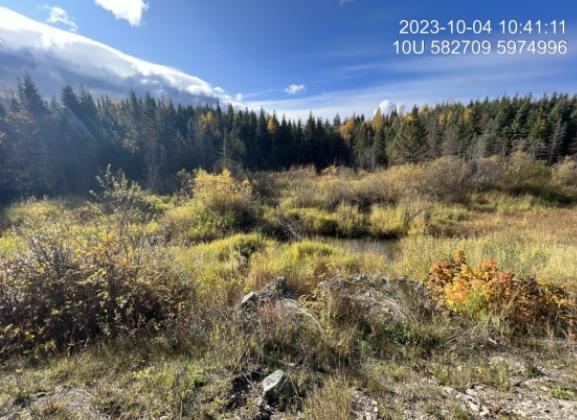
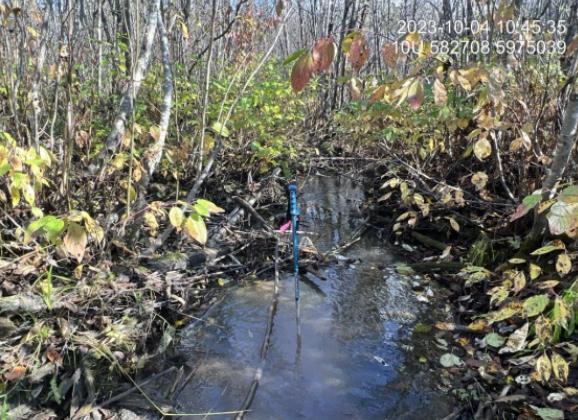
Photos: PSCIS ID 13903183. From top left clockwise: Road/Site Card, Barrel, Outlet, Downstream, Upstream, Inlet.

Location and Stream Data		Crossing Characteristics	
Date	2023-10-04	Crossing Sub Type	Round Culvert
PSCIS ID	199257	Diameter (m)	1.2
External ID	13903183	Length (m)	30
Crew	AI	Embedded	No
UTM Zone	10	Depth Embedded (m)	–
Easting	582694	Resemble Channel	No
Northing	5975012	Backwatered	No
Stream	Tributary to Kenneth Creek	Percent Backwatered	–
Road	Highway 16	Fill Depth (m)	3.5
Road Tenure	MOTI	Outlet Drop (m)	0.35
Channel Width (m)	2.2	Outlet Pool Depth (m)	0.7
Stream Slope (%)	1.5	Inlet Drop	Yes
Beaver Activity	Yes	Slope (%)	1.5
Habitat Value	Medium	Valley Fill	Deep Fill
Final score	37	Barrier Result	Barrier
Fix type	Replace with New Open Bottom Structure	Fix Span / Diameter	16.5

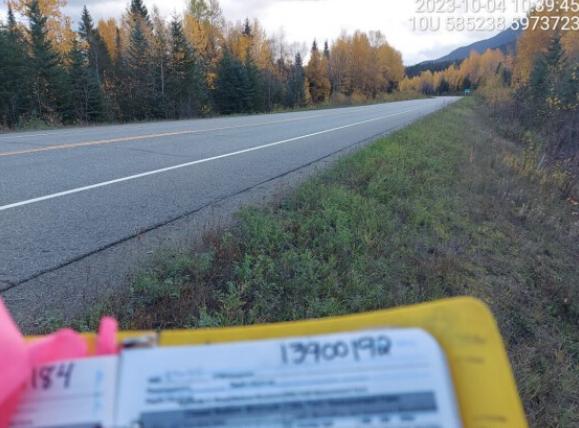
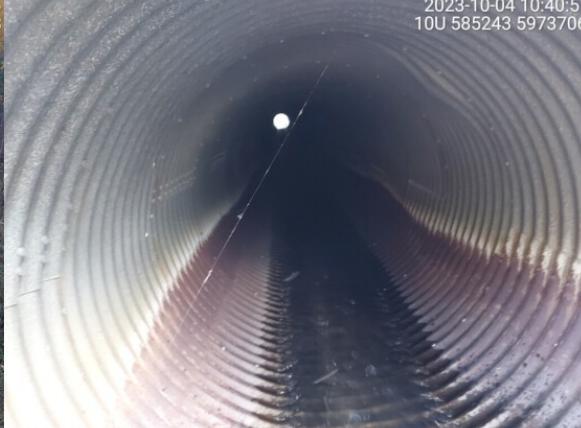
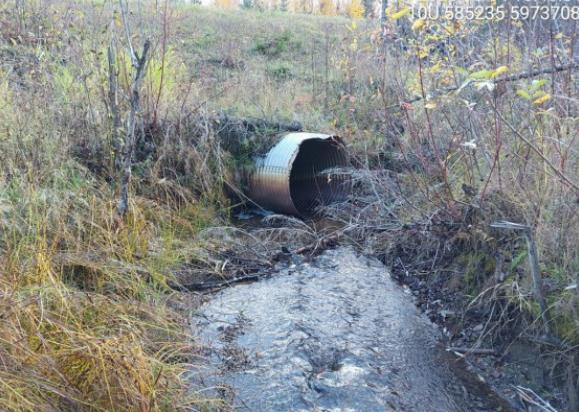
Photos: PSCIS ID 13900192. From top left clockwise: Road/Site Card, Barrel, Outlet, Downstream, Upstream, Inlet.

Location and Stream Data		Crossing Characteristics	
Date	2023-10-04	Crossing Sub Type	Round Culvert
PSCIS ID	199258	Diameter (m)	1.2
External ID	13900192	Length (m)	31
Crew	MW	Embedded	No
UTM Zone	10	Depth Embedded (m)	–
Easting	585255	Resemble Channel	No
Northing	5973726	Backwatered	No
Stream	Tributary to Kenneth Creek	Percent Backwatered	–
Road	Highway 16	Fill Depth (m)	2
Road Tenure	MOTI	Outlet Drop (m)	1.7
Channel Width (m)	2.3	Outlet Pool Depth (m)	0.6
Stream Slope (%)	4.5	Inlet Drop	No
Beaver Activity	No	Slope (%)	5
Habitat Value	High	Valley Fill	Deep Fill
Final score	42	Barrier Result	Barrier
Fix type	Replace with New Open Bottom Structure	Fix Span / Diameter	15

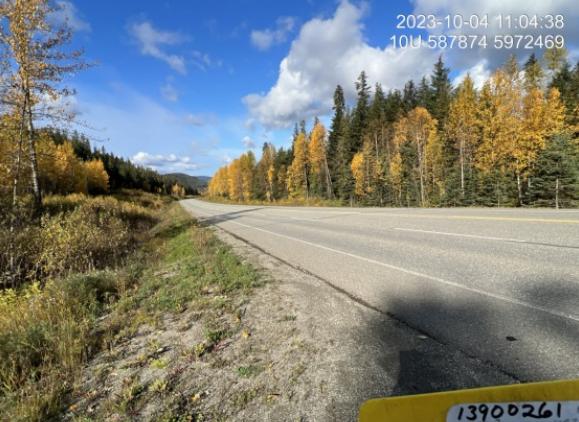
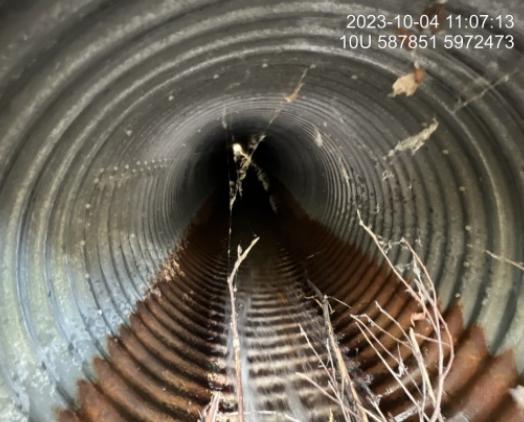
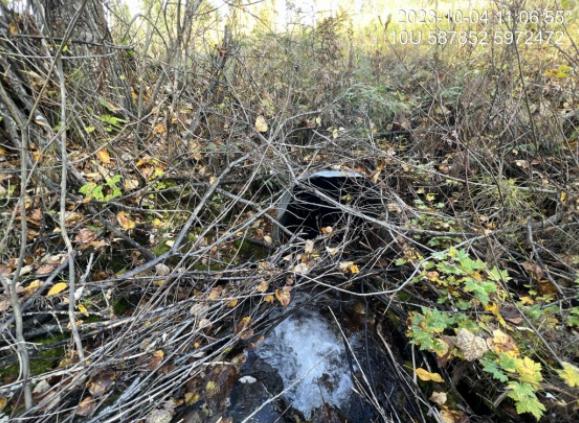
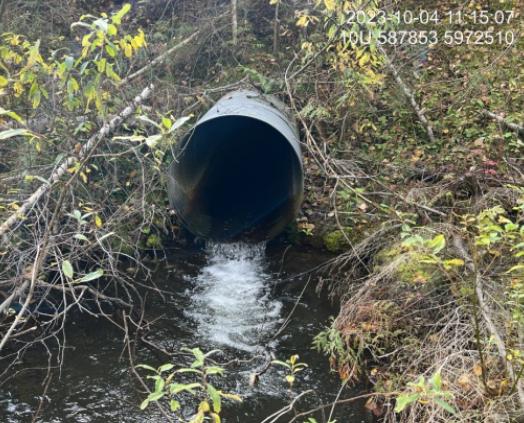
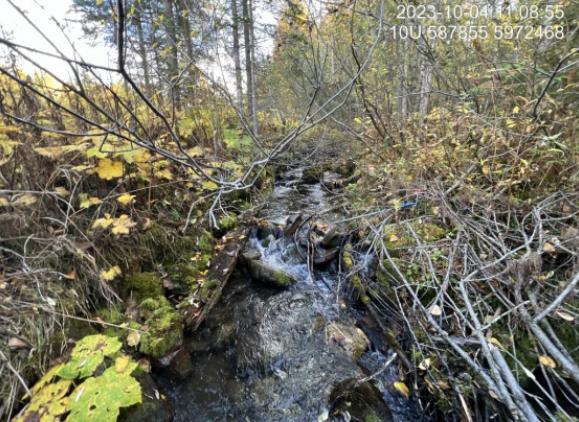
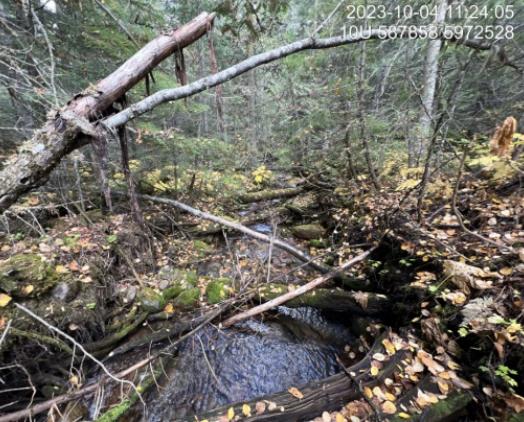
Photos: PSCIS ID 13900261. From top left clockwise: Road/Site Card, Barrel, Outlet, Downstream, Upstream, Inlet.

Location and Stream Data	.	Crossing Characteristics	-
Date	2023-10-04	Crossing Sub Type	Round Culvert
PSCIS ID	199259	Diameter (m)	1.1
External ID	13900261	Length (m)	42
Crew	AI	Embedded	No
UTM Zone	10	Depth Embedded (m)	-
Easting	587876	Resemble Channel	No
Northing	5972476	Backwatered	No
Stream	Tributary to Sugarbowl Creek	Percent Backwatered	-
Road	Highway 16	Fill Depth (m)	7
Road Tenure	MOTI	Outlet Drop (m)	0.2
Channel Width (m)	2.5	Outlet Pool Depth (m)	0.7
Stream Slope (%)	9	Inlet Drop	Yes
Beaver Activity	No	Slope (%)	12
Habitat Value	Medium	Valley Fill	Deep Fill
Final score	37	Barrier Result	Barrier
Fix type	Replace Structure with Streambed Simulation CBS	Fix Span / Diameter	4.5

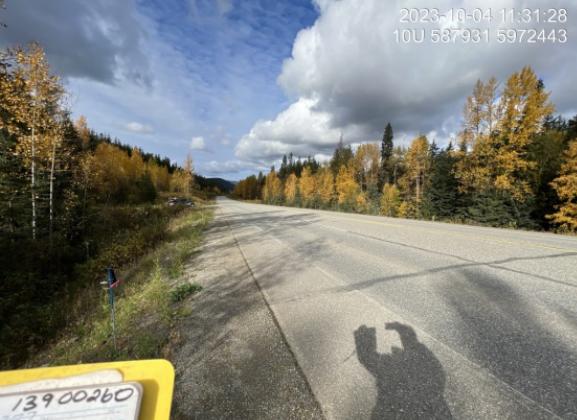
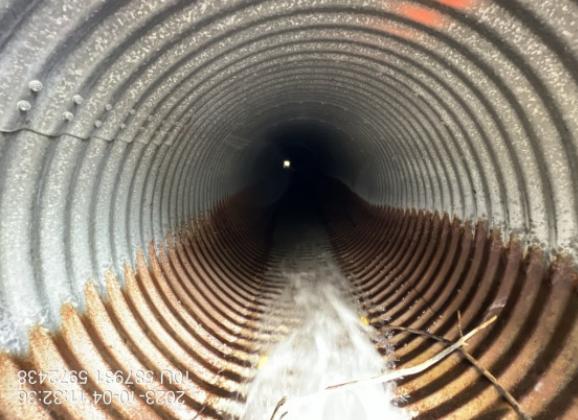
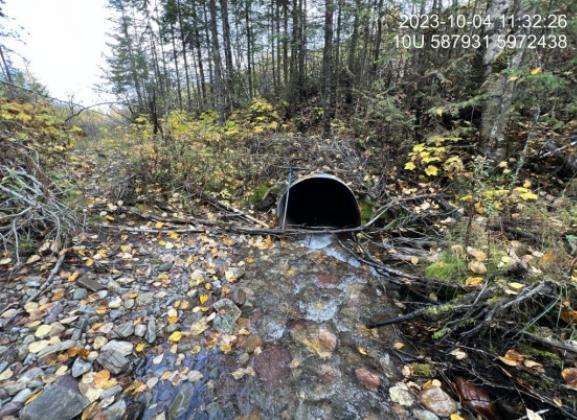
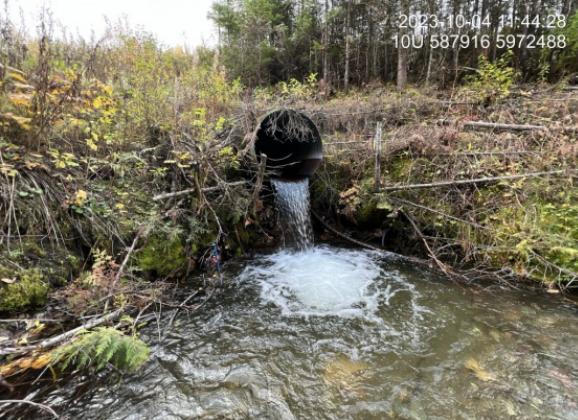
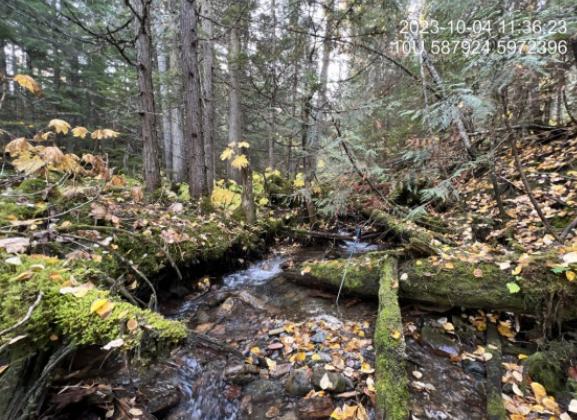
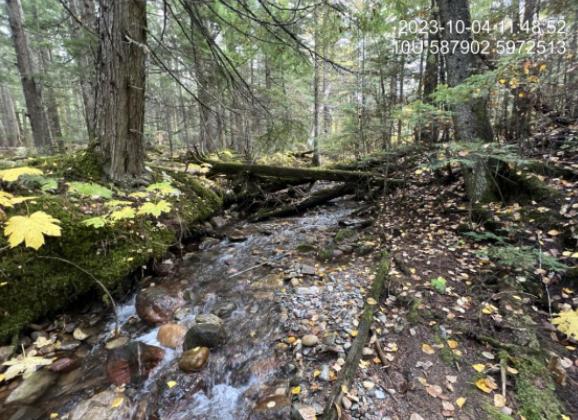
Photos: PSCIS ID 13900260. From top left clockwise: Road/Site Card, Barrel, Outlet, Downstream, Upstream, Inlet.

Location and Stream Data		Crossing Characteristics	
Date	2023-10-04	Crossing Sub Type	Round Culvert
PSCIS ID	199260	Diameter (m)	1.2
External ID	13900260	Length (m)	38
Crew	AI	Embedded	No
UTM Zone	10	Depth Embedded (m)	–
Easting	587936	Resemble Channel	No
Northing	5972452	Backwatered	No
Stream	Tributary to Sugarbowl Creek	Percent Backwatered	–
Road	Highway 16	Fill Depth (m)	8
Road Tenure	MOTI	Outlet Drop (m)	1.15
Channel Width (m)	5.2	Outlet Pool Depth (m)	0.8
Stream Slope (%)	9	Inlet Drop	Yes
Beaver Activity	No	Slope (%)	7
Habitat Value	High	Valley Fill	Deep Fill
Final score	42	Barrier Result	Barrier
Fix type	Replace with New Open Bottom Structure	Fix Span / Diameter	30

Comments: Large stream with abundant gravels present upstream suitable for spawning. Massive outlet drop with powerline riparian cleared downstream of the highway. Old growth cedar hemlock riparian within Sugar bowl grizzly den provincial park. Follow up with habitat confirmation recommended. MoTi chris_culvert_id: 1992815. 11:30:20

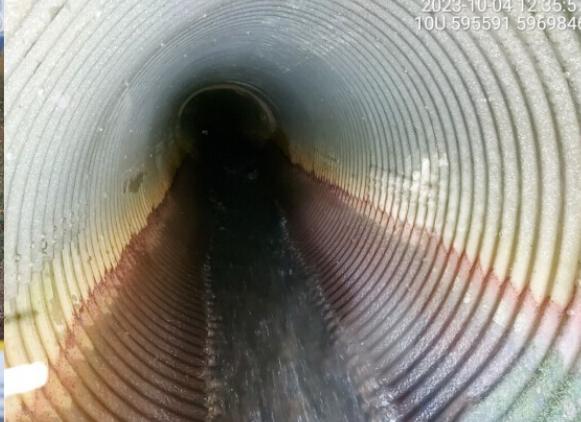
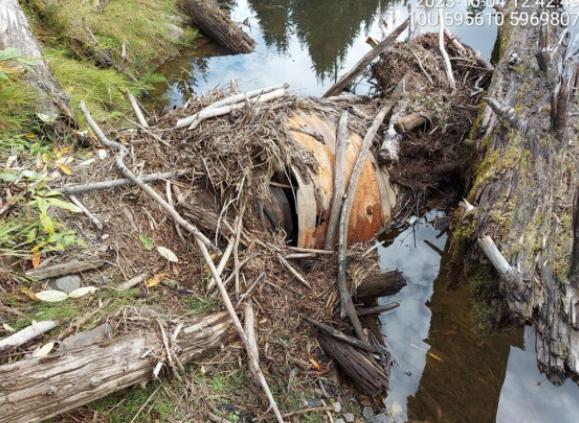
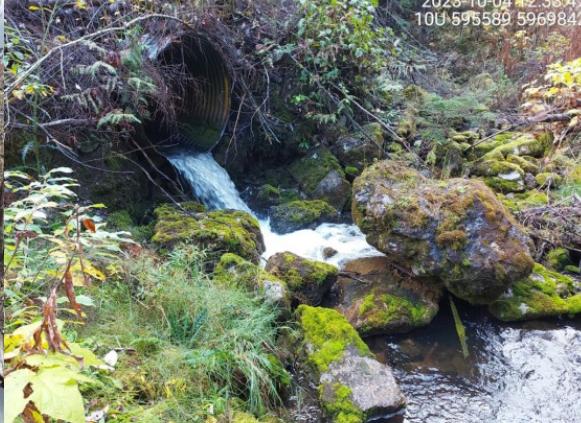
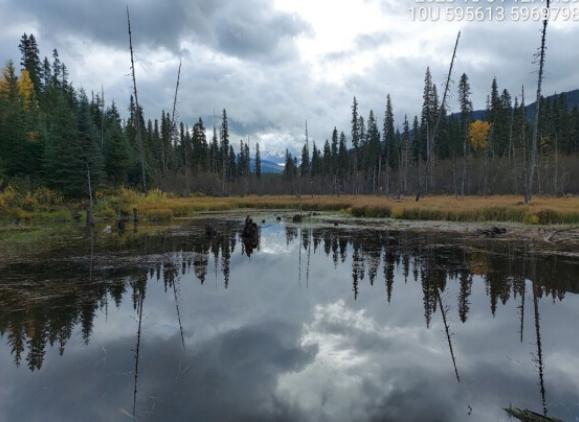
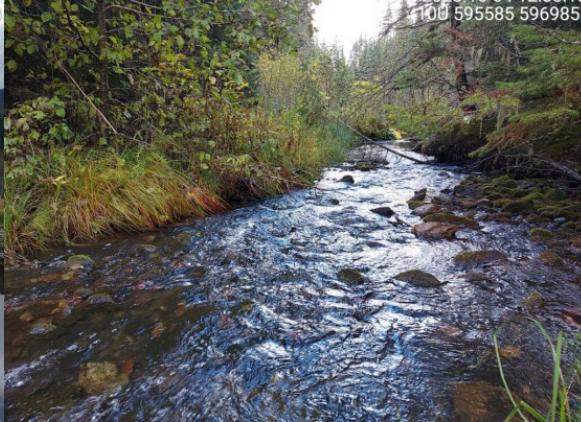
Photos: PSCIS ID 13900270. From top left clockwise: Road/Site Card, Barrel, Outlet, Downstream, Upstream, Inlet.

Location and Stream Data		Crossing Characteristics	
Date	2023-10-04	Crossing Sub Type	Round Culvert
PSCIS ID	199261	Diameter (m)	1.2
External ID	13900270	Length (m)	56
Crew	MW	Embedded	No
UTM Zone	10	Depth Embedded (m)	—
Easting	595602	Resemble Channel	No
Northing	5969818	Backwatered	No
Stream	Tributary to Sugarbowl Creek	Percent Backwatered	—
Road	Highway 16	Fill Depth (m)	6
Road Tenure	MOTI	Outlet Drop (m)	0.9
Channel Width (m)	3.7	Outlet Pool Depth (m)	0.4
Stream Slope (%)	4	Inlet Drop	No
Beaver Activity	Yes	Slope (%)	3
Habitat Value	Medium	Valley Fill	Deep Fill
Final score	42	Barrier Result	Barrier
Fix type	Replace with New Open Bottom Structure	Fix Span / Diameter	24

Comments: Culvert very old. Big wetland complex upstream. Inlet barely visible, covered in woody debris and rusty metal. Culvert slope estimated. High velocity coming out of outlet with moderate drop. Habitat looks good downstream, wide channel with high flow. Crossing is within the Sugarbowl grizzly den provincial park. MoTi chris_culvert_id: 1992569. 12:49:05

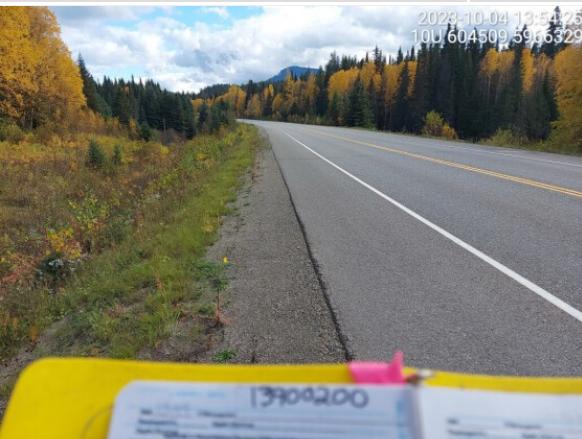
Photos: PSCIS ID 13900200. From top left clockwise: Road/Site Card, Barrel, Outlet, Downstream, Upstream, Inlet.

Location and Stream Data	.	Crossing Characteristics	–
Date	2023-10-04	Crossing Sub Type	Round Culvert
PSCIS ID	199265	Diameter (m)	0.6
External ID	13900200	Length (m)	36
Crew	MW	Embedded	No
UTM Zone	10	Depth Embedded (m)	–
Easting	604596	Resemble Channel	No
Northing	5966257	Backwatered	No
Stream	Tributary to Driscoll Creek	Percent Backwatered	–
Road	Highway 16	Fill Depth (m)	4
Road Tenure	MOTI	Outlet Drop (m)	0.2
Channel Width (m)	1.1	Outlet Pool Depth (m)	0
Stream Slope (%)	2	Inlet Drop	No
Beaver Activity	No	Slope (%)	1.5
Habitat Value	Low	Valley Fill	Deep Fill
Final score	32	Barrier Result	Barrier
Fix type	Replace Structure with Streambed Simulation CBS	Fix Span / Diameter	3

Comments: Big wetland upstream. Inlet could not be found, likely submerged. Small channel downstream, pipe looks old and in bad shape. Overflow pipe near first pipe but not functioning currently. MoTi chris_culvert_id: 1992855.

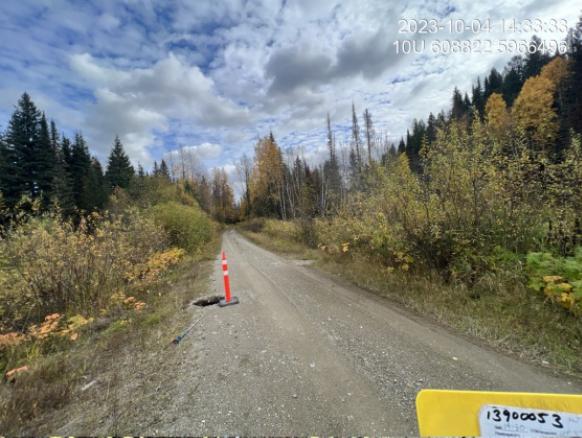
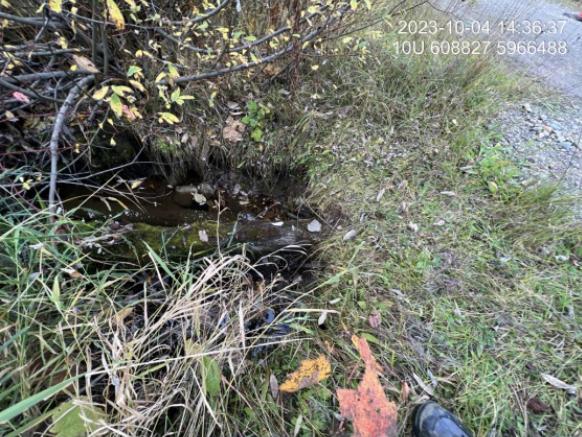
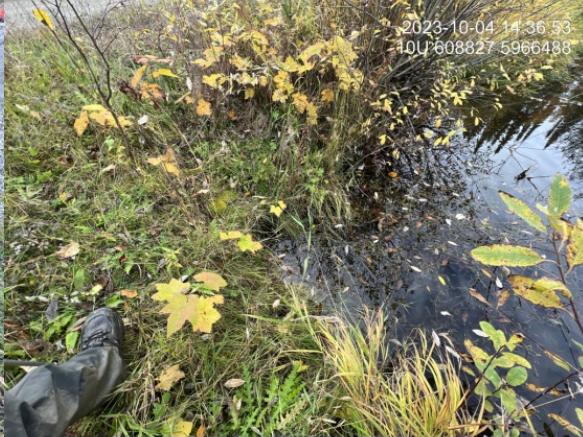
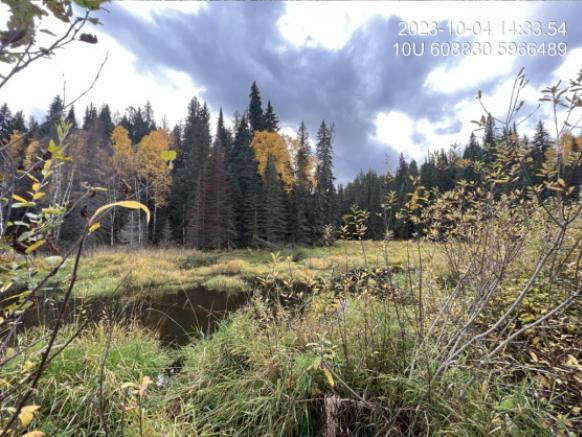
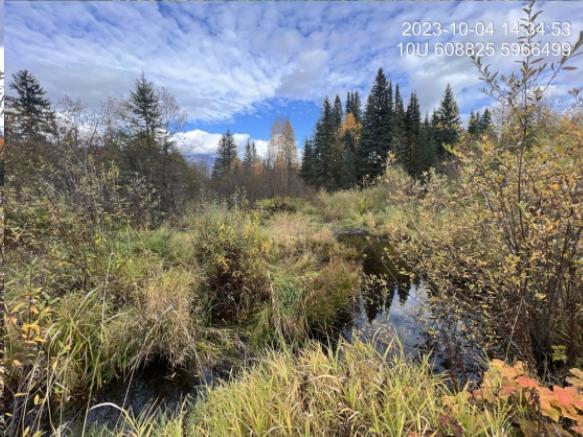
Photos: PSCIS ID 13900053. From top left clockwise: Road/Site Card, Barrel, Outlet, Downstream, Upstream, Inlet.

Comments: Could not locate pipe as it is underwater at both inlet and outlet. There appears to be a bunch of logs under the road so suspect that there may be no structure at all as the drainage may have been put in with logs - although MOT culvert layer says 0.6 m galvanized pipe.. Road is failing with 3 foot deep and 2 foot wide hole in the road marked with a pilon. MoTi chris_culvert_id: 1993428. 14:32:19

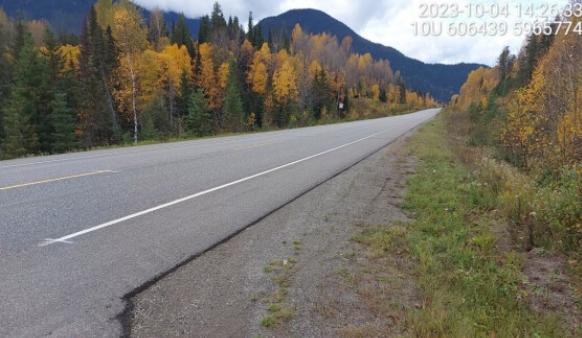
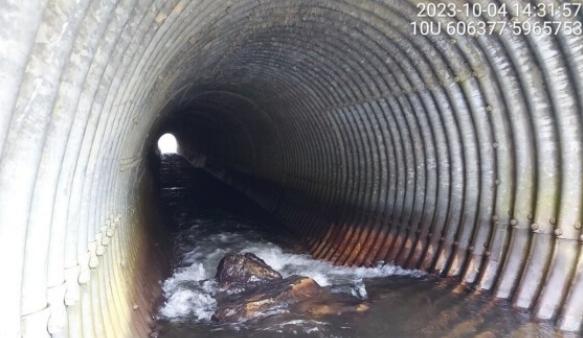
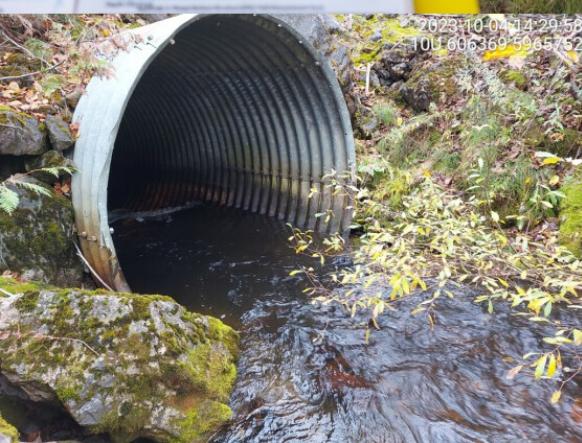
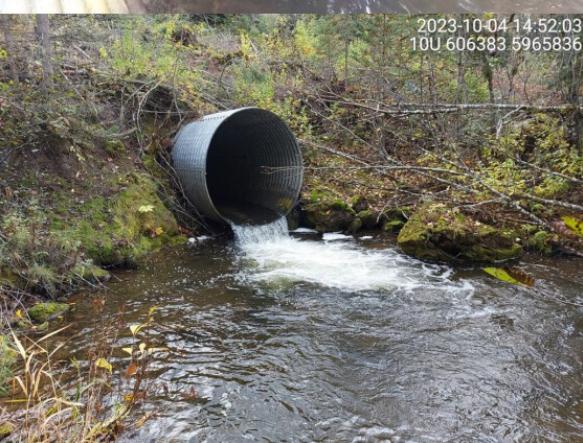
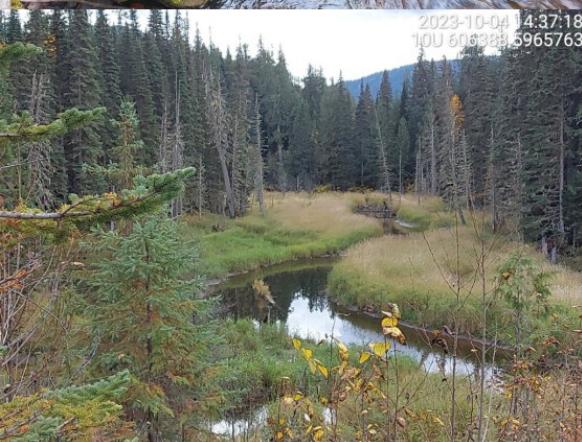
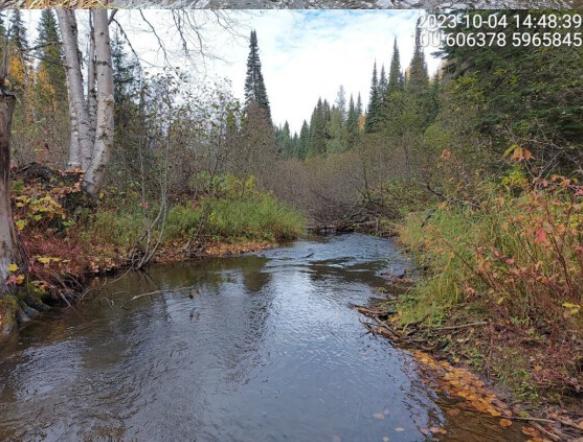
Photos: PSCIS ID 13900201. From top left clockwise: Road/Site Card, Barrel, Outlet, Downstream, Upstream, Inlet.

Comments: Big beaver dam near inlet of culvert spanning across whole channel approx 1.2m high. Boulders in pipe near inlet creating small drop and increasing velocity. Channel widens downstream, high value habitat. RB and CCG confirmed upstream and downstream with chinook observed way downstream at mouth. Low gradient upstream and downstream with decent outlet drop so resampling to determine chinook presence could be insightful. MoTi chris_culvert_id: 1992674. 14:54:00

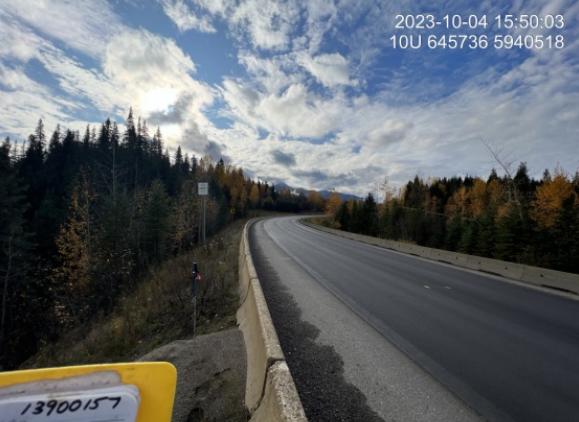
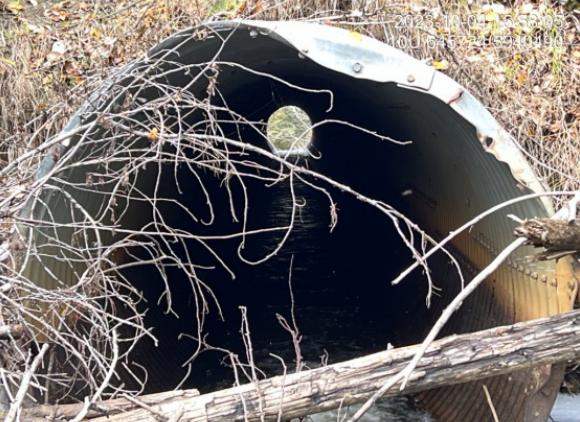
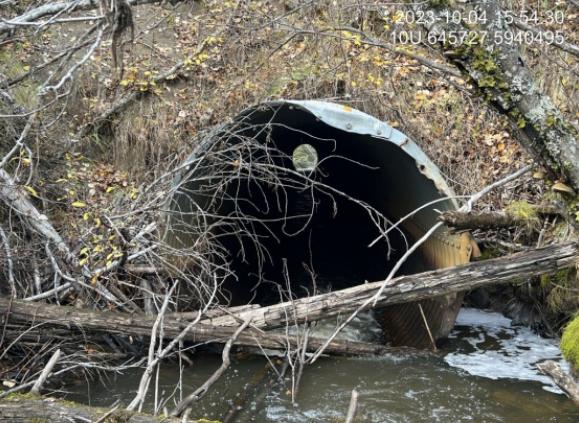
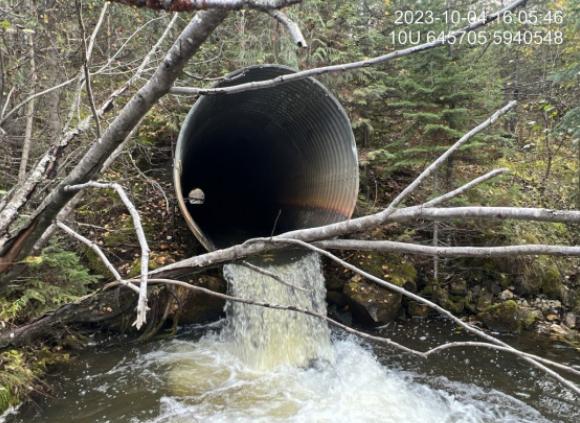
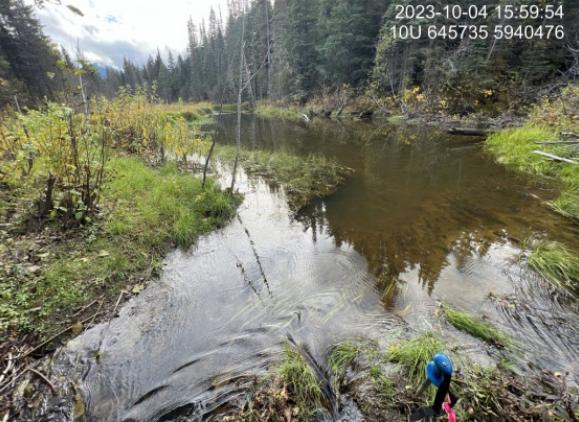
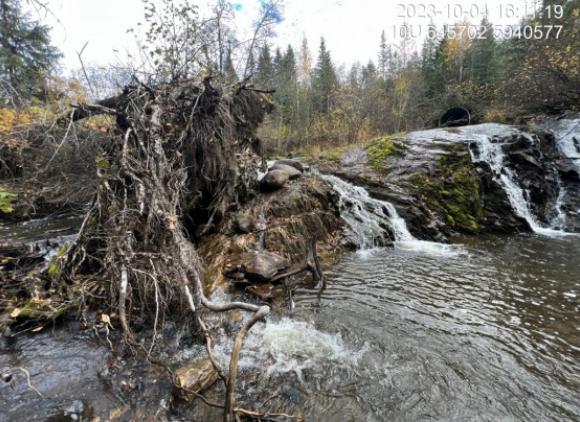
Photos: PSCIS ID 13900157. From top left clockwise: Road/Site Card, Barrel, Outlet, Downstream, Upstream, Inlet.

Comments: Very large system with beaver complex upstream, including a large beaver dam approximately 1.3m high located 25m upstream of the inlet. Approximately 20m downstream of the outlet is a rock chute that is over 30% gradient but only for 5m with a total height of 1.7m. There are two other falls noted as FISS obstacles between this crossing and the Fraser River downstream. There is significant erosion of the road prism on the upstream side above the culvert. Culvert is located on the bend of Highway 16 under 10m of road fill. Noted falls and lack of fish observations indicated access issues downstream. MoTi chris_culvert_id: 1992752. 16:16:08

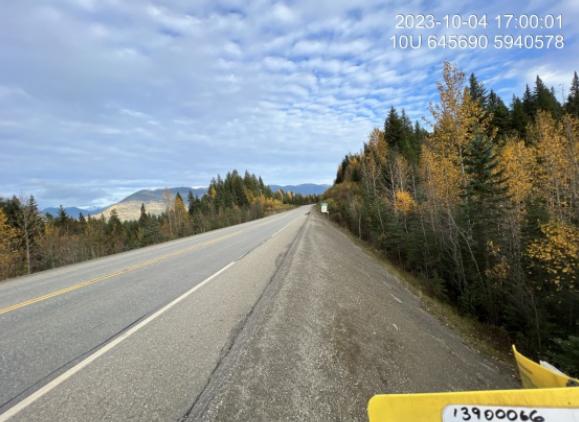
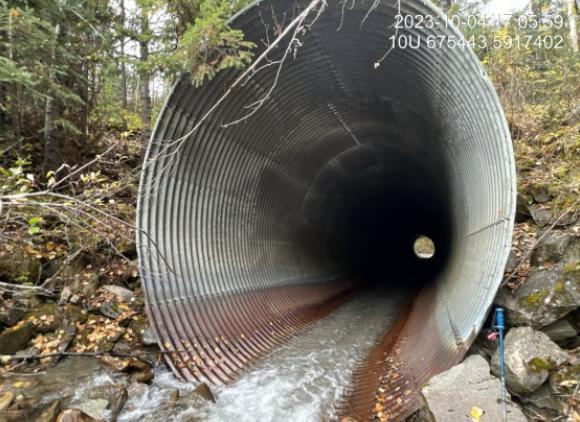
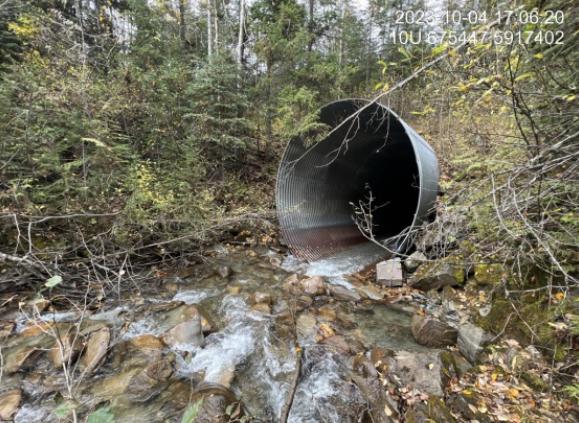
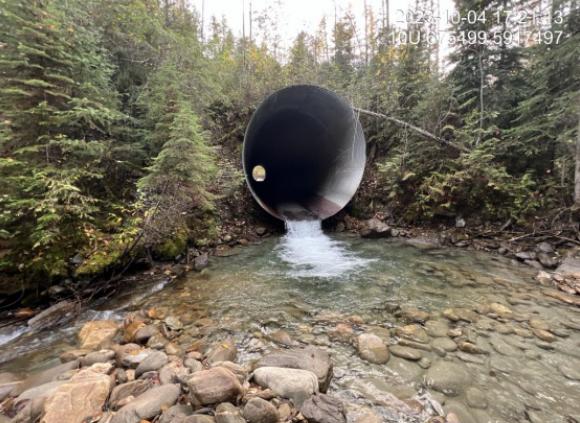
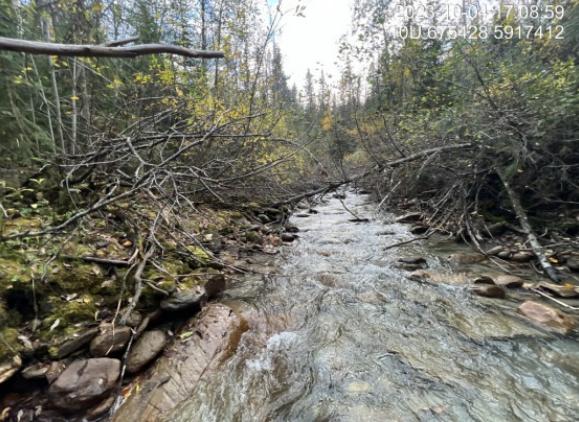
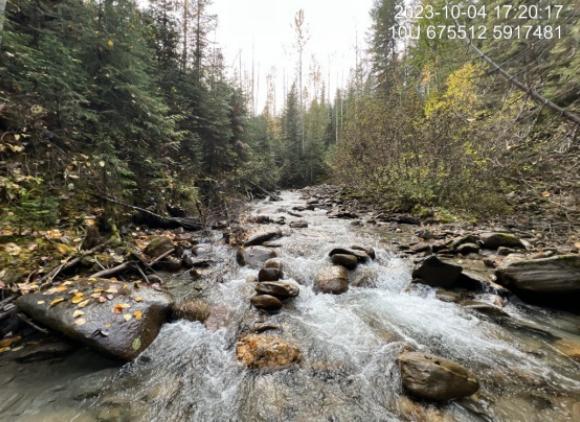
Photos: PSCIS ID 13900066. From top left clockwise: Road/Site Card, Barrel, Outlet, Downstream, Upstream, Inlet.

Location and Stream Data		Crossing Characteristics	
Date	2023-10-04	Crossing Sub Type	Round Culvert
PSCIS ID	199270	Diameter (m)	5
External ID	13900066	Length (m)	90
Crew	AI	Embedded	No
UTM Zone	10	Depth Embedded (m)	—
Easting	675449	Resemble Channel	No
Northing	5917446	Backwatered	No
Stream	Clyde Creek	Percent Backwatered	—
Road	Highway 16	Fill Depth (m)	9.9
Road Tenure	MOTI	Outlet Drop (m)	0.75
Channel Width (m)	6.4	Outlet Pool Depth (m)	1.8
Stream Slope (%)	3.5	Inlet Drop	Yes
Beaver Activity	No	Slope (%)	4
Habitat Value	High	Valley Fill	Deep Fill
Final score	39	Barrier Result	Barrier
Fix type	Replace with New Open Bottom Structure	Fix Span / Diameter	35.5
Comments: Absolutely massive structure with 12 m of fill plus the height of the culvert which appears to be approximately 7m. Fill depth changed to 9.9m to satisfy submission template macros. Very nice large stream with boulder step pool habitat suitable for bull trout. Falls noted just downstream in FISS but not observed in field with minimal survey. MoTi chris_hwy_structure_road_id: 3691. 17:00:34

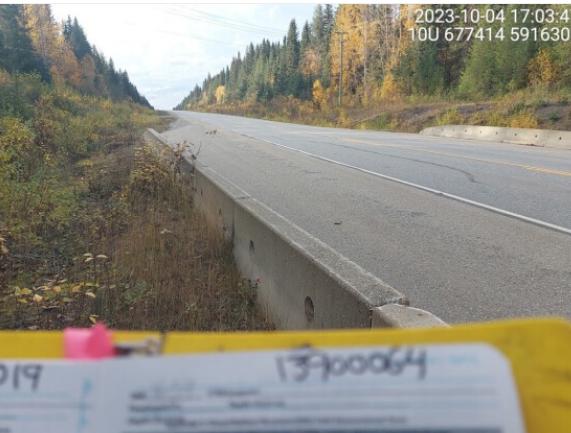
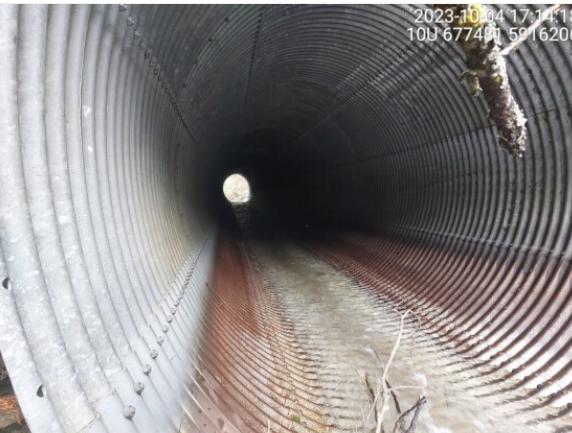
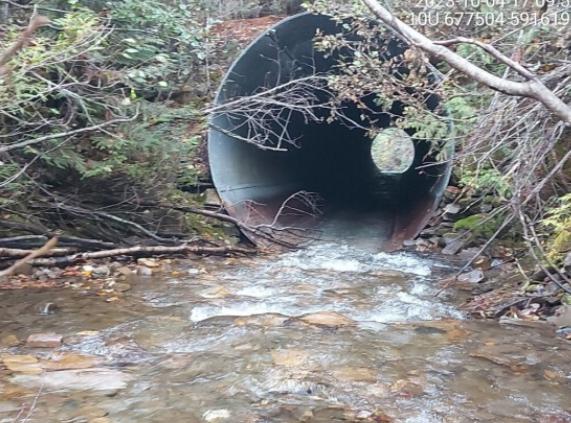
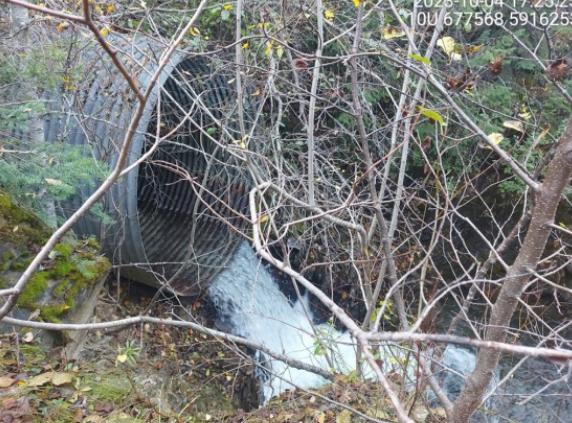
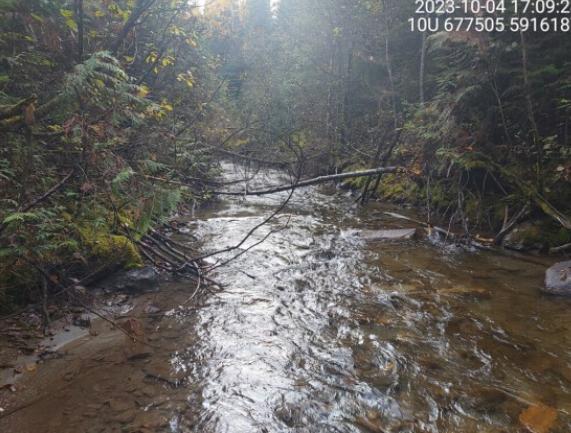
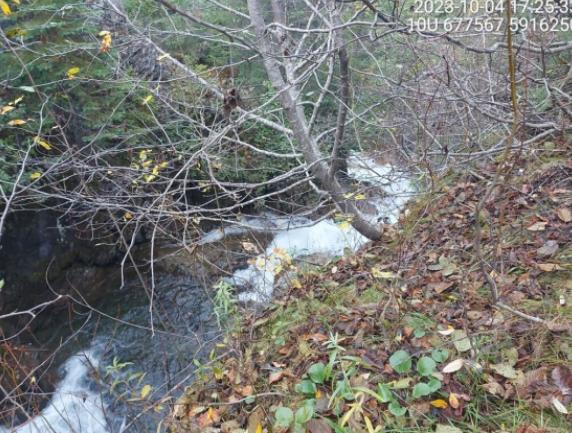
Photos: PSCIS ID 13900064. From top left clockwise: Road/Site Card, Barrel, Outlet, Downstream, Upstream, Inlet.

Comments: Deep canyon and high waterfall directly downstream of crossing which is a definite barrier to all fish. Rough estimate 20m height. Outlet drop and pool estimated because it was unsafe to get near stream due to steep embankment. RB confirmed upstream of crossing in 2017 and 2020, but the falls downstream is a definite barrier. MoTi chris_hwy_structure_road_id: 30367. 17:27:23

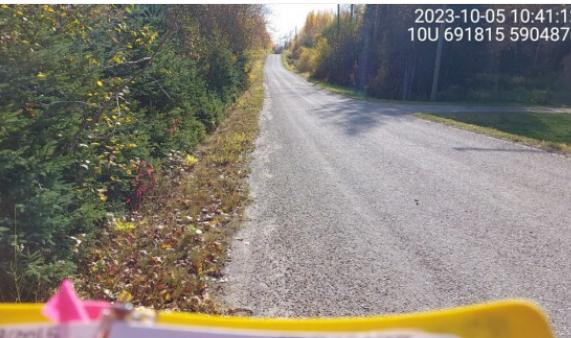
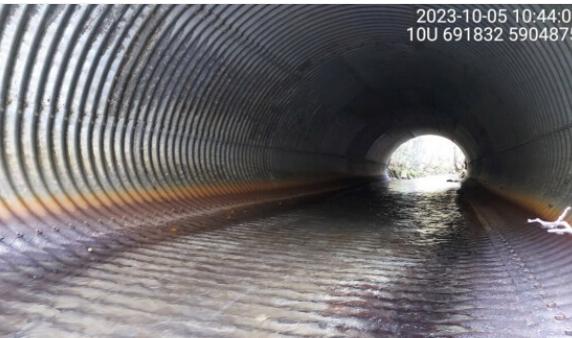
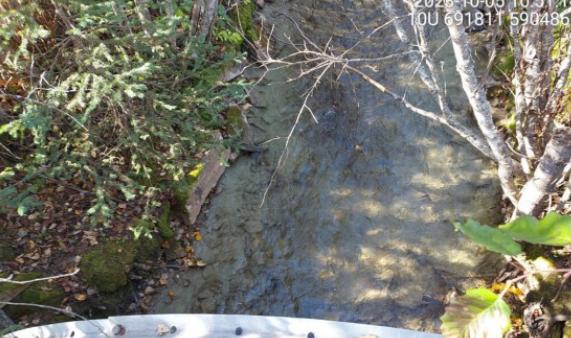
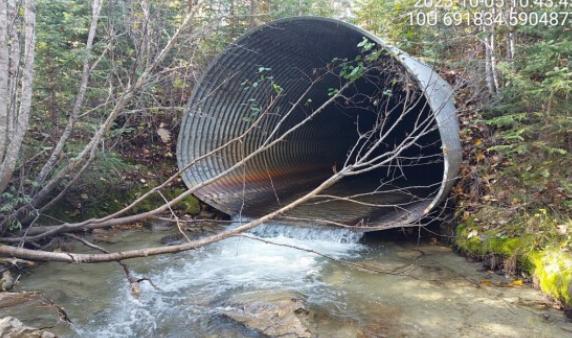
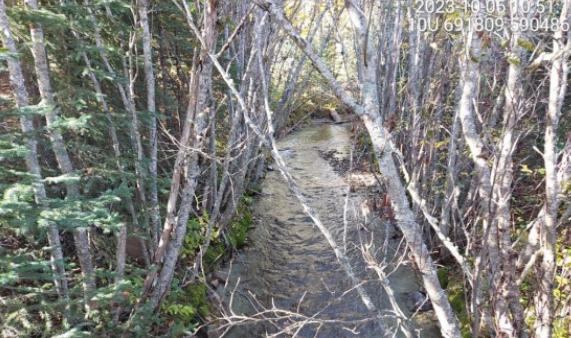
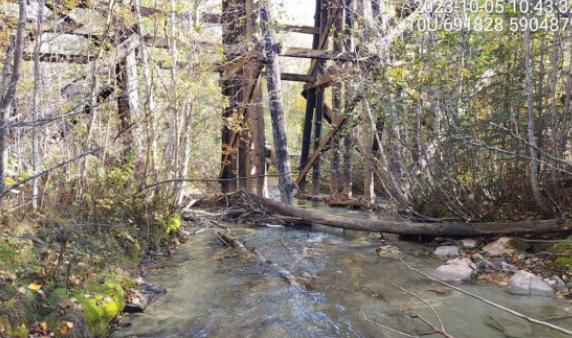
Photos: PSCIS ID 13900077. From top left clockwise: Road/Site Card, Barrel, Outlet, Downstream, Upstream, Inlet.

Location and Stream Data		Crossing Characteristics	
Date	2023-10-05	Crossing Sub Type	Oval Culvert
PSCIS ID	199273	Diameter (m)	4.5
External ID	13900077	Length (m)	28
Crew	MW	Embedded	No
UTM Zone	10	Depth Embedded (m)	—
Easting	691822	Resemble Channel	No
Northing	5904863	Backwatered	No
Stream	Hankins Creek	Percent Backwatered	—
Road	Eddy Rd	Fill Depth (m)	1.5
Road Tenure	MOTI Local	Outlet Drop (m)	0.3
Channel Width (m)	6.7	Outlet Pool Depth (m)	0.2
Stream Slope (%)	1.5	Inlet Drop	No
Beaver Activity	No	Slope (%)	0.5
Habitat Value	High	Valley Fill	Deep Fill
Final score	29	Barrier Result	Barrier
Fix type	Replace with New Open Bottom Structure	Fix Span / Diameter	15
