Appendix - Phase 1 Fish Passage Assessment Data and Photos

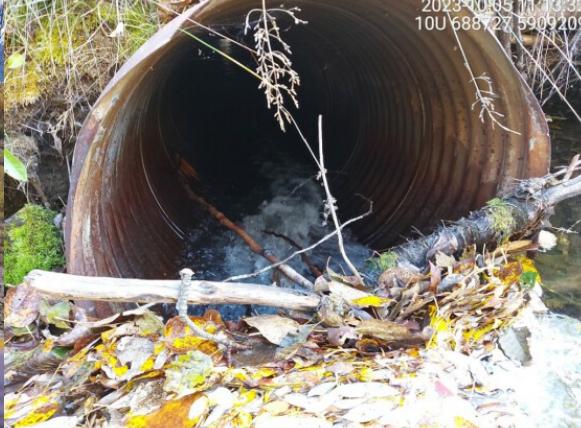
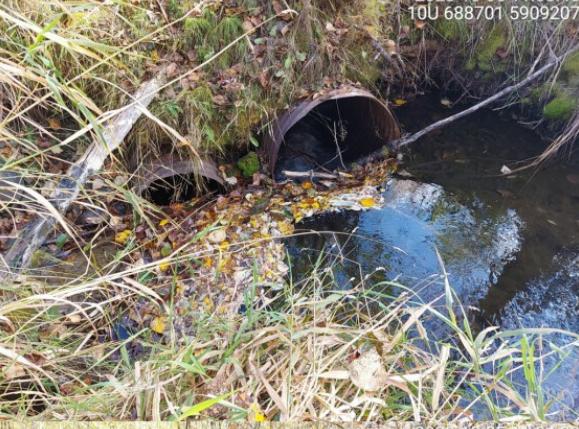
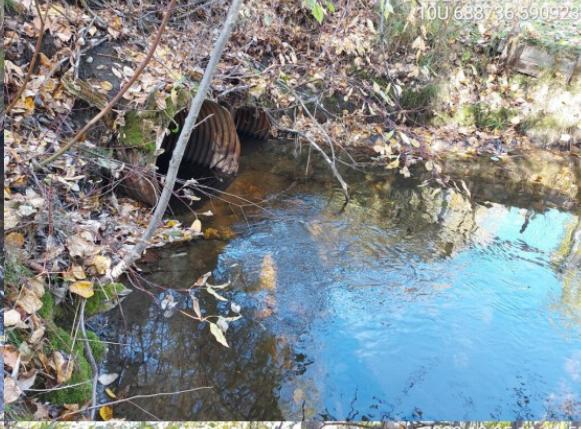
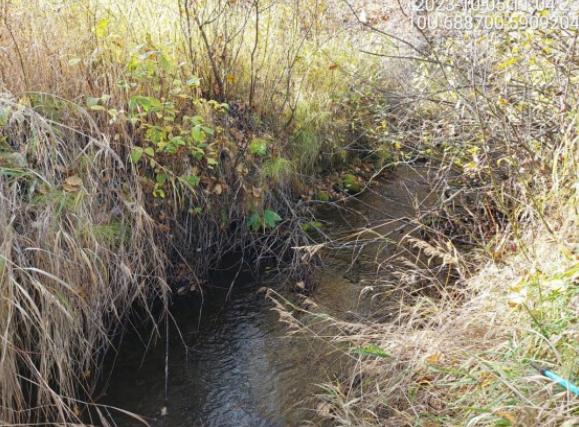
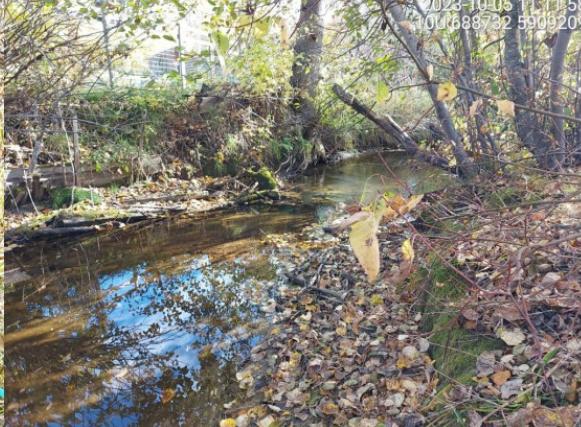
Photos: PSCIS ID 13900003. From top left clockwise: Road/Site Card, Barrel, Outlet, Downstream, Upstream, Inlet.

Location and Stream Data		Crossing Characteristics	
Date	2023-10-05	Crossing Sub Type	Round Culvert
PSCIS ID	199274	Diameter (m)	1.5
External ID	13900003	Length (m)	18
Crew	MW	Embedded	No
UTM Zone	10	Depth Embedded (m)	–
Easting	688720	Resemble Channel	No
Northing	5909202	Backwatered	No
Stream	Dominion Creek	Percent Backwatered	–
Road	1st Ave	Fill Depth (m)	3
Road Tenure	McBride	Outlet Drop (m)	0
Channel Width (m)	2.3	Outlet Pool Depth (m)	0
Stream Slope (%)	2	Inlet Drop	Yes
Beaver Activity	No	Slope (%)	1
Habitat Value	High	Valley Fill	Deep Fill
Final score	24	Barrier Result	Barrier
Fix type	Replace with New Open Bottom Structure	Fix Span / Diameter	15

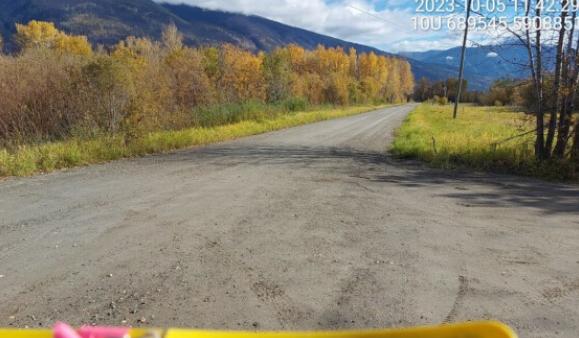
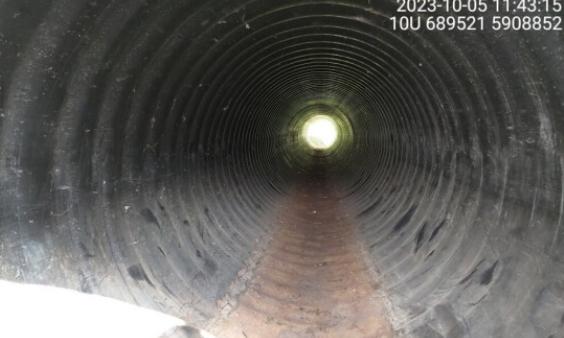
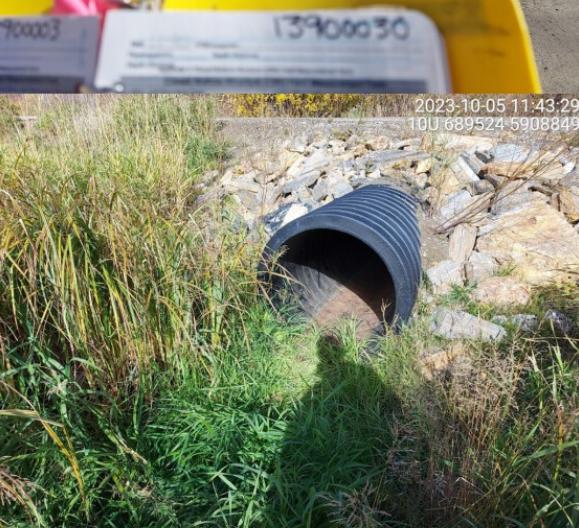
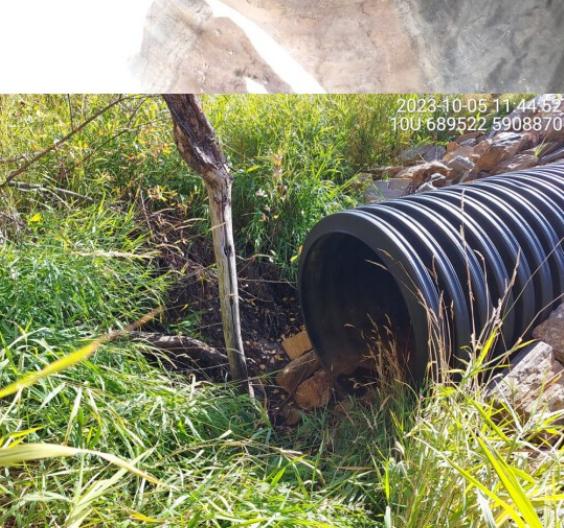
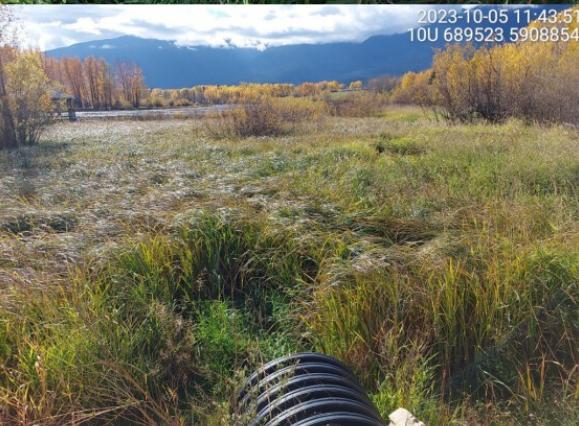
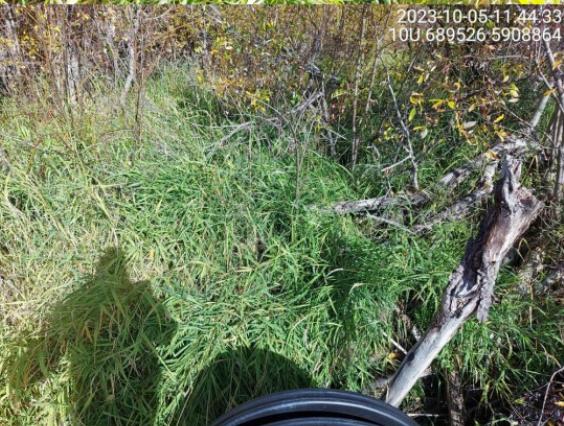
Photos: PSCIS ID 13900030. From top left clockwise: Road/Site Card, Barrel, Outlet, Downstream, Upstream, Inlet.

Location and Stream Data		Crossing Characteristics	
Date	2023-10-05	Crossing Sub Type	Round Culvert
PSCIS ID	199275	Diameter (m)	0.9
External ID	13900030	Length (m)	15
Crew	MW	Embedded	No
UTM Zone	10	Depth Embedded (m)	—
Easting	689523	Resemble Channel	No
Northing	5908856	Backwatered	No
Stream	Tributary to Dominion Creek	Percent Backwatered	—
Road	Horseshoe Lake Rd	Fill Depth (m)	0.5
Road Tenure	MOTI Local	Outlet Drop (m)	0
Channel Width (m)	0.9	Outlet Pool Depth (m)	0
Stream Slope (%)	1	Inlet Drop	No
Beaver Activity	No	Slope (%)	1
Habitat Value	Low	Valley Fill	Deep Fill
Final score	21	Barrier Result	Barrier
Fix type	Replace Structure with Streambed Simulation CBS	Fix Span / Diameter	3

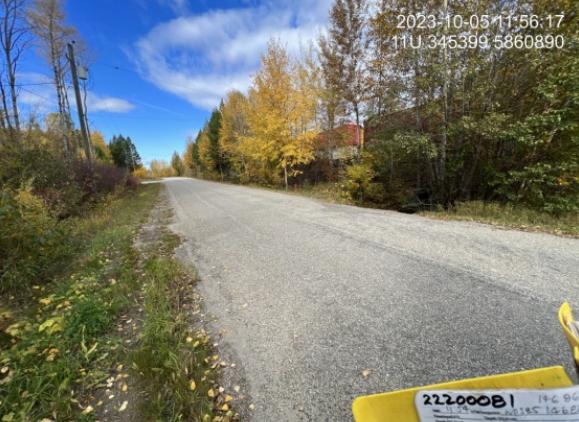
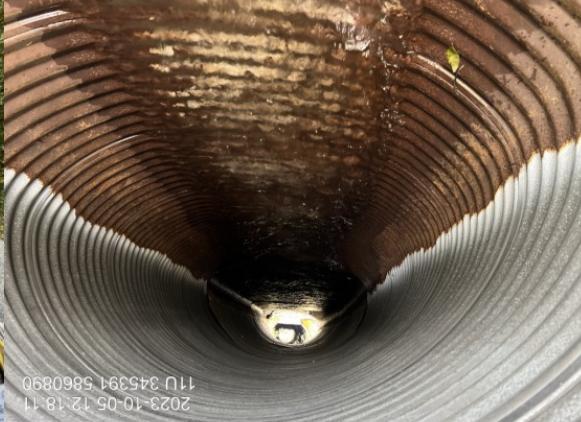
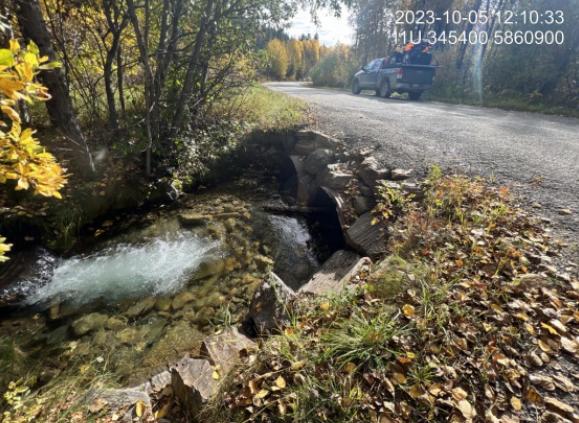
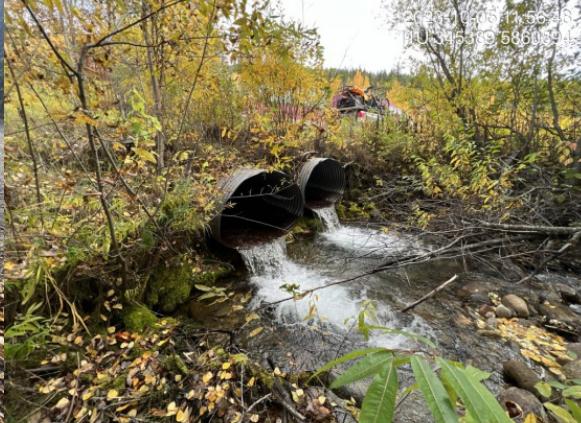
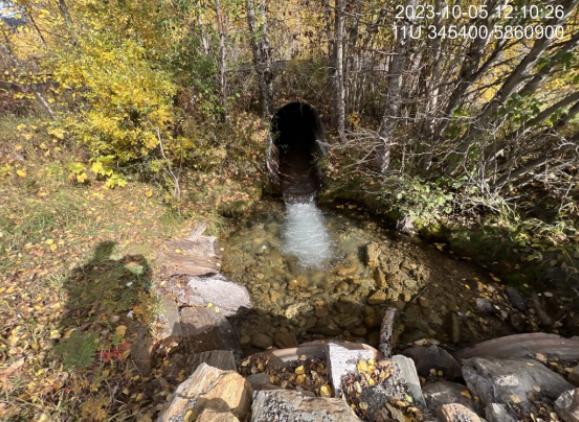
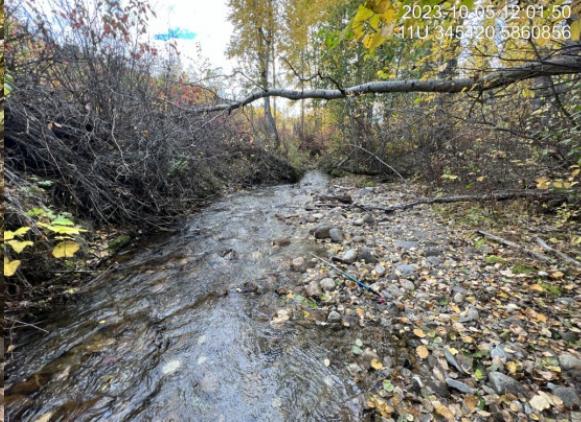
Photos: PSCIS ID 22200081. From top left clockwise: Road/Site Card, Barrel, Outlet, Downstream, Upstream, Inlet.

Location and Stream Data		.	Crossing Characteristics	-
Date	2023-10-05		Crossing Sub Type	Oval Culvert
PSCIS ID	199276		Diameter (m)	2.8
External ID	22200081		Length (m)	13
Crew	MW		Embedded	No
UTM Zone	11		Depth Embedded (m)	-
Easting	345396		Resemble Channel	No
Northing	5860898		Backwatered	No
Stream	Crooked Creek		Percent Backwatered	-
Road	Loseth Road		Fill Depth (m)	1
Road Tenure	MOTI		Outlet Drop (m)	0.42
Channel Width (m)	3.4		Outlet Pool Depth (m)	0.5
Stream Slope (%)	4.5		Inlet Drop	No
Beaver Activity	No		Slope (%)	4
Habitat Value	Medium		Valley Fill	Deep Fill
Final score	33		Barrier Result	Barrier
Fix type	Replace with New Open Bottom Structure		Fix Span / Diameter	15

Comments: Two pipes at 1.4m diameter each. Crossing is only 5m downstream of the railway crossing. The stream has bigger volume of water at this location than it did below Highway 5 downstream. Water may be recharging beaver influenced wetlands downstream. Road edge has been armoured with riprap and downstream side of road bank is eroding significantly for approximately 60m. MoTi chris_culvert_id: 1468680, 1468681. 12:14:12

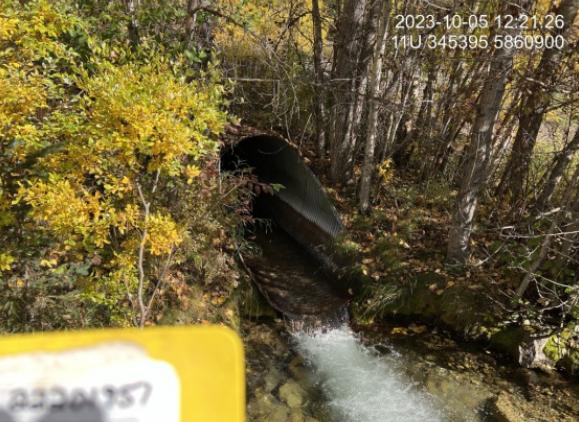
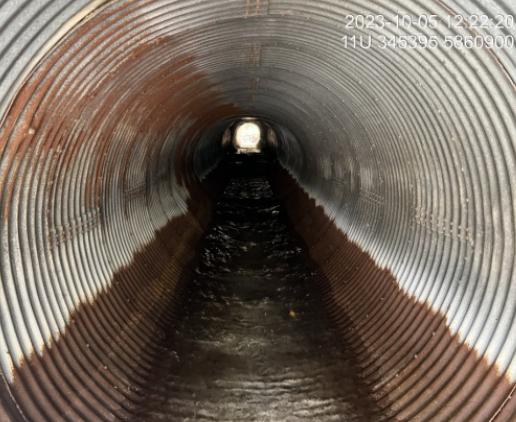
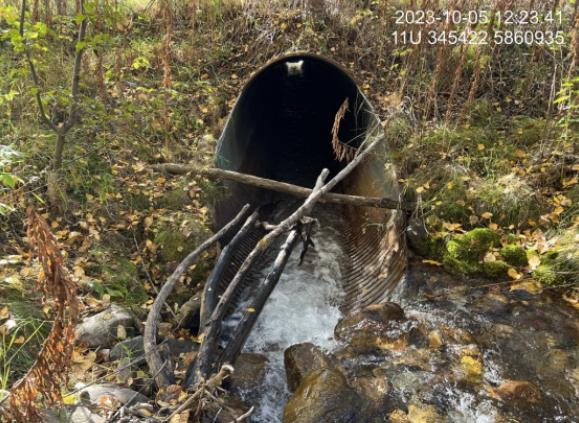
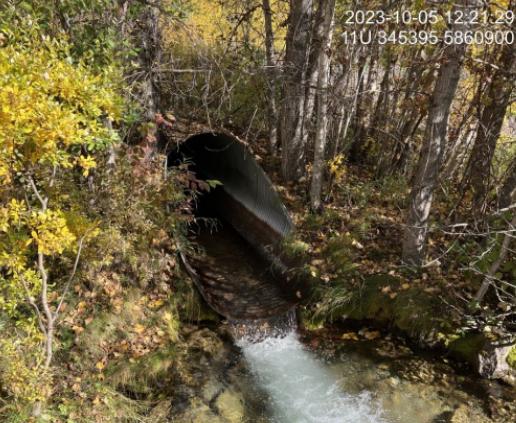
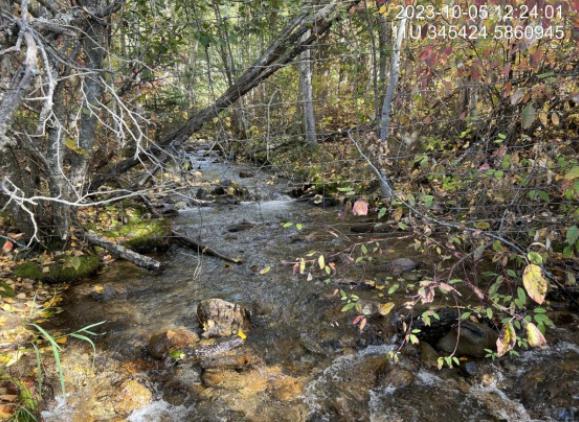
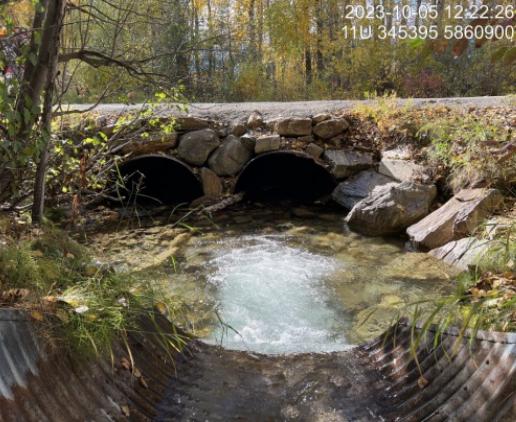
Photos: PSCIS ID 22201951. From top left clockwise: Road/Site Card, Barrel, Outlet, Downstream, Upstream, Inlet.

Location and Stream Data		Crossing Characteristics	
Date	2023-10-05	Crossing Sub Type	Round Culvert
PSCIS ID	199277	Diameter (m)	1.7
External ID	22201951	Length (m)	40
Crew	MW	Embedded	No
UTM Zone	11	Depth Embedded (m)	—
Easting	345405	Resemble Channel	No
Northing	5860914	Backwatered	No
Stream	Crooked Creek	Percent Backwatered	—
Road	Railway	Fill Depth (m)	2.5
Road Tenure	CN Rail	Outlet Drop (m)	0.2
Channel Width (m)	3.6	Outlet Pool Depth (m)	0.75
Stream Slope (%)	4.5	Inlet Drop	Yes
Beaver Activity	No	Slope (%)	2.5
Habitat Value	Medium	Valley Fill	Deep Fill
Final score	32	Barrier Result	Barrier
Fix type	Replace with New Open Bottom Structure	Fix Span / Diameter	15

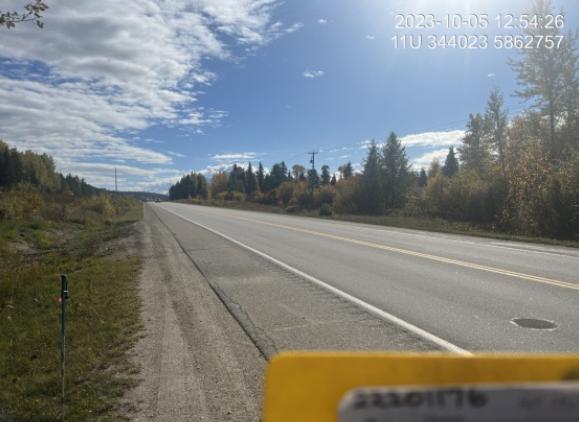
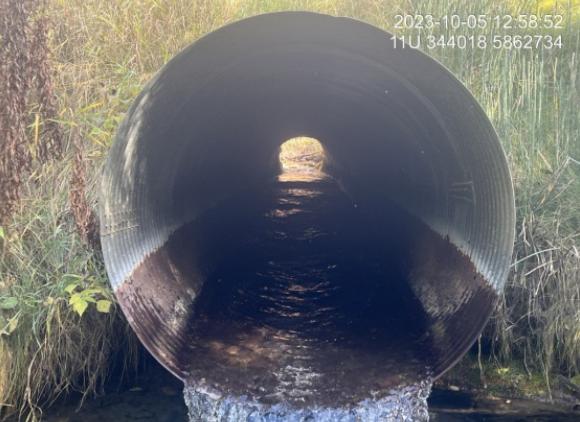
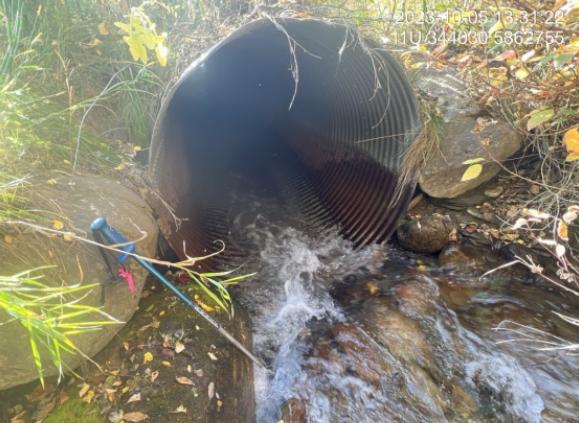
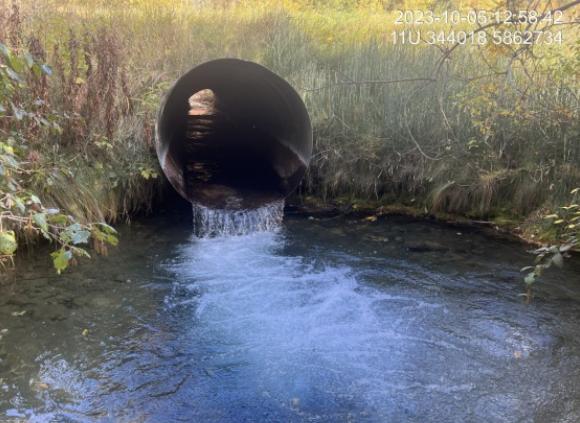
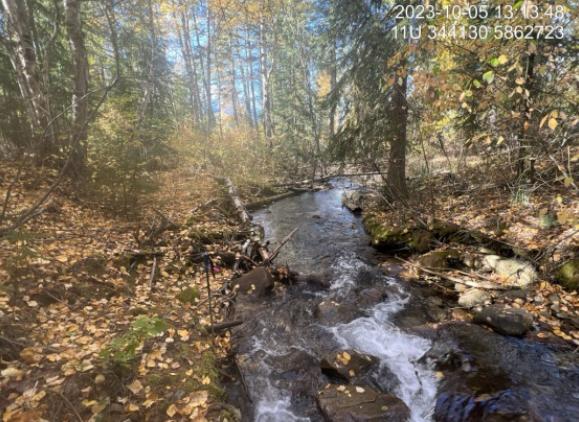
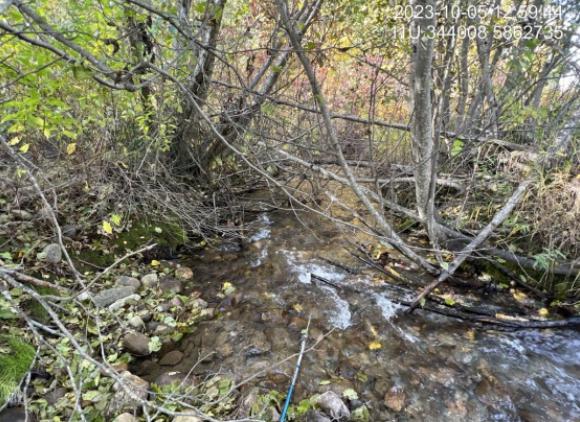
Photos: PSCIS ID 22201176. From top left clockwise: Road/Site Card, Barrel, Outlet, Downstream, Upstream, Inlet.

Location and Stream Data		Crossing Characteristics	
Date	2023-10-05	Crossing Sub Type	Round Culvert
PSCIS ID	199278	Diameter (m)	1.5
External ID	22201176	Length (m)	26
Crew	MW	Embedded	No
UTM Zone	11	Depth Embedded (m)	—
Easting	344016	Resemble Channel	No
Northing	5862741	Backwatered	No
Stream	Teepee Creek	Percent Backwatered	—
Road	Highway 5	Fill Depth (m)	1.5
Road Tenure	MOTI	Outlet Drop (m)	0.4
Channel Width (m)	4.5	Outlet Pool Depth (m)	1
Stream Slope (%)	3.5	Inlet Drop	Yes
Beaver Activity	No	Slope (%)	1.5
Habitat Value	High	Valley Fill	Deep Fill
Final score	34	Barrier Result	Barrier
Fix type	Replace with New Open Bottom Structure	Fix Span / Diameter	15

Comments: Very nice stream with salmon point in FISS located upstream. Very good flow with some pools present to 80cm deep upstream. Unassessed railway crossing approximately 200m upstream. There is no crossing at the pipeline but construction activities have resulted in a small cascade of boulders at the pipe which is similar to the natural cascade section observed approximately 50m upstream. Railway crossing downstream which is ranked as a barrier.
MoTi chris_culvert_id: 1467202. 12:56:09

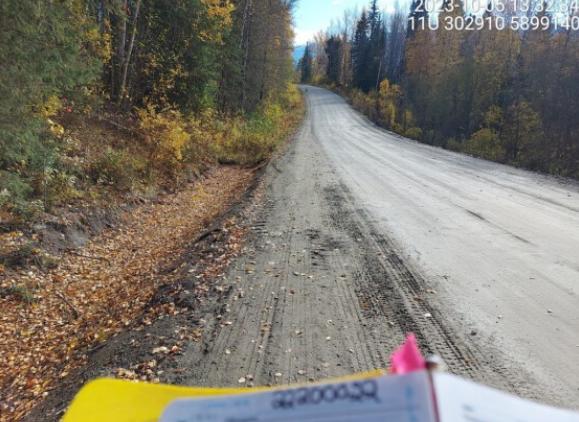
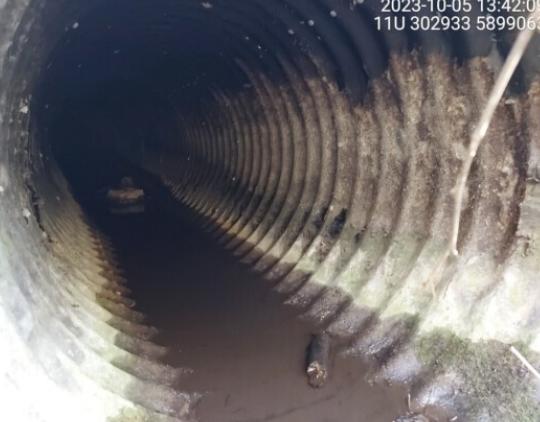
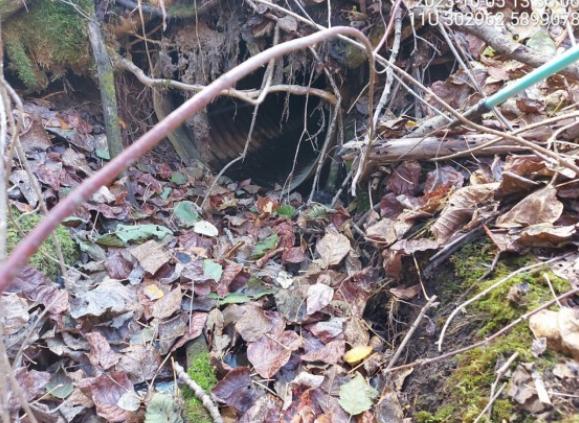
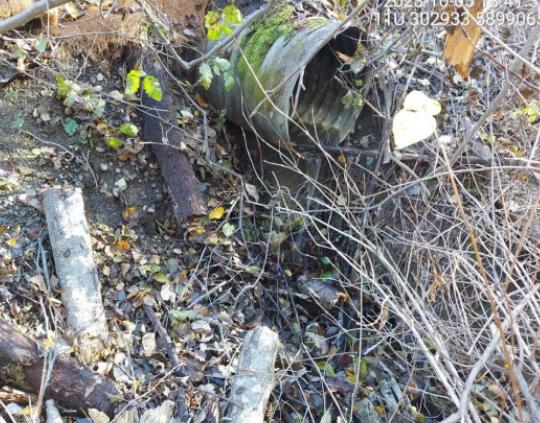
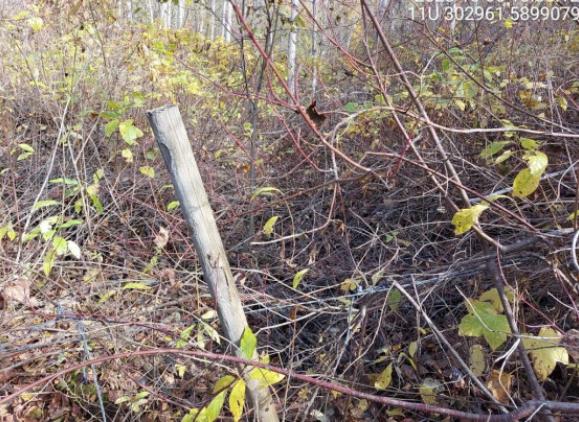
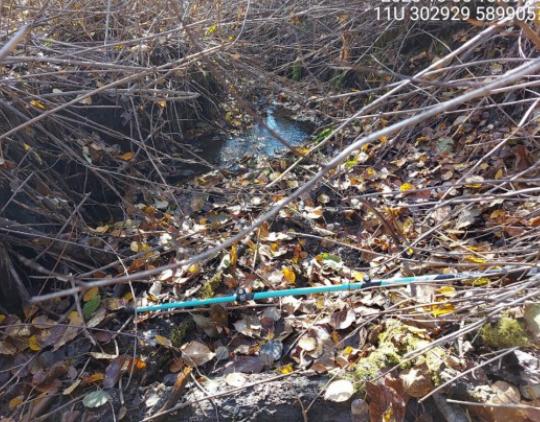
Location and Stream Data		Crossing Characteristics	
Date	2023-10-05	Crossing Sub Type	Round Culvert
PSCIS ID	199279	Diameter (m)	0.6
External ID	22200022	Length (m)	20
Crew	MW	Embedded	No
UTM Zone	11	Depth Embedded (m)	—
Easting	302951	Resemble Channel	No
Northing	5899072	Backwatered	No
Stream	Tributary to Fraser river	Percent Backwatered	—
Road	Hinkelman Rd	Fill Depth (m)	5
Road Tenure	MOTI Local	Outlet Drop (m)	0.7
Channel Width (m)	1.4	Outlet Pool Depth (m)	0
Stream Slope (%)	3	Inlet Drop	No
Beaver Activity	No	Slope (%)	1
Habitat Value	Low	Valley Fill	Deep Fill
Final score	34	Barrier Result	Barrier
Fix type	Replace Structure with Streambed Simulation CBS	Fix Span / Diameter	3
Comments: Very small stream with low flow. Embankment above outlet has been covered to prevent rockslide. MoTi chris_culvert_id: 1461358. 13:46:10			
Photos: PSCIS ID 22200022. From top left clockwise: Road/Site Card, Barrel, Outlet, Downstream, Upstream, Inlet.

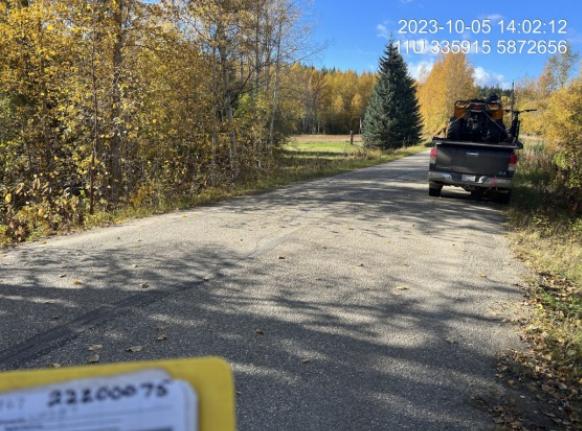
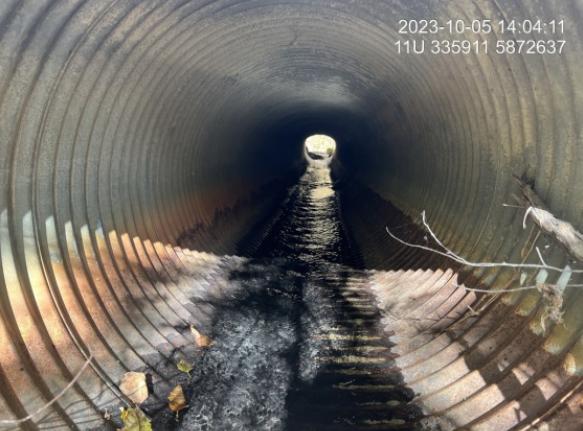
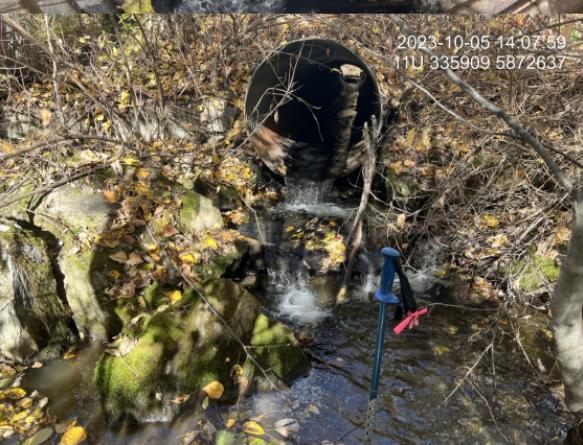
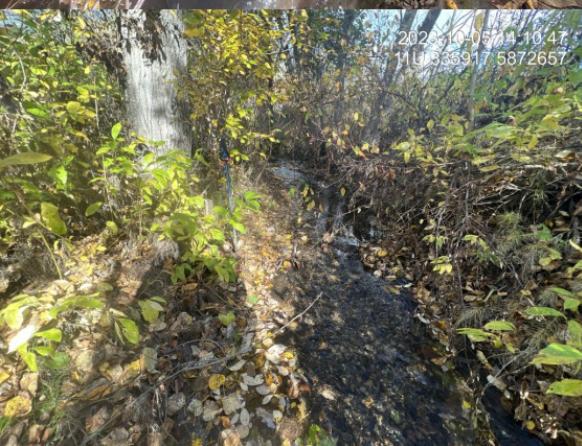
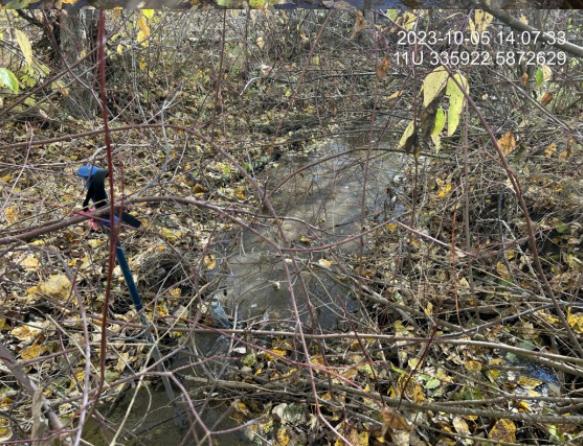
Photos: PSCIS ID 22200075. From top left clockwise: Road/Site Card, Barrel, Outlet, Downstream, Upstream, Inlet.

Location and Stream Data	.	Crossing Characteristics	
Date	2023-10-05	Crossing Sub Type	Round Culvert
PSCIS ID	199280	Diameter (m)	1.05
External ID	22200075	Length (m)	19
Crew	MW	Embedded	No
UTM Zone	11	Depth Embedded (m)	–
Easting	335908	Resemble Channel	No
Northing	5872652	Backwatered	No
Stream	L'Esrange Creek	Percent Backwatered	–
Road	L'heureux Road	Fill Depth (m)	1.8
Road Tenure	MOTI	Outlet Drop (m)	0.5
Channel Width (m)	2.2	Outlet Pool Depth (m)	0.4
Stream Slope (%)	2	Inlet Drop	No
Beaver Activity	No	Slope (%)	3
Habitat Value	Medium	Valley Fill	Deep Fill
Final score	39	Barrier Result	Barrier
Fix type	Replace with New Open Bottom Structure	Fix Span / Diameter	15
Comments: Nice little stream with good flow and abundant small gravel's upstream. There may be crossings downstream on private land. Significant amount of large riprap placed around inlet and outlet to protect the crossing. Outlet is placed on large piece of riprap, so 0.3m was added to the 0.2m outlet drop to account for the additional distance from the stream to the outlet. RB observed upstream. MoTi chris_culvert_id: 1466467. 14:00:15

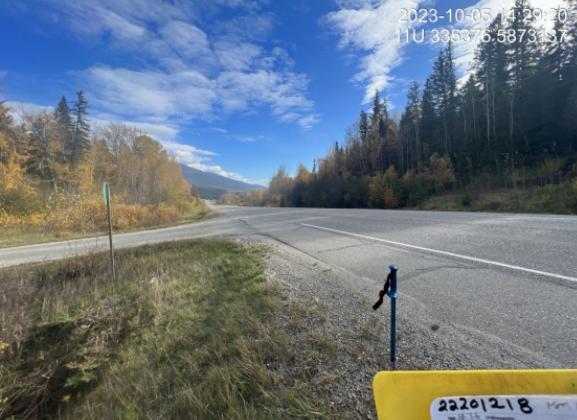
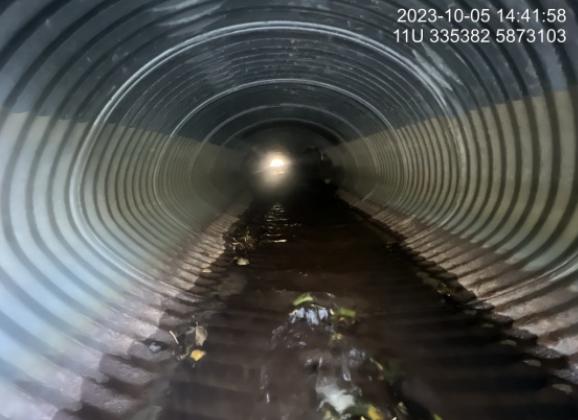
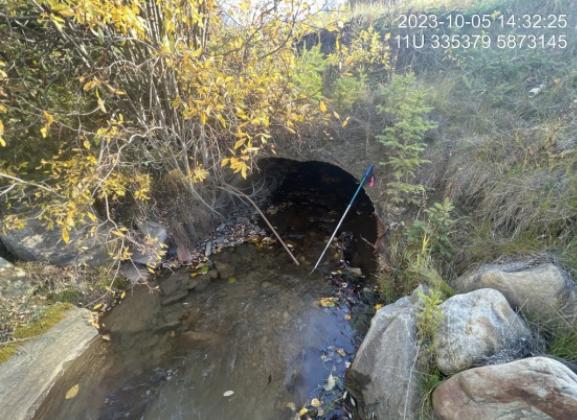
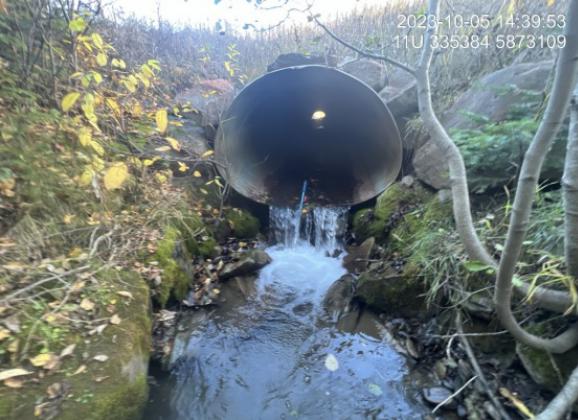
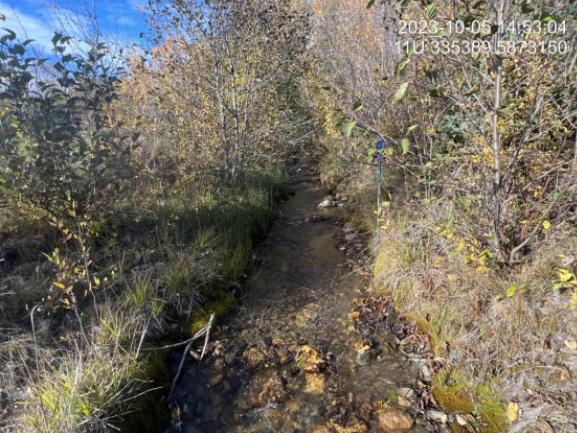
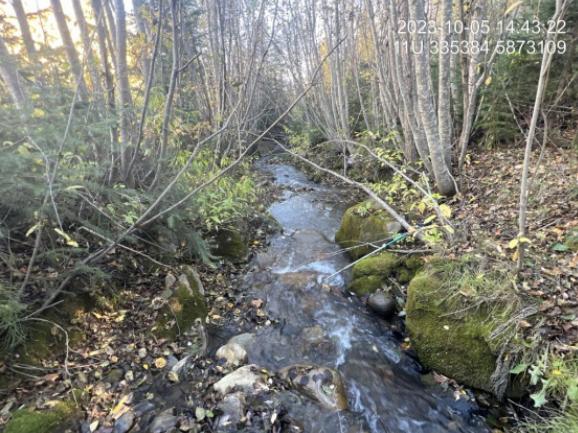
Photos: PSCIS ID 22201218. From top left clockwise: Road/Site Card, Barrel, Outlet, Downstream, Upstream, Inlet.

Location and Stream Data		•	Crossing Characteristics	-
Date	2023-10-05		Crossing Sub Type	Oval Culvert
PSCIS ID	199281		Diameter (m)	1.7
External ID	22201218		Length (m)	35
Crew	MW		Embedded	No
UTM Zone	11		Depth Embedded (m)	-
Easting	335375		Resemble Channel	No
Northing	5873132		Backwatered	No
Stream	Goslin Creek		Percent Backwatered	-
Road	Highway 16		Fill Depth (m)	2
Road Tenure	MOTI		Outlet Drop (m)	0.4
Channel Width (m)	1		Outlet Pool Depth (m)	0.4
Stream Slope (%)	0		Inlet Drop	No
Beaver Activity	No		Slope (%)	2
Habitat Value	Medium		Valley Fill	Deep Fill
Final score	31		Barrier Result	Barrier
Fix type	Replace Structure with Streambed Simulation CBS		Fix Span / Diameter	3
Comments: Very nice stream with good flow and abundant gravels upstream. Pipe is an extremely bad shape with extensive corrosion inside of the pipe particularly at the downstream end - see photos. Likely at least one crossing downstream on private land. Transmission line corridor is located immediately upstream and the channel appears to be modified in this location to be straighter and narrower than its natural state. No crossing immediately upstream on Goslin Road (no road - crossing should be removed as potential barrier in bcfishpass) MoTi chris_culvert_id: 1465295. 14:28:28

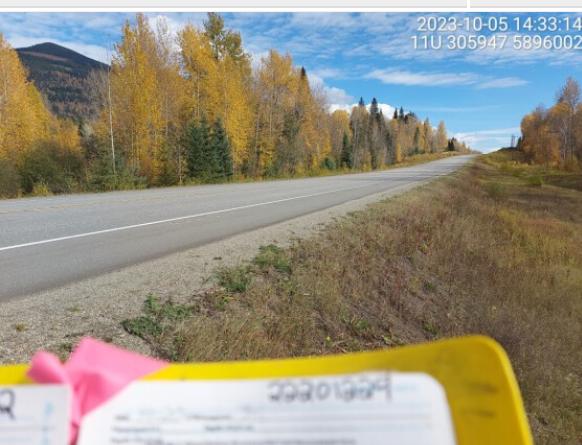
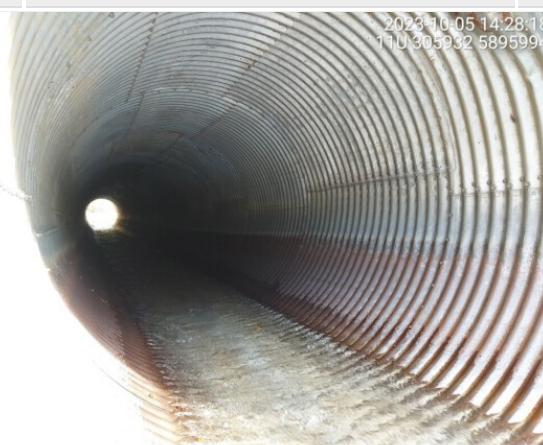
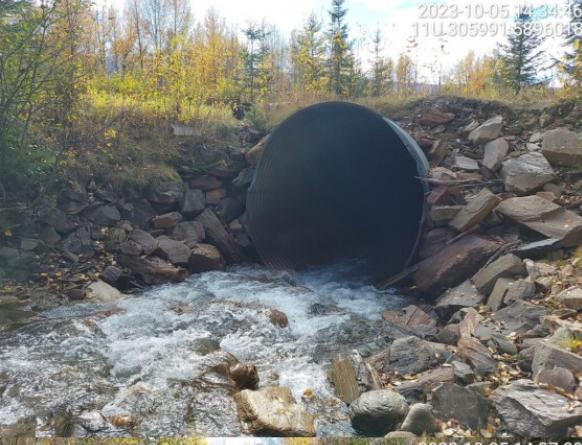
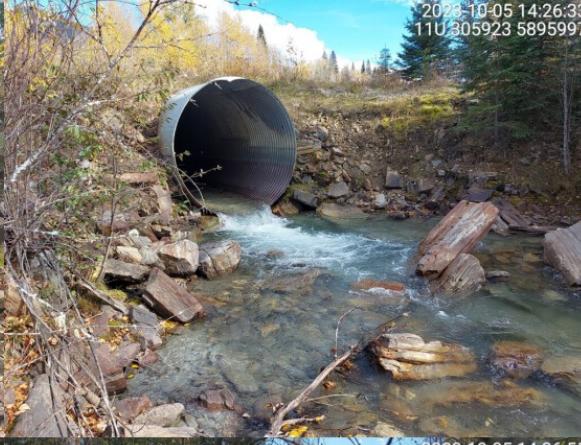
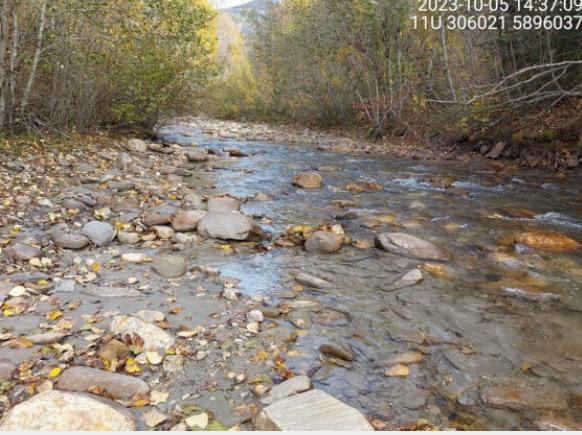
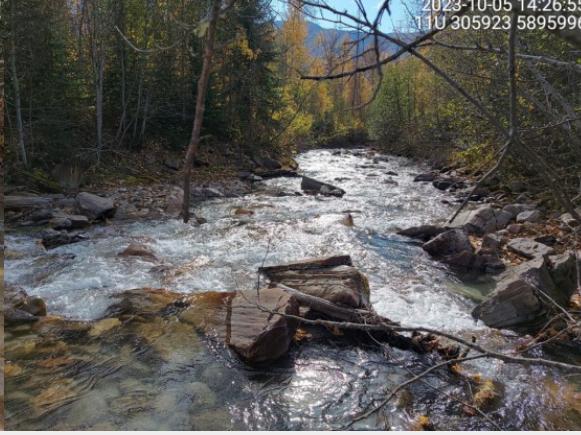
Photos: PSCIS ID 22201229. From top left clockwise: Road/Site Card, Barrel, Outlet, Downstream, Upstream, Inlet.

Location and Stream Data		Crossing Characteristics	
Date	2023-10-05	Crossing Sub Type	Round Culvert
PSCIS ID	199282	Diameter (m)	2.5
External ID	22201229	Length (m)	56
Crew	MW	Embedded	No
UTM Zone	11	Depth Embedded (m)	–
Easting	305965	Resemble Channel	No
Northing	5896000	Backwatered	No
Stream	Holliday Creek	Percent Backwatered	–
Road	Highway 16	Fill Depth (m)	2.3
Road Tenure	MOTI	Outlet Drop (m)	0.4
Channel Width (m)	10.8	Outlet Pool Depth (m)	0.3
Stream Slope (%)	5	Inlet Drop	No
Beaver Activity	No	Slope (%)	2
Habitat Value	High	Valley Fill	Deep Fill
Final score	37	Barrier Result	Barrier
Fix type	Replace with New Open Bottom Structure	Fix Span / Diameter	15

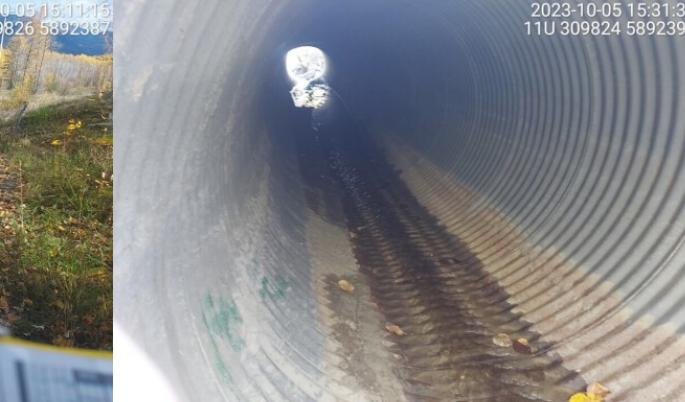
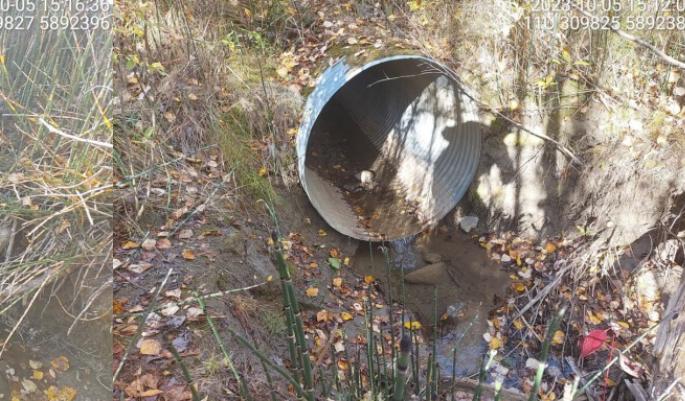
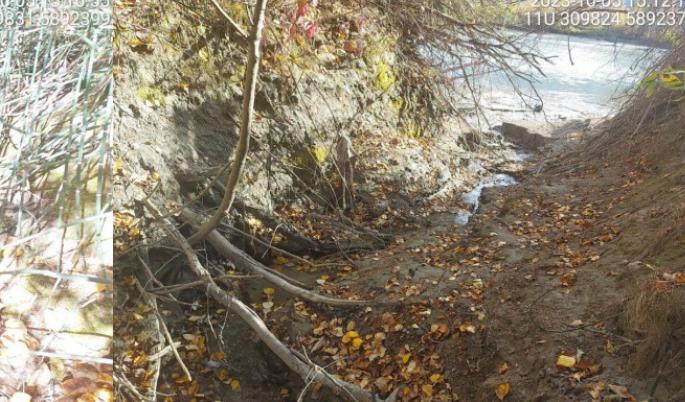
Comments: Pipes and road are in extremely poor condition with evidence of embankment failure and pipes rusted all the way through on the bottom side in places. Small side road parallel to Highway 16 with residences that could be accessed from either side. Removal of crossing could perhaps be considered. Large high value system suitable for bulltrout rearing. Culvert upstream is relatively new concrete box culvert on the highway which is over half embedded and 3.7m wide. MoTi chris_culvert_id: 1466350. 15:53:19

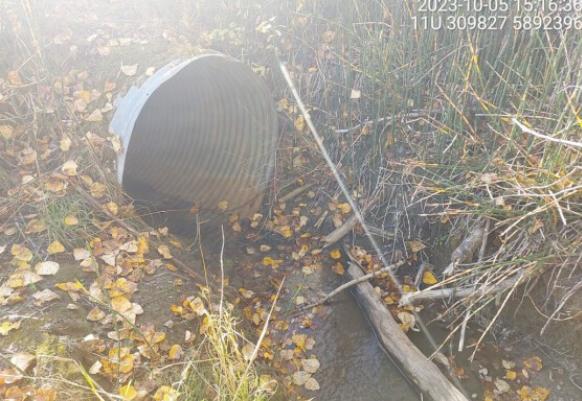
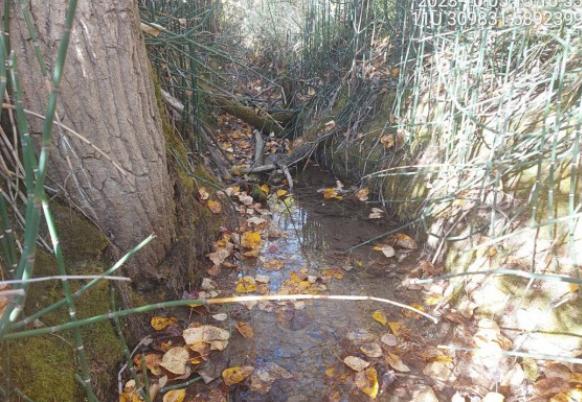
Photos: PSCIS ID 22200029. From top left clockwise: Road/Site Card, Barrel, Outlet, Downstream, Upstream, Inlet.

Location and Stream Data		Crossing Characteristics	
Date	2023-10-05	Crossing Sub Type	Round Culvert
PSCIS ID	199283	Diameter (m)	1.4
External ID	22200029	Length (m)	19
Crew	MW	Embedded	No
UTM Zone	11	Depth Embedded (m)	—
Easting	309830	Resemble Channel	No
Northing	5892394	Backwatered	No
Stream	Tributary to Fraser River	Percent Backwatered	—
Road	River Rd	Fill Depth (m)	2.2
Road Tenure	MOTI Local	Outlet Drop (m)	0.2
Channel Width (m)	1.2	Outlet Pool Depth (m)	0.2
Stream Slope (%)	3.5	Inlet Drop	No
Beaver Activity	No	Slope (%)	0
Habitat Value	Low	Valley Fill	Deep Fill
Final score	18	Barrier Result	Potential
Fix type	Replace Structure with Streambed Simulation CBS	Fix Span / Diameter	3

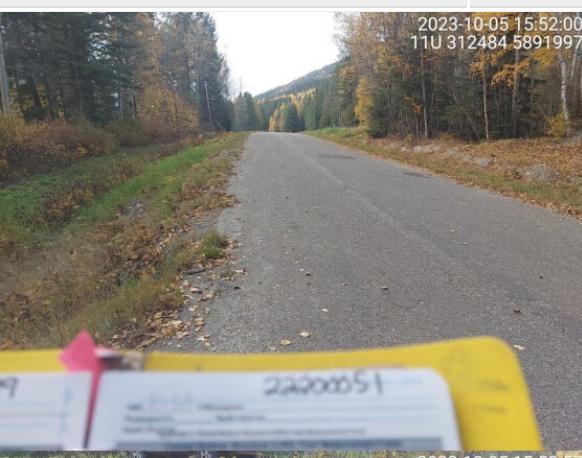
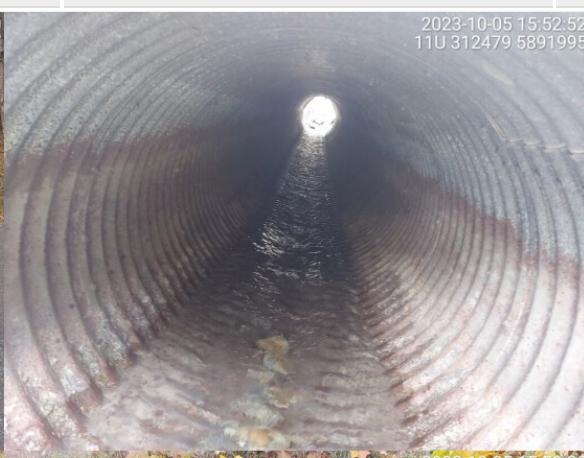
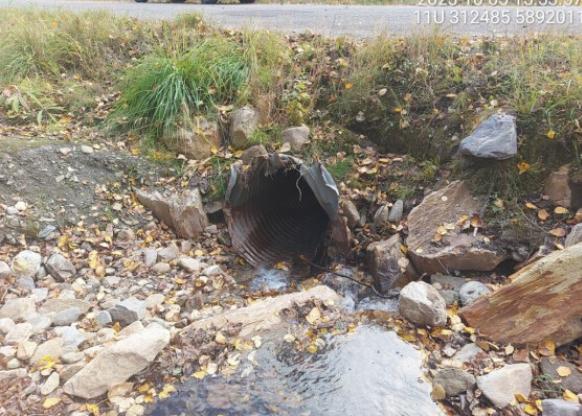
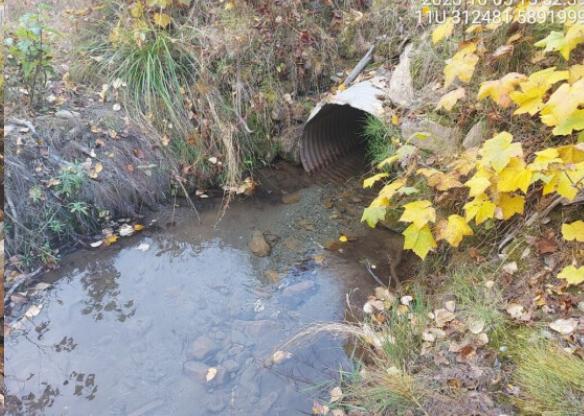
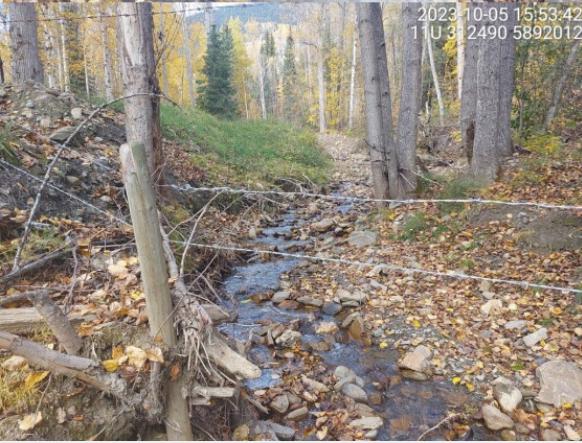
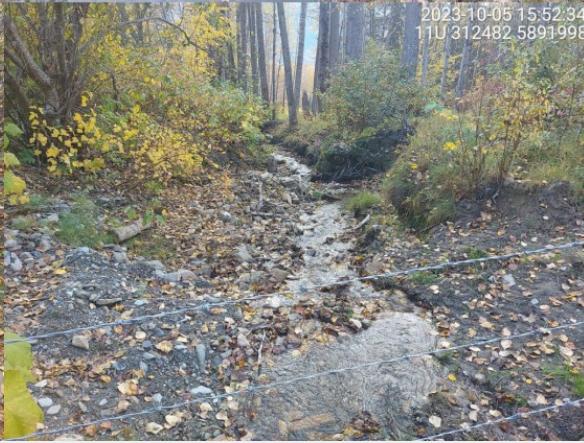
Photos: PSCIS ID 22200051. From top left clockwise: Road/Site Card, Barrel, Outlet, Downstream, Upstream, Inlet.

Location and Stream Data		Crossing Characteristics	
Date	2023-10-05	Crossing Sub Type	Round Culvert
PSCIS ID	199285	Diameter (m)	1.1
External ID	22200051	Length (m)	8
Crew	MW	Embedded	No
UTM Zone	11	Depth Embedded (m)	–
Easting	312484	Resemble Channel	No
Northing	5892004	Backwatered	No
Stream	Tributary to Fraser River	Percent Backwatered	–
Road	Read Rd	Fill Depth (m)	1
Road Tenure	MOTI Local	Outlet Drop (m)	0
Channel Width (m)	2.5	Outlet Pool Depth (m)	0
Stream Slope (%)	4.5	Inlet Drop	No
Beaver Activity	No	Slope (%)	5
Habitat Value	Medium	Valley Fill	Deep Fill
Final score	26	Barrier Result	Barrier
Fix type	Replace with New Open Bottom Structure	Fix Span / Diameter	15

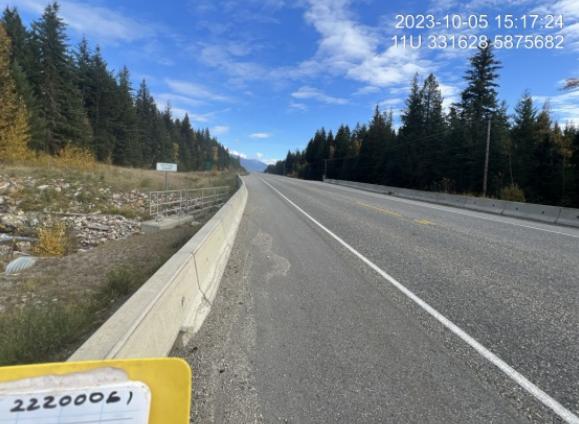
Photos: PSCIS ID 22200061. From top left clockwise: Road/Site Card, Barrel, Outlet, Downstream, Upstream, Inlet.

Location and Stream Data		Crossing Characteristics	
Date	2023-10-05	Crossing Sub Type	Concrete Box
PSCIS ID	199286	Diameter (m)	3.65
External ID	22200061	Length (m)	21
Crew	MW	Embedded	No
UTM Zone	11	Depth Embedded (m)	—
Easting	331629	Resemble Channel	No
Northing	5875684	Backwatered	No
Stream	Spittal Creek	Percent Backwatered	—
Road	Highway 16	Fill Depth (m)	1.5
Road Tenure	MOTI	Outlet Drop (m)	0
Channel Width (m)	5.8	Outlet Pool Depth (m)	0.2
Stream Slope (%)	6	Inlet Drop	Yes
Beaver Activity	No	Slope (%)	6
Habitat Value	High	Valley Fill	Deep Fill
Final score	29	Barrier Result	Barrier
Fix type	Replace with New Open Bottom Structure	Fix Span / Diameter	15

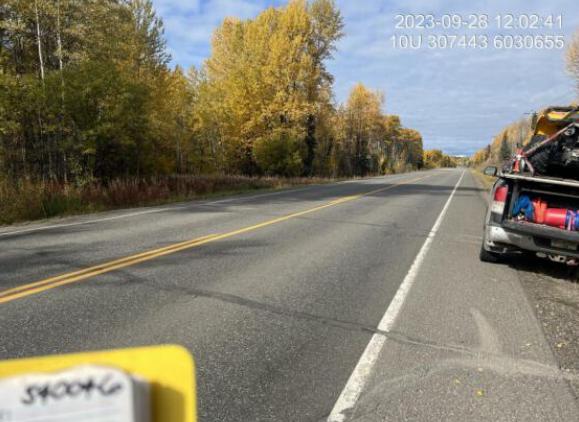
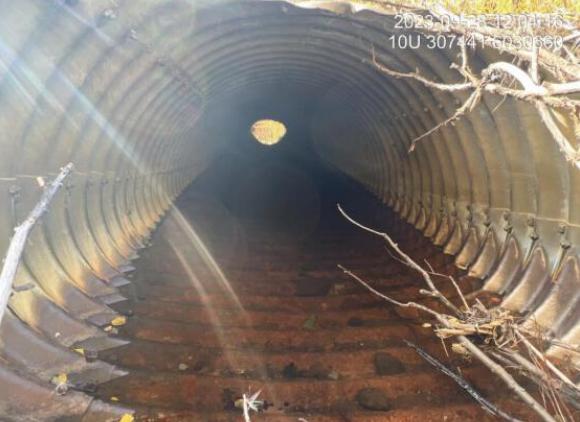
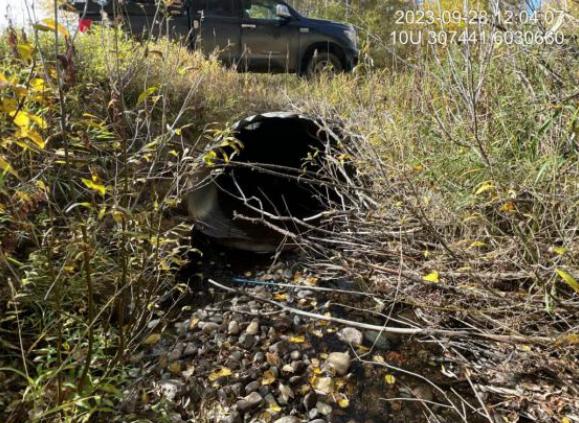
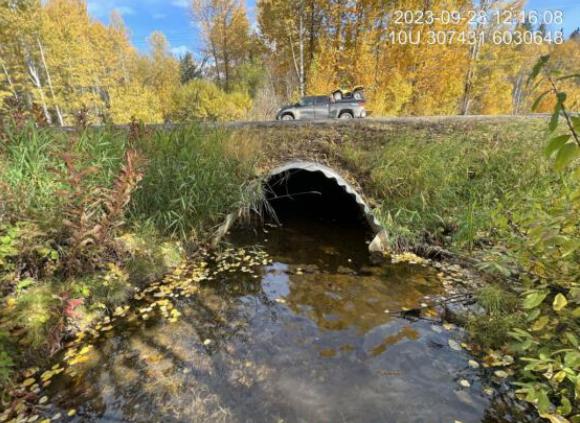
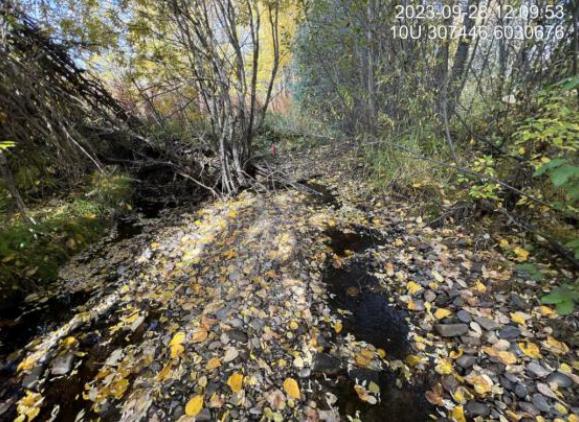
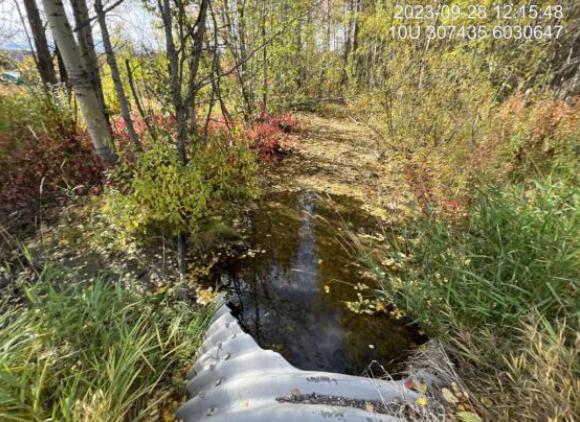
Photos: PSCIS ID 5400446. From top left clockwise: Road/Site Card, Barrel, Outlet, Downstream, Upstream, Inlet.

Location and Stream Data		Crossing Characteristics	
Date	2023-09-28	Crossing Sub Type	Round Culvert
PSCIS ID	199287	Diameter (m)	2.25
External ID	5400446	Length (m)	22
Crew	AI	Embedded	No
UTM Zone	10	Depth Embedded (m)	–
Easting	307446	Resemble Channel	No
Northing	6030655	Backwatered	Yes
Stream	Rentoul Creek	Percent Backwatered	100
Road	Highway 16	Fill Depth (m)	1
Road Tenure	MOTI	Outlet Drop (m)	0
Channel Width (m)	3.8	Outlet Pool Depth (m)	0.3
Stream Slope (%)	2	Inlet Drop	No
Beaver Activity	No	Slope (%)	1.5
Habitat Value	High	Valley Fill	Deep Fill
Final score	24	Barrier Result	Barrier
Fix type	Replace with New Open Bottom Structure	Fix Span / Diameter	15

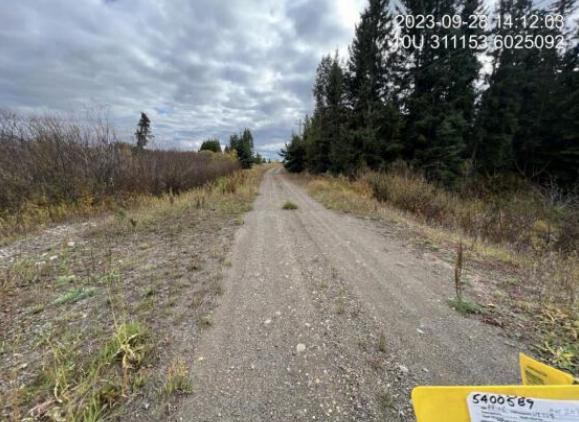
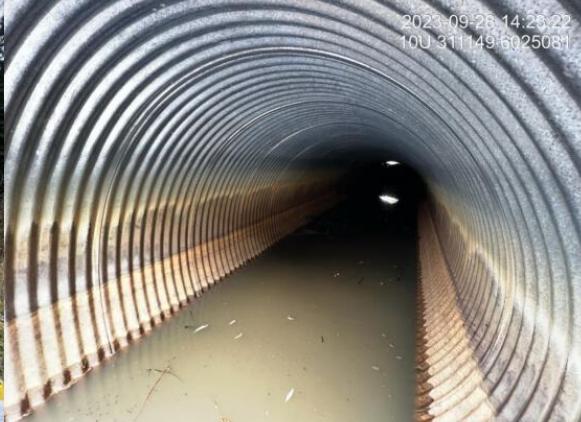
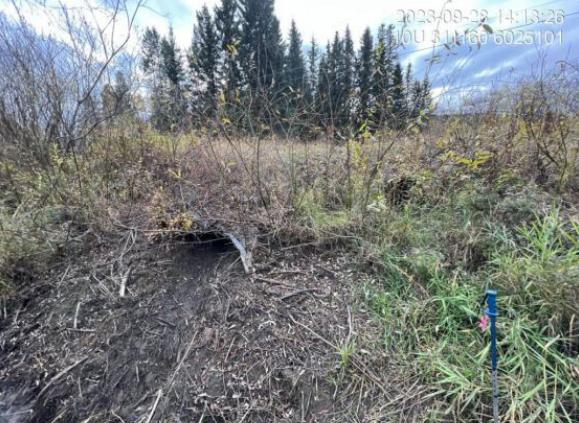
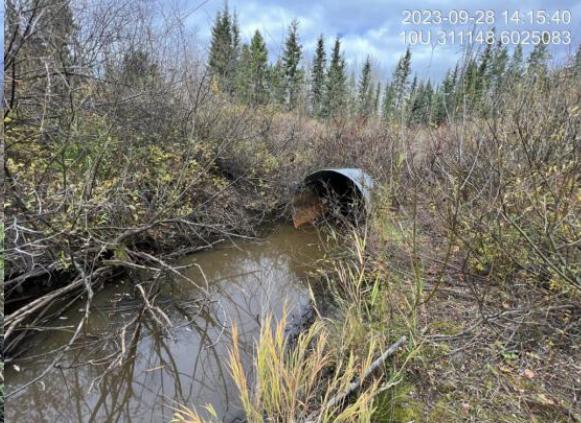
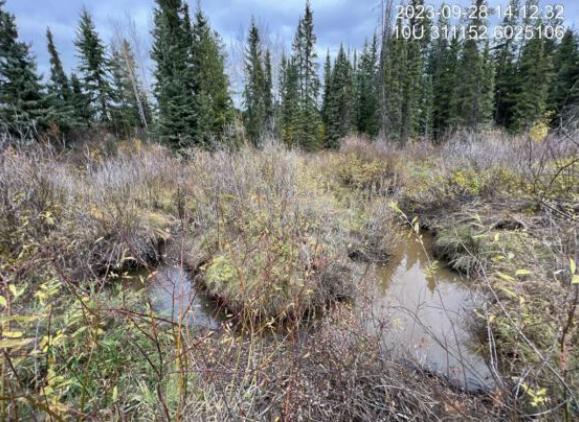
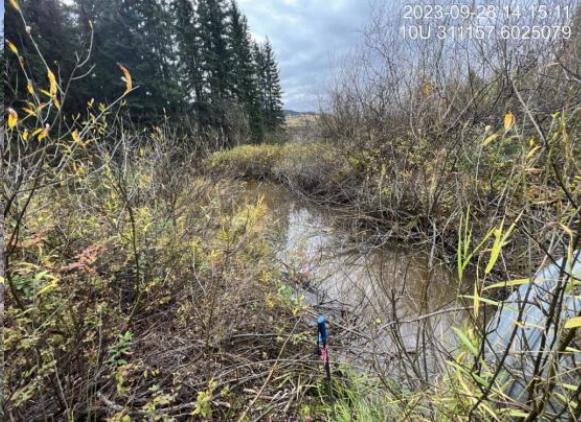
Photos: PSCIS ID 5400589. From top left clockwise: Road/Site Card, Barrel, Outlet, Downstream, Upstream, Inlet.

Location and Stream Data		Crossing Characteristics	
Date	2023-09-28	Crossing Sub Type	Round Culvert
PSCIS ID	199288	Diameter (m)	1.7
External ID	5400589	Length (m)	22
Crew	AI	Embedded	No
UTM Zone	10	Depth Embedded (m)	—
Easting	311154	Resemble Channel	No
Northing	6025092	Backwatered	Yes
Stream	Tributary to Endako River	Percent Backwatered	100
Road	West Decker Rd	Fill Depth (m)	1
Road Tenure	MOTI	Outlet Drop (m)	0
Channel Width (m)	4.5	Outlet Pool Depth (m)	1
Stream Slope (%)	0	Inlet Drop	No
Beaver Activity	Yes	Slope (%)	0
Habitat Value	Medium	Valley Fill	Deep Fill
Final score	19	Barrier Result	Potential
Fix type	Replace with New Open Bottom Structure	Fix Span / Diameter	15
