Appendix - Phase 1 Fish Passage Assessment Data and Photos

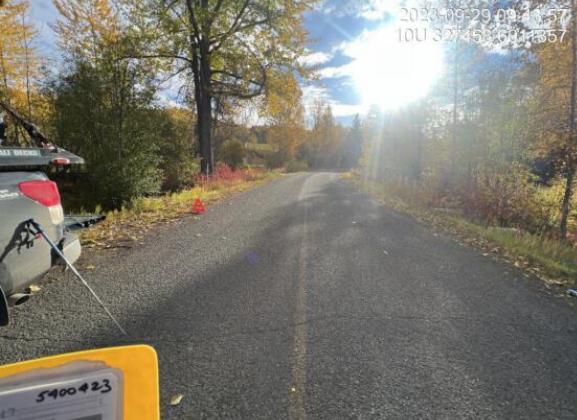
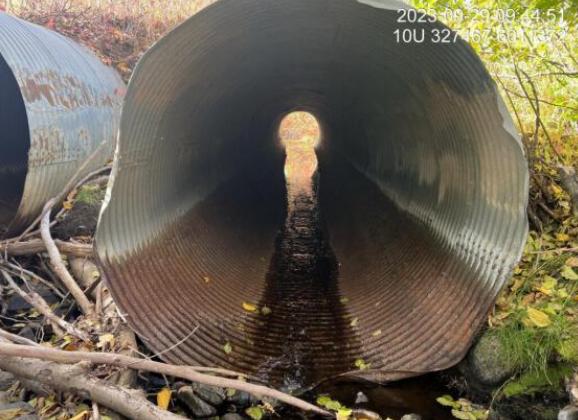
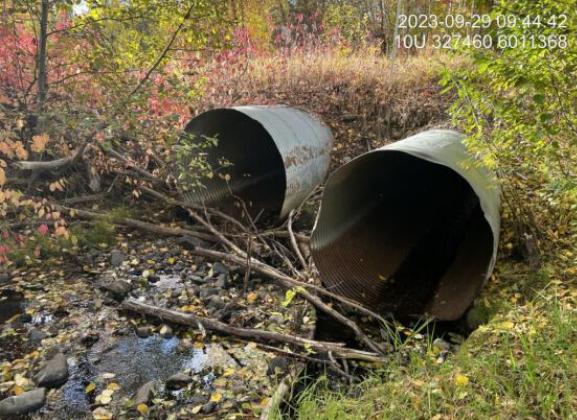
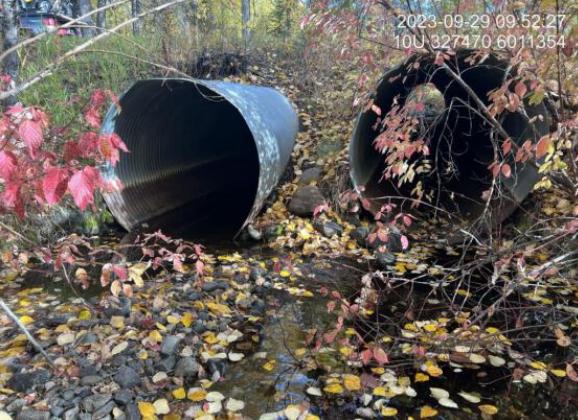
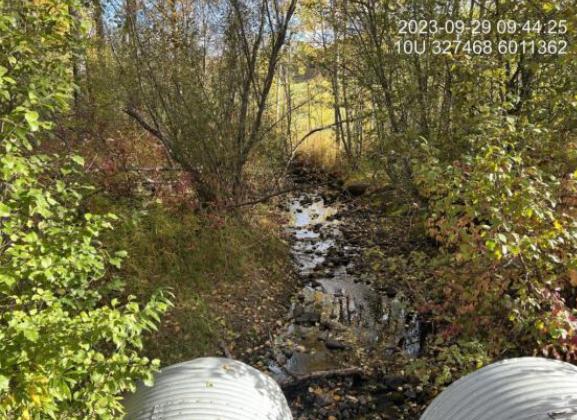
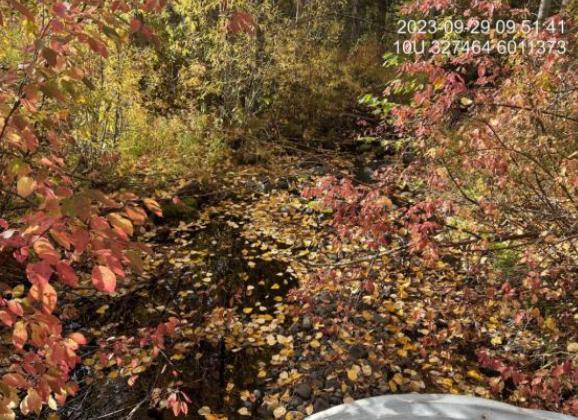
Photos: PSCIS ID 5400423. From top left clockwise: Road/Site Card, Barrel, Outlet, Downstream, Upstream, Inlet.

Location and Stream Data		Crossing Characteristics	
Date	2023-09-29	Crossing Sub Type	Round Culvert
PSCIS ID	199289	Diameter (m)	3.6
External ID	5400423	Length (m)	22
Crew	AI	Embedded	No
UTM Zone	10	Depth Embedded (m)	—
Easting	327463	Resemble Channel	No
Northing	6011366	Backwatered	Yes
Stream	Stearns Creek	Percent Backwatered	60
Road	Tintagel Road	Fill Depth (m)	1
Road Tenure	MOTI	Outlet Drop (m)	0
Channel Width (m)	5	Outlet Pool Depth (m)	0.1
Stream Slope (%)	1.5	Inlet Drop	No
Beaver Activity	No	Slope (%)	1.5
Habitat Value	High	Valley Fill	Deep Fill
Final score	24	Barrier Result	Barrier
Fix type	Replace with New Open Bottom Structure	Fix Span / Diameter	15

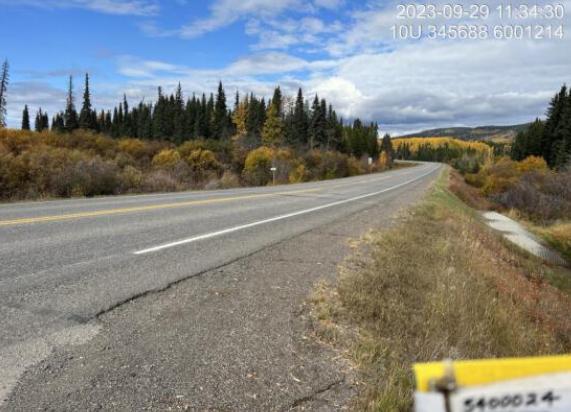
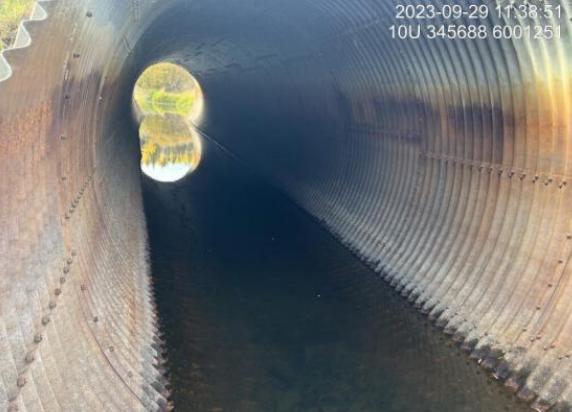
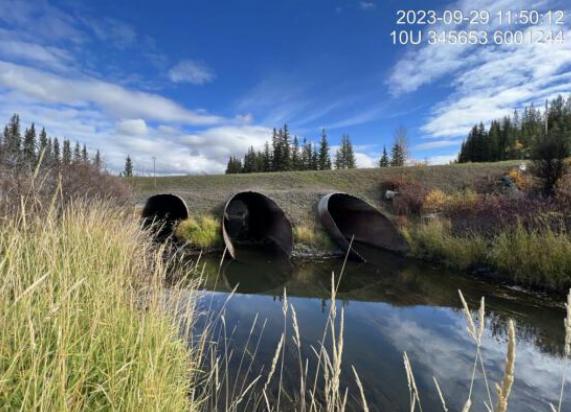
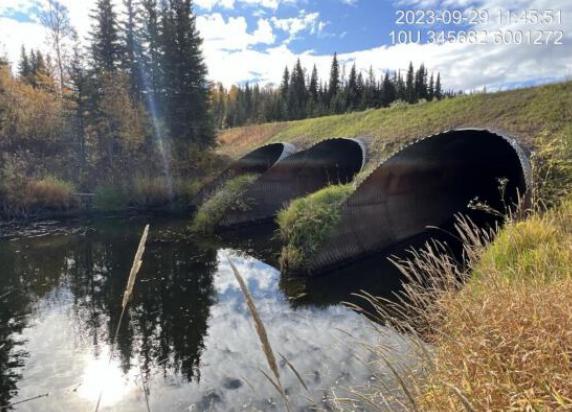
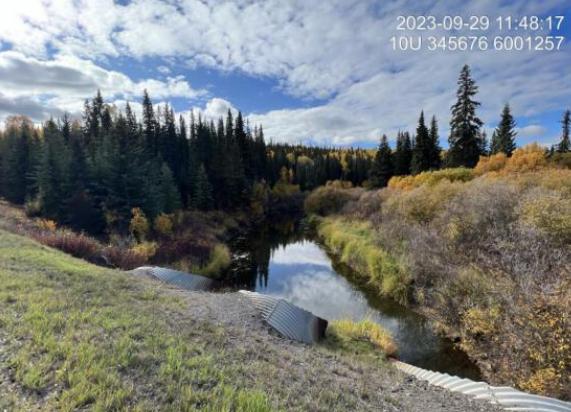
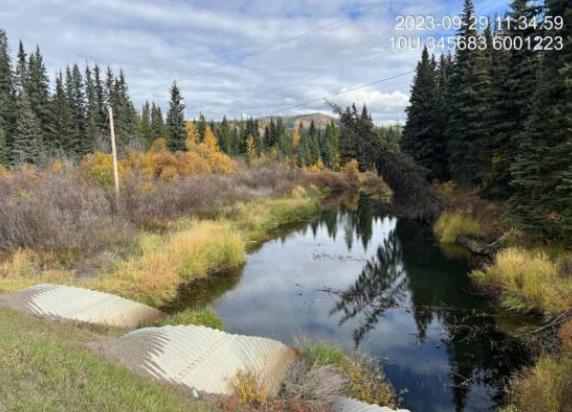
Photos: PSCIS ID 5400024. From top left clockwise: Road/Site Card, Barrel, Outlet, Downstream, Upstream, Inlet.

Comments: Three 4 m diameter pipes. All three pipes are 100% backwatered, and passable. Road prism and pipes appear to be in good condition. Extensive beaver activity upstream and downstream. Diameter changed from 12m to 9.99m to meet spreadsheet requirements. MoTi chris_hwy_structure_road_id: 3812. 11:35:39

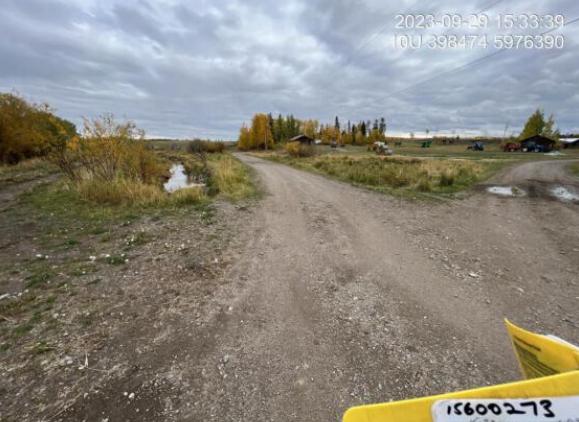
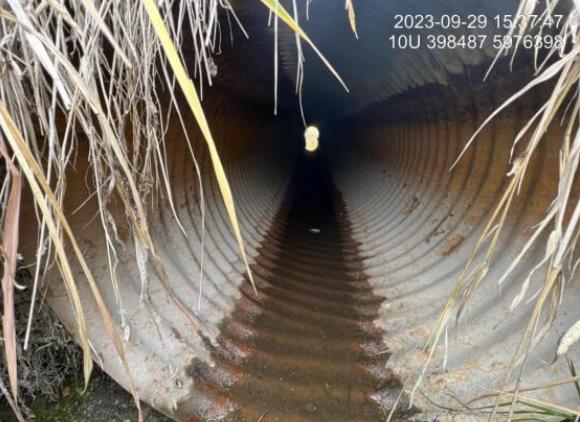
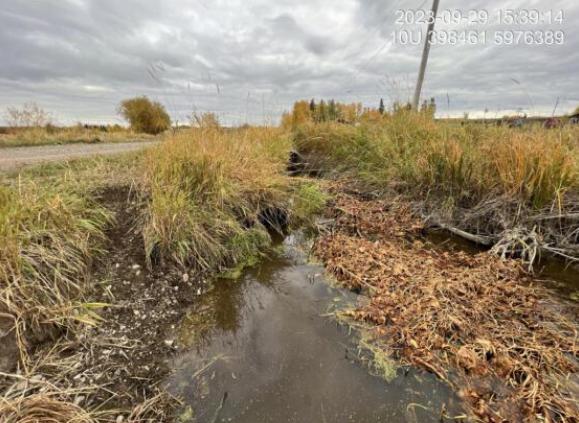
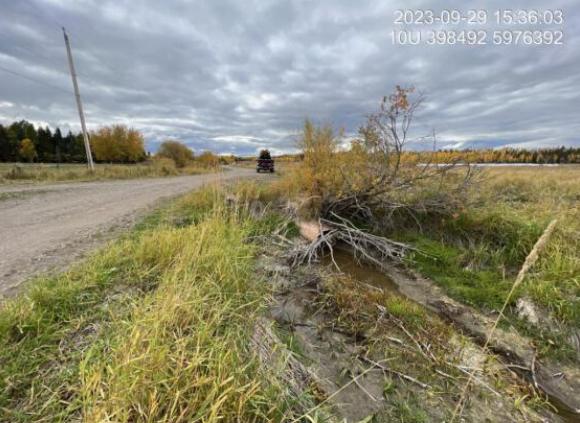
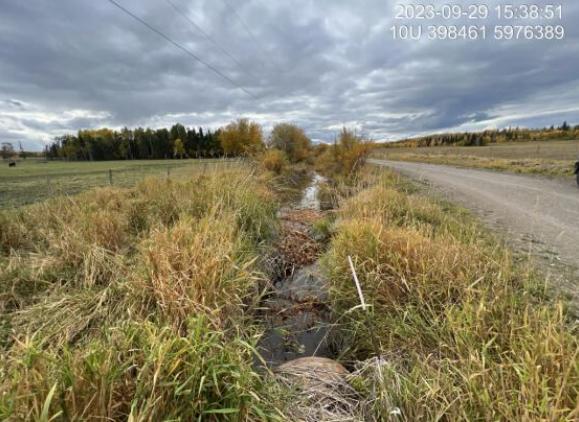
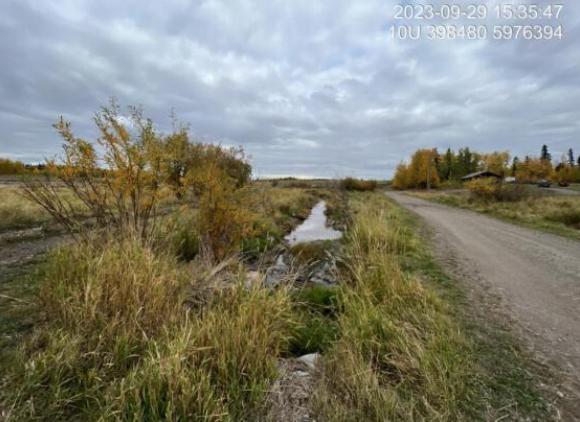
Photos: PSCIS ID 15600273. From top left clockwise: Road/Site Card, Barrel, Outlet, Downstream, Upstream, Inlet.

Location and Stream Data		Crossing Characteristics	
Date	2023-09-29	Crossing Sub Type	Round Culvert
PSCIS ID	199291	Diameter (m)	1.5
External ID	15600273	Length (m)	18
Crew	AI	Embedded	No
UTM Zone	10	Depth Embedded (m)	–
Easting	398480	Resemble Channel	No
Northing	5976390	Backwatered	Yes
Stream	Tahultzu Creek	Percent Backwatered	100
Road	Zalenski Road	Fill Depth (m)	0.5
Road Tenure	MOTI	Outlet Drop (m)	0
Channel Width (m)	3	Outlet Pool Depth (m)	0.3
Stream Slope (%)	0	Inlet Drop	No
Beaver Activity	No	Slope (%)	0.5
Habitat Value	Medium	Valley Fill	Deep Fill
Final score	19	Barrier Result	Potential
Fix type	Replace with New Open Bottom Structure	Fix Span / Diameter	15
Comments: Stream is extremely impacted by cattle ranching. Banks eroded and trampled. Algae indicates nutrient inputs from cows are high. Pipes are old with a lot of rust. Habitat value is currently very poor, but historically would've been high. Still a good amount of flow for a dry year. 100% backwatered however, depth of the water is only approximately 1 cm. Absolutely no riparian vegetation or cattle exclusion fencing on the upstream side for as far as the eye can see (approximately 1 km.). MoTi chris_culvert_id: 1790770, 1790769. 15:33:57

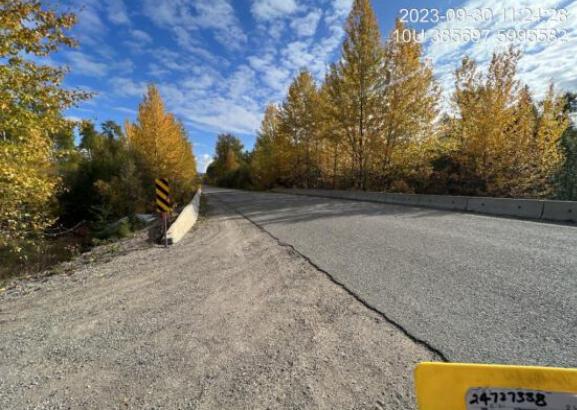
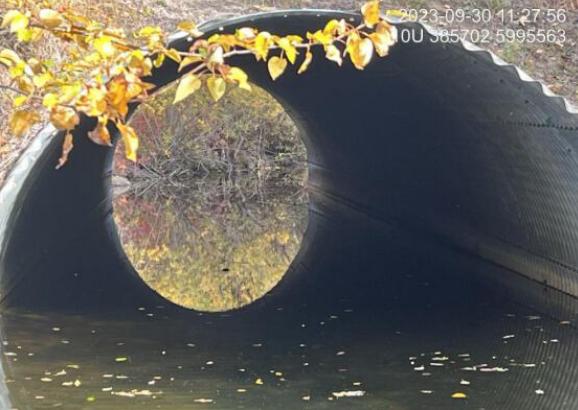
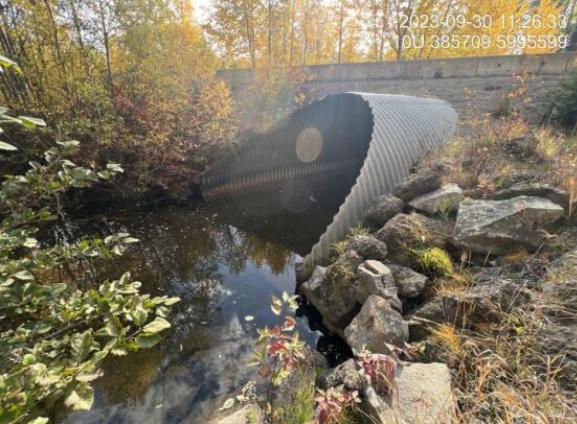
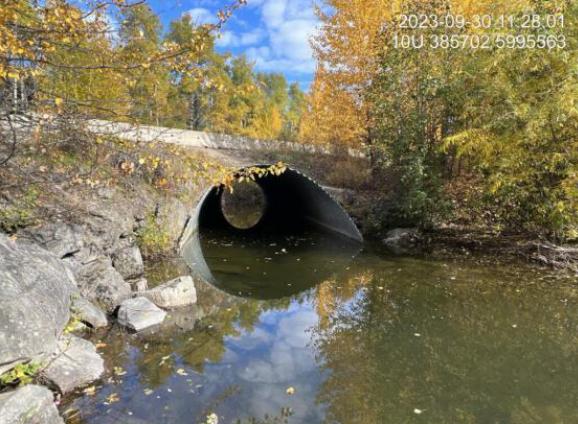
Photos: PSCIS ID 24727338. From top left clockwise: Road/Site Card, Barrel, Outlet, Downstream, Upstream, Inlet.

Location and Stream Data		.	Crossing Characteristics	-
Date	2023-09-30		Crossing Sub Type	Oval Culvert
PSCIS ID	199292		Diameter (m)	4.5
External ID	24727338		Length (m)	32
Crew	AI		Embedded	No
UTM Zone	10		Depth Embedded (m)	-
Easting	385711		Resemble Channel	No
Northing	5995594		Backwatered	Yes
Stream	Ormond Creek		Percent Backwatered	100
Road	Stella Road		Fill Depth (m)	1
Road Tenure	MOTI		Outlet Drop (m)	0
Channel Width (m)	6		Outlet Pool Depth (m)	1.3
Stream Slope (%)	0		Inlet Drop	No
Beaver Activity	Yes		Slope (%)	0
Habitat Value	High		Valley Fill	Deep Fill
Final score	22		Barrier Result	Barrier
Fix type	Replace with New Open Bottom Structure		Fix Span / Diameter	15

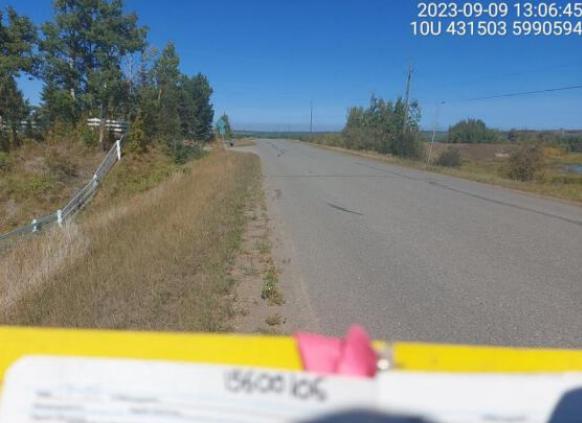
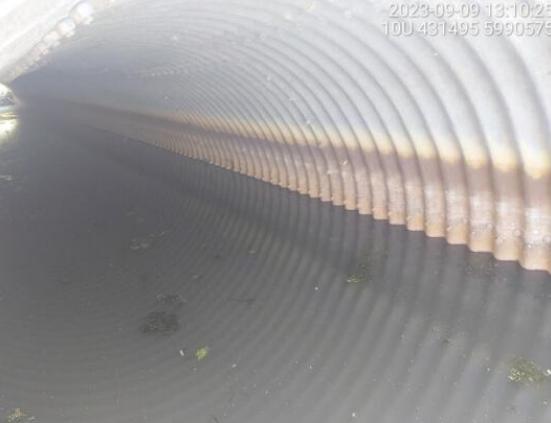
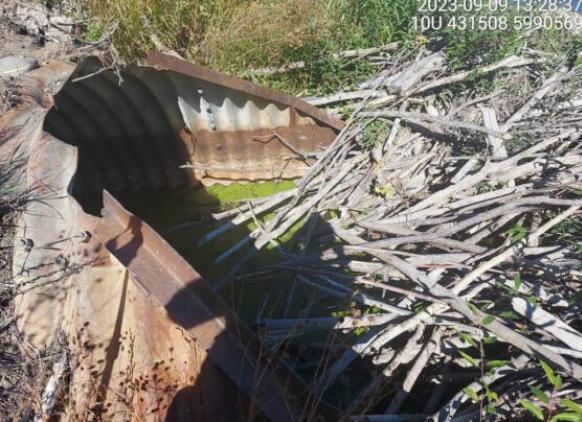
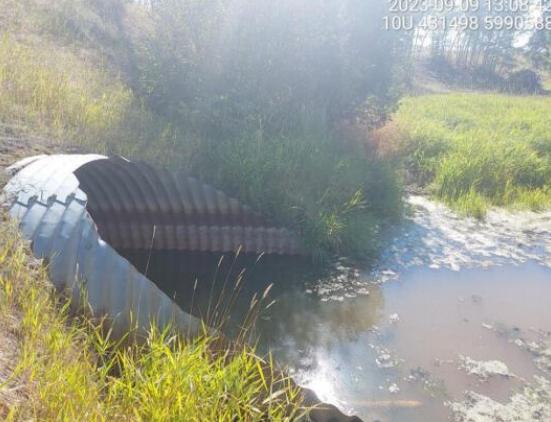
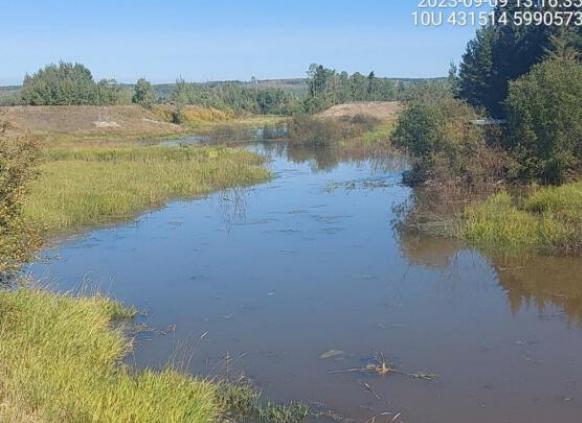
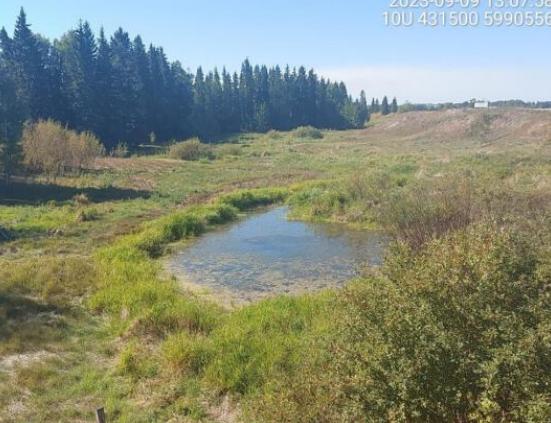
Photos: PSCIS ID 15600106. From top left clockwise: Road/Site Card, Barrel, Outlet, Downstream, Upstream, Inlet.

Location and Stream Data		Crossing Characteristics	
Date	2023-09-09	Crossing Sub Type	Round Culvert
PSCIS ID	199295	Diameter (m)	2.5
External ID	15600106	Length (m)	18
Crew	MW	Embedded	No
UTM Zone	10	Depth Embedded (m)	–
Easting	431487	Resemble Channel	No
Northing	5990586	Backwatered	Yes
Stream	East Murray Creek	Percent Backwatered	100
Road	Northside Rd	Fill Depth (m)	3
Road Tenure	MOTI	Outlet Drop (m)	0
Channel Width (m)	2.5	Outlet Pool Depth (m)	1.5
Stream Slope (%)	1	Inlet Drop	Yes
Beaver Activity	Yes	Slope (%)	1
Habitat Value	Low	Valley Fill	Deep Fill
Final score	21	Barrier Result	Barrier
Fix type	Replace with New Open Bottom Structure	Fix Span / Diameter	15

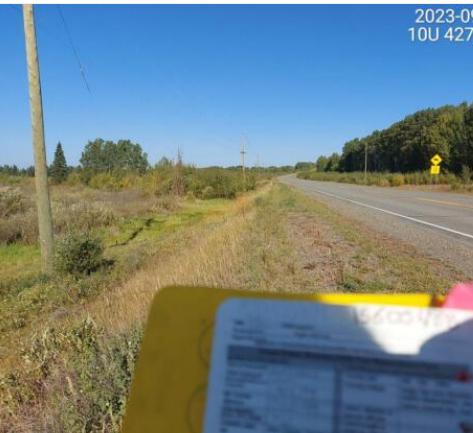
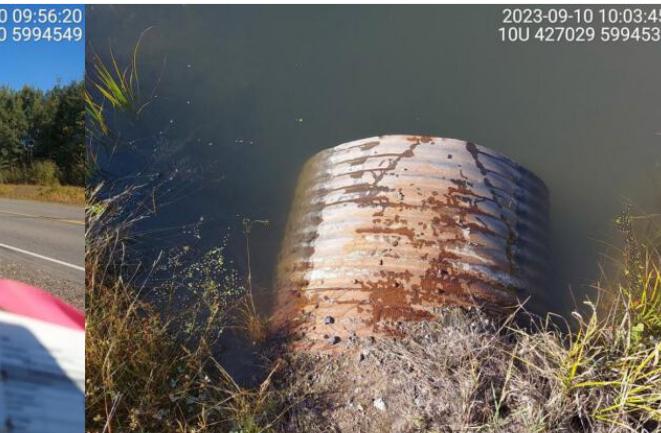
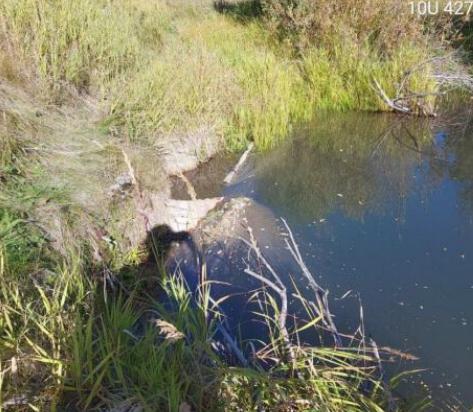
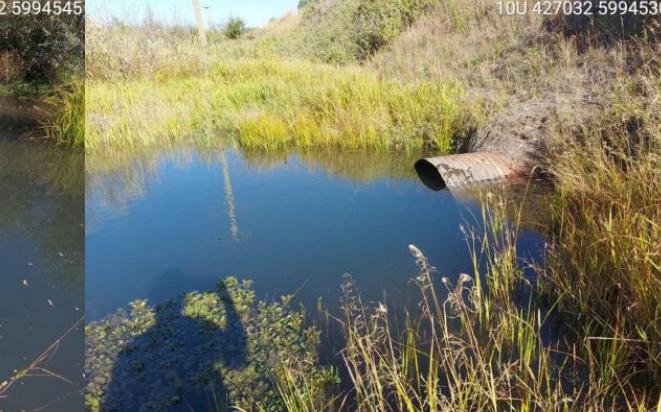
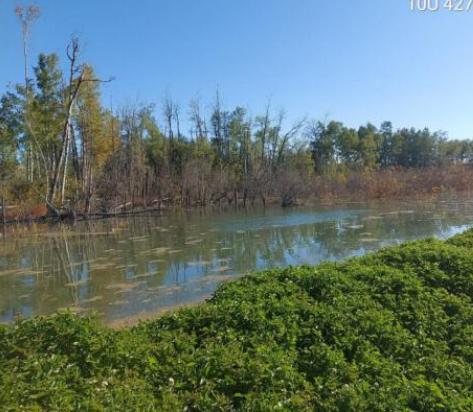
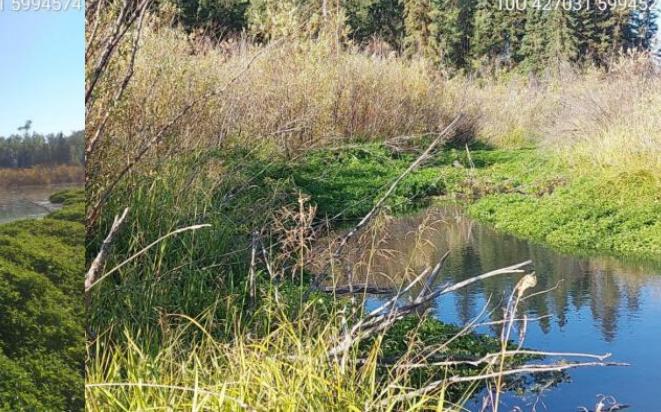
Photos: PSCIS ID 15600488. From top left clockwise: Road/Site Card, Barrel, Outlet, Downstream, Upstream, Inlet.

Location and Stream Data	.	Crossing Characteristics	–
Date	2023-09-10	Crossing Sub Type	Round Culvert
PSCIS ID	199296	Diameter (m)	1.3
External ID	15600488	Length (m)	20
Crew	MW	Embedded	No
UTM Zone	10	Depth Embedded (m)	–
Easting	427033	Resemble Channel	No
Northing	5994538	Backwatered	Yes
Stream	Tributary to Clear Creek	Percent Backwatered	100
Road	Highway 27S	Fill Depth (m)	2.5
Road Tenure	MOTI	Outlet Drop (m)	0
Channel Width (m)	1.3	Outlet Pool Depth (m)	0.8
Stream Slope (%)	1	Inlet Drop	No
Beaver Activity	Yes	Slope (%)	1
Habitat Value	Medium	Valley Fill	Deep Fill
Final score	21	Barrier Result	Barrier
Fix type	Replace Structure with Streambed Simulation CBS	Fix Span / Diameter	3

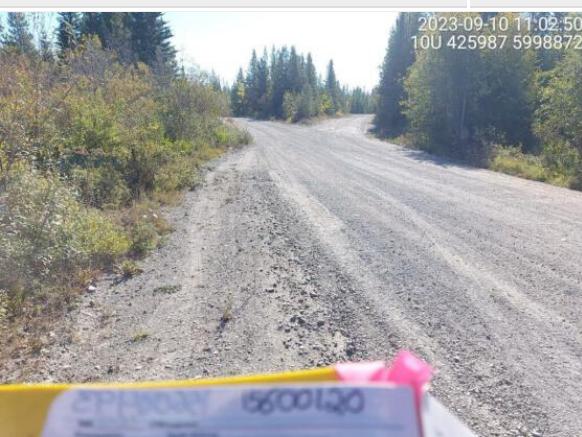
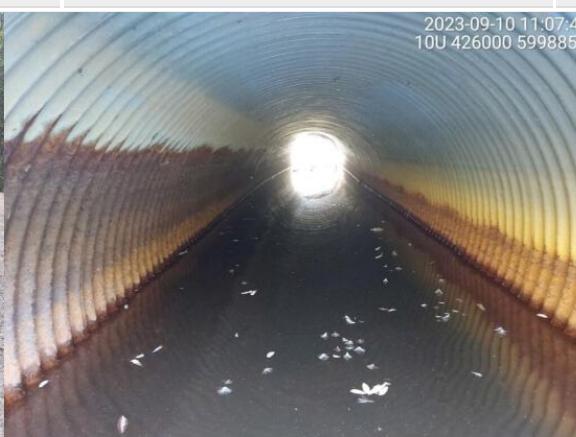
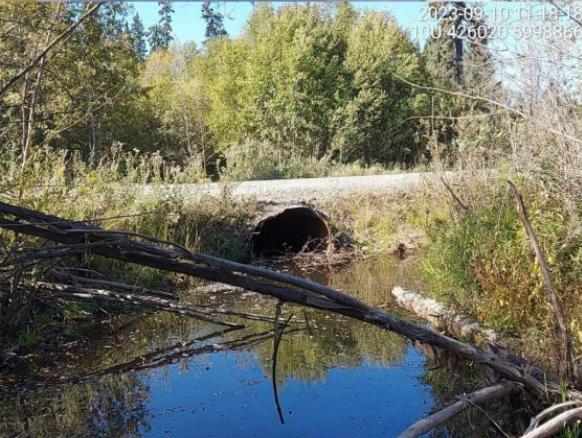
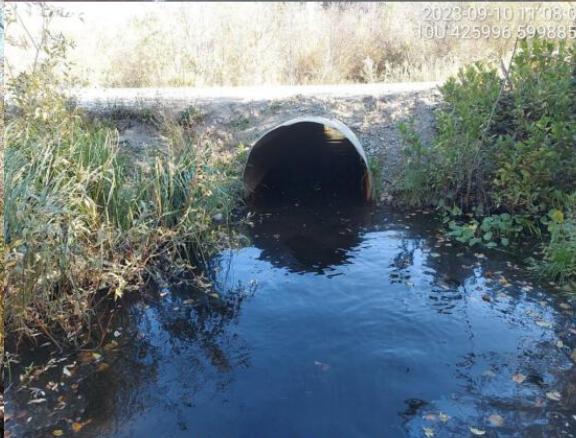
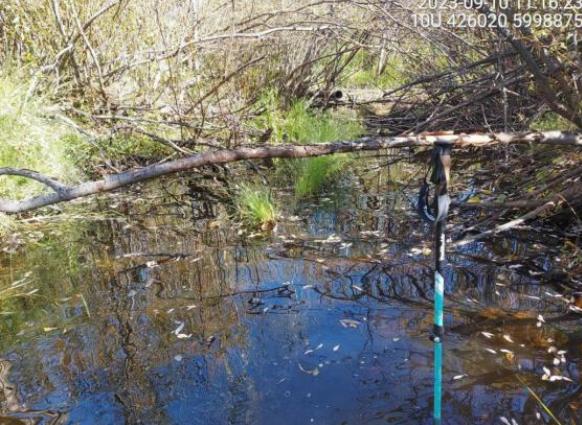
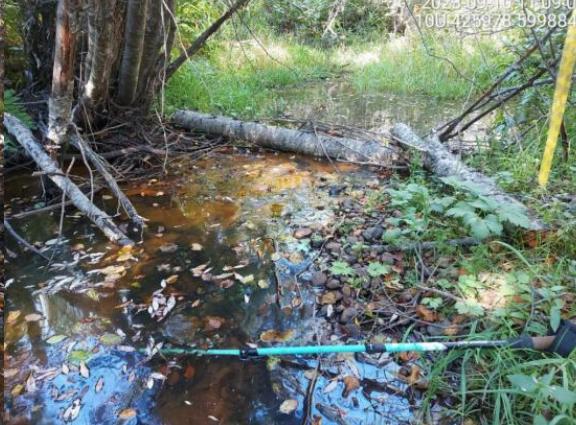
Photos: PSCIS ID 15600120. From top left clockwise: Road/Site Card, Barrel, Outlet, Downstream, Upstream, Inlet.

Location and Stream Data		.	Crossing Characteristics	-
Date	2023-09-10		Crossing Sub Type	Round Culvert
PSCIS ID	199297		Diameter (m)	2.35
External ID	15600120		Length (m)	10
Crew	MW		Embedded	No
UTM Zone	10		Depth Embedded (m)	-
Easting	426006		Resemble Channel	No
Northing	5998858		Backwatered	Yes
Stream	Clear Creek		Percent Backwatered	100
Road	Fourteen Mile Rd		Fill Depth (m)	0.3
Road Tenure	MOTI Local		Outlet Drop (m)	0
Channel Width (m)	2.5		Outlet Pool Depth (m)	0.4
Stream Slope (%)	4		Inlet Drop	No
Beaver Activity	Yes		Slope (%)	1
Habitat Value	Medium		Valley Fill	Deep Fill
Final score	18		Barrier Result	Potential
Fix type	Replace with New Open Bottom Structure		Fix Span / Diameter	15

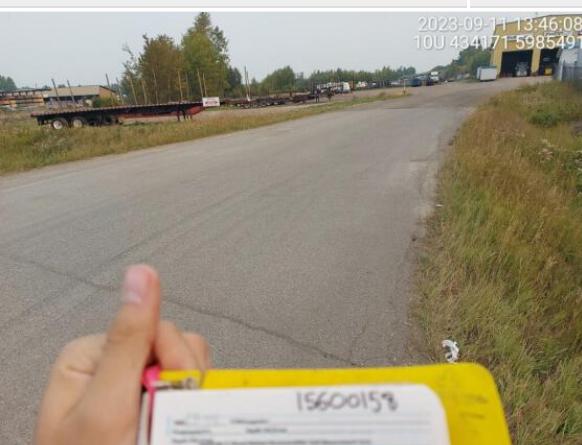
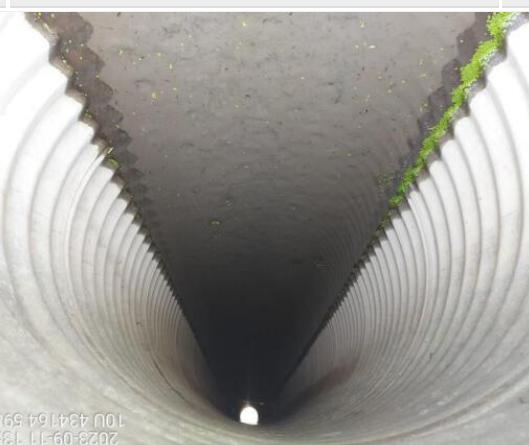
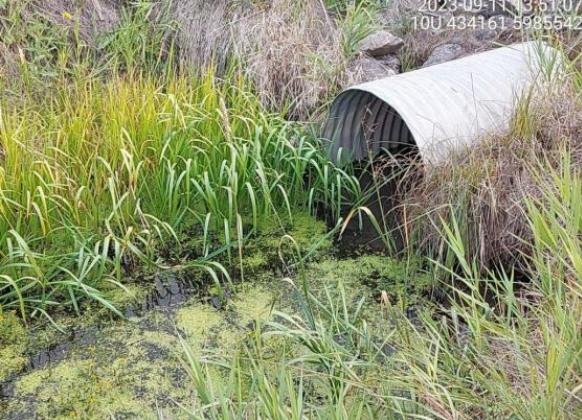
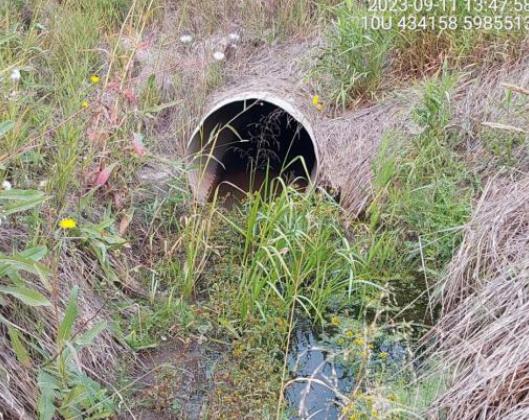
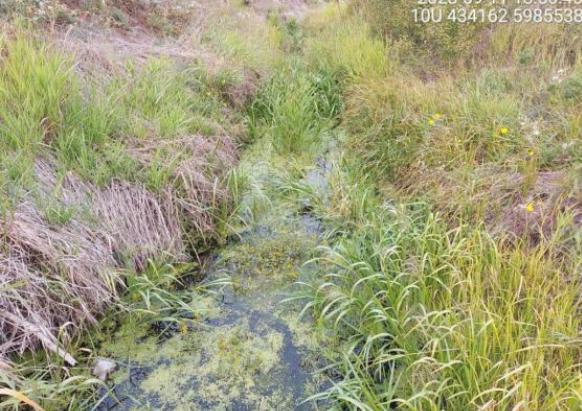
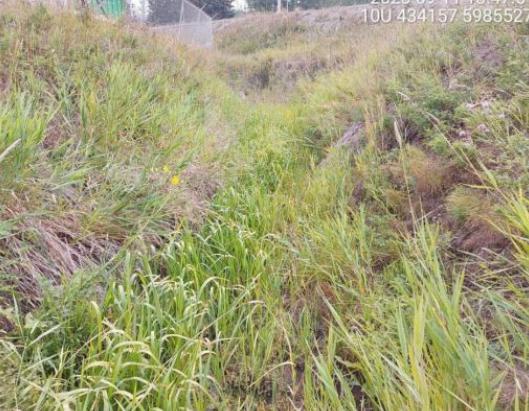
Photos: PSCIS ID 15600158. From top left clockwise: Road/Site Card, Barrel, Outlet, Downstream, Upstream, Inlet.

Location and Stream Data	.	Crossing Characteristics	–
Date	2023-09-11	Crossing Sub Type	Round Culvert
PSCIS ID	199298	Diameter (m)	0.8
External ID	15600158	Length (m)	16
Crew	MW	Embedded	No
UTM Zone	10	Depth Embedded (m)	–
Easting	434160	Resemble Channel	No
Northing	5985531	Backwatered	Yes
Stream	Tributary to Nechako River	Percent Backwatered	100
Road	Chilco Ave	Fill Depth (m)	2
Road Tenure	Vanderhoof	Outlet Drop (m)	0
Channel Width (m)	1.5	Outlet Pool Depth (m)	0
Stream Slope (%)	1	Inlet Drop	No
Beaver Activity	No	Slope (%)	0
Habitat Value	Medium	Valley Fill	Deep Fill
Final score	19	Barrier Result	Potential
Fix type	Replace Structure with Streambed Simulation CBS	Fix Span / Diameter	3

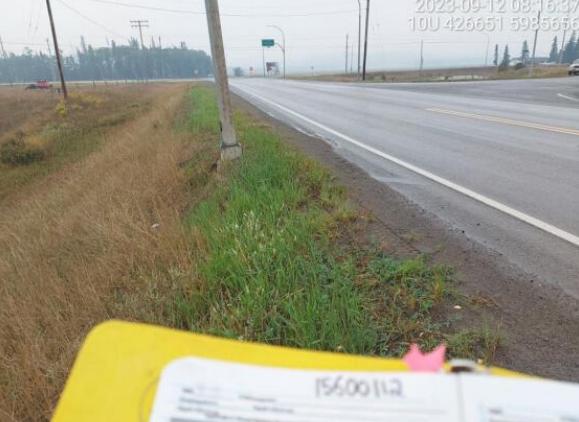
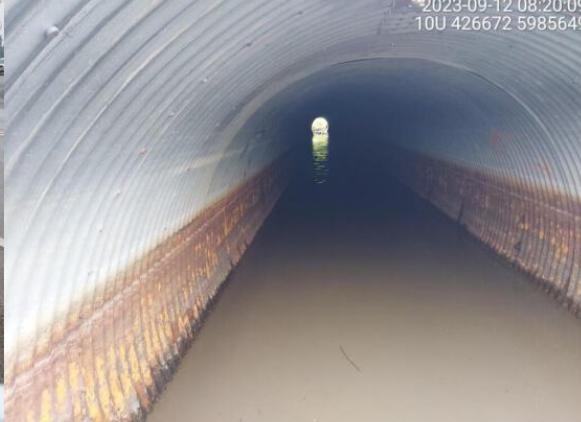
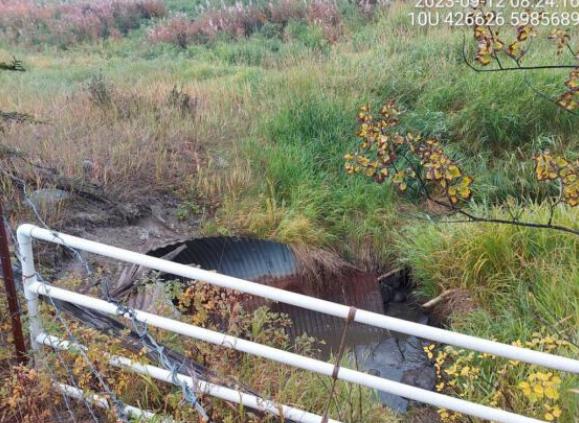
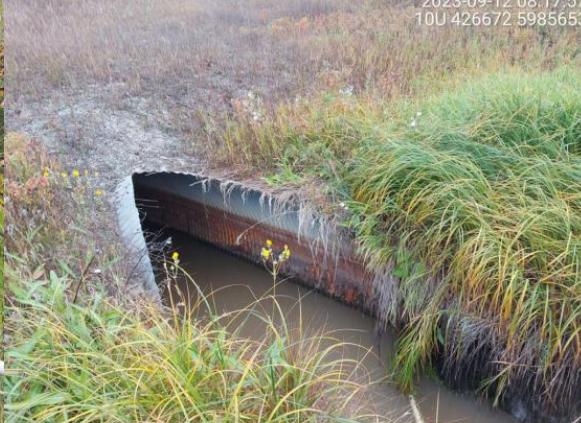
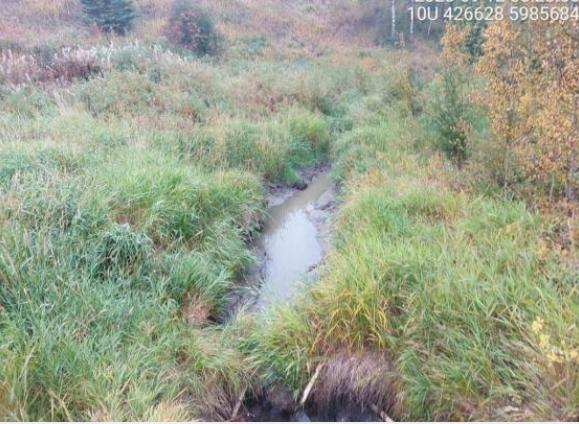
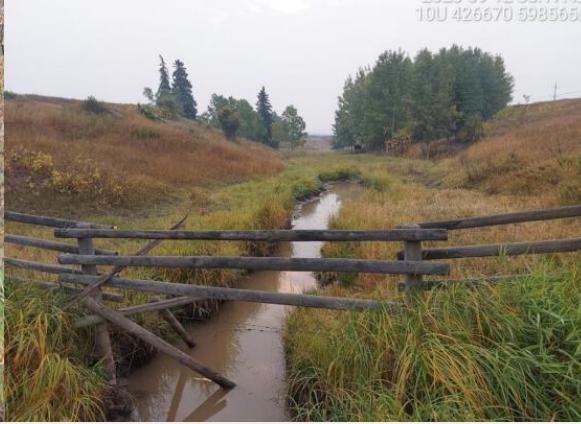
Photos: PSCIS ID 15600112. From top left clockwise: Road/Site Card, Barrel, Outlet, Downstream, Upstream, Inlet.

Location and Stream Data		Crossing Characteristics	
Date	2023-09-12	Crossing Sub Type	Round Culvert
PSCIS ID	199300	Diameter (m)	2.2
External ID	15600112	Length (m)	30
Crew	MW	Embedded	No
UTM Zone	10	Depth Embedded (m)	—
Easting	426644	Resemble Channel	No
Northing	5985671	Backwatered	Yes
Stream	Goldie Creek	Percent Backwatered	100
Road	Highway 27 S	Fill Depth (m)	4
Road Tenure	MOTI	Outlet Drop (m)	0
Channel Width (m)	2.2	Outlet Pool Depth (m)	0.5
Stream Slope (%)	1.5	Inlet Drop	No
Beaver Activity	No	Slope (%)	1
Habitat Value	Medium	Valley Fill	Deep Fill
Final score	24	Barrier Result	Barrier
Fix type	Replace with New Open Bottom Structure	Fix Span / Diameter	18

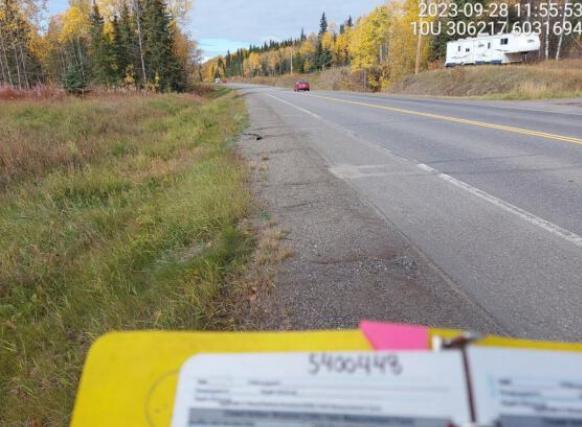
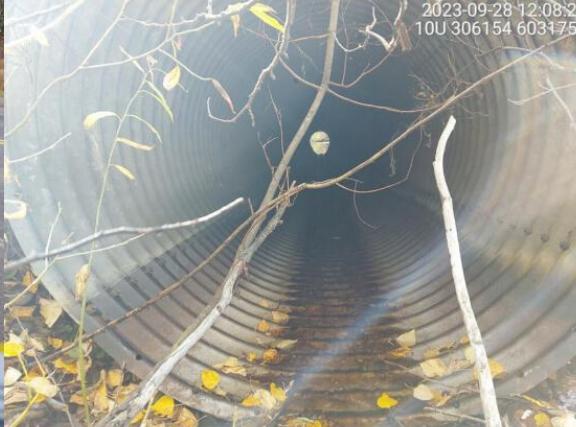
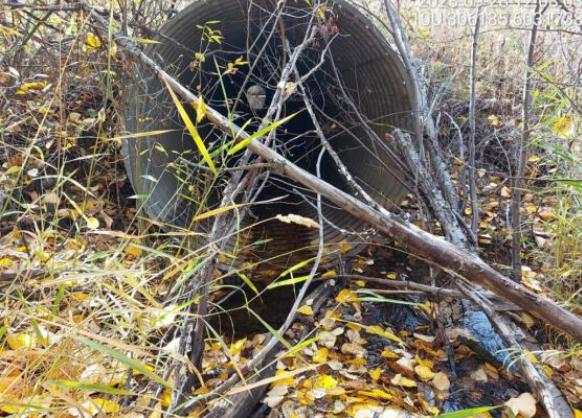
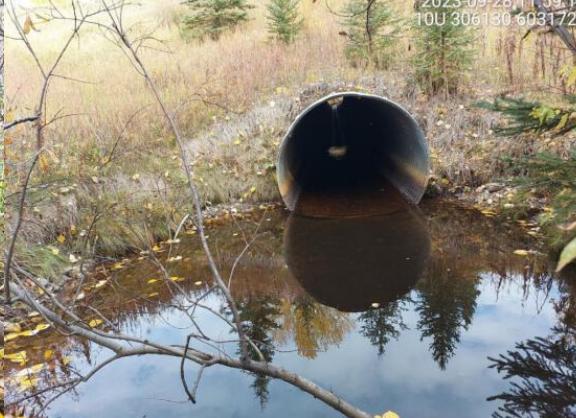
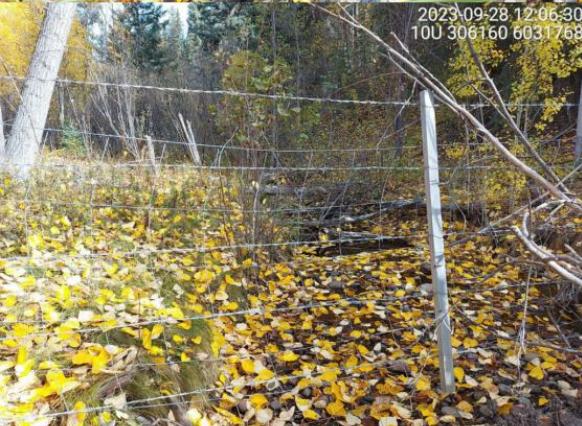
Location and Stream Data		Crossing Characteristics	
Date	2023-09-28	Crossing Sub Type	Round Culvert
PSCIS ID	199301	Diameter (m)	2.1
External ID	5400448	Length (m)	44
Crew	MW	Embedded	No
UTM Zone	10	Depth Embedded (m)	–
Easting	306137	Resemble Channel	No
Northing	6031749	Backwatered	Yes
Stream	Relief Creek	Percent Backwatered	25
Road	Highway 16 W	Fill Depth (m)	4
Road Tenure	MOTI	Outlet Drop (m)	0
Channel Width (m)	2.4	Outlet Pool Depth (m)	0.5
Stream Slope (%)	3	Inlet Drop	No
Beaver Activity	No	Slope (%)	3
Habitat Value	High	Valley Fill	Deep Fill
Final score	29	Barrier Result	Barrier
Fix type	Replace with New Open Bottom Structure	Fix Span / Diameter	18
Comments: Long pipe, no outlet drop but culvert is partially backwatered at outlet. Small fish spotted in outlet pool. Upstream goes into private land and is fenced off. MoTi chris_culvert_id: 2076443. 12:13:13			
Photos: PSCIS ID 5400448. From top left clockwise: Road/Site Card, Barrel, Outlet, Downstream, Upstream, Inlet.

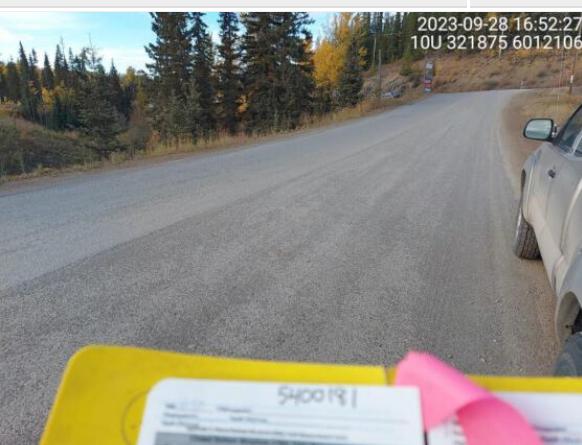
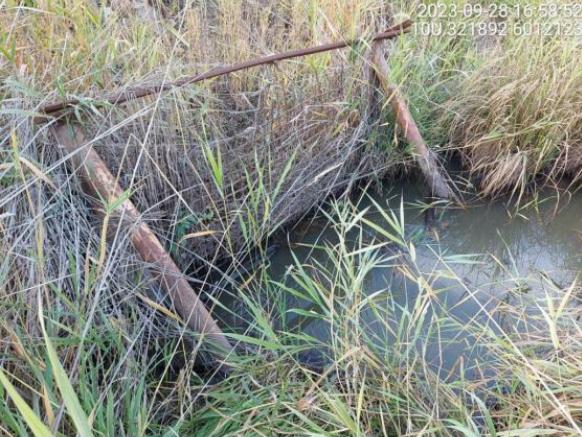
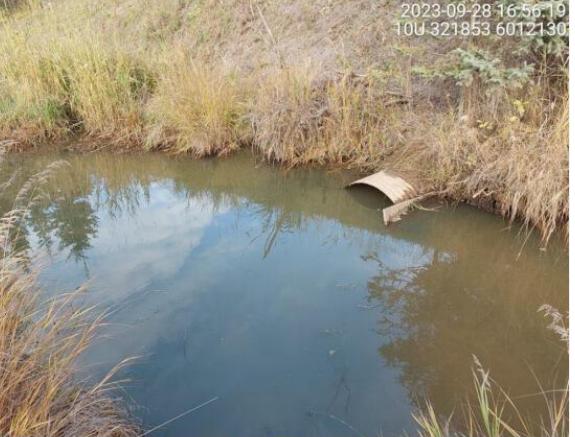
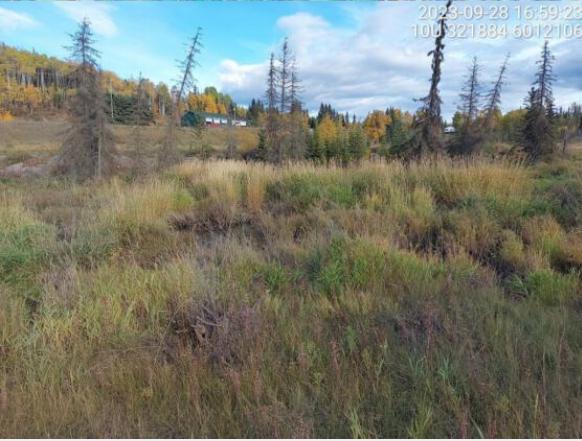
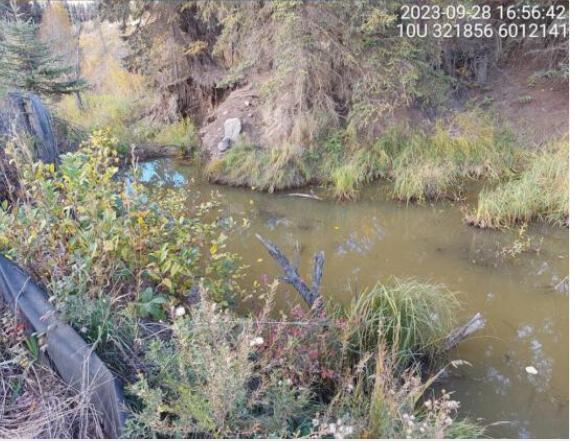
Photos: PSCIS ID 5400181. From top left clockwise: Road/Site Card, Barrel, Outlet, Downstream, Upstream, Inlet.

Location and Stream Data	.	Crossing Characteristics	-
Date	2023-09-28	Crossing Sub Type	Round Culvert
PSCIS ID	199302	Diameter (m)	0.8
External ID	5400181	Length (m)	28
Crew	MW	Embedded	No
UTM Zone	10	Depth Embedded (m)	-
Easting	321873	Resemble Channel	No
Northing	6012125	Backwatered	Yes
Stream	Wardrop Creek	Percent Backwatered	100
Road	Roumieu drive	Fill Depth (m)	3
Road Tenure	Burns Lake	Outlet Drop (m)	0
Channel Width (m)	0.8	Outlet Pool Depth (m)	0.5
Stream Slope (%)	1	Inlet Drop	No
Beaver Activity	Yes	Slope (%)	2
Habitat Value	Medium	Valley Fill	Deep Fill
Final score	21	Barrier Result	Barrier
Fix type	Replace Structure with Streambed Simulation CBS	Fix Span / Diameter	3

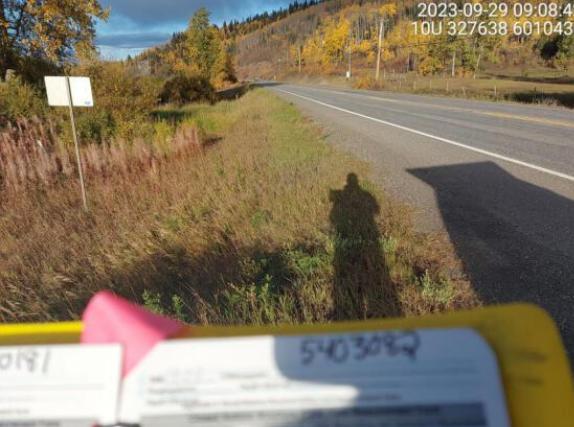
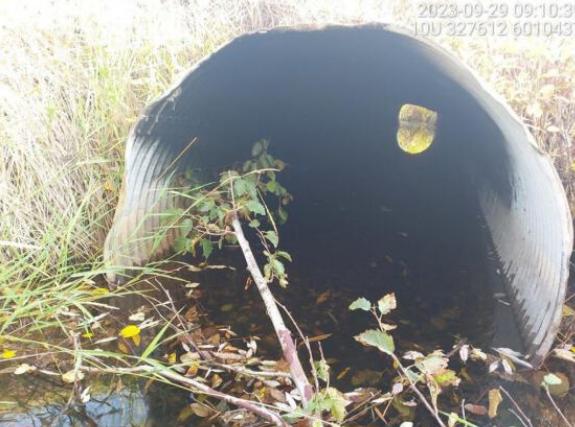
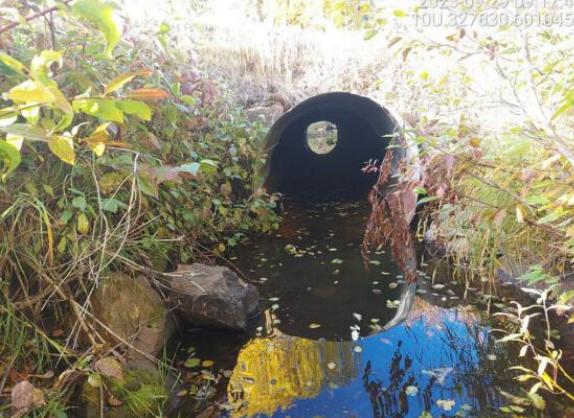
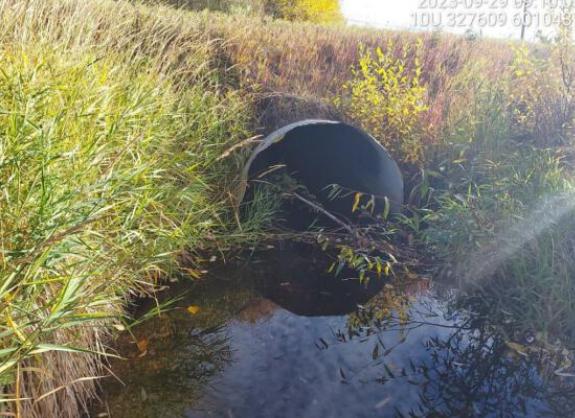
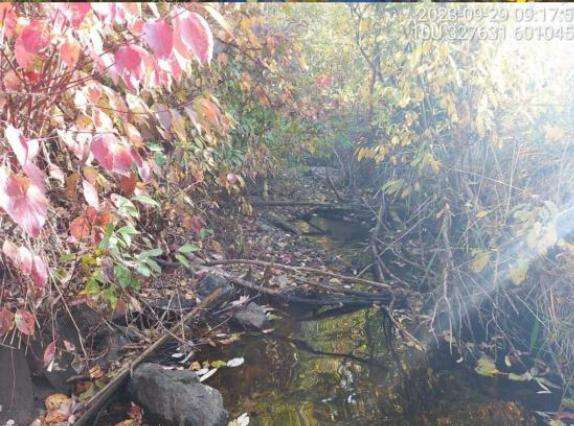
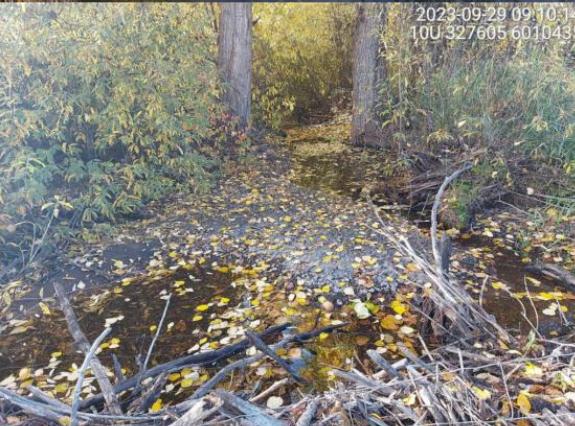
Photos: PSCIS ID 5403082. From top left clockwise: Road/Site Card, Barrel, Outlet, Downstream, Upstream, Inlet.

Location and Stream Data		Crossing Characteristics	
Date	2023-09-29	Crossing Sub Type	Round Culvert
PSCIS ID	199303	Diameter (m)	1.7
External ID	5403082	Length (m)	22
Crew	MW	Embedded	No
UTM Zone	10	Depth Embedded (m)	–
Easting	327620	Resemble Channel	No
Northing	6010443	Backwatered	Yes
Stream	Stearns Creek	Percent Backwatered	100
Road	Highway 16	Fill Depth (m)	1.8
Road Tenure	MOTI	Outlet Drop (m)	0
Channel Width (m)	3.1	Outlet Pool Depth (m)	0
Stream Slope (%)	2	Inlet Drop	No
Beaver Activity	No	Slope (%)	2.5
Habitat Value	High	Valley Fill	Deep Fill
Final score	24	Barrier Result	Barrier
Fix type	Replace with New Open Bottom Structure	Fix Span / Diameter	15

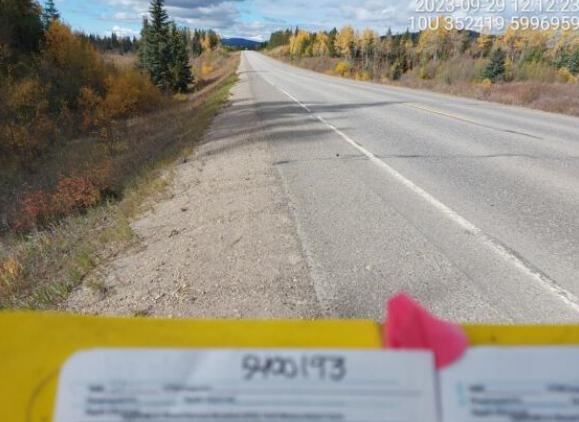
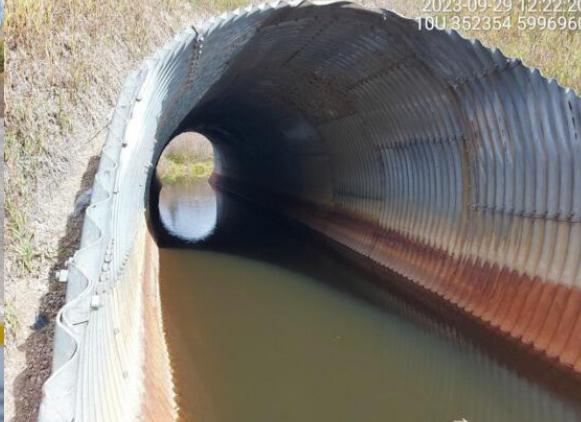
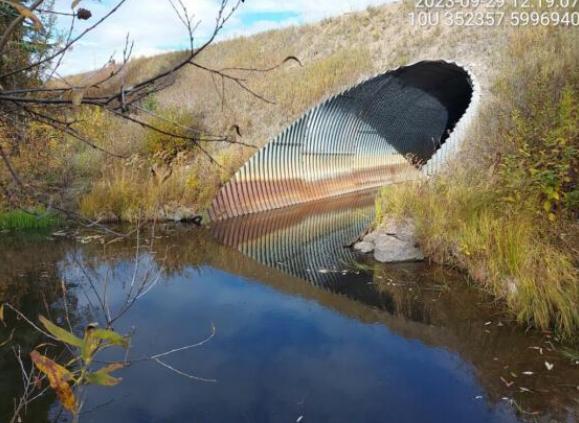
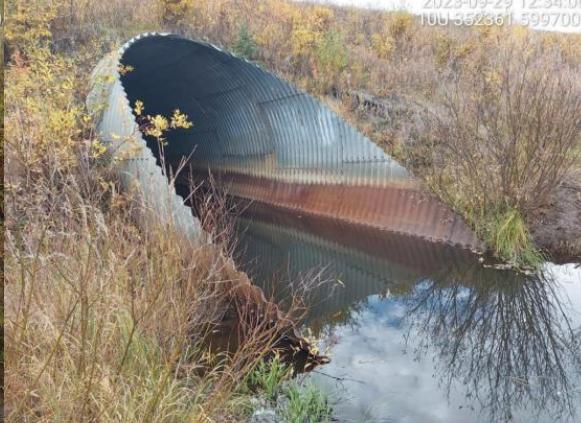
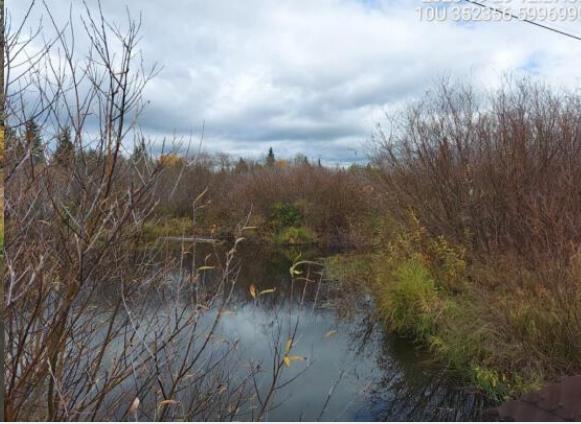
Photos: PSCIS ID 5400193. From top left clockwise: Road/Site Card, Barrel, Outlet, Downstream, Upstream, Inlet.

Location and Stream Data		Crossing Characteristics	
Date	2023-09-29	Crossing Sub Type	Round Culvert
PSCIS ID	199304	Diameter (m)	4
External ID	5400193	Length (m)	32
Crew	MW	Embedded	No
UTM Zone	10	Depth Embedded (m)	–
Easting	352357	Resemble Channel	No
Northing	5996976	Backwatered	Yes
Stream	Tchesinkut Creek	Percent Backwatered	100
Road	Highway 16	Fill Depth (m)	2.2
Road Tenure	MOTI	Outlet Drop (m)	0
Channel Width (m)	8.4	Outlet Pool Depth (m)	0
Stream Slope (%)	1	Inlet Drop	No
Beaver Activity	No	Slope (%)	1
Habitat Value	Medium	Valley Fill	Deep Fill
Final score	27	Barrier Result	Barrier
Fix type	Replace with New Open Bottom Structure	Fix Span / Diameter	15

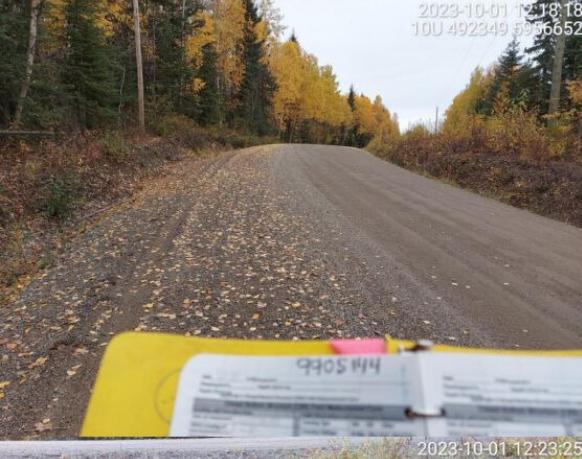
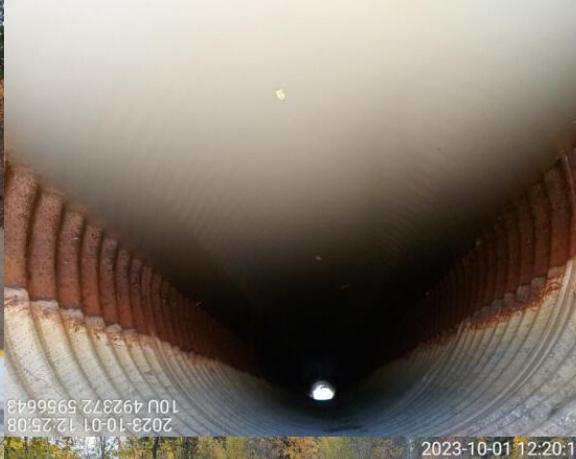
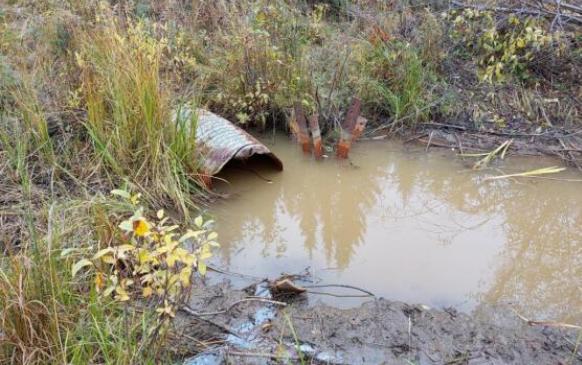
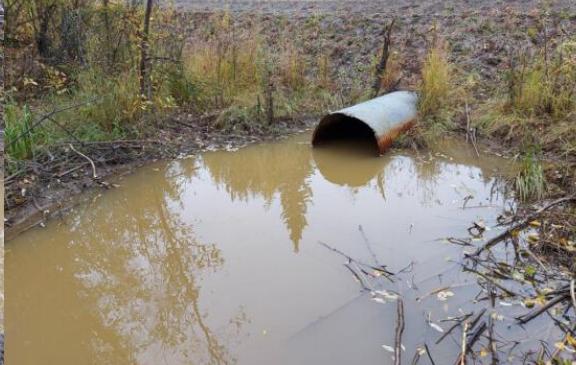
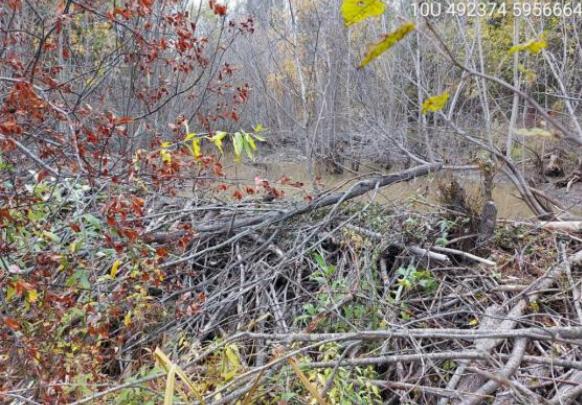
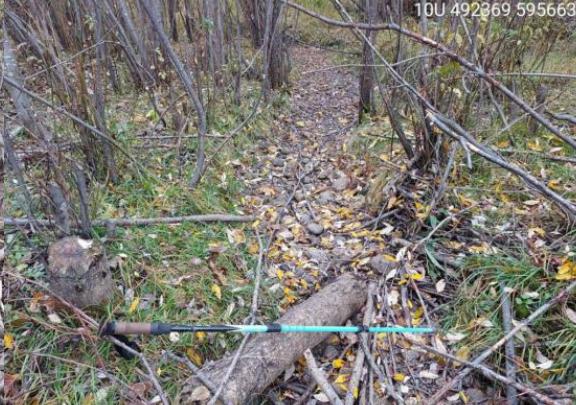
Photos: PSCIS ID 9905144. From top left clockwise: Road/Site Card, Barrel, Outlet, Downstream, Upstream, Inlet.

Location and Stream Data		Crossing Characteristics	
Date	2023-10-01	Crossing Sub Type	Round Culvert
PSCIS ID	199305	Diameter (m)	0.9
External ID	9905144	Length (m)	16
Crew	MW	Embedded	No
UTM Zone	10	Depth Embedded (m)	—
Easting	492375	Resemble Channel	No
Northing	5956652	Backwatered	Yes
Stream	Tributary to Chilako River	Percent Backwatered	100
Road	Gregg FSR	Fill Depth (m)	1.6
Road Tenure	MOTI Local	Outlet Drop (m)	0
Channel Width (m)	1	Outlet Pool Depth (m)	0.5
Stream Slope (%)	1	Inlet Drop	No
Beaver Activity	Yes	Slope (%)	1.5
Habitat Value	Low	Valley Fill	Deep Fill
Final score	21	Barrier Result	Barrier
Fix type	Replace Structure with Streambed Simulation CBS	Fix Span / Diameter	3
